# The Bible College of Wales, Lower Sketty, Swansea.

Archaeological Desk Based Assessment & Standing Building Recording

HRSWales Report No: 130

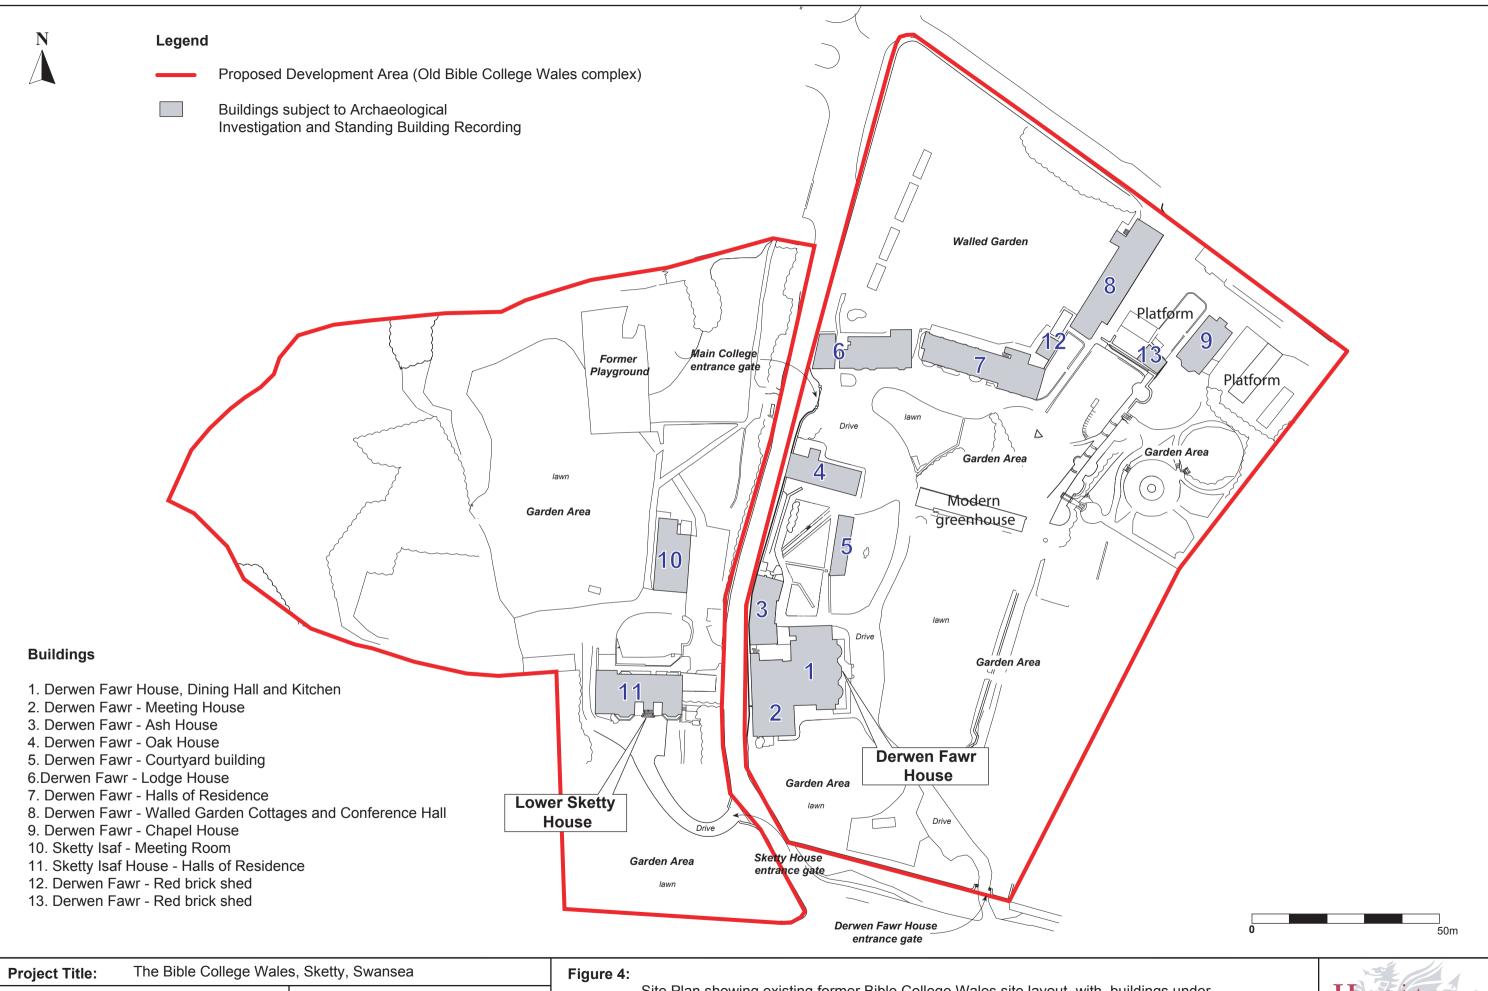
Site Plan showing existing former Bible College Wales site layout, with buildings under archaeological investigation and standing building recording shown numbered 1-13

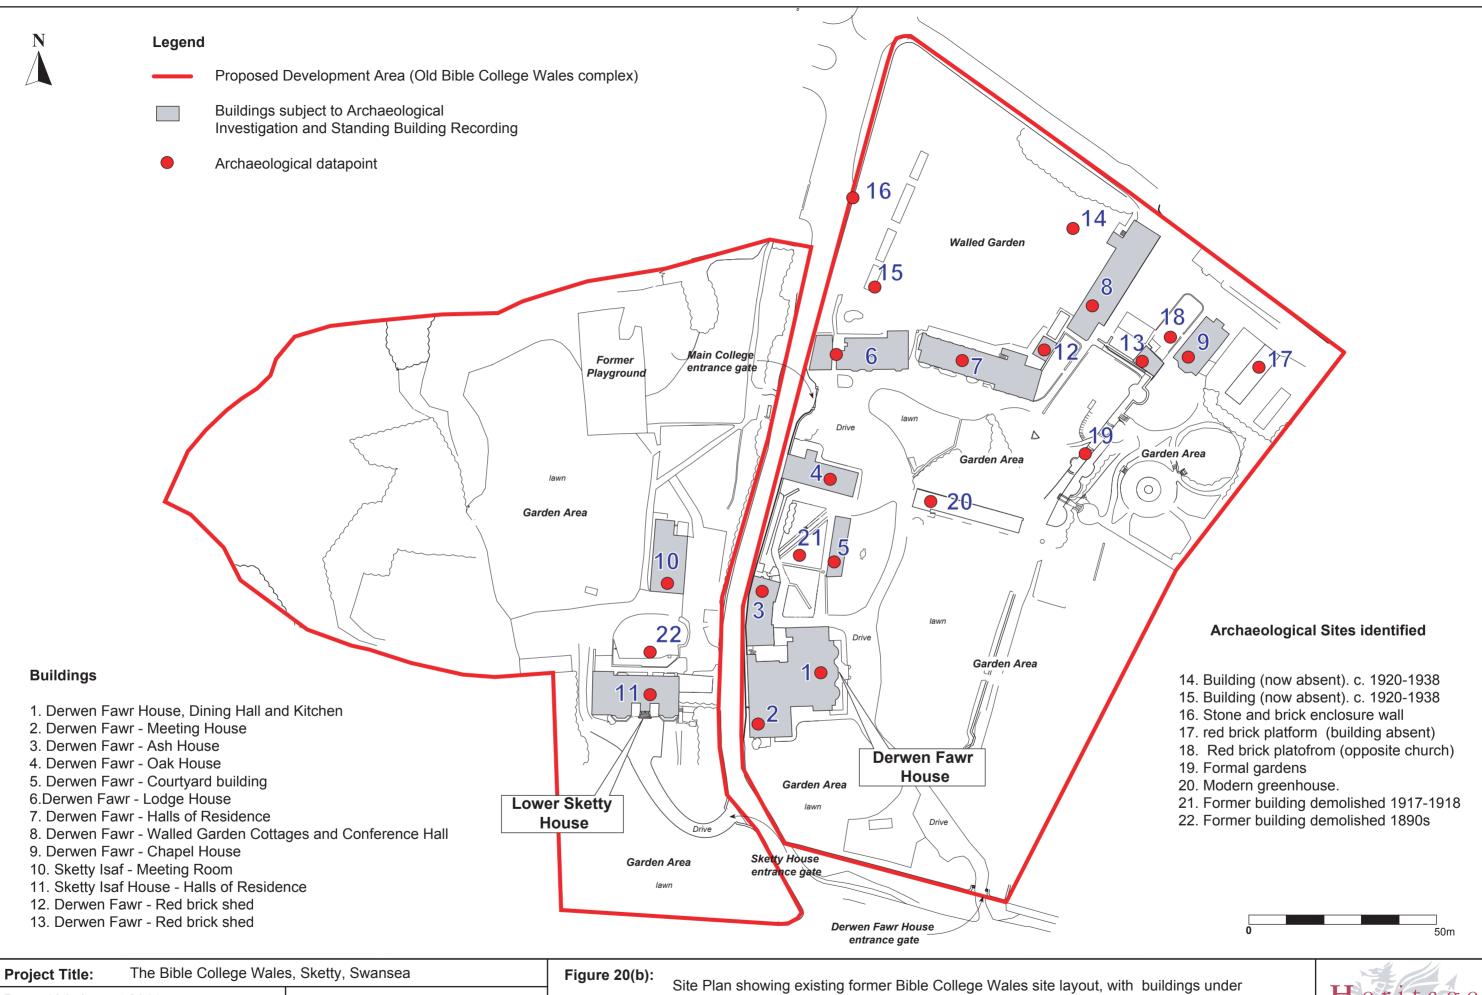
Site Plan showing existing former Bible College Wales site layout, with buildings under archaeological investigation and standing building recording shown numbered 1-13 and archaeological sites identified from site visit and cartographic study (numered 14-22).

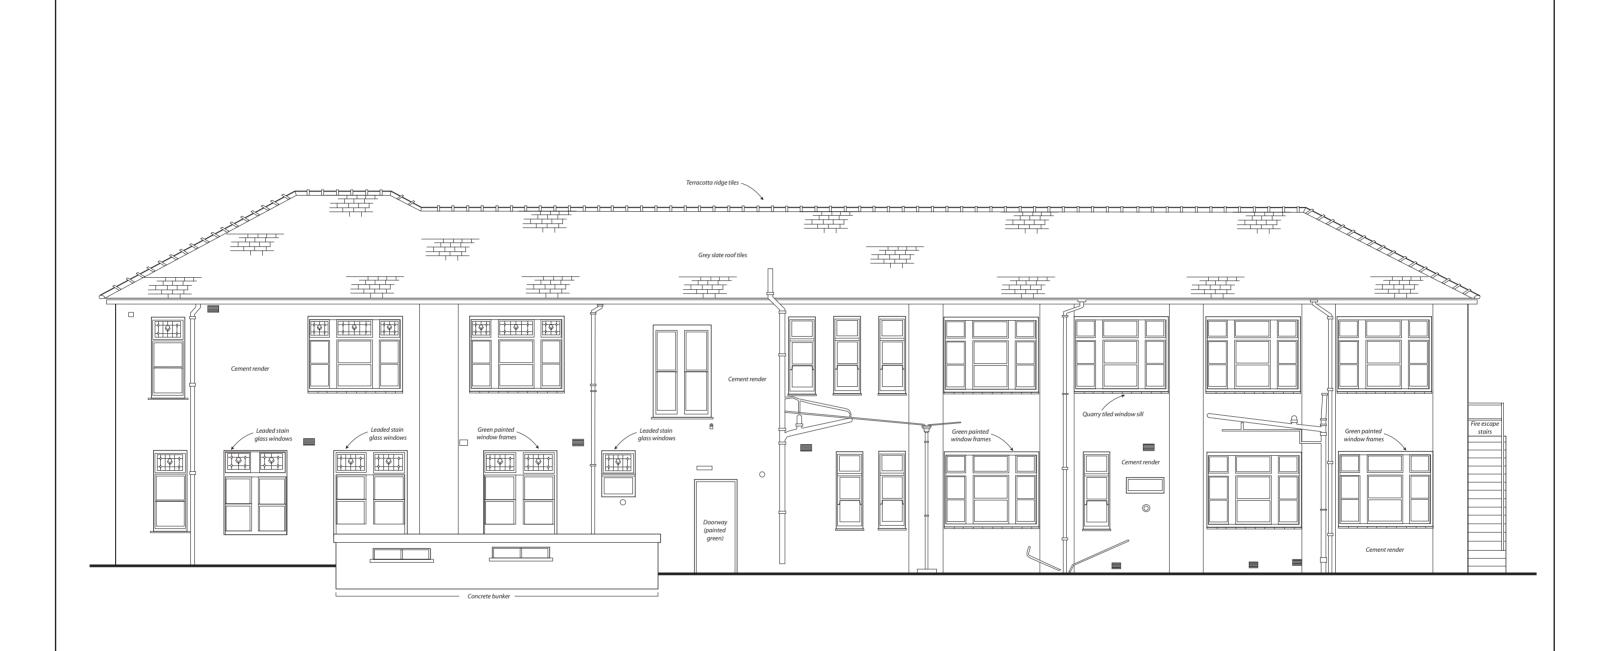
Building No. 7 - DERWEN FAWR - HALLS OF RESIDENCE - North Facing Elevation

- Building No. 7 Halls of Residence
- 5.34 The Halls of Residence building is a long two-storey building immediately adjacent to the east end of the Lodge House. The building was built in the 1930s as part of the Bible College's building program. The building is of brick construction covered in a smooth cement render. The defining characteristic of the building is the series of windows and doors that punctuate both the front south and rear north facing elevations. The majority of the windows at both ground and first floor level have repeated small leaded stained glass windows at their upper frames. All doors in the front south facing elevation are painted dark green and flanked by a series of windows with frames painted mid green. The far eastern end of the building appears to have received an extension at some time, given its apparent square ground plan when compared to the main range.

- 5.35 The north facing elevation is much the same as the front south facing elevation, however, without the same entrance doors and many of the windows are missing the leaded stained glass window additions. An interesting feature in the rear north facing elevation of this building is a long concrete bunker-like structure attached to the building toward the eastern end. The character and form of this structure suggests that it was built as a WWII bomb shelter.

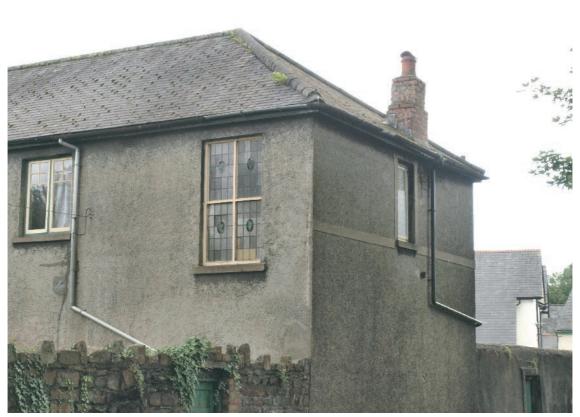
Plate No. 51: Derwen Fawr - Oak House. Detail showing stained glass window in north facing elevation. Looking southeast.

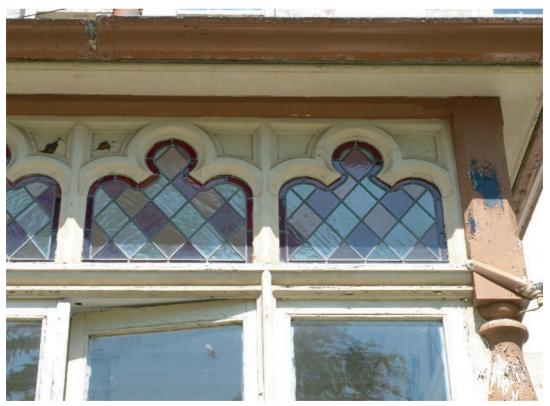
Plate No. 118: Lower Sketty House - Detail of stained galls windows in central porch. Looking north

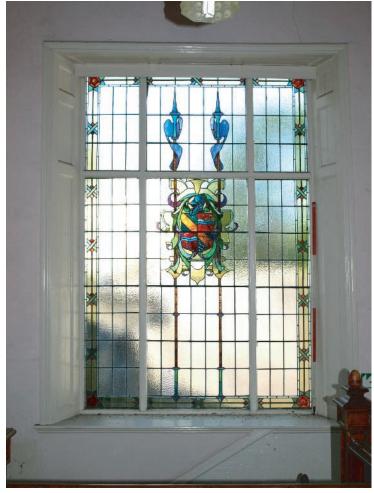
- 5.13 On accessing the first floor from the main guest stairs, the first feature that gets attention is the large approximately 3m high x 2m wide leaded stained glass window at the first landing stage. This window is decorated by a Coat of Arms in stained glass (See Photo plates 168 169). The defining character and symbolism of this Coat of Arms suggests that it belonged to Sir Charles Ruthen, given that the main shield is flanked by two lances, which normally signifies a knight of the realm. However, this armorial design needs specialist research in order to determine conclusively, whose family Coat of Arms it represents who once resided at the house.

Plate No. 168: Derwen Fawr (Internal) - First floor. Stained glass window with heraldic shield. Looking west.

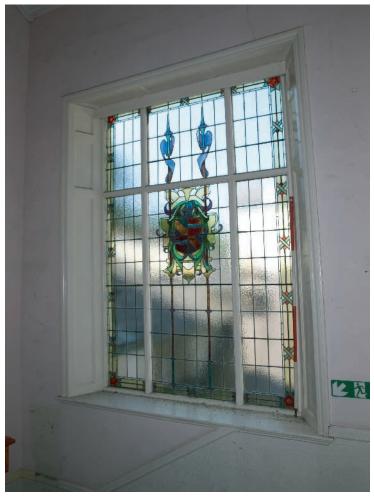
Plate No. 169: Derwen Fawr (Internal) - First floor. Stained glass window with heraldic shield. Looking southwest.

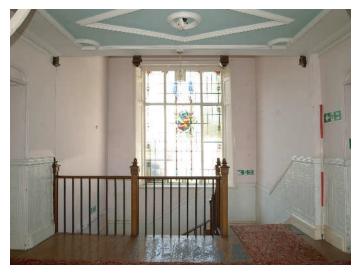
Plate No. 170: Derwen Fawr (Internal) - First floor. Stained glass window and stair landing. Looking west

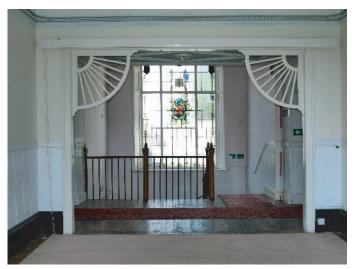
Plate No. 172: Derwen Fawr (Internal) - First floor. View from viewing room toward stair and stain glass window.. Note Art Deco sun ray design at entry to room. Looking west.

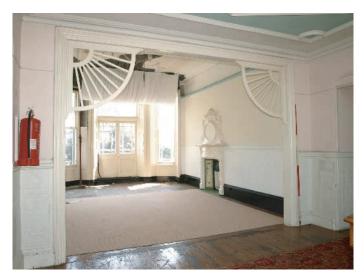
Plate No. 171: Derwen Fawr (Internal) - First floor. View from topof stairs to central front viewing room. Note Art Deco sun ray design on entry to room. Looking east.
