Laugharne Castle, Laugharne Carmarthenshire

**Listed Building No.9653
Scheduled Ancient Monument CM003**

Archaeological Evaluation

Report No: 1581

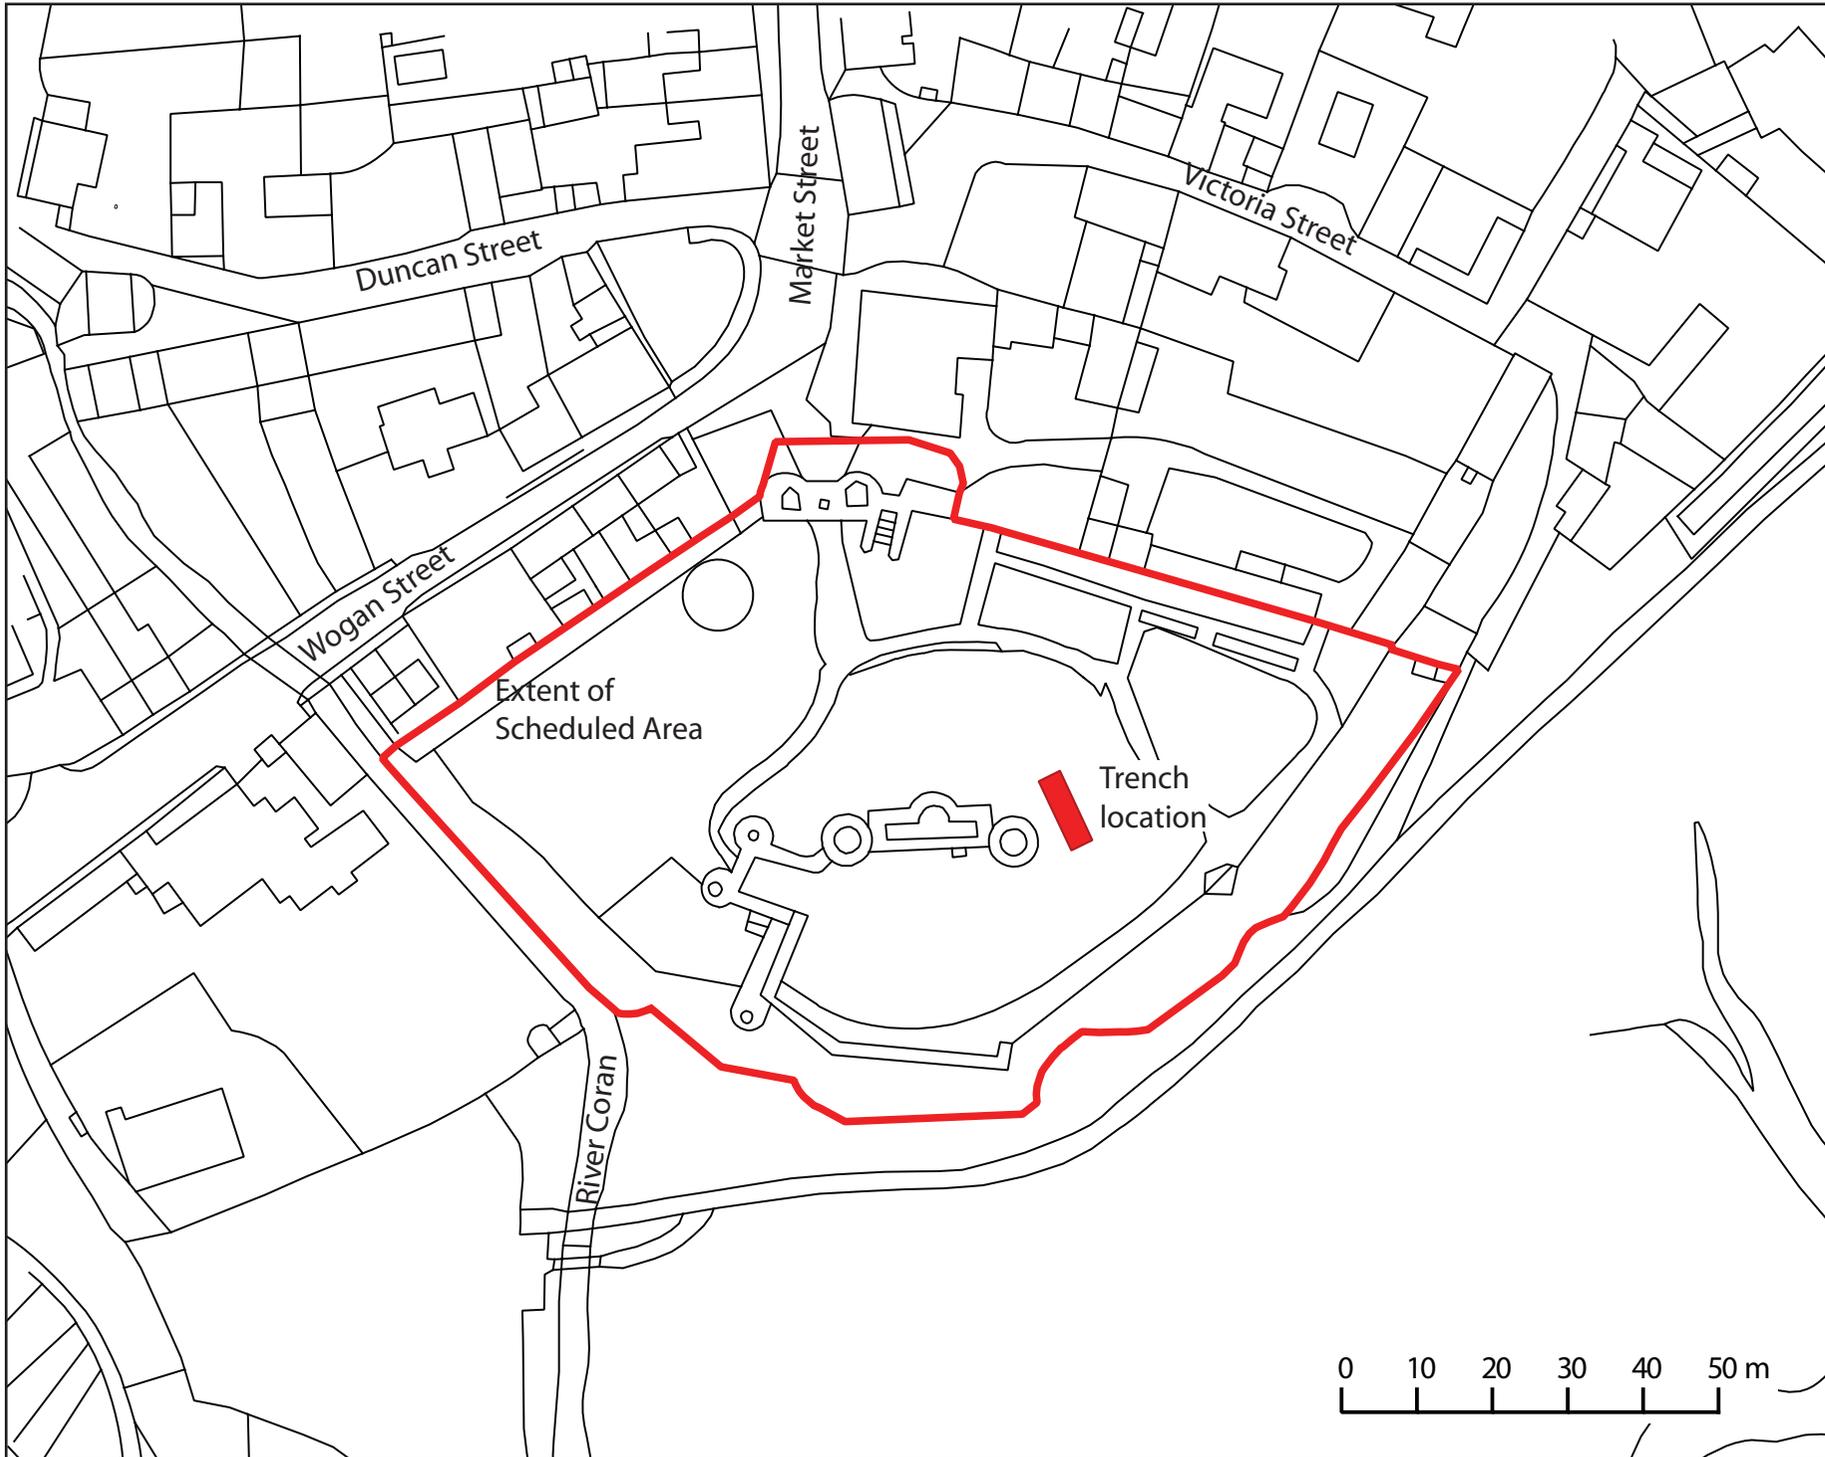
Figure 2: Site and trench location map, 1:1000 @ A4

- 4.2 A single hand-excavated evaluation trench was placed over the area of subsidence (Figures 2 & 3). The location of the trench was agreed following on-site consultation with Polly Groom of Cadw and the property services manager. The Trench measured 9m long, by 3m wide, and was orientated north-northeast to south-southwest.

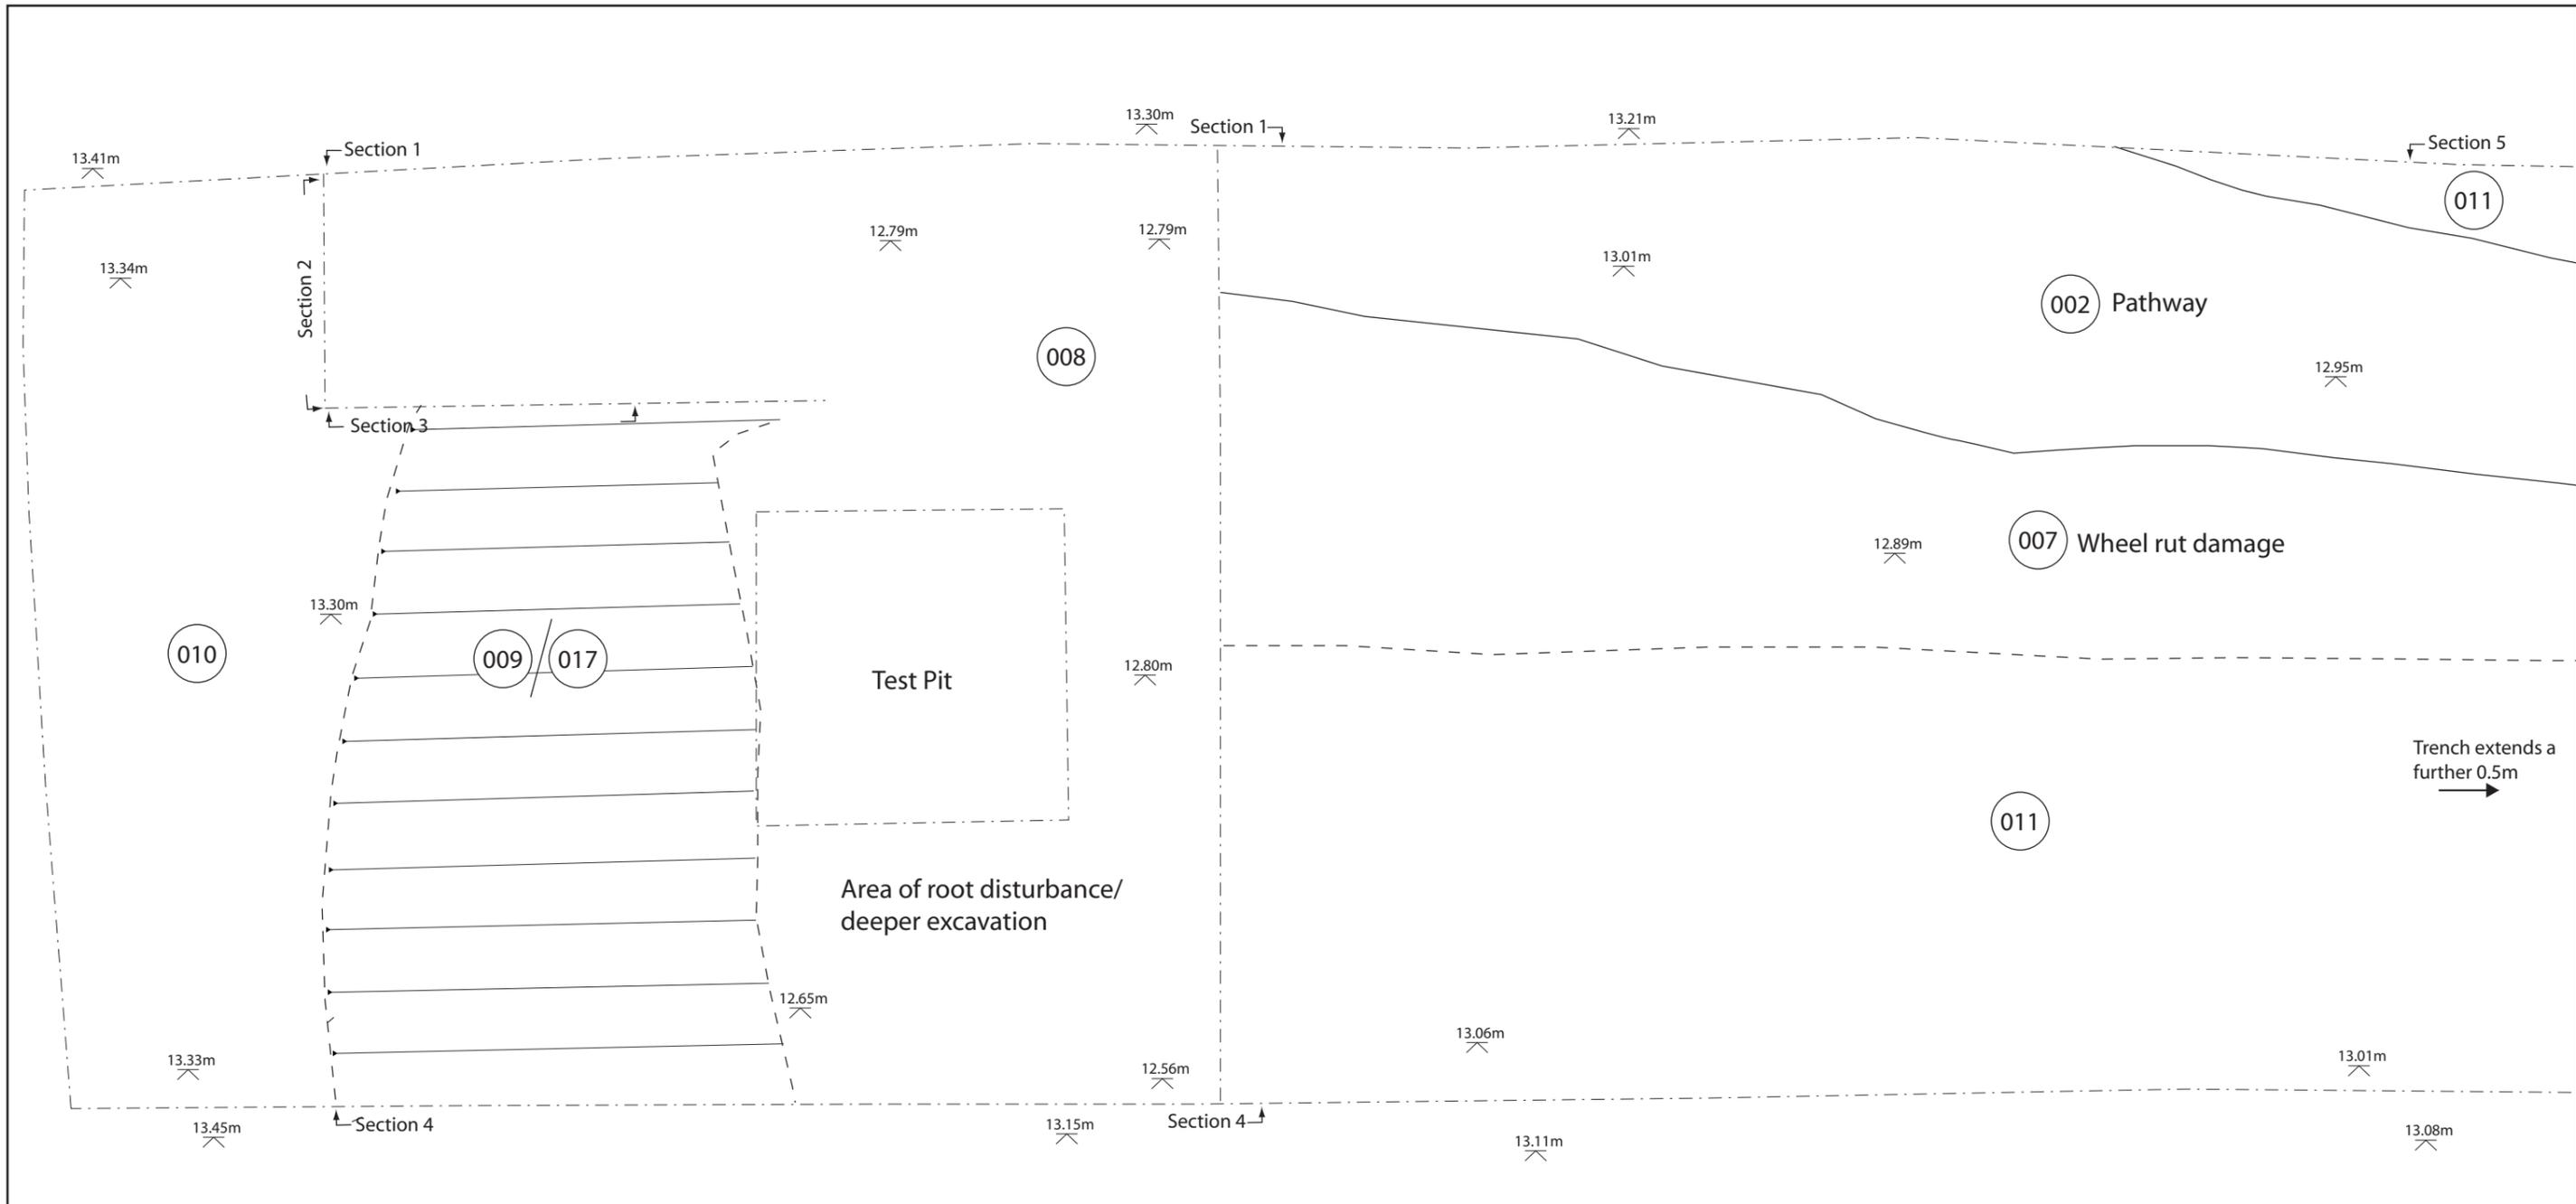
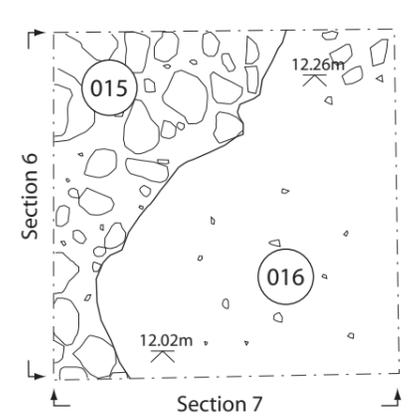
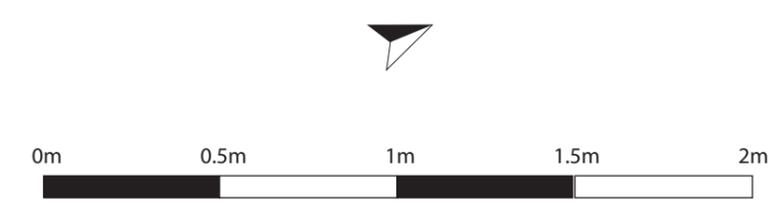
Job Title: Laugharne Castle
Figure 4: Site plans
Date: May 2017
Drawn By: PP
Scale: 1:20

5.1 Evaluation Trench (Figures 4 & 5; Photos 1-14)

- 5.1.2 Sequentially the earliest deposit found within the confines of the trench comprised a compact mid orangey-brown silty-clay (**deposit 016**), which contained abundant inclusions of small sub-angular stones, small pieces of coal and flecks of mortar. This was encountered at a depth of 1.18m below current ground levels. This deposit is considered to be the remains of a probable redeposited natural clay.

- 5.1.3 Overlying (016) a spread of stones had been deposited (**deposit 015**), which ranged in shape from sub-rounded to sub-angular, and appeared to have been tipped in from the south. The full extent of this deposit was not revealed, but where exposed it was 0.05m thick. This in turn was covered by another layer (**deposit 013**) that appears to have been tipped in from the south. Deposit (013) comprised a mid-brown sandy-clay with no noticeable inclusions, 0.1m thick. Above this lay a more level deposit (**deposit 014**) of fairly compact dark brown-grey silt, containing abundant fragments of mortar and small sub-angular stone inclusions. Oyster shells and animal bone fragments were also found throughout this deposit, and the deposit appears to have been compacted, possibly through trampling.

- 5.1.5 These deposits were overlain by a 0.4m thick deposit of moderately compacted pale brownish-grey gritty silt (**deposit 008**), extending beyond the excavated area. It appears to have been tipped into from the southwest. This deposit was rich in inclusions and contained frequent small flecks of mortar, the occasional larger fragment of lime-mortar, and the occasional fragment of coal and slate. Pieces of post-medieval pottery were also found spread widely throughout this deposit, appearing largely to date to the 18th century, along with what appears to be a Georgian coin. The base of the deposit was recorded at 12.4mOD, 0.9m below current ground levels. Intrusive root action and areas of collapsed ground extended into this deposit, with some further, more minor, root action extending to a depth of 12.12mOD which is 1.18m below current ground levels.

- 5.1.8 A previous pathway (**deposit 002**) constructed entirely of mollusc shells was revealed running across the excavated area, orientated roughly north-northeast by south-southwest. The path was 0.8m wide, the shell deposit 0.06m thick, and it was laid directly over deposits (010) and (011). Overlying the pathway along the western side of the excavated area was a low curving bank constructed of a moderately compacted black silty clay (**deposit 005**), containing abundant inclusions of mollusc shell, small fragments of coal and late post-medieval (18th/19th century) ceramics. A large wheel rut [**cut 006**] (**fill 007**) cut into the eastern edge of the bank. The rut itself is orientated roughly north south, 0.6m wide. It would appear to relate to modern construction vehicles involved in late-20th century restoration work at the castle. Topsoil (**deposit 001**) covering across the site comprised a turf-covered moderately compacted dark brown silty-clay, which measured up to 0.18m thick.

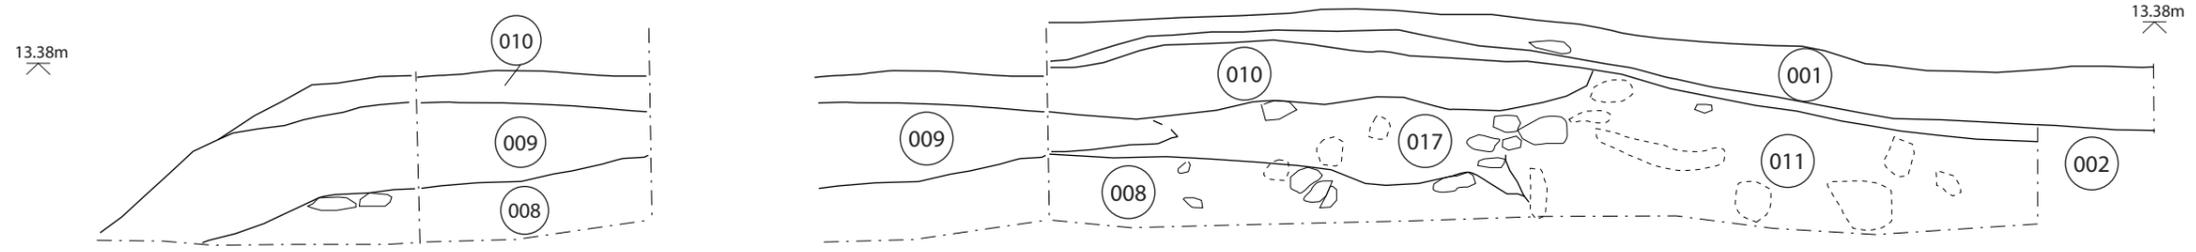
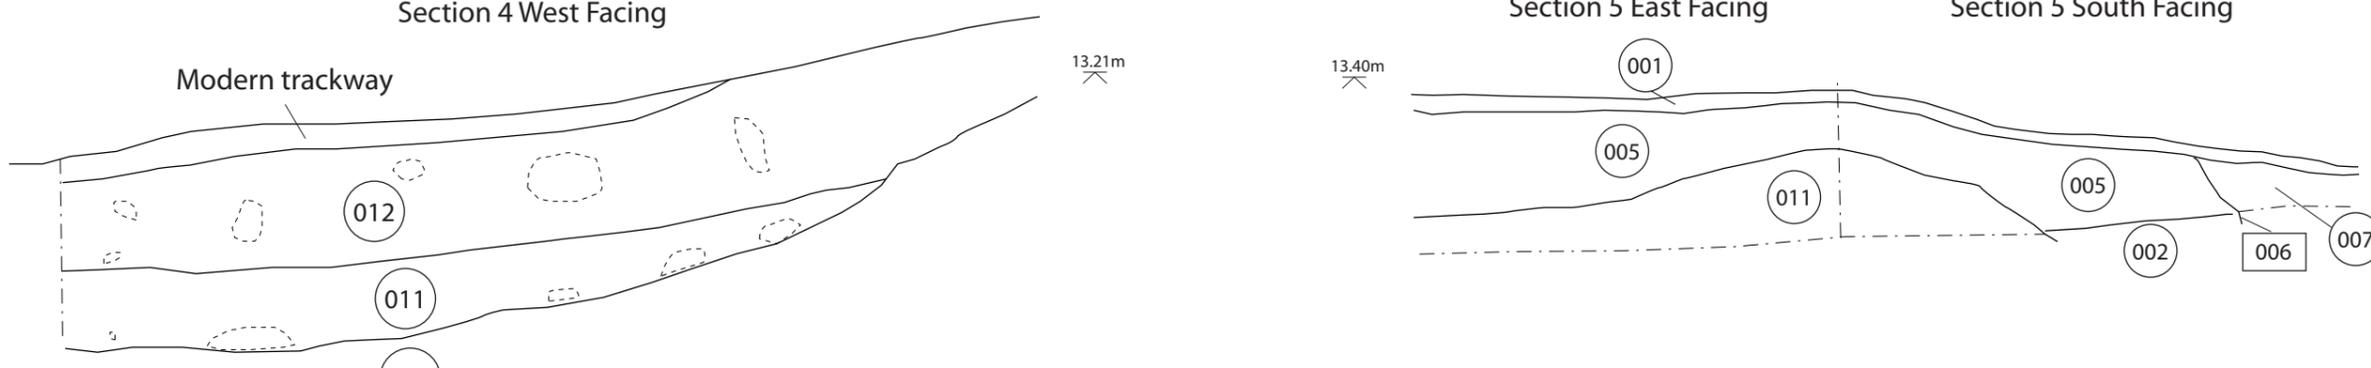
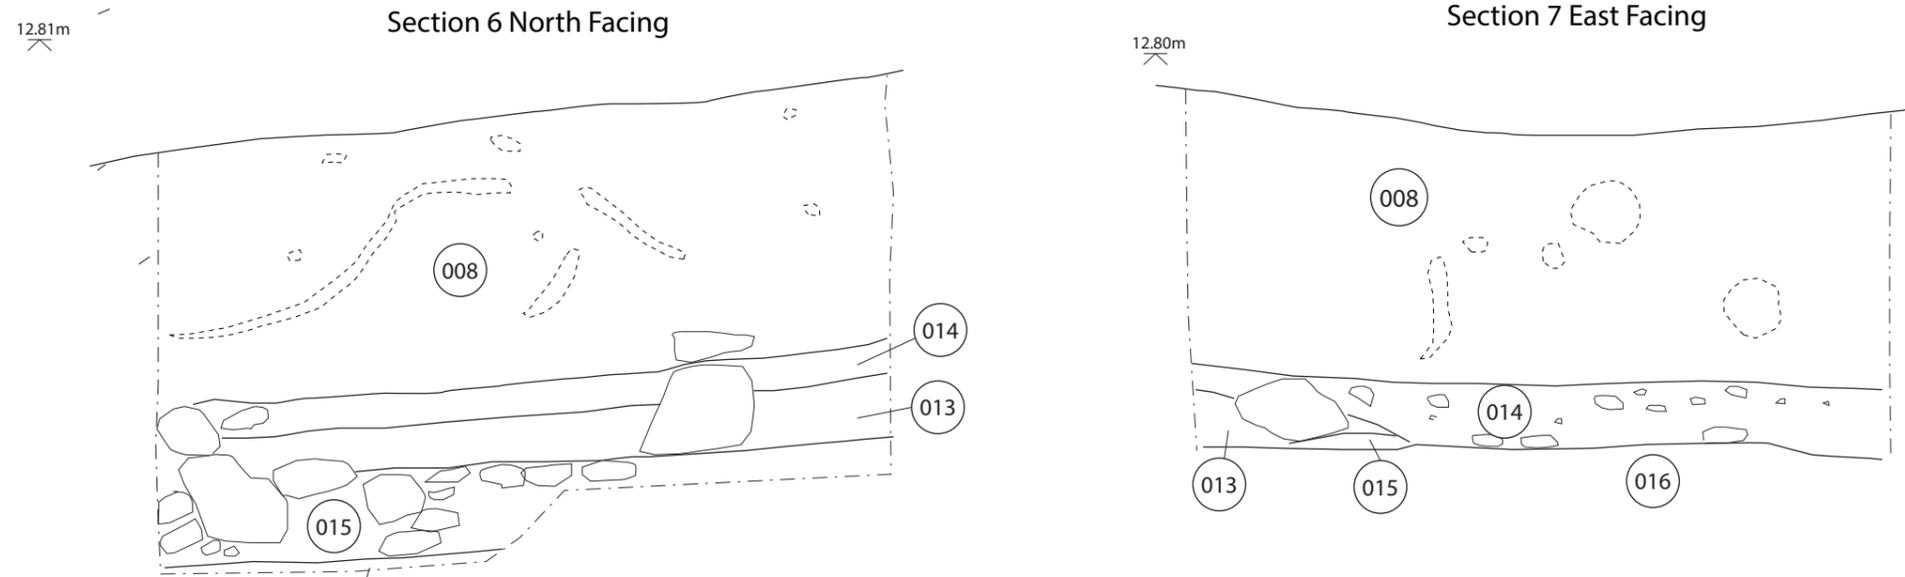
Figure 5: Site sections

- 5.1.4 Deposits (016), (015), (013) and (014) were all recorded in the confines of the 1m by 1m exploratory test pit excavated into the base of the evaluation trench.

- 5.1.6 This was overlain by a moderately compacted, light to mid yellow clay (**deposit 009**), containing common inclusions of small sub-angular stones. This deposit measured a maximum of 0.30m thick and also appears to have been tipped in from the southwest. This deposit had an uncertain interface with a light to mid greyish-brown silty-clay (**deposit 017**), containing frequent inclusions of mortar flecks, coal and mollusc shells, which lay to the north. Both deposits were 0.3m thick.

- 5.1.7 To the north of these deposits was a moderately compacted dark brown silty-clay (**deposit 011**), with common small sub-angular stone inclusions. This deposit was approximately 0.4m deep, and appeared quite extensive, visible for at least 6.5m north to south. At the southern end of this deposit, close to its interface with deposits (009) and (017), it was heavily affected by intrusive root action. At the southern end this deposit appears to have been partially overlaid by a compacted mid-red silty-clay (**deposit 010**) with abundant inclusions of small sub-rounded and sub-angular stones. However, this interface may have been disturbed through subsequent root action, and the stratigraphic relationship between the two deposits remains uncertain. To the east deposit (011) was overlaid by a similar moderately compacted blackish brown silty-clay (**deposit 012**), 0.3m thick. This too was heavily disturbed through intrusive root action, but appears to represent a garden soil. This deposit runs underneath the current trackway that defines the eastern edge of the excavated area. Fragments of late post-medieval (18th/19th century) brick, glass and clay pipe stem, and a Victorian penny coin were recovered from this deposit.

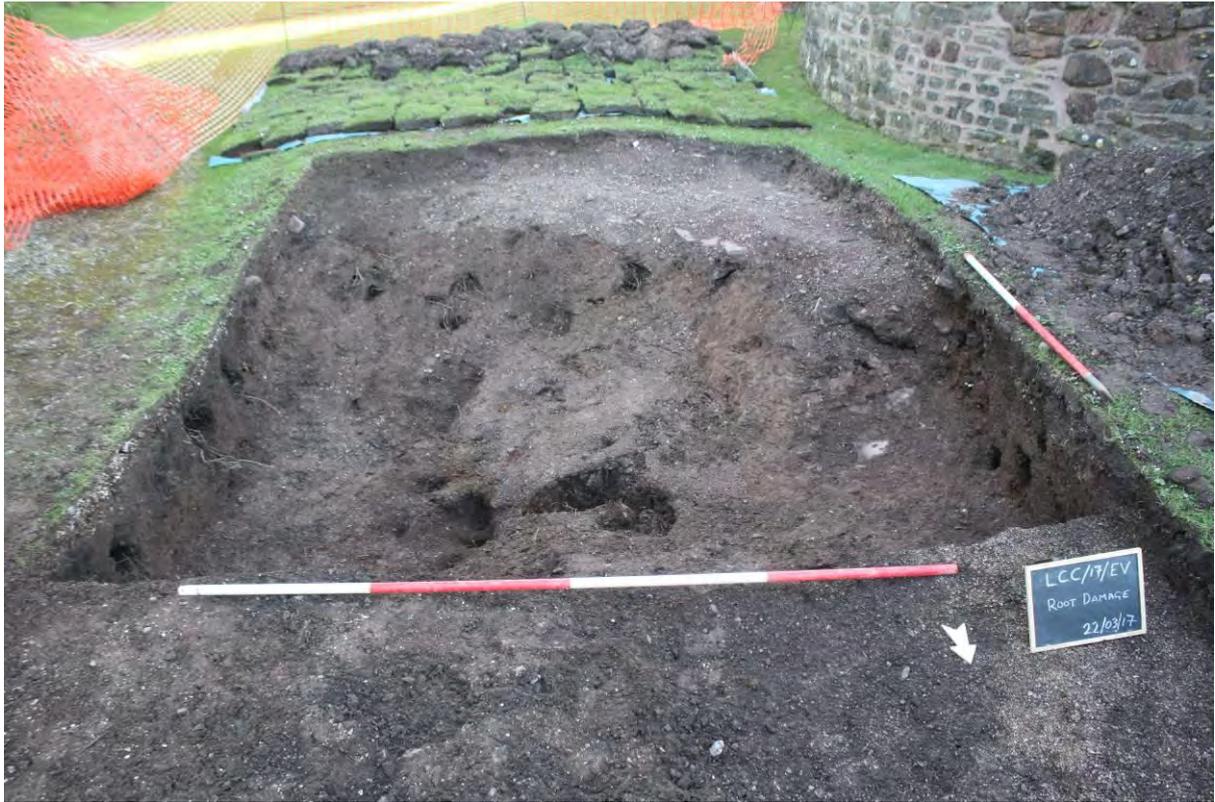
- 6.1 One of the primary aims of the evaluation was establish the cause and extent of ground subsidence in the area. This was found to be caused by the rotting of a tree trunk and its associated roots that had been left *in situ* under the present ground surface. Further research by the Cadw property services manager determined that this tree was removed as part of restoration works in the area in the late 20th century. The main area of disturbed ground extended across an area approximately 2.5m by 2.5m and reached a depth of 0.9m below current ground levels (12.4mOD), with some root action extending to a depth of 1.18m below current ground levels (12.12mOD). Further roots were noted extending to the west and east beyond the excavated area, but these were of a size that was unlikely to cause further subsidence. All rotten organic material and unstable ground was removed to more intact, stable deposits.

Photo 5: Shot taken during excavation, showing extent of tree root activity after the removal of the main stump. Facing south. 2m & 1m scales.

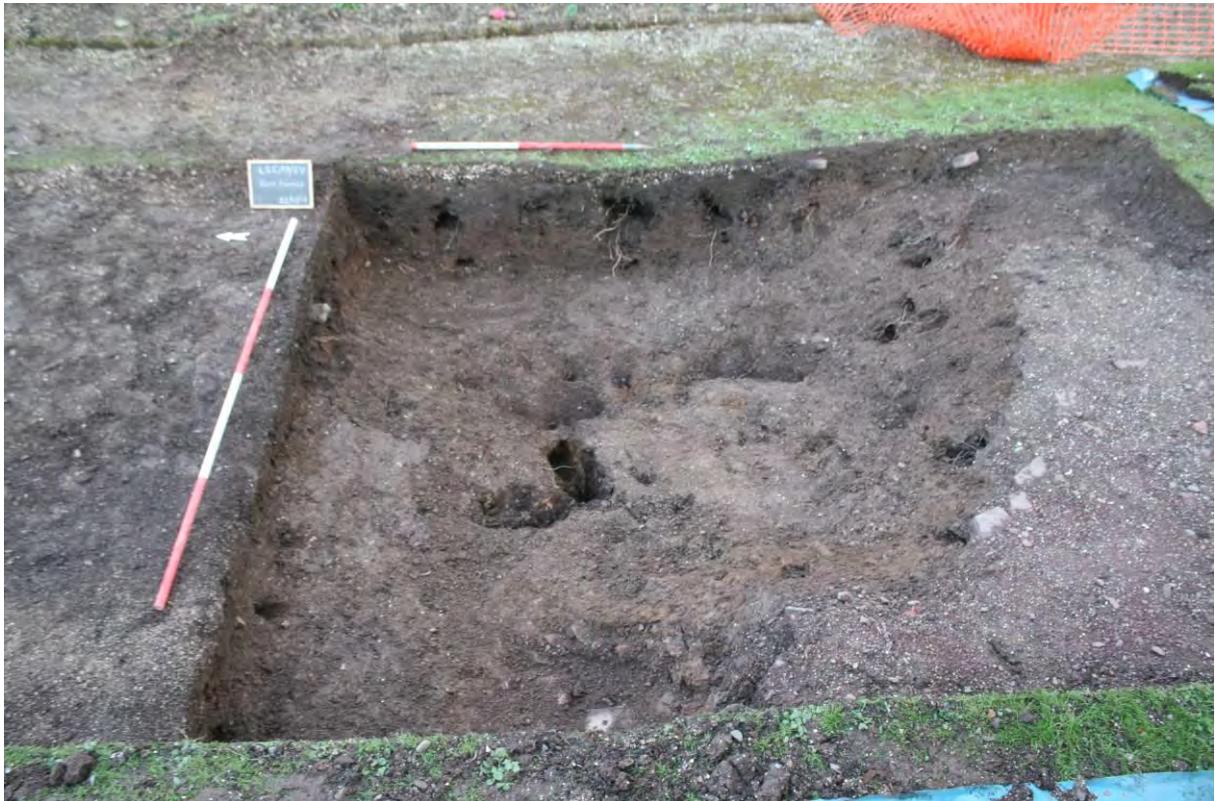
Photo 6: Shot taken during excavation, showing extent of tree root activity after the removal of the main stump. Facing east. 2m & 1m scales.

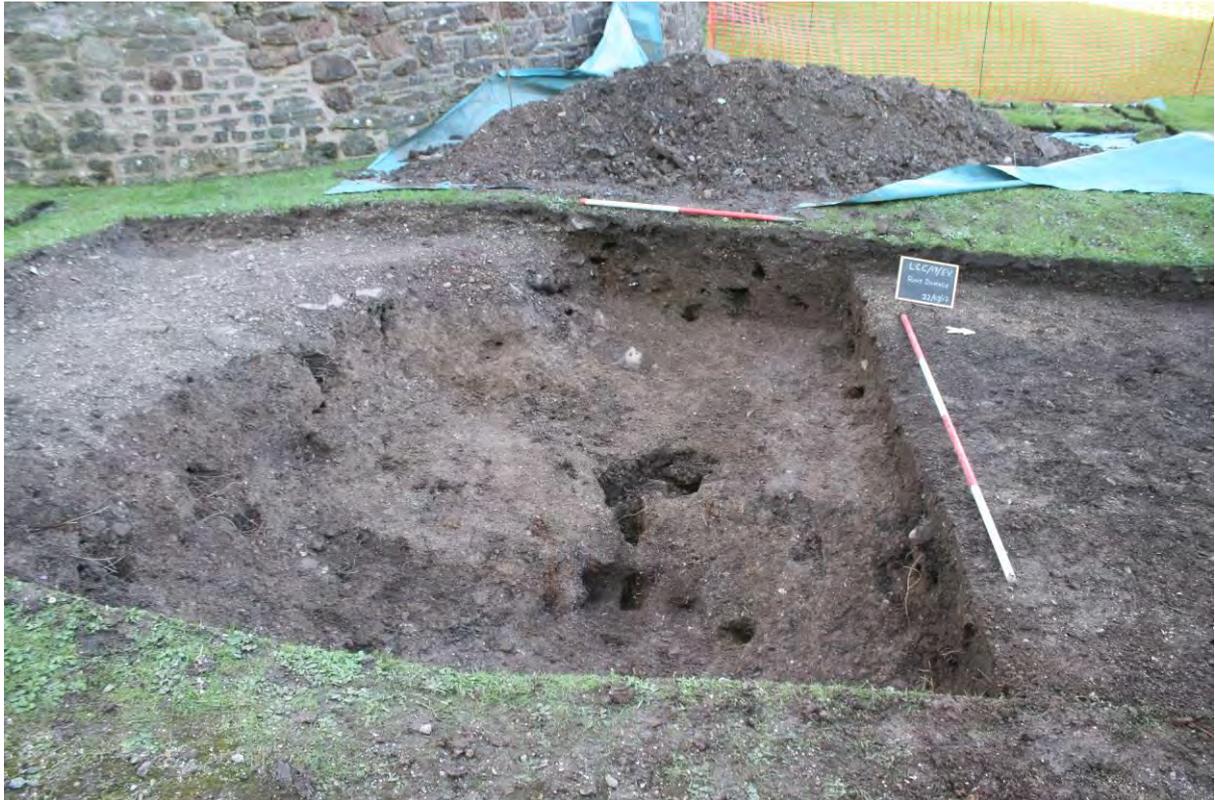
Photo 7: Shot taken during excavation, showing extent of tree root activity after the removal of the main stump. Facing west. 2m & 1m scales.

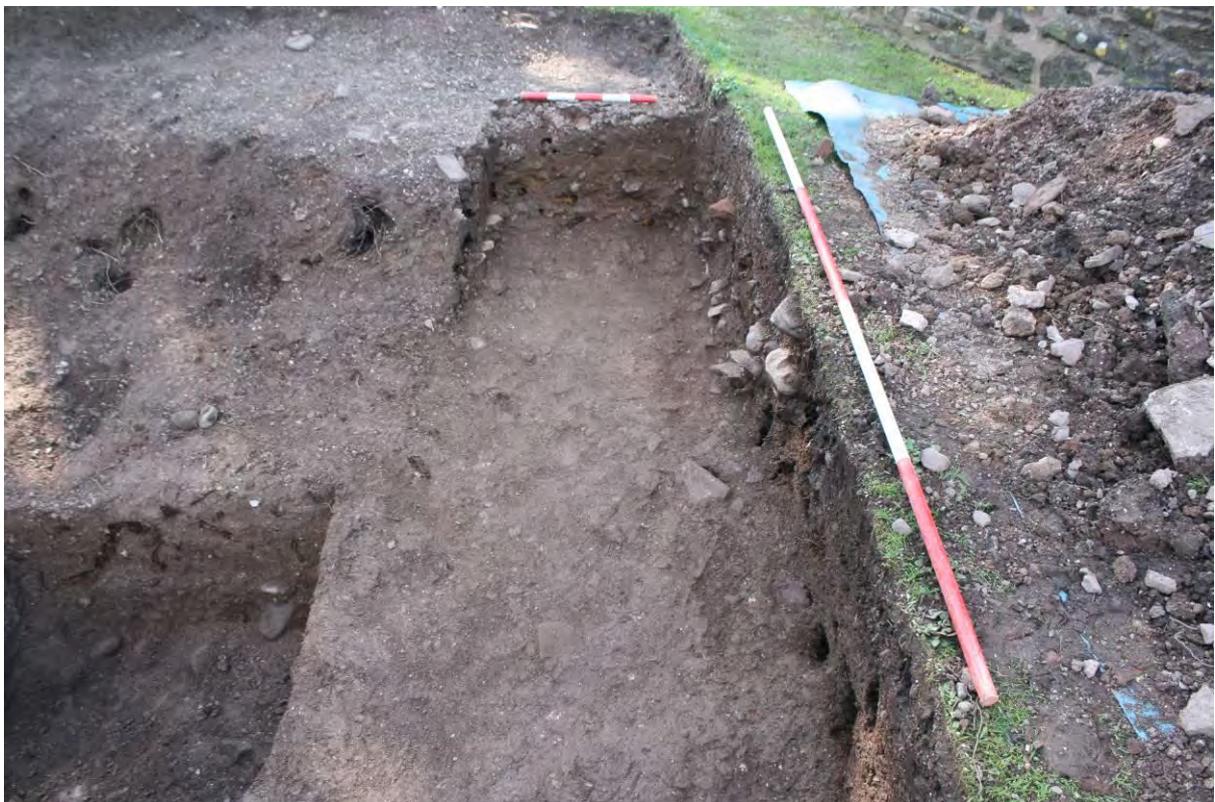
Photo 8: Section excavated through the deposits along the western side of the evaluation trench, excavated down to reveal deposits (008) and (011). Facing south. 2m & 0.5m scales.

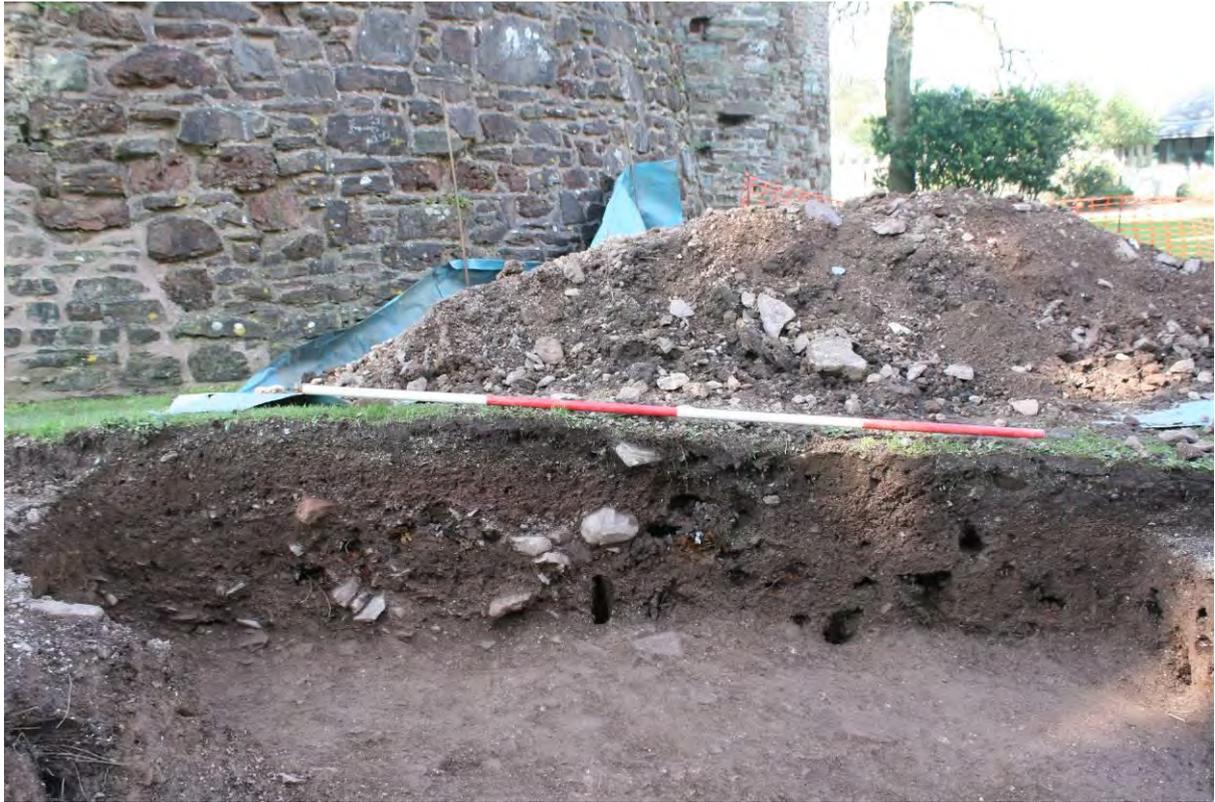
Photo 9: West facing shot of the section along the western side of the evaluation trench. 2m scale.

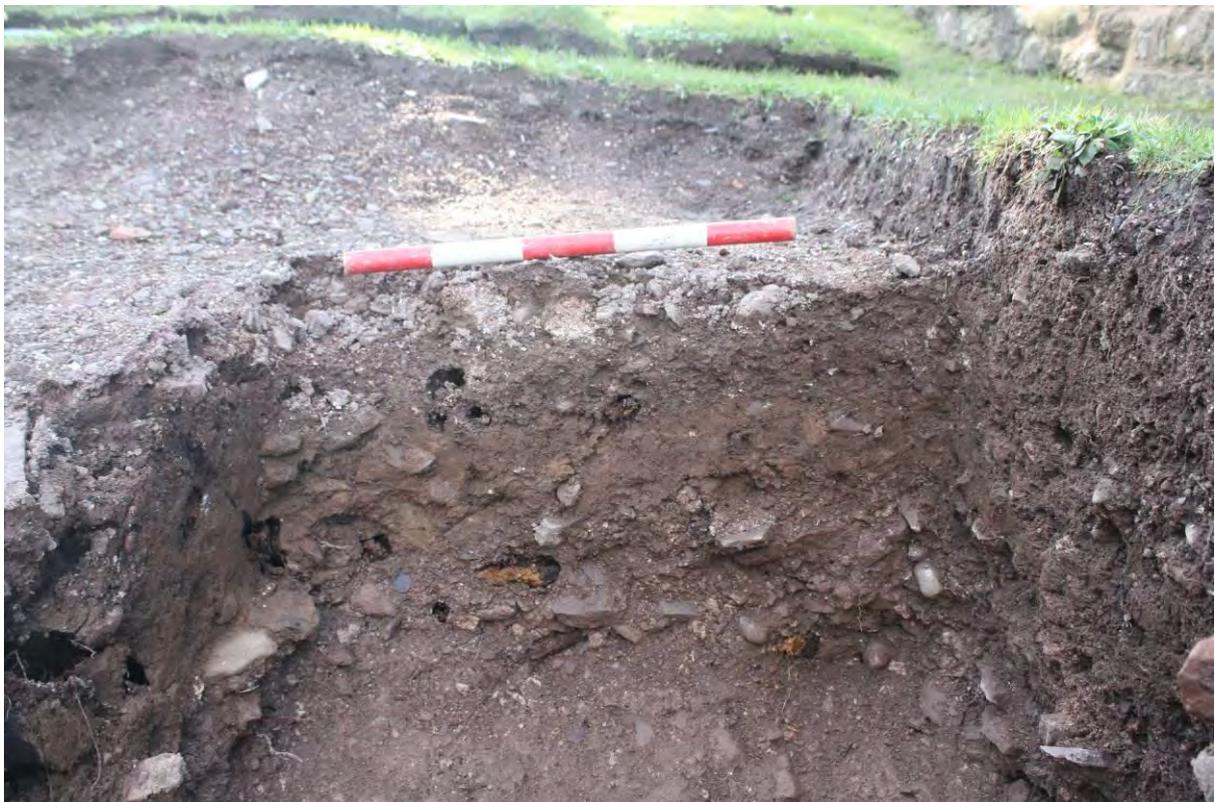
Photo 10: South facing shot of the southern section of the excavated slot within the evaluation trench. 0.5m scale.

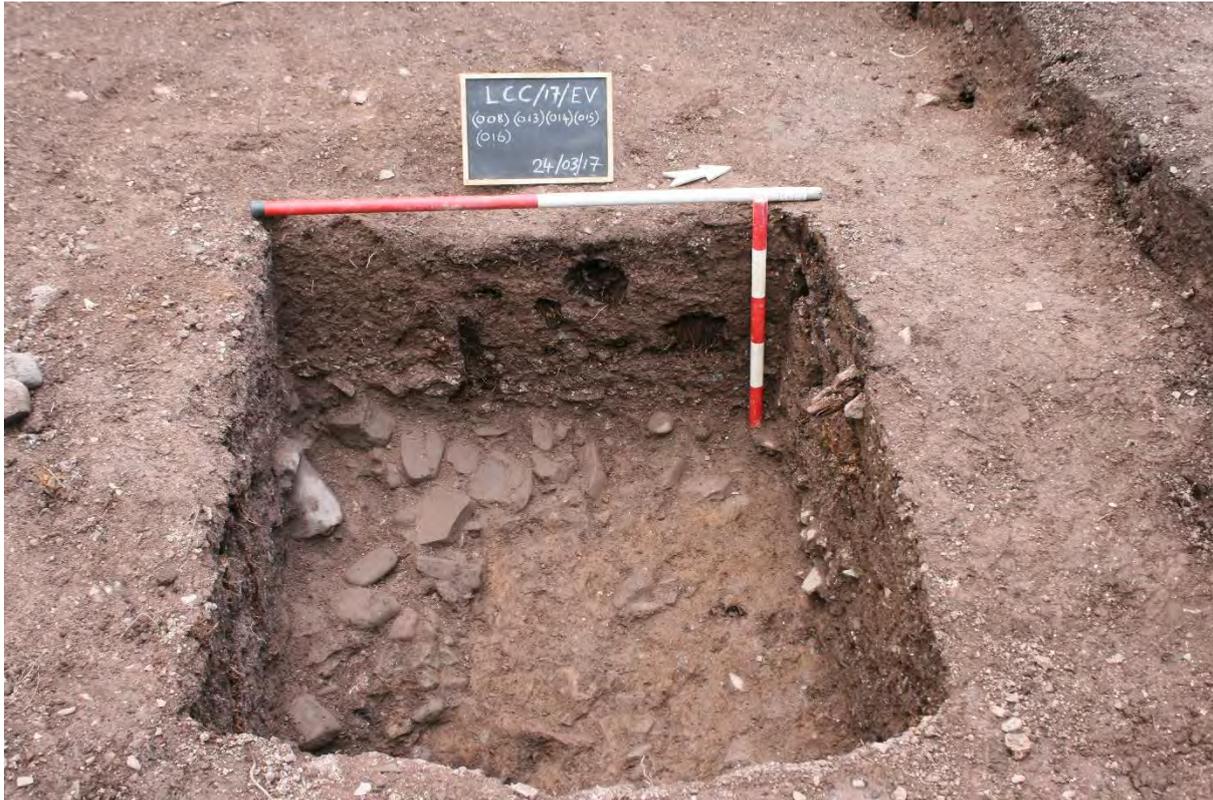
Photo 11: West facing shot of the test pit within the evaluation trench, showing deposits (015) and (016). 1m & 0.5m scales.

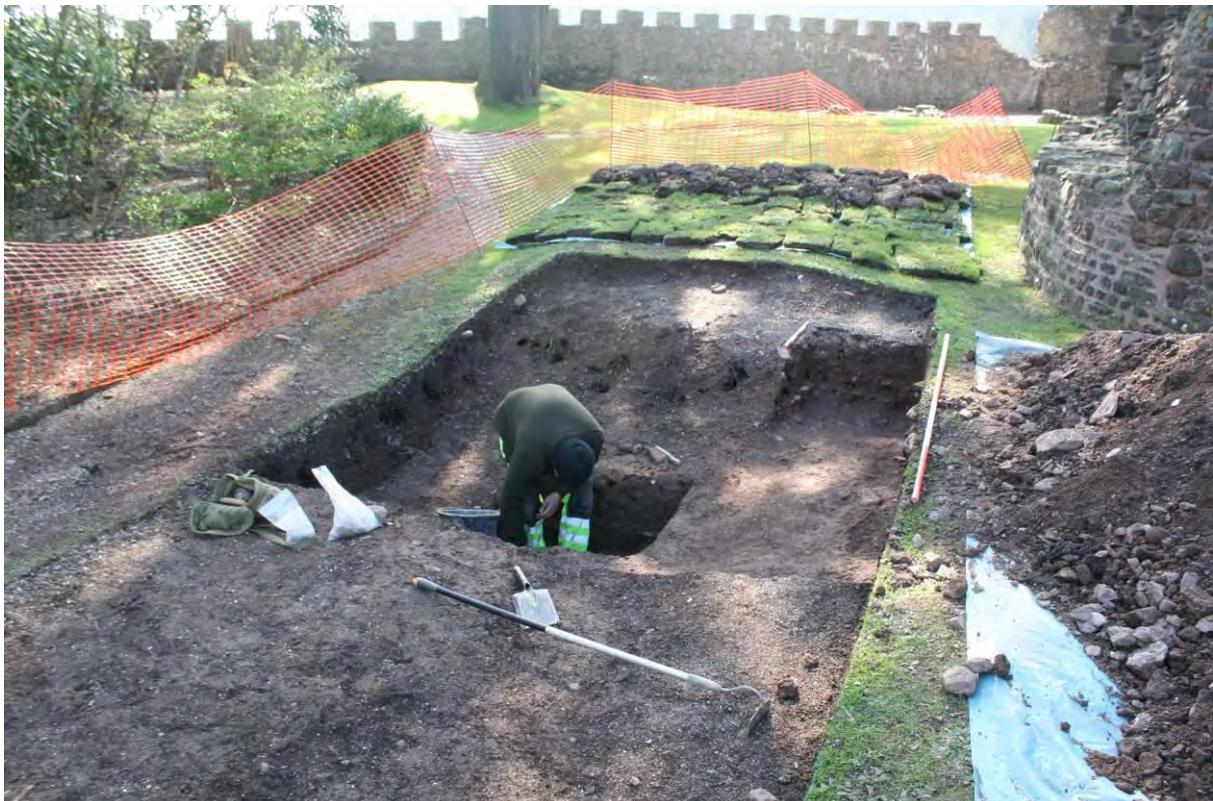
Photo 12: Working shot of evaluation trench, facing southeast, showing level reached at the base of the tree root disturbance.

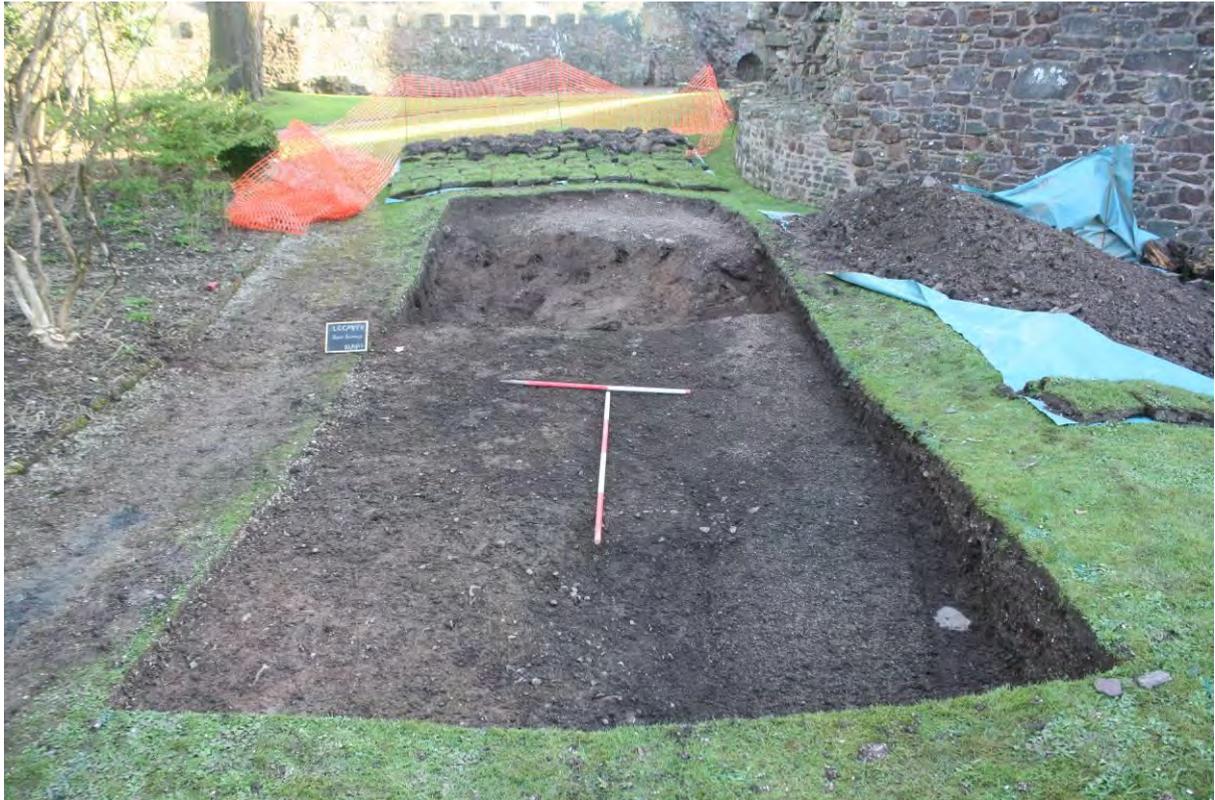
Photo 13: South facing shot of the evaluation trench, showing the shell pathway (002) along the right. 2m & 1m scales.

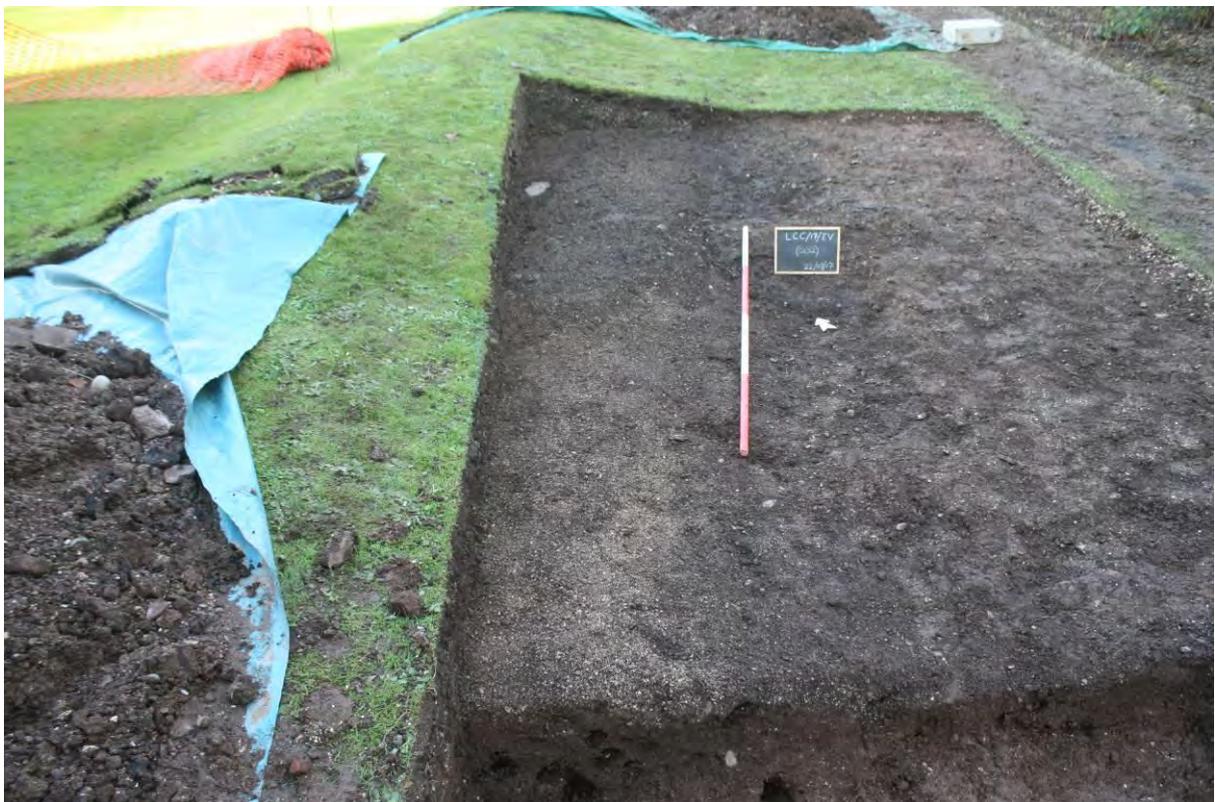
- 5.2.6 A curving bank was partially investigated within the evaluation area. Stratigraphically this proved to be a relatively late feature, with bank material (deposit 005) overlying part of the aforementioned pathway. Eight fragments of pottery were recovered from this deposit, of a general post-medieval to late post-medieval date. Given the stratigraphic relationship of this feature to underlying 19th century deposits, it would seem likely that these pottery fragments are residual, with the bank formed from disturbed earlier deposits. A fragment of window glass and an iron nail were also retrieved from this deposit.

Photo 14: North facing shot showing the shell pathway (002) along the left, partially covered by the low curving bank (005). 2m scale.
