CPAT Report No. 1654

Former British School, Llanidloes, Powys

Building Survey

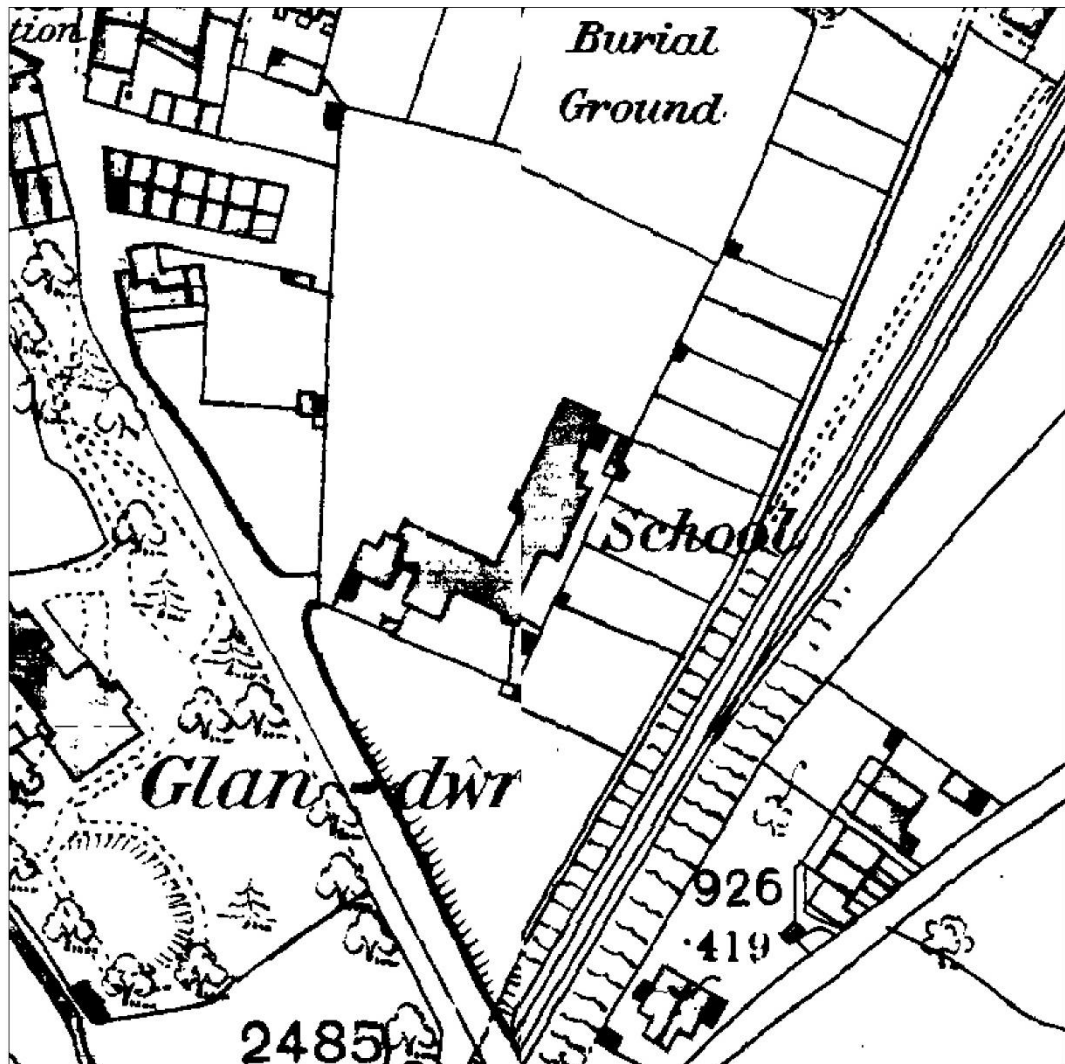
Fig. 2 Extract from the 1886-7 Ordnance Survey 1st edition 25" mapping

- 2.1. It is understood that the British School was built around 1865, six years after the opening of the adjacent Newtown and Llanidloes Railway and one year after the Cambrian Railways completed Llanidloes Station, which was used as the company headquarters.
- 2.2. The original extent of the school cannot be determined but by the mid-1880s the Ordnance Survey depicted an extensive range of buildings (Fig. 2), of which the surviving building formed the southern wing, along with the adjoining School House.

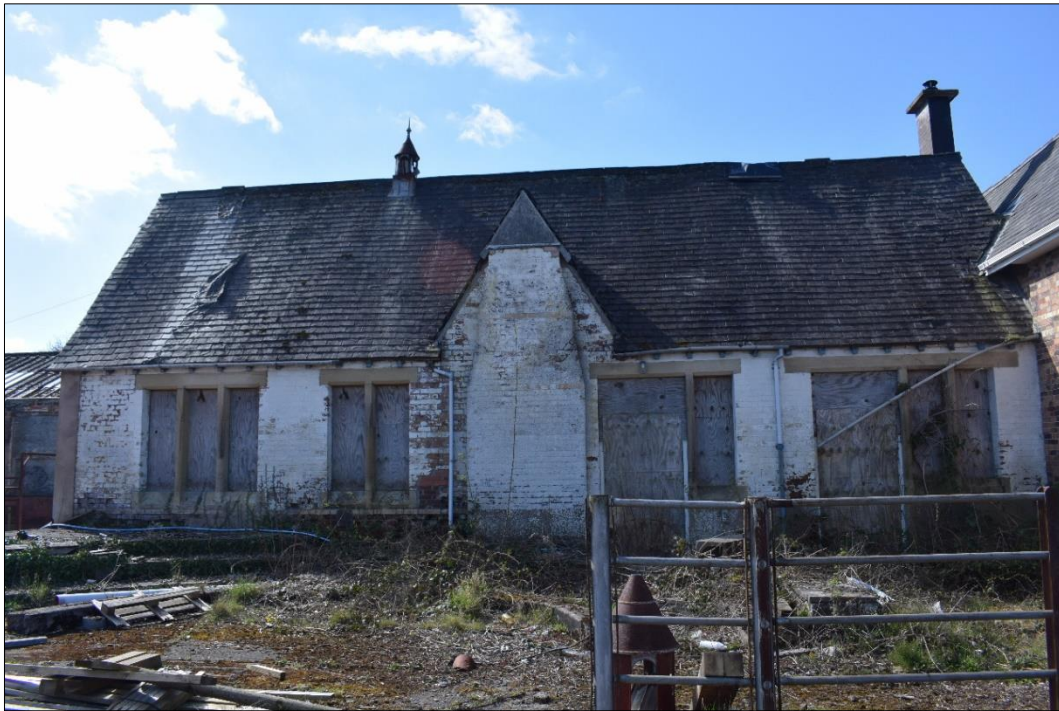
- 3.3. The original building was aligned west-north-west to east-south-east, but is referred to below as west to east for the sake of convenience. The north elevation had two doors to the west of the chimney, both with adjoining windows, with a double and a triple window to the east (Fig. 3). The roof had two iron ventilation cowls along the ridge, one of which had been removed. A name plate records 'Shorelands. Patent, Manchester'. What is now the eastern gable end (Fig. 4) was originally an internal wall.

Fig. 3 The north elevation of the original building. Photo CPAT 4634-0023

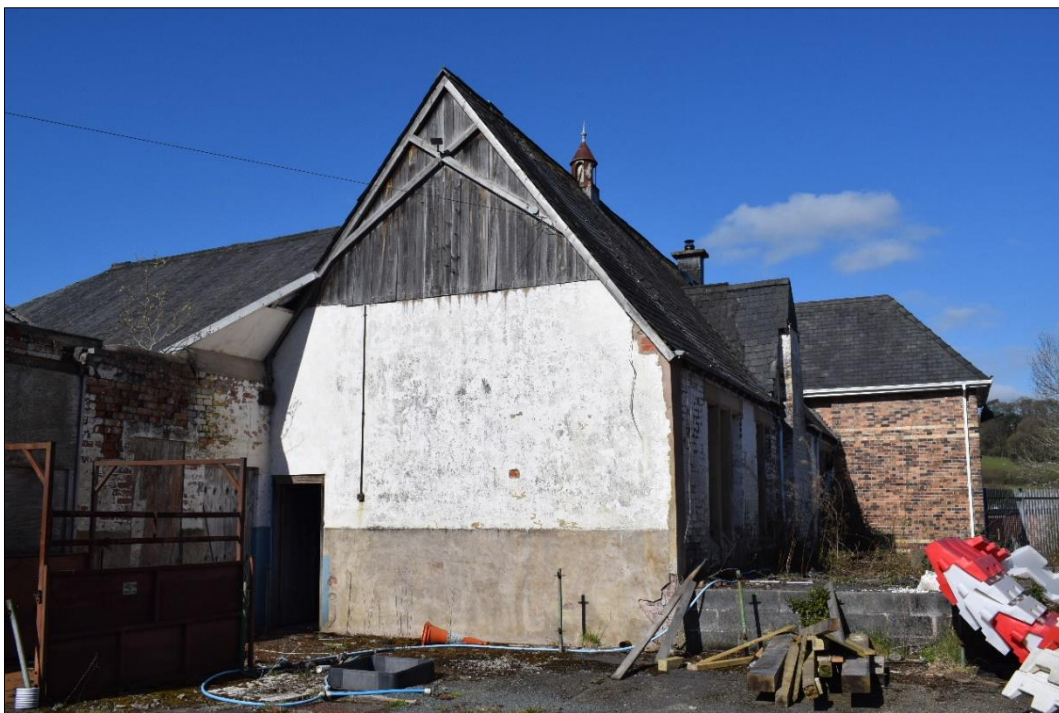
Fig. 4 The east elevation of the original building. Photo CPAT 4634-0003

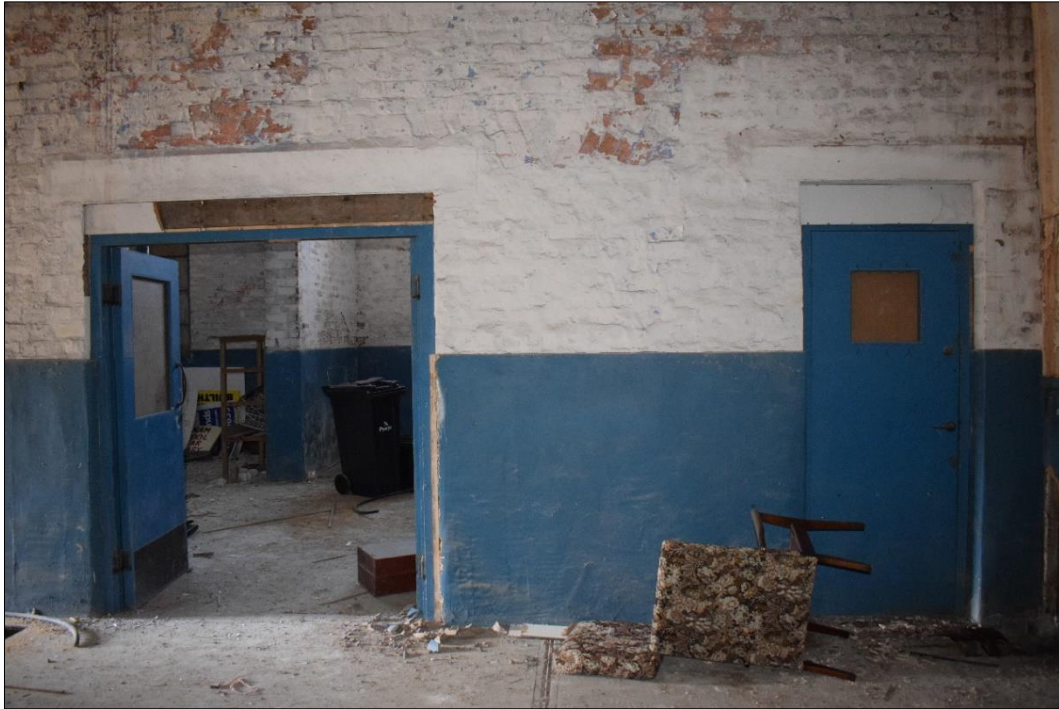
- 3.4. The original southern elevation contained one timber-framed window at the western end and a smaller opening, perhaps a door, now blocked, which had a flat, brick voussoir (Fig. 5).

Fig. 5 The south wall of the original building showing the modern inserted doorways, with the voussoir of the blocked opening just visible between. Photo CPAT 4634-0019

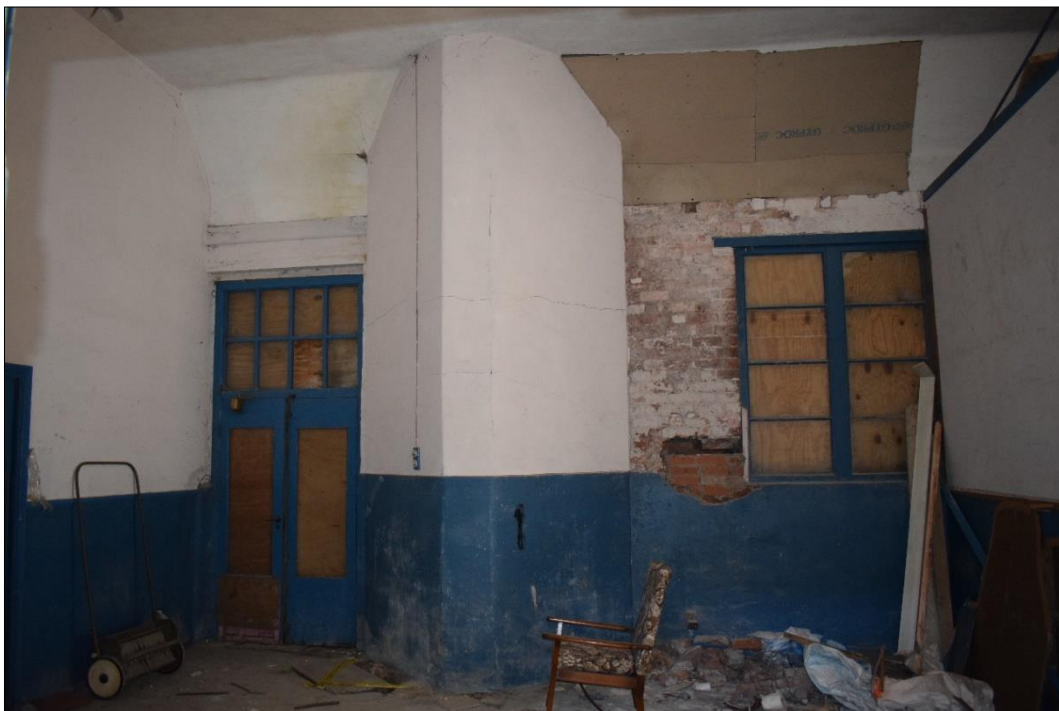
- 3.5. The surviving section of the building was divided into two rooms, although the divide has since been removed. A central chimney projected from the northern elevation, while internally there were two fireplaces, one for each room, angled at 45° (Fig. 6). The roof structure was not accessible, although there were two iron braces set below the high lath and plaster ceiling, which may have been later additions (Fig. 7).

Fig. 6 The interior of the original building showing the angled fireplaces and chimneys. Photo CPAT 4634-0007

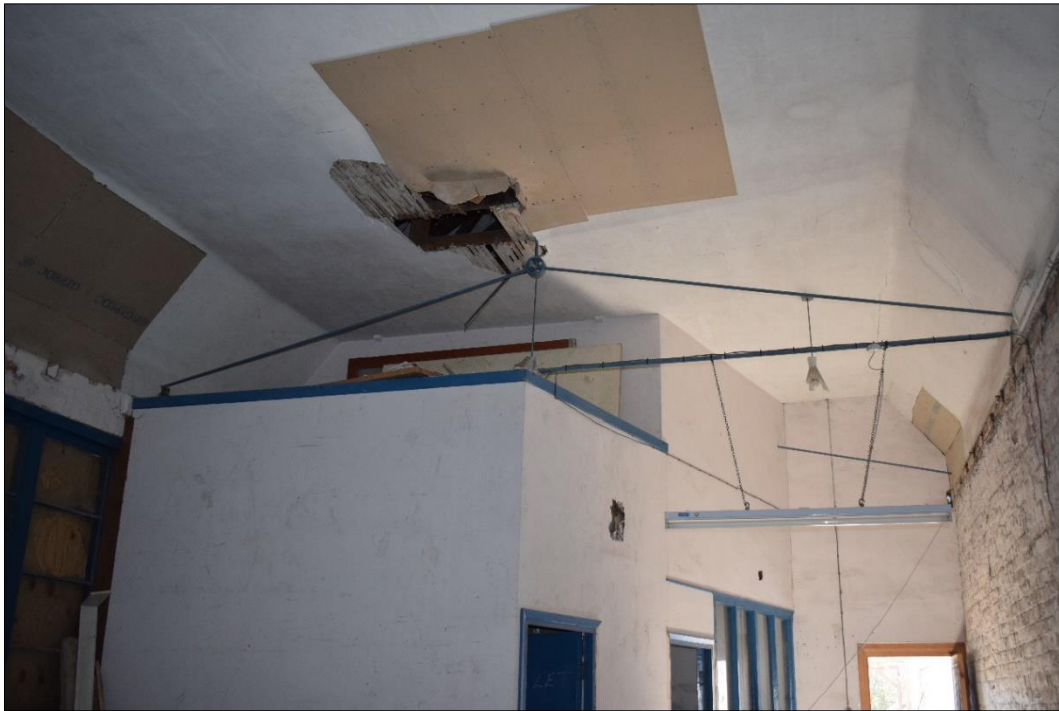
Fig. 7 The interior of the original building showing the iron bracing and later partitions. Photo CPAT 4634-0006

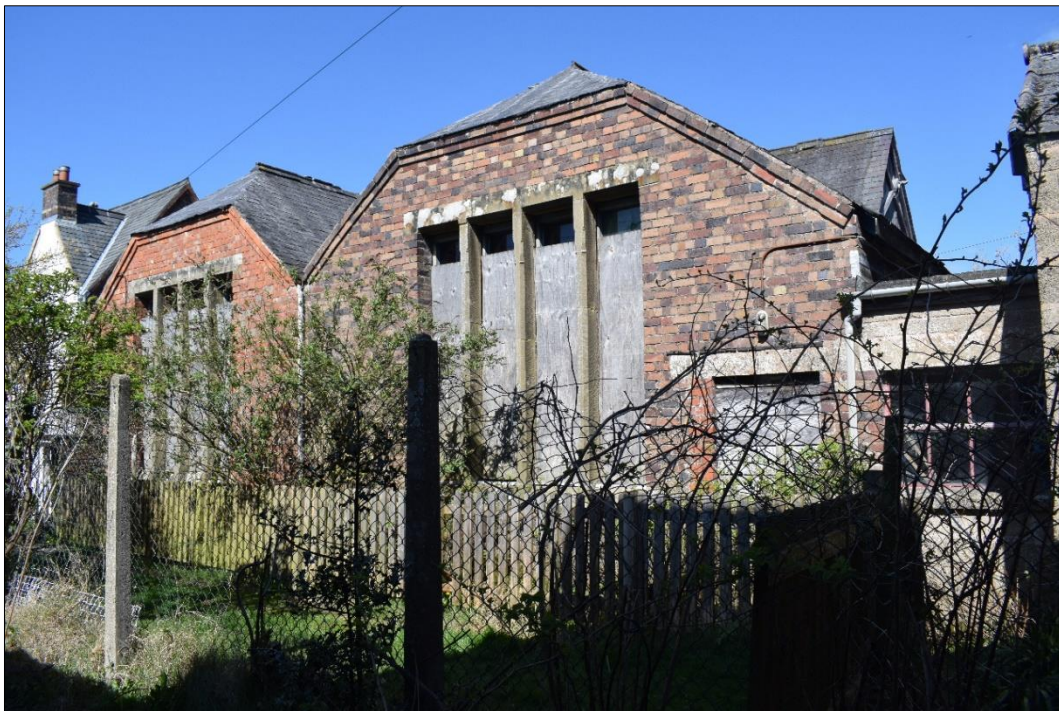
- 3.6. Two adjoining classrooms were later added to the south, both with ridged, half-hipped roofs and tall, four-sectioned windows with dressed sandstone mouldings (Fig. 8). The eastern part also incorporated a through passage.

Fig. 8 The south elevation of the later classrooms. Photo CPAT 4634-0027
