Land off Ty Du Road, Glan Conwy

Archaeological Assessment

Prosiect Rhif / Project No. G2615

Adroddiad Rhif / Report No.1493

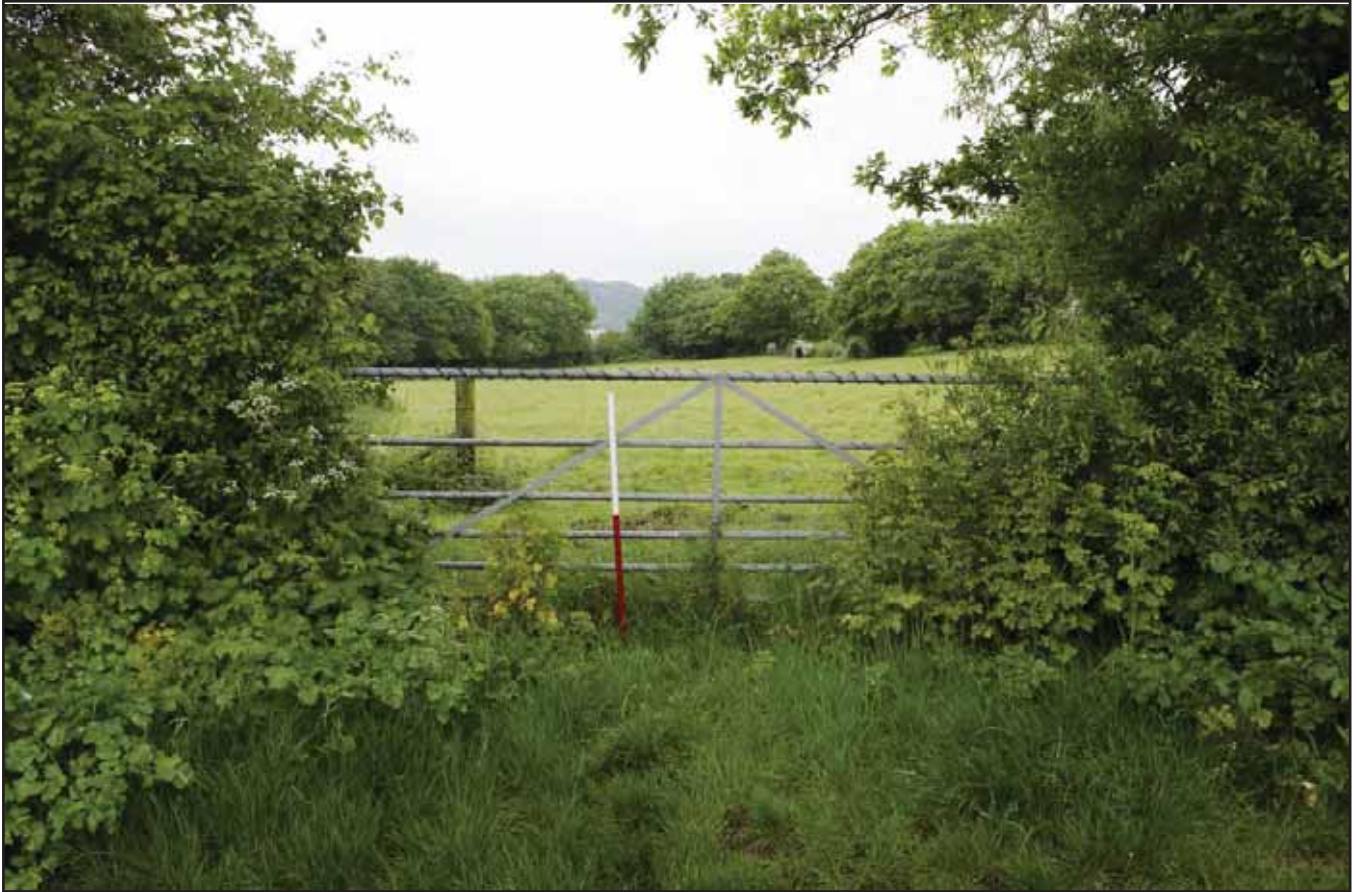
Plate 01: Access gate to G2 viewed from Ty Du Road; scale: 1x1m; (archive reference: G2615_001).

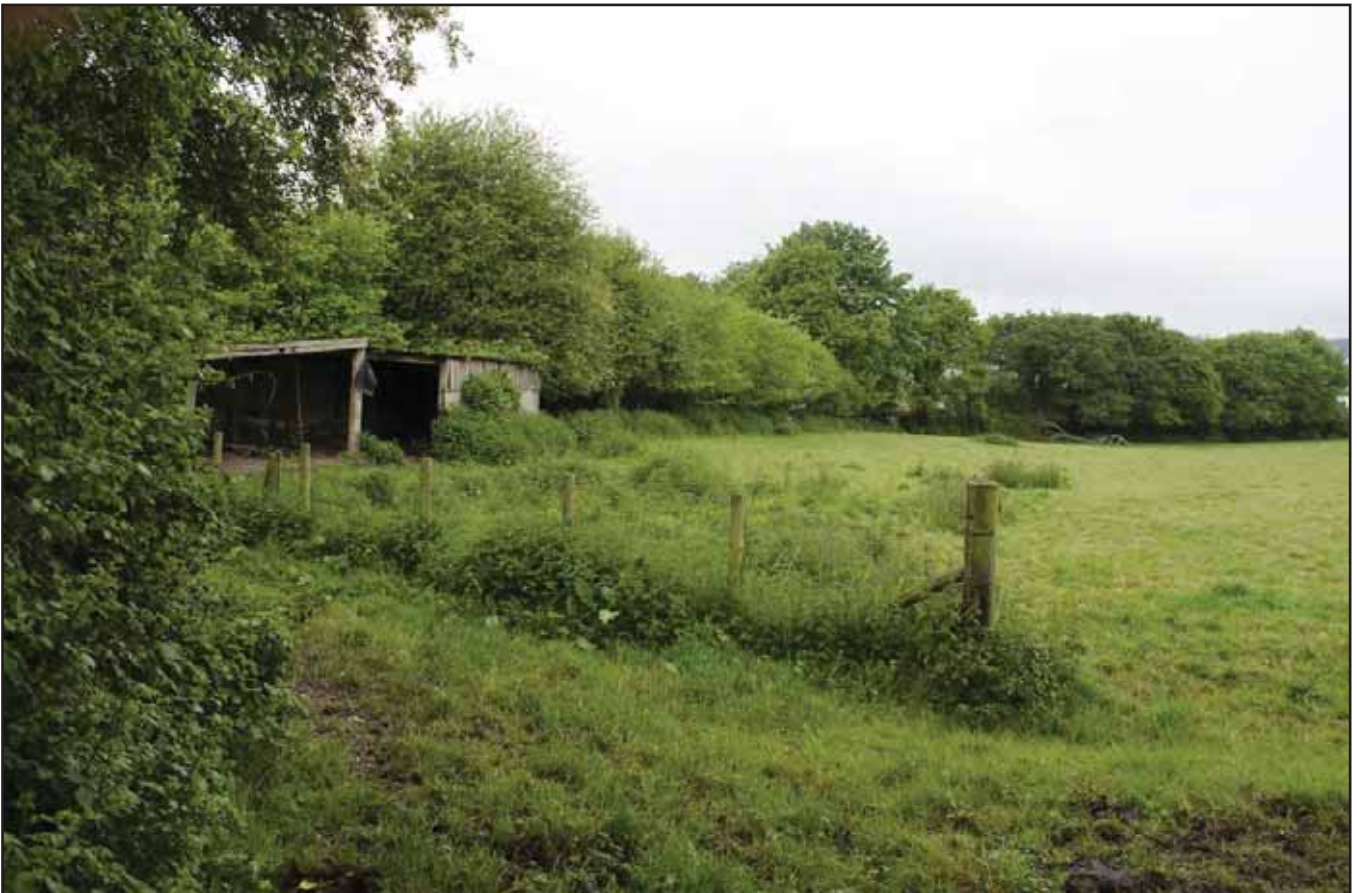
Plate 02: Farm outbuilding in field G2; no scale; (archive reference: G2615_002).

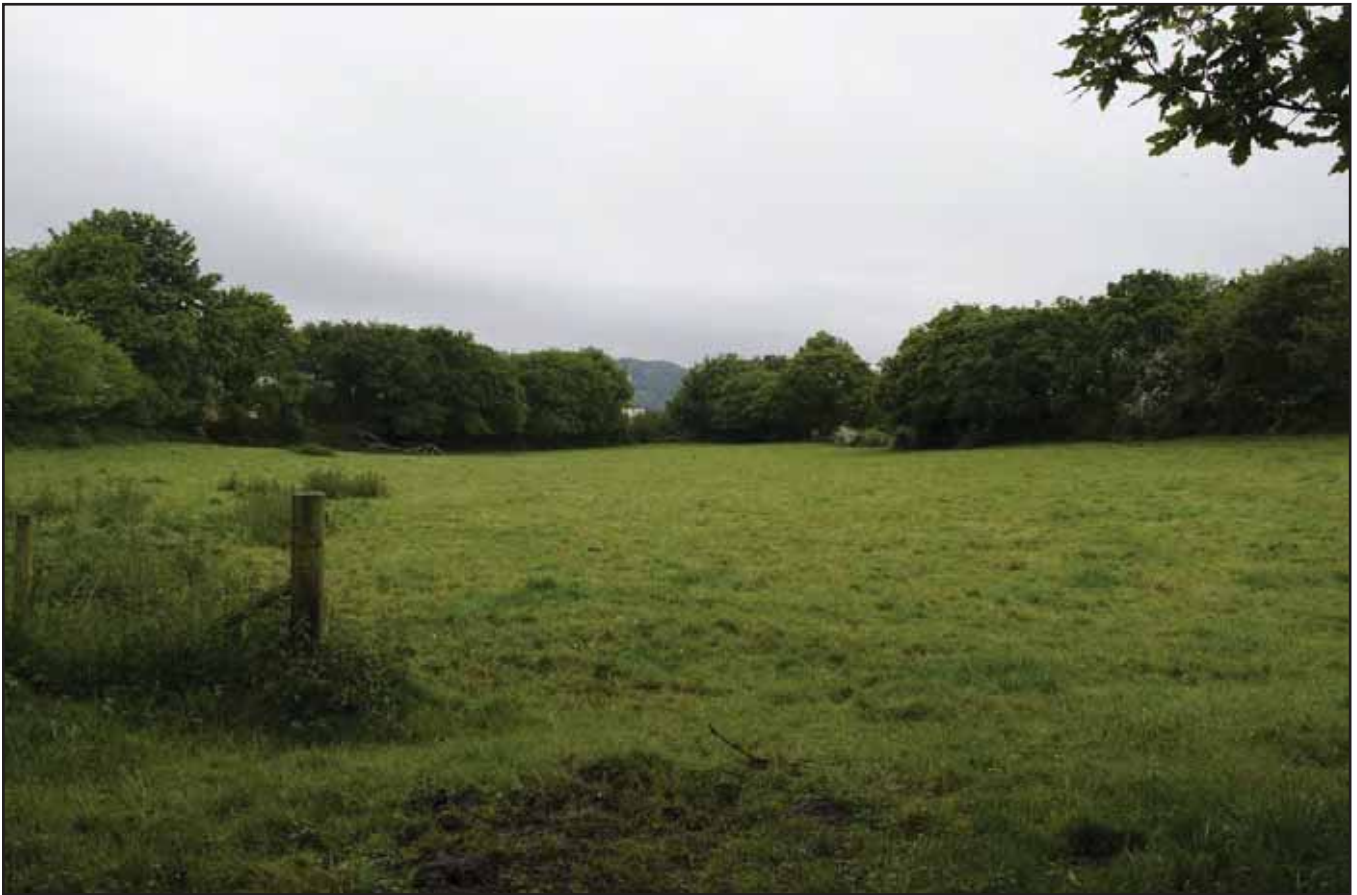
Plate 03: Main view of field G2; no scale; (archive reference: G2615_003).

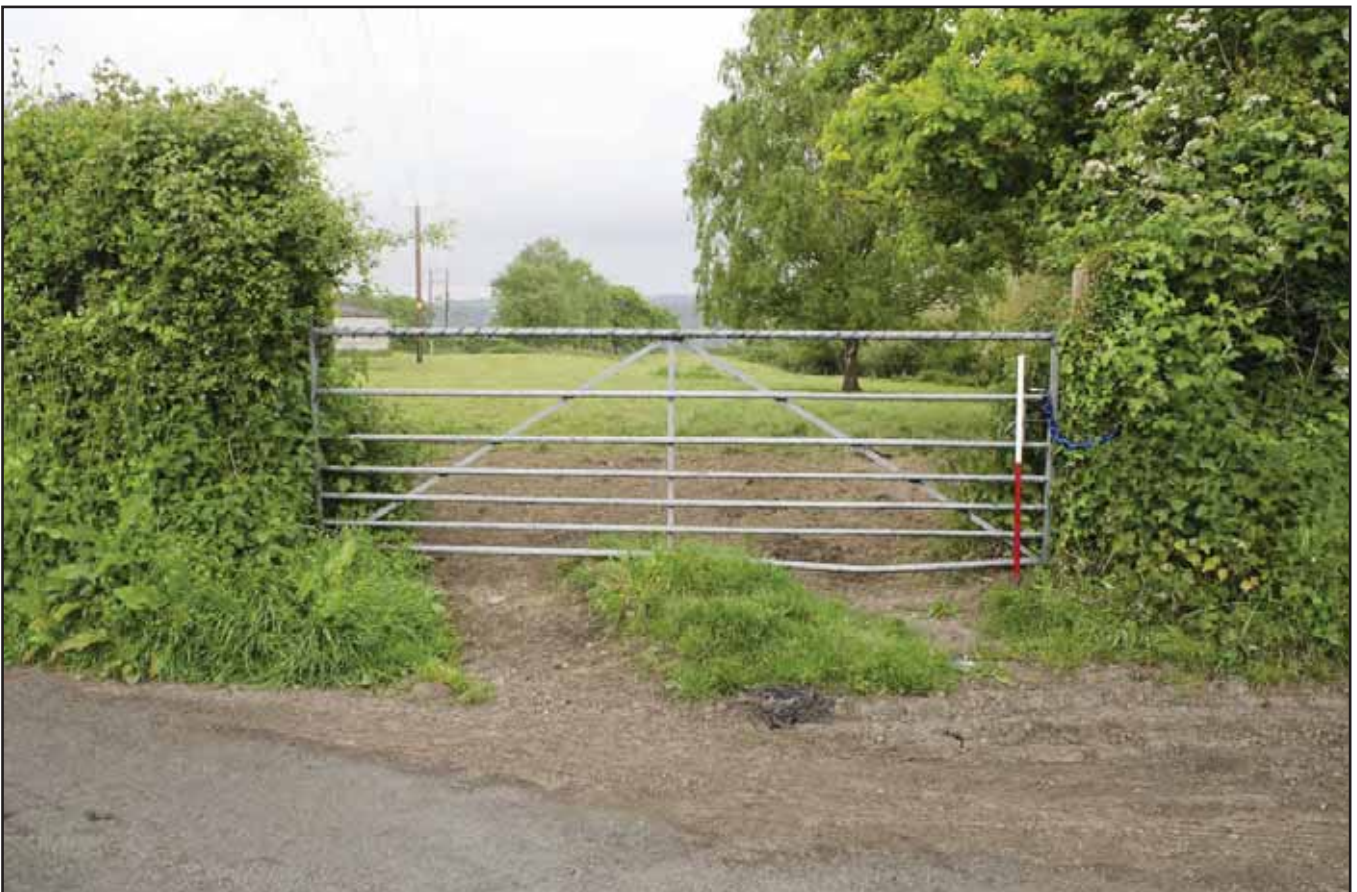
Plate 04: Access gate to field G7; scale: 1x1m; (archive reference: G2615_012).

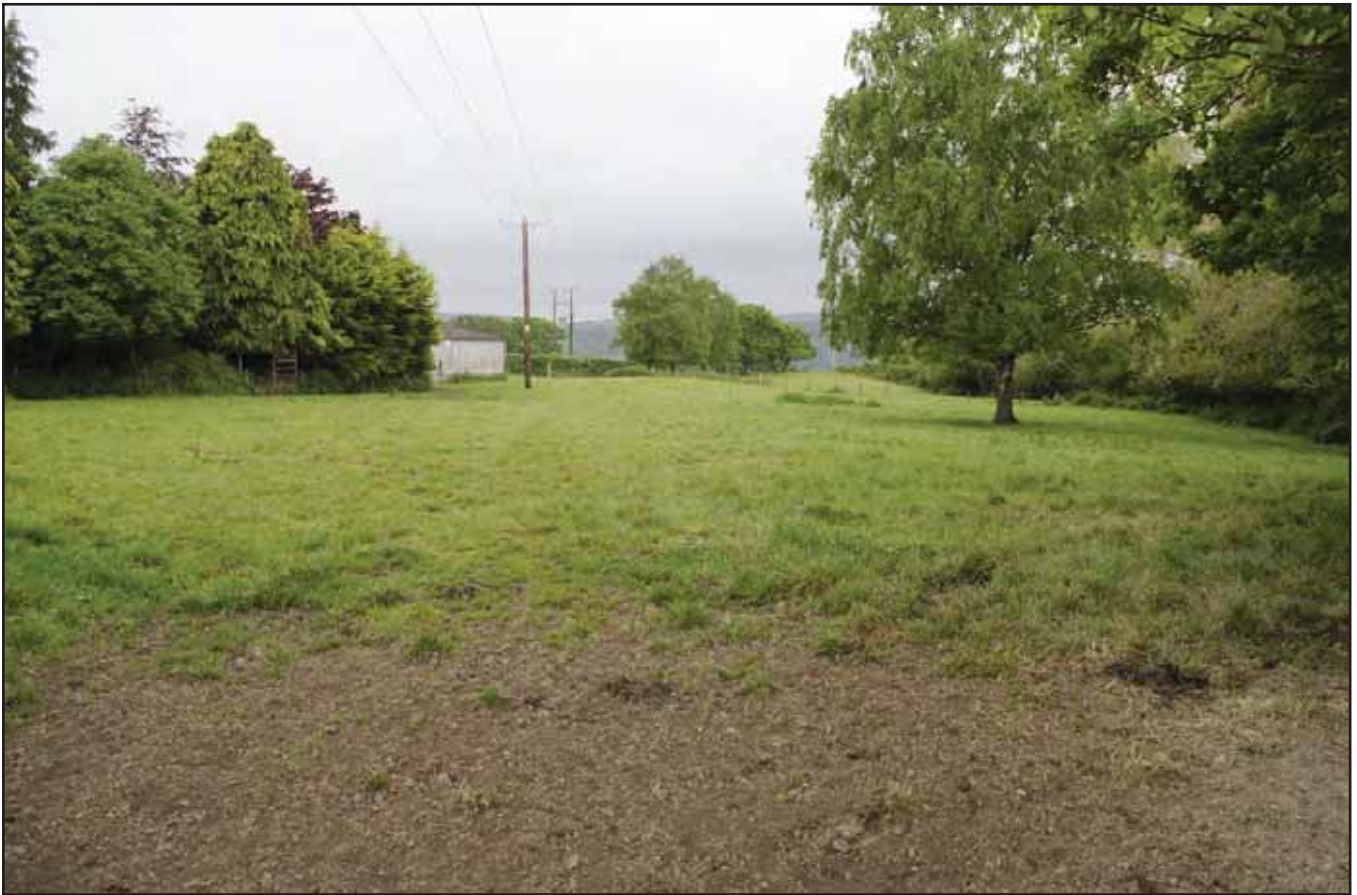
Plate 05: View of G7 from access gate with G4 in the background; no scale; (archive reference: G2615_014).

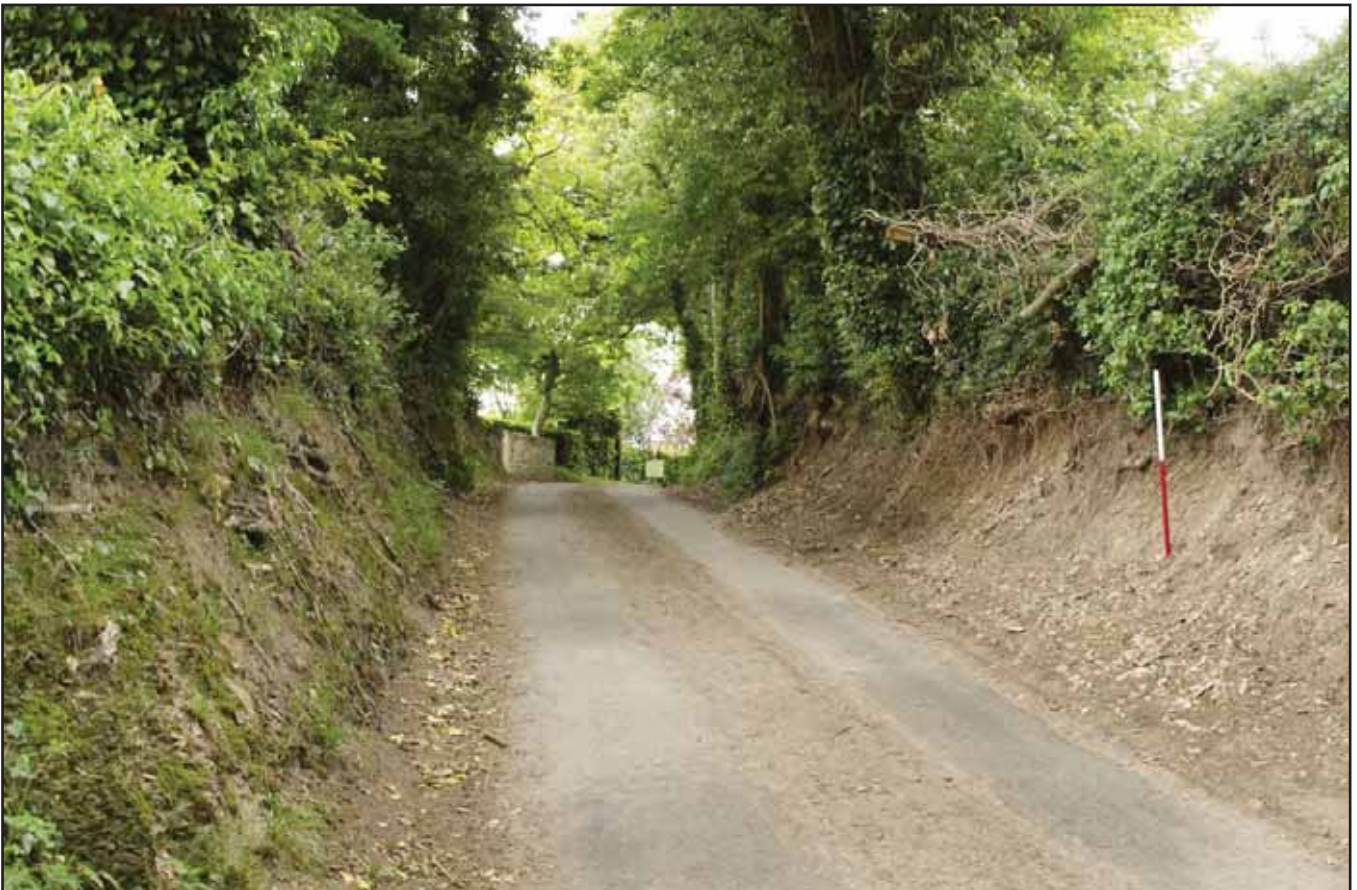
Plate 06: Possible Holloway leading to Hafod; scale: 1x1m; (archive reference: G2615_005).

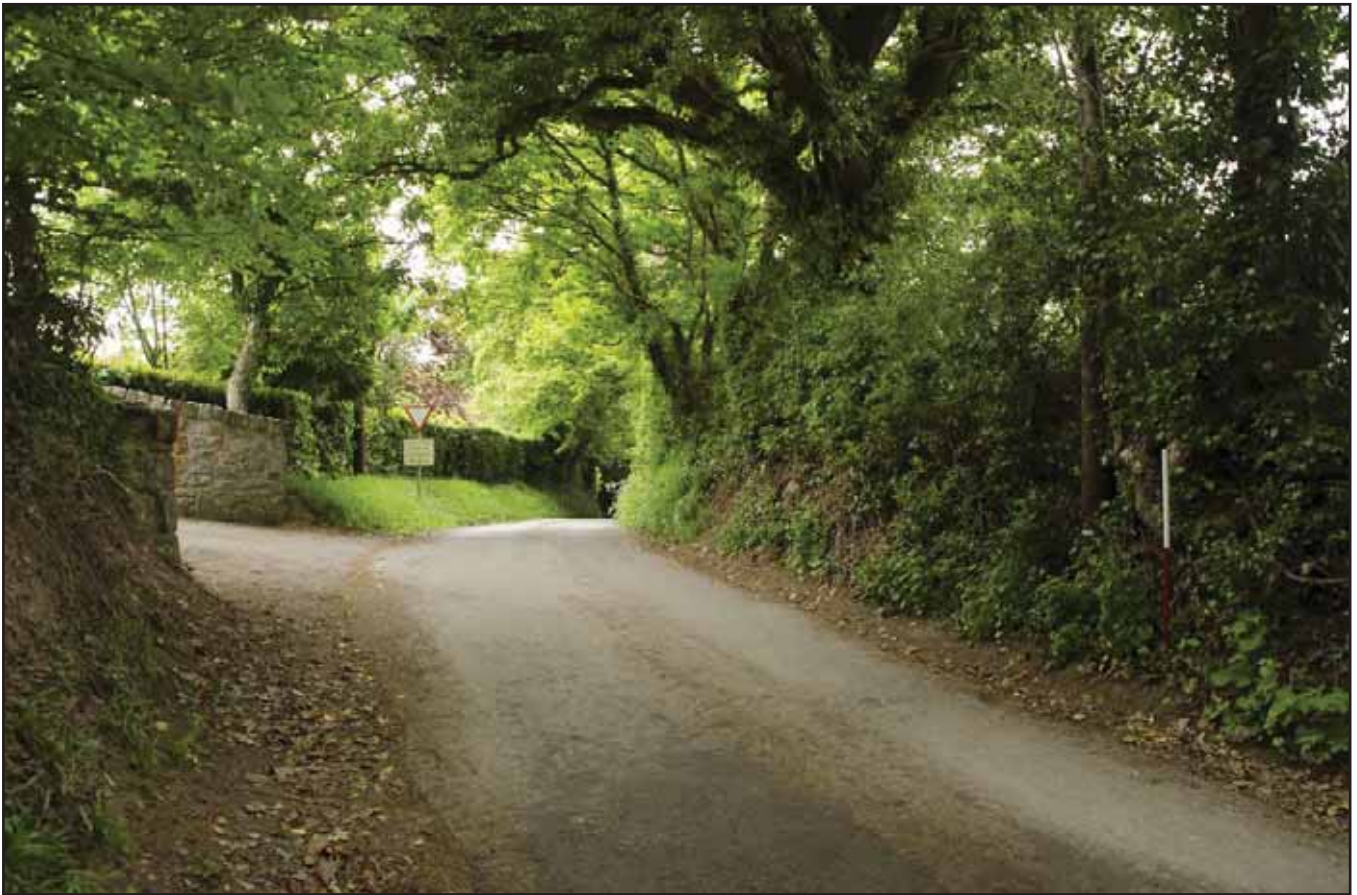
Plate 07: Mature trees bounding G1 opposite entrance to Hafod; scale: 1x1m; (archive reference: G2615_006).

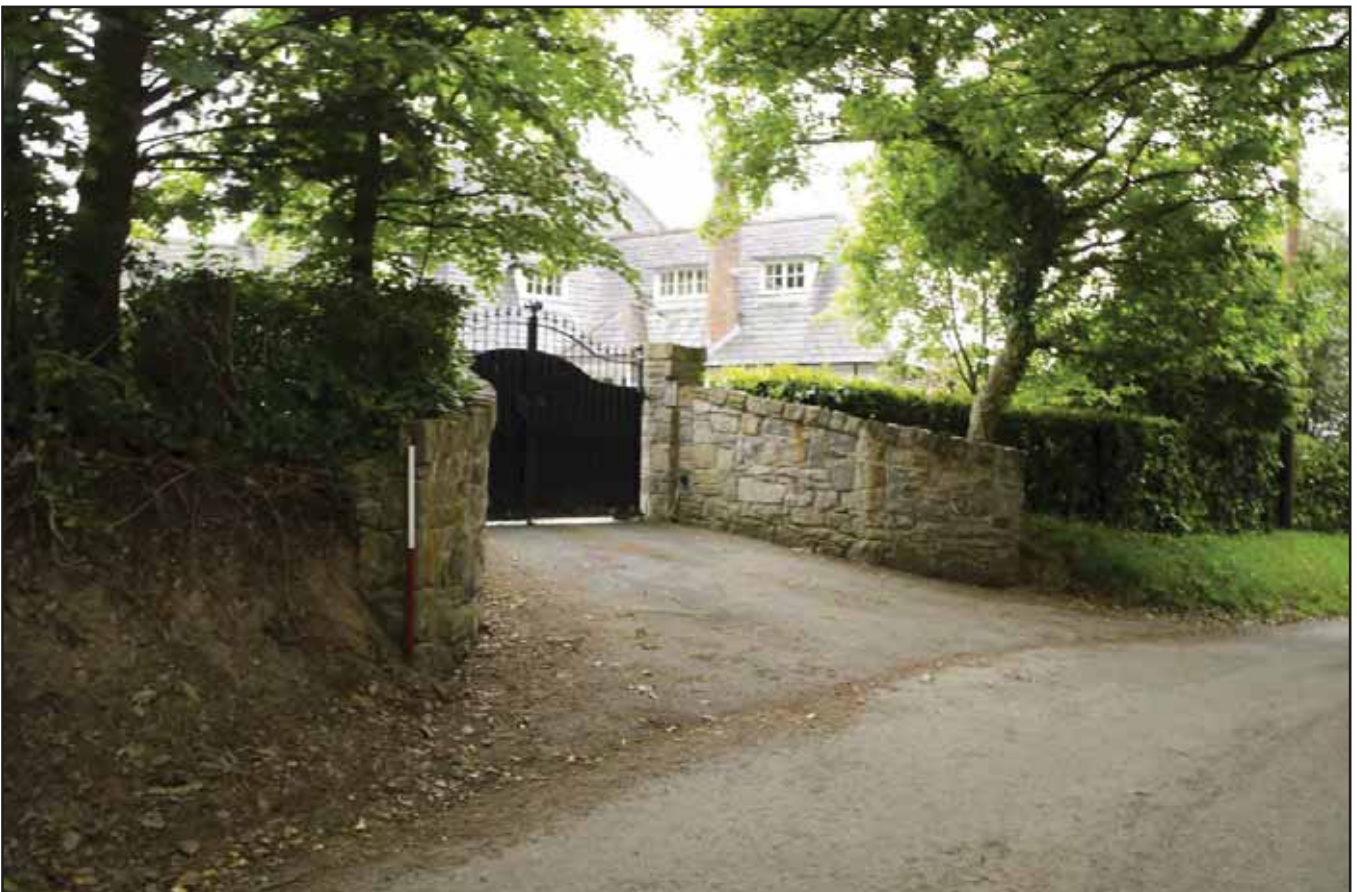
Plate 08: Entrance to Hafod house; scale: 1x1m; (archive reference: G2615_007).

Feature Number	10
Site Name	Hafod
PRN Number	66870
Grid Reference	SH8047675378
Period	Post Medieval
Site Type	Villa
Assessment Category	B
Description	Grade II listed butterfly-plan villa of c.1930. Built in the neo-vernacular style of Arts and Craft derivation. Designed by architect Herbert Luck North. (Voelcker, 2011)
Impact	None
Recommendation for further assessment/evaluation	None
Recommendation for mitigatory measures	Avoidance

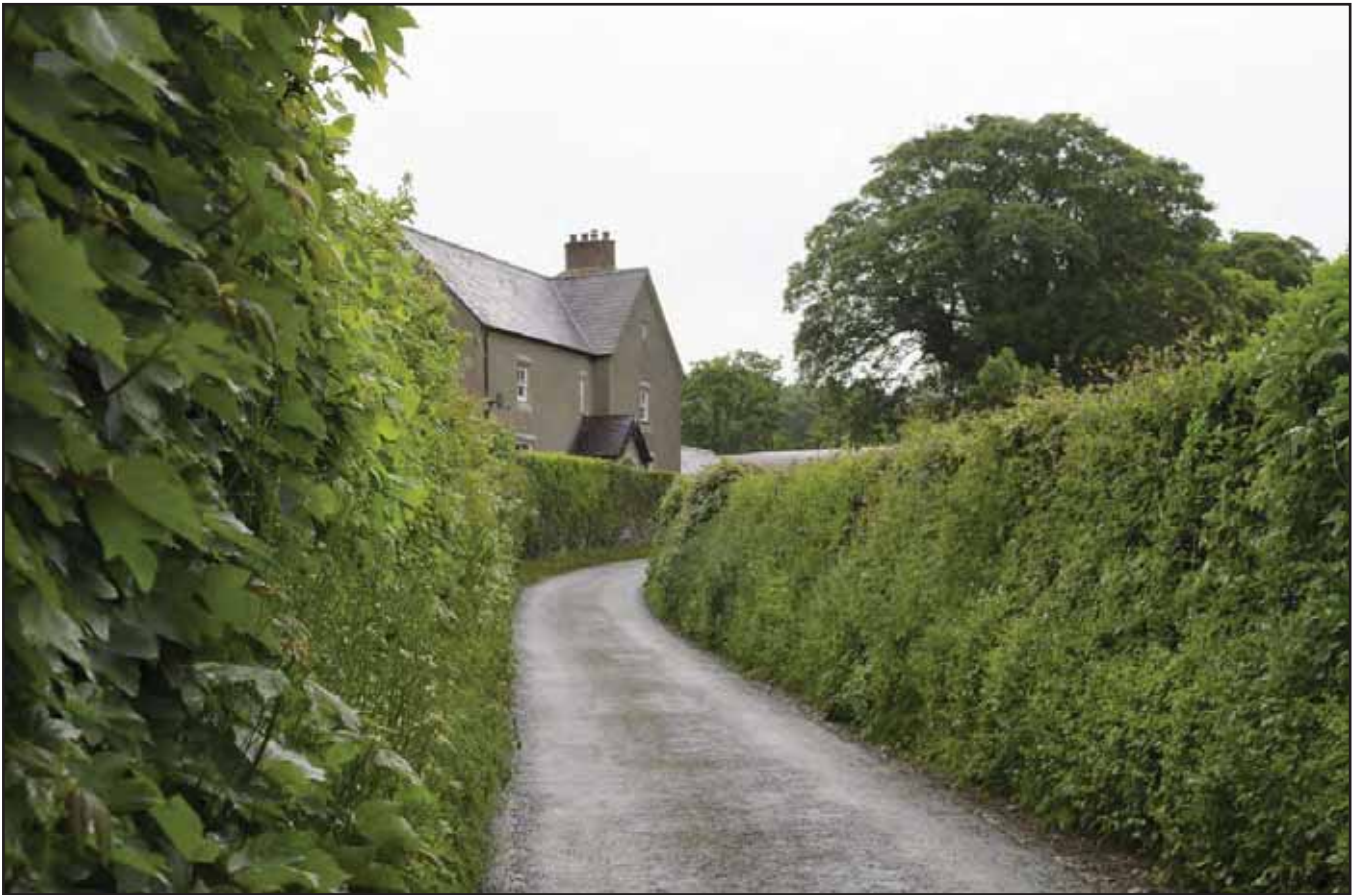
Plate 09: Road leading to Ty Du Farmhouse; no scale; (archive reference: G2615_017).

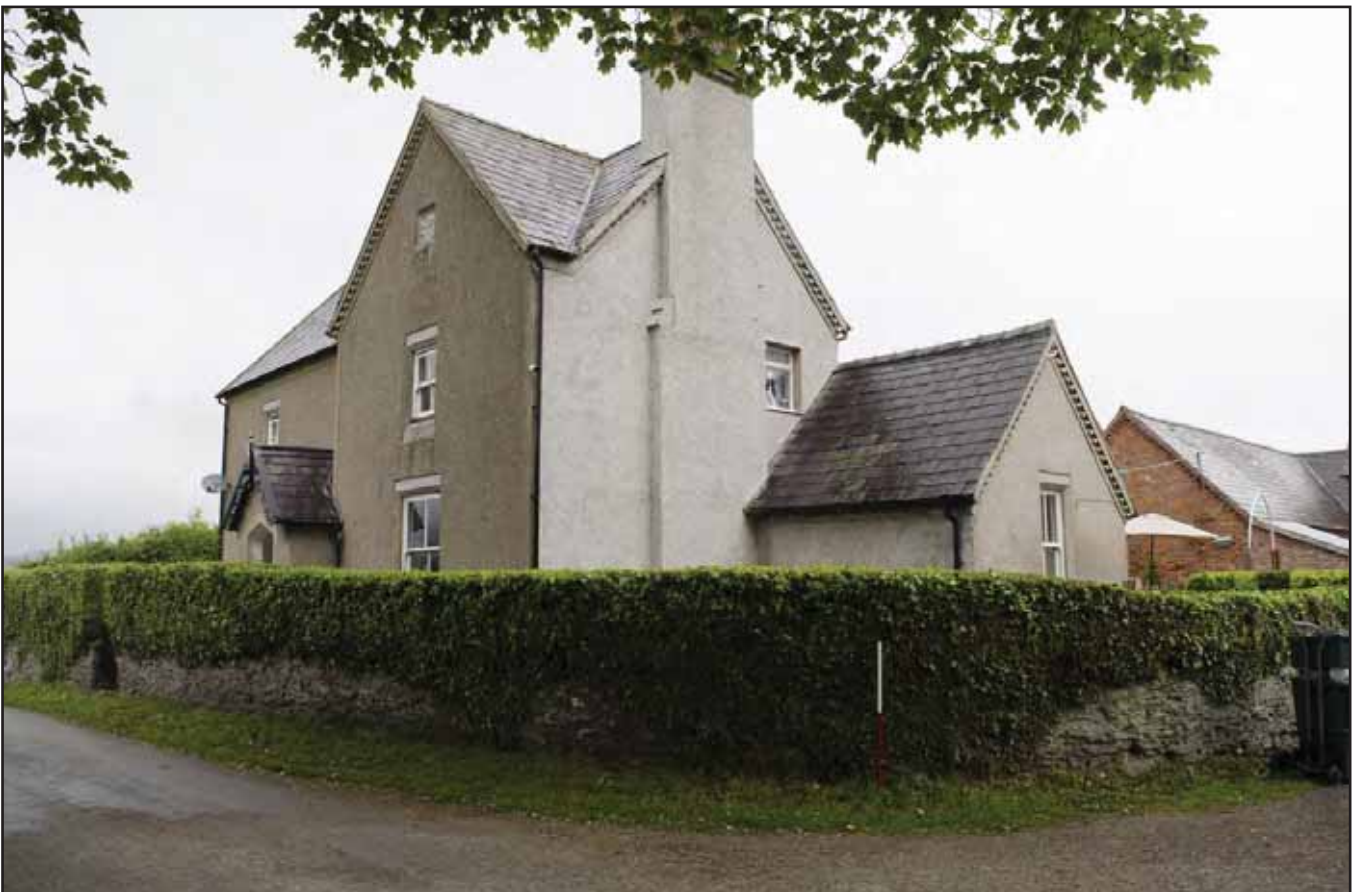
Plate 10: Ty Du Farmhouse; scale: 1x1m; (archive reference: G2615_022).

Feature Number	21
Site Name	Ty Du Farmhouse, Llansanffraid
PRN Number	12613
Grid Reference	SH8074875594
Period	Post Medieval
Site Type	Farmstead
Assessment Category	B
Description	Grade II listed farmhouse built in 1857 by Whitehall Dod (1823-1878), local estate owner. Believed locally to have been built after fire destroyed the previous farm on the site (hence name Ty Du, 'the black house'. A good example of a 19 th Century farmstead. (Cadw, 2019)
Impact	Unlikely
Recommendation for further assessment/evaluation	None
Recommendation for mitigatory measures	Avoidance

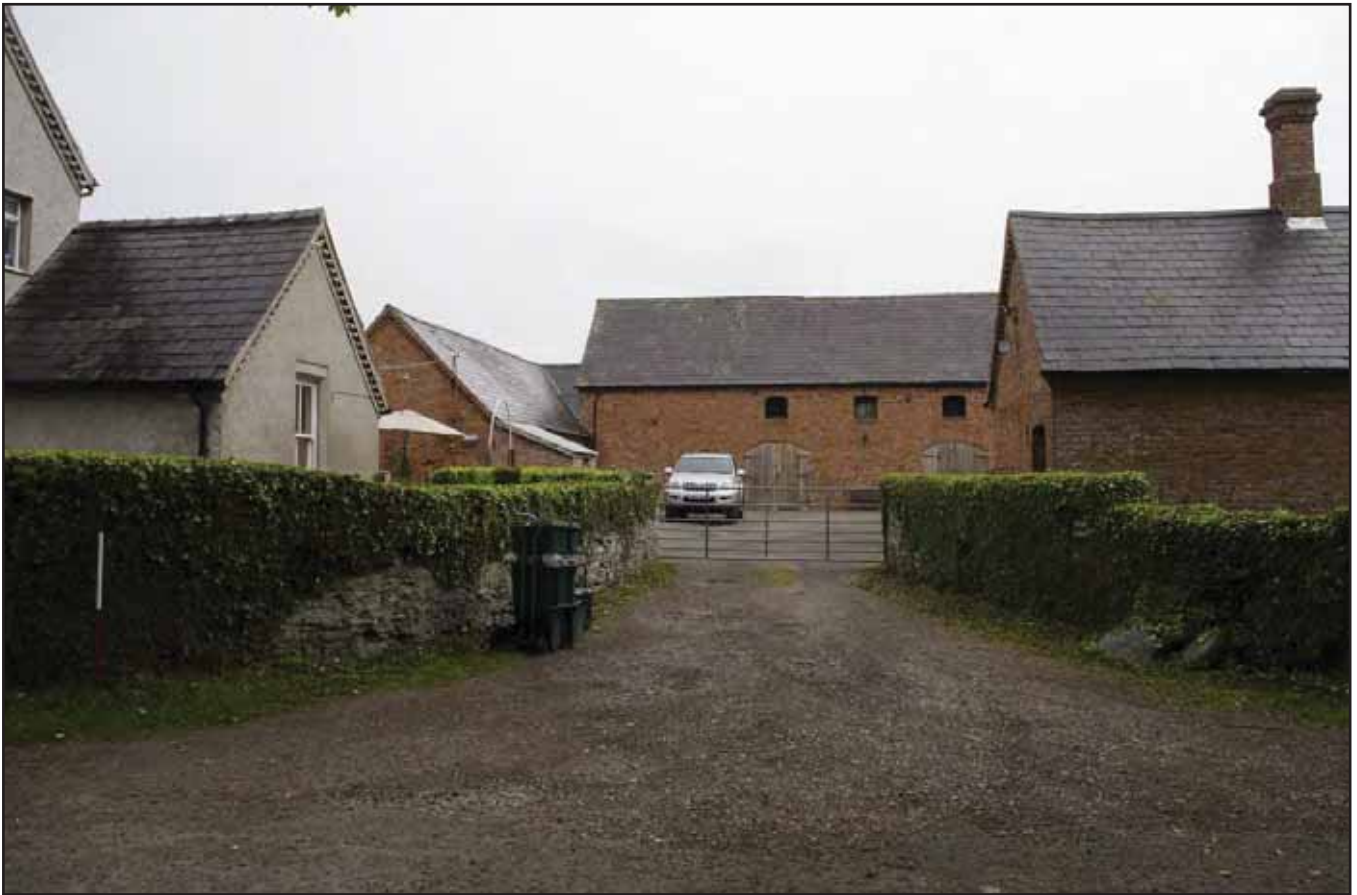
Plate 11: Ty Du farmstead outbuildings; scale: 1x1m; (archive reference: G2615_021).

Feature Number	15
Site Name	Ranges, Ty Du Farm, Llansanffraid
PRN Number	69014
Grid Reference	SH8077475617
Period	Post Medieval
Site Type	Farm Building
Assessment Category	B
Description	Grade II listed agricultural ranges built in 1857 by Whitehall Dod, local estate owner. Believed locally to have been built after fire destroyed the previous farm on the site. A good example of a 19 th Century farmstead. (Cadw, 2019)
Impact	Unlikely
Recommendation for further assessment/evaluation	None
Recommendation for mitigatory measures	Avoidance

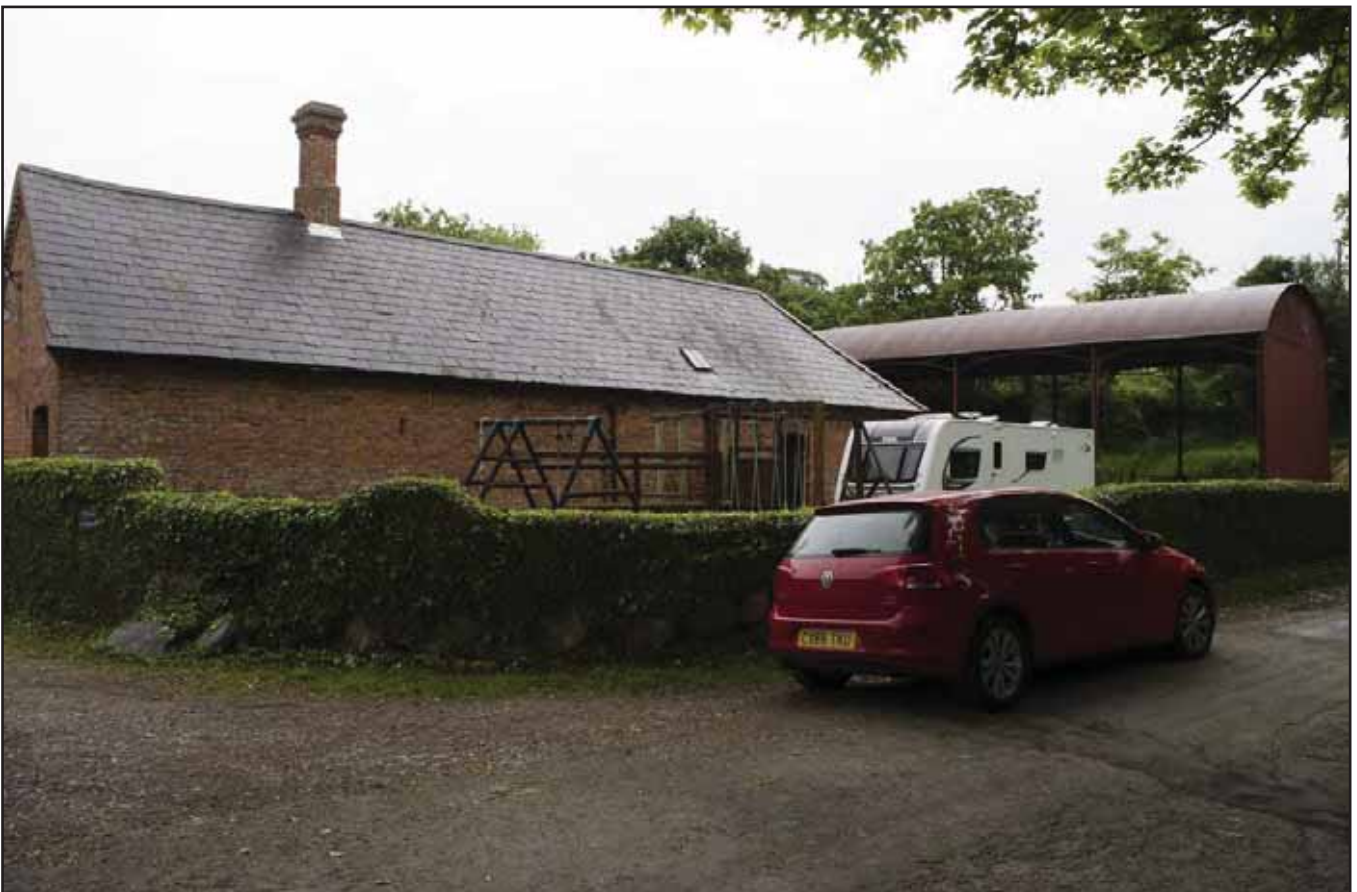
Plate 12: Ty Du Farmstead outbuildings; no scale; (archive reference: G2615_023).

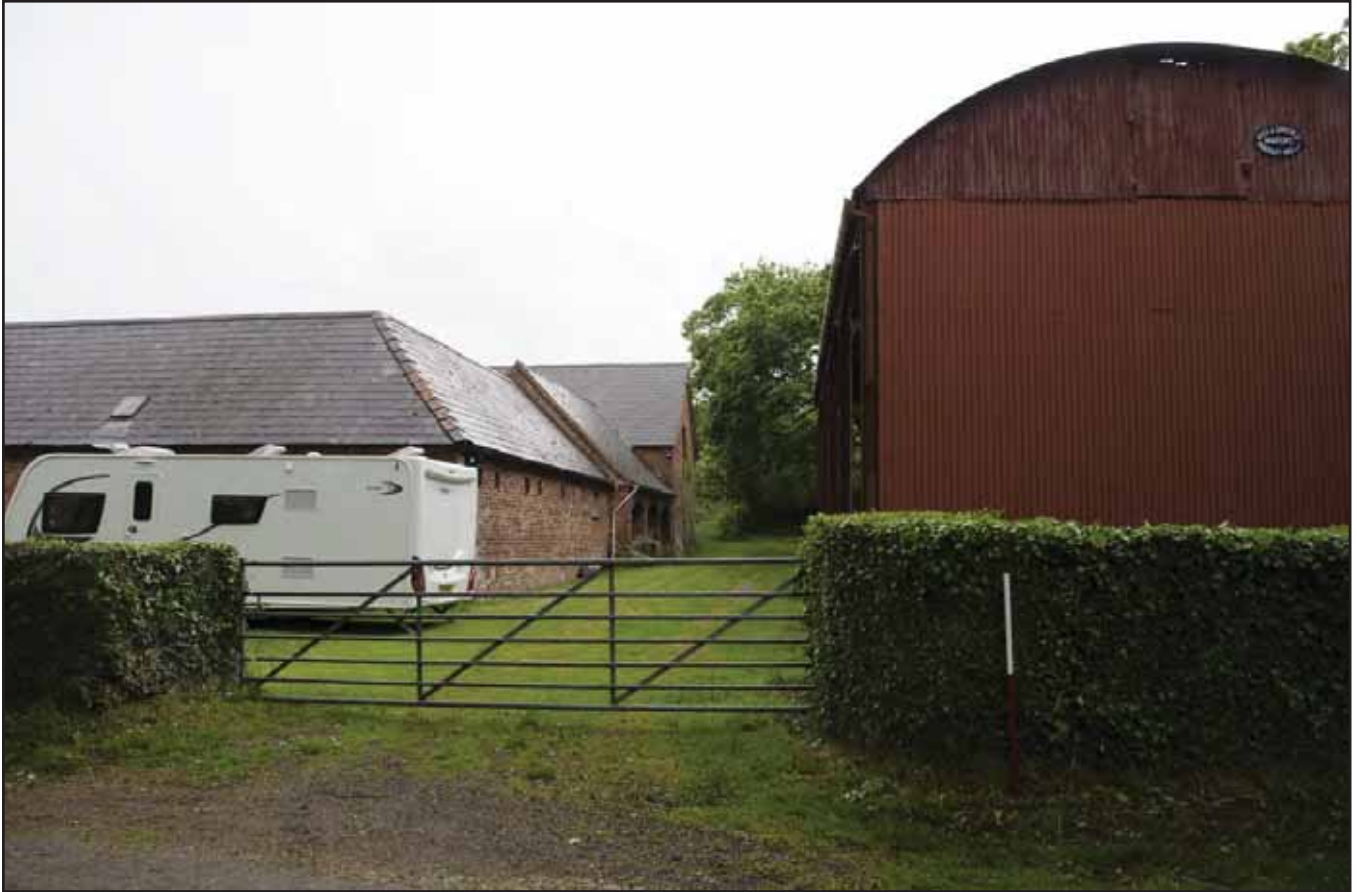
Plate 13: Ty Du Farmstead outbuildings & barn; scale: 1x1m; (archive reference: G2615_025).
