Land Adjacent to Ty Newydd Beulah, Ceredigion Watching Brief

Trysor Project No. 2015/447

RHIF YR ADRODDIAD - REPORT NUMBER: Trysor 2015/447

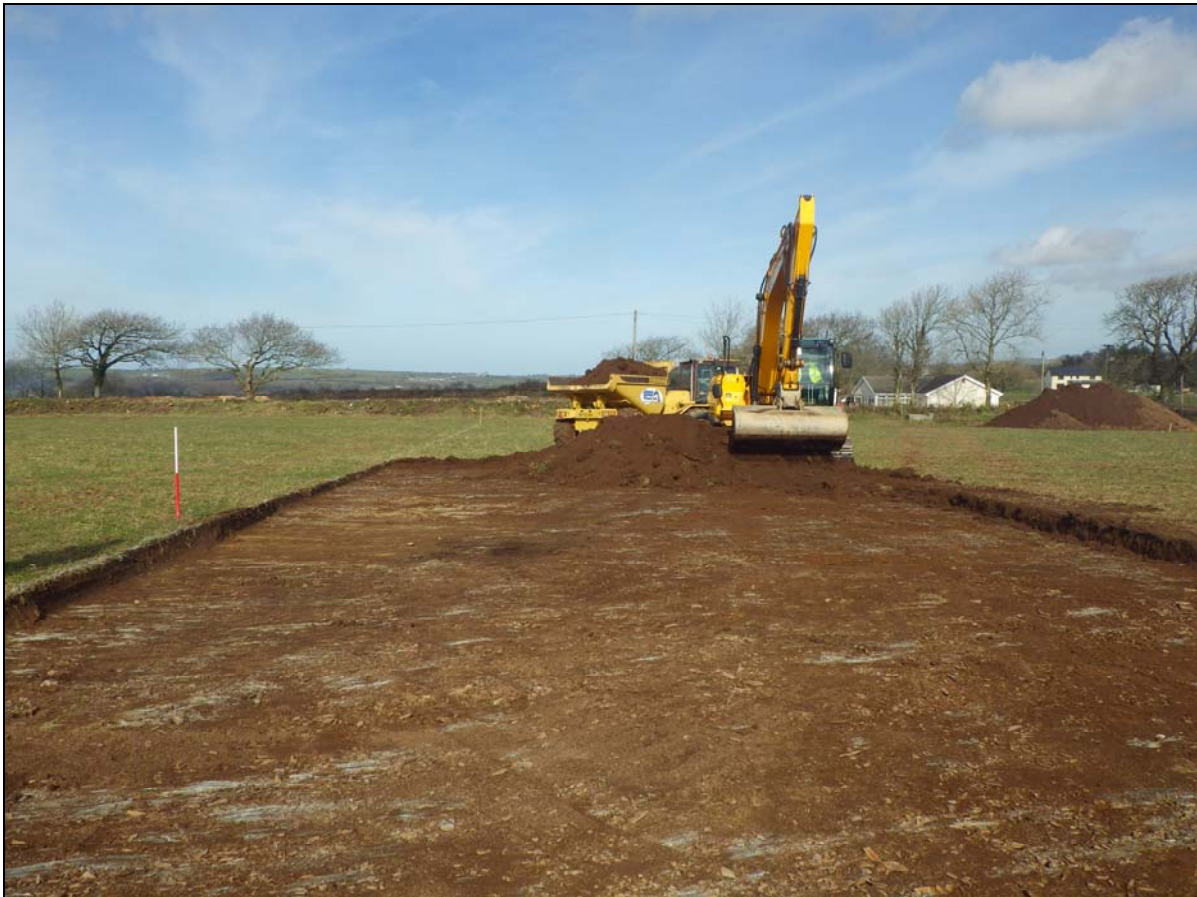
Cover photograph: Removal of topsoil, looking north northwest

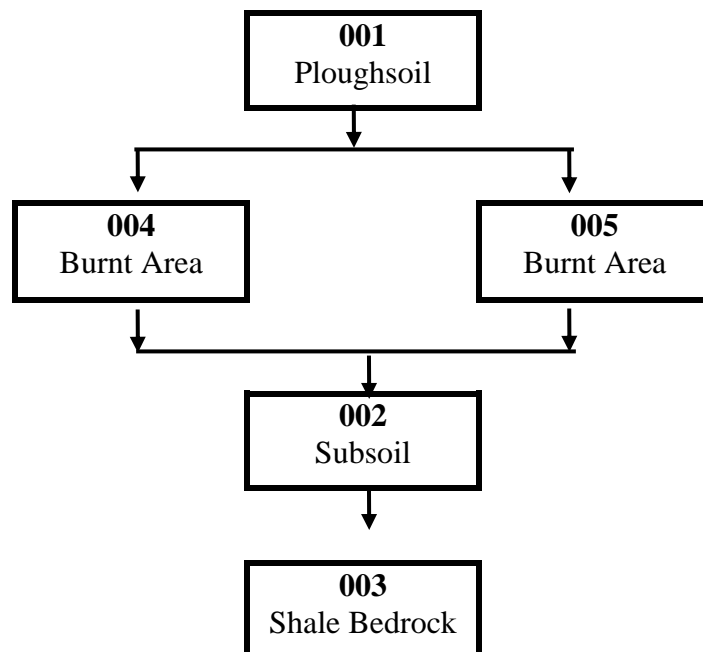
Figure 3: Location of contexts 004 & 005

Context Number	Depth	Description	Interpretation
001	Up to 0.20 metres	7.5YR 3/2 friable loam	Ploughsoil
002	Less than 0.06 metres	10YR3/4 , variable depth	Thin layer of subsoil between ploughsoil and bedrock
003	-	Shale	Shale bedrock
004	0.002	Shallow, small patch of reddened soil, shale and some charcoal at SN2755844073. It was approximately 0.50 metres by 0.30 metres	Area of burning of unknown date and origin
005	0.002	Shallow, small patch of reddened soil, and some charcoal at SN2753643996, approximately 0.50 metres in diameter.	Area of burning of unknown date and origin

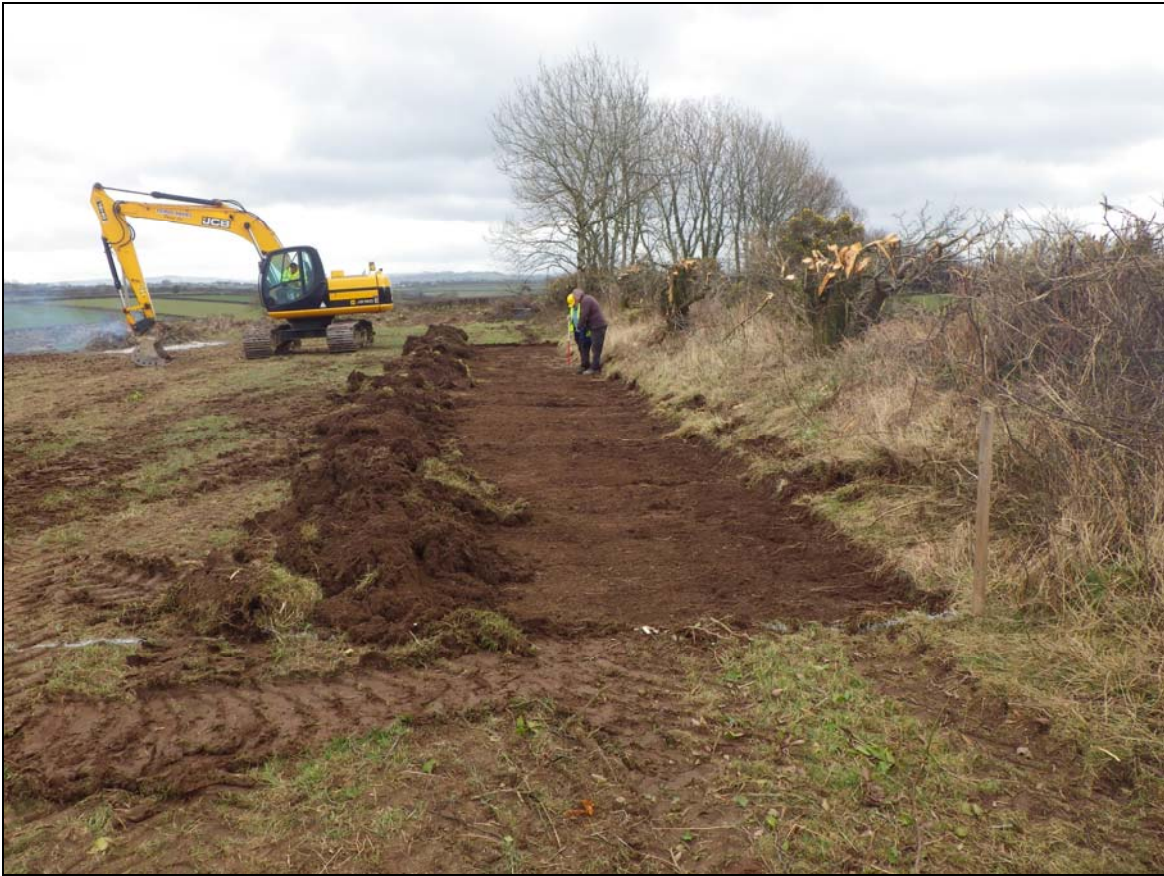
Plate 1: TNB2015_101: Starting stripping at the southern end of the development site, looking east

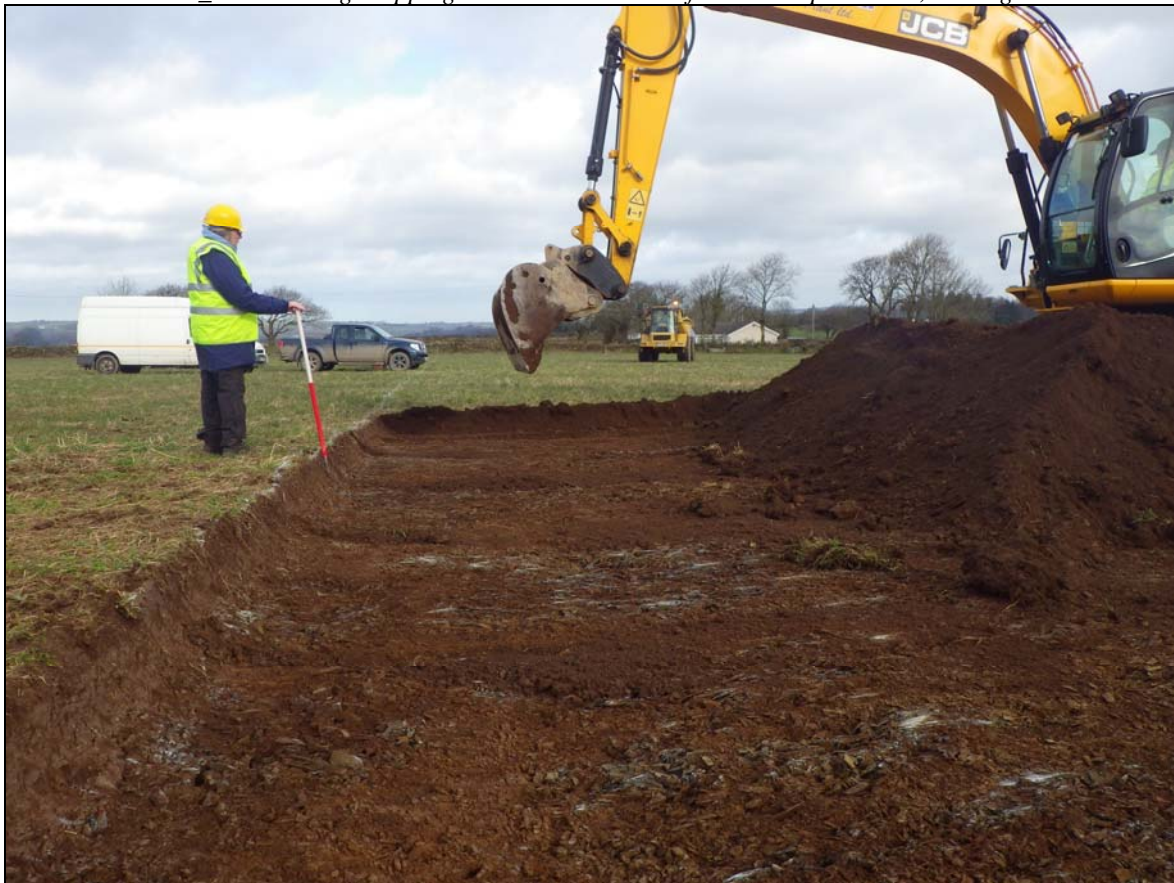
Plate 2: TNB2015_102: Stripping the development area, looking north northwest, bedrock visible in places

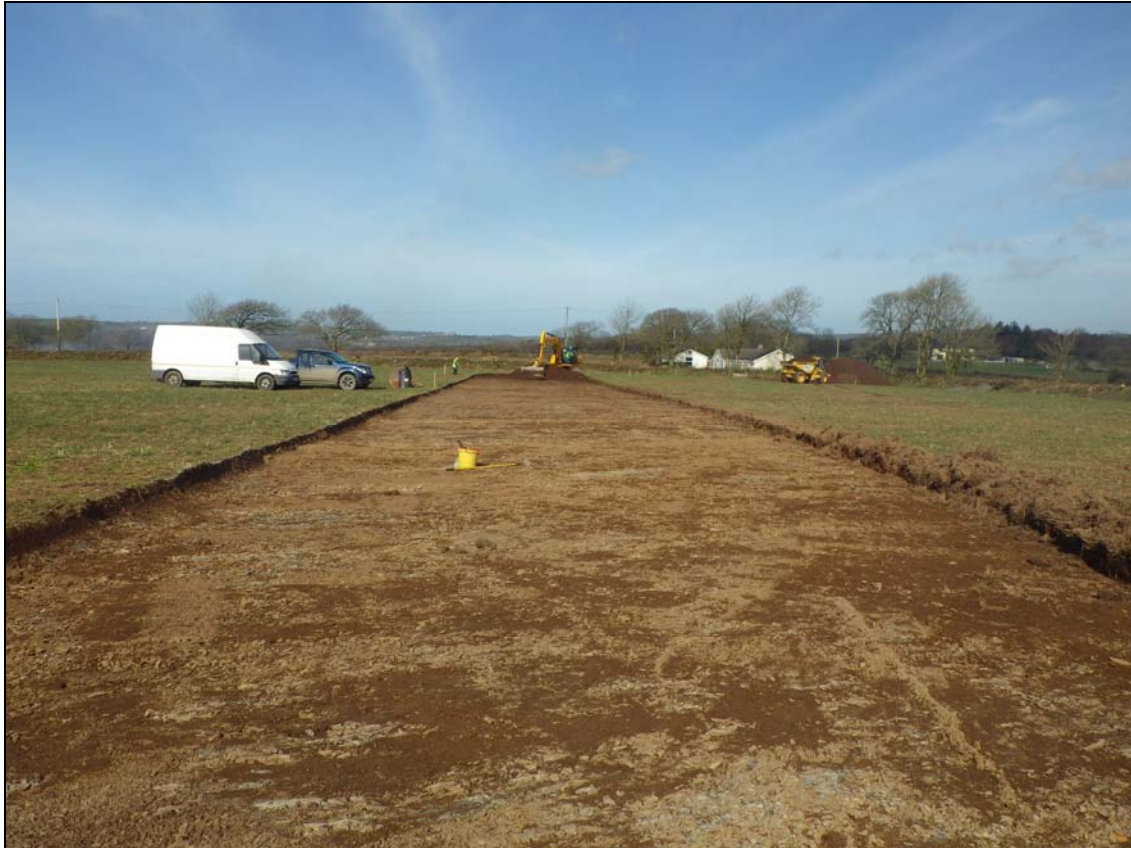
Plate 3: TNB2015_103: Stripping area, looking north northwest, shallowness of the ploughsoil down to bedrock noticeable.

11.1 A thin layer of topsoil overlay a very thin, intermittent layer of subsoil, which occurred in pockets in the top of the underlying bedrock.

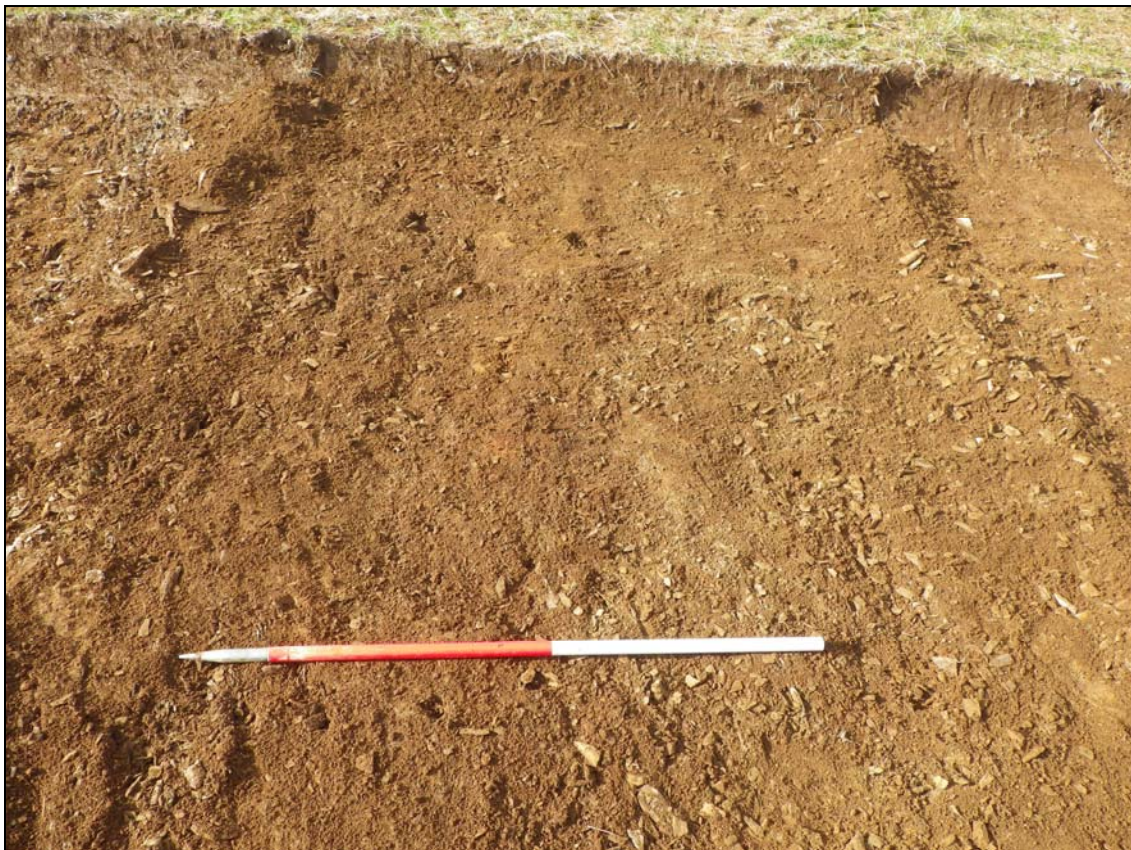
Plate 4: TNB2015_104: Small patch of burning 004, below 001 and above 002, its origin are unknown but , could be agricultural burning, looking west southwest.

11.2 Two small areas of burning, 004 & 005, were recorded below the ploughsoil. Their origin is not known although they could be the result of some agricultural process such as ploughing in of burnt organic material.

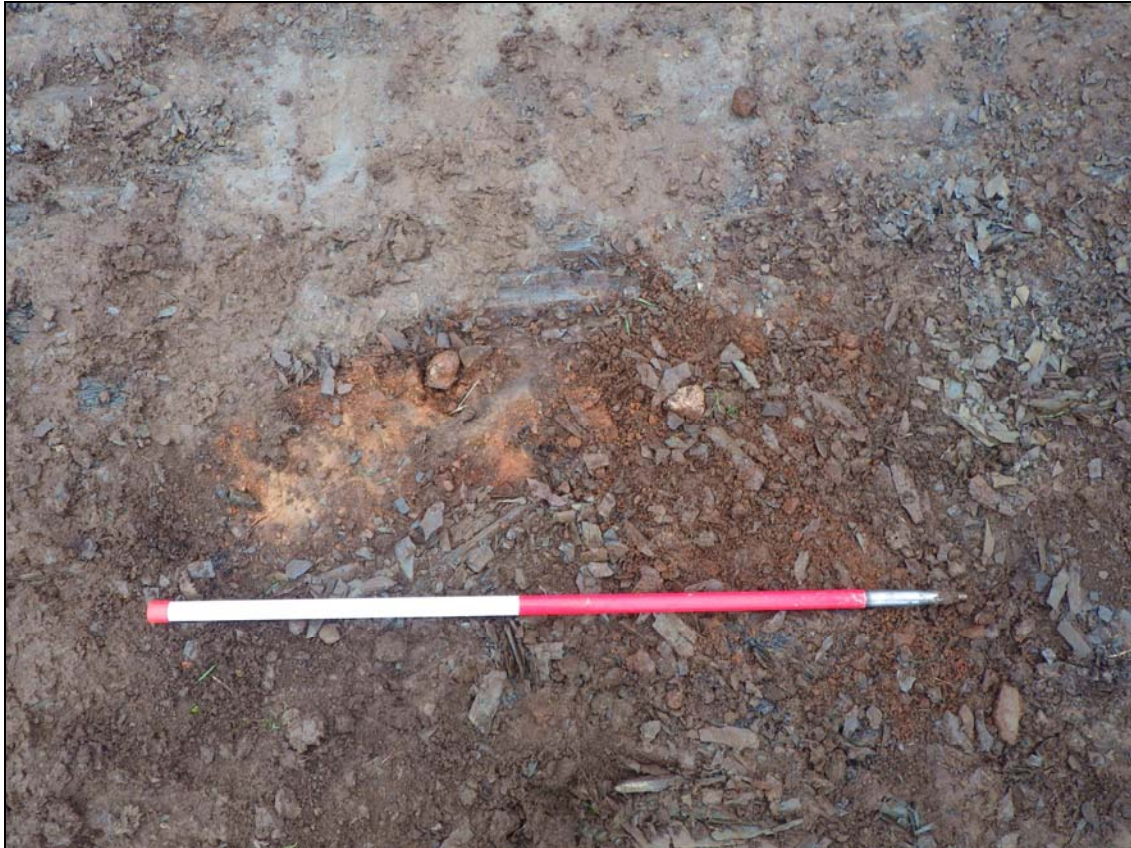
Plate 5: TNB2015_105: Small patch of burning 005, below 001 and above 003, its origin are unknown but , could be agricultural burning, looking north northwest.

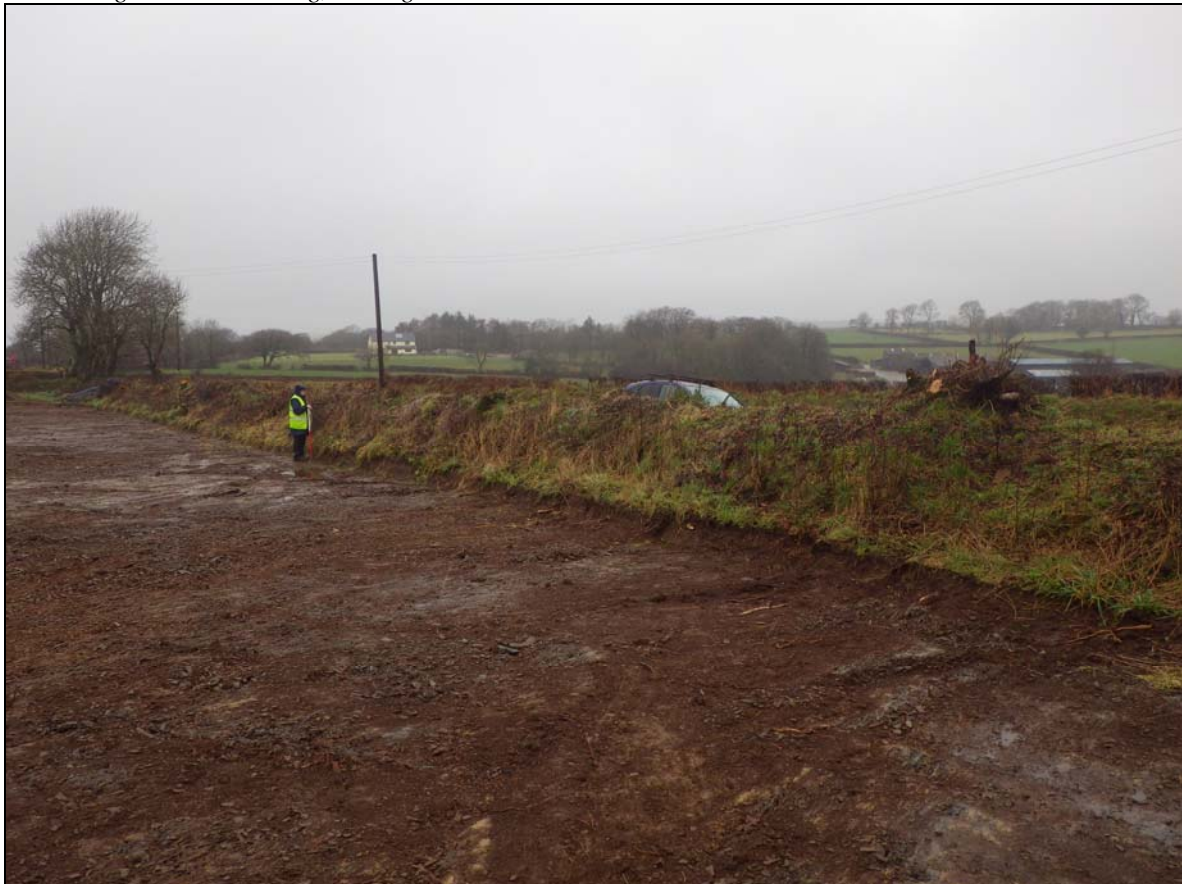
Plate 6: TNB2015_106: Eastern side of the development area, boundary bank to be breached for access, looking north northeast

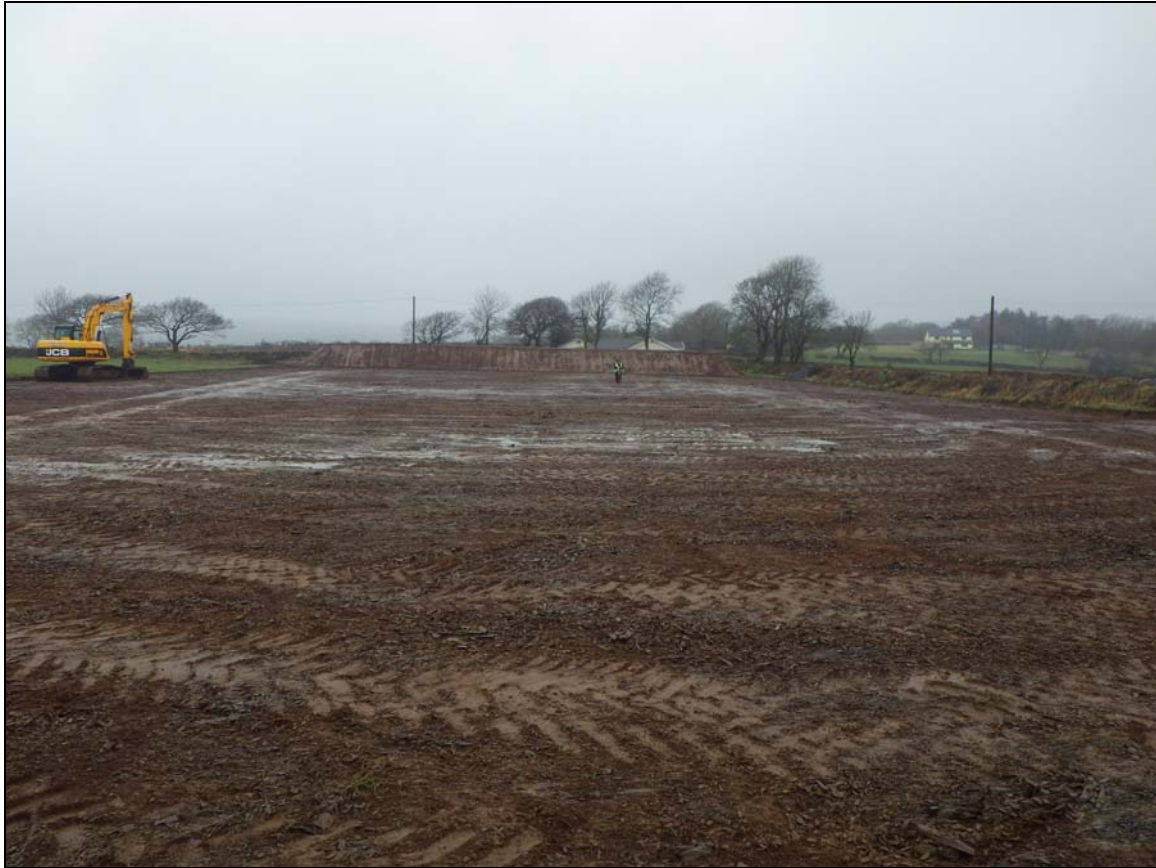
Plate 7: TNB2015_107: Development area fully stripped, looking north northwest.
