Upper House Farm, Painscastle Powys

Archaeological Watching Brief

By
Adrian Hadley BA (Hons) MA
Report No. 1272

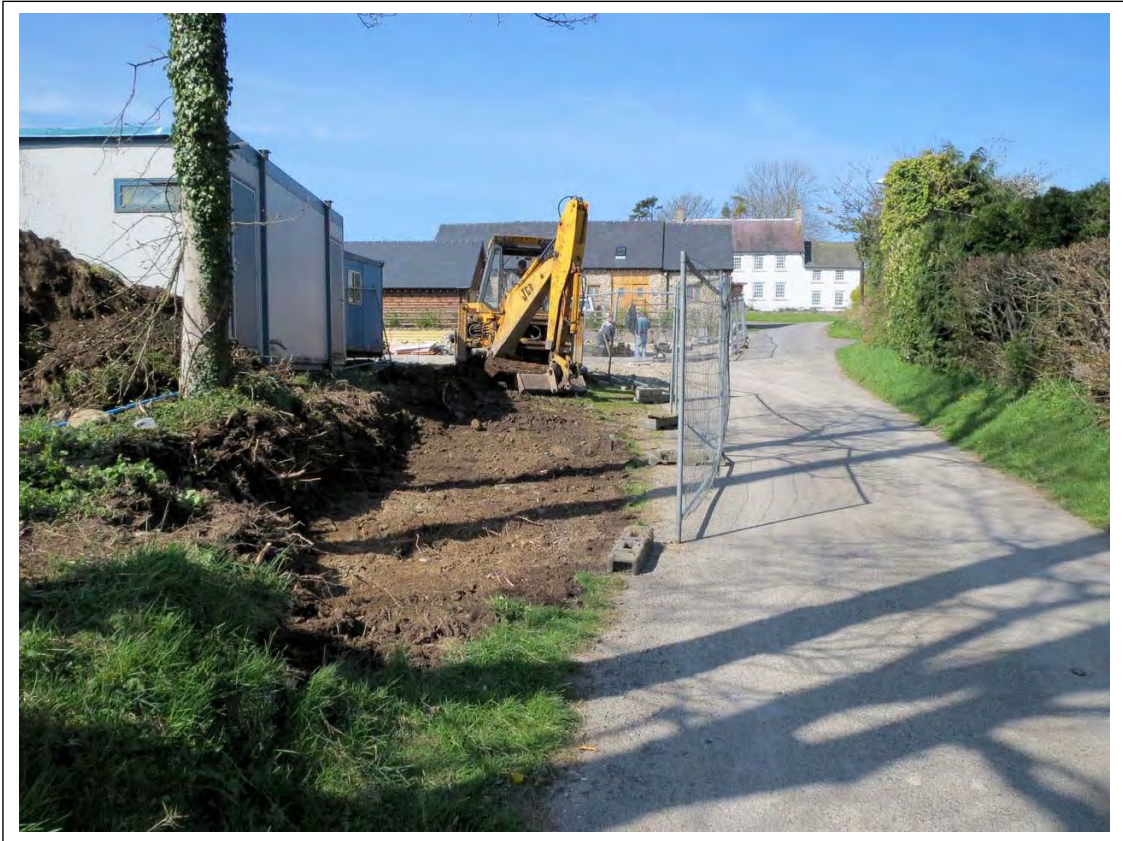
Plate 1. Working shot of the machine excavation, stripping topsoil (20) along the northern perimeter of the development site. Cruck Barn (built in stone) and Castle Farm (rendered and whitewashed) are shown in the background. Looking West.

- 3.1.1 The excavations were undertaken using a wheeled mechanical excavator (JCB 3CX) with a toothless ditching bucket. All machine excavation was under direct archaeological supervision and control (Plates 1&2).

- 4.1.1 The soil strip (Plates 1&2) along the northern side of the development site extended across an area some 20m long (east-west) and 3m across (north-south) with an additional 10m (east-west) excavation along the roadside narrowing to 1.2m wide (north-south). The soil sequence encountered comprised 10cm-62cm of topsoil (20), a dark brown humic silt, above a subsoil (29) of mottled orange and grey-brown gravelly silt. Between 38cm and 63cm of the (natural) subsoil was excavated in successive level spits of approximately 5cm. The stratigraphy is shown in Sample

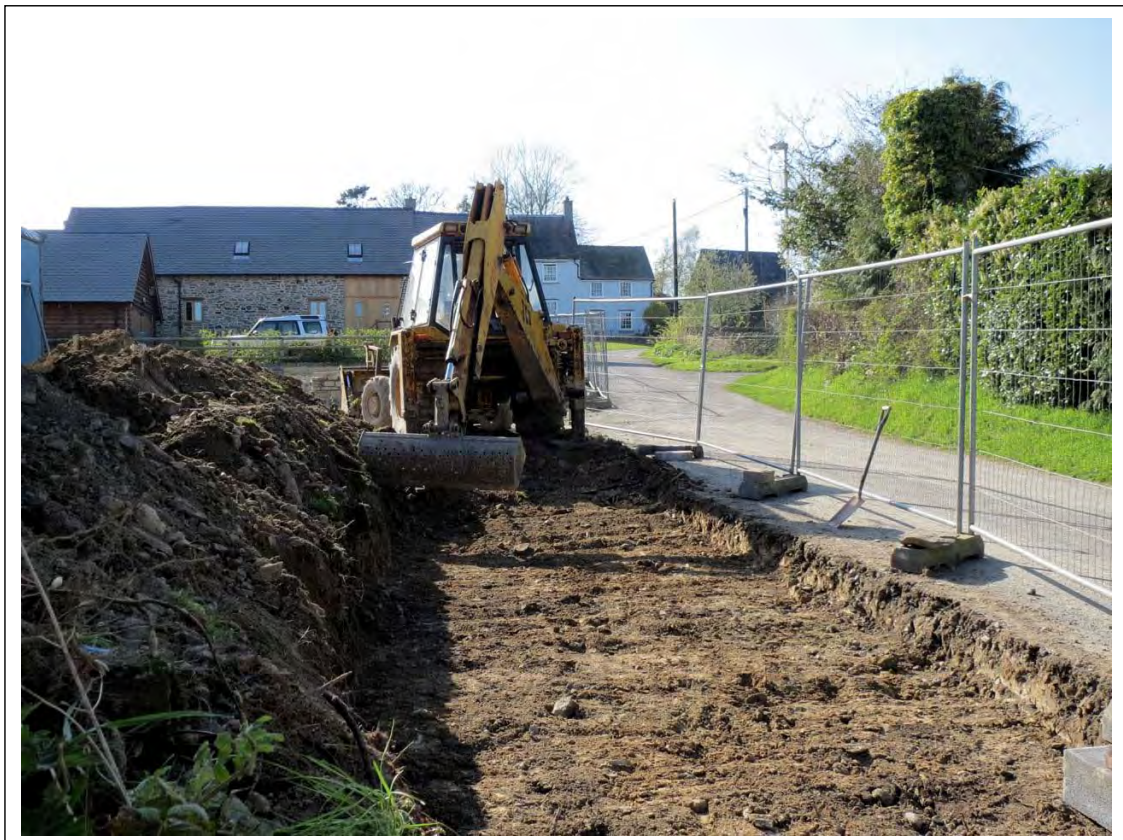
Plate 2. Working shot of the soil strip down to natural subsoil, a light grey-brown silt (29). Looking West.

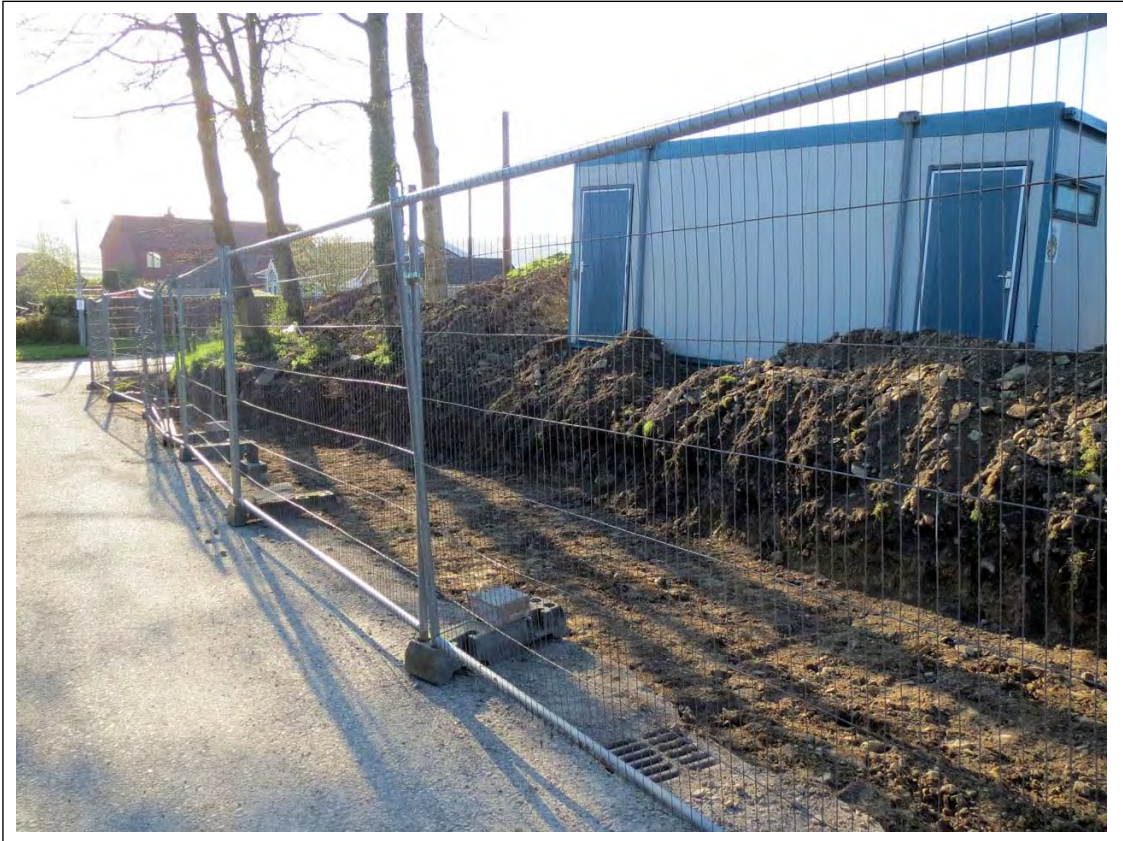
Plate 3. General shot of the excavation along the northern site boundary following the soil strip. Looking East-South-East.

- 4.1.2 No features or stray finds were identified during the soil strip along the northern site boundary (Plates 3, 4 & 8).
- 4.1.3 The excavation extended up to the existing carriageway, allowing examination of the road construction running from the village thoroughfare up towards the Castle (as well as Upper House and Castle Farm). A 25m long section was cleaned by hand to expose a layer of compacted stone (27) below the modern road surface (21). The recorded stratigraphy comprised approximately 5cm of tarmac (21) overlying a sub-base of sub-angular to sub-rounded medium and coarse siltstone or mudstone gravel (27). The latter was recorded as 8cm-10cm thick. The excavation exposed 20cm-25cm of (natural) subsoil (29). These deposits are shown in Sample Section 2 (Plate 10).

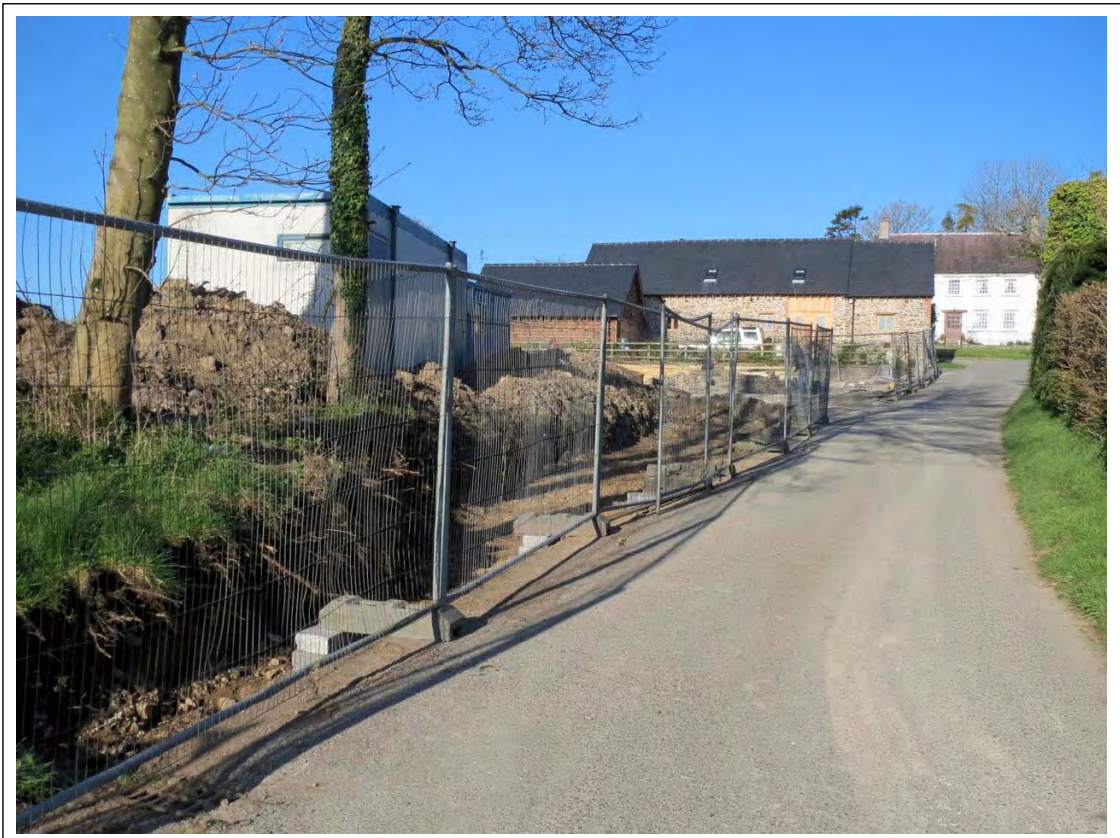
Plate 4. General shot of the excavation along the northern site boundary following the soil strip. Looking West-South-West.

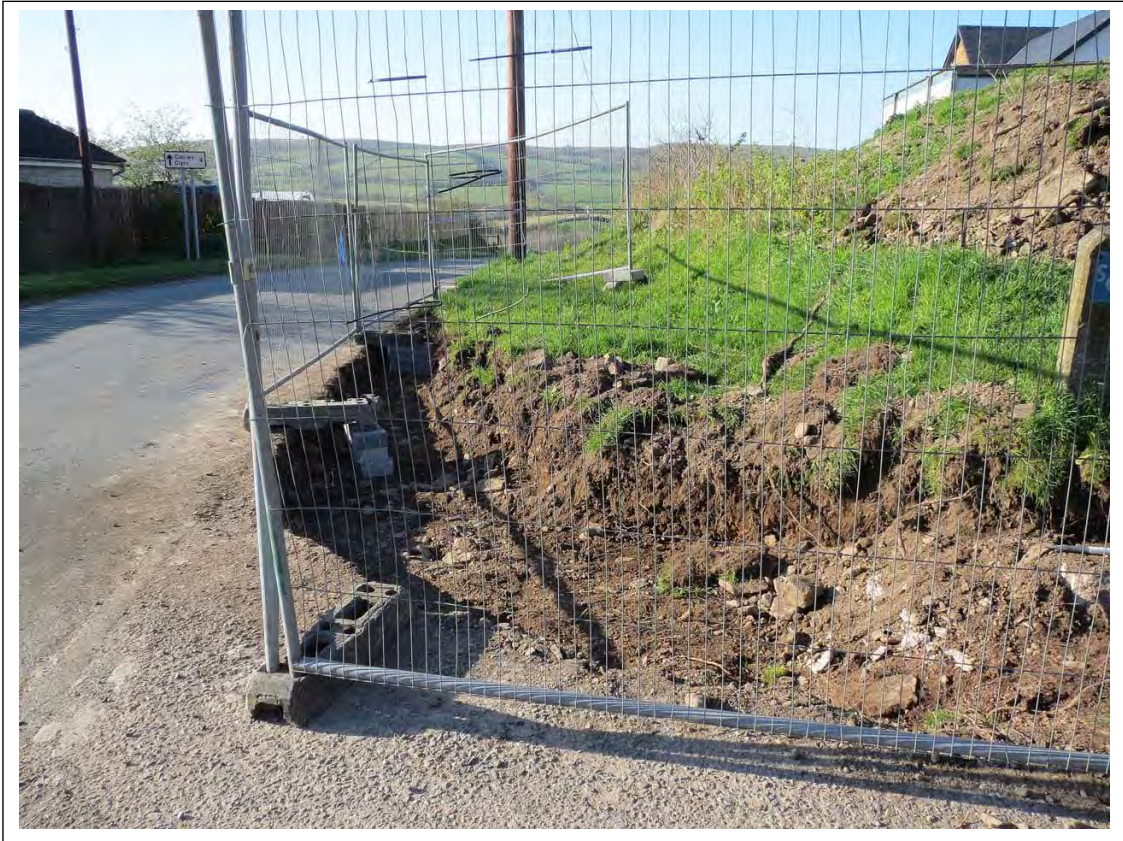
Plate 5. General shot of the excavation at the north-east corner of the site, showing stone rubble (24) below the topsoil (20). Looking South.

- 4.2.1 The soil strip along the eastern side of the development was approximately 6.6m long and 0.7m-1.6m wide (Plates 6&7). A considerable quantity of stone rubble (24) was identified during the excavation (Plates 5&11). This area was hand excavated to expose *in situ* stone foundations (25) about 33cm below the level of the road surface and 70cm below the top of the earth bank along the verge.

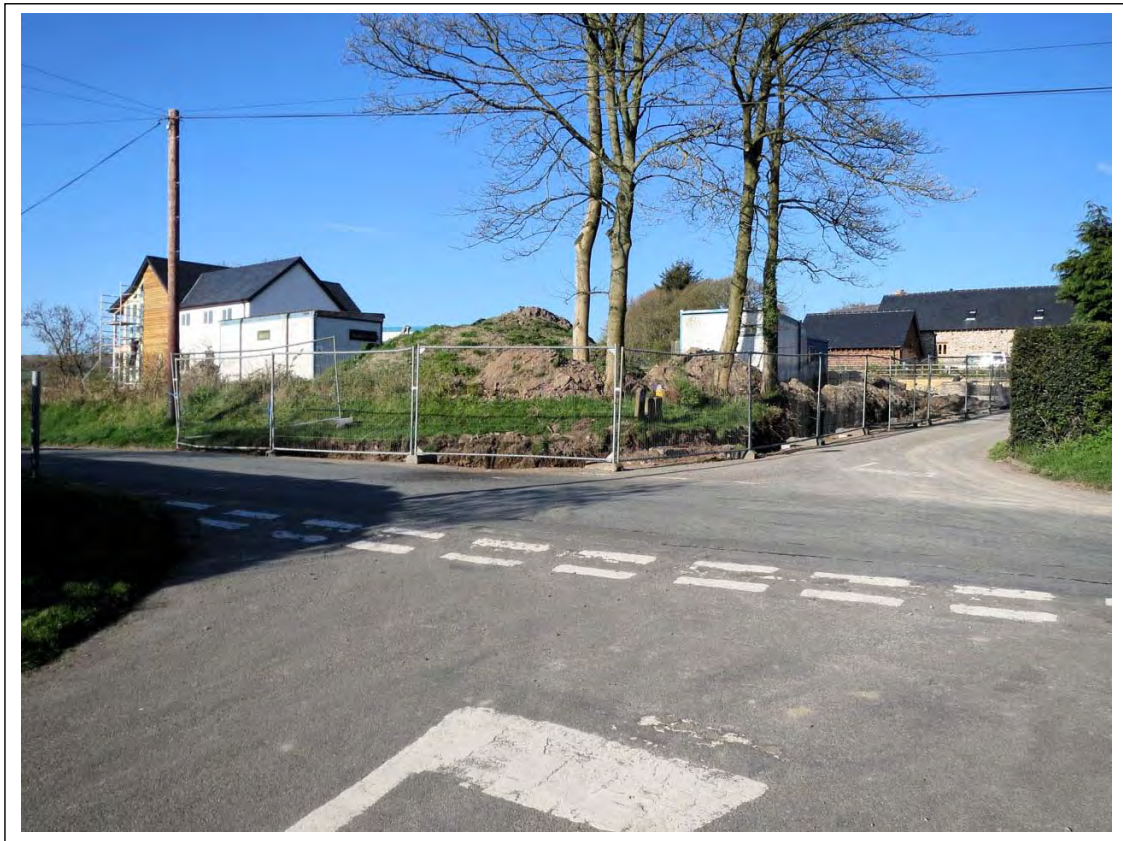
Plate 6. General view of the excavation area. Looking South-West.

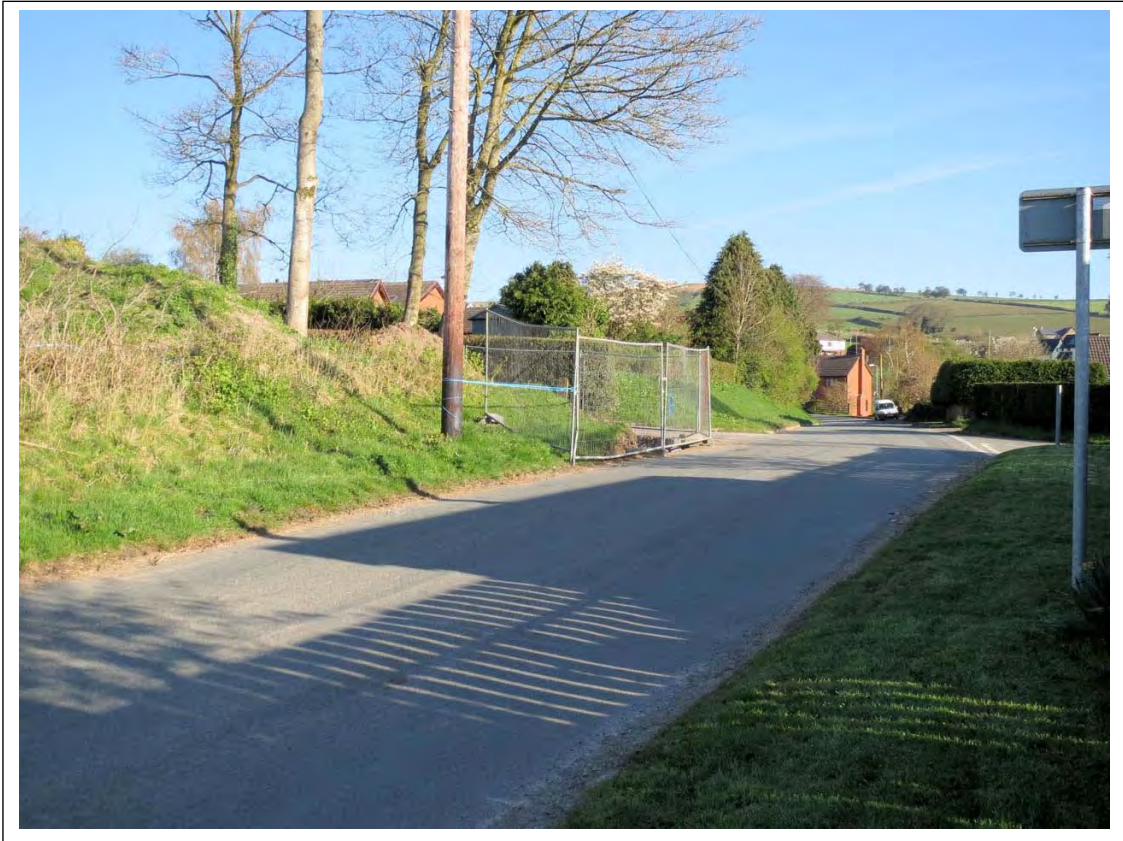
Plate 7. General view of the north-east corner of the development site. Looking North-West.

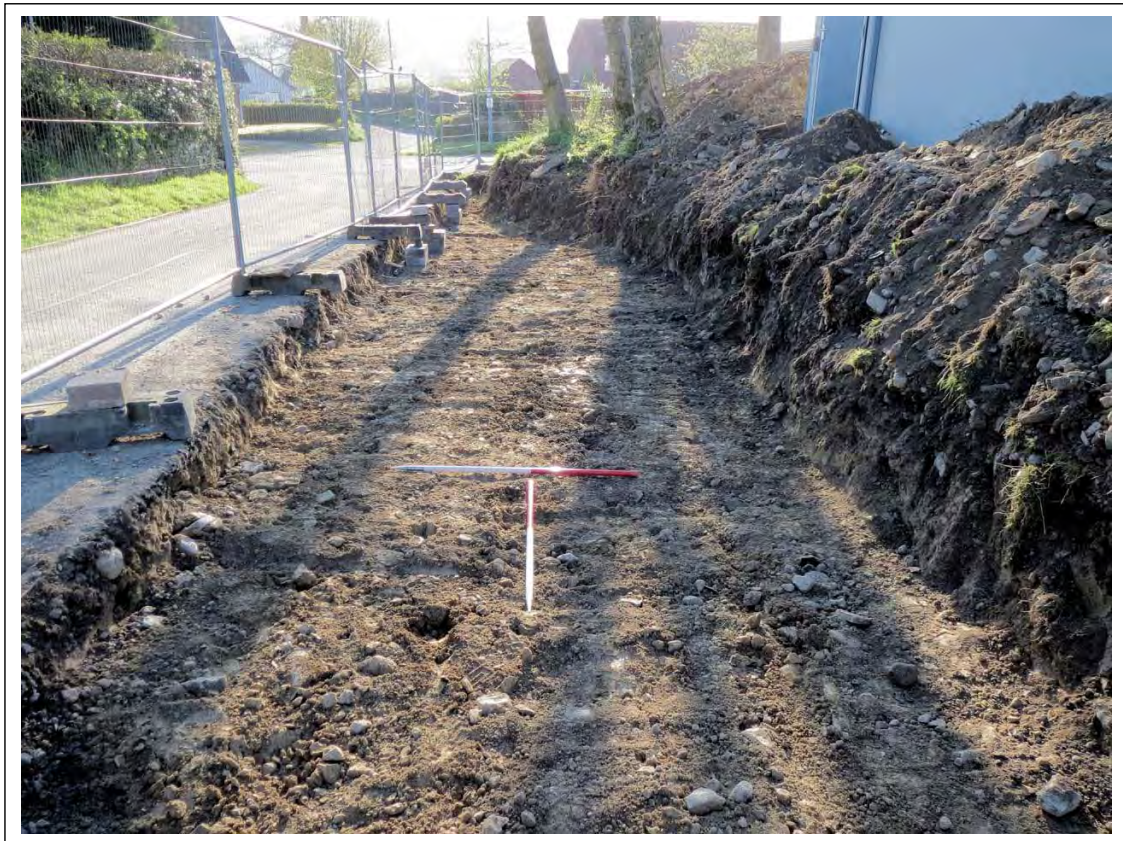
Plate 8. Post-excitation shot of the soil strip down to the silt subsoil (29) along the northern site boundary. Scales: 2 x 1m. Looking East.

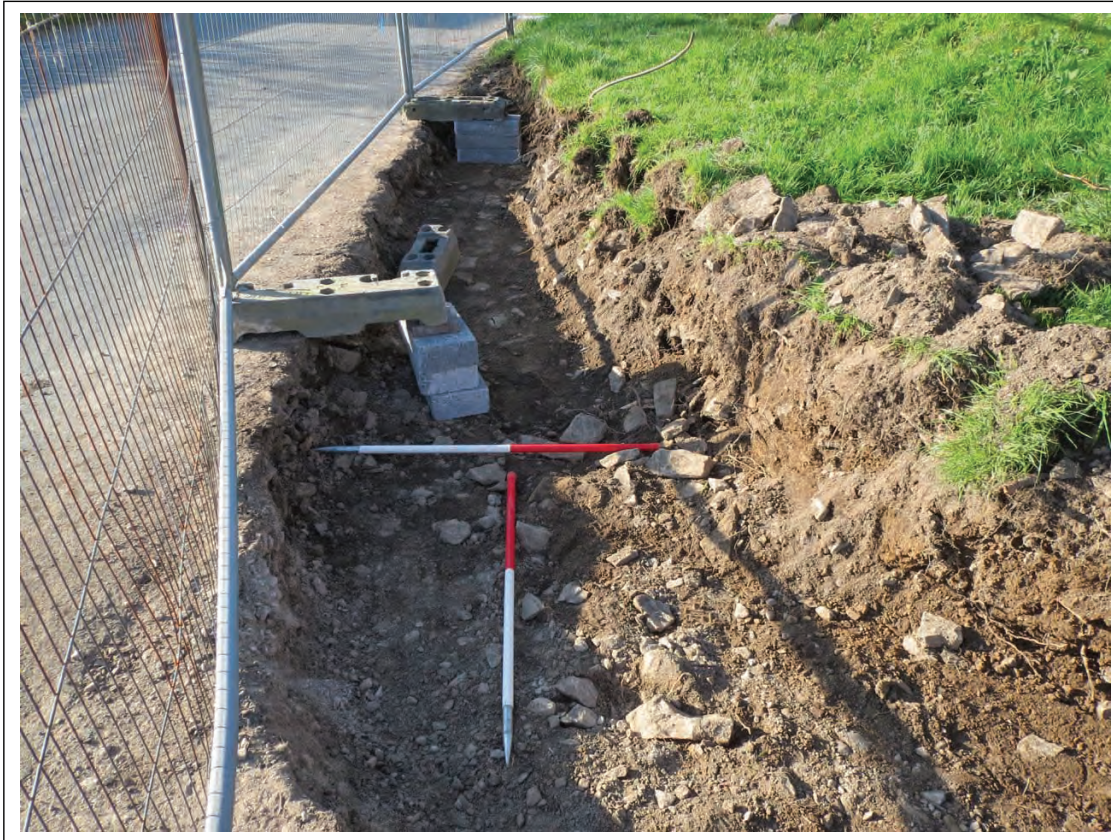
Plate 11. Post-excitation shot of the soil strip on the road junction at the north-east corner of the site, showing stone rubble (24) derived from the historic collapse or demolition of a post-medieval building (marked on the tithe map). Scales: 2 x 1m. Looking South.

- 5.1.5 The stone rubble (24) recorded above the *in situ* foundations (25) [26] represents material from the walls of the former building on this site. The map evidence indicates this structure has collapsed or been demolished at some point over the past 110 years. It should be noted that no traces of mortar were identified within the rubble layer (24).

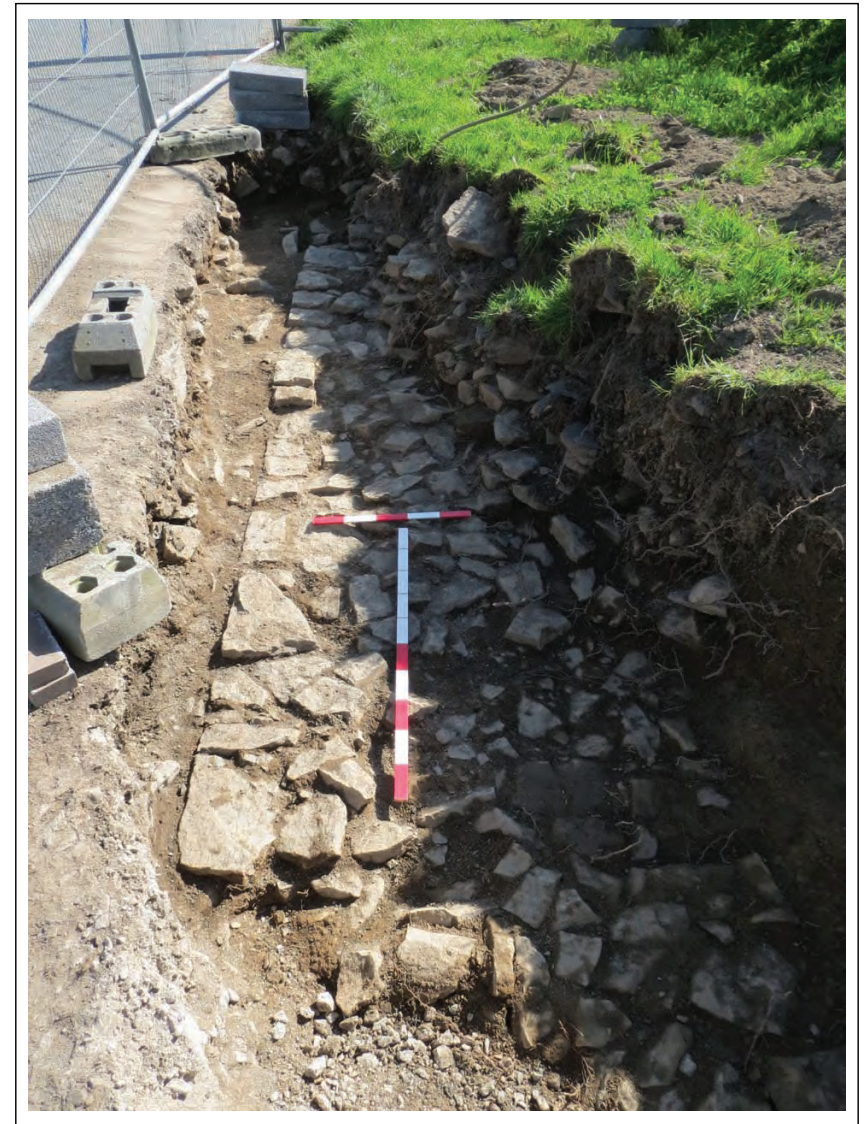
Plate 12. Post-excitation shot of stone foundations (25) at the north-east corner of the site. Scales: 1 x 0.5m & 1 x 1m. Looking South.

- 4.2.3 The stone foundations (25) [26] were encountered at approximately 260.70m OD. These comprised sub-angular cobbles and boulders of sandstone or siltstone. The stones were bedded into the subsoil and not mortared. This structure [26] was noted to be 1.24m wide (east-west), extending below the earthen bank, and over 4.96m long (north-south), extending southwards beyond the trench (Plates 12&13). The foundations were truncated to the north (Plates 14&15) by a modern service trench [23] backfilled with imported crushed stone (22).

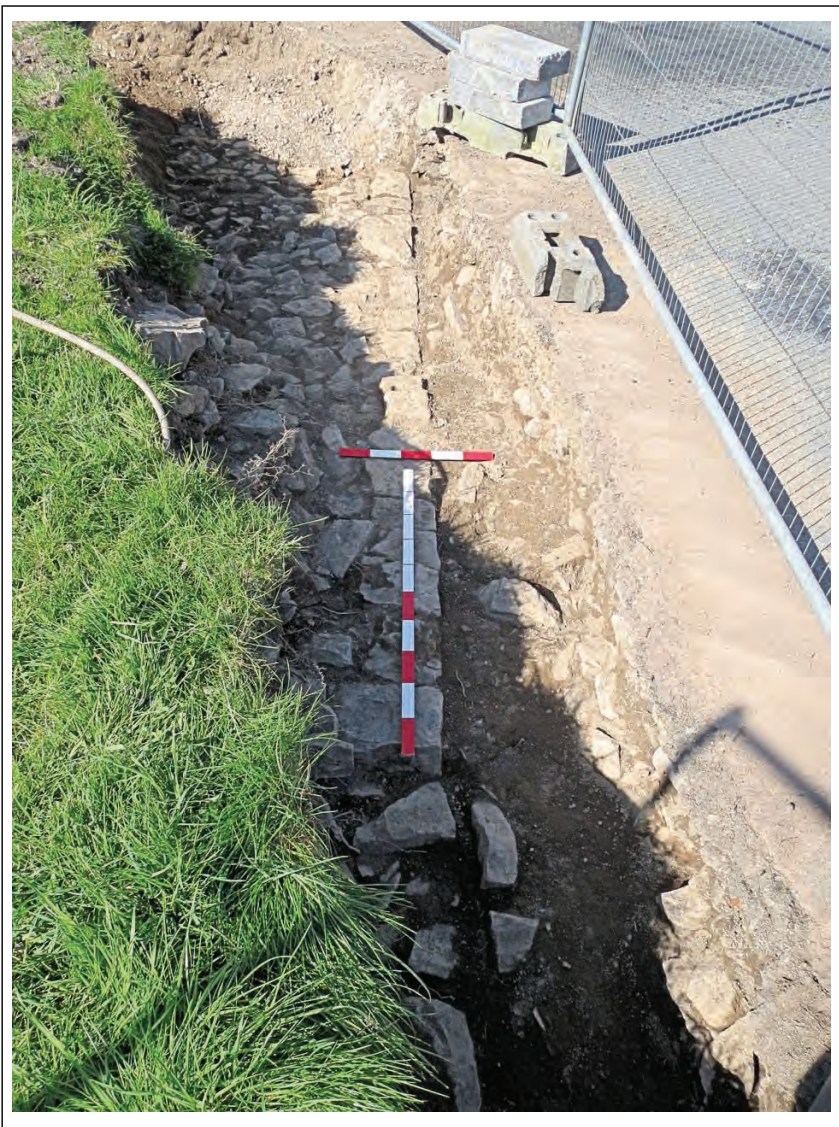
Plate 13. Post-excitation shot of stone foundations (25) at the north-east corner of the site. Scales: 1 x 0.5m & 1 x 1m. Looking North.

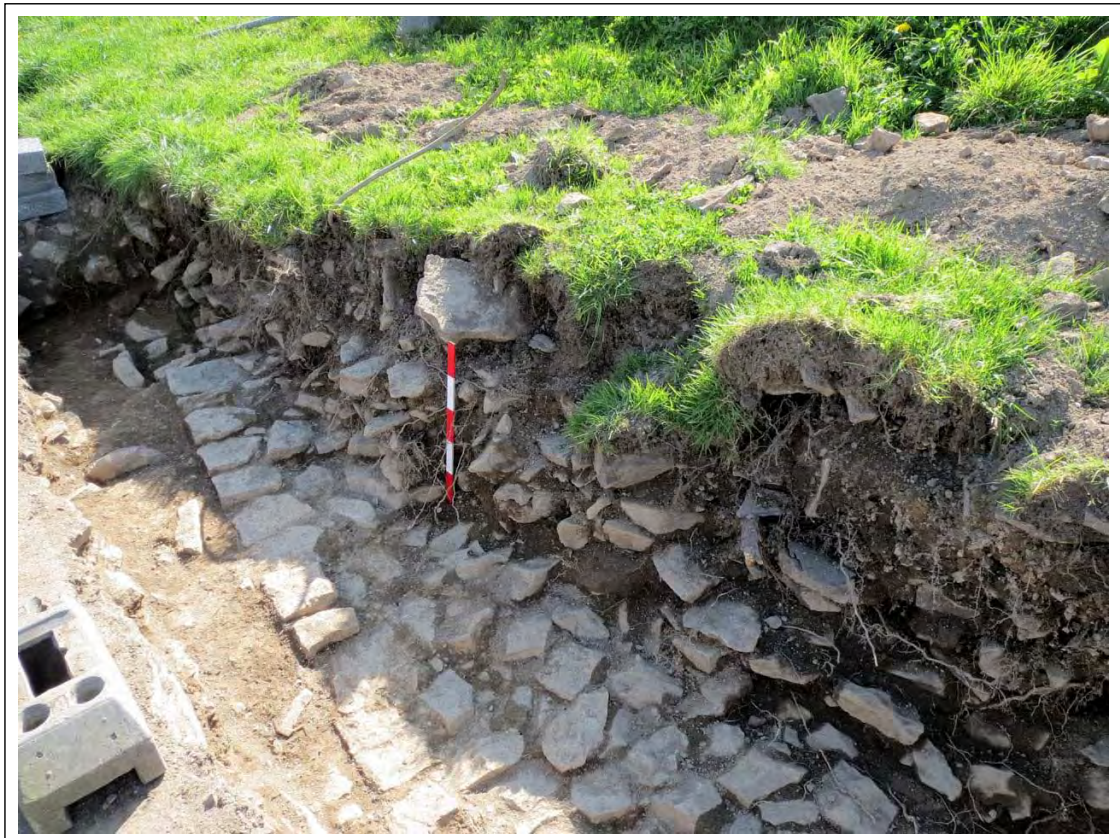
Plate 16. Oblique view of Sample Section 3, showing stone rubble (24) above *in situ* foundations (25). Scales: 1 x 0.5m. Looking South-South-West.

- 4.2.2 The stratigraphy comprised about 5cm-10cm of topsoil (20) above stone rubble (24) recorded as 60cm-65cm deep. The rubble extended over 4m, continuing southwards beyond the limit of excavation (Plates 16&17). The layer (24) consisted of sub-angular cobbles and boulders of sandstone or siltstone within a soil matrix of loose dark brown humic silt (topsoil). This overlay *in situ* stone foundations (25). The stone rubble is shown in Sample Section 3 (Plate 16).

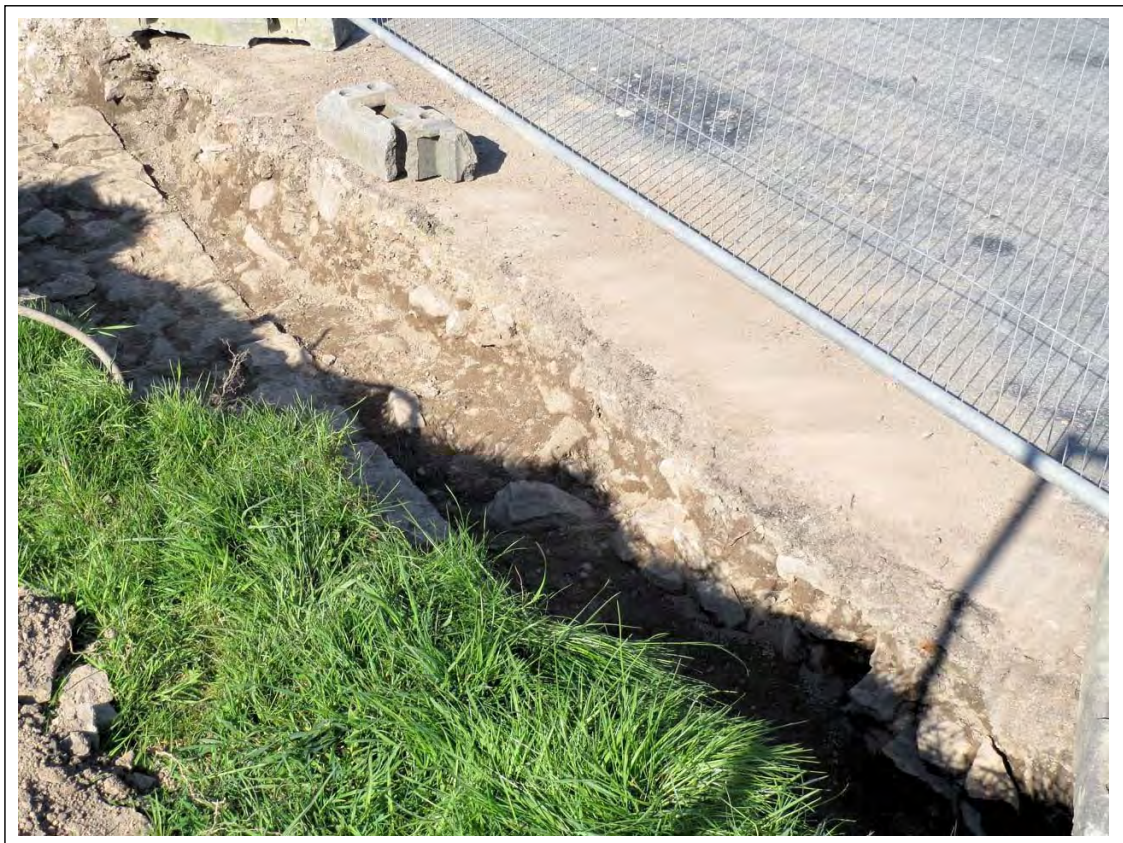
Plate 18. Oblique view of the road construction along the eastern site boundary, showing a layer of compacted stone (28) below the tarmac (21). Looking North-North-East.

- 4.2.4 No finds were retrieved during the hand excavation of the rubble layer (24) or the stone foundations (26).
- 4.2.5 The excavation extended up to the existing carriageway, allowing examination of the road construction along the village thoroughfare (Plate 18). This is the road running southwards from Painscastle village. A 5m long section was cleaned by hand to expose a layer of compacted stone (28) below the modern road surface (21). The stratigraphy comprised approximately 5cm of tarmac (21) overlying a sub-base of sub-rounded coarse siltstone/mudstone gravel and cobbles within a soil matrix of mid brown gravelly silt (28). The latter was recorded as 27cm-32cm thick, in most places continuing below the limit of excavation. This deposit also extended within the excavation area (beyond the present carriageway). The boundary between the compacted stone (28) and the subsoil (29) was diffuse; the gravelly sub-base layer

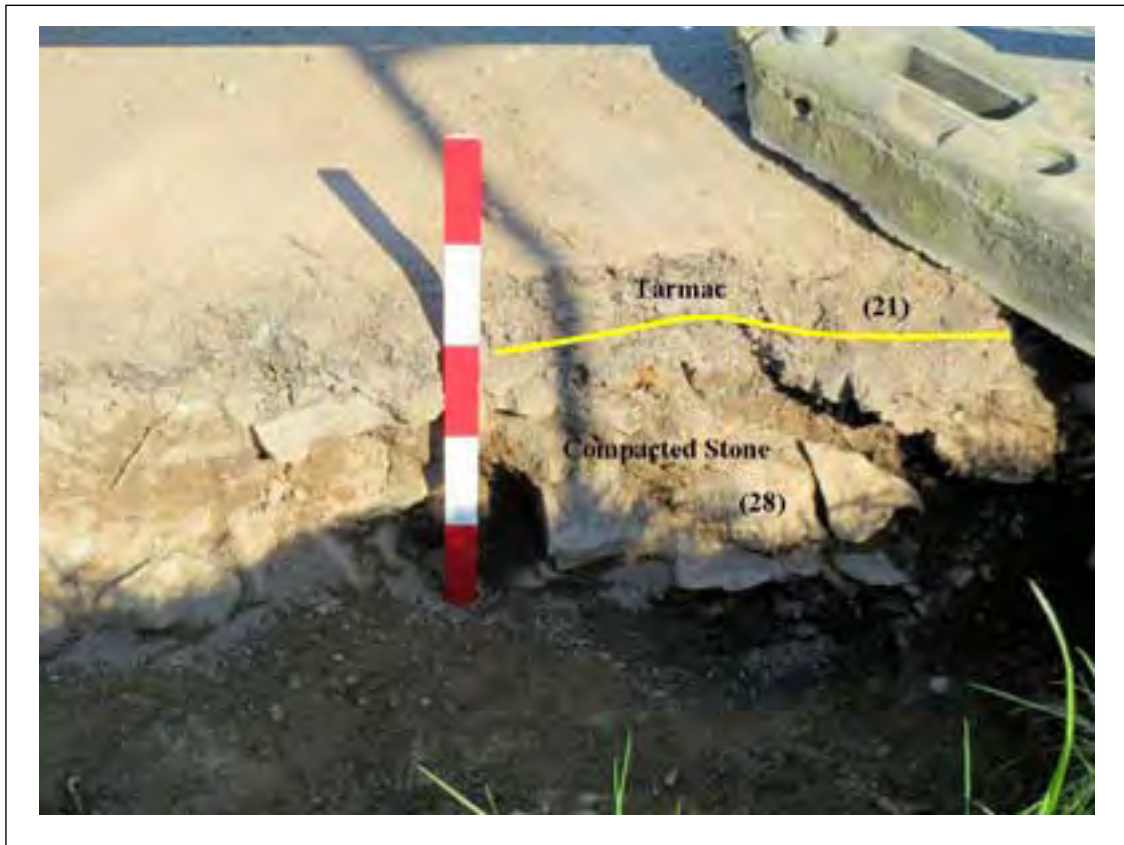
Plate 19. Sample Section 4 (facing west). Partly annotated photograph showing 5cm of tarmac (21) overlying 27-32cm of compacted stone (28). Scales: 1 x 0.5m. Looking East.

appeared to derive from the natural deposits of siltstone and mudstone encountered within Painscastle. These deposits are shown in Sample Section 4 (Plate 19).

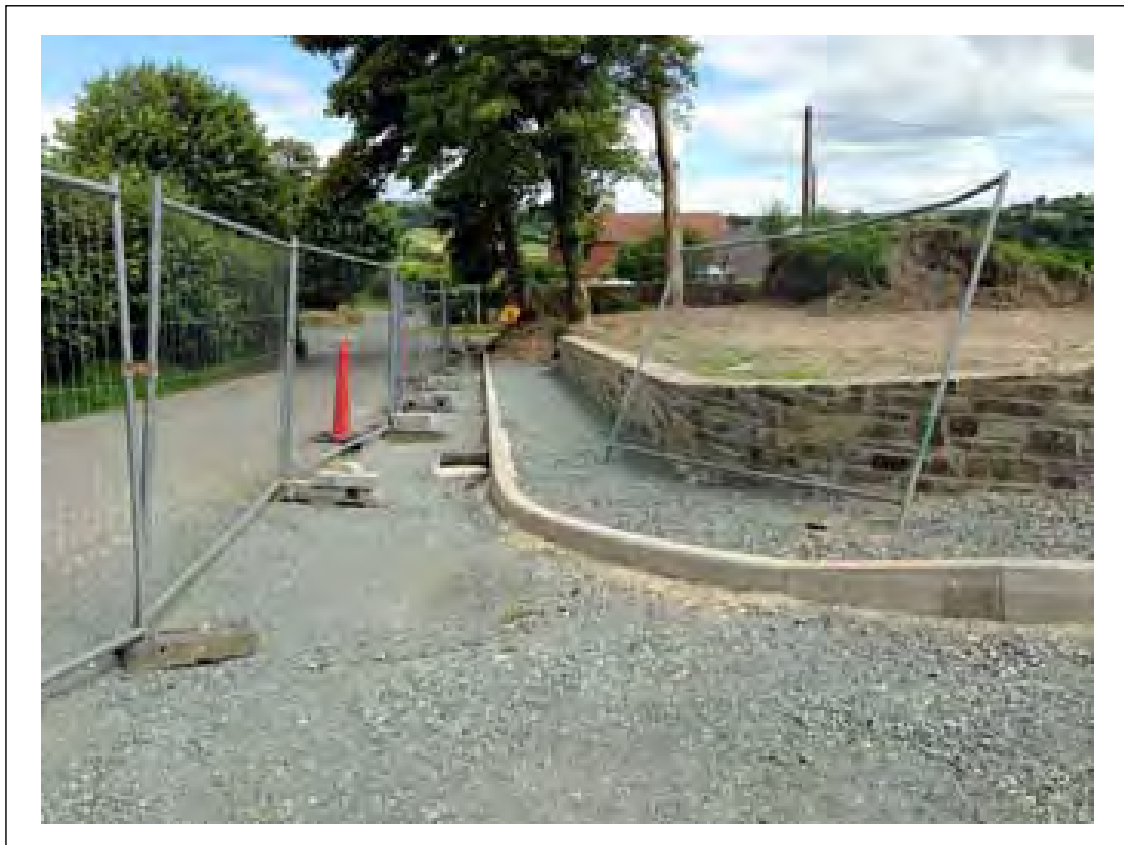
Plate 20. View of the new access, pavements and road kerb for the widened roadway to the north of the development site. Looking East.

- 5.2.2 The stone foundations were recorded then subsequently preserved *in situ*; the foundations were covered with a layer of sand and then sub-base material (in order to widen the carriageway adjacent to the development). The earth bank was subsequently reinstated (Plates 20&21).

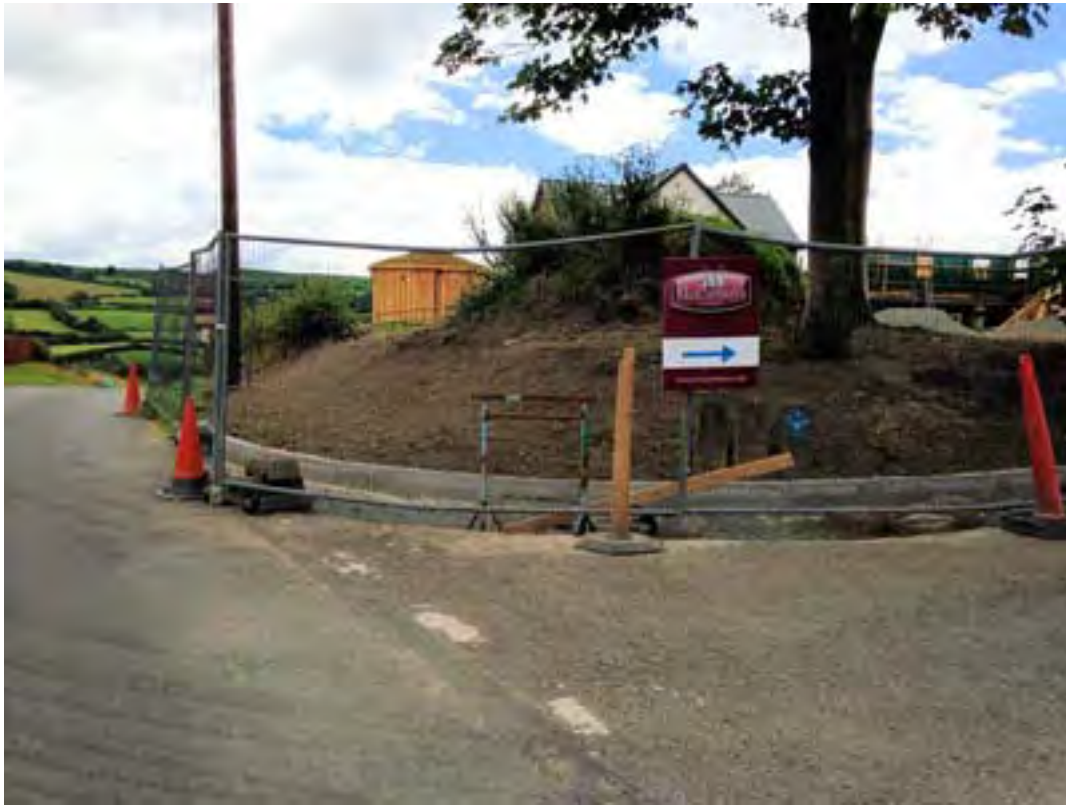
Plate 21. View of the new road kerb at the north-east corner of the site. The remains of the stone-built structure identified in this area have been left *in situ* below the reinstated bank. Looking South-South-West.
