Porth-y-dwr, Rhuthin

Date of Survey: Nov 2013, Mar 2014

Porth-y-dwr, Ruthin, Denbighshire

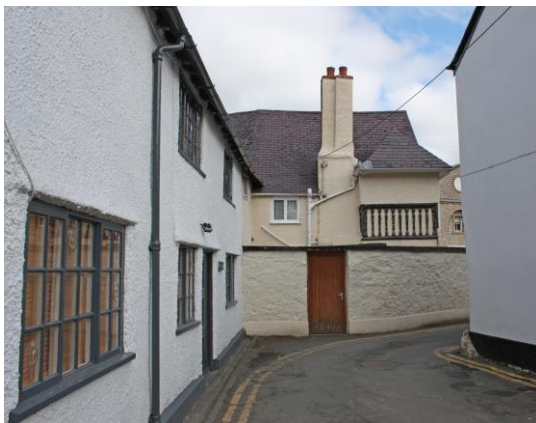
Fig.1a. DS2013_386_001

Fig.1a. View of hall/service bays to left and cross-wing beyond with 17th century first-floor balustrade balcony and chimneys, viewed from Mill Street. Fig.1b. East elevation and projecting balustrade balcony and later shop (2008).

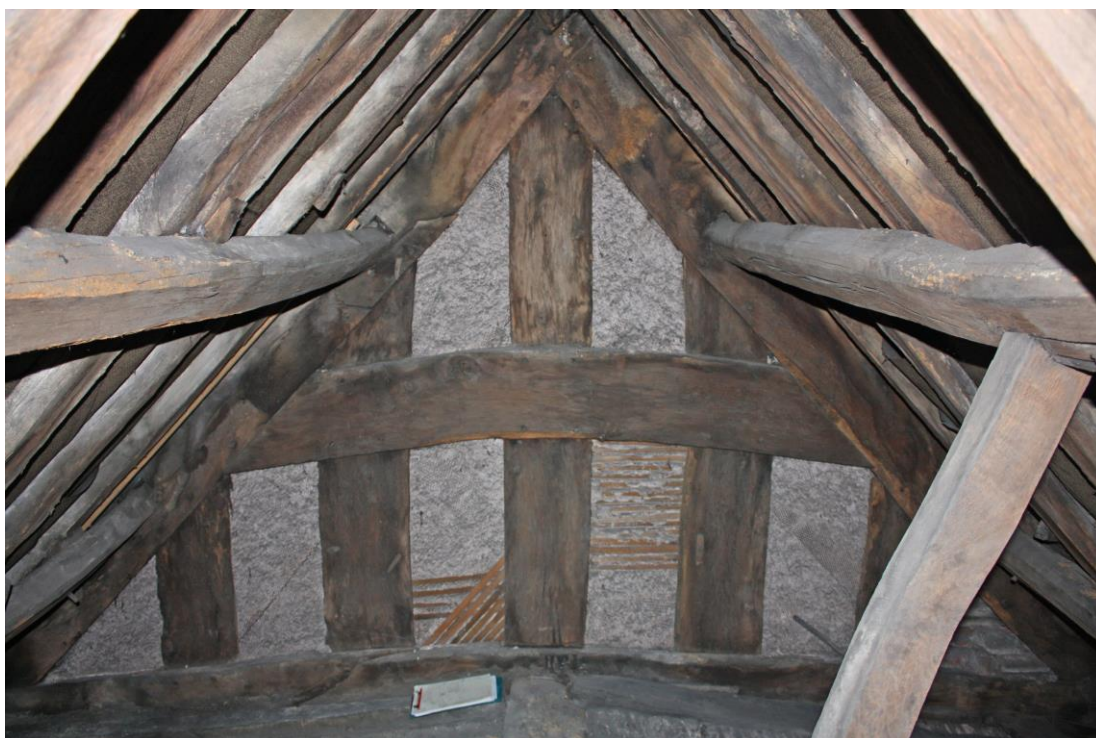
Fig. 3. Cross-wing, east gable-end. DS2013_386_018

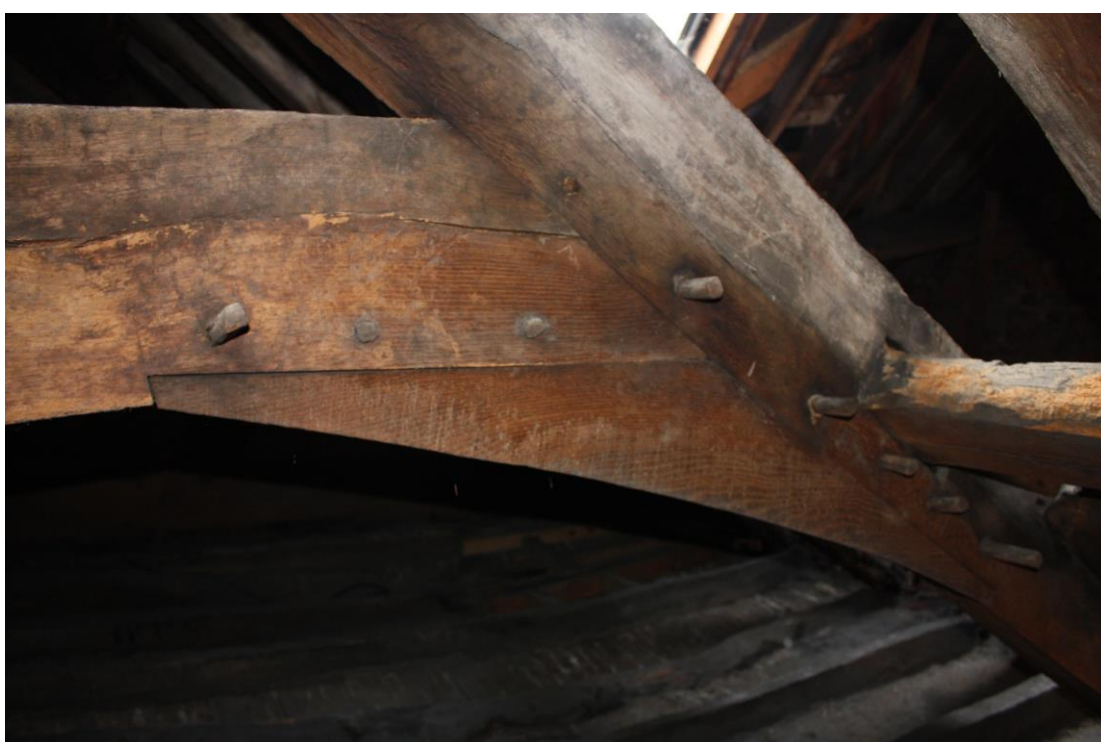
Fig.4. Cross-wing arched-brace. DS2013_386_023

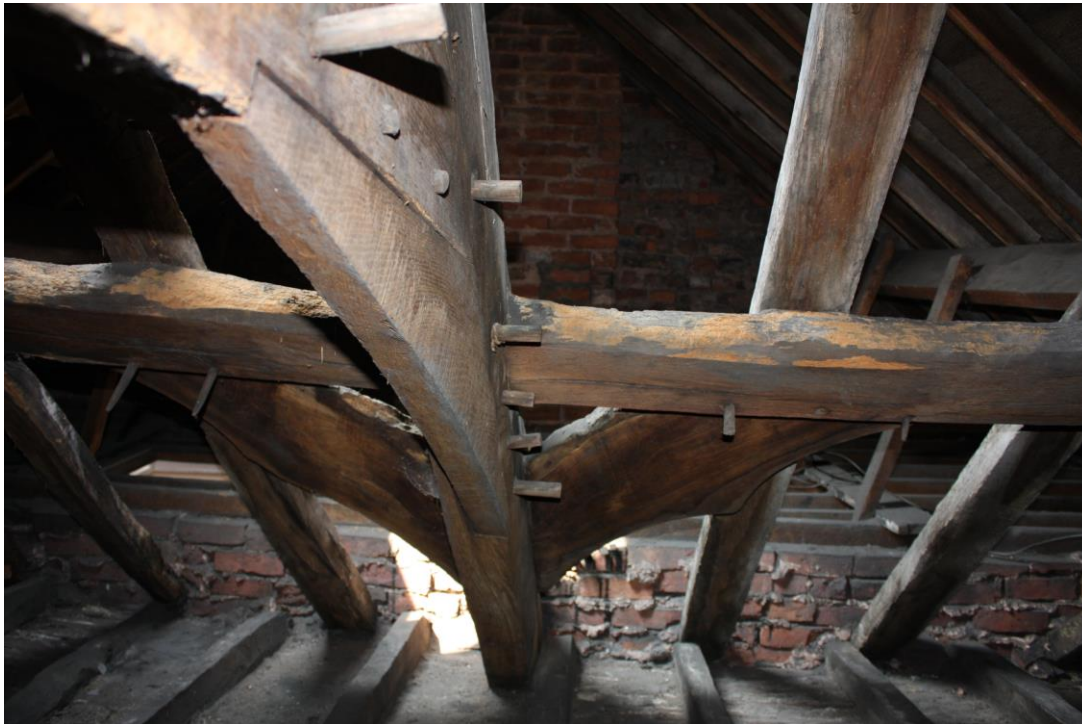
Fig. 5, Cross-wing arch-braced truss and wind-braces (note projecting pegs). DS2013_386_016

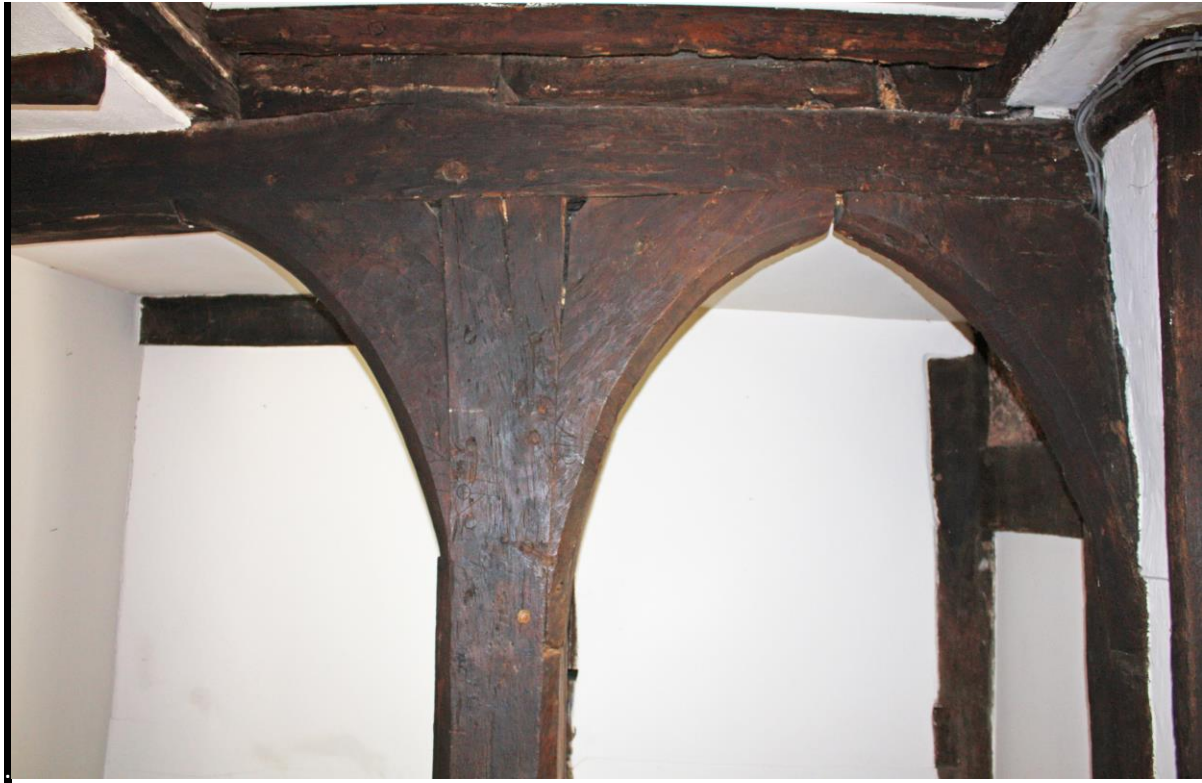
Fig. 6. Dais-canopy, view from hall with doorway to right providing access to shop bay and parlour behind, through the blocked dais-partition behind. DS2013_386_004

The cross-wing's west end two-bay part against the hall has been partly removed by 19th century reworking but its cut-back central closed truss partly survives with studs between a collar and tie-beam. At ground-floor facing the hall the elaborate dais-canopy with chamfered arch-braced, beam and dais-partition behind, survive as part of the cross-wing's framing. The open hall is separately framed, but as the dais-canopy is within the cross-wing framing it appears to confirm they are coeval. A chamfered gothic arched doorway, set to one side under the canopy beam, provides access to the parlour from the hall through a doorway in the dais-partition and to the shop bay via another doorway in the cross-wing central partition. These two doorways have plain, flat lintels with

chamfered jambs. The gothic doorway jamb has mortice and chamfer evidence for a low partition between its post and the dais-partition, which once separated the dais-bench from the passage-way.

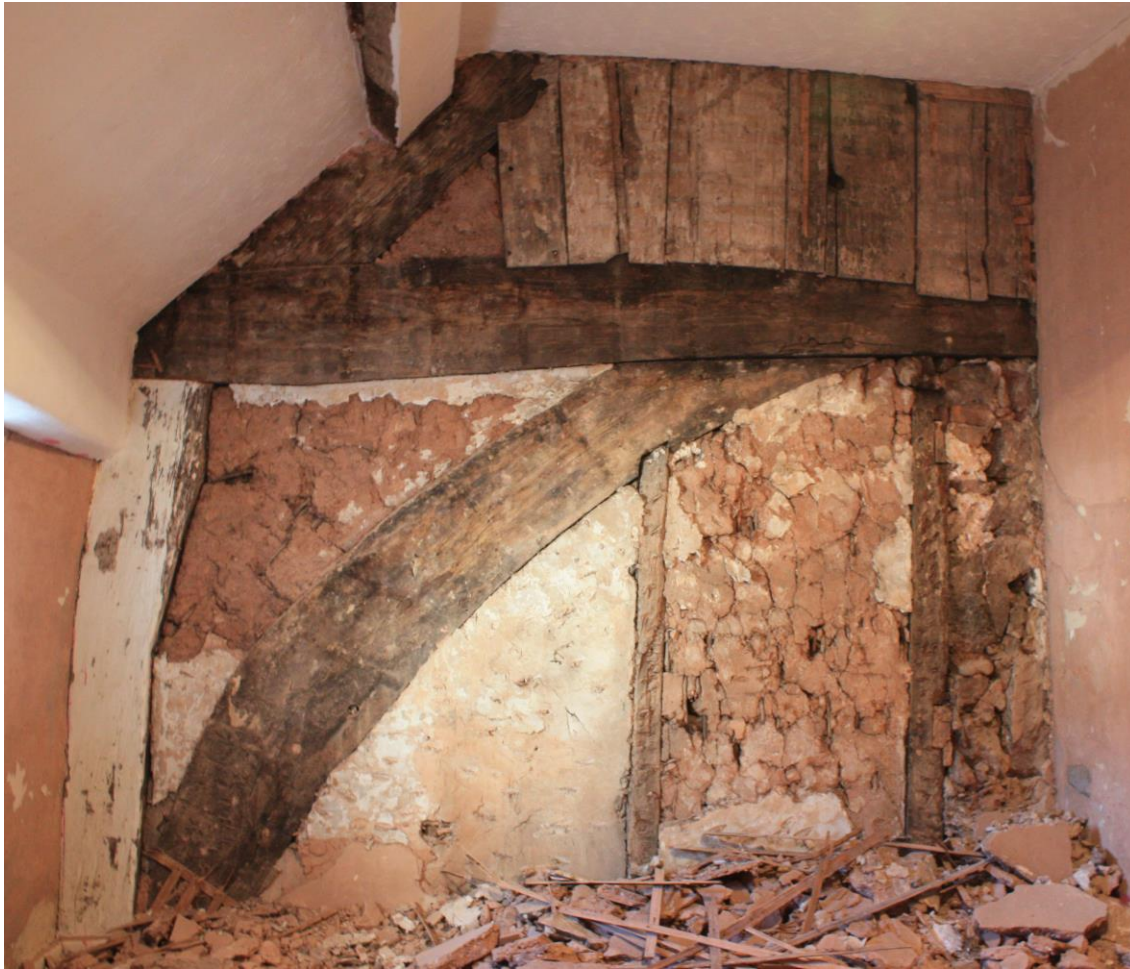
Fig. 8. Hall arch-brace.

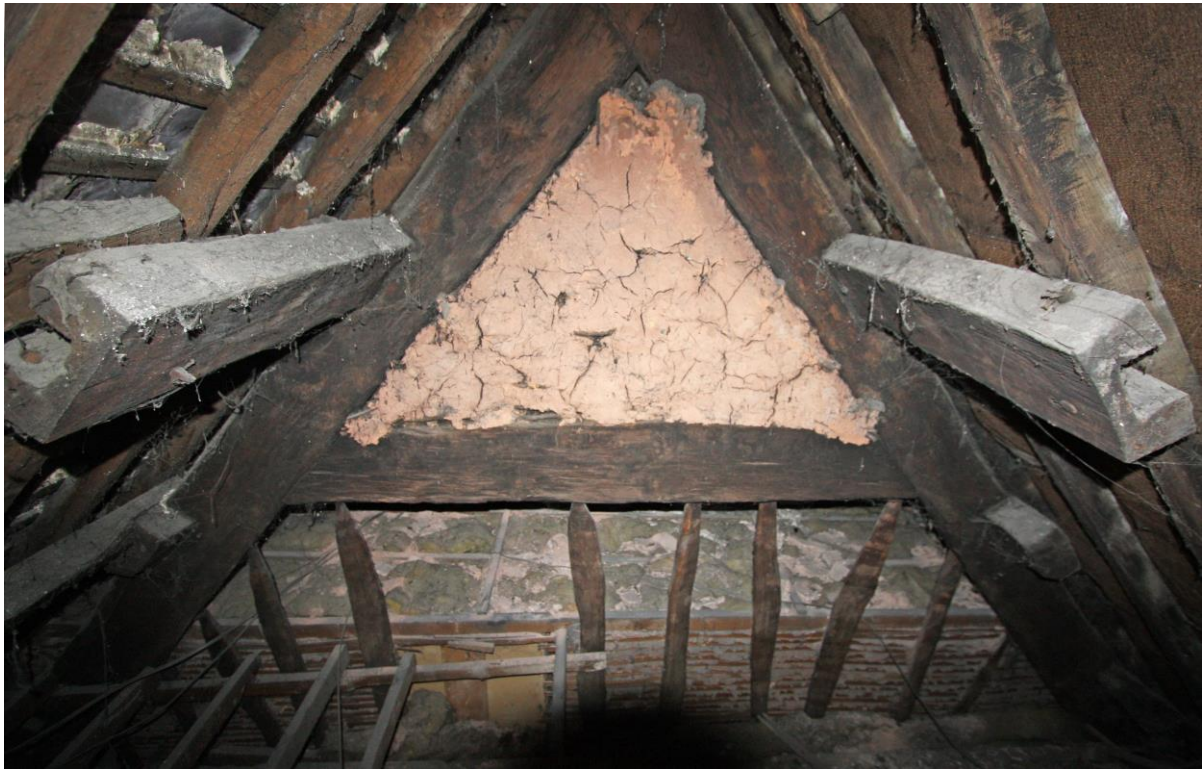
Fig. 9. Hall closed truss against cross-wing.

The hall's principal-post trusses are separately framed up against the cross-wing, and no assembly marks were visible at the time of survey. The dais-partition is set back into the cross-wing and has assembly marks similar to the rest of the cross-wing.
