Archaeological Desktop Study
of land at
**LLYNFI ROAD,
MAESTEG, SOUTH WALES.**
for
Morbaine Ltd.

Report No. 889/2001

Archaeological Desktop Study
of land at
**LLYNFI ROAD,
MAESTEG, SOUTH WALES.**

Centred on
N.G.R. SS 8500 9160

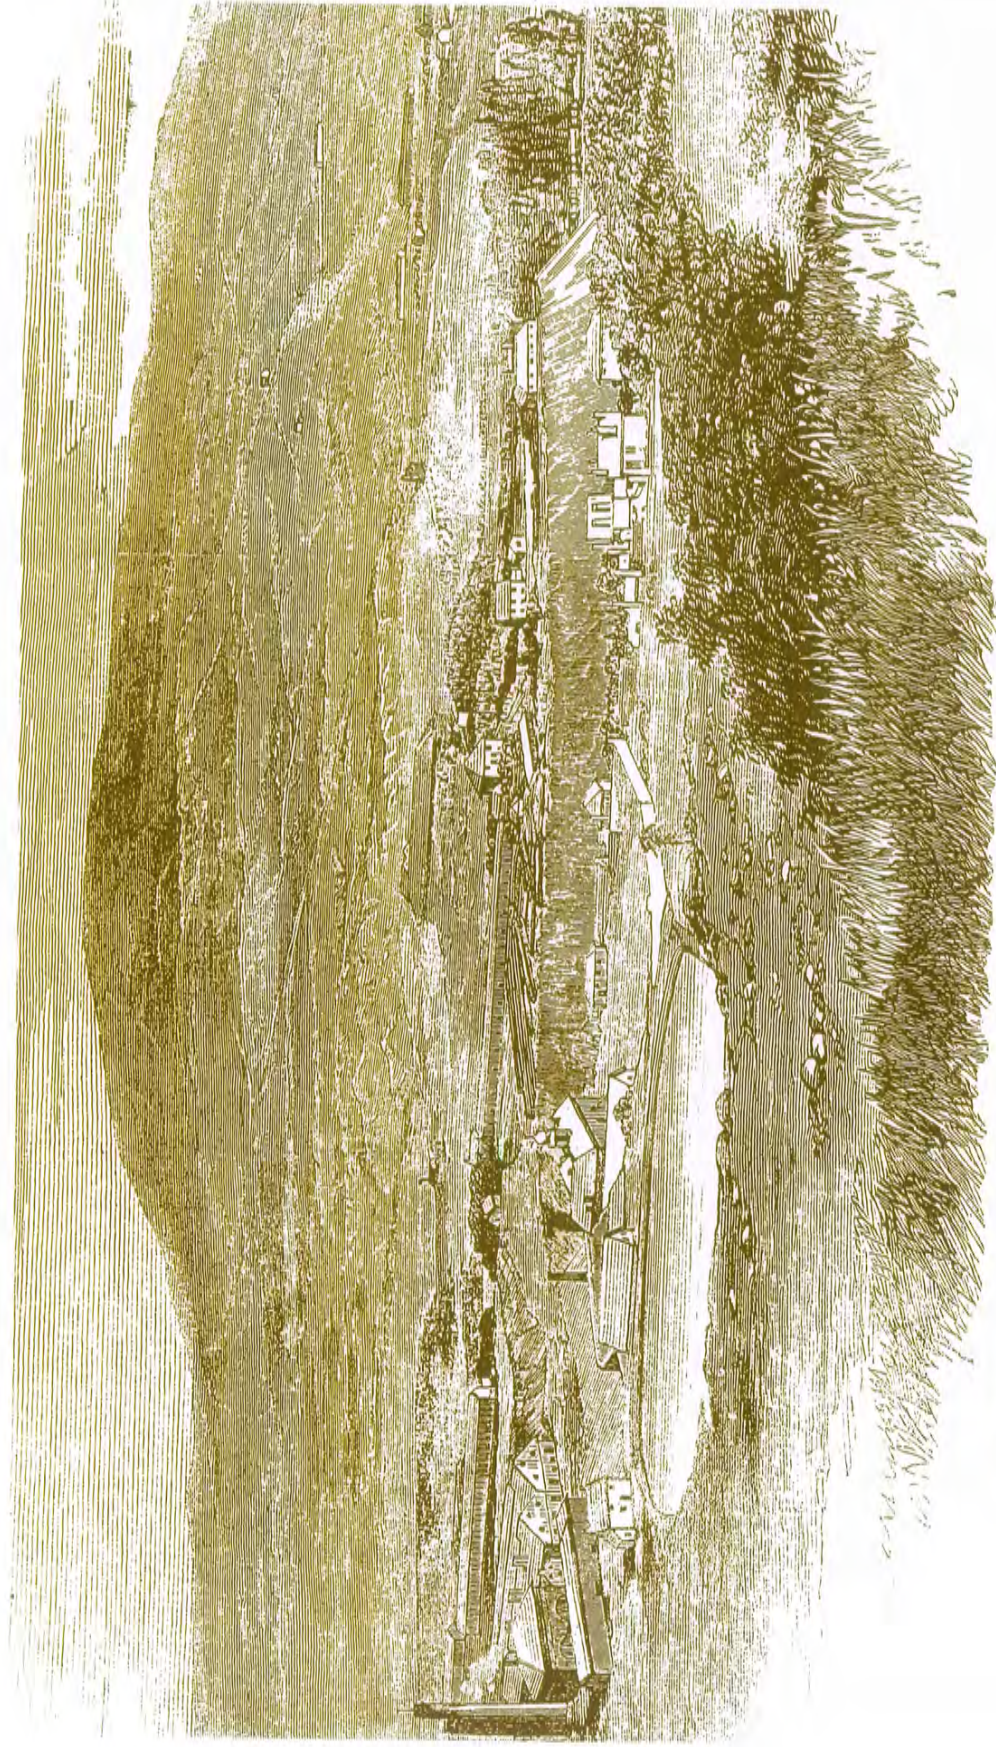
Fig.4 View across Llynfi Valley, 1858, present site on left

43 Taken from the Illustrated London News of July 15th 1858 this magnificent print shows the following (left to right) Llynfi Iron Works (Gwaith Newydd) with the blast engine-house (Corn Stores), Nant-y-Crynwydd Farm, Bryant's Pond (Works Reservoir). In the background are Cavan Row (formerly Cambrian Row), Talbot Terrace (formerly Puddler's Row), Zoar Chapel, Castle Hotel, Plasnewydd House; in the foreground are Llynfi Lodge (formerly Bowrington Lodge) with the New Works School (formerly Bowrington School) adjacent

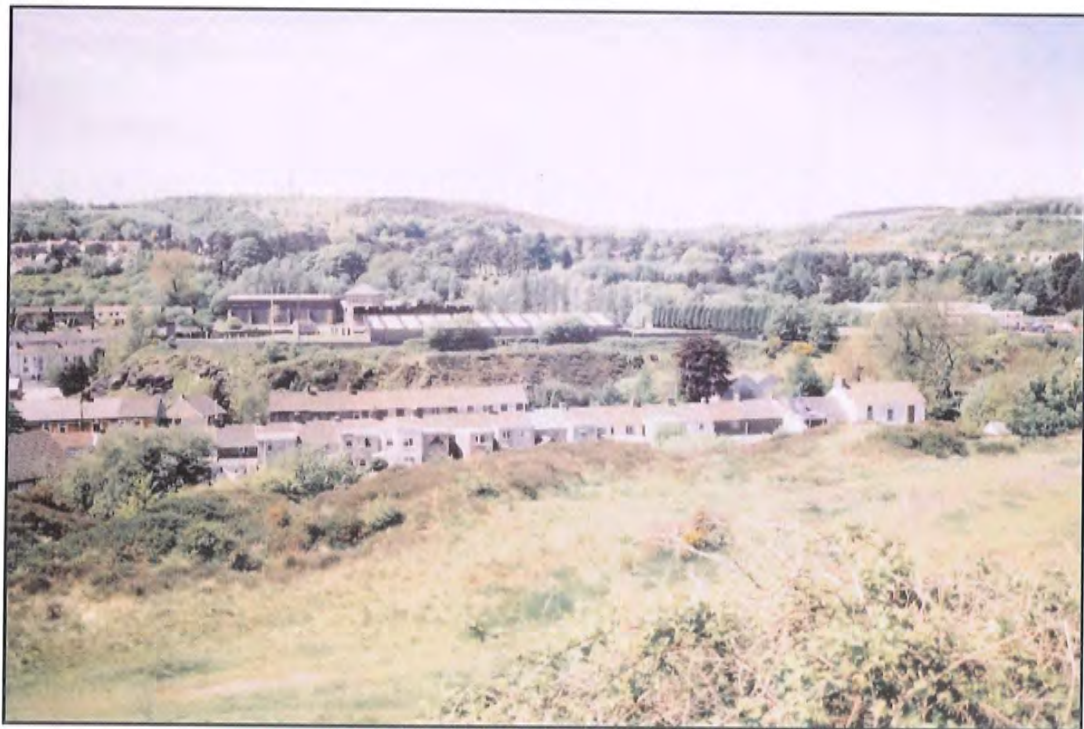
Plate 1 South-western part of the site, with blast furnace in background

- 2.5 Two modern industrial units stand adjacent to the northern boundary of the site (**Cover**). To their south is the Sports Centre car park, with, on the opposite side of the access road, a large gravel-surfaced car park (**Plate 1**). Close to the industrial units is a small concrete-block structure. North of the rugby ground is a practice pitch, illuminated by four lighting posts along its southern edge. Between there and the Llynfi River and Castle Street is a scrub-covered slope with occasional lumps of slag visible, some being of substantial size. The river is culverted at this point (**Plate 8**). Beyond the river is a two-storey double-pile house and outbuilding of nineteenth century date, although the dwelling has modern rendering, roofing and fenestration (**Plate 9**). There is a small rubble-built outbuilding with a slate roof to the north of the house. Some slag is visible in the steep grassy bank alongside the northern end of Llynfi Road. At the base of the bank are two brick arched features of unknown function, now bricked up (**Plate 10**). Parts of one of the original stone field walls survive nearby. North of the blast furnace a zig-zag path climbs to the open ground above to the west.

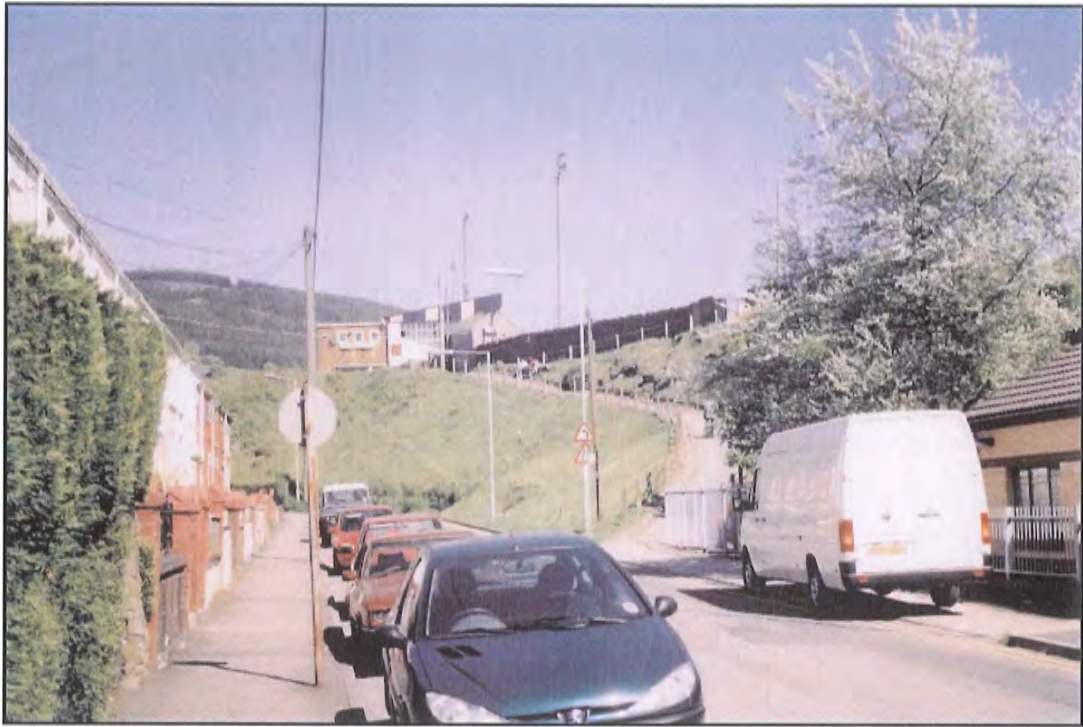
Plate 6 Former No.1 blast furnace

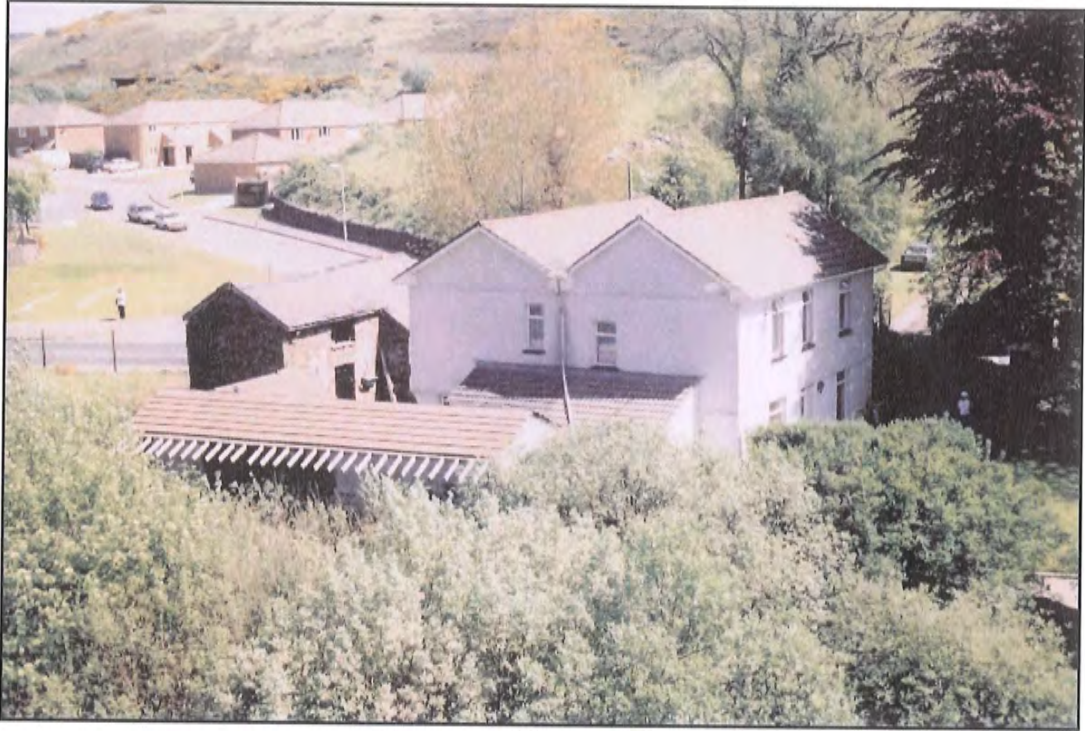
Plate 9 No.102 Castle Street, from the south-west

- 4.11 Alongside Castle Street on the strip between there and the river, currently lies no.102 (**Plate 9**). This is a house of mid- to late- nineteenth century date. Although not shown on the 1841 Tithe map, it had been constructed by the time of the 1876 survey.

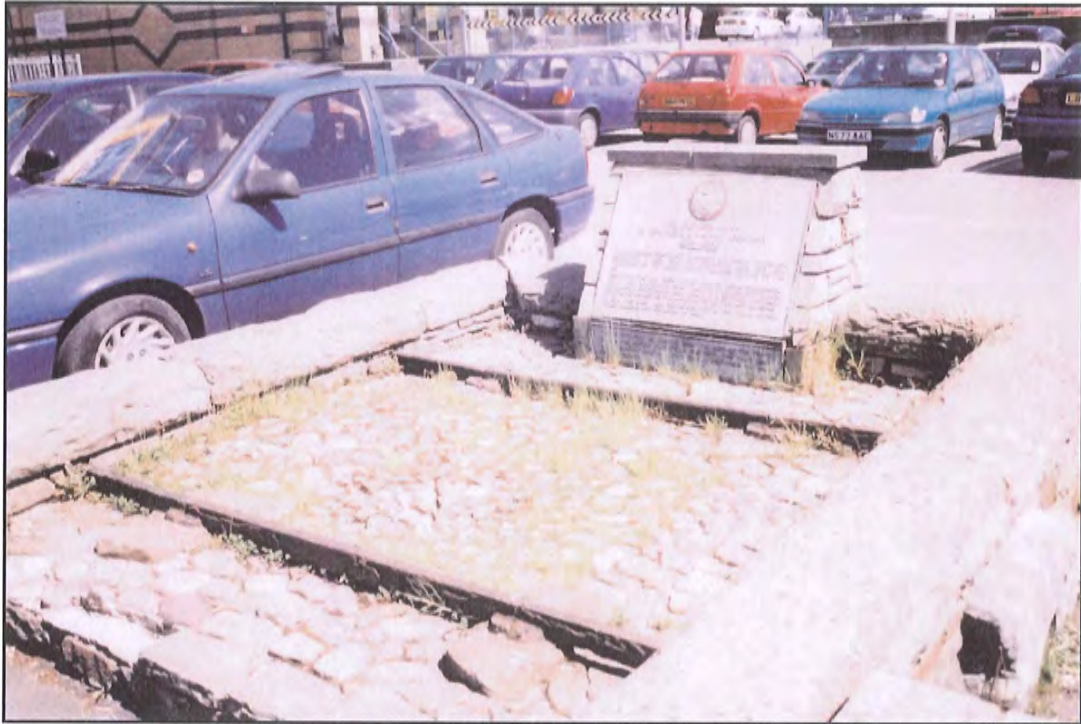
Plate 11 Section of reconstructed tramway

- 4.20 A block of four shops was erected off Llynfi Road in the latter half of the 1990's in the area formerly occupied by the spoil heap south of the rugby ground between the road and river. At the Llynfi Road side of the car park is a short stretch of reconstructed tramway together with a plaque (**Plate 11**).

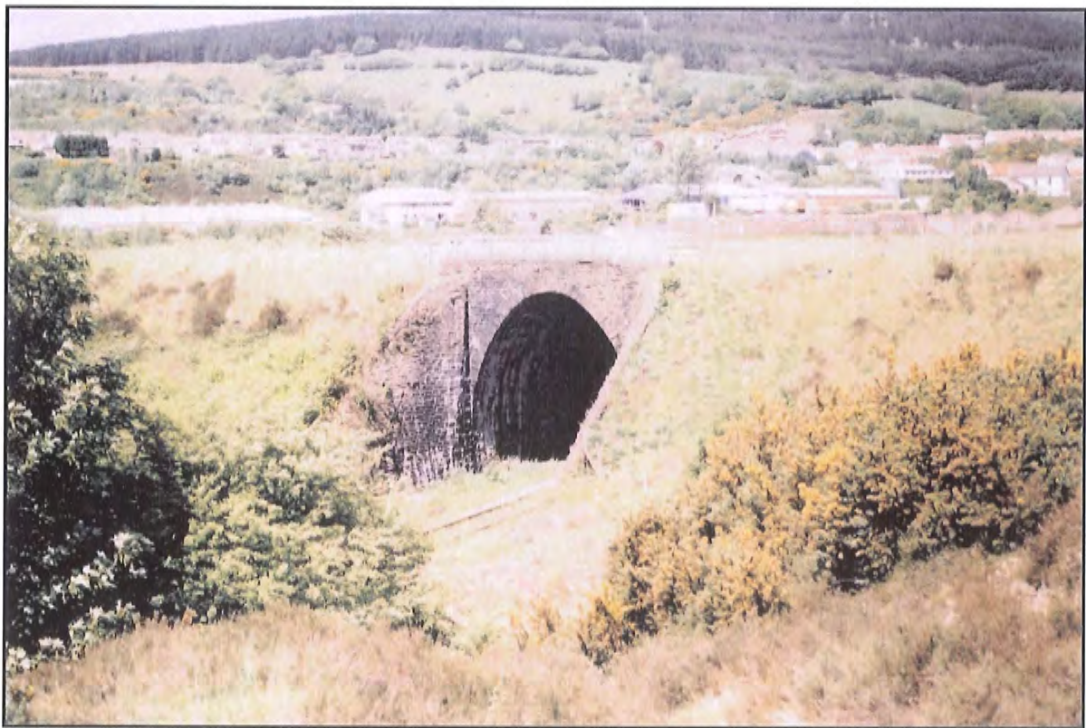
Plate 12 Bridge crossing Llynfi Valley Railway

- 4.9 In 1858 work was begun on a railway to run from Tywith, half a mile up-valley from the present site, down to Bridgend and Porthcawl. This was on a new route following the valley bottom, most of which is still utilised by the modern railway. Officially opened for mineral traffic in 1861 as the Llynvi Valley Railway, this replaced the old tramway. However, the gauge was 7 feet ¼ inch, the same width as Brunel's broad gauge on the South Wales Railway. Later in the 1860's mixed gauge track was provided, the broad gauge finally disappearing in 1872. In 1866 the Llynvi and Ogmore Railway Company was formed by an amalgamation of the L.V.R. and the standard gauge Ogmore Valley Railway. An agreement made in the following year enabled construction of a rail connection between the L. & O.R.Co. and the Llynvi Iron Works. This branched off the main line at Tywith, following the route of the old tramway down to the iron works. At the same time a rail connection was proposed between the Llynvi and Maesteg iron works. This involved culverting a short stretch of the Llynfi River (**Plate 8**) and building an elliptical-arched bridge over the valley road (Castle Street), with a similar bridge across the main L. & O.R. line (**Plate 12**).
