Sarnau, Cilrhedyn, Pembrokeshire

Sarnau Cilrhedyn, Pembrokeshire

Trysor Project No. 2015/421

RHIF YR ADRODDIAD - REPORT NUMBER: Trysor 2015/421

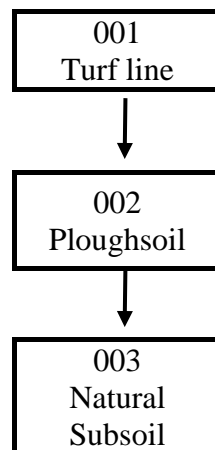
10.2 A test pit, 1 metre long north to south by 0.50 metres wide was hand excavated at SN2857032229. Natural subsoil was reached at a depth of 0.28 metres.

Context Number	Depth	Description	Interpretation
001	0.10m	10YR 3/4 dark yellowish brown friable loam	Turf horizon
002	0.18m	10YR 3/6 dark yellowish brown friable loam, gravel and charcoal	Ploughsoil – the charcoal thought to be from agricultural activity.
003	-	10YR 4/4 dark yellowish brown clay and shale gravel	Natural subsoil

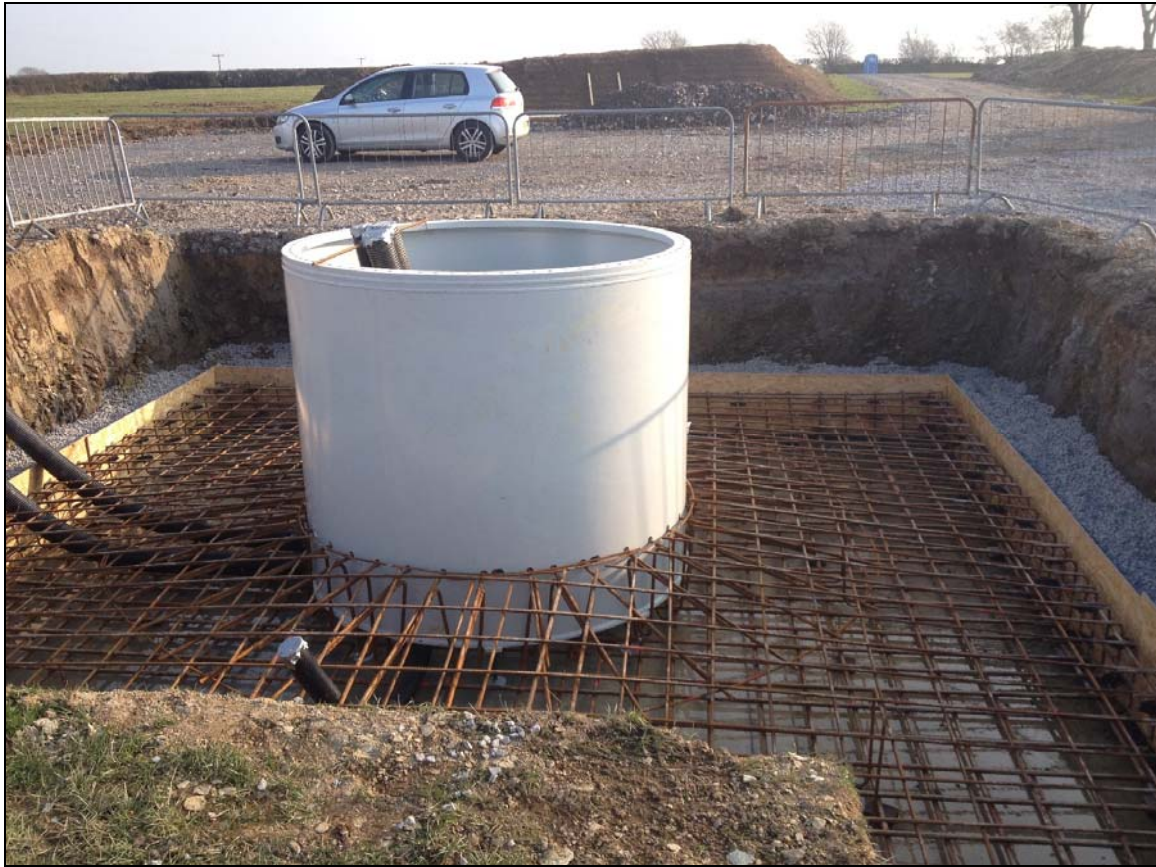
Plate 1: SAR2015_101, foundation hole, looking south.

Photo Number	Description	Date Taken	Direction
SAR2015_101	<p>This photo was taken by the client during construction of the turbine. The south section of the foundation hole is partially visible as well as the southern ends of the east and west sections.</p> <p>The south section has been truncated by removal of the turf layer and laying down of a gravel surface to create a hardstanding area to the south of the turbine.</p> <p>Two contexts are visible, interpreted as being the ploughsoil and natural subsoil, equivalent to contexts 002 and 003 in the test pit to the south. No features were visible.</p>	17/03/2015	Looking south
SAR2015_102	<p>This photo was taken by the client during construction of the turbine. The northern end of the eastern section of the foundation hole is visible as well as an oblique view of the north section.</p> <p>The turf layer is visible in the north section. It may be present in the east section. The section does not appear to have been truncated but the upper part has been smeared by the bucket and can't be seen clearly. No features were visible.</p>	17/03/2015	Looking east

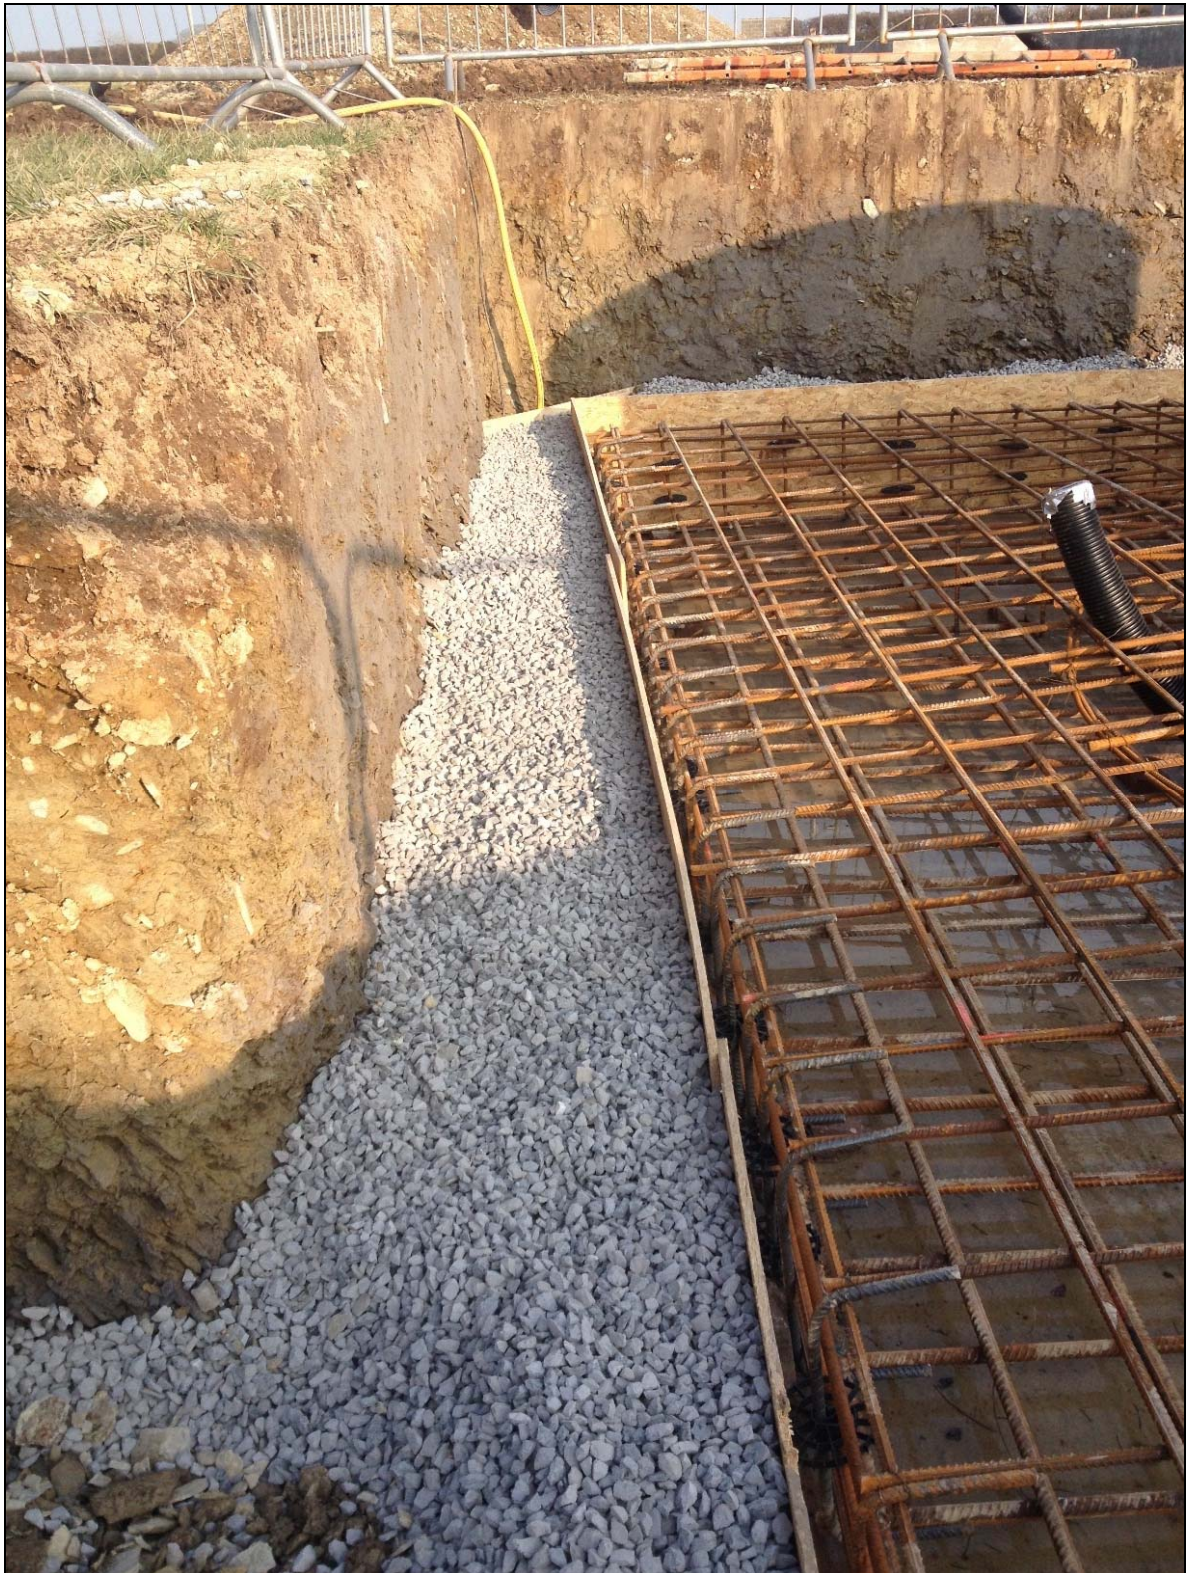
Plate 2: SAR2015_102, foundation hole, looking east.

10.4 Three photos taken by Kinetica Energy on 17th March 2015, see section 11 and Appendix C, were examined to look for features cut into the subsoil visible in the sections of the foundation hole.

10.5 The sections were partly weathered and had been cut with a toothed bucket, but the photos were still reasonably clear. They conformed to the contexts seen in the test pit to the south and no features are visible.

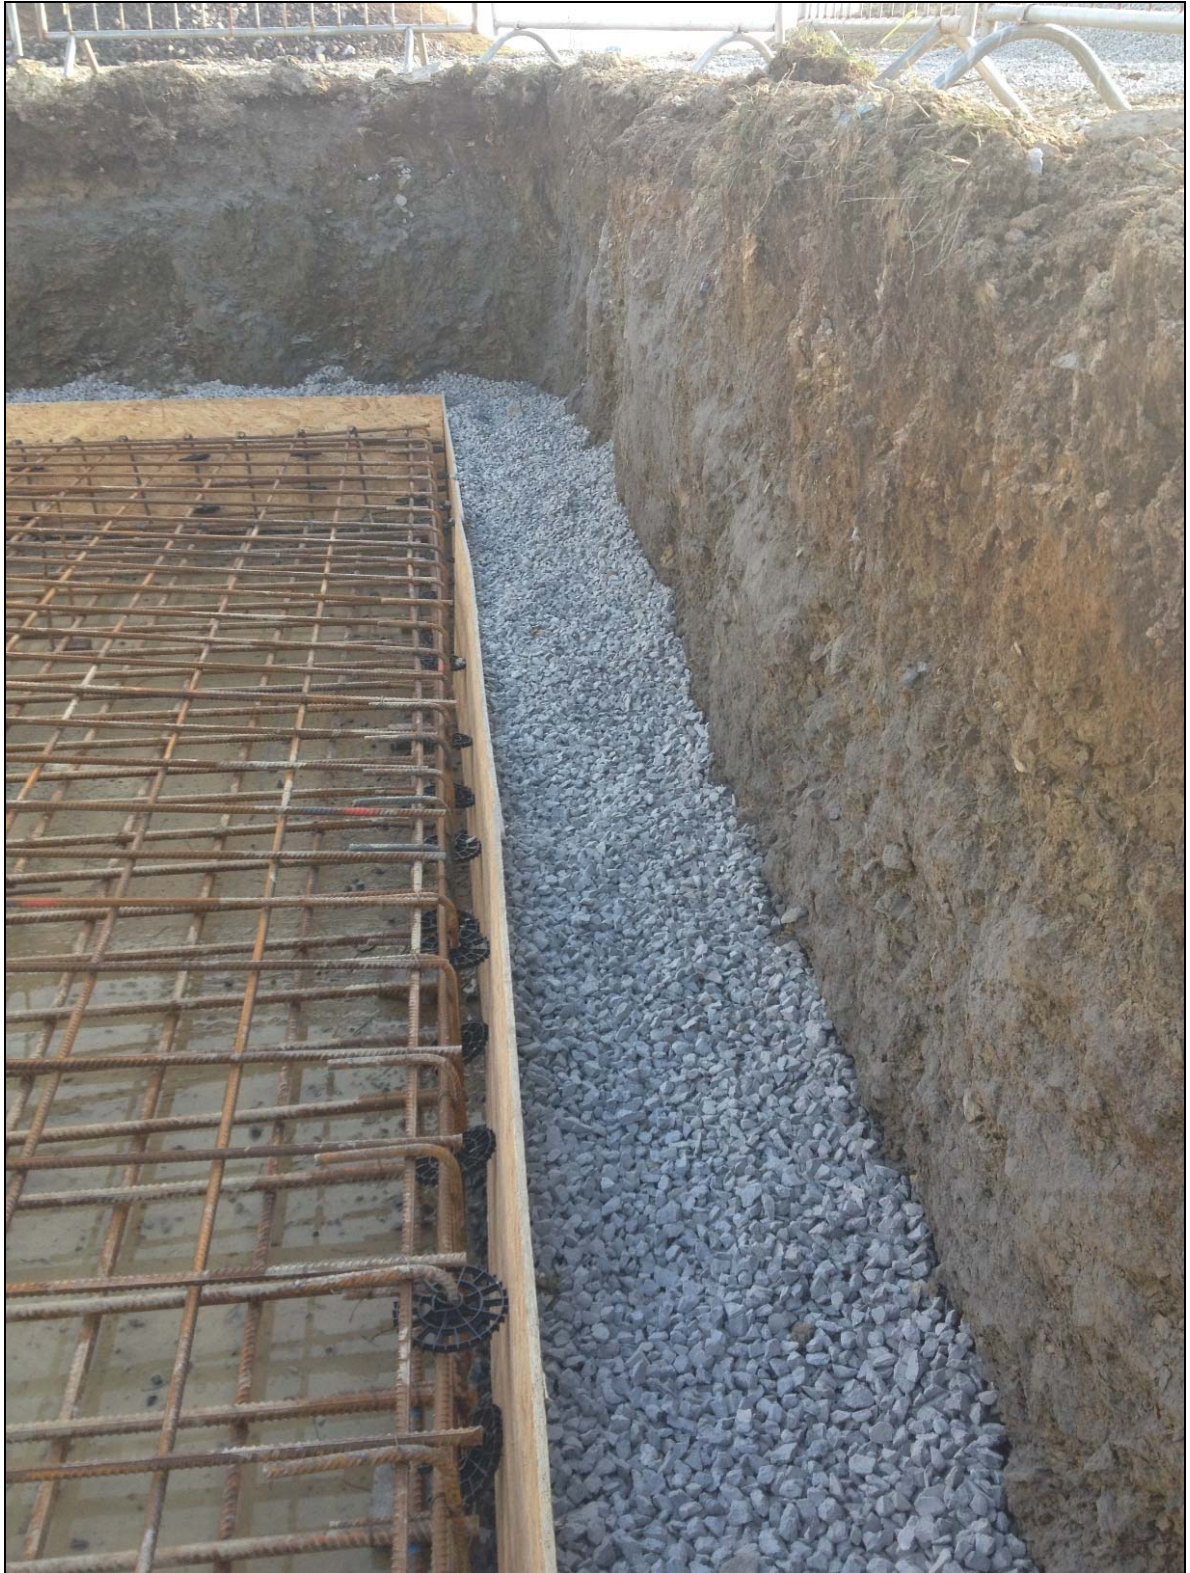
Plate 3: SAR2015_103, foundation hole, looking south.

SAR2015_103	<p>This photo was taken by the client during construction of the turbine. The western end of the south section of the foundation hole is visible as well as an oblique view of the west section. The south and west sections have been truncated by removal of the turf layer and laying down of gravel surface to create a hardstanding area to the south and west of the turbine. Two contexts are visible, interpreted as</p>	17/03/2015	Looking south

being the ploughsoil and natural subsoil, equivalent to contexts 002 and 003 in the test pit to the south. No features were visible.		
SAR2015_104	The access track.	15/06/2015	Looking south
SAR2015_105	The spoil heap left on site with hardstanding, substation and turbine behind.	15/06/2015	Looking north northwest
SAR2015_106	Breaking up of the compacted spoil heap.	15/06/2015	Looking west.
SAR2015_107	Breaking up of the compacted spoil heap.	15/06/2015	Looking southwest
SAR2015_108	Excavating test pit	15/06/2015	Looking northeast.
SAR2015_109	Excavated test pit down to context 003, subsoil. Contexts 001 and 002 are clearly visible.	15/06/2015	Looking east
SAR2015_110	Excavated test pit down to context 003, subsoil. Contexts 001 and 002 are clearly visible.	15/06/2015	Looking east

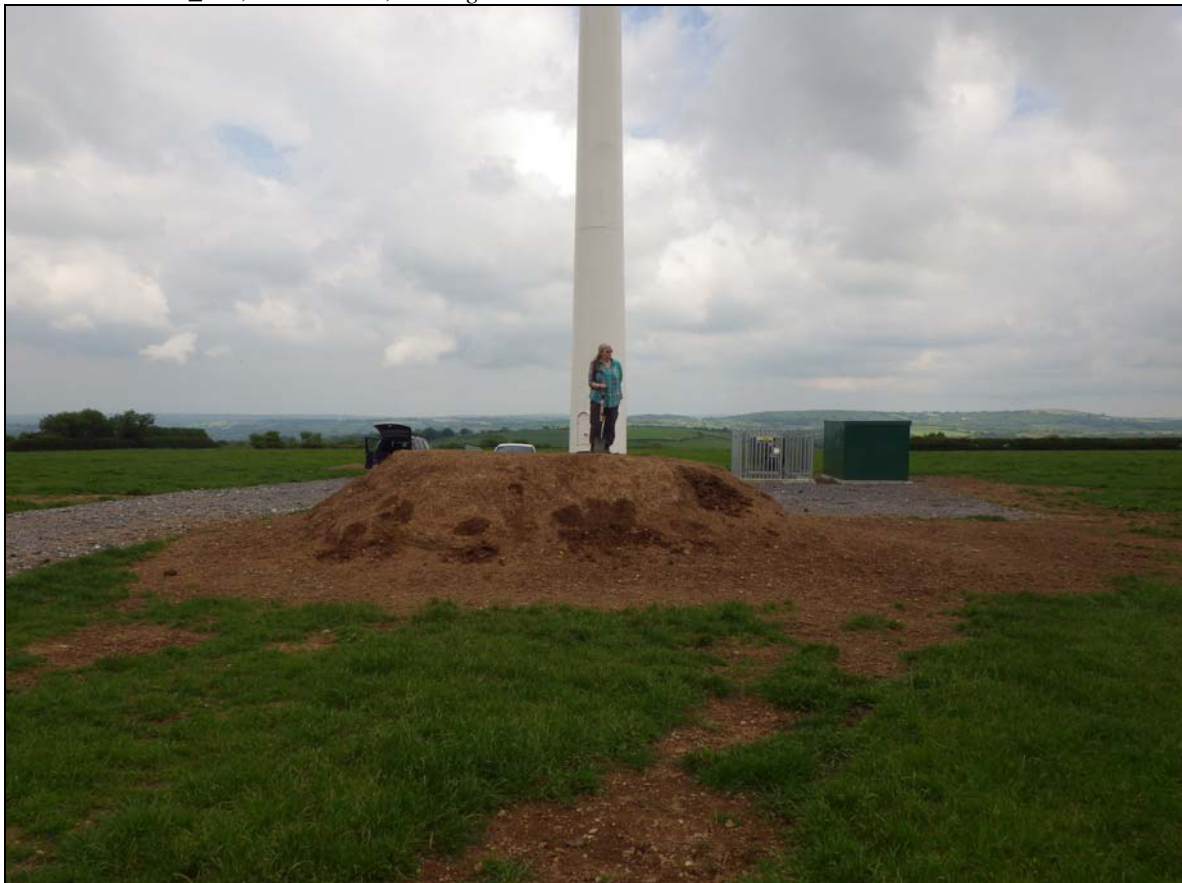
Plate 5: SAR2015_105, spoil heap, hardstanding, substation and turbine tower, looking north northwest.

10.6 The spoil heap mound was largely made up of the turf layer and ploughsoil, equivalent to contexts 001 and 002. It had been compacted by machine previously, compounded by weathering. The mound was broken up and searched for artefacts. Nothing was found, including nothing of late post medieval and modern date.
