Former Church of St David, Garthbrengy, Powys

Archaeological Evaluation

Report No. 1267

September 2014

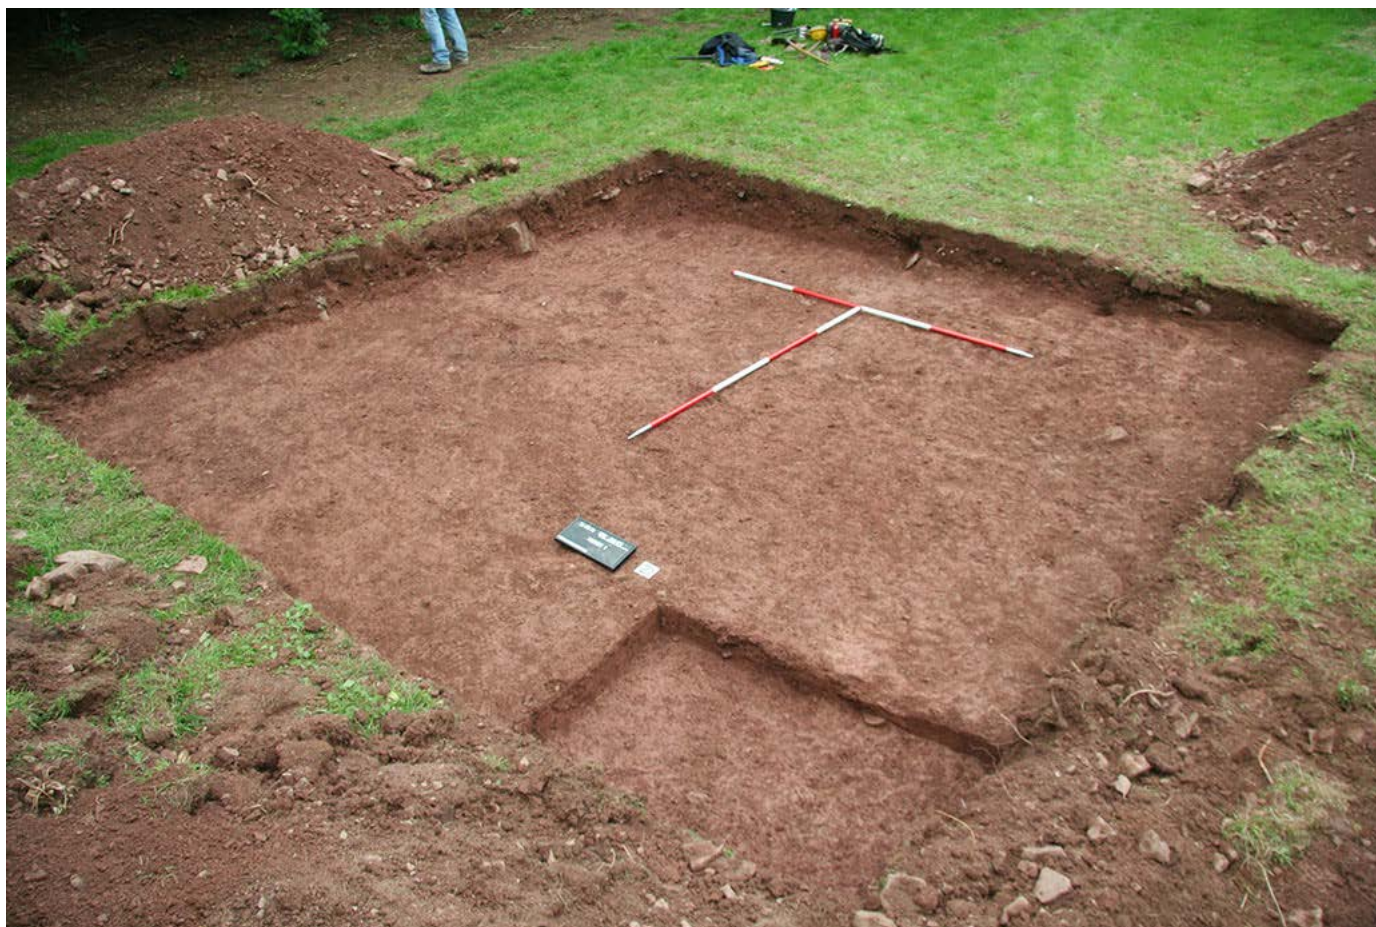
Fig. 1
Trench 1 post-ex

Trench 1 was located in the north-eastern corner of the graveyard (fig. 2), in the proposed location of the new cess pit. It measured 5m by 5m and was excavated to a depth of 0.45m across much of the area (fig. 3), with a small sondage excavated to a depth of 1.1m in the north-eastern corner of the trench. The excavation of the trench was initially carried out by hand however a small mechanical excavator was used to remove the subsoil.

Below the turf the topsoil (1001) comprised a moderately loose mid brown/red sandy clay containing few sub-angular stones and two sherds of modern pottery (not retained). The topsoil depth varied between 0.15m and 0.2m across the extent of the trench. The topsoil was remarkably sterile with no evidence of anthropogenic disturbance. A layer of burning was identified in the south-eastern corner of the topsoil, comprising charcoal and heat affected clay. This occupied only the upper section of the topsoil and is modern in date.

The topsoil overlay a compact reddish brown silty clay subsoil (1002) that varied between 0.13m and 0.25m in depth. The subsoil contained several small concentrations of charcoal, with charcoal flecks identified throughout the subsoil horizon. No artefacts were recovered from the subsoil.

The natural geology (1003) was identified below the subsoil (1002) and comprised a compact reddish clay silt with frequent stones. Two areas of burning, (1004) and (1005), were identified on the surface of the natural, both of which corresponded to a concentration of charcoal in the overlying subsoil (1002). The burning was identified as ephemeral spreads of heat affected clay and large chunks of charcoal, and is thought to be the result of tree stumps being burnt (fig. 3). No evidence for anthropogenic activity was associated with the charcoal and burnt clay. In the

north-eastern corner of the trench a cone-shaped cut [1006] into the natural was investigated (fig. 3). This contained topsoil (1002) and is thought to be the result of tree root penetration.

No finds or features of archaeological significance were identified in trench 1.

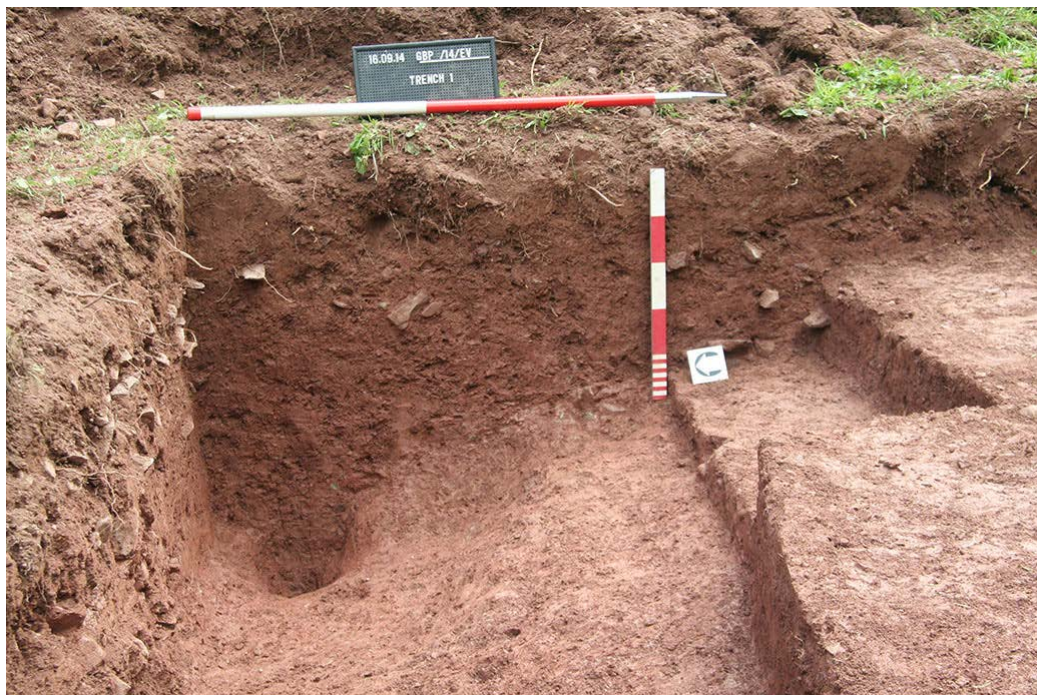
Cone of topsoil produced by root activity
Scale 1m and 0.5m
Looking E

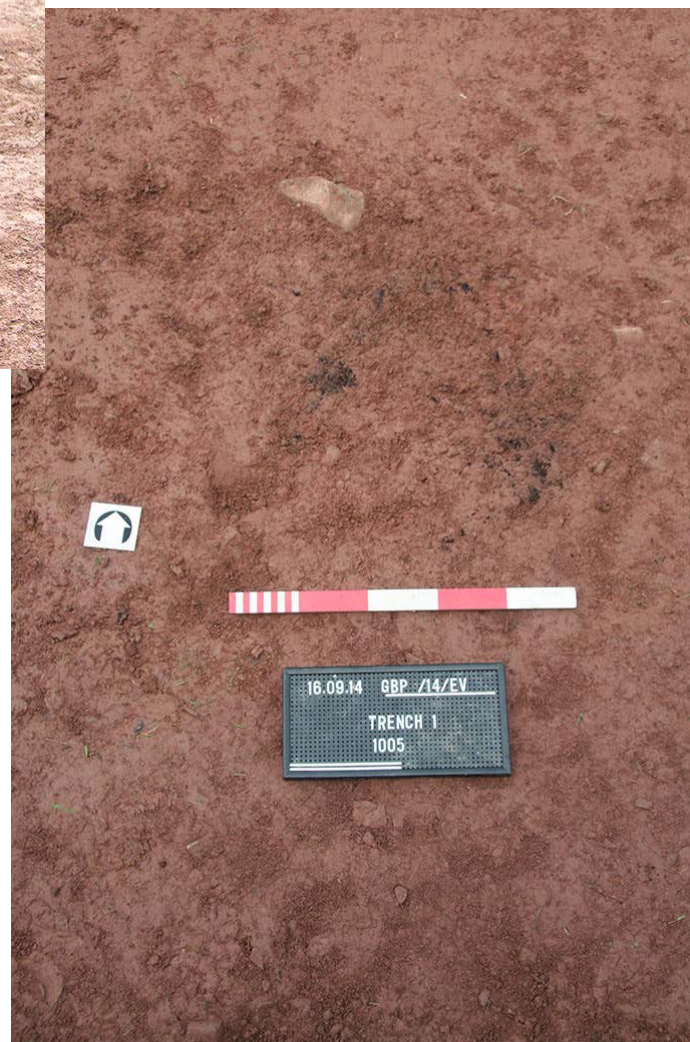
Fig. 4
Features within
Trench 1

Concentration of charcoal and heat
affected clay in the top of the natural
Scale = 0.5m
Looking N

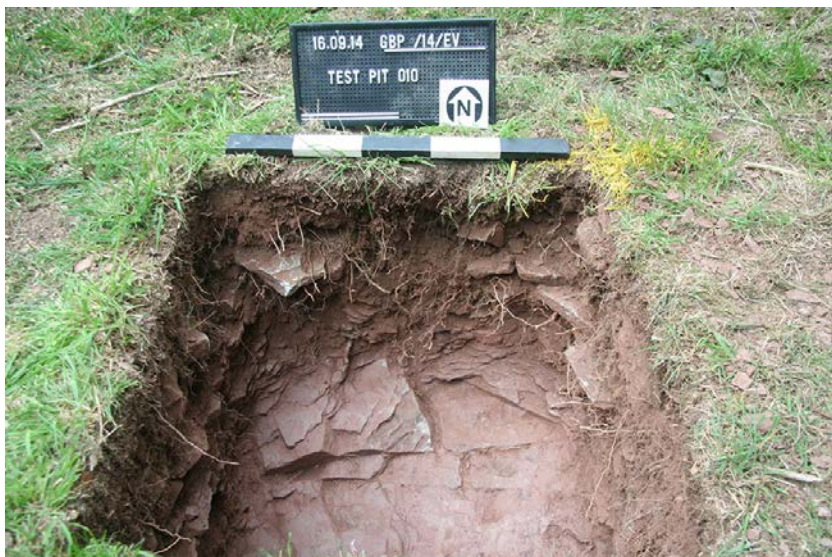
Below the turf the test pit contained a loose mid/dark brown silty loam topsoil (012) containing occasional sub-angular stones. The topsoil was 0.13m deep and contained no artefacts. The underlying subsoil (013) comprised a loose mid brown silty clay with occasional stones. It was 0.25m deep and contained no artefacts or evidence of disturbance. The subsoil overlay the natural bedrock (014).

TP 010
Scale = 0.5m
Looking N

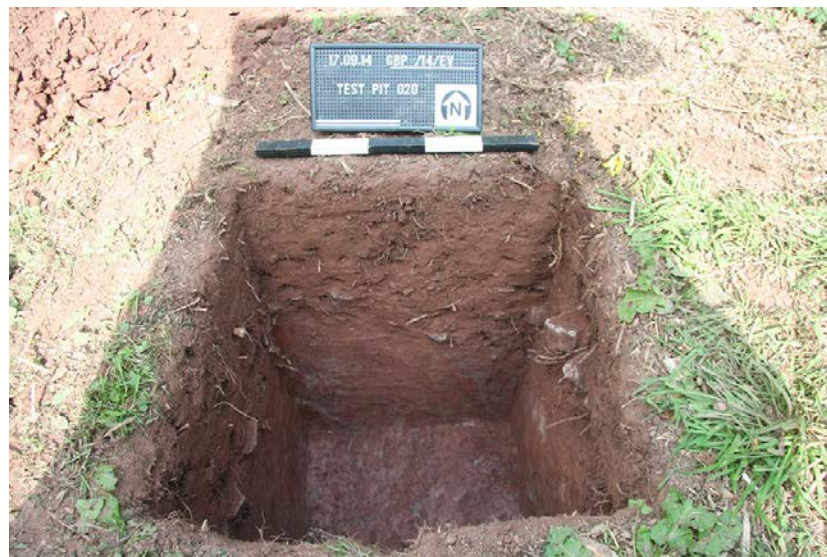
Below the turf the test pit contained a loose mid/dark brown silty loam topsoil (022) containing frequent sub-angular stones. The topsoil was 0.34m deep and overlay a probable till deposit (023). The till comprised a compact reddish silty clay that was excavated to a maximum depth of 0.39m. The base of the till was not reached and this is thought to be a glacial deposit.

TP 020
Scale = 0.5m
Looking N

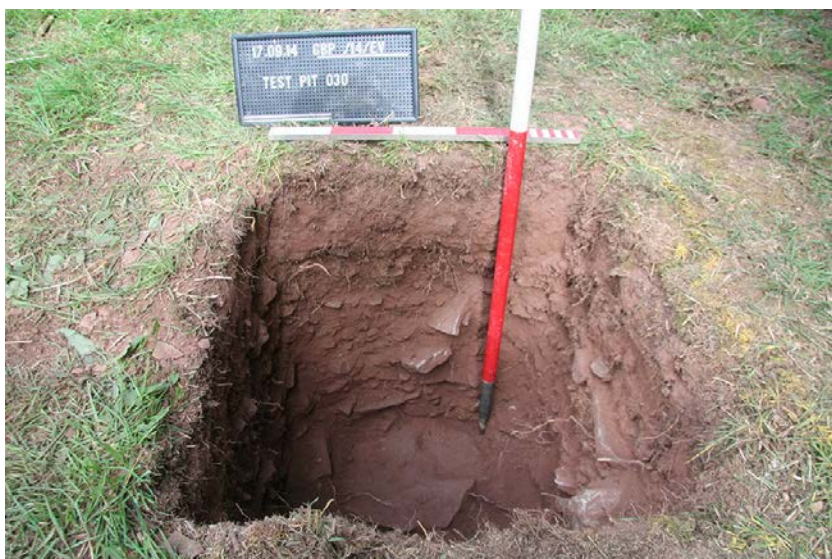
Below the turf the topsoil (032) comprised a loose mid brown silty loam, 0.18m deep. The topsoil overlay a loose mid/light brown silty clay subsoil (033) containing frequent sub-angular stones. The subsoil was 0.36m deep and overlay the natural bedrock (034).

TP 030
Scale = 1m and 0.5m
Looking N

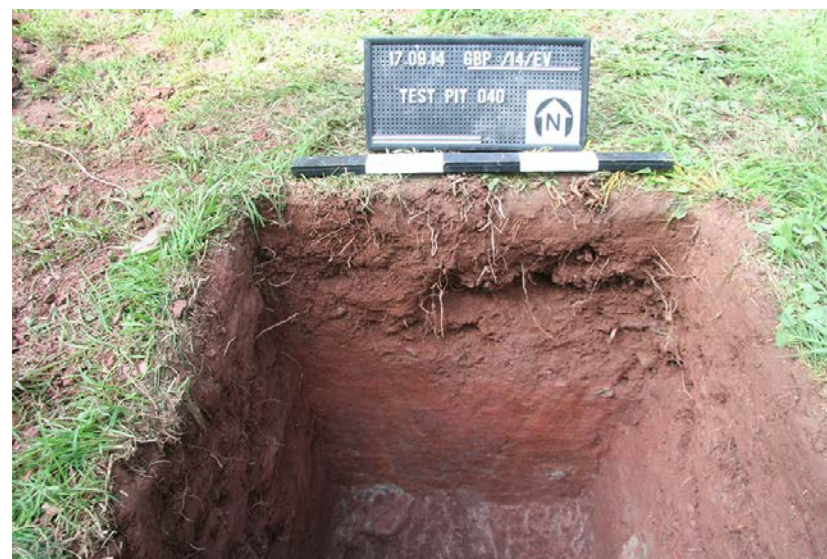
Below the turf the topsoil (042) comprised a loose mid/light reddish brown silty loam with occasional sub-angular stones. The topsoil overlay a deposit of till (043) comprising compact reddish clay which was excavated to a depth of 0.4m. The base of the deposit was not reached and it is thought to be glacial in origin.

TP 040
Scale = 0.5m
Looking N

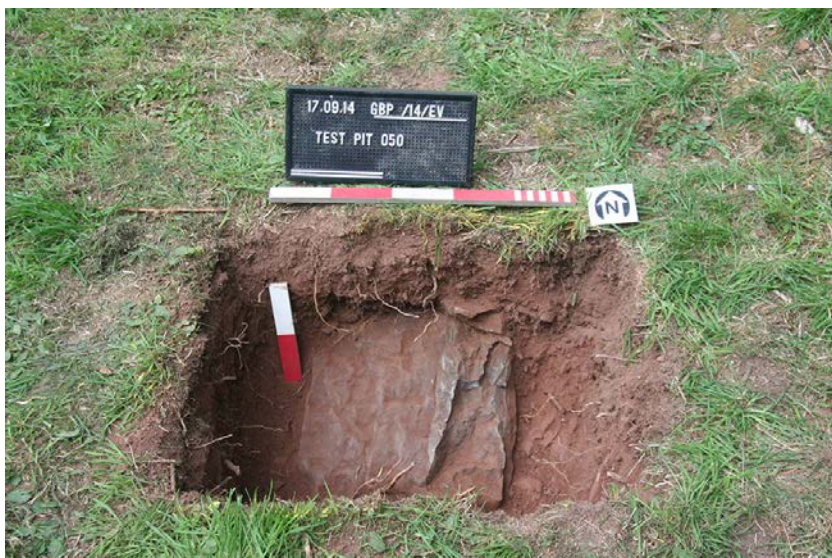
Below the turf the topsoil (052) comprised a loose dark/mid brown silty loam, 0.25m deep. The topsoil overlay the natural bedrock (053).

TP 050
Scale = 0.5m and 0.2m
Looking N

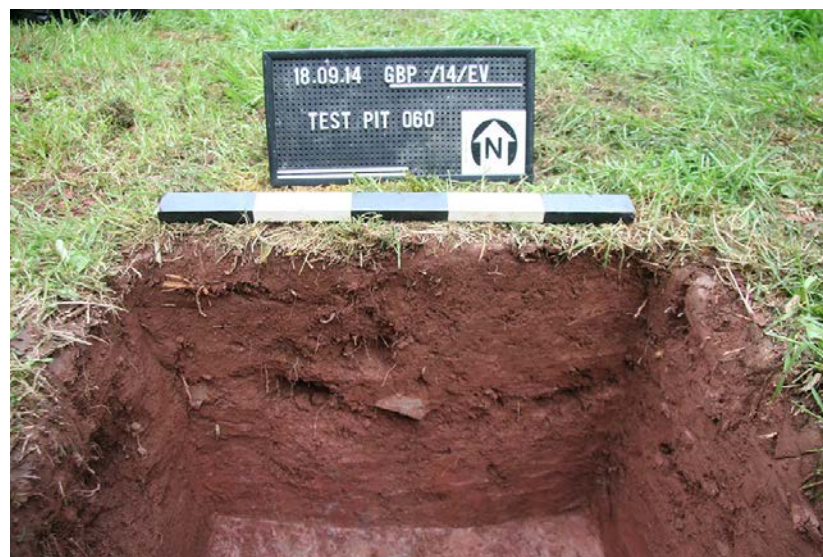
Below the turf the topsoil (062) comprised a loose dark brown silty loam 0.15m deep. A single piece of modern pottery (not retained) was recovered from the topsoil. The topsoil overlay a subsoil (063) comprising loose reddish brown silty clay containing occasional sub-angular stones. The subsoil was 0.16m deep and overlay the natural bedrock (064).

TP 060
Scale = 0.5m
Looking N

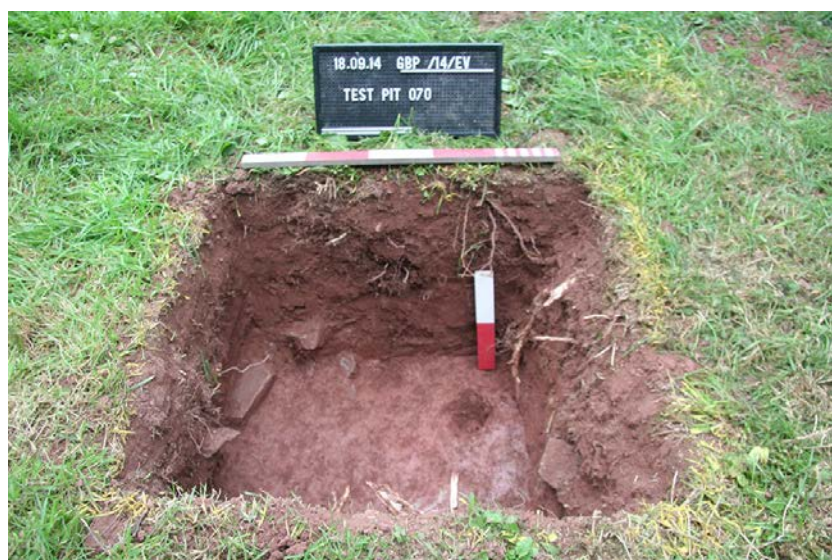
Below the turf the topsoil (072) comprised a loose mid brown silty loam containing occasional sub-angular stones. The topsoil was 0.35m deep and overlay the subsoil (073). The subsoil comprised a loose mid reddish brown silty clay containing occasional sub-angular stones. It was excavated to a depth of 0.4m but the base of the deposit was not reached.

TP 070
Scale = 0.5m and 0.2m
Looking N

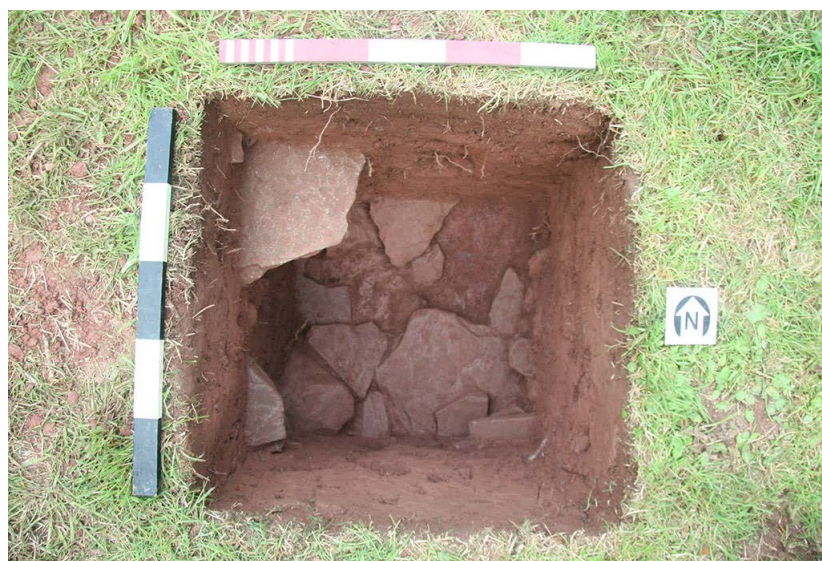
Below the turf the topsoil (082) comprised a loose light brown silty clay containing occasional sub-angular stones. The topsoil was 0.17m deep and overlay a subsoil deposit (083) comprising a loose light reddish brown silty clay. The subsoil was 0.47m deep and overlay a loose light reddish brown silty clay (085) containing large flat stones that appear to have been laid across the top of the silty clay deposit. The stones and the silty clay sat within a shallow concave cut [084], which truncated the top of the natural. The cut was 0.04m deep, its other dimensions not possible to discern due to the small size of the test pit. The feature was not fully investigated during the evaluation, but is thought to be a roughly paved surface and may relate to the early ecclesiastical use of the site, perhaps functioning as a path into the enclosure.

One of the test pits, test pit 080, revealed a possible roughly paved surface below the subsoil. This feature comprised a layer of flat stones laid over a shallow silt-filled cut. The small size of the test pit precluded full investigation of the feature, but it is postulated that it could be a path or a track associated with the early Christian use of the site. This test pit is located at the south-western end of the footprint for the proposed outbuilding and it is likely that the feature continues to the north and south of the pit.

TP 080
Scale = 0.5m
Looking N

The evaluation demonstrated that the locations chosen for the cess pit and the outbuilding do not contain burials or significant archaeological features that could be impacted by the development. The possible paved surface in test pit 080 is located at the base of the formation depth for the outbuilding foundations and consequently can be preserved in situ. Any additional excavation to be carried out in this area should, however, be subject to a watching brief.
