CPAT Report No. 1656

Modrydd Farm, Libanus, Powys

Building Survey

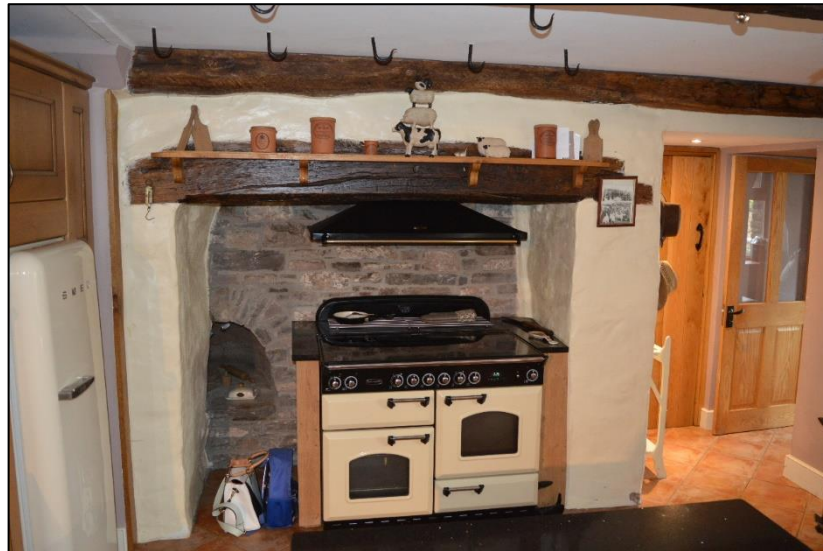
Fig. 4 The fireplace and bread oven. Photo CPAT 4635-0010

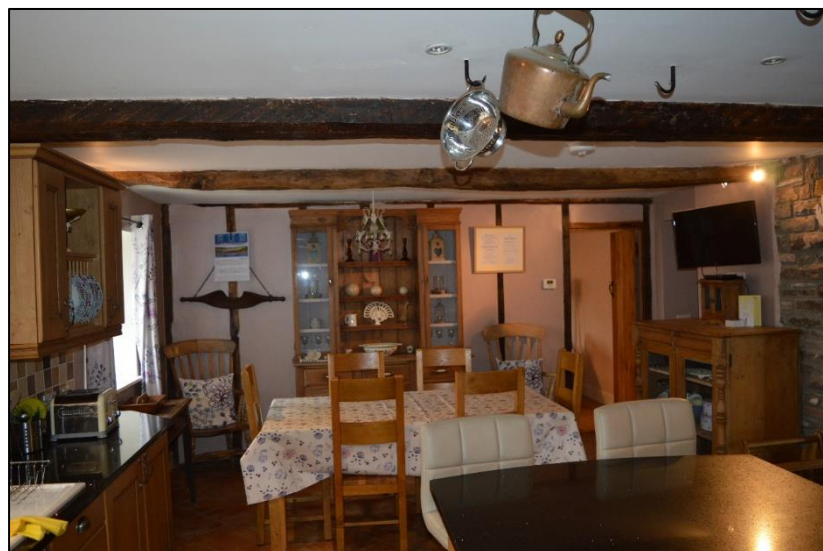
Fig. 5 View of the former hall from the north. Photo CPAT 4635-0012

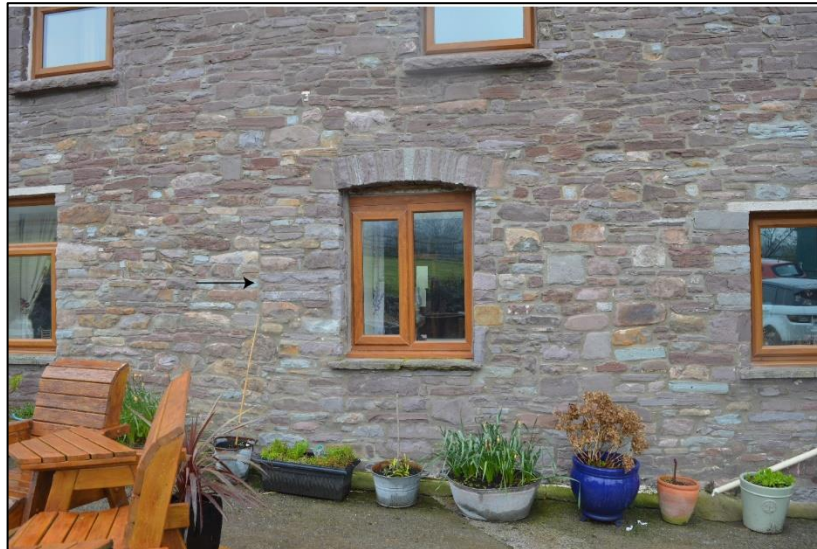
*Fig. 6 Former doorway (arrowed) on east elevation into the passageway at the south end of the hall.
Photo CPAT 4635-0036*

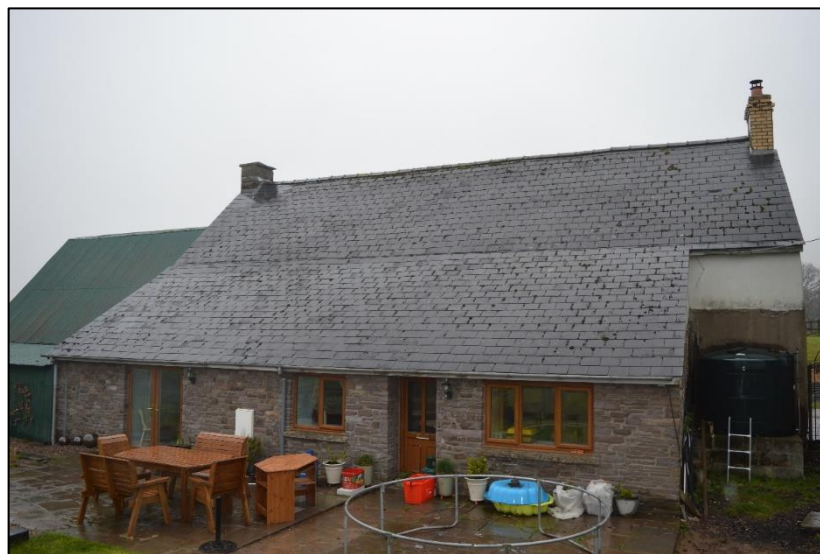
Fig. 7 The single storey extension, comprising a kitchen (left of doorway) and the later pantry (right of doorway) viewed from the west. Photo CPAT 4635-0023

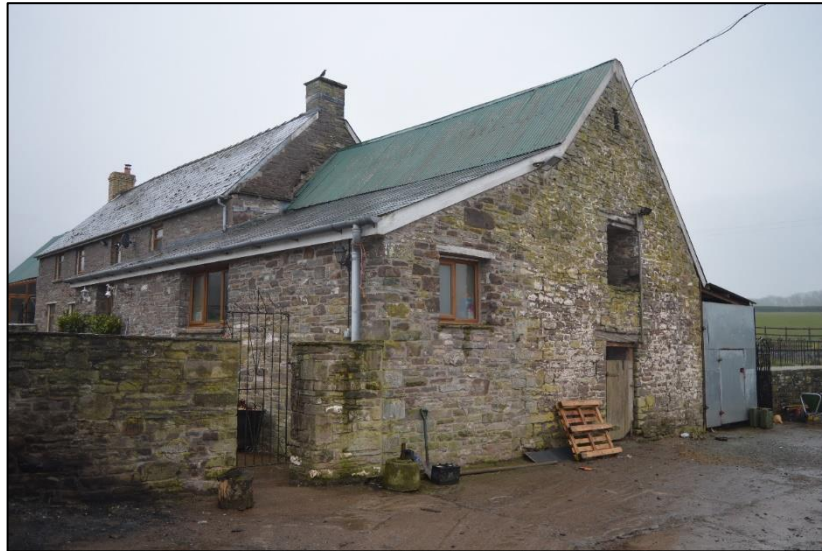
Fig. 8 View of the byre from the north-east. Photo CPAT 4635-0030

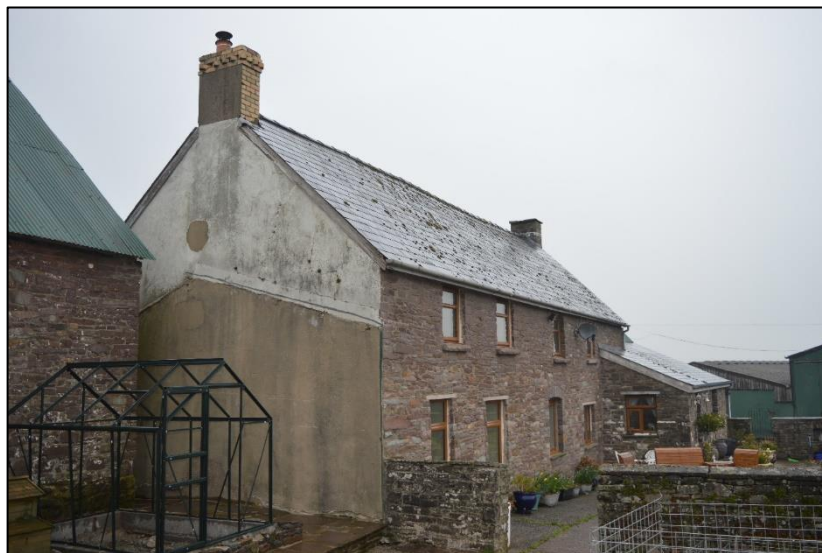
Fig. 9 View of the extension to the south end of the house containing the parlour. Photo CPAT 4635-0018

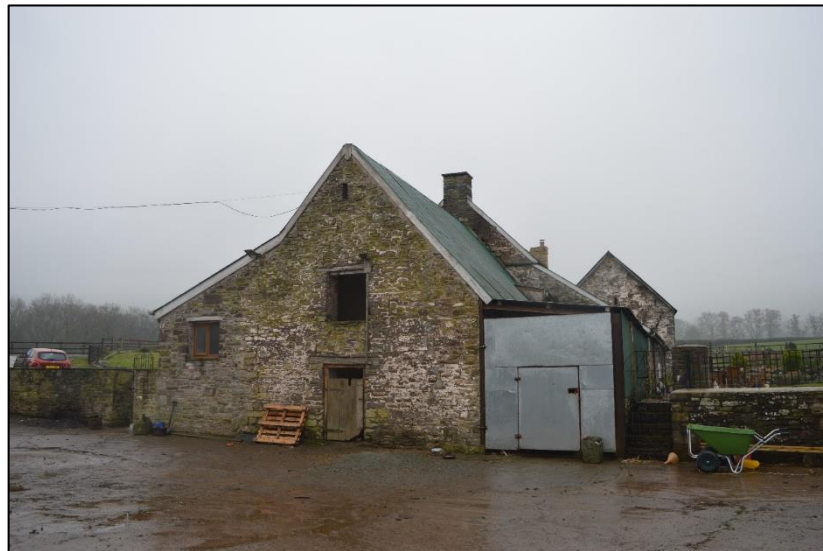
- 3.12. It was noted during the survey that the roof pitch for the house seemed rather shallow for a building of this type and age. Additionally, the stonework visible in the upper northern gable end was rather different from that below it. It was not possible to examine the stonework of the southern gable end as it was rendered. It is possible that the roof was originally thatched, which would require a steeper pitch for weather keeping. A conversion to roof slates would have permitted a shallow pitch, allowing the wall elevations to be raised in height in order to make the upper storey more habitable. This would have been contemporary with the construction of the corridor along the upper floor.

Fig. 10 View from the north showing the relative difference in roof pitch between the byre (in the foreground) and house behind it. Photo CPAT 4635-0026

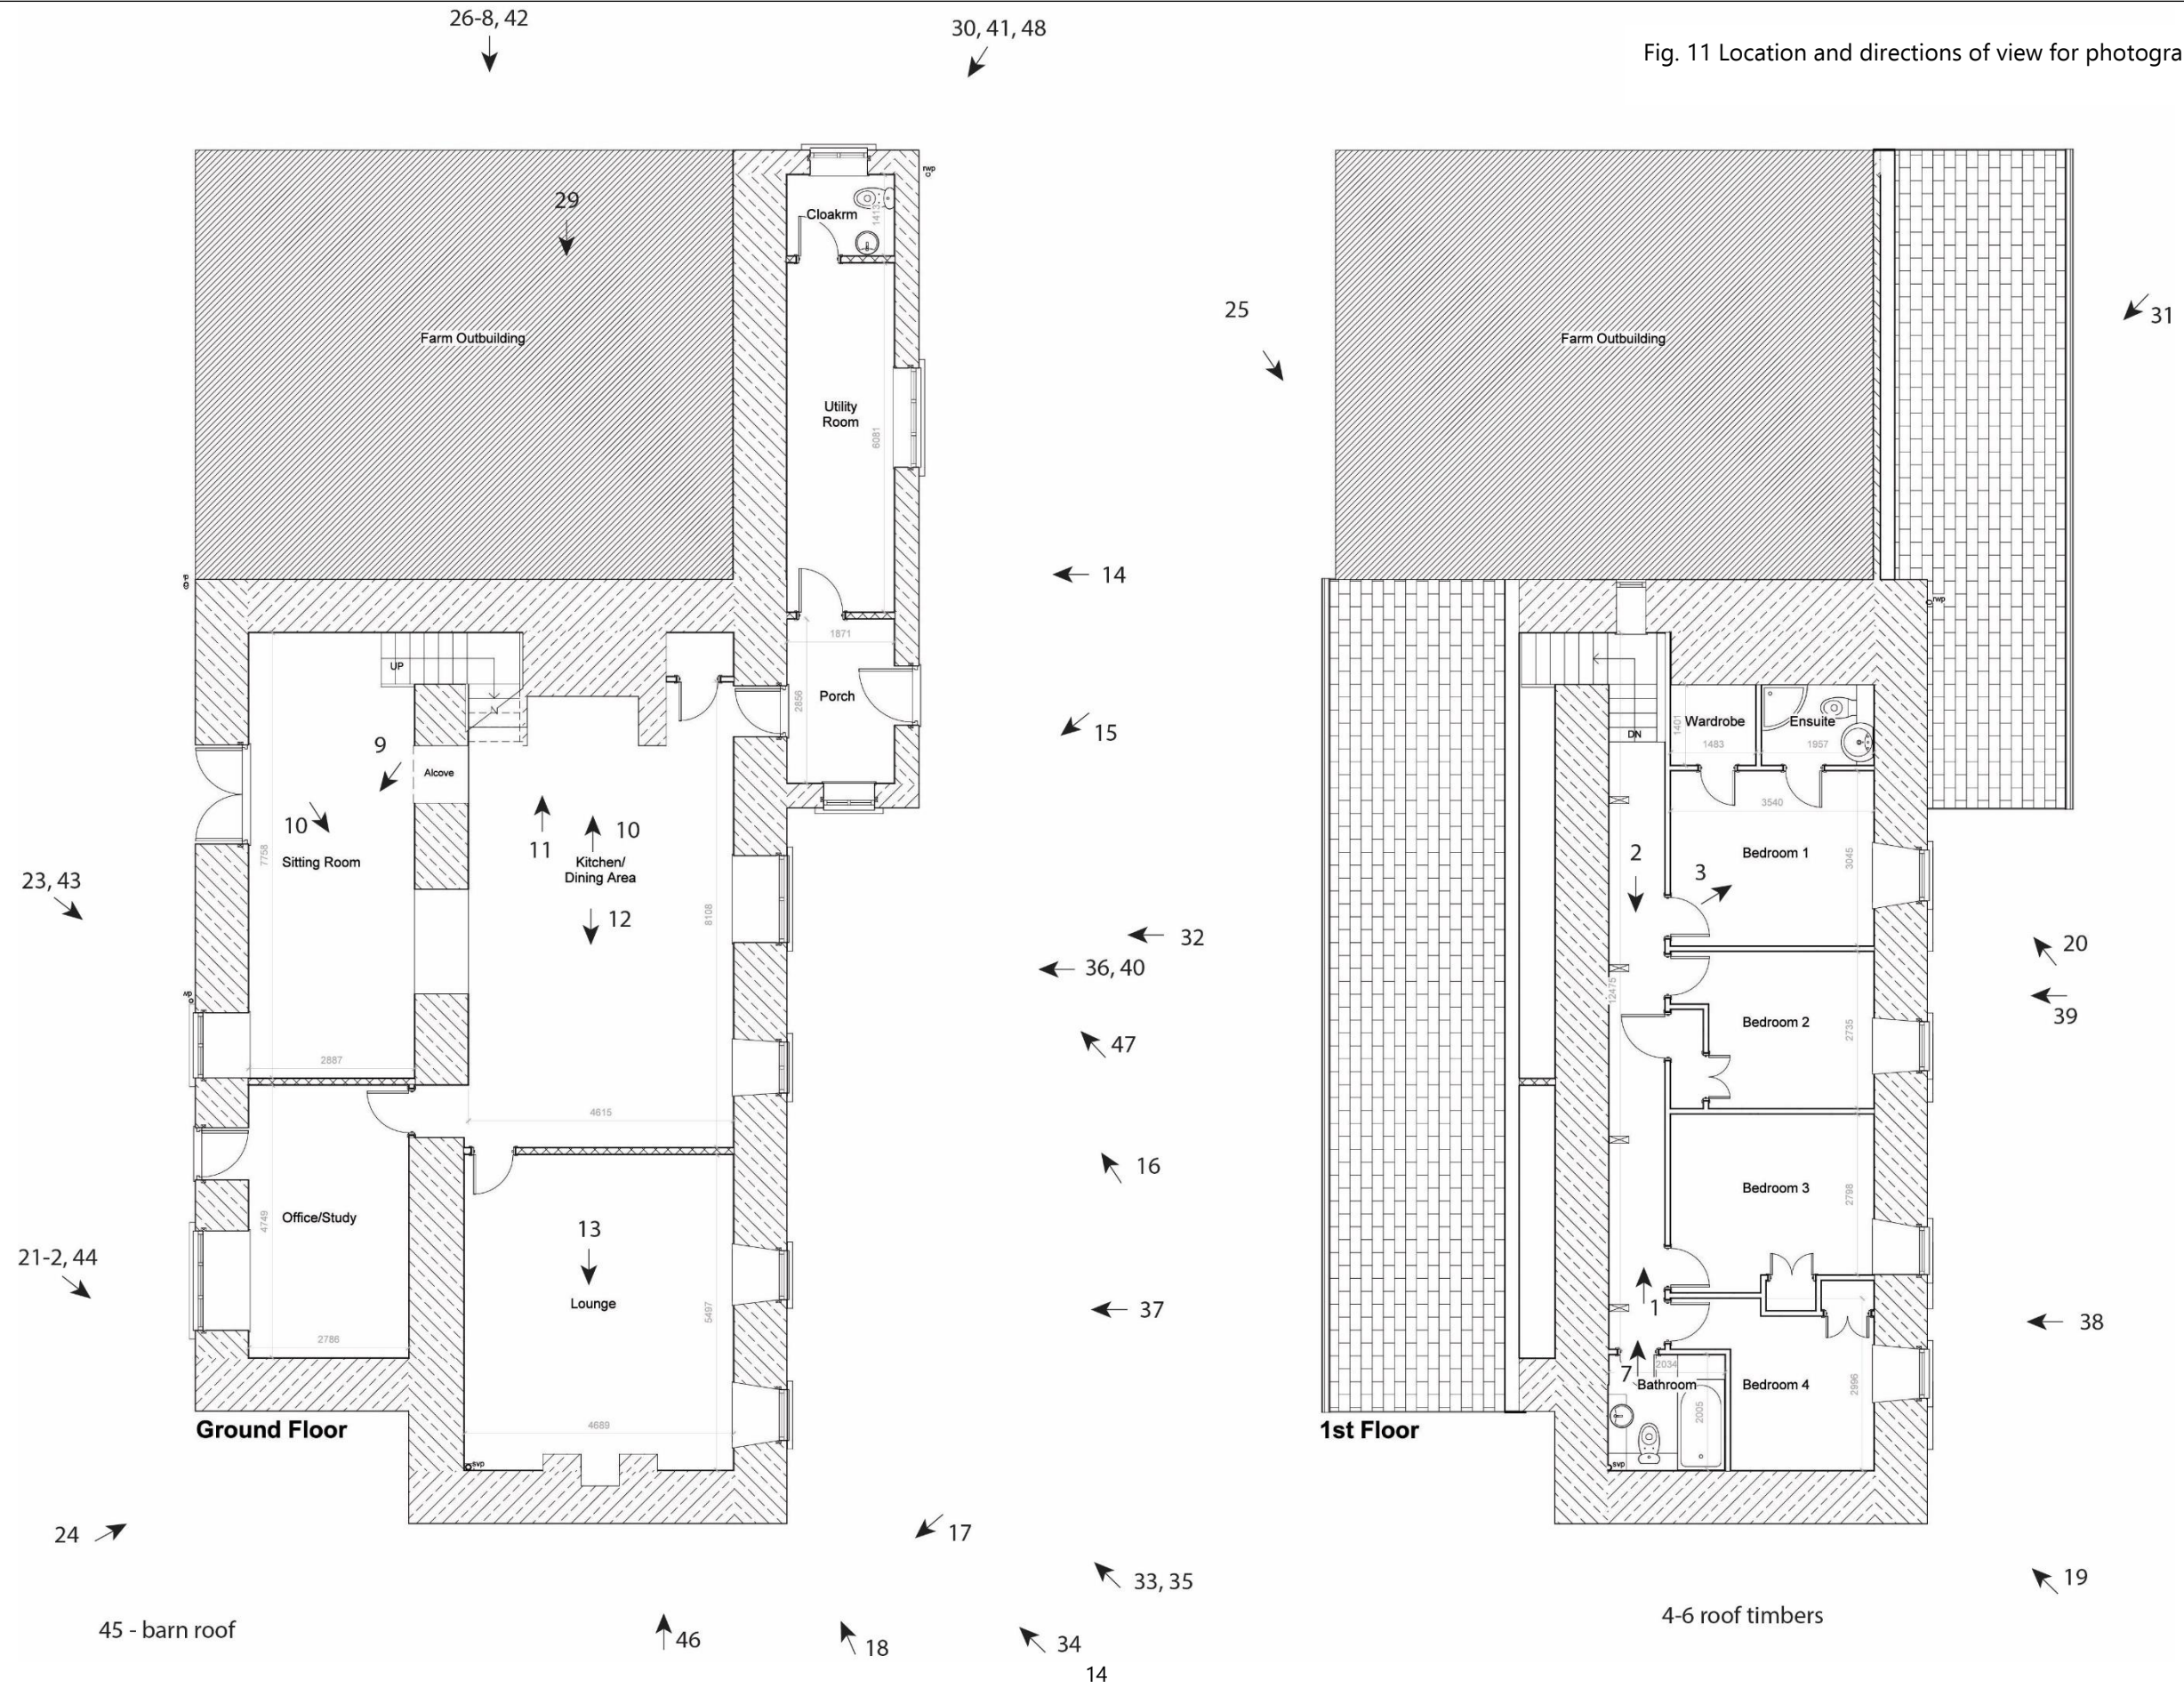
Fig. 11 Location and directions of view for photographic survey

48 digital photographs, CPAT film no 4635 – see Fig. 11 at the end of this report for photo locations and directions of view
