TOMEN Y MUR (ME002), TRAWSFYNYDD
ARCHAEOLOGICAL WATCHING BRIEF AND OTHER WORKS REPORT
05 APRIL 2018

By
Tomos Jones
Archaeologist

Snowdonia National Park Authority
Report produced on 11 July 2018

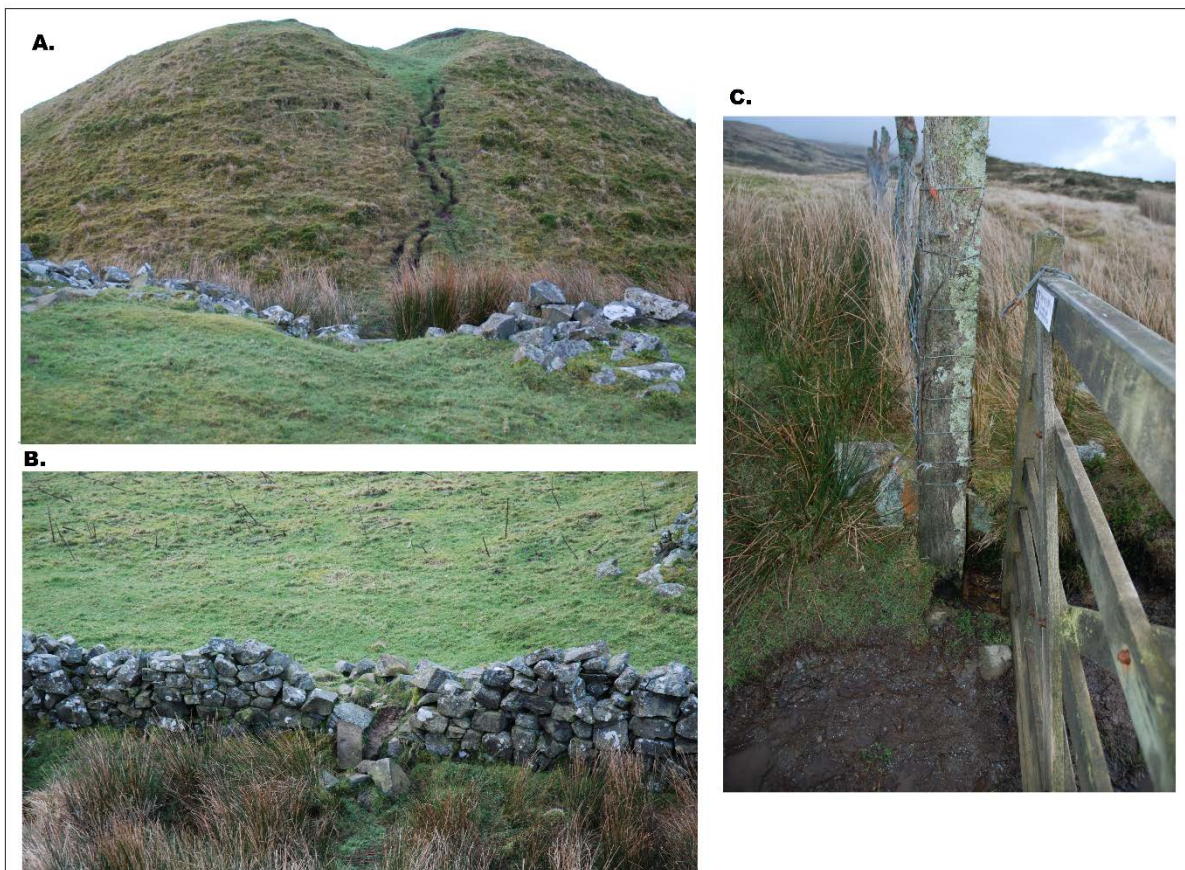
A watching brief was carried out at the site of Tomen y Mur, Trawsfynydd (SH 70886 38521) by Snowdonia National Park Authority's designated archaeologist on 05 April 2018. This was to enable mitigation work to take place at the site to reduce the degree of erosion on the mound (or 'Tomen') (see figure 1A below) and also to carry out general maintenance at the site as per the management agreement (see appendix 1). This included:

Figures 1A. Shows the degree of erosion on the northeast side of the mound and the gap in the stones at the base of the mound. **1B.** Shows gap at the base of the mound on the southwest side of the mound. **1C.** Shows the gate getting caught on the stone.

- Installing a way marker (SH 70556 38696) post to encourage visitors to walk around the base of the motte, rather than walk to the top of it which contributes to further erosion (noted as 'Work area 1' in appendix 1)
- Re-distribute stones at the base of the motte to block the gaps (figures 1A and 1B) that encourage visitors to walk up the mound (SH 70556 38694 & SH 70537 38657) (noted as 'Work area 2' in appendix 1).
- Remove stone from underneath an access gate, to enable the gate to close properly without getting caught on the stone (figure 1C) (SH 70782 38634) (noted as 'Work area 3' in appendix 1).

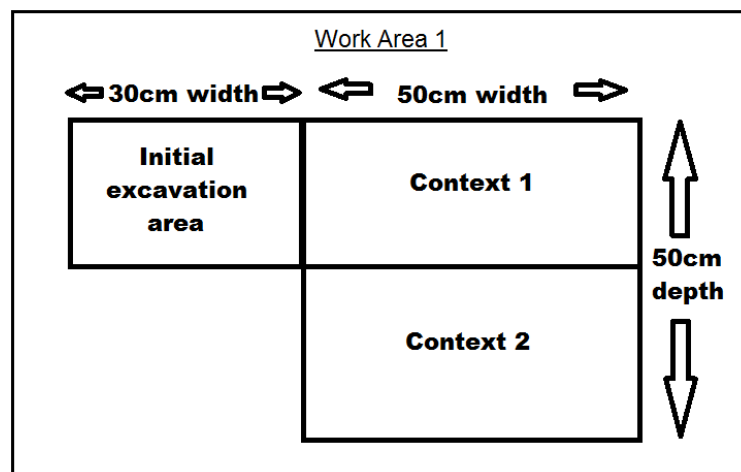
In order to install the way marker post a 50cm² surface area to a depth of 50cm had to be excavated. After initial excavation of the selected area, it became apparent that the surface area was not suitable as it contained a high number of large stones/slates. To mitigate this issue, the excavation was moved 30cm to the northwest. This resulted in ground disturbance over a surface area of 50cm by 80cm. However, as the installation area was moved by 30cm, this meant that the original plan to excavate an area of 50cm² to a depth of 50cm was retained (see figure 2).

Figure 2. Diagram showing area of initial excavation and final excavation area (contexts 1 and 2)

The watching brief identified two contexts; context 1 (or top layer) was 20cm in depth and consisted of a soil layer with stones of various shapes and sizes. A sample of the soil has not been retained as this appears natural and non-archaeological. In the case of the stones (see context 1, bags 1 and 2), these have been retained as it is possible that they may be archaeological and relate to previous occupations of the site (see context 1, bags 1 and 2). Context 2 (or lower layer) was 30cm in depth and consisted of a clay layer with stone of various shapes and sizes similar to those in context 1. A sample of the clay (see context 2, bag 1) and the stones (see context 2, bags 2-6) have been retained as these may be archaeological and relate to previous occupation of the site. No other finds or artefacts were identified in either contexts.

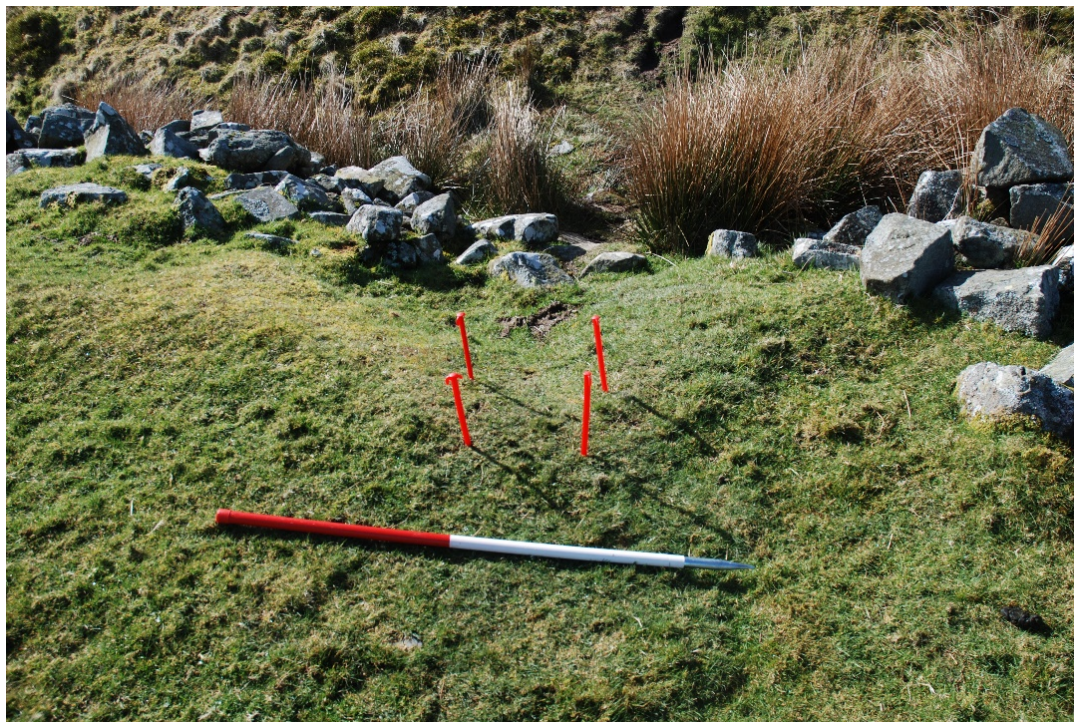
Plate 1. Southwest view showing the initial excavation location where waymarker would be installed.

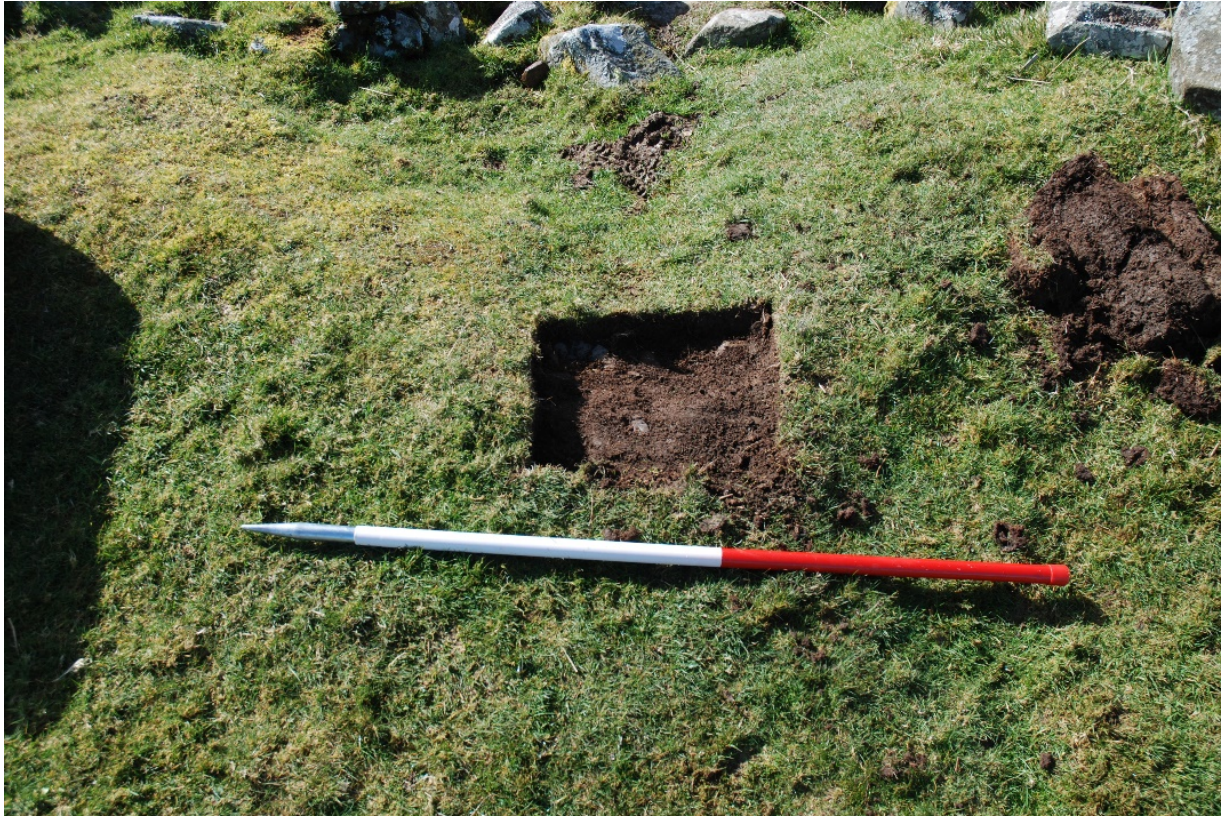
Plate 2. Southwest view showing the initial excavation location with turf layer removed and top of context 1.

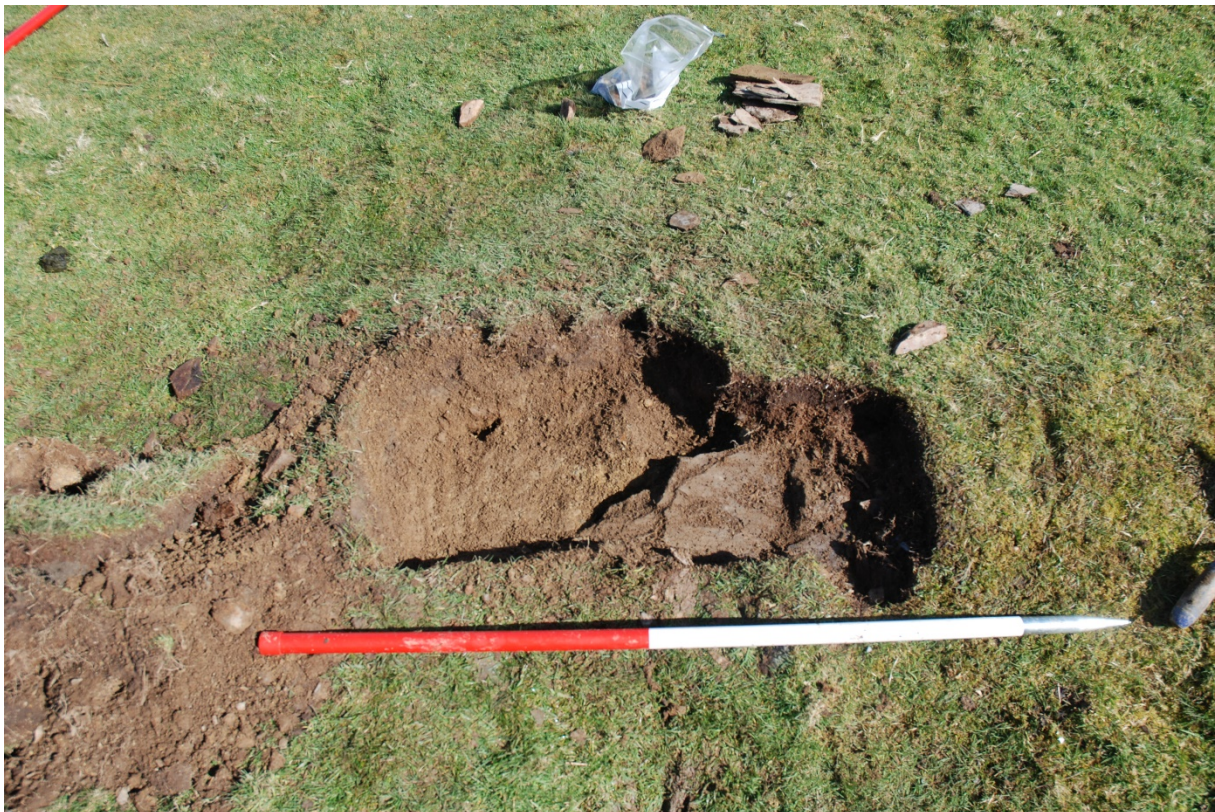
Plate 3. Northeast view showing the initial excavation location with stone (on right) and final excavation location with turf and content of context 1 removed. Also showing top of context 2.

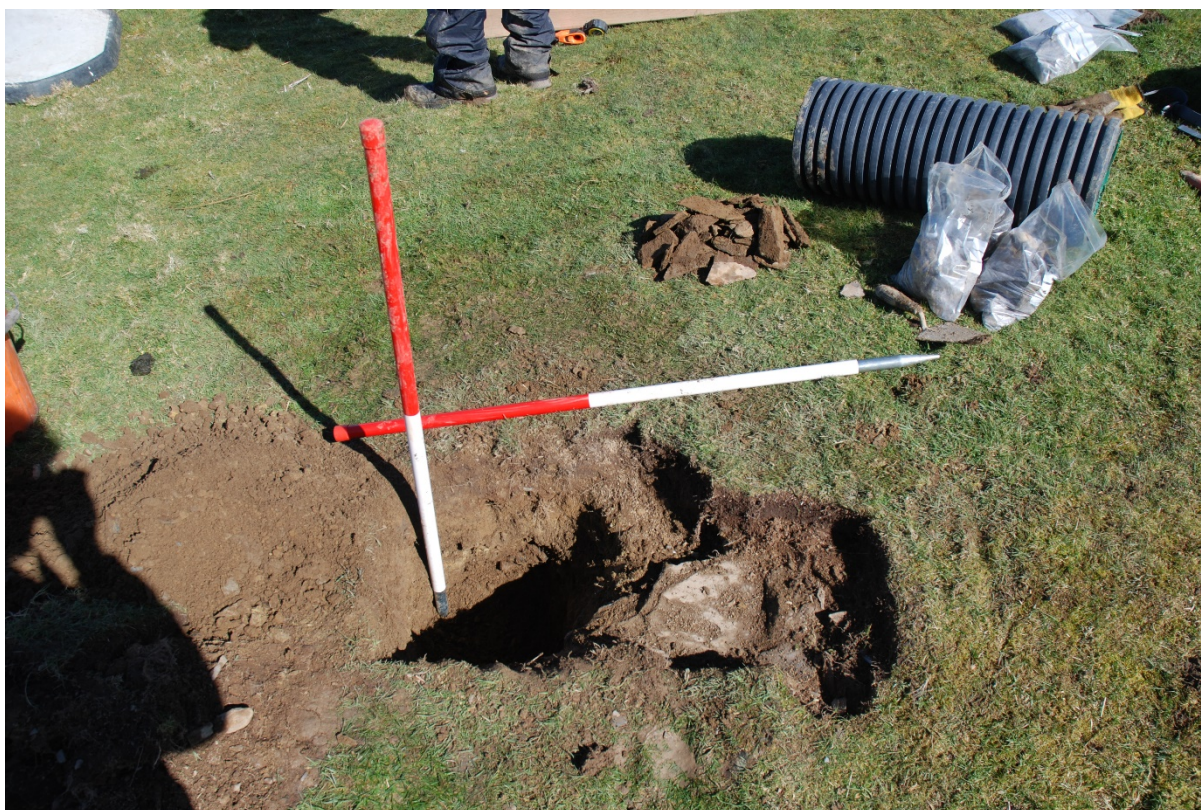
Plate 4. Northeast view showing content of context 2 removed.

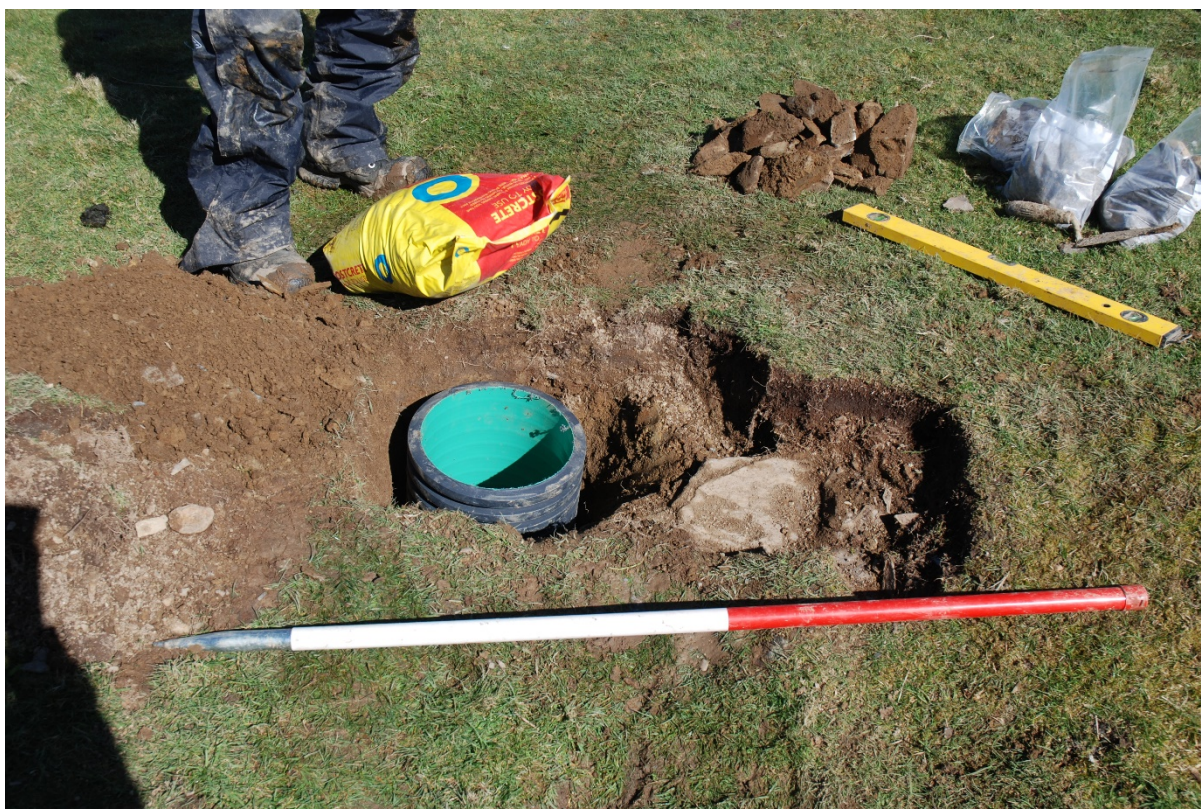
Plate 5. Northeast view showing plastic pipe that will hold the waymarker in place.

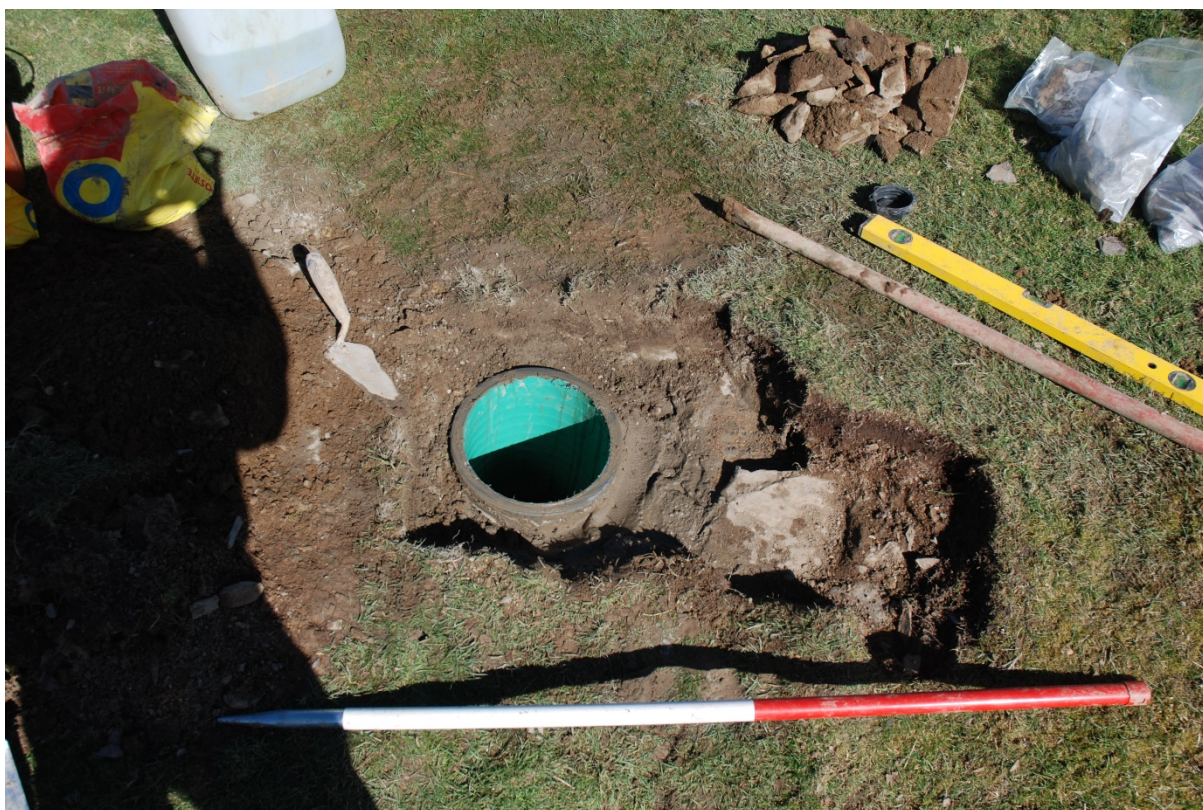
Plate 6. Northeast view showing postcrete in place around plastic pipe.

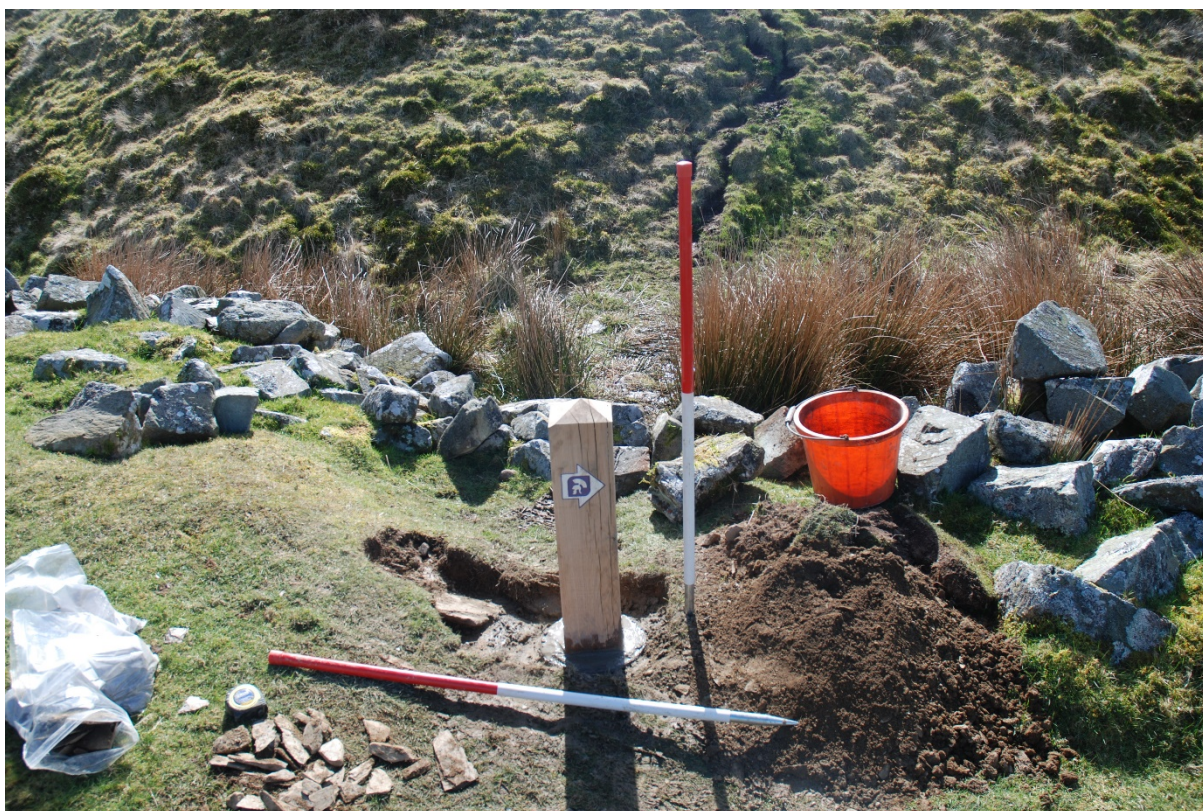
Plate 7. Southwest view showing waymarker cemented in place.

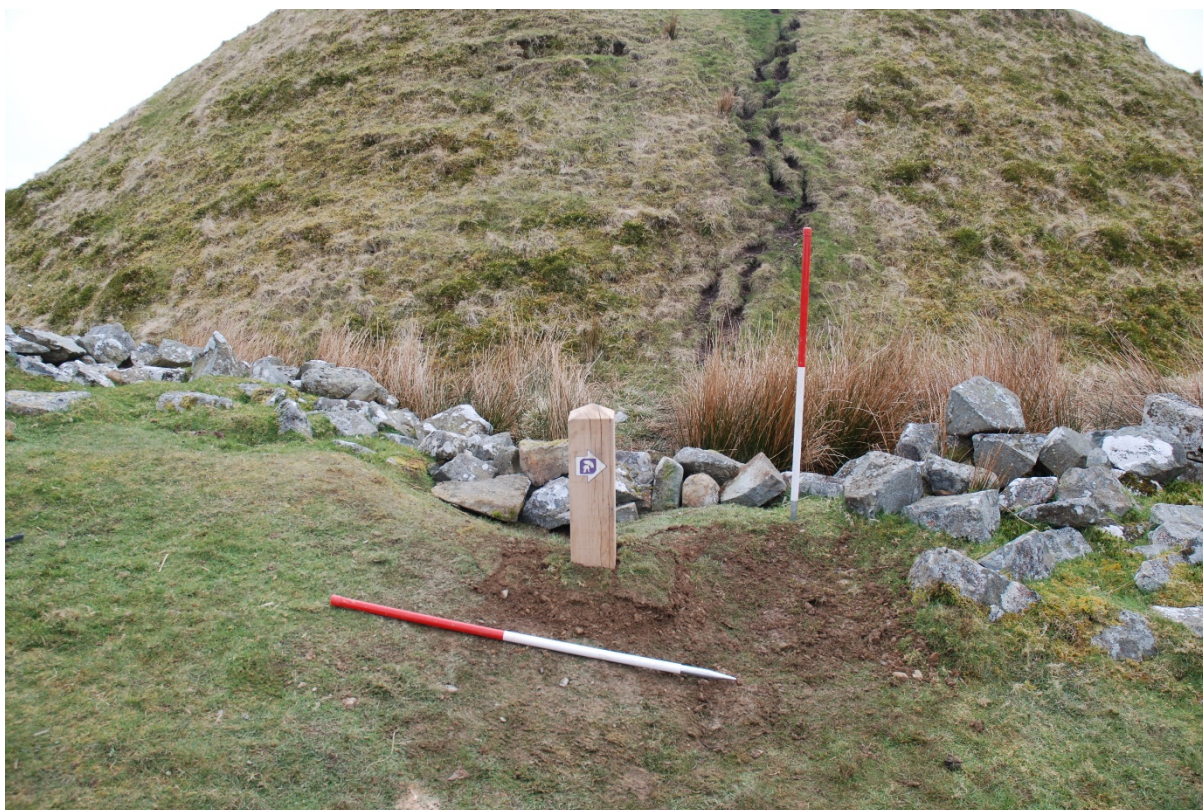
Plate 8. Southwest view showing waymarker in place with soil and turf backfilled.

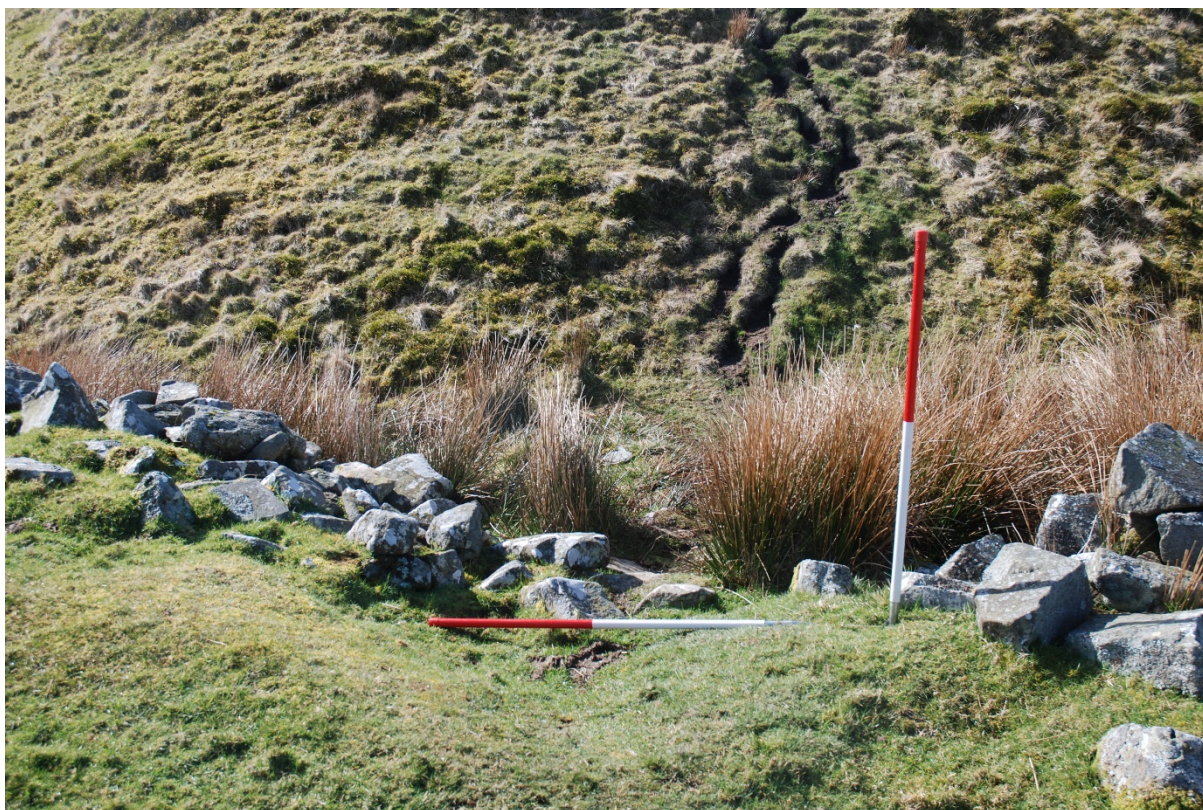
Plate 9. Southwest view showing gap in wall at base of the motte (northeast side of the motte).

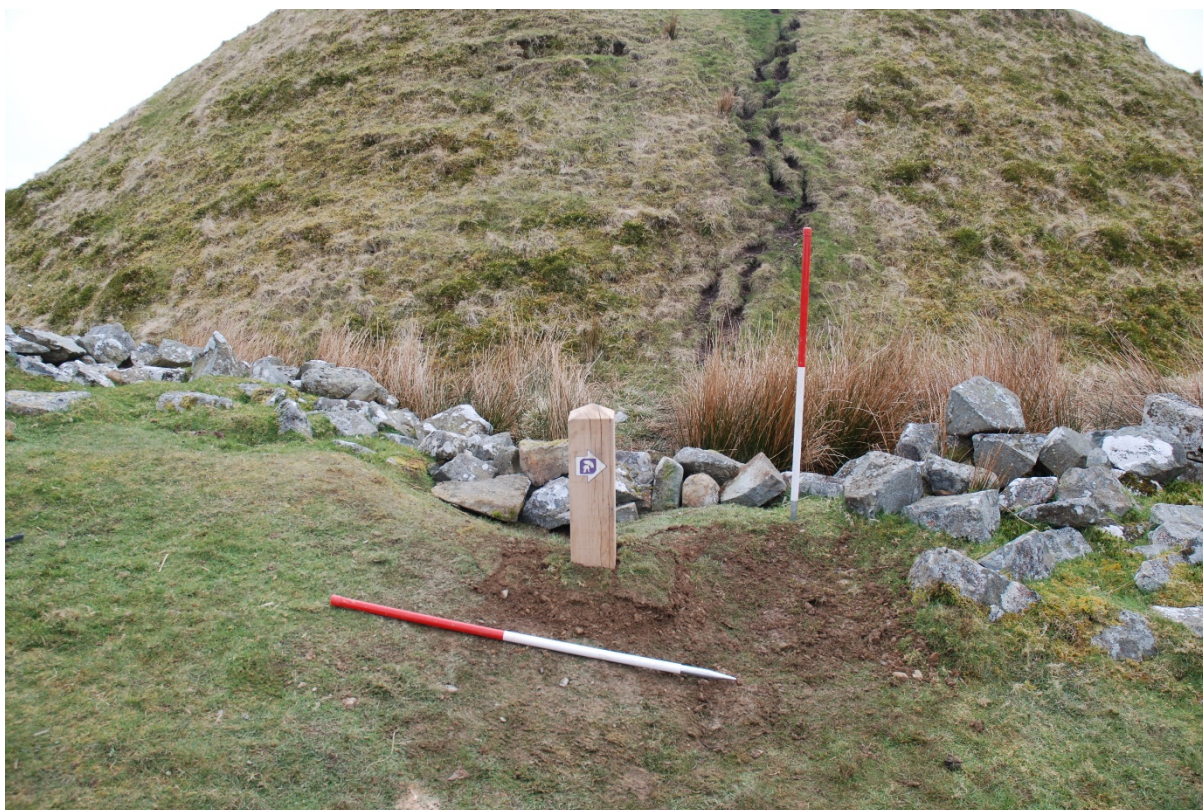
Plate 10. Southwest view showing the gap filled with stones at the base (northeast side of the motte)

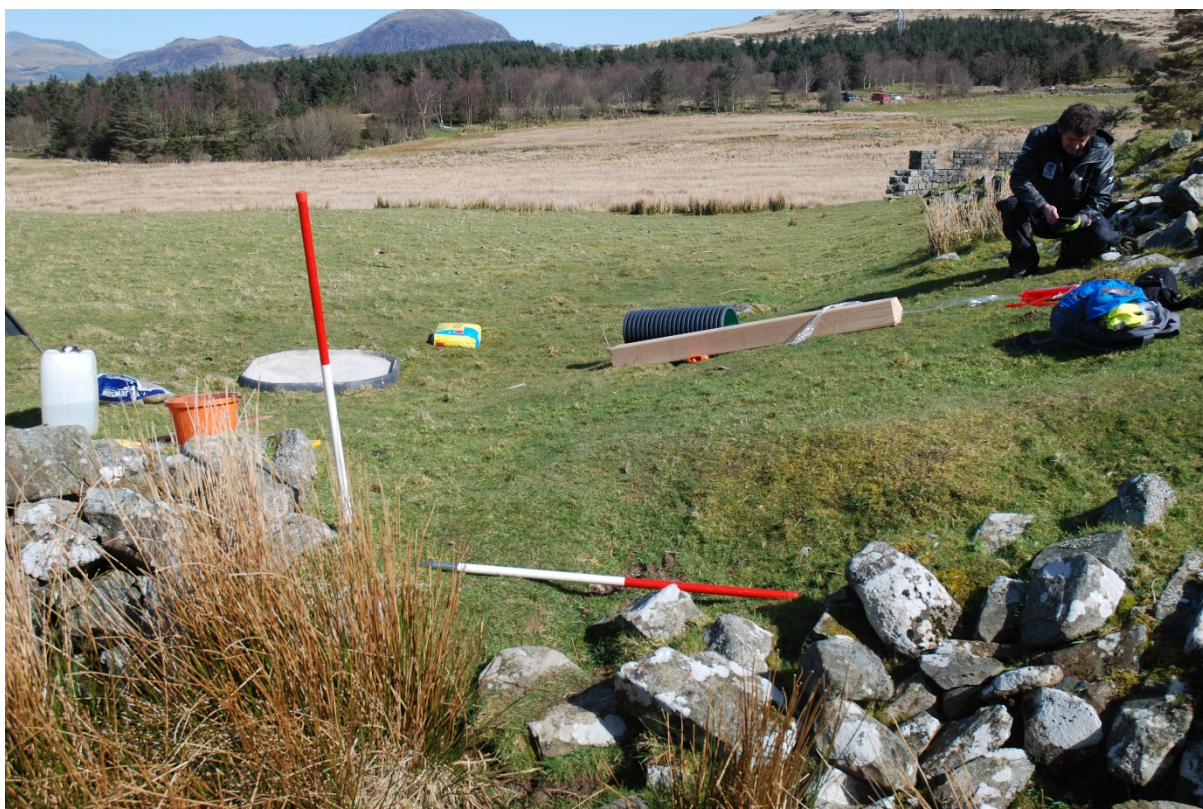
Plate 11. Northeast view showing gap in wall at base of the motte (northeast side of the motte).

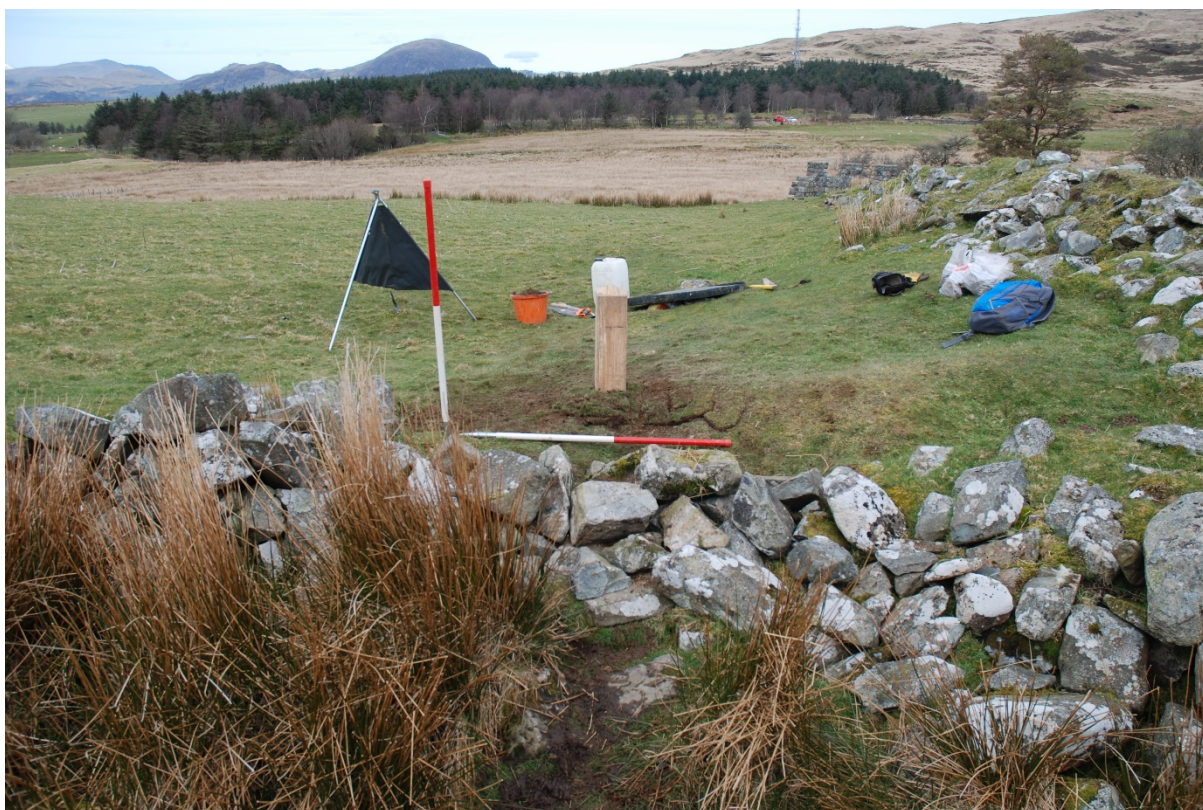
Plate 12. Northeast view showing the gap filled with stones at the base (northeast side of the motte).

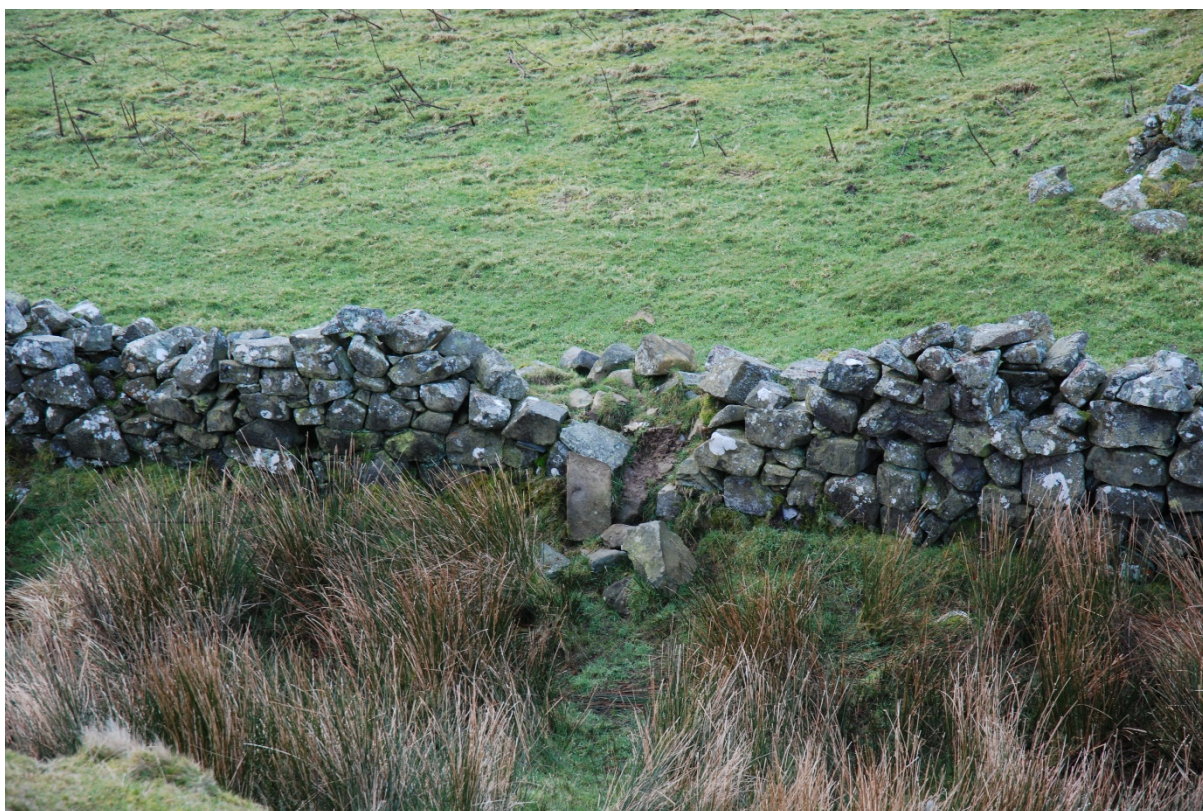
Plate 13. Southwest view showing collapsed stone and gap at the base of the motte (southwest side of the motte)

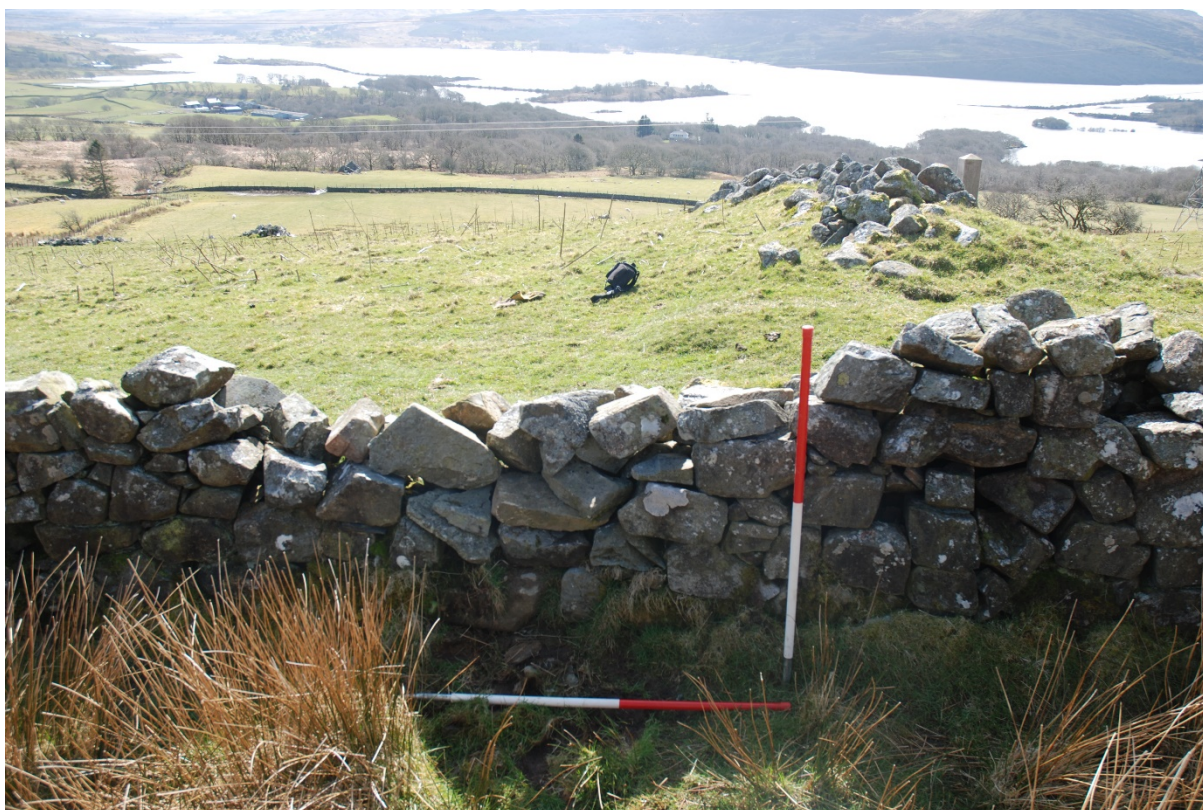
Plate 14. Southwest view showing the gap filled with stones at the base (southwest side of the motte)

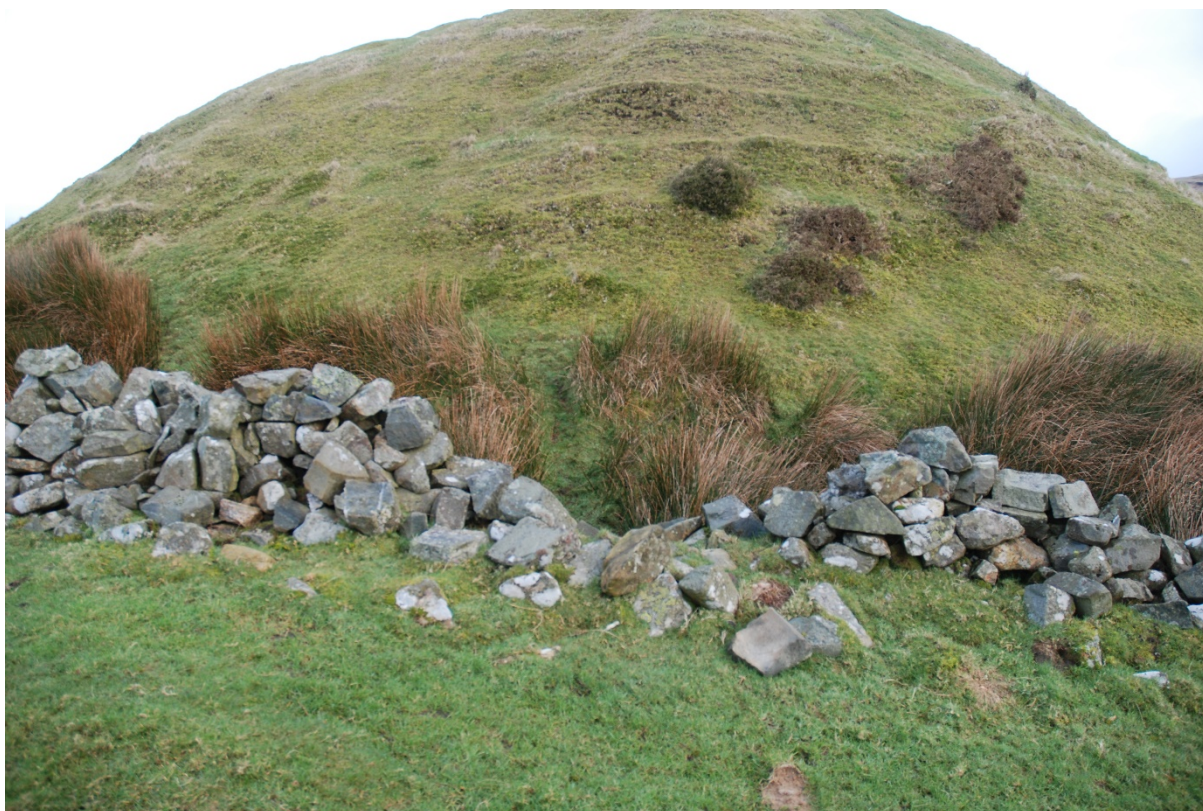
Plate 15. Northeast view showing collapsed stone and gap at the base of the motte (southwest side of the motte)

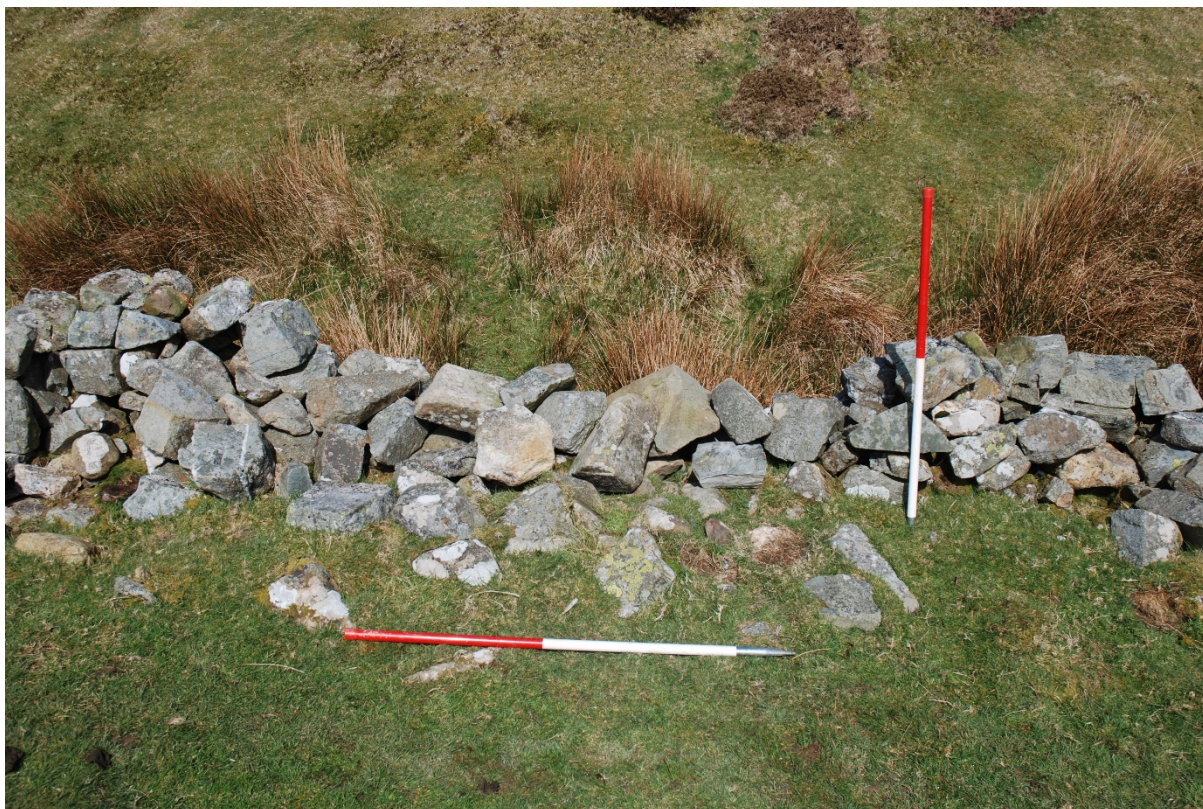
Plate 16. Northeast view showing the gap filled with stones at the base (southwest side of the motte).

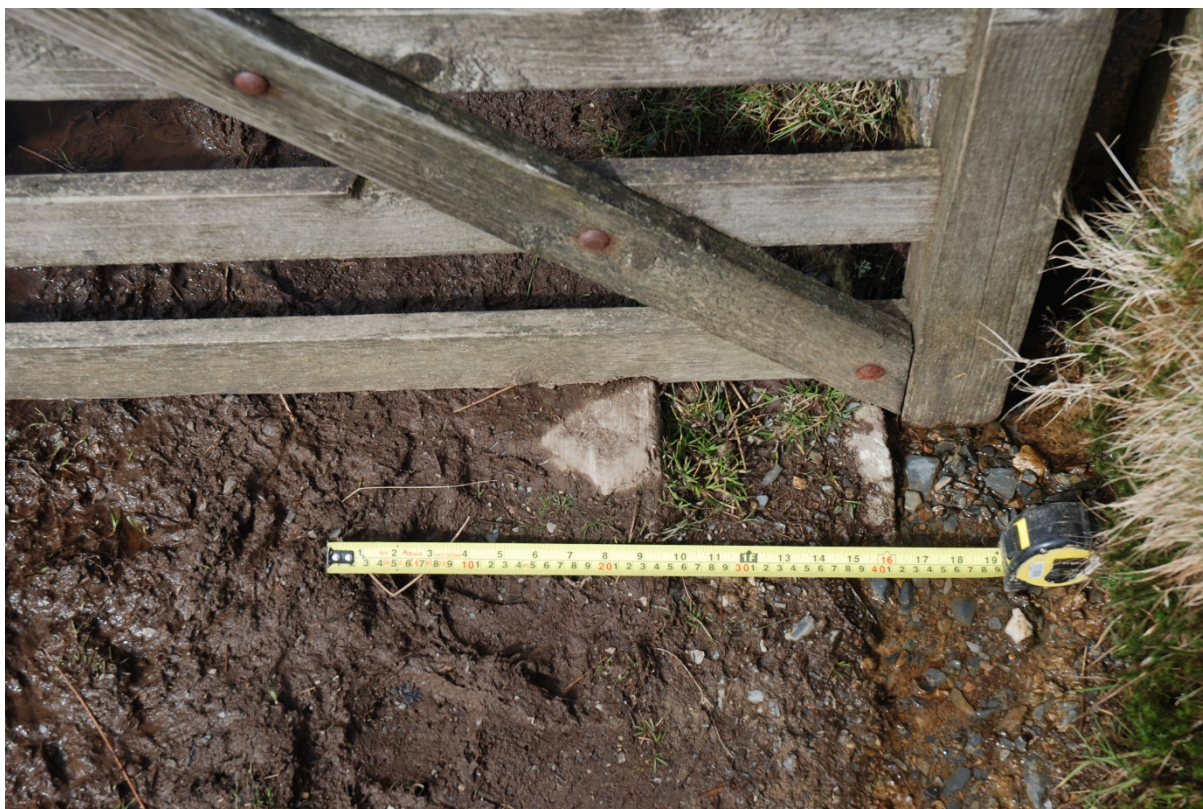
Work area 3 involved the removal of a stone that was stopping the gate from closing properly. The exposed part of the stone indicated that it was trapezium shaped and no longer than 10cm on its longest side. During removal of the stone, it became apparent that it was much larger than it first appeared and in a triangular shape (see 3.3 Photographic record below). The stone itself does not appear to be archaeologically significant although it is possible that it was part of the adjacent field enclosure walls at some point in the past as it is similar in style and type of stone. No other finds were identified during the removal this stone and the gap created by the removal of the stone was backfilled with spare top soil from work area 1.

Plate 17: Northeast view showing the gate area with the stone to be removed.

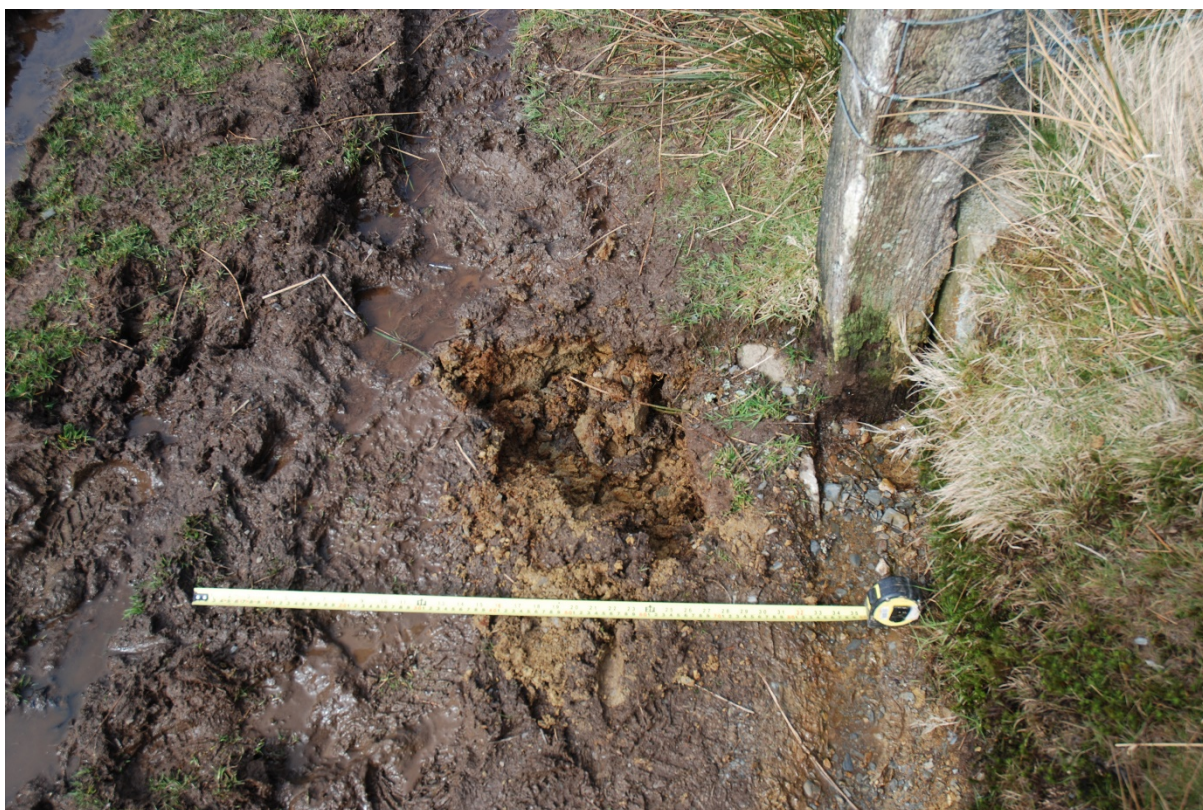
Plate 18. Northeast view showing gate area with the stone removed.

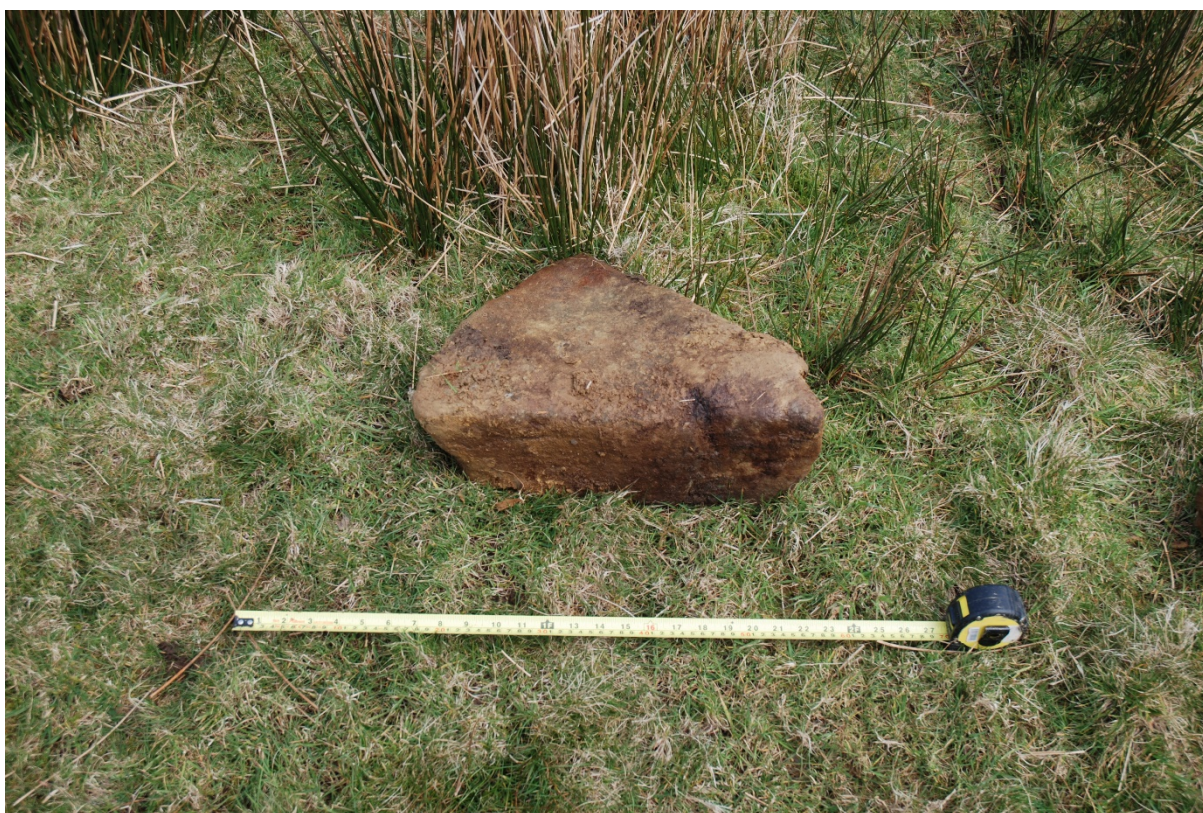
Plate 19. East view showing the removed stone.

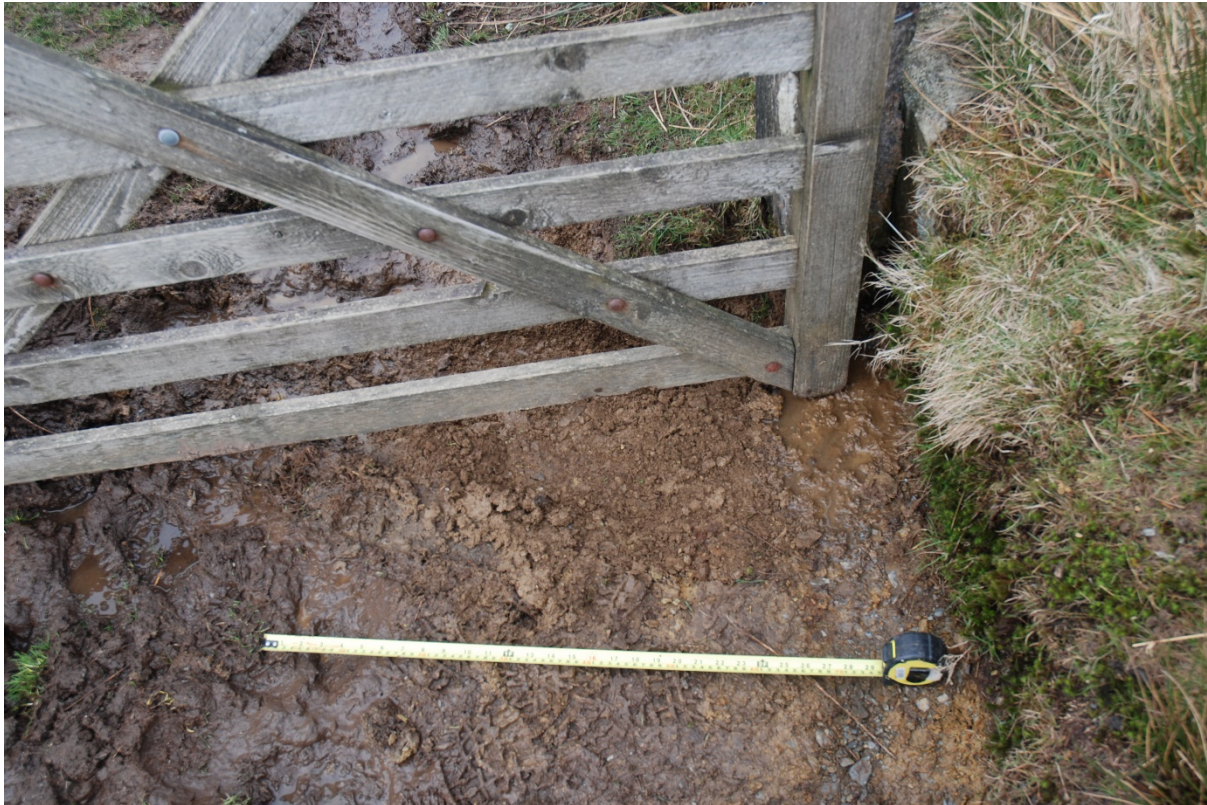
Plate 20. Northeast view showing gate area with a backfill of redundant soil from work area 1 (see appendix 1).
