# **CPAT Report No. 1603**

# Land at Penley Hall, Wrexham (Outline Planning Application)

# HERITAGE IMPACT ASSESSMENT

Project Name: Penley Hall, Wrexham

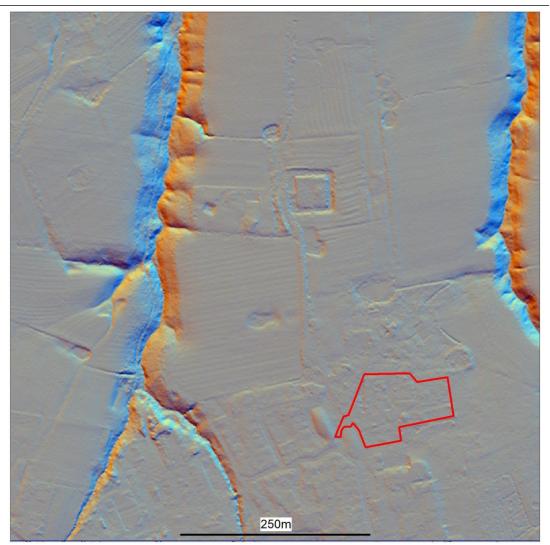
Fig. 2 1m-resolution LiDAR Digital Terrain Model, showing the Development Area in red

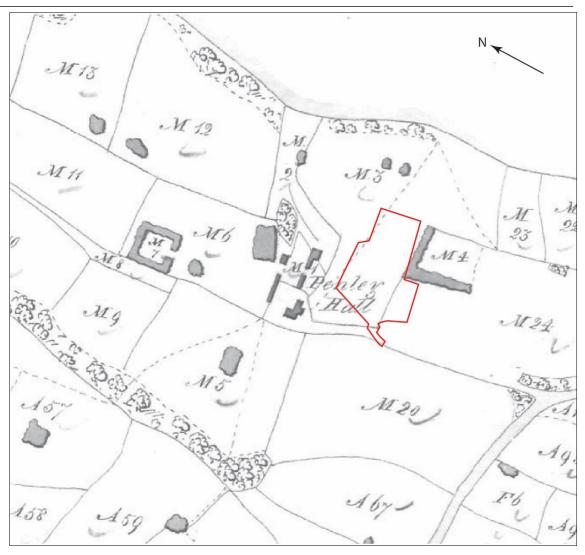
Fig. 3: Extract from the 1838 Tithe Survey for Ellesmere parish, township of Penley, showing the Development Area outlined in red (north to left)

- 3.17. The earliest available mapping, the Ordnance Survey One Inch Map of 1833 provides little useful information, being at too small a scale.
- 3.18. The 1838 Tithe map for Ellesmere parish, township of Penley (Fig. 3), and the 1837 tithe apportionment, records Penley Hall (M1) as being in the ownership of Edward Dymock, occupied by James Atty, while plot M3, into which the Development Area extends, is recorded as an 'Intack', which was mown. Plot M4, to the south of the Development Area, is recorded as a rickyard.

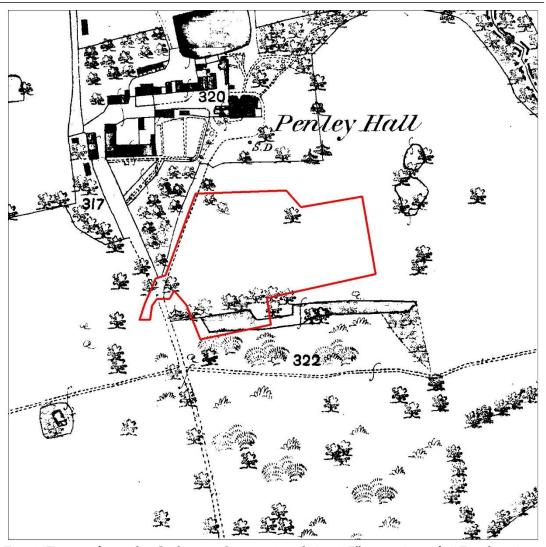
Fig. 4: Extract from the Ordnance Survey 1st edition 25" mapping of 1879, showing the Development Area in red

- 3.19. The large-scale Ordnance Survey mapping from the late 19th and early 20th centuries (Figs 4-5) shows the Development Area as lying within the grounds of Penley Hall. Curiously, what appears to be a linear pond is also shown, extending into the southwest corner of the Development Area. The pond may be a feature of the landscaped parkland surrounding the Hall, and in part incorporates an L-shaped feature depicted on the Tithe Survey, which at that time defined two sides of the rick yard.

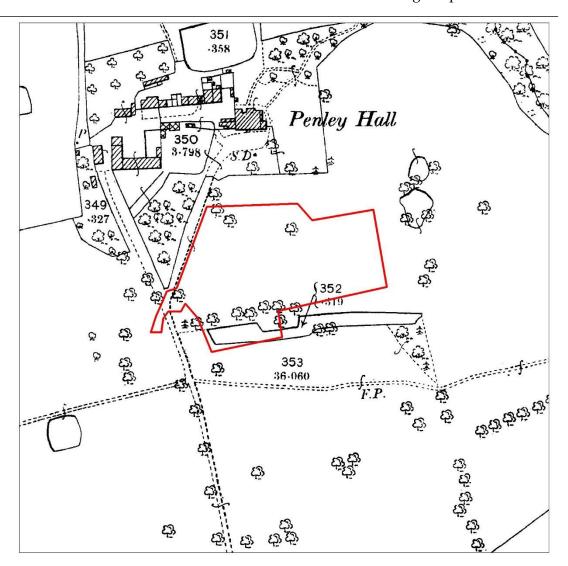
Fig. 5: Extract from the Ordnance Survey 2<sup>nd</sup> edition 25" mapping of 1899, showing the Development Area in red

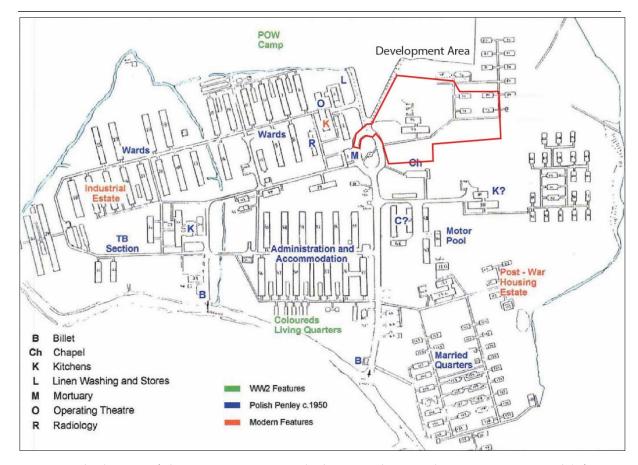
Fig. 6 The layout of the US Army Hospital, showing the Development Area in red (after Hewitson 2005, fig. 4).

3.20. The Development Area contains seven buildings which formed part of the WWII US Army Hospital (Fig. 6). A building survey was undertaken in 2005 to record a number of hospital buildings to the west of the Development Area, prior to their demolition (Hewitson et al. 2005).

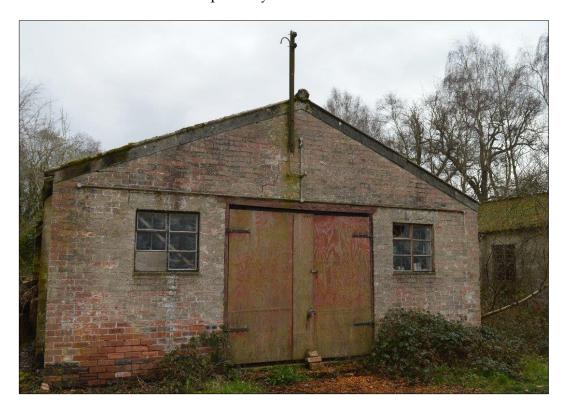
Fig. 7 West elevation of Building 1. Photo CPAT 4486-0085

4.3. Building 1 was the only building of its type in the Development Area and was located to the south of the Development Area. It measured 17m in length and 8m wide, and was connected to Building 2 via a covered access way. The building was constructed in brick, with a pitched roof clad with asbestos sheeting. The roof structure was not visible but was probably metal framed as in Building 2. The building was broadly divided into two spaces, the larger of which comprised a rectangular area measuring 11m by 8m, accessed via large double doors on the west elevation, a small doorway on the south elevation or via an internal entrance to the east. This part of the building was not accessible at the time of the survey, so the original use of the space could not be determined. A chimney and overhead heating pipes running through the access way, suggested that there was a boiler room in the north-east corner of this space.

4.4. To the west was a complex of rooms comprising a store room, two toilets, a cupboard and a small office, located off a passageway leading to the covered access way to Building 2. The building probably housed a works unit containing a boiler room and other essential equipment such as a backup generator for Building 2. The attached office and other facilities were probably for the use of staff.

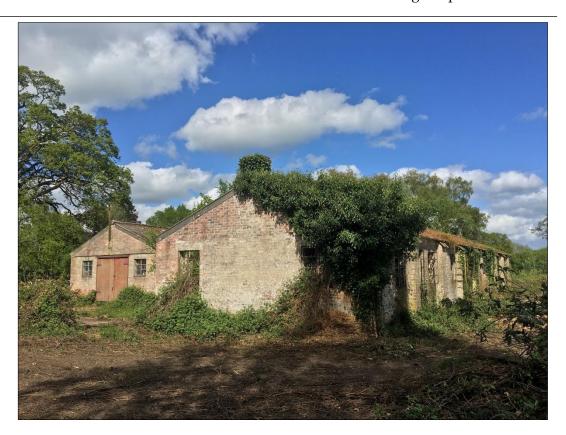
Fig. 8 Buildings 1 and 2, viewed from the south-west. Photo K. Barker.

4.5. Building 2 was located approximately 8m to the south of Building 1, and was connected to it. It was 31.5m in length and 8m wide. This was the only building of this type in the Development Area. It was brick built with a metal framed pitched roof sheeted with asbestos. There were four entrances, large double doorways located on the east elevation and the west end of the north elevation, and two smaller doorways on the south and north elevations, the latter leading into the covered access way to Building 1. A chimney was located on the west elevation, this appeared to be an original feature although the upper portion of the structure had been rebuilt in stone. The interior was well lit, with steel framed casement windows on all four elevations. There was no evidence of any internal subdivision.

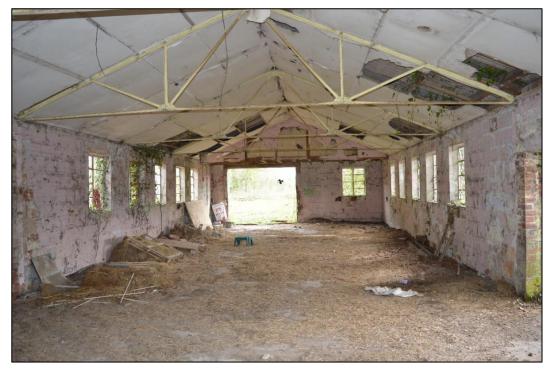
Fig. 9 The interior of Building 2, viewed from the west. Photo CPAT 4486-0095

4.6. This building was probably used as communal area or day room although the size and proportions of the building suggest that it could have been used as a hospital ward if required.

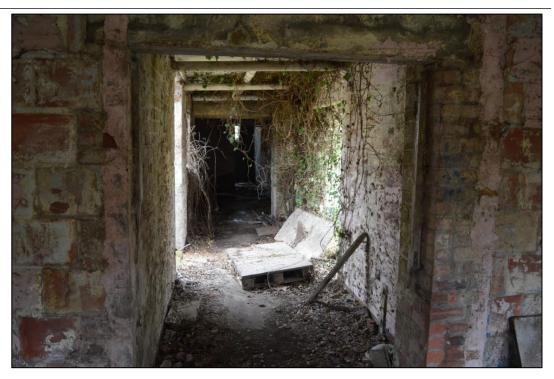
Fig. 10 The covered access way between Buildings 1 and 2, from the south. Photo CPAT 4486-0097

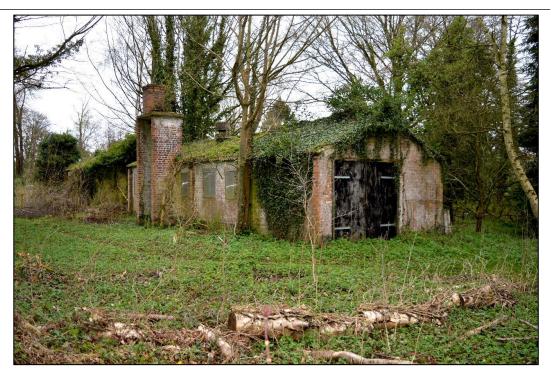
Fig. 11 The toilet and bath block from the east. Photo CPAT 4486-0051

- 4.9. The building was divided into two areas internally. At the west end was a series of small storerooms, which were accessed via a door in the west elevation. These rooms were filled with wood at the time of survey, which prevented access into the boiler room on the south elevation.

- 4.10. The east side of the building was accessed via a double door set asymmetrically in the east gable. Nine toilet cubicles were arranged along the north elevation, although most of them had been removed and the subdivisions knocked down. At the east end of the north elevation was an area subdivided into two, surrounded by runoff drainage, probably for showers. Along the south elevation were three bathrooms, from which the internal fixtures had been removed.

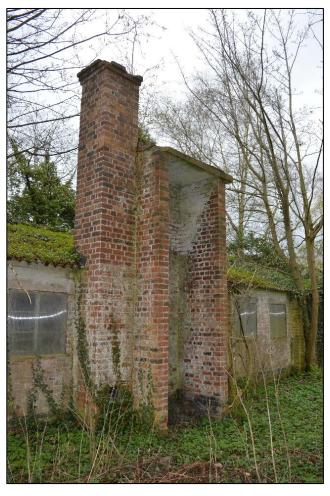
Fig. 12 The chimney stack and water tank support, viewed from the south. Photo CPAT 4486-0066

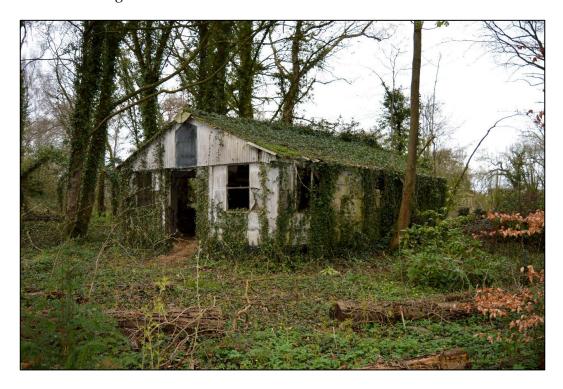
Fig. 13 The intact ward (Building 4), from the north-east. Photo CPAT 4486-0052

4.11. Four examples of this type of building lay within the Development Area, each measuring 9.5m in length and 6m wide. However, only Building 4 survived intact, while the concrete supports are all that remain from Buildings 5, 6 and 7. They were a prefabricated design, constructed with moulded concrete upright supports and roof beams supporting a pitched roof. The roof and sides were clad with asbestos sheeting. Doorways 1.6m wide were located at either gable end, and had both subsequently been narrowed by 0.4m after 1946. The window layout in these buildings was asymmetrical, with three windows in the south elevation and two in the northern elevation. These buildings were probably small hospital wards, accommodating ten beds.

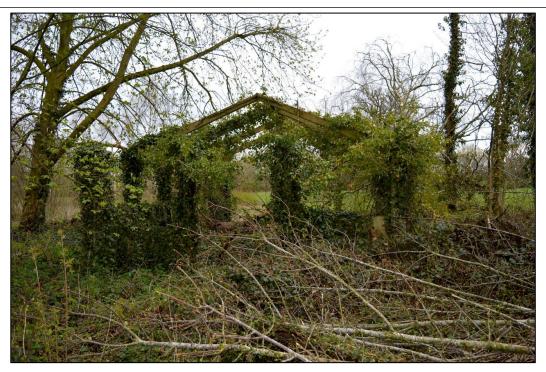
Fig. 14 A derelict ward, viewed from the west. Photo CPAT 4486-0054

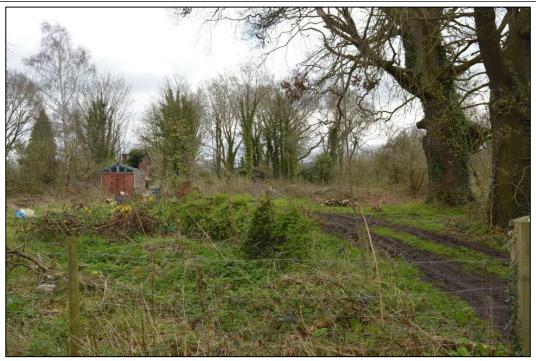
- 5.7. The ornamental gardens, shrubberies and kitchen garden extended over a total area of 2.75 acres. Historic mapping locates the ornamental gardens and shrubberies within an irregular area to the south and east of the Hall, 80m to the north of the Development Area. The kitchen gardens are located within an irregular walled enclosure 34m north-west of the Development Area. Three glass houses were located in the north-west corner of the walled garden.
- 5.8. The ornamental gardens and shrubbery have become overgrown and have reverted to wooded scrubland. The north and west wall of the kitchen garden have survived, although the glasshouses have been removed.

Fig. 15 View from the east extent of the kitchen gardens towards the Development Area Photo CPAT 4486-0118

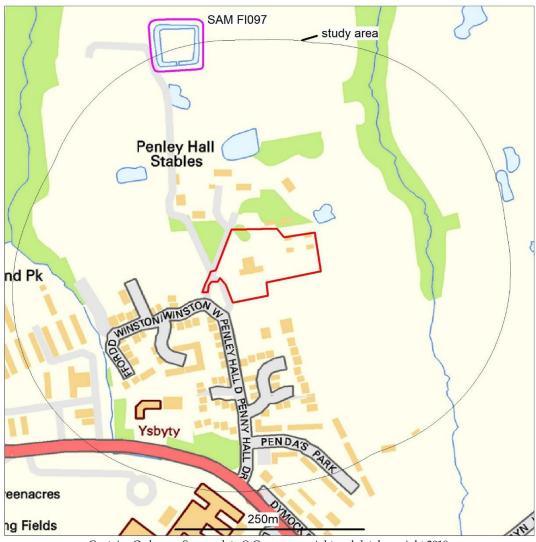
Fig. 16: Designated assets within 250m of the Development Area

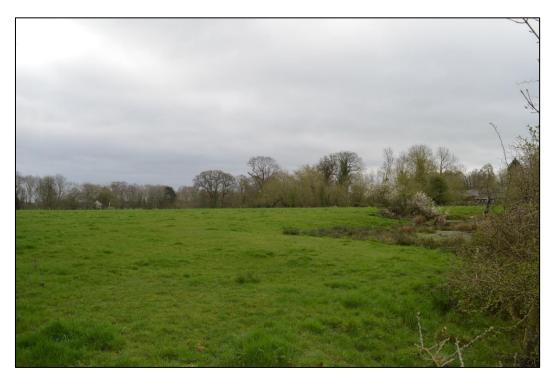
5.22. The pond, which was recorded on the Tithe Map c.1840, is located approximately 130m to the north-west of the Development Area.

Fig. 18 View south-east towards the Development Area, with pond 720 to the right of shot Photo CPAT 4486-0003

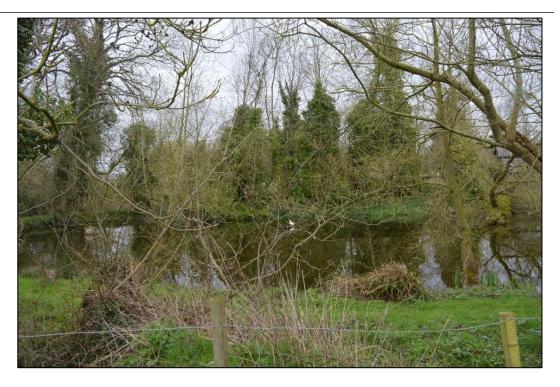
5.23. This pond, which was recorded on the Tithe Map c.1840, is located approximately adjacent to the north-west side of the Development Area.

Fig. 19 View from the north across pond 721 towards the Development Area Photo CPAT 4486-0014

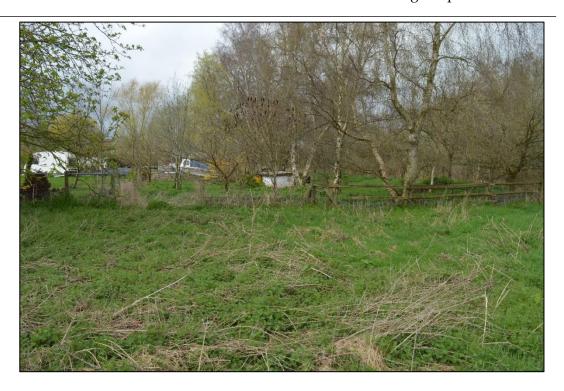
5.24. An L-shaped feature, possible a pond, which is depicted on the tithe survey. It is recorded in the regional HER as a possible medieval moated site, although the tithe apportionment identifies the area as a rick yard. It appears that the northern part of the feature was later incorporated into what may be an ornamental pond as part of the parkland surrounding Penley Hall. The possible moat lies outside the Development Area, while part of the later pond lies in the south-west corner.

Fig. 20 View from the east of the site of the possible moat Photo CPAT 4486-0128

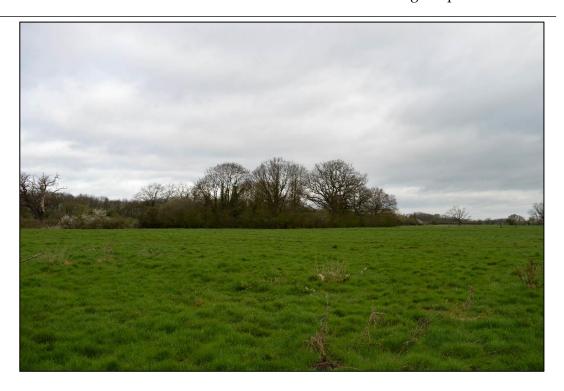
- 6.7. The only scheduled ancient monument within 250m of the Development Area is Penley Hall Moated Site (Fl097), located 210m to the north-west.
- 6.8. There is no intervisibility between the moated site and the Development Area. The impact is considered to be **no change** and significance is **neutral**.

Fig. 21 View north towards the scheduled moated site Photo CPAT 4486-0016

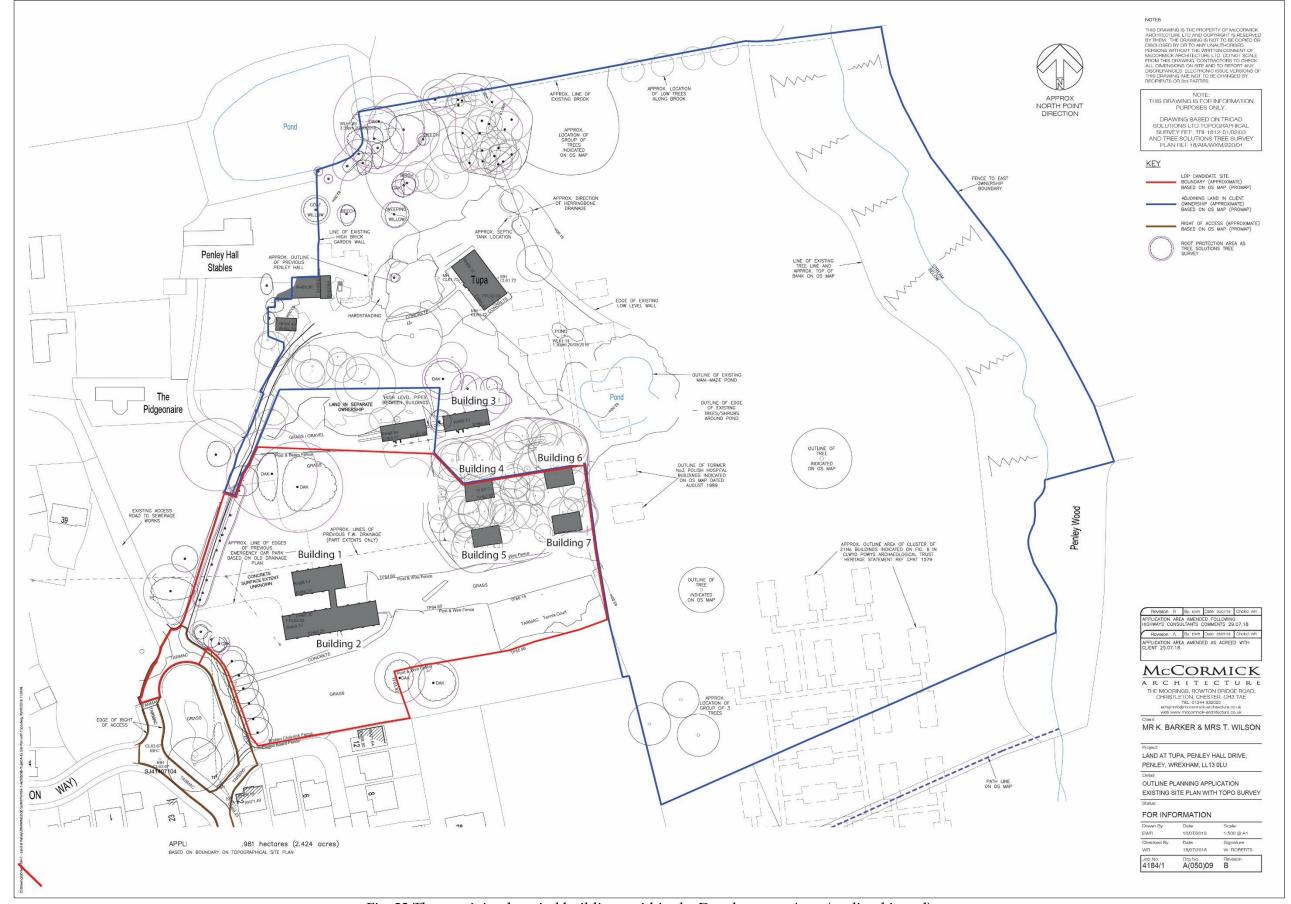
Fig. 22 The surviving hospital buildings within the Development Area (outlined in red)

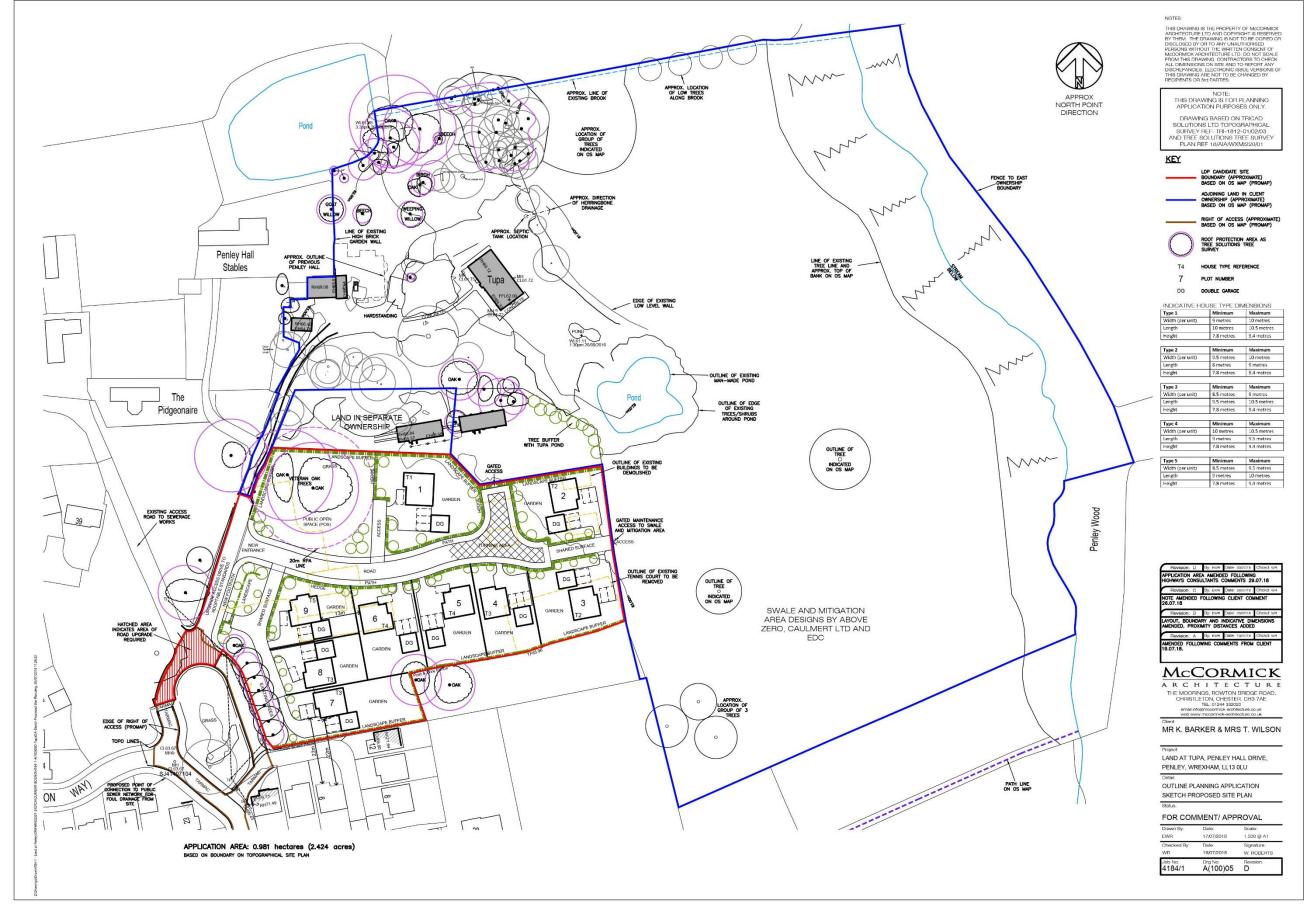
Fig. 23 Plan showing the layout of the proposed development area

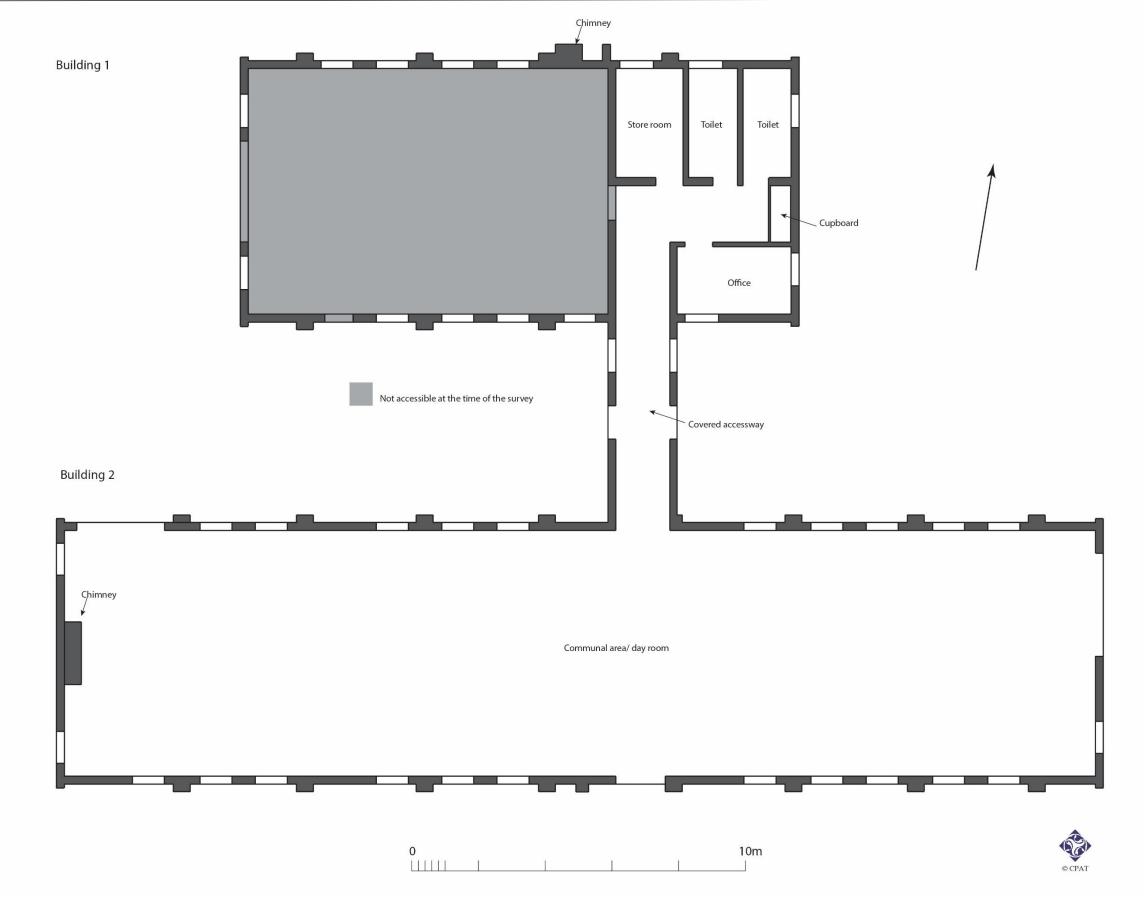
Fig. 24 Hospital Buildings 1 and 2

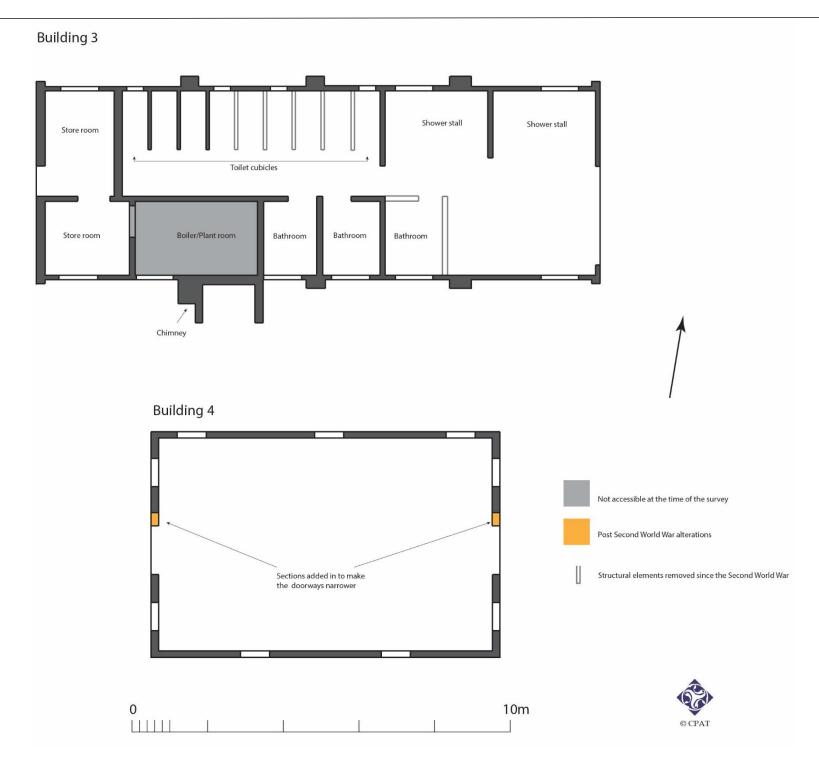
Fig. 25 Hospital Buildings 3 and 4
