CPAT Report No. 1589

# St Cynhafal's Church, Llangynhafal, Denbighshire

ARCHAEOLOGICAL EVALUATION

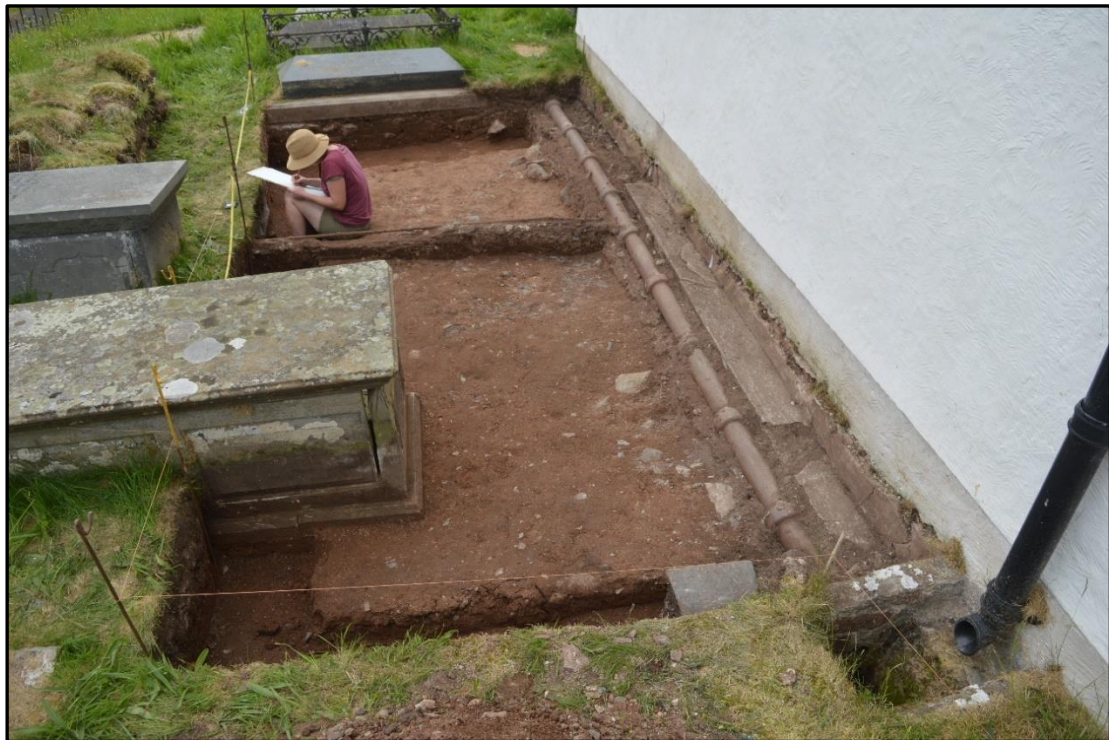
Cover: Evaluation trench, viewed from the south-east. Photo CPAT 4507-0021

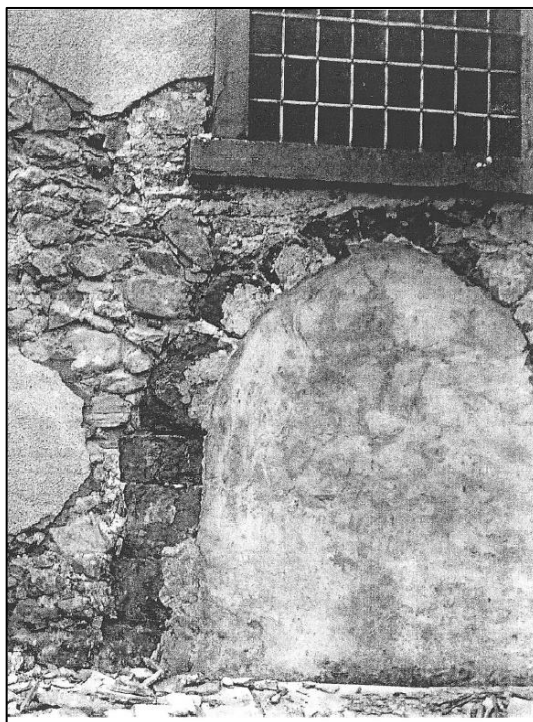
Fig. 2 Blocked doorway, west wall of the north nave, revealed during restoration in 2007. Photo G. Holland.

- 1.1. The Clwyd-Powys Archaeological Trust (CPAT) was invited by Graham Holland Associates, on behalf of the Parochial Church Council, to undertake an archaeological evaluation in connection with proposals for a small extension to St Cynhafal's Church, Llangynhafal, in Denbighshire (Fig. 1; SJ 13296 63402). The new extension at the west end of the church, which would measure around 5m by 2.8m, would include the provision of a lavatory and kitchenette to be accessed via an existing, but blocked, doorway from the nave (Fig. 2).

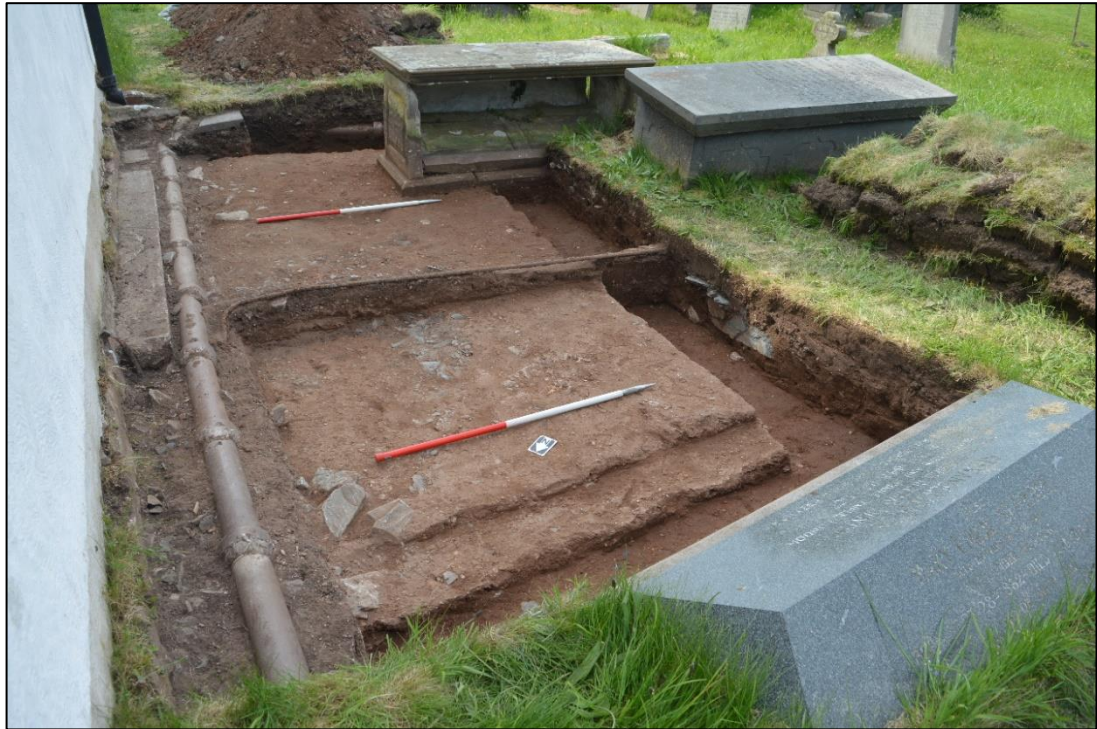
Fig. 4. The excavation viewed from the north. Photo CPAT 4507-0002

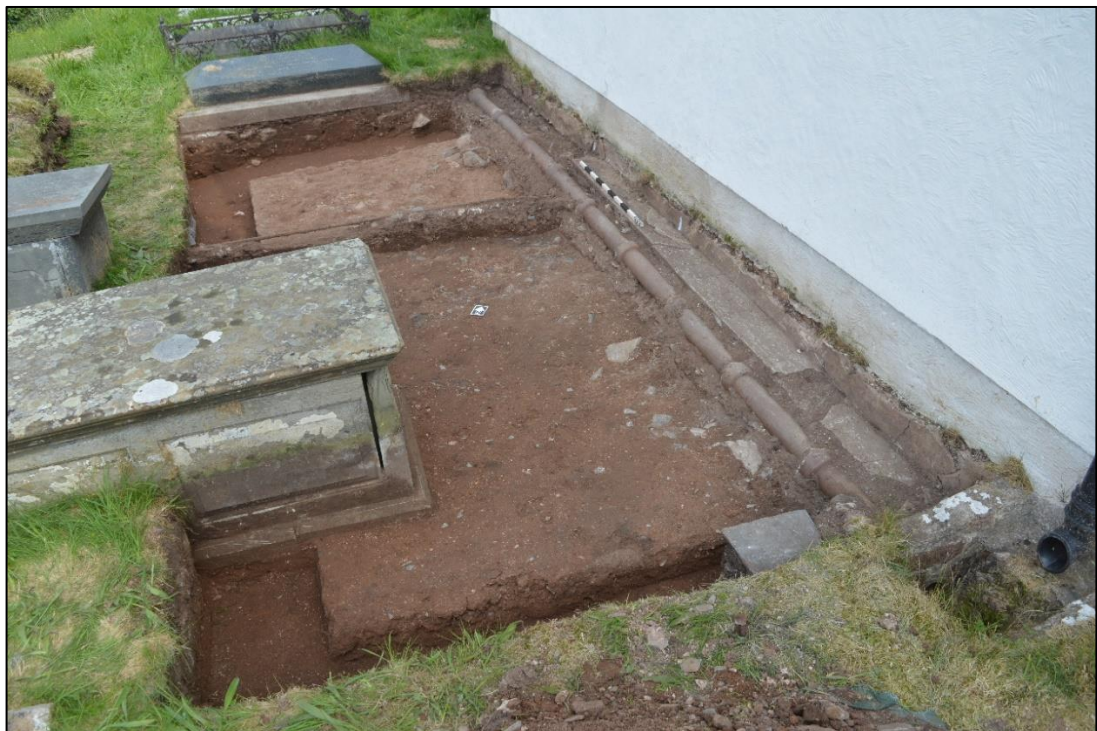
Fig. 5. The excavation viewed from the south. Photo CPAT 4507-0016

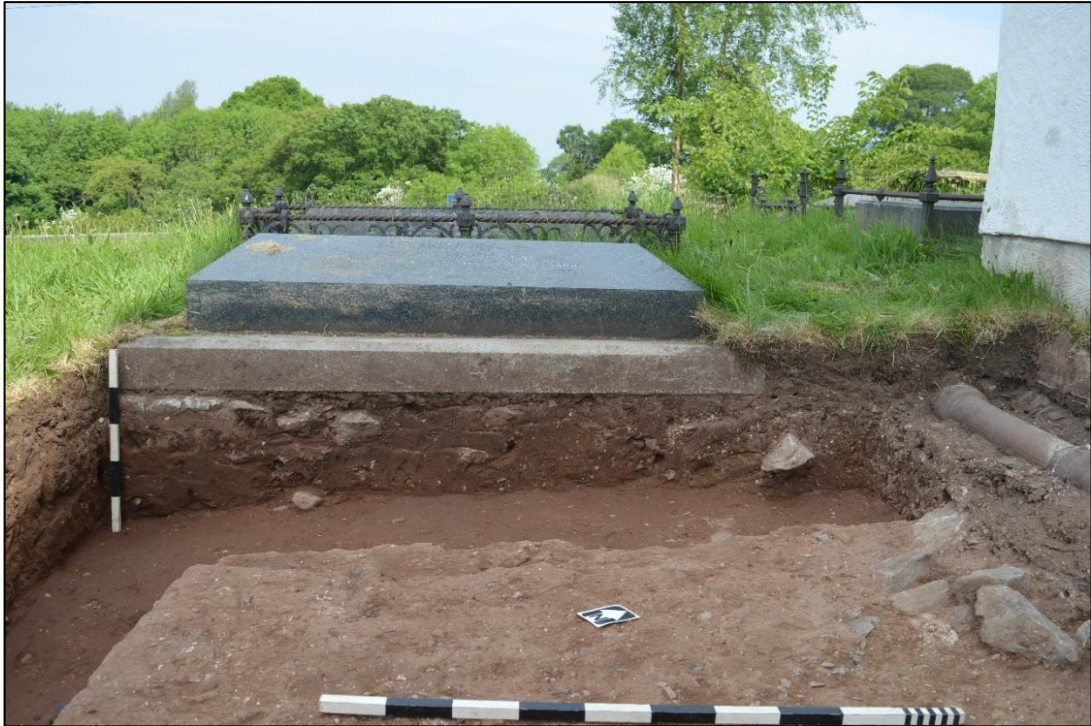
Fig. 6. South-east-facing section. Photo CPAT 4507-0005

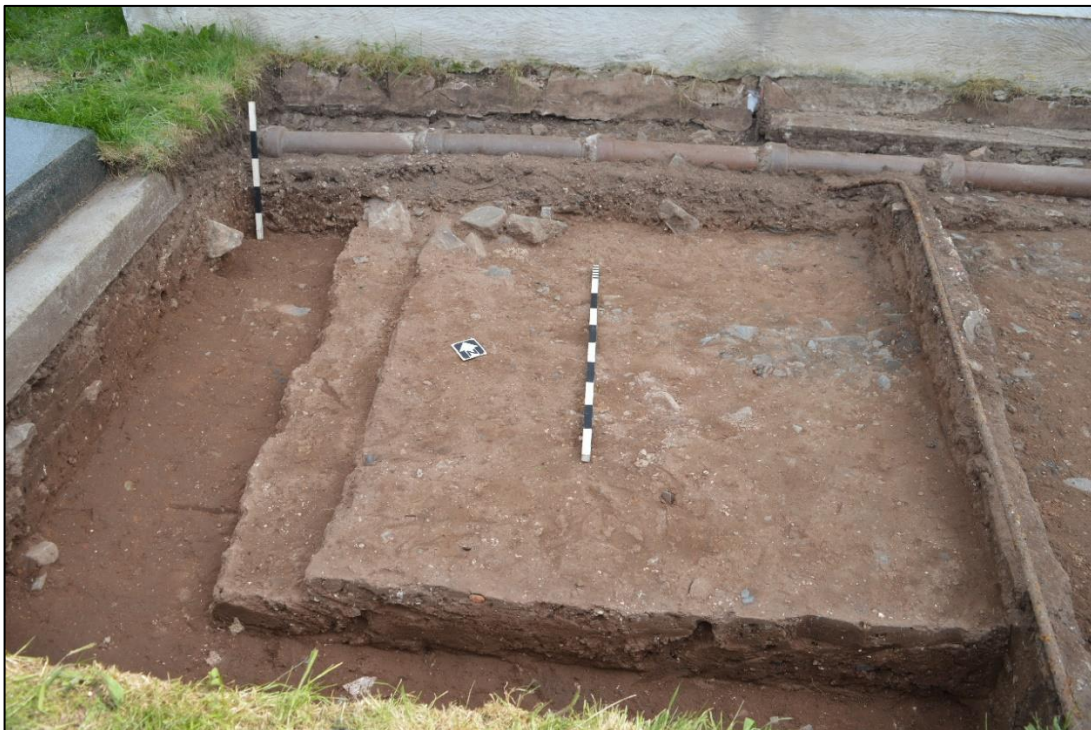
Fig. 7. Excavated ring beam footings, deposit 04 *in-situ*. Electrical cable (13) to the right. Viewed from the west. Photo CPAT 4507-0003

- 3.3. At a depth of 0.1m below the present ground surface an electrical service cable, orientated east to west, was recorded at a point adjacent to the blocked doorway in the west wall. It is unknown whether or not the cable, which extended beyond the bounds of the excavation, is redundant (Fig. 7).

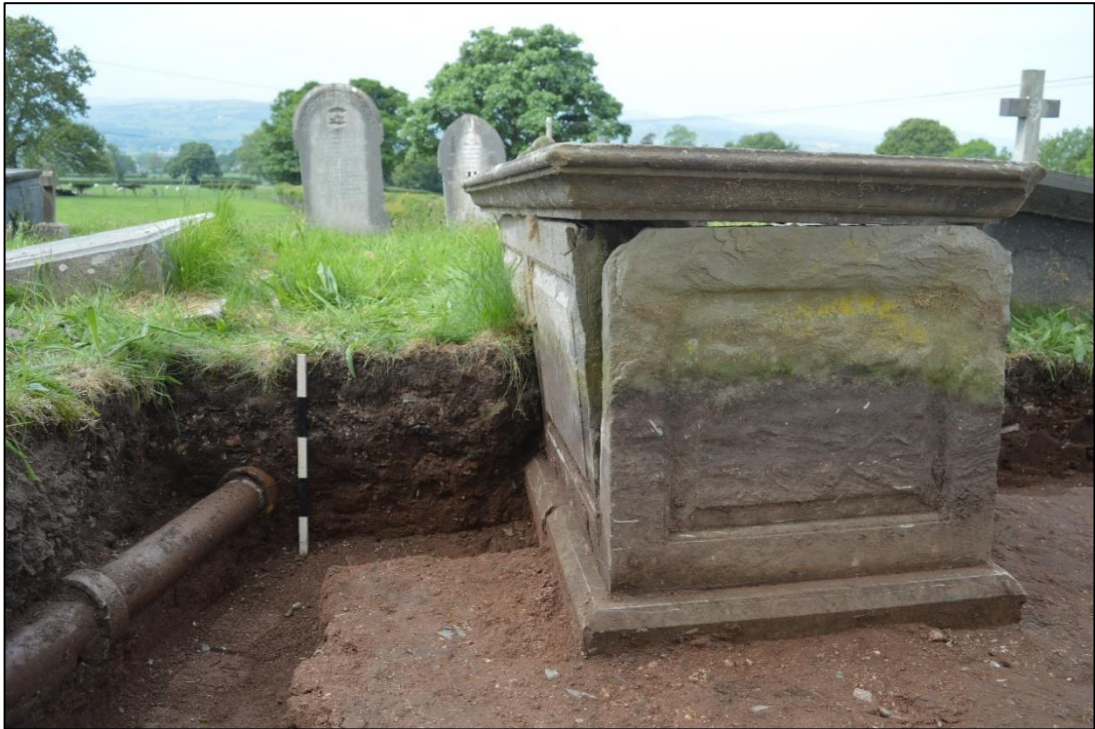
Fig. 9. South-west corner footings, drainage (03) and tomb (10). Viewed from the east. Photo CPAT 4507-0014

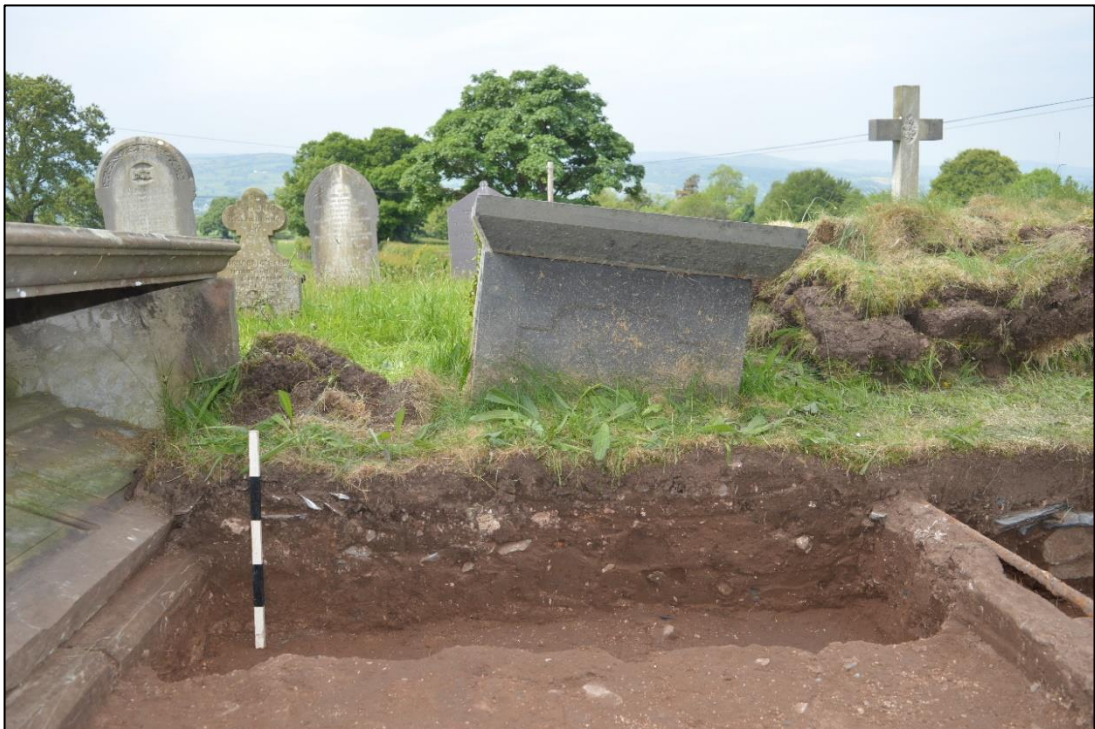
Fig. 10. East-facing section. Photo CPAT 4507-0007

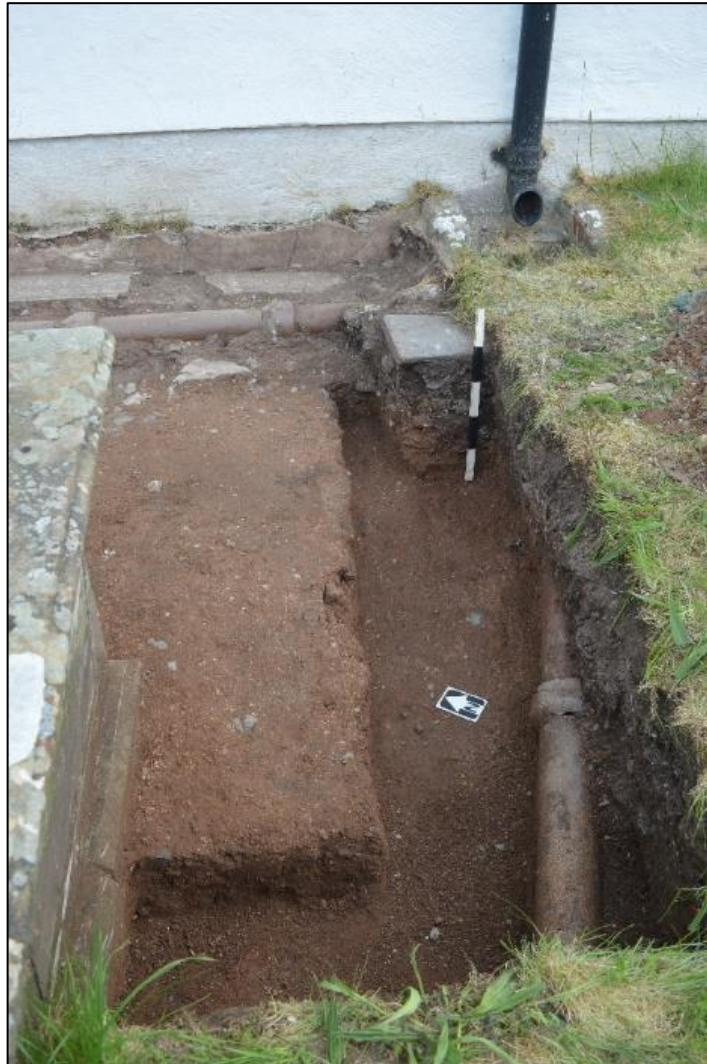
Fig. 11. View of the west wall showing the location of the south-east footings and drainage (03). Viewed from the west. Photo CPAT 4507-0013
