CPAT Report No 1264

52-54 Vale Street, Denbigh

Archaeological Watching Brief

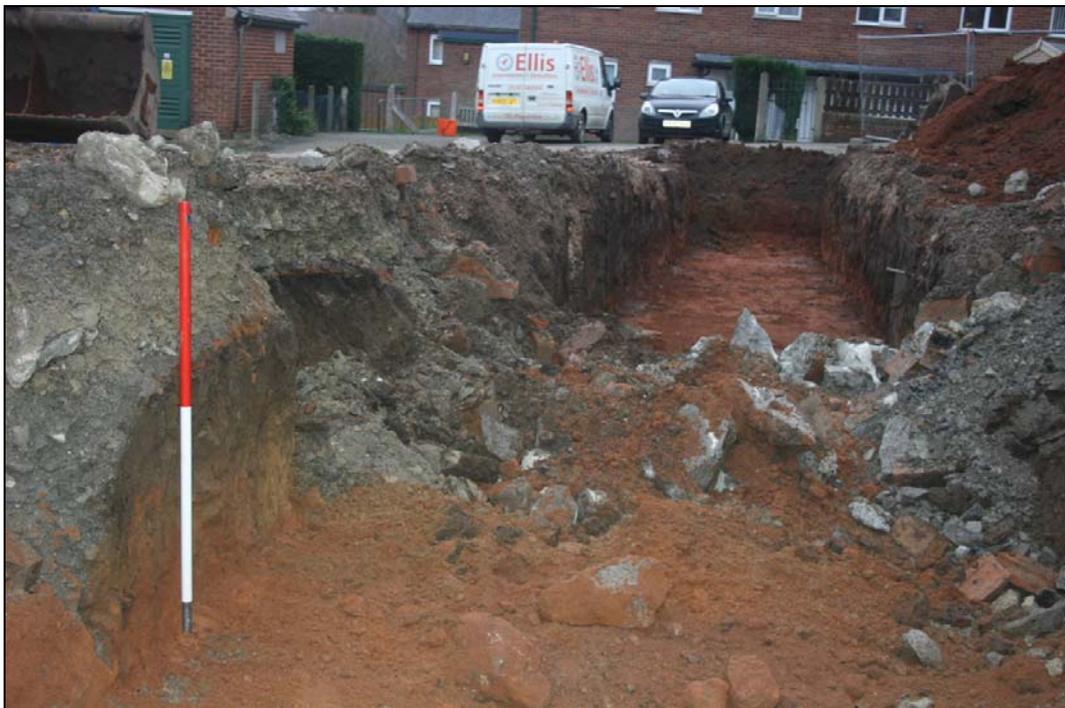
Fig. 2 The service trench (viewed from the street frontage), showing modern footings in the foreground. Photo CPAT 3747-0006

- 3.1 The watching brief was conducted between 16 December 2013 and 12 February 2014 with the timing being determined by the contractors' programme of work. In all seven visits were made to site. The initial site works consisted of the relocation of existing services and the excavation of a new service trench in the area formerly occupied by No 52 Vale Street. The trench, which was 1.9m wide, was excavated by machine under archaeological supervision.

- 3.2 The service trench provided an opportunity to re-examine the stratigraphic sequence across the plot, and in particular this identified the level of the natural subsoil, which varied between 0.6m around the foundations of No. 52 to as little as 0.4m at the rear of the property. Along the street frontage the stratigraphic sequence indicated the presence of a terrace which corresponded with the position of the 'Grove', documented on earlier mapping. The new service trench cut across the western end of the 2012 evaluation trench to the rear of No. 52, but no further archaeological features were identified.

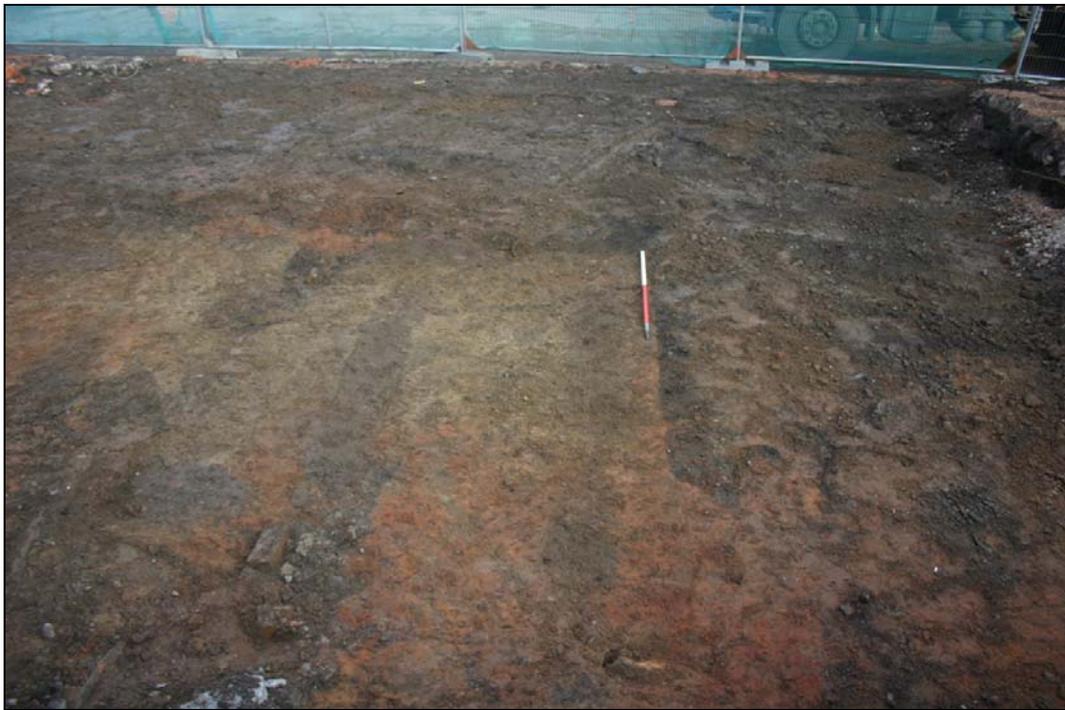
Fig. 3 The two parallel slots and other features prior to investigation. Photo CPAT 3747-0031

- 3.3 Following the relocation of services the ground level was reduced within the footprint of the new building. Again this was conducted under close archaeological supervision. Along the western edge of the footprint up to 1.1m of overburden was removed, the amount reducing to 0.45m along the eastern perimeter. In general the area had been heavily truncated by a combination of building footings and service trenches. However, small patches of a reddish/buff deposit were identified in an area measuring around 5m by 5m, which was similar to that associated with archaeological features revealed in the 2012 evaluation.

- 3.4 Further investigation by hand cleaning of the area revealed the outline of two parallel linear features (39 and 40; Fig. 3), orientated east to west and 0.3m apart. Each was approximately 0.4m wide and 0.18m deep and the investigation of one (39) revealed a post-hole (43) in its base. The features have been interpreted as possible beam slots associated with a timber building. They contained similar fills and from these a number of animal bones with butchery marks were recovered, as well as fragments of roofing tile. The features, together with a number of post-holes and pits (41–45) identified in the same area (see Figs 4-5), appear to be contemporary with a linear feature (16) excavated during the 2012 evaluation which was attributed to the later medieval period.

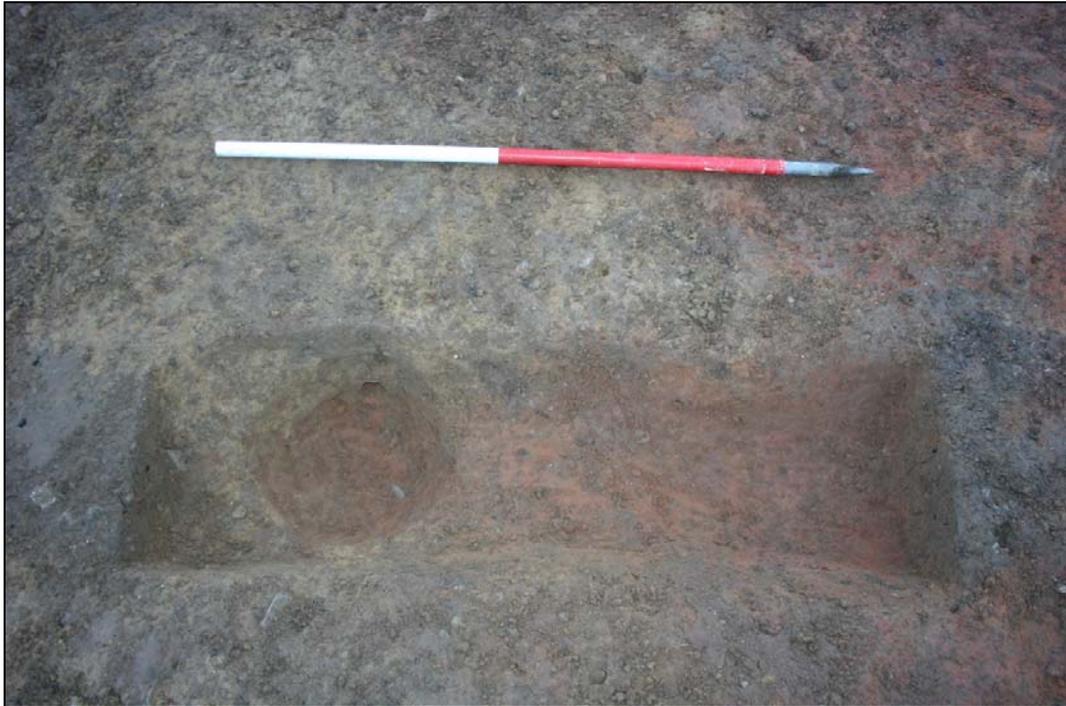
Fig. 4 Section through slot 39, which contained a post-hole (43) in its base. Viewed from the north. Photo CPAT 3747-0050

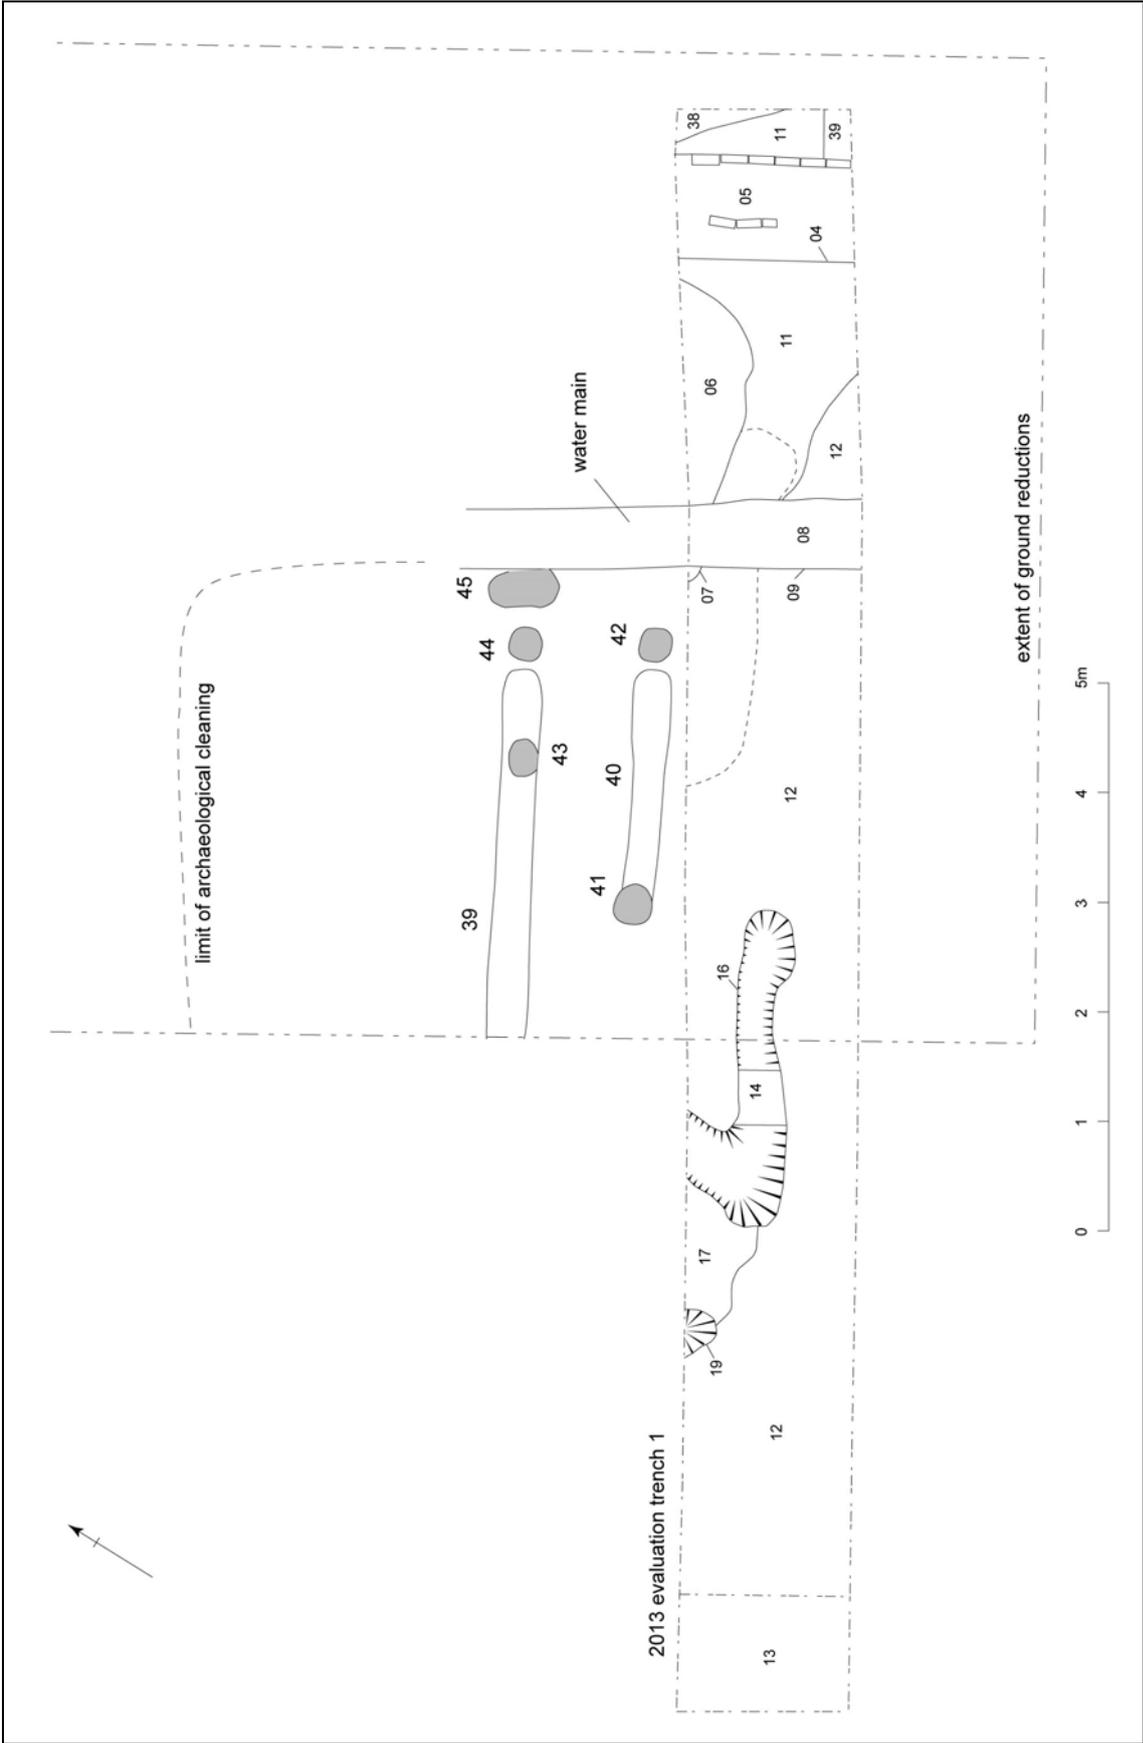
Fig. 5 Plan of 2013 trench 1 and adjacent features revealed during the watching brief

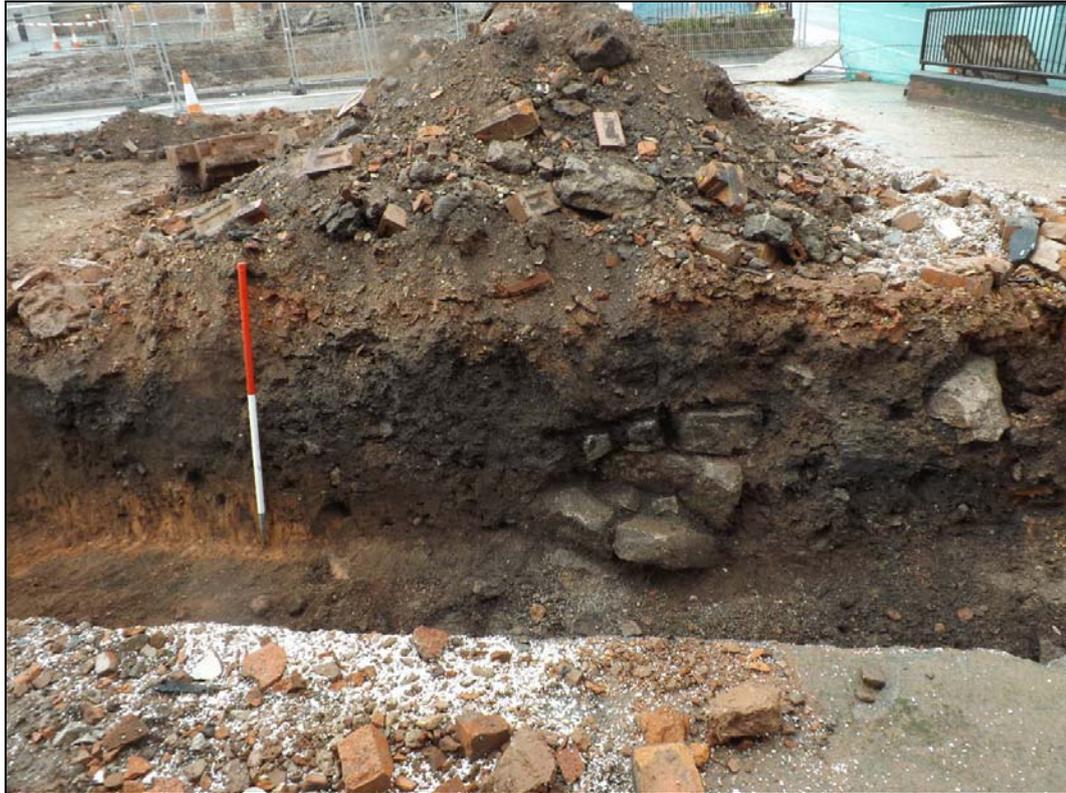
Fig. 6 The north-east-facing section of wall 50. Photo CPAT 3747-0062

- 3.7 Approximately 3m south of and parallel to the street frontage, the remains of a wall were identified, measuring 0.9m wide and 0.4m high. The wall was built from limestone blocks, without the use of mortar, and extended beyond the area of groundworks to the east and west. The wall was sealed by a series of demolition layers dating from the 18th and 19th centuries. As a result of later disturbance within the area it was not possible to determine the date and function of the wall, though it is possible that it related to a building (see Figs 6 – 8).

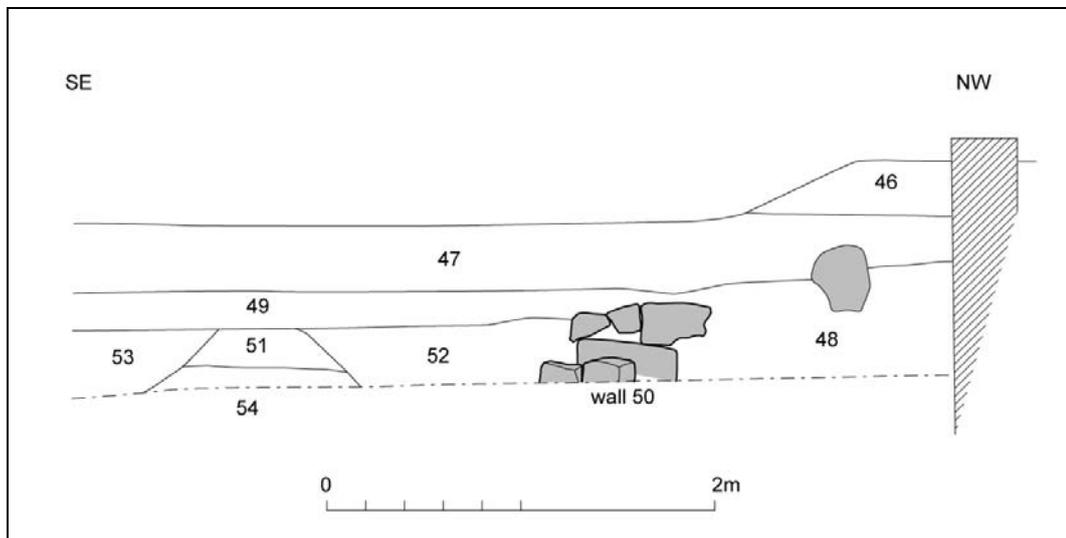
Fig. 7 The north-east-facing section of wall 50

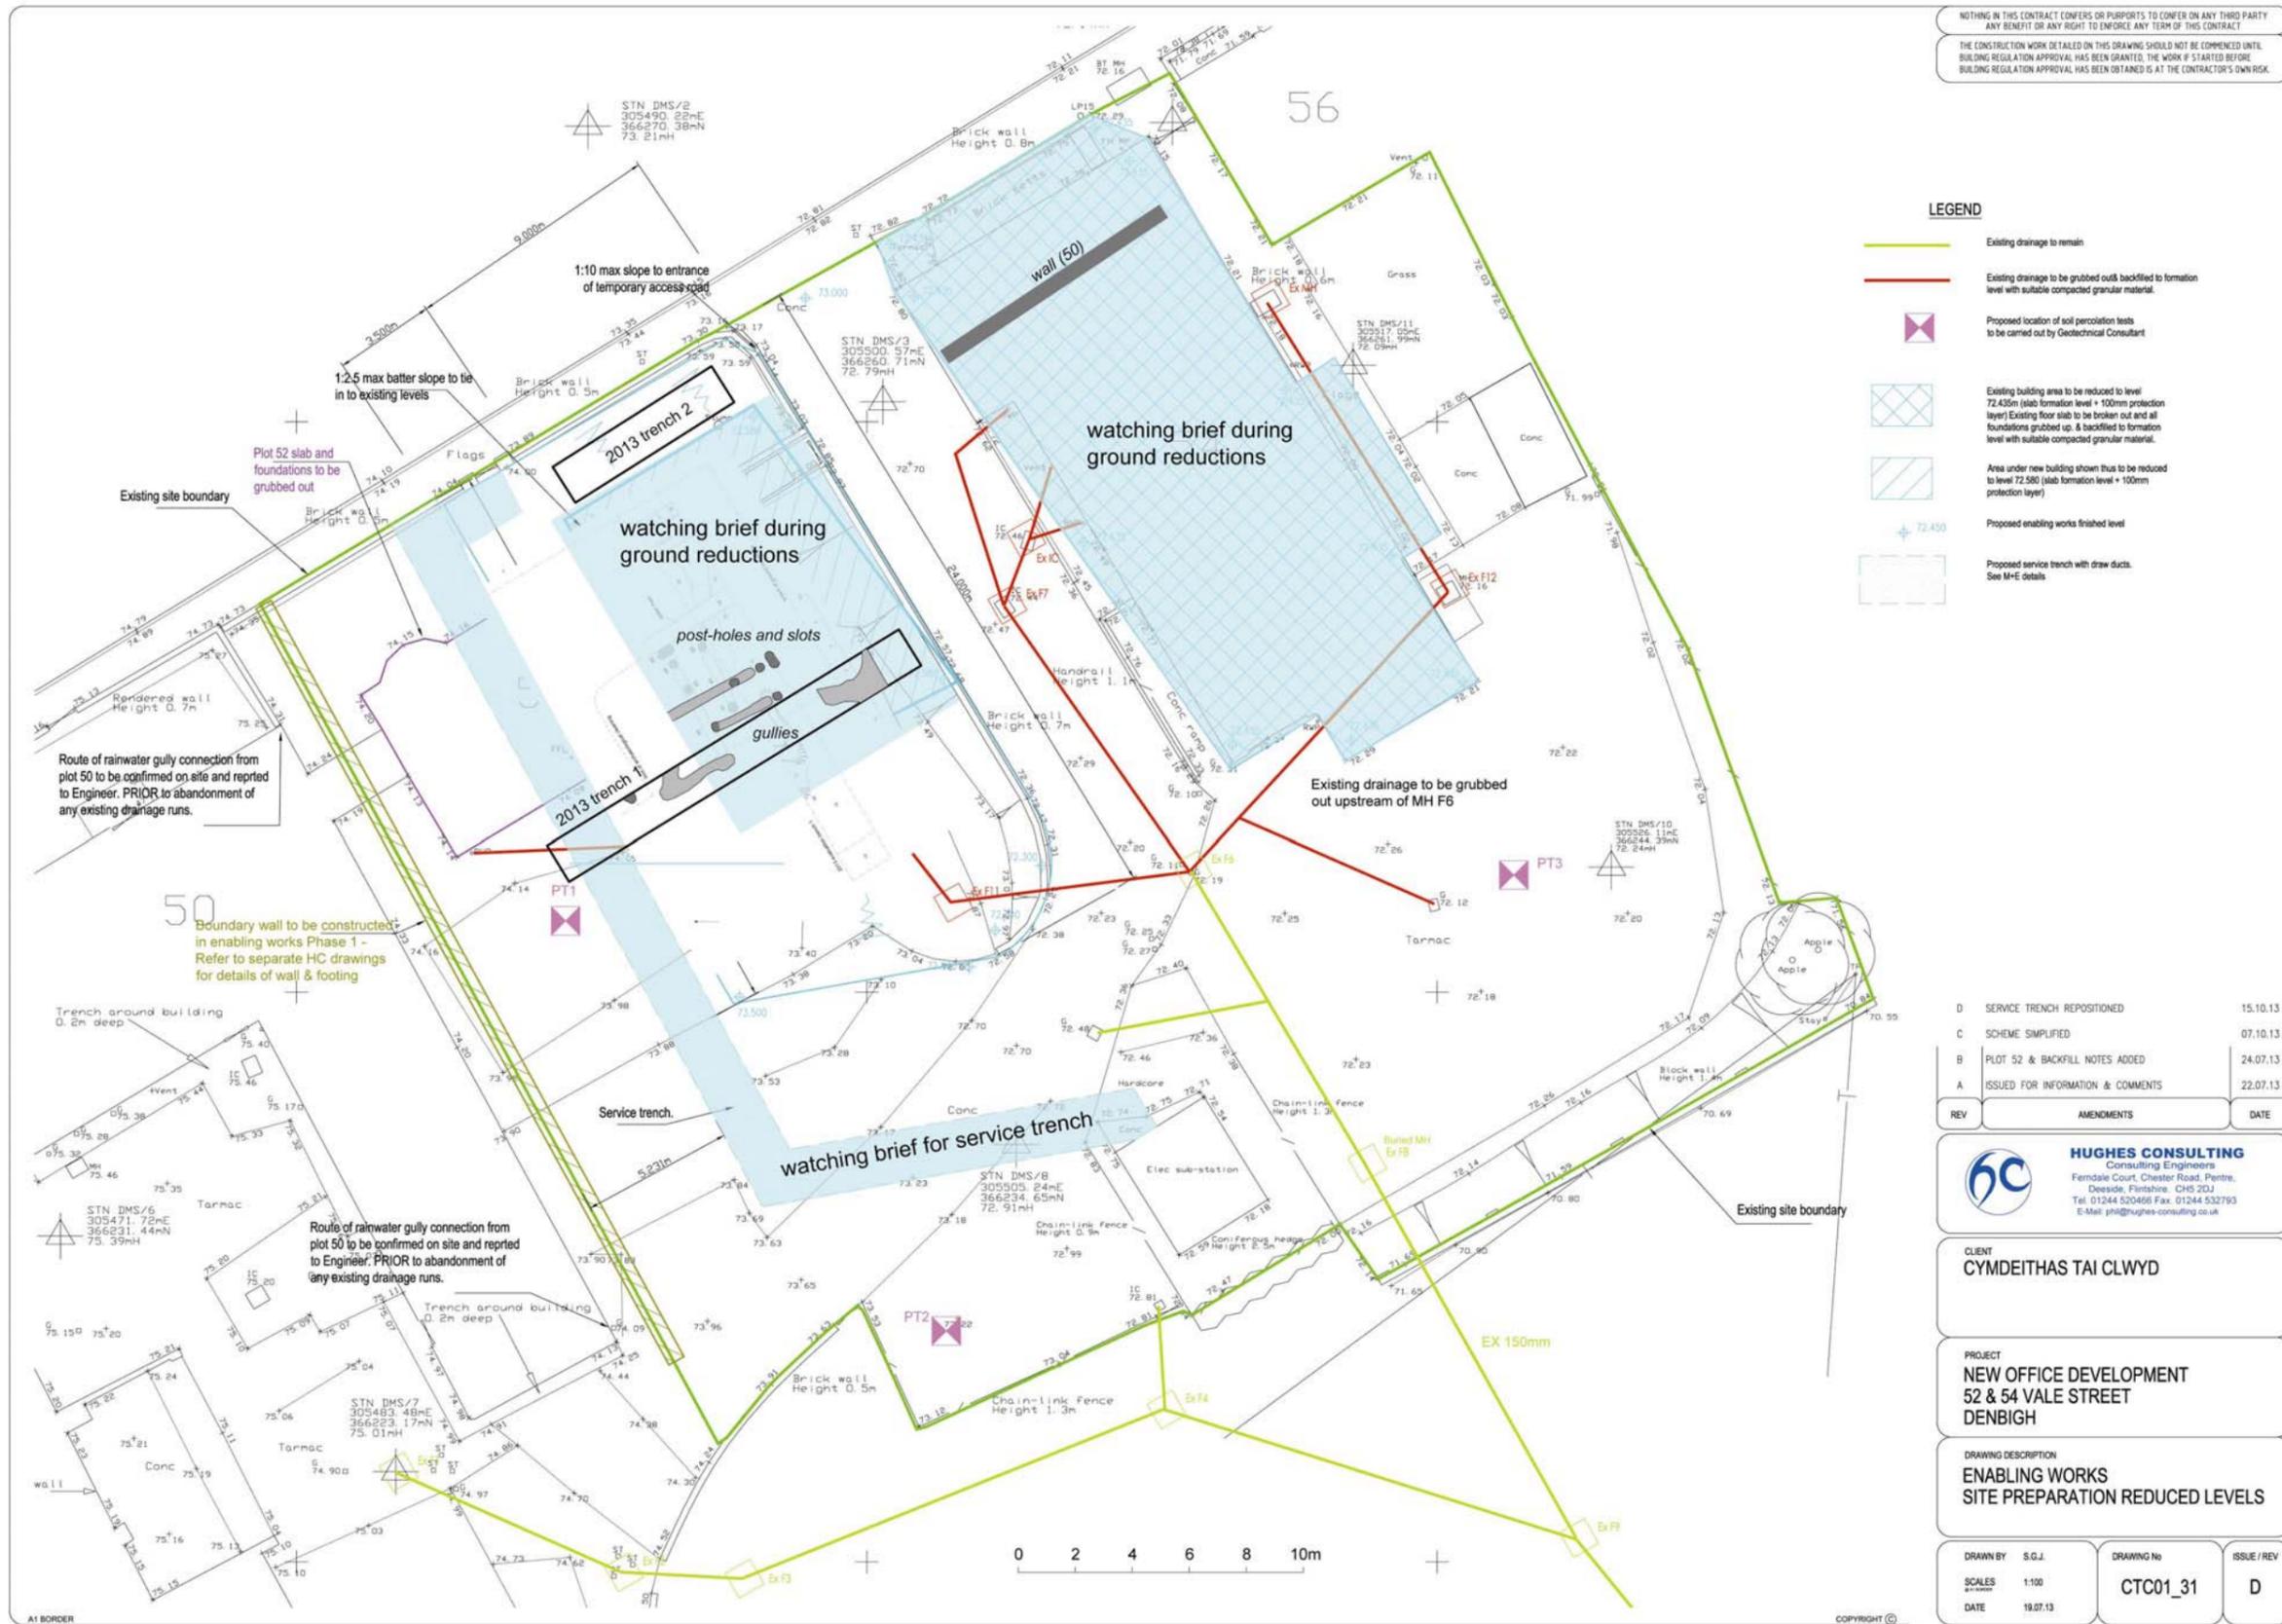
Fig. 8 Overall site plan showing areas monitored by the watching brief, archaeological features and the location of the 2013 trenches
