CPAT Report No. 1290

Hen Caerwys Community Excavation, Caerwys, Flintshire

The Fourth Season

Excavation

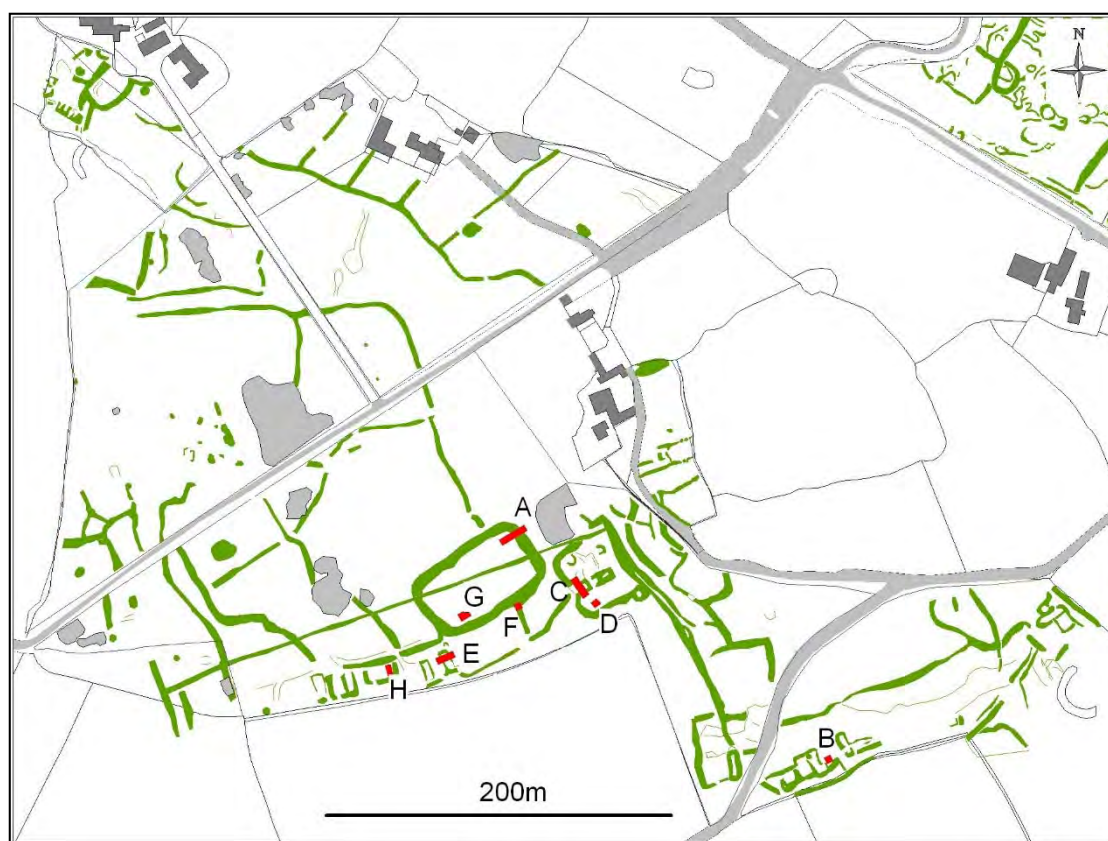
Fig 1. Plan of the Hen Caerwys earthworks (in green) showing the locations of the major trenches (in red). Because of their small sizes trenches J to V have not been depicted.
© Crown Copyright and database right 2009. All rights reserved. Welsh Government. Licence number 100017916.

Not until 1993 was a full survey made of the complex, hardly surprising in view of the fact that virtually all of it was covered by vegetation that must have deterred all but the most resilient and thick-skinned of investigators. Commissioned by Cadw and undertaken by the Gwynedd Archaeological Trust at the instigation of the now defunct Clwyd Archaeology Service, the plan has remained our sole guide to the extent and layout of the earthworks at Hen Caerwys and GAT's achievement in producing it, in conjunction with the landowner, is a constant source of amazement to us when working on site. In 2013 the survey was redrawn at the instigation of Cadw, and this new draft now forms the basis of our Fig. 1.

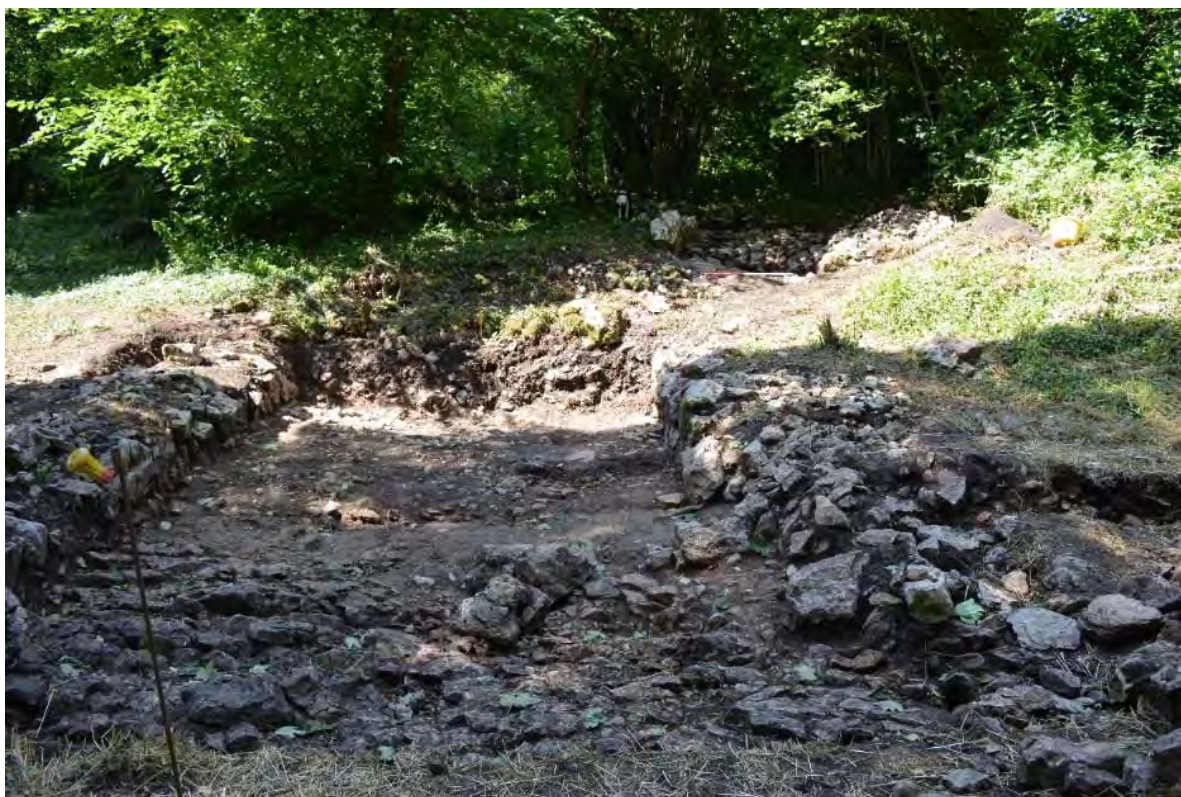
Fig 2. Trench E extended to take in most of the house including the long side walls. The quarry (Trench O) lies above the platform, to the right of centre top in the photograph. Photo: CPAT 3848-0168

The inner faces of the walls themselves were preserved on both sides of the trench and consisted of uncoursed blocks of random size and shape. The northern part of the east wall rested on a foundation of flat slabs set into the lower clay surface, the west wall apparently being based directly upon the clay. A small 2m by 1m sondage was opened on the projected outer face of the western wall, parallel with the north-west corner of the trench in order to establish its width and relationship to the cutting of the uphill end of the platform. The outer face of the wall was not identified and would appear either not to have existed or to have survived only below the level to which the sondage was excavated (approximately 0.3m below the external ground surface), the clay cutting of the platform against which the wall was set being clearly defined in section.

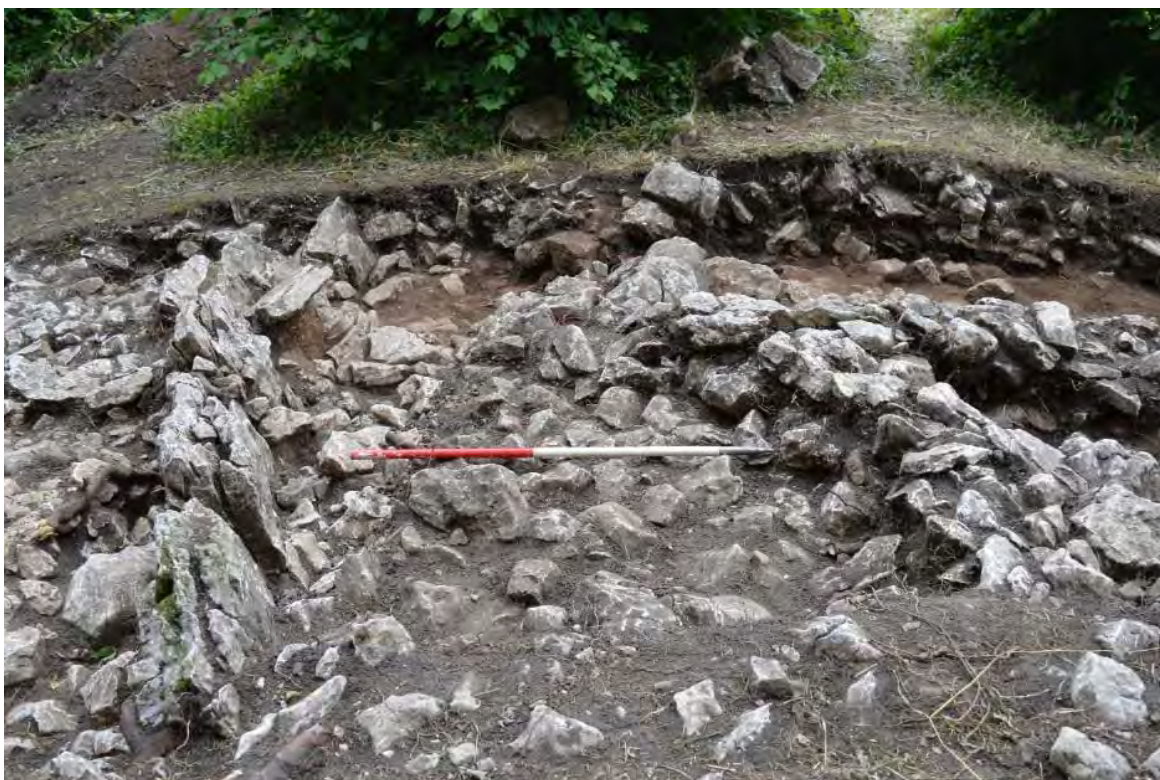
Fig. 3. Trench F with the wall facing slabs to the left of the ranging rod.
Photo: CPAT 3848-0123

An area of 10m by 4m was opened, incorporating the 2013 trench. Rubble limestone layers continued to fill the trench and were methodically peeled away to reveal the inner face of the main enclosure. The profile of a bank, as it had appeared from the surface, was in fact a considerable wall-like structure, which had collapsed. The nature of the collapse had left the misleading humped profile which, on the ground, we had previously interpreted as a bank. In this part of the enclosure the outer face was made up of the upright slabs that we had

revealed the previous year. The inner face survived as at least two, and in places three, roughly hewn, irregular courses of limestone. The core was made up of a mix of large and medium rubble within a sandy-soil matrix.

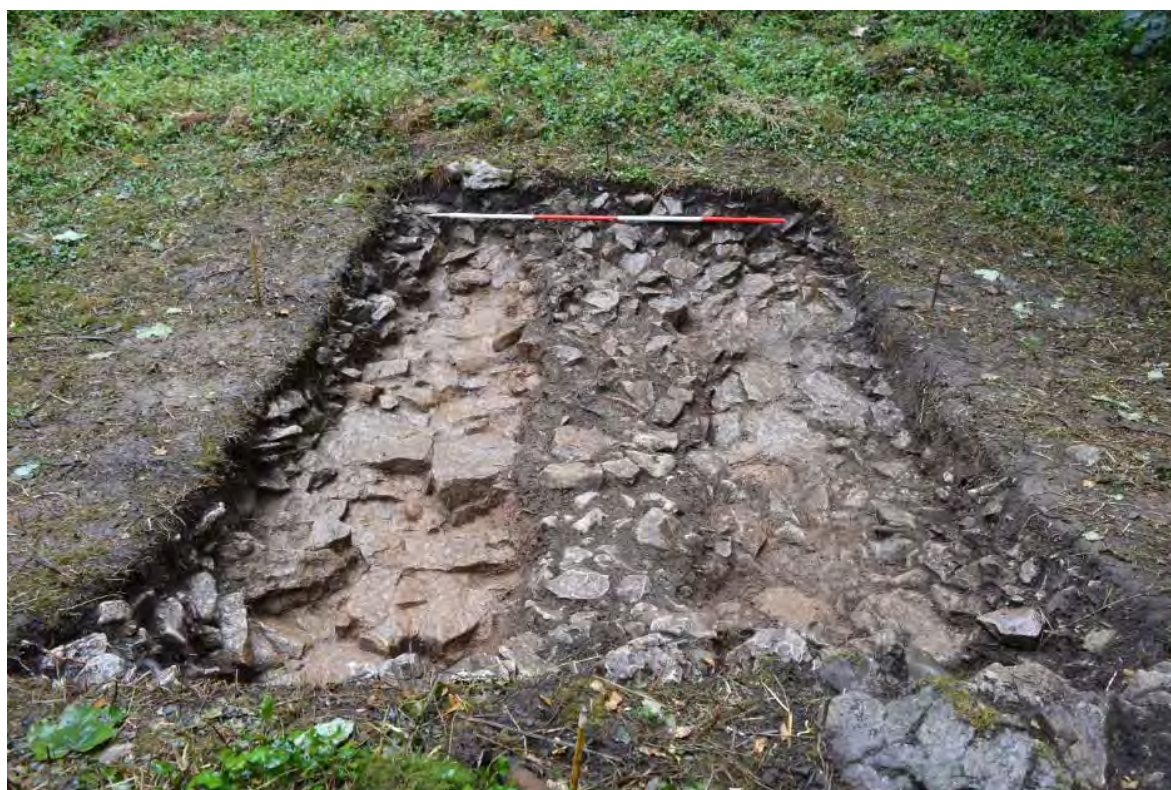
Fig 4. Trench H after excavation, seen from the south
Photo: CPAT 3848-0129

The trench, measuring 2.6m wide and 4.3m long, partially revealed a limestone boulder wall, running east/west at the southern limit of the platform. A north/south extension was excavated in the south-eastern corner of the trench, over the wall, to establish its width and character. Just over 1m in width, what remained were two courses of limestone rubble boulders that also incorporated a mudstone boulder, and a rubble core. The northern wall of the putative building or structure was not picked up in the trench and presumably survives further into the slope. The original height of the wall(s) remains completely unknown.

It seems that the natural limestone pavement was utilised as the platform for the building; it appeared that irregularities and voids in the pavement, already relatively level, were packed with re-deposited subsoil and flatter rubble slabs were laid as levelling. The northern wall

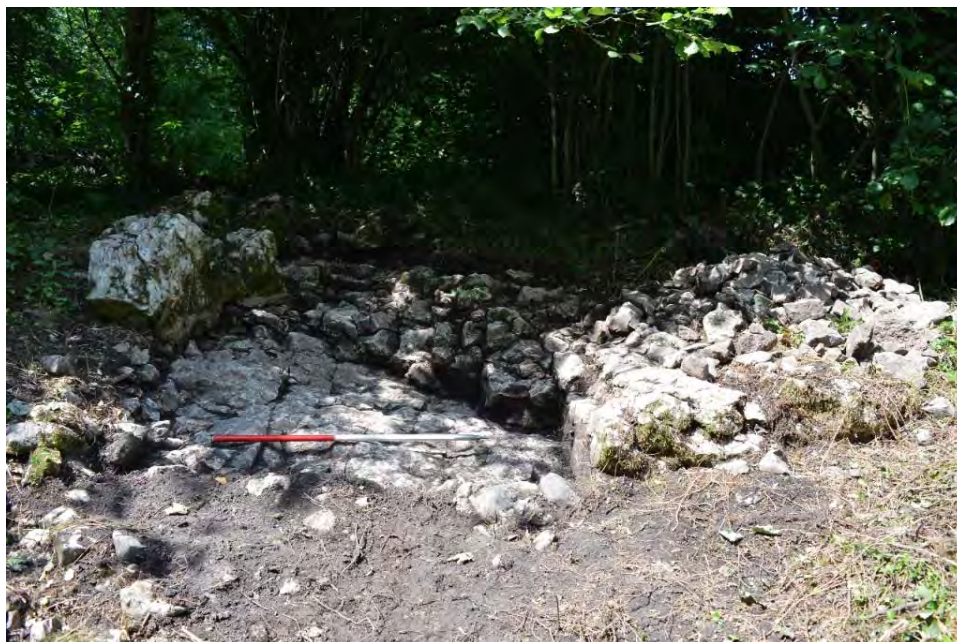
Fig 5. The quarry in Trench O after excavation
Photo: CPAT 3848-0158

Rather than being the storage place for the house below which is what we had anticipated, this was clearly only a quarry, presumably where lumps of limestone had been levered out of a natural outcrop in order to erect the wall facings of the house. The large blocks of limestone on the surface were simply the residue of what had been a useful rock outcrop.

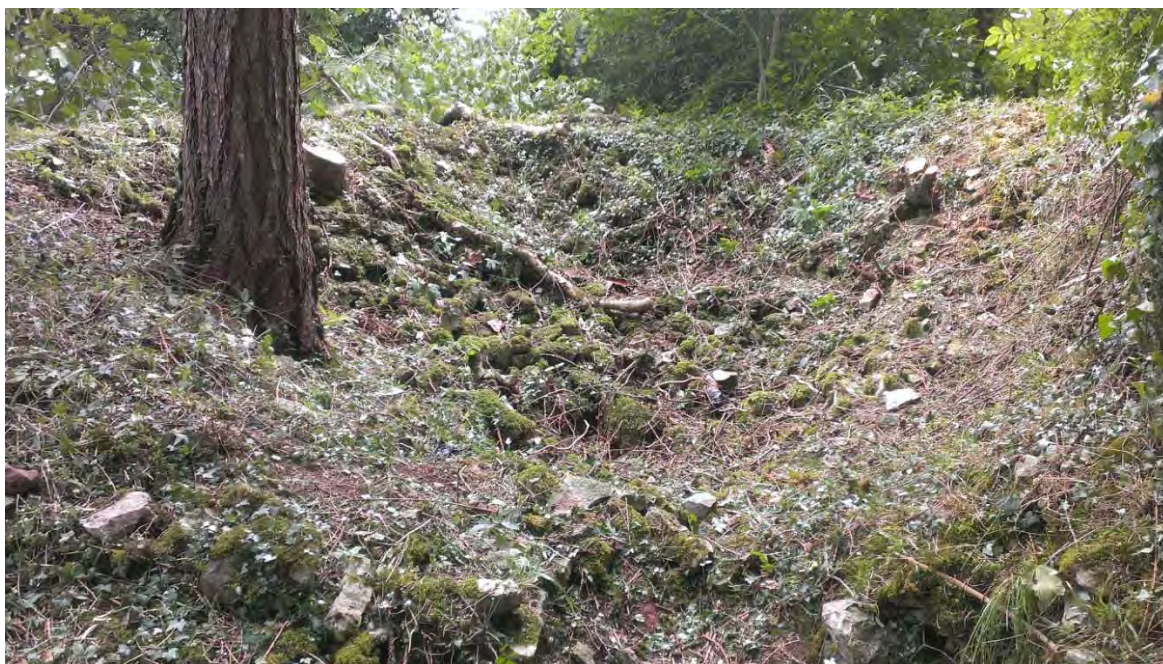
Fig. 7. View of the structure looking west before excavation, showing the extent of collapse.

The limestone structure was approximately 12.50m in diameter in plan overall. It consisted of a rubble wall which stood up to 3.00m above the modern ground surface; this wall was largely free-standing around its eastern, southern and western sides, but to the north it was either built into or abutted by an earthen bank. This bank curved around to the north east, and connected with a small quarry some 20m to the east of the structure. Owing to vegetation cover it was not possible to determine the physical or stratigraphic relationships between the bank, the quarry and the structure. The structure itself had undergone progressive collapse over many years, with the resulting tumble obscuring the original form and construction. The internal diameter at the top of the wall was approximately 8.50m.

Trench U was located in order to cross the wall of the structure at the most convenient point for access, which was on the eastern side (Fig. 7). The trench measured 2.70m north-south and 4.50m east-west in plan, and was excavated to a maximum depth of 1.50m below the modern ground surface.

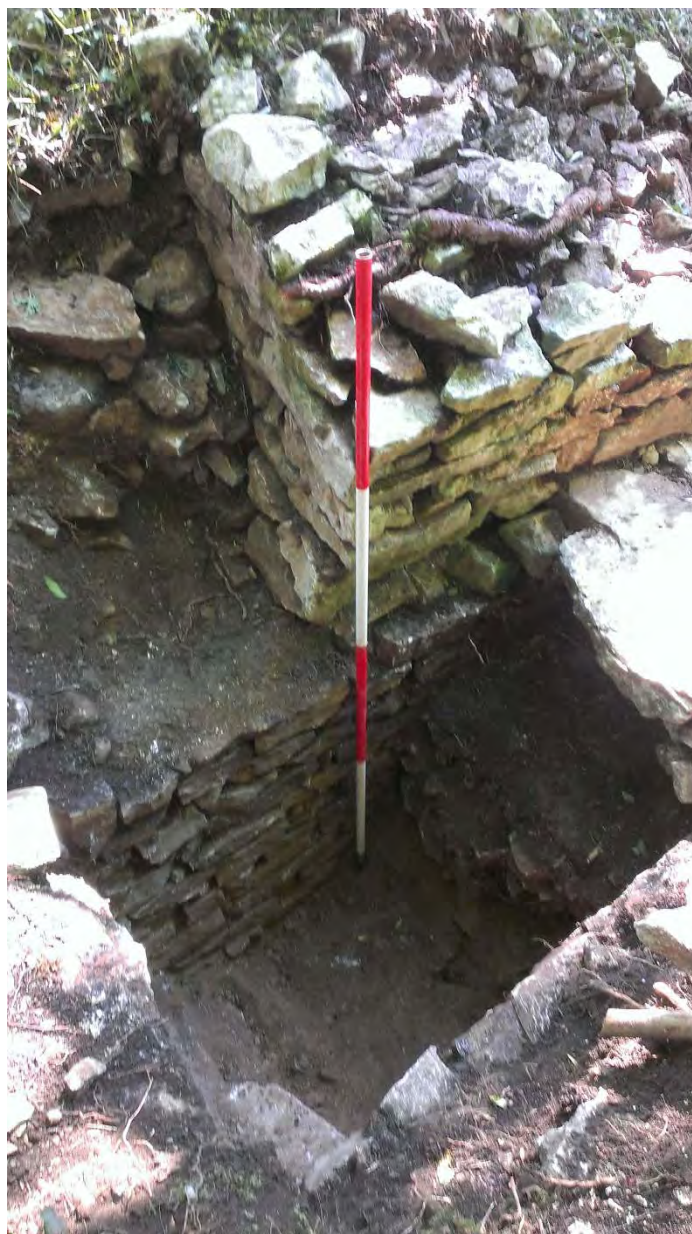
Fig. 8. View of the entrance/drain structure after excavation, looking south-west. The scale rod is at the south-west corner of the entrance. The lining of the lower level can be seen extending beyond the structure to the east; the slab capping/floor can also be seen within the entrance to the west. Scale 2m.

The lower level had been excavated down to the natural limestone bedrock which formed the base – this was very irregularly finished and was clearly not intended as a floor surface. The sides of the resulting chamber were lined by coursed limestone blocks, and at this level the feature extended outside (ie. to the east of) the main structure by at least 1.65m, as well as internally for the full width of the main wall. The side-walls returned at each end to create a completely sealed chamber measuring around 1.10m deep. This had been roofed with large limestone slabs at approximately the modern ground level; one of these had subsequently been removed and another had collapsed into the chamber, allowing access for a partial excavation of the interior fill (Fig. 8).

The upper level of the feature was perhaps an entrance to the structure. Its base was formed by the sandstone slabs, and it simply created a passageway to the interior – there was no extension outside the structure comparable to that of its subterranean counterpart.
