Land at Maes-y-Meillion, Leeswood, Flint

Desk Based Study, Field Evaluation & Excavation

Report No. 1567

Desk Based Study and Excavation Report

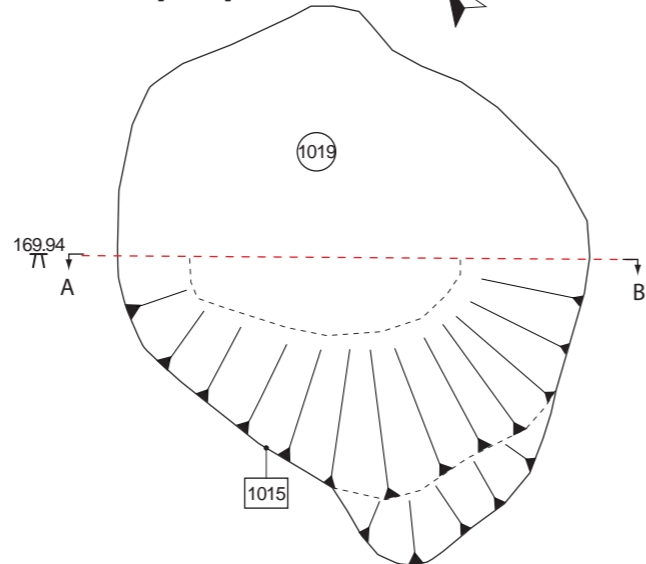
Figure 10

Section of Stone Plinth [1007] and Foundation cut [1034]

Plan of Pit [1015]

Section of Pit [1015]

Sections of possible Drainage Gully [1013]

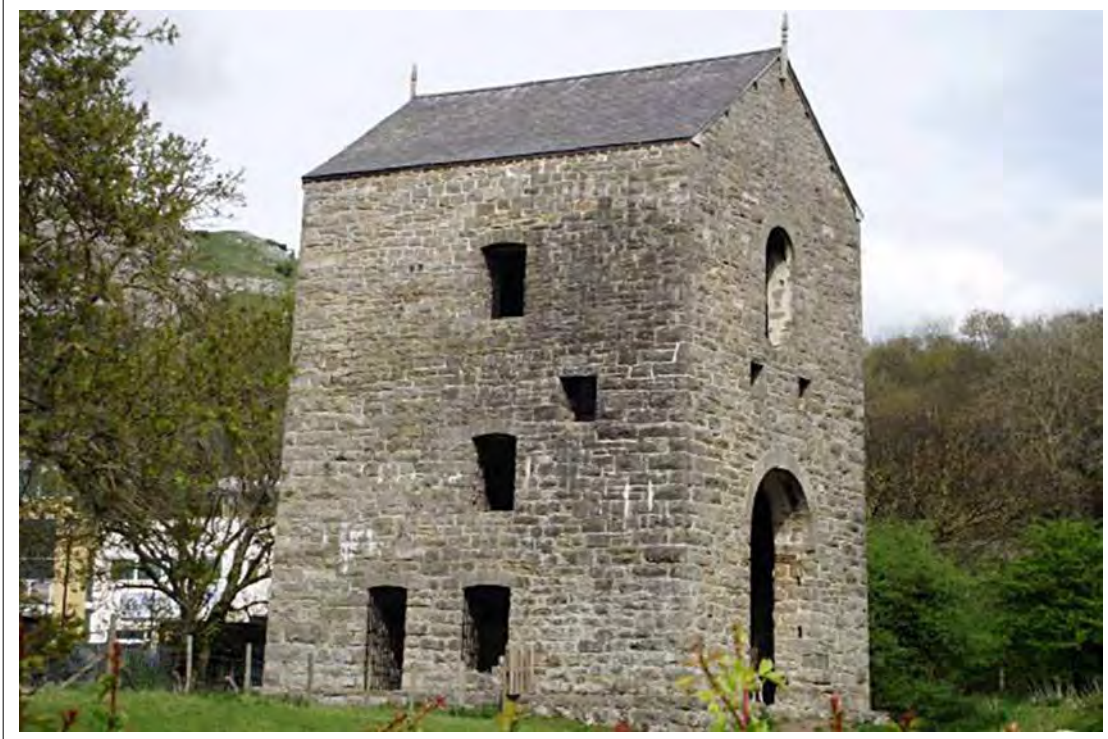
Plate 1. Example of Engine House at Talargoch, Dyserth, Flintshire

Plates 1 and 2 show examples of existing Flintshire engine houses at Talargoch mine, Dyserth, and Minera, New Brighton.

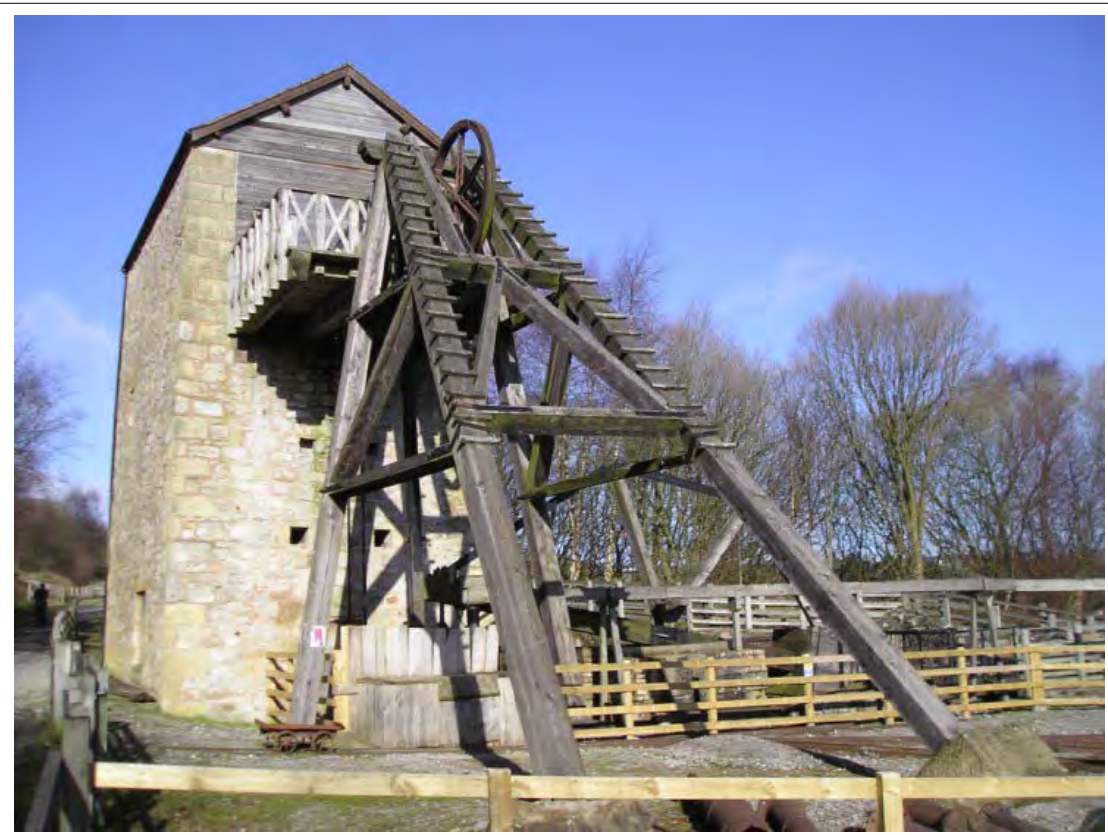
Plate 2. Example of Engine House at Minera, Wrexham

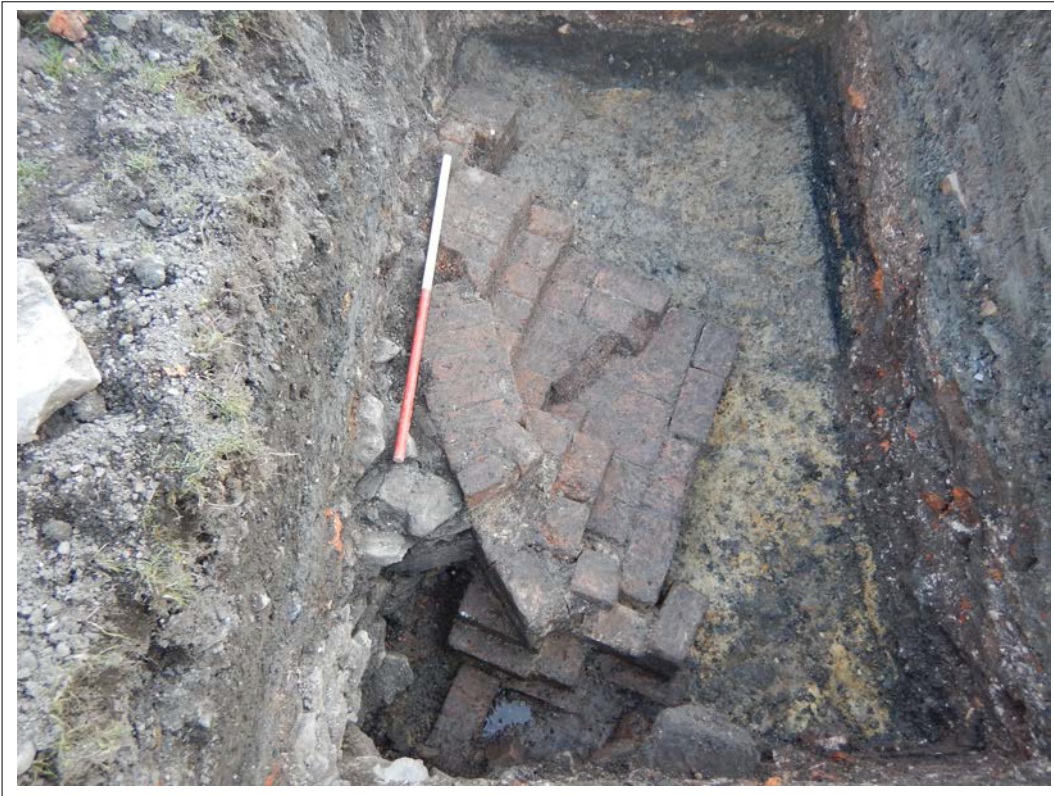
Plate 7. View of likely Brick Boiler Base [016]. Scale 1m

- Within the centre of the trench an irregularly shaped brick feature (16) was noted sat above the natural (013) (Plate 7). It was overlain by compacted brick rubble, mortar and masonry (33), likely derived from demolition or later robbing.

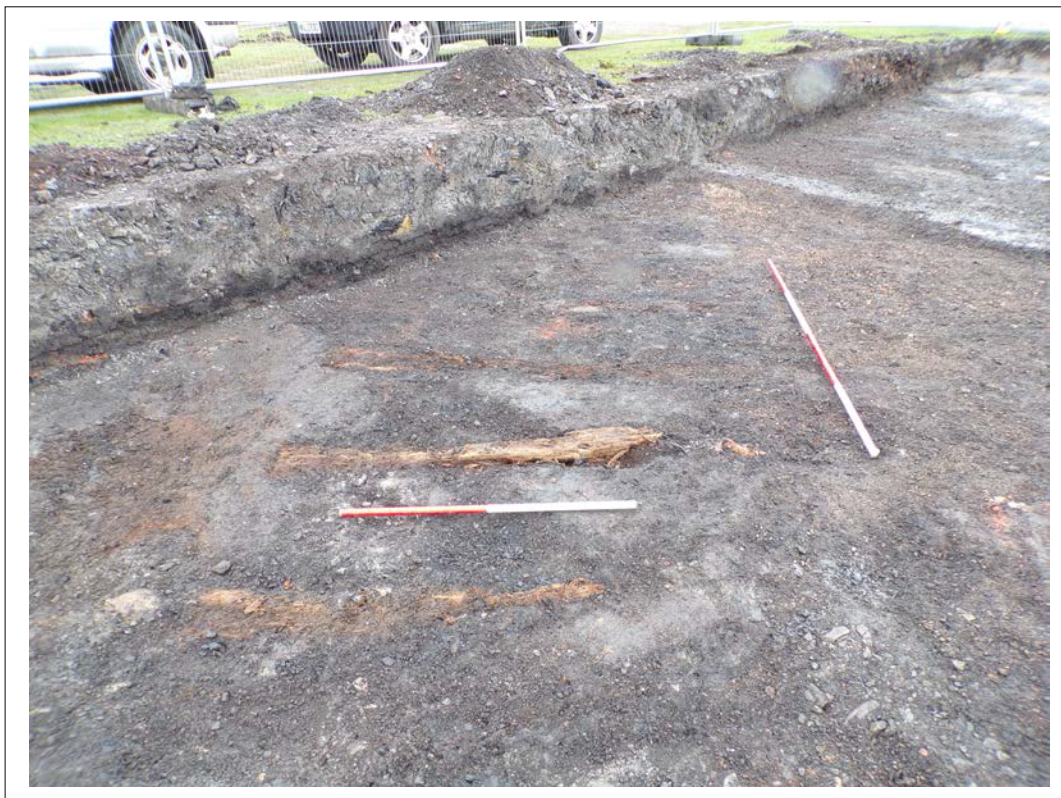
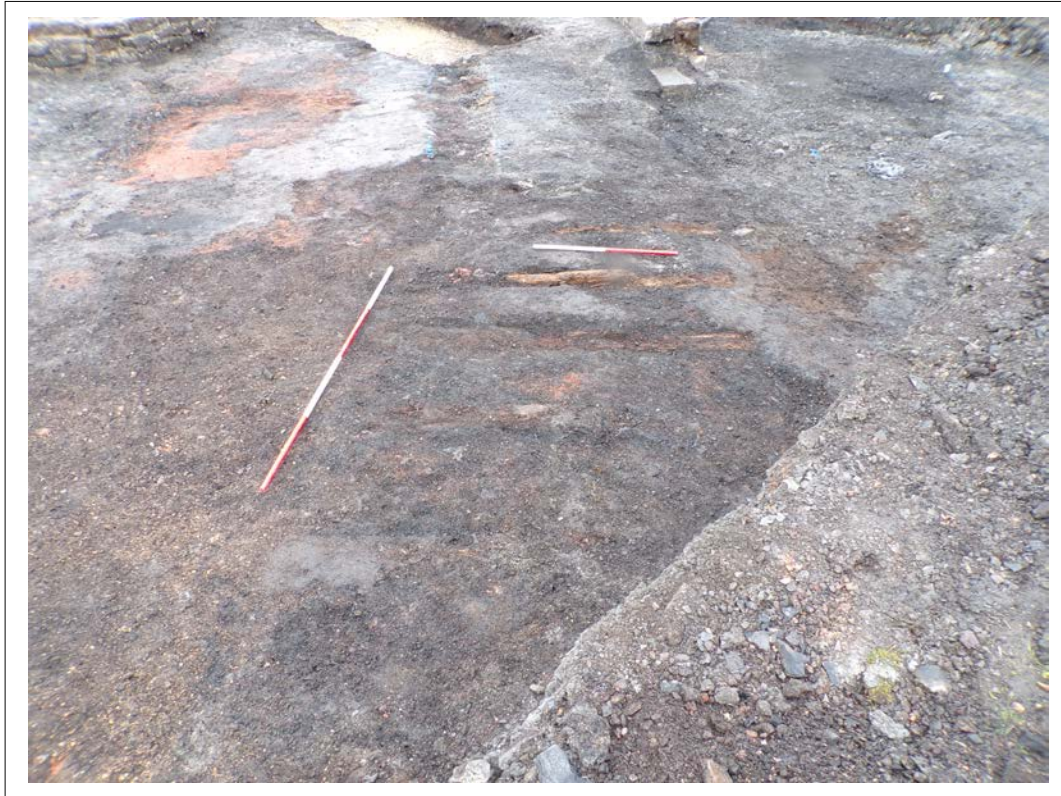
Plate 26. View of *in-situ* Timbers of Tramway [1008]. Looking east. Scale 1m & 2m

Plate 27. View of *in-situ* Timbers of Tramway [1008]. Looking west. Scale 1m & 2m

Excavation across the surface of levelling deposit (1023) revealed a series of eight regularly spaced and parallel beam slots [1033] (Plates 26-27). The beam slots were aligned approximately east to west. Each measured approximately 1.8m in length by 0.3m wide. Of the eight beam slots forming part of group 1033, three were found to have timber remnants forming their fills. The fills of the remaining five beam slots contained cinder material into which they were cut (1023).

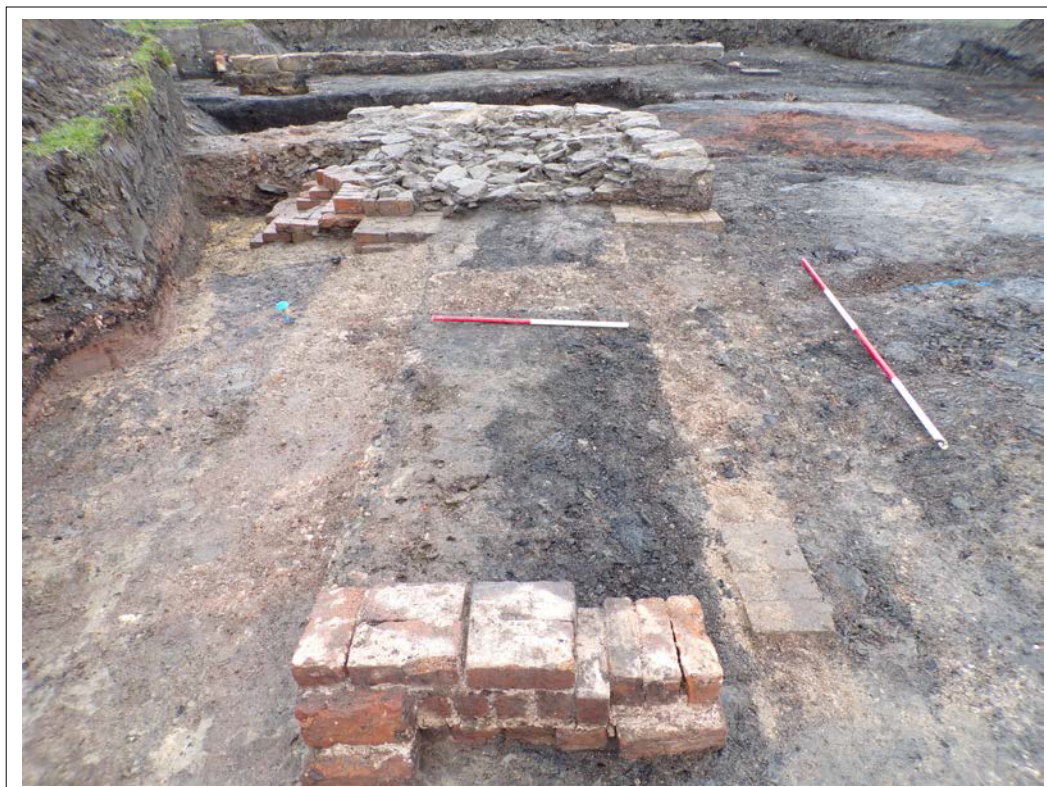
Plate 30. View of clearly defined robbed wall lines. Looking north-west.
Scales 1m & 2m

A small brick pier structure, 1029, identified in the evaluation phase, was noted set at a 90° angle to brick walls 1027 and 1028, the course now represented by the lines of robber trenches [1038/72] (Plate 30 – Foreground). Structure 1029 was extant and was largely the same in build as walls 1027 and 1028. A further robber trench [1037], representing another small pier, was noted to the northwest – again between, and perpendicular to robber trenches [1038/72]. Excavation of sections of the robber trenches showed them to be very shallow (between 0.05m and 0.1m) and have a single fill composed largely of loosely compacted lime mortar (1073/1039) (Plate 37). The bases of each robber trench consisted of heavily compacted clay (1024) with material trampled in. This is most likely to represent the flat and levelled base of the original foundation trenches, the robbed material simply having been removed.

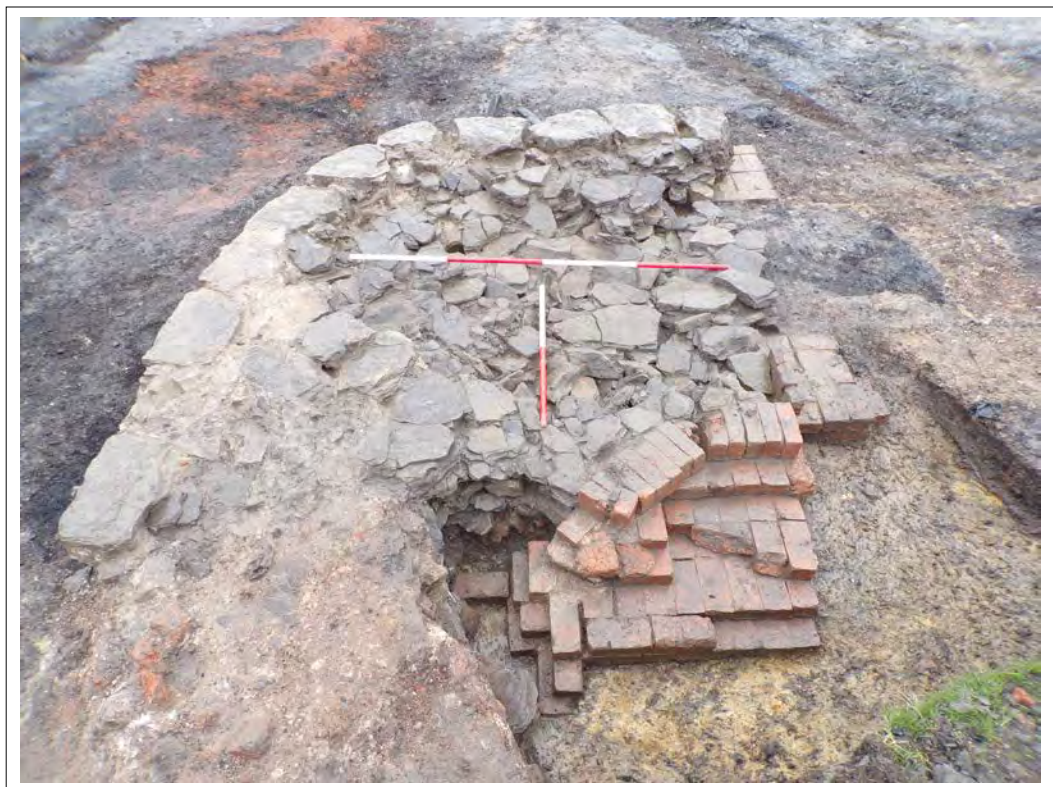
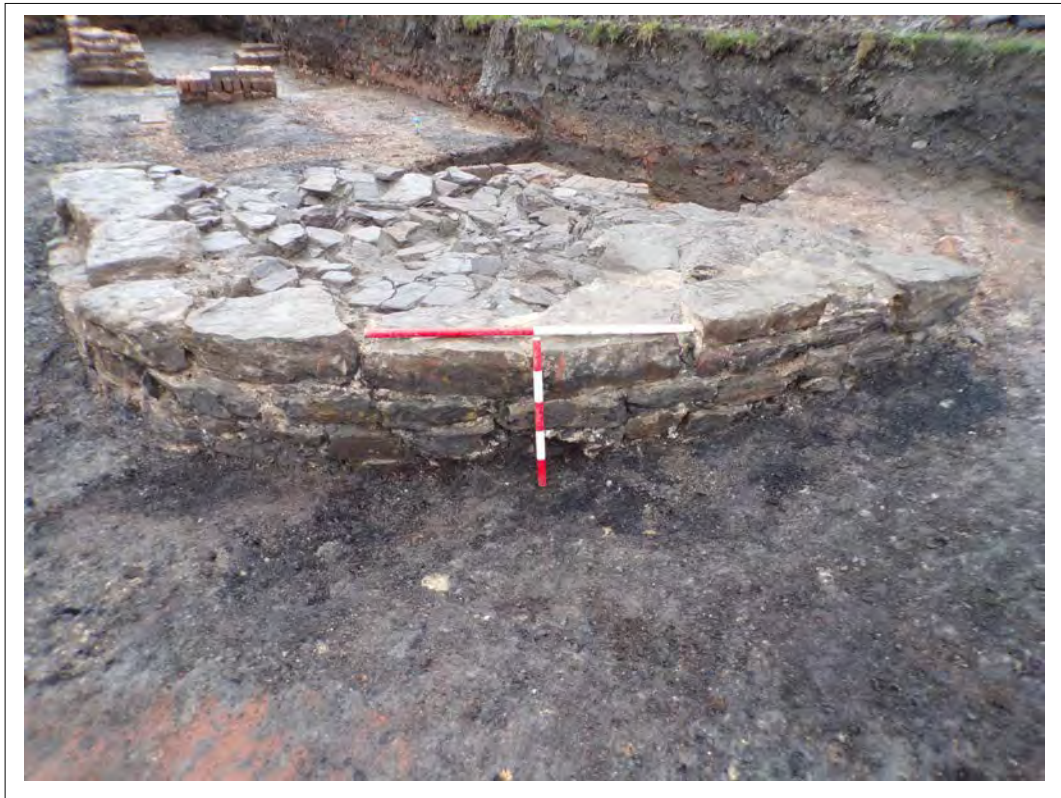
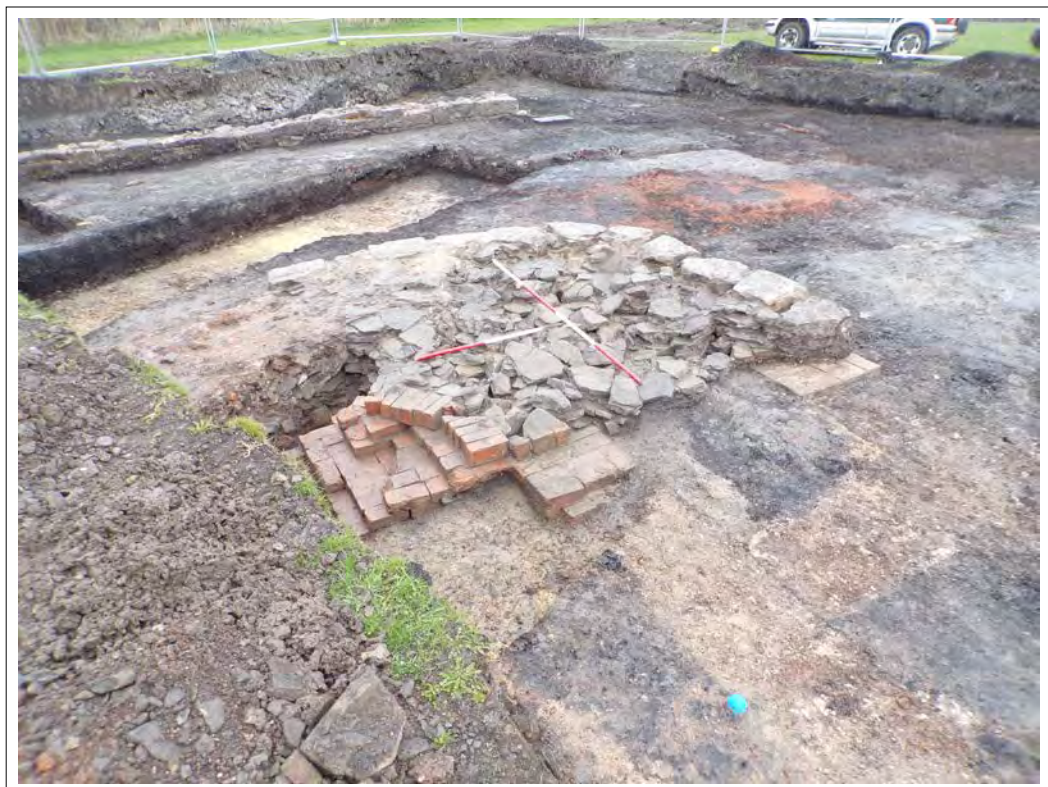
Plate 32. View of apsidally ended Stone Feature [1007]. Looking east. Scales 1m & 2m

Plate 33. View of apsidally ended Stone Feature [1007]. Looking south.
Scales 0.5m & 1m

Plate 34. View of absidally ended Stone Feature [1007]. Looking north.
Scales 1m & 2m

The apsidal end of the structure 1007, the only part built in stone, comprised a roughly faced curving stone wall, its component blocks (mixed limestone and shale) bonded with patchy off-white/beige lime mortar with occasional coal fleck inclusions. The outside face of the curving stone wall had been roughly finished. The inside of the curve was filled with loosely packed, occasionally mortared, randomly sized stones (mixed limestone and shale). The stones of this fill varied in size from 0.1m to 0.5m. The stone deposit forming the centre of the feature was found to be 0.5m deep and was located directly above the natural clay (1003) (Plates 35-36). Whilst the curving stone face of structure 1007 retained the loosely packed central stone

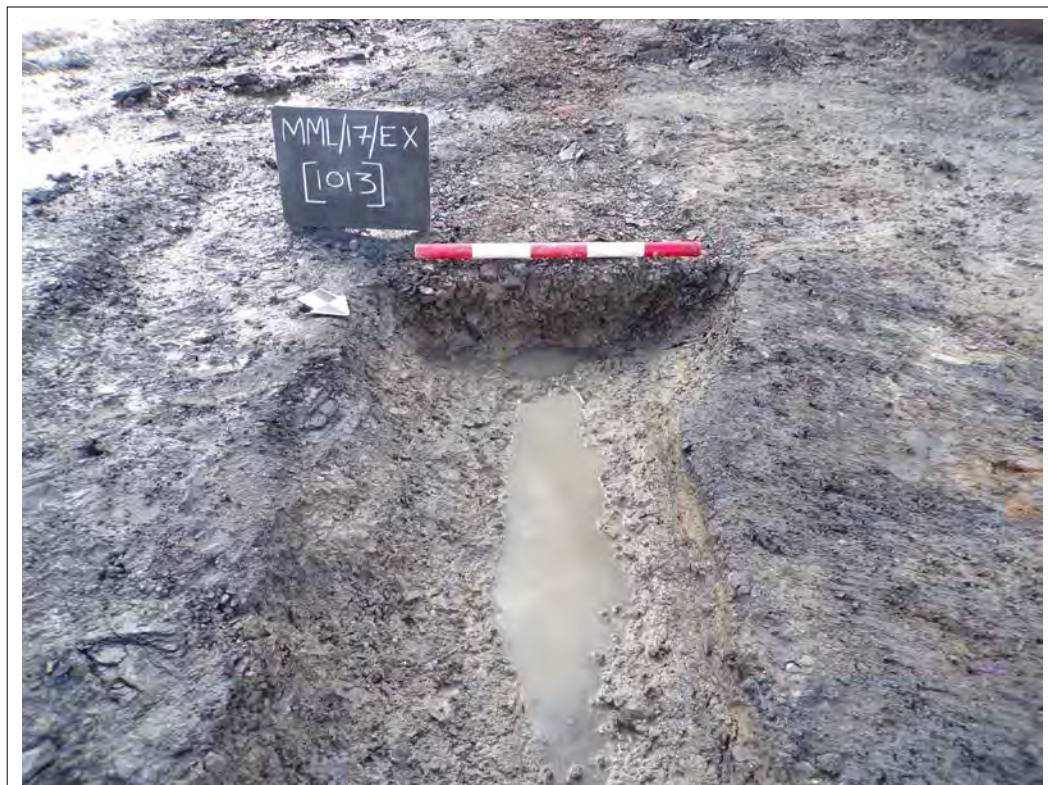
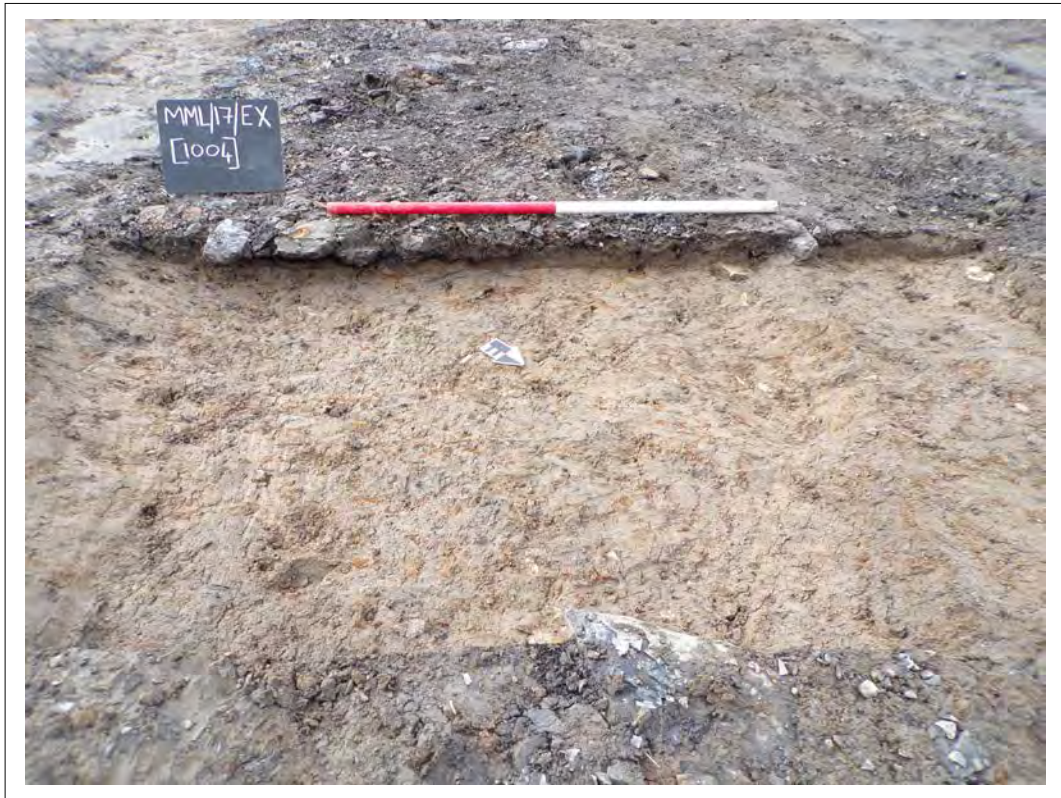
Plate 38. Post-excitation shot of Gully [1013]. Looking south-west. Scale 0.5m

Plate 39. Post-excitation shot of Ditch [1004]. Looking south-west. Scale 1m

Two parallel linear features, a narrow gully [1013] and a wider ditch [1004], were noted cut into the clay substrate material (1024) and the natural (1003) running on a northeast to southwest alignment (Plates 38 & 39). These linear features were approximately 10m long and appeared to terminate immediately to the northeast of the likely boiler base structure formed by [1007/26-9]. Excavation of two 1m sections across gully [1013] showed it to have 45° sloping sides and a flattish base. It contained a single fill of crushed shale mine waste (1014): no datable material was recovered from this deposit. Excavation of two 1m sections across linear 1004 showed it to be an extremely shallow (0.15m max), wide (up to 1.8m) ditch with a flat base and only a single shale mine waste fill (1010). Again, no datable material was recovered from this feature. These two linear features were recorded in the southwest-facing section of the trench. Only gully [1013] differed from that observed within the excavated sections, in that it appeared to be cut in from a slightly higher level and filled only with the mine waste overburden that covered most of the site (1002/14). This suggests ditch was open when the dumping of mine waste on the site began, presumably post-1881 when the site was likely out of use.

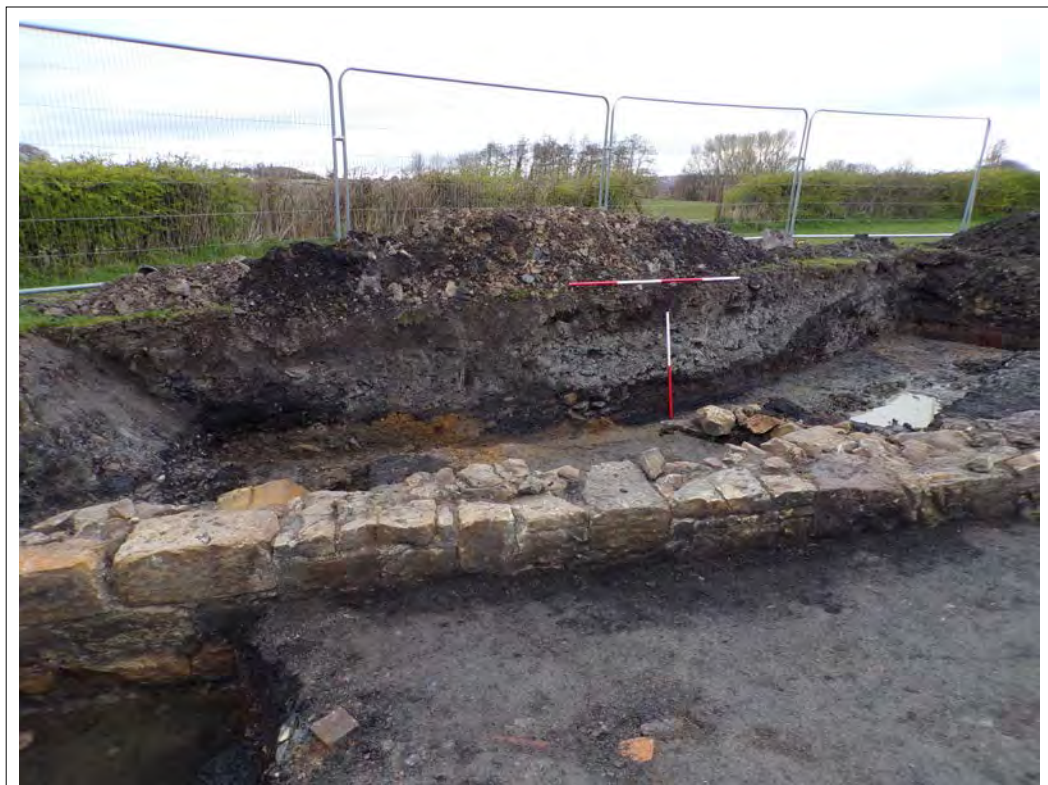
Plate 40. View of north-western Trench Section. Looking north. Scales 1m & 2m

The hand excavation of a large sondage at the base of the trench, against the north-western trench edge, showed considerable amounts of made ground in this area, including redeposited natural (Plate 40). Contexts 1023, 1042 and 1049 to 1060 appear as dumped, possibly levelling material in this section (Figure 10). It is likely that they were overlain by the continuation of surface 1022 prior to its later truncation. The truncation and apparent removal of surface 1022 may coincide with the cutting of foundation trench 1040 (for wall 1009) through the made ground deposits 1023, 1042 and 1050-2. Foundation cut 1040 also clearly truncates horizon 1044, which overlays surface 1022. It is therefore likely that wall 1009 and surface 1022 belong to differing phases of activity within this area of the site; surface 1022 being buried at the time wall 1009 was constructed. A final phase of activity evidenced within this section is the cutting of a large pit [1071] which truncated wall 1009 as well as made ground 1042. It contained a single fill composed entirely of crushed shale mine waste material (1041).

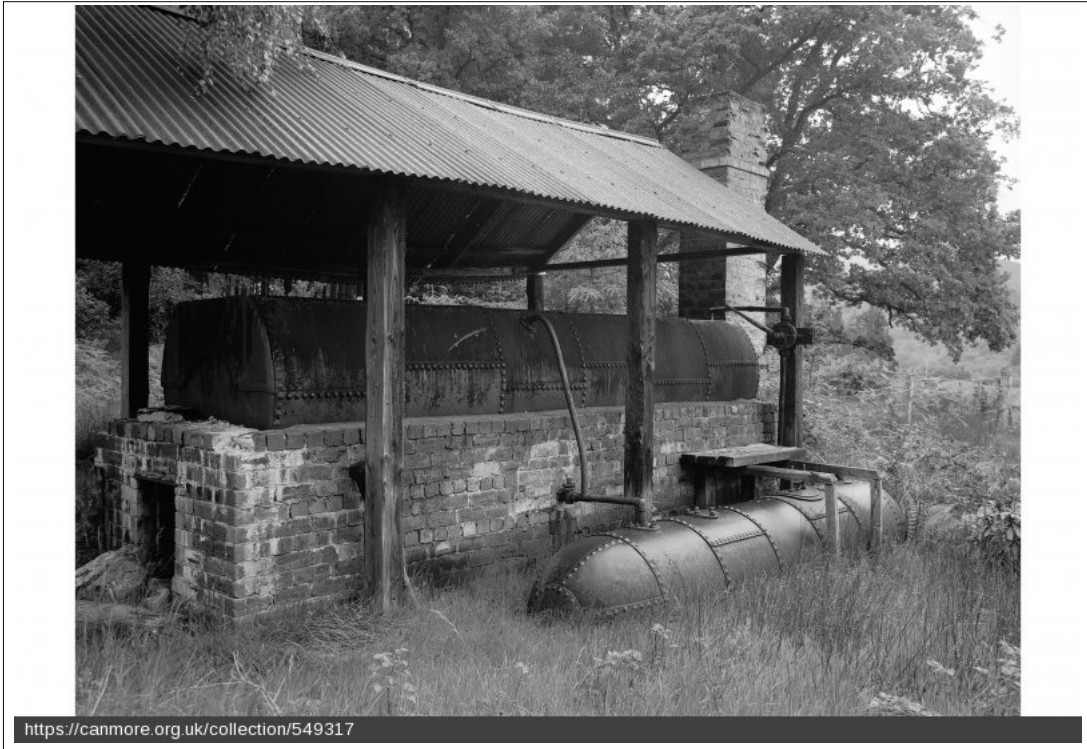
Plate 41. Example 1 of extant Egg End Boiler.

Plate 42. Example 2 of extant Egg End Boiler.

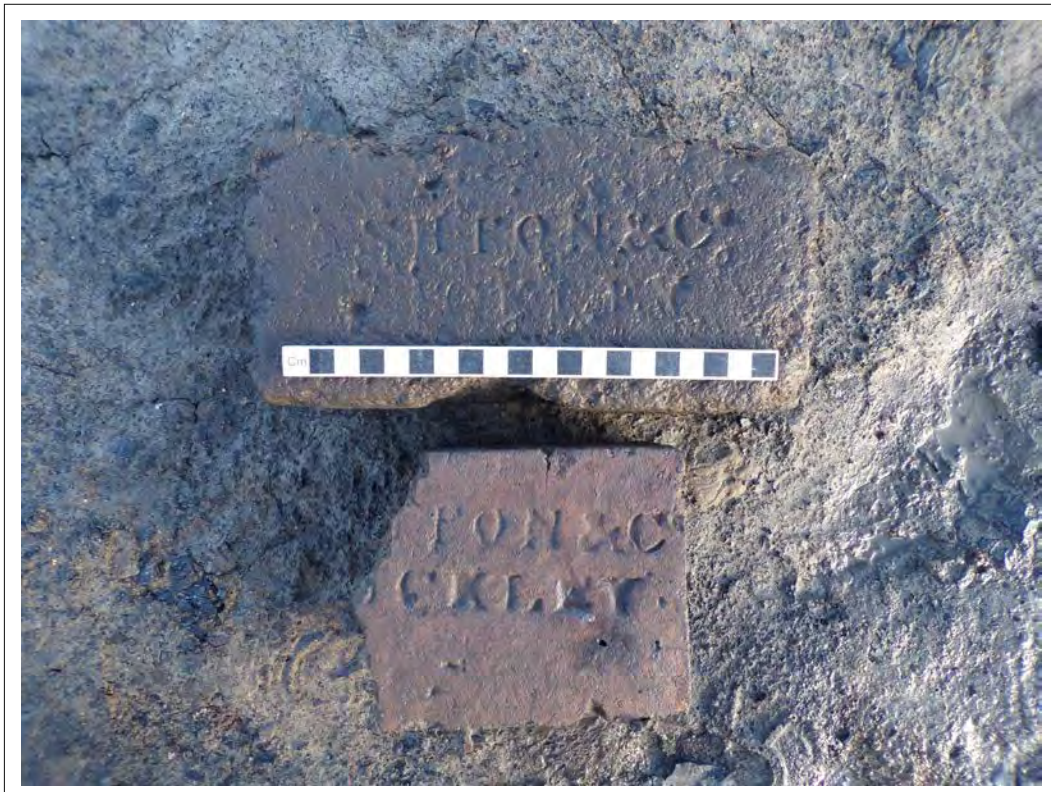
Plate 45. Shot of 'R Ashton & Co - Buckley' Bricks from context [1026] & [1029].
Scale 0.2m
