CPAT Report No. 1533

# Brenig Wind Farm, Denbighshire

Archaeological Mitigation Works

Client name: Brenig Wind Ltd  
 CPAT Project No: 2234  
 Project Name: Brenig Wind Farm  
 Grid Reference: SH 9943 5756 (centre)  
 County/LPA: Denbighshire  
 Planning Application: 25/2007/0565/PF  
 CPAT Report No: 1533  
 Event PRN: 140203  
 Report status: Final  
 Confidential: No

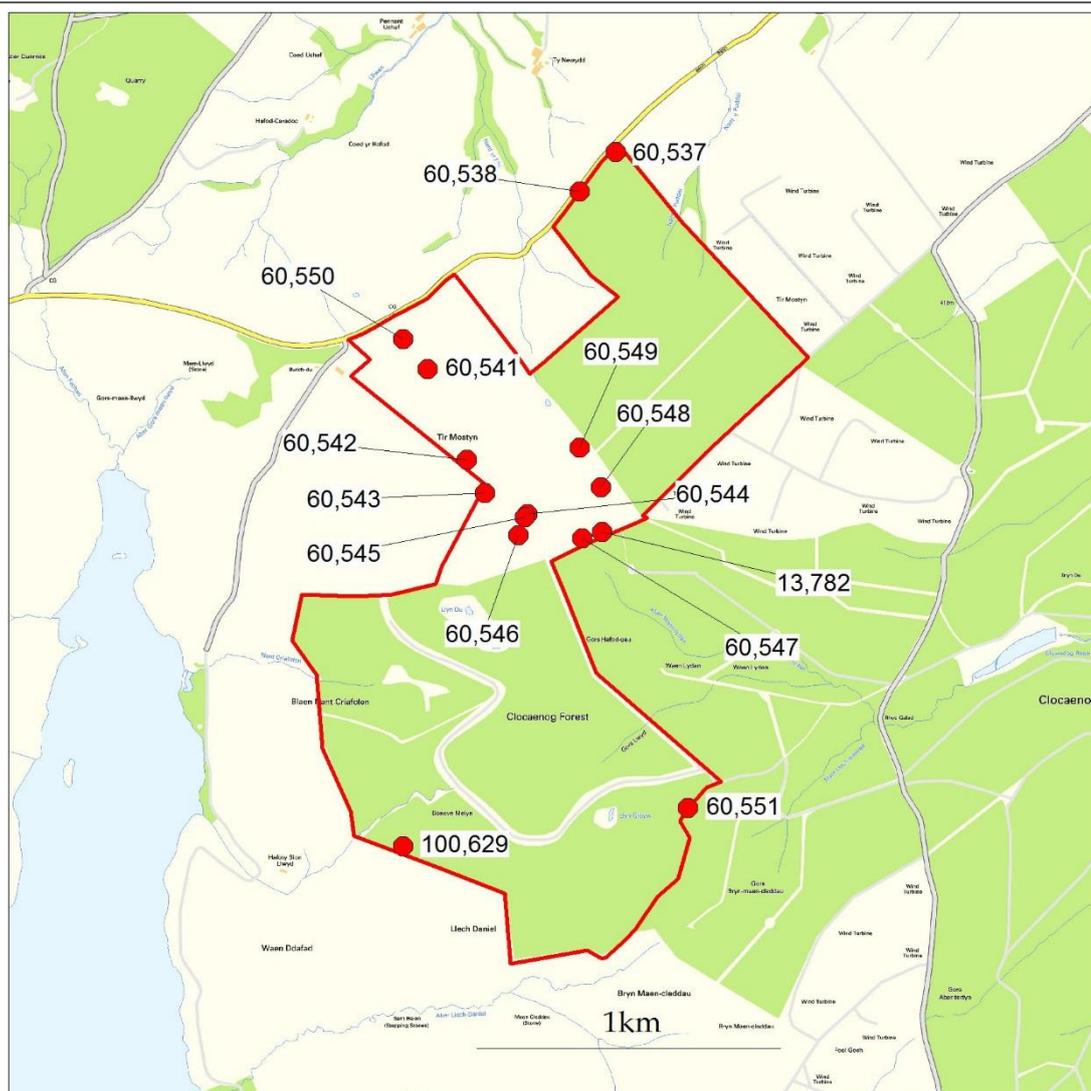
Fig. 2: Heritage Assets within the Brenig Wind Farm

- 5.2. The 30m buffer zones were defined from the perimeter of the relevant asset, not from its central point; their integrity was checked periodically during the construction works. Each buffer zone was defined by CPAT staff and demarcated by the site contractor, under CPAT's direction, using wooden posts with a single strand of plain wire; some zones were merged so that they contained more than one asset.

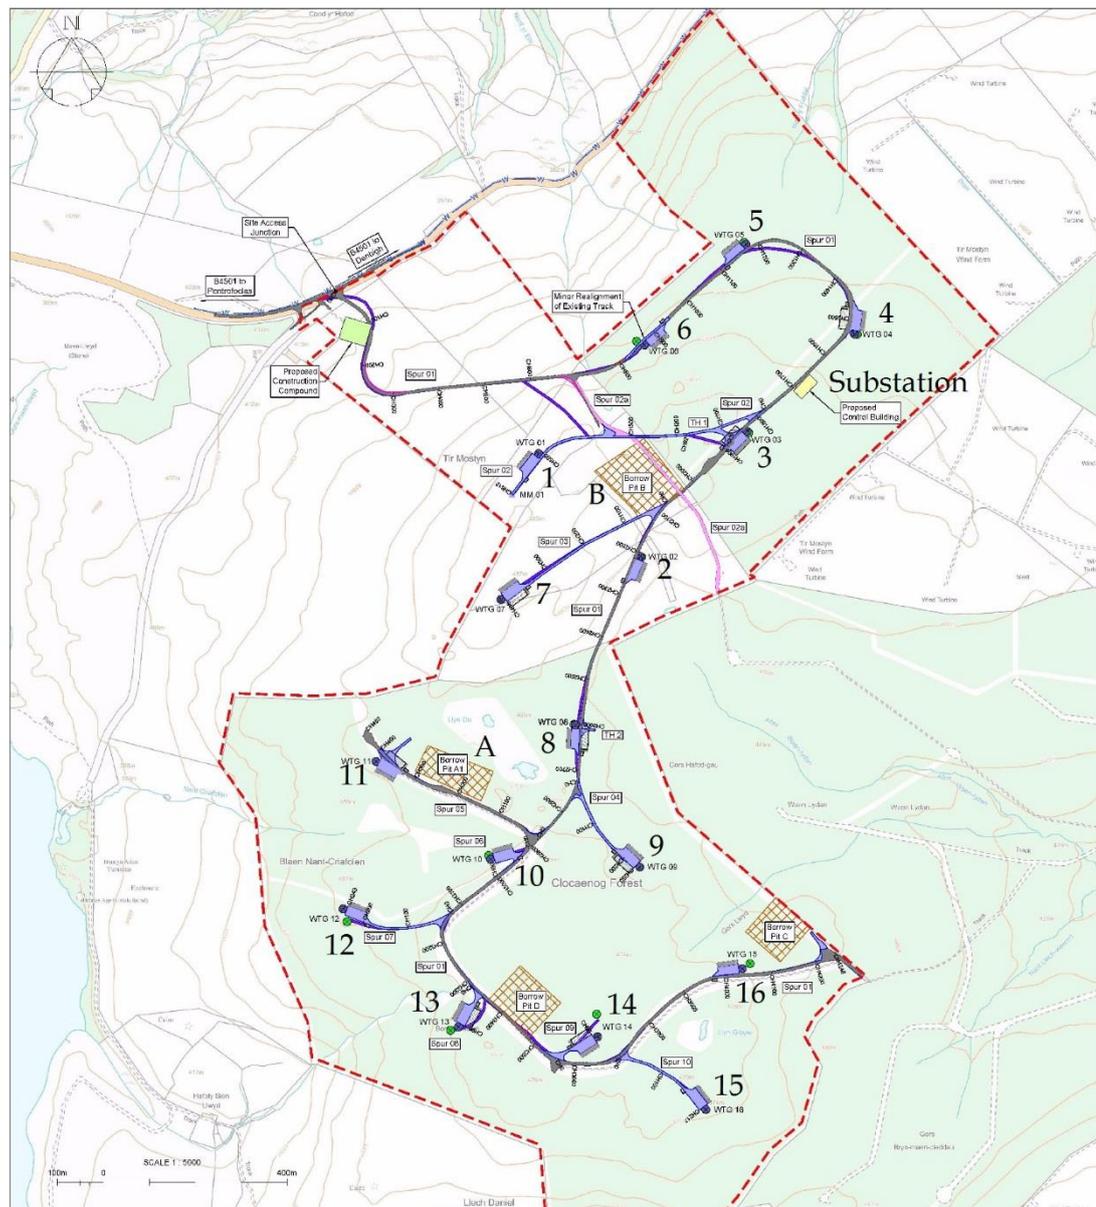
Fig. 3: Wind Farm layout, courtesy of the client (contains Ordnance Survey data © Crown copyright and database right 2017)

- 6.1. As has been noted above, the construction of the main spine road leading through the wind farm, from the entrance to Turbine 16, was subject to a watching brief in 2015. A watching brief was also conducted on the site of Borrow Pit B at this time but no evidence of heritage assets was revealed at either location.
- 6.2. The 2017 watching brief was carried out from 27 July to 12 October. In total, the initial soil removal at 16 turbine bases with their associated crane pads (1-16), one borrow pit (A), the site of the substation and the remaining site access roads was monitored (see Fig. 3).

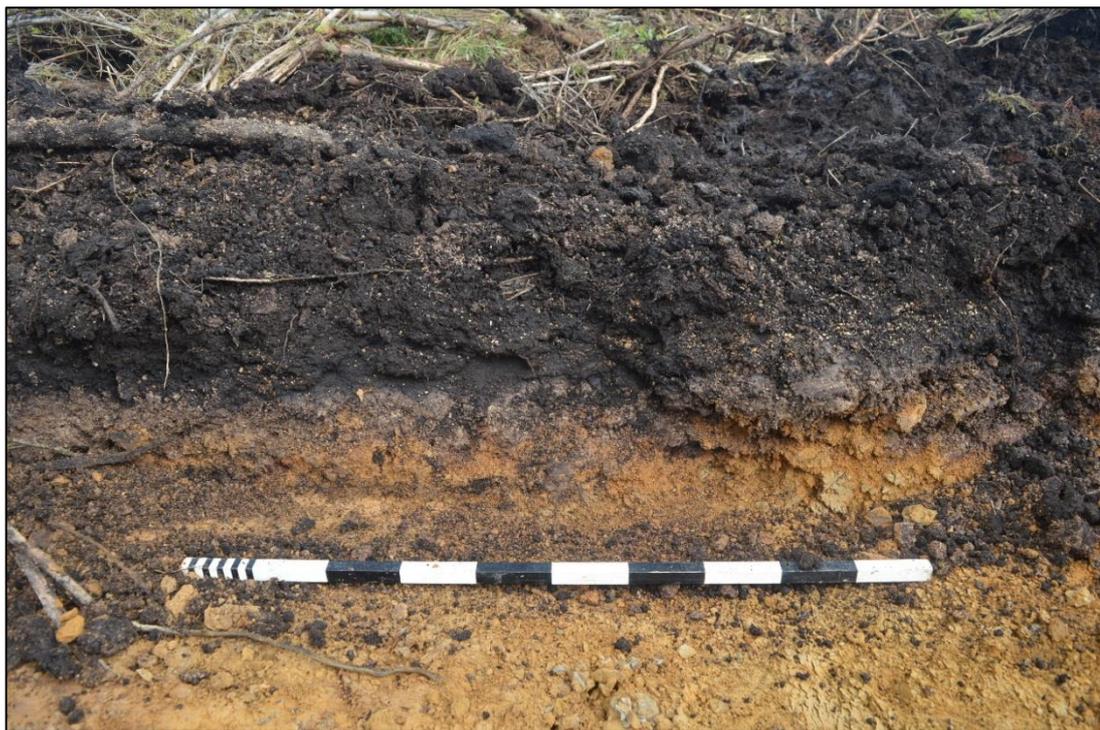
- 6.5. The general stratigraphy in the clear-felled areas comprised approximately 0.3m of humic vegetation and roots, overlying 0.3m of dark brown/black peat. Between the peat and the natural substrate was a thin horizon of greyish white, gleyed soil, measuring 0.05-0.10m thick. The natural substrate comprised an orange brown, stony clay.

Fig. 4: Typical soil profile in the formerly afforested areas, see para 6.4 (Photo CPAT 4378-0079)

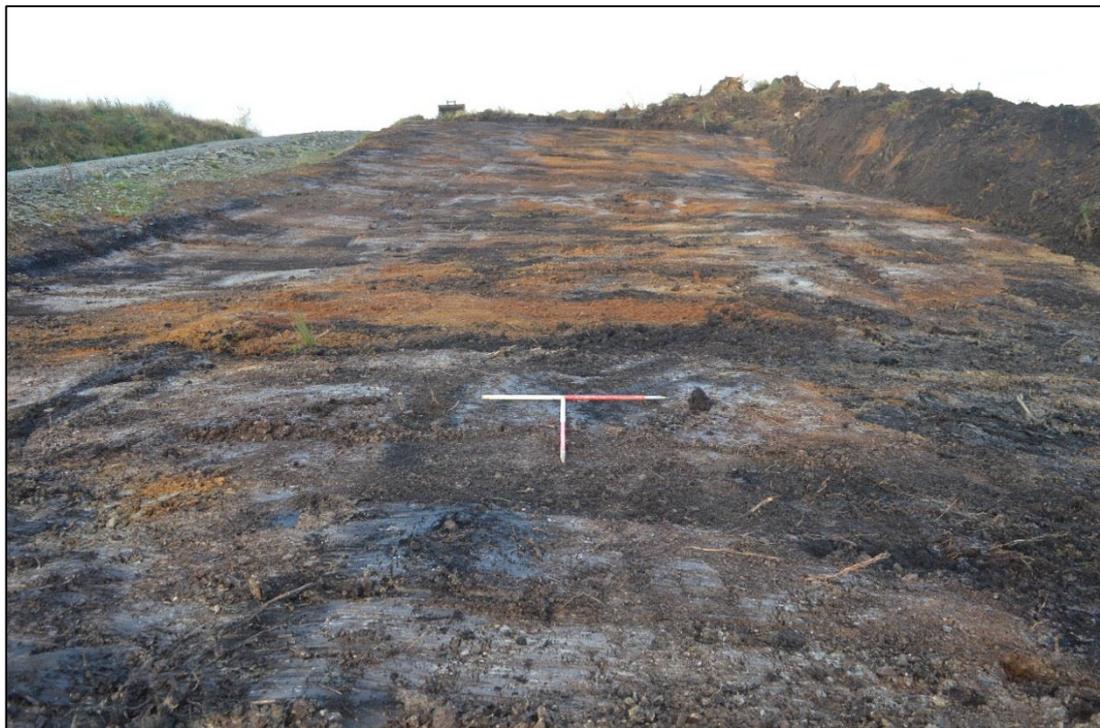
Fig. 5: The linear features observed at Turbine 15 (Photo CPAT 4378-0081)

- 6.10. At Turbine 15, following machine stripping of the southern half of the area, two straight parallel linear features were identified running in an east-west direction, approximately 7 metres apart. They were visible for 28m, each feature being 0.3m

wide, and filled by a dark brown peaty topsoil, similar to that at Turbine 4. There was no dating evidence for these features, which were most likely the remains of drainage/ploughing connected with the forestry plantation.

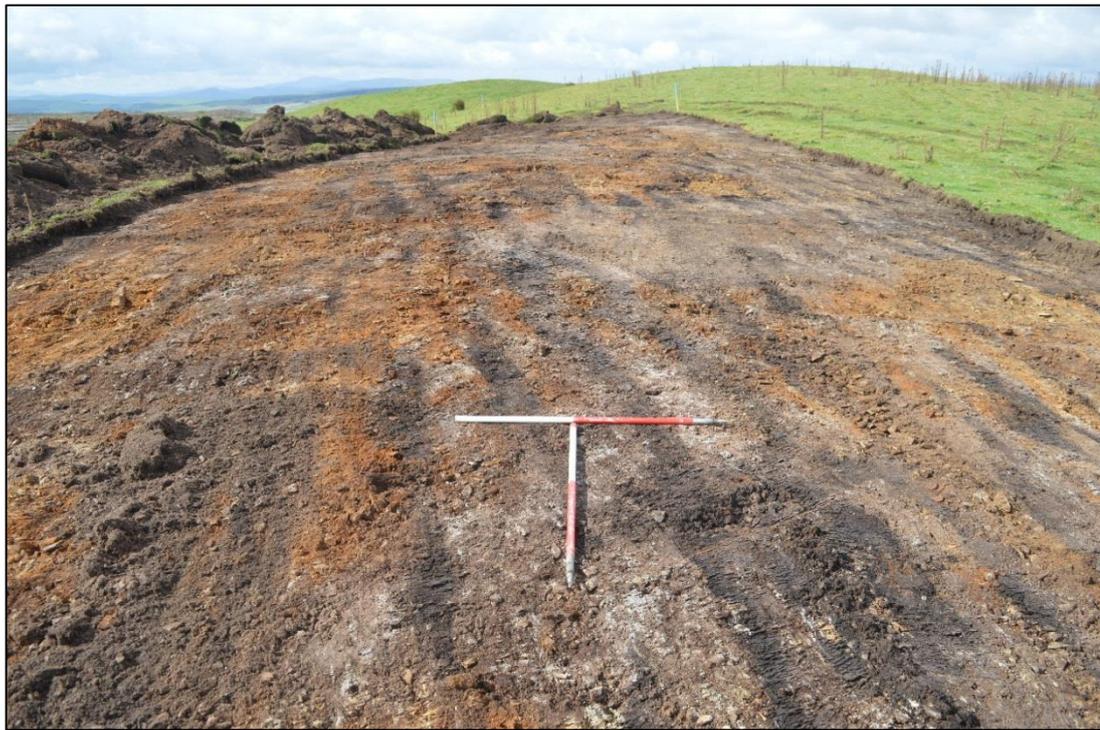
- 6.11. At Turbines 1 and 7, in the pasture areas, the underlying substrate showed evidence of intensive plough scarring (see Fig. 6), which was no doubt related to land improvement; no significant archaeological evidence was forthcoming at either location.

Fig. 6: Plough scarring of the underlying soils in improved pasture (Photo CPAT 4378-0065)
