ARCHAEOLOGICAL WATCHING BRIEF

WB/PTT/15

Public Toilets, Tintern

Planning Applications: DC/2013/01061

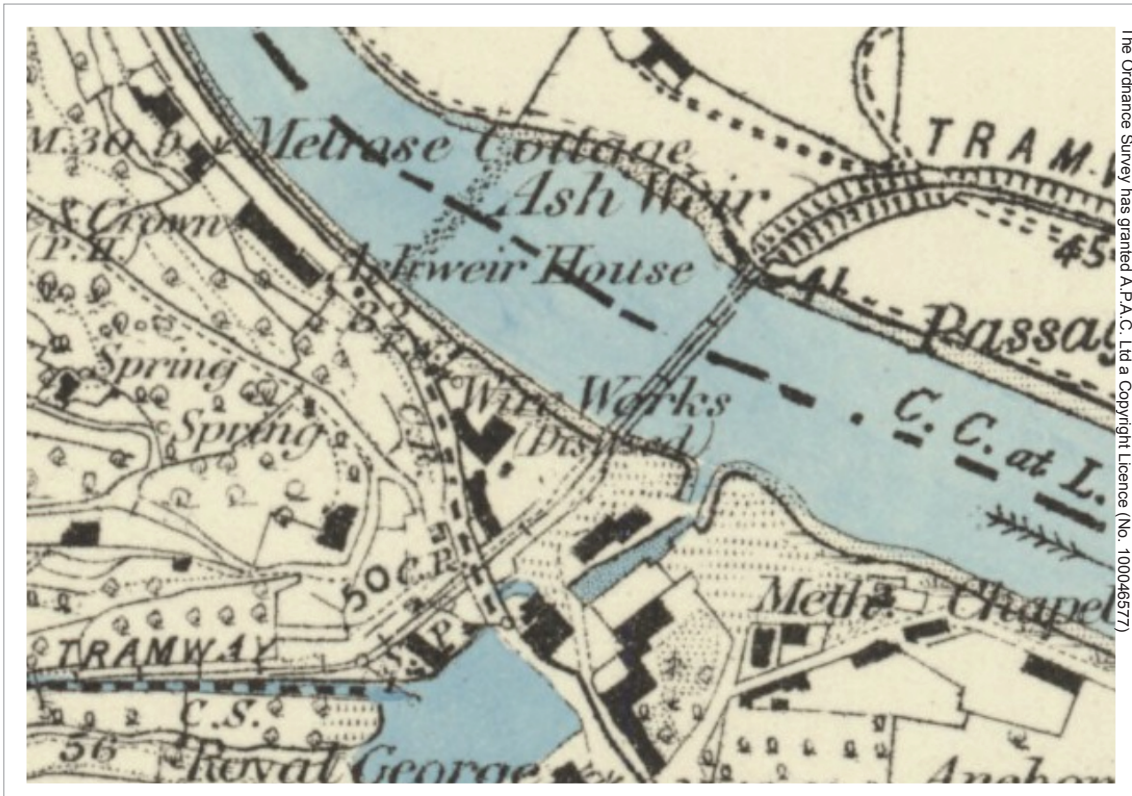
Fig 03 Ordnance Survey 6" Gloucestershire XLVI SW 1880-1 published 1887

The first enlightening information comes from the 1st edition, Ordnance Survey, 1880-1 map, fig 03, which shows the site devoid of structures, enclosed on three sides and abutting the northwest gable of a building which possibly still stands today.

A small circle is drawn in the centre its purpose not understood.

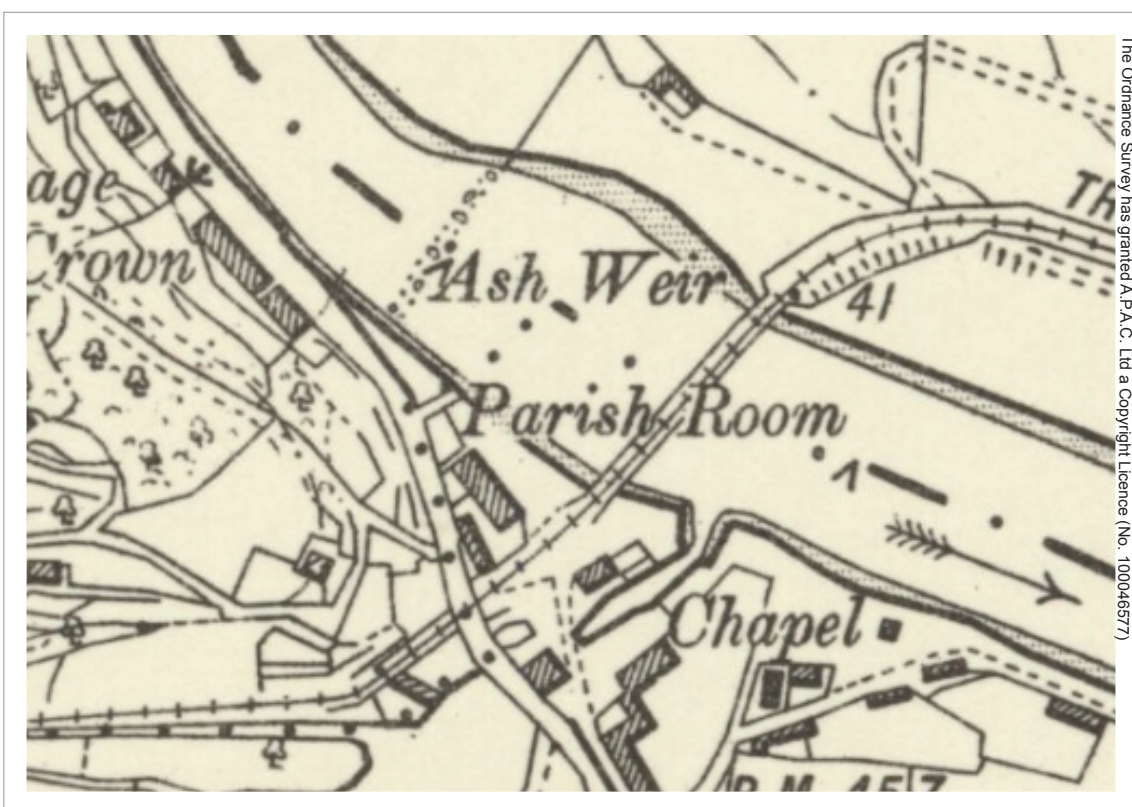
Fig 04 Ordnance Survey 6" Gloucestershire XLVI SW 1900 published 1887

Some 20 years later on the 1900 map, fig 04, annotation has become less intrusive and it is possible to see that the site has been reduced to its present boundaries including the path along the south east and the retaining wall along the west.

Access is also provided from the road to the North West as it was at the start of the watching brief.

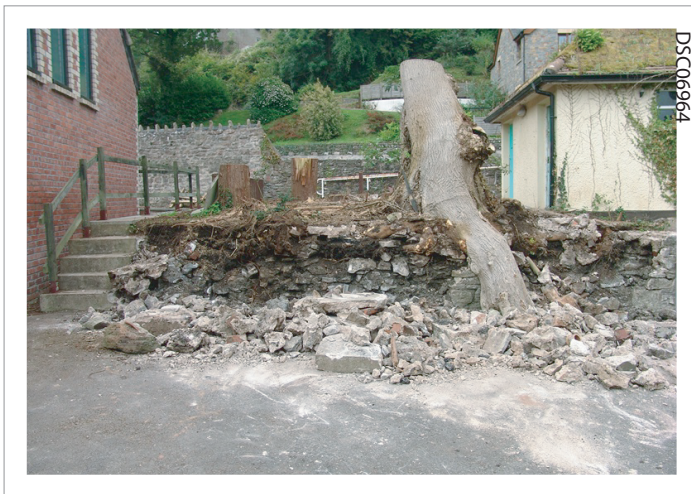
Plate 01: Retaining wall dismantles to remove tree. [101], [102], [104], [105], [129].

Clearance involved the removal of a number of large tree boles which unavoidably caused some considerable disturbance to the underlying ground, as plates PL01, PL02, PL 03 & PL04 show.

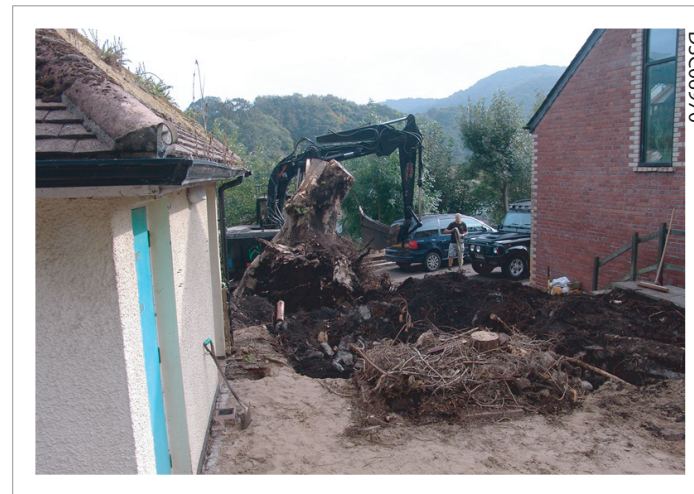
Plate 02: Large tree being lifted clear. [100], [103], [104], [105], [106].

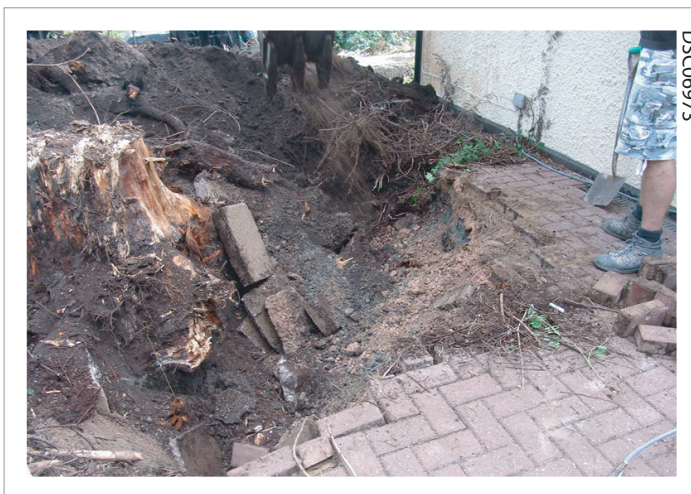
Plate 03: North of toilet block tree being removed. [105], [107], [108], [109], [110], [111], [111], [112].

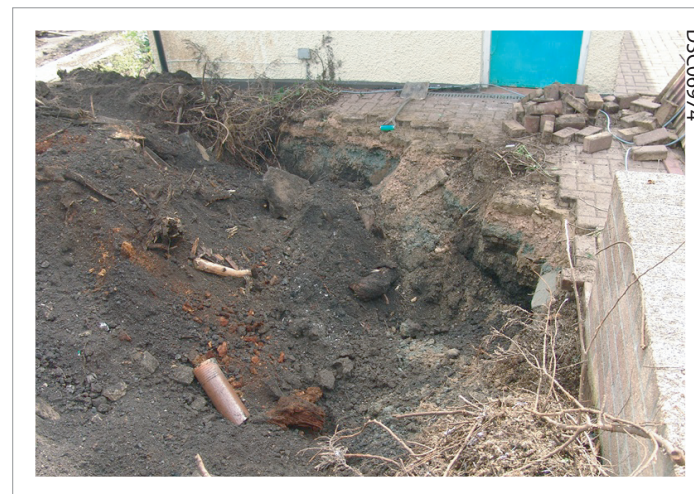
Plate 04: North of toilet block, tree removed. [104], [107], [108], [109], [110], [111], [111], [112] [113].

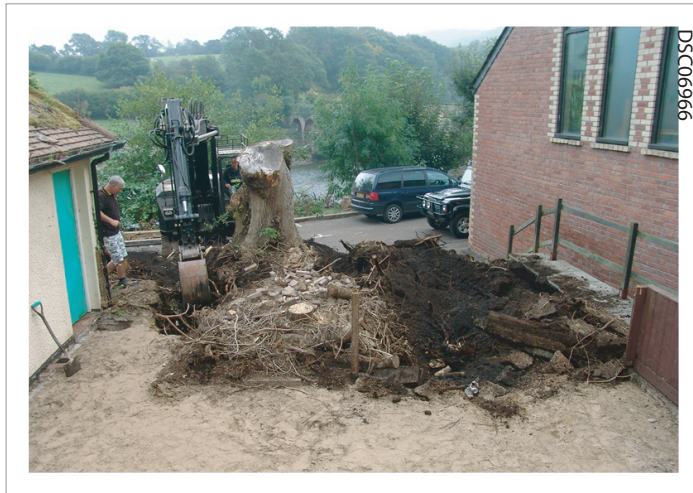
Plate 05: Two stumps gone, one left. [101], [102], [103], [104], [105].

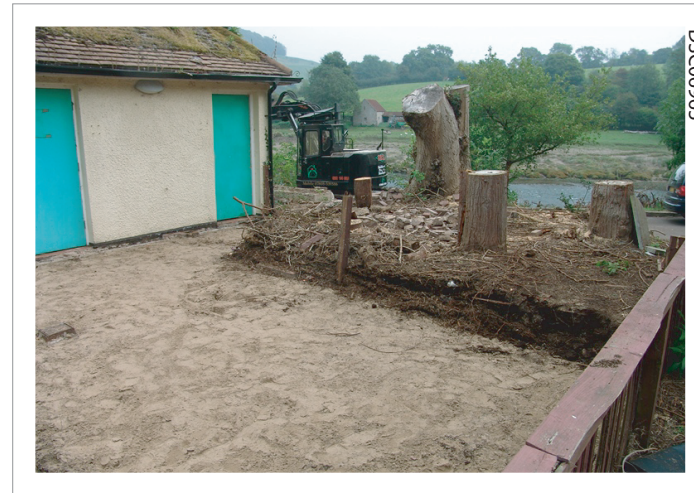
Plate 06: Three tree stumps in garden of toilet. Bedding surface in foreground paving slabs removed. [100], [101], [105].

Most of the ground disturbance during the removal of the tree boles appeared to be limited to the landfill construction deposits for the 20th century toilet block [105] including: services [106] & [113] PL05 & PL04, retaining wall [102] PL01, deposits [103-109] PL02 & PL03 and the later landscaping and access features: [100], [101-107], [104], [108], [110], [111], [112], PL06 & PL07.

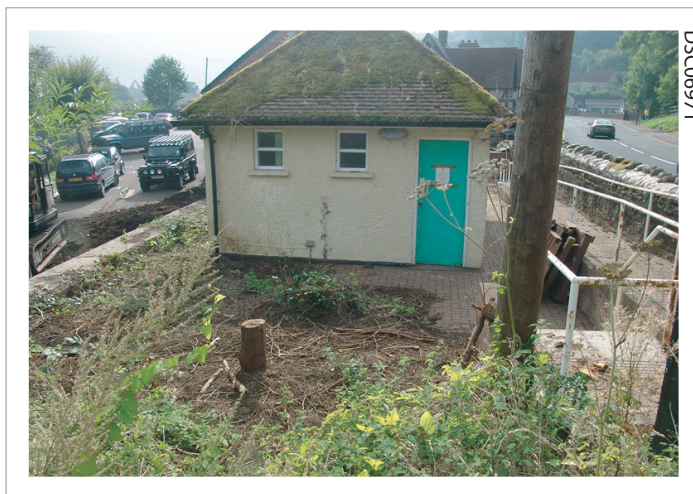
Plate 07: North edge of toilet block. [107], [108].

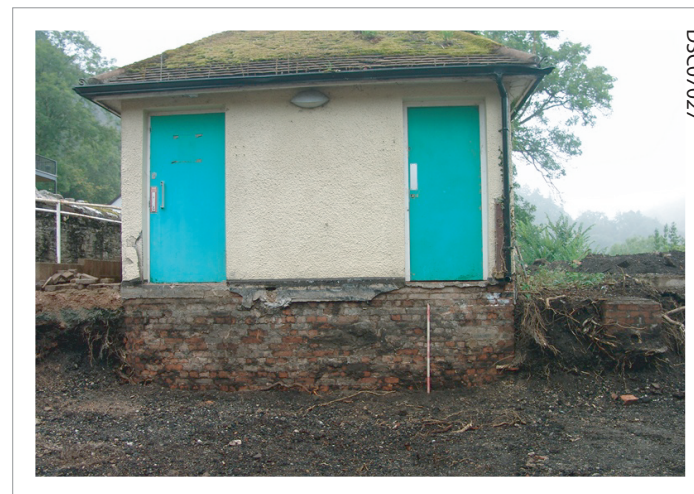
Plate 08: South side of toilet block on 1.2m high brick foundation. [101], [103], [104], [105], [114].

Once the tree root boles had been removed excavation concentrated on reducing the ground level by 1.25m, to that of the adjacent car park [129], PL08.

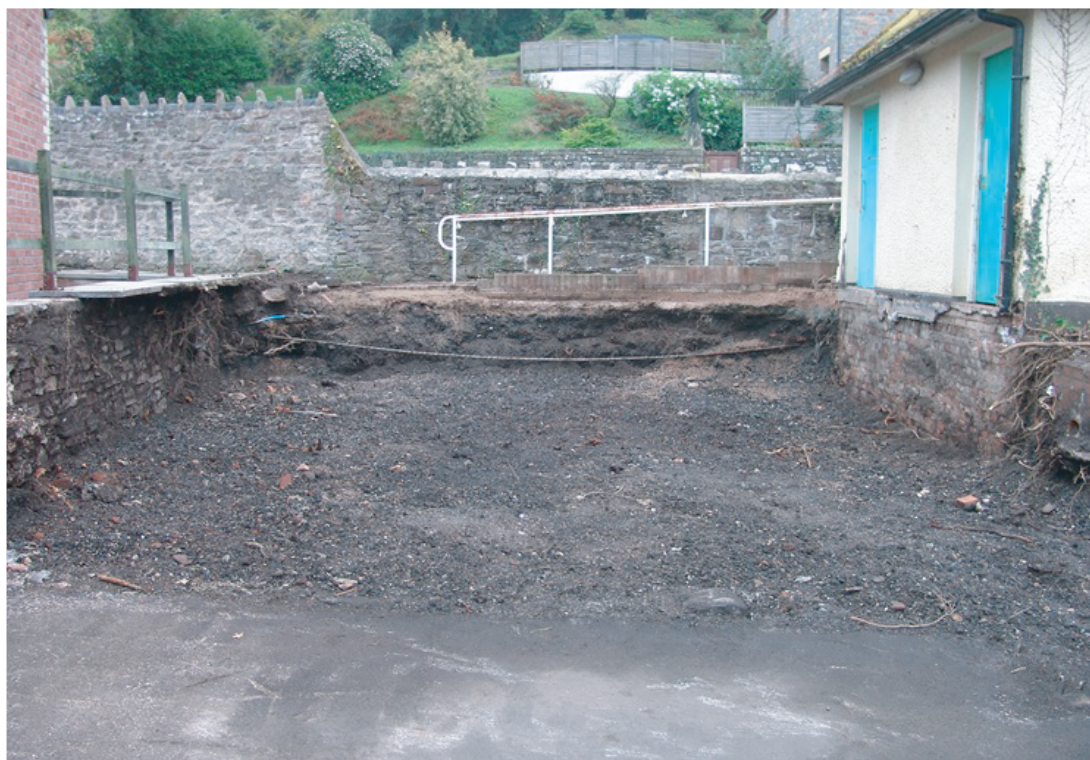
DSC07026

Plate 09: Levelled site with trees removed. [100], [103], [104], [105], [114], [115], [116], [129].

This reduction cut into a deposit with a large percentage of railway ballast material [114], assumed to be associated with the nearby Tintern Works Branch of the Wye Valley Railway built in 1874, PL09.

The cable [115] seen in PL09 was assumed to be live and as no cut or fill was evident, nor any warning tape or brick cover it may have been laid at the time of the toilet block construction.

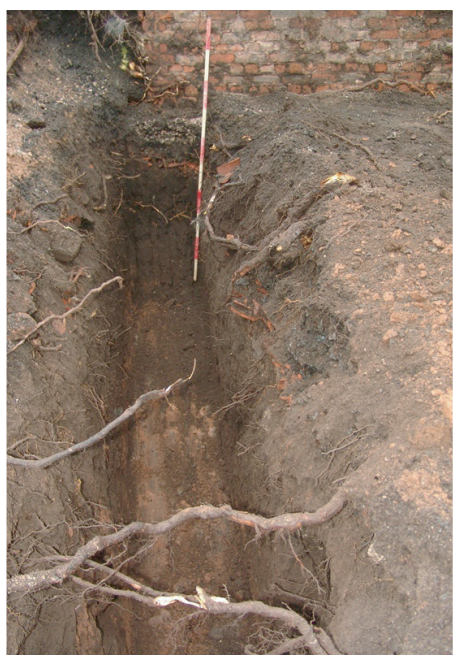
DSC07030

Plate 10: Trench 1 North west corner, depth 1.5. [114], [115], [116], [117], [118], [119].

Trenching began at the North West corner encountering the concrete foundation block for the toilet [117], PL10 before cutting down 100mm through the remaining [114] deposit.

Beneath [114] was a 300mm landfill deposit [116] of building rubble and pan tile, over almost 600mm of dark brown sandy clay [118], before natural orange, river terrace deposit, [119] was reached.

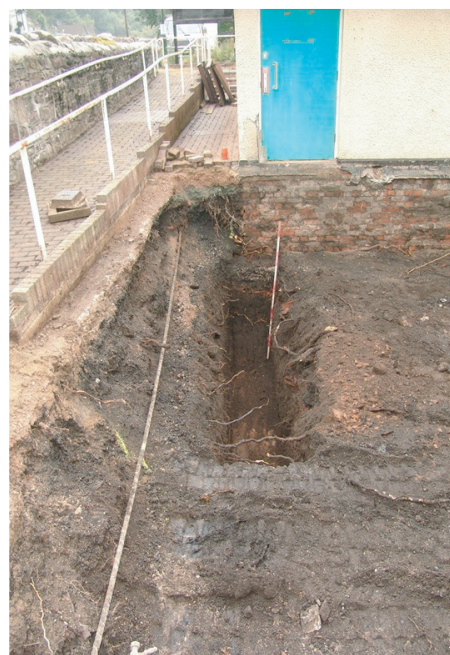
DSC07031

Plate 11: Trench 1 North west corner overview, depth 1.5. [104], [105], [108], [109], [114], [115], [116], [117], [118], [119].

The restrictive nature of the site for the mechanical digger can be seen in PL11 which shows an overview of the first half of trench 1 completed before the mechanical digger tracked south to complete the excavation.

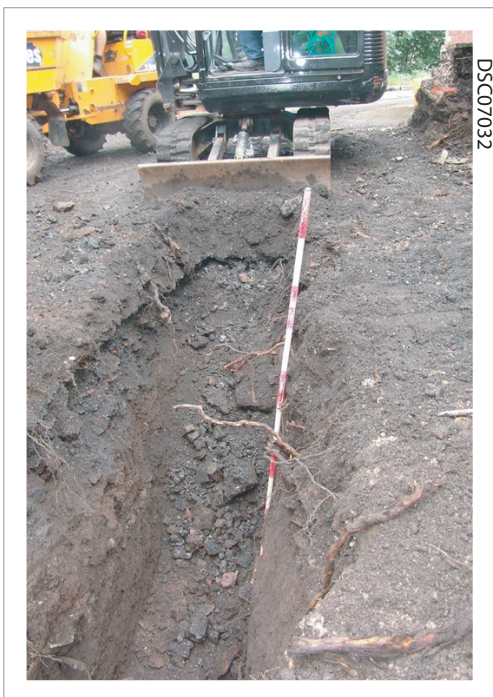
DSC07032

Plate 12: Trench 2 western end. [120], [121], [122], [123], [129].

The stratigraphy of trench 1 was uniform along its length, however once trench 2 was excavated, a general slope to the east was revealed as can be seen in PL12 which shows the corner of the trenches 1 & 2 with the clear dip of [119], dropping 600mm in 1.4m.

As trench 2 was continued eastward a very solid band of ferric material was encountered [120], PL12, which from the vibration caused by its removal could be felt to extend across the remaining site.

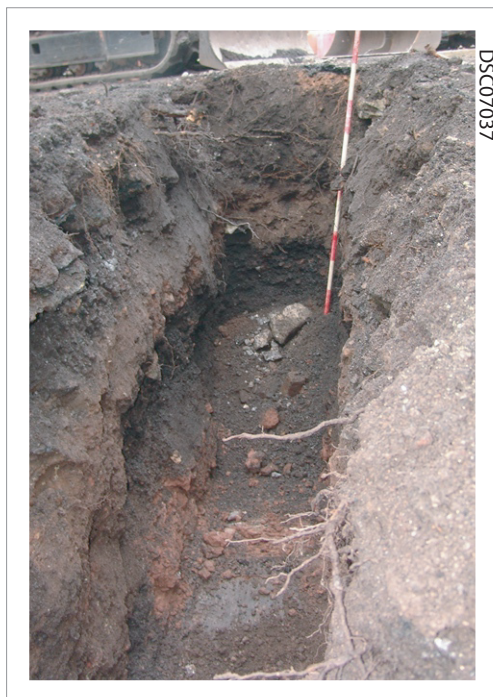
DSC07037

Plate 13: Trench 3 complete at 1.75m. [120], [121], [122], [123], [125], [129].

Beneath the ferric floor [120] was a deposit of [116-121] which overlay a dark sandy gravel [122]; PL13 & PL14, which dipped to a red sandy clay [124] at 1.7m.

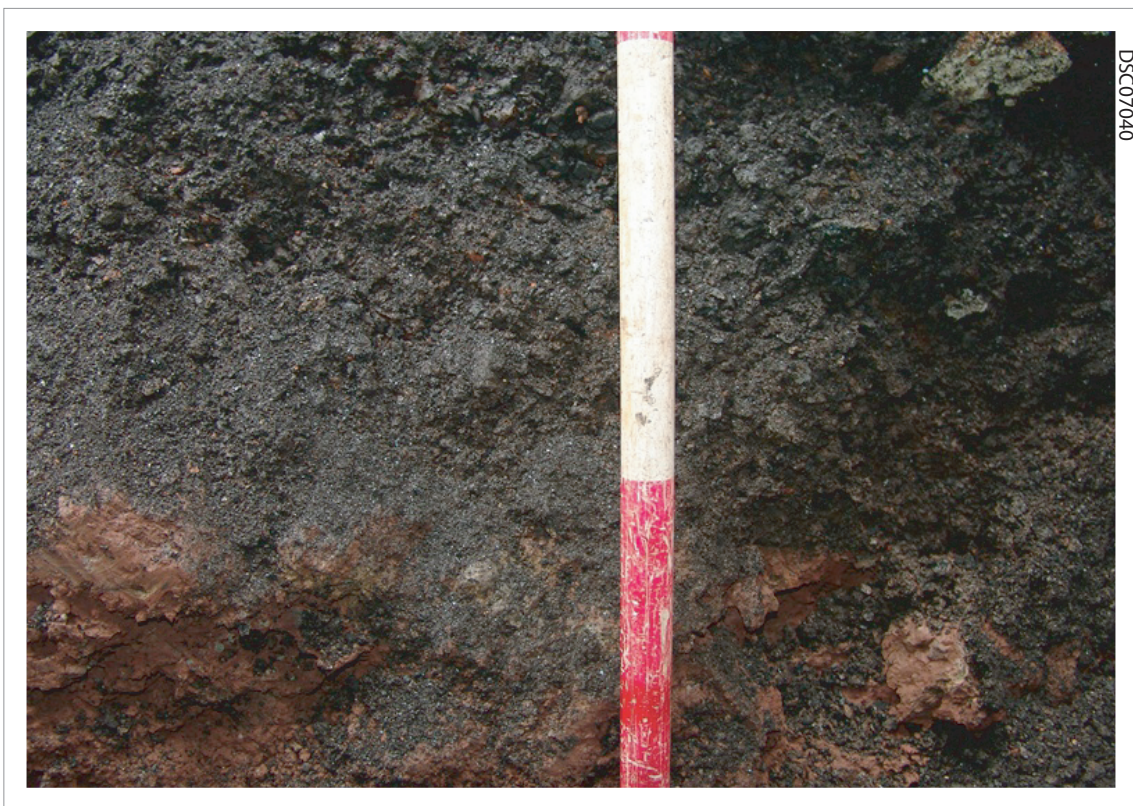
DSC07040

Plate 14: Trench 3 mid. [122], [125].

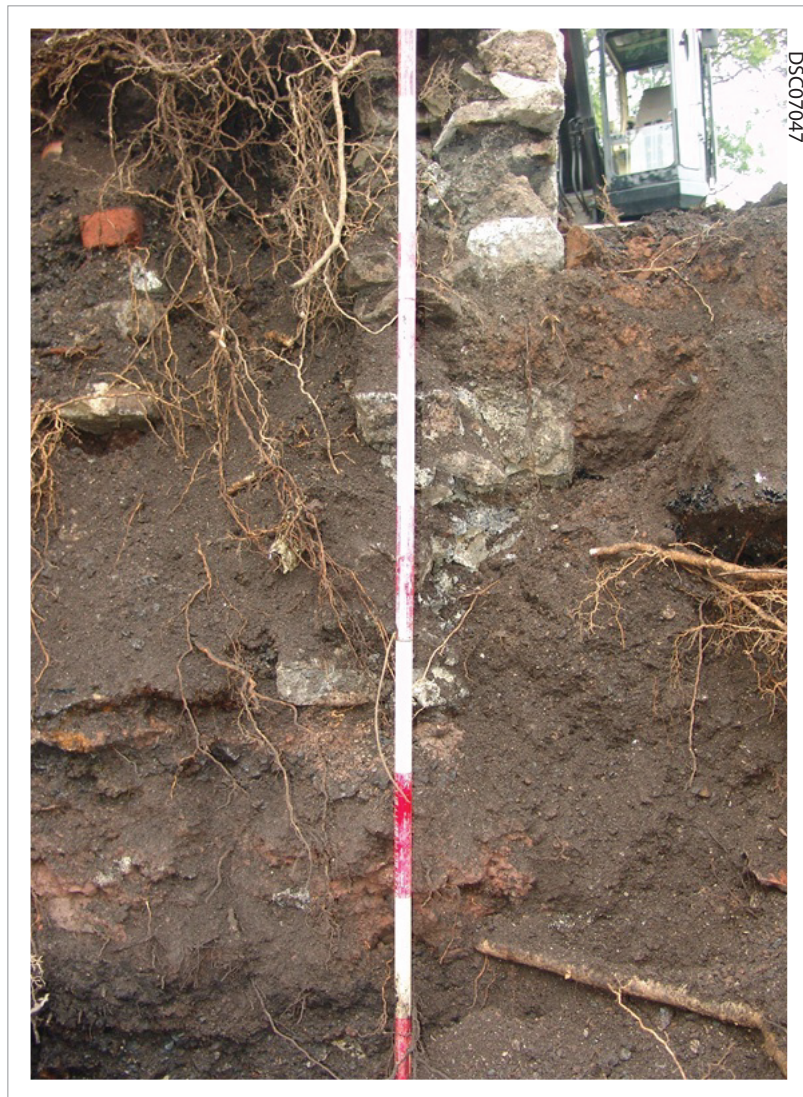
Plate 15: Trench 3, end at masonry retaining wall. [102], [126], [127], [128].

The photograph in PL15 gives some idea of the general stratigraphic makeup of the site along the eastern edge, unfortunately, the instability did not allow for any clearing to be done so an annotated sketch is provided as an aid for interpretation.

Of particular interest is a narrow foundation for the wall [102] directly on the edge of the ferric surface [120], in comparison with the wider remains at the level with the present car park [129].

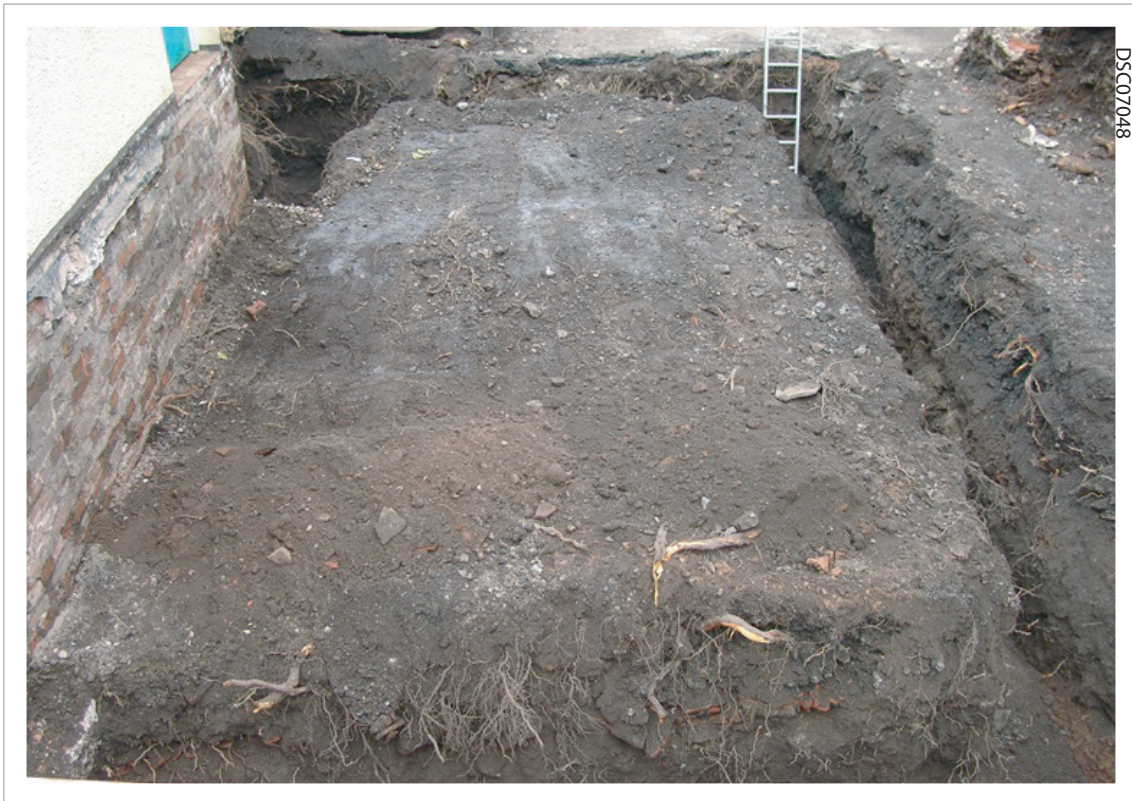
Plate 16: Trench 1 foreground, 2 right, 3 top & 4 short return top left. [105], [116], [117], [118], [121], [122], [123], [125], [127], [128], [129].

The last trench was a narrow return to the toilet block, PL 16, again unstable and again showing the remains of the ferric floor [120], this time providing solid ground for the 20th century toilet block [105] construction, PL 17.

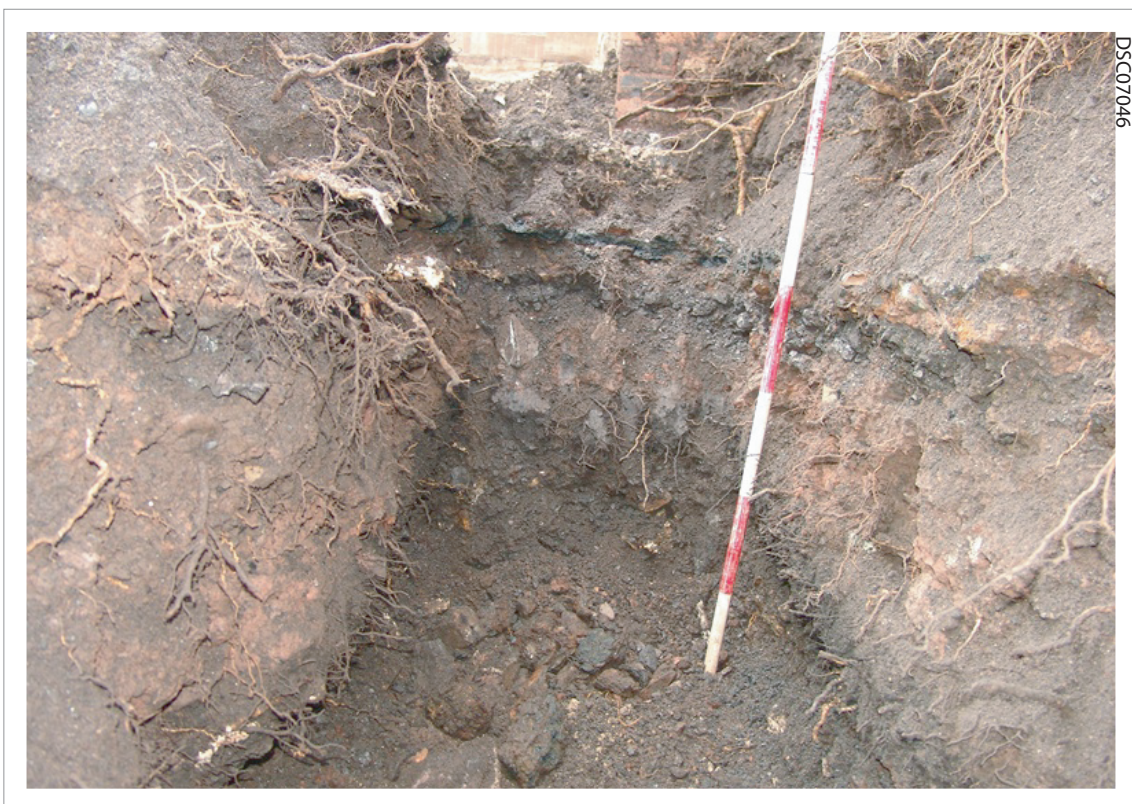
Plate 17: Trench 4, end at toilet block brick foundation. [105], [126], [127], [128].

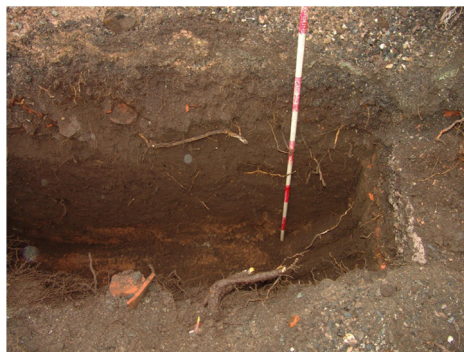
DSC07028.jpg

118	TR1	Deposit	Dark brown sandy clay, ≥ 600mm Same as [123]		DSC07028, DSC07029, DSC07030, DSC07031, DSC07048
119	TR1	Natural	Orange clay/sand, ≥ 300mm exposed. Same as [124]		DSC07028, DSC07029, DSC07030, DSC07031,
120	TR2	Surface	Ferric surface, possibly forge scale, 80mm 150mm below [130]. Same as [126]	{5}	DSC07032, DSC07033, DSC07034, DSC07037, DSC07043, DSC07044,
121	TR2	Land fill	Loose land fill; rubble, pan tile, slag. Same as [116 & 127]		DSC07032, DSC07033, DSC07034, DSC07037, DSC07038, DSC07042, DSC07043, DSC07044, DSC07048
122	TR2	Land fill	Dark red/brown sandy gravel with loose stone. Same as [128]		DSC07032, DSC07033, DSC07034, DSC07035, DSC07037, DSC07038, DSC07039, DSC07040, DSC07041, DSC07042, DSC07048
123	TR2 W	Deposit	Dark brown sandy clay, ≥ 600mm Same as [118]		DSC07032, DSC07033, DSC07034, DSC07035, DSC07037, DSC07038, DSC07048
124	TR2 W	Natural	Orange clay/sand, ≥ 300 reducing to 0mm. Dipping down towards east. Same as [119]		DSC07034, DSC07035,

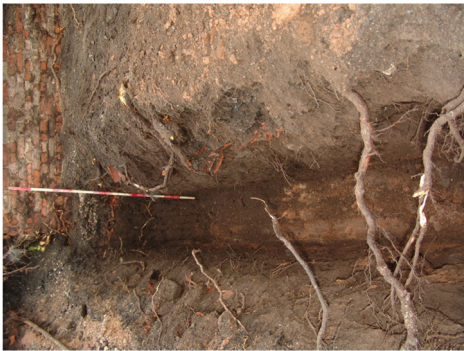
DSC07030.jpg

DSC07030	20/09/2014	DSC F828	2448x3264	NW	Trench 1 North west corner, depth 1.5. [114], [115], [116], [117], [118], [119].	PL10
DSC07031	20/09/2014	DSC F828	2448x3264	NW	Trench 1 North west corner overview, depth 1.5. [104], [105], [108], [109], [114], [115], [116], [117], [118], [119].	PL11
DSC07032	20/09/2014	DSC F828	2448x3264	NE	Trench 2 western end. [120], [121], [122], [123], [129].	PL12
DSC07033	20/09/2014	DSC F828	2448x3264	E	Trench 2 western end. [120], [121], [122], [123], [129].	
DSC07034	20/09/2014	DSC F828	2448x3264	E	Trench 2 end western long view. [120], [121], [122], [123], [124], [129].	
DSC07035	20/09/2014	DSC F828	3264x2448	S	Trench 1, trench 2 corner. [122], [123], [124].	
DSC07036	20/09/2014	DSC F828	3264x2448	NE	Levelling spoil. [129].	
DSC07037	20/09/2014	DSC F828	2448x3264	E	Trench 3 complete at 1.75m. [120], [121], [122], [123], [125], [129].	PL13
DSC07038	20/09/2014	DSC F828	2448x3264	E	Detail, Trench 3 complete at 1.75m. [121], [122], [123], [125], [129].

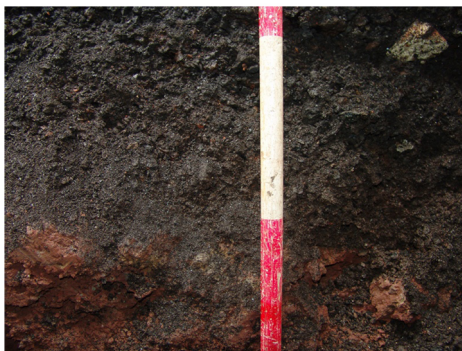
DSC07040.jpg

DSC07039	20/09/2014	DSC F828	3264x2448	N	Trench 3 bottom. [122], [125].	
DSC07040	20/09/2014	DSC F828	3264x2448	N	Trench 3 mid. [122], [125].	PL14
DSC07041	20/09/2014	DSC F828	3264x2448	N	Trench 3 mid. [122]	
DSC07042	20/09/2014	DSC F828	3264x2448	N	Trench 3 mid. [121], [122].	
DSC07043	20/09/2014	DSC F828	3264x2448	N	Trench 3 mid. [120], [121].	
DSC07044	20/09/2014	DSC F828	3264x2448	N	Trench 3 top. [120], [121].	
DSC07045	20/09/2014	DSC F828	3264x2448	N	Trench 4, north & eastern face. [120], [121].	
DSC07046	20/09/2014	DSC F828	3264x2448	SW	Trench 4, end at toilet block brick foundation. [105], [126], [127], [128].	PL17
DSC07047	20/09/2014	DSC F828	2448x3264	N	Trench 3, end at masonry retaining wall. [102], [103], [114], [126], [127], [129].	PL15
DSC07048	20/09/2014	DSC F828	3264x2448	NE	Trench 1 foreground, 2 right, 3 top & 4 short return top left. [105], [116], [117], [118], [121], [122], [123], [125], [127], [128], [129].	PL16

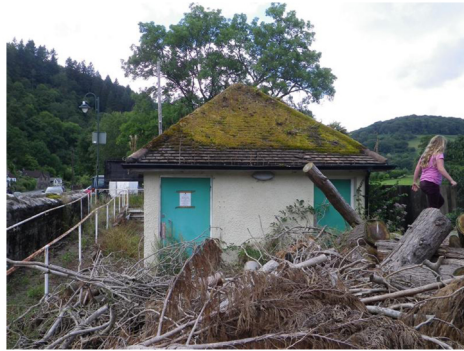
IMGP0377.jpg

Cover Photograph: IMG0377. Site Visit. Disused Toilet Block and surrounding vegetation

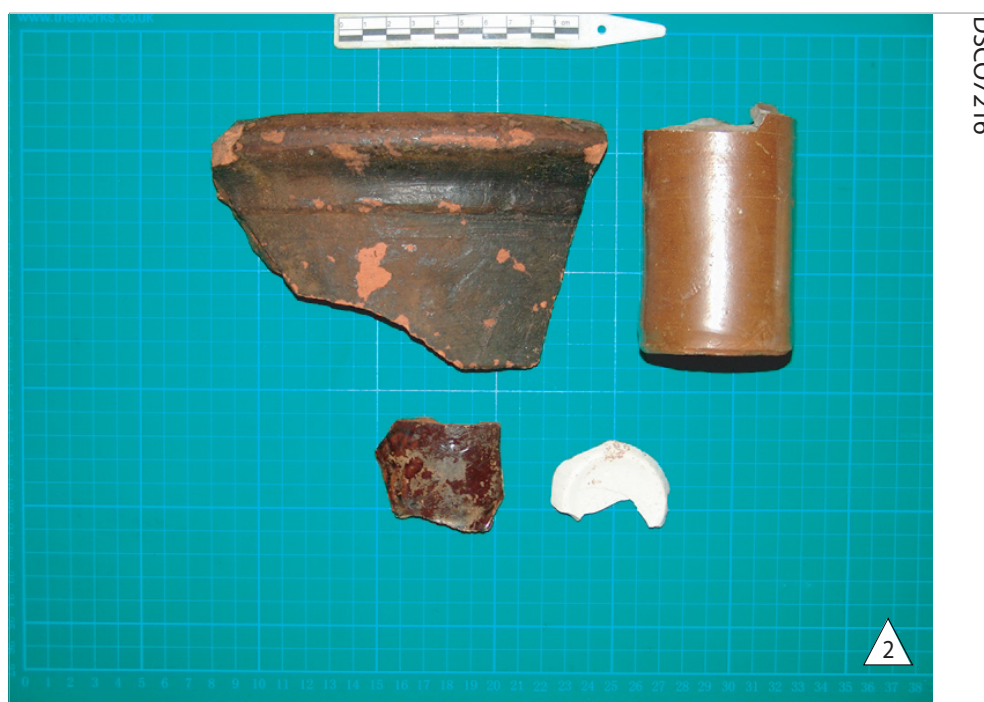
Find no	Area	Context	Description	Period	Date
1		101	2 sherd (refit) yellow glazed stoneware bowl rim, with emboldened ball rim 1 sherd white china with blue design 1 sherd white china	19 th	17/09/14
