## **Aberthaw Power Station, Aberthaw Vale of Glamorgan**

Archaeological Walkover Survey

Report No. 1588

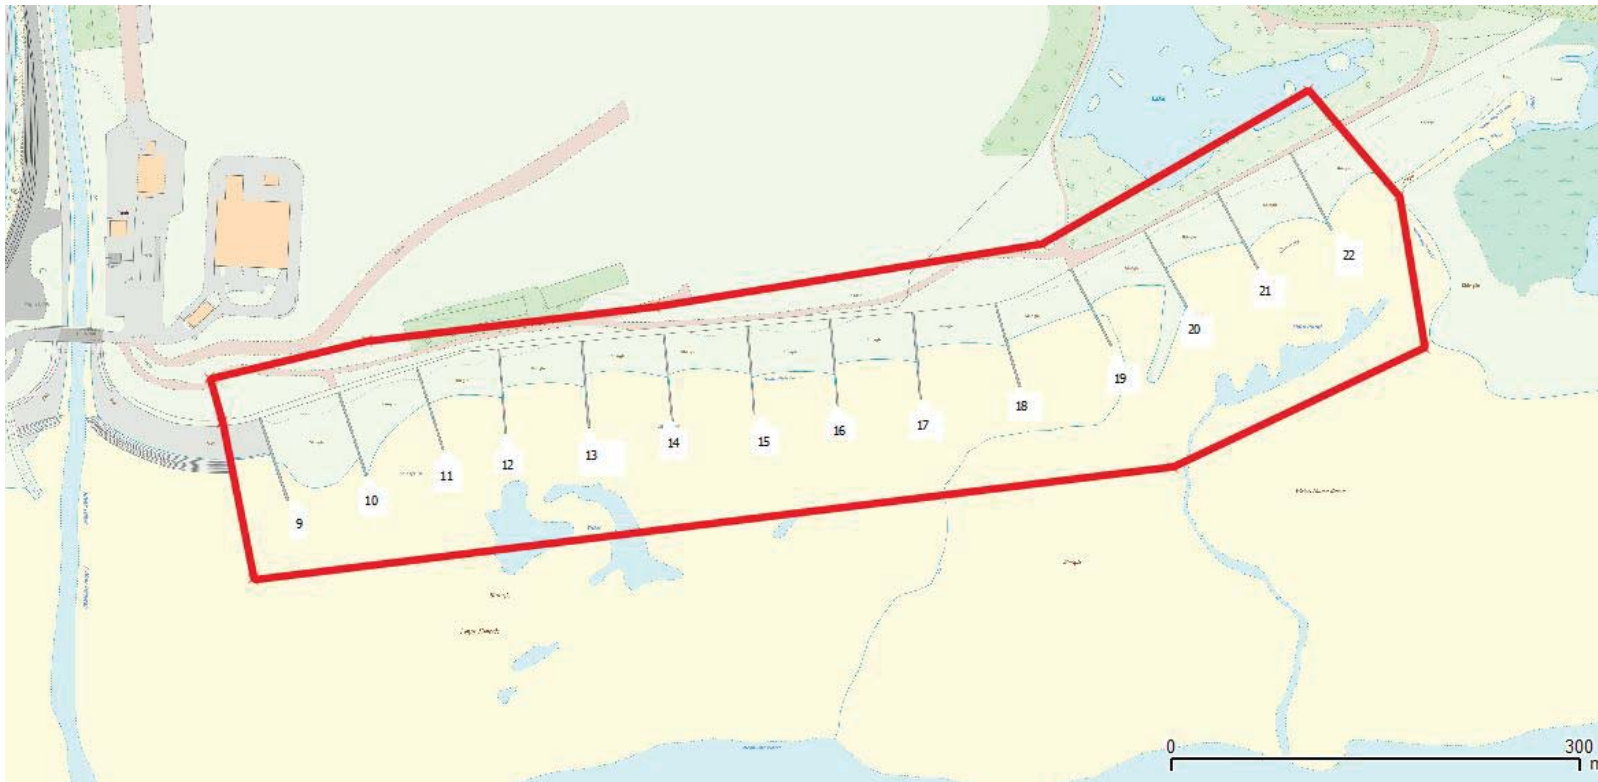
Figure 2. Site location in red showing current groyne locations.

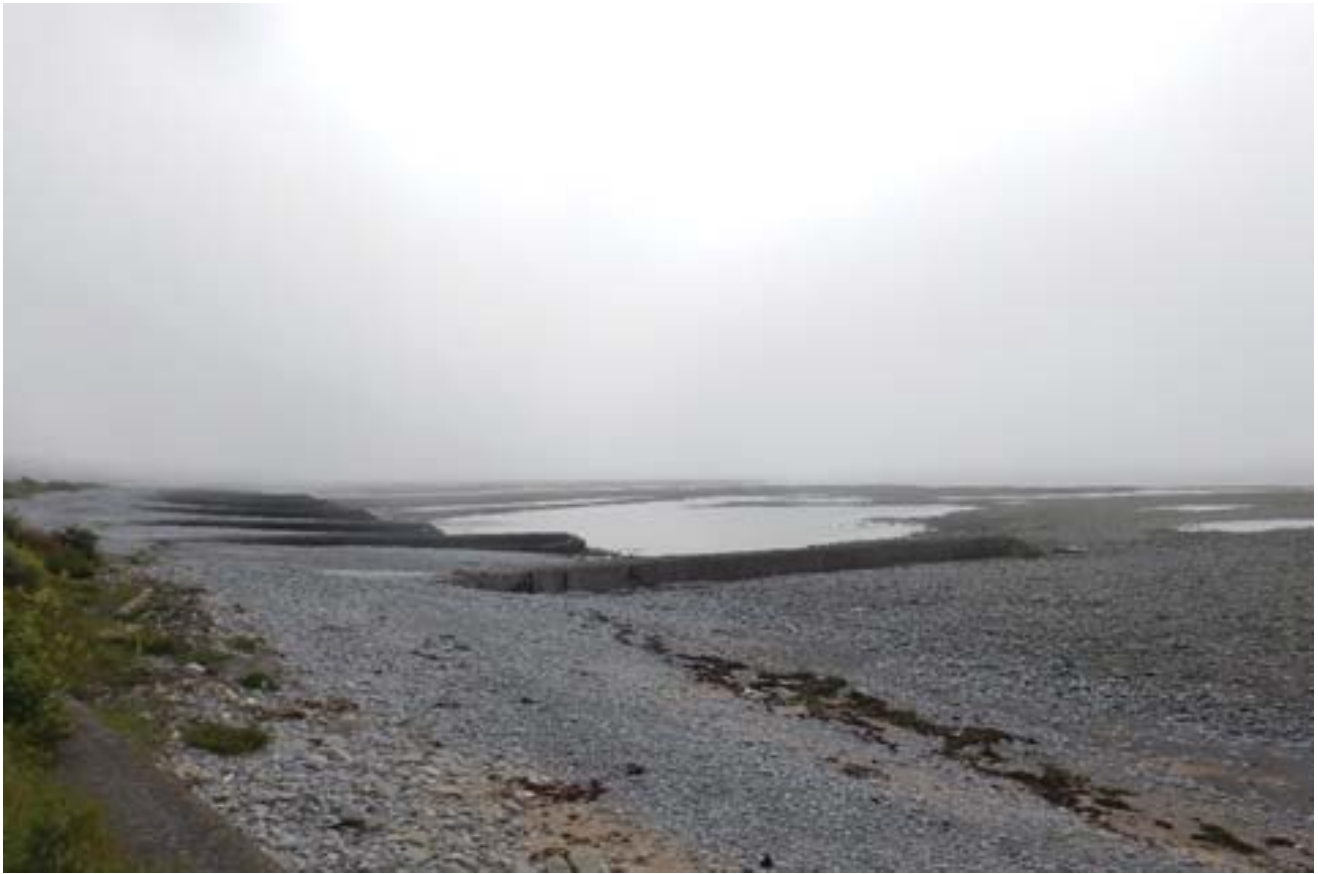
Within the area of the site are 14 post medieval groynes (PRN PRN03983s), which extend along the beach (Plate 1). These were all constructed from concrete that was poured into a frame, a construction method that post-dates the First World War. Analysis of the historic mapping for the area shows that these groynes first appear on the 1940s Ordnance Survey map sheets but not on the 1920's Ordnance Survey map.

Plate 1: View south-west across the site showing a number of the groynes (PRN03983s).

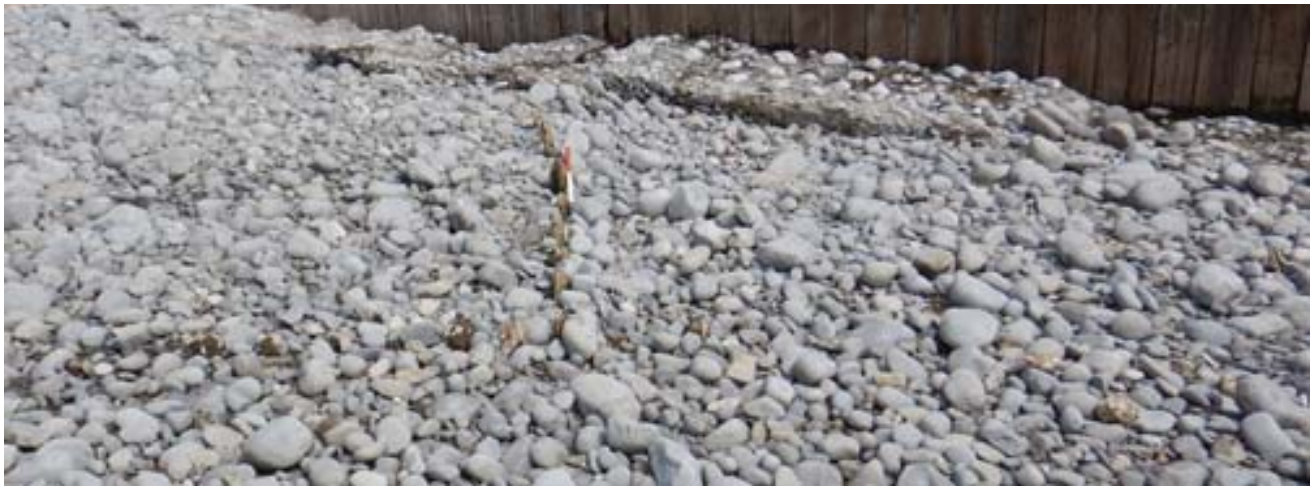
The remains of 6 wooden fish traps (PRN02483s), located on the western side of groyne 10 were previously recorded as part of the Thaw Valley Survey conducted by Glamorgan Gwent Archaeological Trust (Graves-Brown, 1997). This site was not definitely found, rather a T-shaped arrangement of 31 stakes in the correct location was apparent. Stakes 1-17 extend south-west at approximately 45 degrees from groyne 10. Stake number 1 is within the concrete of groyne 10. Stakes 18-31 the run at 90 degrees across the top of this line, forming the top of the T (Plate 2). Stake 31 has been knocked out of alignment and lies 1.5 metres from stake 30. The tallest visible stake is 0.23 metres above ground level but on average they are approximately only 0.1 metres and some are hardly visible (Plate 3). The stakes are on average 0.14 metres diameter but several are severely eroded and so smaller. The alignment of these stakes makes it unlikely that they belong to separate fish traps, but are instead one much larger feature.

Plate 2: View of the stakes that form (PRN02483s). The newly discovered stakes form the line running up through the centre of the photograph. Looking north-east.

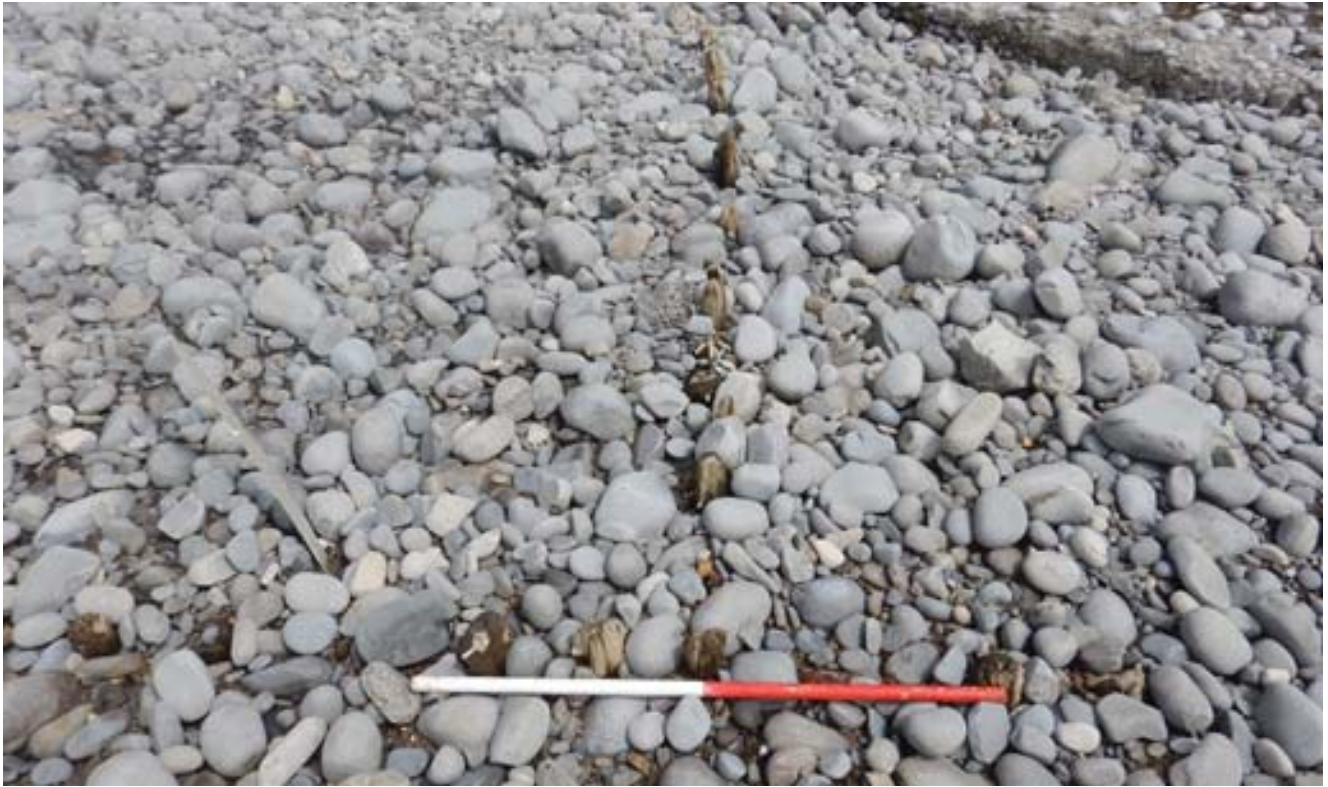
Plate 3: Detail of the newly discovered stakes, part of fish trap (PRN02483s). Looking north-east.

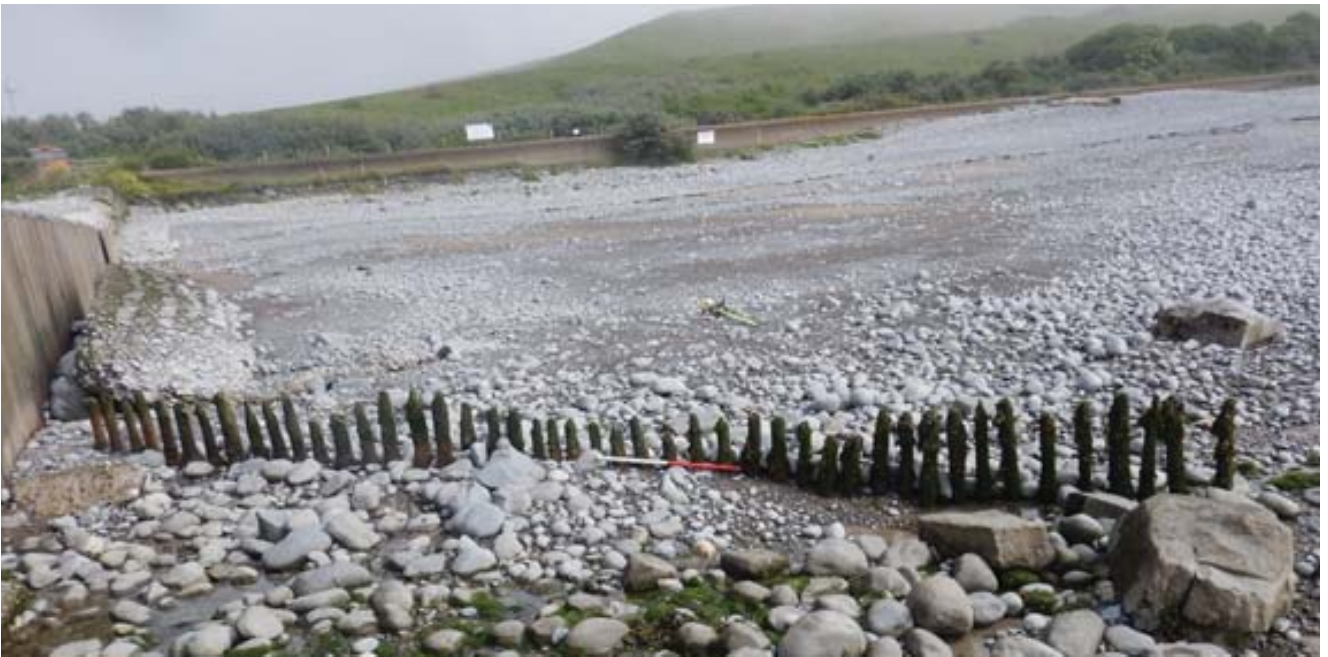
The remains of 29 post-medieval wooden stakes (PRN03984s) are located on the eastern side of groyne 10. This site had also altered since it was recorded in the 2005 coastline survey (Dunning and Howell, 2005). There are now 46 stakes visible that extend at 45 degrees to the south-east from groyne 10 (Plate 4). There is approximately 0.13-0.15 metres between each stake and the extant heights range from 0.6 – 0.2 metres. The stakes are more heavily eroded in the middle of the alignment than in 2005.

Plate 4: View of stake line (PRN03984s. Looking north-east.

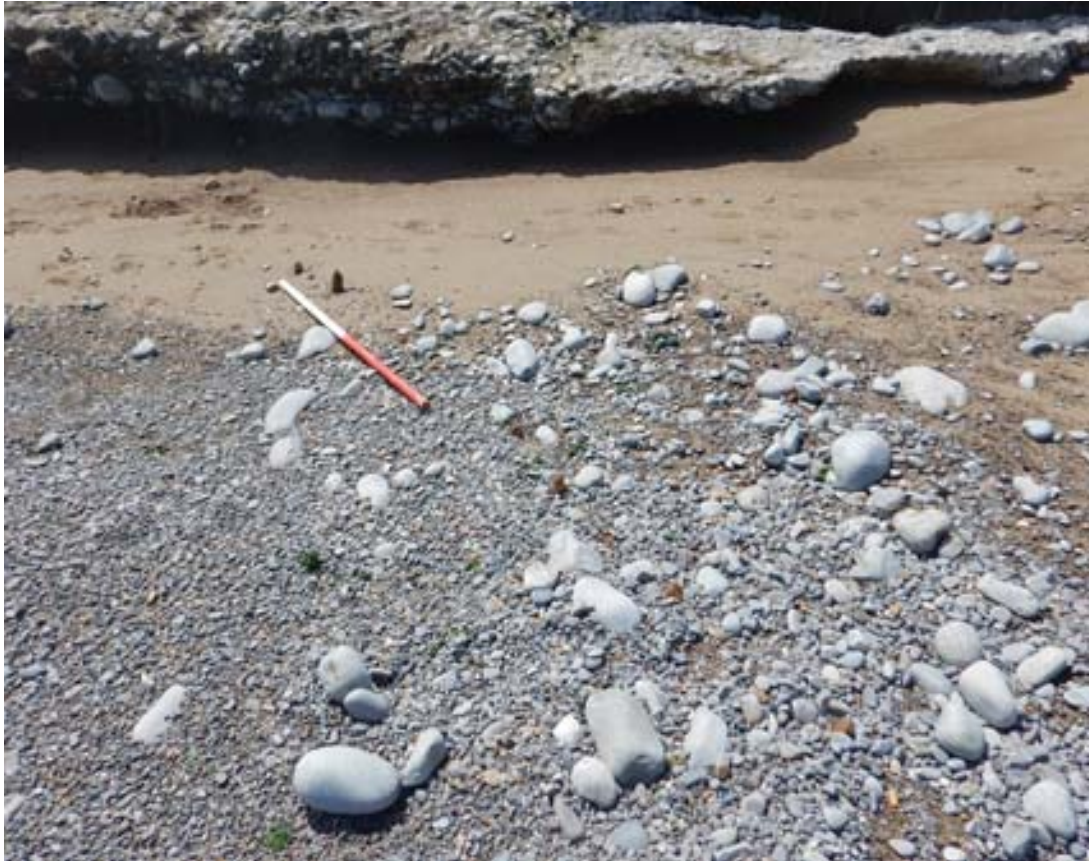
Just to the north of PRN03984s, on the eastern side of groyne 10, a further row of stakes was identified (NGR ST03143 65786). There were 20 stakes in total, in a linear alignment, that extended approximately 4.5 metres from the groyne on a north-west to south-east alignment (Plate 5). Five of the stakes were visible below the concrete of groyne 10, where the sand had eroded out from underneath it (Plate 6). The tallest stake stands to approximately 0.8 metres above ground level, although several have are likely to have eroded and are barely visible above the sand. On average the stakes are approximately 0.08 metres in diameter and there is on average 0.15 metres between each. The stakes appear to be connected to both PRN03948s and 02483s as they are on the same alignment and a similar diameter/spacing.

Plate 5: Newly identified line of stakes on the western side of groyne 10. View south-west.

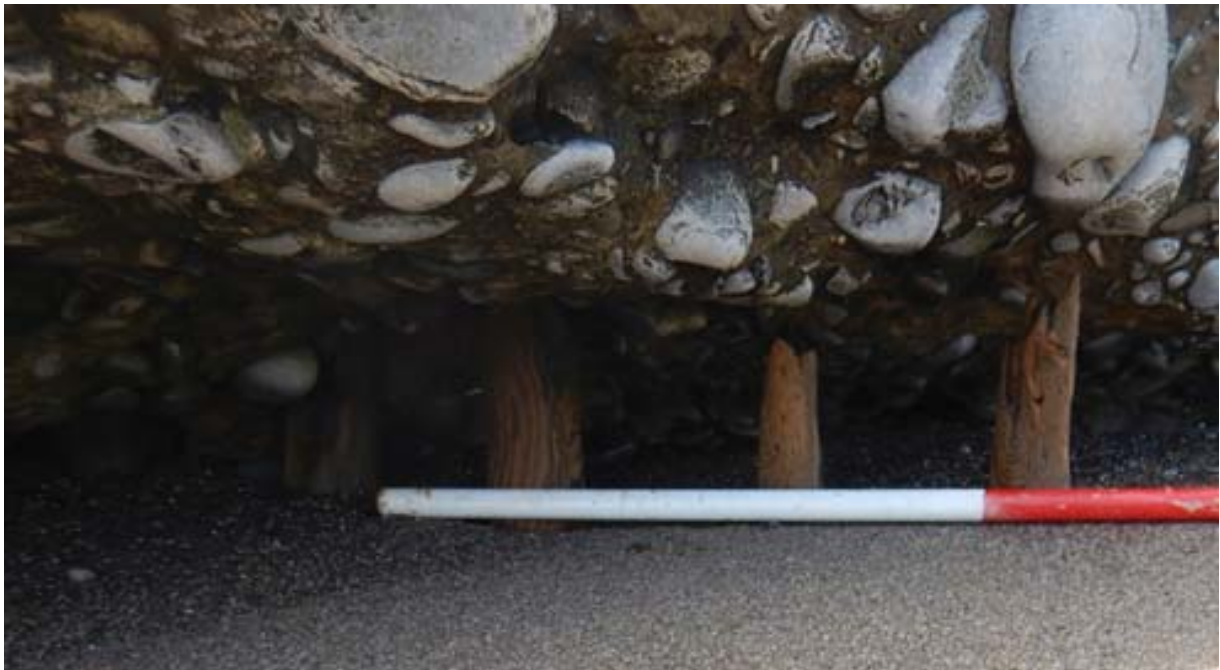
Plate 6: Stakes below groyne 10.

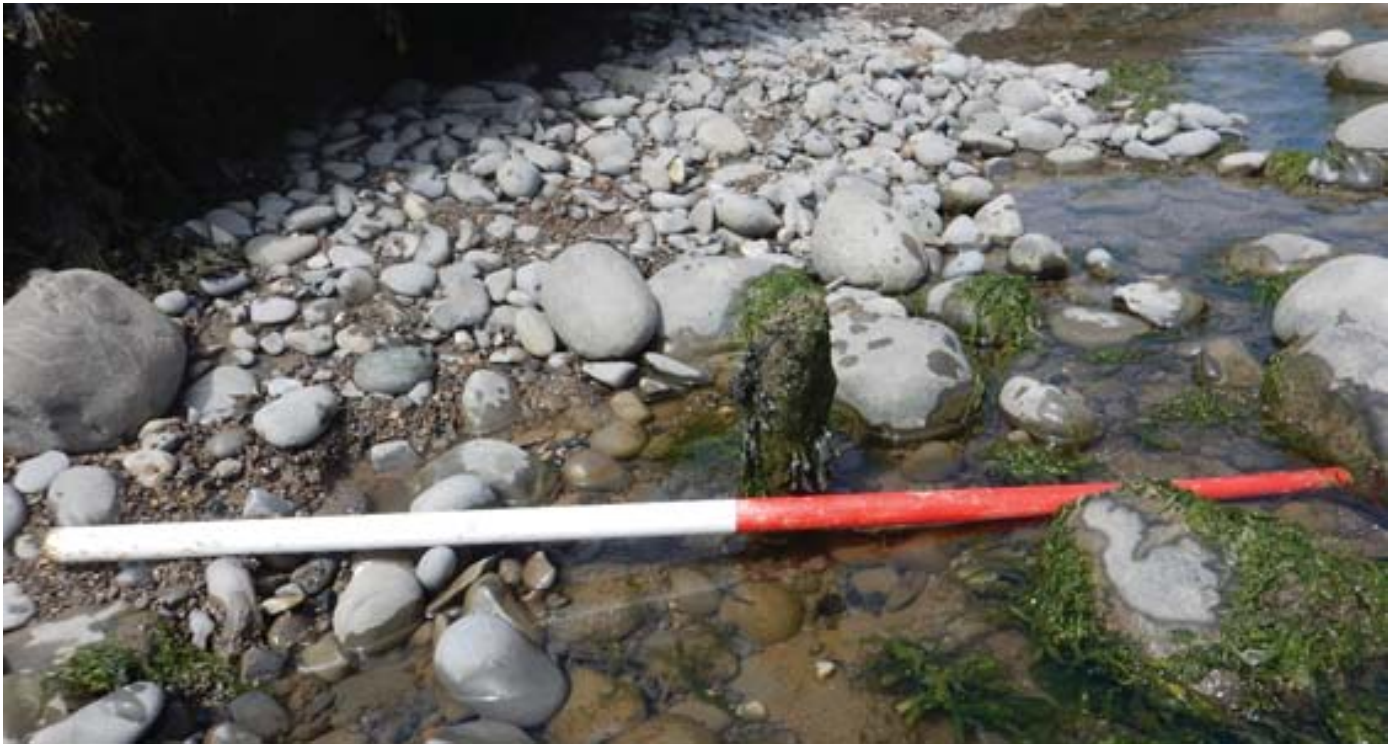
A single wooden stake was identified approximately 0.8 metres from groyne 9, towards the southern end of the groyne at NGR ST03087 65741 (Plate 7). It is 0.26 metres height and 0.08 metres in diameter. Its function is unknown and no others are evident nearby.

Plate 7: Singular stake identified west of groyne 9.

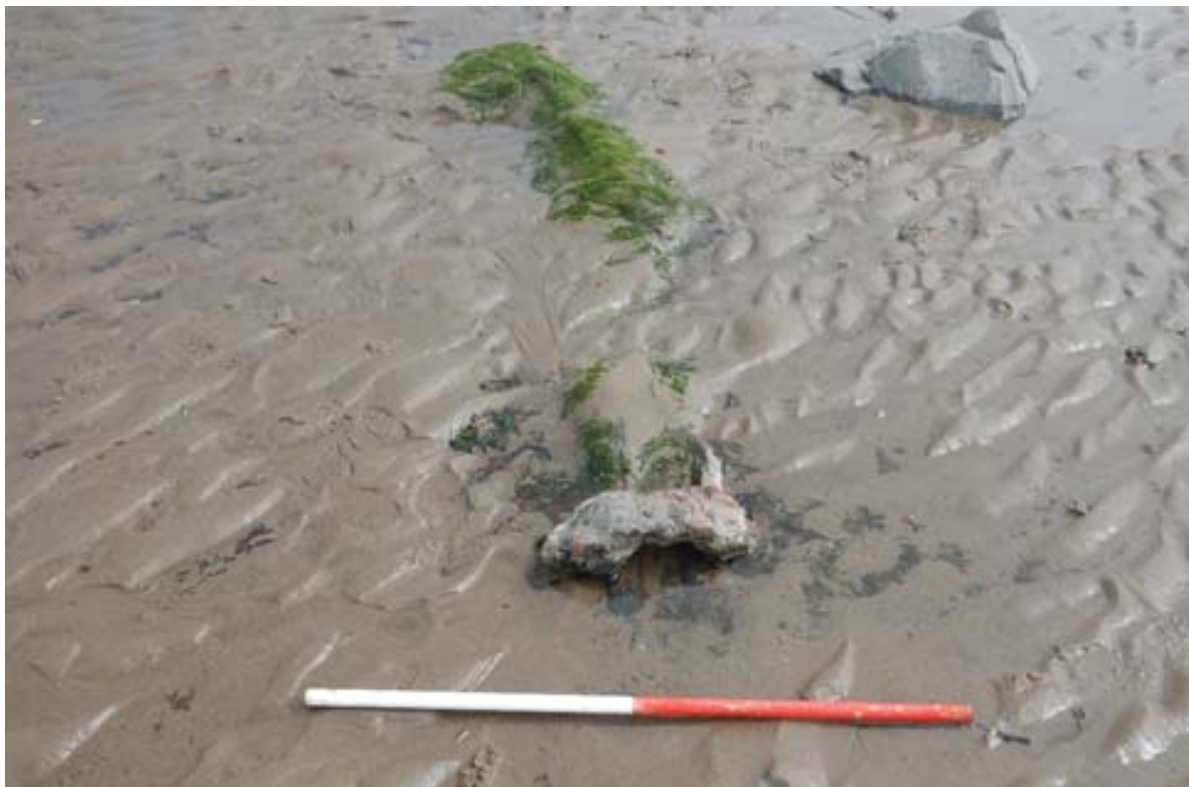
At the end of groyne 17 (NGR ST 03584 65803) an unknown feature was recorded. This is an east-west aligned linear wooden feature with a metal loop at the western end (Plate 8). The loop is embedded in the sand and it is unclear whether it is a fixed or separate feature. The wooden feature is 0.55 x 0.25m x 0.15 metres, while the observable dimensions of the metal loop are approximately 0.4 x 0.2 x 0.15 metres. It is possible this functioned as an anchorage point for small boats.

Plate 8: View of the anchorage point located at the end of groyne 17. View north.

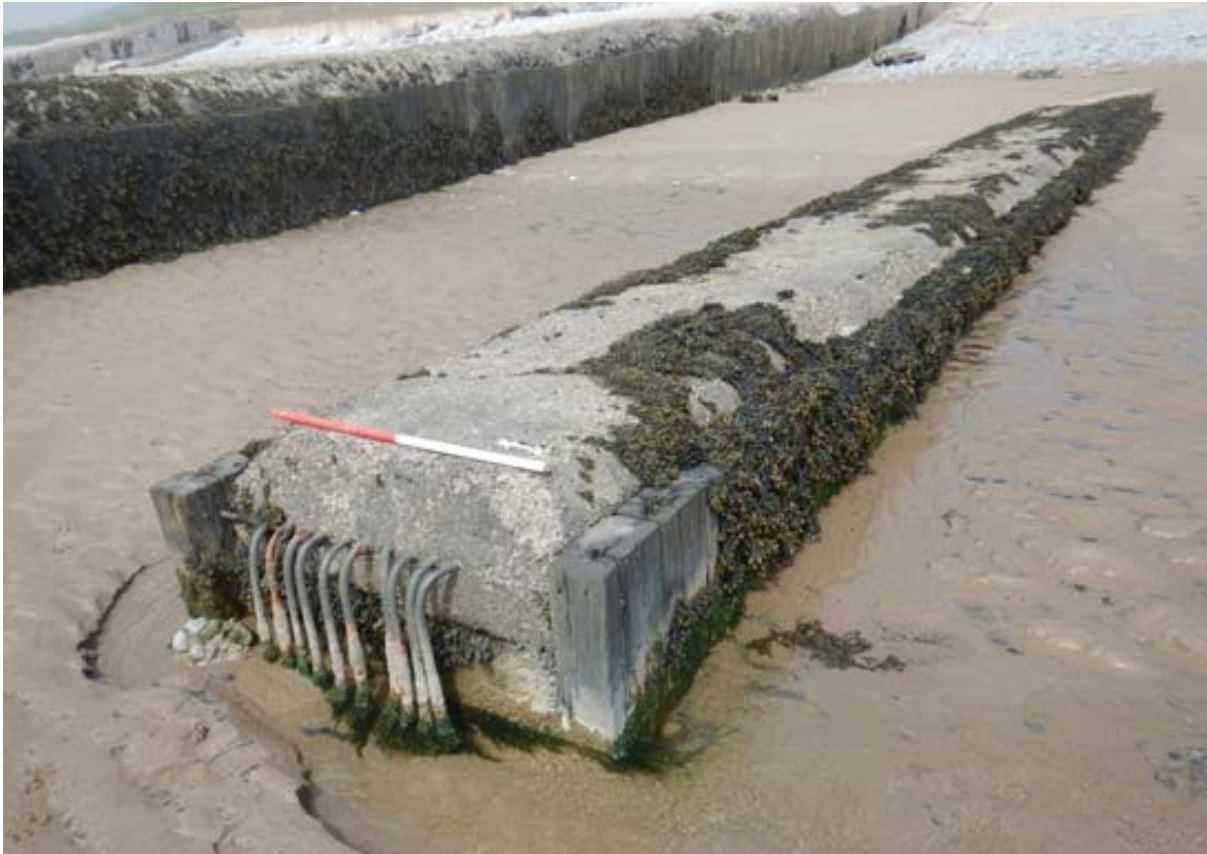
A lagoon exchange pipe was recorded between groynes 19 and 20 centred on NGR ST 03724 65861 (Plate 9). It appears to be contemporary with the construction of the groynes. It consists of a number of wooden sleepers, which run along the sides of the concrete which encases the pipe. The total visible length of the feature is 18.3m.

Plate 9: The lagoon exchange pipe alongside groyne 19. View north-west.

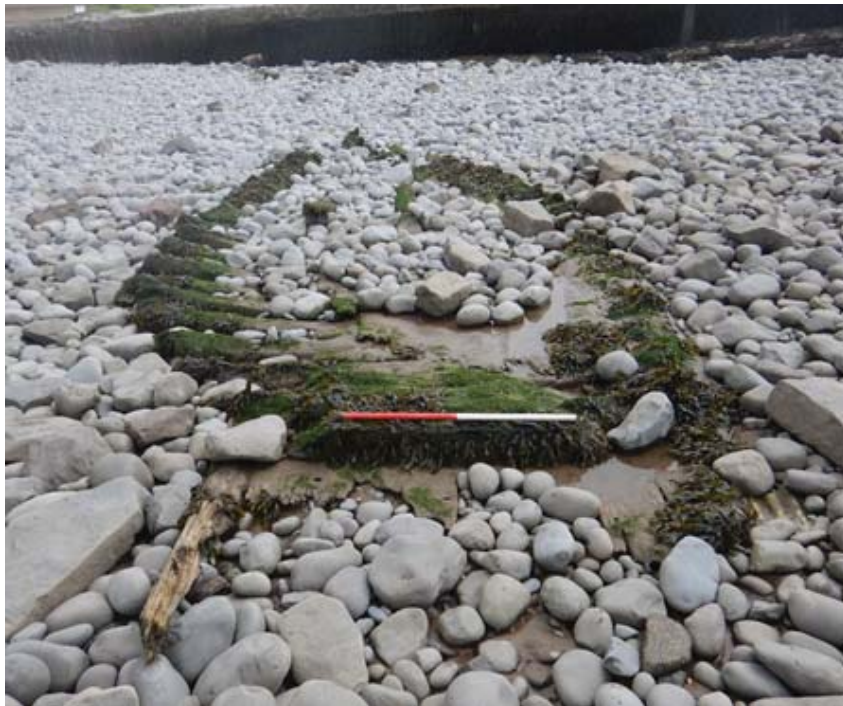
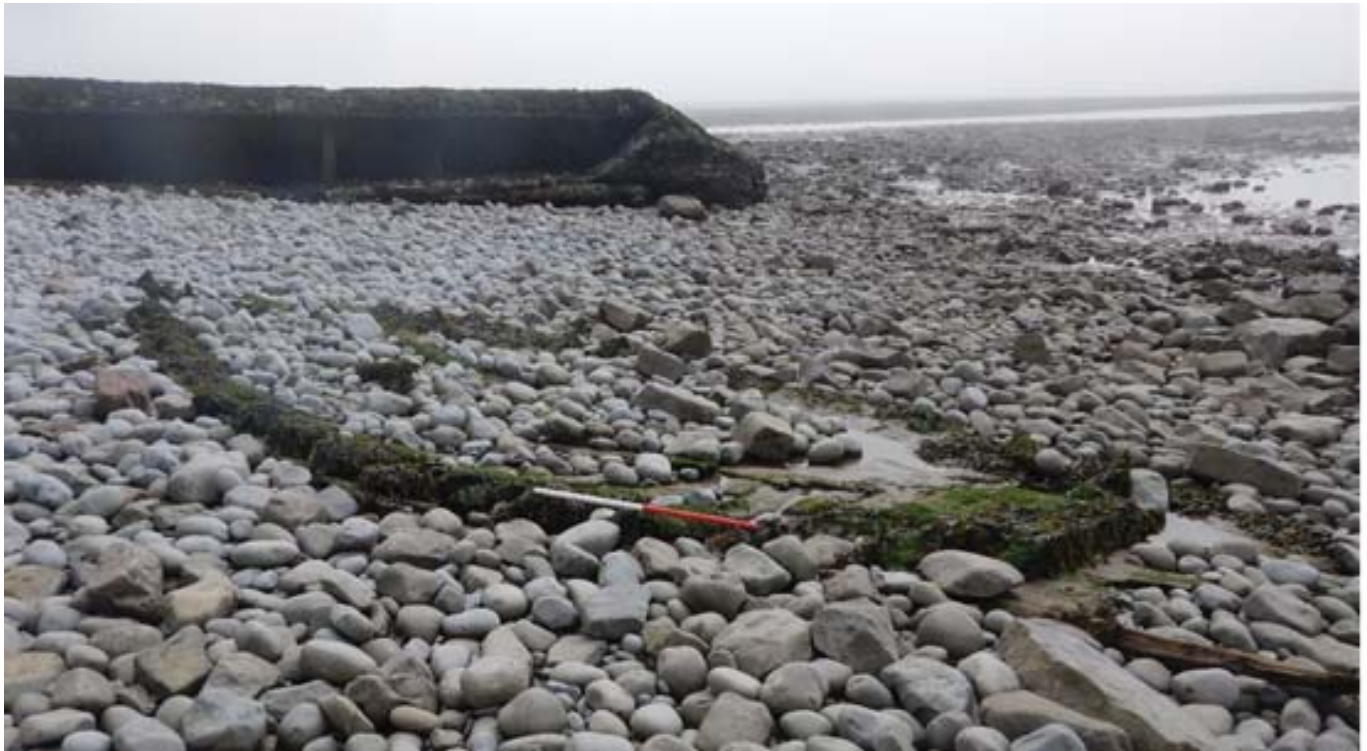
Lastly the remains of a small boat were recorded between groynes 12 and 13 centred on NGR ST 03300 65786 (Plates 10 and 11). The stern was missing but the remaining length from bow to beyond the beam of the boat measured 9.7 metres. There were 22 ribs remaining on the north (shore) side of the boat and the largest of these measured approximately 0.2 x 0.15 x 1.3 metres. The widest point of the boat was 3 metres. At the point at which the boat was broken it measured 2.1 metres in width. The boat is better preserved on the north side but is heavily covered with seaweed and beach pebbles. Some boards appear to be fallen to the sides, particularly on the north side. No metal fixtures were identified but these may have rusted out. The boat is likely to be modern in date and is part of a series of wrecks along this part of the coast line.

Plate 10: View of the remains of a small boat located between groynes 12 and 13. View east.

Plate 11: Remains of a small boat located between groynes 12 and 13. View south-east.
