# Capel Hermon, Llandrillo, Denbighshire: Photographic Survey

*EAS Client report 2019/01*

Llandrillo Calvinist Methodist Chapel was built in 1880, in the Lombardic/Italian style, to the design of architect Richard Owens of Liverpool. The chapel has two-storeys, stone walls and a slate roof. (<http://www.welshchapels.org/search/nprn/8447>)

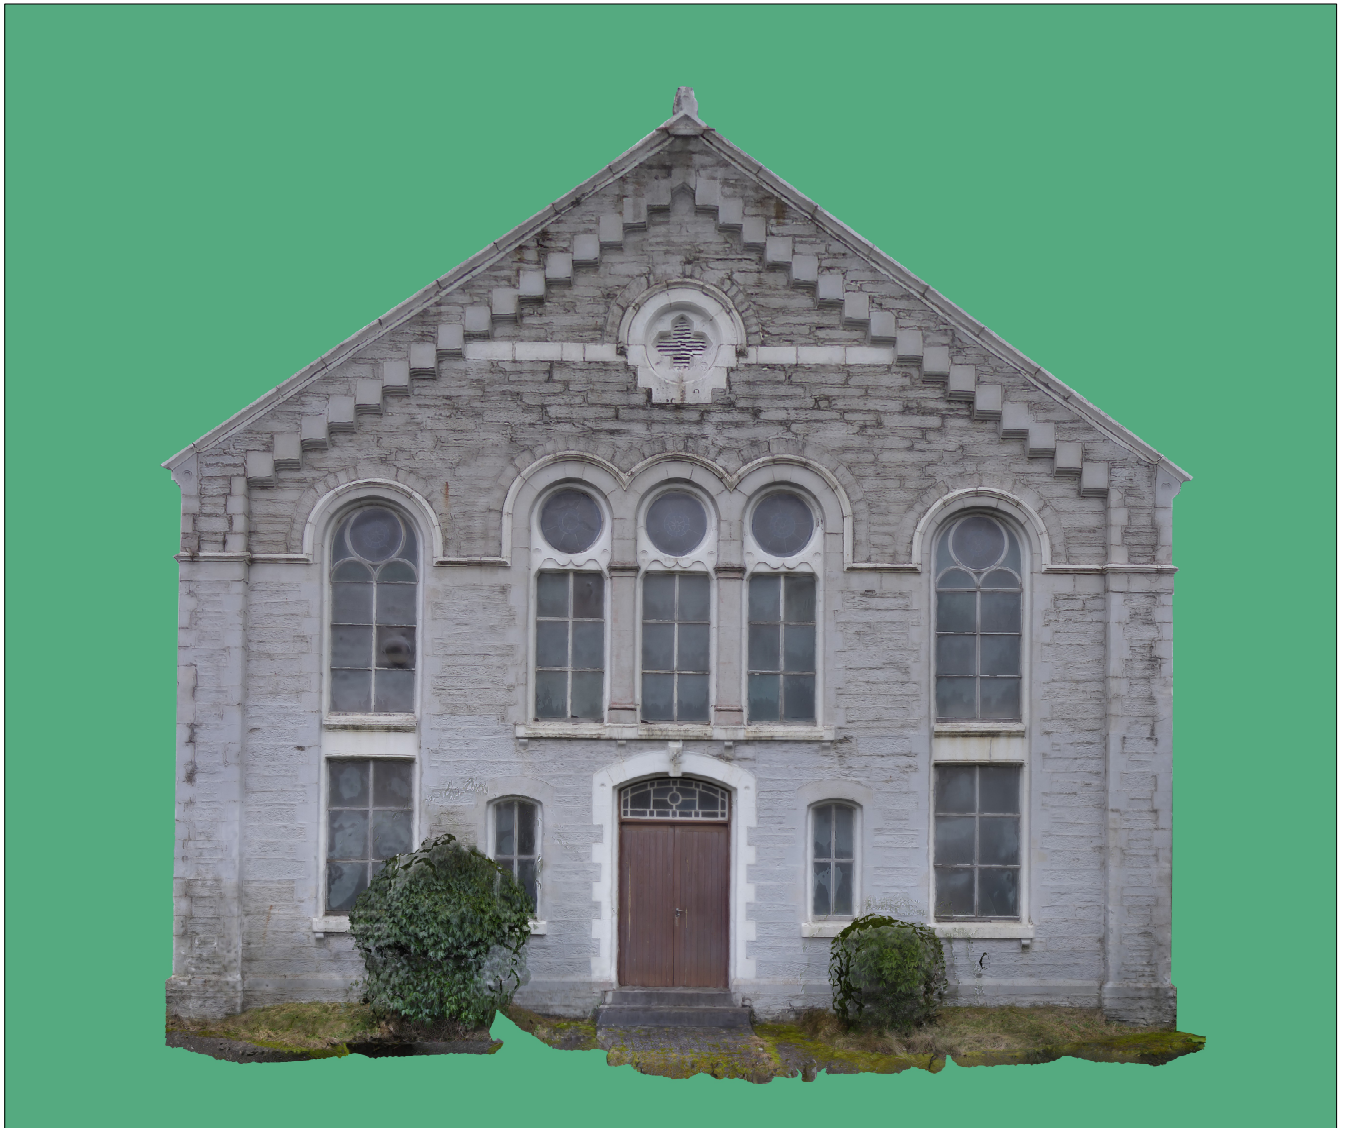
Figure 2: Photogrammetric Elevation  
Scale 1:100

The opportunity was also taken to take a series of overlapping digital photographs which were processed using Agisoft Photoscan to produce a three-dimensional model of the building from which the photogrammetric elevation (Figures 2) could be extracted.

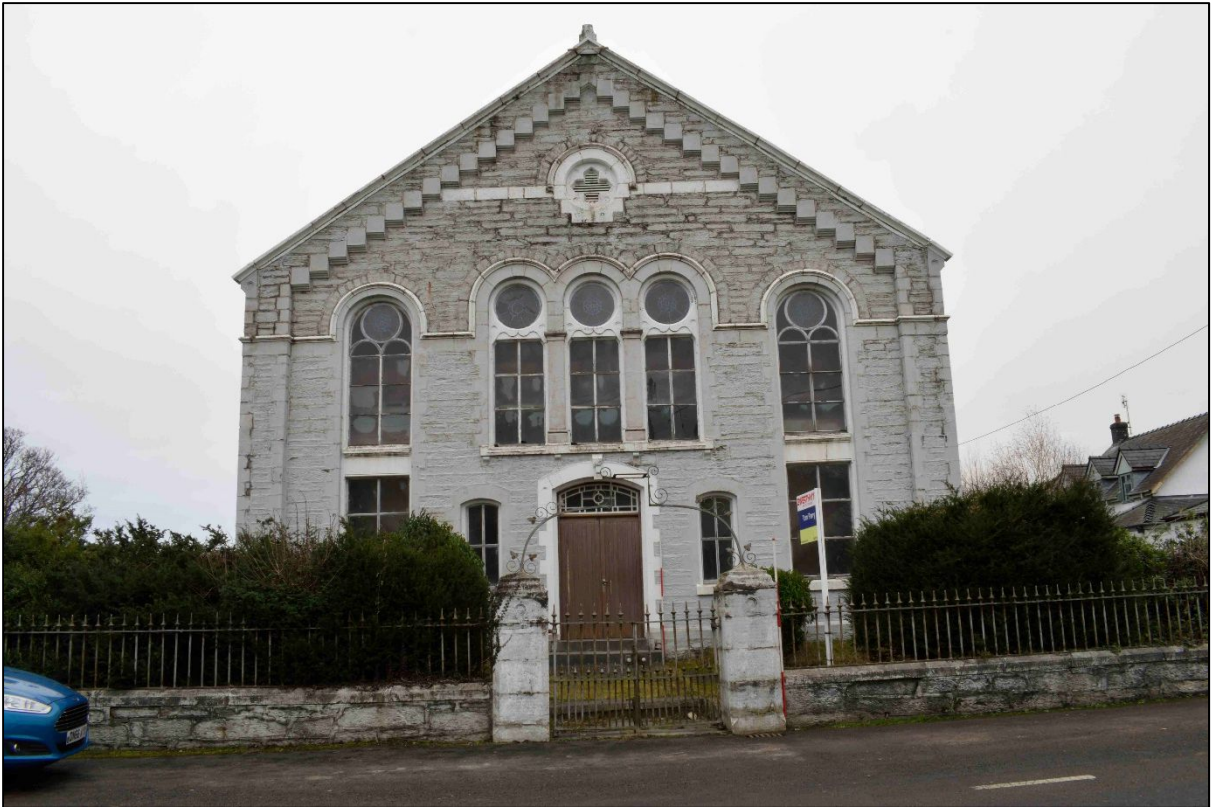
Plate 3: Front elevation

Capel Hermon is set slightly back from High Street, Llandrillo, Denbighshire towards the western side of the village (Plates 1 – 2). The enclosure containing the building is entered through a double gateway with a cast iron arch (Plates 3 and 7) and has its most developed façade facing the street. The chapel consists of a stone-built, two-storey range with a single storied range to the rear of the building containing the vestry and Sunday school (Plates 4 – 6). The front façade has a triple widow, held in blind arches and with circular windows within the arches, above the main door (Plate 8). Flanking this are double height widows with arched tops (Plate 9).

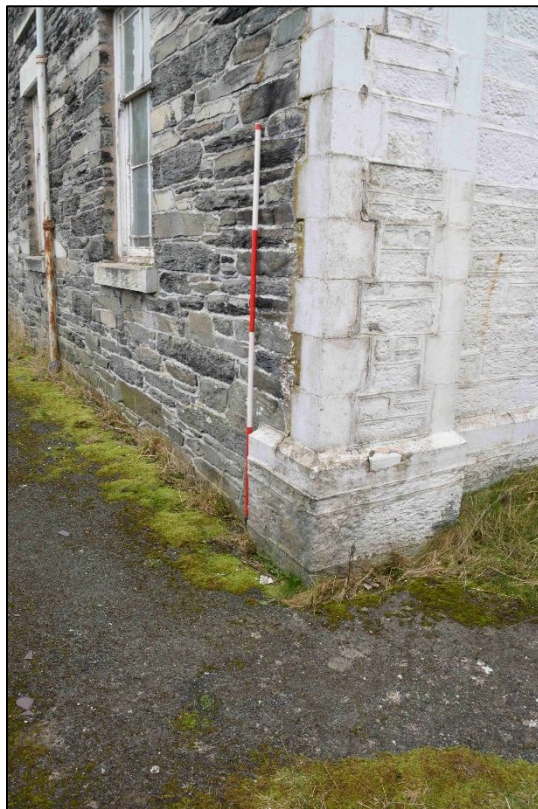
Plate 10: Location of the bench mark

The south western elevation (Plate 4) included a bench mark near to the south western corner of the building (Plates 10 and 11) and a fenced enclosure defining the steps down to the cellar door near to the north western corner (Plates 12 and 13). At the rear of the plot are two, brick-built toilet blocks (Plates 14 and 15) which are clearly later than the chapel itself and are from different phases of construction.

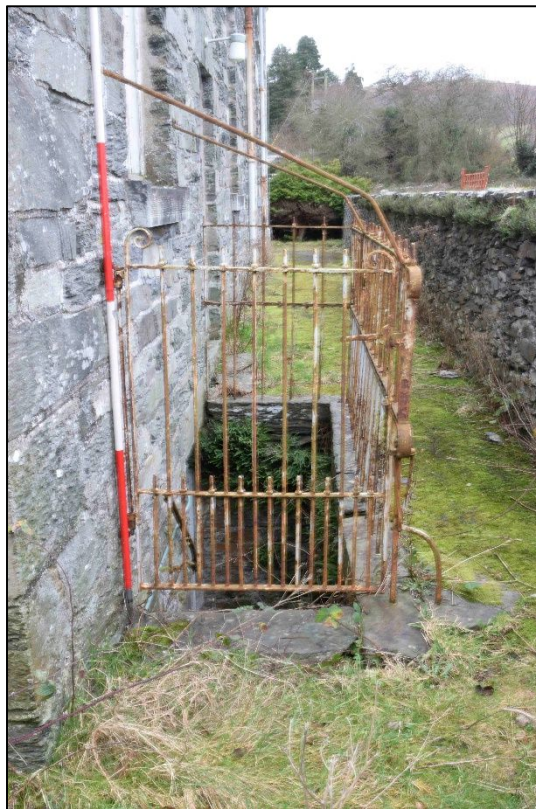
Plate 12: Enclosure around the access to the cellar

The cellar (Plates 61 and 62) are access from the outside, down a short flight of steps within a fenced enclosure (Plates 12 and 13). The cellar has a brick floor and contains the heating boiler, although this is clearly a modern boiler, presumably replacing an earlier coal fired boiler. There is also a brick patch in the south eastern corner of the cellar suggesting there may have been a vent leading to the chapel itself (Plate 63).

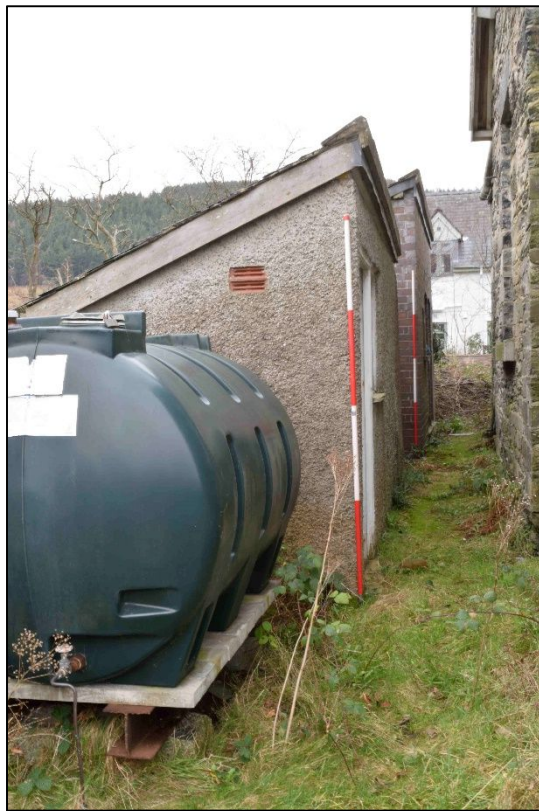
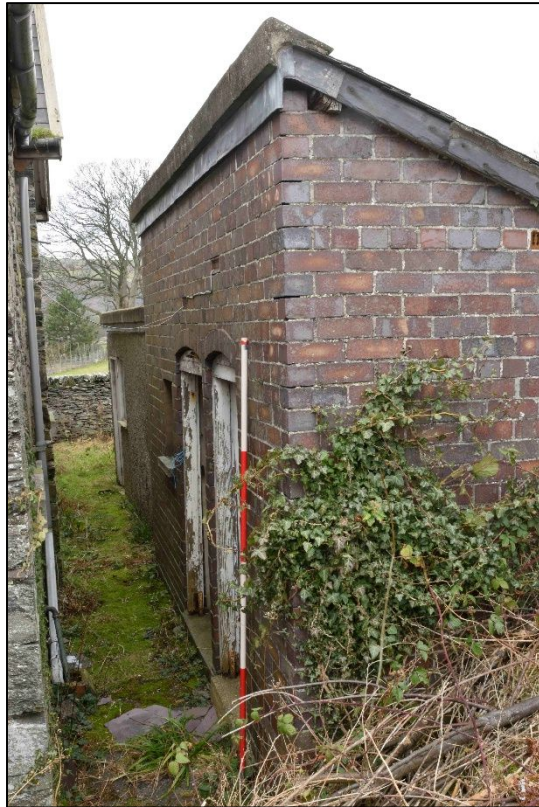
Plate 14: Toilet blocks looking south east

Plate 15: Toilet blocks looking north west

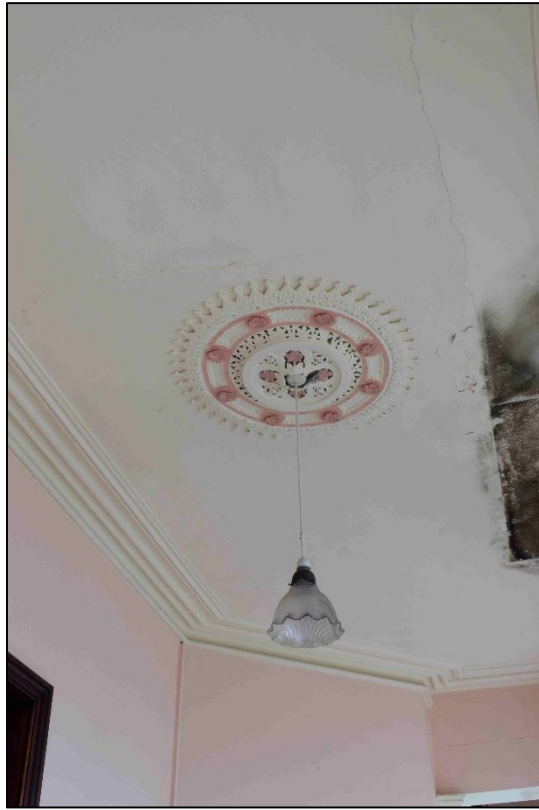
Plate 19: Ceiling rose in the lobby

The main entrance to the chapel is through the double doors in the front elevation, this gives access to a lobby (Plates 16 – 18) which, in turn, gives access to the two doors to the nave and two stair cases leading to the gallery. The lobby has a patterned tile floor, a decorative ceiling rose (Plate 19) and contains a stained-glass window between the lobby and the nave of the chapel (Plate 16). For this window to give light to the main body of the chapel the front doors would have had to be left open. On either side of the lobby are stair cases leading to the balcony or gallery of the chapel, which are partly defined by moulded plaster consoles (Plate 20). They also have carved handrails with spiral terminals (Plate 21).

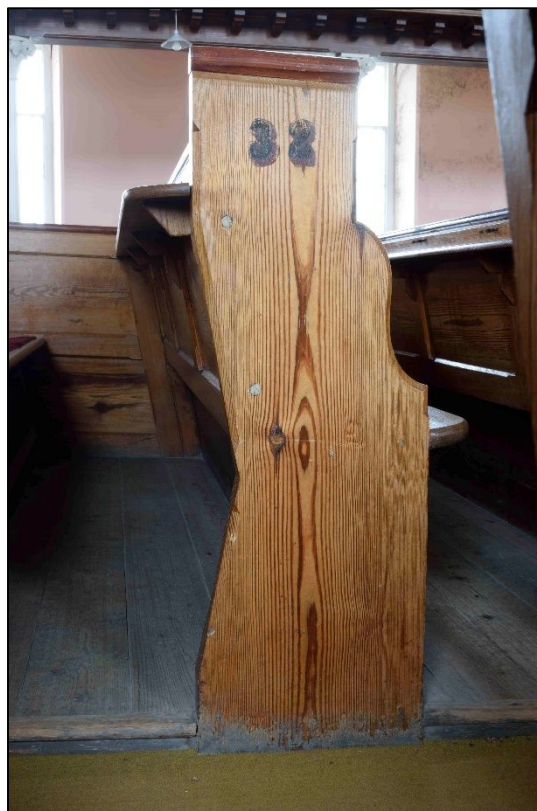
Plate 24: Detail of pew end

The main body of the chapel consists of two storied space with a gallery running along three sides of the nave. The north eastern end of the space contains the organ and pulpit (Plate 22) which are contained within a sanctuary defined by a wooden rail (Plate 26). The main body of the nave (Plate 23) contains a series of pews each of which has a carved end on which is

printed a “row number” (Plate 24). Also, within this space are a series of cast iron pillars with acanthus decorated capitals which supports the gallery above (Plate 25).

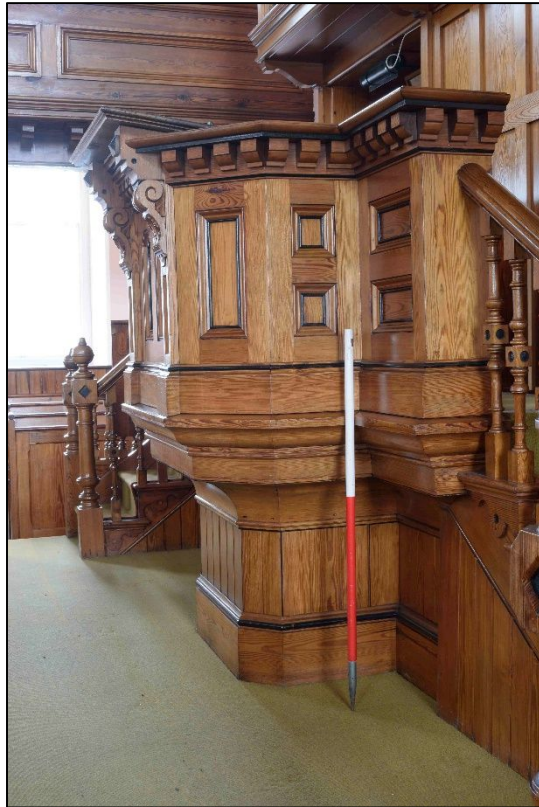
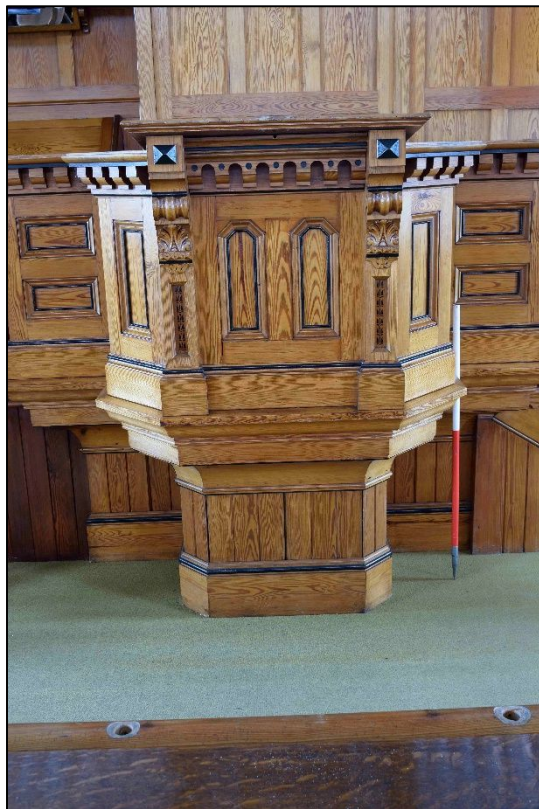
The sanctuary contains the pulpit (Plates 28 and 28) in the Arts and Crafts style which is accessed by means of a short stair case (Plate 29) on the southern side of sanctuary. The “organ loft” is accessed by a similar set of steps (Plate 30) on the other side of the sanctuary, however, the space is very limited such that there is no space for a seat in the organ loft which must have been played whilst standing. Outside the sanctuary is an upright piano (Plate 31).

Plate 27: Pulpit looking north west

Plate 28: Pulpit looking north west

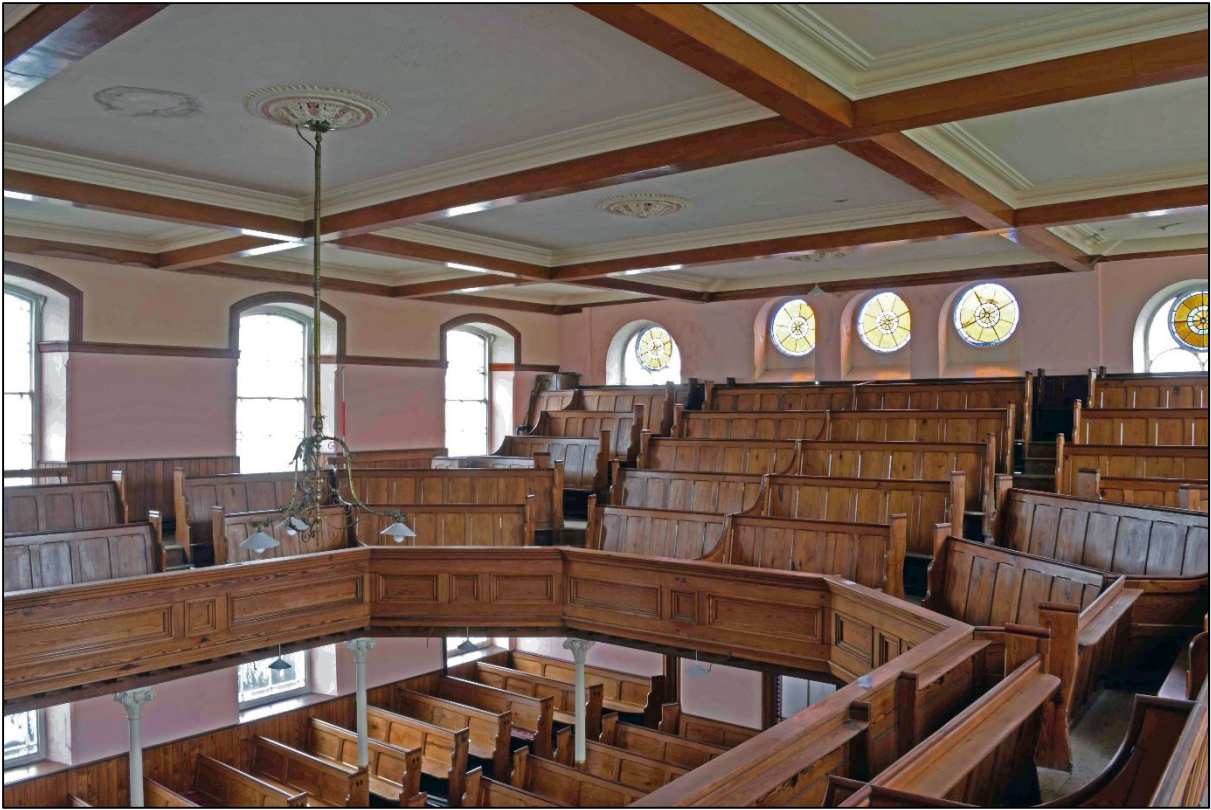
Plate 33: Gallery, looking south

The gallery (Plate 32) has two rows of pews on either side of the chapel and four rows across the south western gable end (Plate 33) all of which are raked so that all of the congregation could see the pulpit. Lighting the south western gable are three circular windows (Plate 34) which contain glass stained yellow and blue. There is a surviving four light chandelier which springs from a plaster rose decoration in the ceiling (Plate 37). This is one of four ceiling roses which are within a coffered ceiling design (Plate 36). Access to the gallery is through one of two doors placed at either end of the south western gable (Plates 38 and 39). A small hatch in the south eastern corner of the chapel gives access to the roof space (Plate 40). Each of the trusses have three posts braced by raking struts.

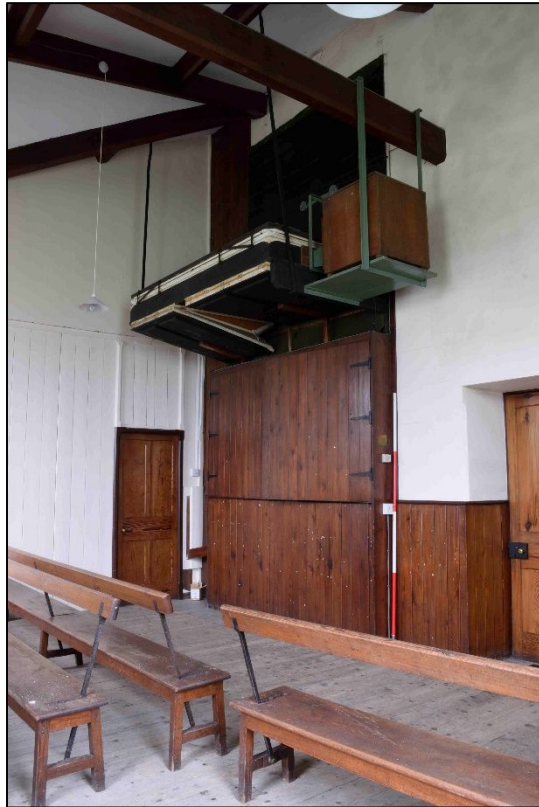
Plate 45: Organ mechanism

The single storied space behind the sanctuary contains two room, a slightly larger room to the north, is assumed to be the Sunday School and a smaller room, to the south, which is assumed to have been the Vestry. These two rooms are separated by a simple wooden partition. The Sunday School (Plates 41 and 42) contains a series of wooden benches with backs which can be moved so that the direction of the seating can be changed. In the north western corner of the room is an internal “porch” which gives access to the back door of the chapel (Plate 43). Immediately adjacent to this “porch” is a coat rack (Plate 44), which also continues onto the back of the “porch”. The back of the organ dominates the south western corner of the room (Plate 45) with what is assumed to be a later electric bellows above. The original pump handle for the organ extends through the wall between the Sunday School and the Vestry (Plates 46 and 47). There is also a brass plaque on the side of the organ case (Plate 48) which reads:

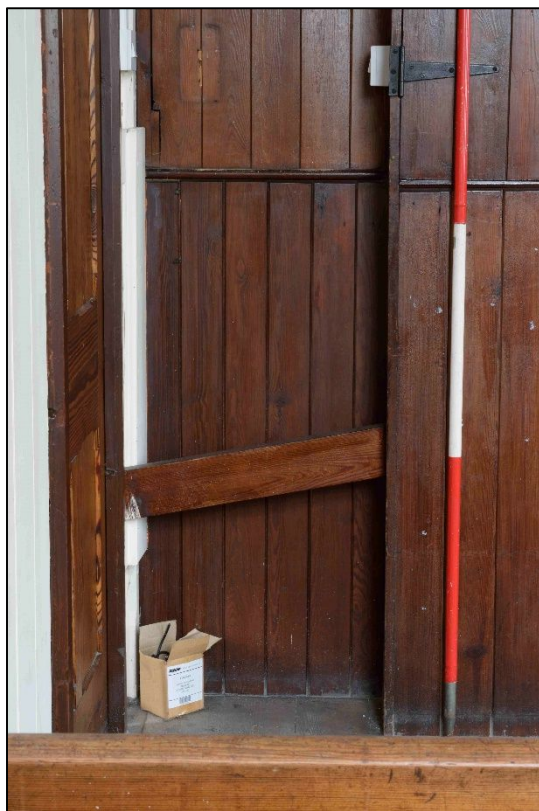
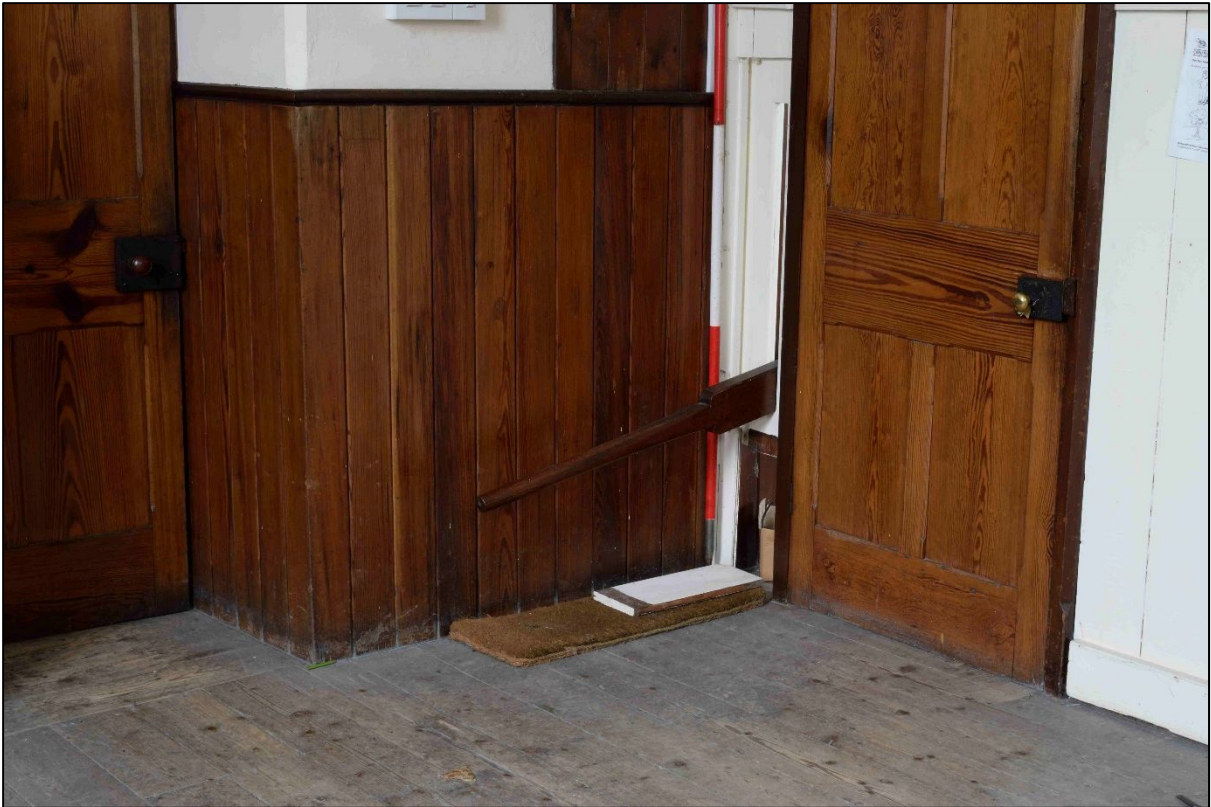
Plate 46: Organ pump handle in the Sunday School Room

Plate 47: Organ pump handle in the vestry

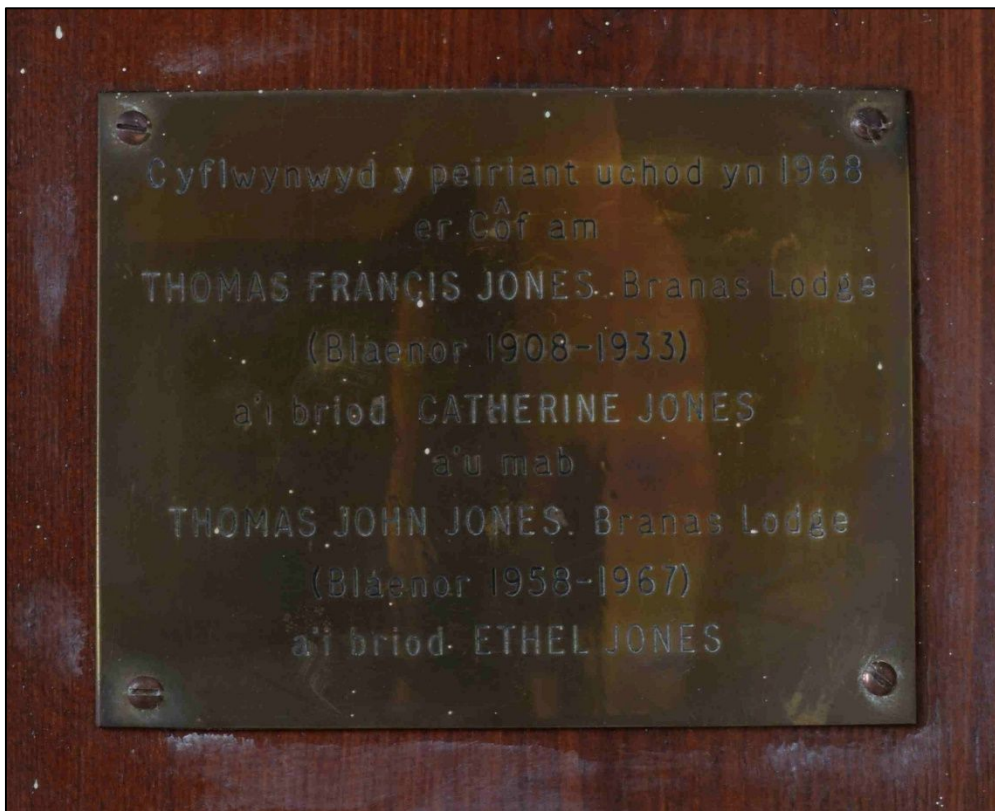
Plate 48: Brass plaque on the side of the organ

Cyflwynwyd y peiriant uchod yn 1968  
er Cōf am  
THOMAS FRANCIS JONES. Branas Lodge  
(blaeor 1908 – 1933)  
a’i briod CATHERINE JONES  
a’u mab  
THOMAS JOHN JONES. Branas Lodge  
(blaenor 1958 – 1967)  
a’l briod Ethel Jones

This would suggest that the organ was converted from a hand pumped instrument to an electrically blown instrument as late as 1968. There is also a cast iron fireplace on the north eastern wall. In the corner of the room a fragment of a previous decorative scheme is exposed (Plate 50). This is similar to that exposed in the vestry (Plate 55) which has a frieze of stencilled floral pattern. In the doorway between the Sunday School and the nave is a cast iron plate (Plate 51) of unknown function.

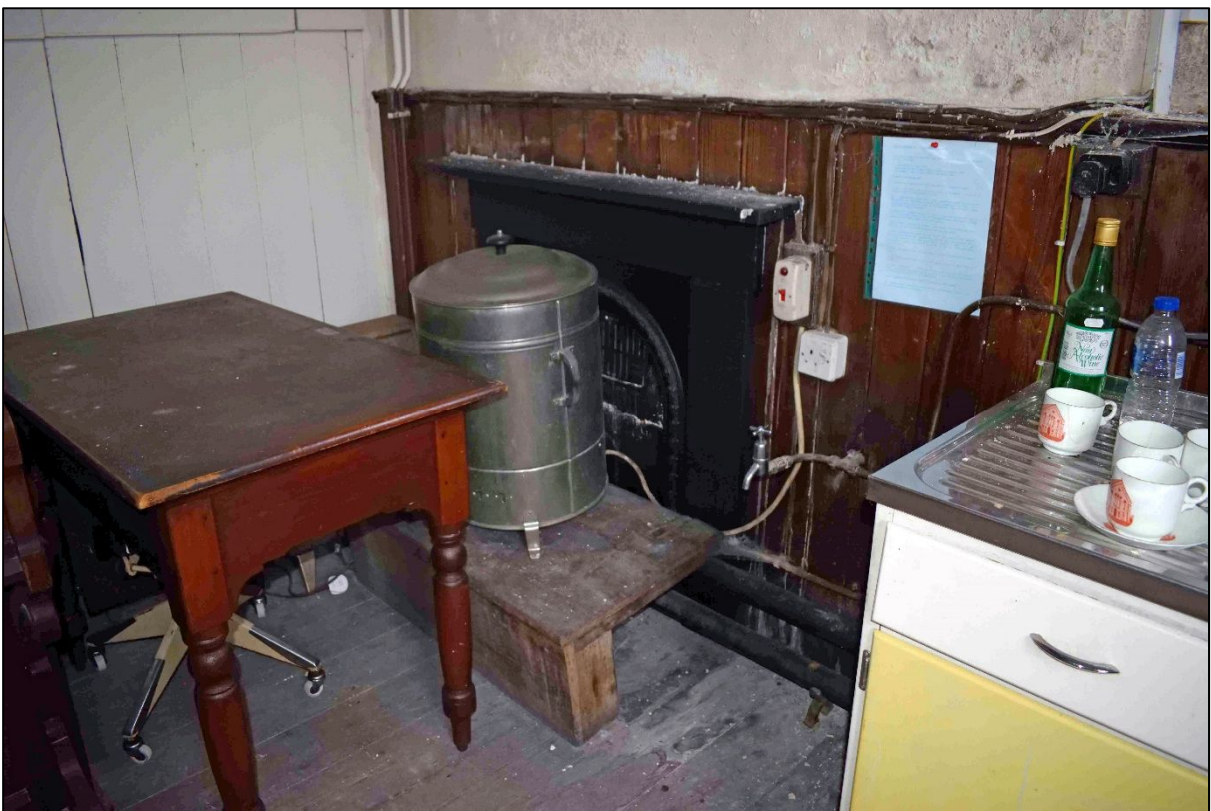
Plate 54: Fireplace in the vestry

The Vestry (Plates 52 – 53) also has a cast iron fireplace in its north eastern corner (Plate 54) and it contains a small pump organ (Plate 56). Also, within the Vestry and a series of ceramic items all of which have a transfer print of the chapel. This is assumed to be part of a dinner service as a dish lid, dinner plate, side plate and cup (Plates 57 – 60) were recorded. It is likely that these were made as part of a commemoration within the chapel.

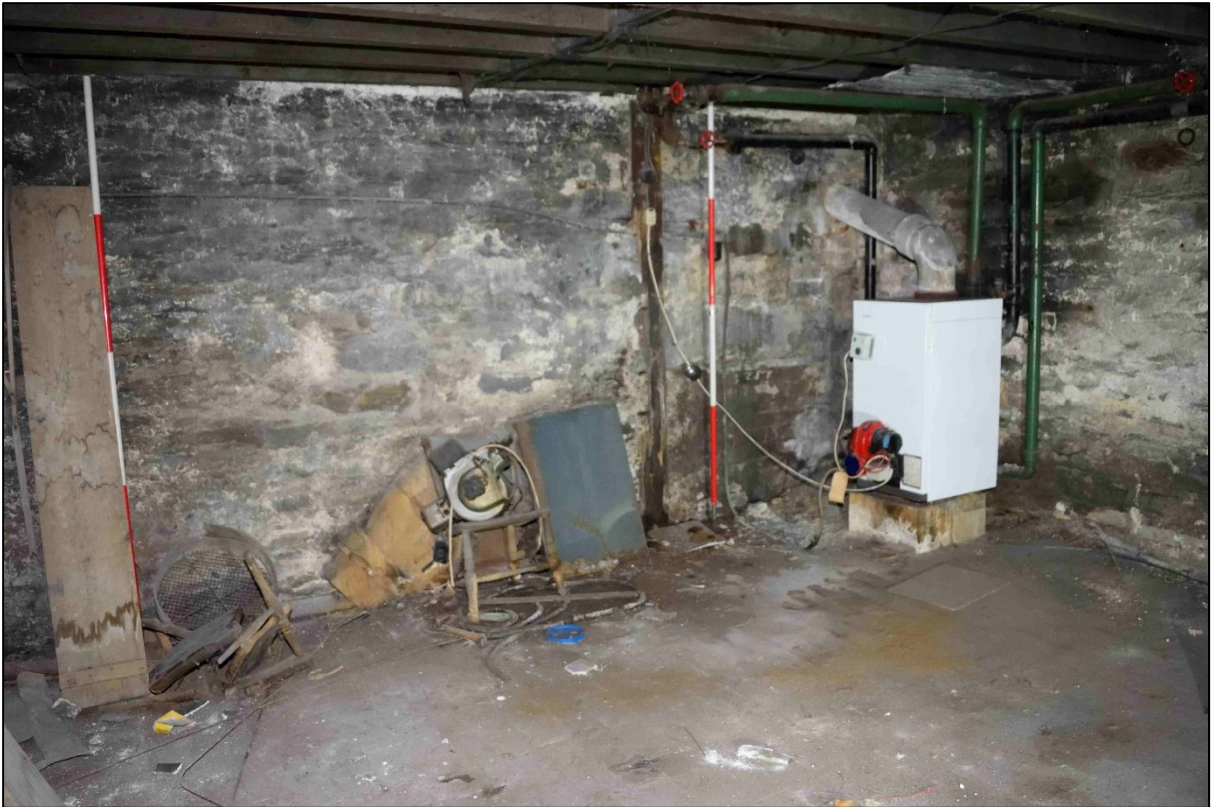
Plate 61: Cellar, looking east

Plate 62: Cellar looking north west
