CPAT Report No. 1664

Clydach County Primary School, Abergavenny

Building Survey

Client name: Glyn Smith Architect
 CPAT Project No: 2382
 Project Name: Clydach County Primary School, Abergavenny
 Grid Reference: SO 2255 1293
 County/LPA: Monmouthshire/ Brecon Beacons National Park
 Planning Application: 16/13499/FUL
 CPAT Report No: 1664
 Report status: Final
 Confidential until: N/A

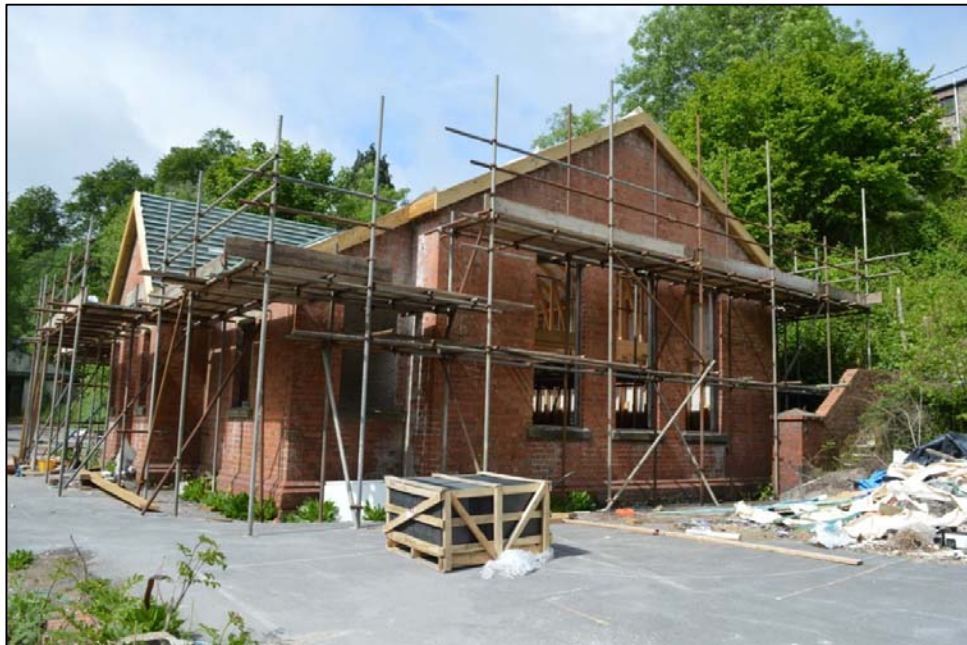
Cover Photo. The former infant school at Clydach viewed from the north-east.

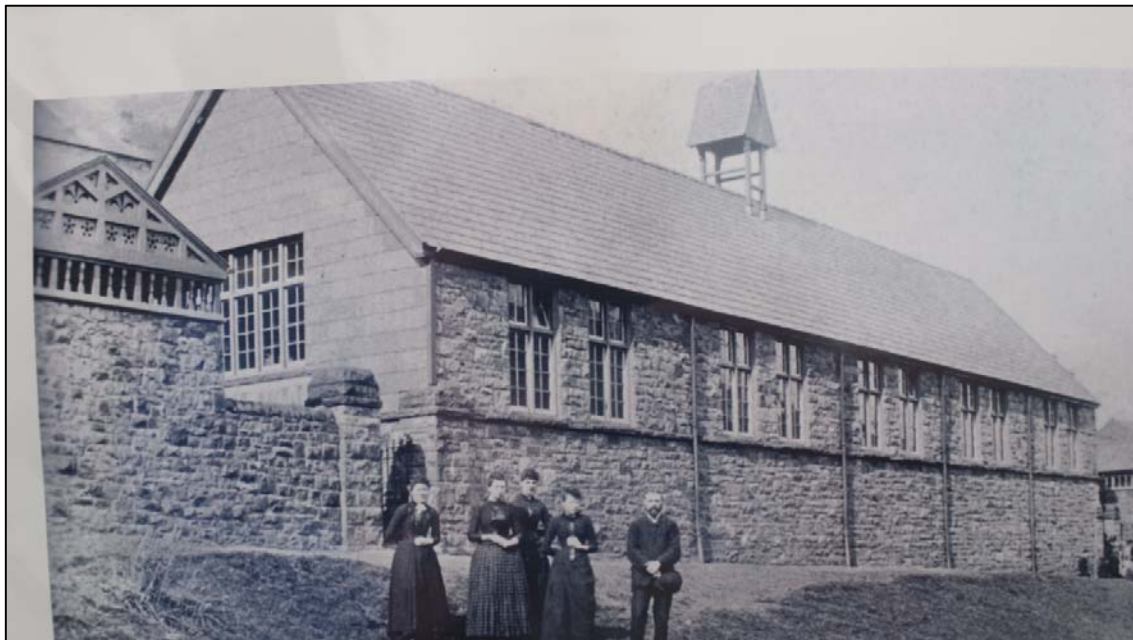
Fig. 5 The south-east elevation of the primary school building photographed during the late 19th century

-
- 4.2. It is unclear where the external main entrance was originally as there was a porch and entranceway on the south-west elevation in 1897 (Fig. 6) but no porch in an earlier image (Fig. 5). The internal doorways between the three rooms were offset, although there is no indication that they ran through a separate corridor.

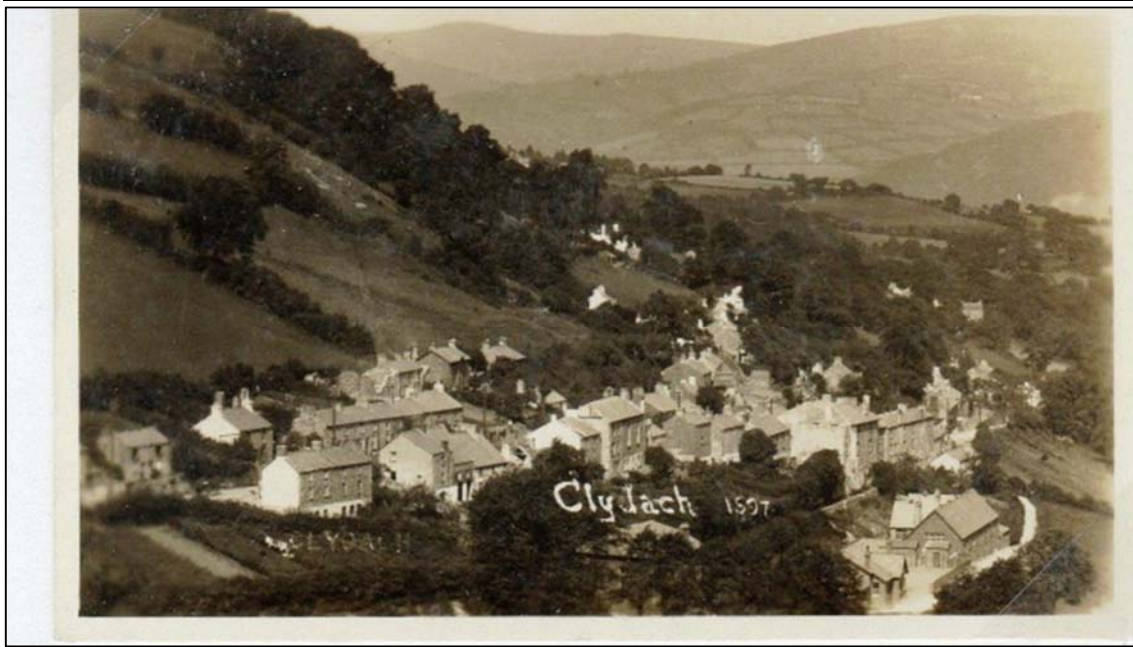
Fig. 6 Clydach North viewed from the south-east in 1897 (the primary school and infant school are visible in the bottom right hand corner)

- 2.5. The main school building at Clydach (then referred to as Cheltenham) is first recorded on the Ordnance Survey Map of 1880 (Fig. 2) It is unclear exactly when it was constructed but it may have been as a result of the Elementary Education Act of 1870. The infant school to the south-east is not recorded on mapping until the Ordnance Survey Map of 1920 (Fig. 4). However, it is visible in a photograph of Clydach dated 1897 (Fig. 6).

- 4.3. Photographic evidence indicates that the infant school building had already been constructed by 1897 (Fig. 6). The building was not recorded on the 1904 Ordnance Survey Map (Fig. 3). Most of the original fixtures and fittings had been removed, including the windows and roof frame. There was no evidence that the original designed layout of the building had been altered since it was constructed.

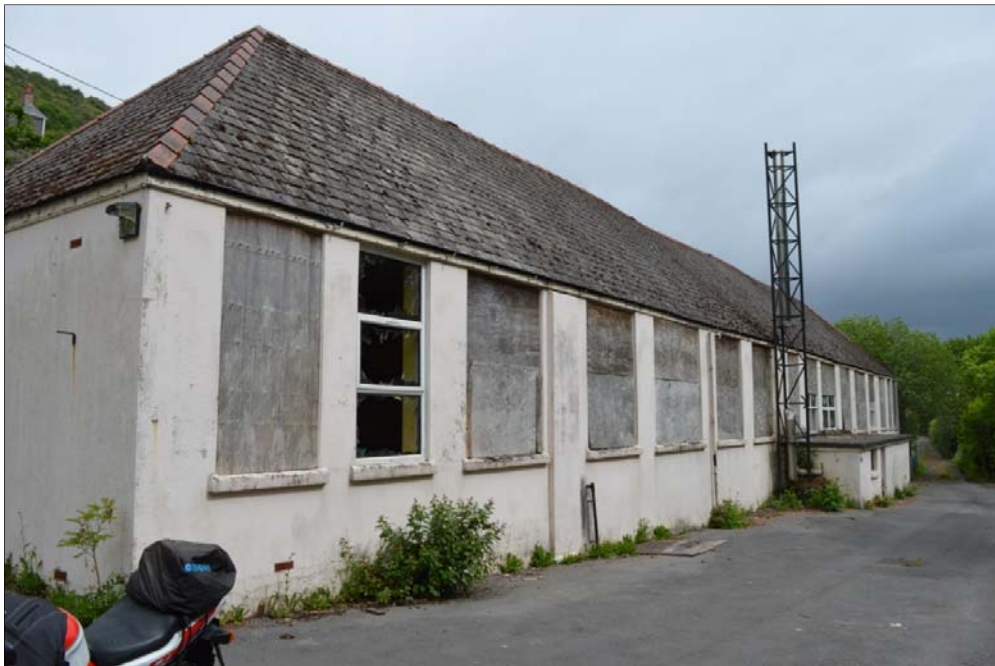
- 3.3. The former primary school building (Fig. 18) was located at the north-east extent of the school grounds. It comprised a single storey block constructed from rendered stone with brick edging, and a steeply pitched hipped slate roof. It comprised a large central hall or gymnasium, with two classrooms at either end. There were large window apertures on the south-east elevation fitted with UPVC windows. Windows on the north-west elevation were metal framed. A dormer skylight and ventilator ran along the central section of the north-west roof section.

Fig. 8 The main Primary School building (Building 1), viewed from the south-east. Photo CPAT 4650-005

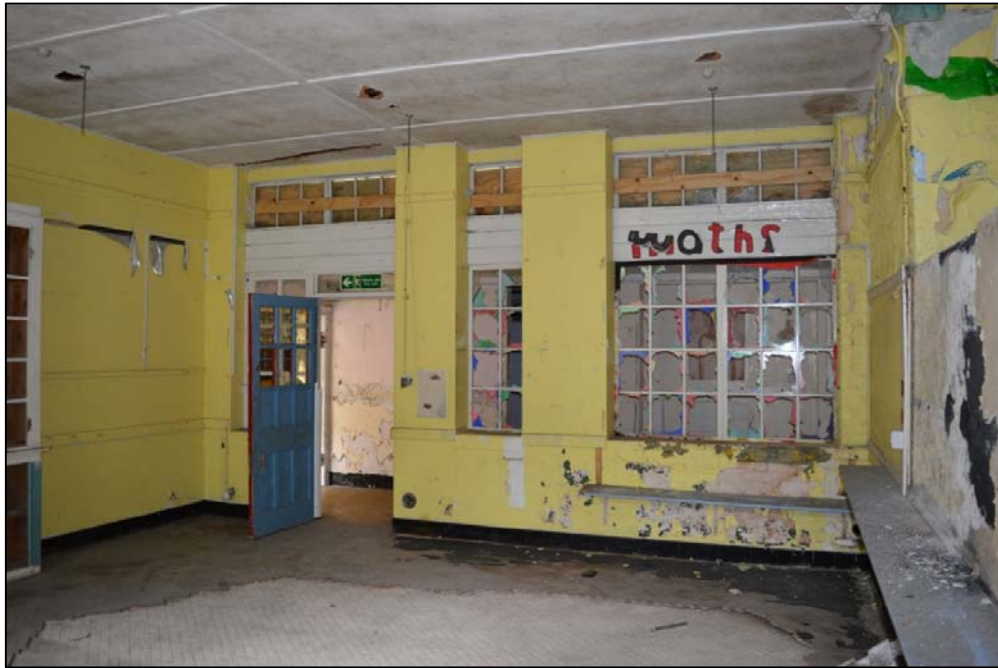
Fig. 9 Interior of Classroom 1. Photo CPAT 4650-016

- 3.5. The central block of the building, consisting of the main hall and classrooms 2 and 3 was noted to have been constructed in an earlier phase than the outer two classrooms (1 and 4). The roof structure in both classrooms 1 and 4 was obscured by a suspended ceiling but there was no trace of the long ends of the roof beams visible in either room, as there was in the central 3 rooms.
- 3.6. A large blocked aperture in the wall separating Classroom 1 and 2 was the location of a window in the south-west elevation of the earlier school building. A similar blocked aperture was located in the wall between classrooms 3 and 4, for a window on the north-east elevation.

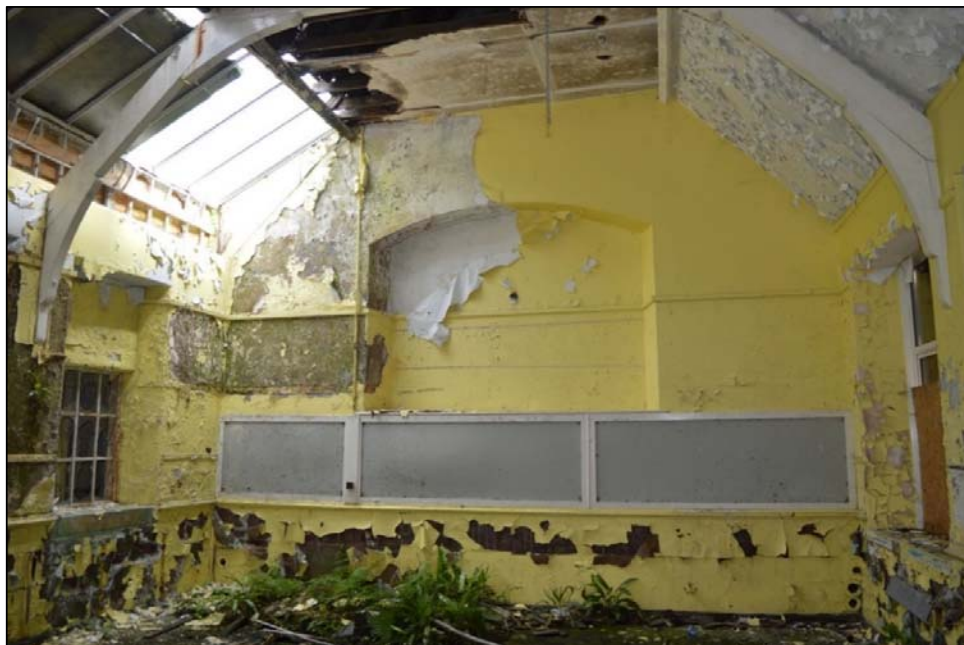
Fig. 10 Blocked window aperture between Classroom 3 and Classroom 4. Photo CPAT 4650-047

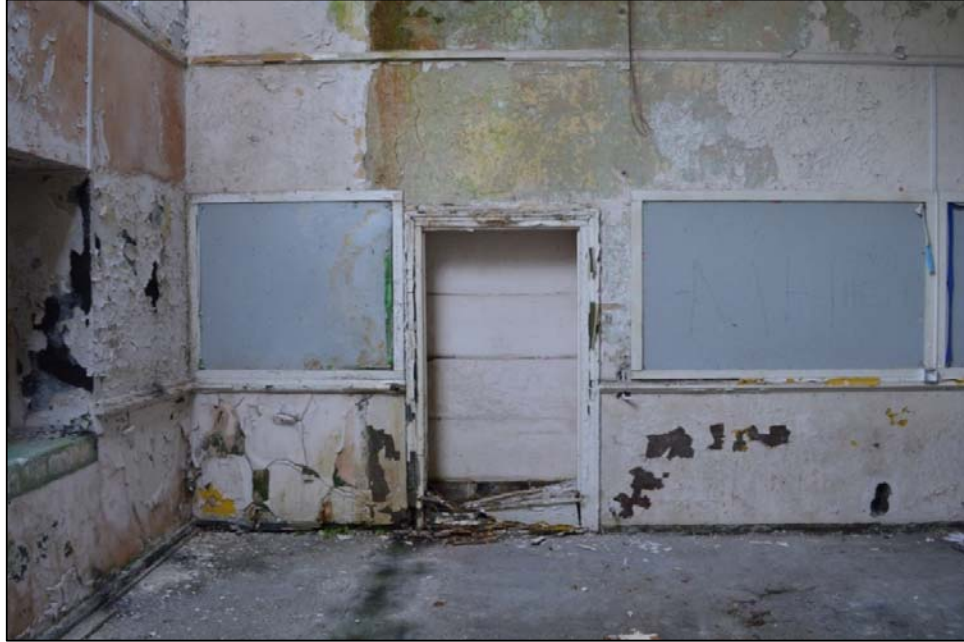
- 3.7. A blocked internal doorway between classroom 2 and the main hall was located in the north-west end of the dividing wall. A blocked doorway between the hall and classroom 3 was located in the corresponding position on the dividing wall between these two rooms.

Fig. 11 Former internal doorway between Classroom 2 and Hall. Photo CPAT 4650-028

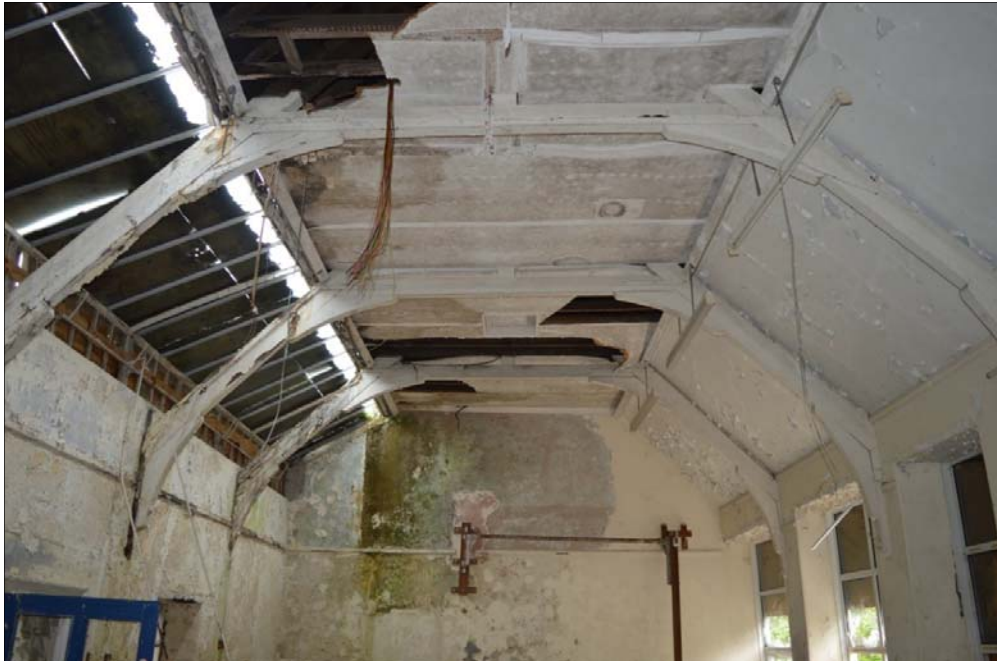
- 3.8. The roof ventilator and skylight ran along the north-west side of the roof between classrooms 2 and 3, and was in good condition although the winding gear was no longer present. A large wall mounted roller blackboard frame was attached to the north-east wall of the hall.

Fig. 12 The interior of the main Primary School building (Building 1), showing the roof trusses and ventilator. Photo CPAT 4650-031

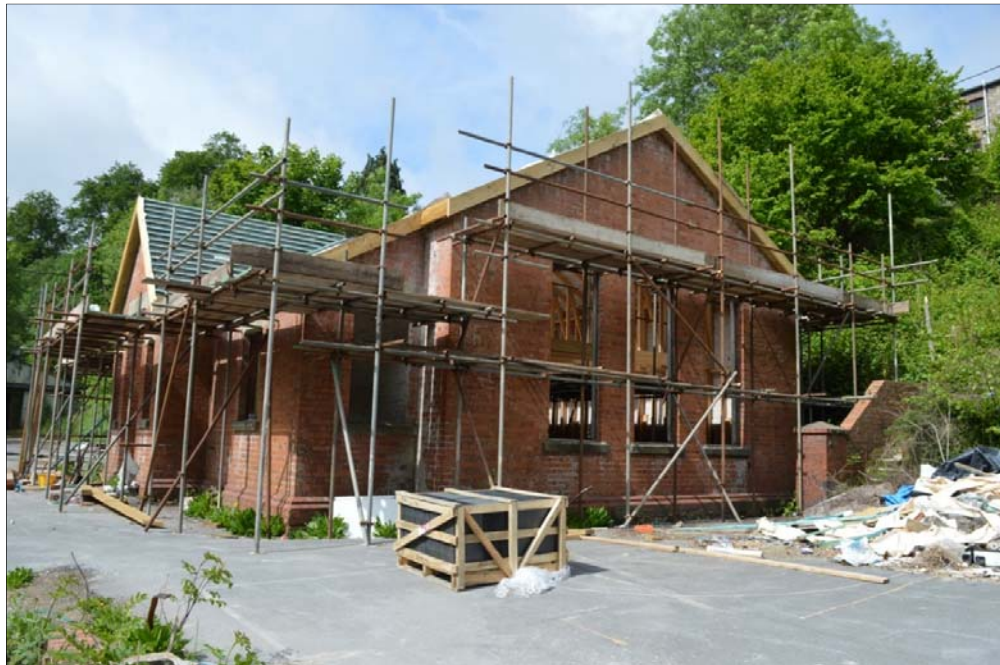
- 3.9. The infant school building was located centrally within the school grounds. It comprised a single-storey building constructed from brick. The window lintels and sills were made from detailed Portland stone. The main building consisted of a large open classroom with three long windows in each gable end and subdivided by a folding screen door (since removed). The classroom was accessed from the eastern side via a gabled porch, with internal and external double doors and window lights. The porch opened onto a corridor running along the east side of the building which led to toilets located at the northern end and stores at the southern end.
- 3.10. The roof frame and slates, the window frames and much of the interior of the building had been completely removed during ongoing renovation work.

Fig. 13 The Infant School building (Building 2), viewed from the north-east. Photo CPAT 4650-063

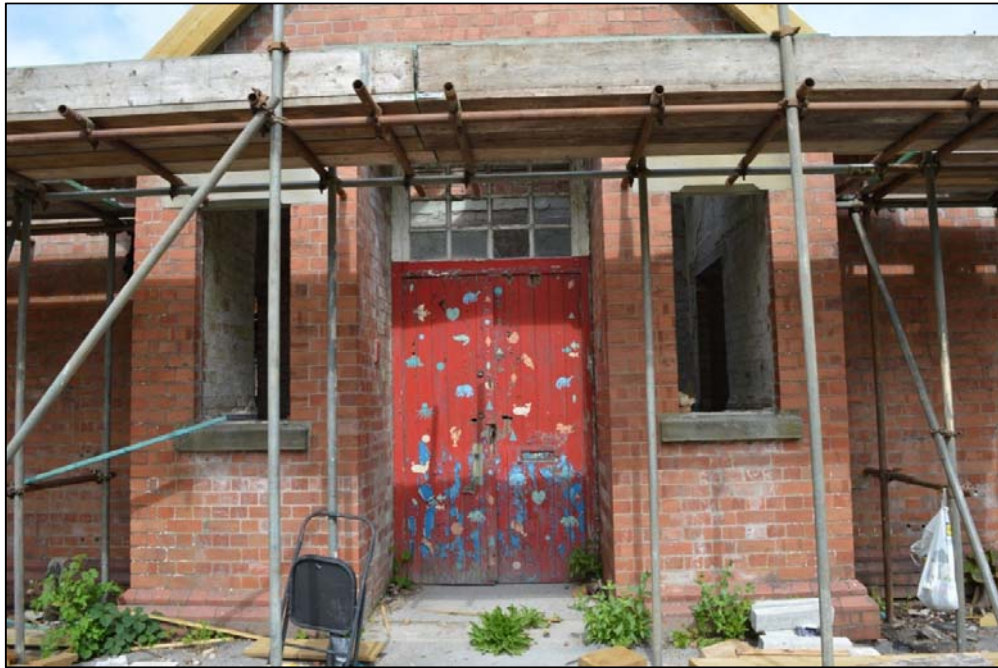
Fig. 14 The Infant School building (Building 2), viewed from the east. Photo CPAT 4650-063

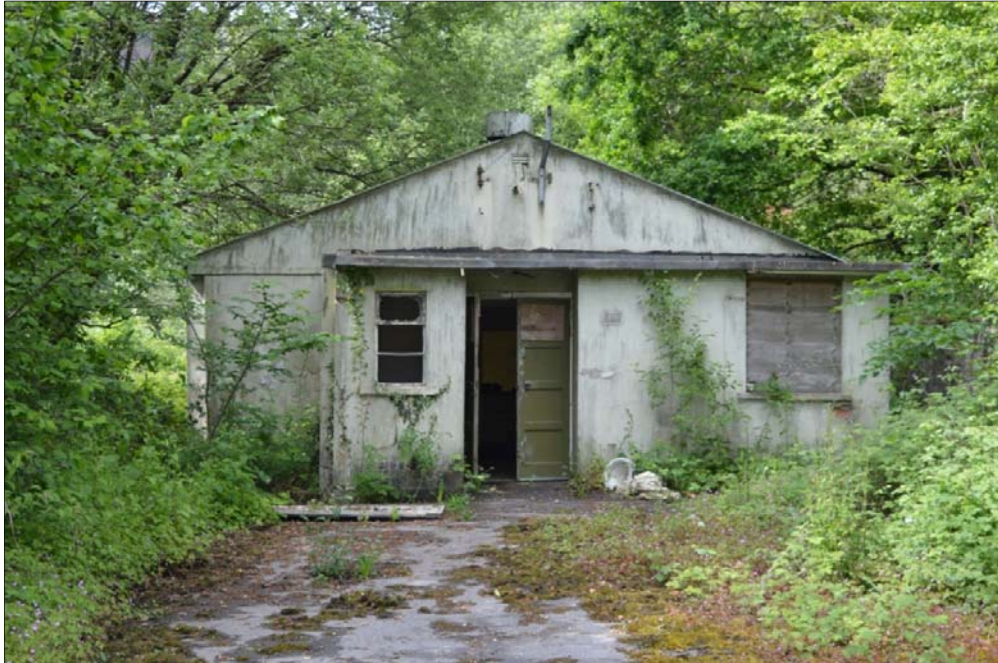
- 3.11. The canteen building was a low single-storey, prefabricated building, constructed from concrete side and roof members, strengthened with steel cross members. The wall infills were constructed from brick, with an external render. The roof was sheeted with asbestos.
- 3.12. The building comprised a canteen area, with a utility room to the south of it, accessed via a screened entranceway. Kitchens, stores and a toilet were located at the north end of the building either side of the main entrance doorway.

Fig. 15 The canteen building (Building 3), viewed from the north. Photo CPAT 4650-081

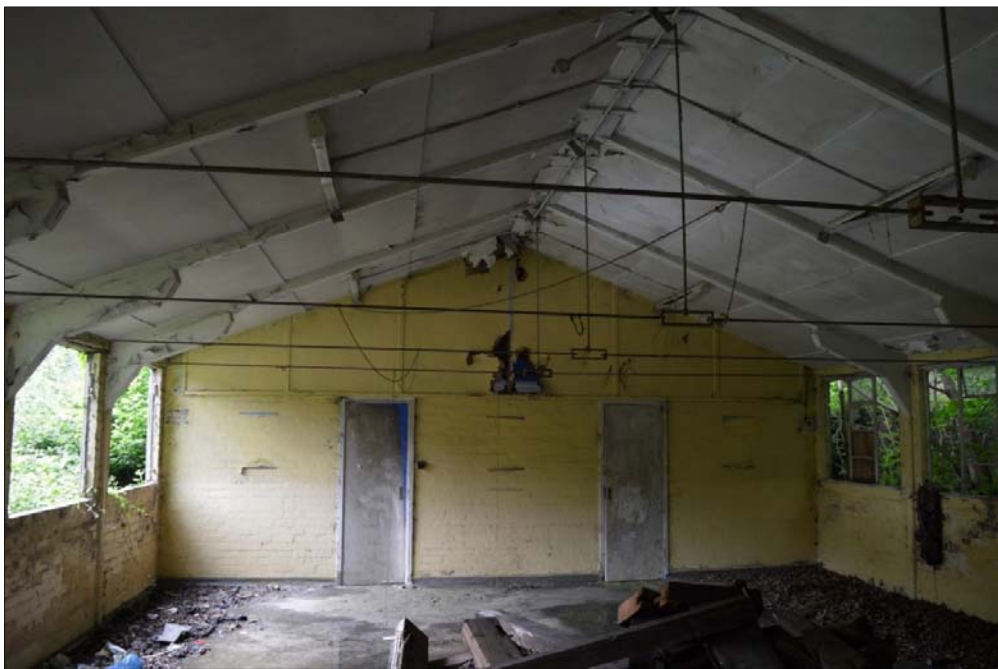
Fig. 16 The interior of the canteen building (Building 3). Photo CPAT 4650-088
