Extension to Withybush Industrial Estate, Haverfordwest Written Scheme of Investigation

Trysor Project No. 2013/312

EXTENSION TO WITHBUSH INDUSTRIAL ESTATE, HAVERFORDWEST WRITTEN SCHEME OF INVESTIGATION

Planning permission - 05/0849/PA

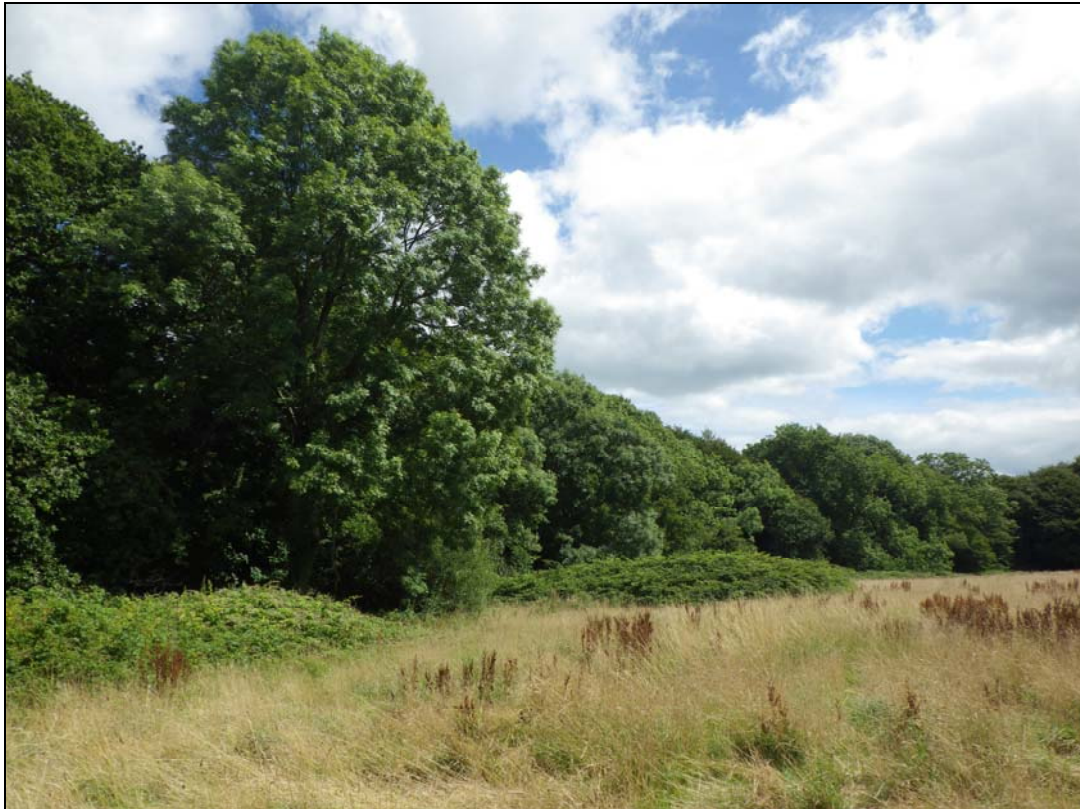
3.2.2 Trysor found no visible trace of RAF features in the field, apart from the base of one of the latrines (ID number 6) photographed in 2006. The second latrine (ID number 7) noted in 2006 also appeared to have been demolished, and its site was obscured by a large bramble bush.

Plate 1: A view of the area taken in August 2013 where the RAF latrines (Id number 6 & 7) formerly stood.

- i. the identification and photographic recording of the bases of the RAF buildings (ID numbers 1 to 9) at the northern end of the development area
- ii. the photographic recording and description of the standing RAF buildings within the development area (ID numbers 15 & 16) comparable with an English Heritage Level 2 building survey (English Heritage, 2006)
- iii. the investigation of the linear feature (ID number 12) and the recording of any features discovered.
