Masterplan for Kiln Park Holiday Centre, Tenby, Pembrokeshire Historic Environment Assessment

For: Bourne Leisure Ltd

Revised January 2017

Trysor Project No. 2015/477

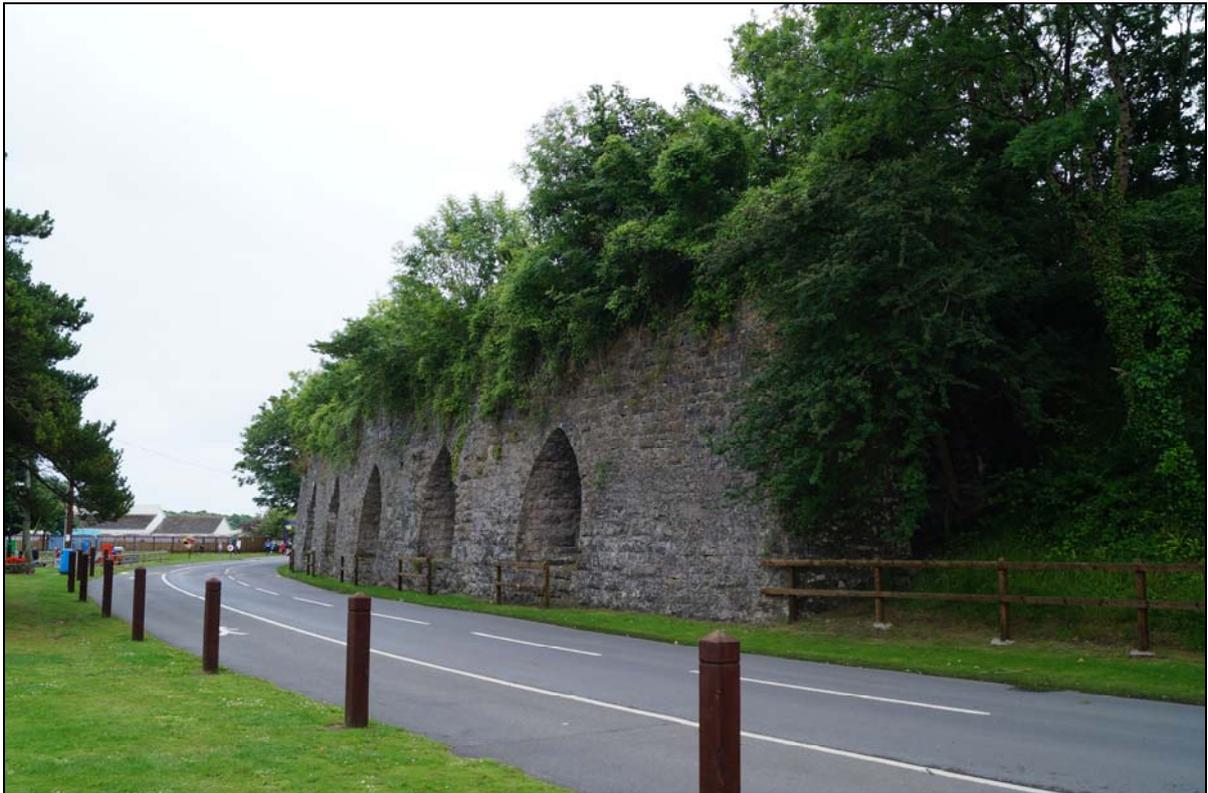
Cover photograph: The eastern bank of kilns, ID number 27, a Scheduled Ancient Monument (PE436) and a Listed Building (16919), looking east

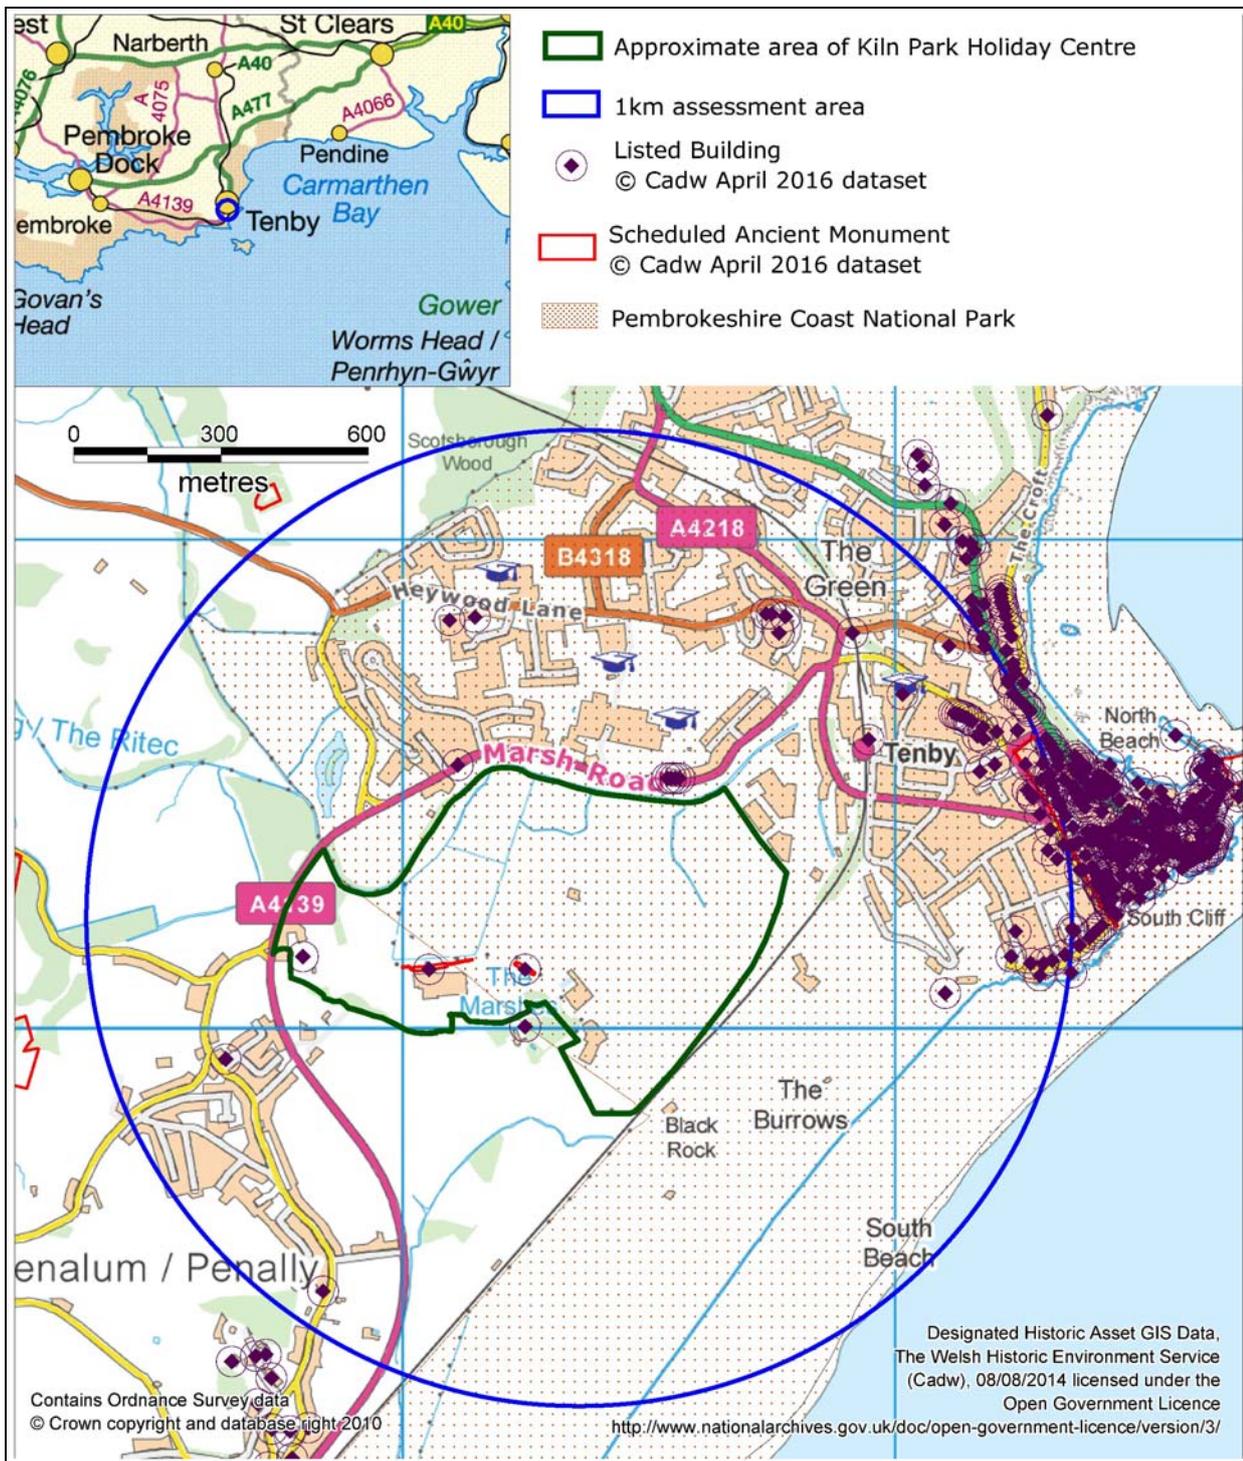
Figure 1: Location of the Kiln Park Holiday Centre, showing the 1km radius assessment area.

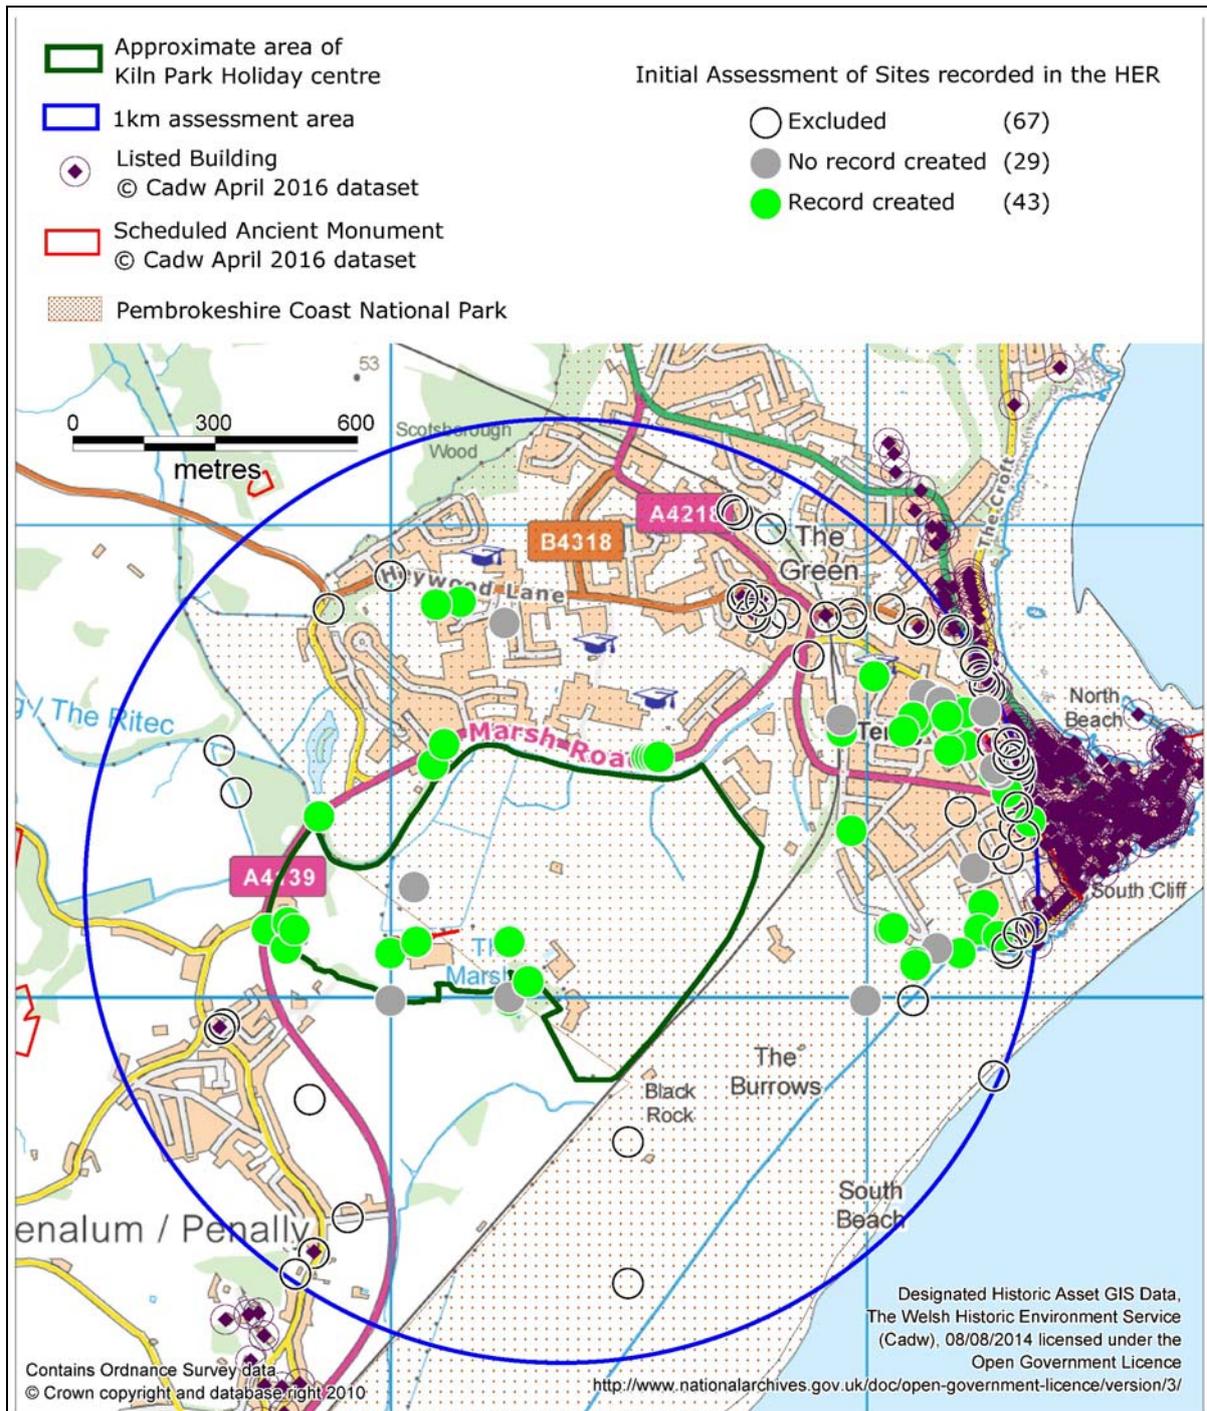
Figure 2: Historic assets excluded from further assessment as no intervisibility, and no impact on setting. Further details in section 10.

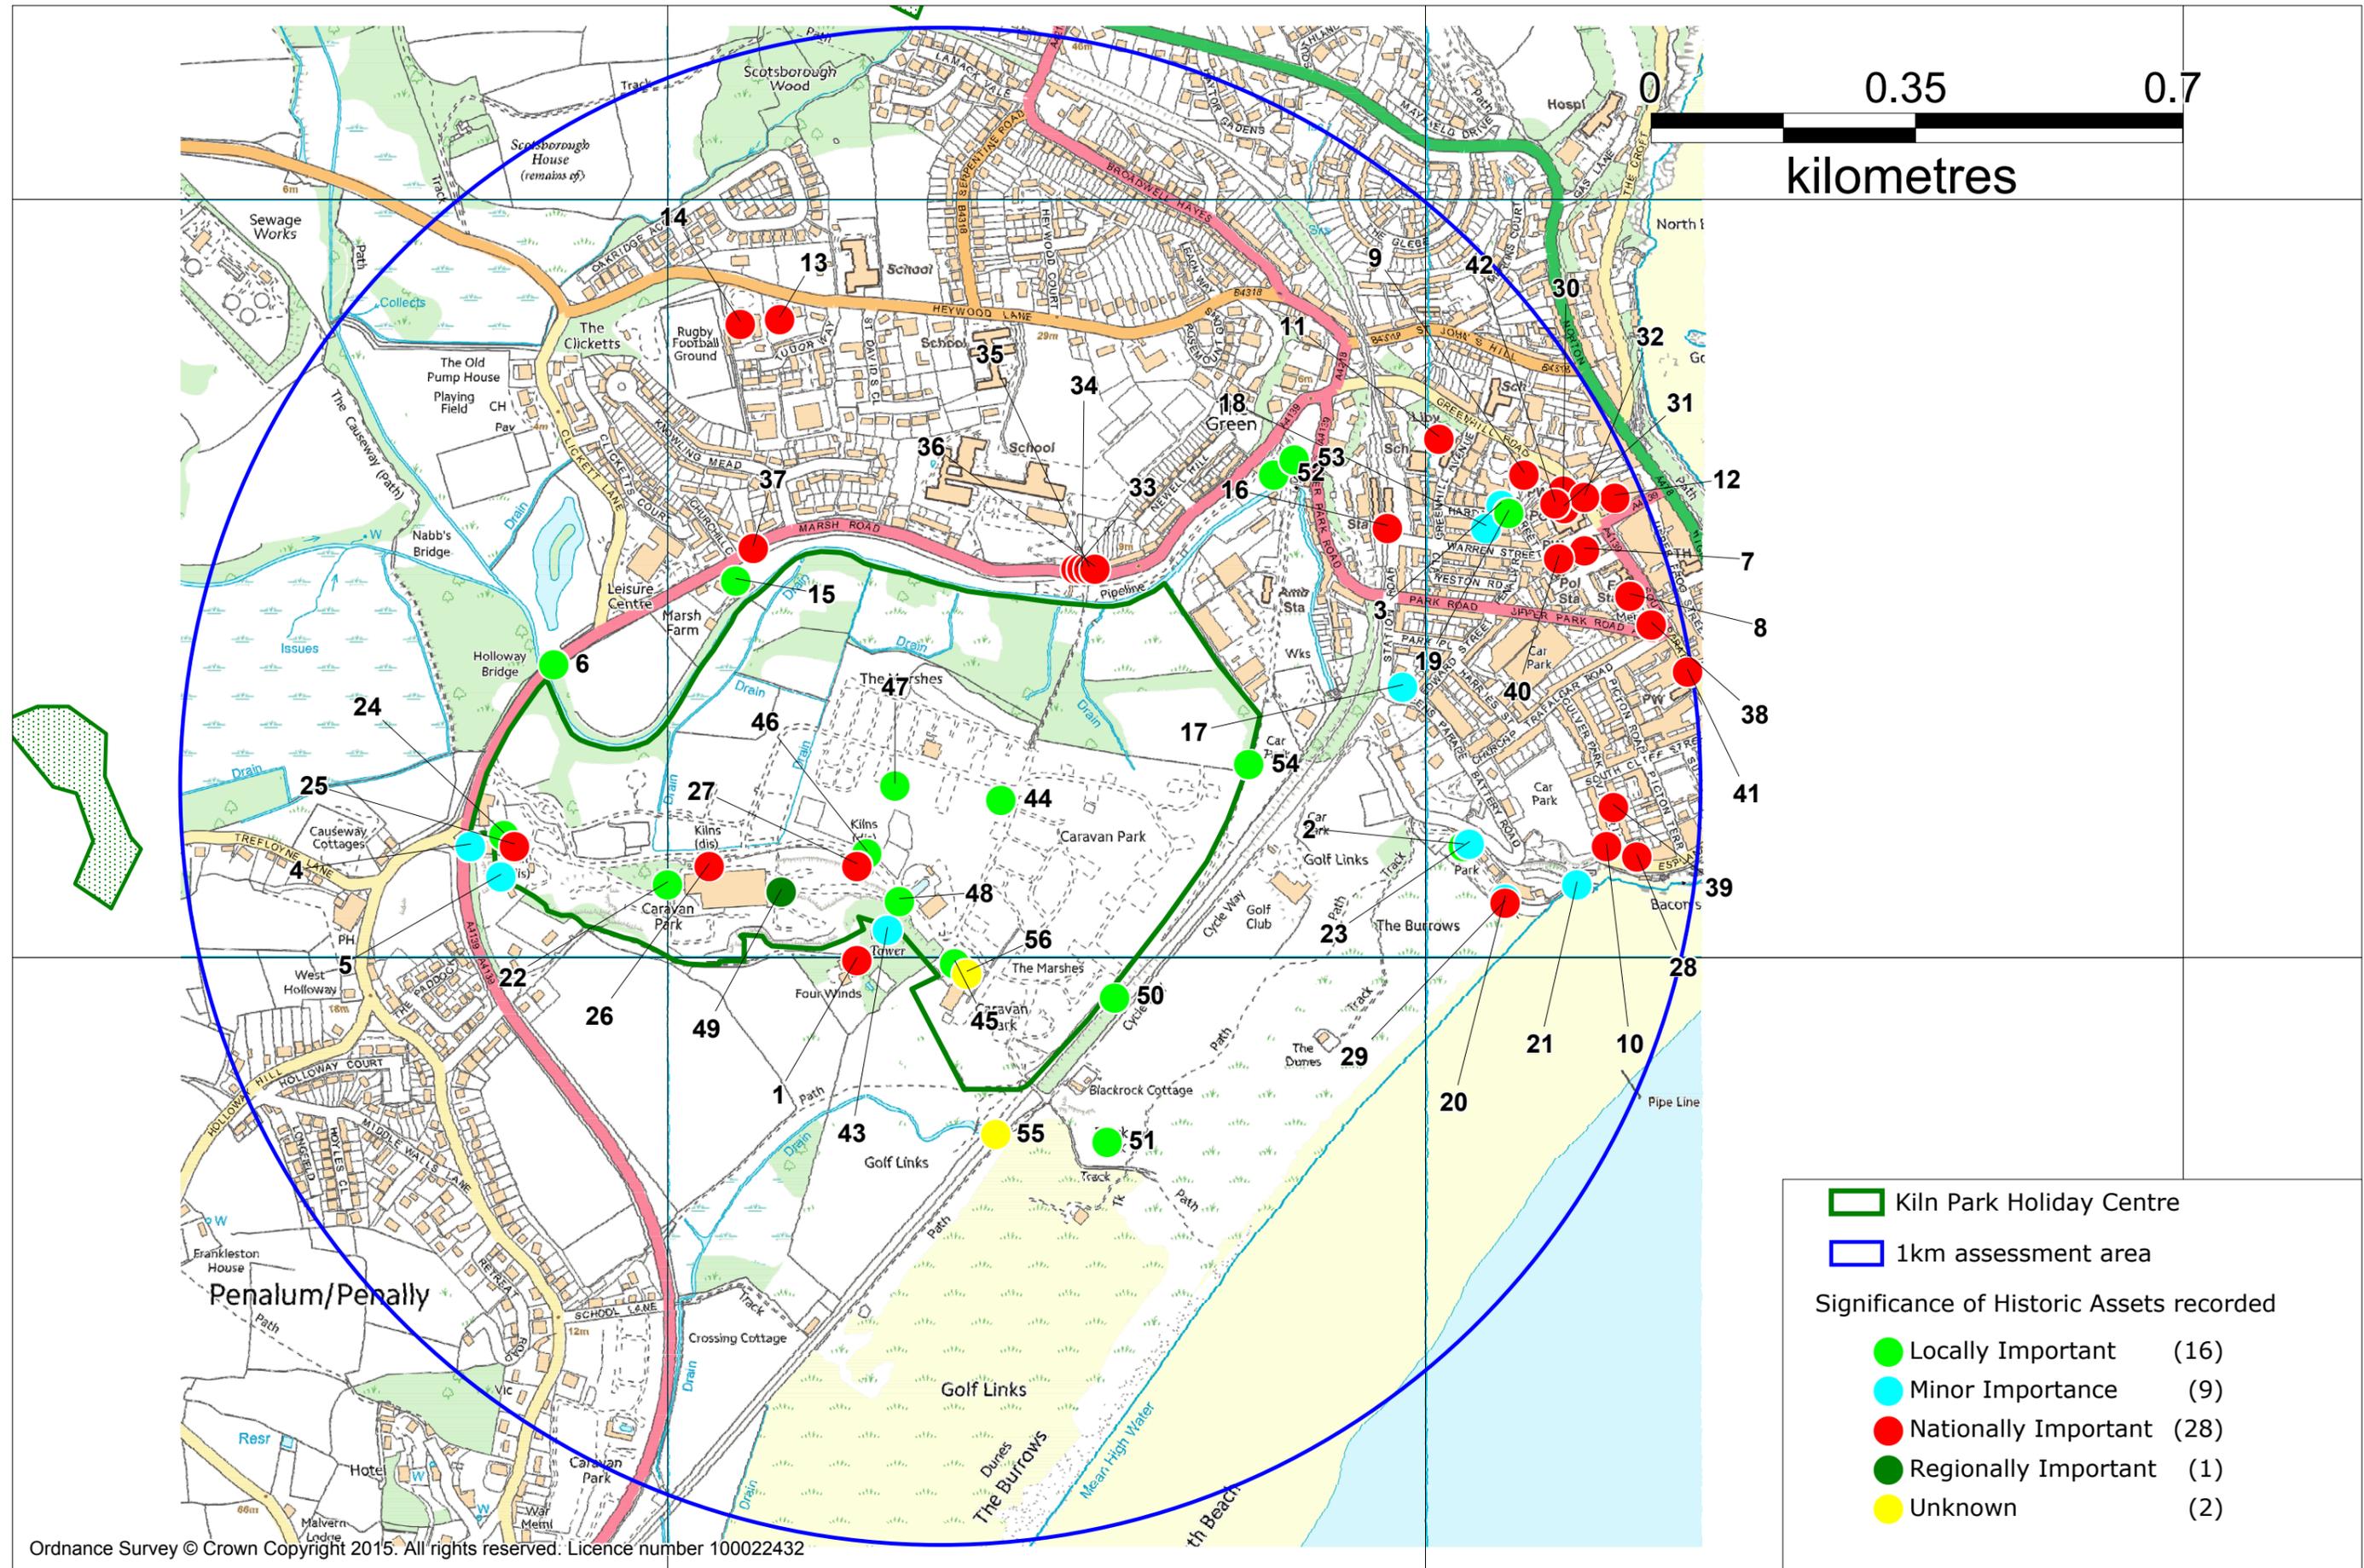
Figure 3: The 1km assessment area showing significance of historic assets, labelled with Project ID number

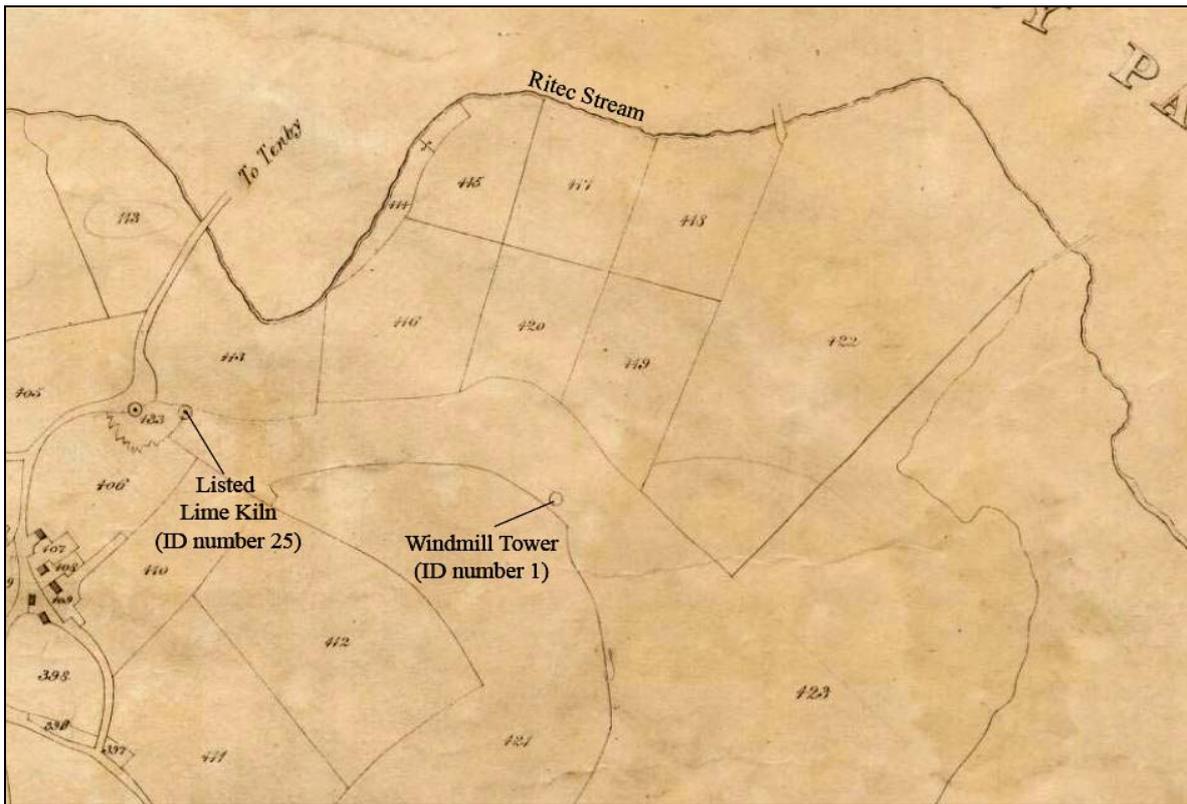
Figure 4; An excerpt from the Penally Parish tithe map of 1842, showing the fields where the Kiln Park Holiday Centre is now situated.

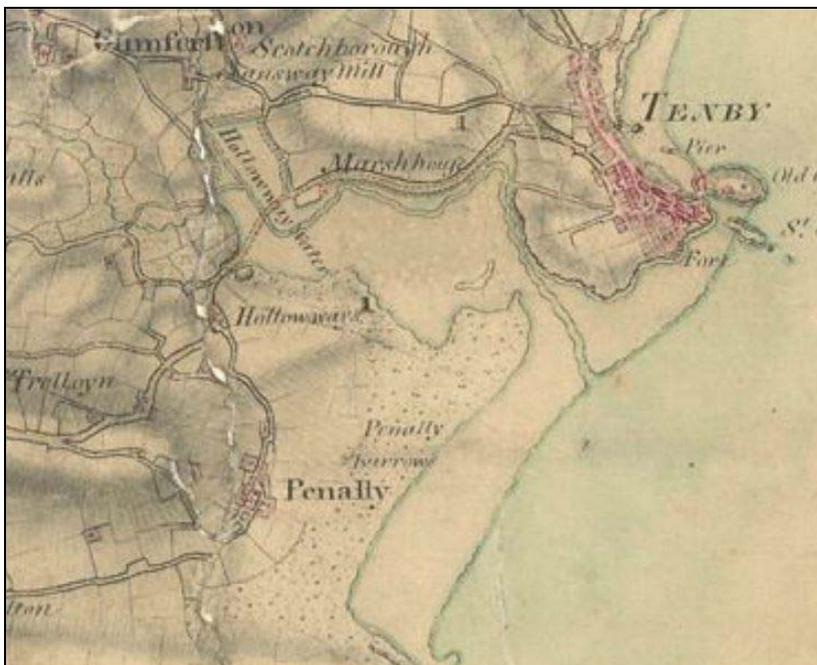
Figure 5: An excerpt from the Ordnance Survey Original Surveyors Drawings of 1809, which shows the Ritec estuary before the first reclamation and drainage attempts had been made in 1811. The upper part of the estuary is labelled as Holloway Water. Note the Windmill Tower (ID number 1) to the south of the estuary.

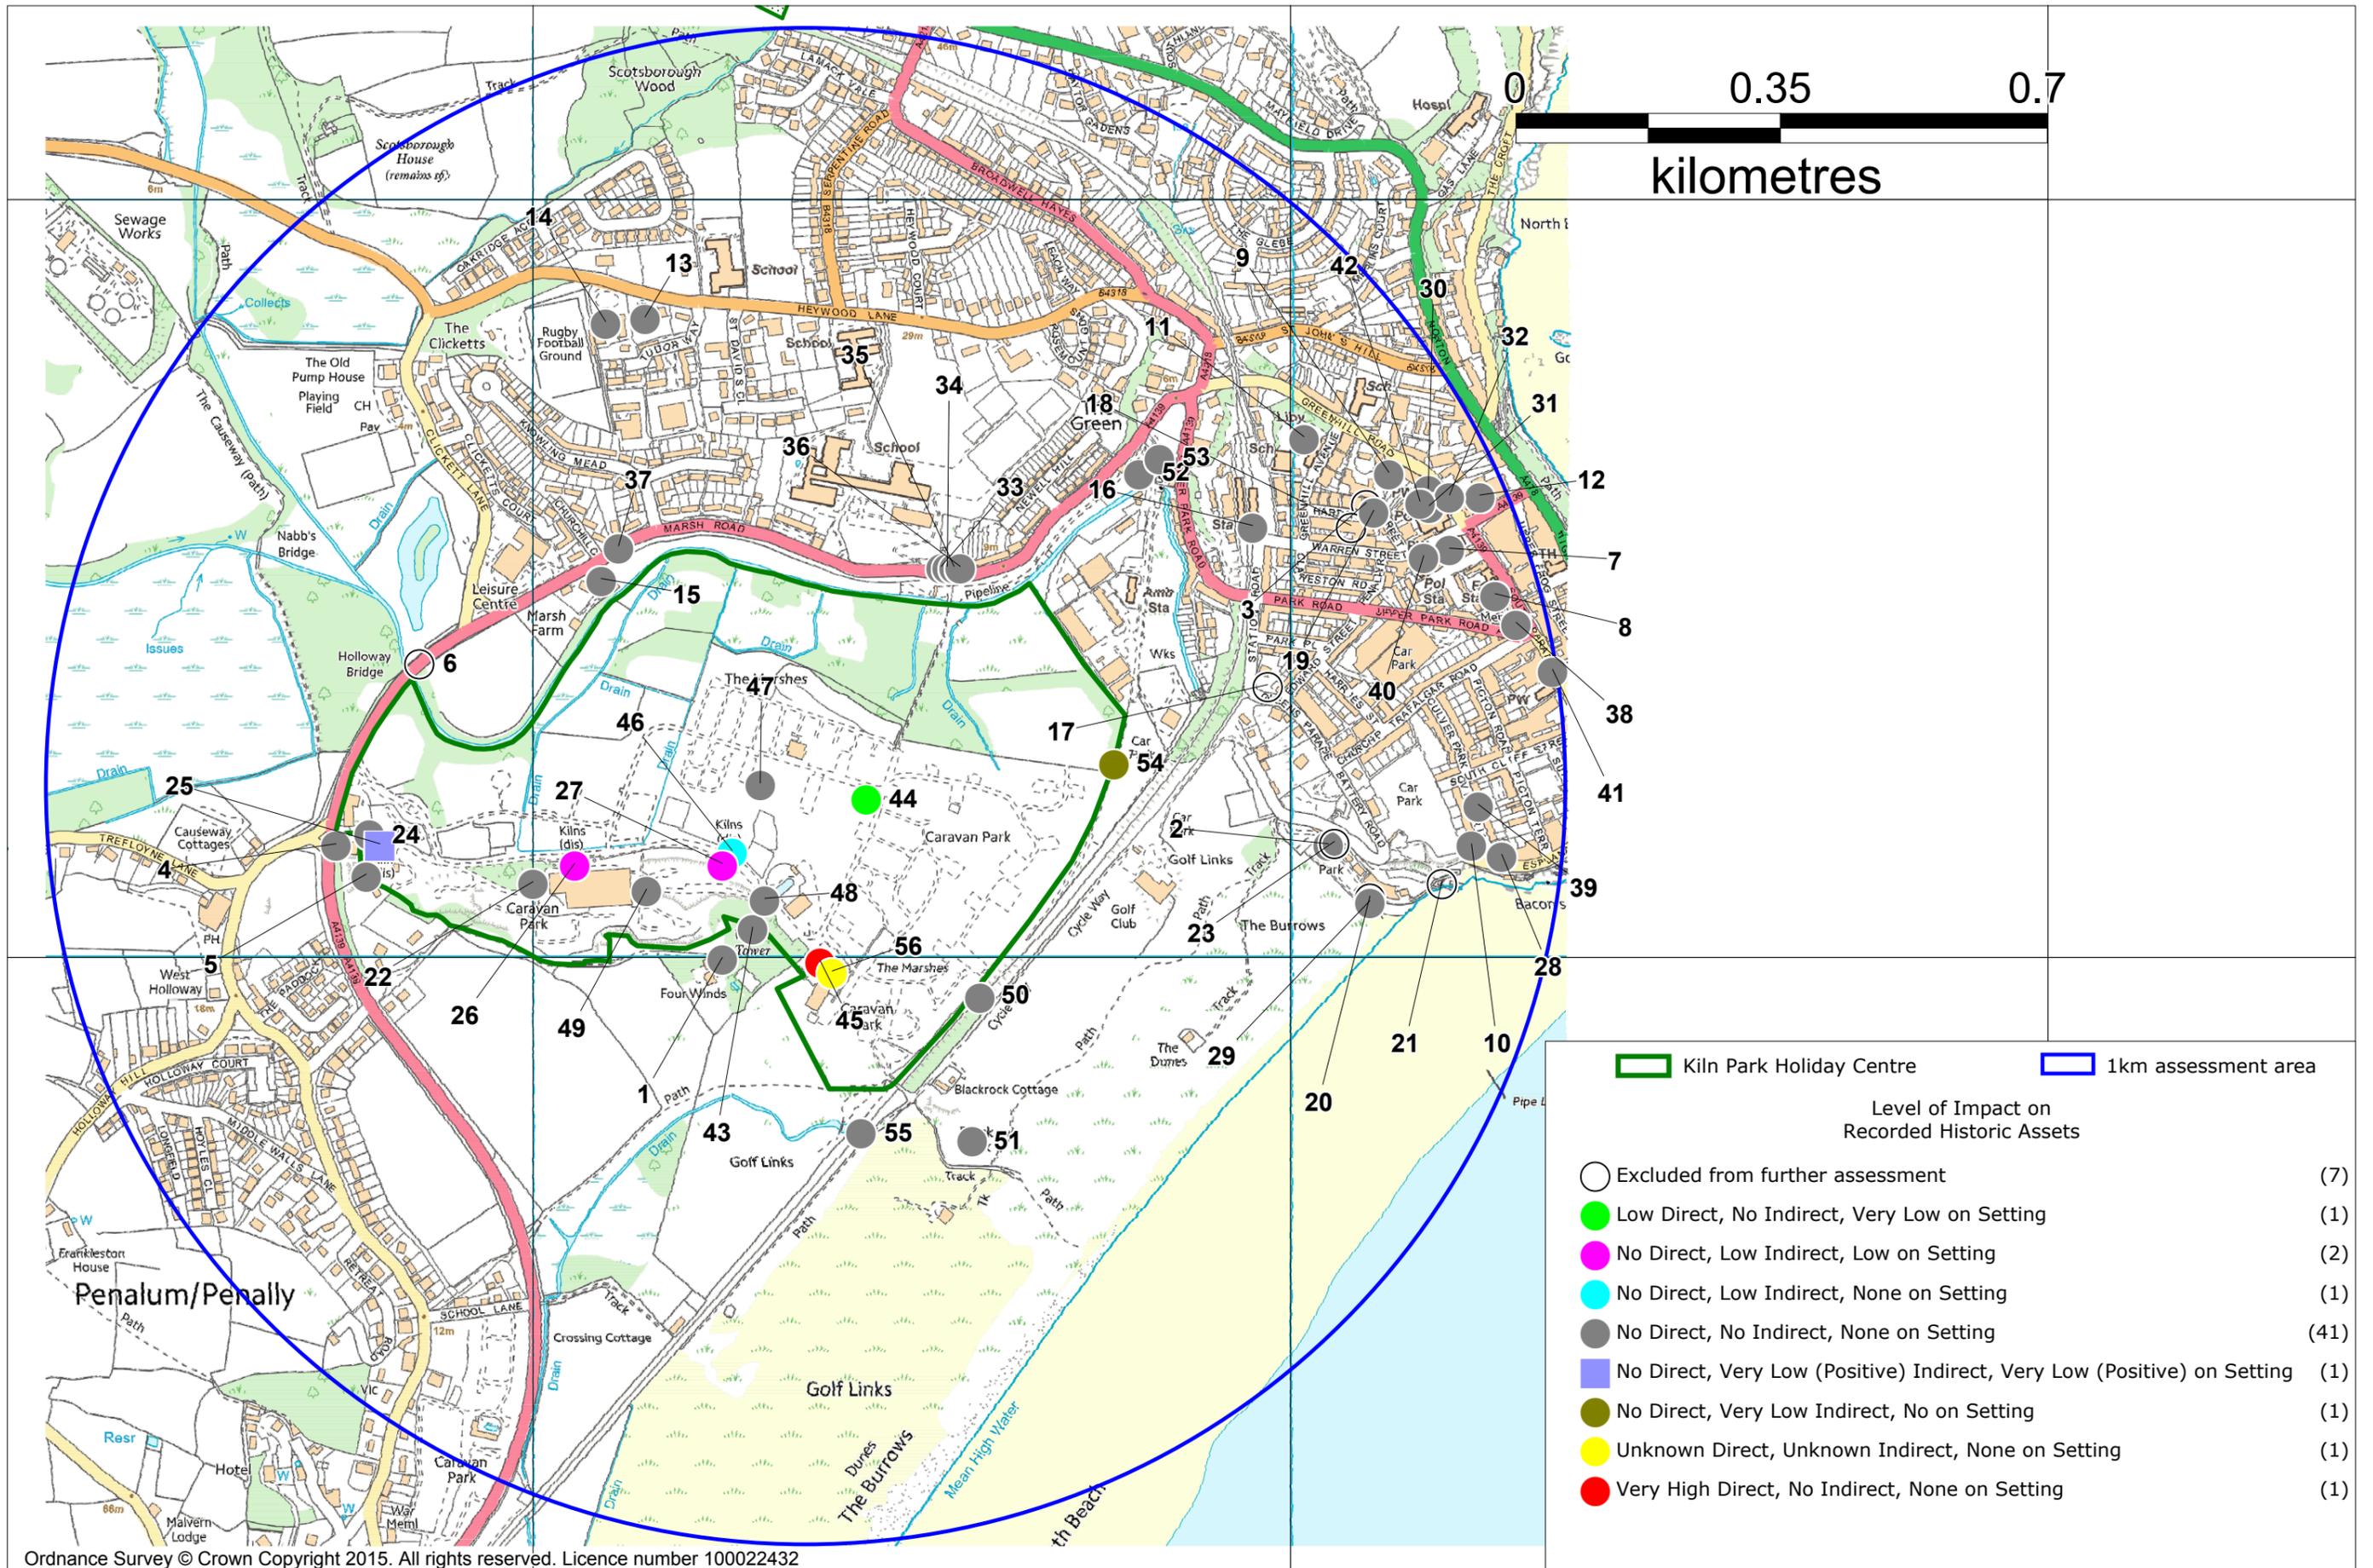
Figure 6: The 1km assessment area showing the level of impact on historic assets recorded, labelled with Project ID number

- 10.9 The Direct and Indirect impact on the remaining historic assets was assessed taking into account both physical and non-physical impacts. Each impact was assessed within the scale Very Low, Low, Moderate, High and Very High, taken into account the significance of the site and the nature of the impact. A full gazetteer is found in Appendix B but a summary is tabulated in Table 3 below and illustrated in Figure 6. These impacts are further discussed in Sections 11 & 121.

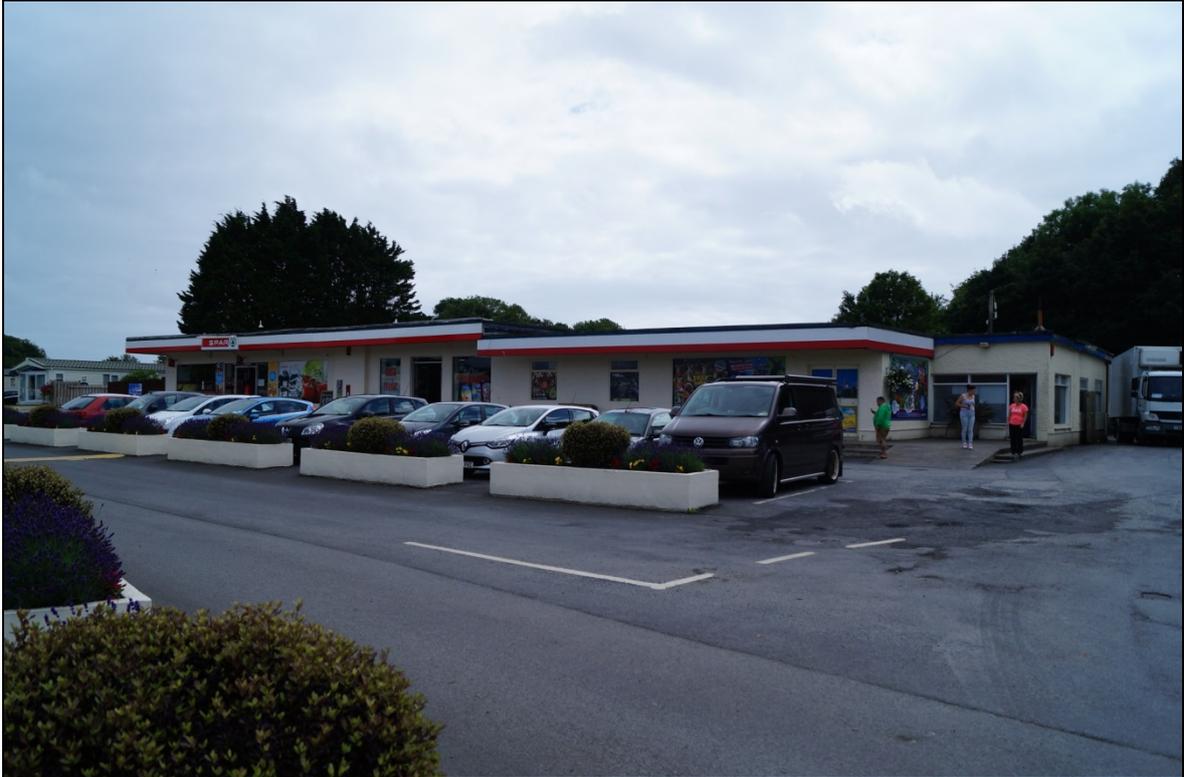
Viewpoint Location; SN1238300025, looking south

12.2.1 This area is currently the location of the site shop (ID number 45), a launderette and an associated parking area, see Photo 1 in Appendix D. These are to be replaced with static caravans served by a new roadway.

Photo 1; A view of the Kiln Park Holiday Centre shop, (ID number 45) in June 2015. This late 20th century building will be removed as part of the redevelopment of Area B. Despite its flat and low-lying situation, it stands where there was a field parcel known as "Burrows Hill" on the parish tithe map of 1842. This suggests it may be located on an area which was formerly characterised by blown sand, at the western edge of the coastal sand dunes known today as "The Burrows."

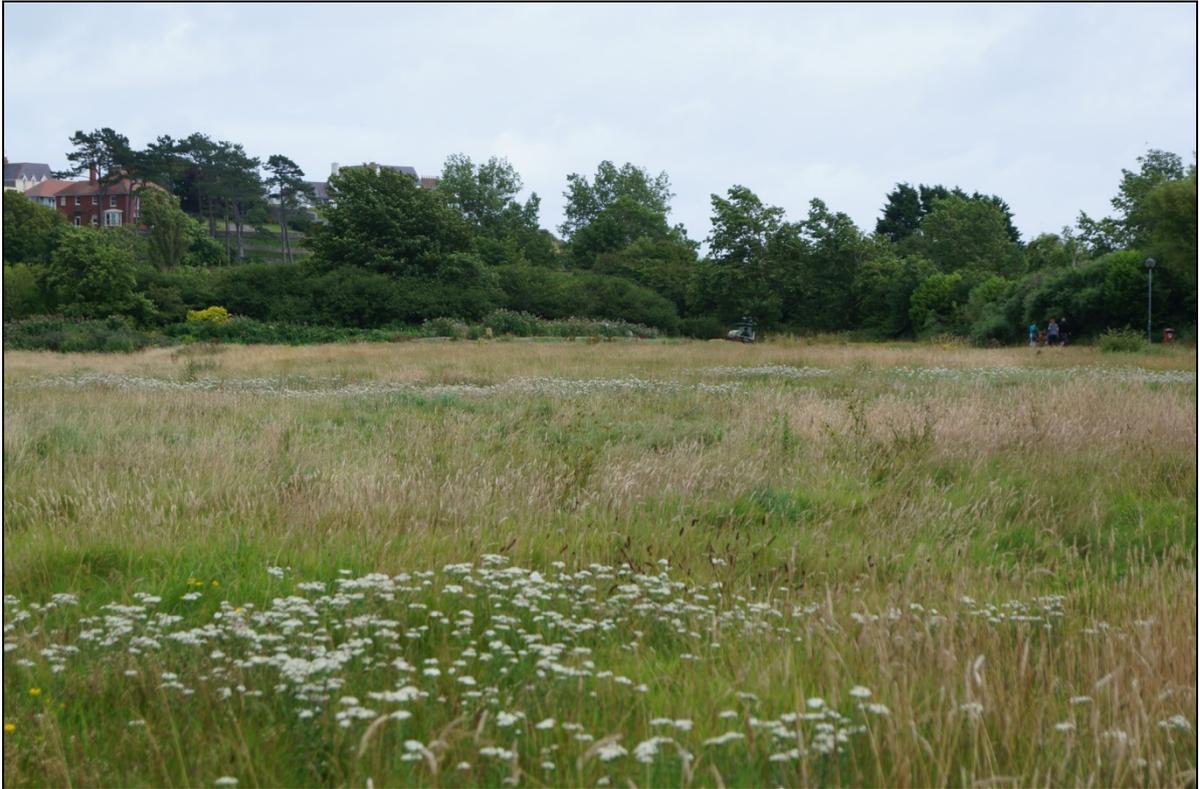
Viewpoint Location; SN1264100328

Photo 2; A view across the field at the northeastern corner of the Holiday Centre, looking southeast in the direction of the Salterns Car Park. In the 19th century a natural pool known as Black Pool was located to the left of the area shown, but it was drained during the 20th century. This parcel of land is also within the area shown as "Burrows Hill" on the parish tithe map of 1842 and may be underlain by blown sand. The large hedgerow at the right hand side of the image is the line of the former Pembroke & Tenby railway, (ID number 54), built in 1862-63, probably along the line of the embankment, (ID number 50), built in 1811 and repaired in 1840 to prevent the tidal flooding of the Ritec estuary. A current footpath from the Holiday Centre passes through the hedgerow into the Salterns Car Park.

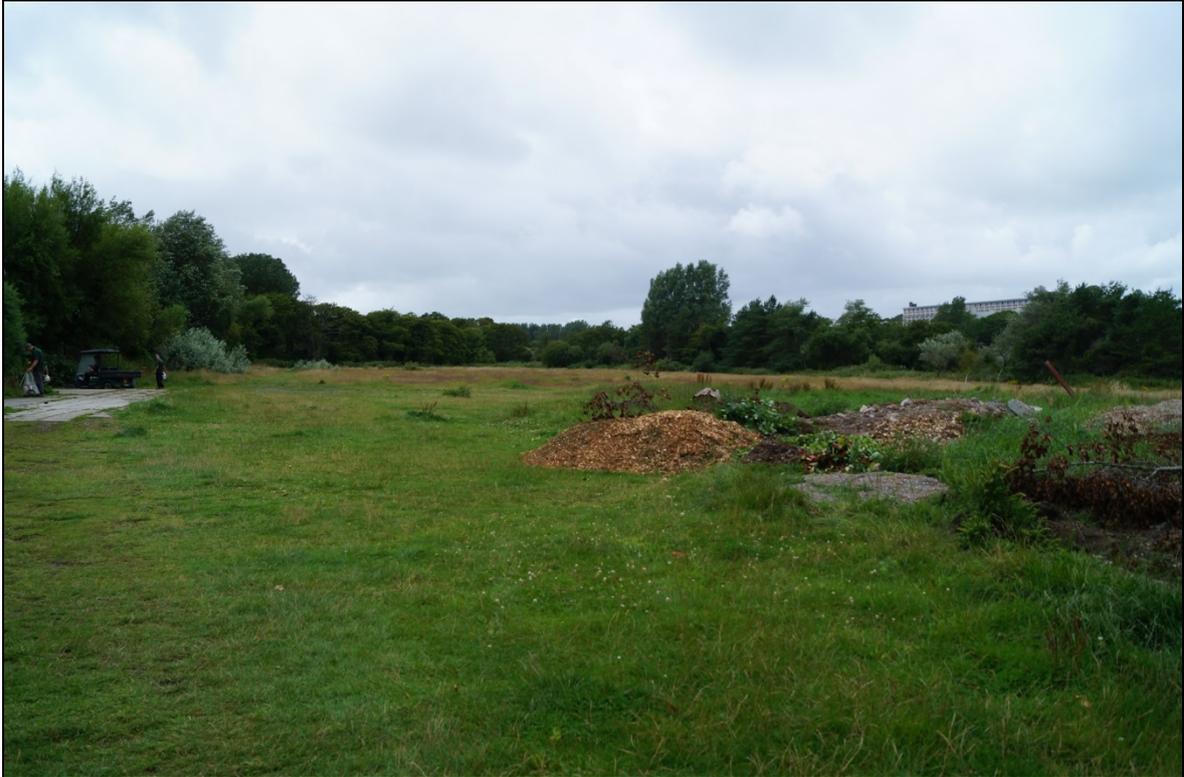
Viewpoint Location; SN1274800270

Photo 3; This view looks northwest from the current footpath from the Holiday Centre into the Salterns Car Park. Greenhill School is visible behind the trees to the right.

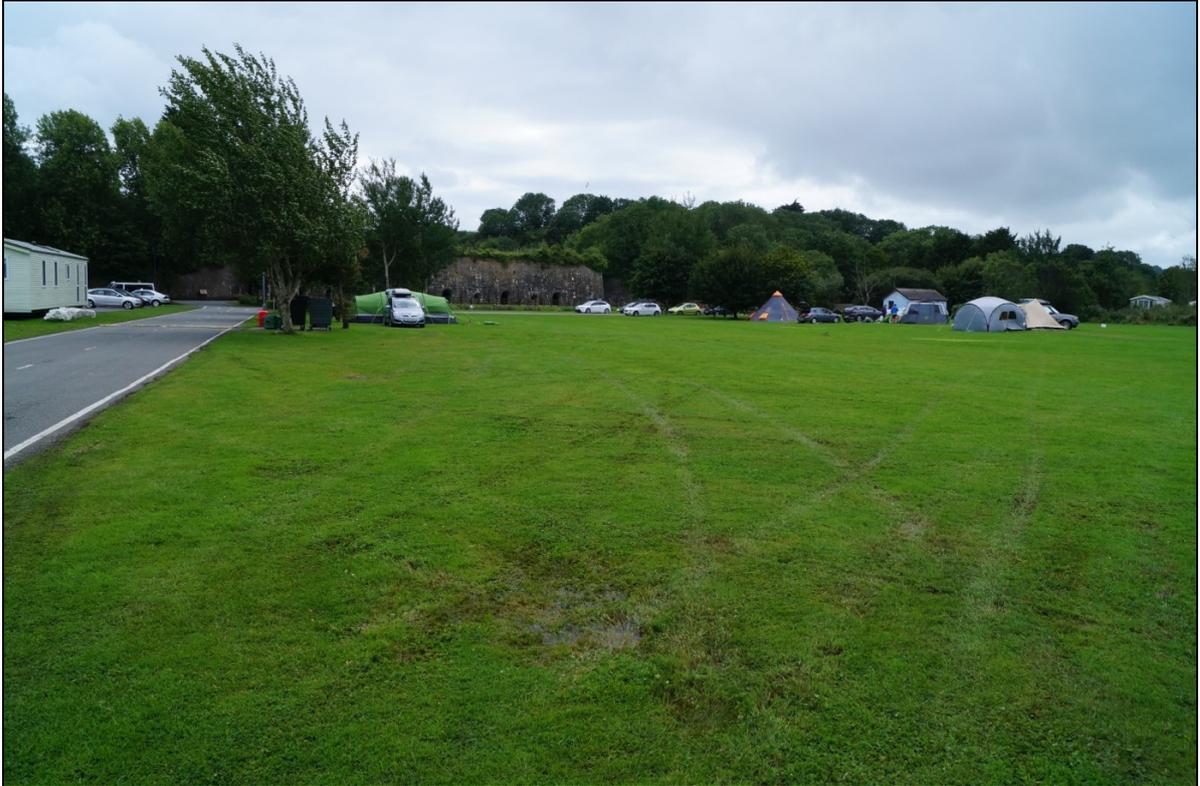
Viewpoint Location; SN1213500290

Trysor Description: The westernmost of two large bank kilns built in the late 19th century to burn limestone quarried at the adjacent Blackrock Quarry. It was used into the early 20th century. The kiln has been disused for about a century but remains relatively intact. It was served by a railway branch which ran from the kiln to the main line closer to Tenby. See Photos 5 & 6.

Photo 5; A view looking south-southwest across Area J. The western bank kiln (ID number 26) is visible in the distance beyond.

Comment on Impact: These kilns will only be affected by the proposed changes to the caravan park within Area J, which will cause a Low, indirect, visual impact. This will see caravans introduced into an area which is now open ground. However, in the context of the modern setting of the kilns within the Holiday Centre, the impact on setting is Low. Mitigation has been undertaken to ensure that an open area is retained between the development and the kilns to ensure that the key view of the kilns will not be lost. The kilns will only be viewed, as now, with the receptors back to the caravan park. The development would have no physical impact on the kilns.

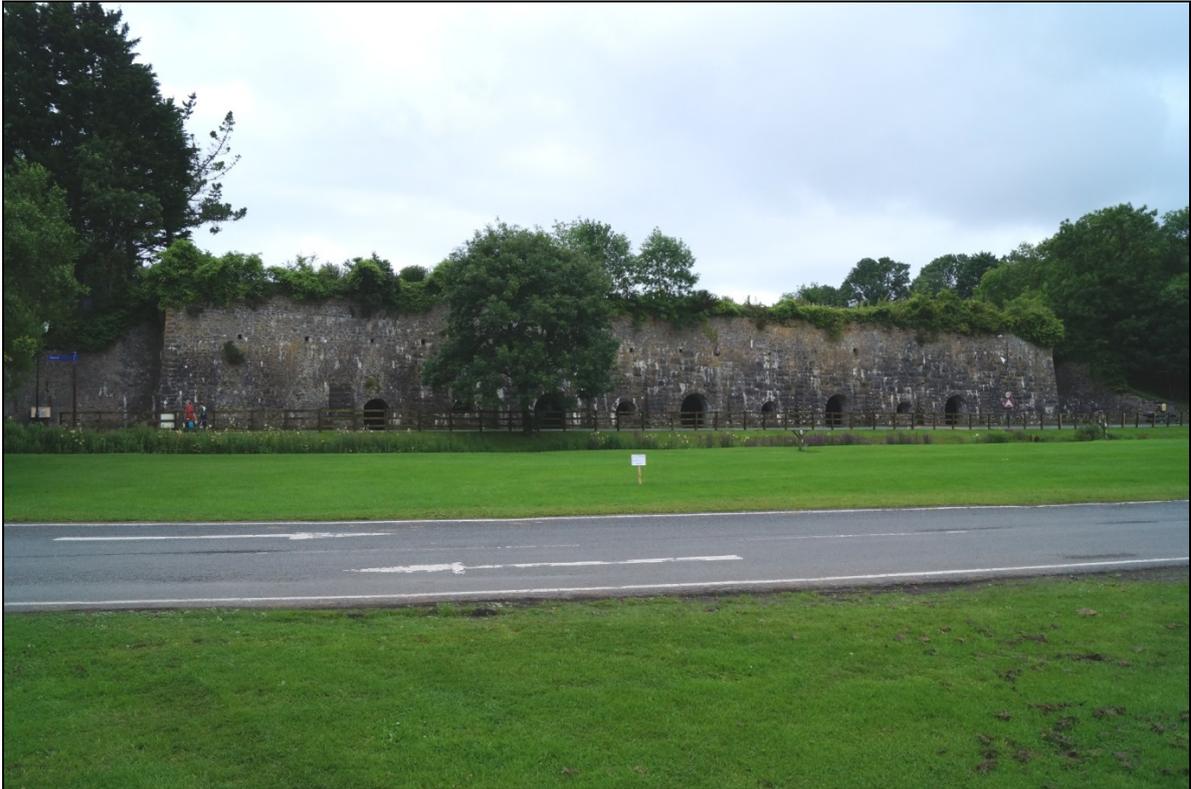
Viewpoint Location; SN1206600188

Photo 6; A closer view, looking south, of the western bank kiln (ID number 26). A single row of static caravans would be located beyond the road in the foreground, within Area J. However, the southern half of the green strip between the road and the kilns would be retained as an open area, therefore providing ample open ground from where the best views of the kilns would still be obtained.

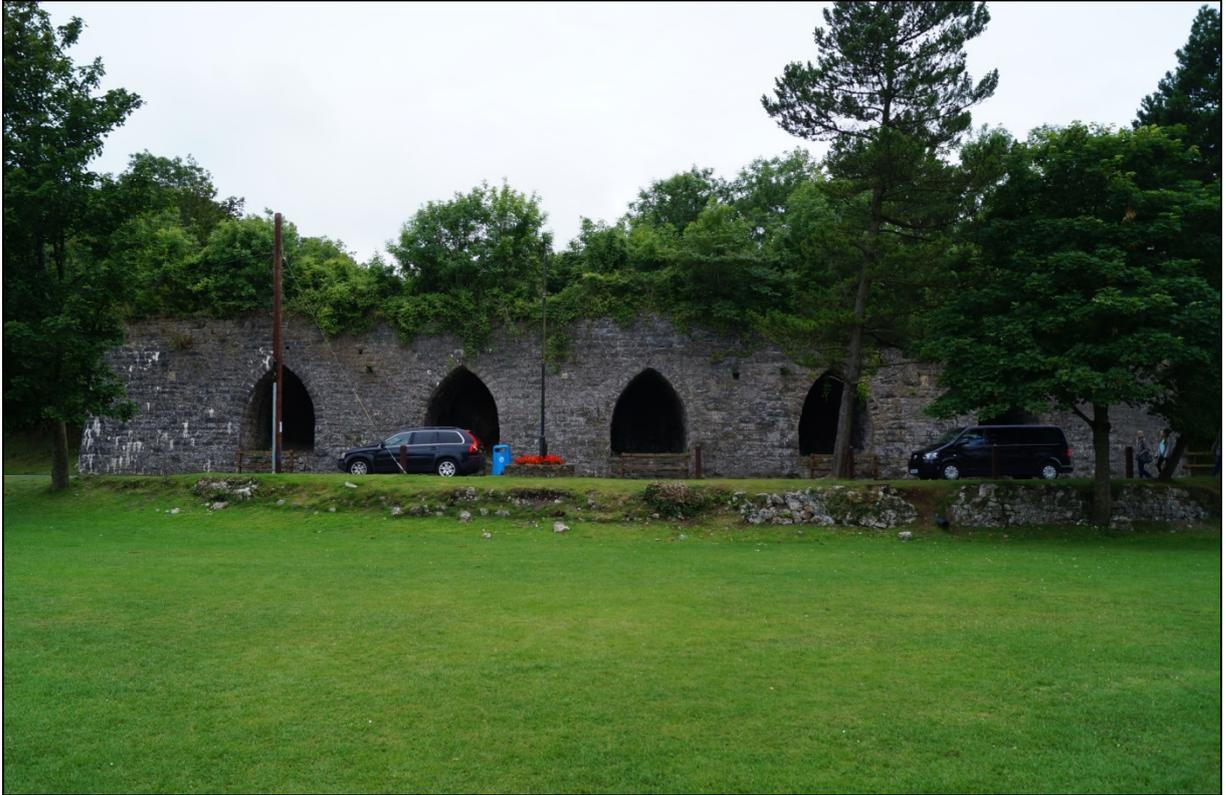
Viewpoint Location; SN1227300152 looking south southwest

Trysor Description: The easternmost of two large bank kilns built in the late 19th century to burn limestone quarried at the adjacent Blackrock Quarry. It was used into the early 20th century. The kiln has been disused for about a century but remains relatively intact. It was served by a railway branch which ran from the kiln to the main line closer to Tenby. See photos 7 & 8.

Photo 7; A close view of the eastern bank kiln (ID number 27), again showing the key view from the north. Amendments to the proposed development plan will ensure that the open space to the north of this kiln will remain open ground to protect this view. The wall in the foreground is the revetment wall (ID number 46) which defined the edge of the former quarry railway line. The railway track bed is now overlain by the entrance road into the holiday park, along which the vehicles in the photograph are travelling.

Comment on Impact: These kilns will only be affected by the proposed changes to the caravan park within Area F, which will cause a Low, indirect, visual impact. This will see caravans introduced into an area which is now open ground. However, in the context of the modern setting of the kilns within the Holiday Centre, the impact on setting is Low. Mitigation has been undertaken to ensure that an open area is retained between the development and the kilns to ensure that the key view of the kilns will not be lost. The kilns will only be viewed, as now, with the receptors back to the caravan park. The development would have no physical impact on the kilns.

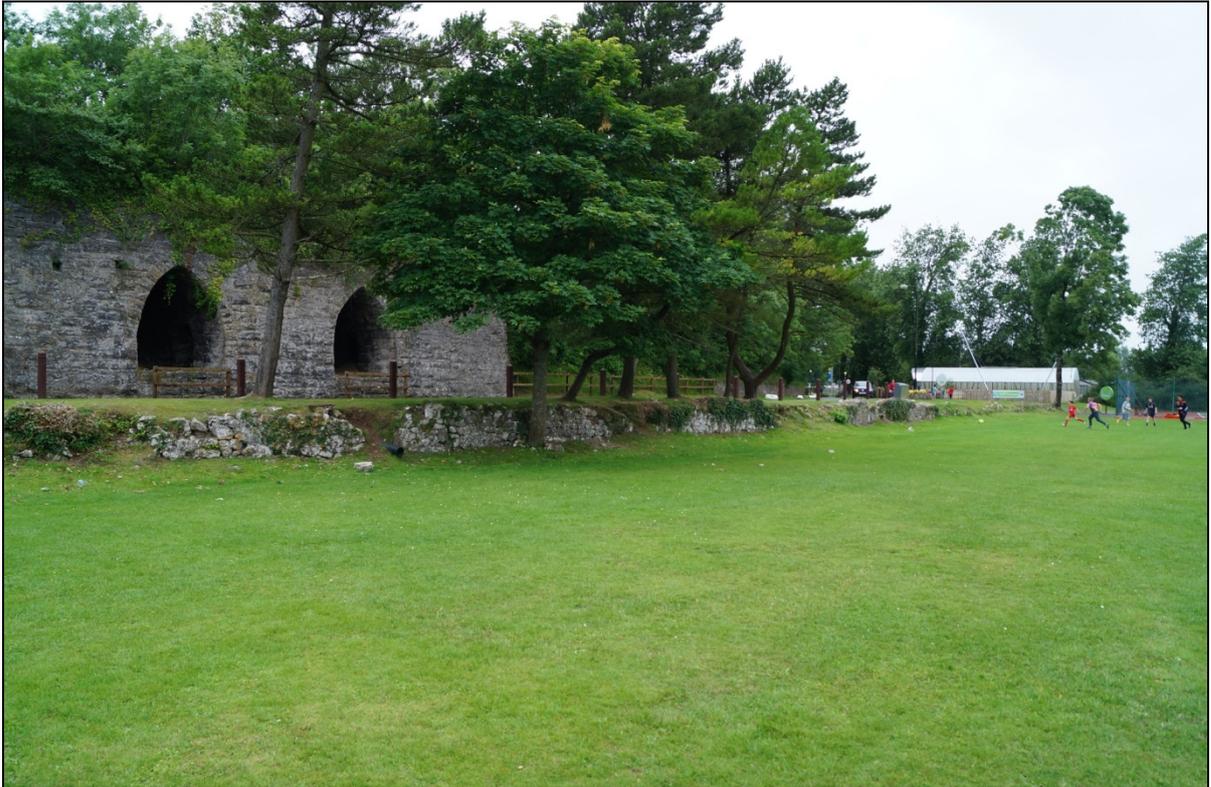
Viewpoint Location; SN1226100163

Photo 8; A view of the eastern bank kiln (ID number 27), and retaining wall (ID number 46), looking southwest and showing the open area to the north of the kiln which will be retained to preserve the setting of the monument.

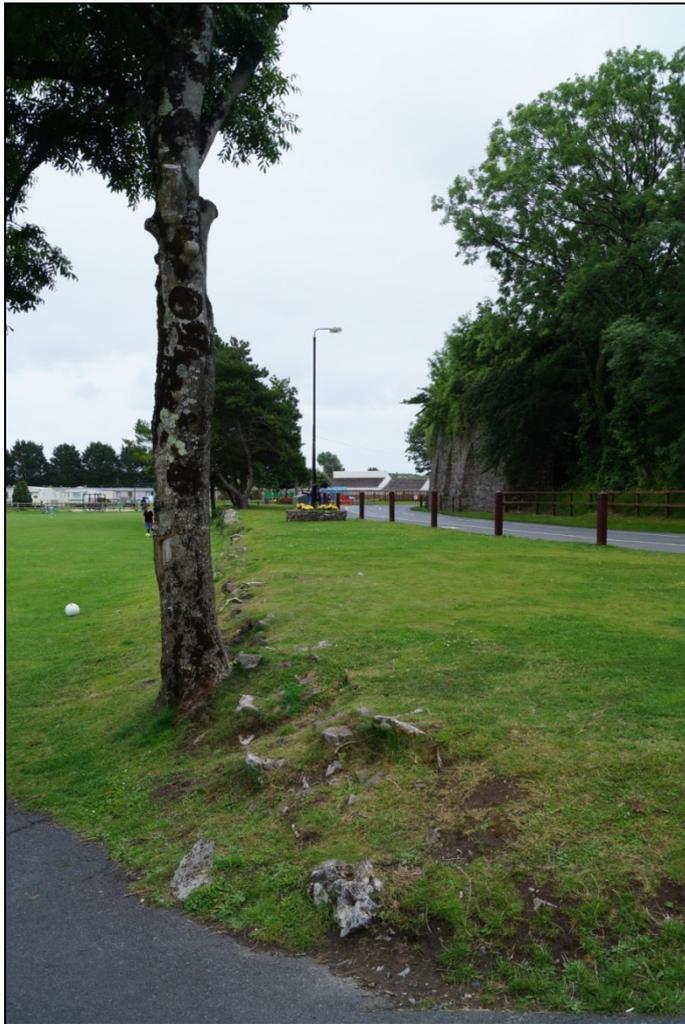
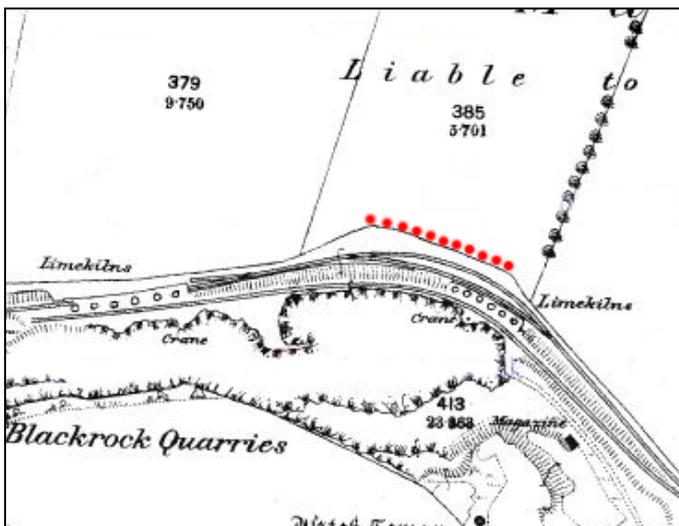
*Viewpoint Location;
SN1219000168*

Photo 9; A view looking east-southeast along the line of the railway revetment wall ID number 46.

The widening of the former railway track bed at this point suggests that the wall defined the edge of an area used for sidings.

The surviving section of wall is marked with a red dotted line in the inset map below, which is taken from the 1890 1:2500 scale Ordnance Survey map.
