Masterplan for Kiln Park Holiday Centre, Tenby, Pembrokeshire Historic Environment Assessment

For: Bourne Leisure Ltd

Revised January 2017

Trysor Project No. 2015/477

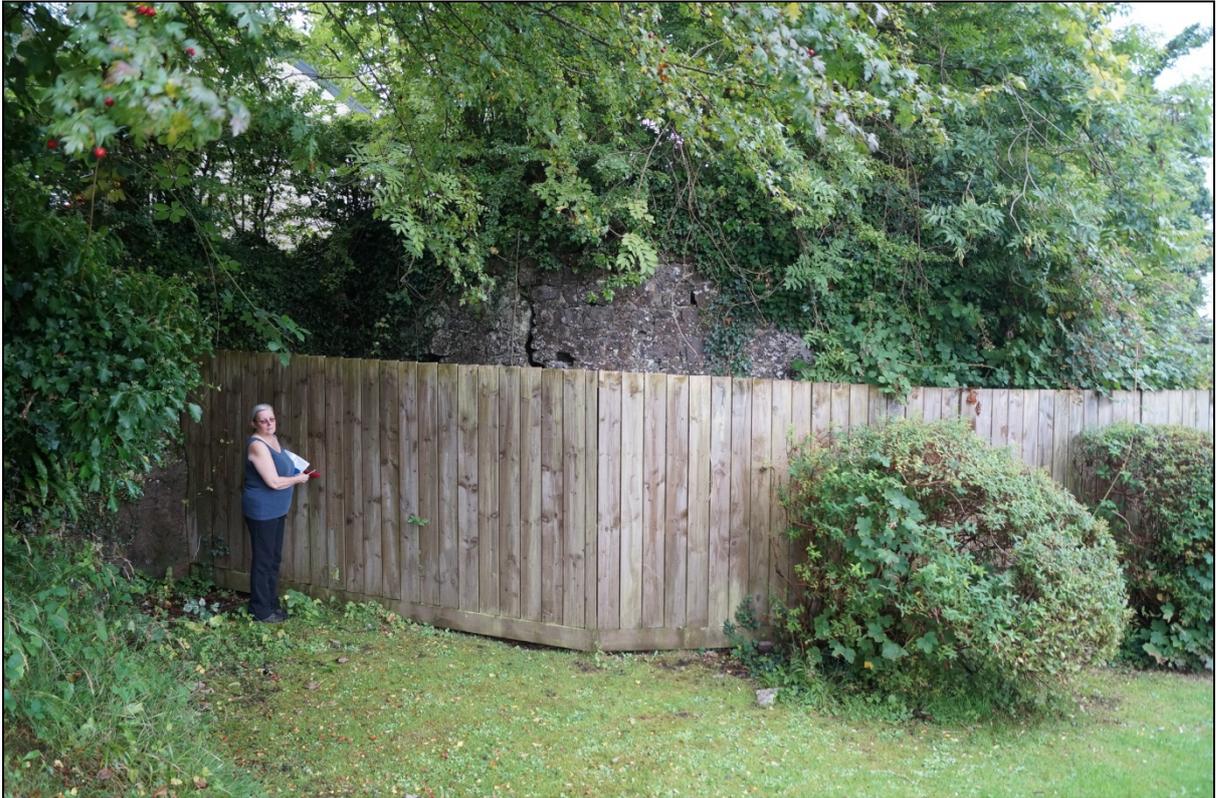
Viewpoint Location; SN1181100149

Photo 10; A view of the listed lime kiln ID number 25, looking west. The kiln is now fenced off and relatively forgotten within the holiday park. The crack above the drawing arch shows that the structure is in a poor condition.
