Tan y Clogwyn, Wybrnant, Betws y Coed, Historic Environment Desk-Based Assessment

Tan y Clogwyn, Wybrnant, Betws y Coed Historic Environment Desk-Based Assessment

Trysor Project No. 2016/527

For: TGVHydro Ltd

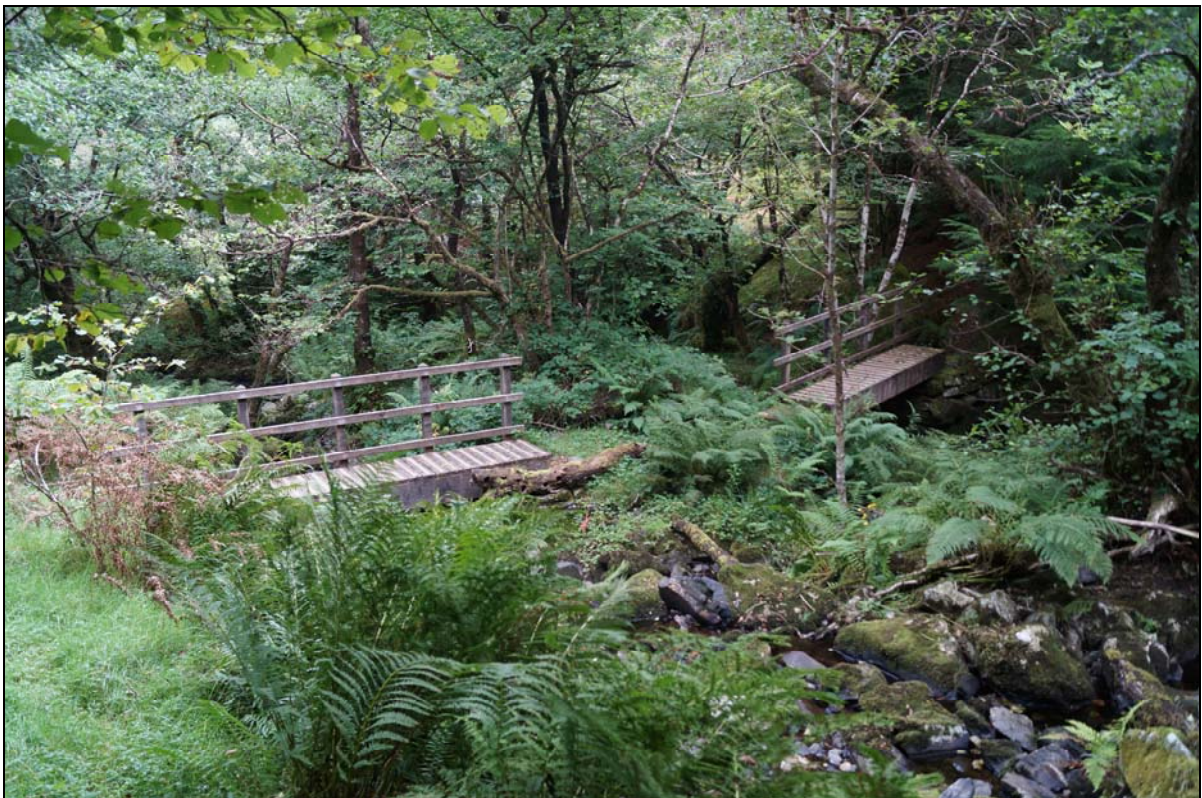
Cover photograph: A two part, modern footbridge (ID number 4) across the Afon Wybrnant, in the same location as a footbridge shown on historic mapping

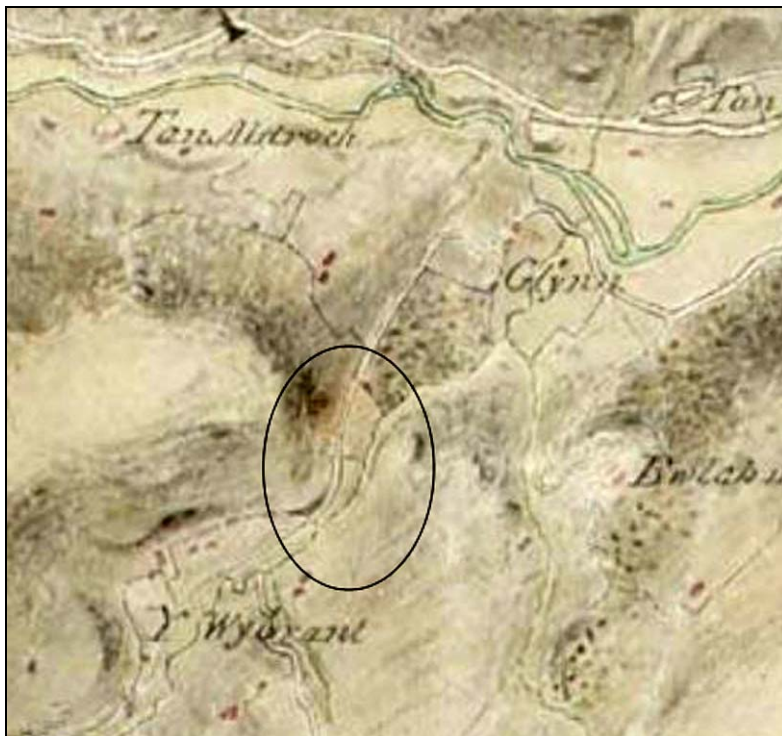
Figure 2; The 1818 Ordnance Survey Original Surveyors Drawing of the development area (circled). There are no buildings shown at Cyfyng, where the chapel and cottage stood by the later 19th century

cottages stood here as early as 1720, but the earliest Ordnance Survey map of 1818 does not show any buildings at this location (see Figure 2).

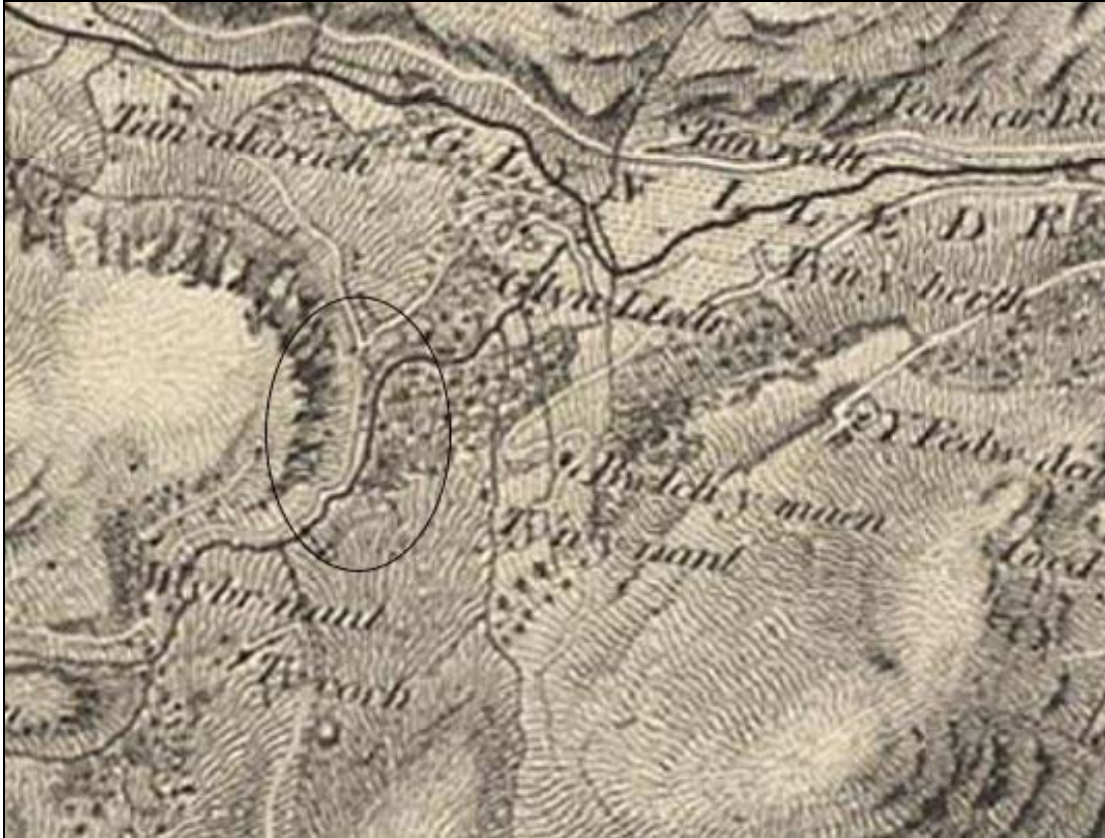
Figure 3; The 1849 Ordnance Survey First Series map of the development area (encircled) appears to show a building at Cyfyng.

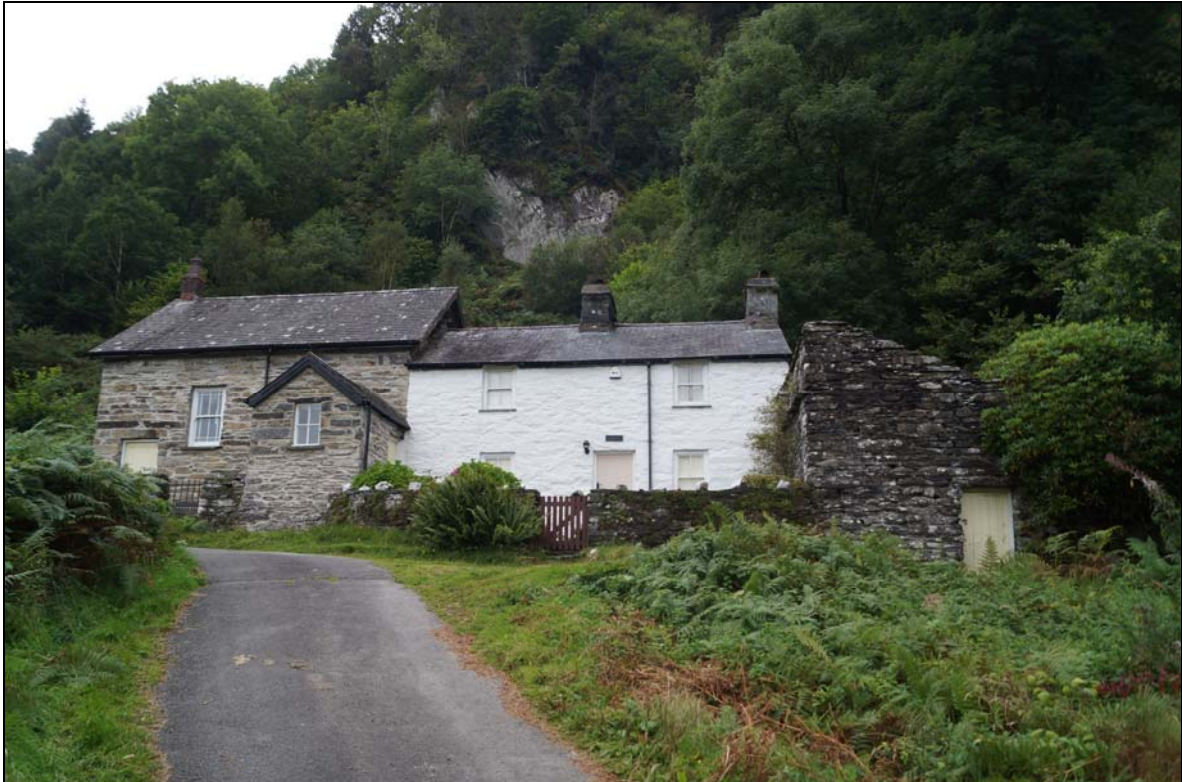
Plate 1: TYC2016_101 – the former chapel/school at Cyfyng, ID numbers 7 & 8 and the attached cottage, ID number 9, looking west.

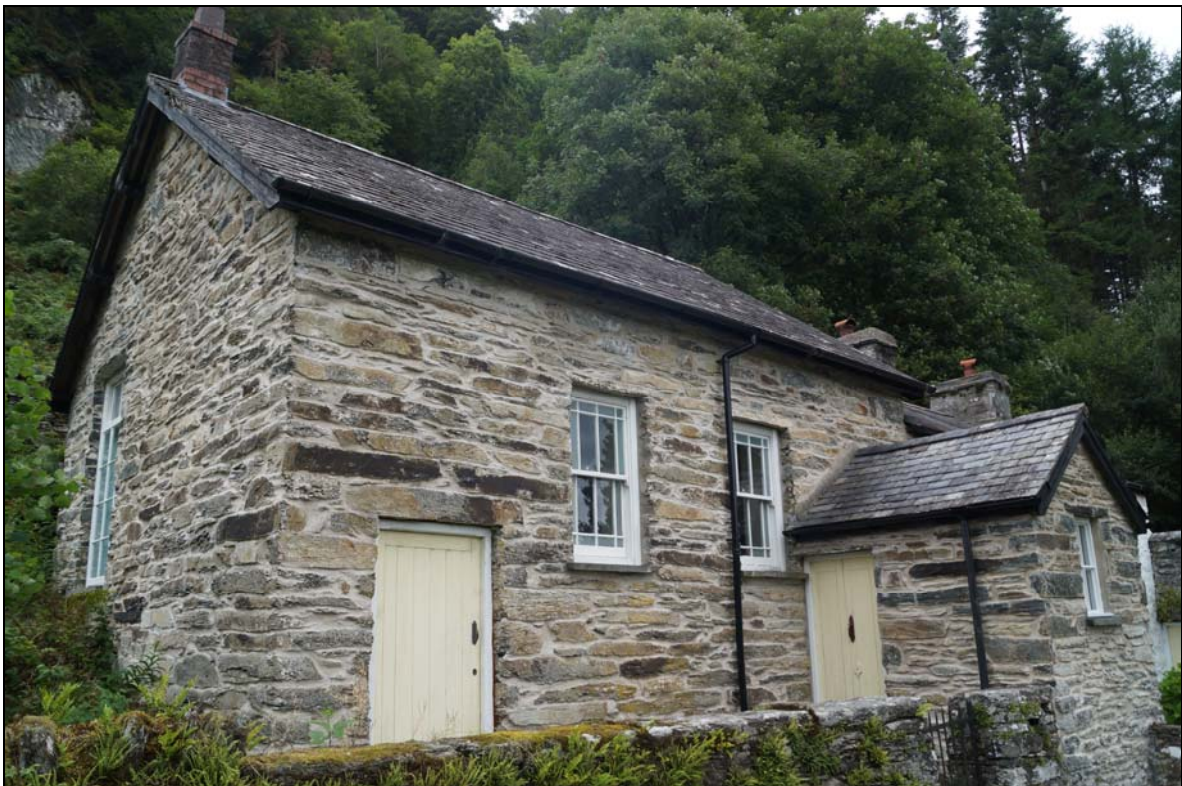
Plate 2: TYC2016_102 – the former chapel/school at Cyfyng, ID numbers 7 & 8, looking northwest.

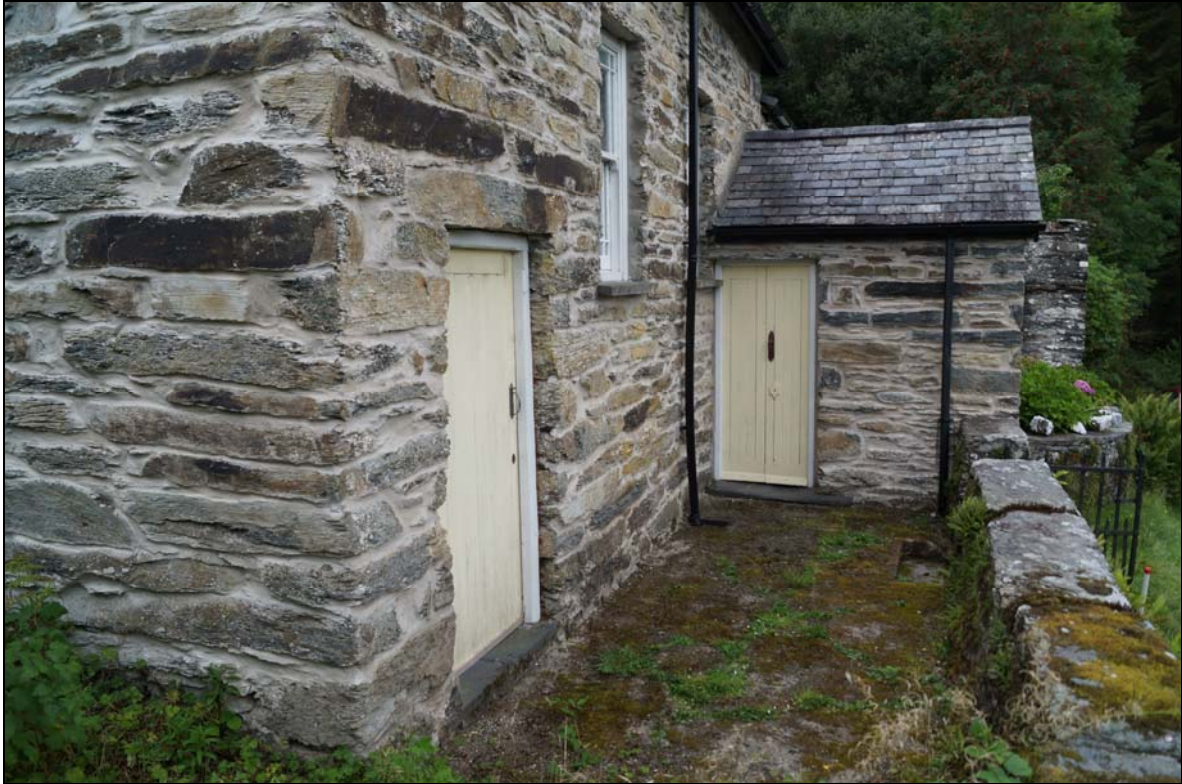
Plate 3: TYC2016_103 - the former chapel/school at Cyfyng, ID numbers 7 & 8, looking northwest. The porch was added after 1900 when the building was used as a school.

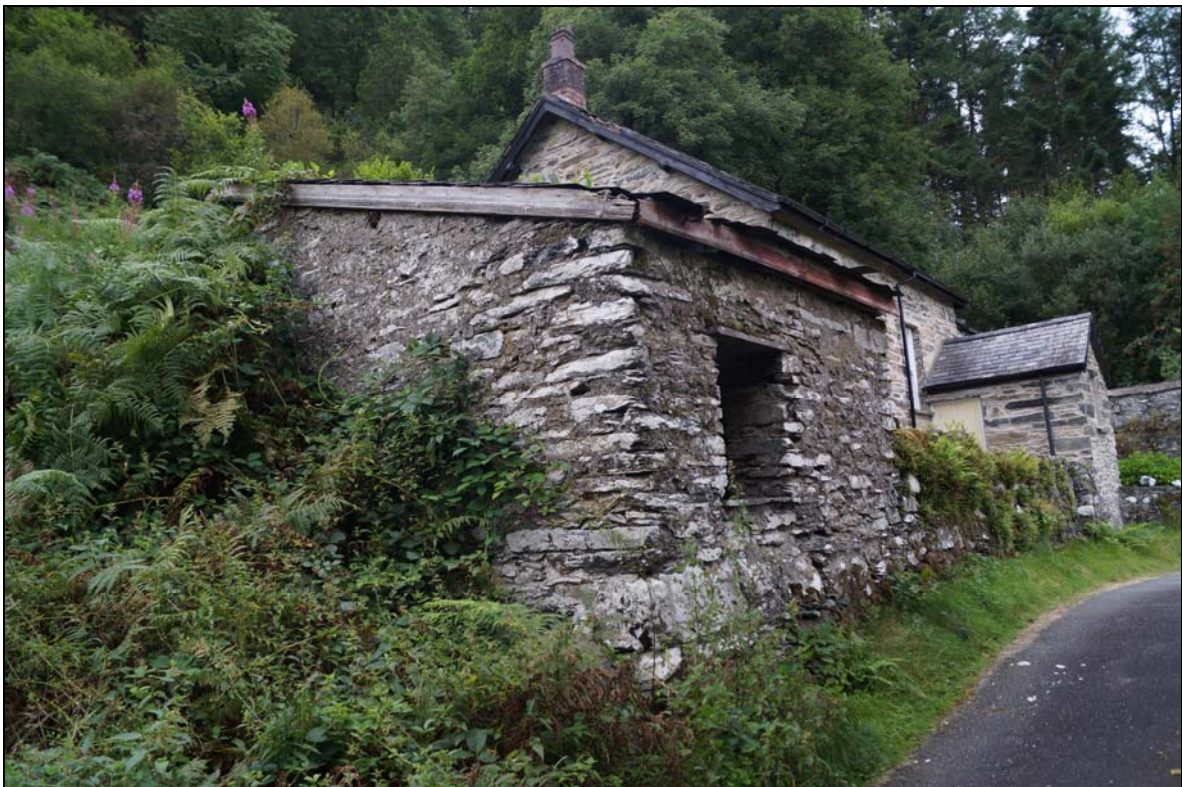
Plate 4: TYC2016_104 - the former chapel/school at Cyfyng, ID numbers 7 & 8, looking northwest. The outbuilding in the foreground was also added after 1900 when the building was used as a school.

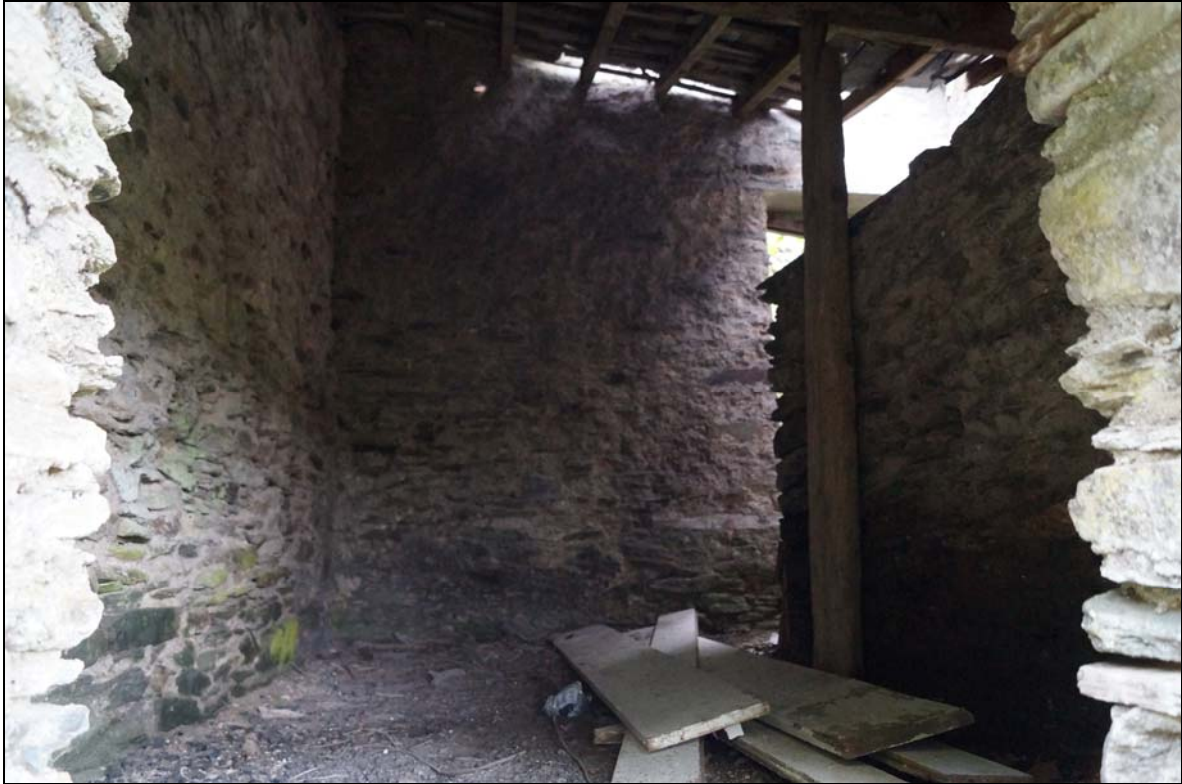
Plate 5: TYC2016_105 – the interior of the small outbuilding added to the former school at Cyfyng, ID numbers 7 & 8, looking west.

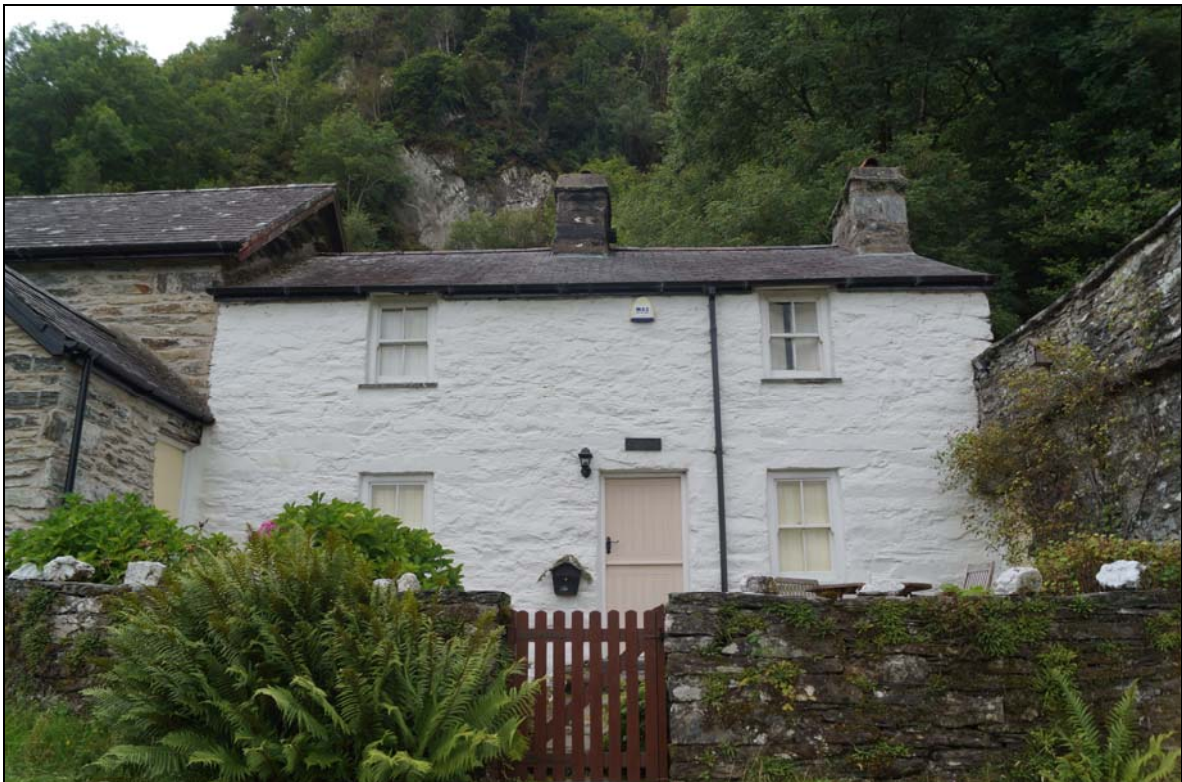
Plate 6: TYC2016_106 – Cyfyng cottage, ID number 9, looking west. It was once two cottages, with the lintel of a blocked up doorway still visible at the extreme left hand side of the front elevation.

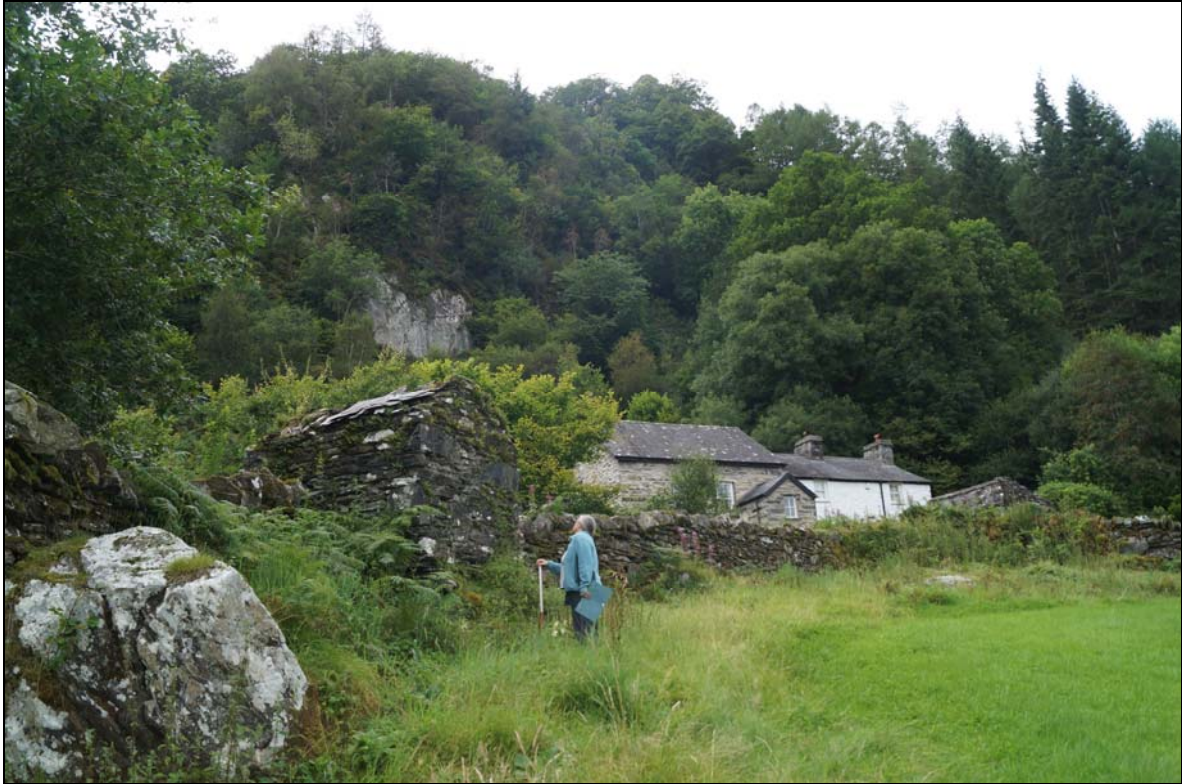
Plate 7: TYC2016_107 - the latrine of the former school at Cyfyng, ID number 3, looking west-northwest.

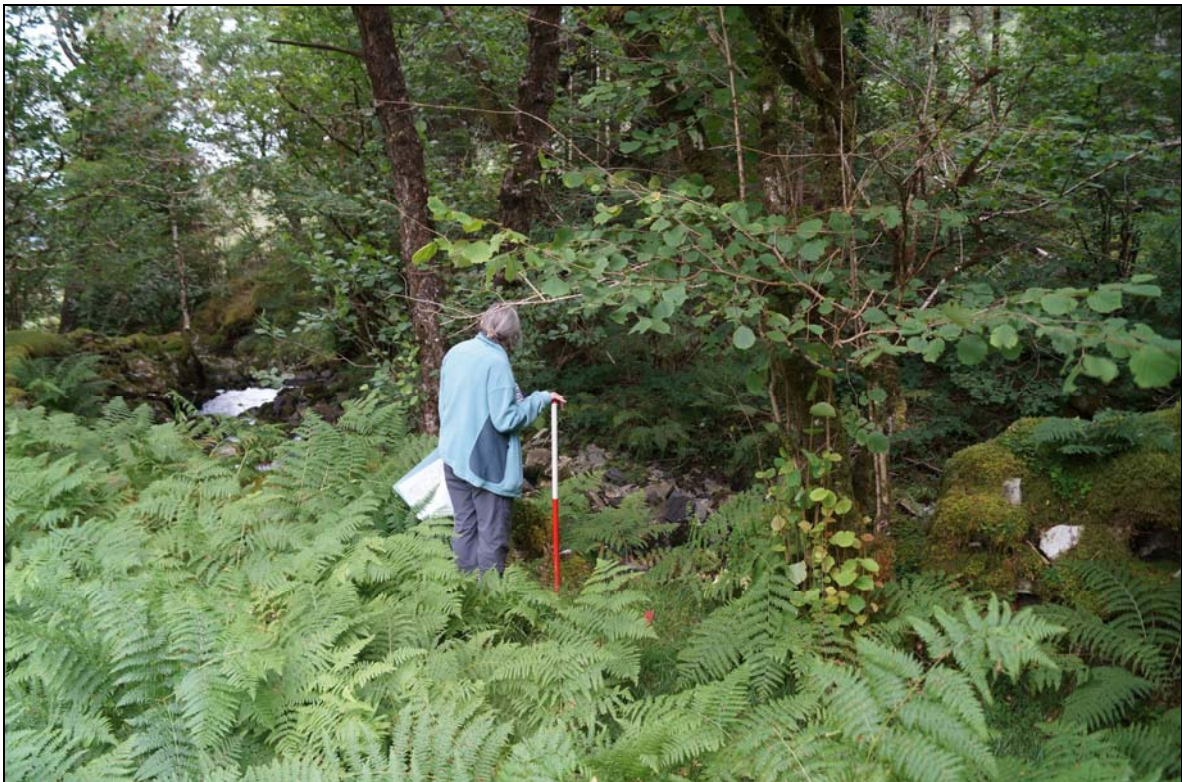
Plate 8: TYC2016_110 – a view of the proposed turbine housing site on the western bank of the Afon Wybrnant, looking east. Standing sections of Wall, ID number 1, are visible at the left and right sides of the image.

Any Indirect Impact?: Yes
Very Low
Standing sections of the wall could be damaged accidentally during construction.

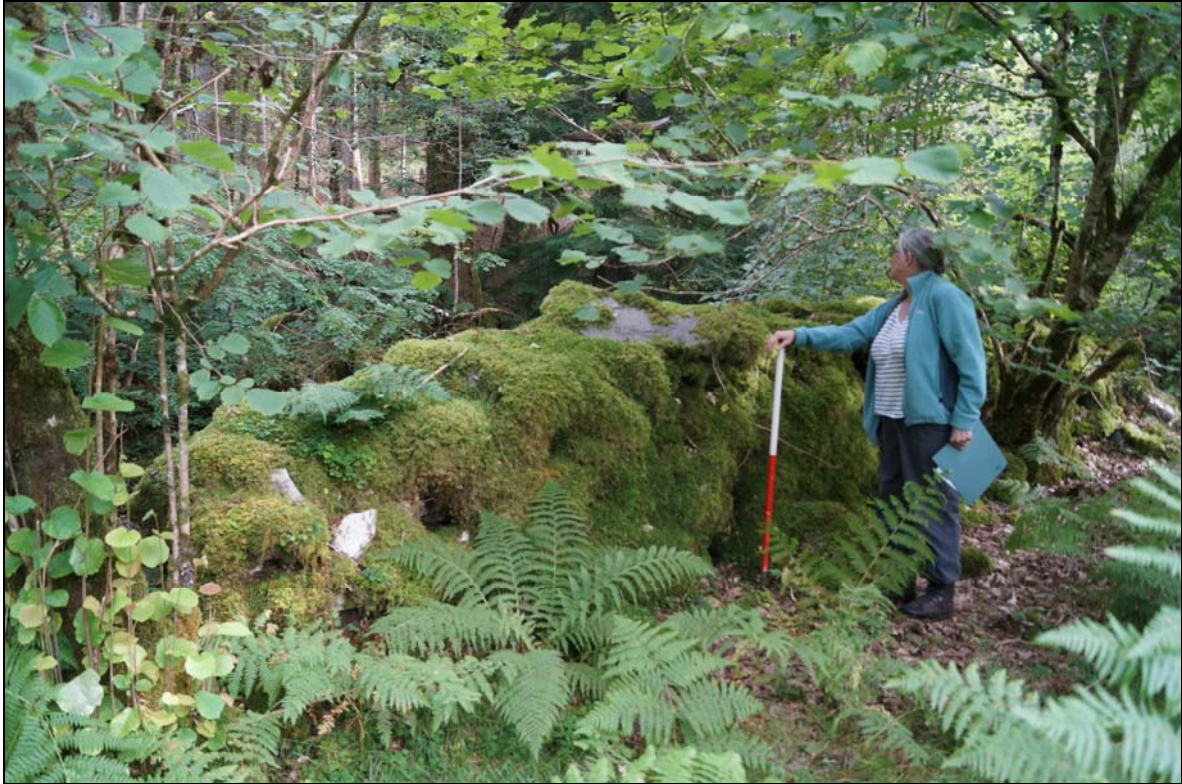
Plate 9: TYC2016_111– A standing section of Wall ID number 1 close to the proposed site of the turbine housing, looking south.

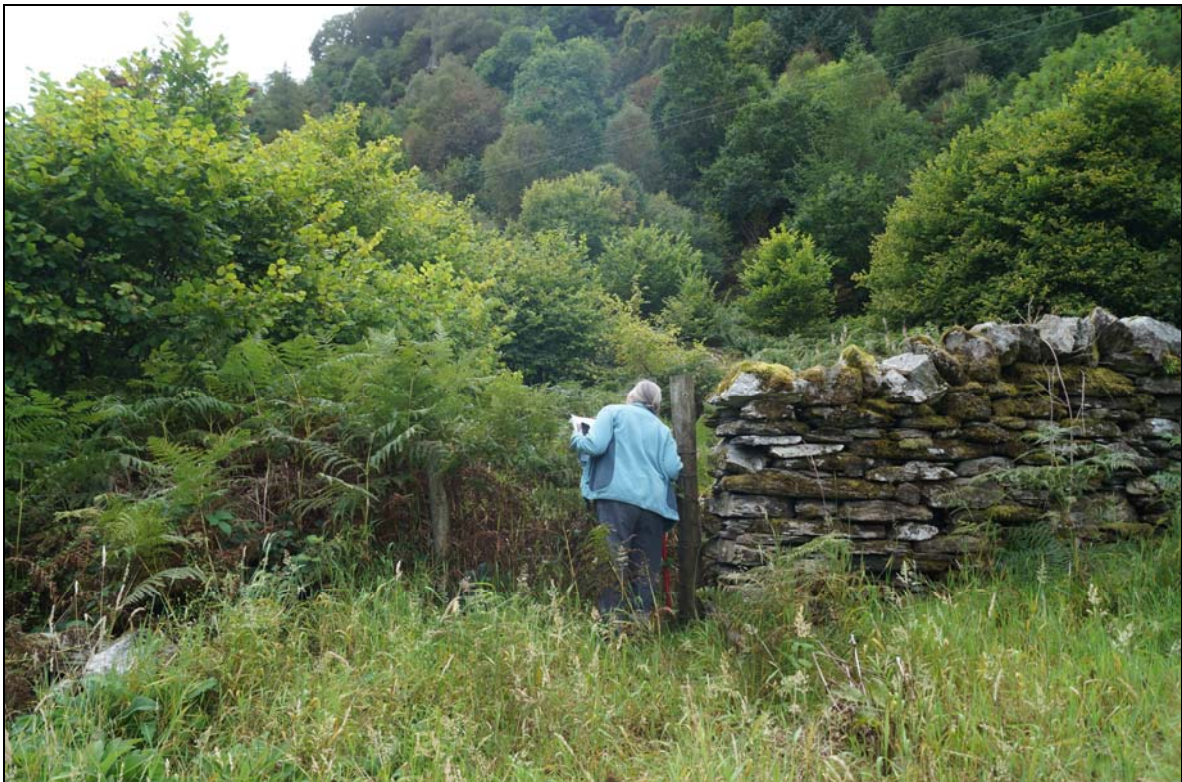
Plate 10: TYC2016_112 – the pipeline would pass through this former gateway through Wall ID number 2, looking southwest. Note the density of the scrub beyond the wall, in a field which would have been pasture a century ago.

Comment on Impact: The buried pipeline would pass through an existing gap in the wall line and should have no impact on the wall. Care should be taken during pipe-laying that machines do not hit the wall and cause damage.

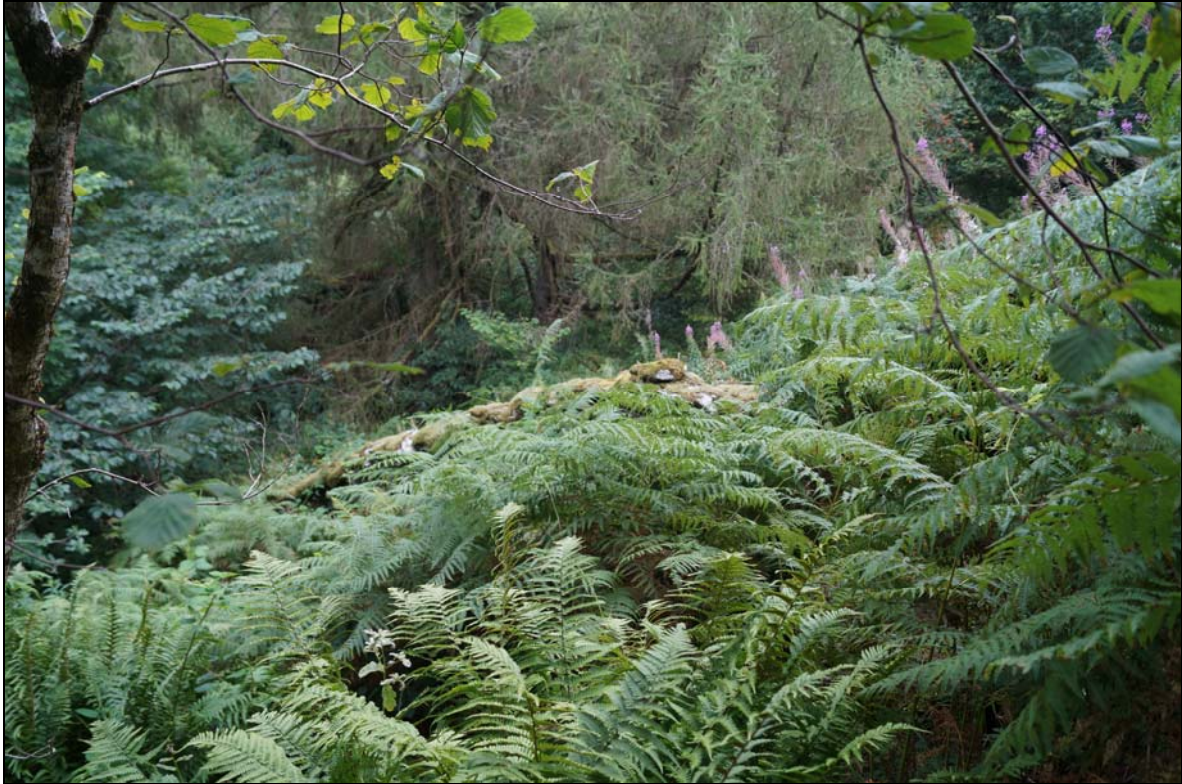
Plate 11: TYC2016_113 – a glimpse of Wall ID number 5 looking east-southeast from the road between Cyfyng and Tan y Clogwyn. This steep slope was enclosed in the 19th century and used as pasture but in modern times has become overgrown as scrub has spread along the valley side.

Comment on Impact: The proposed pipeline will cross the line of this wall. When visited in September 2016 the ground vegetation made it difficult to assess the condition of the wall where the pipeline would run. Damage to the wall should be avoided by either moling the pipe beneath the wall or by restoring the affected section of wall to its present condition once the pipe has been laid.

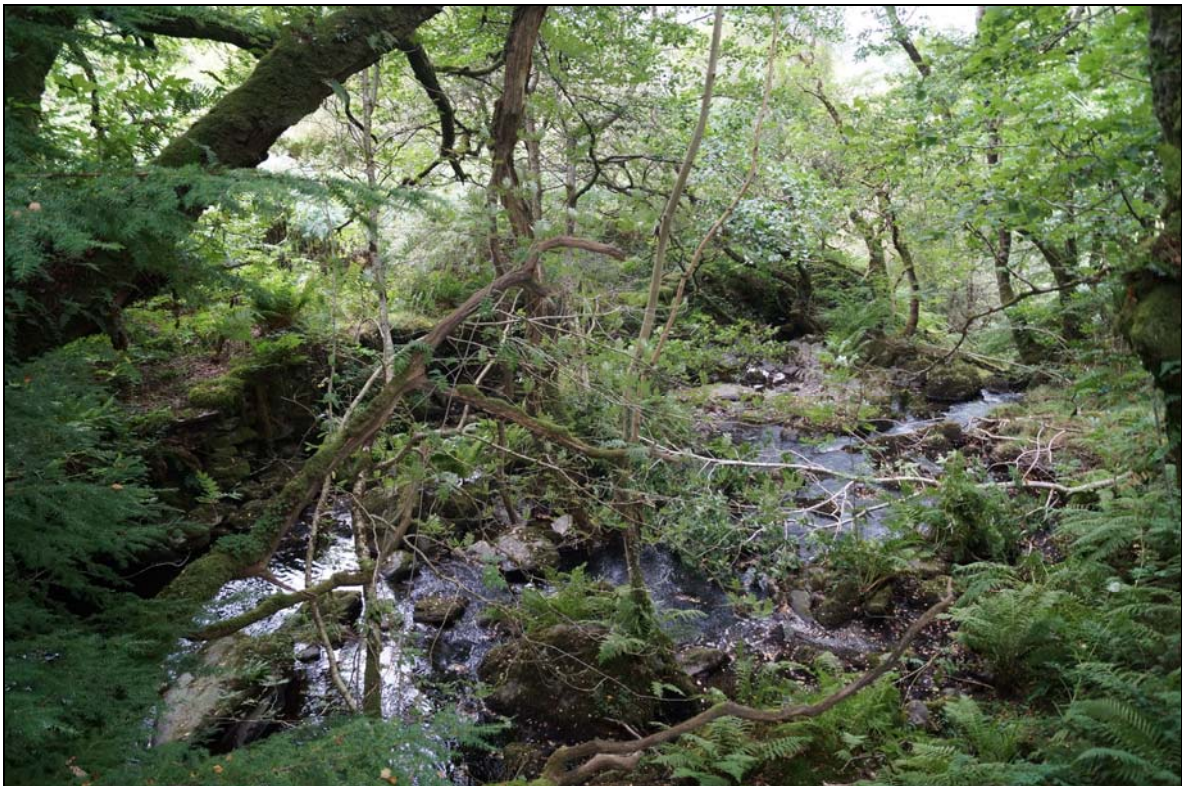
Plate 12: TYC2016_114 – the section of the Afon Wybrnant below where the intake tank would be positioned, looking north-northwest. The concrete dam of the intake tank would be positioned in the bottom left-hand corner of this image.

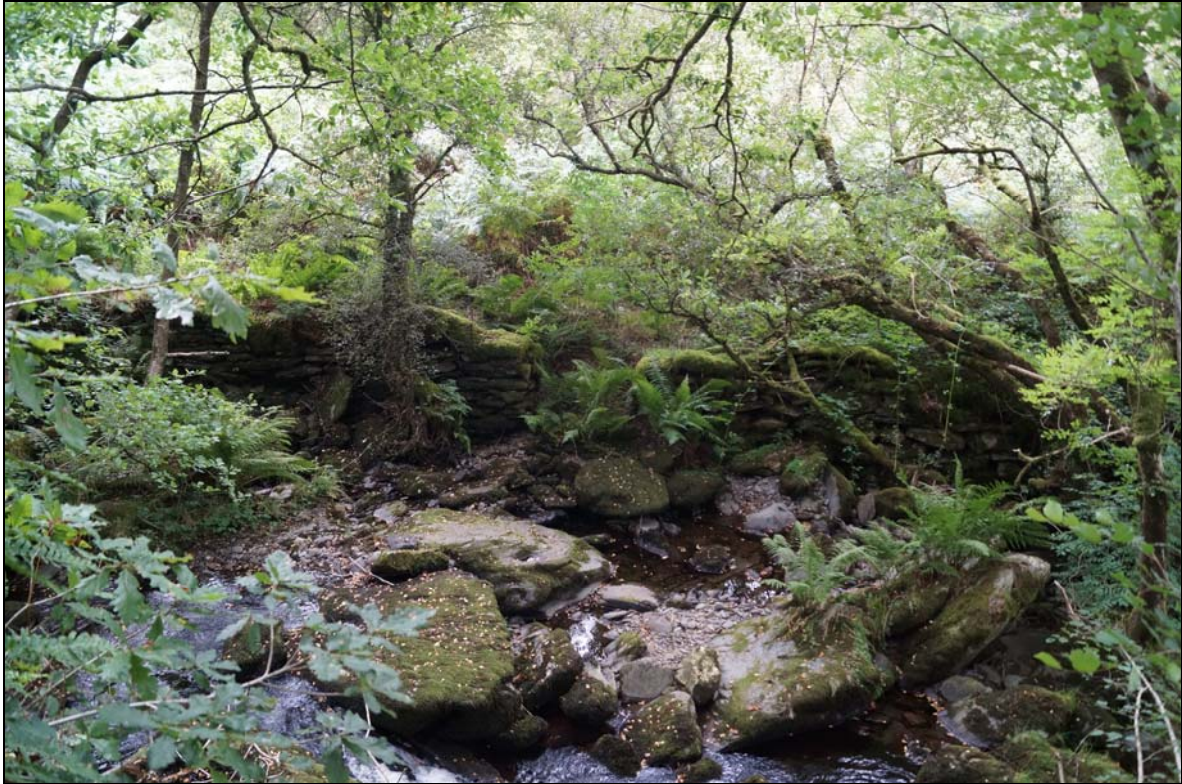
Plate 13: TYC2016_115 – the western riverbank below the proposed site of the intake tank has been revetted (ID number 6). This revetment may be a continuation of Wall Id number 5.

Comment on Impact: The intake tank would be positioned at the end of the revetment and the construction of the tank and the inlet pipe are likely to impact on a small section of it. This is a feature of minor importance and the loss of a small section should not be seen as a matter of concern. The remainder of the revetment is in better condition and would not be impacted upon.

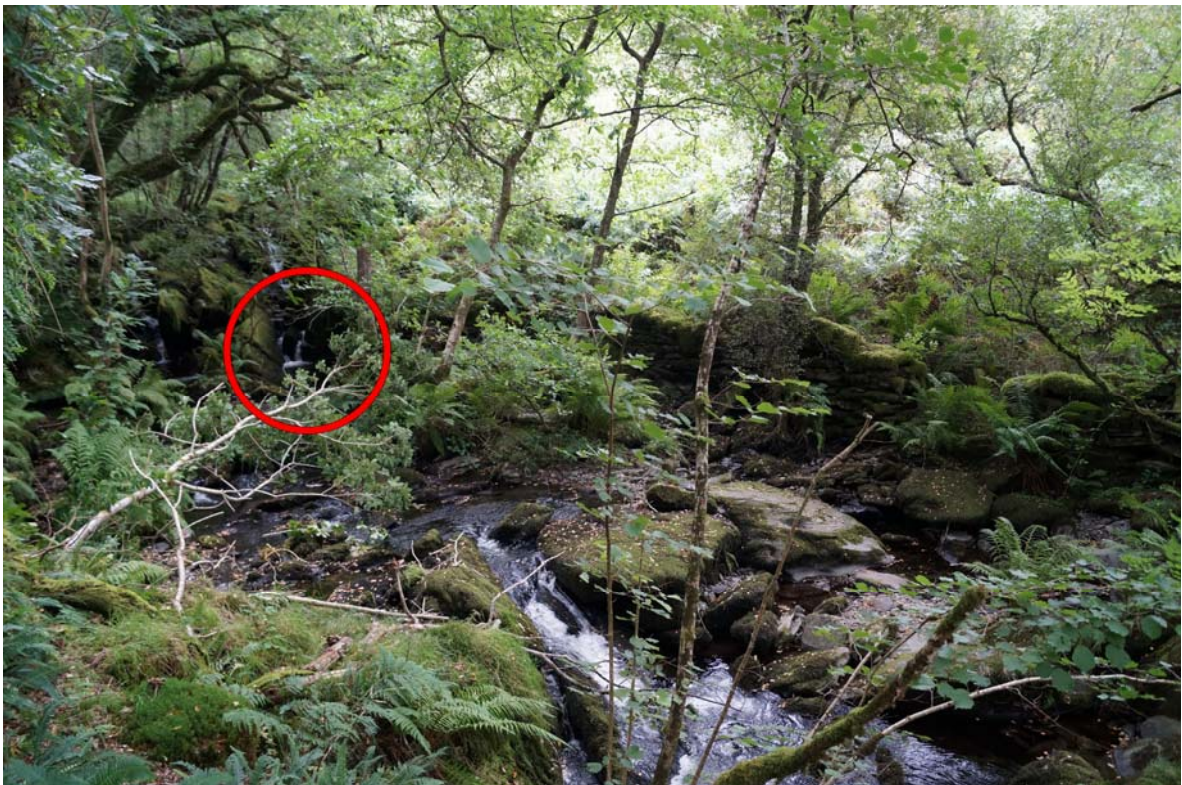
Plate 14: TYC2016_116 – another view of the site of the proposed intake tank, looking southwest. The concrete dam of the intake tank would be positioned in front of the small cascade circled in the image. It would slightly disturb the southwestern end of the revetment wall ID number 6, but the impact on this minor feature would not be considered to be significant.

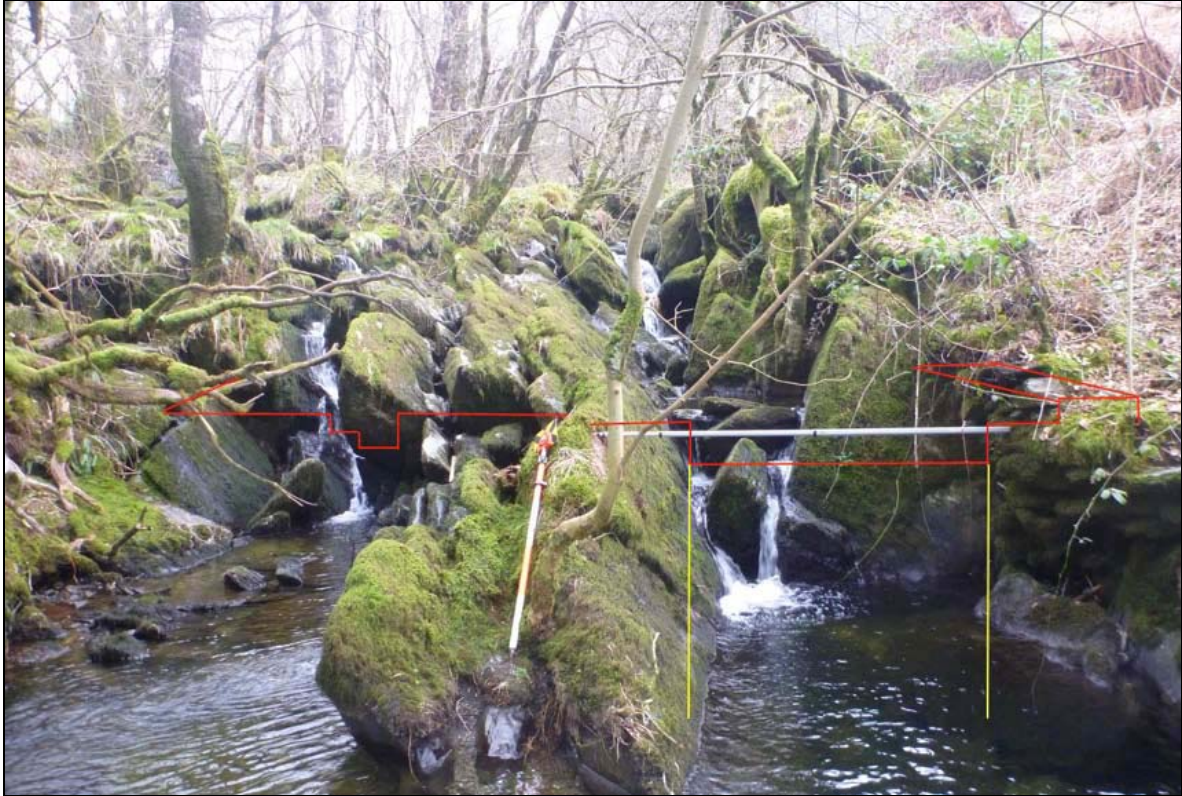
pipeline would cross both of these walls, whilst the intake tank would be built against the revetment and be likely to disturb a small portion of it (see Plate 15 in Appendix C). All three are minor features and the damage to each would not be significant.

Plate 15: A view of the site of the proposed intake tank, looking southwest, with the outline of the intake tank and outlet overlain. Note the end of the revetment wall (ID number 6) to the right, which would experience some impact from the development. Photograph supplied by TGV Hydro.
