CPAT Report No. 1694

Pentre Barns, Llandyssil, Powys

BUILDING SURVEY

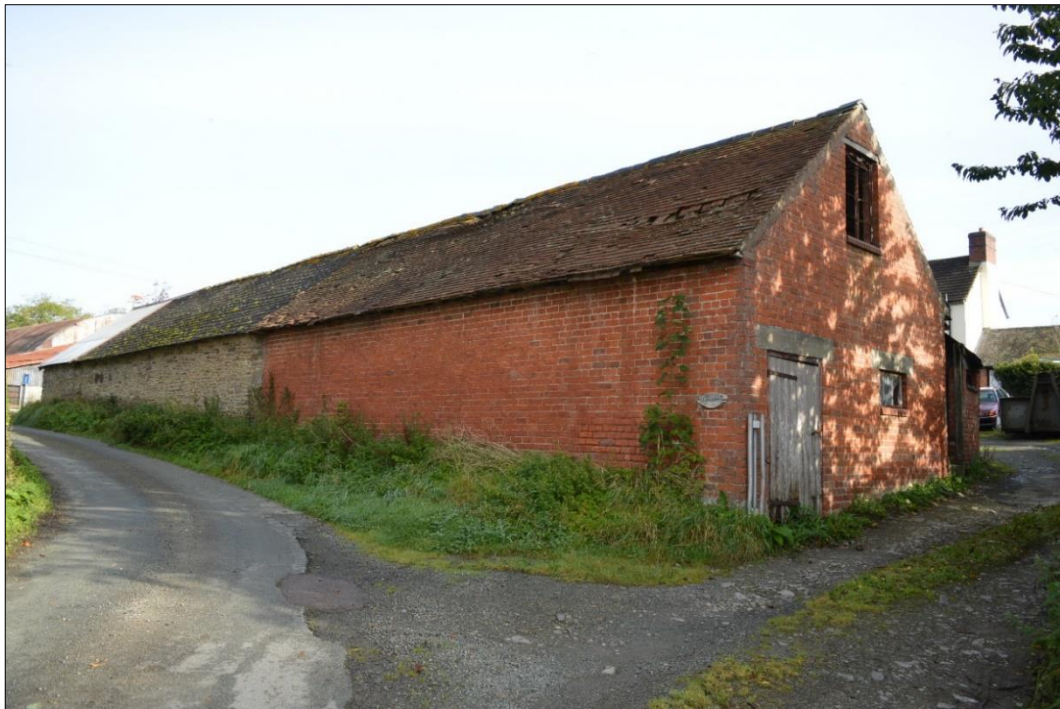
Fig. 4 Building A, south-west elevation. Photo CPAT 4697-0009

- 3.3. Building A was a long range, positioned alongside the lane. The original barn or cow house was of stone construction, with five bays internally, divided by simple trusses and timber partitions with a central king post truss. Carpenters' marks survived on several of the trusses.

- 3.4. A passage ran along the south-western side of the building with a feeding trough and hay rack running along its north-eastern side. An additional passage ran down the north-eastern side of the building, with a step up to the feeding trough.

- 3.5. The current roof of the original stone barn on the north-western side (alongside the lane) comprised what appear to be partly asbestos tiles and partly corrugated sheeting. On the north-eastern side, facing the farmhouse the roofing comprised rounded red clay tiles.

- 3.6. Original stone walling survived to the south-western elevation and the north-western gable but had gone elsewhere, presumably having been removed when the building was extended sometime in red brick between 1886 and 1902. This brick extension provided an additional four bays to the buildings south-eastern end and the feeding trough and passages were extended across the new bays internally apart from the south-eastern bay in which the floor level is considerably lower owing to the slope on which the barn is positioned.

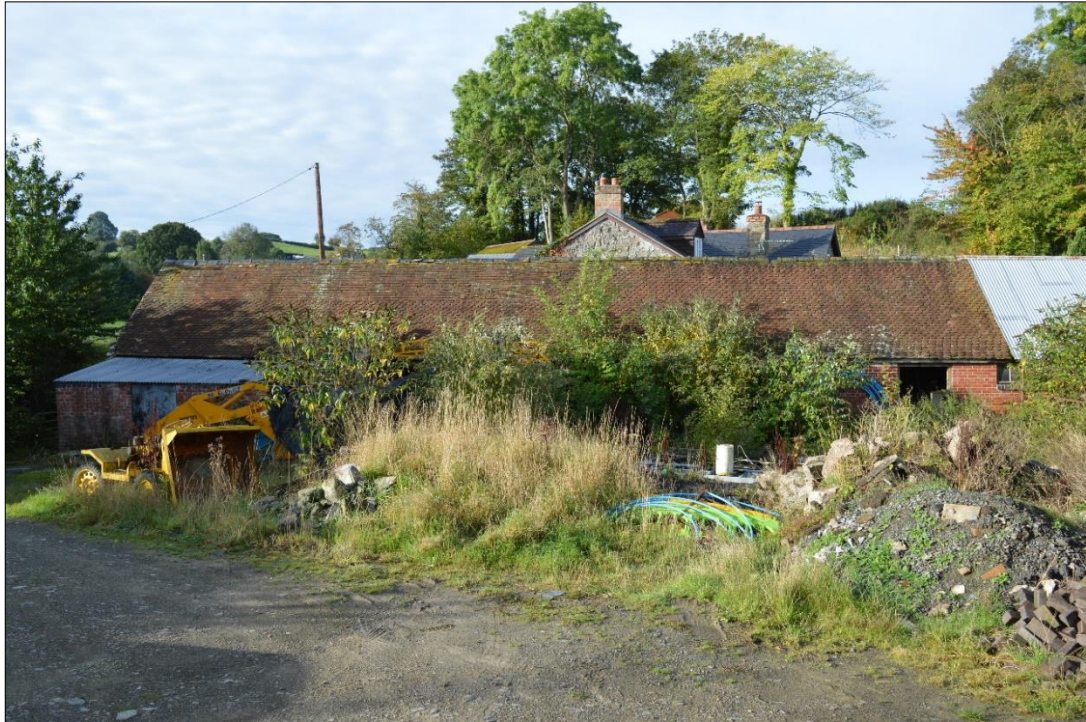
Fig. 5 Building A, viewed from the north-east. Photo CPAT 4697-0002

- 3.9. A brick lean-to adjoined the south-western end of the north-eastern elevation of the barn, which appears to be contemporary with the brick extension. Beyond this, the north-eastern elevation of the entire barn appears to have been subsequently rebuilt, probably sometime in the 20th century in similar red-brick style, employing bull-nosed bricks for the window sills and door jambs, as well as small iron framed windows.

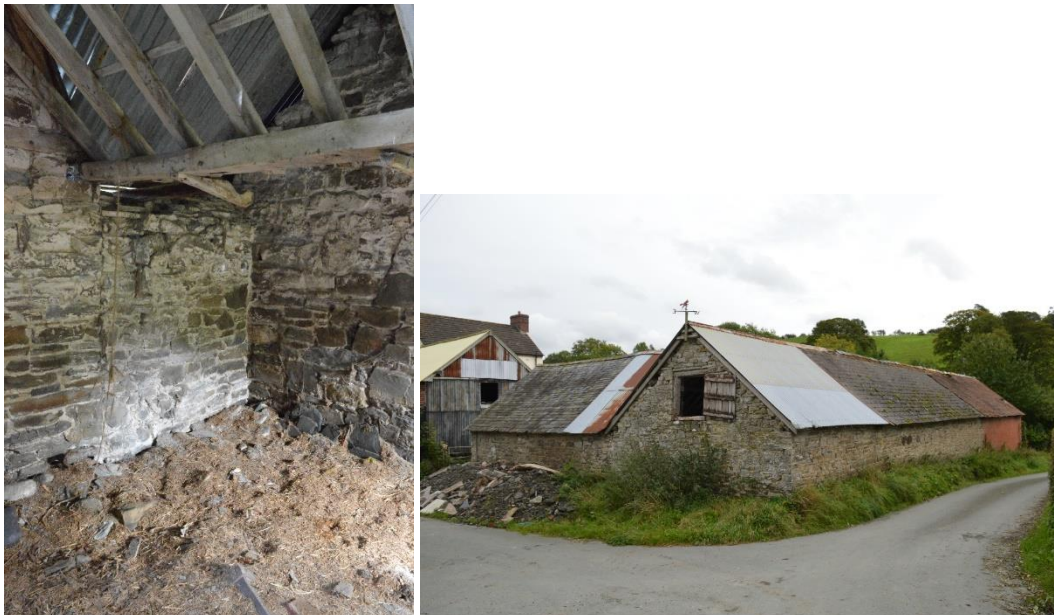
Fig. 6 Building A and the smaller stone building viewed from the north-west. Photo CPAT 4697-0048 and Building A internally showing the join in the stone work beside the north-west gable. Photo CPAT 4697-0028

- 3.10. Between 1902 and 1953, the original stone barn was joined to a smaller stone building located at right angles at its north-eastern end. The small gap (1.38m) between the two buildings was infilled with grey stone walling, using stone which may have originated from the original stone barn. The join within the stone walling can be seen externally and internally. At this time it appears that the north-western end of the barn and the small space between it and the smaller building were roofed in corrugated sheeting.

- 3.11. The smaller stone building which adjoins Building A was a single storey stone building with slated roof and a central king post truss. A single doorway in the south-western gable allowed access from the main barn.

- 3.12. A feeding trough of breeze block construction was positioned across the south-western end and internally the floor had been concreted. A large double doorway had been inserted within the north-eastern gable and the south-eastern elevation had been entirely re-built in red brick, most likely when the original stone barn was extended by the appearance of the brick work.

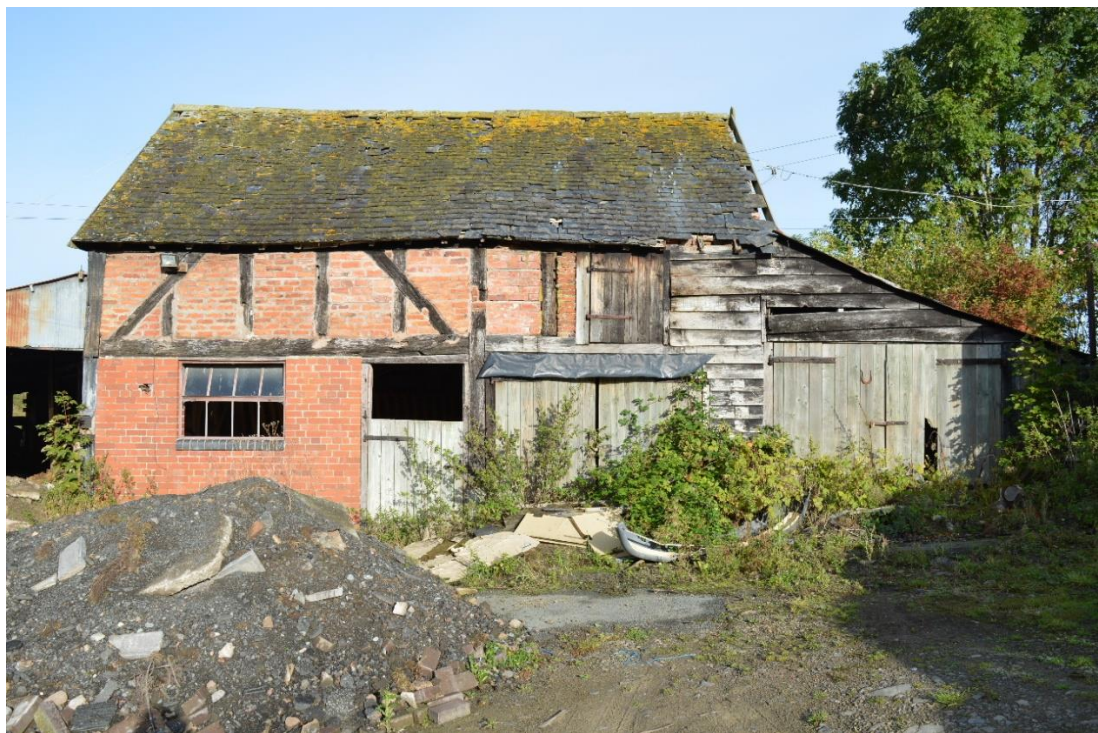
Fig. 7 Building B viewed from the south-east. Photo CPAT 4697-0001

- 3.14. Building B comprised a single-storey building with loft above. The building was timber-framed with red brick infill panels and a slate roof. Externally, the elevations had been partly weatherboarded and covered with corrugated sheeting. A lean-to at the north-eastern end was built in brick and breeze block, while a lean-to at the north-western side was built using timber-frame and breeze block.

- 3.15. Timber framing survived on the south-eastern elevation to the loft floor (see figure 4), though very little survived at ground level, with a large modern red brick infill, probably of late 19th-century date, to the south-western side and an inserted metal framed window. A single, central doorway provided access to the ground floor, though it was not possible to gain entry owing to the quantity of material deposited outside the building. To the right of this was a large double doorway.
- 3.16. Elsewhere, despite being obscured externally by corrugated sheeting and the additional lean-to structures, timber framing survived on all remaining external elevations and internal partition walls. A hand drawn and/or photographic record was made where possible.

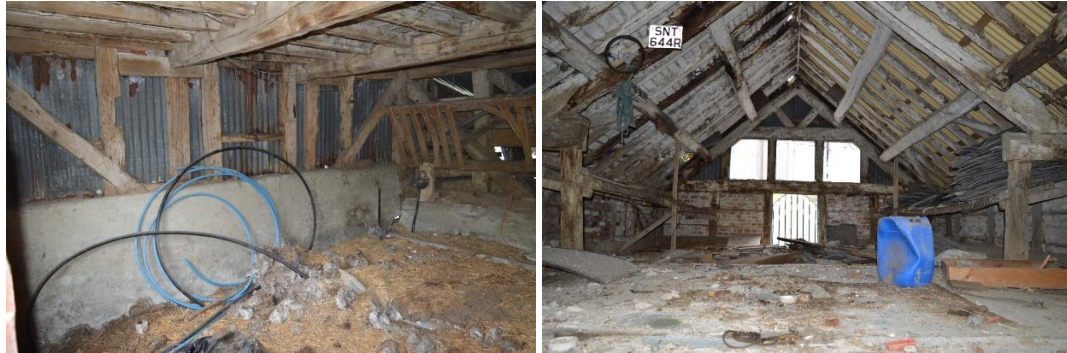
Fig. 8 Building B, south-west internal elevations. Photo CPAT 4697-0053 / 4697-0057

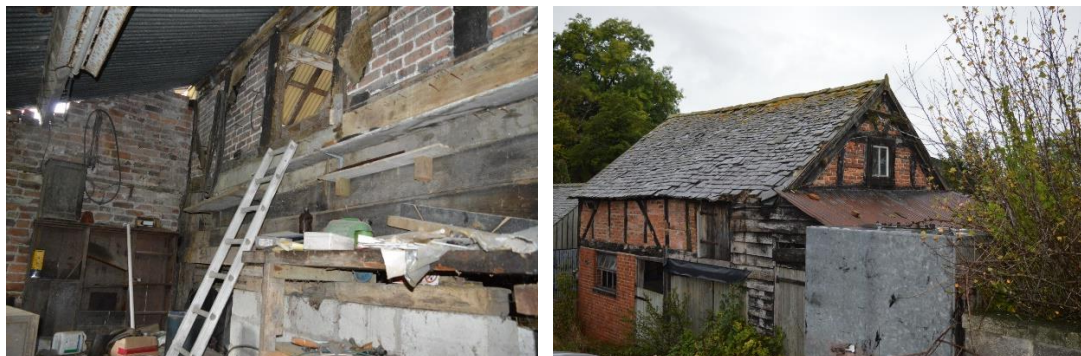
Fig. 9 Building B, north-east gable. Photo CPAT 4697-0055 / 4697-0067

- 3.17. The north-east gable (see figure 9 above) contained a small, metal-framed window to the loft, with a hatch below providing access to the loft area. This arrangement was mirrored on the south-west gable although there was no window insert surviving. Access to the loft floor was also possible from the north-eastern side of the building from the ground floor via a ladder up through a hole in the floor (figure 10).

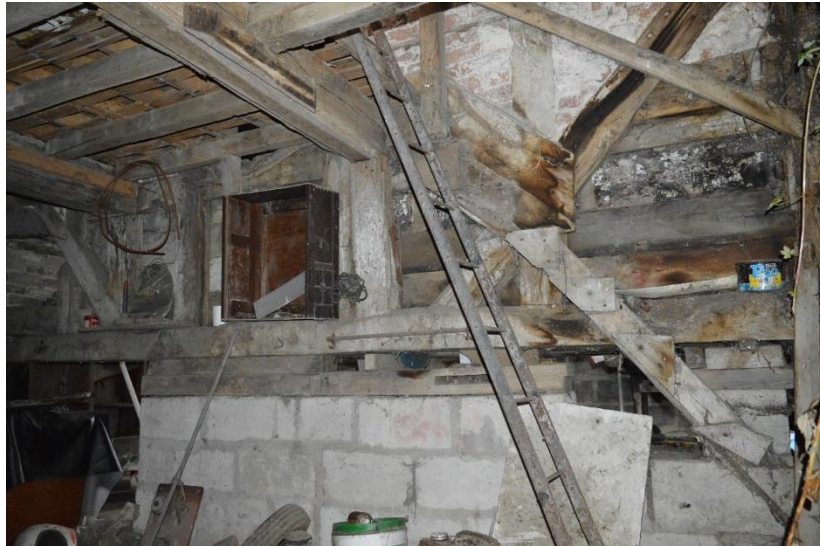
Fig. 10 Building B internal view of the north-east gable. Photo CPAT 4697-0066

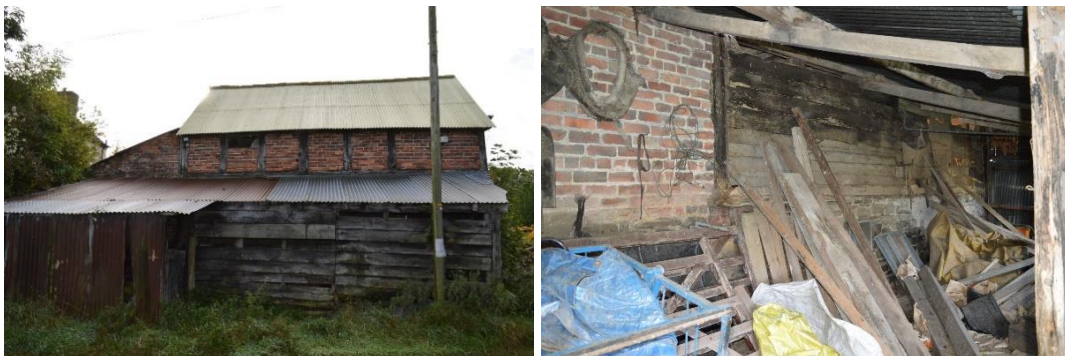
- 3.18. A lean-to was constructed against the north-western elevation of the building, which was partly breeze block and partly timber-framed, with cladding in either weatherboard or corrugated-iron. The interior permitted partial views of the lower section of the original external elevation, while the exterior of the loft was visible above the lean-to.
- 3.19. Internally the original building comprised two bays, the south-western side being inaccessible at the time of the survey, although it was possible to obtain some photographs through the doorway and loft hatches.

Fig. 11 Building B, north-west elevation. Photo CPAT 4697-0013 / 4697-0015

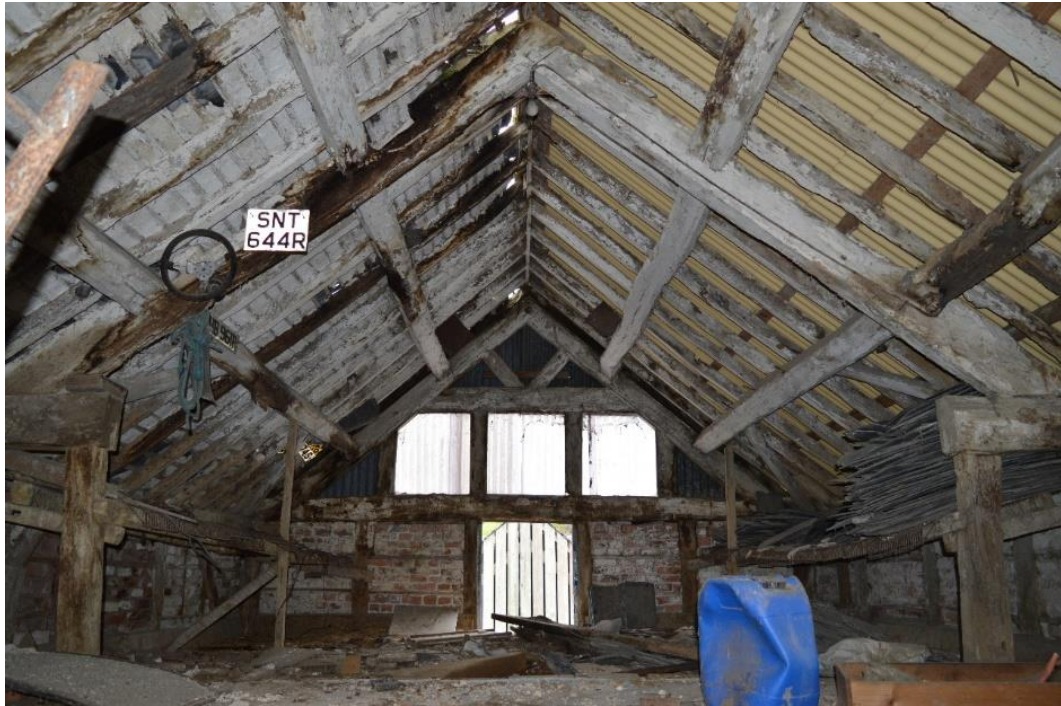
Fig. 12 Building B, south-west gable – internal view. Photo CPAT 4697-0058

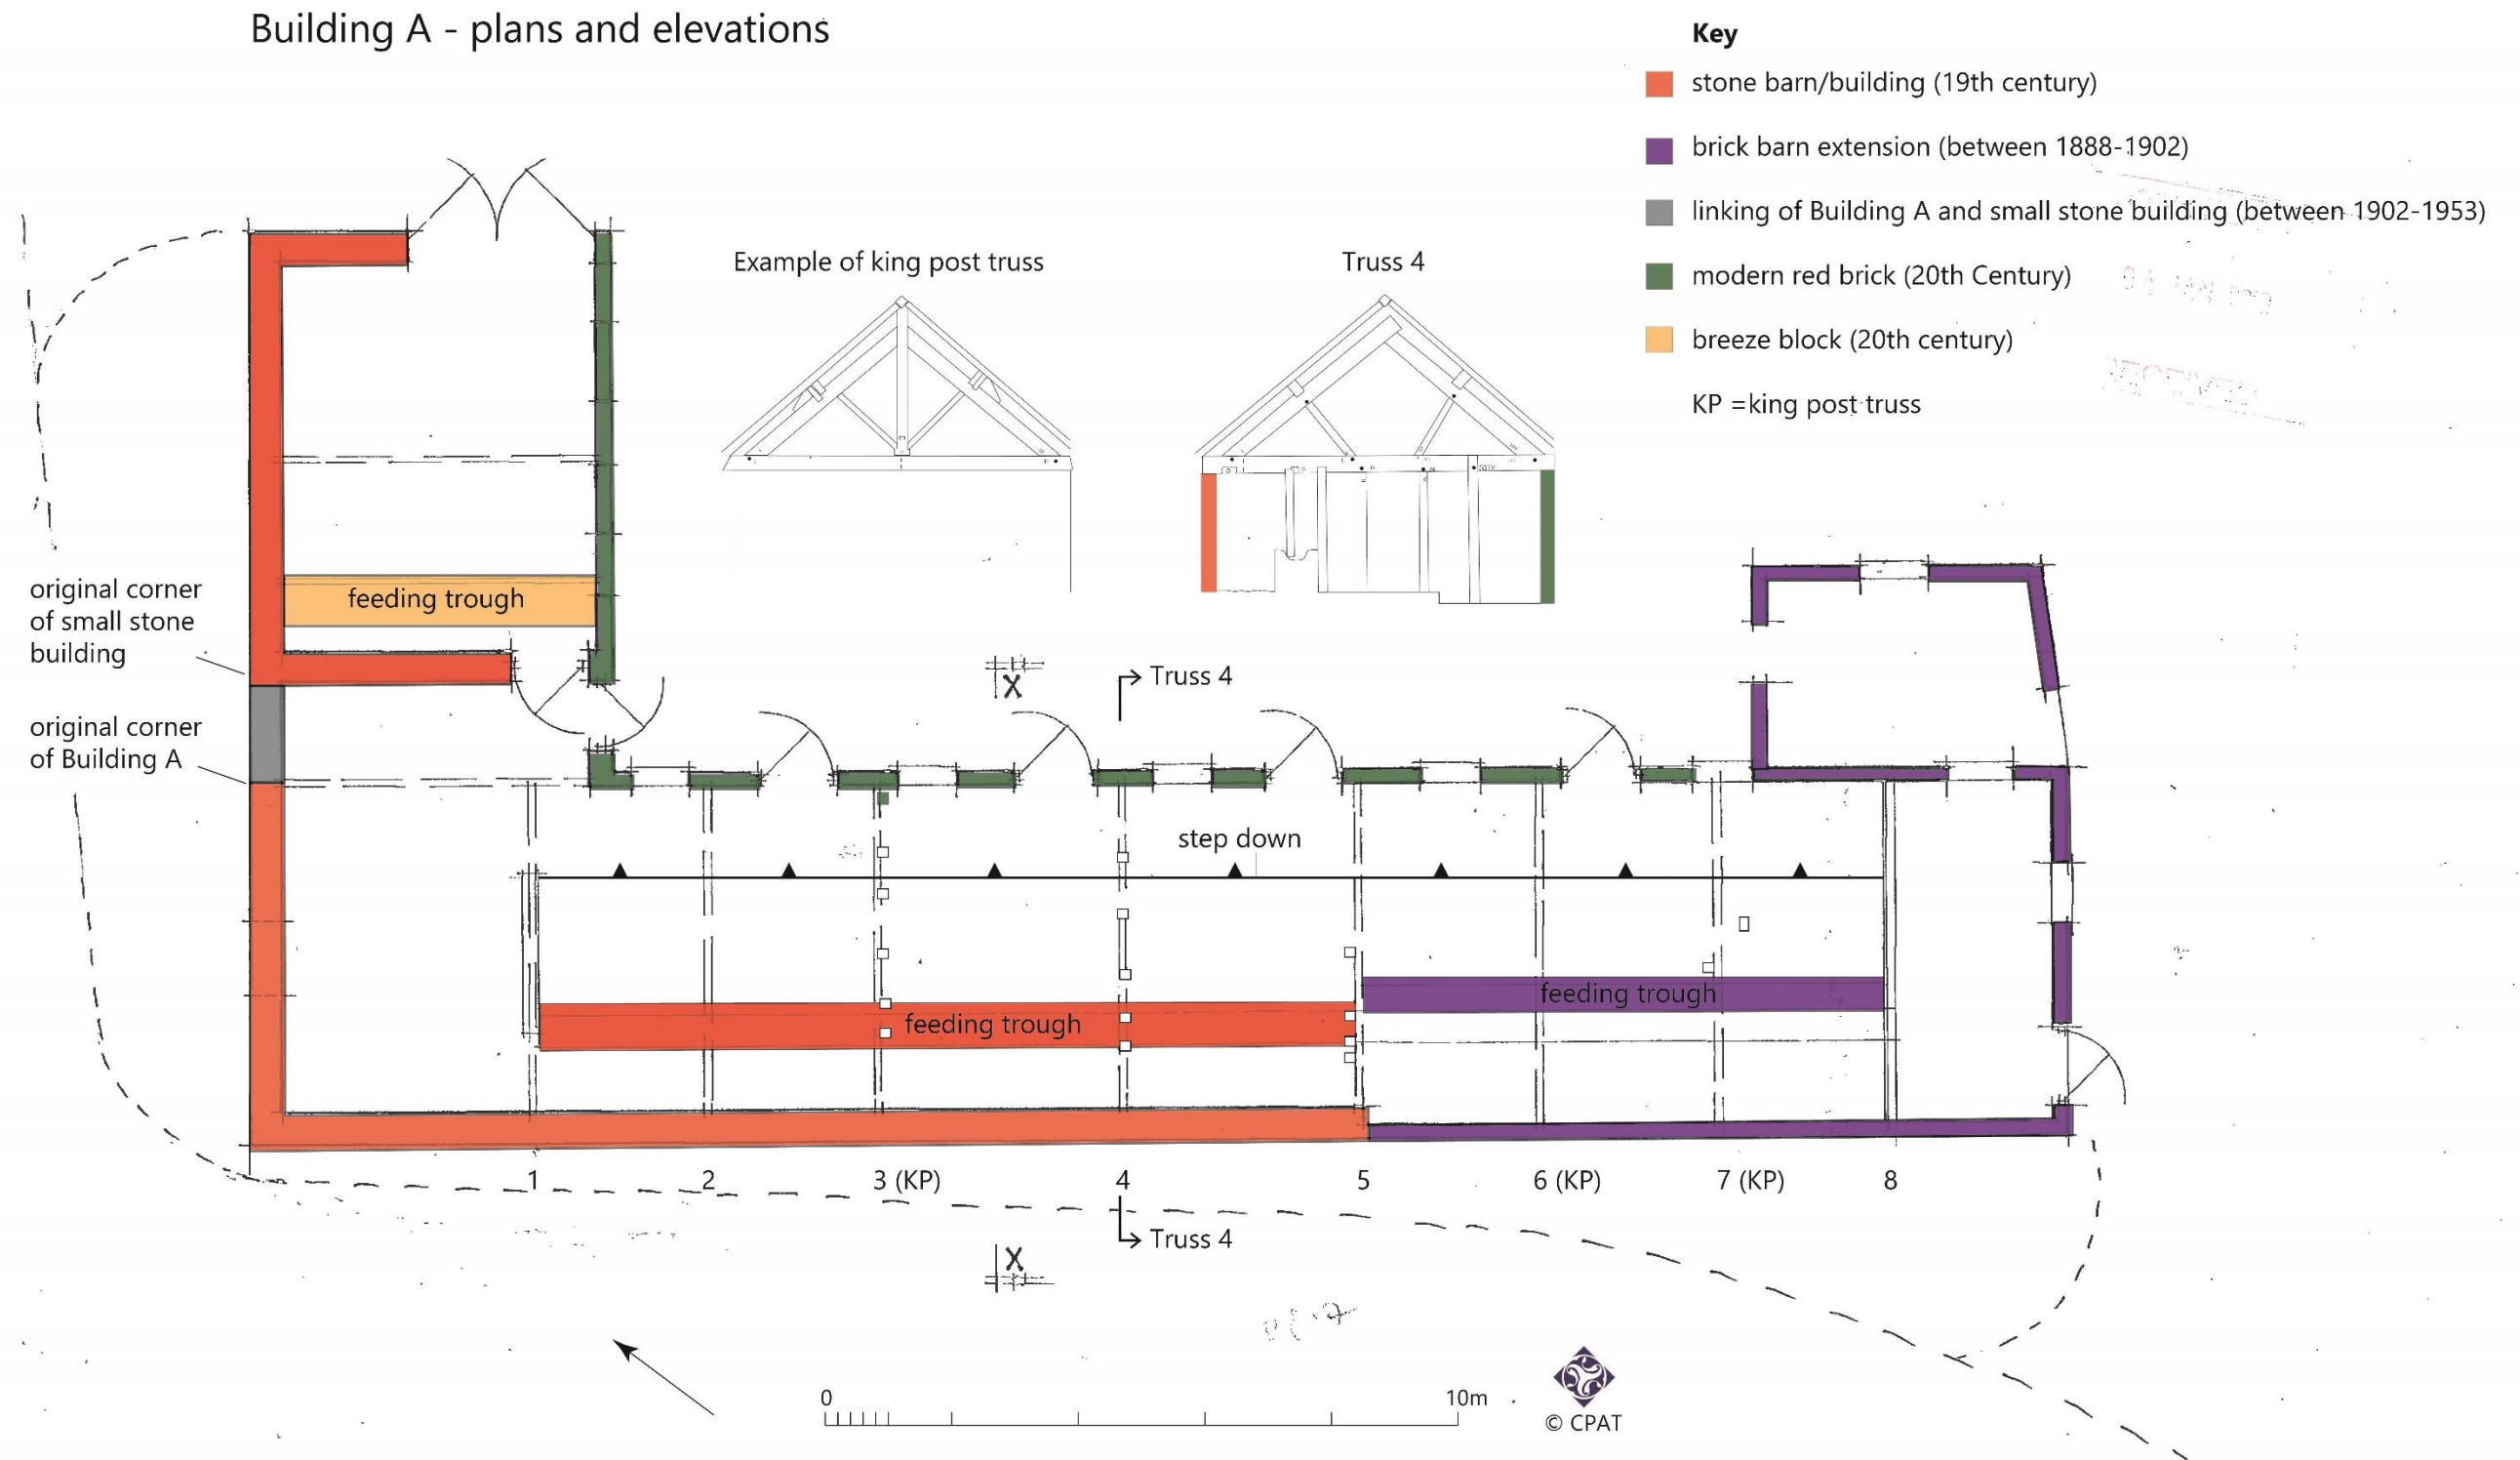
Fig. 16 Building A phase plan with truss examples (based on existing architects plans supplied by the client)
