# Plas Gwyn, Y Ffor Archaeological Watching Brief Commissioned by J. Ellis

# Plas Gwyn, Y Ffor, Archaeological Watching Brief I.P. Brooks

EAS Client Report 2017/04

March 2017

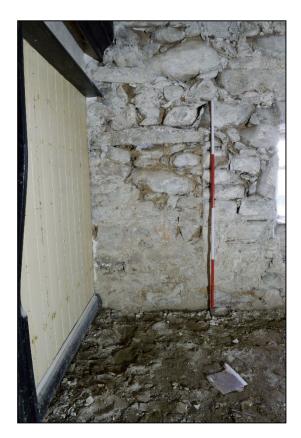
The removal of the plaster from the walls of the ground floor level revealed several features which were previously hidden. In the southern wall of the Hall (Figure 3) there is a blocked doorway (Plate 1) in the south-eastern wall of the Hall, adjacent to the cross-passage screen. The door way was 1.0 m wide and had a stone lintel. The scar for this doorway, although difficult to see, can also be traced in the exterior wall of the house (Plate 2). The position of this doorway may suggest that the building was sub-divided at some point in its history, into two smaller properties.

Plate 1: Blocked door in the eastern corner of the hall

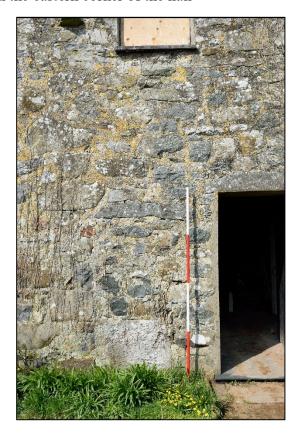
Plate 2: External appearance of blocked door

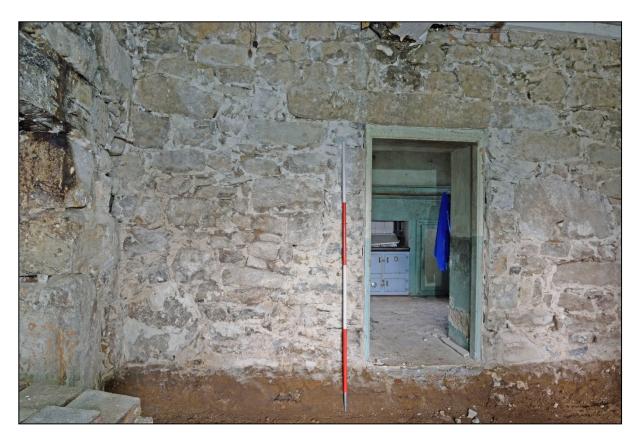
A second blocked opening was recorded in the north-western wall of the hall, a window (Plate 3) immediately adjacent to the inserted door to the kitchen. This window was probably blocked when the kitchen extension was built as the dividing wall between the Kitchen and the Utility also blocks the external face of the window.

Plate 3: Blocked window in the western wall of the Hall

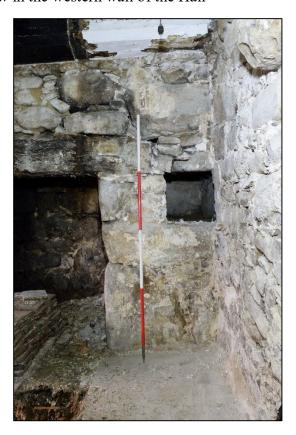
The removal of the plaster exposed the bressumer of the fireplace in the southwestern end of the Hall together some surrounding features. To the north-west, a deep alcove was exposed (Plate 4). This alcove is 0.55 m wide, but 1.1 m deep and is of unknown function. Found within this alcove were two Britannia Metal vessel (see below) which were part of a late nineteenth century tea set. On the other side of the fireplace, and slightly above is the socket for a timber beam (Plate 5). The function of this socket is not entirely clear; however, it is possible that there was a screen dividing the side of the hearth from the door to the intramural stairs, thereby reducing any draft. The fireplace itself has a large, slightly curved, wooden, bressumer (Plate 6) over which there is a stone corbel (Plate 7). This is centrally placed over the fireplace; however, it is at a lower level than the current ceiling and thus may have been either the evidence for an earlier ceiling level. It is more likely, however, that it was used to support some other feature now lost. The door to the intra-mural staircase to the south-east of the fireplace, has a cyclopean door head with a depressed basket arch (Plate 8). The door, itself is a plank door with, blacksmith made, strap hinges (Plate 9) with spade terminals and a zig-zag decoration. It would seem likely that these hinges are contemporary with the construction of the house, however, similar hinges have also been recorded as late as 1740 in Henley, Oxfordshire (Hall, 2005, 49)

Plate 4: Niche adjacent to the fireplace in the hall

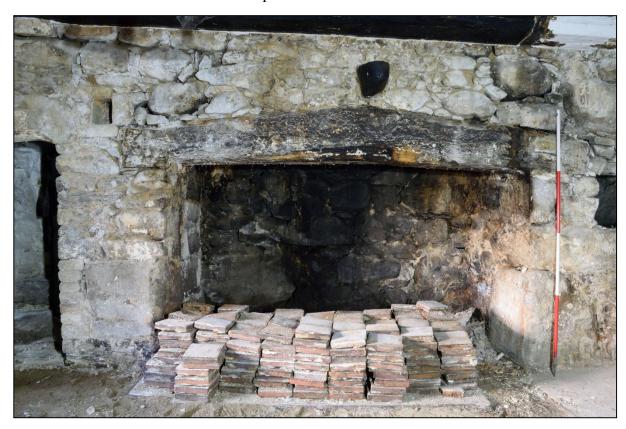
Plate 6: Fireplace in the Hall

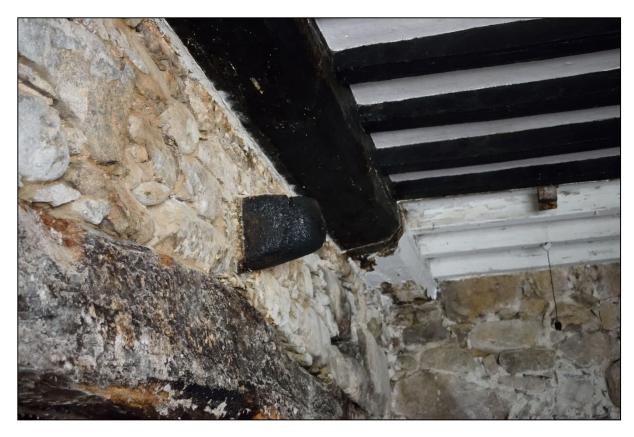
Plate 7: Corbel over the fireplace in the hall

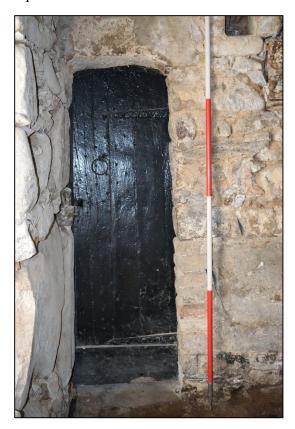
Plate 8: Door to the intra-mural stairs

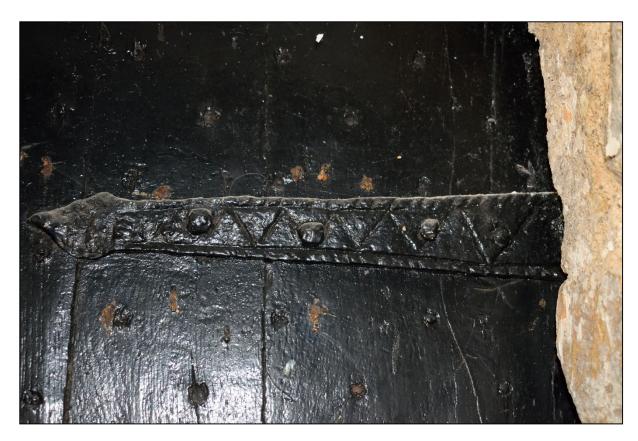
Plate 9: Detail of the hinge

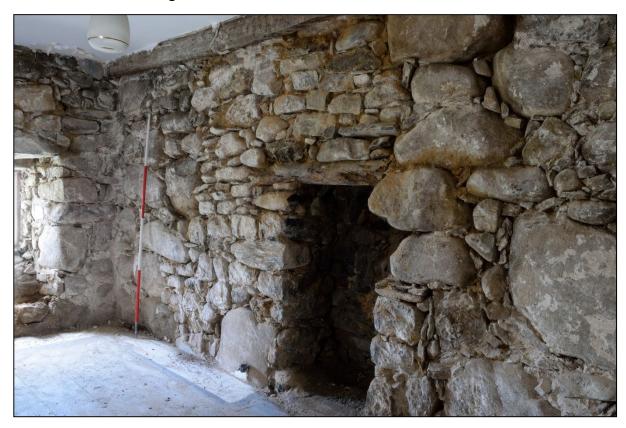
In the Parlour, the current, somewhat small, fireplace sits within a much larger, infilled opening. This opening was 2.72 m wide, which is comparable with the 2.98 m of the fireplace in the Hall. It is likely that the current fireplace represents the replacement of a much larger fireplace, probably in the nineteenth century. There is a second blocked opening adjacent to the window in the south-eastern wall of the Parlour (Plate 11). The exact form and size of this opening is difficult to determine and its function is unknown. In the north-west corner of the Parlour are two large stone projecting from the ceiling level (Plate 12). Although the function of these stones is not entirely clear, it is possible that they supported a staircase, and are therefore associated with the possible division of the property suggested by the blocked doorway in the Hall.

Plate 10: Infilled fireplace in the Parlour

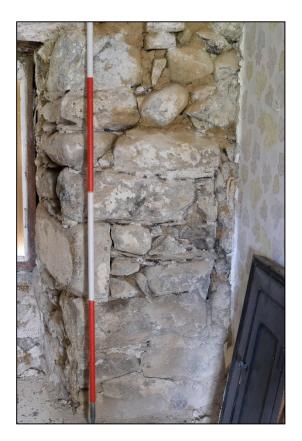
Plate 11: Infilled opening in the Parlour

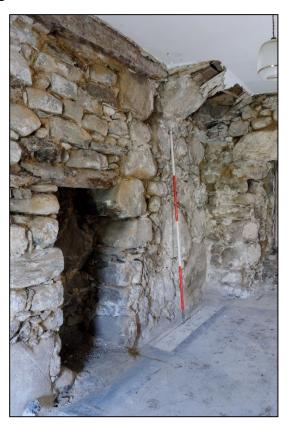
Plate 12: Possible supports for a staircase in the Parlour

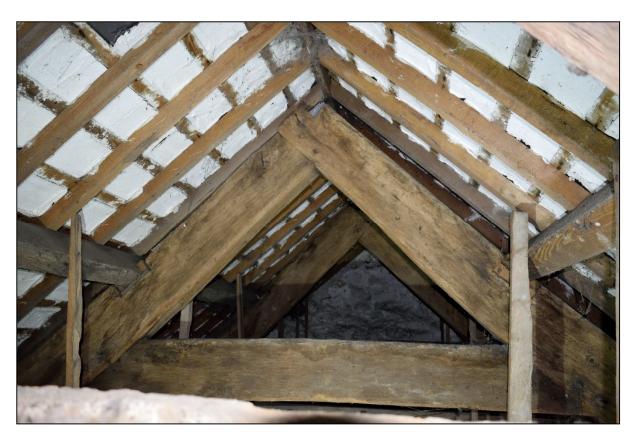
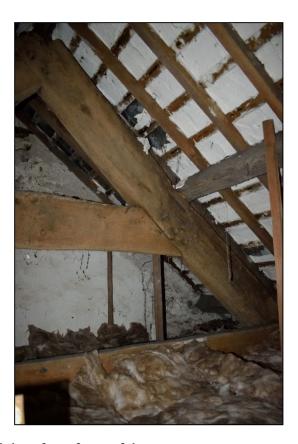
It was possible to look within the roof space of the property (Plates 13 and 14) revealing three, relatively simple trusses with slightly cranked collars and trenched purlins.

Plate 13: Trusses

Plate 14: Western principle rafter of one of the trusses

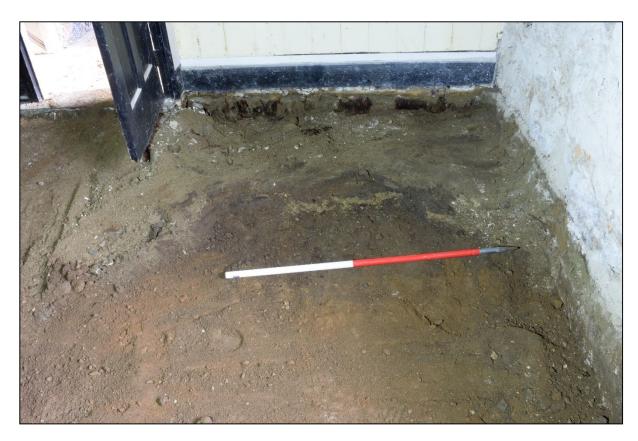
Plate 15: Mortared surface by the blocked door in the Hall

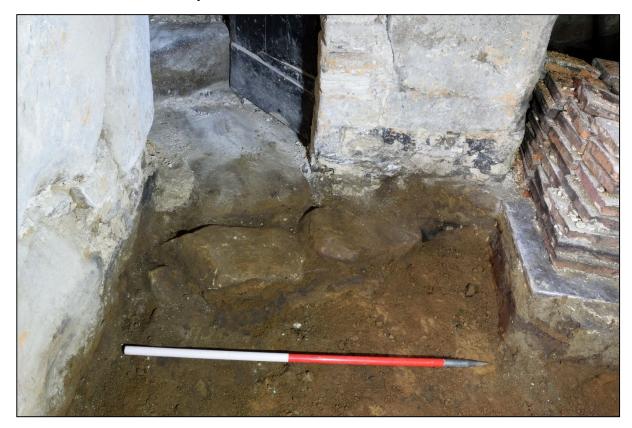
In the southern corner of the Hall, the remains of the bottom steps of the spiral staircase were recorded (Context 4, Plate 16). Three large stone blocks, each with a heavily worn top

surface, cut off the southern corner of the hall, extending the line of the spiral, intra-mural staircase into the Hall itself. The clay floor (Context 2) appears to be packed around the northern side of these stones probably suggesting that the steps pre-dates the laying of the clay floor. It is therefore possible that the rammed clay floor is a replacement for an earlier surface.

Plate 16: Remains of lower steps of the spiral staircase

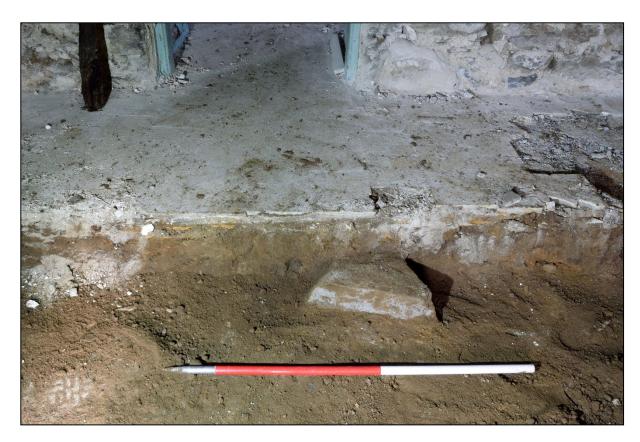
Towards the north-western side of the hall, approximately 1.0 m from the wall, was a single stone block (Context 6, Plate 17). This stone was below one side of a doorway in a nineteenth century partition, which had been removed before the watching brief took place, and it is likely that this stone was used to support one side of the doorway.

Plate 17: Stone block, Context 6

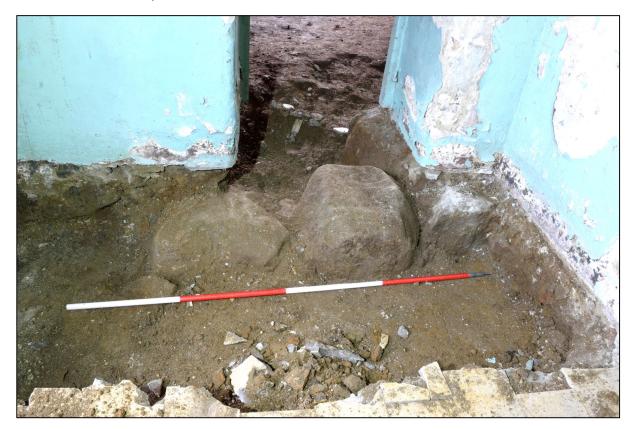
The removal of the floor in the doorway between the Hall and the Kitchen revealed the footings of the original rear wall to the property (Context 7, Plate 18). These consist of a series of natural boulders up to 1.06 x 0.54 x 0.50 m in size with an orange/brown clay bonding. The footings are thicker than the wall they support being up to 1.37 m wide, whilst the wall itself is only 0.98 m thick. It is assumed that the boulders exposed in the southeastern end of the Utility Room (Plate 19) is also part of the foundations.

Plate 18: Foundations of the rear wall of the property

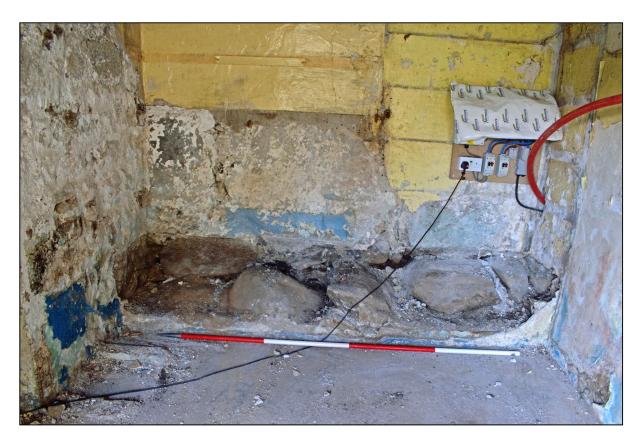
Plate 19: Foundation exposed in the Utility Room.

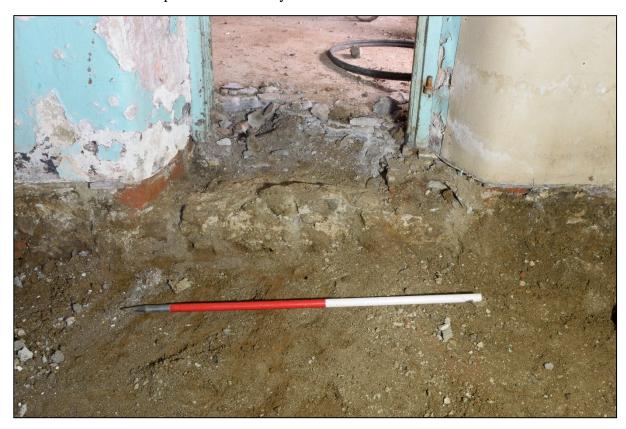
No archaeological features were recorded in the Kitchen with only 0.2 m of an orange/brown clayey makeup (Context 8) over natural clay. A similar lack of archaeological features was also noted in the Utility Room which had a sequence of concrete floors directly over the natural clay. Two levels of cement flooring (Contexts 9 and 11) were separated by a thin (0.03 m) layer of orange brown sandy material, presumably a base for the upper cement floor. The upper floor was 0.08 m thick whilst the lower floor was only 0.03 m thick and this layer sat immediately over the natural clay of the area.

Plate 20: Concrete floors in the Utility Room (from the Kitchen)

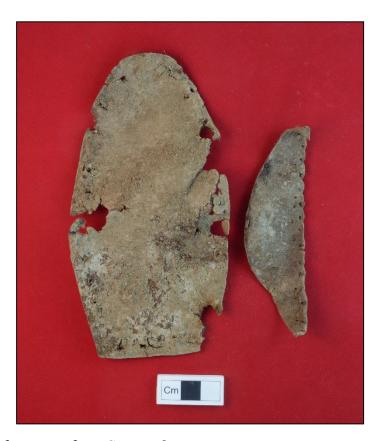
Plate 21: Leather fragments from Context 8

The two fragments of leather, probably come from the same shoe (Plate 21). The larger piece, is the sole of relatively small shoe and is 155 mm long and 80 mm wide, whilst the smaller (125 x 38 mm) curved fragment, has stitch holes along its straight edge.

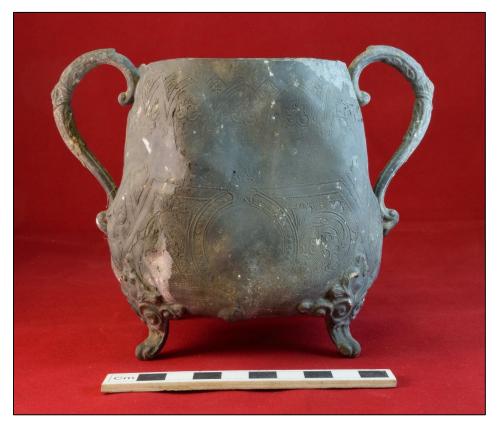
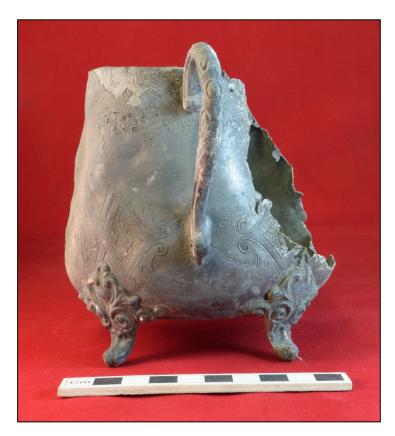
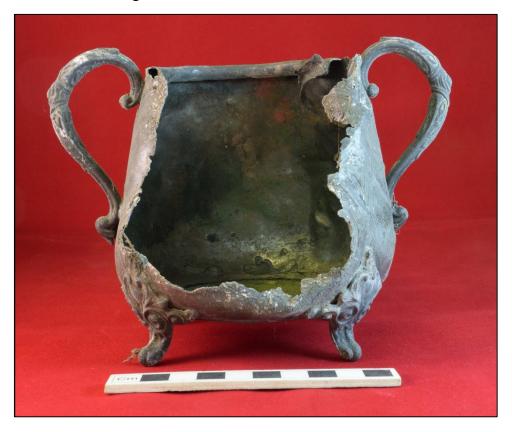
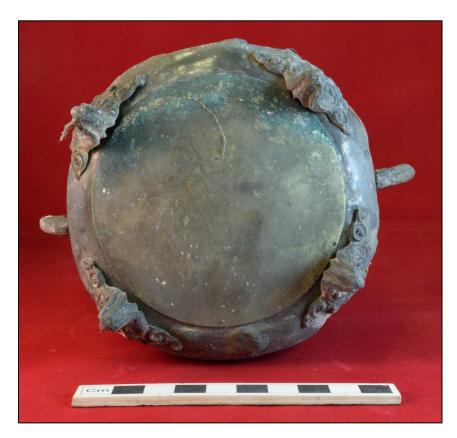
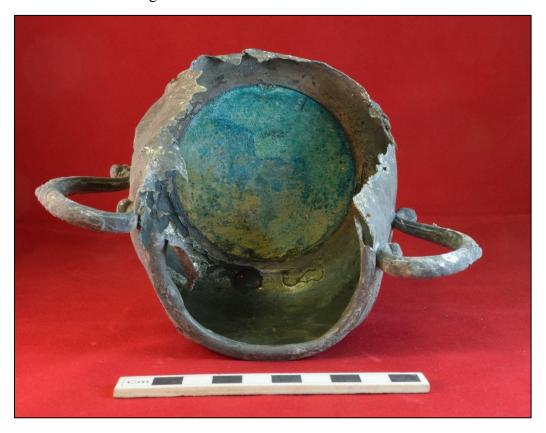
- A sugar bowl (Plates 22 26) 120 mm high, 115 mm in diameter with a bag like profile and a rim 87 mm in diameter. The external surface has a chased decoration with the lower panel based on floral pattern whilst the pattern around the rim has a more architectural theme, based on a series of intersecting pointed arches, each containing a scrolled pattern. The internal surfaces appear to be silvered, although the base plate appears to be a separate entity which is of a copper alloy with a silvered surface (Plates 25 and 26). The vessel sits on four cast feet in the form of a zoomorphic face, possibly a dragon (Plate 31) and has cast handles (Plate 32) with floral designs.

Plate 22: Britannia metal sugar bowl

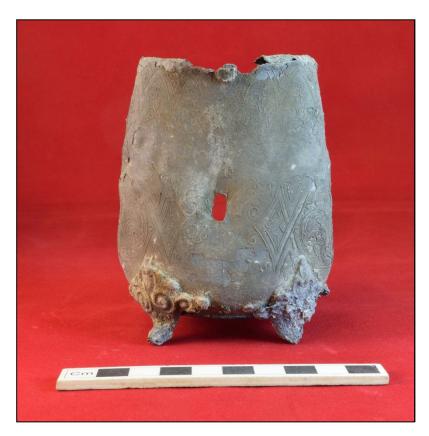
Plate 27: Britannia metal cream jug

- The remains of a cream jug (Plates 27 30) 105 mm tall and 80 mm in diameter with a 65 mm diameter rim. It has a similar decorative treatment to the sugar bowl and sits on similar cast feet. Once again, the vessel appears to have a copper alloy base plate and Britannia metal body and is silvered inside. The handle has not survived, but a hole in the body (Plate 27) shows the position of the fixing point. The lip is also missing.

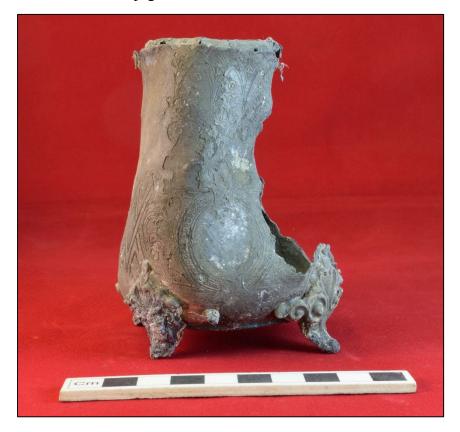
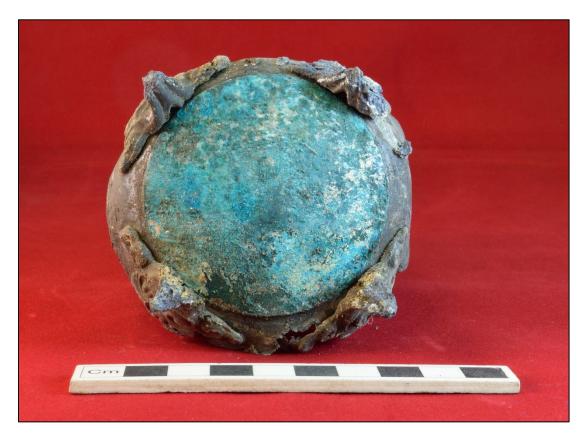
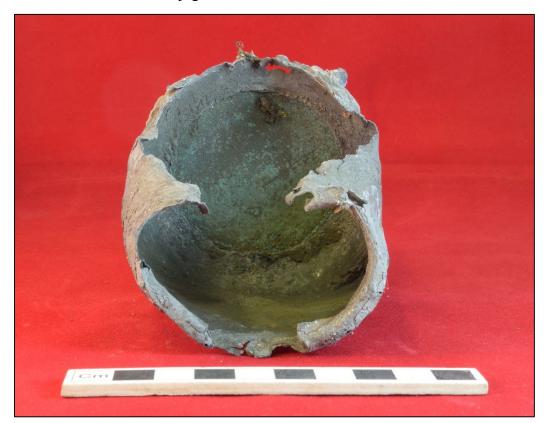
Plate 28: Britannia metal cream jug

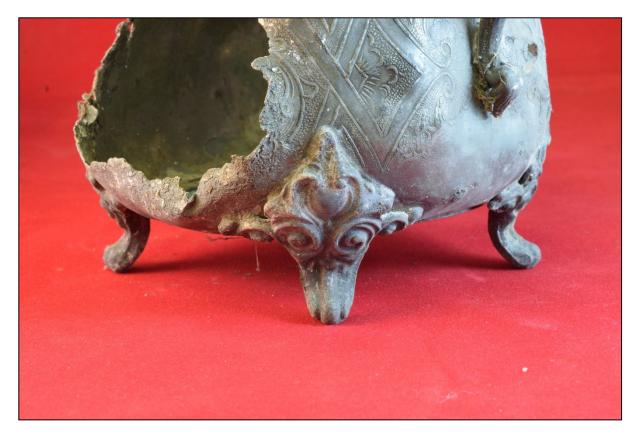
Plate 31: Detail of the foot of the sugar bowl

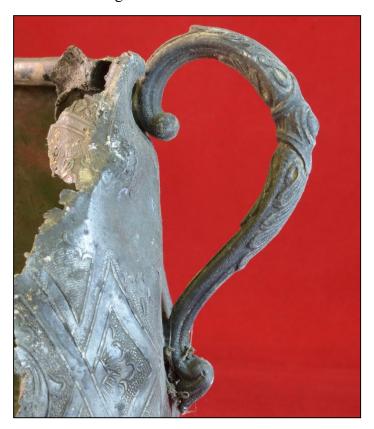
Plate 32: Detail of the handle of the sugar bowl
