Archaeological Excavation
at
LLYNFI VALE IRON WORKS (NEW WORKS),
LLYNFI ROAD, MAESTEG,
GLAMORGAN, SOUTH WALES
for
Morbaine Ltd.

Report No. 1299/2009

Bristol and Region Archaeological Services

Centred on
N.G.R. SS 84880 91620

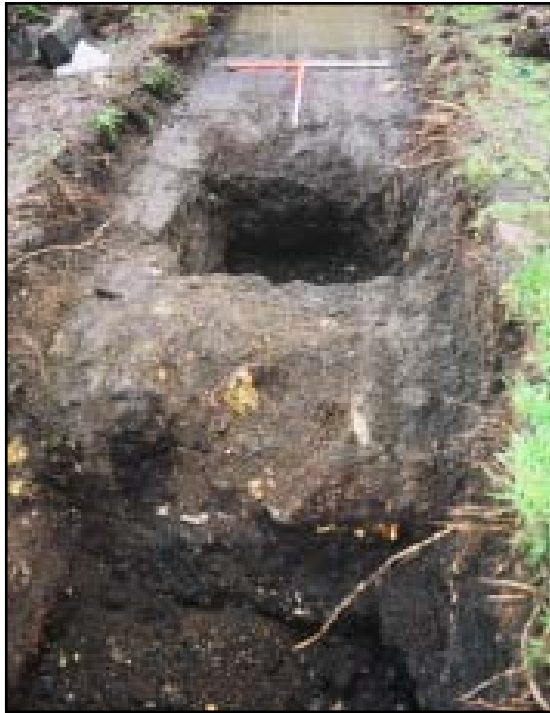
Plate 1
Trench 1, cuts 105 and
107 at eastern limit of
trench

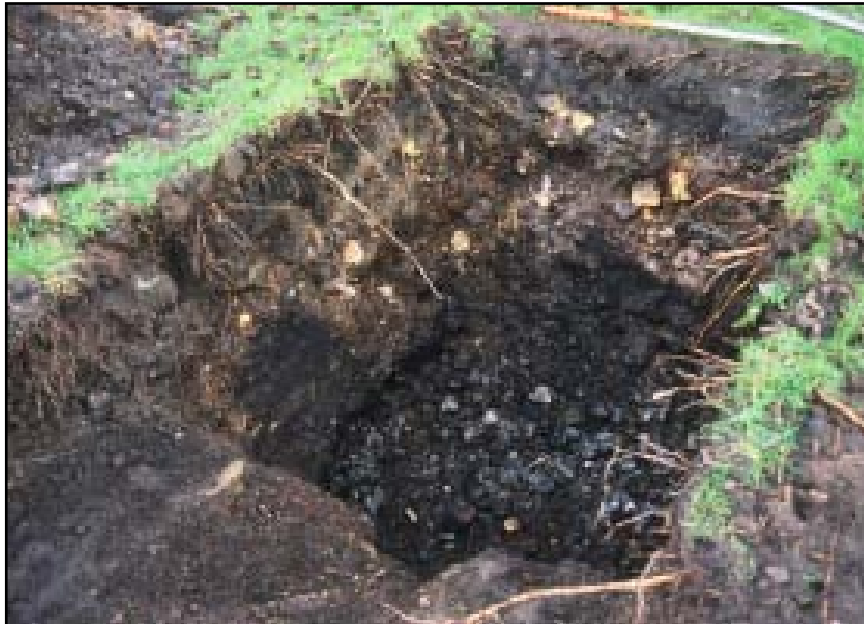
Plate 2
Trench 1, cut feature 107
and fills 106 and 108

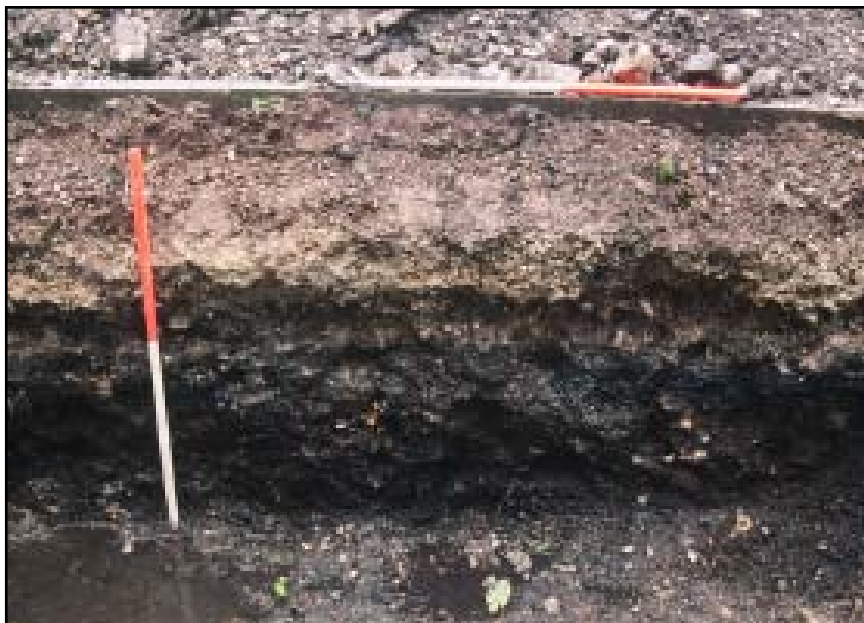
Plate 3
Trench 2, north-facing
section

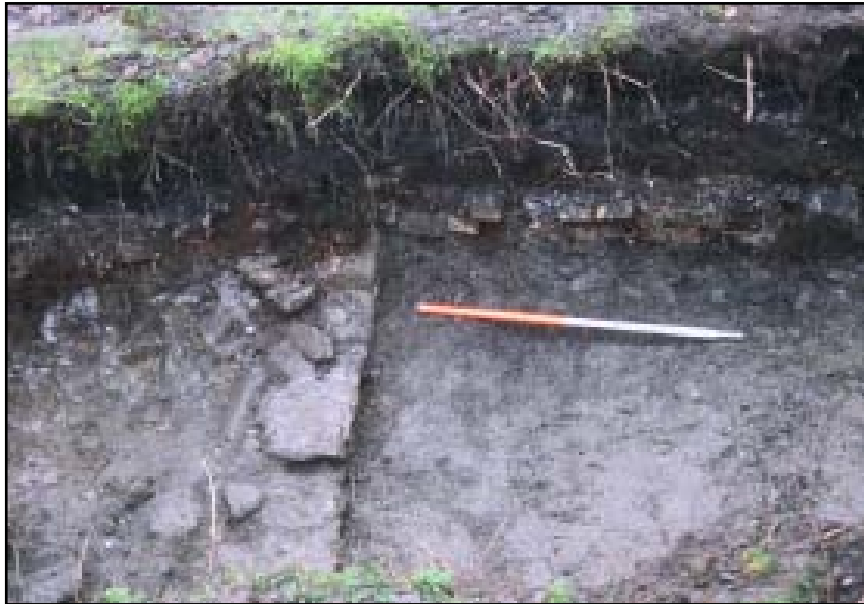
Plate 4
Trench 3, walls 302 and
304 and north-facing
section

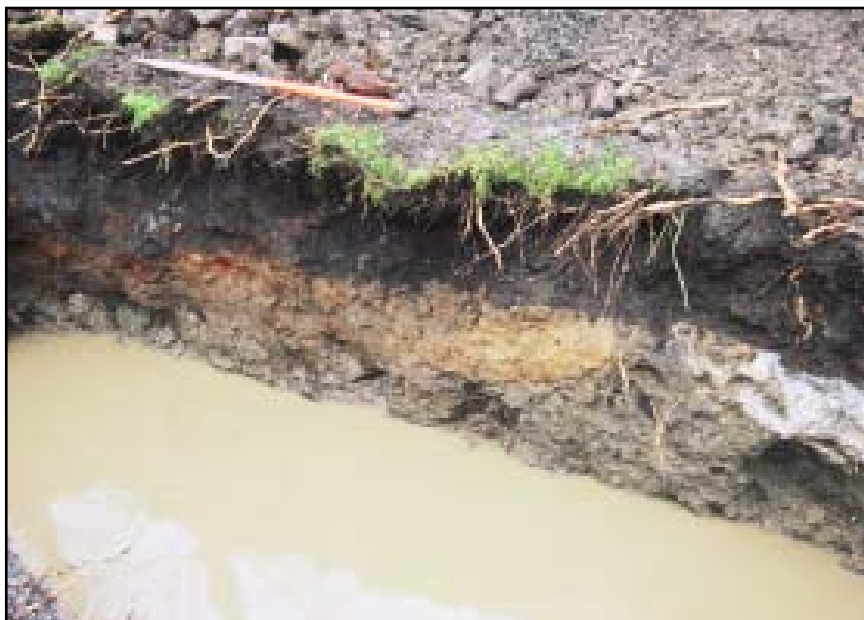
Plate 6
Trench 3, Casting House
floor at western limit of
trench

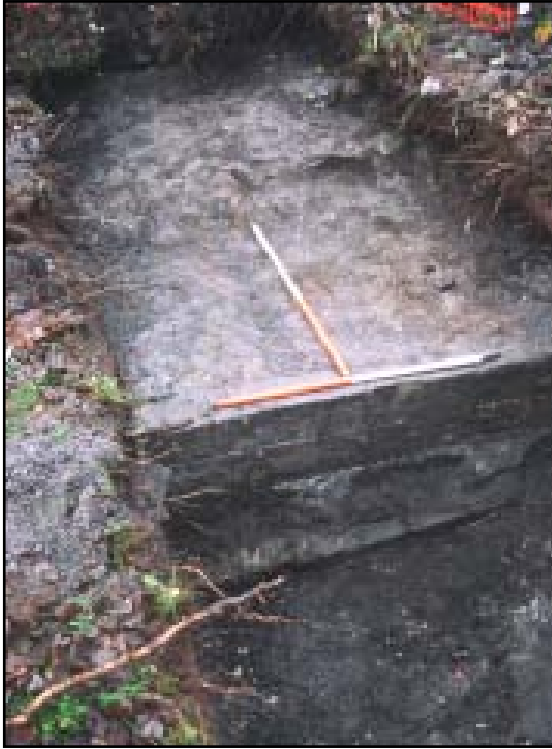
Plate 7
Trench 4, wall 405 and rubble infill 406

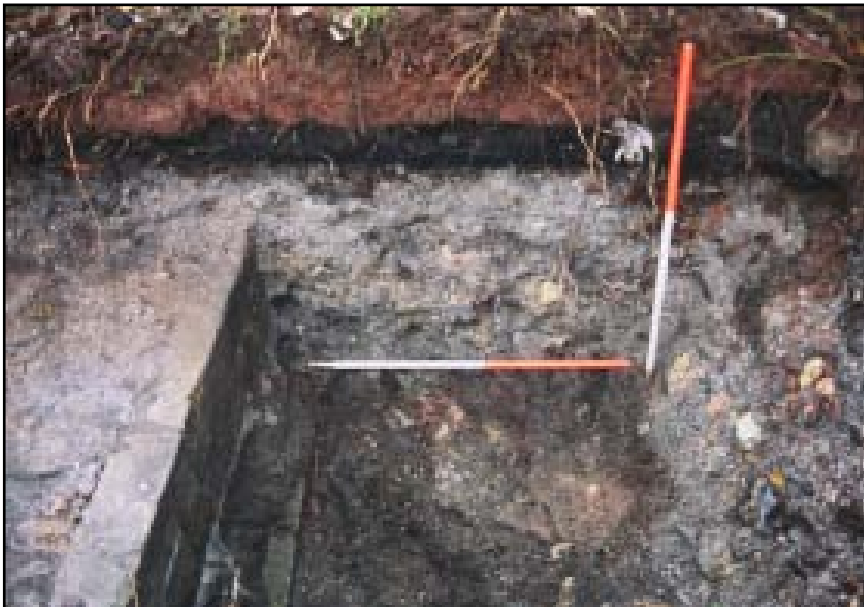
Plate 8
Trench 4, wall 405 and
associated demolition
debris and landscaping
horizons

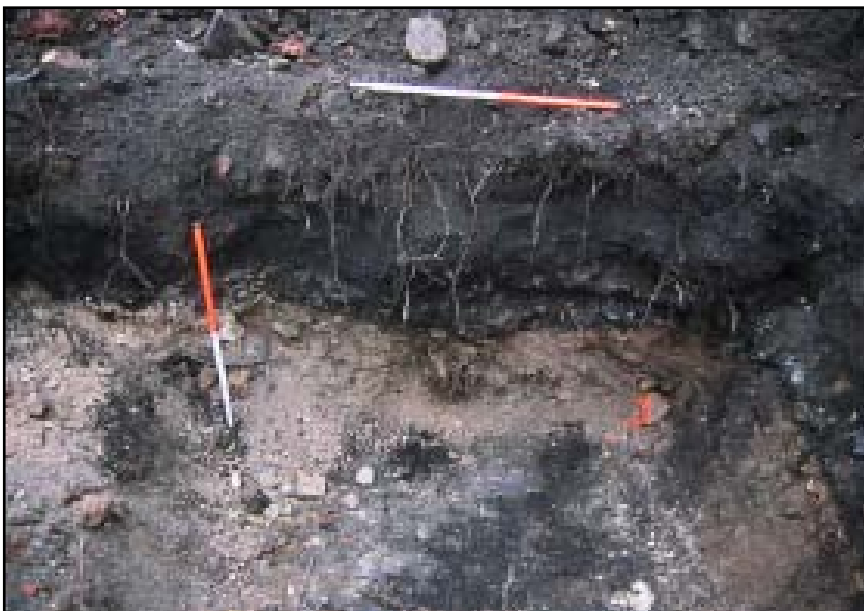
Plate 9
Trench 5, east-facing
section

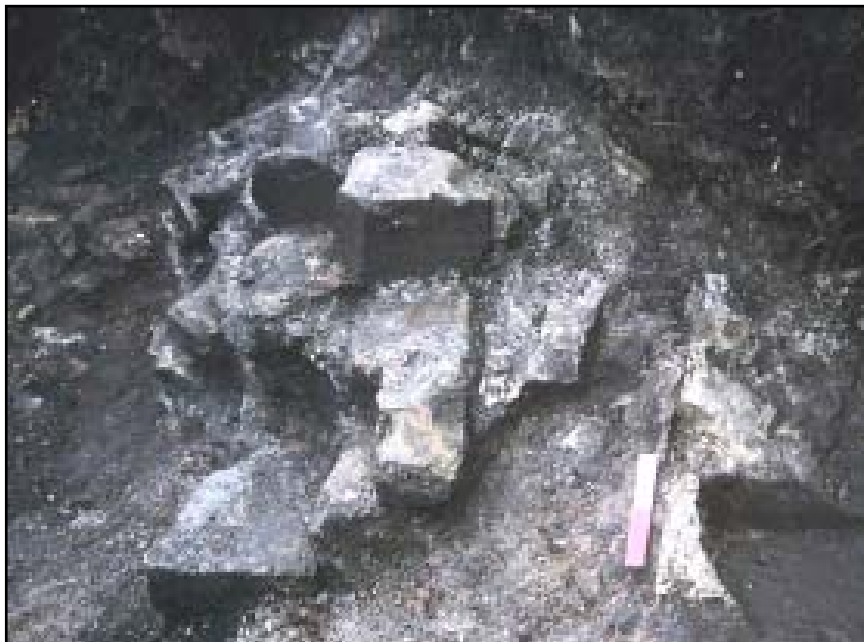
Plate 11
Trench 6, wall 608 and
internal fire bricks

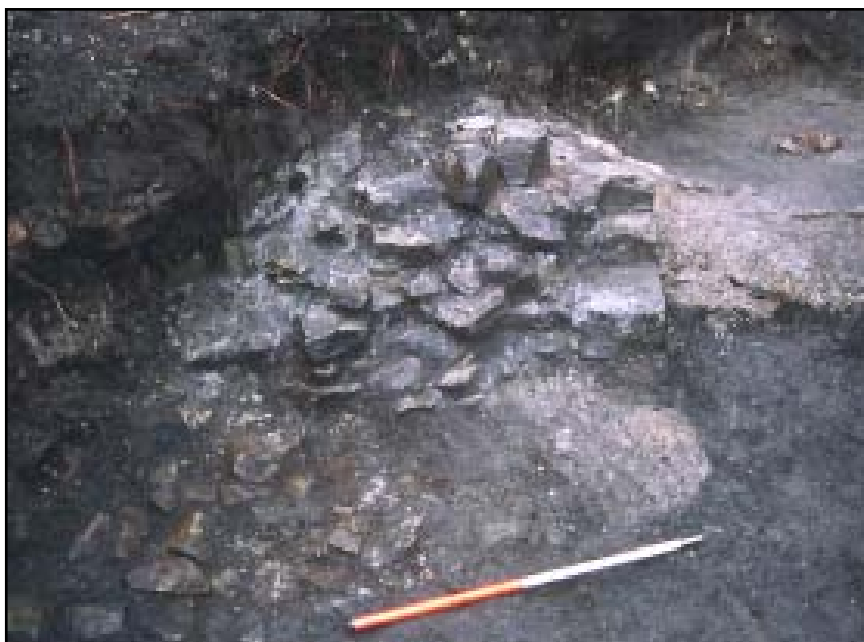
Plate 12
Trench 6, view of
structural features and
robber trench to north-
west of trench

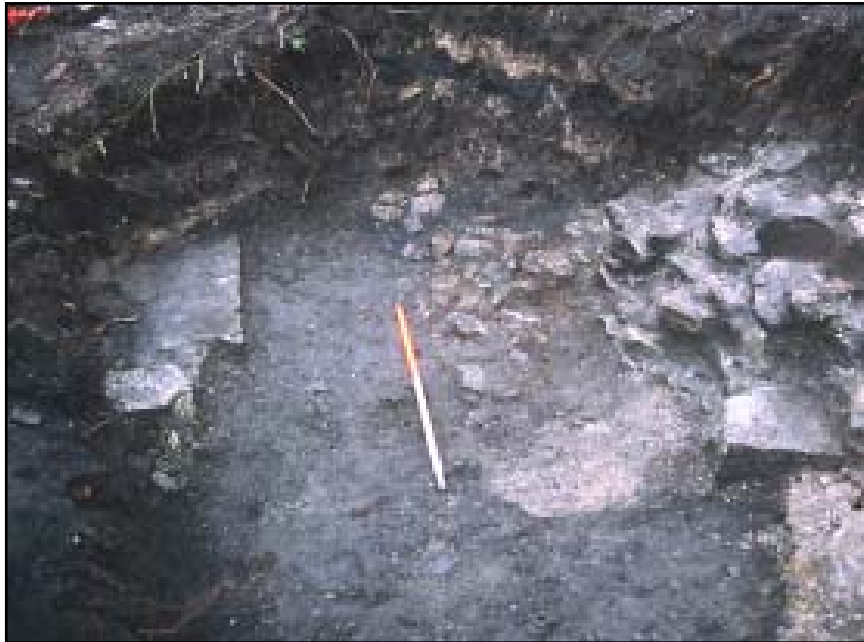
Plate 13
Trench 6, wall 608 and
615 and robber trench

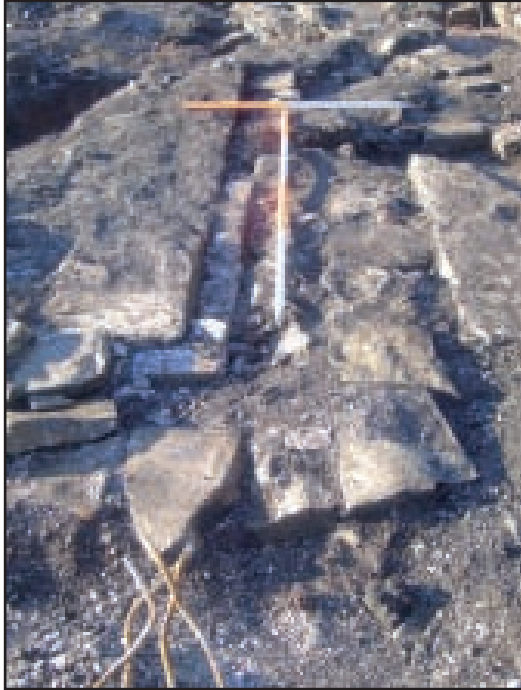
Plate 19
View north-west along the line
of a 'flue-like' structure formed
by walls 116 (left) and 114
(right) in 'new puddling' (forge).
Note remnant of fire brick lining
to left

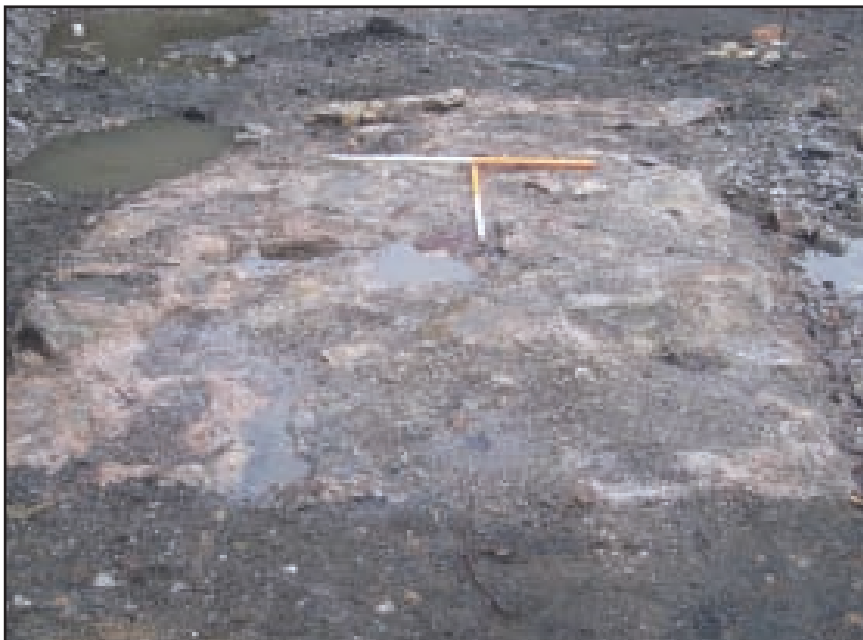
Plate 21
Large Pennant sand-
stone built 'plinth-like'
feature (160), a possible
machine base located
within the former 'Casting
House' – looking north

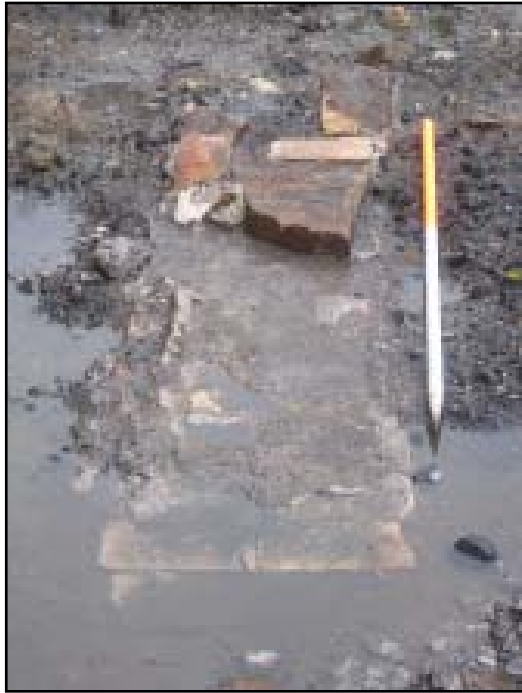
Plate 22
Looking north at truncated
masonry feature 156, within the
former 'Casting House'

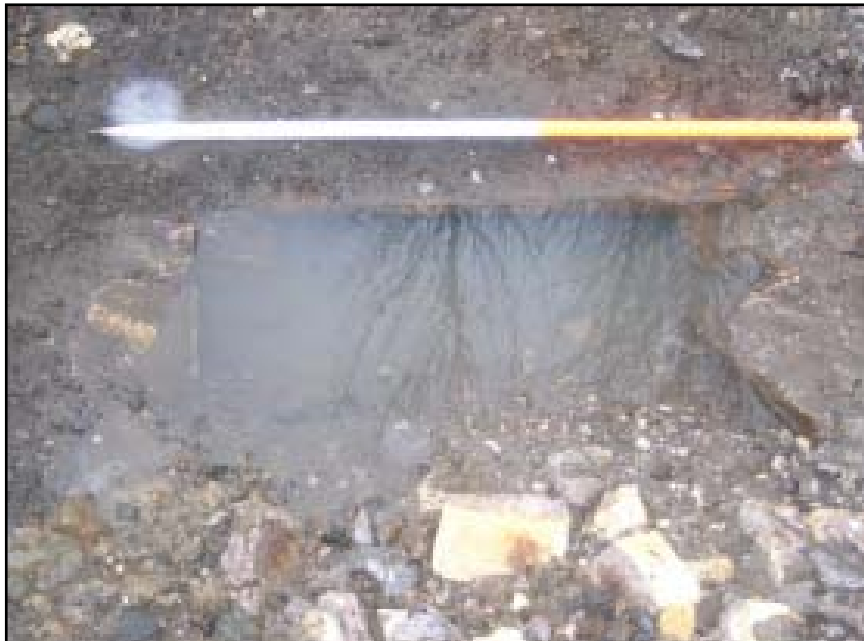
Plate 23
A 'flue-like' feature (157)
constructed using fire
bricks and capped with
rectangular cast iron
plates – looking south-
west

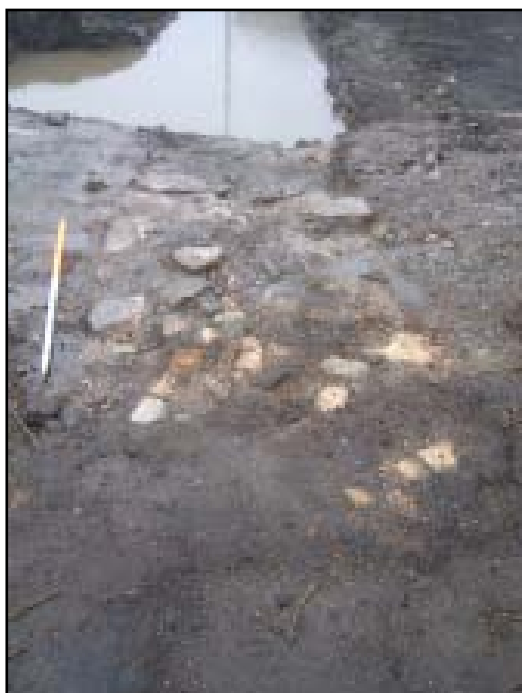
Plate 24
View north-east along the line of
wall 163 – the eastern exterior
wall of the 'Casting House'

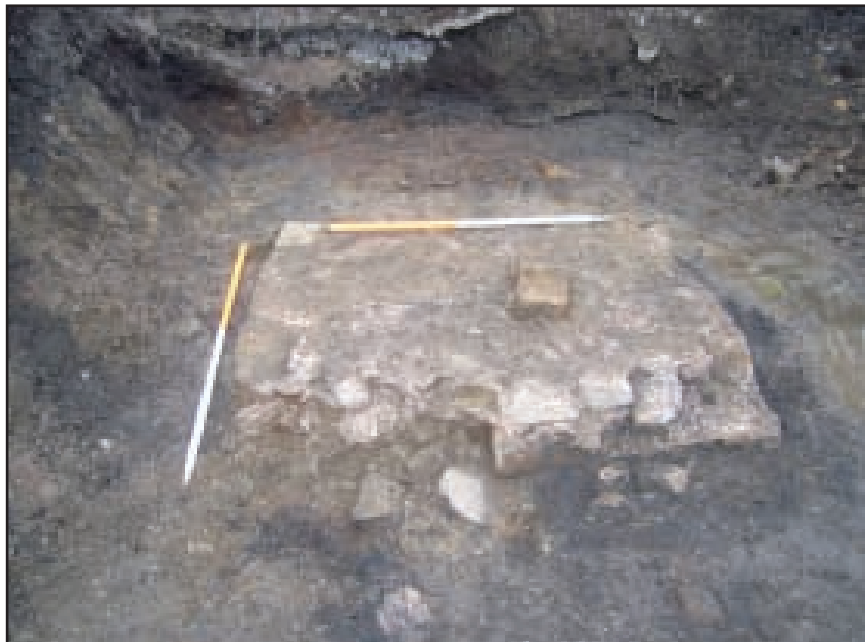
Plate 28
Looking north at the
Pennant sandstone pier
base 253. Note the in-
situ cast iron mounting
to which an iron column
would have been bolted
to help support the roof
structure of the 'mills and
forges' building

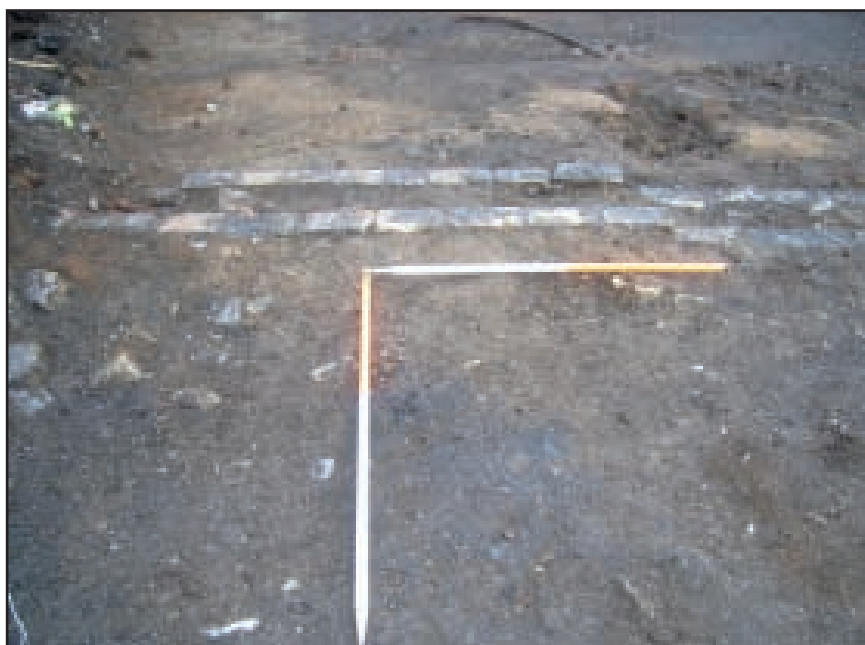
Plate 29
Looking north, within the
former 'Casting House',
at traces of the sand
casting floor (159) and a
brick-built possible flue

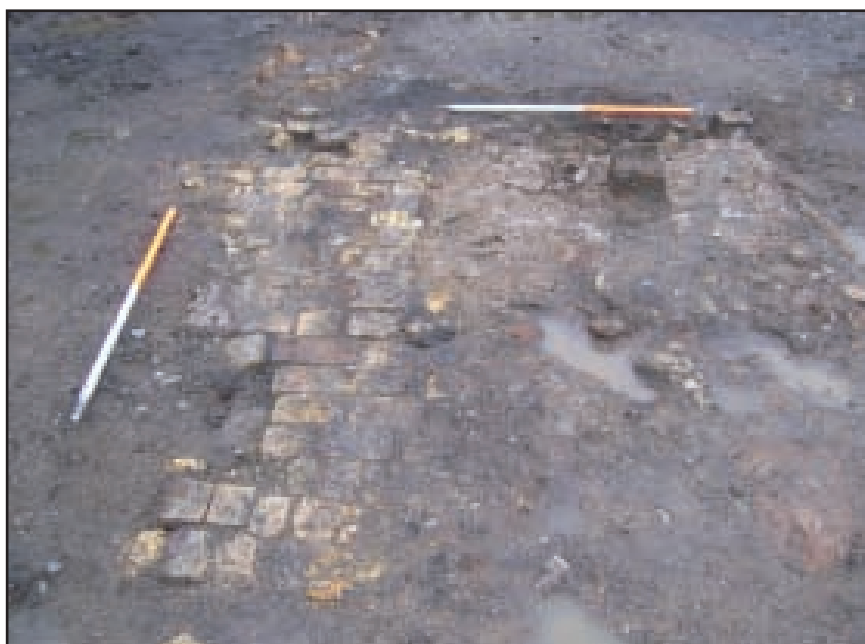
Plate 30
View of brick floor 216
and Pennant sandstone
pier base 214, complete
with integral cast iron
mounting – looking north
in the former 'mills and
forges' building

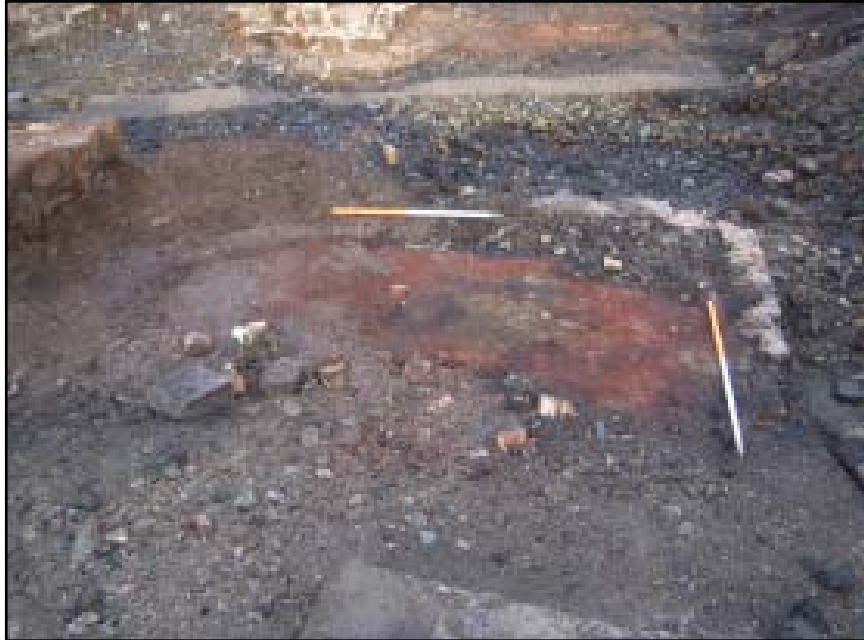
Plate 31
View of south-east corner
of 'mills and forges'
building showing furnace
chimney base 231 (left),
heat affected deposits
228 and 229 (centre) and
remains of pier base 227
(right)

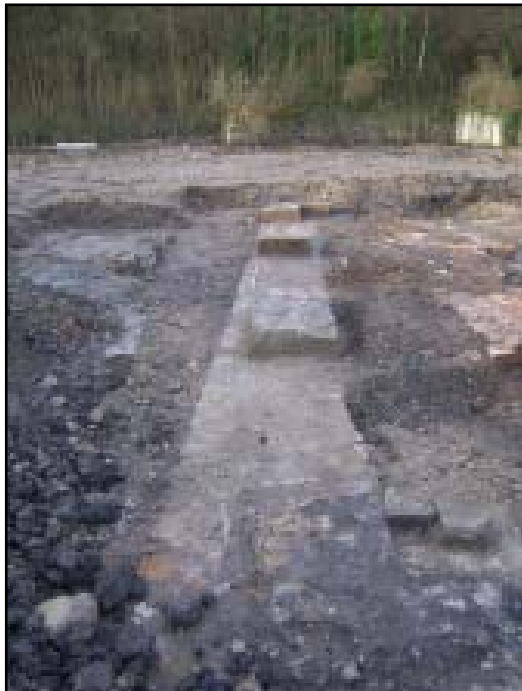
Plate 32
Looking north-west along the
line of wall 235, the southern
gable-end wall of the former
'mills and forges' building (see
Fig. 10)

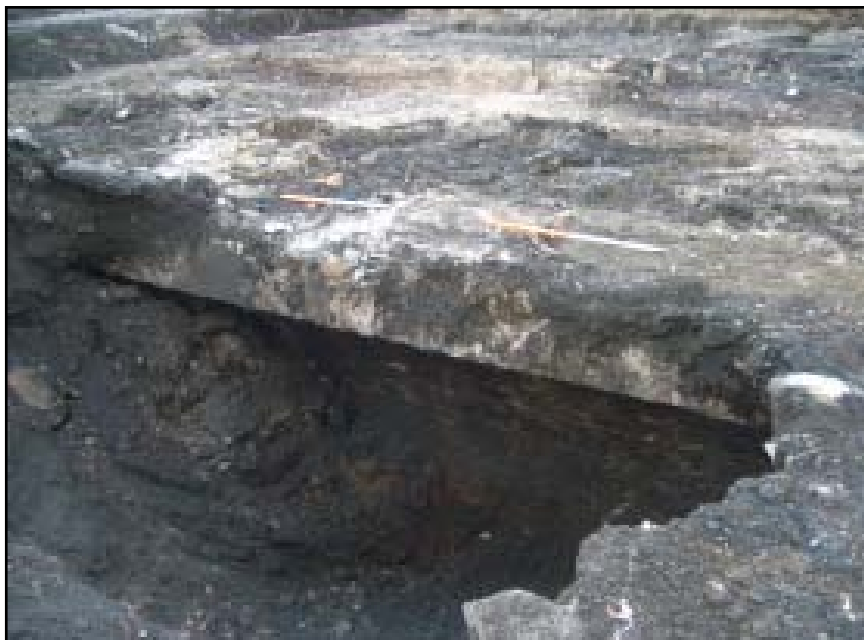
Plate 33
West-facing elevation of
east wall (339) of N-S
oriented tunnel located
between 'boilers' (Boiler
House) and 'new mill'
(Rail Mill)

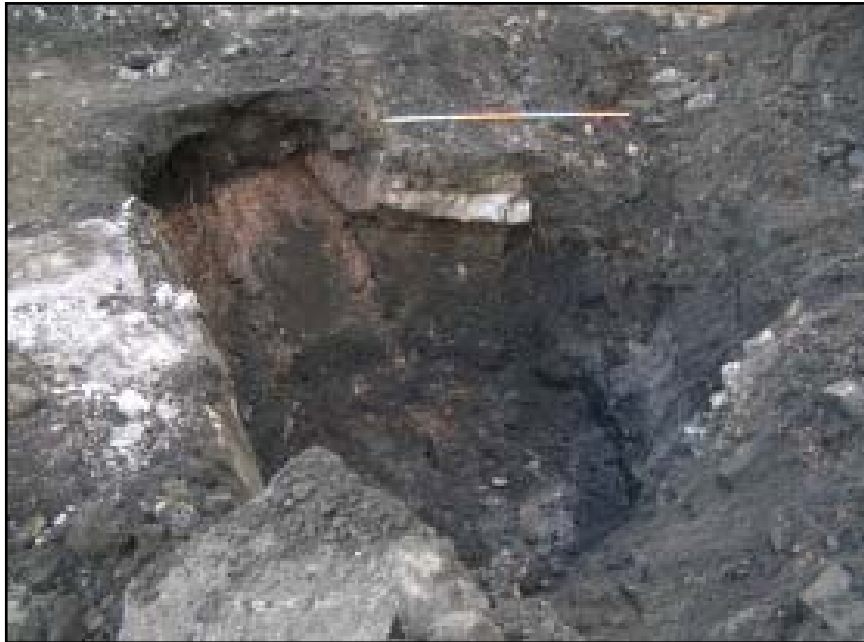
Plat3 34
Surviving remnant of
Pennant sandstone wall
at junction of N-S
oriented and E-W
oriented tunnels next to
'new mill' (Rail Mill) –
looking south-west

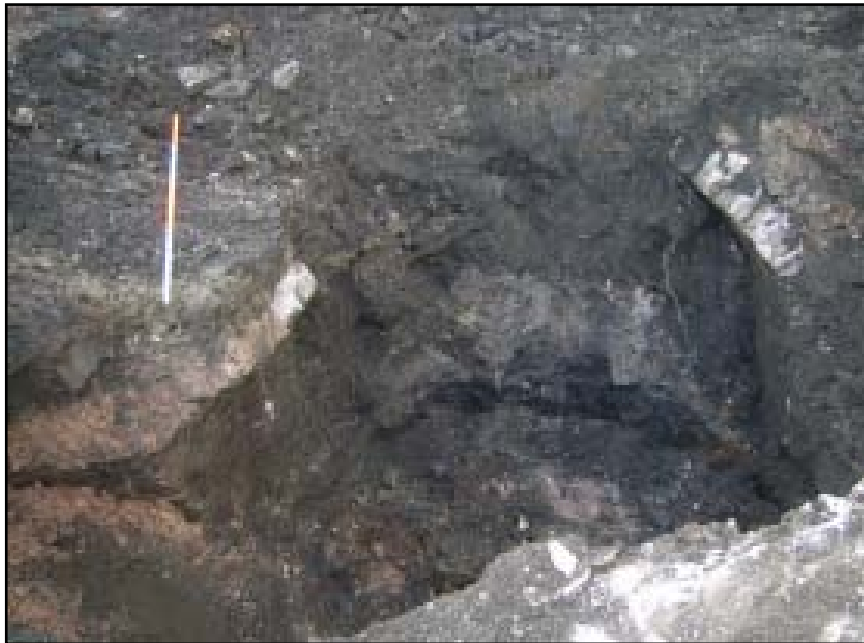
Plate 35
Looking west at the
remains of the E-end of
the E-W oriented tunnel
that lay north of the
'boilers' (Boiler House)

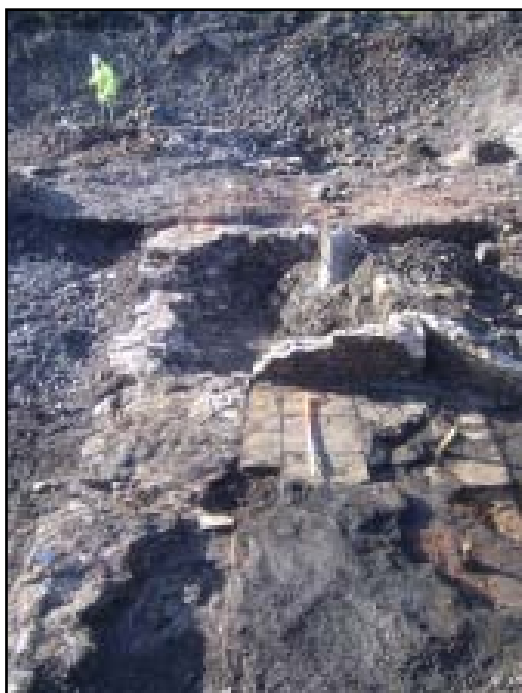
Plate 36
View west, through the middle
of the 'new puddling' (forge)
building, showing (in the
foreground) floor surface 282,
complete with two cast iron
holding down bolts (mountings)
for some sort of machine

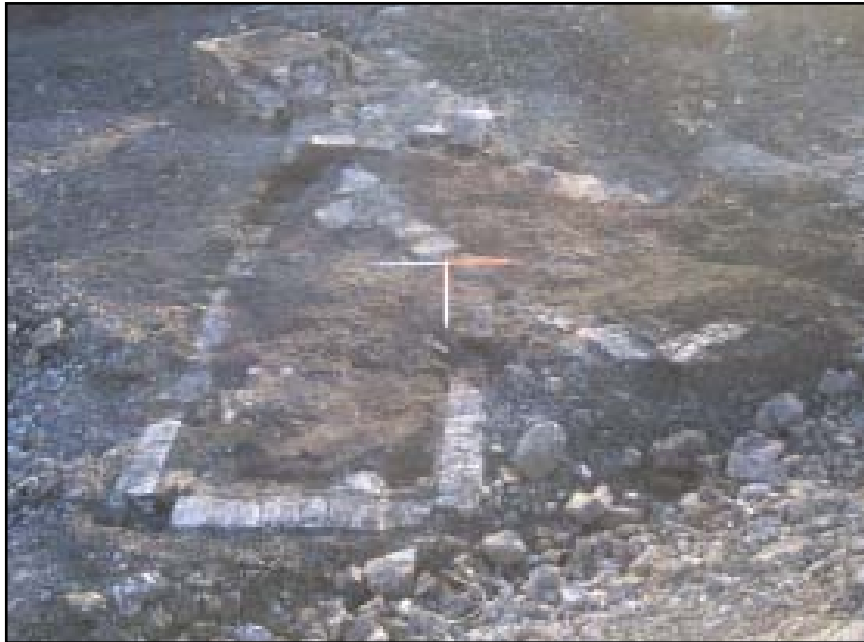
Plate 37
View east, of a brick reverberatory furnace structure (contexts 299/302/304), a chimney base (312) and a pier base (132) within the former 'new puddling' (forge)

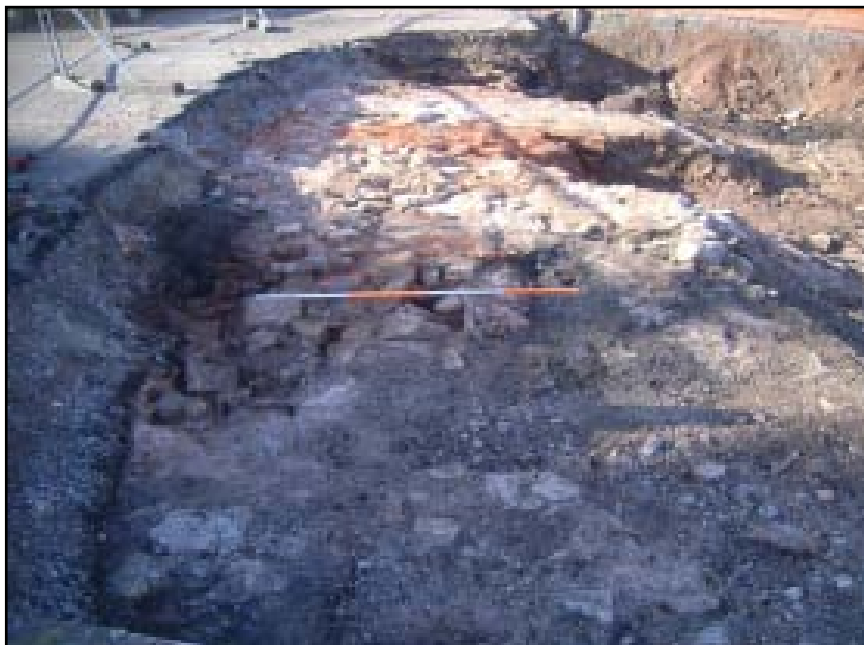
Plate 38
Looking west at the remains of the 'boilers' (Boiler House), showing three thermal halos caused by the intense heat generated by furnaces used to heat the boilers

- Plate 38 Looking west at the remains of the 'boilers' (Boiler House), showing three thermal halos caused by the intense heat generated by the furnaces used to heat the boilers

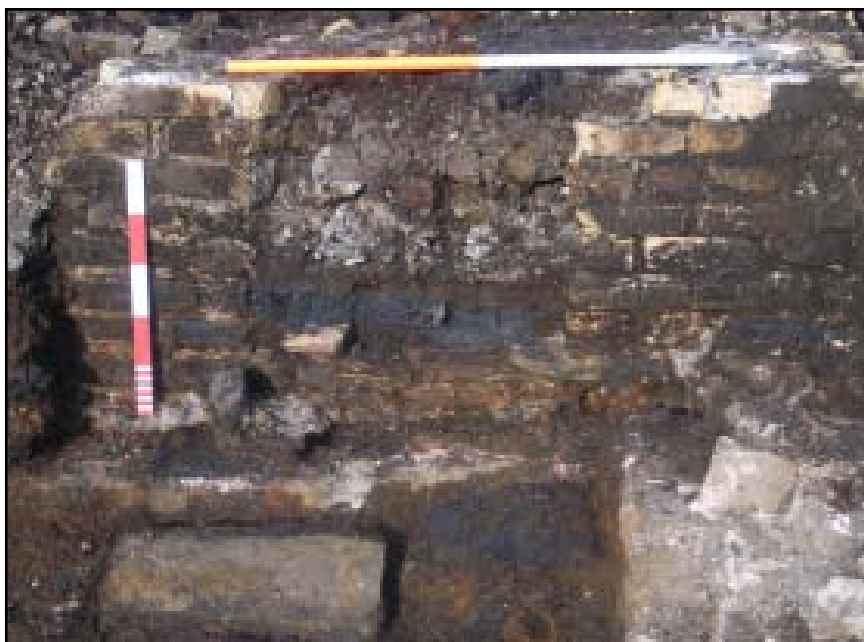
Plate 39
South-facing section in brick-built flue 101. Note cast iron tuyere reused in the construction of flue 317 (left foreground)

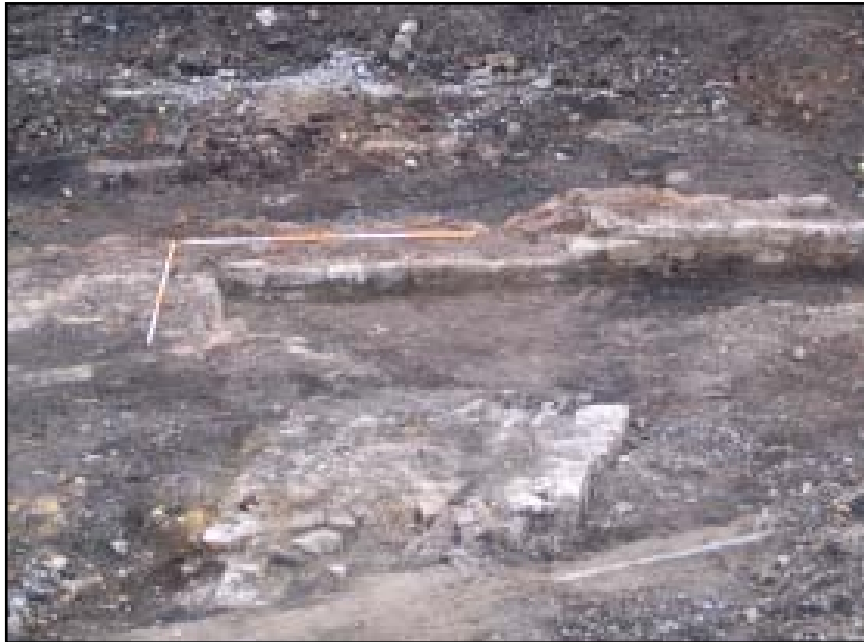
Plate 40
Looking south-east,
within the 'new puddling'
(forge), at a chimney
base (329) – foreground,
a brick floor (326) – left,
a Pennant sandstone
wall (324) – centre and a
Pennant sandstone
feature (361) –
background

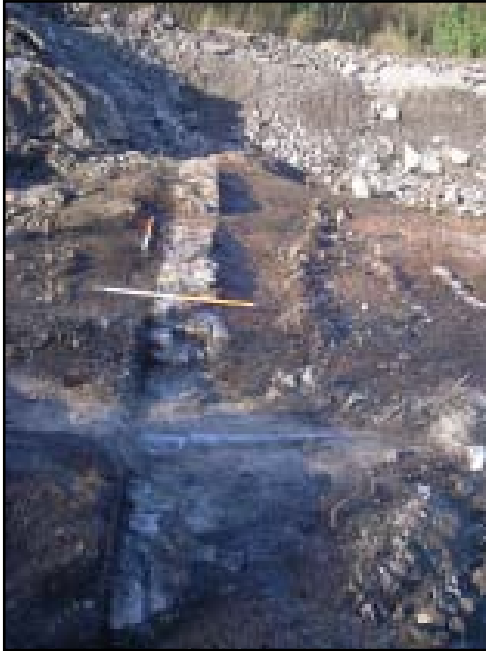
Plate 43
Looking north-west
along the line of wall
362, the south-end wall
of the 'new puddling'
(forge)

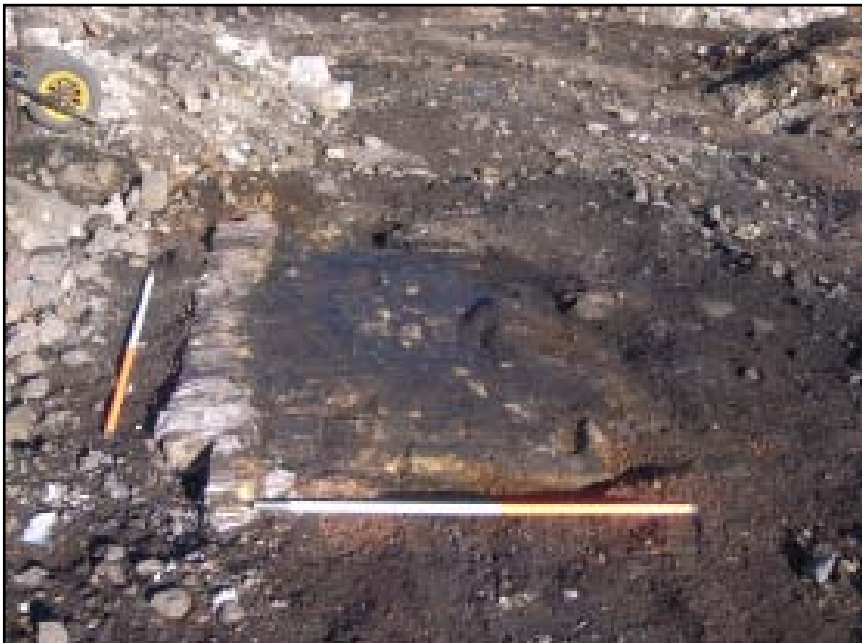
Plate 44
Looking north-east at
brick feature 363/371, a
brick working surface
associated with furnace
chimney 329

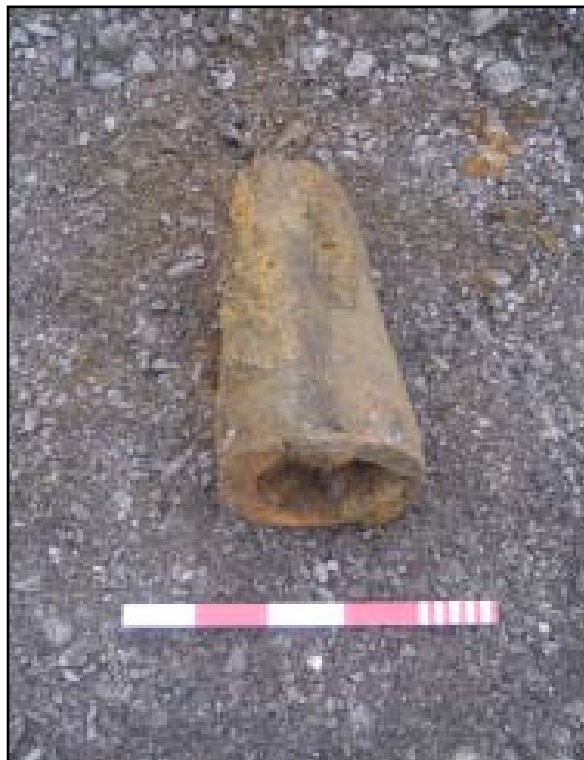
Plate 47
The 19th century cast
iron tuyere that was
recovered from the site
of the 'new puddling'
(forge)

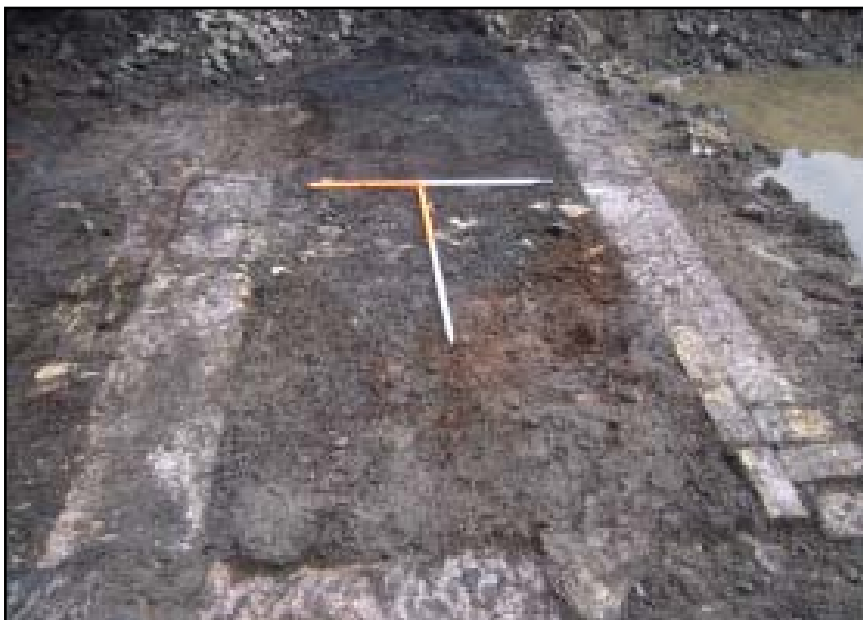
Plate 48
View east of brick-built
flue-like structure
comprising walls 373 and
381. Located to the
north of the 'Casting
House'

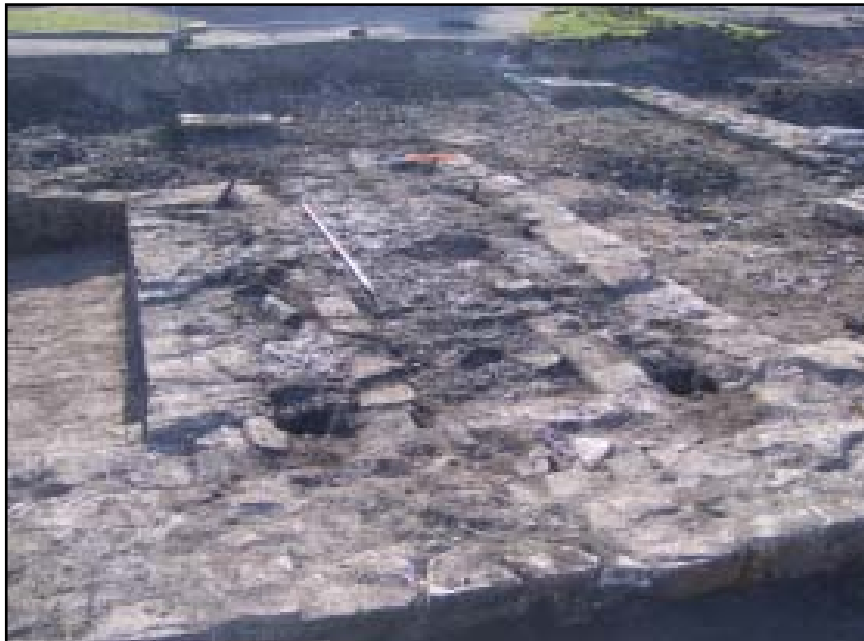
Plate 50
Looking south-west at the remains of the north end of the 'new mill' (Rail Mill). In the centre of the photograph is a massive structure, built using Pennant sandstone masonry, complete with seven integral cast iron holding down pins attached to which was a machine or machines used in the process of manufacturing iron rails

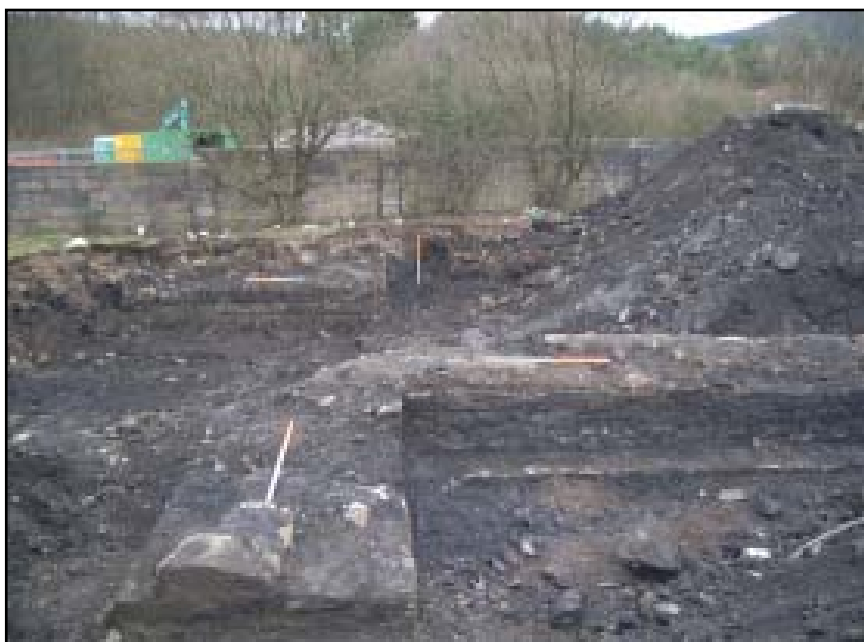
Plate 51
Looking north-west (the main excavation site was beyond the concrete block wall) at the remains of stone piers belonging to a railway bridge (see Figs. 12 – 14) that carried the G. W. R. line over a branch line leading to sidings

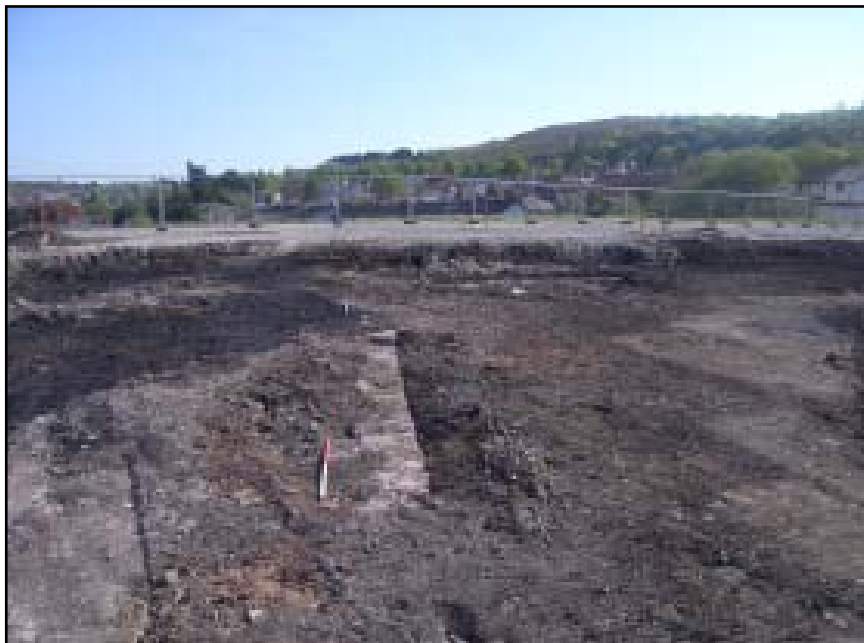
Plate 53
Looking south-east along the line of the eastern exterior wall of the rail mill, located beneath the former rugby club car park

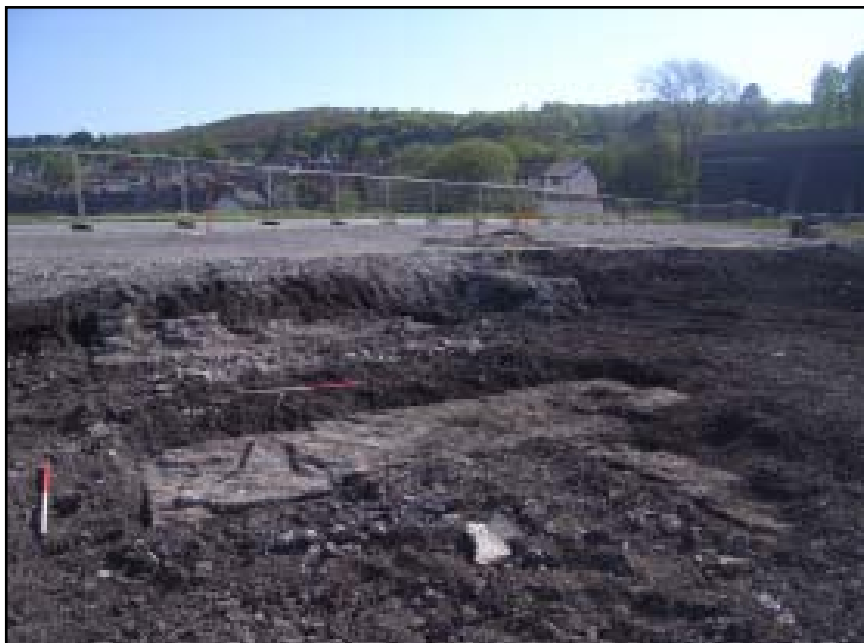
Plate 54
Two stone-built machine plinths, complete with cast iron holding down pins, located towards the south-east corner of the former rail mill, looking south-west

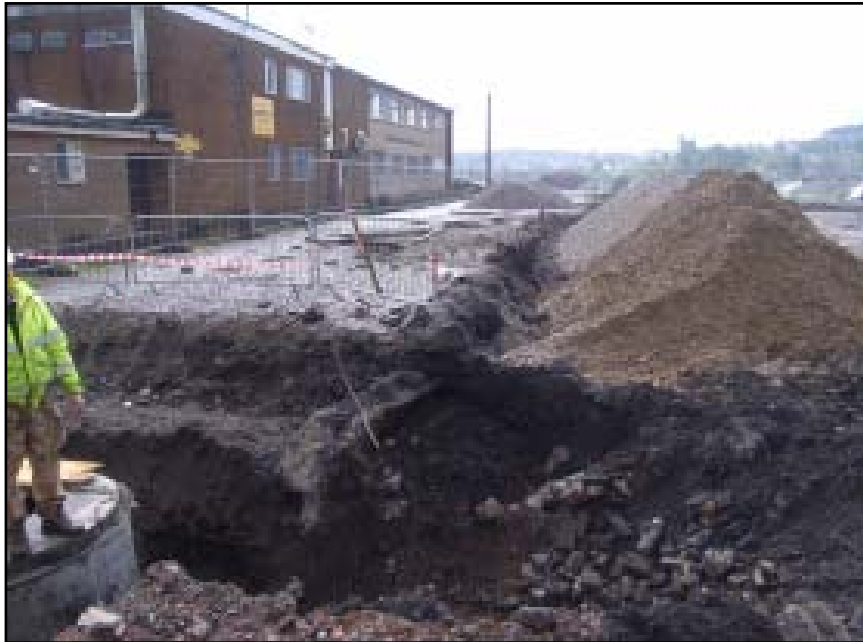
Plate 55
Looking south-east at
the brick remains of a
'flue-like' structure within
the footprint of the rail
mill

- Plate 55 Looking south-east at the brick remains of a 'flue-like' structure within the footprint of the rail mill
- Plate 56 Excavation of a pipe trench across the former rugby club car park, looking south

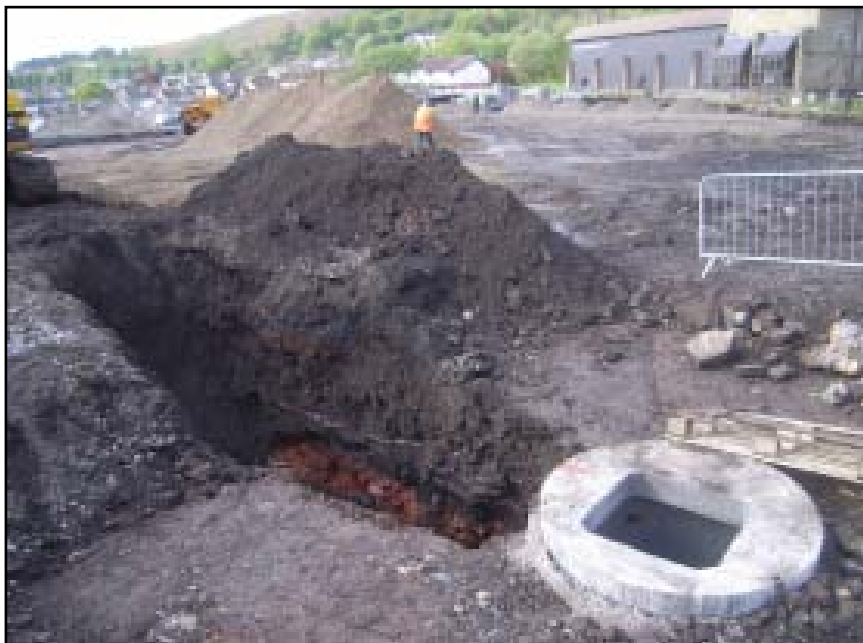
Plate 56
Excavation of a pipe
trench across the former
rugby club car park,
looking south

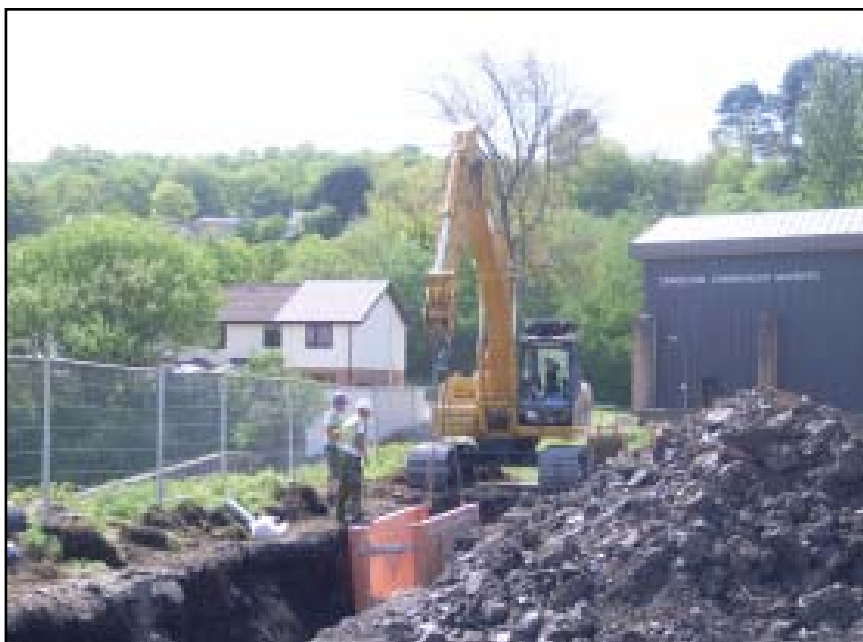
Plate 57
Excavation of a pipe
trench close to the
southern limit of the site,
looking west towards
Maesteg Sports Centre

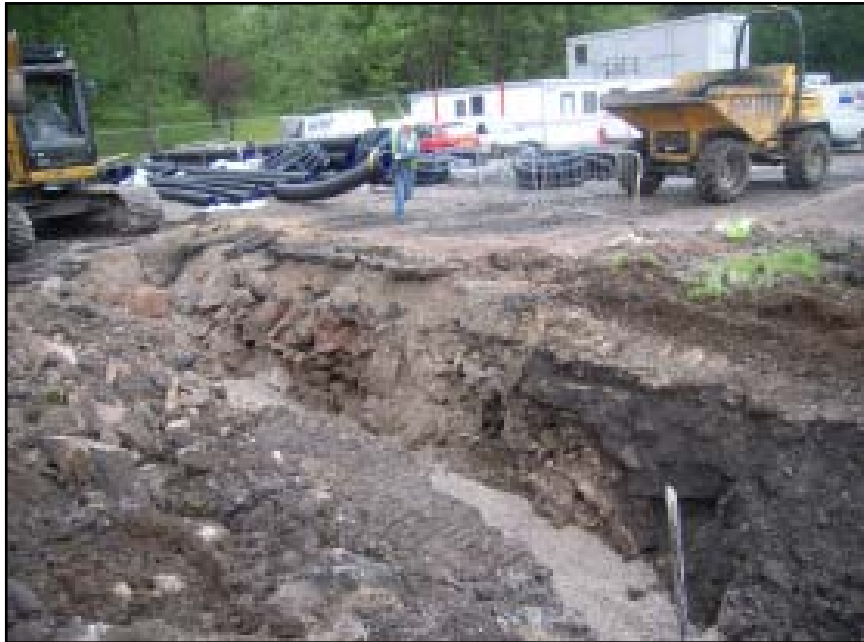
Plate 58
Excavation of a pipe trench across the sports centre car park. It exposed much redeposited sandstone masonry used to infill partially demolished brick built tunnel

- Plate 57 Excavation of a pipe trench close to the southern limit of the site, looking west towards Maesteg Sports Centre
- Plate 58 Excavation of a pipe trench across the sports centre car park. It exposed much redeposited sandstone masonry used to infill partially demolished brick built tunnel
