Archaeological Excavation
at
LLYNFI VALE IRON WORKS (NEW WORKS),
LLYNFI ROAD, MAESTEG,
GLAMORGAN, SOUTH WALES
for
Morbaine Ltd.

Report No. 1299/2009

Bristol and Region Archaeological Services

Centred on
N.G.R. SS 84880 91620

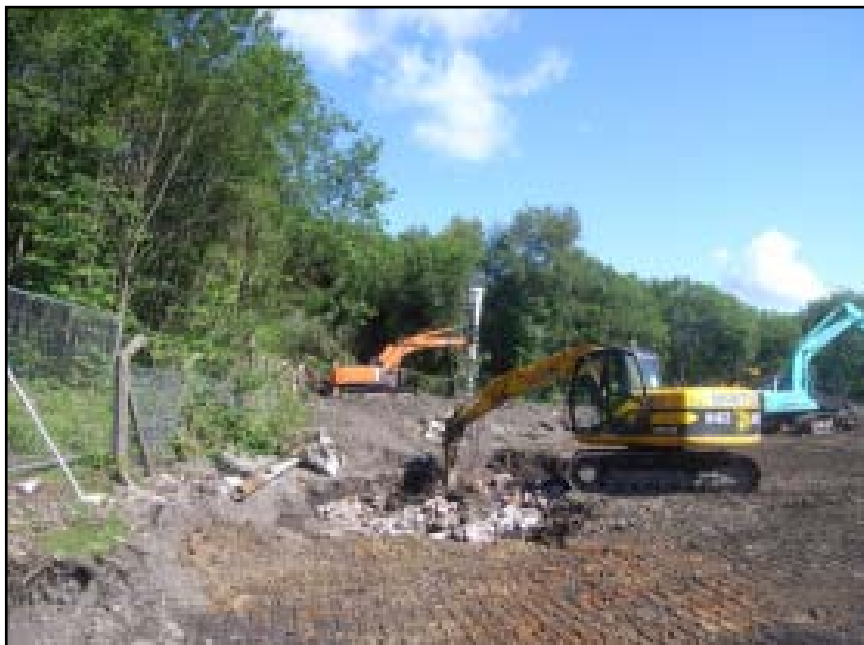
Plate 59
View of ground work in progress in the vicinity of the former casting house, close to the western site boundary, looking north-west

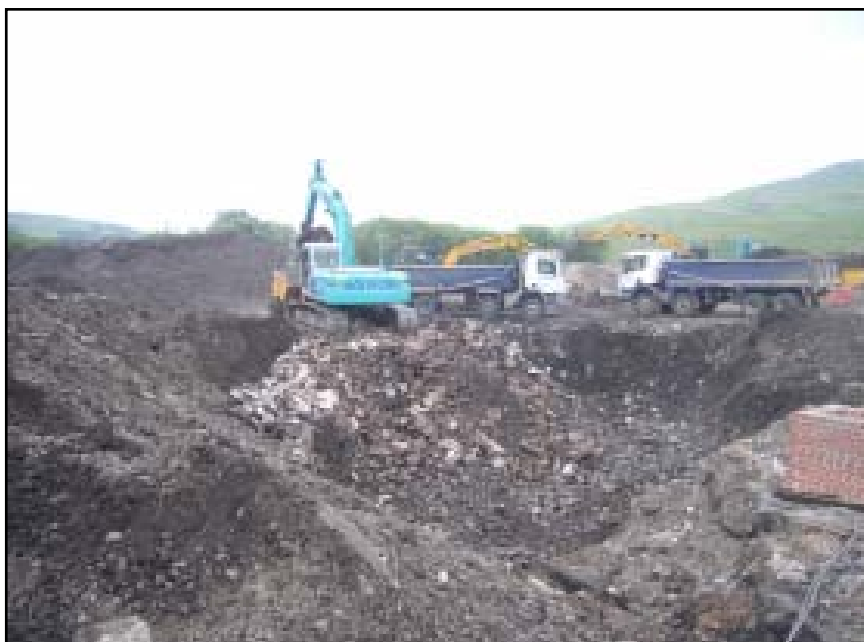
Plate 60
Looking north-east, during construction ground work, at the site of the 2006-7 excavation

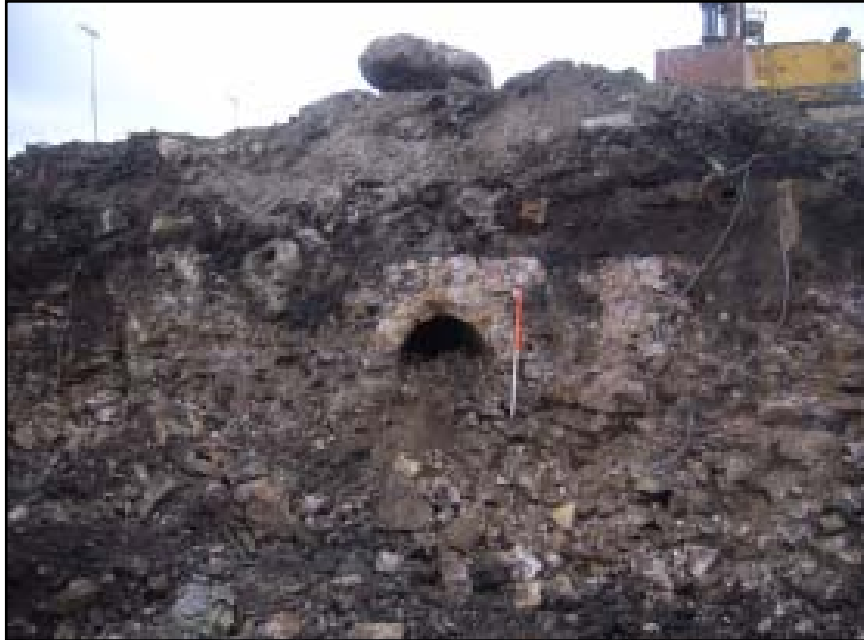
Plate 61
North-facing section through exposed Pennant sandstone structure of northern part of rail mill. Within masonry base can be seen a semi-circular brick-built flue or duct

- Plate 61 North-facing section through exposed Pennant sandstone structure of northern part of rail mill. Within masonry base can be seen a semi-circular brick-built flue or duct

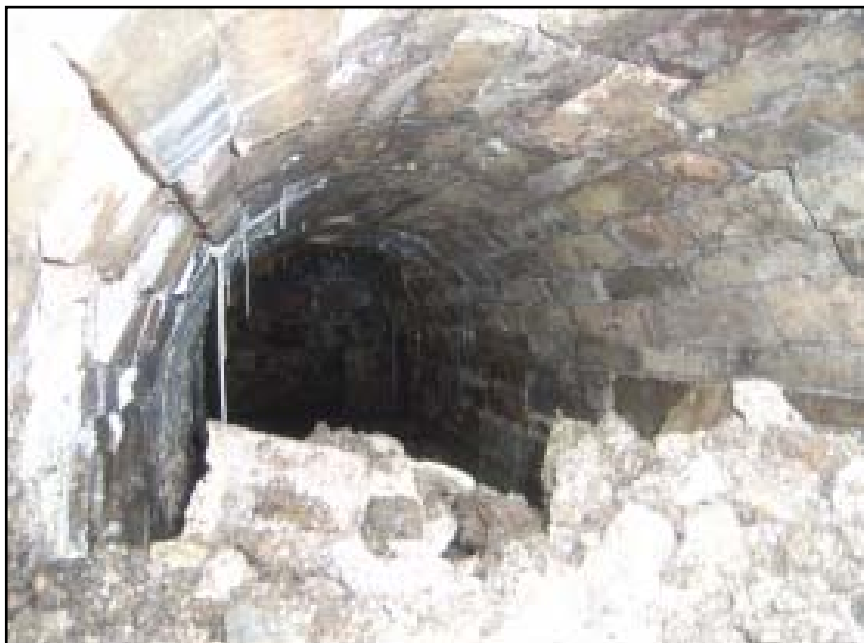
Plate 62
A view within the flue-like structure. The lack of any signs of heat affected brickwork indicates that it may have been an air duct

- Plate 62 A view within the flue-like structure. The lack of any signs of heat affected brickwork indicates that it may have been an air duct
- Plate 63 Looking south-east at the exposed roof of a mid 19th-century stone-built tunnel through which flows the river Llynfi. It is the surviving remnant of a three-arched railway bridge that carried a line to/from the Llynfi Vale ironworks

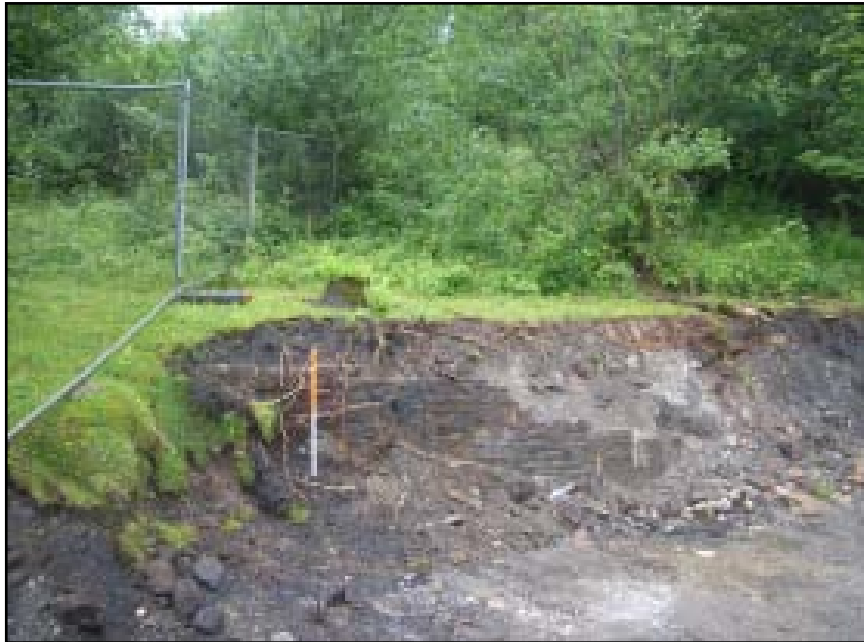
Plate 63
Looking south-east at the exposed roof of a mid 19th-century stone-built tunnel through which flows the river Llynfi. It is the surviving remnant of a three-arched railway bridge that carried a line to/from the Llynfi Vale ironworks

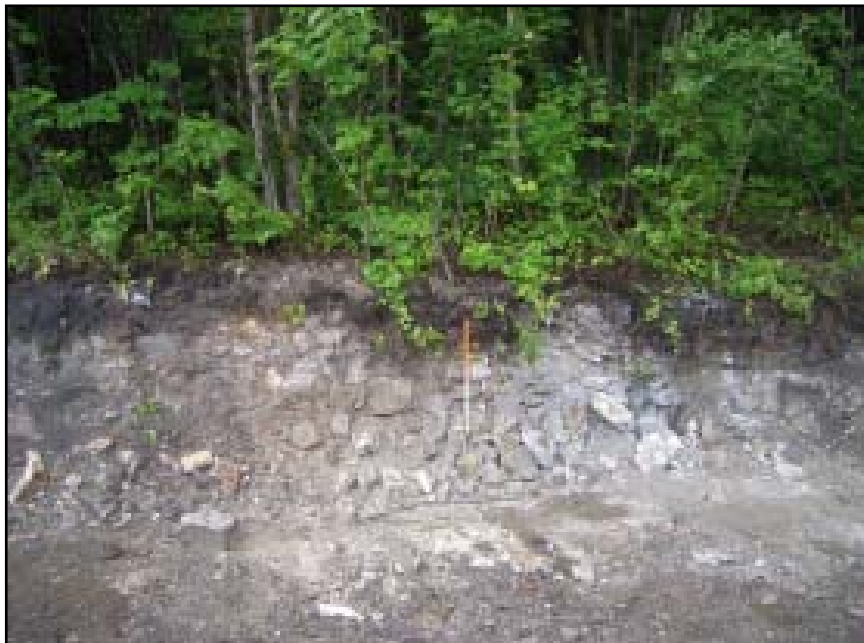
Plate 64
Looking north-west at part
of the surviving east wall
of Blast Furnace No. 3

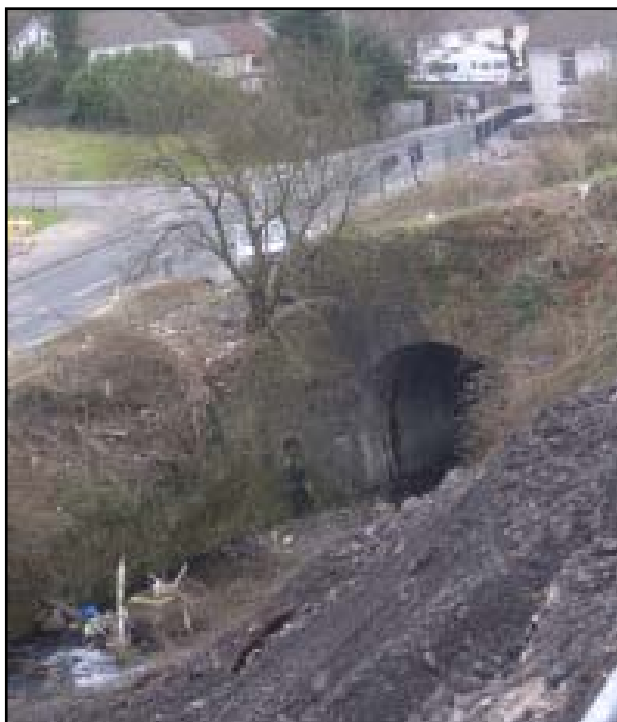
Plate 66
View of north-facing
archway of tunnel through
which flows the river Llynfi.
A second arch, belonging to
the former railway bridge,
formerly spanned the road

- Plate 66 View of north-facing archway of tunnel through which flows the river Llynfi. A second arch, belonging to the former railway bridge, formerly spanned the road
