Glenview, Camnant Road, Banwen Watching Brief

May 2016

Trysor Project No. 2016/505

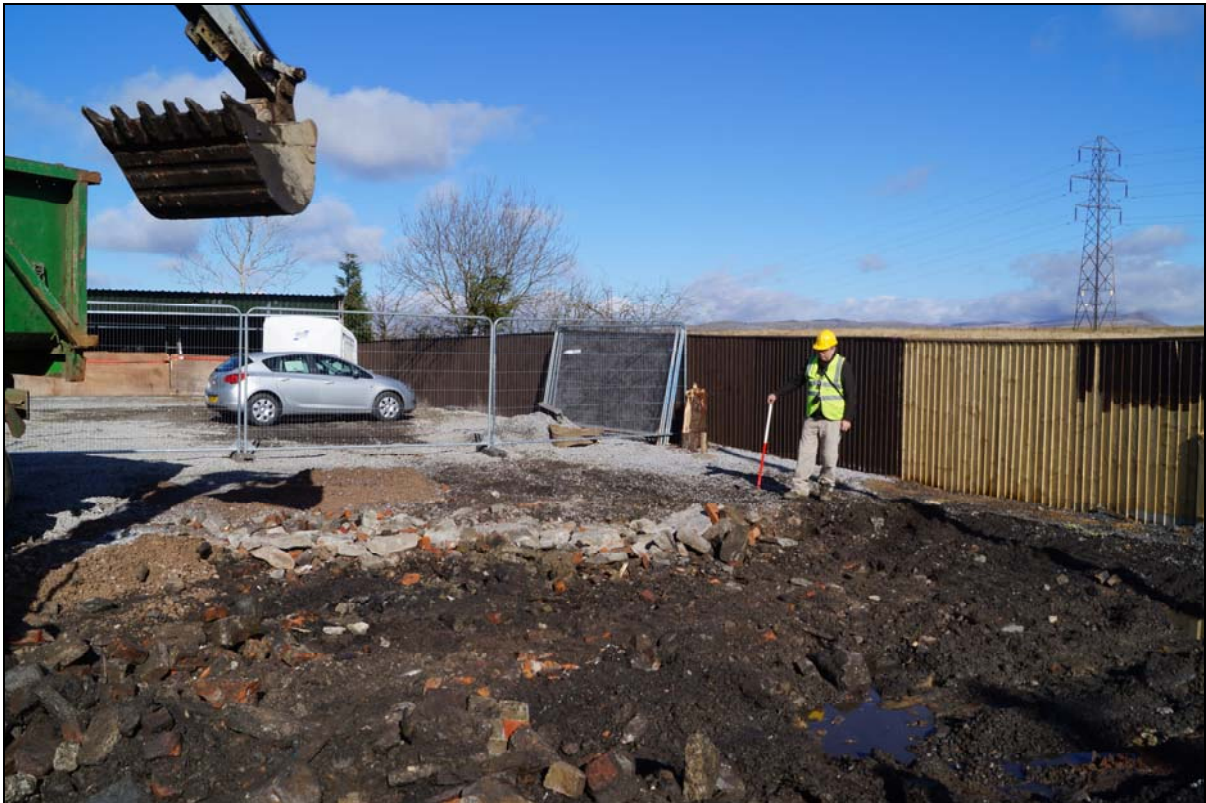
Cover photograph: Excavation of rubble fill, looking northwest

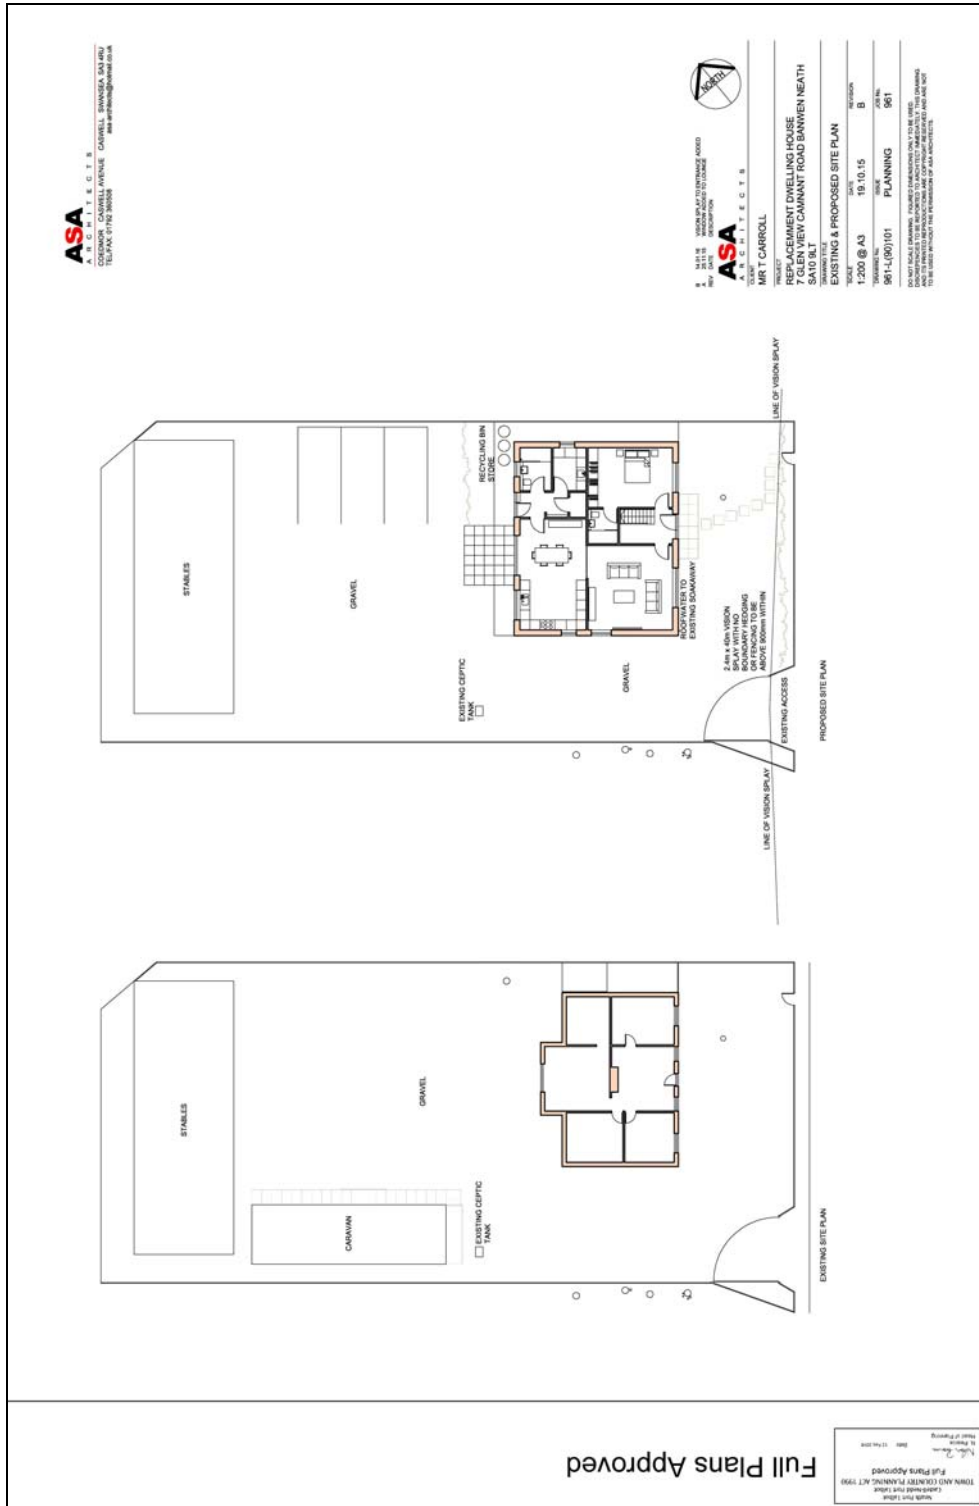
Figure 2: Detailed plan of proposed new build at Glenview, Camnant Road, Banwen. This overlies the footprint of the current building

5.1 The development is likely to lie to the west of the Roman road line. No features were found during a watching brief on the western side of the road, 400 metres to the south. The development is set back from the modern road line by approximately 7 metres, see Figure 2. There will be no groundworks in the 7 metres between the development and the modern road line as the utilities are already in place. The new house will be built on the footprint of the building already there.

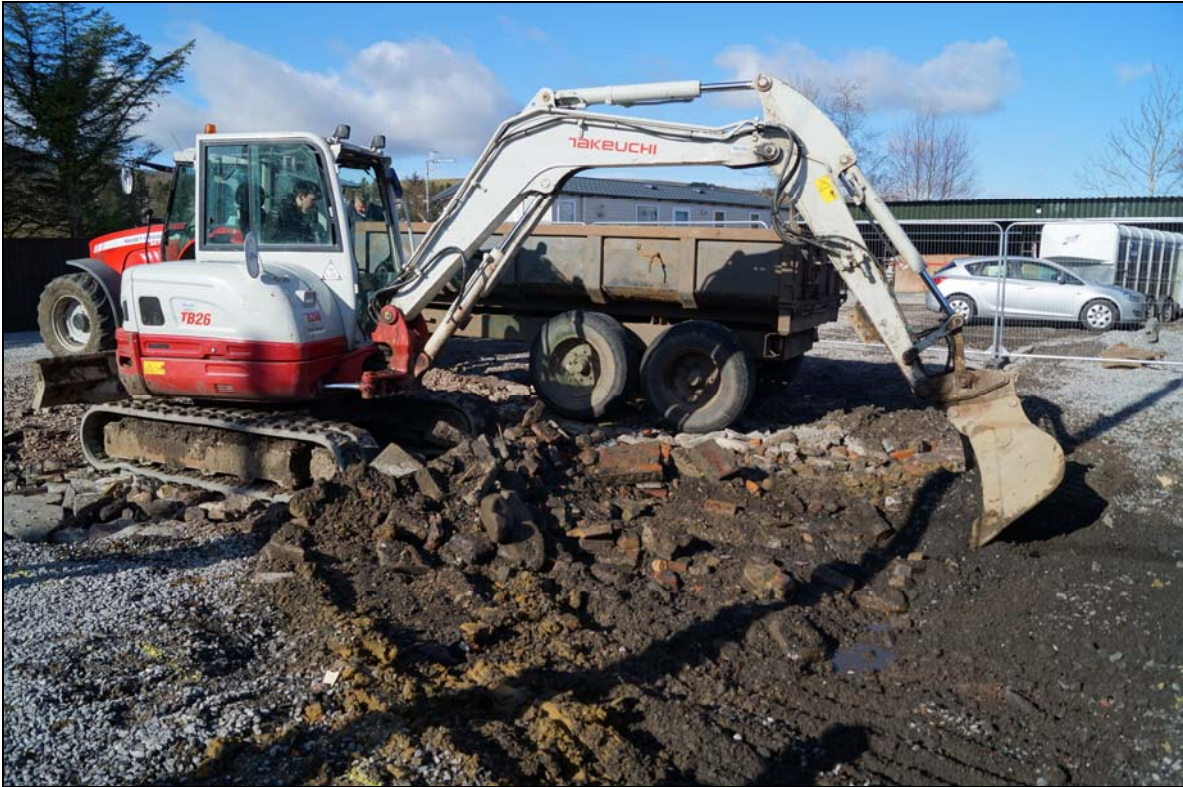
Plate 1: GVB2016_101, Starting to remove the building rubble, 001, which was shallower on the east and northern sides of the area excavated, looking west.

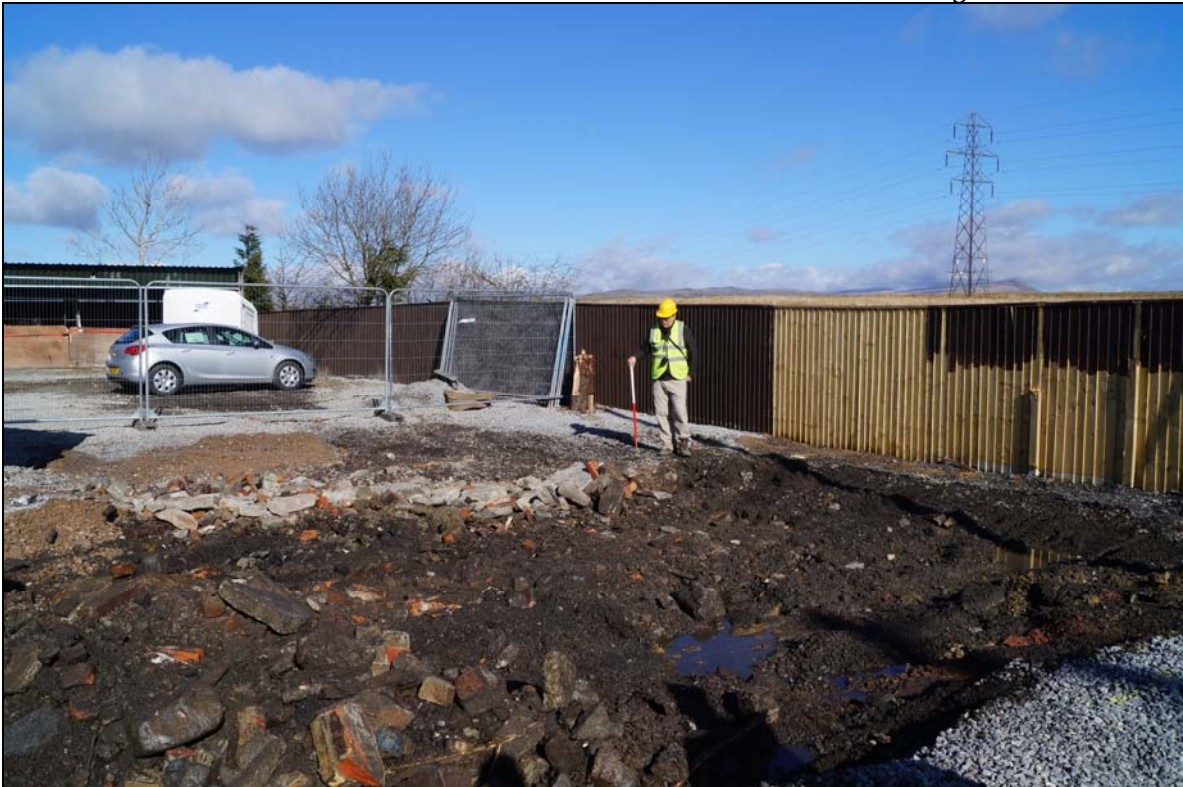
Plate 2: GVB2016_102, during removal of building rubble, 001, looking north northwest.

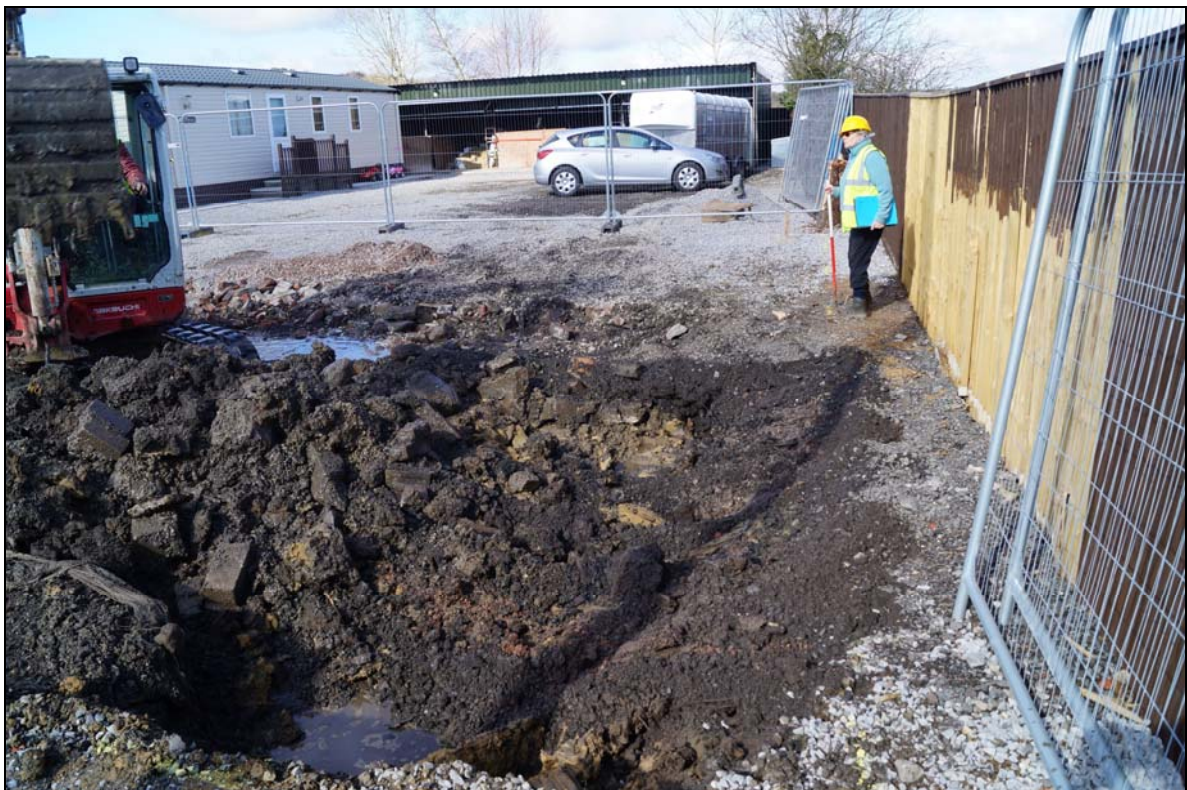
Plate 4: GVB2016_104, During removal of building rubble, 001, with clay layers, 002 and 003, just visible. Also groundwater is visible seeping into the excavated areas, looking northwest.

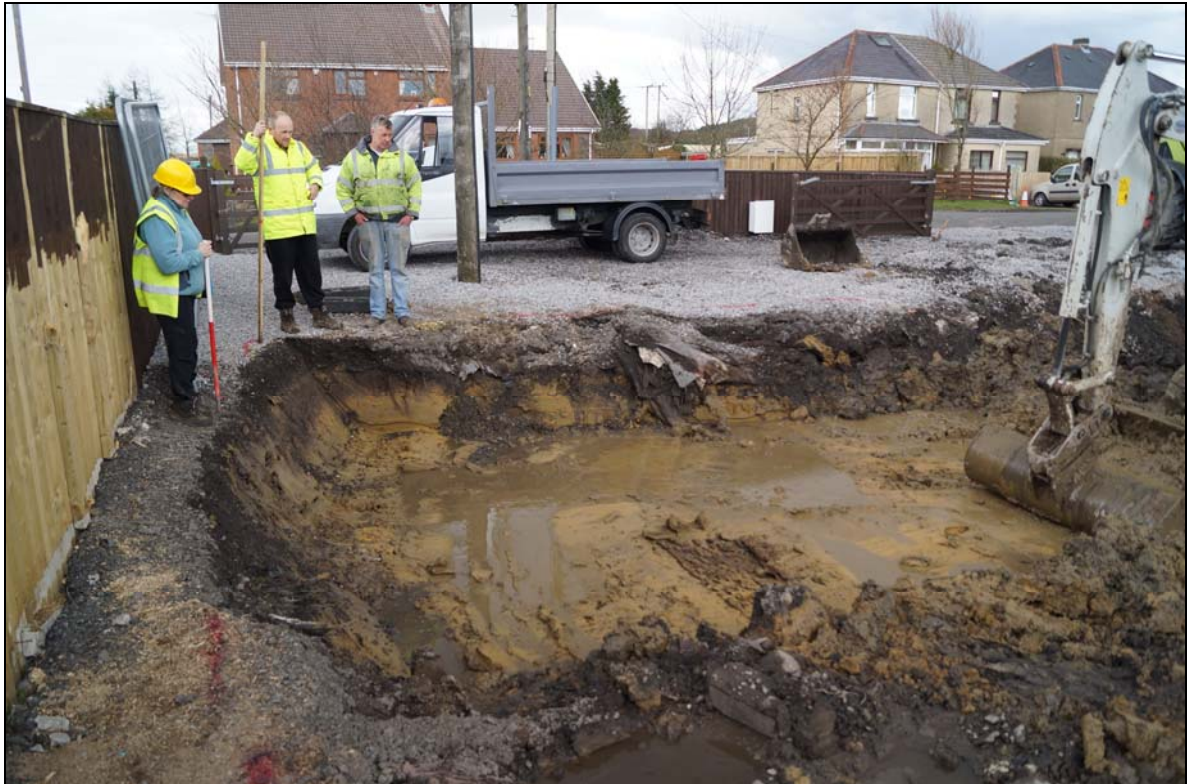
Plate 6: GVB2016_106, Building rubble removed and clay 002 and 003 visible in base, groundwater seeping in fast, looking southeast.

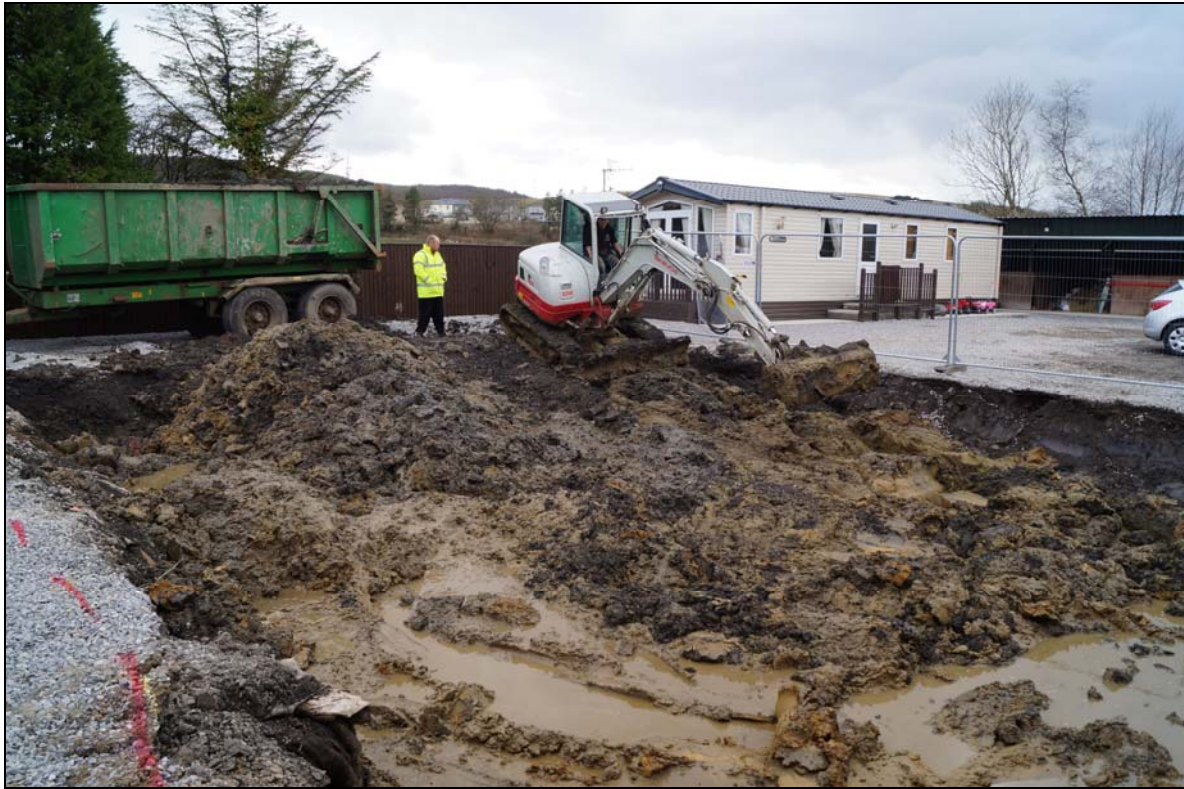
Plate 7: GVB2016_107, as excavation progressed across the plot, the groundwater became more of a problem and the clay subsoils became liquid, looking west.
