CPAT Report No. 1612

Bronllys Hall, Powys

Heritage Impact Assessment

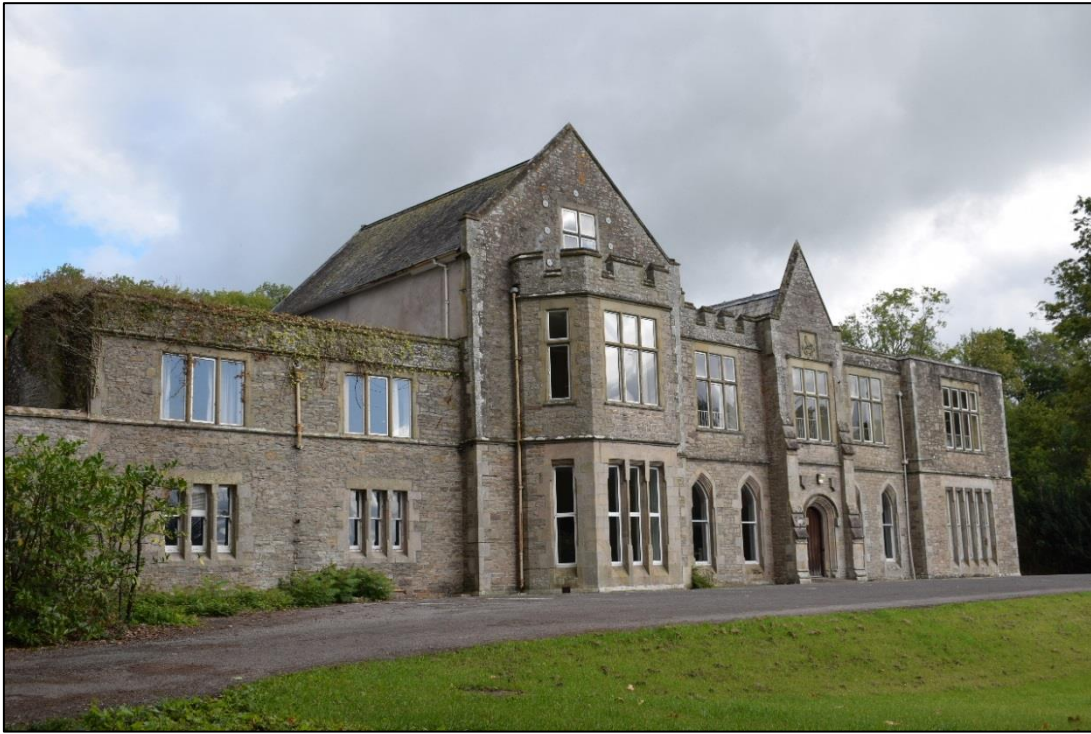
Fig. 16: Main south-facing frontage of Bronllys Hall. CPAT 4537-0005

- 3.15. Externally, the core of the building is constructed from reddish sandstone with decorative elements in a yellow-brown sandstone, its roof is covered with an artificial material with the appearance of slate. The windows on the ground floor south frontage are either single lights, mostly with pointed arch heads, or multiple lights separated by stone mullions; those on the first floor are distinctively different and are generally of mullioned and transomed stone construction. It seems unlikely that any of the original windows survive: most of those on the south frontage have been replaced by metal-framed panes set into the stone surrounds, elsewhere the earliest appear to be sash windows with wooden frames. The top of the walls defining the historic core are battlemented on both the north and south sides.

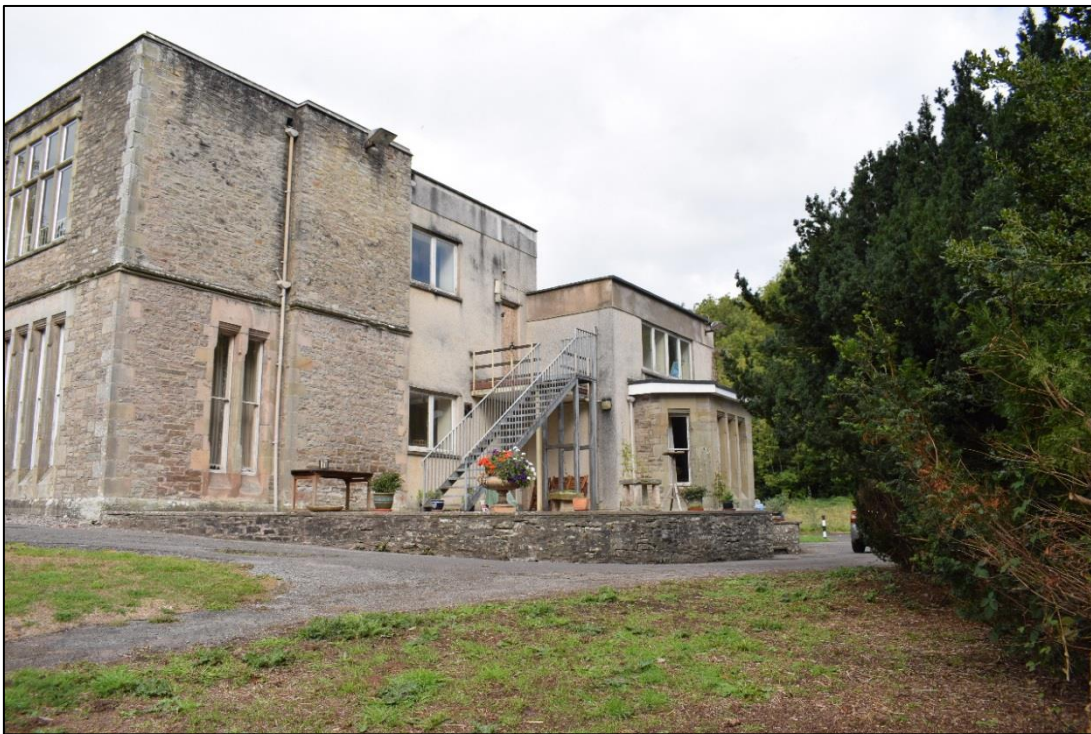
Fig. 17: Eastern end of Bronllys Hall, showing the cement rendered replacement for the part of the hall that was lost to a fire. The bay window is original. CPAT 4537-0013

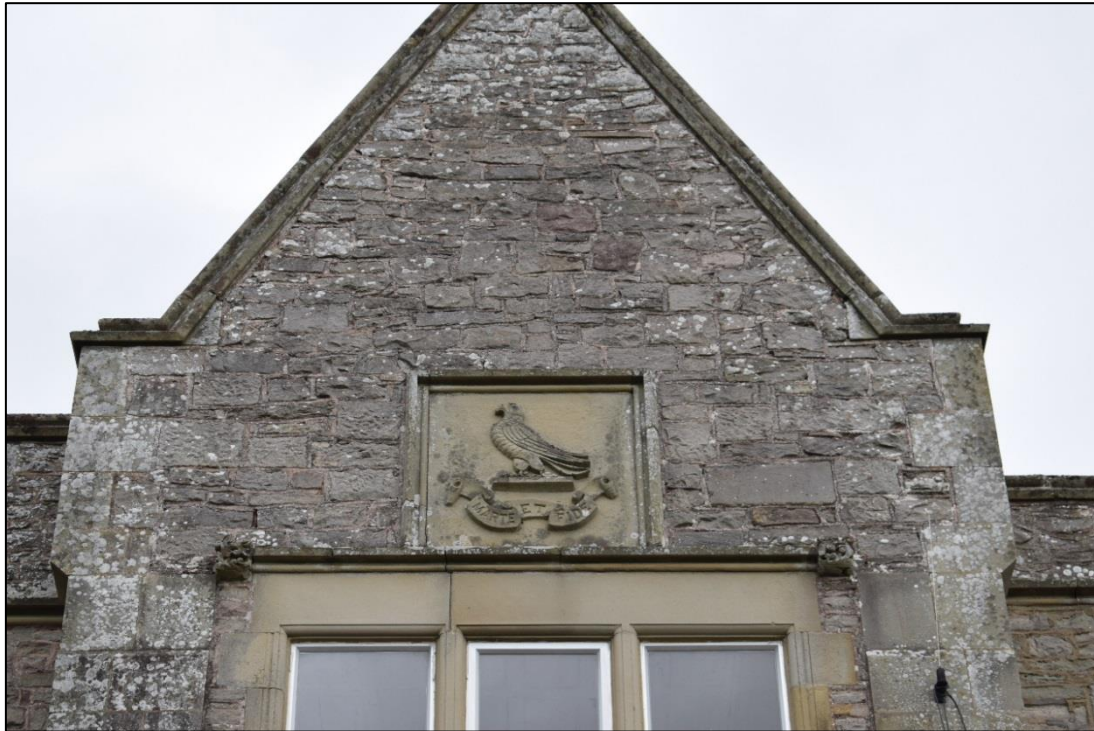
Fig. 18: The probable Crawshay Ralston crest above the entrance hall windows. CPAT 4537-0022

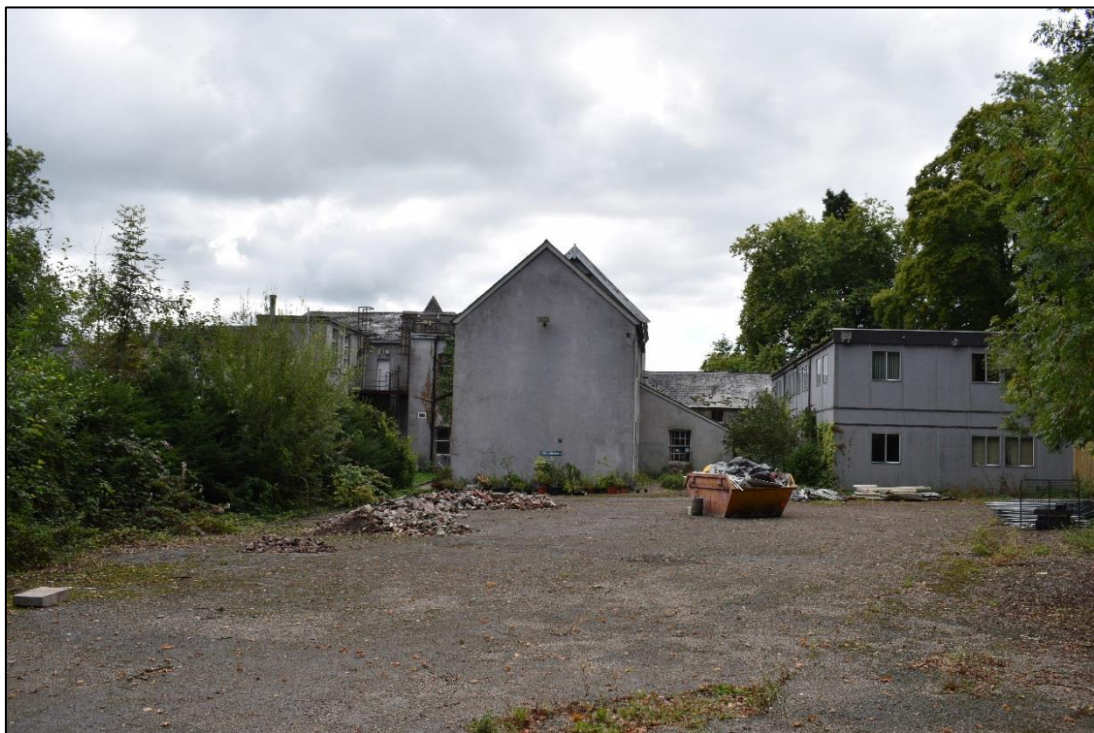
Fig. 19: Rear view of the hall, with the 19th-century wing projecting north from the west end of the historic core of the building in the centre of the frame. The ornamental barge board of the original building is just visible above. CPAT 4537-0039

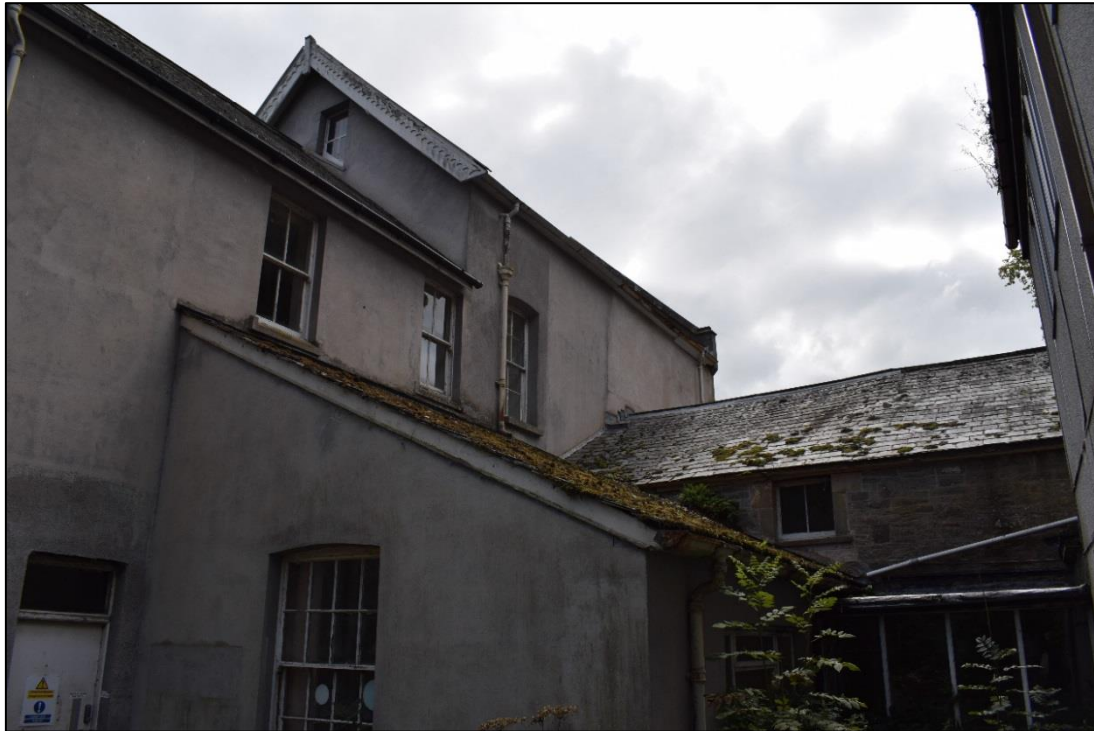
Fig. 20: Close up view, showing the junction between the historic core of the building (centre top) and the piecemeal later additions on its west and north. CPAT 4537-0041

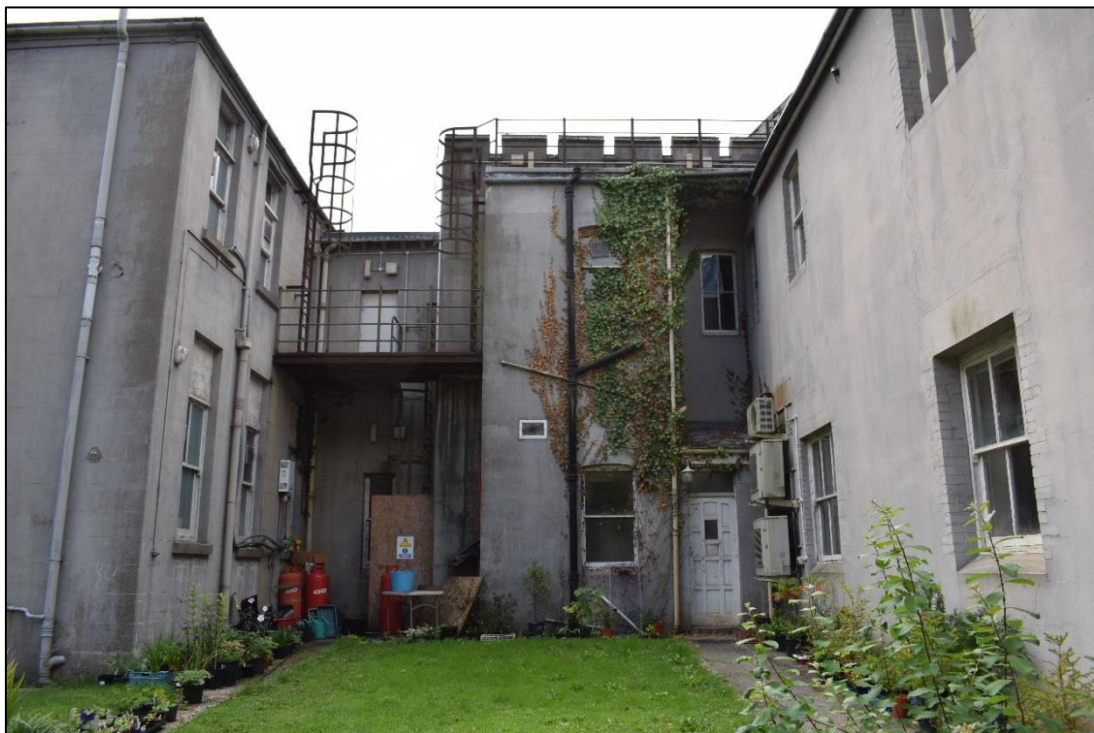
Fig. 21: The rear of the hall, showing the battlemented wall defining the north side of the historic core and the 19th-century north wing. Everything to the left of the battlemented wall is a rebuild following the fire in the late 20th century. CPAT 4537-0042

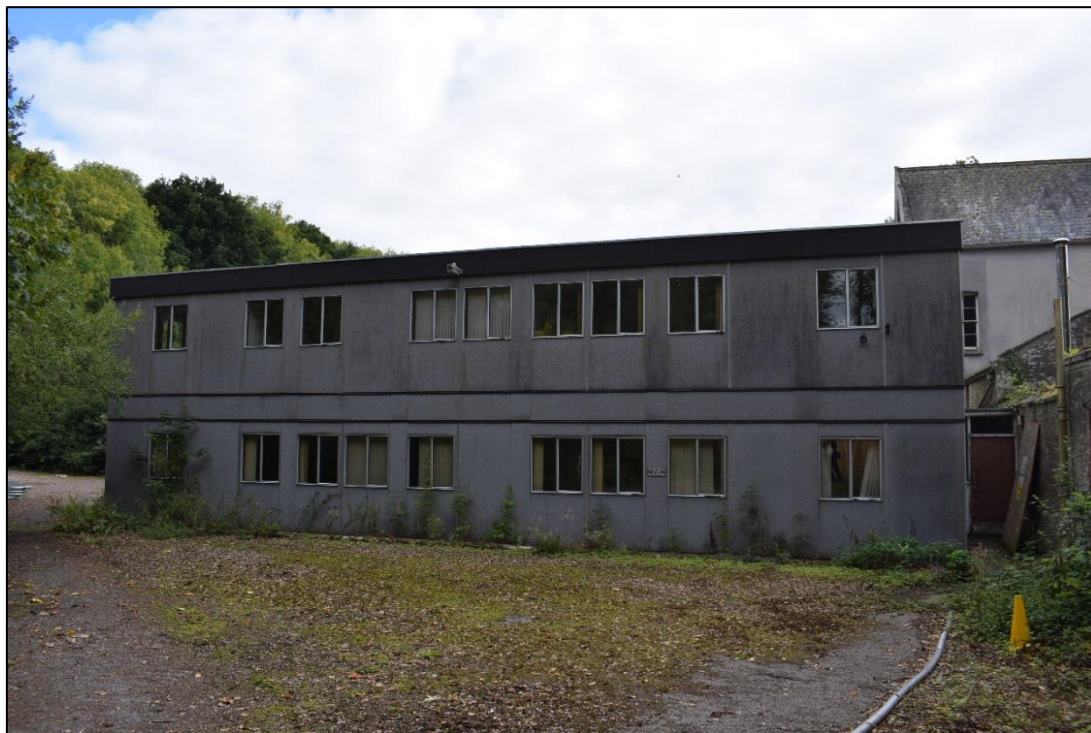
Fig. 22: The prefabricated 20th-century wing to the north of the service court. CPAT 4537-0020

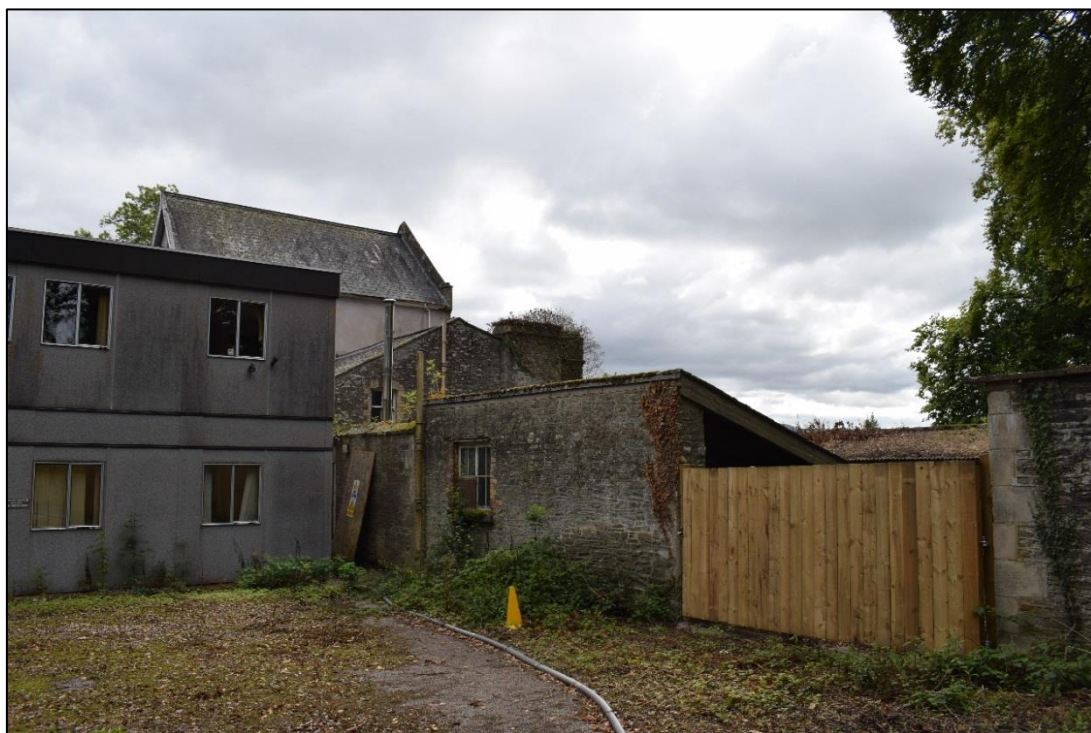
Fig. 23: External view of the service court. CPAT 4537-0038

- 3.20. A walled service court (Fig. 13, G1-G8) lies further to the west of the house and this is clearly of two phases, as is shown by a butt-joint in the walling to the west of an arched door through which it was accessed. The western part (Fig. 13, G1-G5) is the later and the structures here are of no architectural merit, comprising lean-tos attached to the surrounding walls and resting on brick piers. A wider service entrance lies on the north side of G1.

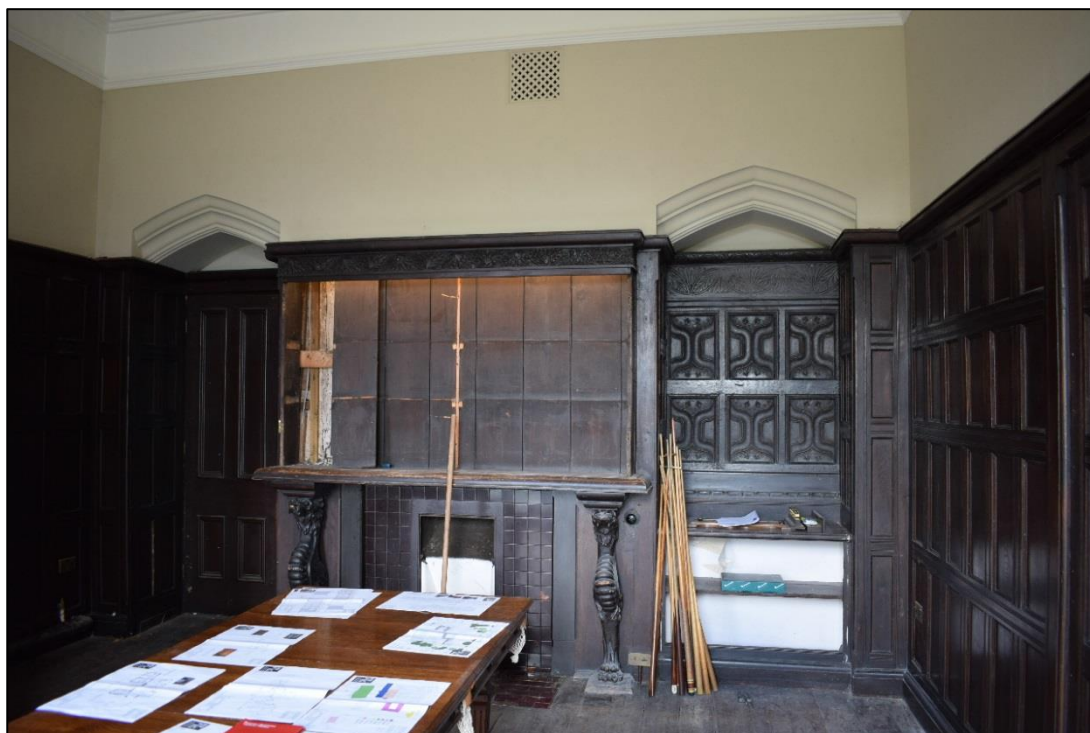
Fig. 26: Inner hall, showing wooden panelling (Fig. 11, G28). CPAT 4537-0074

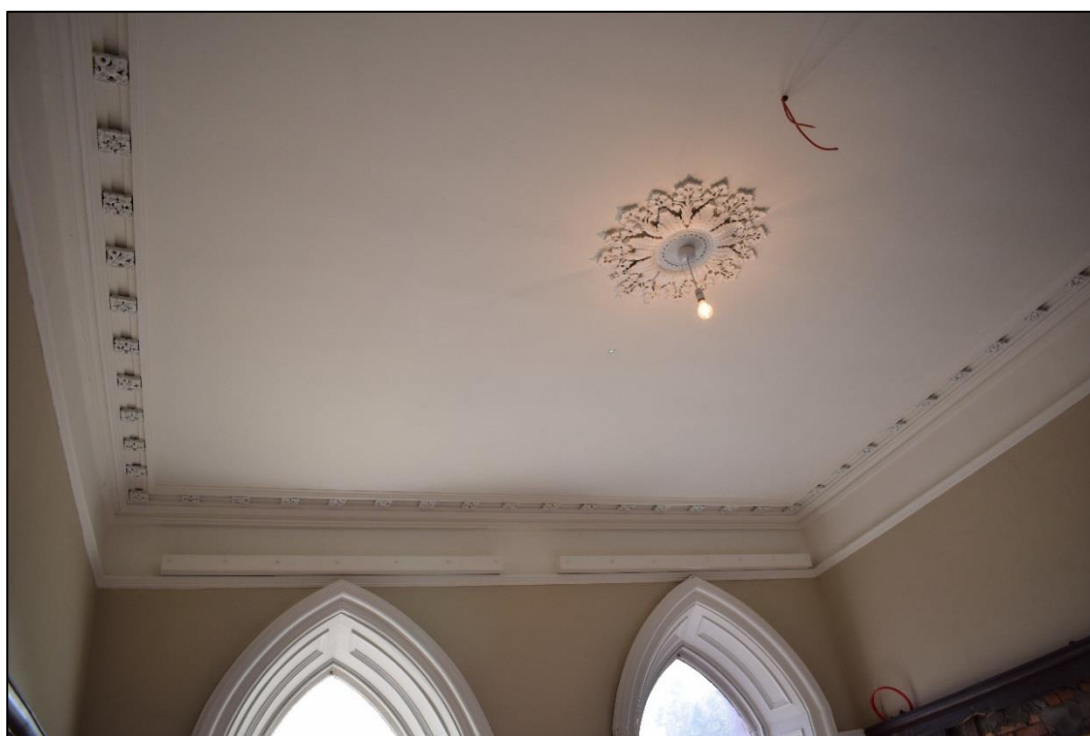
Fig. 27: Ornamental mouldings typical of the historic core of the hall (Fig. 11, G28).
CPAT 4537-0076

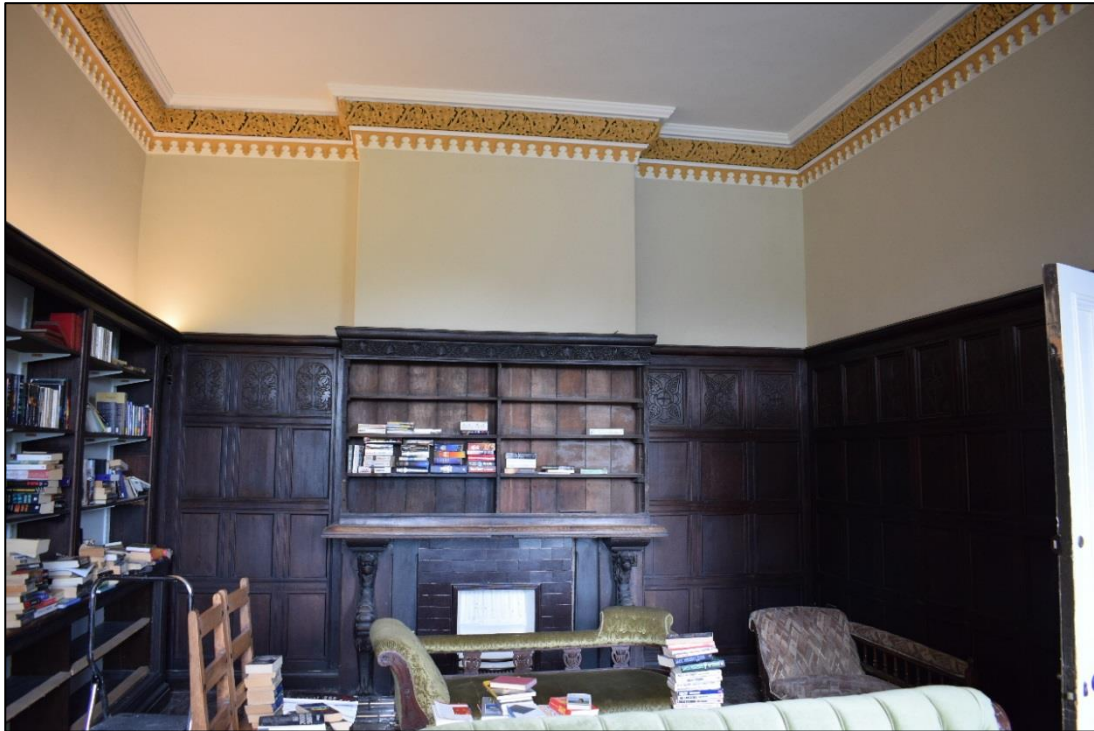
Fig. 28: Wooden panelling and ornamental mouldings in the Library (Fig. 11, G26).
CPAT 4537-0131

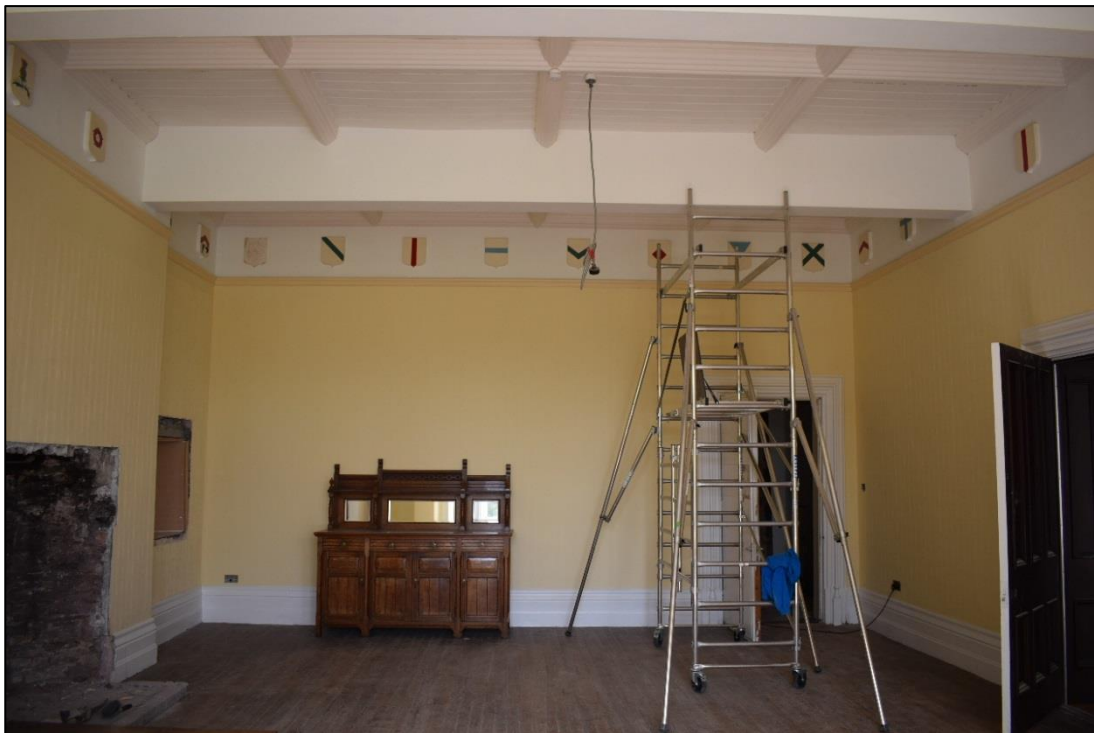
Fig. 29: Decorative shields and wooden ceiling in the western ground floor room of the historic core (Fig.11, G21). CPAT 4537-0140

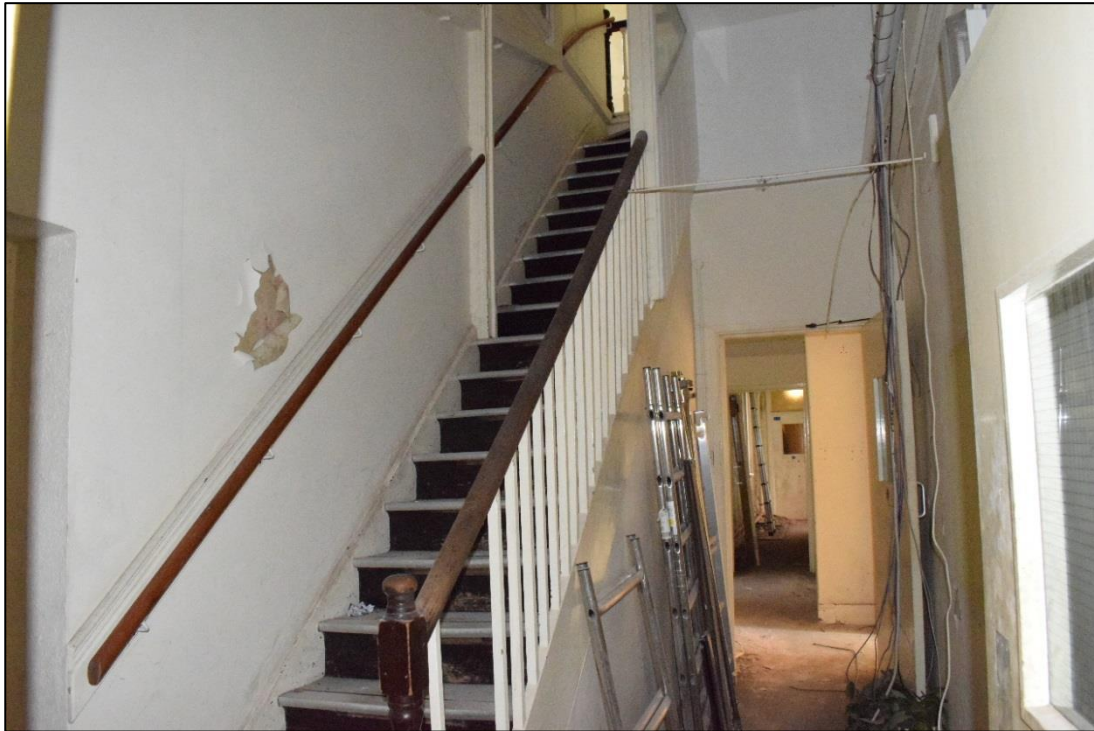
Fig. 30: Stairs to first floor and the passage behind the rooms on the ground floor of the historic core (Fig. 11, G14, G20-G24). CPAT 4537-0143

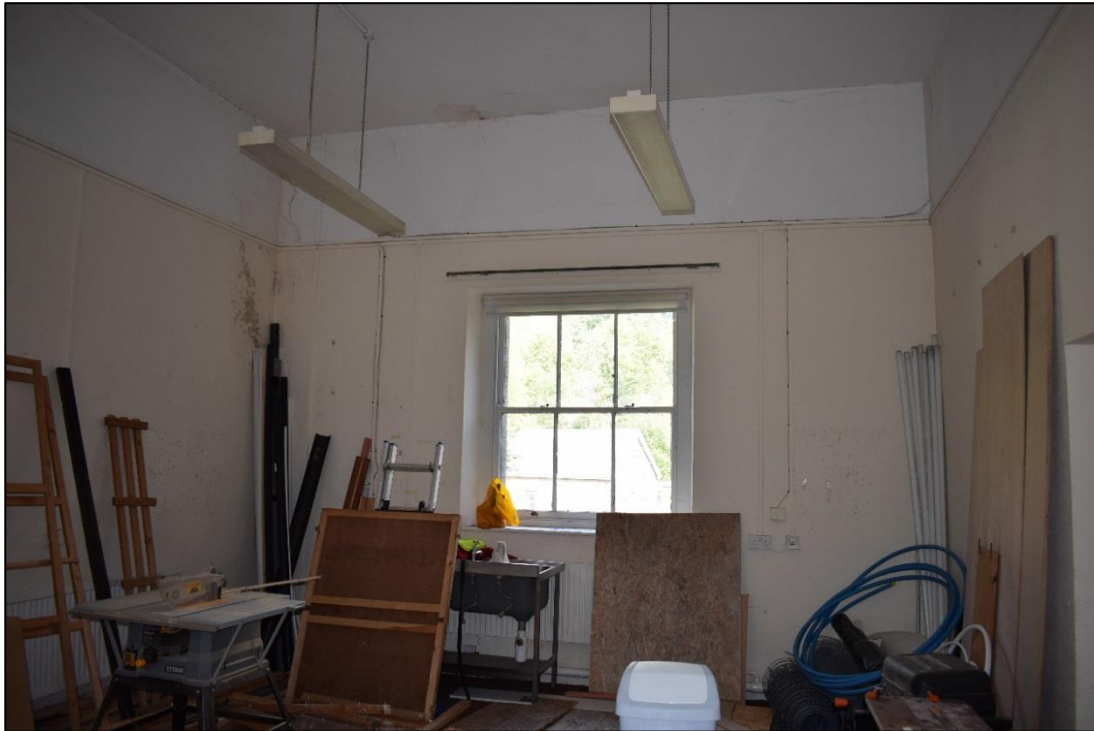
Fig. 32: Typical interior view of a room on the ground floor of the 19th-century extension to the north of the western end of the historic core (Fig. 11, G19). CPAT 4537-0149

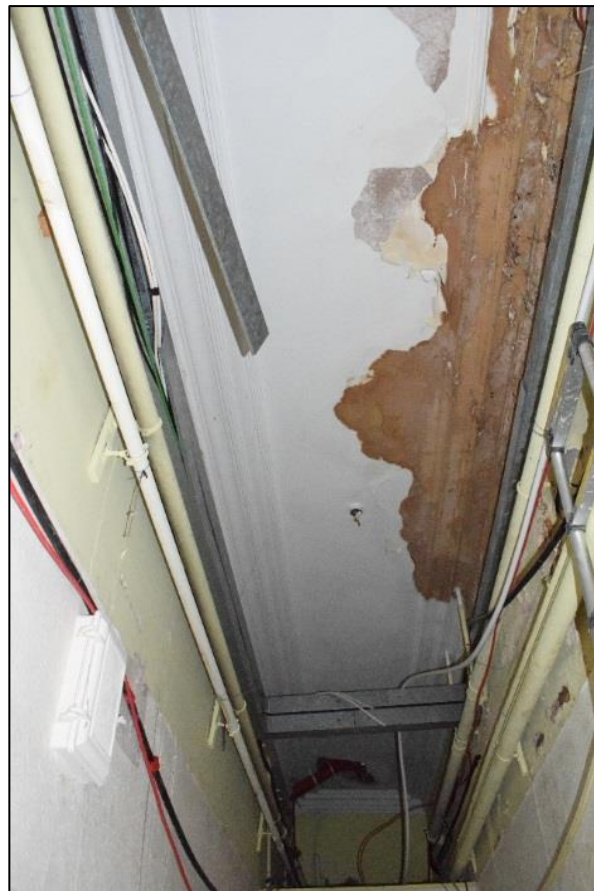
Fig. 33: Ornamental mouldings in the passage behind the rooms on the ground floor of the historic core (Fig. 11, G22). CPAT 4537-0152

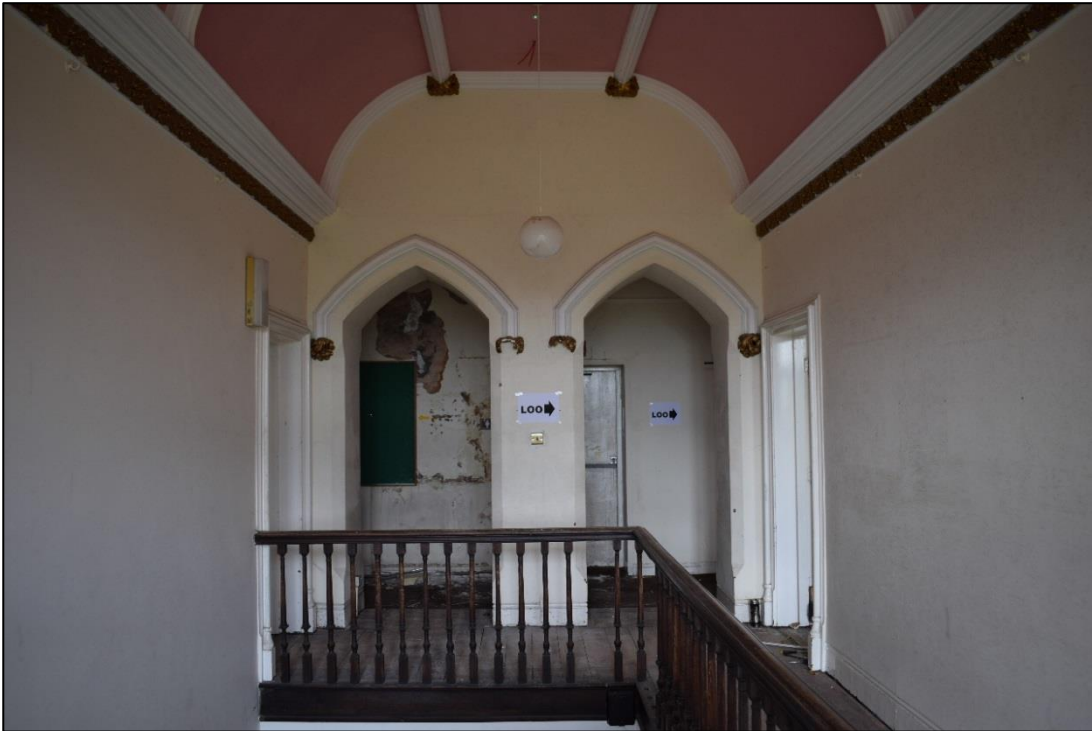
Fig. 34: The upper floor of the entrance hall (Fig. 11, F20). CPAT 4537-0088

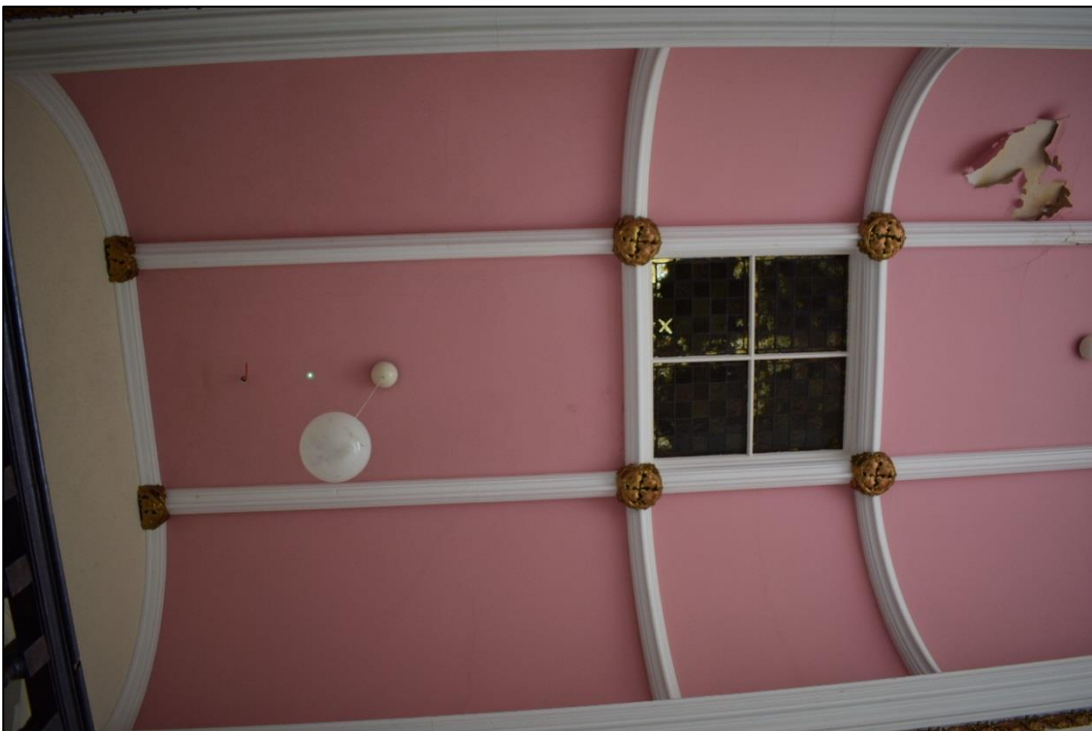
Fig. 35: Ornamental mouldings and roof light above the entrance hall (Fig. 11, F20).
CPAT 4537-0086

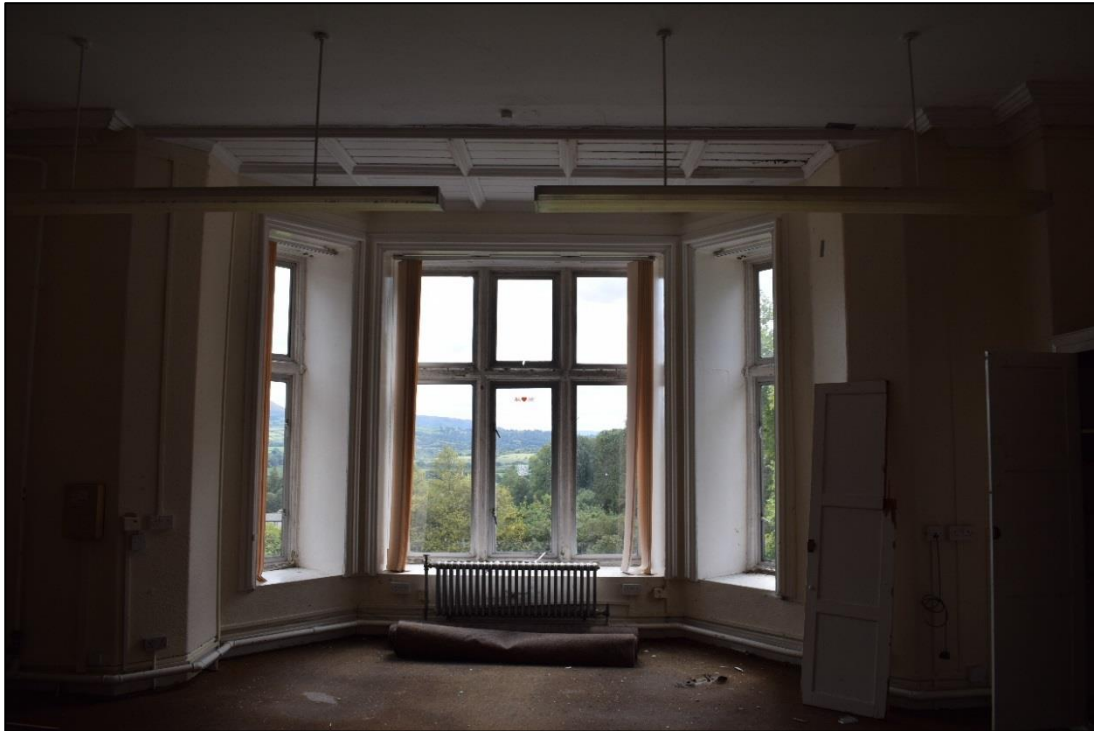
Fig. 36: The interior view of the bay window on the first floor at the western end of the historic core (Fig.12, F6). CPAT 4537-0099

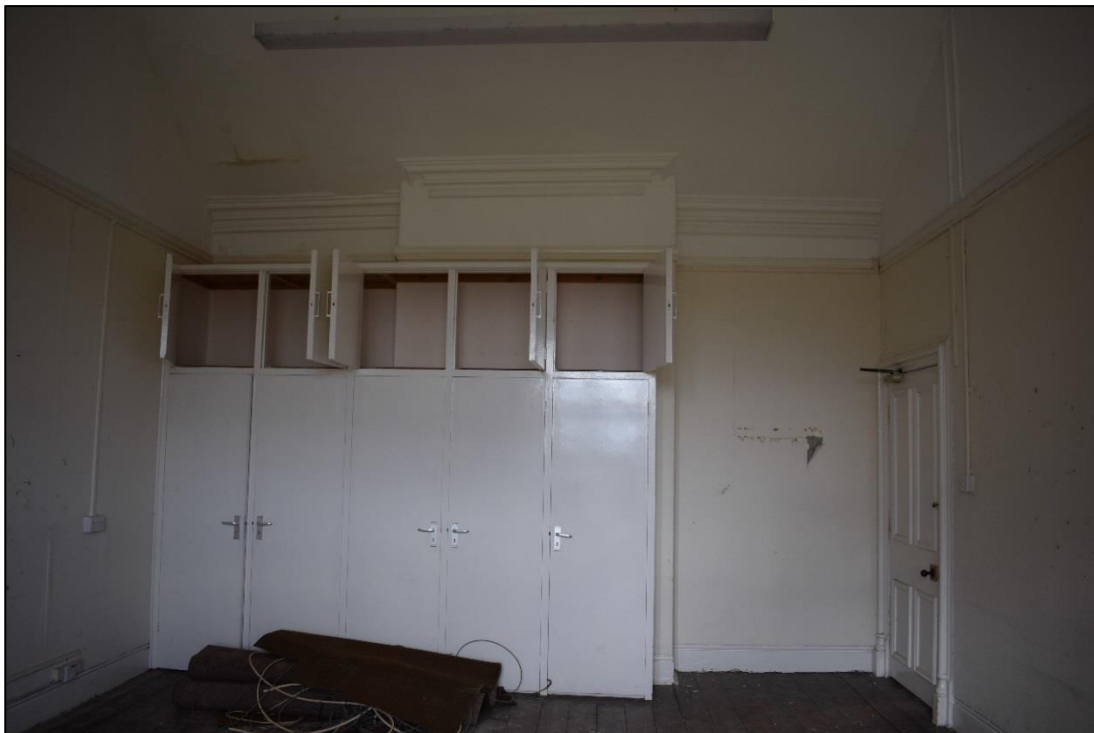
Fig. 37: Ornamental door surround and roof mouldings typical of the first floor in the historic core of the building (Fig. 12, F19). CPAT 4537-0095

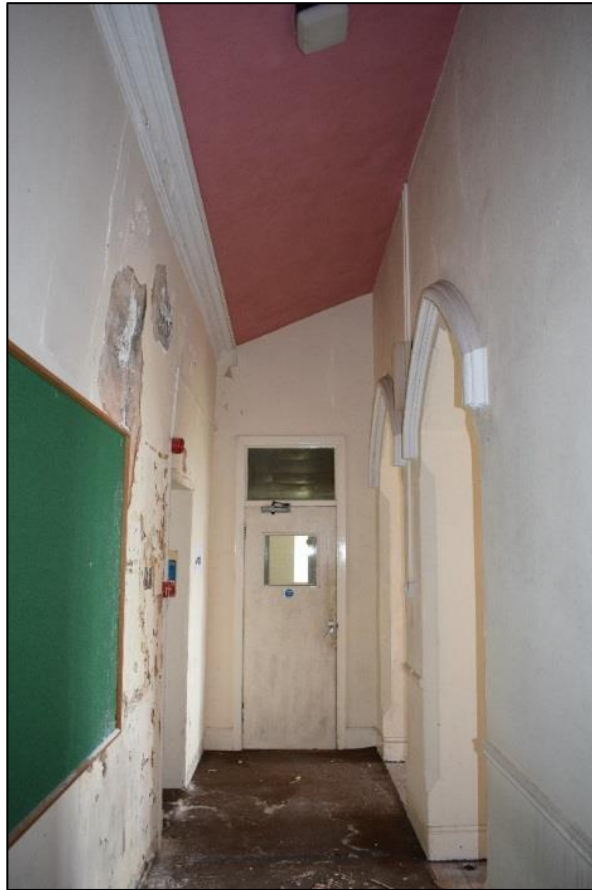
Fig. 38: The passage to the rear of the rooms in the historic core of the building, showing ornamental mouldings (Fig. 11, F18). CPAT 4537-0097

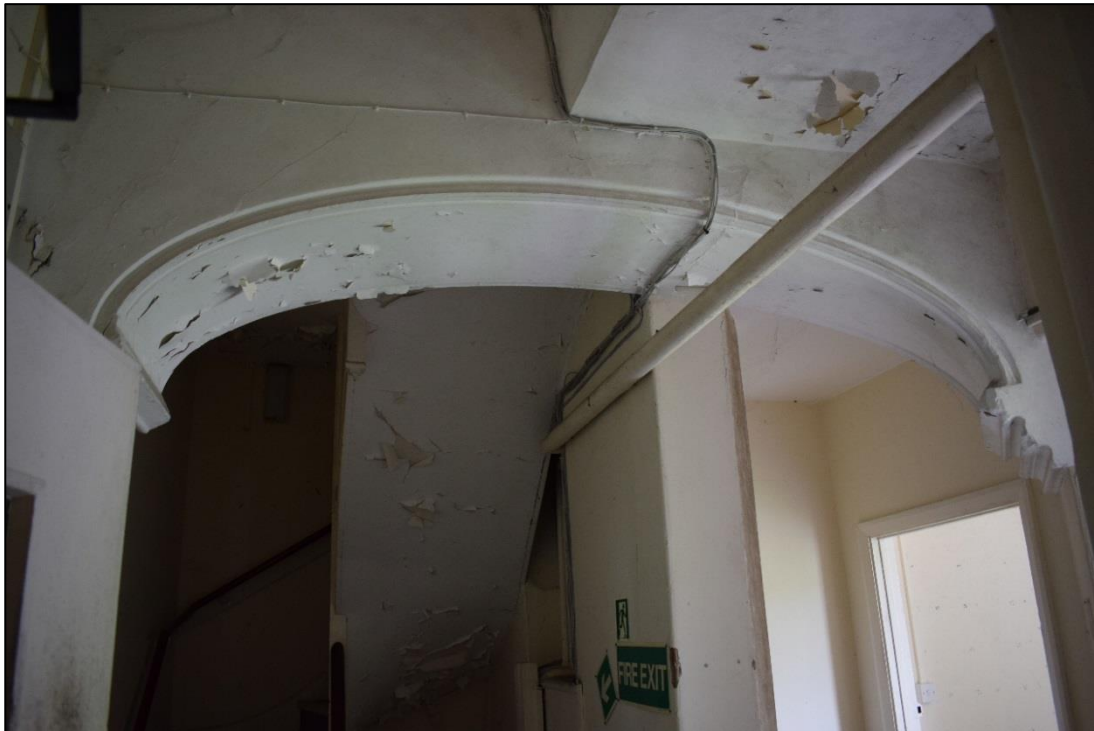
Fig.39: The skewed arch providing access to the 19th-century wing to the north of the western end of the historic core (Fig. 12, F9). CPAT 4537-0098

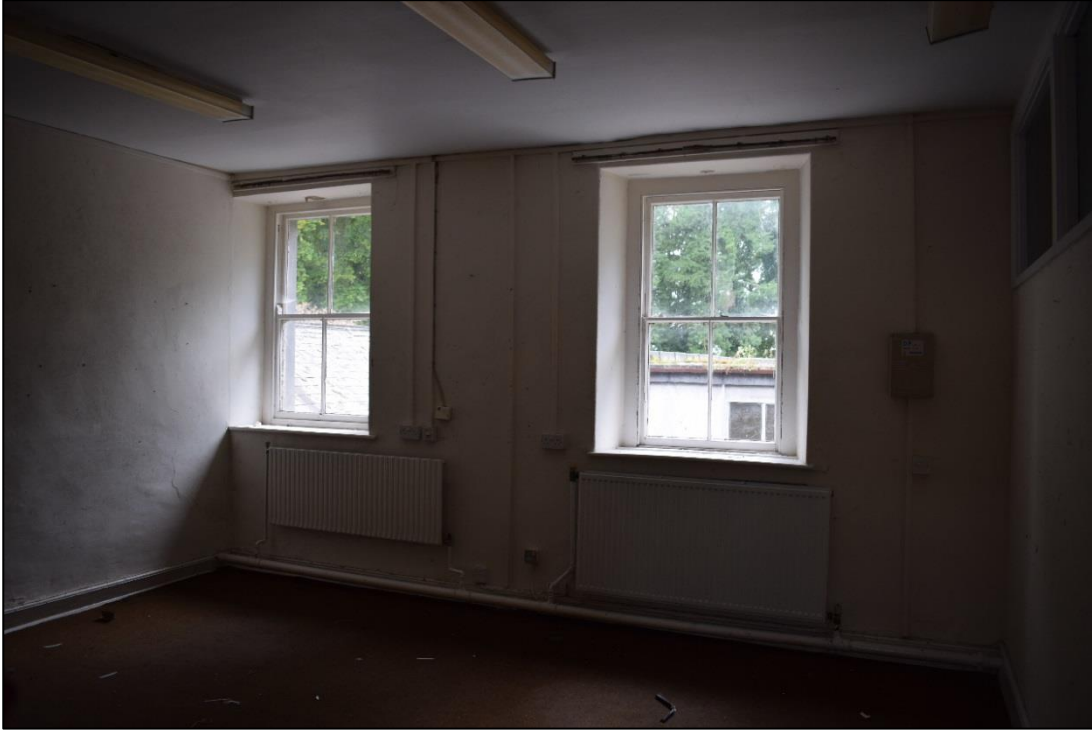
Fig. 40: Typical interior view of the rooms in the 19th-century extension on the north side of the western end of the historic core, the left hand wall was the external wall of the core (Fig. 12, F11). CPAT 4537-0117

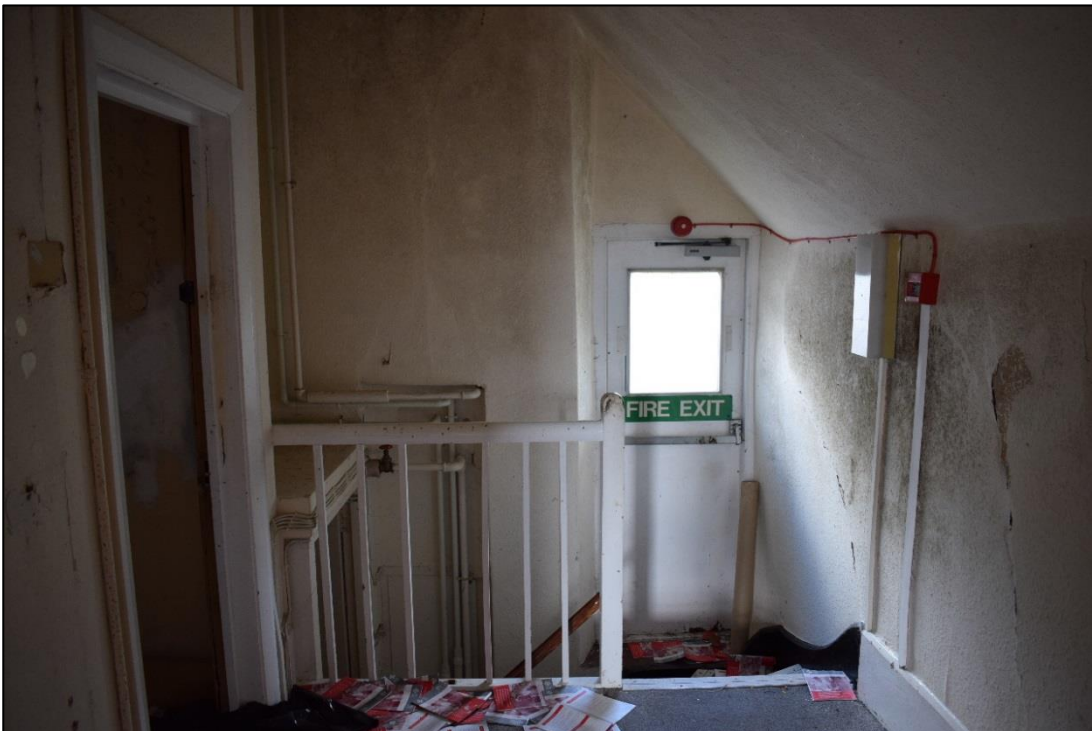
Fig. 41: The top of the stairs leading to the second floor rooms at the west end of the historic core (Fig.13, S1-S2)

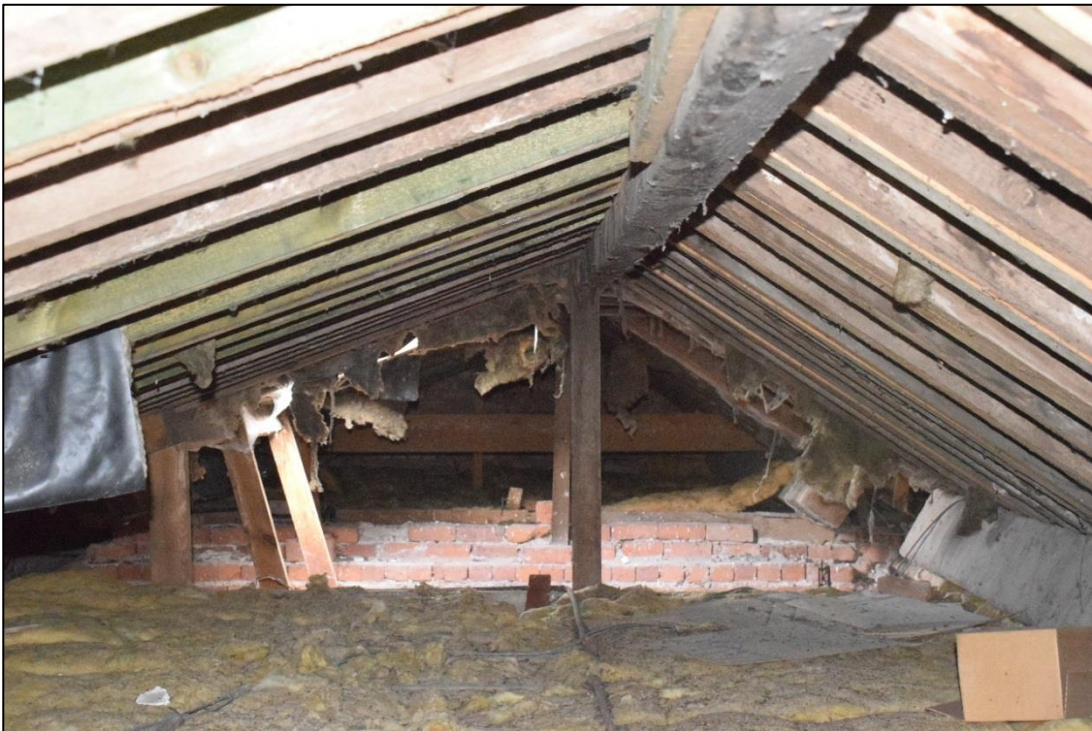
Fig. 43: The roof space above the central part of the historic core, visible through a hatch in room S6. CPAT 4537-0124

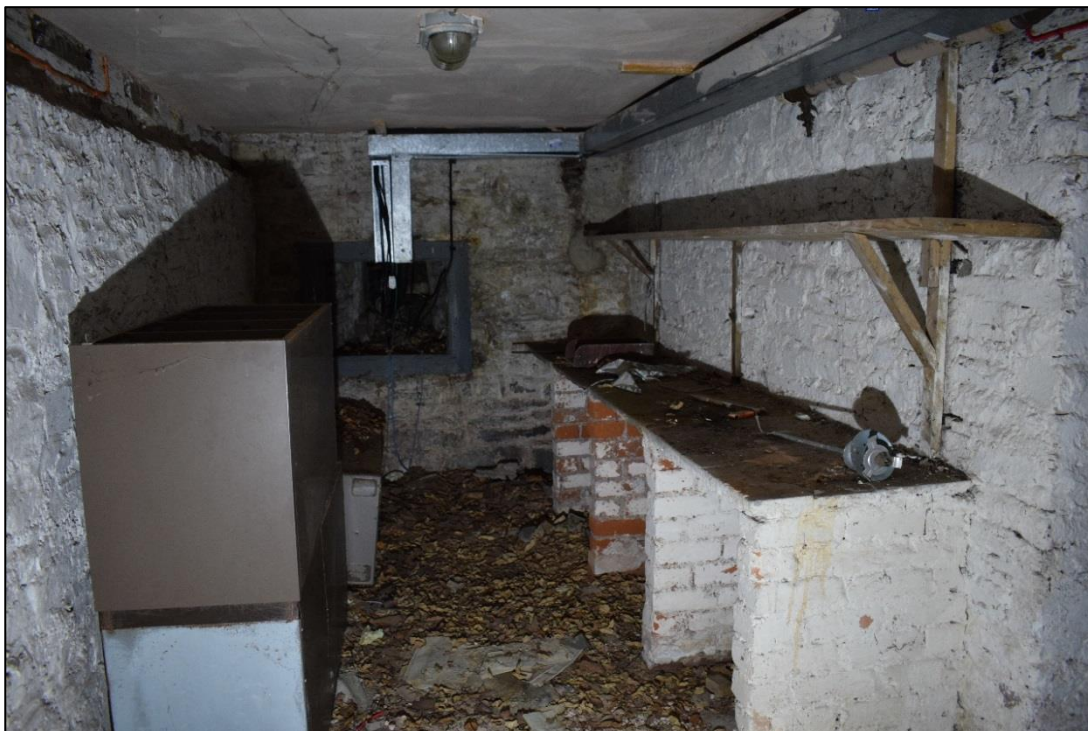
Fig. 44: Central of the three adjoining cellar rooms (Fig. 10, B5). CPAT 4537-0157

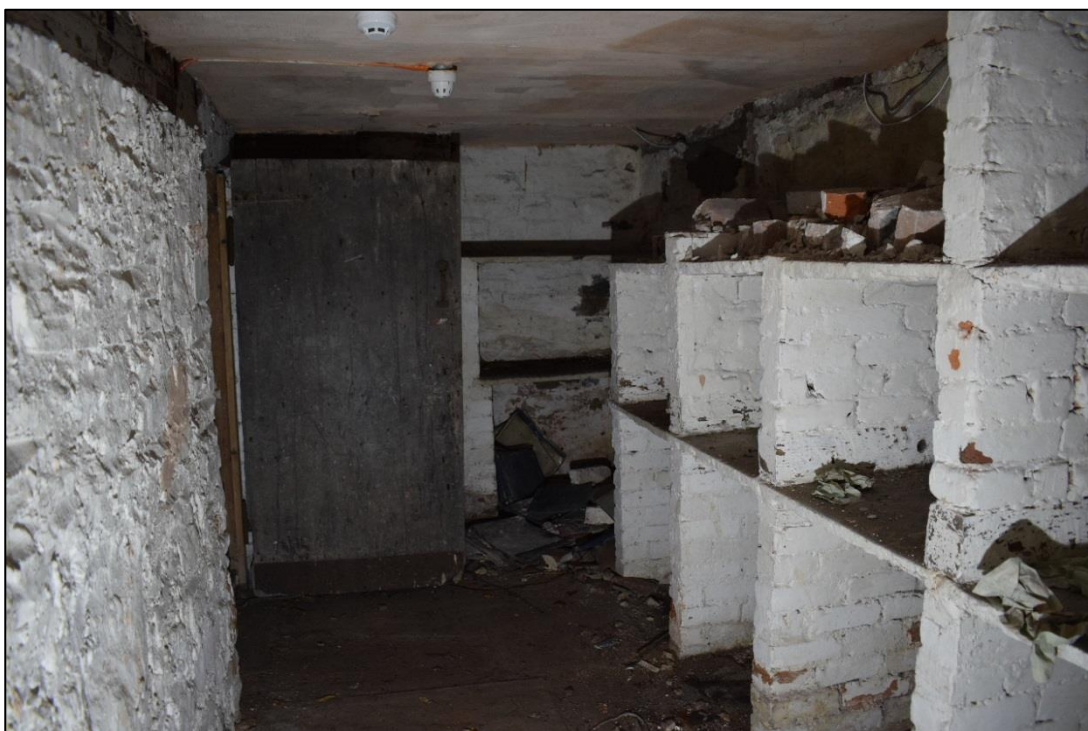
Fig. 45: Eastern of the three adjoining cellar rooms (Fig. 10, B6). CPAT 4537-0159

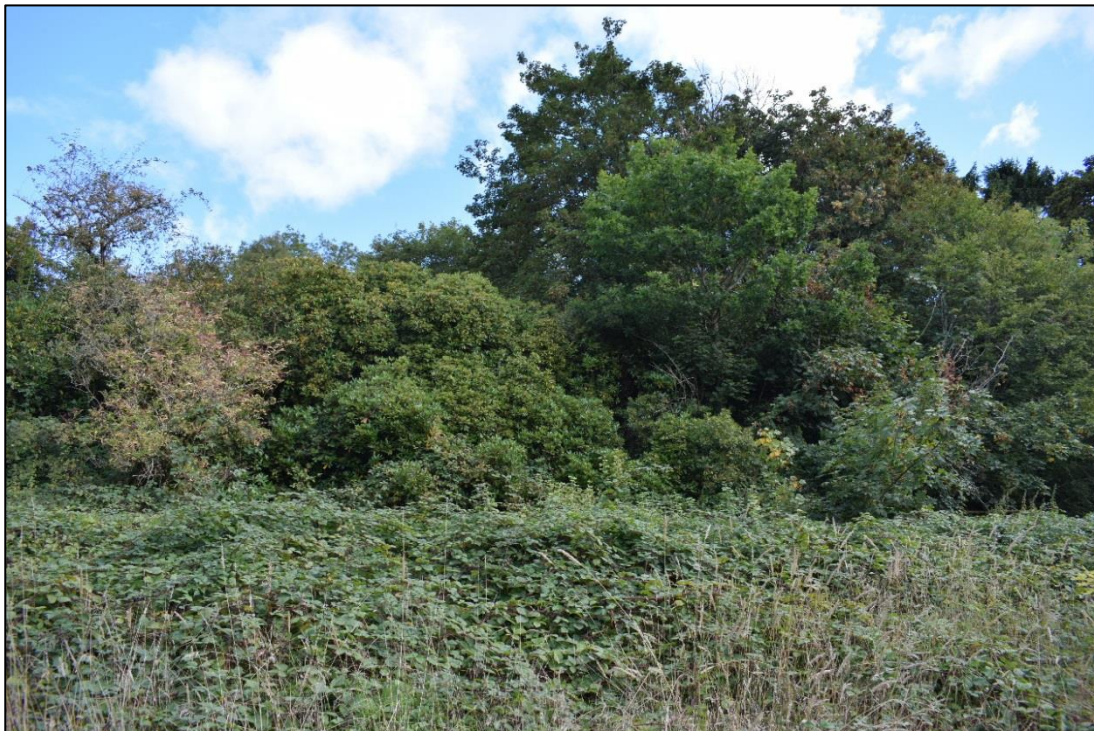
Fig. 47: The view north from the southern boundary of the Development Area demonstrating the effect of tree growth in the area of the ha-ha. (CPAT 4537-0009)

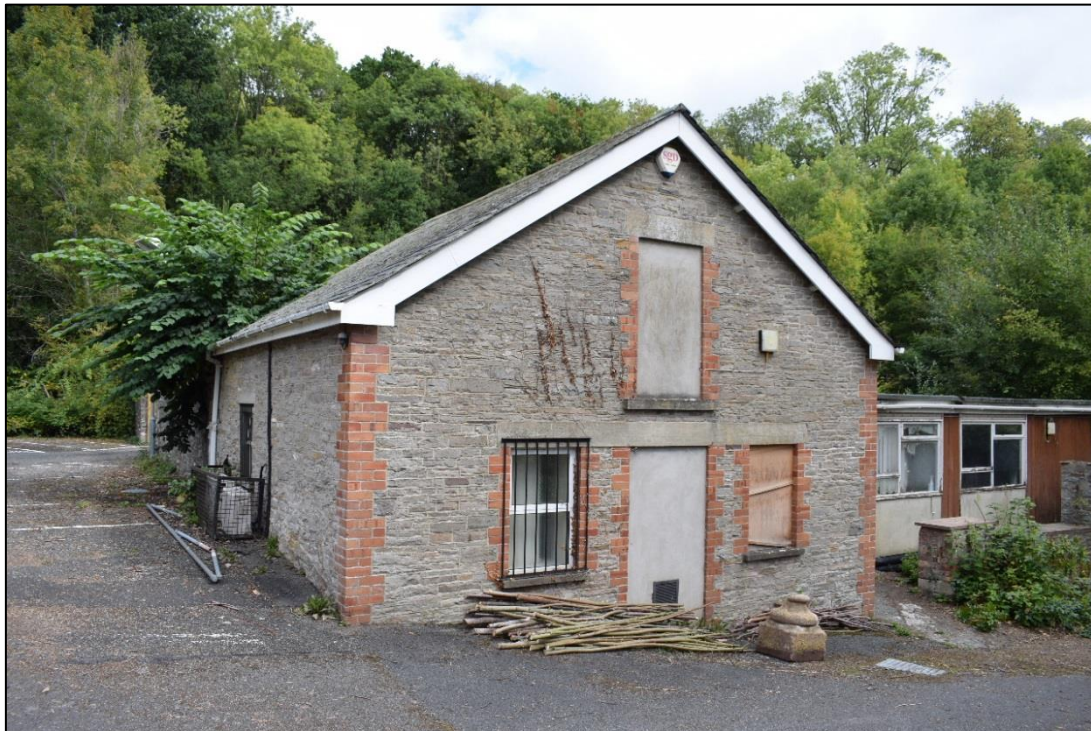
Fig. 49: The coach house at the south-west corner of the walled garden. CPAT 4537-0052
