CPAT Report No. 1612

Bronllys Hall, Powys

Heritage Impact Assessment

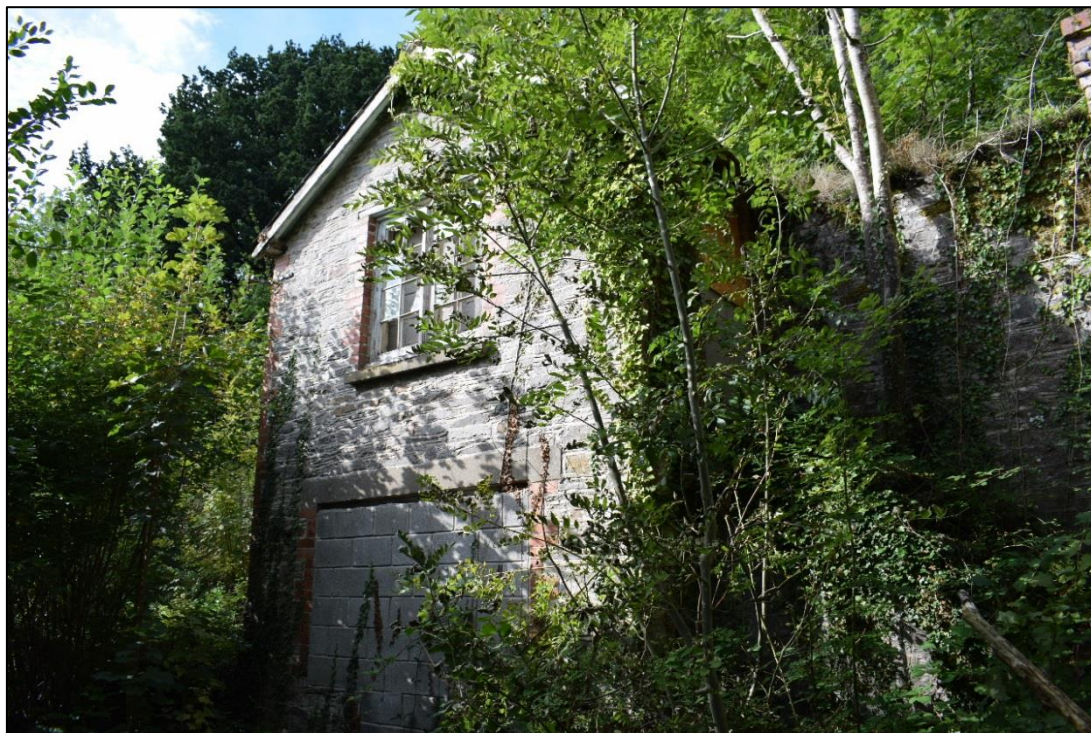
Fig. 50: The gardener's cottage. CPAT 4537-0163

the walled garden is the gardener's cottage and it is proposed that this will be repaired and extended to the east; this should be done sympathetically and by retaining the existing walls and structures that once formed part of the garden features in this area.

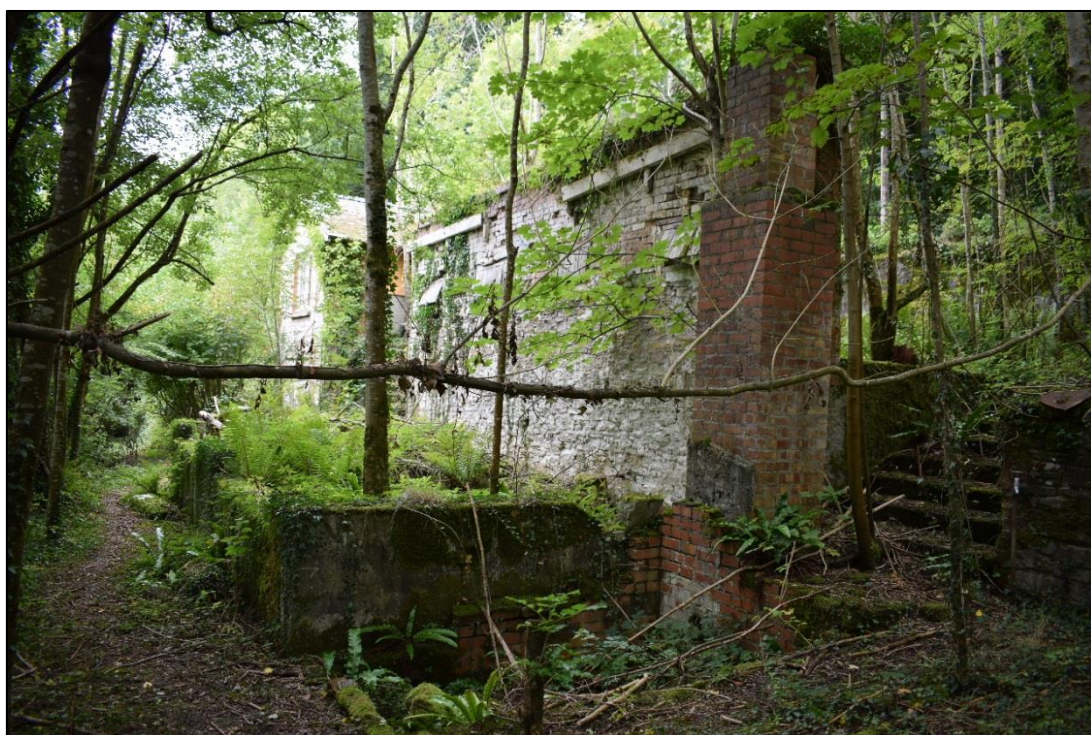
Fig. 51: The walls and features to the east of the gardener's cottage, with the hot-house chimney to the right. CPAT 4537-0067

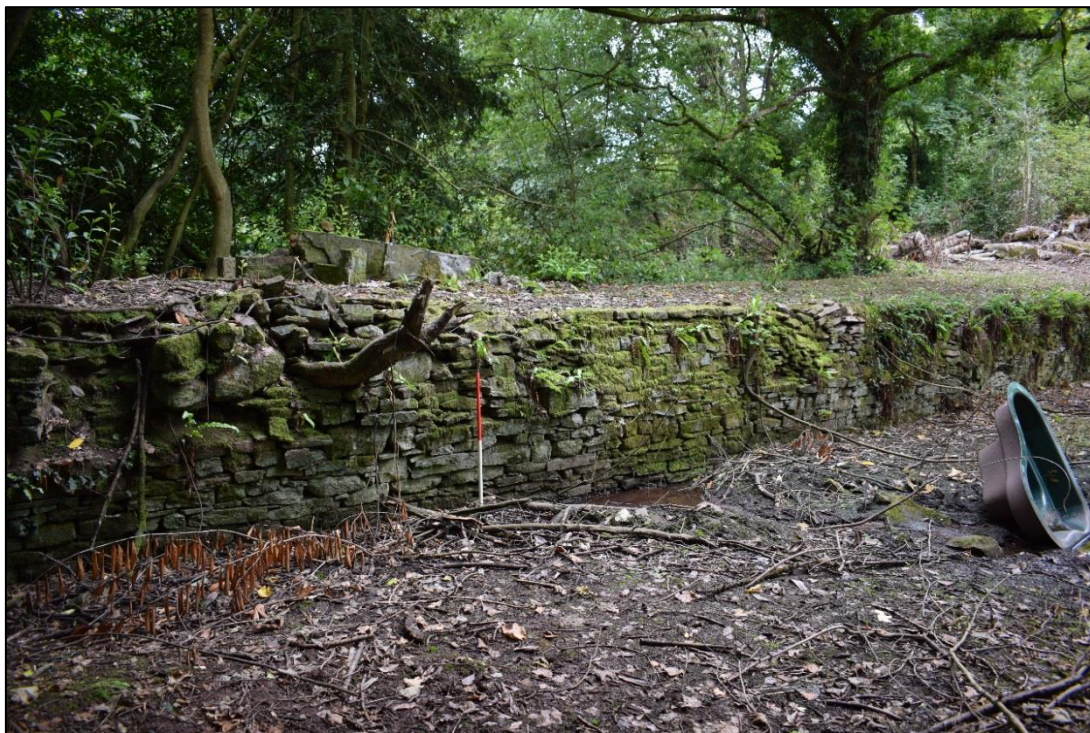
Fig. 52: The causeway/dam for the ornamental pond to the east of the hall. CPAT 4537-0019

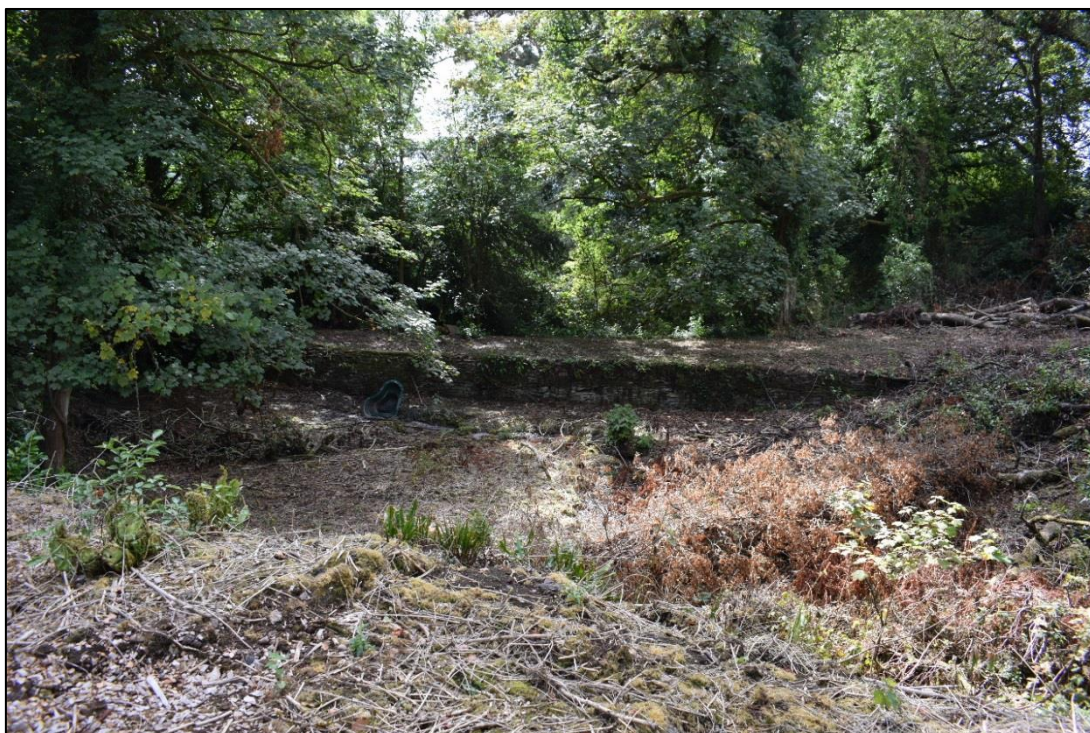
Fig. 53: The site of the pond. CPAT 4537-0046

- 3.25. A pond, recorded on both the 1888 and 1904 Ordnance Survey maps, lay to the east of the house. Although now dry, its waters were held back by a surviving stone-faced dam on which the old lane past the front of the house was probably carried. Whether the dam was an early feature or had originally been a causeway for the lane that was subsequently altered to create a dam and pond cannot be conclusively proven, though the presence of brick modifications to the structure might suggest the latter.

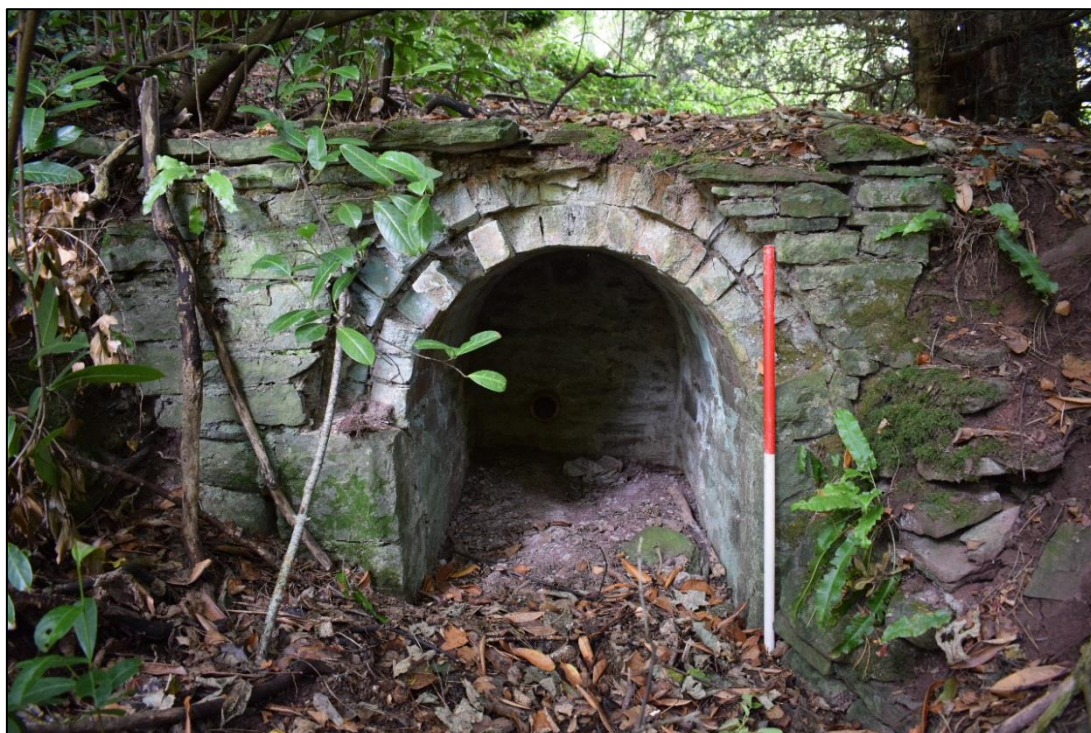
Fig. 54: The ornamental pond feature at the south-east corner of the pond. CPAT 4537-0018

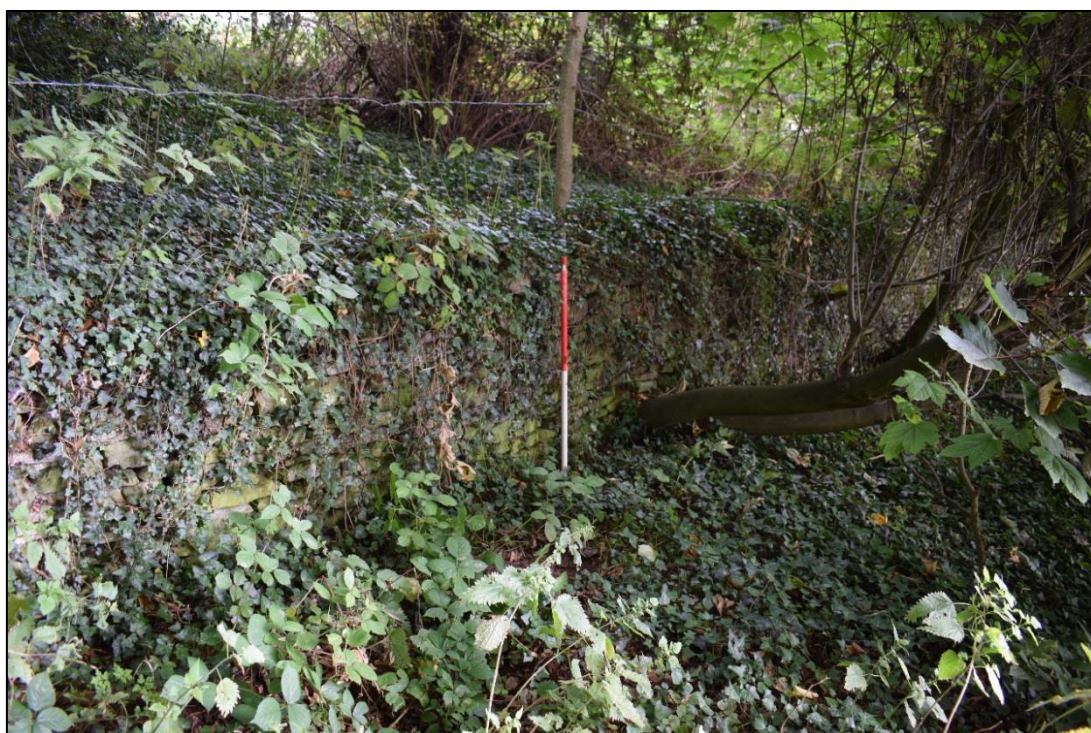
Fig. 55: The ha-ha to the south of the hall, showing tree damage. CPAT 4537-0006
