ADDENDUM TO DOC NO. 351

BS/AIT/17

The Anchor, Tintern

Level II, BUILDING RECORDING SURVEY - ADDENDUM

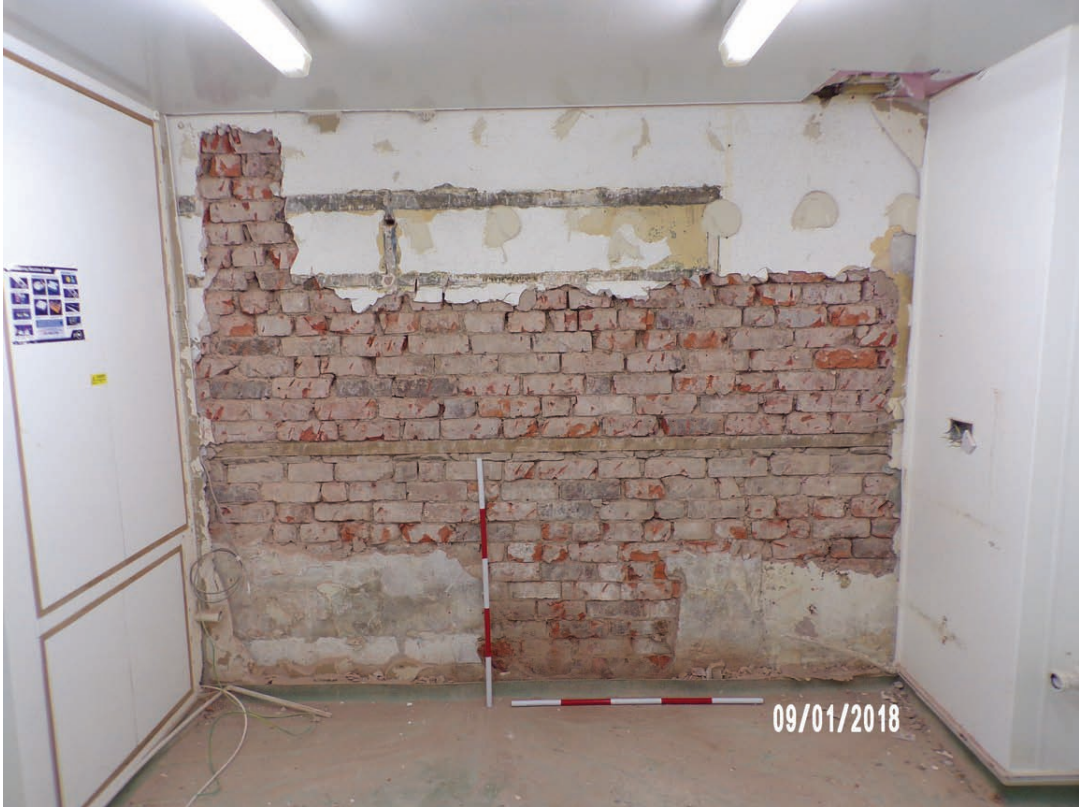
Plate No: 1

Direction of view:
East

Reason for image: Showing architectural detail of internal partition wall within kitchen once furniture and render removed

Plates 1 – 2, show the western and eastern faces of the brick built internal partition wall; a three metre length of which was to be removed as part of the redevelopment program.

Removal of ceramic tiles and cement render from the western wall face showed the partition to be constructed of unfrogged red bricks, uniform in size and bonded with cement. The bricks themselves are likely to have been reused from elsewhere. The internal partition wall itself is likely to be a comparatively modern (20th Century) insert into the 18/19th century kitchen structure.

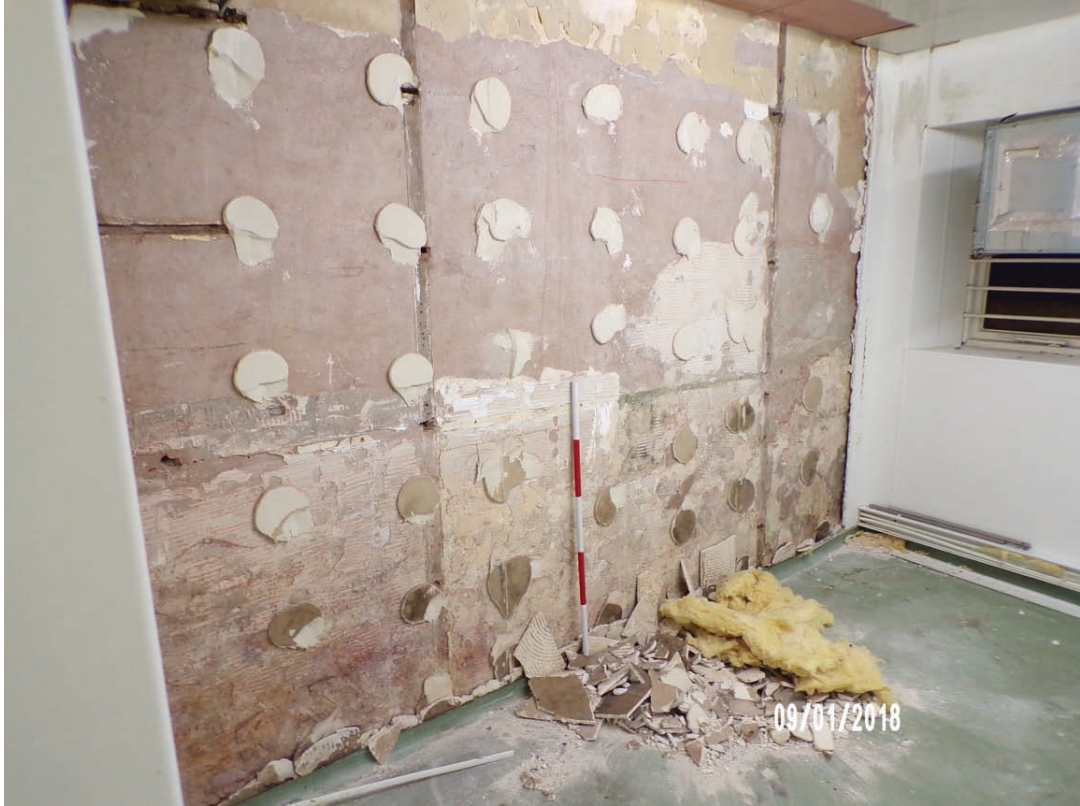
Plate No: 2

Direction of view:
North west

Reason for image: Showing architectural detail of internal partition wall within kitchen once furniture and render removed

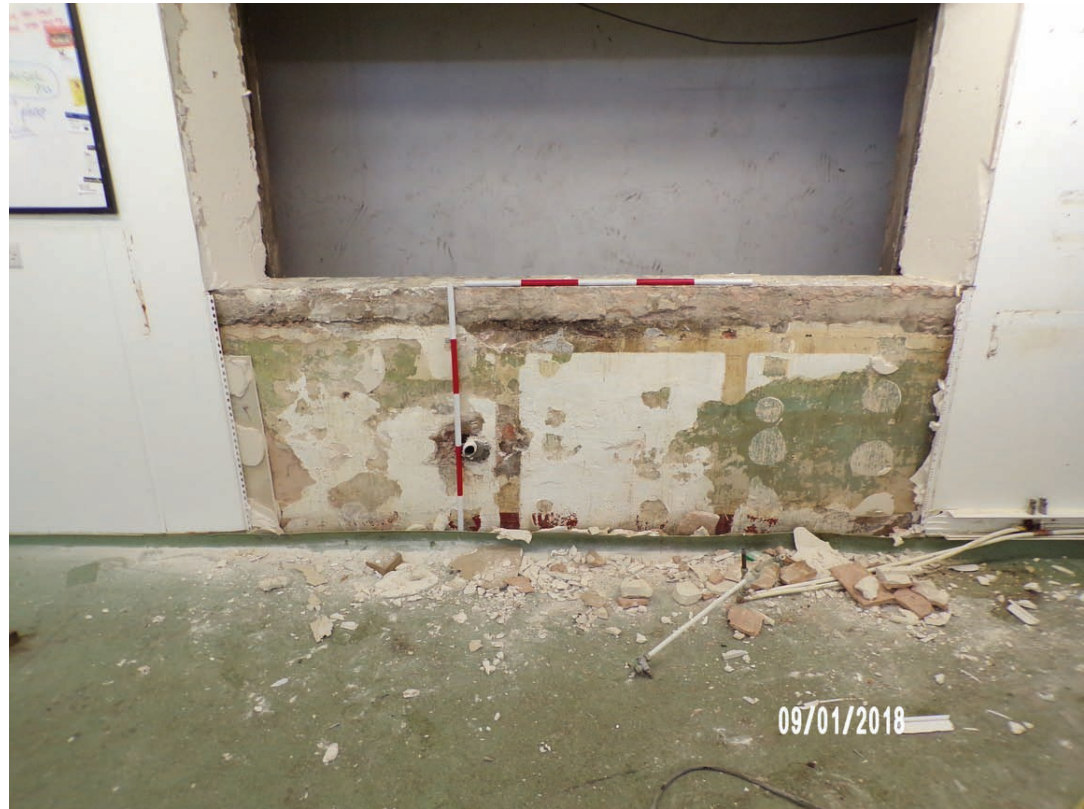
Plate No: 3

Direction of view:
West

Showing architectural detail of internal face of kitchen wall beneath window opening with sink and plasterboard removed

Plates 3-7, show the western and eastern faces of the area of kitchen wall; the eastern face having been exposed after removal of a sink, beneath the window opening which was also to be removed as part of the redevelopment program.

Removal of plasterboard showed the eastern, internal, face of the wall to be constructed of a brick and cement skin. The western, external, face of the wall was constructed of roughly coursed, faced stone blocks forming the original wall of the 18/19th century kitchen structure. The brick skin was butted against the external stone layer and likely represents a later (20th century) addition to the kitchen; possibly contemporary with the insertion of the brick partition wall described above.

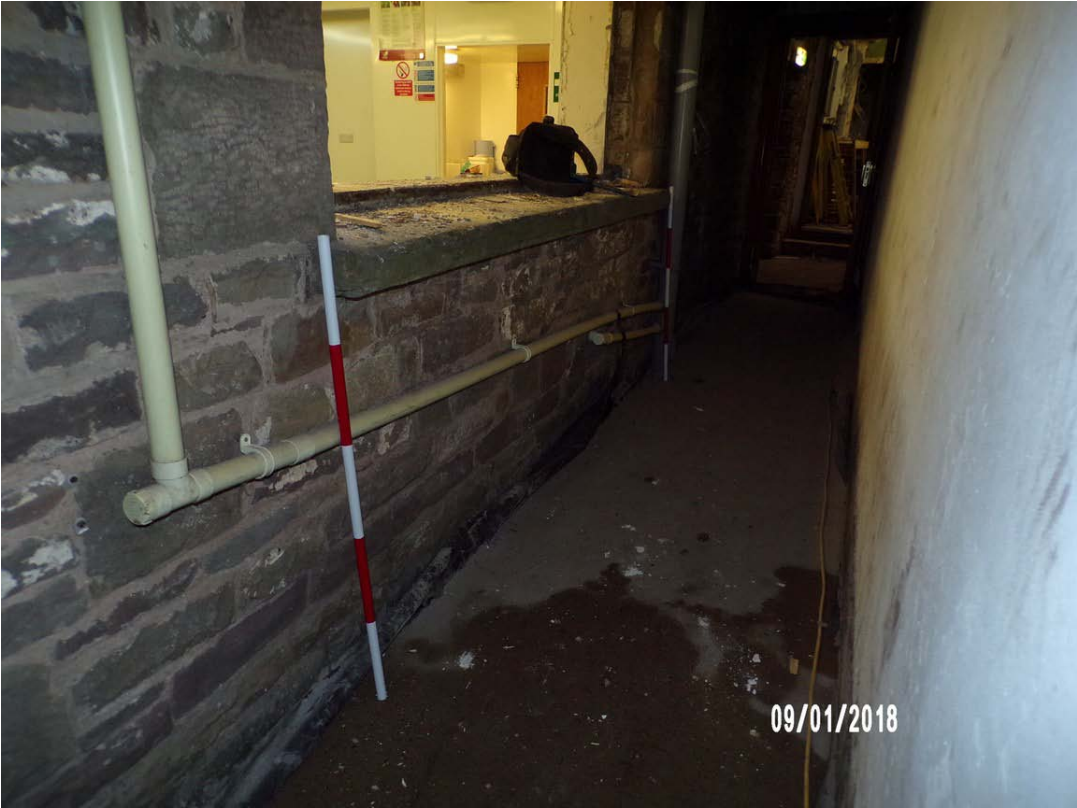
Plate No: 4

Direction of view:
South east

Showing architectural detail of external face of kitchen wall beneath window opening prior to removal

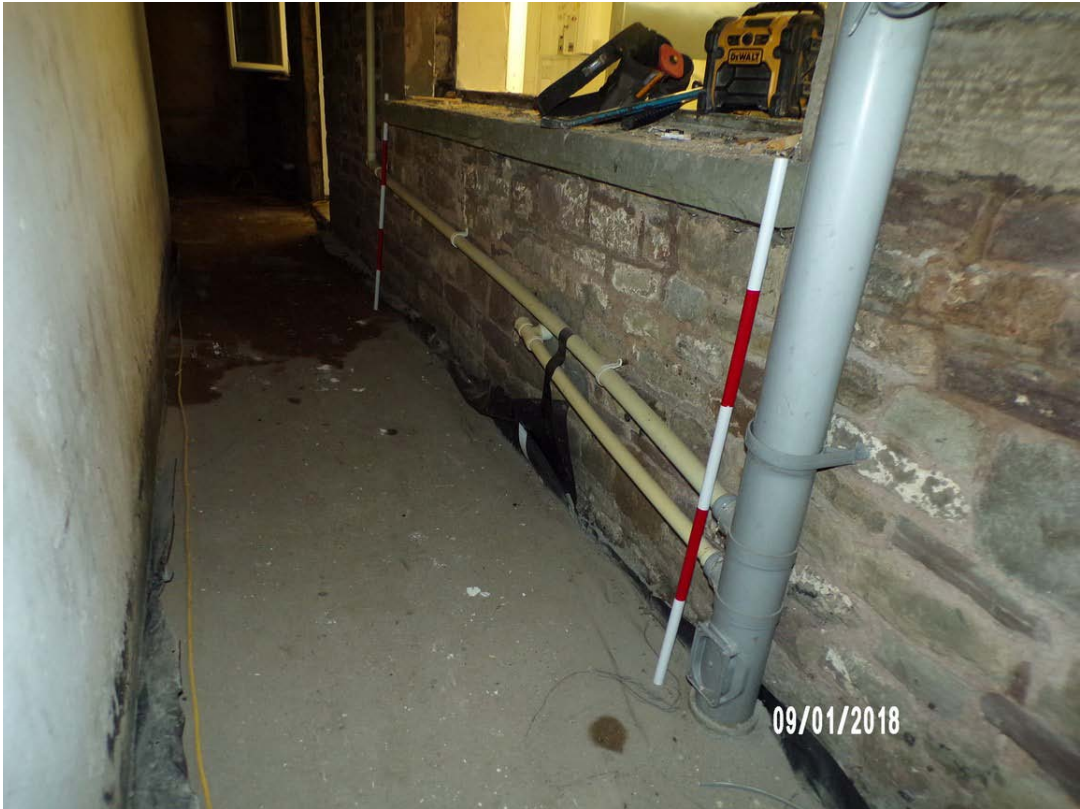
Plate No: 5

Direction of view:
North east

Reason for image: Showing architectural detail of external face of kitchen wall beneath window opening prior to removal

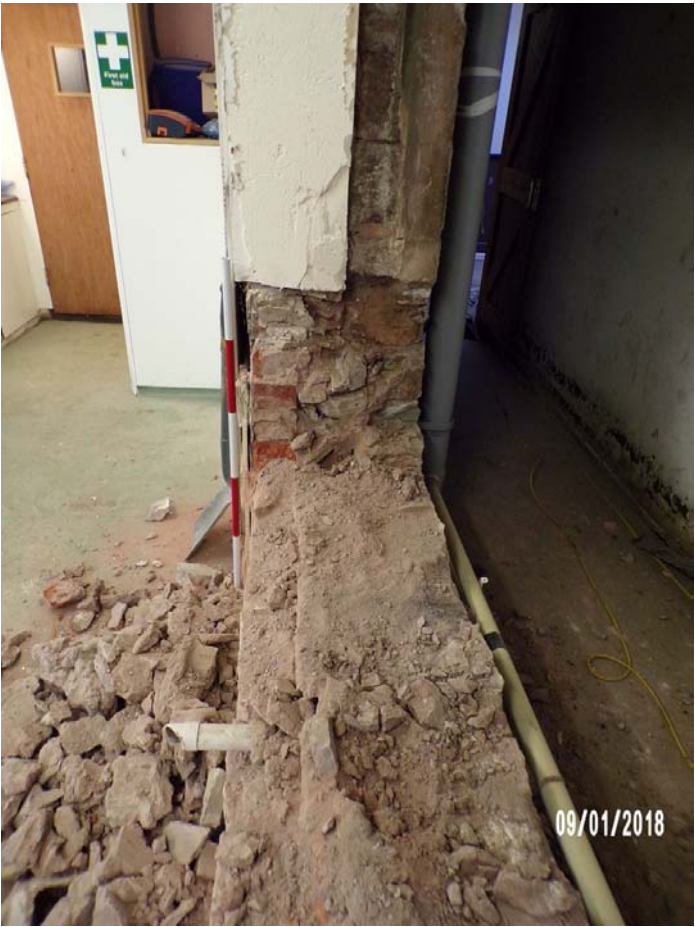
Plate No: 6

Direction of view:
South

Reason for image: Showing internal brick skin butting against earlier 18/19th Century masonry wall of kitchen

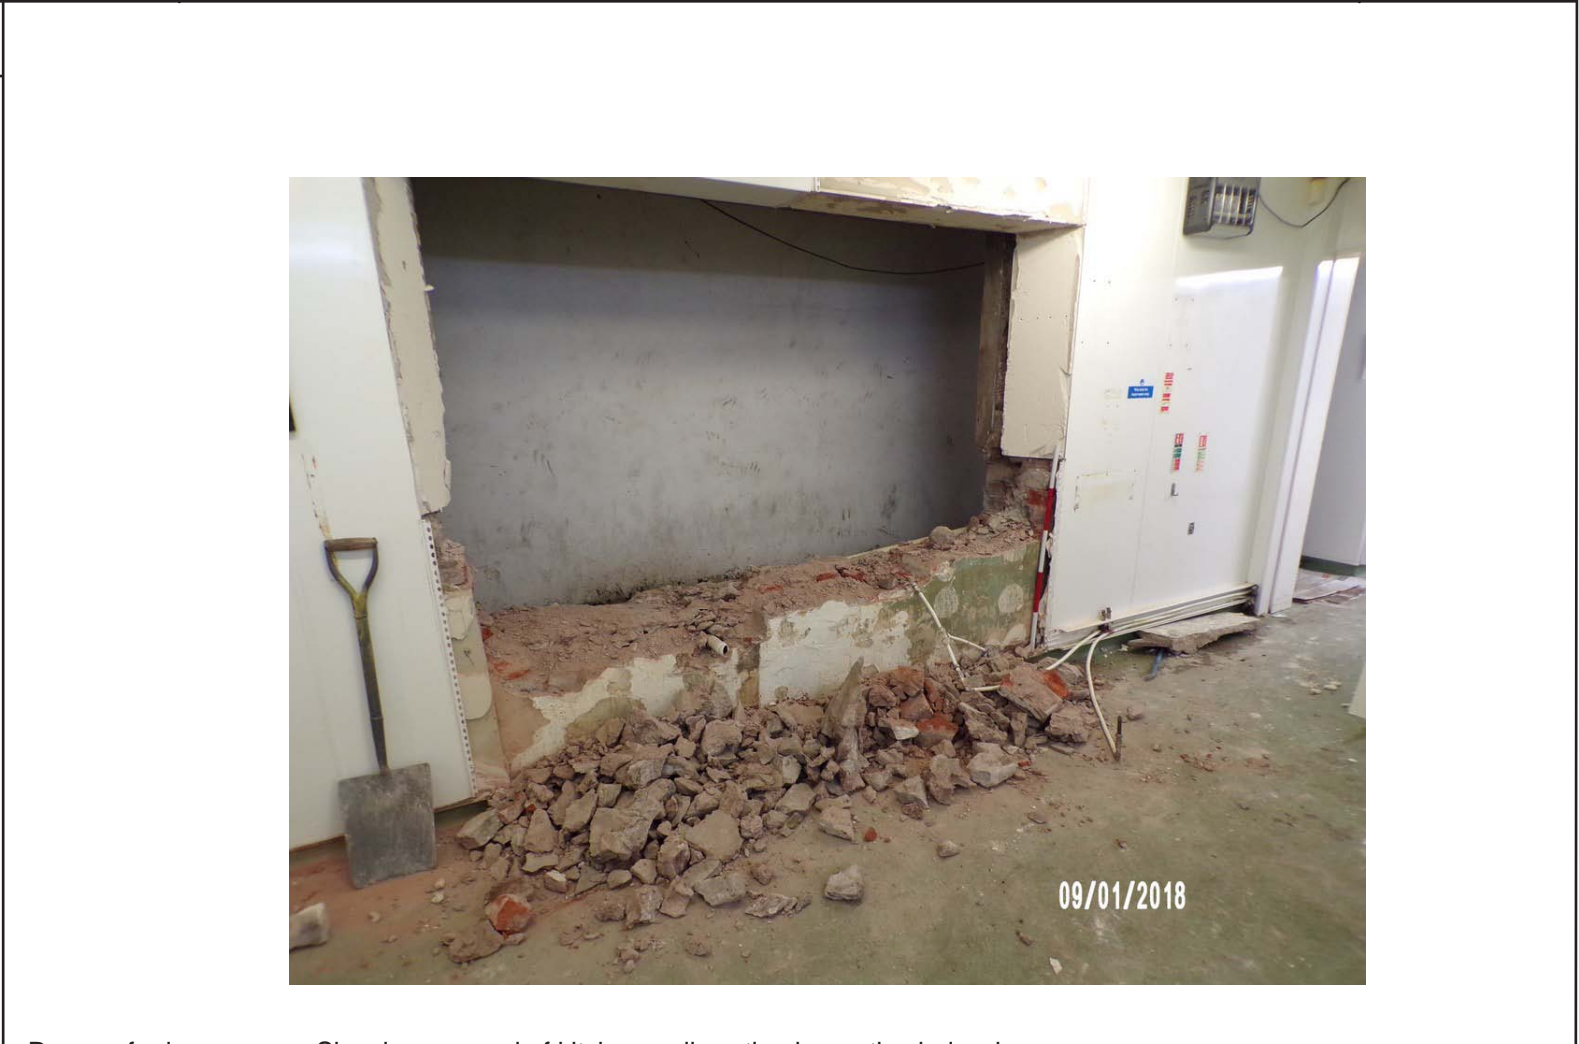
Plate No: 7

Direction of view:
West

Reason for image: Showing removal of kitchen wall section beneath window in progress
