## St Cadfan's Church Tywyn 2014

Archaeological Watching Brief

Report No. 686

Date: 17 June 2014

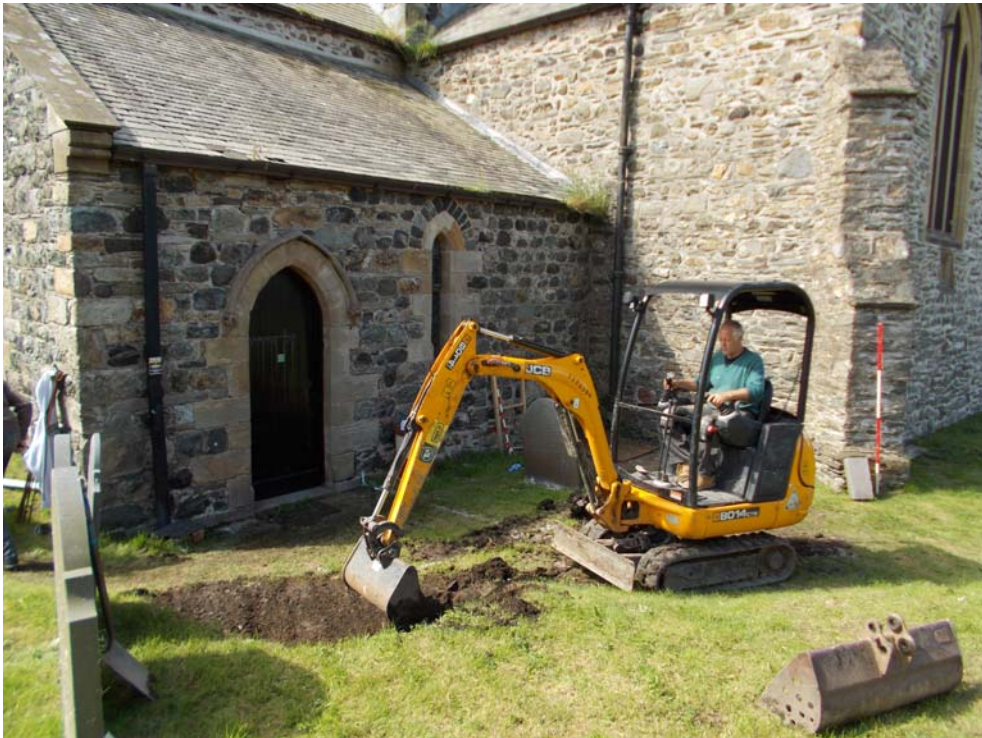
Plate 3: General view of machine work on cutting into raised area, looking south-east. Scale 2m

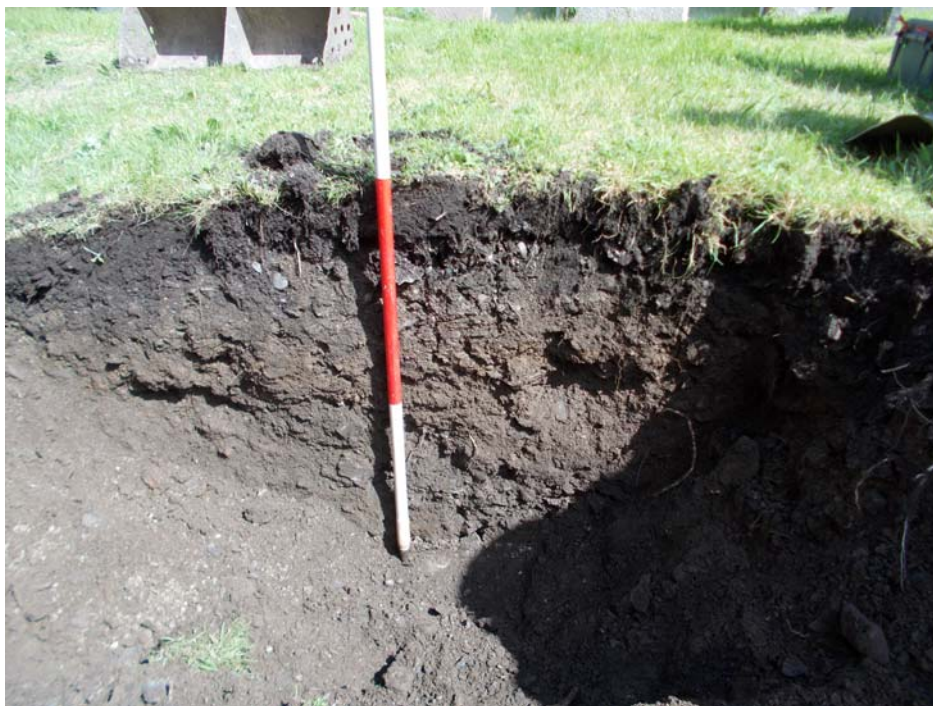
Plate 4: Section of cutting into raised area, looking north. Scale in 0.5m divisions

- 4.2.4 The excavation into the raised area north-west of the vestry revealed the following sequence of deposits: topsoil 0.3m thick (1), over mid-brown sandy gravel (5) which was a re-deposited natural, over a thick layer of slate and mortar rubble (6) presumably material left over from the 1884 restoration work.
