Aberglasney Gardens, Carmarthenshire

Archaeological Watching Brief

Report No. 641

Date: **October 2010**

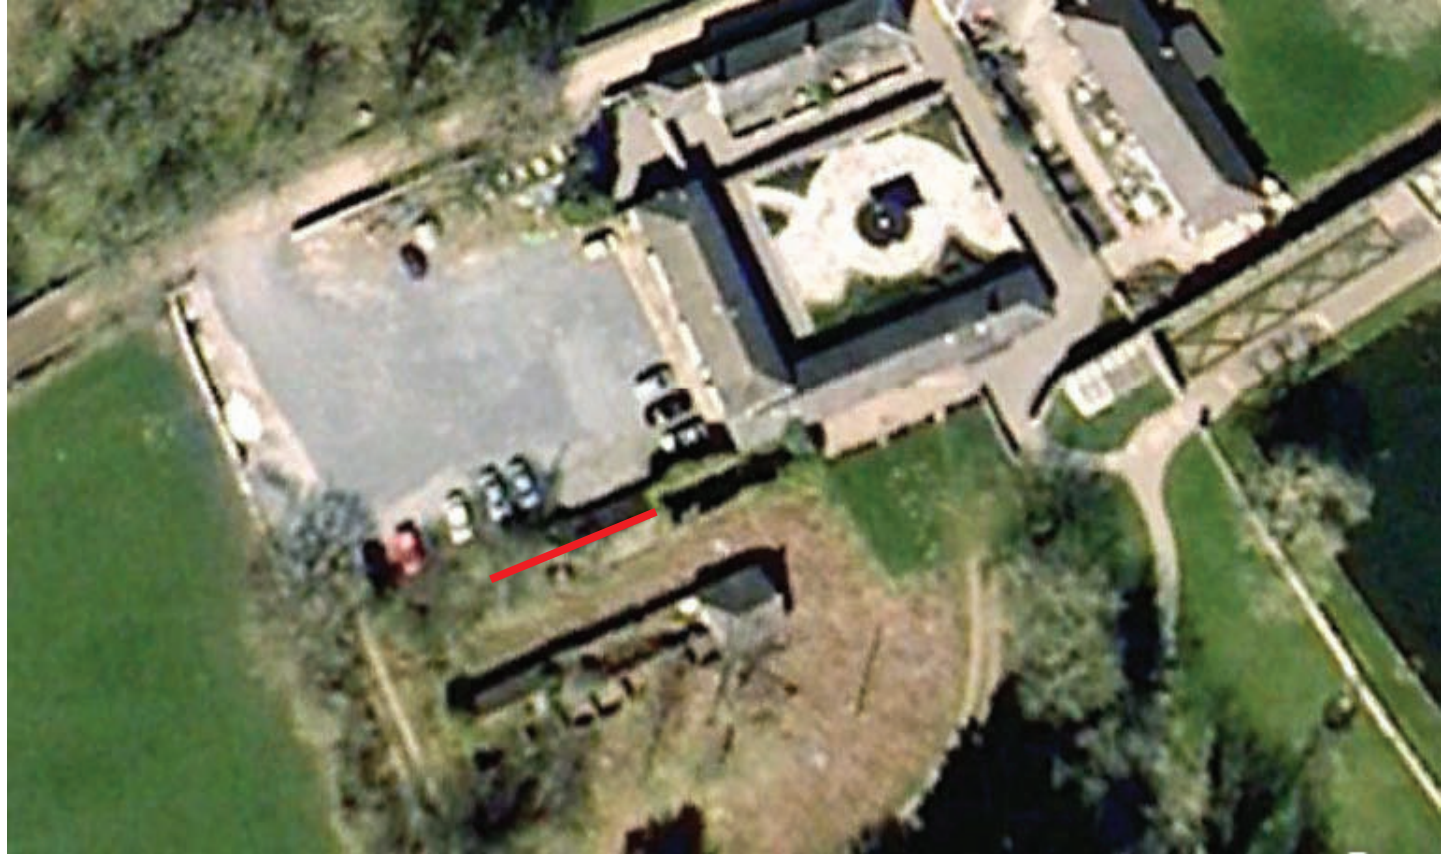
Fig. 2
Location of
foundation trench

In June 2010, Cambrian Archaeological Projects was commissioned by Graham Rankin of the Aberglasney Restoration Trust to undertake an Archaeological Watching Brief during ground works in the area of the Stable Block at Aberglasney Gardens (NGR: SN 5815 2231; fig. 1). The works involved the removal of an existing wall and the excavation of a footings trench along the same line for the construction of a new wall (fig. 2).

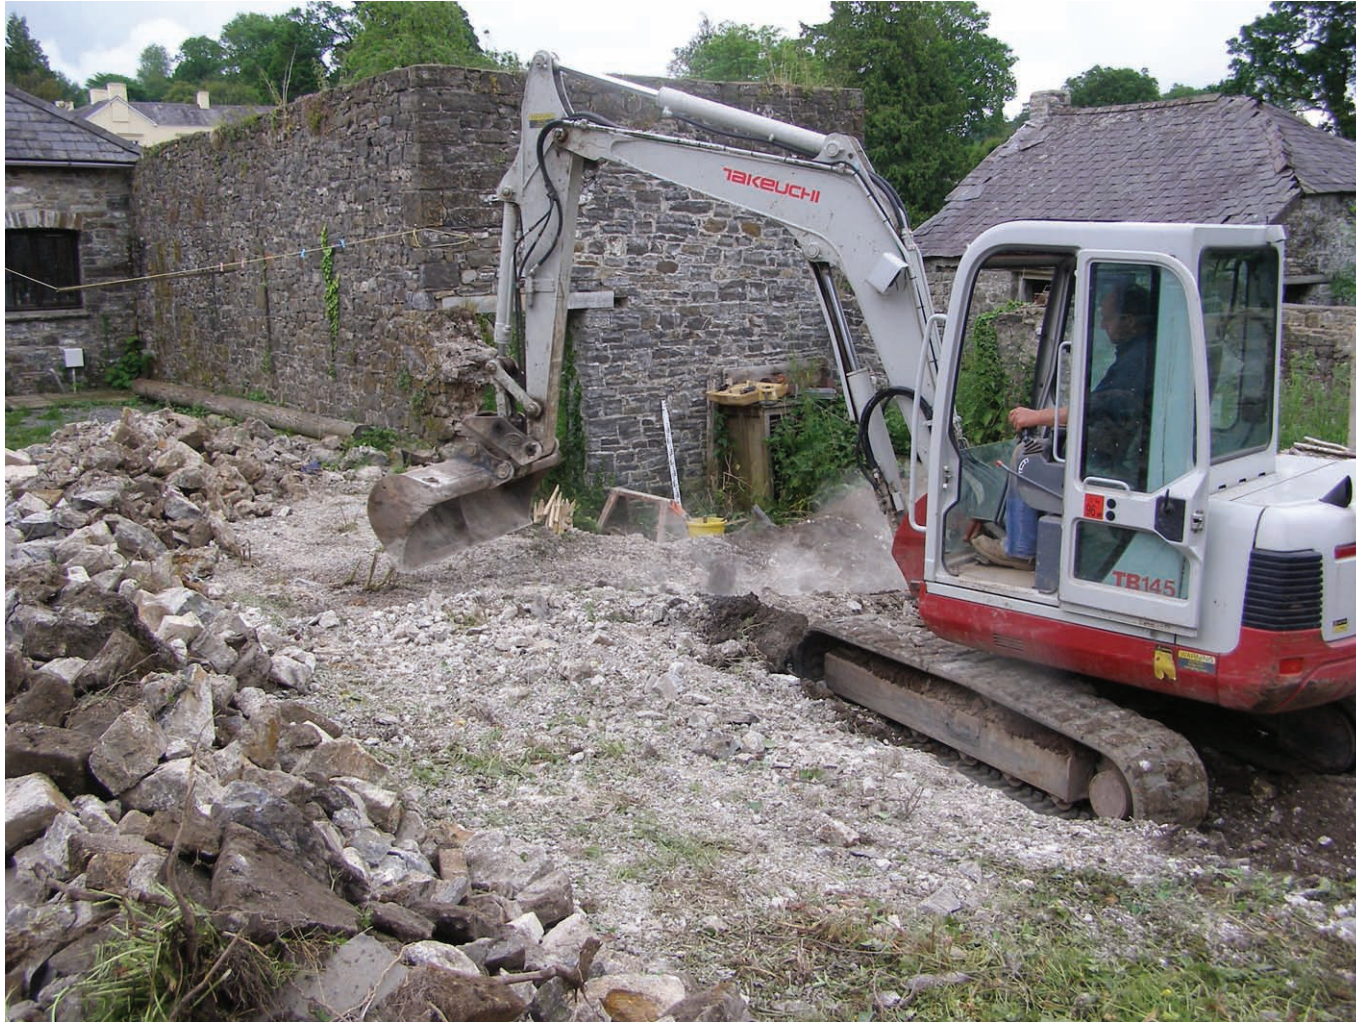
Fig. 3
Working shot
across site after
demolition of wall
Looking SE

An archaeologist was on site for all of the ground works. Following the demolition of the existing wall the area was cleared of rubble using a machine fitted with a toothless ditching blade (fig. 3 and 4). Following the ground clearance, a trench 18m long and 1m wide was excavated using a toothed bucket to a maximum depth of 1m (fig. 5).

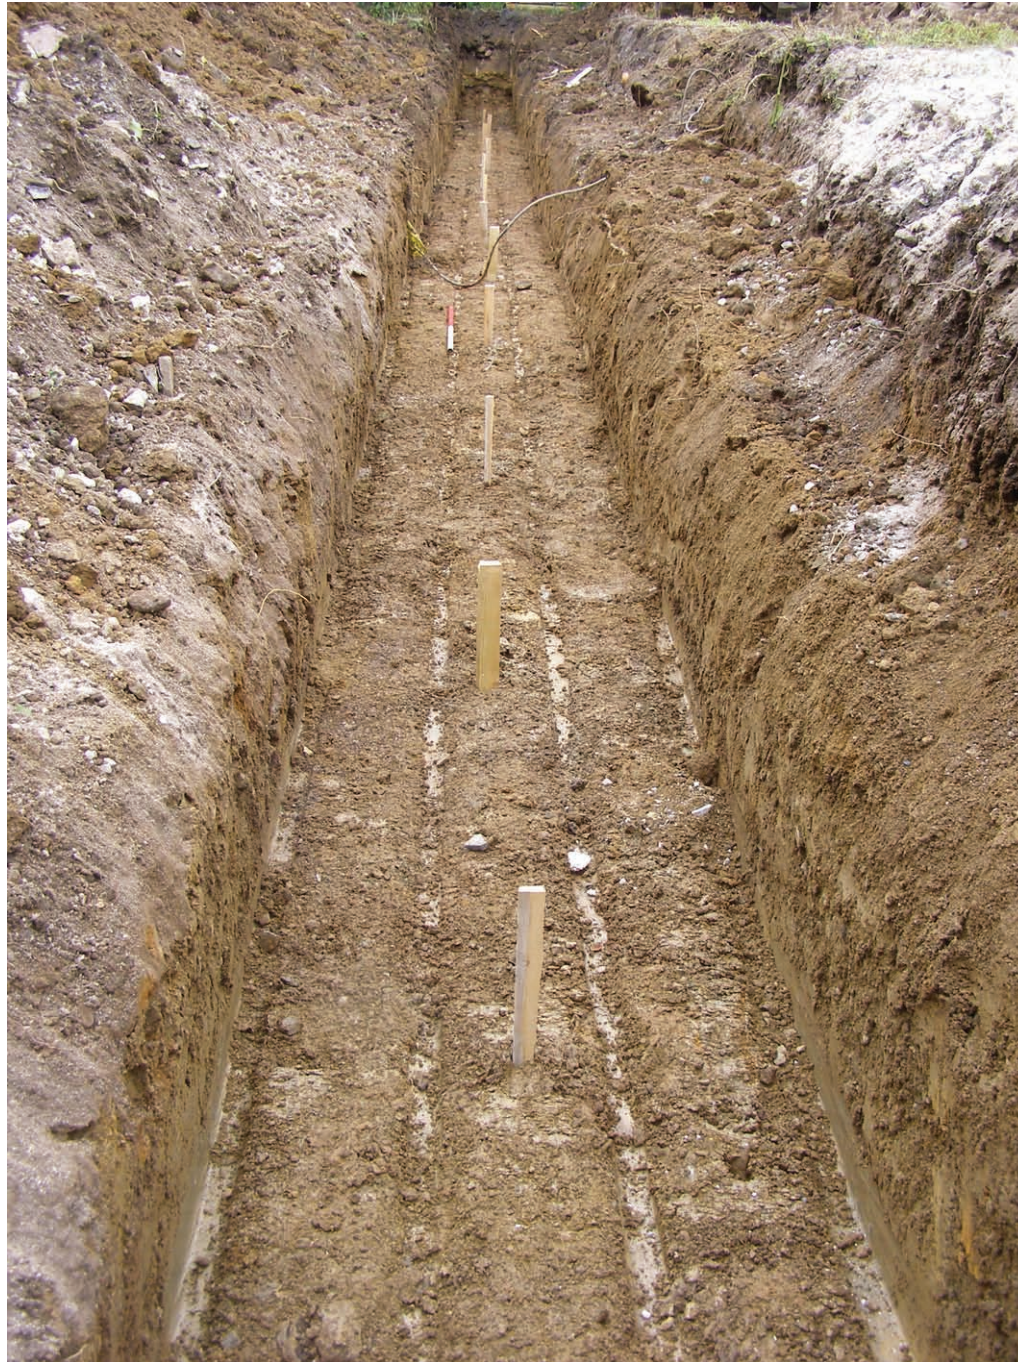
Fig. 5
View SW along
foundaton trench

The foundation trench for the new wall extended to the north of the demolished section of stone wall for a distance of 18m. The garden soil was observed across the entire trench, reaching a maximum depth of 0.6m and overlying the natural clay.

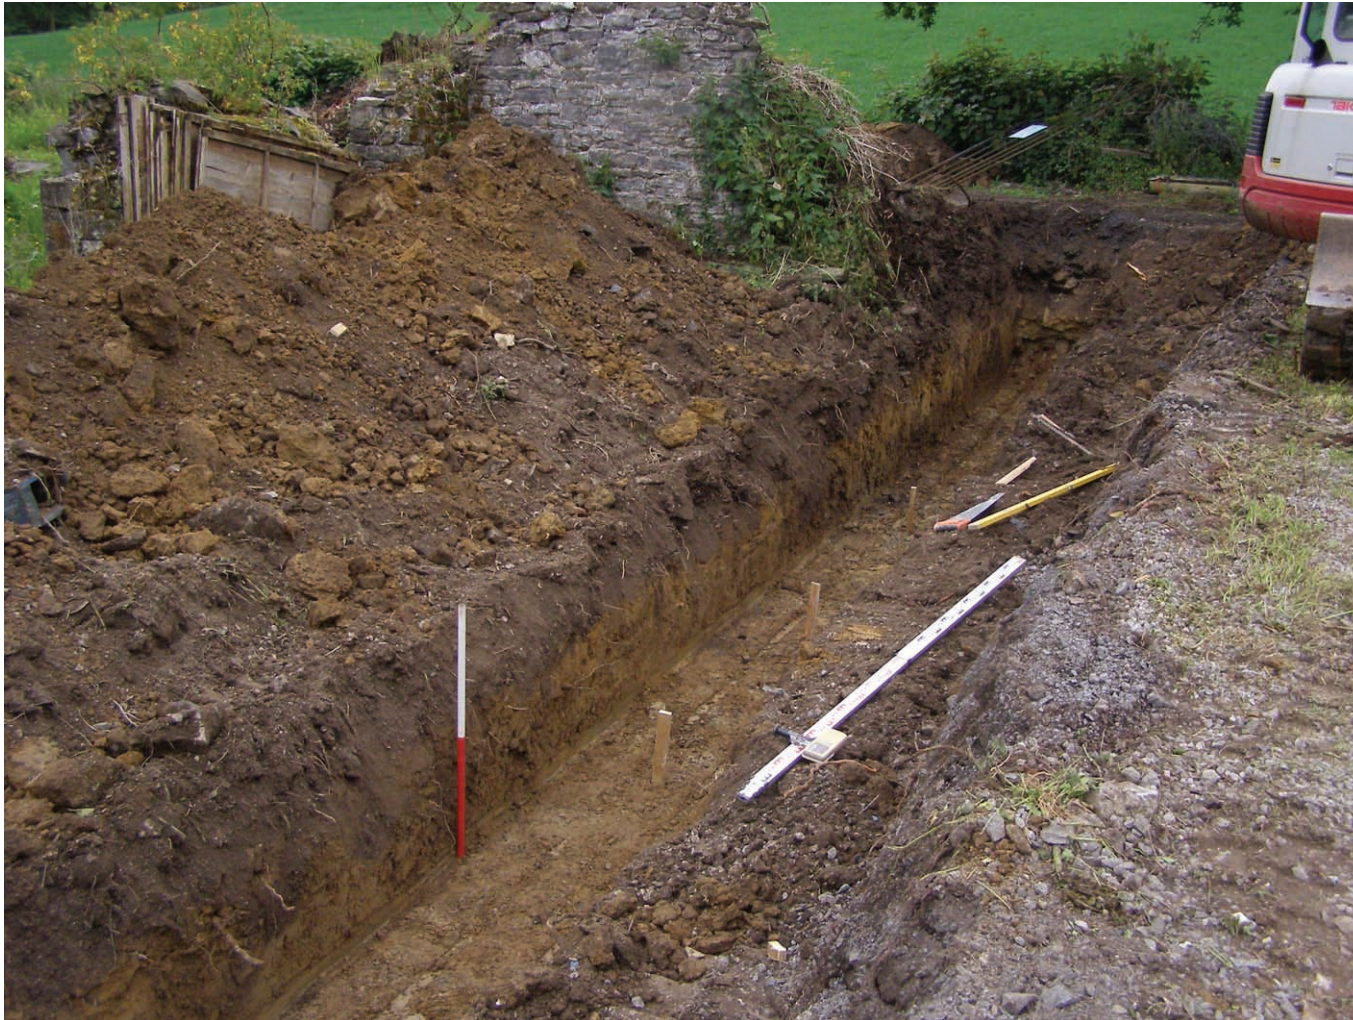
Fig. 6
North-facing
section of trench

On the southern side of the wall a dark brown garden soil was identified; this was heavily root disturbed and reached a maximum depth of 0.6m from the current ground surface (fig. 6). The depth of the garden soil gradually increased to the east.
