Sketty Isaf Meeting Room, Bible College Site, Derwen Fawr, Swansea

Standing Building Recording

By
Louis Stafford BA (Hons)
Report No: 1334

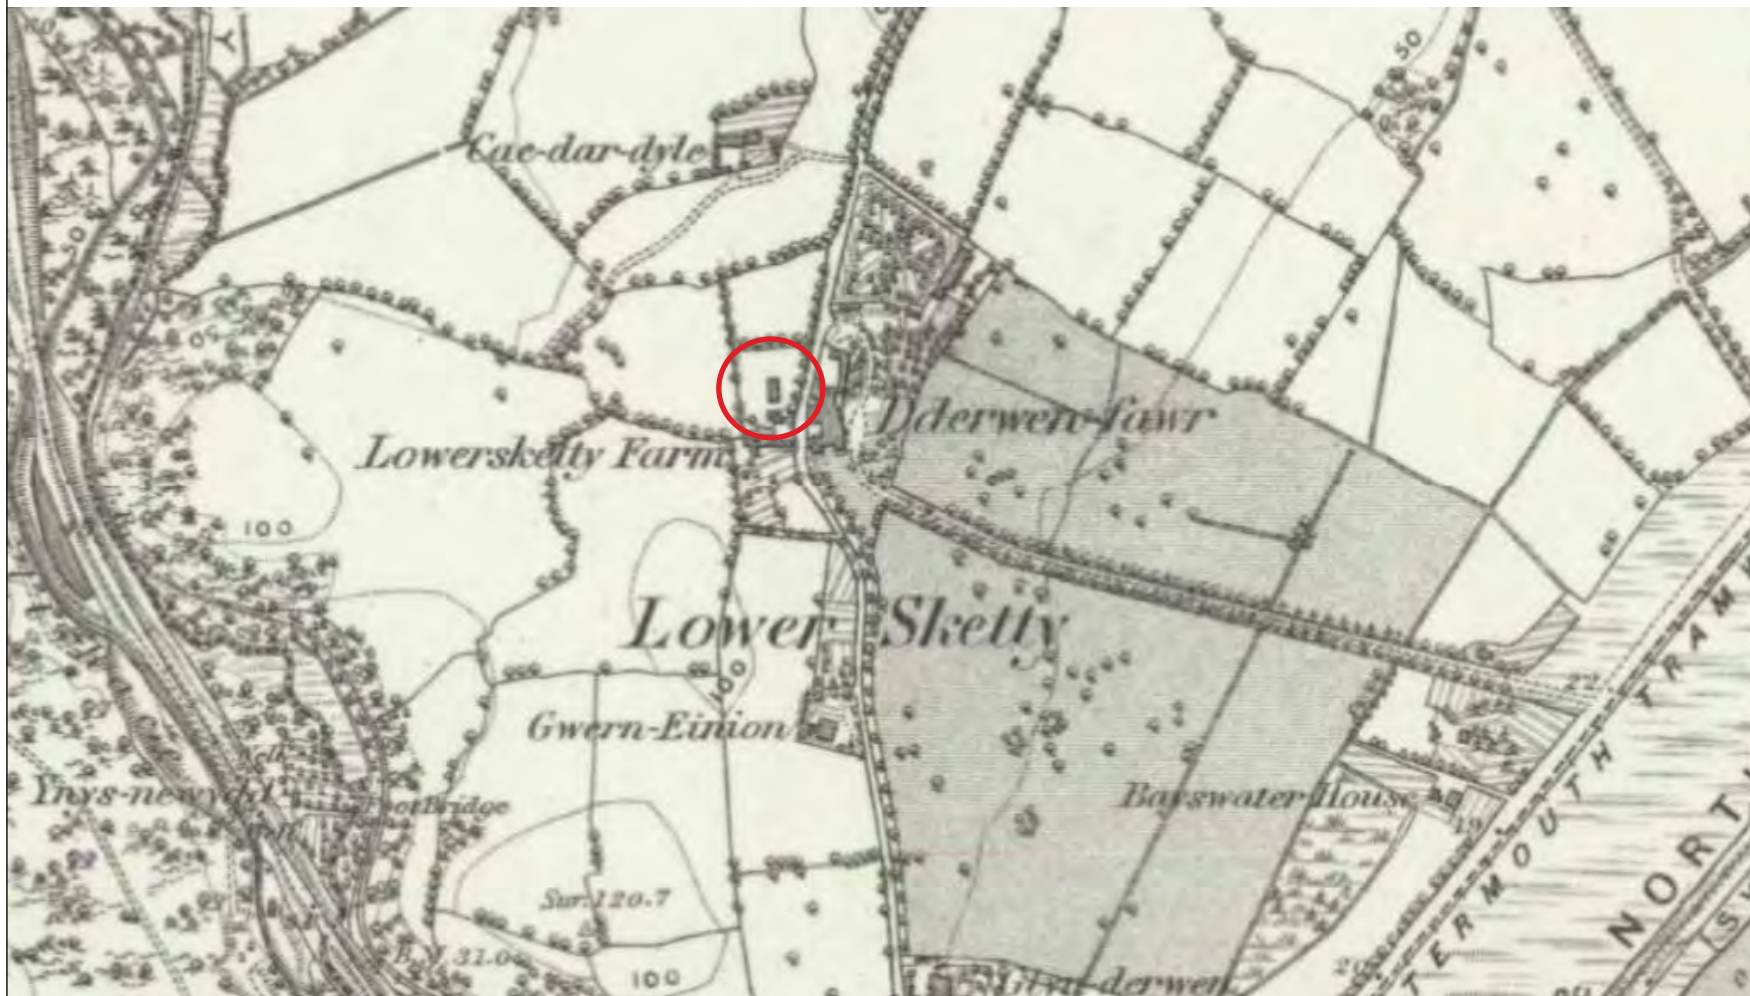
Fig 2: 1878 OS Edition
1:2500

The 1878 Edition OS 1:2500 map (Figure 2) is the first to show the Sketty Isaf Meeting Room in its original state. A rectangular building, orientated north to south, is located just north and within the garden grounds of Sketty Isaf House. A smaller square structure is located between the main house and the Meeting Room, which appears to be the structure depicted on the Tithe Map. The building to the south of the main farmhouse is no longer shown.

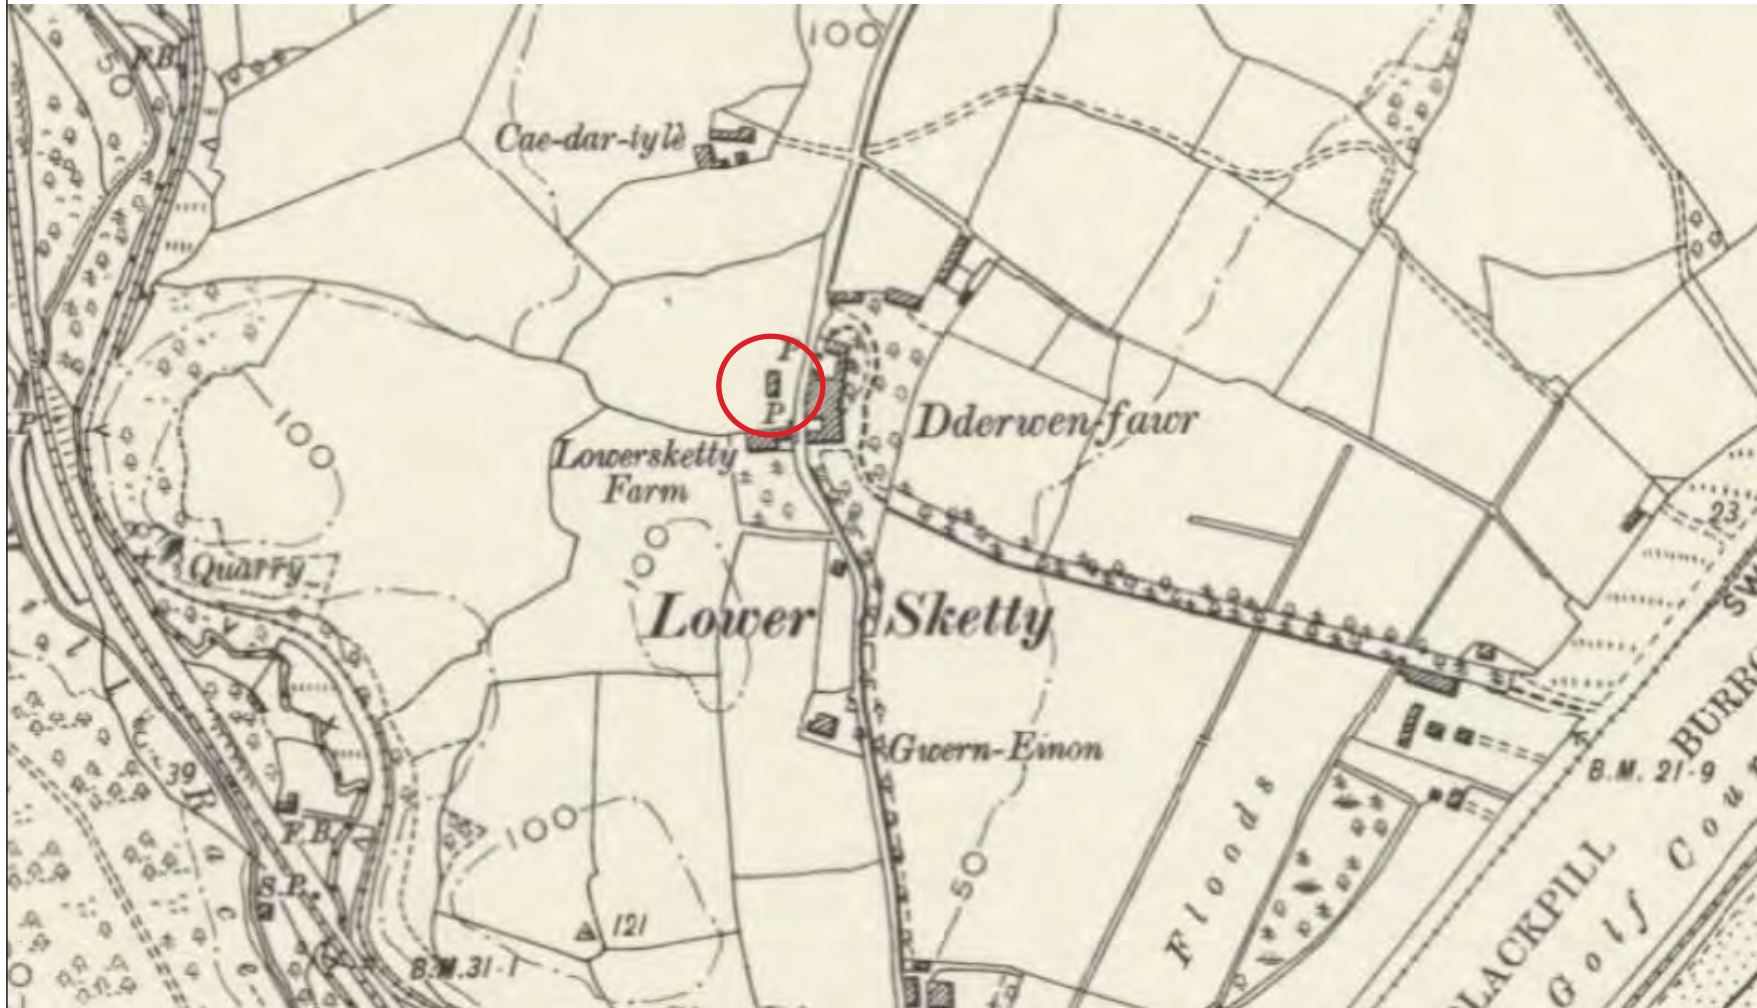
Fig 3: 1897 OS Edition
1:2500

The 1897 Edition OS 1:2500 map (Figure 3) shows the Meeting Room unchanged, but the main farmhouse appears to have been rebuilt and the structure located between this and the main house has been demolished by the time the OS map was compiled. One other feature is now present at southern end of the Meeting Room, that of a water pump, although it does not appear to be attached to the building itself. The previous hedgerows which surrounded the building on the previous map are also absent at this point.

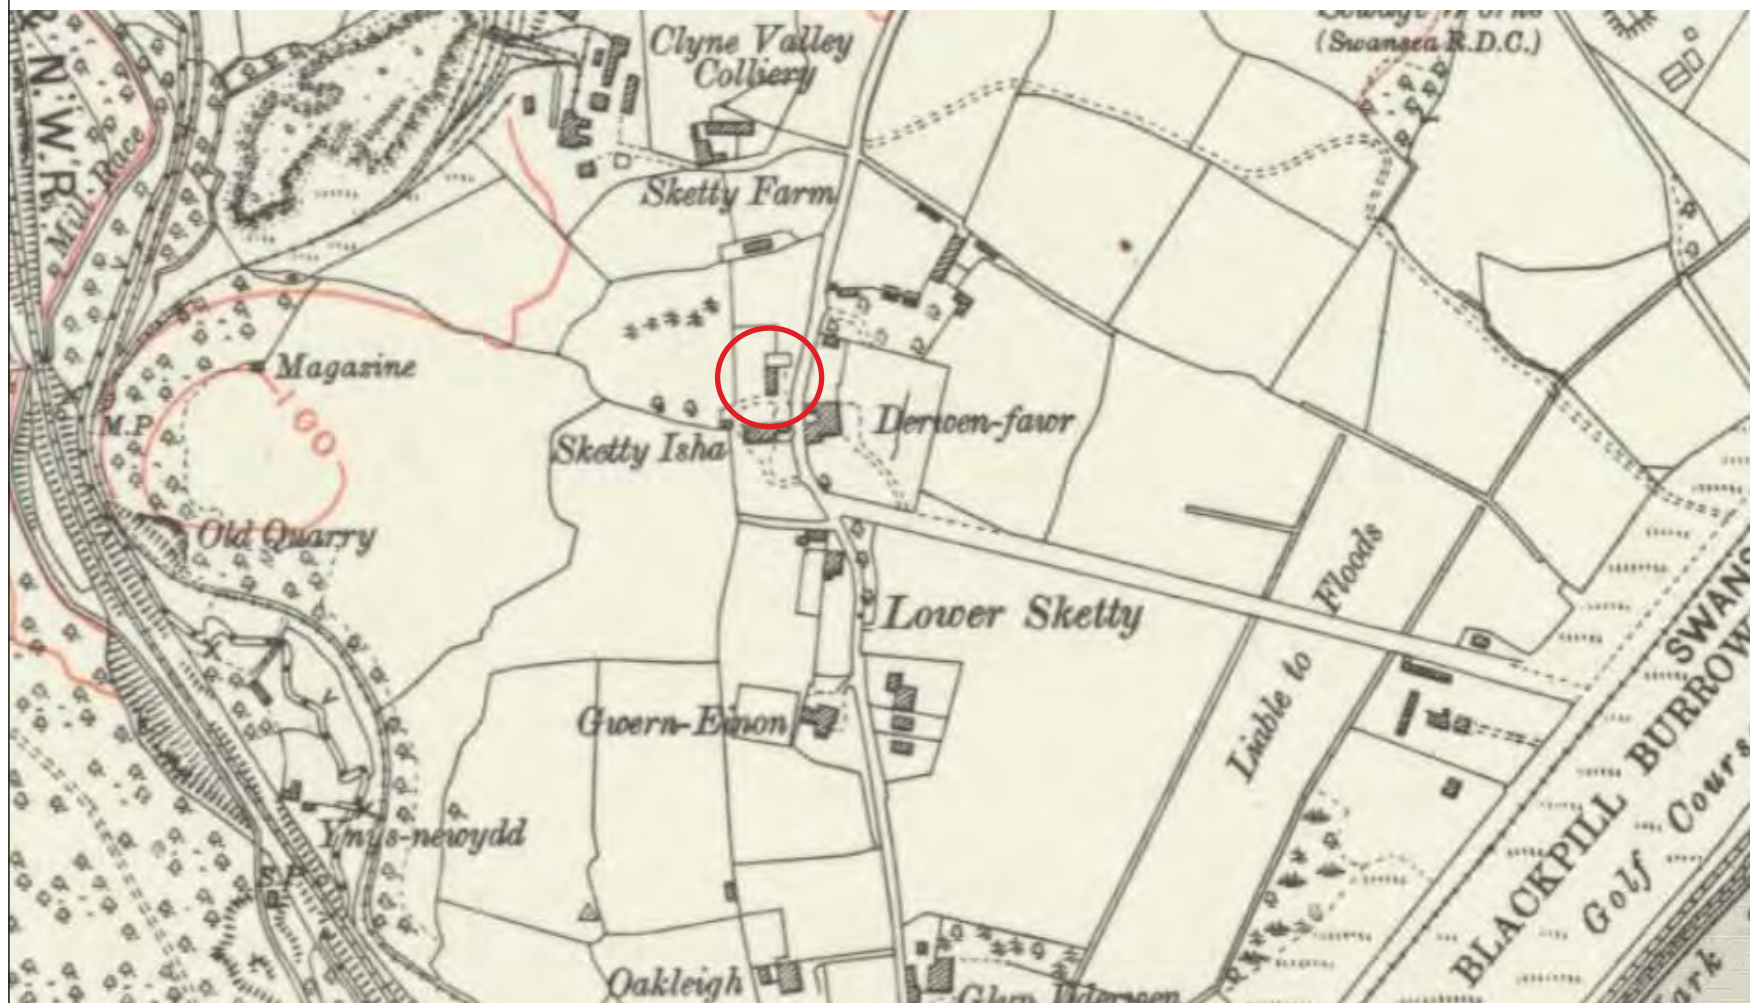
Fig 4: 1914 OS Edition
1:2500

The 1914 Edition OS 1:2500 map (Figure 4) shows the Meeting Room unchanged from the previous, but the water pump now appears to be absent. This appears to be a mapping idiosyncrasy from the previous series of OS map as the 1878 field boundaries are now present again. An additional rectangular partition, orientated east to west, is now located along the northern end of the building, flush with its' western side and extending out to the east. A north south boundary appears at the top of this addition. As the feature is not infilled on the map it may represent a walled or fenced enclosure and not that of a building.

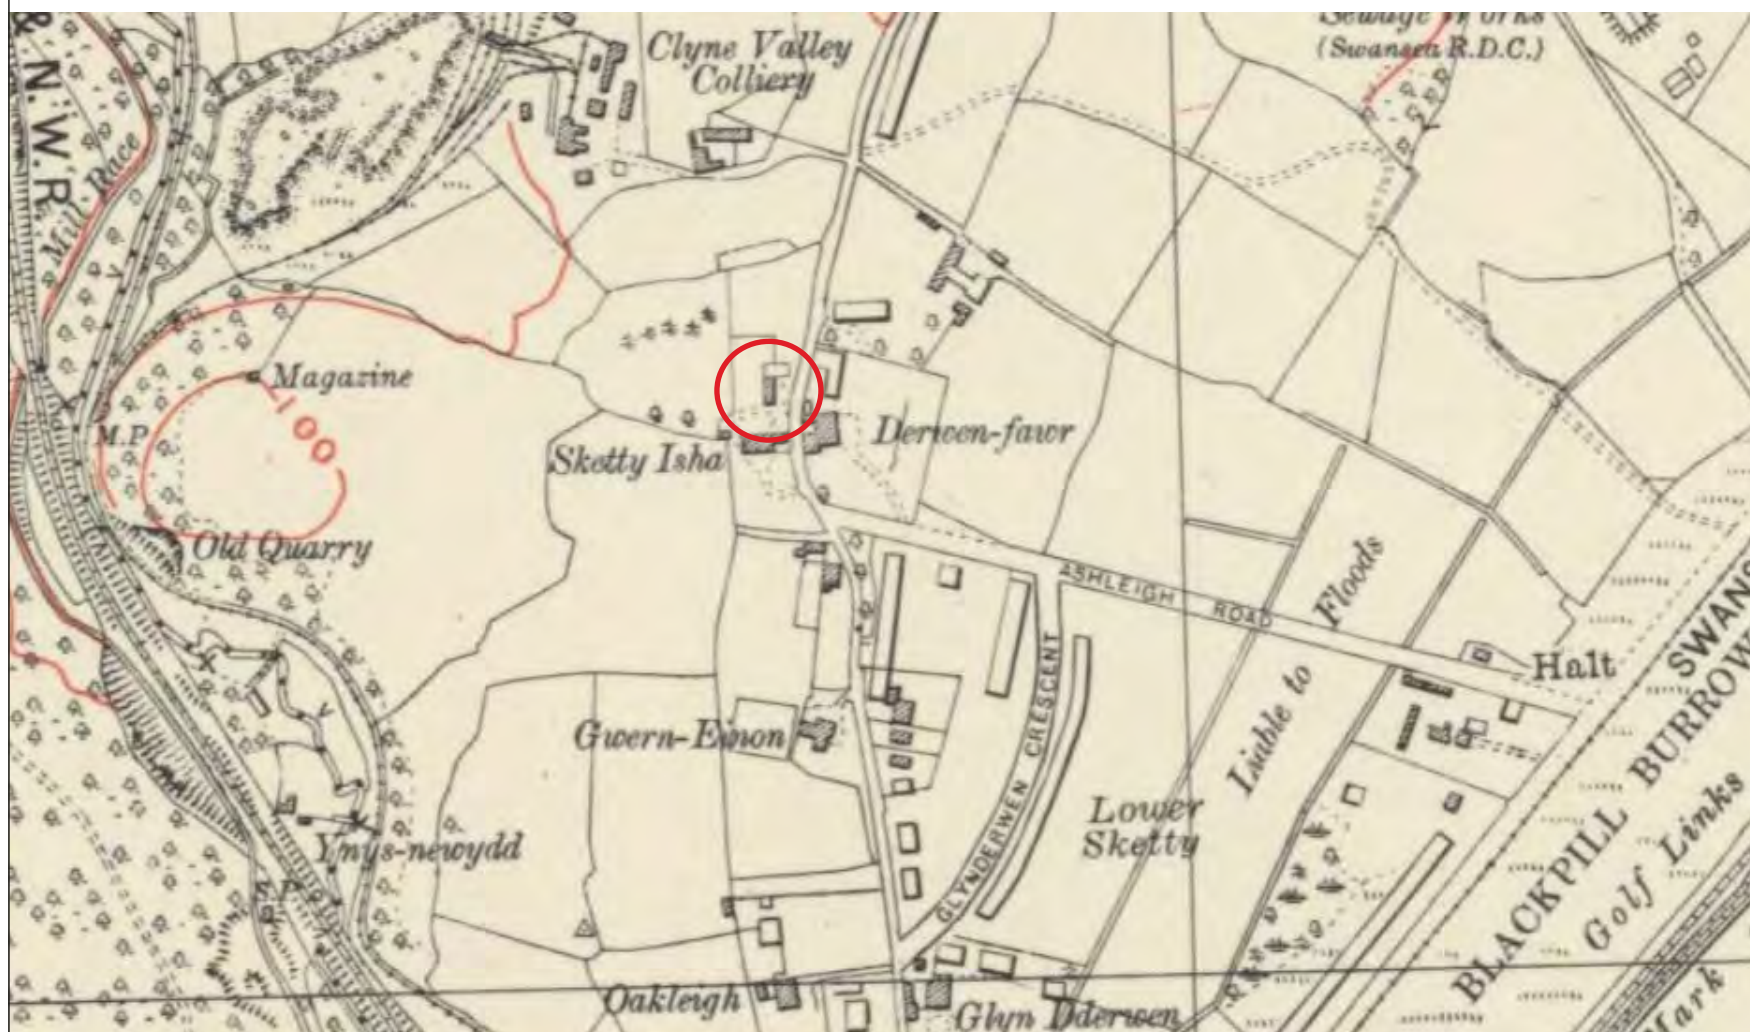
Fig 5: 1938 OS Edition
1:2500

The 1938 (Figure 5) OS 1:2500 map appears to show no further changes to the building or the rectangular structure/enclosure abutting the north end of the structure. The resolution of these OS series do not appear to differentiate between the main building and glass roofed buildings, therefore it is unclear whether or not the glass roofed structure at the southern end of the building was absent by this point.

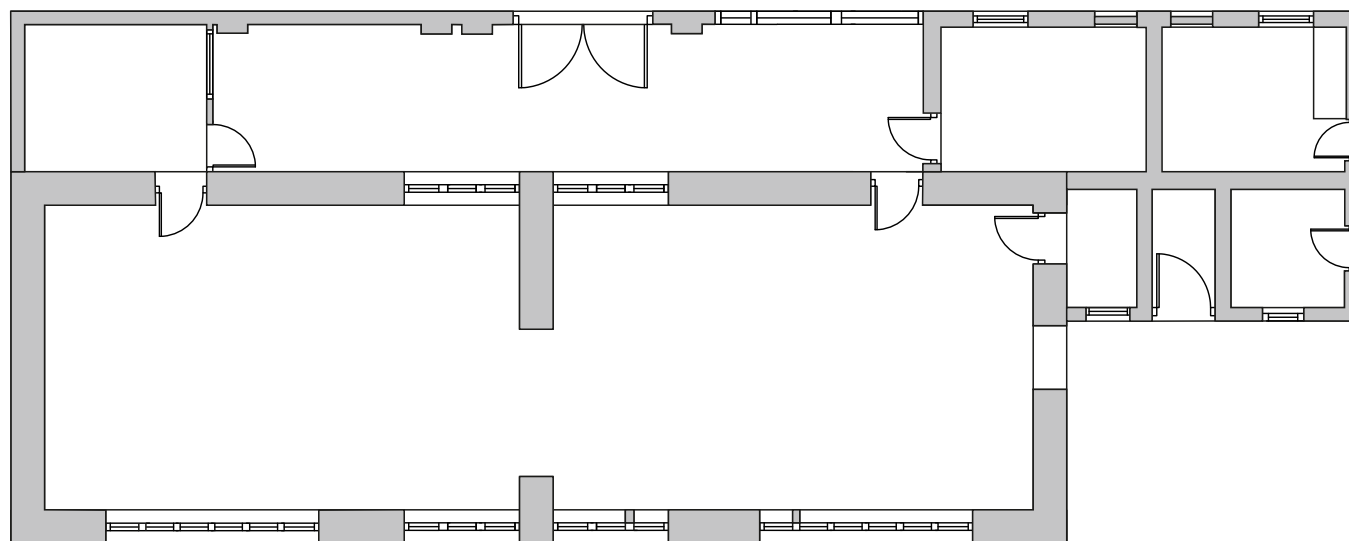
Fig 8: Existing
Ground Floor Plan

Figure 8 shows the existing ground floor plan of Sketty Isaf Meeting Room. Figures 9 and 10 show the existing elevations of the building. Figure 11 shows a phased overlay of the building. Figure 12 shows the location and direction from which the photographic plates were taken. The number after each red arrow corresponds to the plate on which the photograph appears. All photographs taken on site are presented in this report.

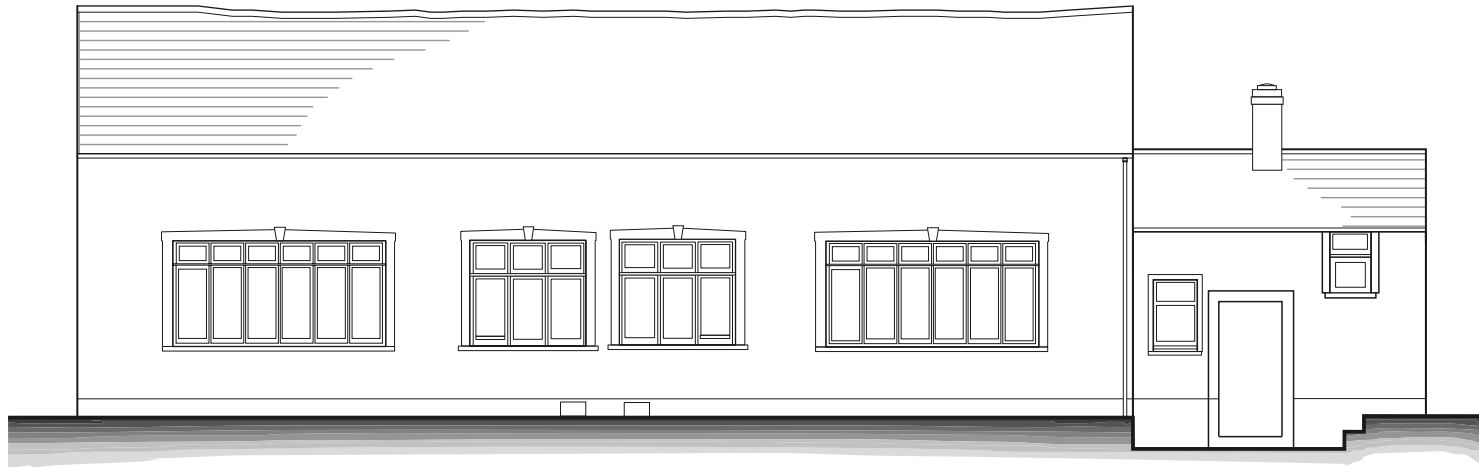
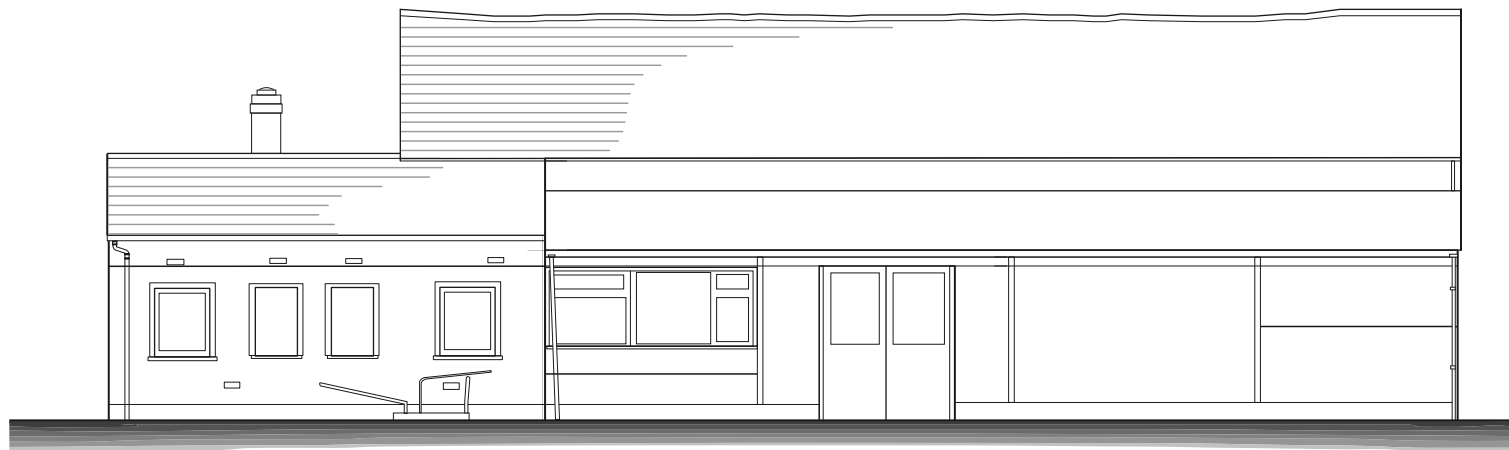
Fig 9: Existing Elevations

East Facing Elevation

West Facing Elevation

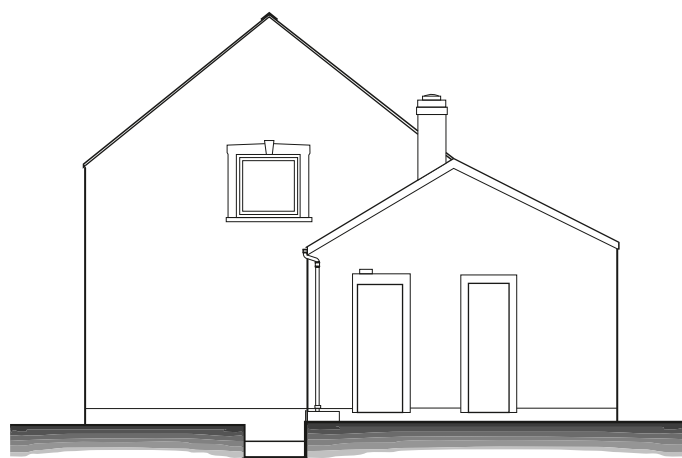
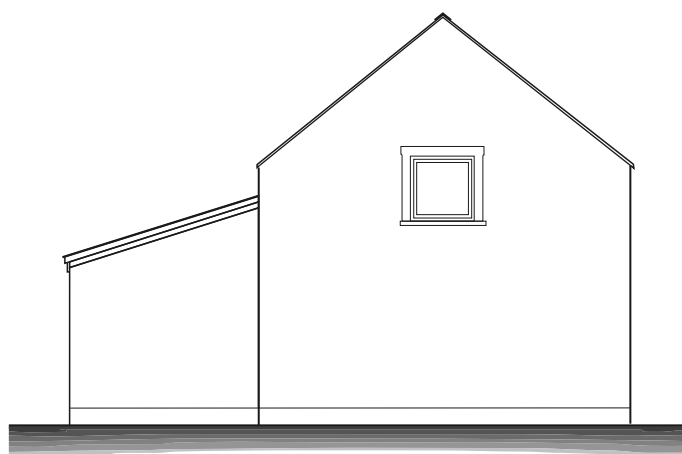
Fig 10: Existing Elevations

North Facing Elevation

South Facing Elevation

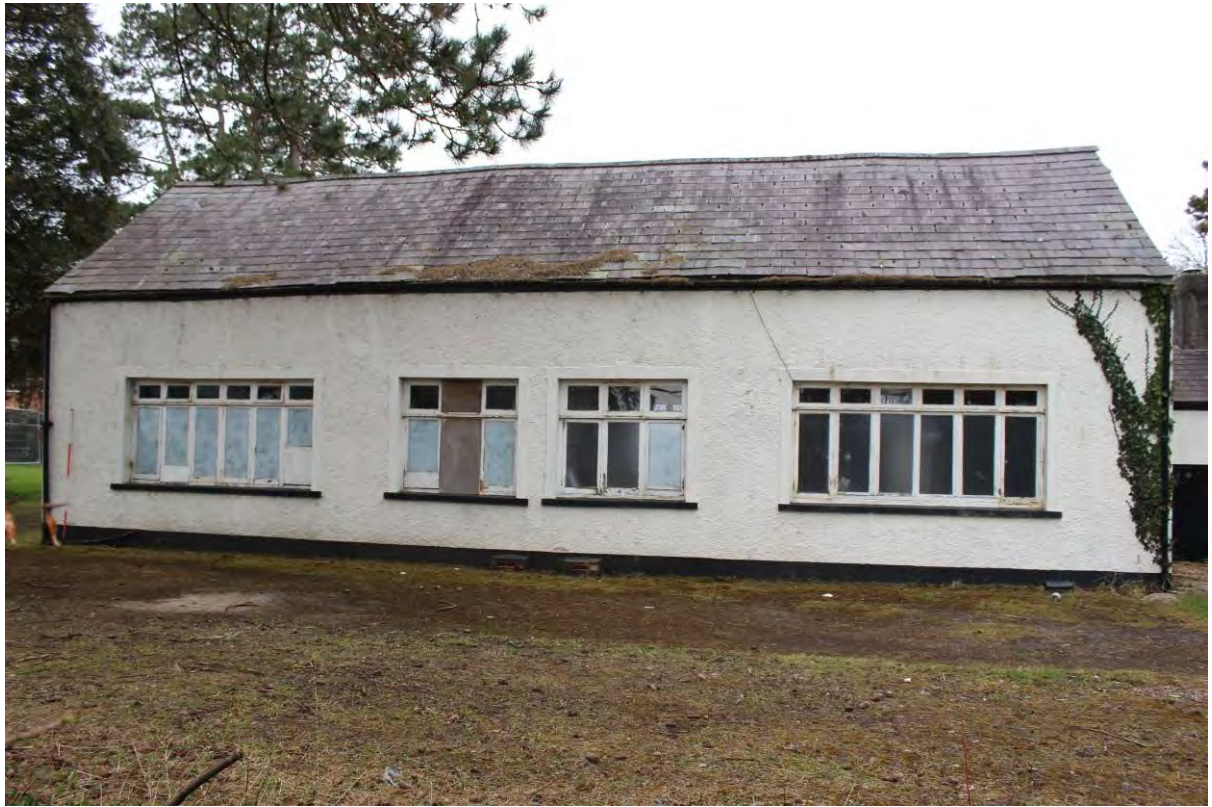
- . The insertion of four windows in the eastern elevation. Plate 1-4, 16.
- . The later insertion of casement windows. Plate 1-4, 16.
- . The decoration of the hay loft windows in the southern and northern elevation. Plate 6-7, 11-12.

The eastern elevation has four windows evenly spaced along its length with two smaller windows toward the centre and two wider windows toward the outer edges (Plate 1). The window surrounds have a flat cement render border painted white, forming a post and lintel effect with the lintel extended slightly out with a semi circular detail on the outer edges and the top of the lintel angled slightly up toward the centre where a keystone protrudes out from the face of the lintel (Plate 2-4). The sill is a flat piece of what appears to be stone covered in cement render, painted black. The windows look to be fairly recent casement type, with the smaller inner windows formed from three over three lights and the outer larger windows six over six light type. The inner windows are mirrored on the western side, visible within the western extension (Plate 16).

Plate 1: East elevation main building

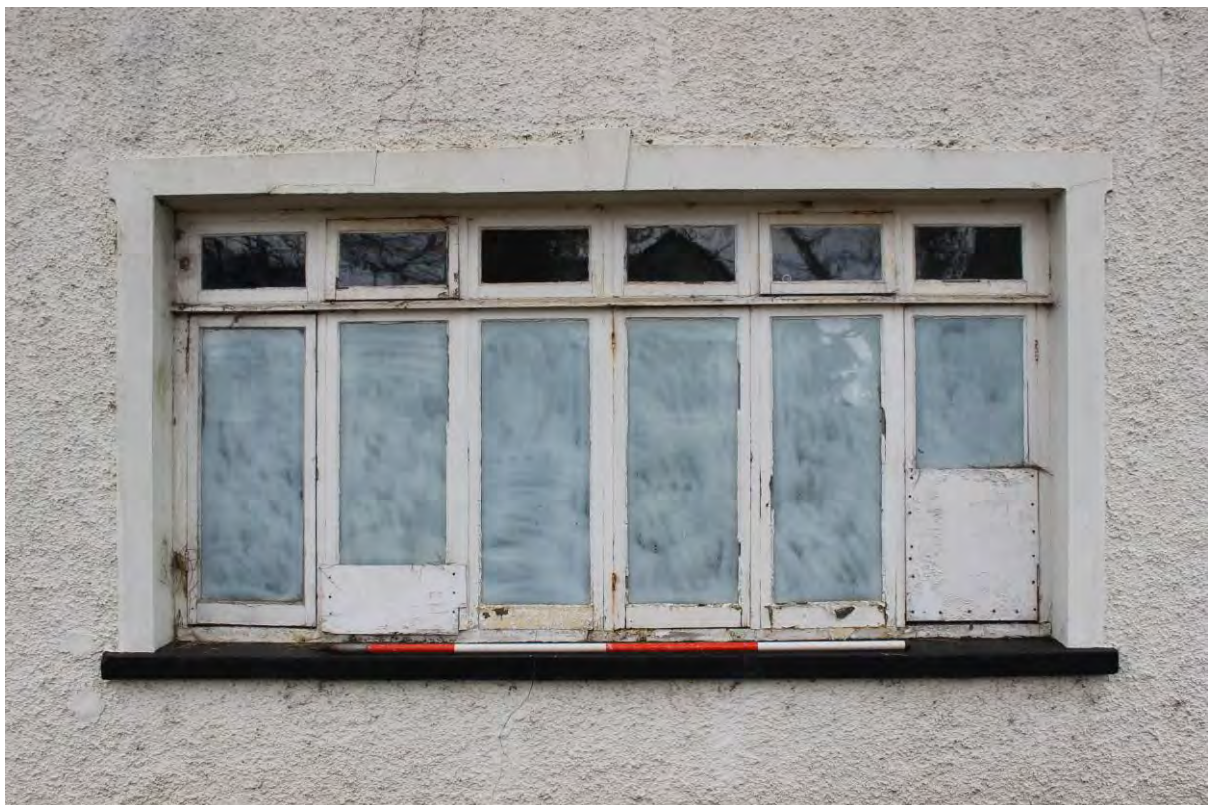
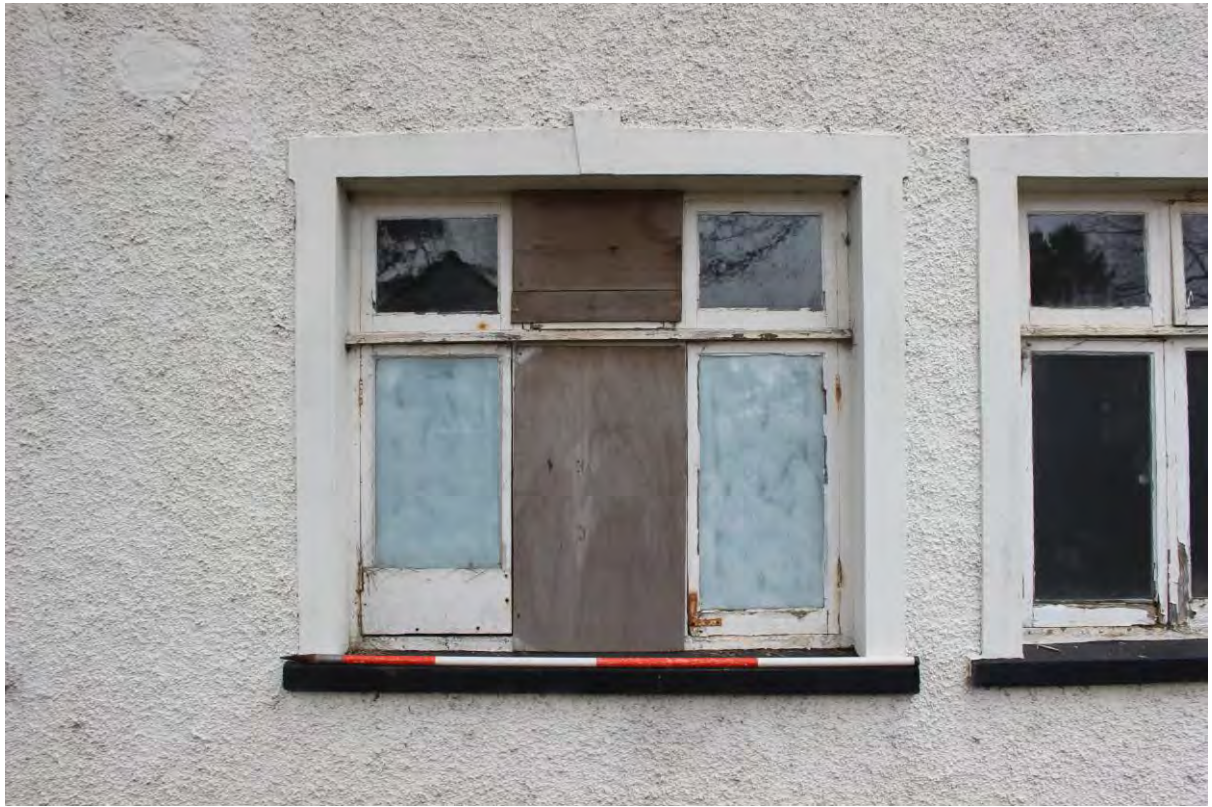
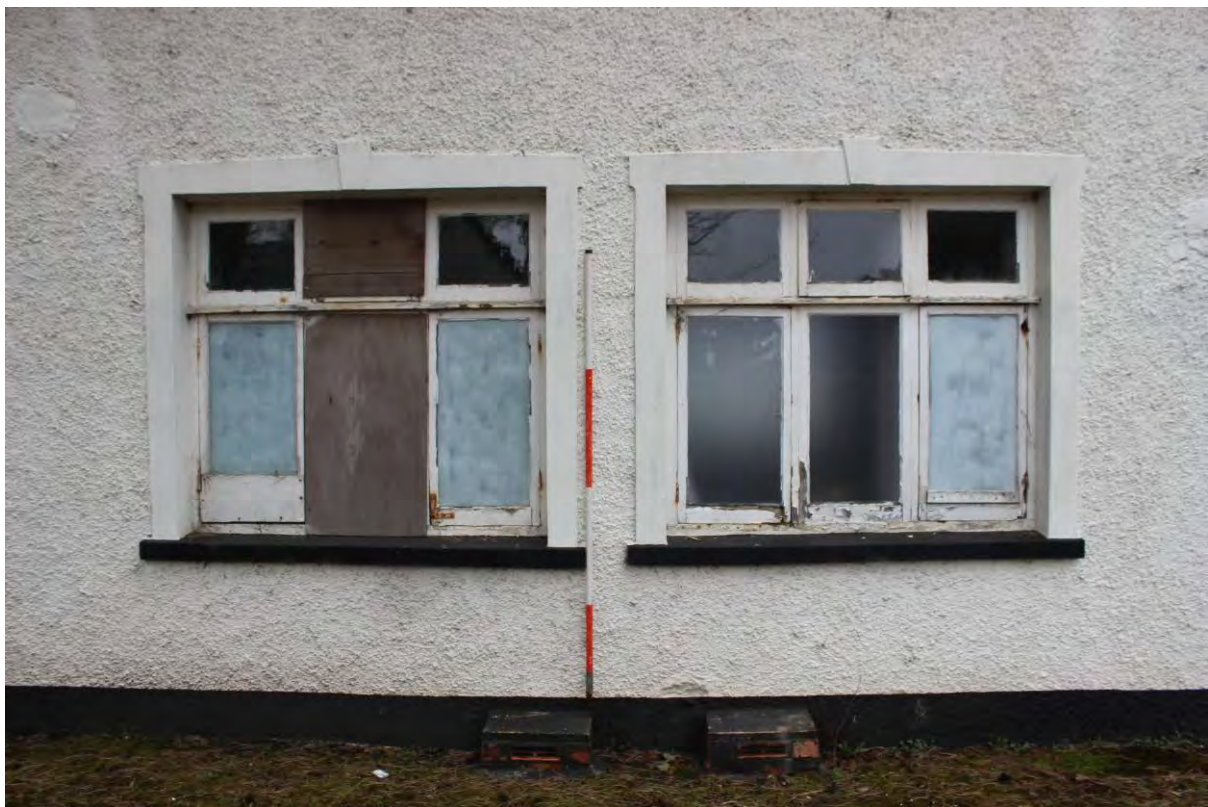
Plate 2: Eastern elevation window detail

Plate 3: Eastern elevation window detail

Plate 4: Eastern elevation window detail

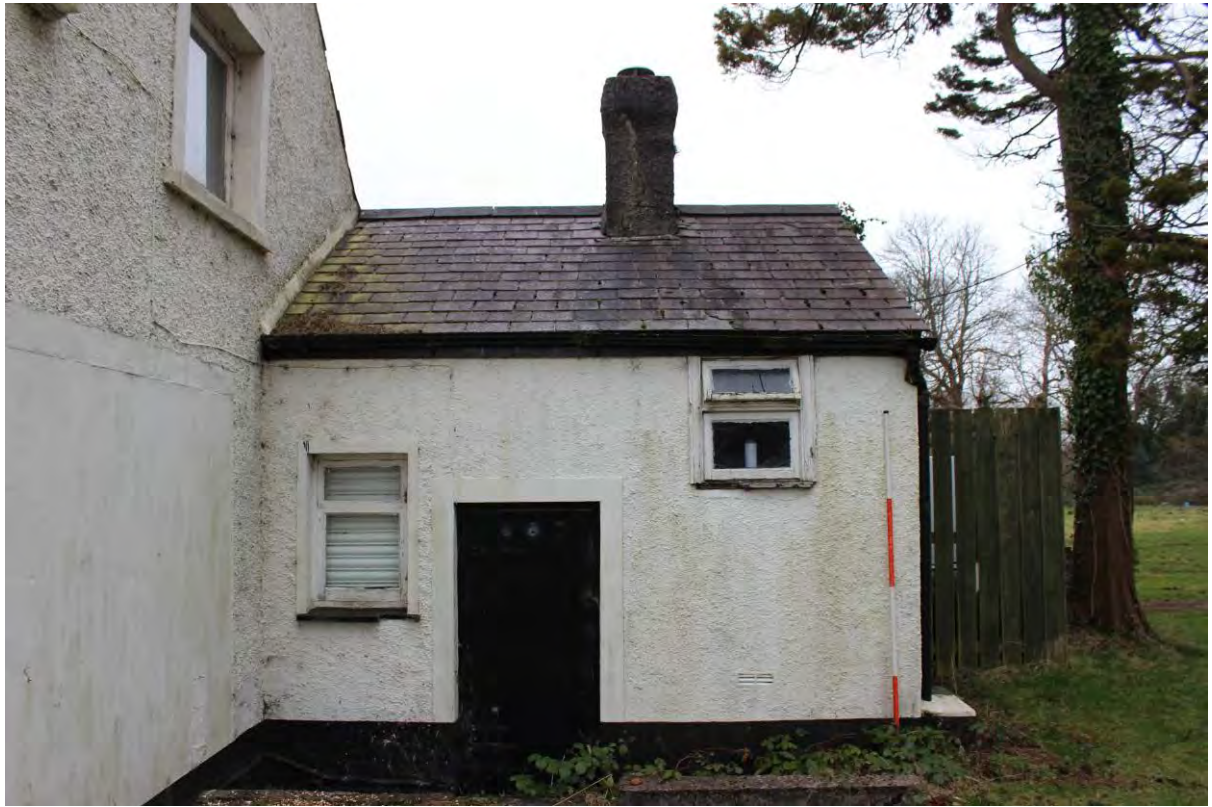
- . The extension of the north-west corner. Plate 5-6, 8.
- . The insertion of a later window in the northern extension, eastern elevation. Plate 5.
- . The demolition of an abutting structure on the northern elevation. Plate 6.

The northern extension, eastern elevation has a doorway centrally, offset toward the south and sunken below ground level with a small flight of steps leading down to it. The casing is plain, flat and squared concrete render. A small window is located to its south with the same casing of concrete render with a stone sill painted black, a second window is toward the north end and abuts the roof, which has a wooden casing and sill painted white. The windows are two over two light with the northern window featuring an awning type (Plate 5). The doorway on the eastern elevation leads to a small room where a boiler of more recent date has been installed and presumably vents through the chimney which is located in the roof above this side of the ridge plates (Plate 32).

Plate 5: Northern extension, eastern elevation

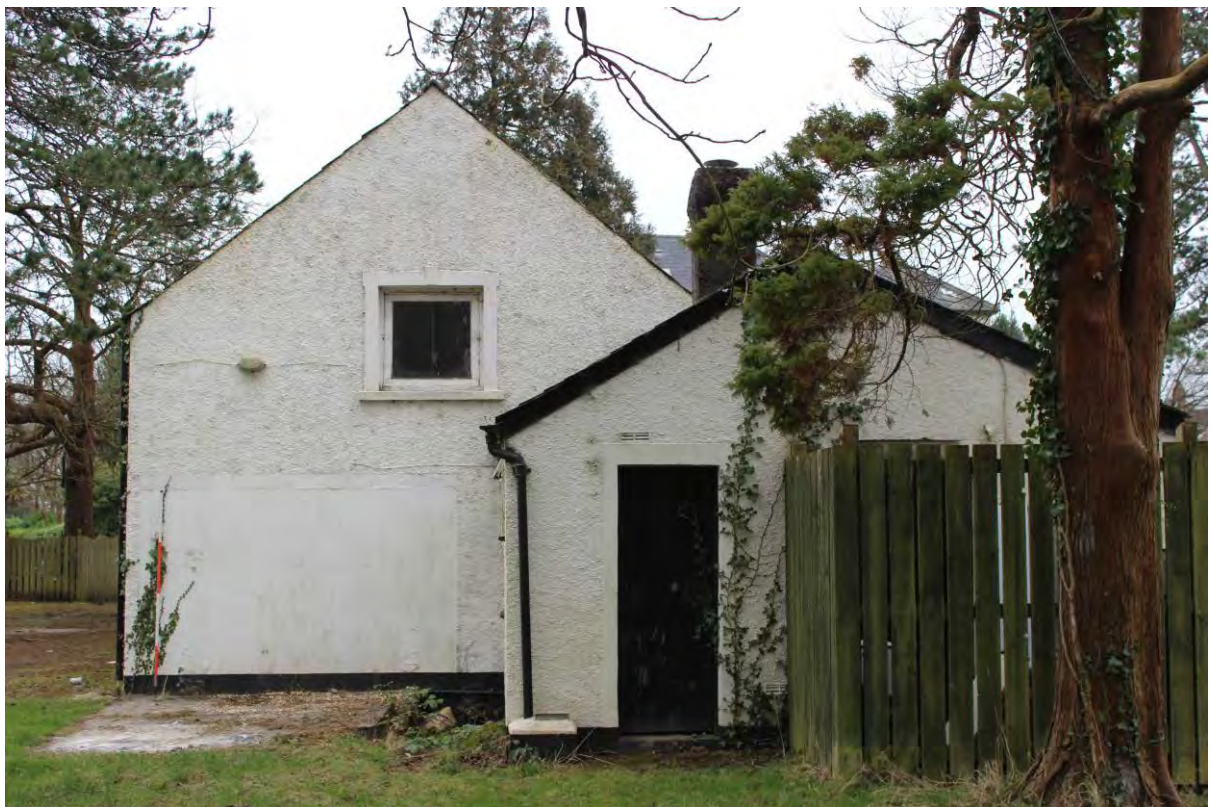
The main building is gable ended (Plate 6 and 11), the north extension is dual pitch, with the western end forming the slightly shallower angle, with an outshot where it joins the main building (Plate 6 and 8). The western extension is a pent roofed construction. The later extensions both have overhanging wooden eaves painted black, the main buildings eaves

The northern elevation has a single hay loft window in between the roof eaves with the same design around the windows on the eastern and western elevation (Plate 6-7). An imprint of where a previous building abutted the north elevation is visible toward the eastern end of the wall and its removal must post date the rough cement render present on the building as it is indented slightly and has a smooth finish (Plate 6). The northern extension covers the western end of the main buildings elevation. The southern elevation has the same hay loft window present in between the roof eaves with the same lintel and post with small semi-circular detail on outer edge of posts where it joins the lintel, but no detail on the upper part of the lintel or keystone suggesting a repair or alteration when the window was blocked (Plate 11-12).

Plate 6: Northern elevation

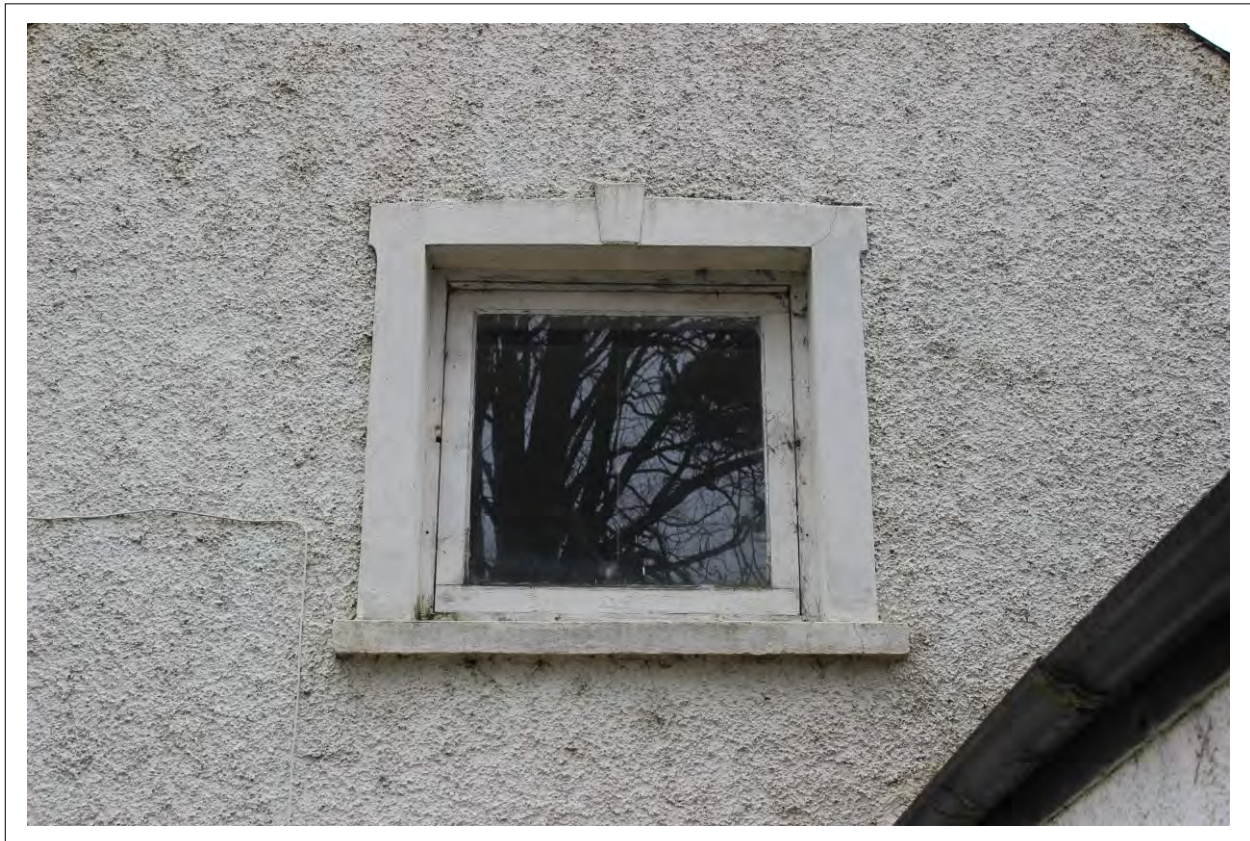
Plate 7: Northern elevation main building window detail

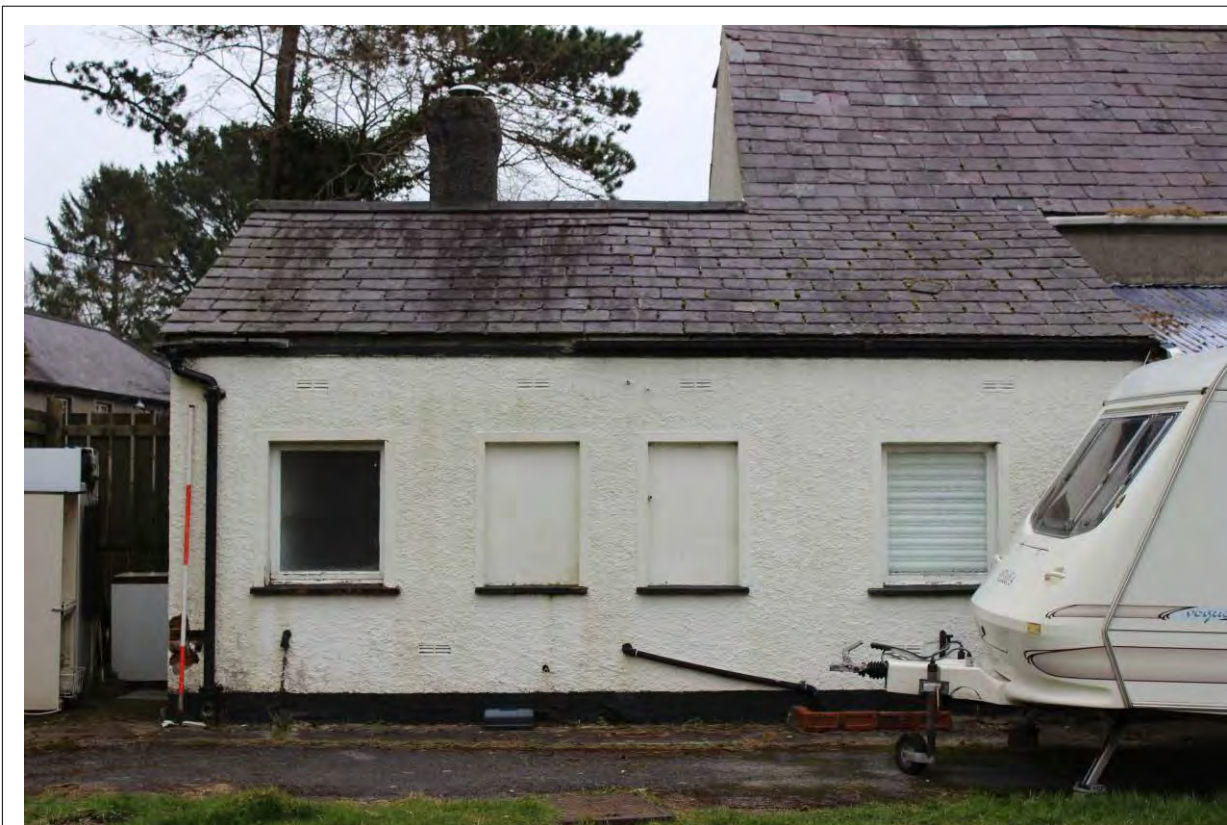
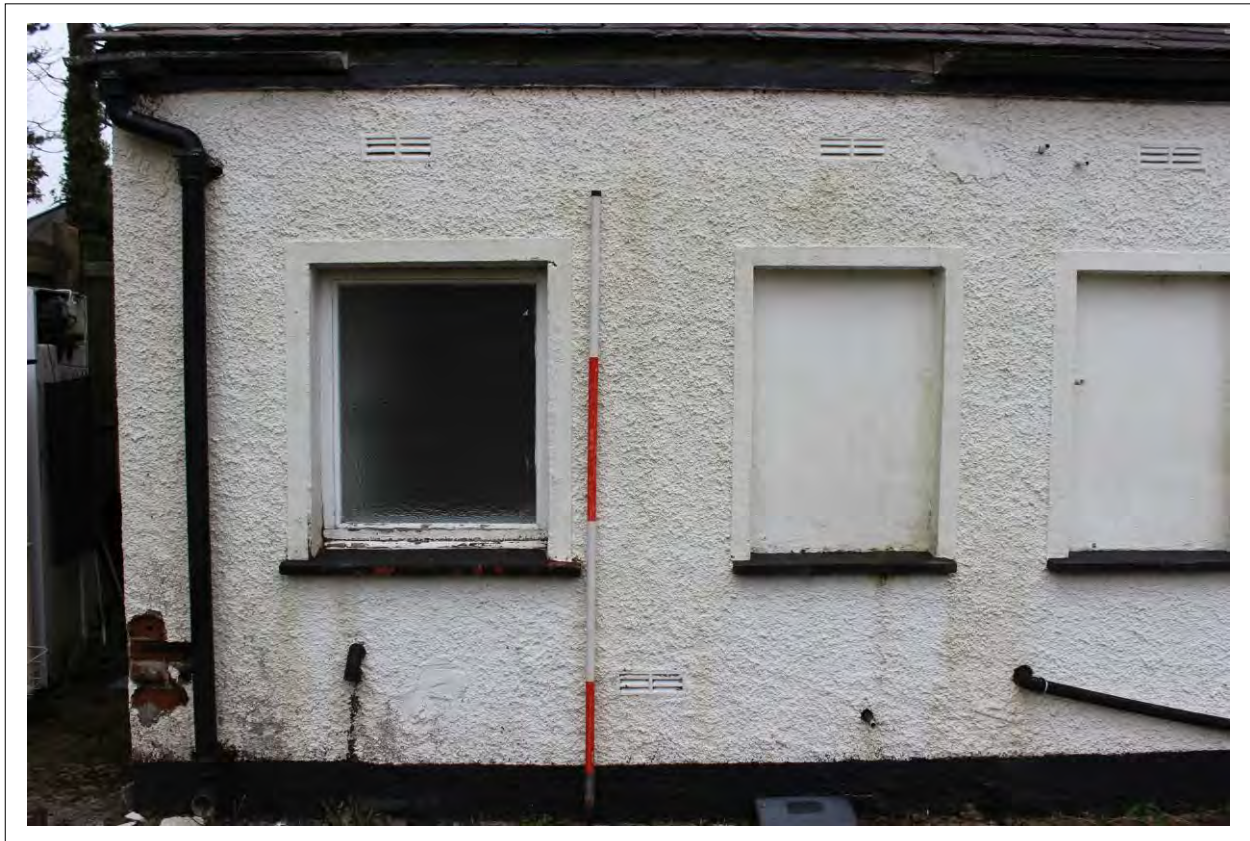
- . The blocking of the northern extension, western elevation windows. Plate 8-9.
- . The extension to the west. Plate 10-11.
- . The later blocking of the western extension glass/perspex walls. Plate 10-11.

Plate 8: Northern extension western elevation

Plate 9: Northern extension western elevation window detail

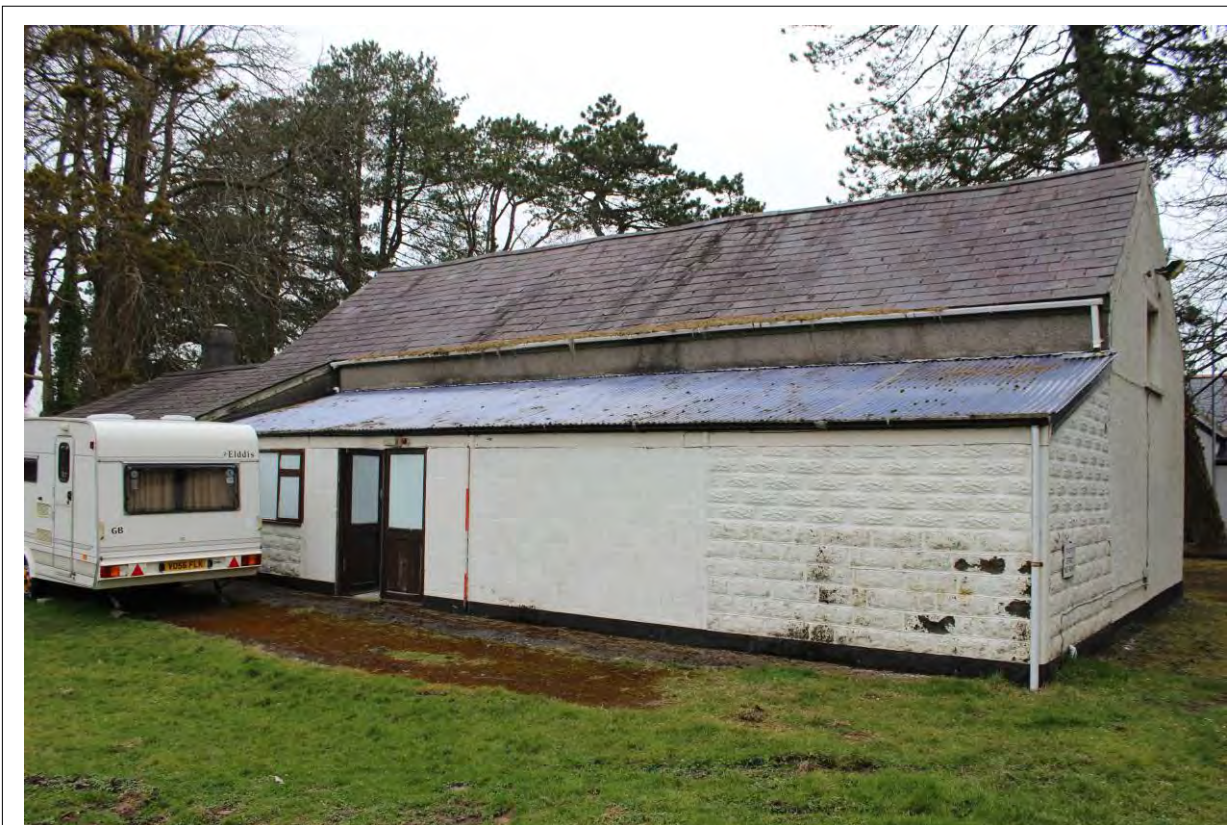
appear to be covered with modern cement render which extends up to the roof. Purple slate roof tiles with angled ceramic ridge plates cover the main building and the north extension with corrugated perspex on the western extension (Plate 10).

Plate 10: Western elevation
