Sketty Isaf Meeting Room, Bible College Site, Derwen Fawr, Swansea

Standing Building Recording

By
Louis Stafford BA (Hons)
Report No: 1334

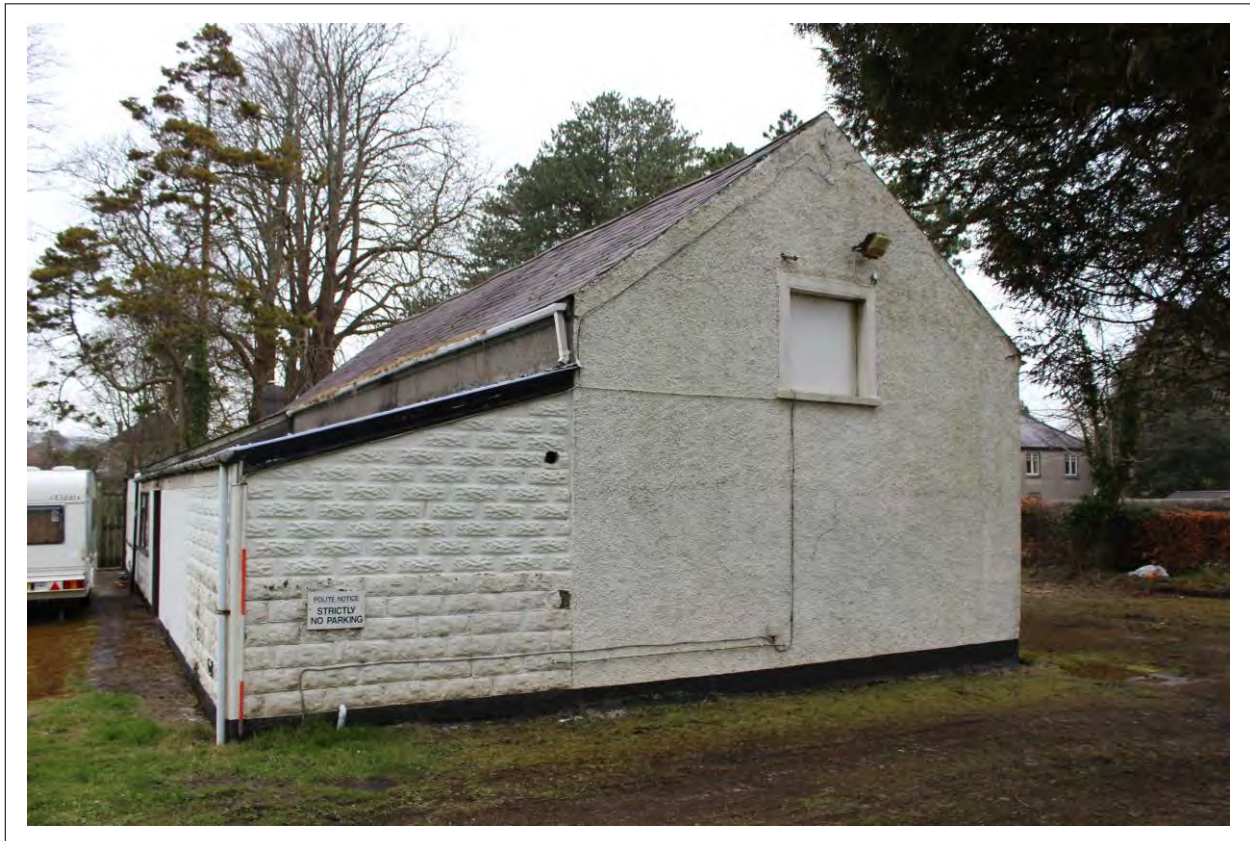
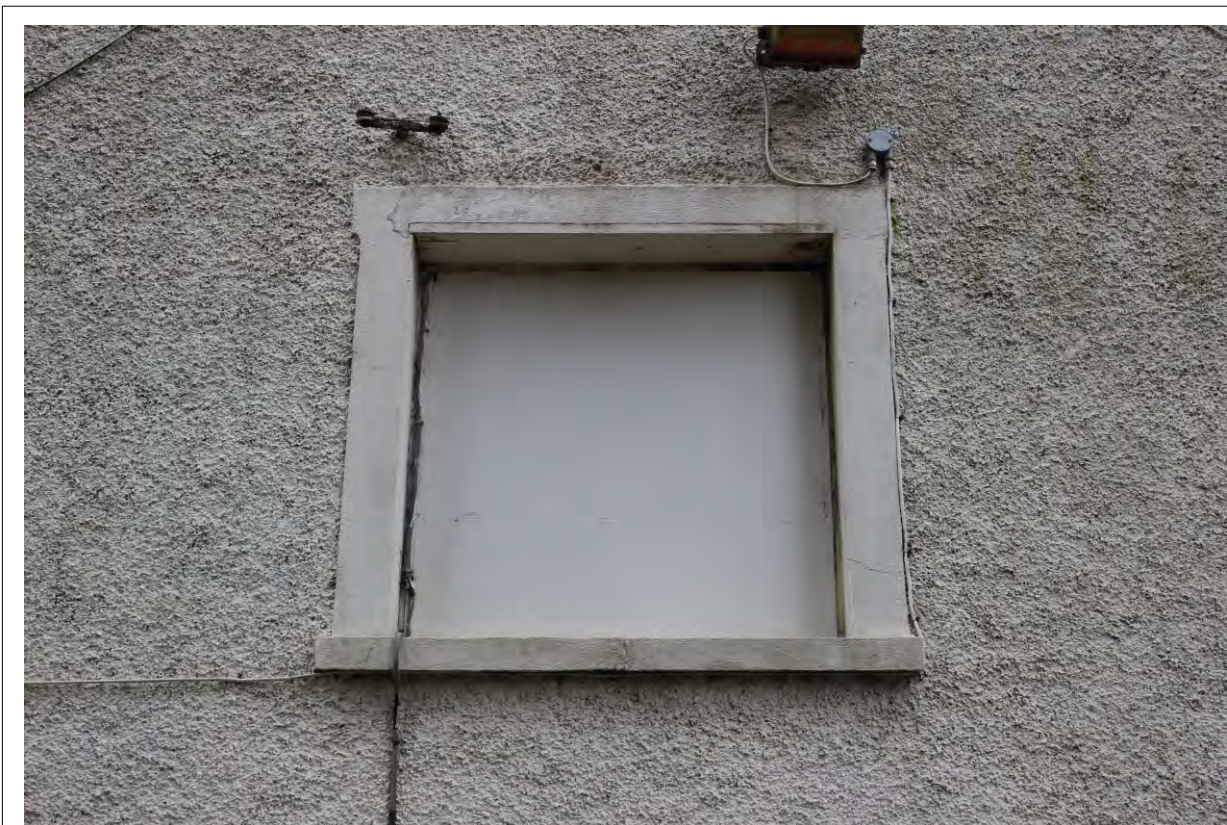
- . The blocking of the southern elevation hay loft window and repair. Plate 11-12.
- . The decoration of the main building western elevation doorways. Plate 17.

The northern elevation has a single hay loft window in between the roof eaves with the same design around the windows on the eastern and western elevation (Plate 6-7). An imprint of where a previous building abutted the north elevation is visible toward the eastern end of the wall and its removal must post date the rough cement render present on the building as it is indented slightly and has a smooth finish (Plate 6). The northern extension covers the western end of the main buildings elevation. The southern elevation has the same hay loft window present in between the roof eaves with the same lintel and post with small semi-circular detail on outer edge of posts where it joins the lintel, but no detail on the upper part of the lintel or keystone suggesting a repair or alteration when the window was blocked (Plate 11-12).

Plate 11: Southern elevation

Plate 12: Southern elevation main building window detail

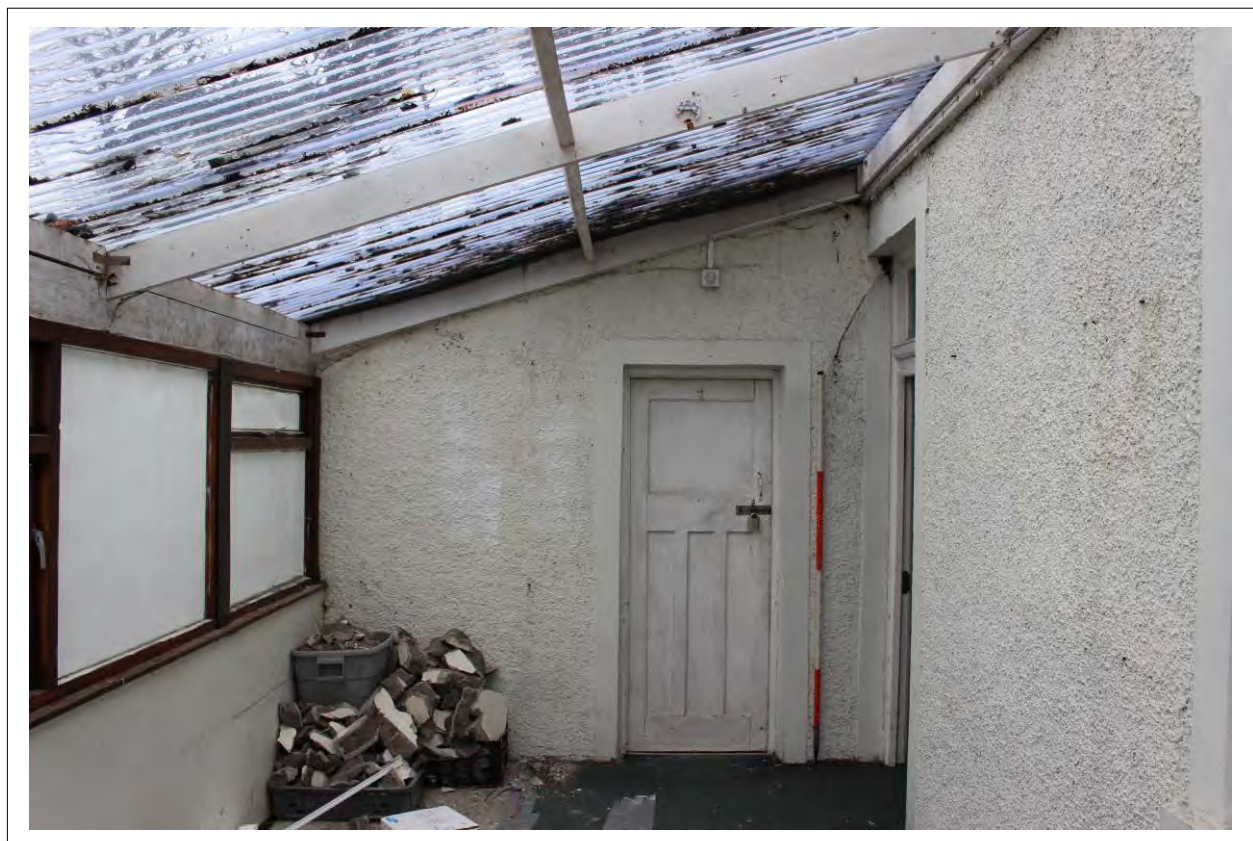
The northern extensions, southern elevation was obscured by the later western extension, but visible from inside, showing the same decorated casing as before. The wall although internal at this point had also been rough rendered with concrete and painted white (Plate 14).

Plate 14: View north in western extension, showing north extension doorway

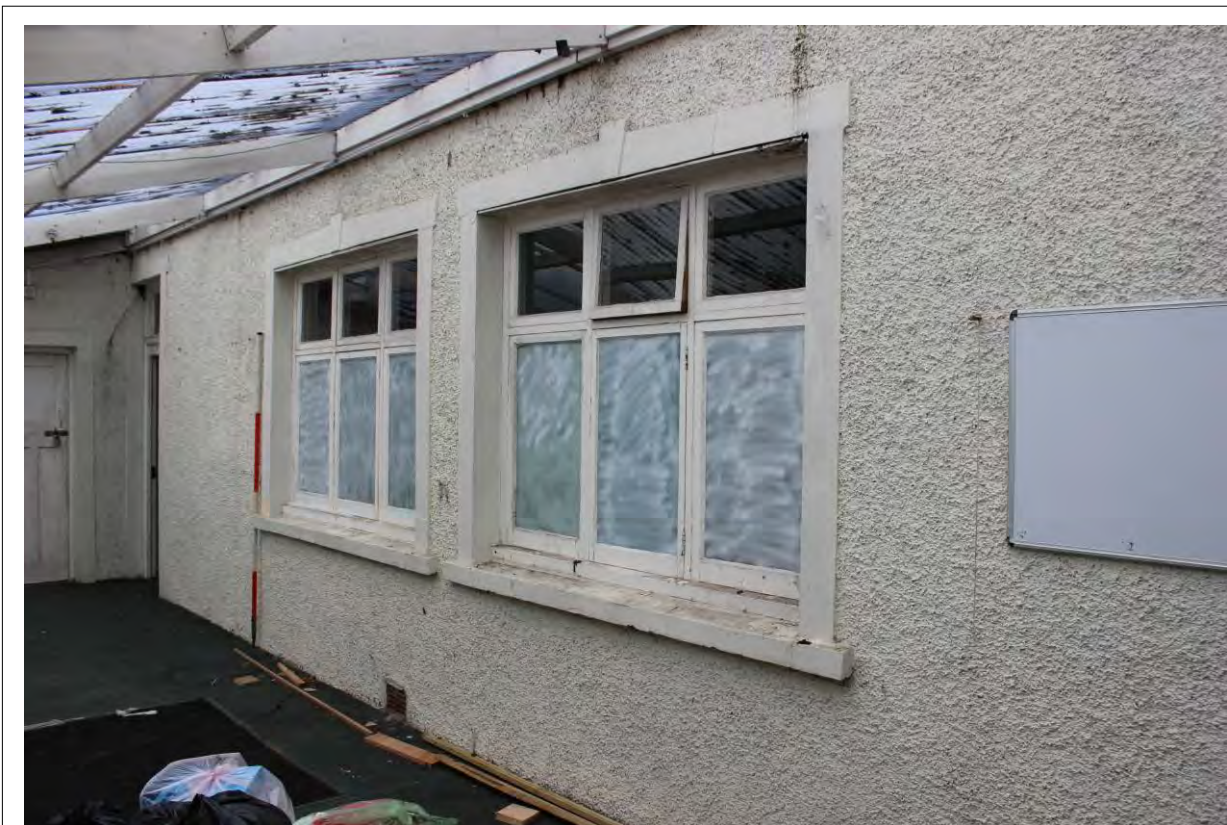
The eastern elevation has four windows evenly spaced along its length with two smaller windows toward the centre and two wider windows toward the outer edges (Plate 1). The window surrounds have a flat cement render border painted white, forming a post and lintel effect with the lintel extended slightly out with a semi circular detail on the outer edges and the top of the lintel angled slightly up toward the centre where a keystone protrudes out from the face of the lintel (Plate 2-4). The sill is a flat piece of what appears to be stone covered in cement render, painted black. The windows look to be fairly recent casement type, with the smaller inner windows formed from three over three lights and the outer larger windows six over six light type. The inner windows are mirrored on the western side, visible within the western extension (Plate 16).

Plate 16: View north-east in western extension, showing main building outer windows

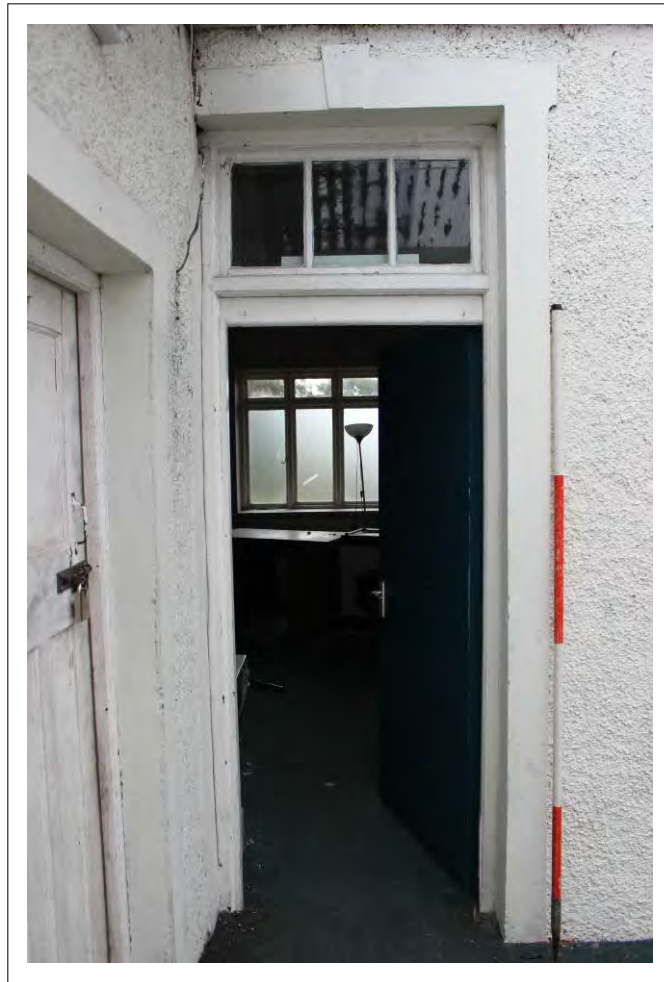
Plate 17: View east of main building doorway

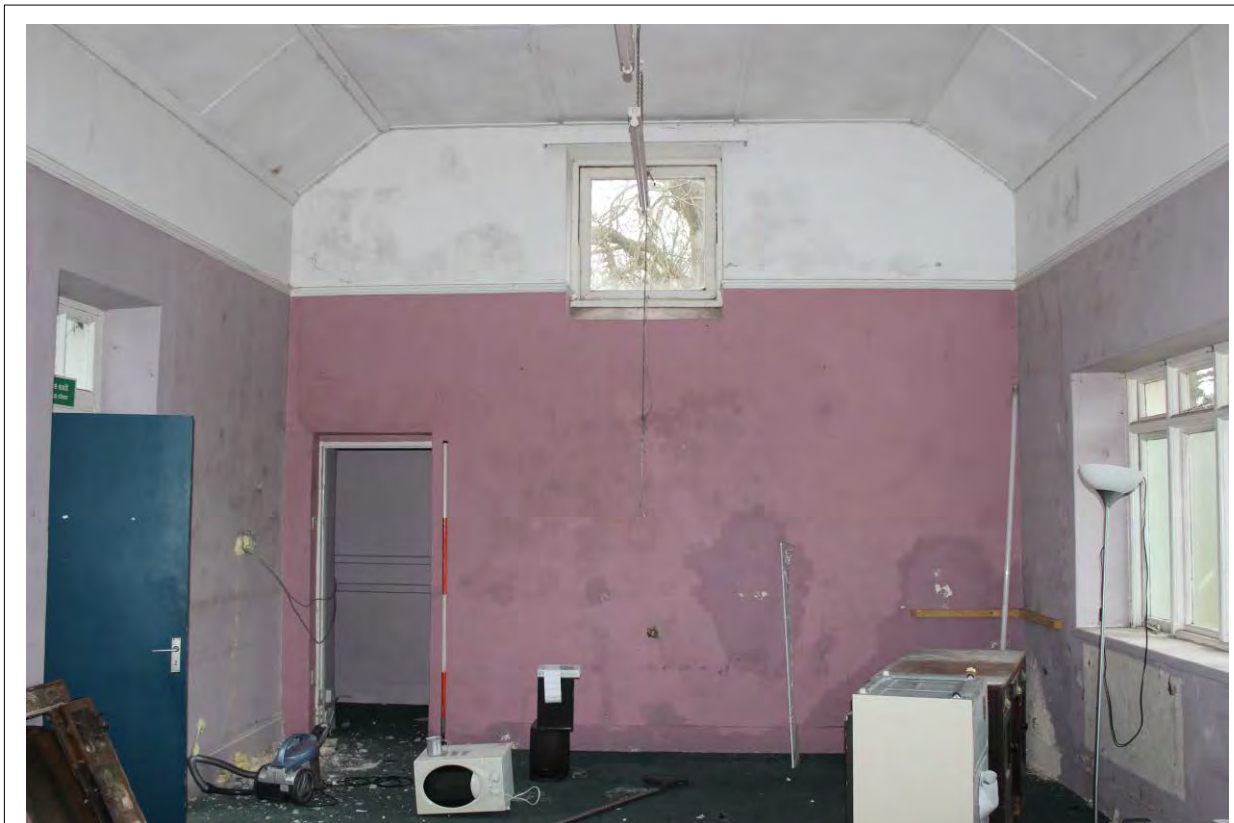
- . The insertion of a doorway in the northern wall of the main building. Plate 18.
- . The partial blocking of the central wall in the main building. Plate 19.

Plate 18: View north in northern half of main building, showing inserted doorway

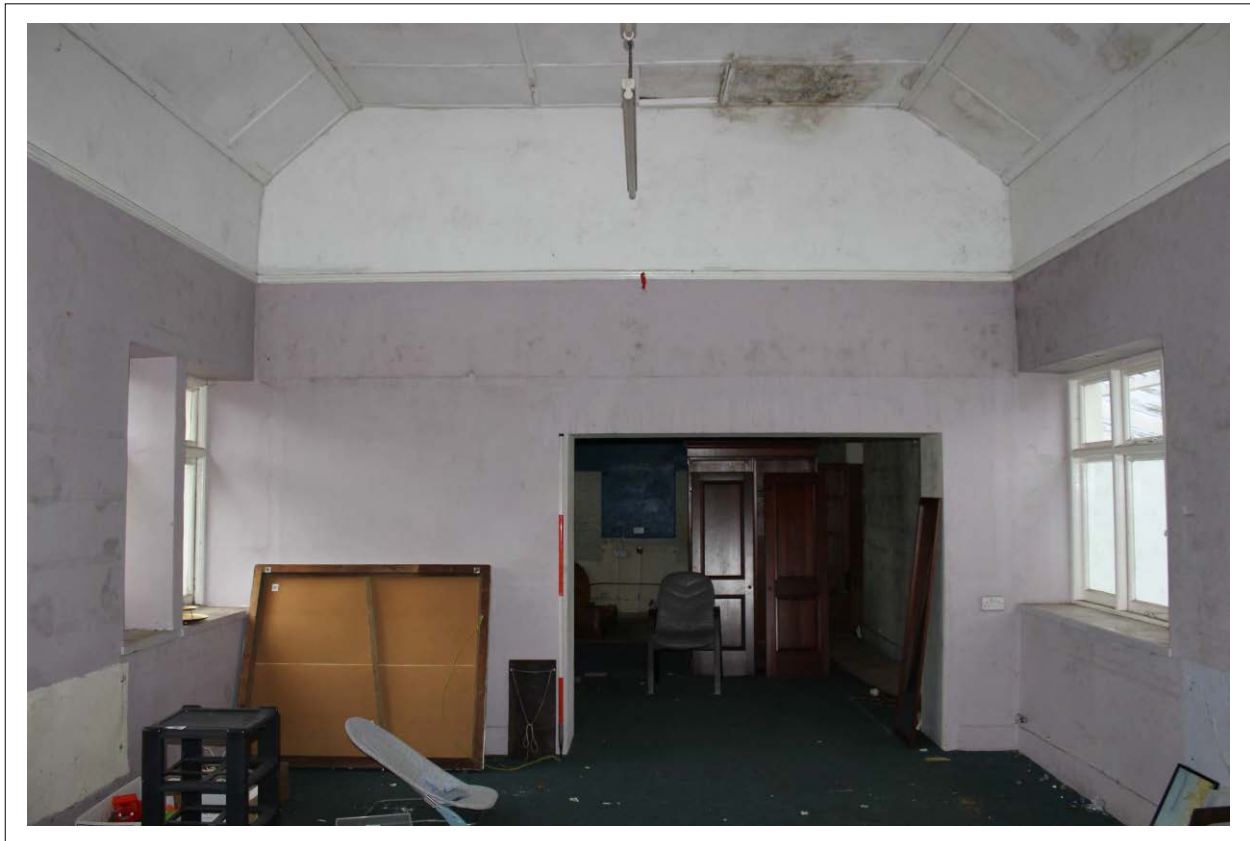
Plate 19: View south in northern half of main building

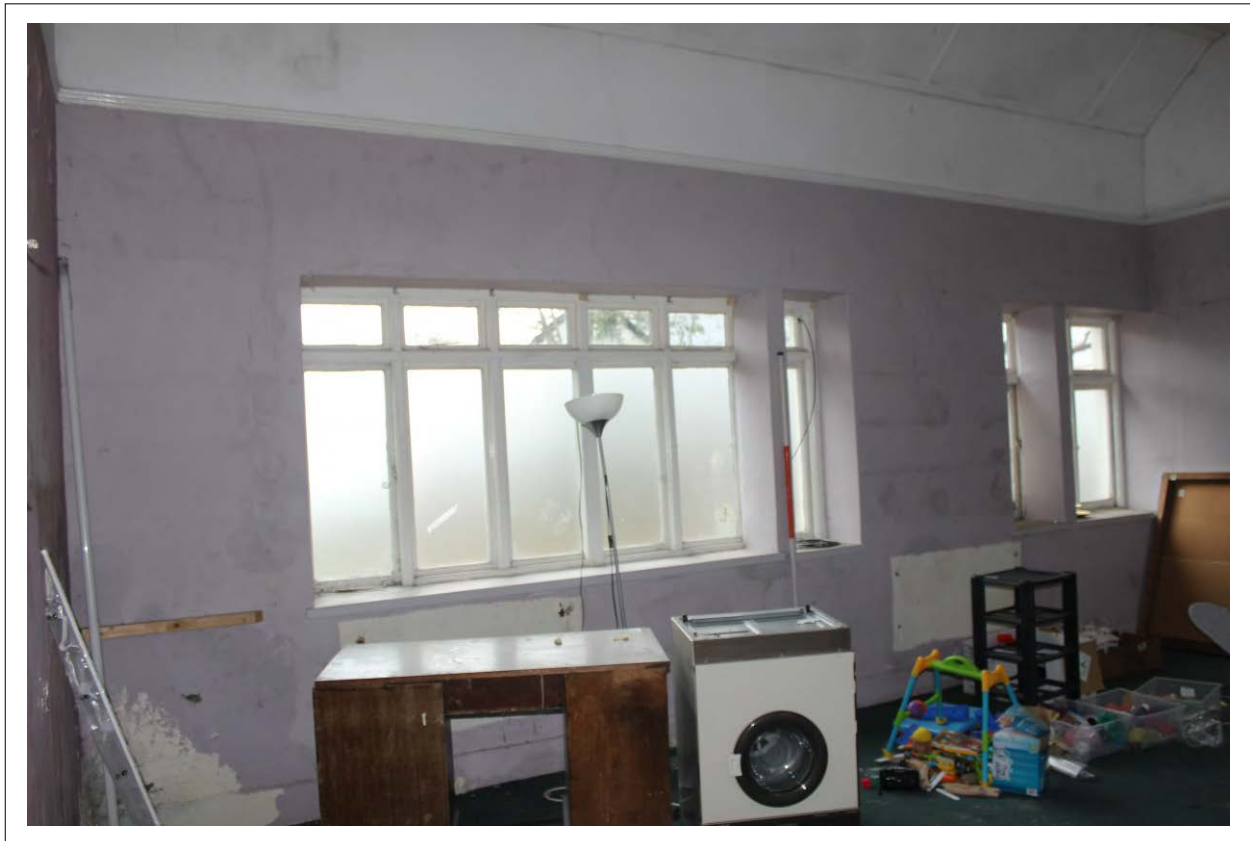
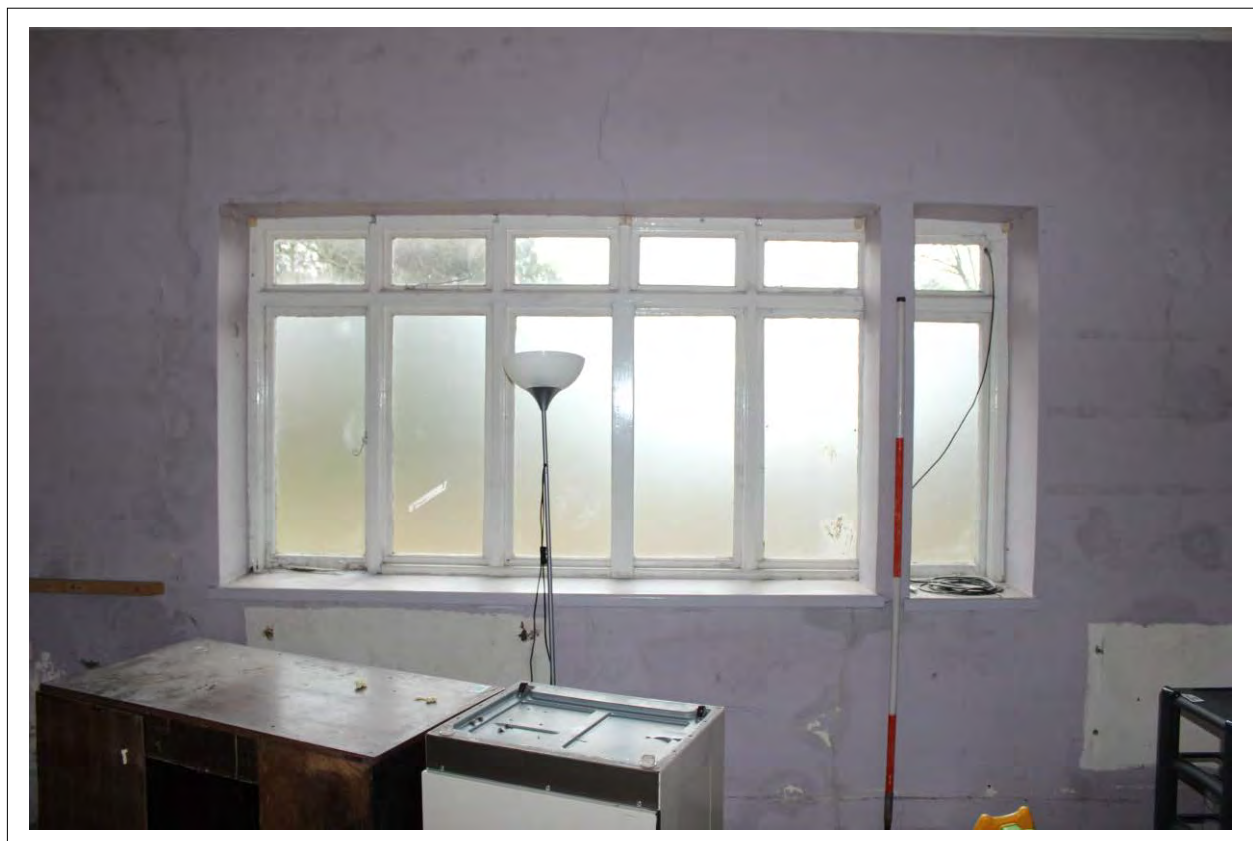
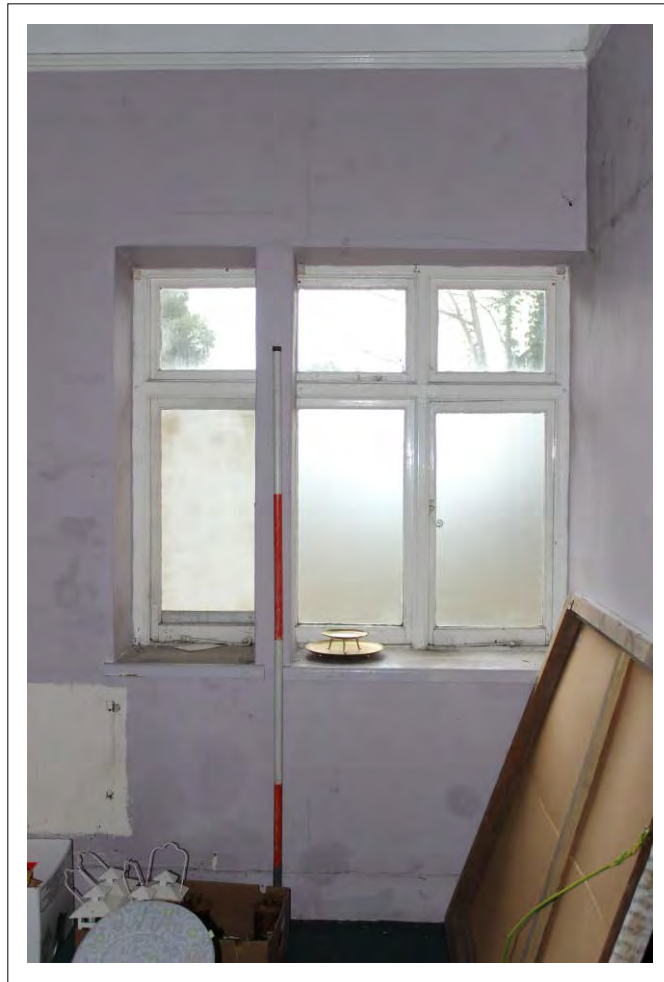
- . The insertion of supports in the northern half main building eastern windows. Plate 21-23.
- . The partial blocking of the main building southern doorway. Plate 27.

In the northern half of the main range eastern windows, slumping appears to have been apparent and upright supports were installed within the window bays to add support (Plate 21-23). The main cross supporting wall appears to have either always had an opening, evident by the blocking toward the eastern end or was knocked through and later reduced in size due to the walls slumping (Plate 19 and 24). As openings within a building of this size (and history) would suggest this building required only access for animals and not cart storage, that the opening was not an original aspect of the building and that it was reduced to stem further slumping of the roof which is evident between the supporting wall and the gable end (Plate 1 and 33).

Plate 21: View east in northern half of main building

Plate 22: View east showing window detail in northern half of main building

Plate 23: View east showing window detail in northern half of main building

The insertion of the window bays appear to be a later addition to the main range and in doing so collapsed the roof slightly forming a double bow either side of the central supporting wall, this appears to have led to uprights being placed within the window bays on the eastern side to combat the slumping and also the reduction in the size of the opening between the northern and southern half of the main range probably occurred at this point. The fenestration casings and the architectural details are likely to be attributed to the 1930's rebuild of the estate once it was acquired by the Bible College, as the post and lintel design with protruding keystone detail appear on other buildings within the estate during this period. It cannot be clarified that the windows were inserted at this point as the fabric was not exposed, the only apparent feature which indicates a slightly earlier date is the use of red quarry tiles on the sills of the windows which are typical in agricultural contexts of a mid to late Victorian date.

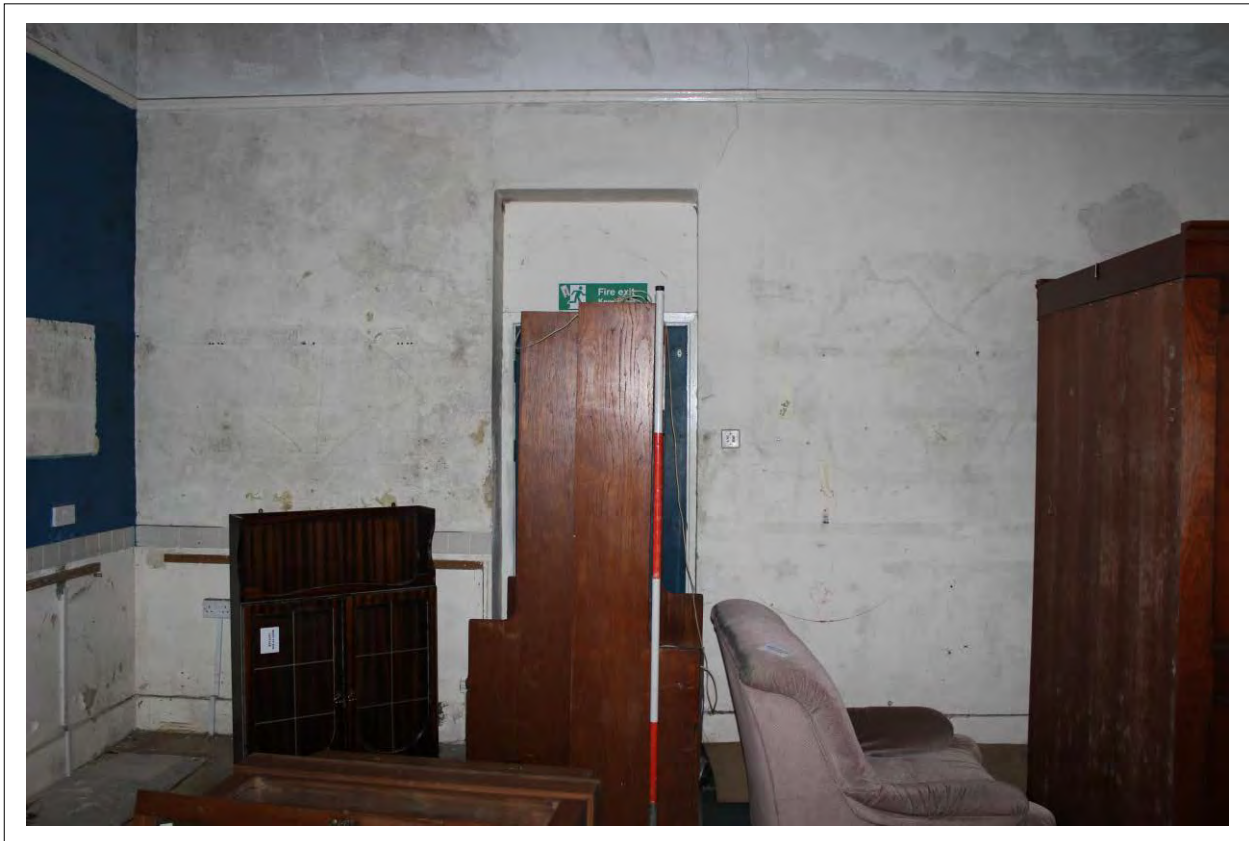
Plate 27: View west in southern half of main building showing doorway

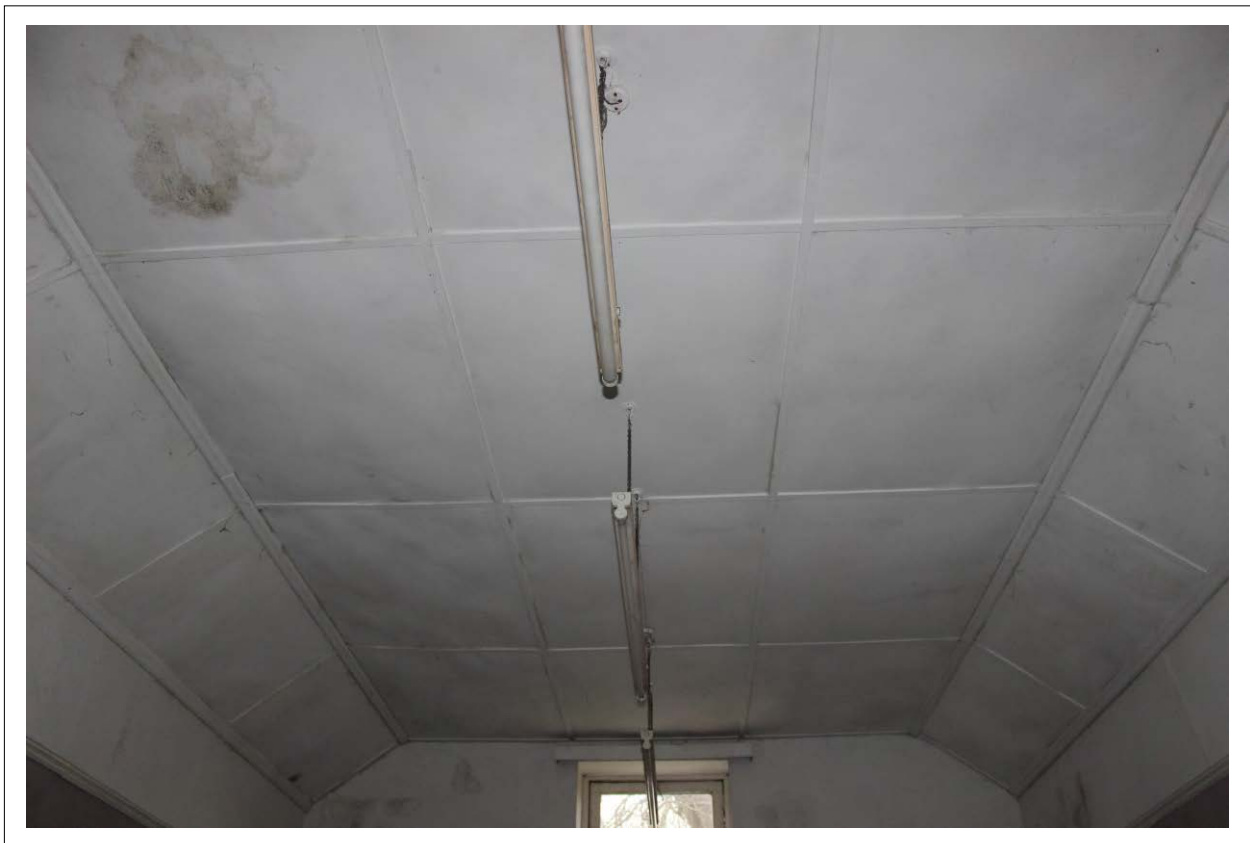
- . The insertion of a suspended ceiling. Plate 29
- . The insertion of modern amenities in the northern extension. Plate 30.
- . The insertion of a later boiler in the northern extension. Plate 32.

The main range is split into two halves with a supporting wall positioned mid way along the building east to west. The interior of the building has been rendered throughout. A later inserted doorway is apparent in the north wall, west corner which leads to a small cupboard room for storage formed by the north extension (Plate 18). The ceiling is a timber grid suspended ceiling type which is present in both halves of the building (Plate 29).

Plate 29: View north showing suspended roof

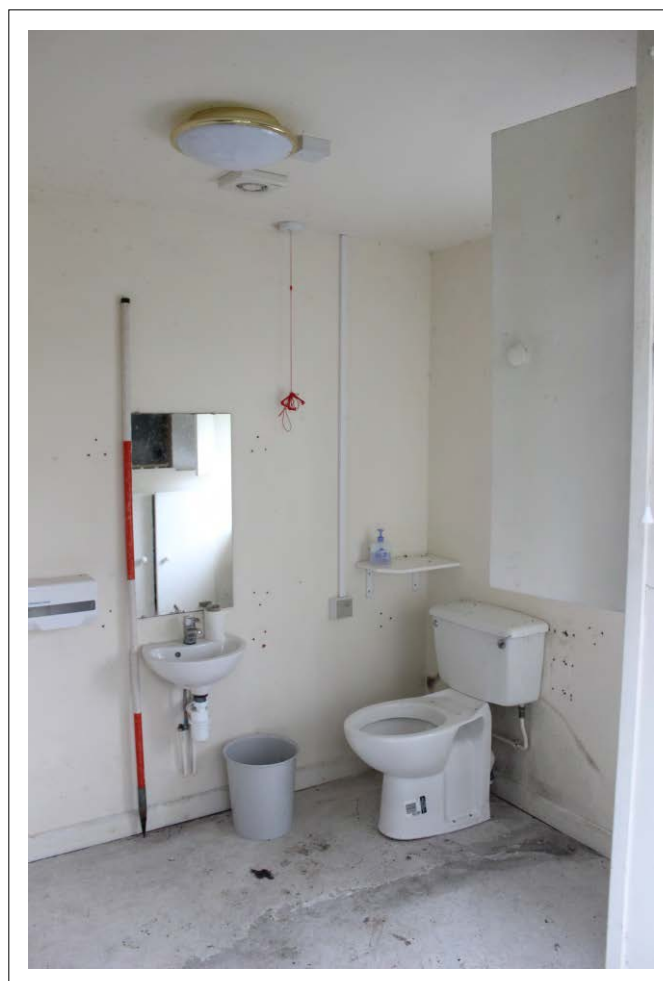
Plate 30: View south in northern extension, showing modern inserted toilet block

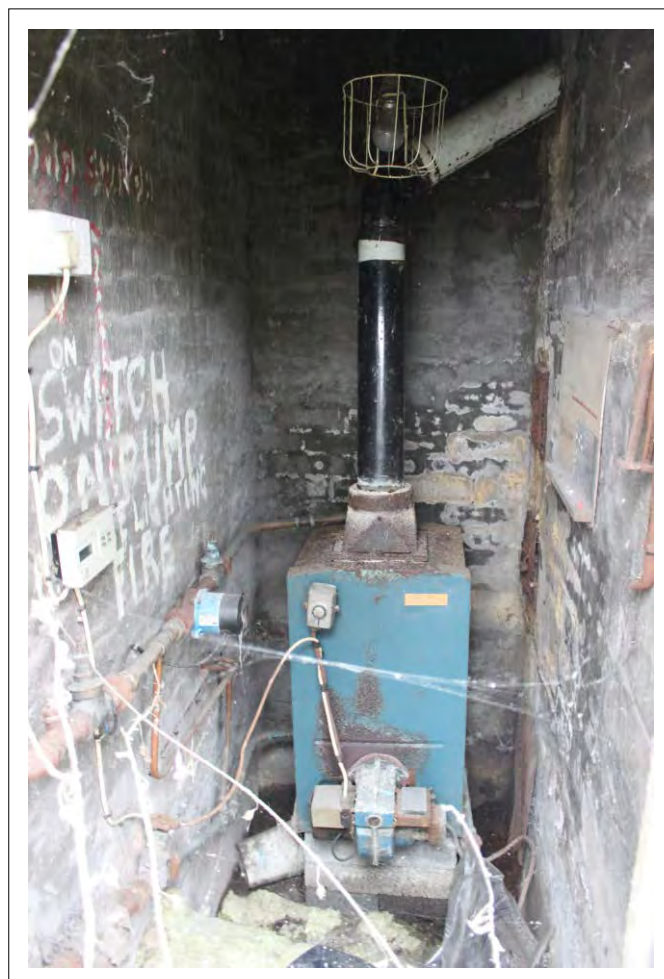
The northern extension, eastern elevation has a doorway centrally, offset toward the south and sunken below ground level with a small flight of steps leading down to it. The casing is plain, flat and squared concrete render. A small window is located to its south with the same casing of concrete render with a stone sill painted black, a second window is toward the north end and abuts the roof, which has a wooden casing and sill painted white. The windows are two over two light with the northern window featuring an awning type (Plate 5). The doorway on the eastern elevation leads to a small room where a boiler of more recent date has been installed and presumably vents through the chimney which is located in the roof above this side of the ridge plates (Plate 32).

Plate 32: View west in northern extension, showing boiler plant
