# **St Margaret's Church, Roath, Cardiff**

## Archaeological Watching Brief

Report No 652.

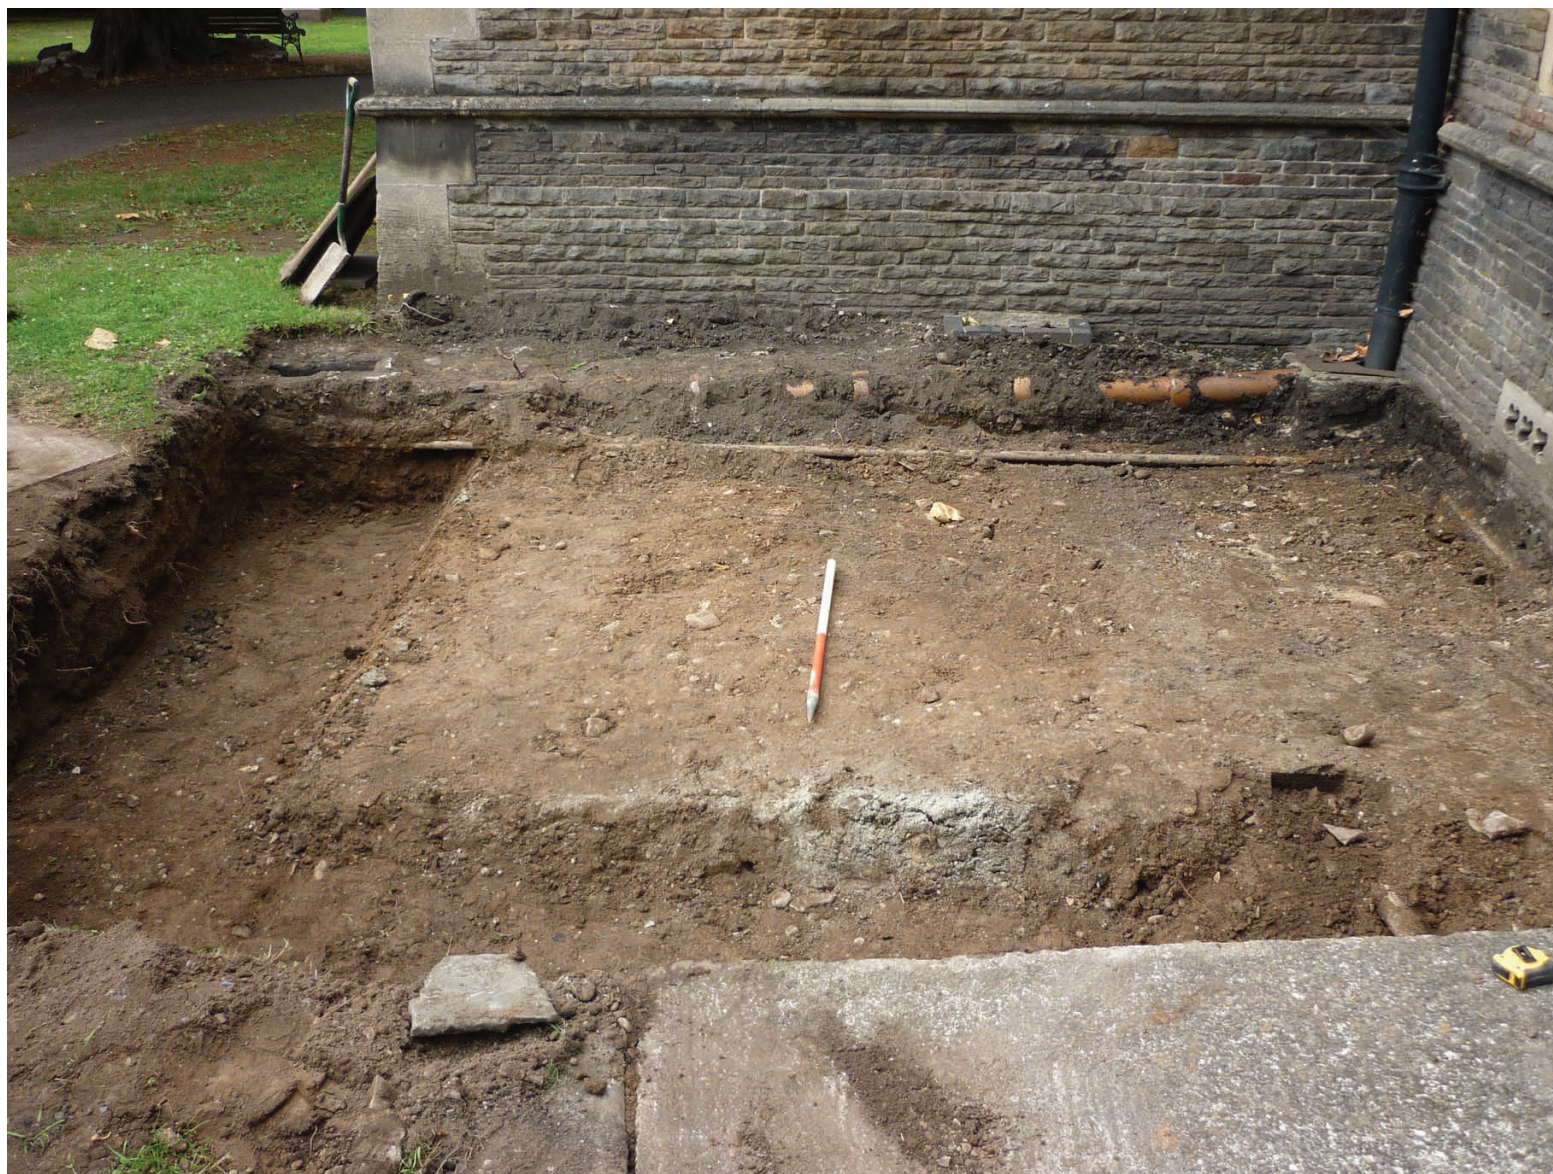
Fig. 3  
Toilet extension  
trench

The extension for the new toilet block was located on the south-eastern side of the church between the southern transept and the vestry door (fig. 2 and fig. 3). The footprint was square in shape, measuring 4m long by 4m wide and was excavated to a depth of 0.3m across the centre and 0.6m around the outside edges.

The excavated area cut through the turf and topsoil and into a deposit of reddish brown subsoil. The subsoil contained occasional fragments of human bone, evidently derived from disturbed graves. Two grave cuts were identified on the southern side of the excavated area. These lay parallel to each other, approximately 0.2m apart. Both were around 2m in length and 0.5m wide and contained fairly compact dark brown clay silt with small fragments of coal.

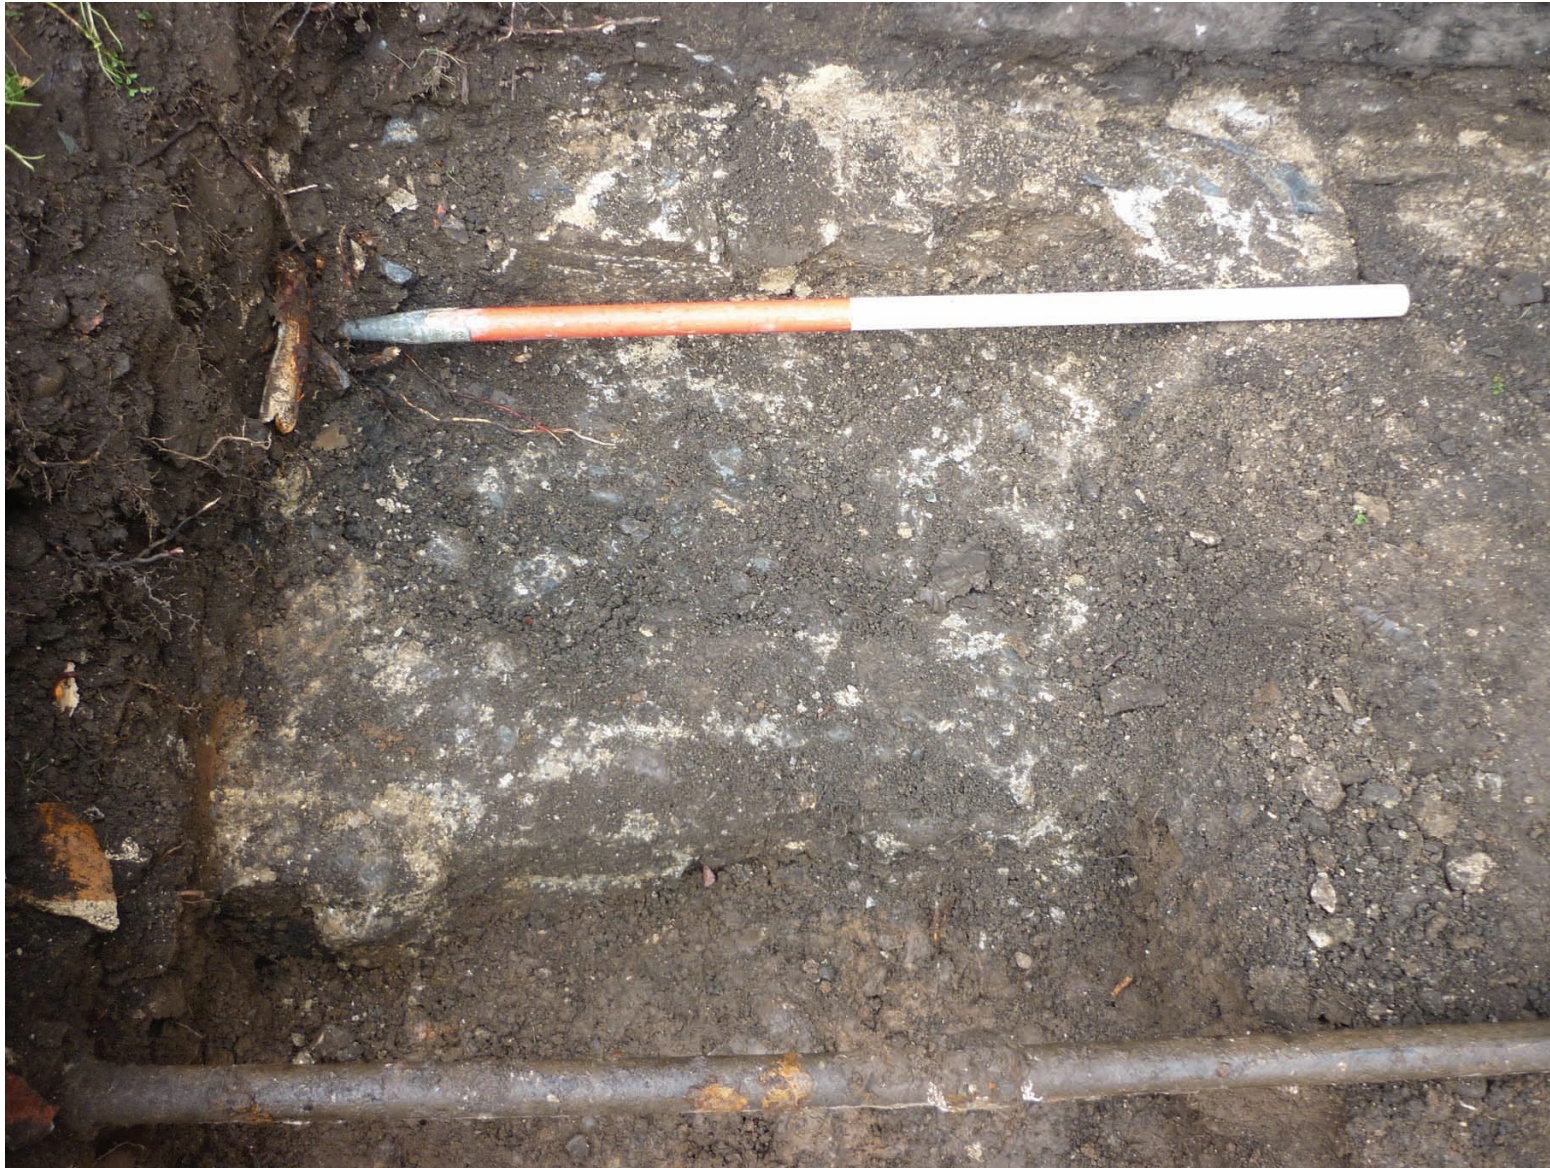
Fig. 4  
Vault within the  
toilet extension  
trench

In the south-western corner of the excavated area the end of a brick-built vaulted grave was revealed (fig. 4). This was exposed for a 1m up to the outer wall of the church. The grave clearly pre-dates the construction of the present church in 1870 as the remainder of the grave must run under the wall. It is likely to have been either destroyed or badly disturbed during the construction of the transept wall.

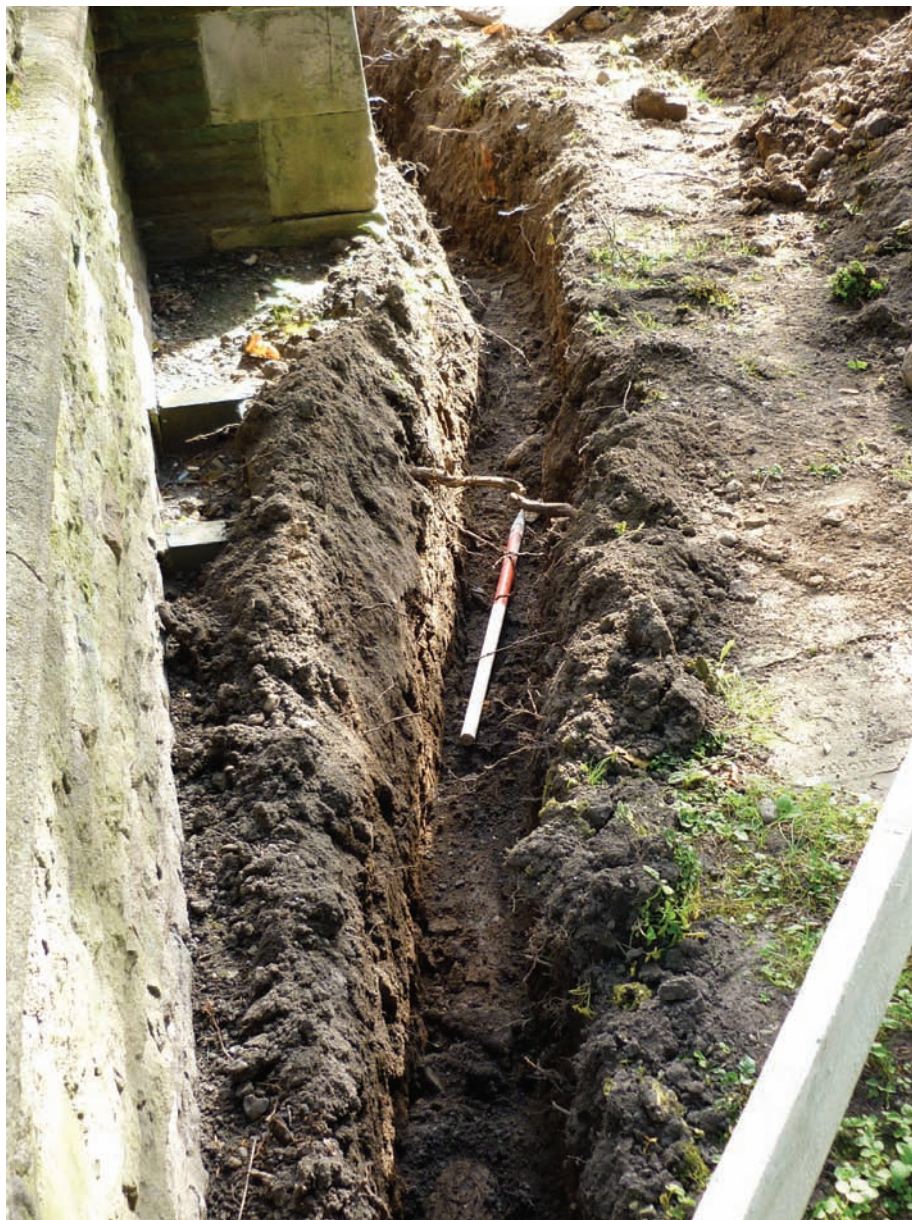
Fig. 5  
View north along  
the trench for the  
electricity cable

A trench measuring 9m in length, 0.3m wide and 0.4m deep was excavated along the southern wall of the southern transept to accommodate an electric cable (fig. 2 and fig. 5). The trench cut through the turf and topsoil and into a mixed layer of topsoil and stone – evidently disturbed during the construction of the new church in 1870. The foundations for the southern transept wall were encountered at both the south-western and south-eastern corners, and where the buttress extends from the wall.

No graves were revealed or evidence of disturbed burials identified in this trench.

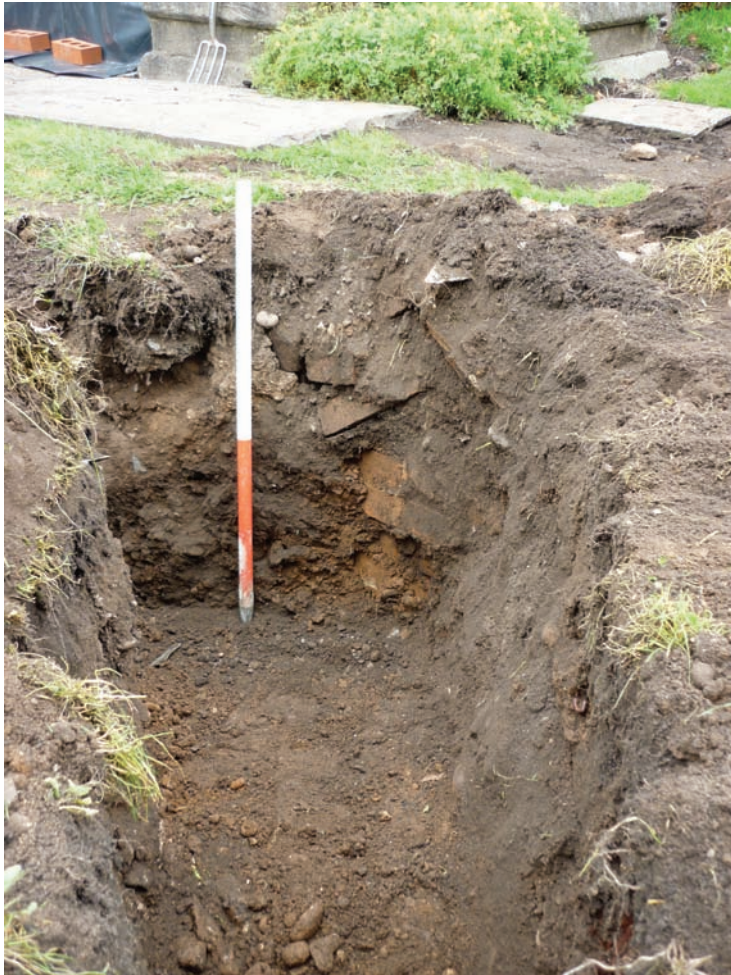
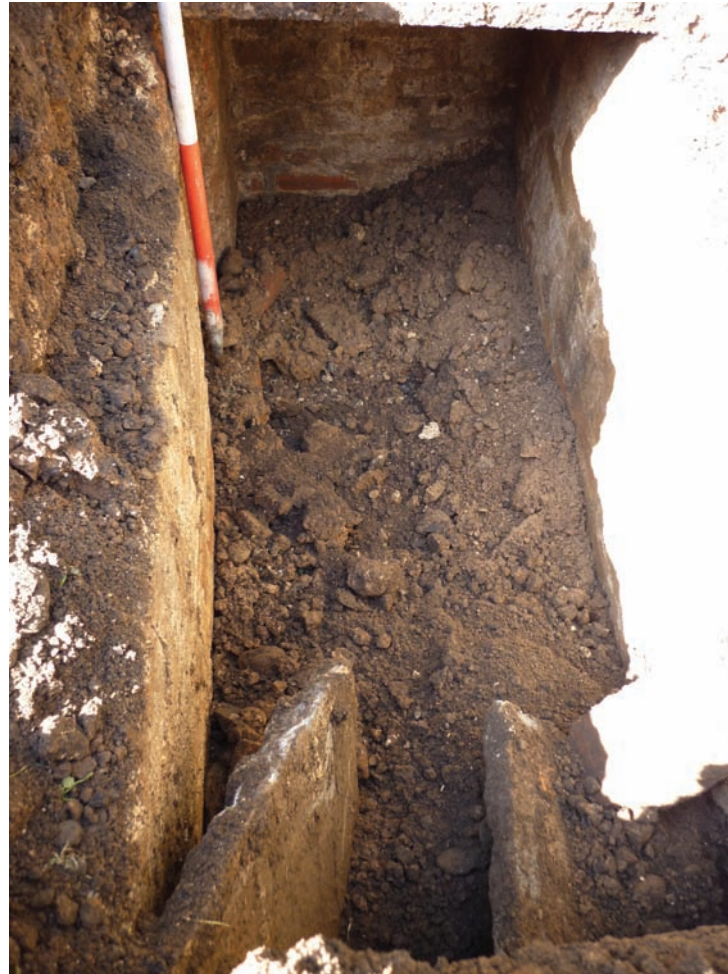
Fig. 6  
Brick-built vaults  
within the drainage  
trench

Two brick-built vaulted graves were identified at the northern end of the trench. These were constructed side by side, 0.2m south of the vault identified in the toilet block extension trench. Both graves were capped by sandstone slabs sitting on the upper courses of brick walling (fig. 6).

The eastern slab on the northern grave was broken and had fallen into the void within the vault, and the middle slab was disturbed during the excavation of the trench. The middle slab was put back in its original position, while the broken southern slab was removed from the grave and replaced with a concrete paving slab. The burial was visible in the base of the vault, partly covered by a layer of slates. The drainage pipe was laid over the top of the grave slabs. Neither grave was disturbed.

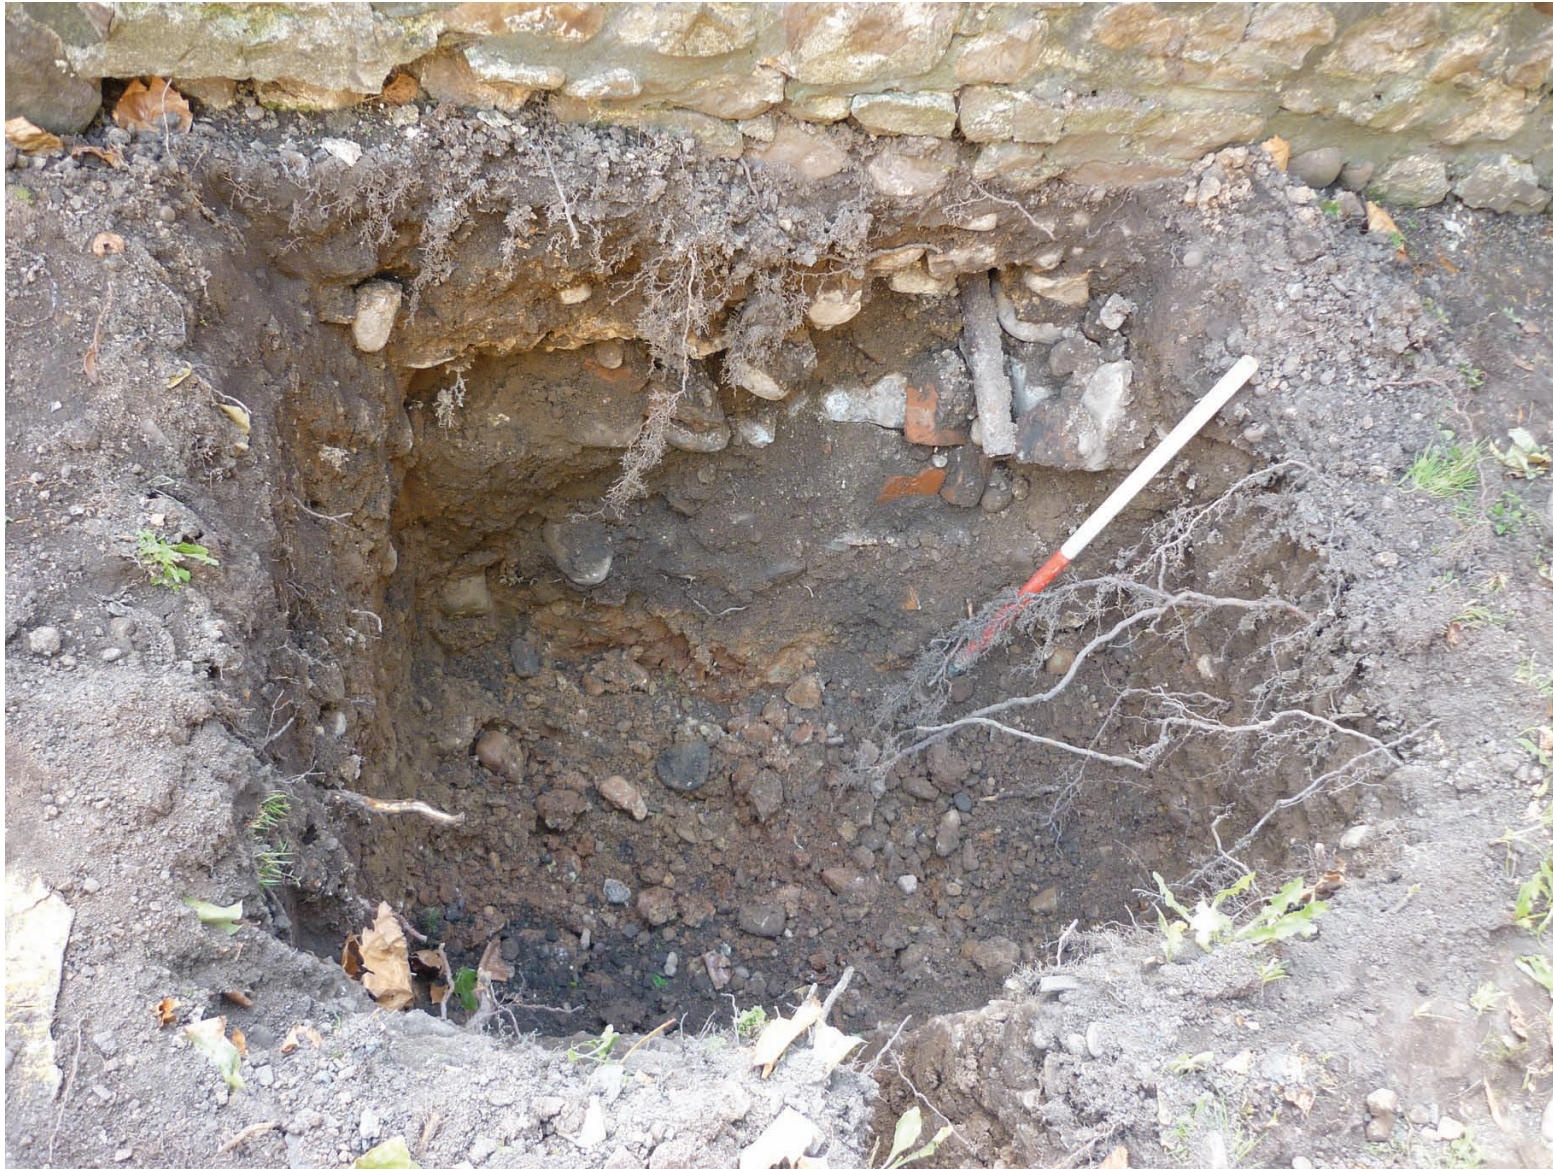
Fig. 7  
Soakaway Trench

The soakaway measured 1m by 1m and was excavated to a maximum depth of 1.2m (fig. 2 and fig 7). It cut through the turf and topsoil and a deposit of shattered gravestones and fragments of laminated wooden Cardiff Council roadworks signs. Judging from the font used in the signs, they date from the 1960s. It is thought that the modern soakaway trench was excavated on the location of an existing one that had been filled with debris and broken marker stones from the graveyard. The base of the soakaway cut into a layer of river gravels. No graves were revealed in the soakaway trench.
