Aberpergwm Colliery, Glyn Neath, Neath.

Archaeological Watching Brief

CAP Report No. 609

Date: December 23rd 2010

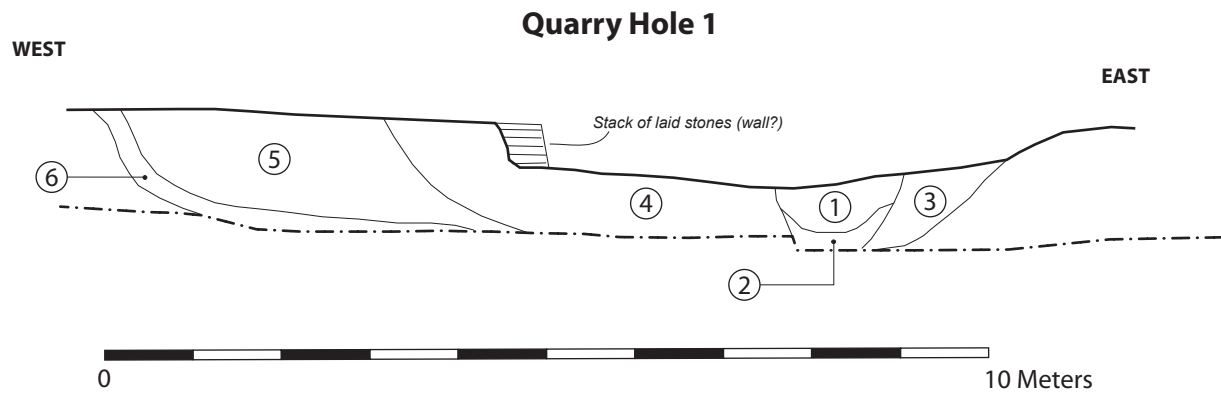
Contexts - Quarry/pit 1

- 1 = Clay and sandstone
- 2 = Peat
- 3 = Natural
- 4 = Stone, gravel and soil mix
- 5 = Stone and clay
- 6 = Peat deposit tu (re-laid turf down).

Figure 6:
East to west facing sections of Quarry pits 1-3

- 5.6 The first pit or hollow appeared to have a stone wall or revetment built into its west side. This was sectioned and photographed prior to top soil stripping in order to identify its character and form. The stone work was of irregular local stone that had not been dressed, although the stones varied considerably in size, the average being approximately 0.50m in length x 0.05-0.10m thick. The upper stone course sloped from front to back but this slope disappeared with depth. The revetment was only one course thick and behind it were roughly stacked stones mixed with the natural subsoil, which showed very little internal organisation. It seems likely that the dry stone walling was therefore used to hold this material in place and keep the working area clear. The section through the quarry would seem to reinforce this conclusion. The Section was dug by machine in a northeast to southwest alignment. This was forced due to proximity of the newly quarried area. The section revealed a three phase structure. The initial cut was to the west the remains consisting of 3.7 metres of infill this rested on a buried Peat layer that was sampled. Sampling revealed that this peat had not formed in situ, but had been deliberately deposited as evidenced by stacked turfs on the edge. The first phase was backfilled then cut by phase 2 to the East this was also backfilled but with no sign of buried peat. Phase two was cut by phase three which extended the quarry further to the East. This cut is the one associated with the dry-stone walling which was probably intended to hold the waste from the clearing of phase 2. Phase three was the smallest being only 1.6m wide but followed a natural fracture in the rock which must have made quarrying simpler. On abandonment the bottom of the cut filled with peat which was then covered by stone and clay. This peat layer being buried was also sampled.

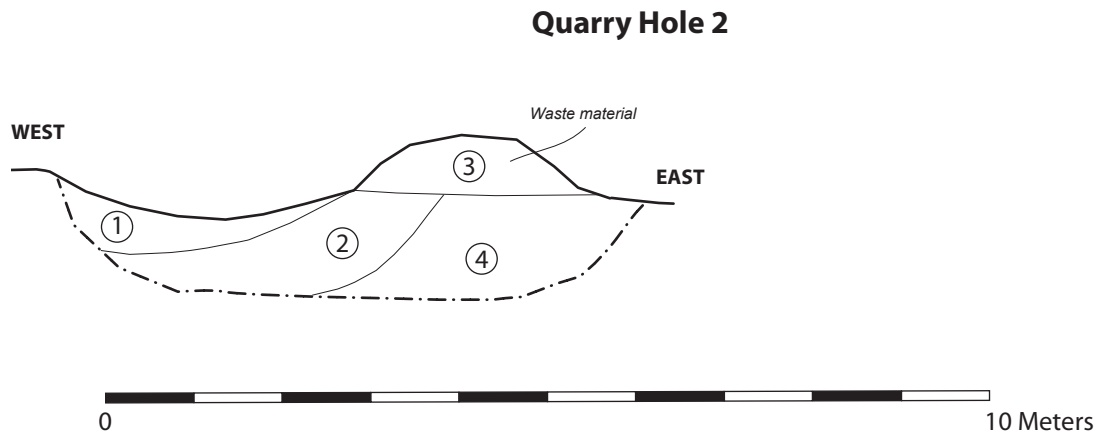
Contexts - Quarry/pit 2

- 1 = Top soil and waste material
- 2 = Clay and waste material
- 3 = Waste material
- 4 = Bedrock

- 5.7 The second quarry pit was approximately 4 metres wide and a maximum of 1.6m deep, dug down to the bedrock. There appeared to be two layers of re-deposited material in the pit, with the bottom being a very unstable clay and stone deposit covered to the west by a layer of topsoil mixed with stones and some subsoil. The bottom deposit rose above the height of the original surface on the east. This shows that this quarry was dug from east to west with the waste being thrown back into areas already quarried.

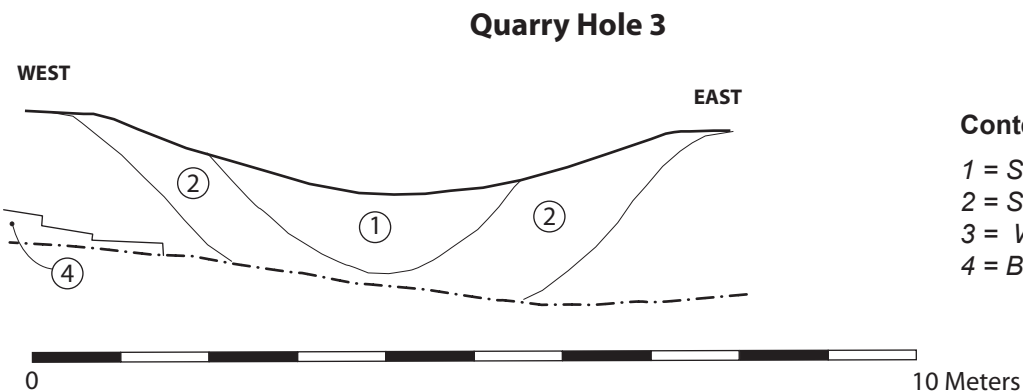
Contexts - Quarry/pit 3

- 1 = Soil and peat
- 2 = Stone quarry material
- 3 = Waste material
- 4 = Bedrock

- 5.7 Top soil stripping of this third pit or hollow showed that the spoil heaps consisted of clean subsoil with the usual mix of stones except that none exceeded 0.30 x 0.30 m in size. A section was machine dug through this northernmost hollow. This showed that the hollow was a flattened 'U' shape and had been dug down and slightly into the bedrock. This had filled initially with material washed in from the spoil heaps and then peat. The peat reached a maximum depth of 0.30m, while the in-wash appeared to have added an extra 0.50m of material on each edge, meaning that the original hollow was a maximum of 4.5m wide. There was no indication of any coal in this pit, which implied that it was most likely a stone quarry pit and not an early coal prospecting pit as was initially thought. In areas, sections of cut peat turf appeared to have been laid turf down, perhaps also for storage or drying purposes.

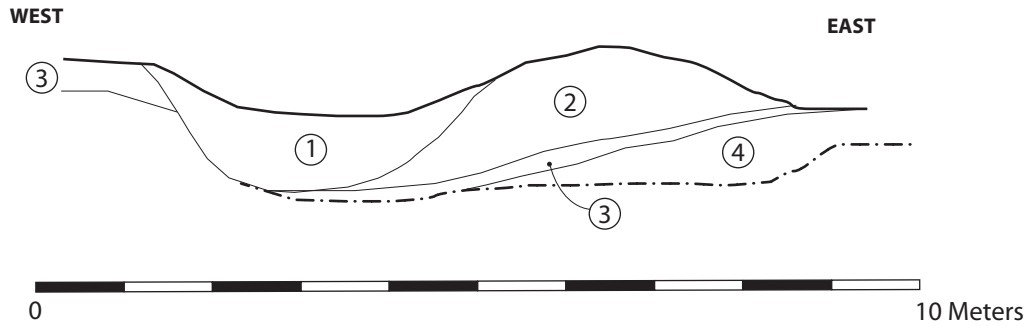
Quarry Hole 4

- 1 = Soil and waste material
- 2 = Clay waste material
- 3 = Peat deposit laid turf down.
- 4 = Rock fragments and clay

- 5.9 The fourth pit was approximately 9m wide with two main layers of re-deposited material, as with *Pit 2*. These deposits were also similar and appeared to have been deposited in the same way as *Pit 2*. However like *Pit 3* there was evidence that the bottom had been lined with peat.

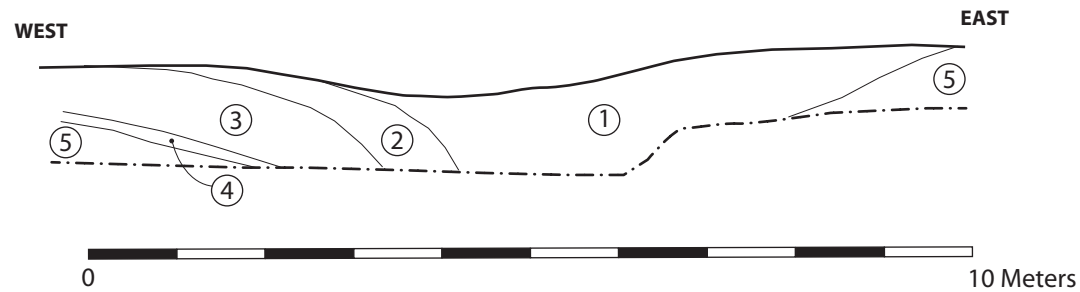
Quarry Hole 5

- 1 = Clay, silt and stone fragments
- 2 = Clay deposit
- 3 = Clay and silt material
- 4 = Peat deposit laid turf down.
- 5. Bedrock

- 5.10 The fifth pit was approximately 10m wide with three layers of re-deposited material, as with *Pit 2*. These deposits were also similar and appeared to have been deposited in the same way as *Pit 2*. However like *Pit 3* there was evidence that the bottom of the pit at its eastern end had been lined with peat laid turf down.
- 5.11 Apart from these five quarry pits or hollows, no other archaeological features were observed or recorded during any of the top soil stripping in the other cuts during the ground work.

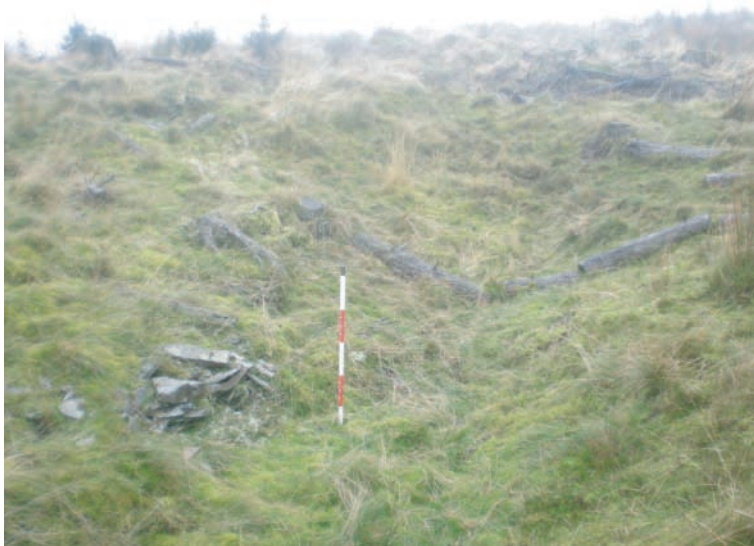
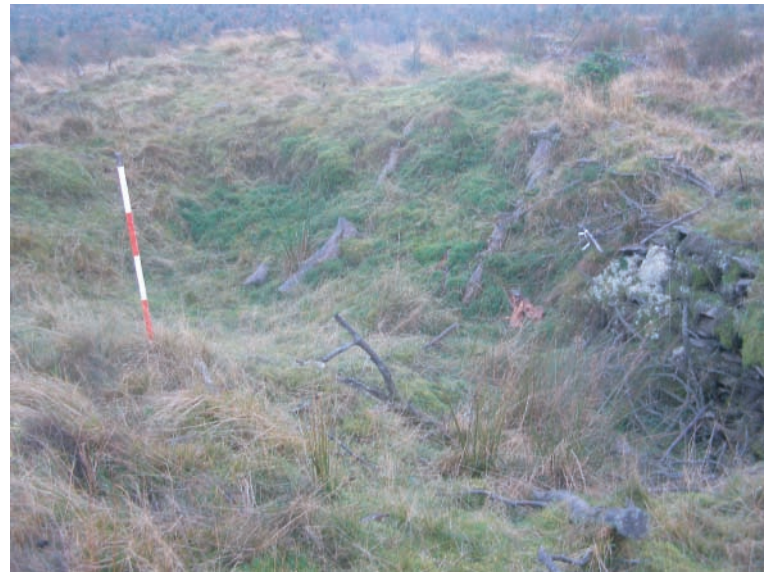
Plate 3. Quarry pit No. 1 in area of cuts 7 - 8. Looking northwards.

Plate 4. Quarry pit No. 1 in area of cuts 7 - 8. Looking southwards.

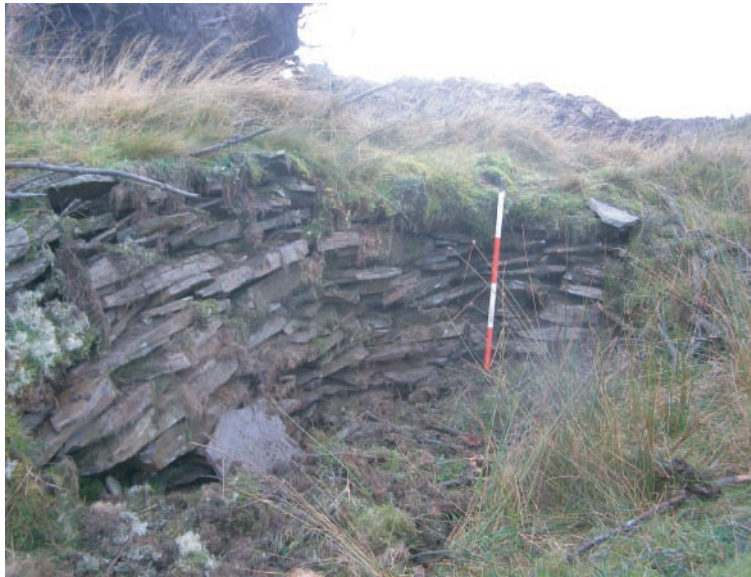
Plate 5. Exposed stone revetting in southern Quarry pit No. 1. Looking northwards.

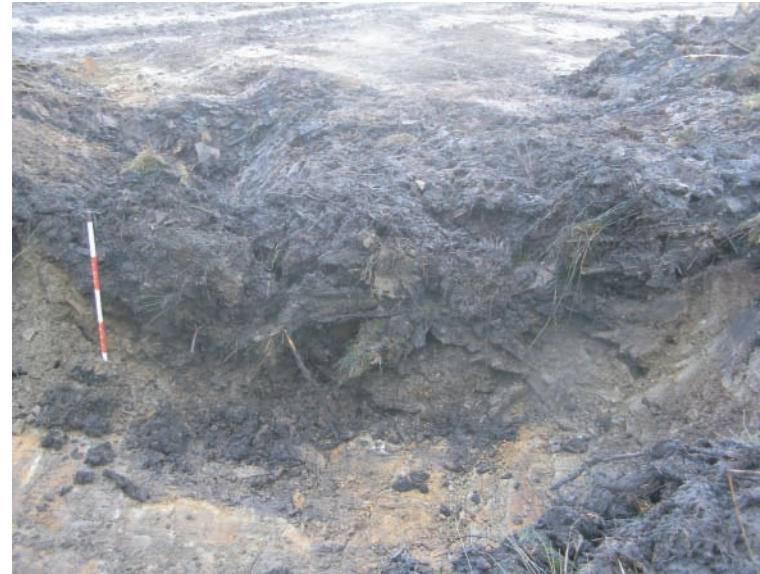
Plate 6. Section through northern Quarry pit No. 4. Looking northwards.

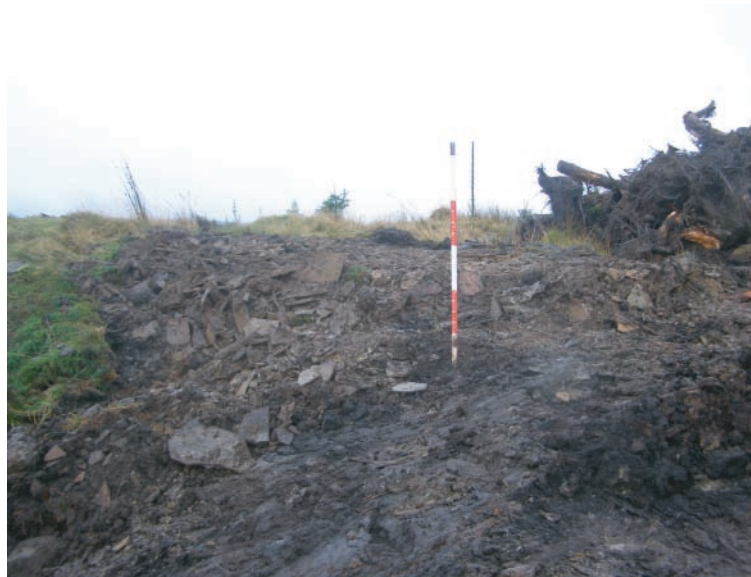
Plate 7. Exposed waste material from northern Quarry pit No. 4 showing build up of material at edge of pit. Looking south.

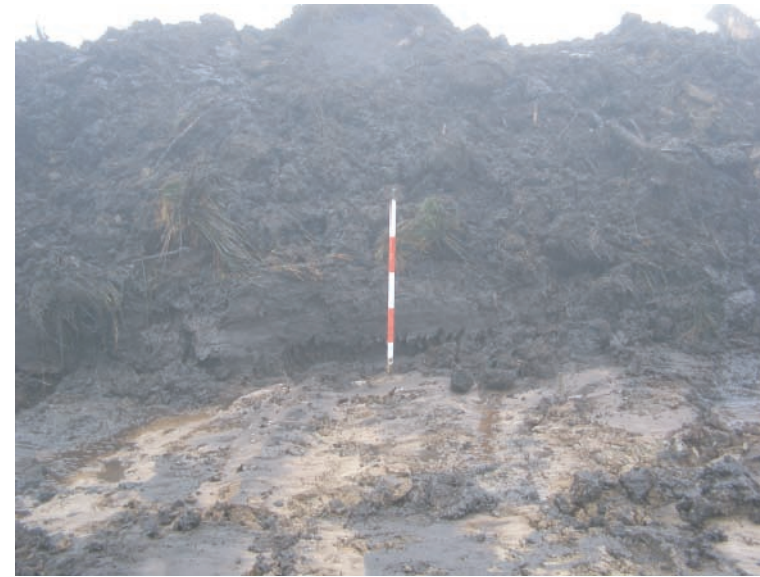
Plate 8. Depth of peat in area of lagoon. Looking east.

- 5.3 In the area of the lagoon to the south, the top soil was stripped over an area of approximately 90m x 95m. This work was undertaken in a series of strips with the topsoil being collected in banks while the track way was improved to allow access for the dump trucks. The peat in this area was fairly thin averaging only 0.10-0.30m. No archaeological features, finds or deposits became exposed or recovered during and following this operation. The north-eastern part of the lagoon area had bedrock very close to the surface. As the ground was prepared for digging the Lagoons the depth of the bedrock beneath the underlying peat was approximately 0.30m.

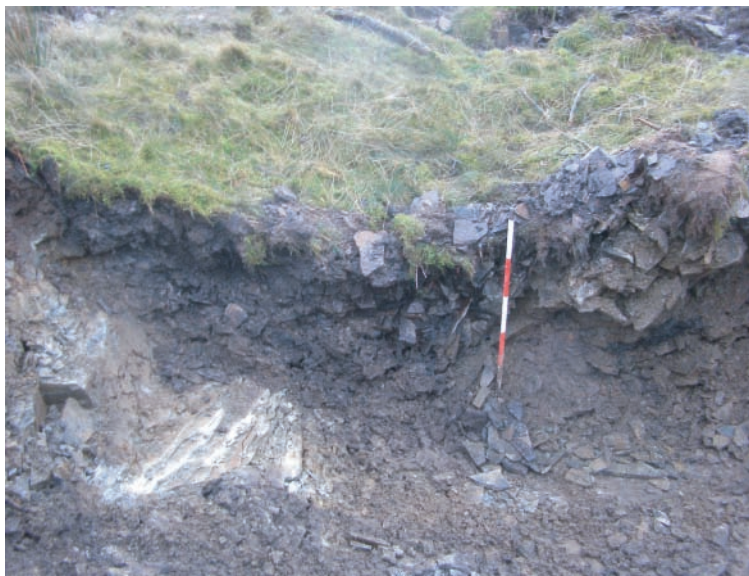
Plate 9. Section through northern Quarry pit No. 3. Looking northwards.

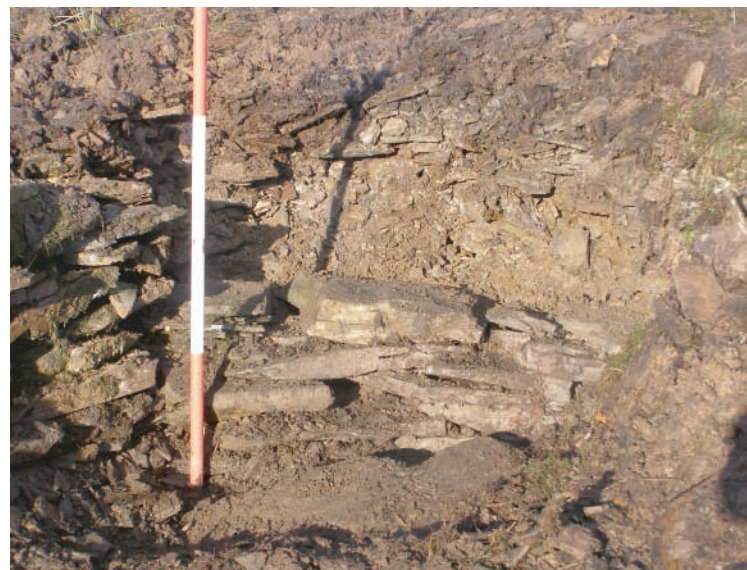
Plate 10. Detail of stone revetting during removal in area of southern Quarry pit No. 1.

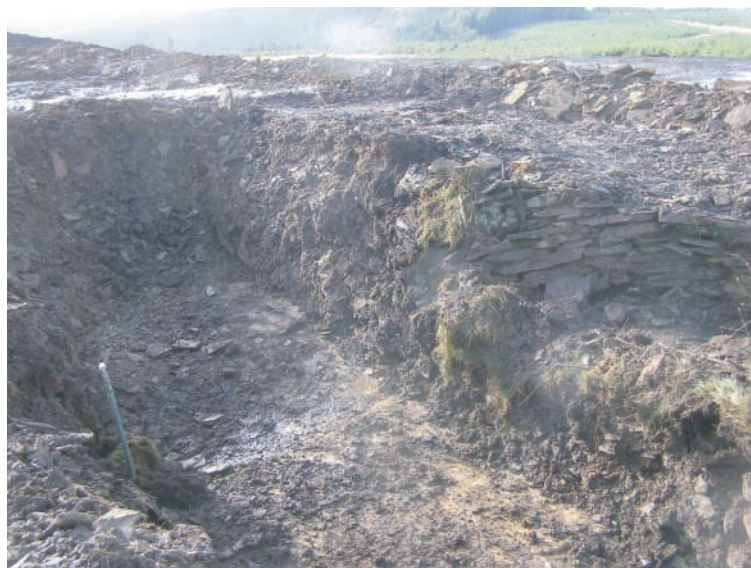
Plate 11. Trench put through Quarry pit No.1 prior to cutting work. Looking southwest.

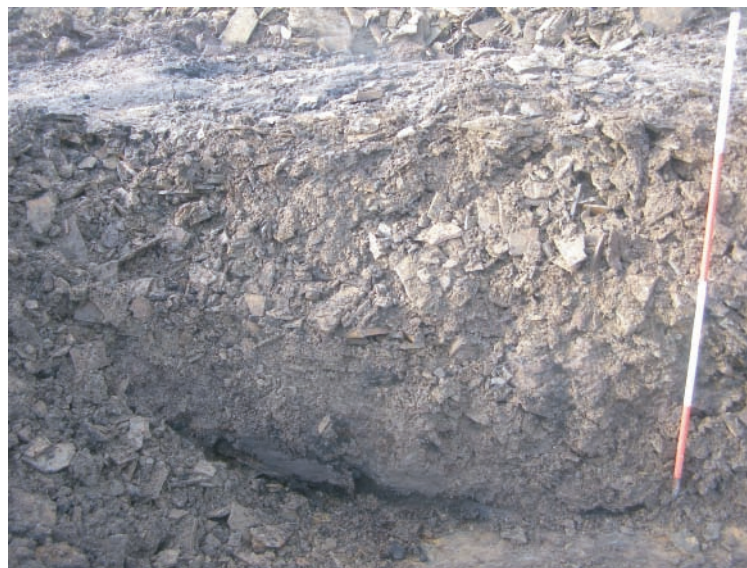
Plate 12. Section through northern Quarry pit No. 4 showing build up of waste material.

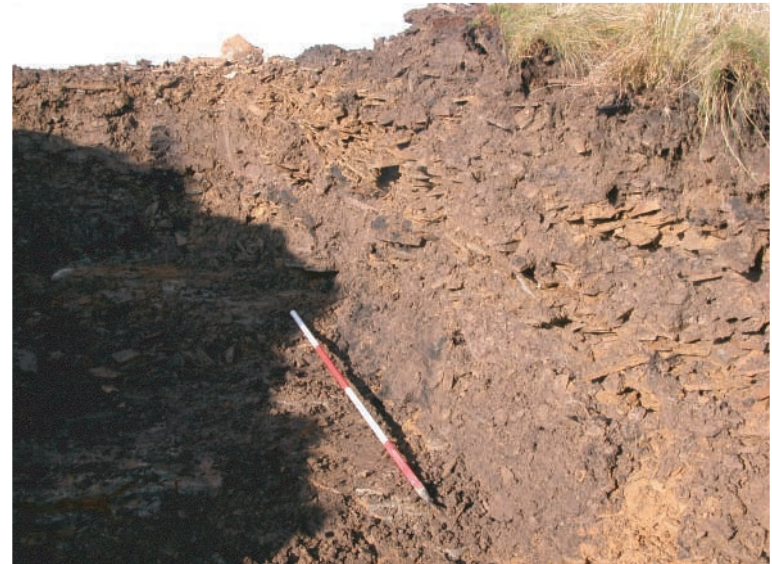
Plate 14. Section through northern Quarry pit No. 3. Looking northwards.

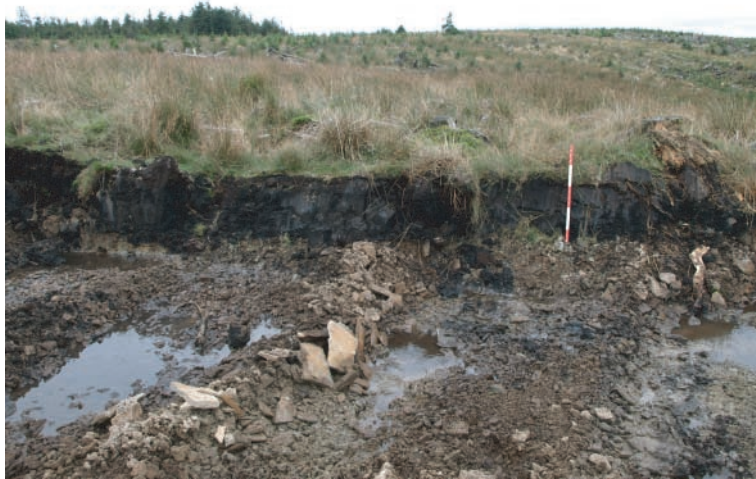
Plate 17. Average peat depth in area of cut 16-17. Looking south.

- 6.2 With respect of peat deposits in the area, the depth of the peat across the area of cuts 2-10 was found to be no deeper than 0.30m. However for the cutting of the lagoons in the southern area, between cuts 15-17, the peat depth was found to be approximately 0.70m. On average however peat deposits in the southern areas was between 0.20-0.50m. Samples of peat were taken from these deeper levels as a potential source for palaeo-environmental information.
