St Cattwgs Church, Port Eynon, Gower

Archaeological Watching Brief

Report No 637.

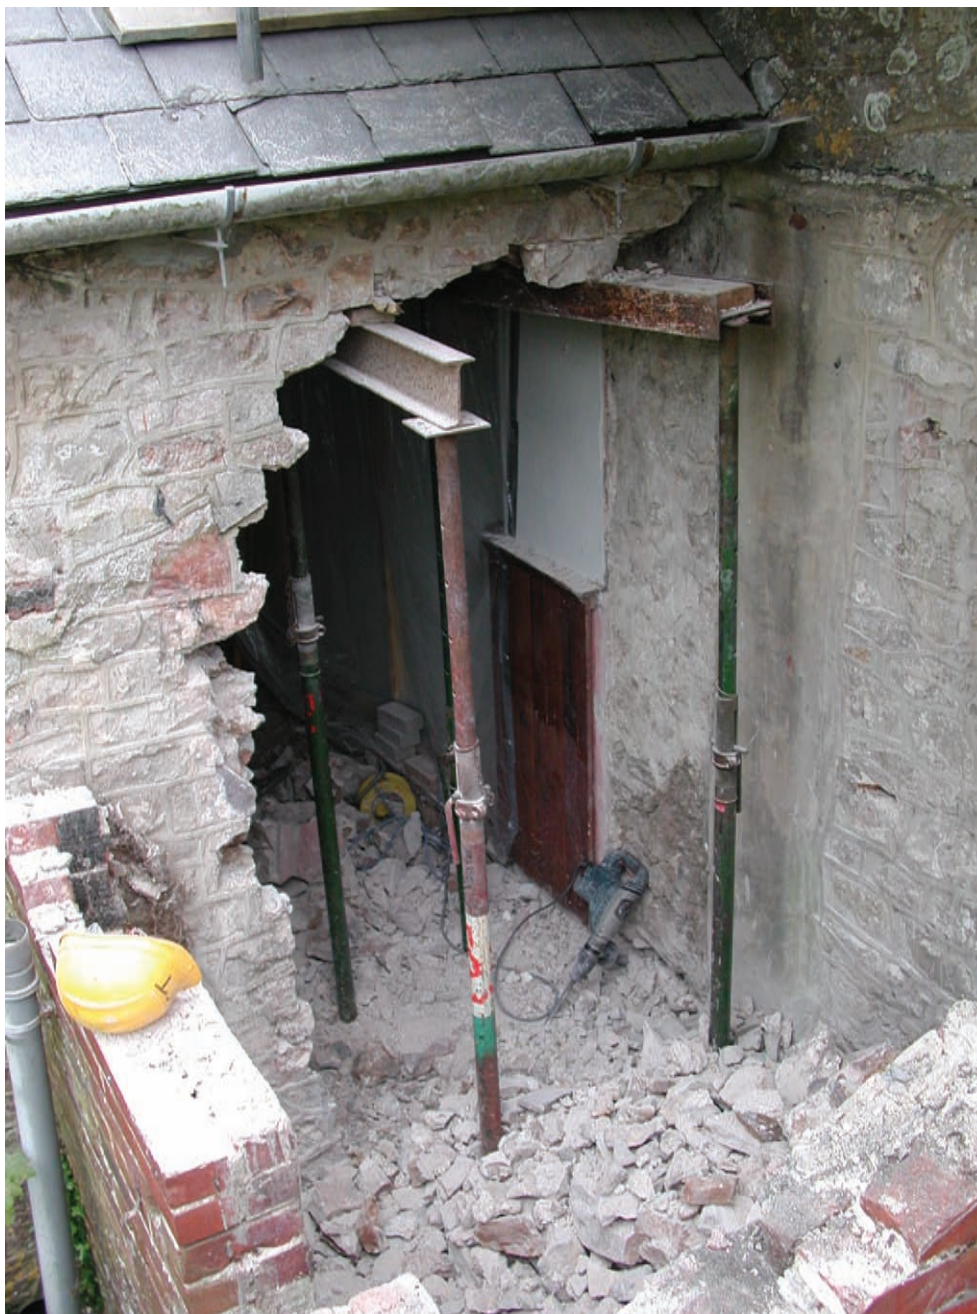
The hole broken through the boiler room wall measured approximately 0.8m wide and 2m high and was 0.5m thick. The wall was stone-built, mortared in lime with modern pointing on the exterior. Internally, the wall was plastered. The lower half of the wall was painted red with a border comprising a simple red and white abstract flower design. The painted design was faded and likely to be nineteenth or early twentieth century in date, judging from the design.

Plate 1.
Wall breakthrough
viewed from
outside

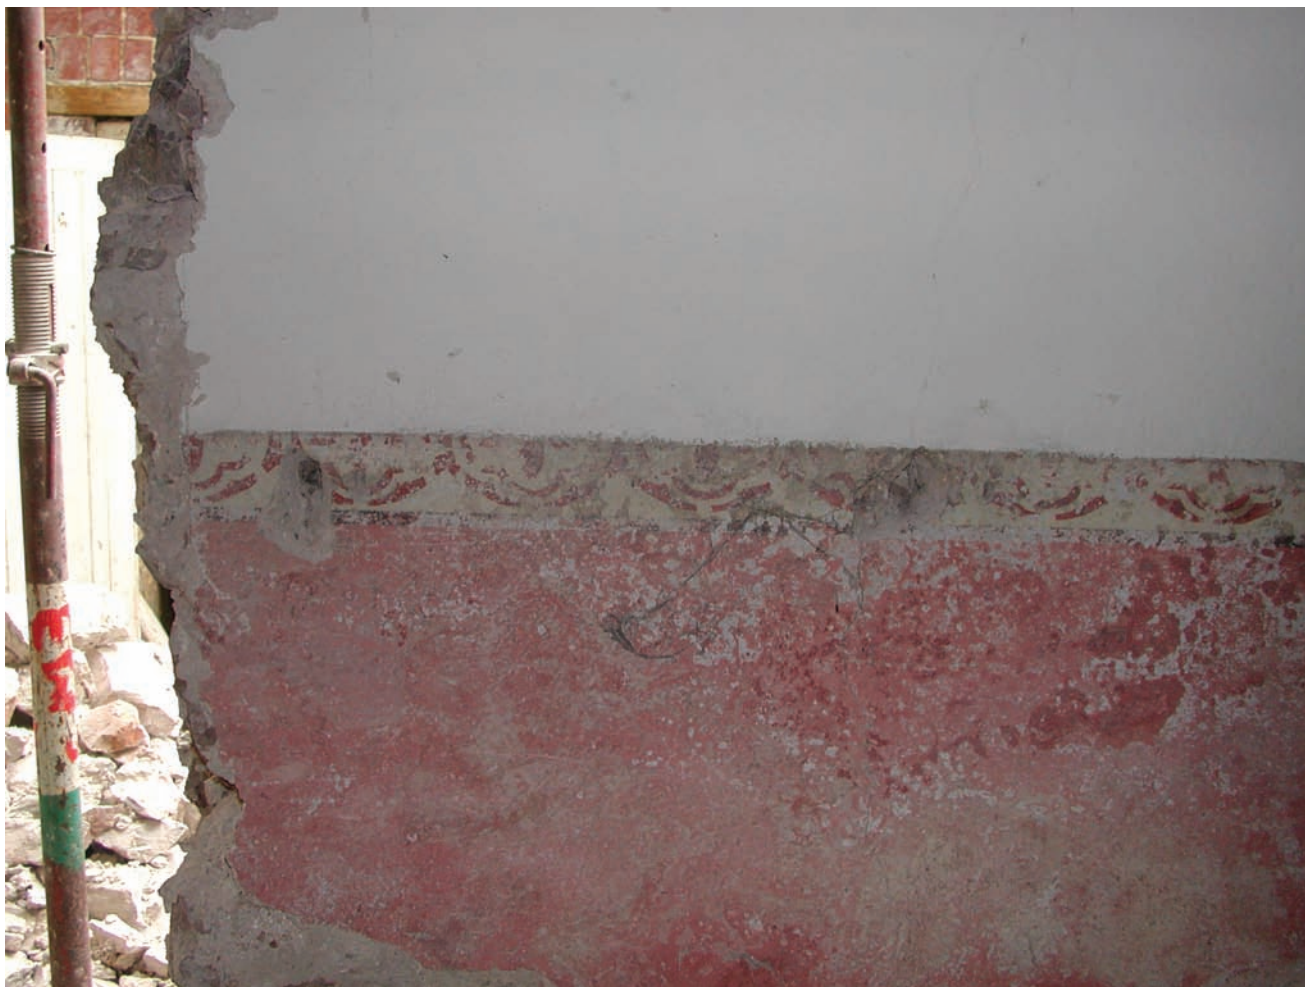
The breakthrough of the wall in the boiler room exposed a section of painted plaster or probable nineteenth or early twentieth century date, a small section of which was destroyed during the works.

Plate 2.
Painted interior
wall

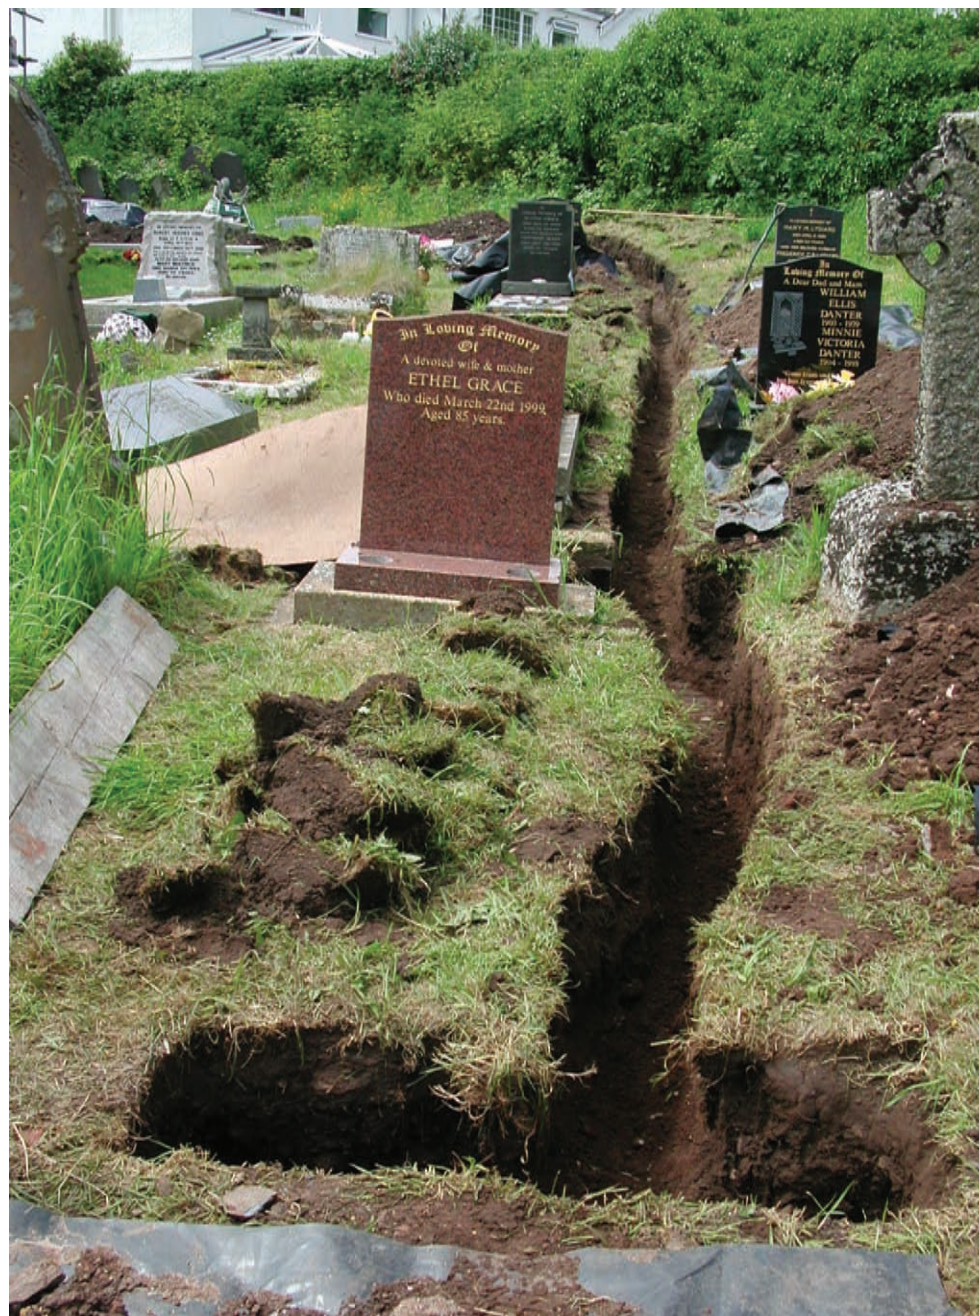
The drainage trench begins at the exterior wall of the vestry on the northern side of the church. It runs northwards for 8m before turning 90° to the east just inside the graveyard wall. The trench continues eastwards for 34.2m until it meets the eastern graveyard wall. The trench averages 0.4m wide and 0.4-0.5m deep. It was dug deeper in three places to accommodate inspection chambers: adjacent to the vestry where it extended to 0.8m deep; at the 90° turn on the northern side of the boundary wall where it again extended to 0.8m deep; and at the far end of the trench, adjacent to the

Below the turf and topsoil, the trench cut through a dark brown organic subsoil containing small rounded pebbles and stones and occasional oyster and cockle shells. This was not bottomed along the majority of the trench but was revealed to be 1.5m deep in the inspection chamber pit at the eastern end of the trench. Here, the subsoil overlay a thin layer of darker organic soil 0.02m deep, which sat on top of a deposit of lighter brown organic soil 0.08m thick which overlay the natural. These are likely to be an old ground surface as they lie at the same height as the ground surface outside the graveyard, adjacent to the road.

Plate 3.
Drainage trench
looking west

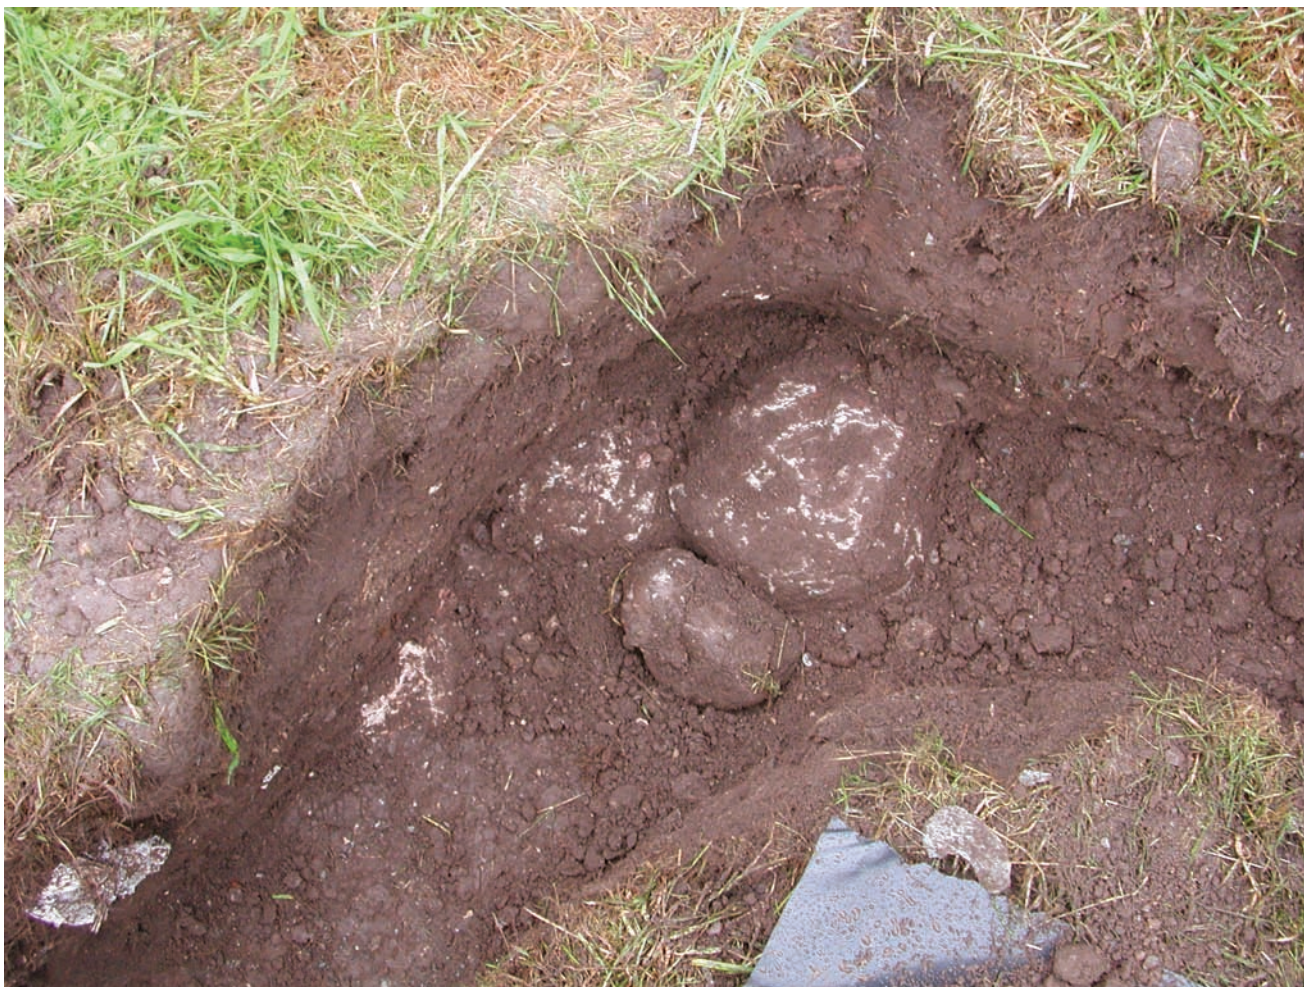
Close to the northern graveyard wall, where the trench turned eastwards, five large cobble stones were found within the subsoil. These varied in size from 0.2m to 0.35m in diameter and probably derived from the adjacent boundary wall which comprises similar cobble stones and is in a poor state of repair.

Plate 4.
Cobbles from
graveyard wall
in drainage trench

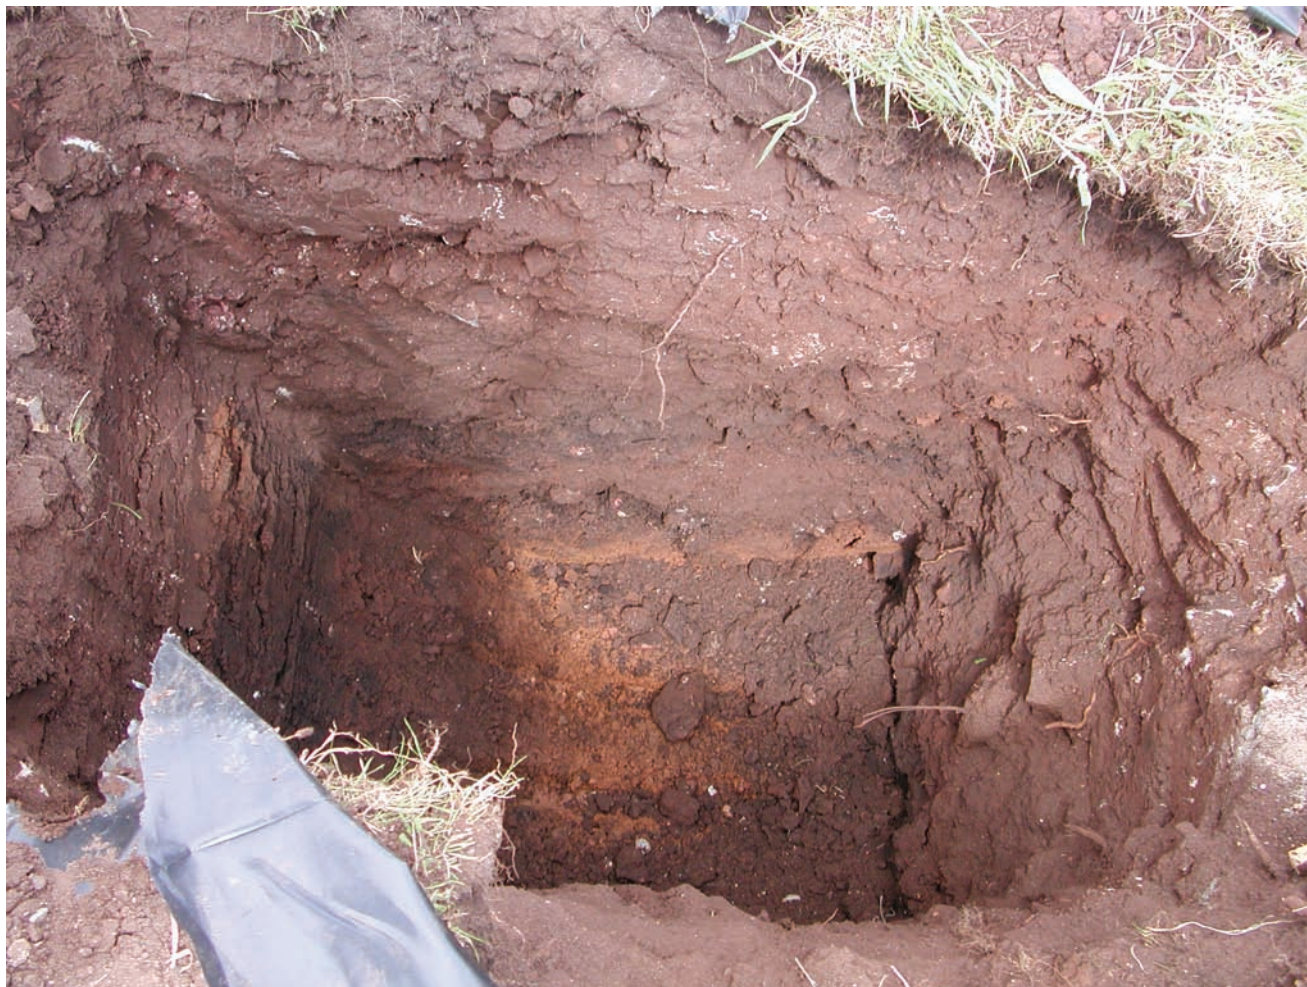
The excavations within St Cattwgs graveyard have revealed that the ground level within the graveyard has been raised by around 1.5m above the surrounding land. This is likely to have occurred to enable the relatively small graveyard to continue in use once it had become full in the post-medieval period. A similar situation was revealed by CAP during drainage works at Saint Tathan's Church, St Athan, Vale of Glamorgan where a thick deposit of subsoil overlay the original ground surface.

Plate 5.
Inspection chamber
at eastern end of
trench showing
depth of made
ground and
buried soils
