GORSAF BOW STREET, BOW STREET, CEREDIGION

Lliniariad Archeolegol: Adroddiad Terfynol/
Archaeological Mitigation: Final Report

Ymddiriedolaeth Archeolegol Gwynedd
Gwynedd Archaeological Trust

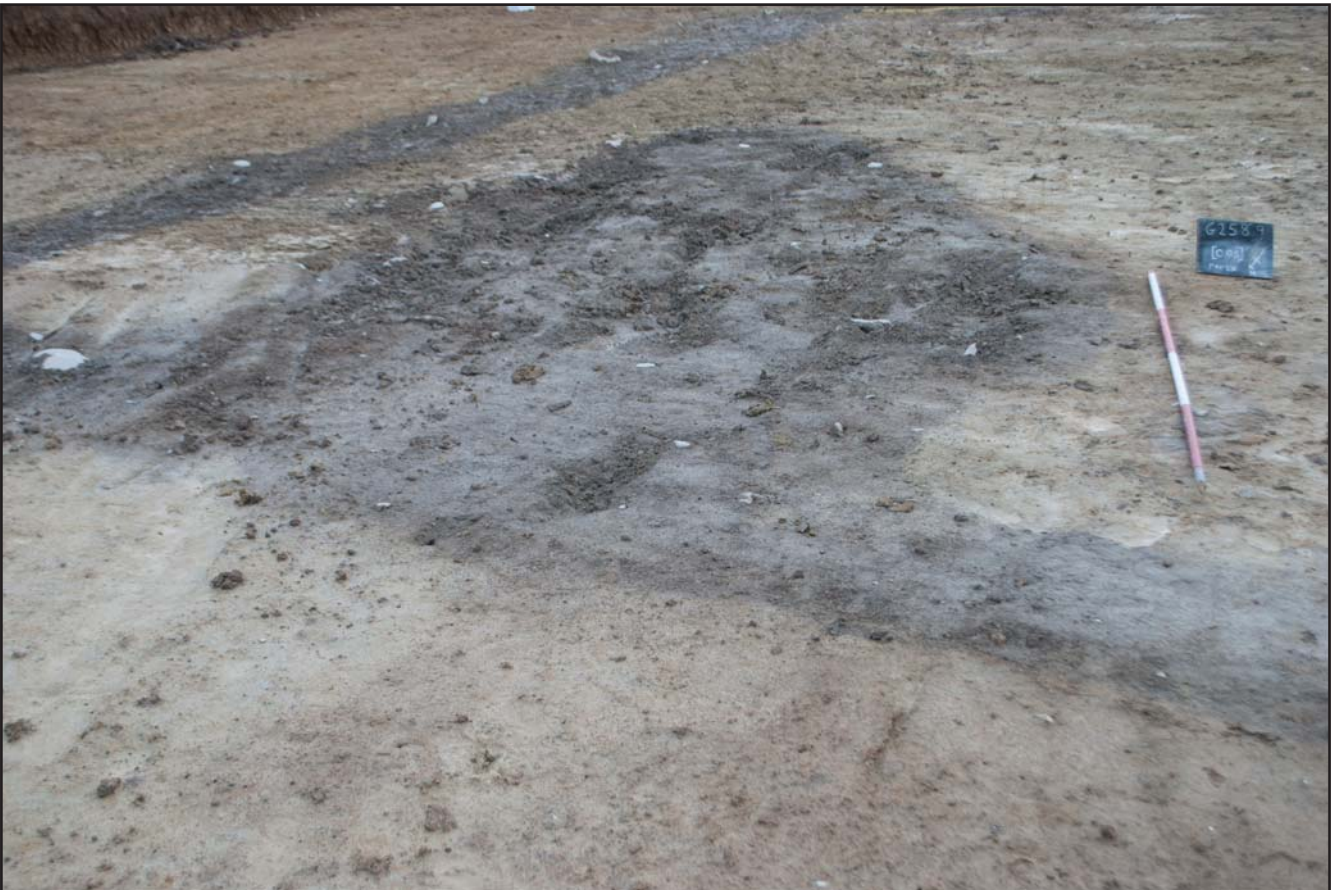
Plate 02: Pit [005] pre-ex, scale 1x2m (archive ref: G2589_086).

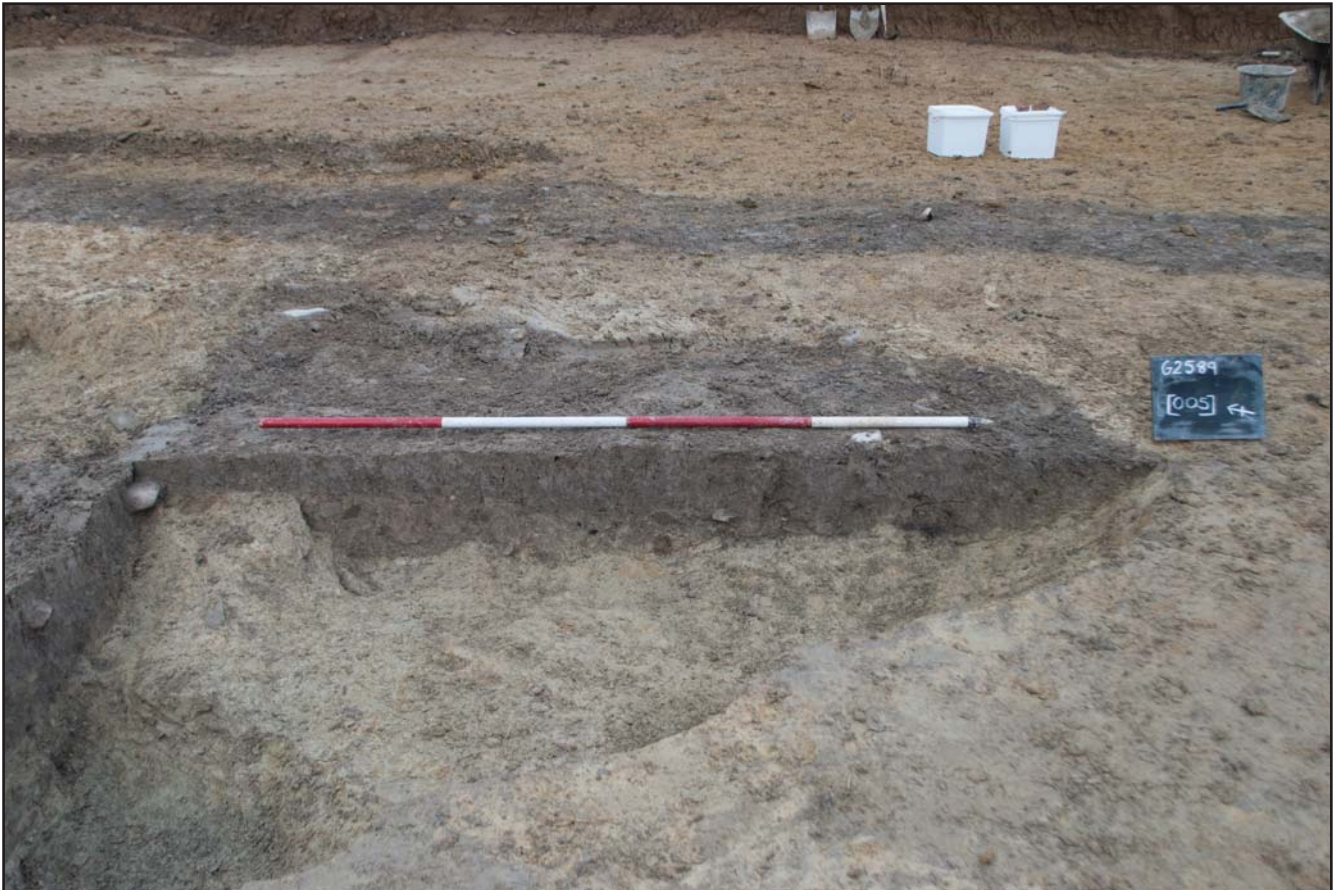
Plate 03: West-southwest facing section in quadranted pit [005] , scale 1x2m
(archive ref: G2589_094).

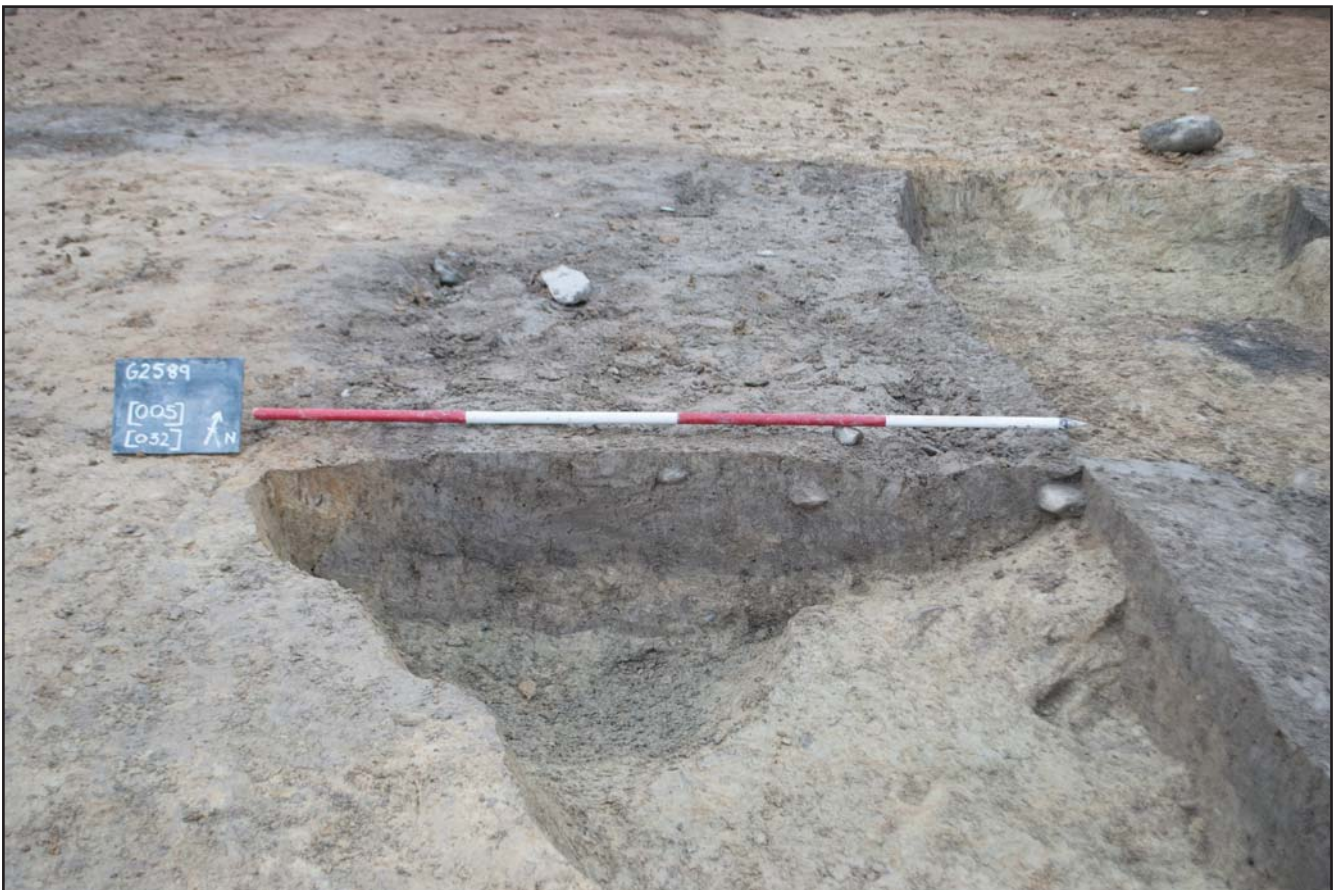
Plate 04: South-southeast facing section in quadranted pit [005] , scale 1x2m
(archive ref: G2589_095).

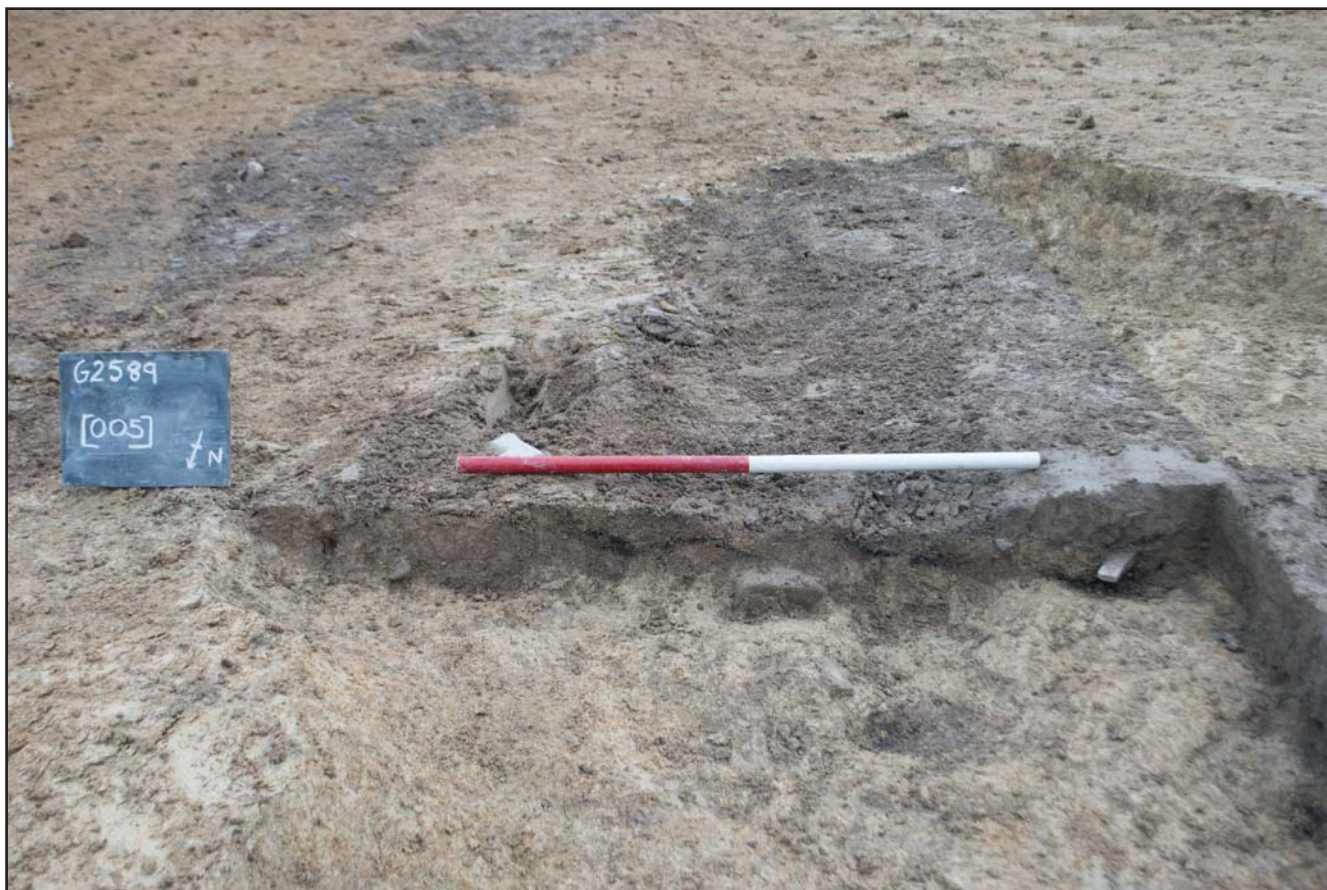
Plate 05: North-northwest facing section in quadranted pit [005] , scale 1x1m
(archive ref: G2589_097).

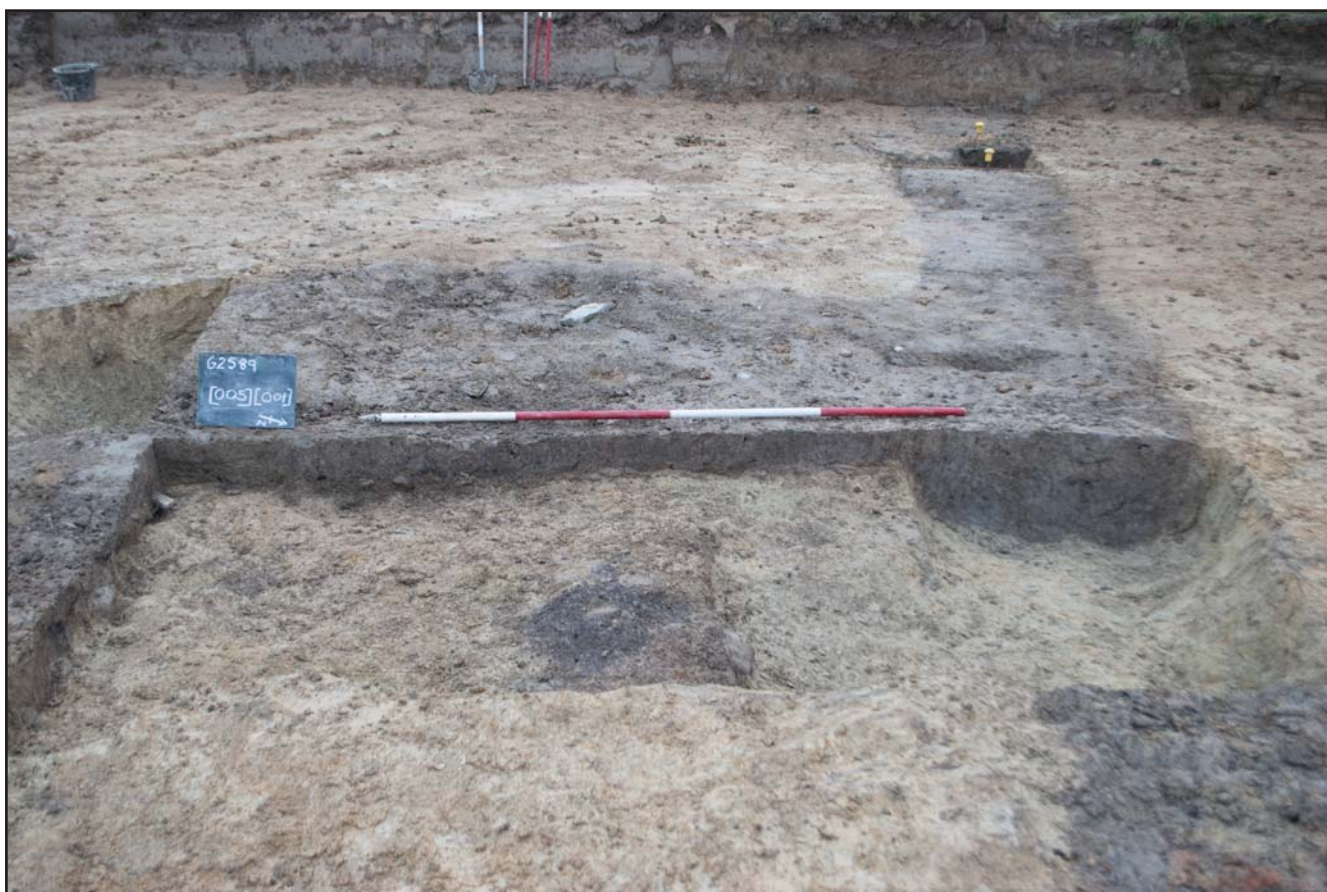
Plate 06: East-northeast facing section in quadranted pit [005] , scale 1x2m
(archive ref: G2589_098).

Pit [005] cut through the corner of the ditched enclosure [1006]/[1008] identified during the evaluation phase, now recorded as **[001]**. Enclosure ditch [001] was 21.3m long and up to 1.42m wide and 0.70m deep and ran in a straight linear fashion broadly east-west from the western side of the excavation area before turning almost 90 degrees and heading southwards. The portion of the enclosure [044] in the north excavated quadrant of pit [005] could clearly be seen to be cut by the pit, confirming the stratigraphic relationship observed during the evaluation phase (Figure 03; Figure 04.2; Figure 04.2; Plate 06; Plate 07).

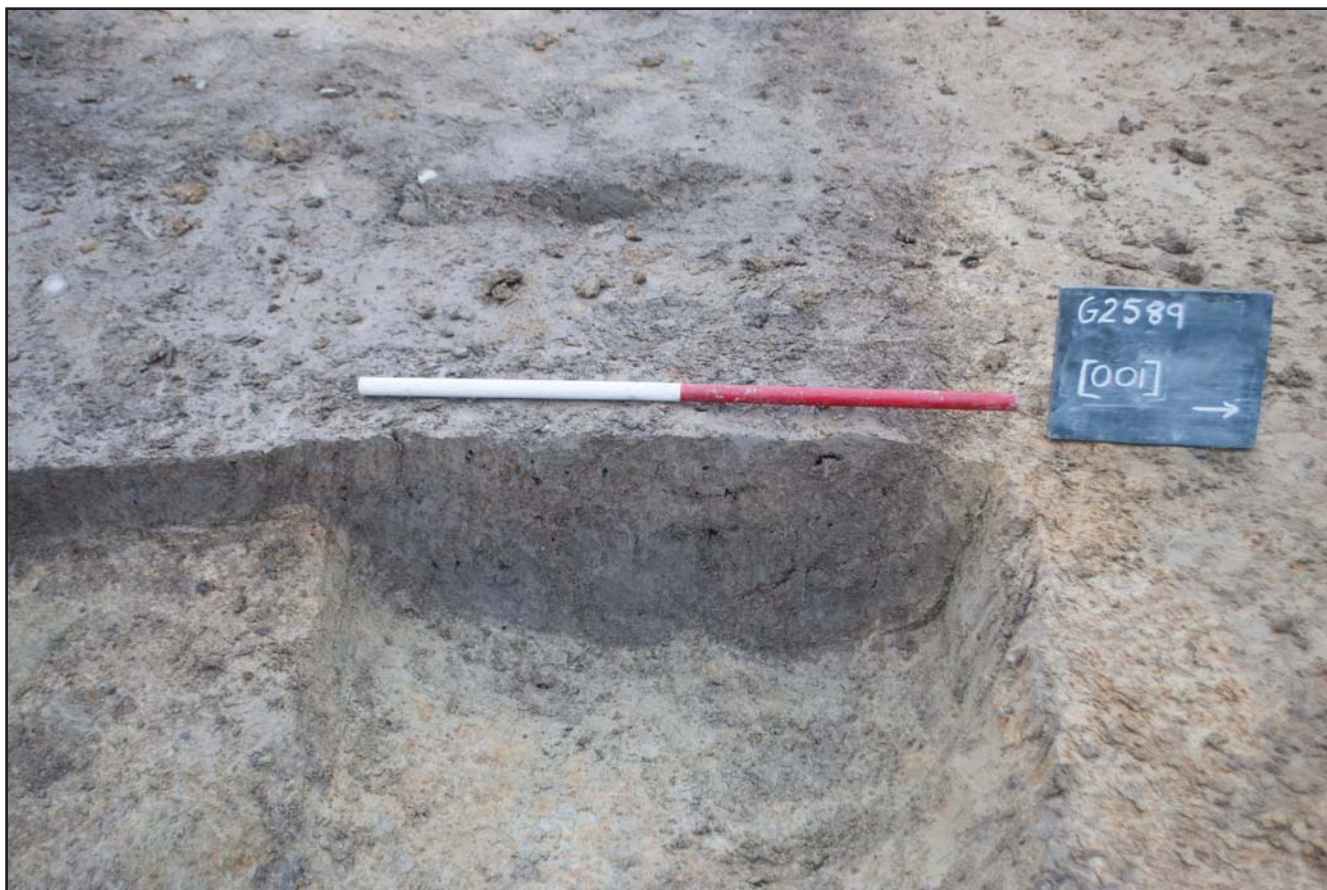
Plate 07: East facing section across ditch [001] / [044] in northeast quadrant of pit [005], scale 1x1m (archive ref: G2589_099).

Intervention **[044]** showed the ditch to be between 0.73 and 0.99m wide, and 0.31-0.37m deep with steep, slightly concave sides that broke gradually to a smooth flattish base (Figure 04.2; Figure 05.1; Plate 07; Plate 08). It contained two fills, (045) and (046), though the latter, later fill was only observed in the west facing section across the ditch (Figure 05.1; Plate 07; Plate 08). Basal fill (045) was 0.38m deep and consisted of a soft, mid grey slightly silty clay with occasional small sub-rounded and sub-angular stones 1-3cm in length, and occasional small fragments of charcoal. A large sub-rounded cobble (38x34x17cm) lay within fill (045) at the base of the ditch at the eastern end of the intervention, almost filling the southern side of the ditch here. The fill appears to have accumulated through natural silting processes in the waterlogged ditch. Fill (046), a slightly brownish clay silty clay, was 0.45m wide and 0.12m deep and could be seen to extend eastwards along the unexcavated portion of the ditch for at least 1m. It contained moderate quantities of flecks and small fragments of charcoal with occasional fragments of burnt clay visible 0.6m east of the eastern limit of the intervention. No finds were recovered from fill (046) but a Roman or medieval pottery sherd SF04 was recovered from the base of fill (045) at the western end of the intervention.

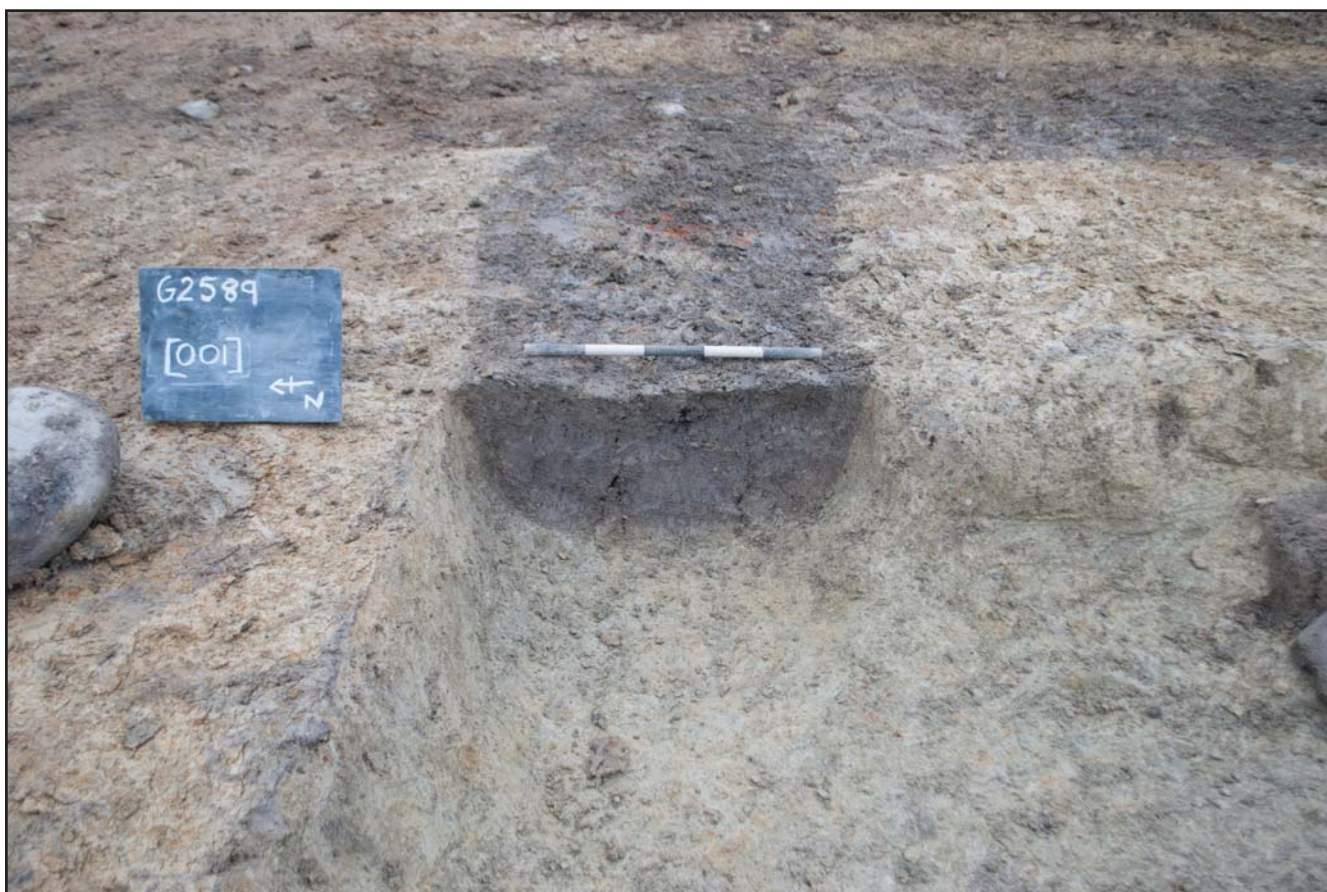
Plate 08: West facing section across ditch [001] / [044] in northeast quadrant of pit [005], scale 1x1m (archive ref: G2589_100).

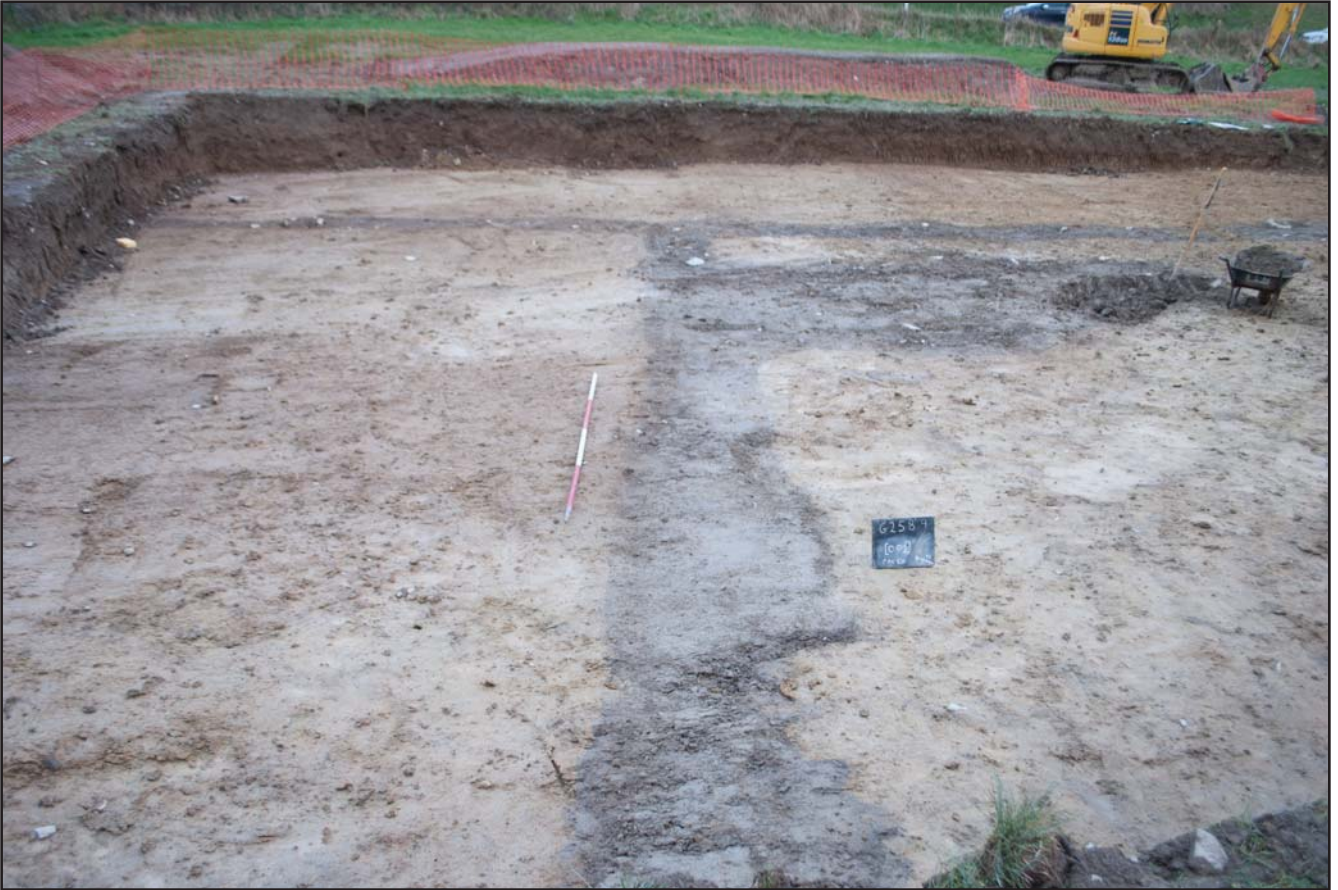
Plate 09: East-west length of enclosure ditch [001] / [039] / [027] from the west pre-ex, scale 1x2m (archive ref: G2589_088).

Enclosure [001] appears to have been re-cut **[027]** and extended **[039]** at its western end (Figure 03; Figure 05.3; Figure 05.2; Figure 05.4; Plate 09, Plate 10; Plate 11; Plate 12). An intervention here demonstrated that the truncated original ditch terminus cut **[037]** was 0.41m wide with a rounded end and smooth sides that broke gradually to a concave base 0.14m deep. It was filled with a single primary fill (029), a loose dark greyish-brown silty clay with occasional small sub-rounded and sub-angular stones and fragments of charcoal. No finds were recovered from the fill.

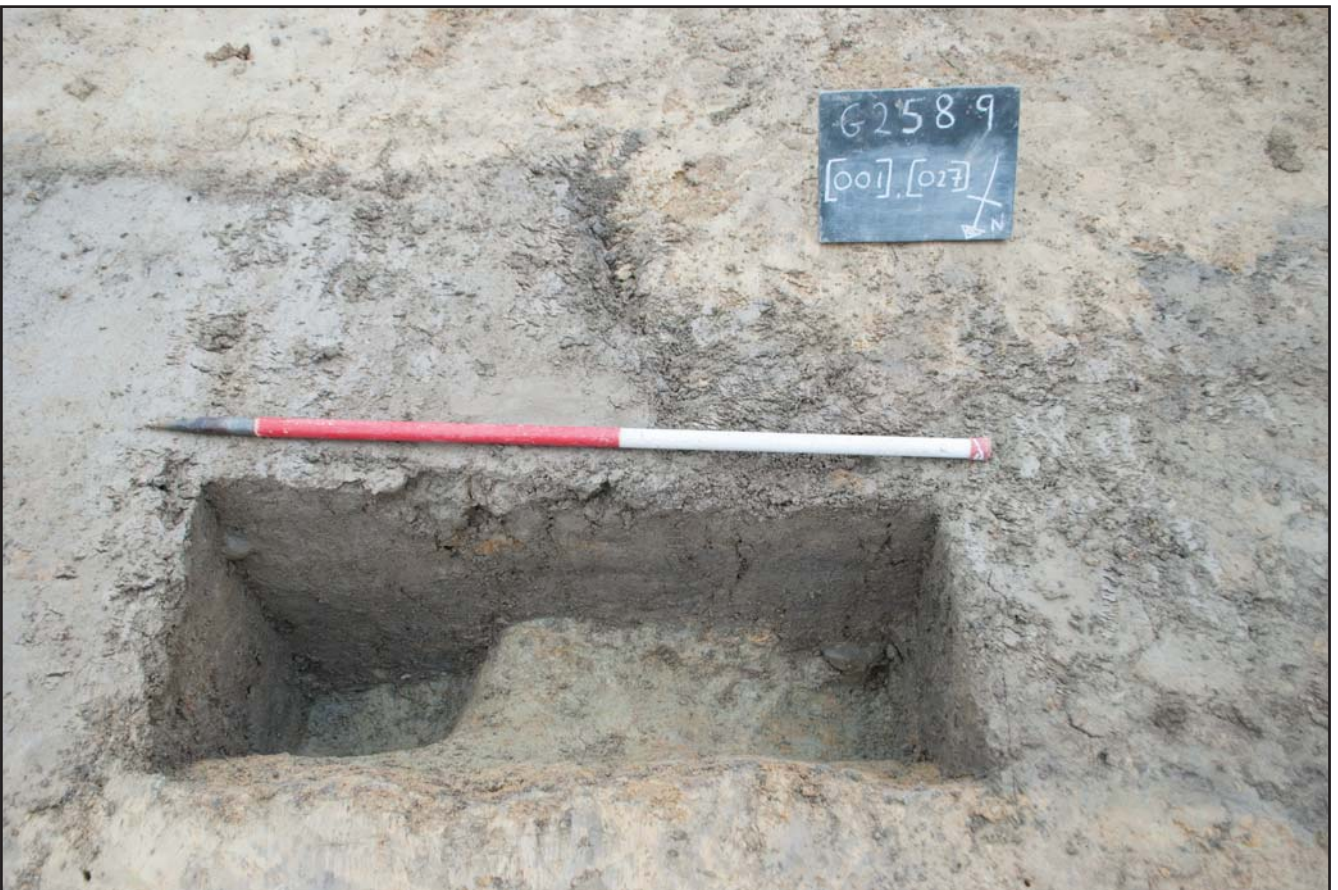
Plate 10: North facing section across ditch [001] / [037], recut [027] and extension [039], scale 1x1m (archive ref: G2589_093).

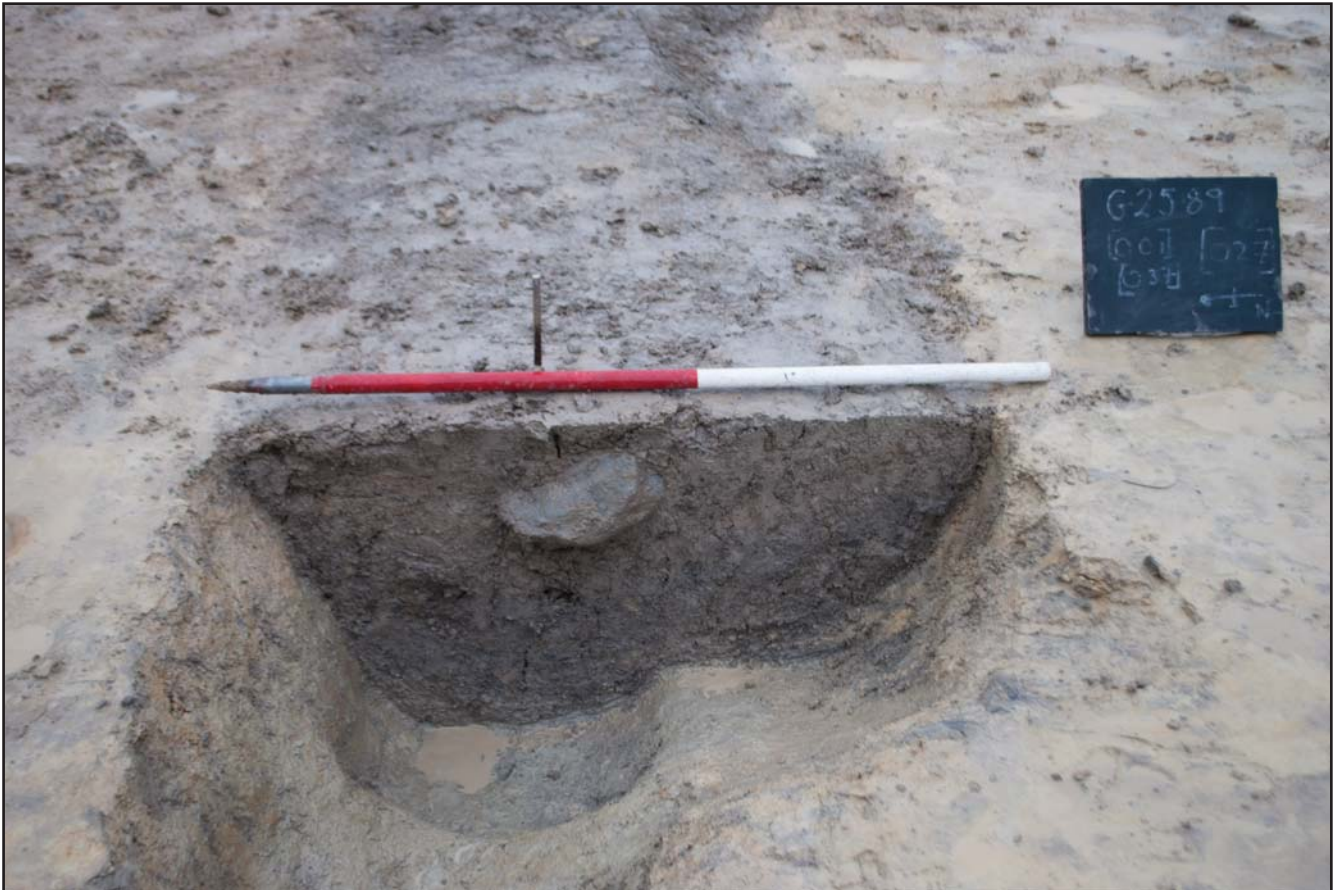
Plate 11: West facing section across ditch [001] / [037] and recut [027] also showing extension [039], scale 1x1m (archive ref: G2589_107).

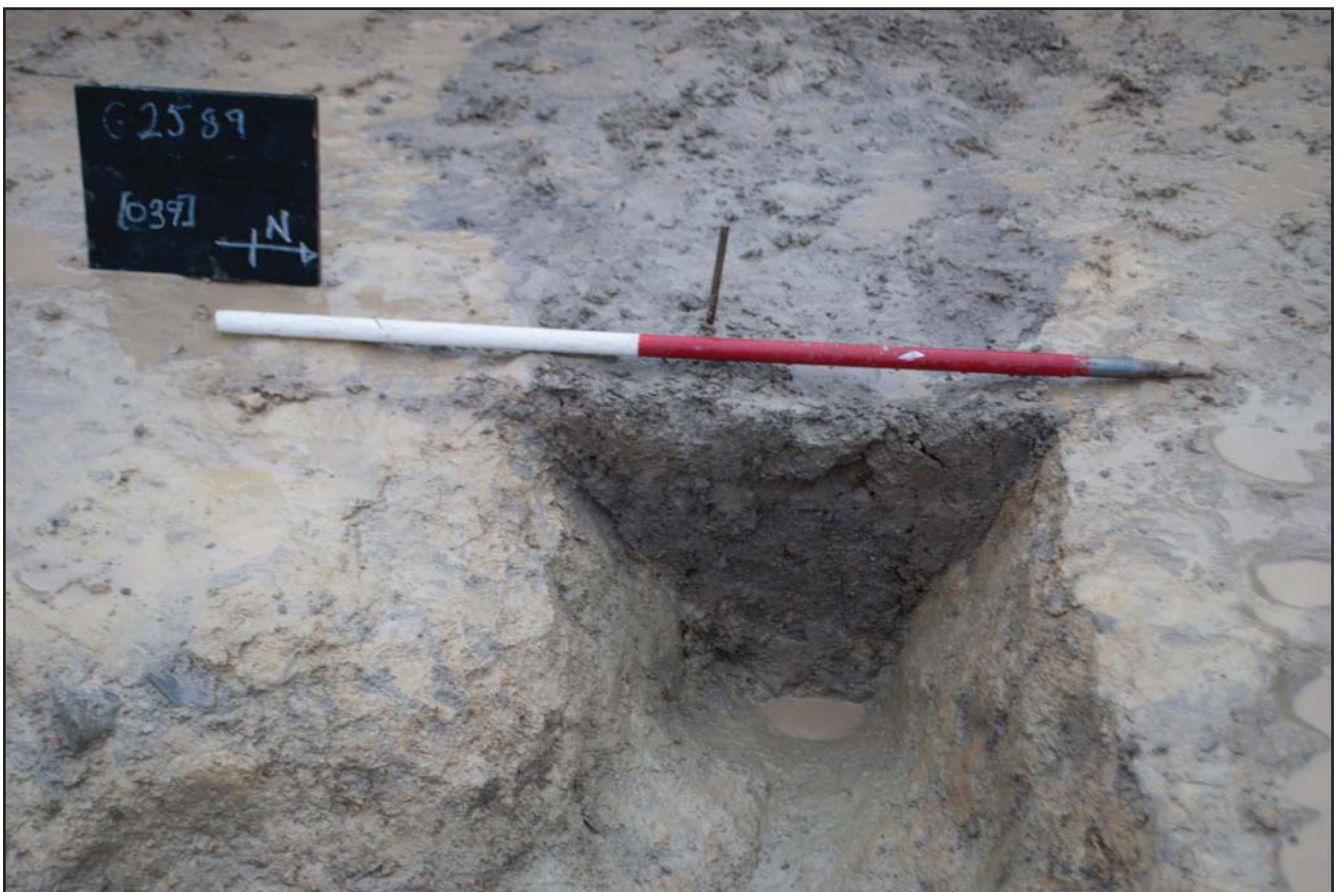
Plate 12: East facing section across enclosure ditch [001] extension [039], scale 1x1m (archive ref: G2589_108).

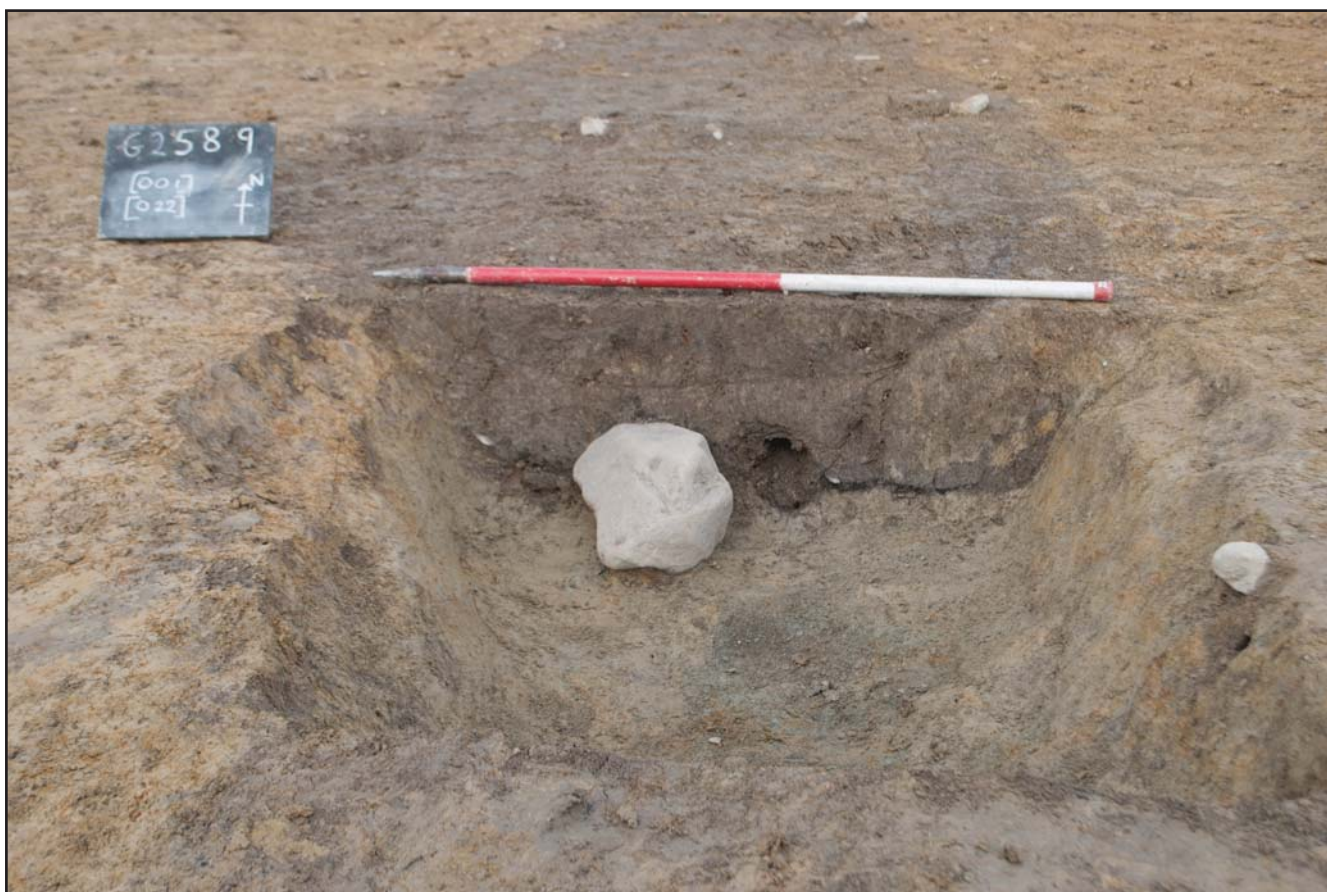
Plate 14: South facing section across [001] / [047] and ditch [022], scale 1x1m (archive ref: G2589_090).

The excavation of enclosure [001]/[047] at its southern terminus demonstrated that the enclosure cut through an earlier field boundary ditch **[022]** (Figure 03; Figure 06.1; Figure 6.2; Plate 14; Plate 15). Ditch cut [022], 11.77m long within the excavation area, was clearly observed to cut through the subsoil (014) during the machining of the site. It ran in a straight linear fashion on a north-south alignment along the eastern side of [001]/[047], continuing past terminus [047] and out underneath the southern baulk of the excavation area. It was 0.9m wide and 0.70m deep. On the northern side of the intervention, truncated along its western edge by [047], its straight, smooth, slightly stepped eastern side broke gradually to a flattish base (Figure 06.1; Plate 14). On the southern side of the intervention, its smooth concave sides broke imperceptibly to a smooth concave base (Figure 06.2; Plate 15).

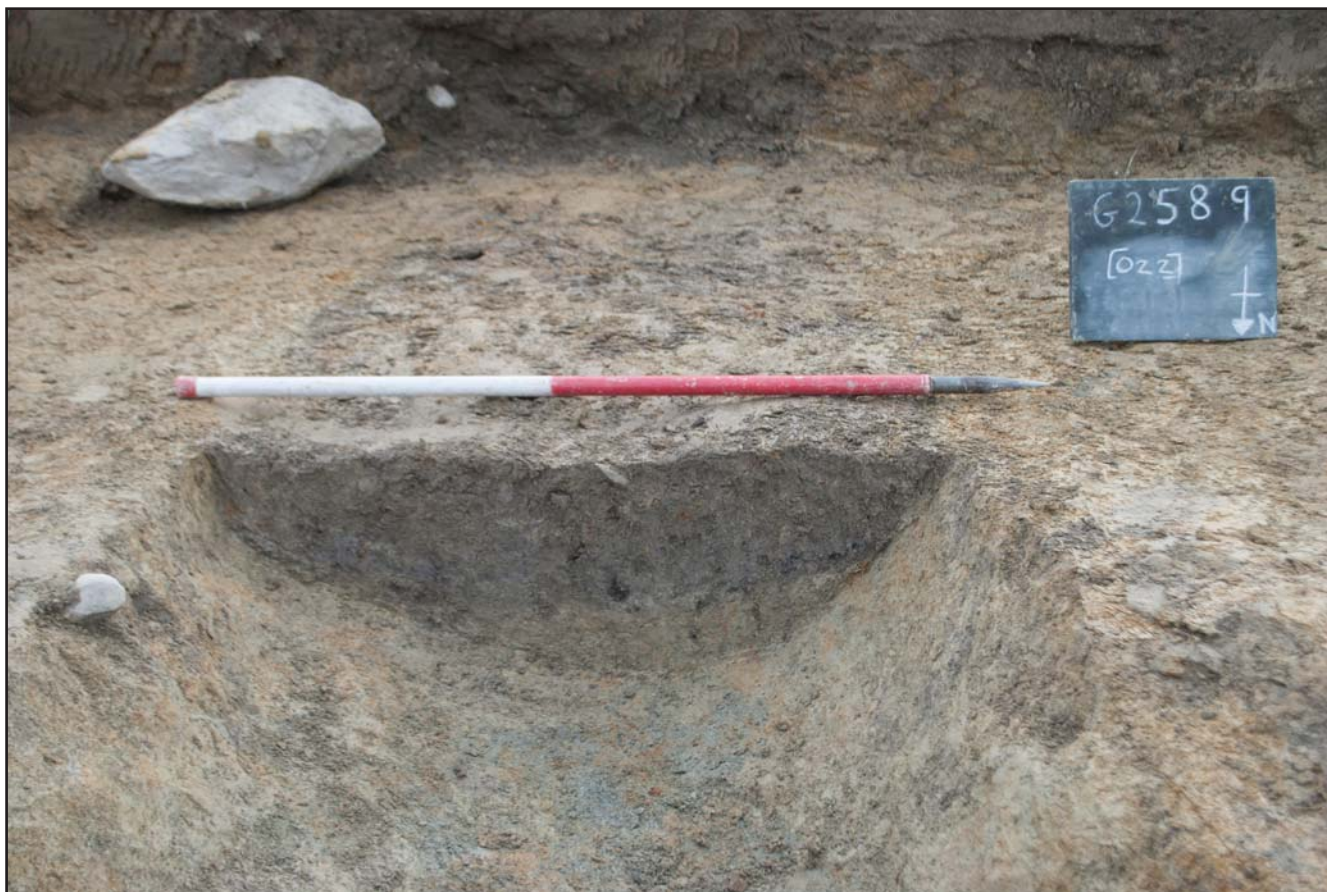
Plate 15: North facing section across ditch [022], scale 1x1m (archive ref: G2589_091).

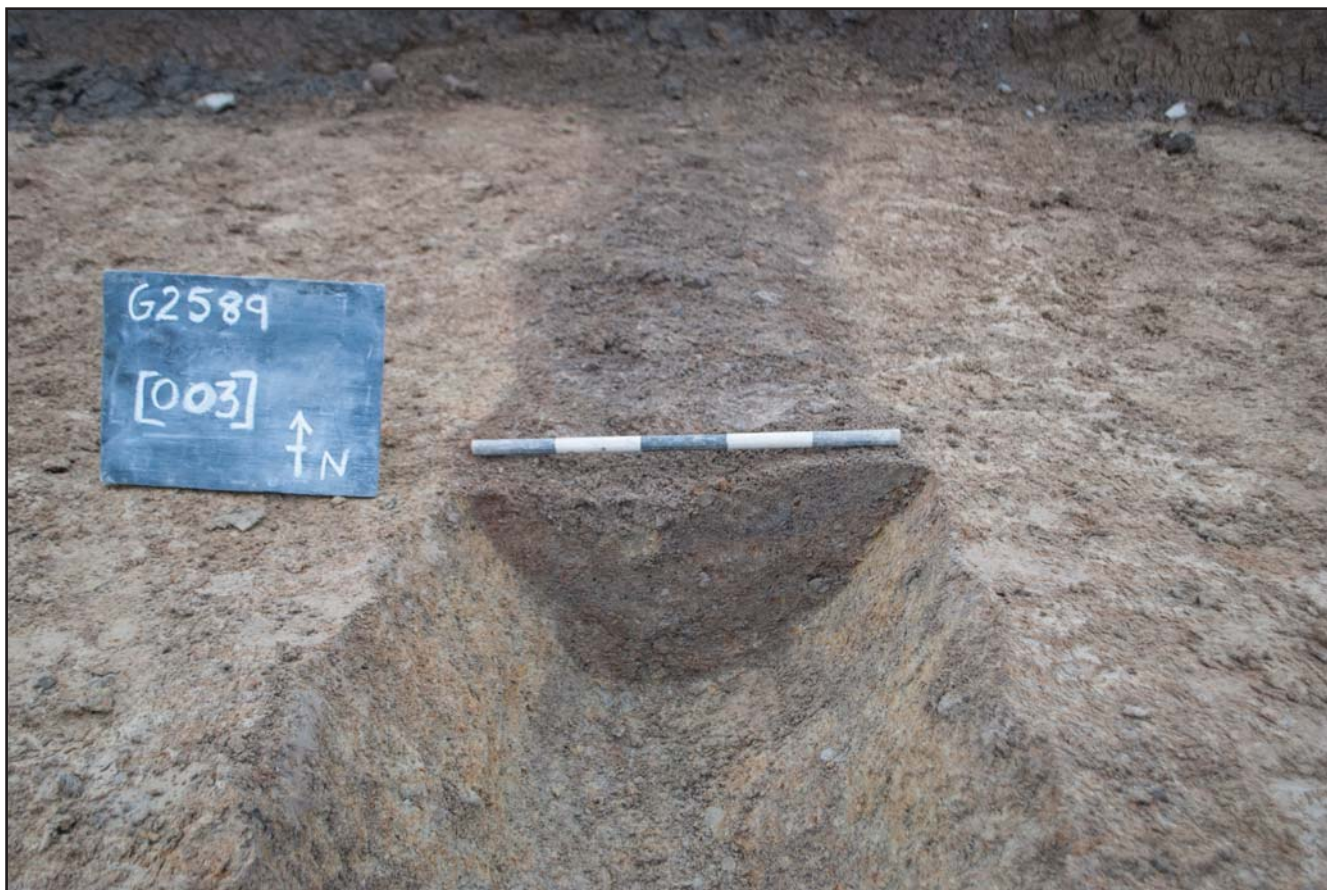
Plate 17: South facing section across ditch [003], scale 1x0.5m (archive ref: G2589_103).

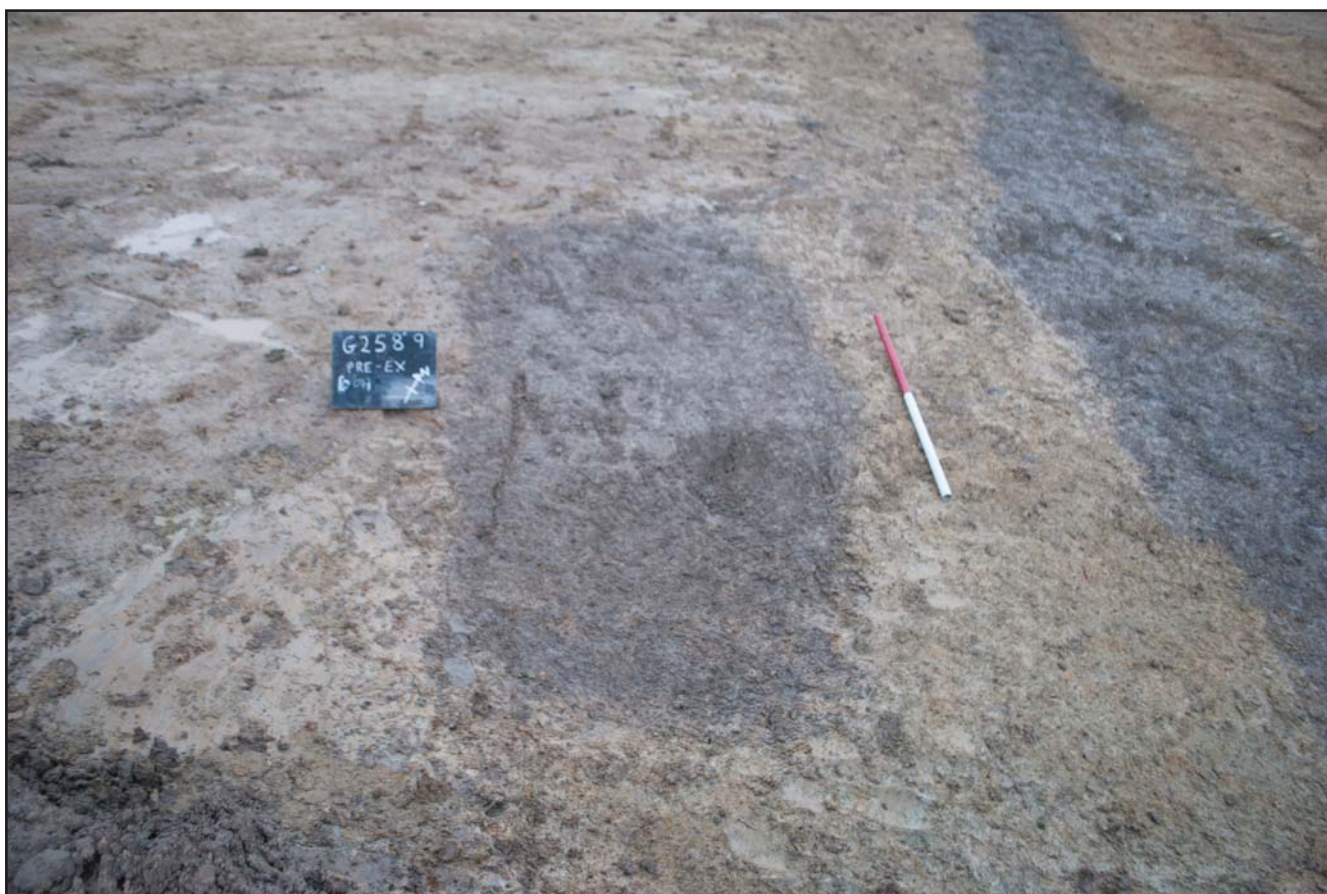
Plate 18: Pre-ex shot sub-rectangular pit [007], scale 1x1m (archive ref: G2589_079).

A large oval-shaped pit [007] was identified at the south of the excavation area just to the west of ditch [022] (Figure 03; Plate 18). Again, it was observed during machining to be cut through the subsoil (014). It was 2.75m long, 1.28m wide and 0.49m deep with steep sides, almost vertical in some places and slumped and undercut in others, that broke sharply to a flattish base. It was filled with a sequence of naturally silted deposits (021), (020), (019), (018) and (008) (Figure 07.1; Plate 19).

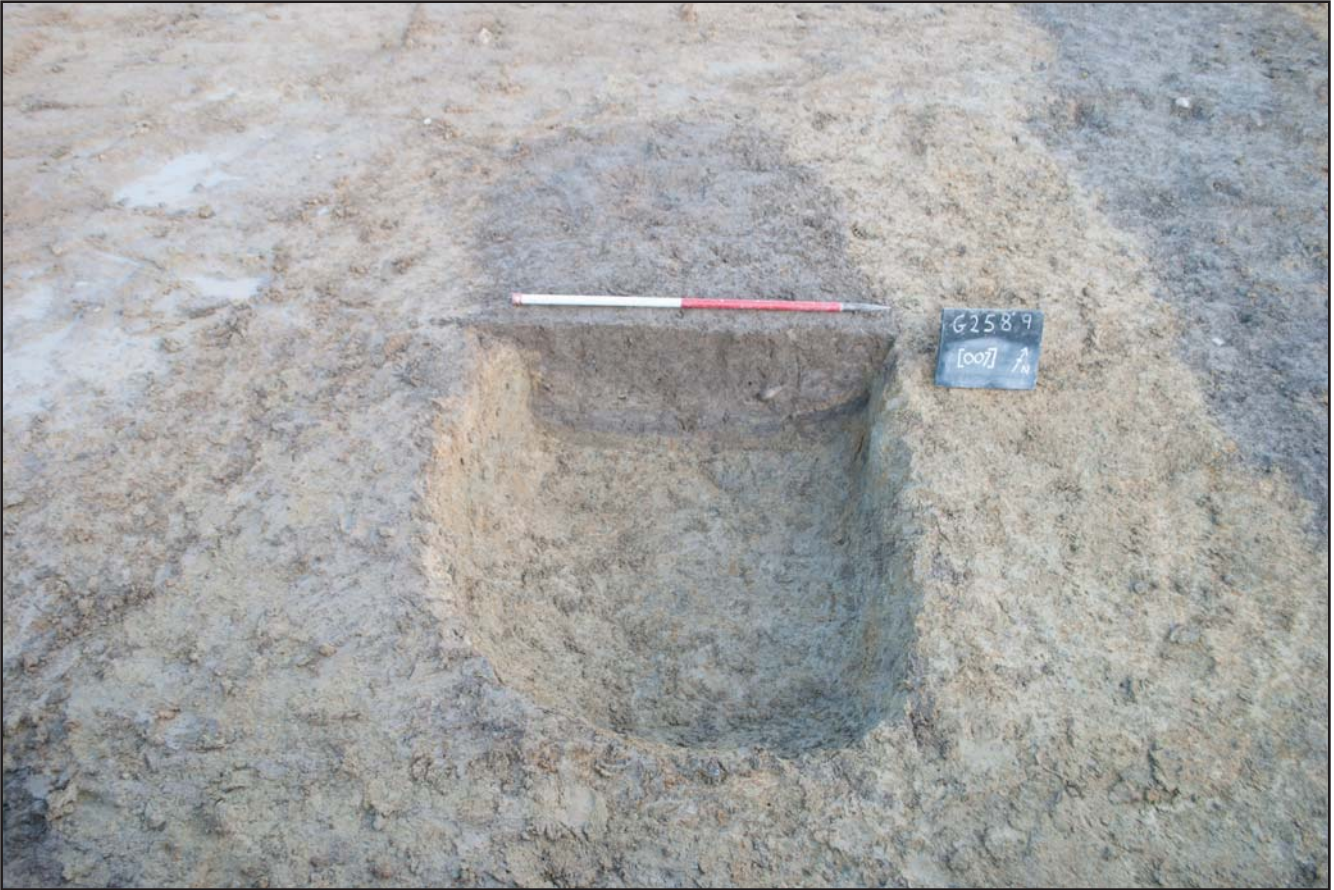
Plate 19: Pit [007] half sectioned, viewed from the south-southeast, scale 1x1m (archive ref: G2589_083).

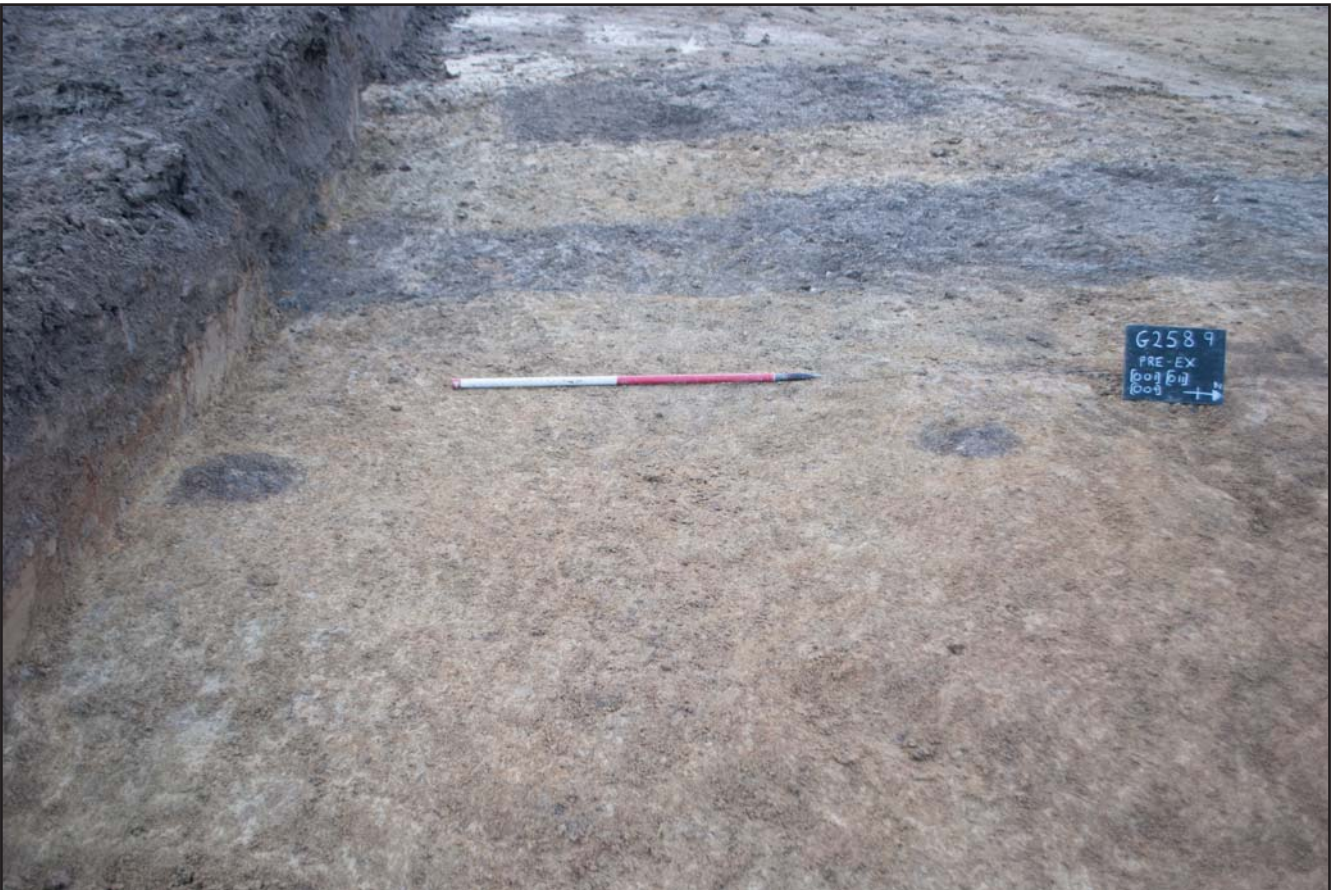
Plate 20: Area pre-ex shot showing south end of enclosure ditch [001] / [047], ditch [022], pit [007] and postholes [009] and [011], viewed from the east, scale 1x1m (archive ref: G2589_076).

Stratigraphically, the earliest features in the mitigation area are the two postholes identified in the south-east corner, [009] and [011] (Figure 3; Plate 20). These were the only features in the mitigation area that were not observed to be cut through subsoil (014). They were both sub-circular in plan, 0.30m wide and 0.35m long and steep sided with a flattish [011], or slightly concave [009], base. Posthole [009] was 0.16m deep and filled with (010) a mid-greyish brown silty clay with occasional small sub-rounded and sub-angular stones and occasional flecks of charcoal (Figure 07.2; Plate 21; Plate 22). A larger flat stone 14cm long was set flat at the base of the fill and may have been the remains of a disturbed post pad stone. Posthole [011] was wider at the base than [009] and slightly shallower at 0.14m deep (Figure 07.3; Plate 23; Plate 24). It was filled with (012), a loose mid greyish brown silty clay with occasional small sub-rounded and sub-angular stones and occasional flecks of charcoal. No finds were recovered from either of their fills. It is possible the two postholes represent the partial remains of a post-built structure, the rest of which may lay to the south outside of the mitigation area.
