GORSAF BOW STREET, BOW STREET, CEREDIGION

Lliniariad Archeolegol: Adroddiad Terfynol/
Archaeological Mitigation: Final Report

Ymddiriedolaeth Archeolegol Gwynedd
Gwynedd Archaeological Trust

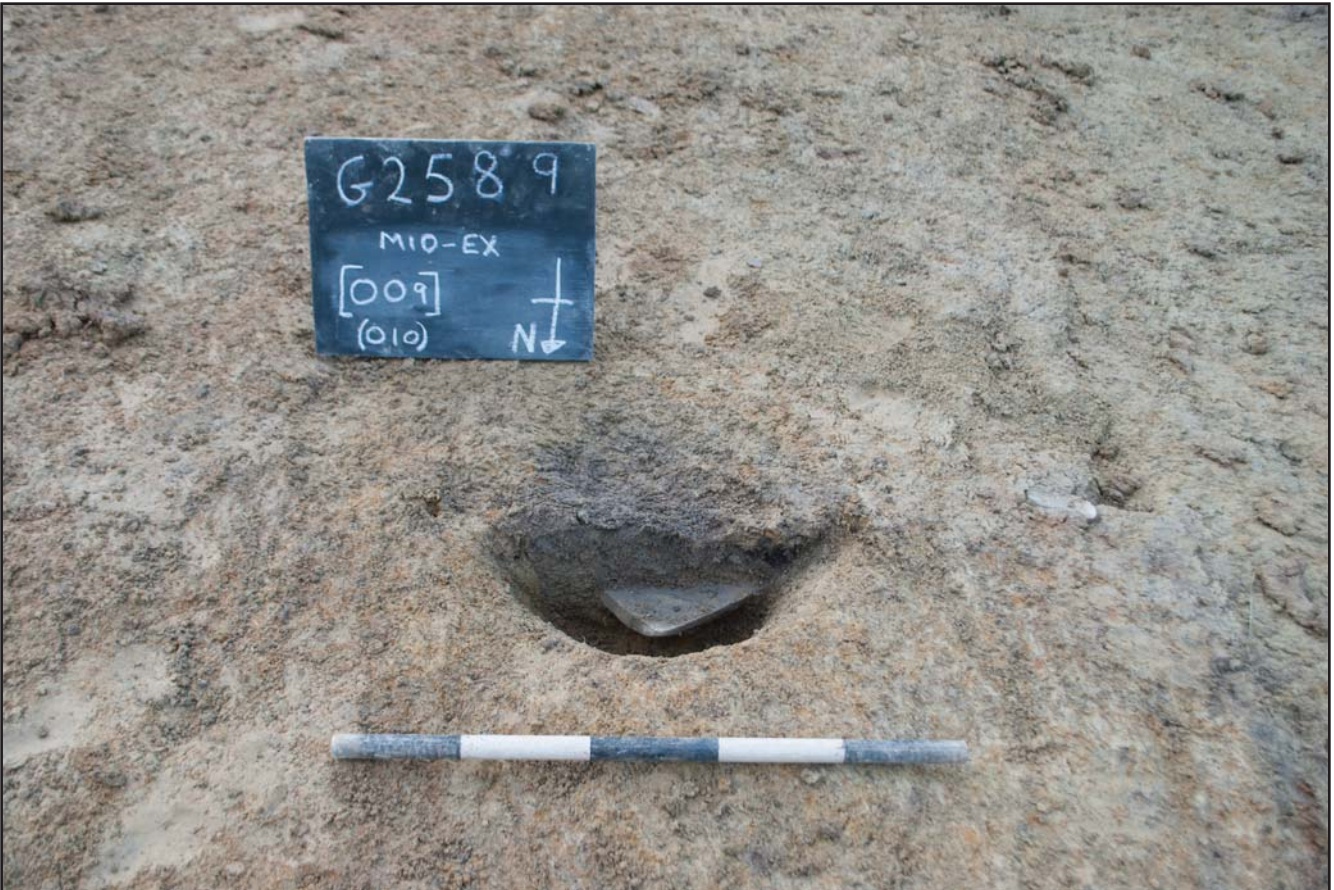
Plate 21: North facing section across posthole [009], scale 1x0.5m (archive ref: G2589_080).

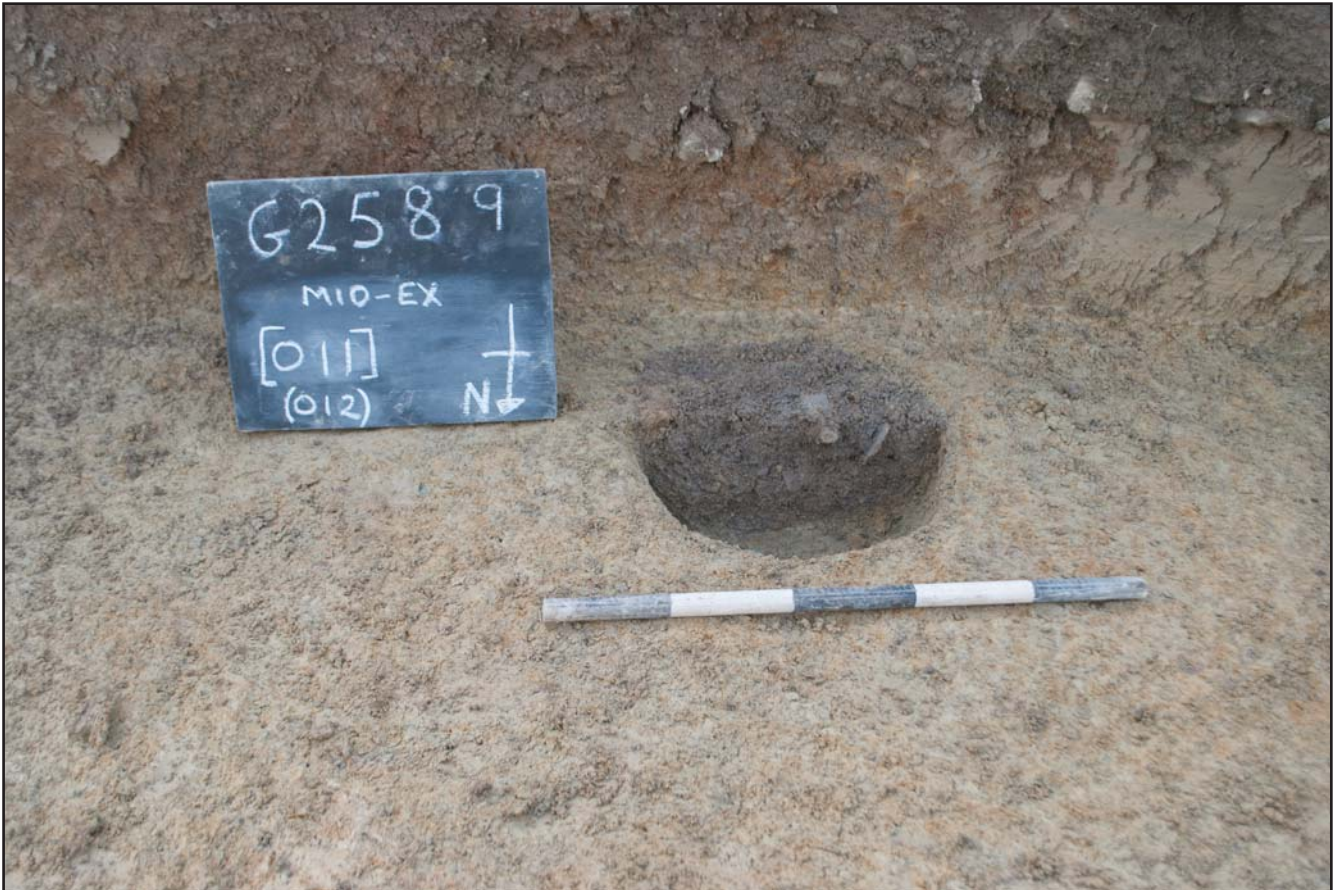
Plate 23: North facing section across posthole [011], scale 1x0.5m (archive ref: G2589_081).

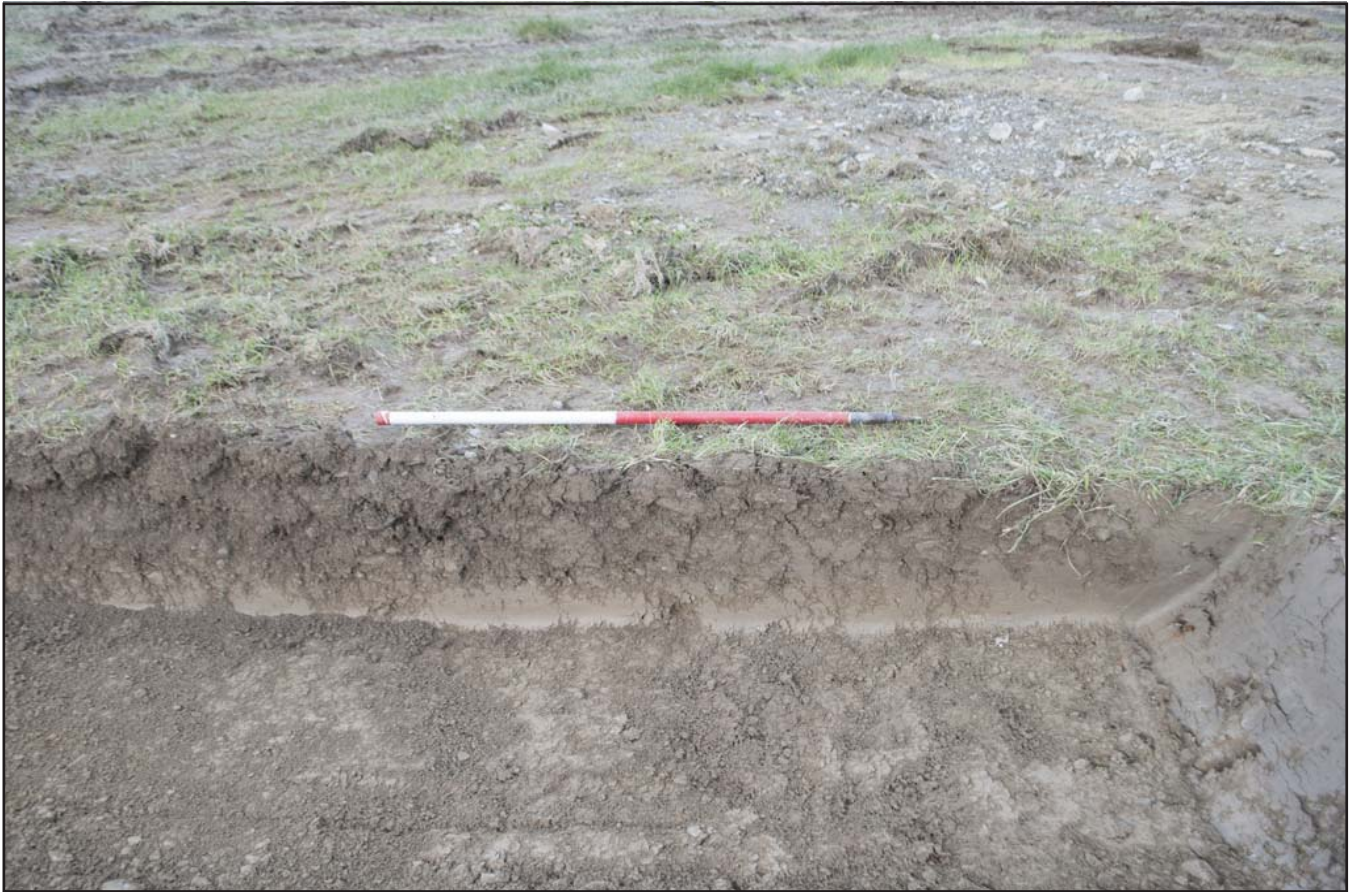
Plate 28: Representative section to a depth of 0.35m at the service crossing; scale 1x1m; view from ESE (archive reference: G2589_115).

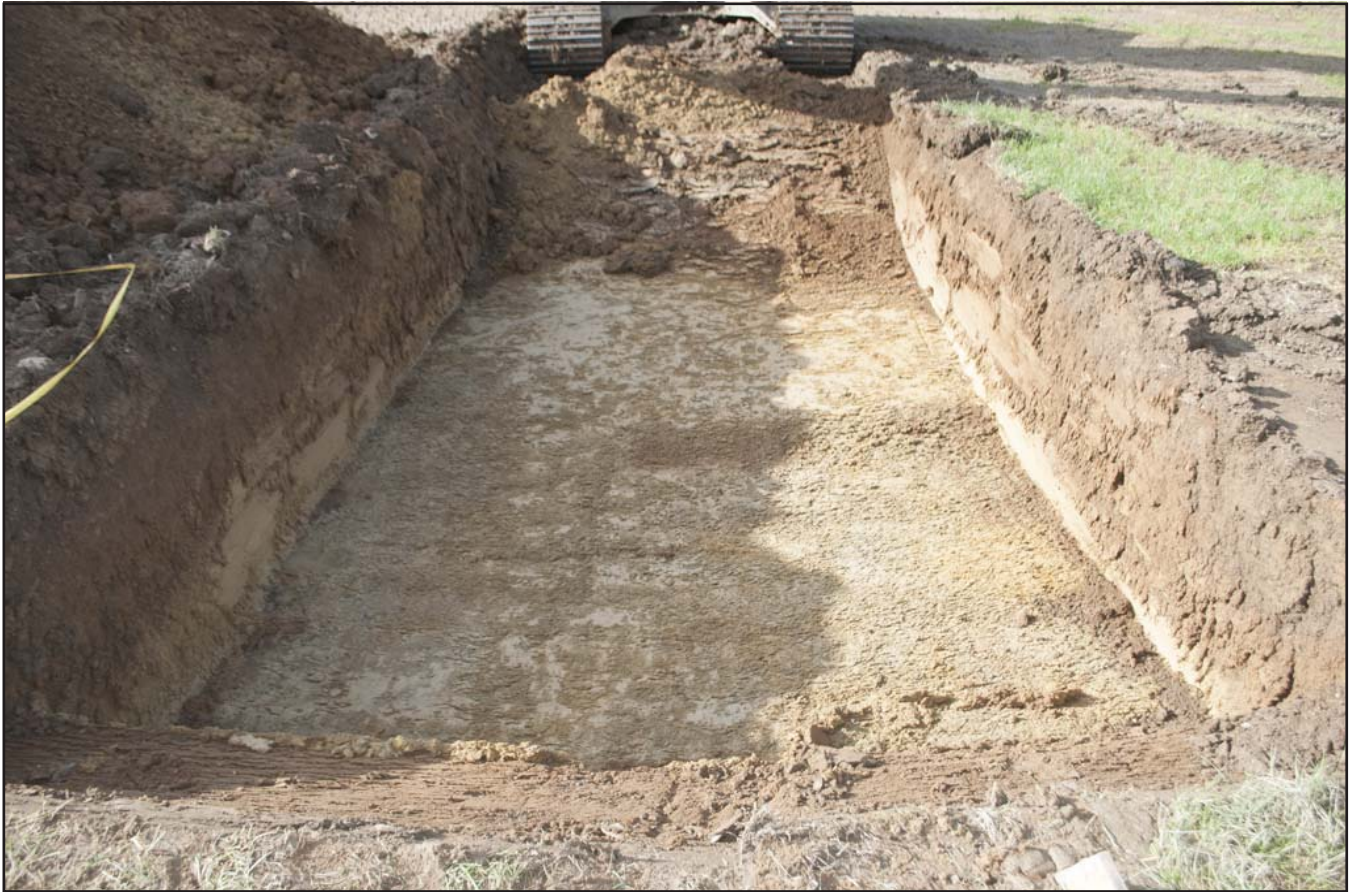
Plate 40: View of Test Pit 3 after excavation to full depth of 1.2m showing glacial clay; scale not used; view from E (archive reference: G2589_157).

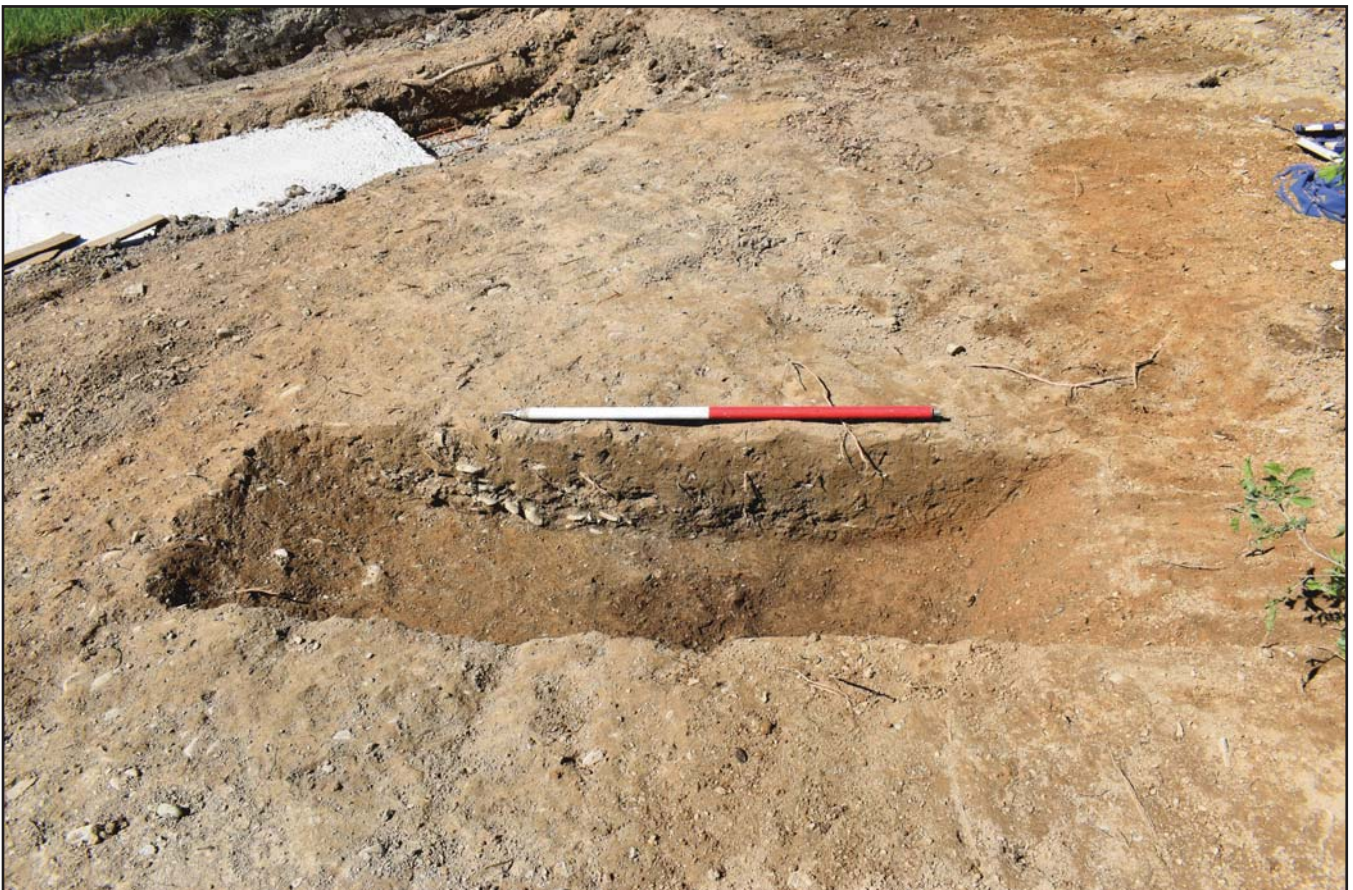
Plate 43: Sondage through ditch [104]; scale 1m; view from S (archive reference: G2589_181).

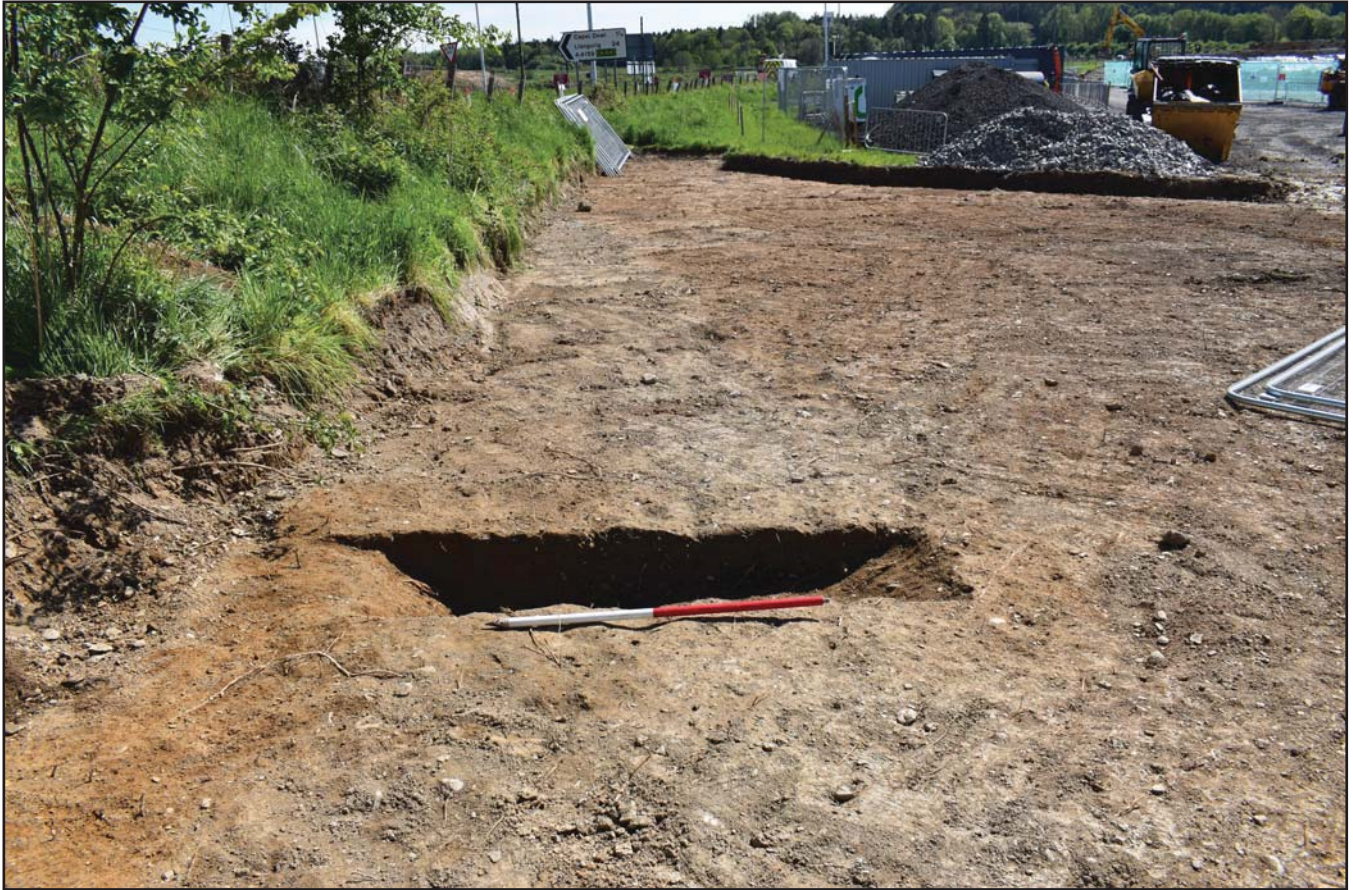
Plate 44: Sondage through ditch with ditch running S beyond sondage [104]; scale 1m; view from N (archive reference: G2589_185).
