**NEUADD MALDWYN,
SEVERN STREET,
WELSHPOOL, POWYS**

Level 1 Historic Building Record

for Lovelock Mitchell Architects

June 2021

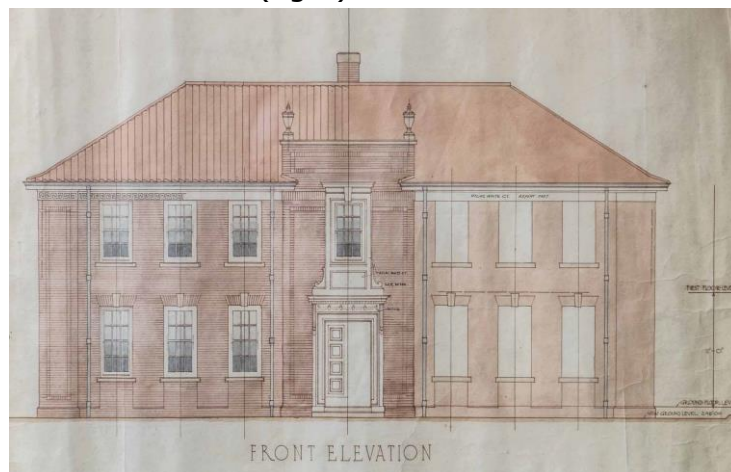
Figure 6. Front elevation, 1927, by Briggs and Thornely © Powys County Council

before Neuadd Maldwyn was designed, and so it should be assumed that the lead architect was Sir Arnold Thornely (1870-1953). Three design drawings show elevations and cross sections. As the drawings are numbered it is evident that originally there was a total of at least seven drawings. The original design comprised a main seven-bay entrance range (fig 6) and a narrower rear wing of three bays at two-storey height, and a further two single-storey bays. The building was opened in 1931, although fenestration of the rear wing differed slightly from the original design.

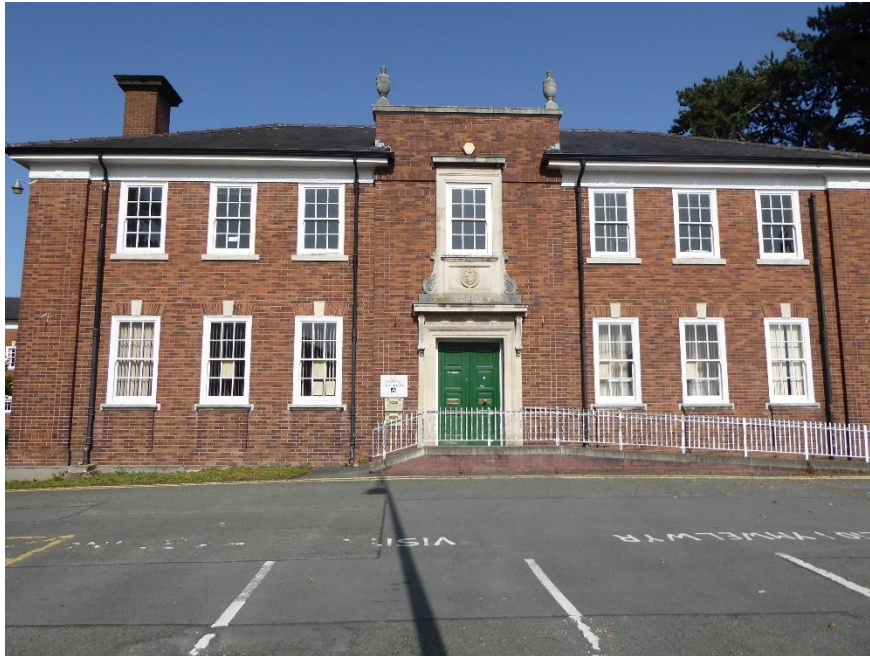
Figure 9. Entrance front and forecourt.

The entrance front to south-west is symmetrical with simple angle pilasters, though on the drawings these are shown as panelled. Its central bay is brought

forward under a raised parapet with urn finials. The entrance has a finely moulded architrave with cornice carried on scrolled brackets and the original panelled double doors are retained. Above, is a window in a stone panel with an apron bearing the date of opening in 1931 and the Montgomeryshire arms (fig 10). There is a painted eaves cornice decorated with a key pattern beneath the projecting eaves.

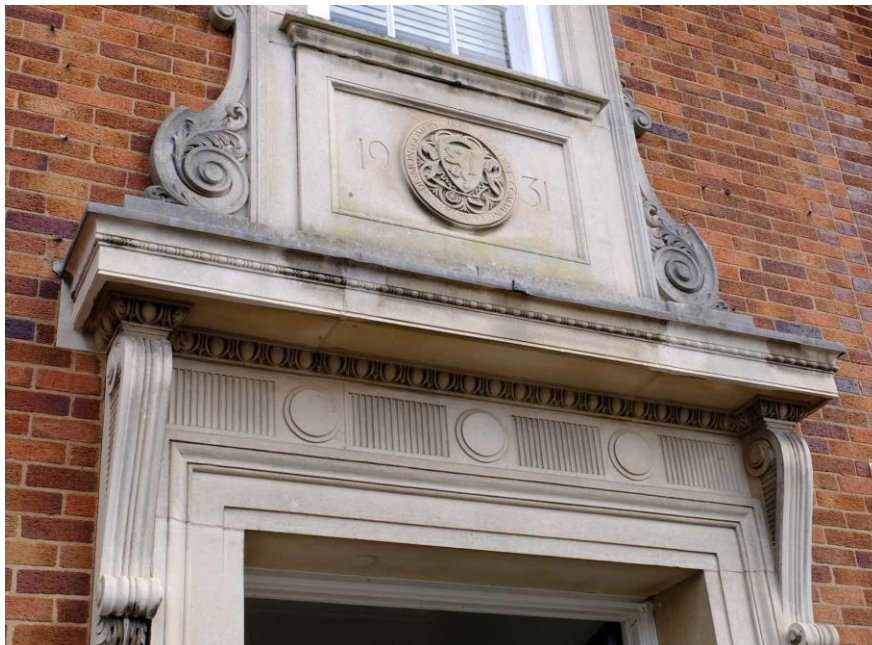
Figure 10. Detail of main entrance.

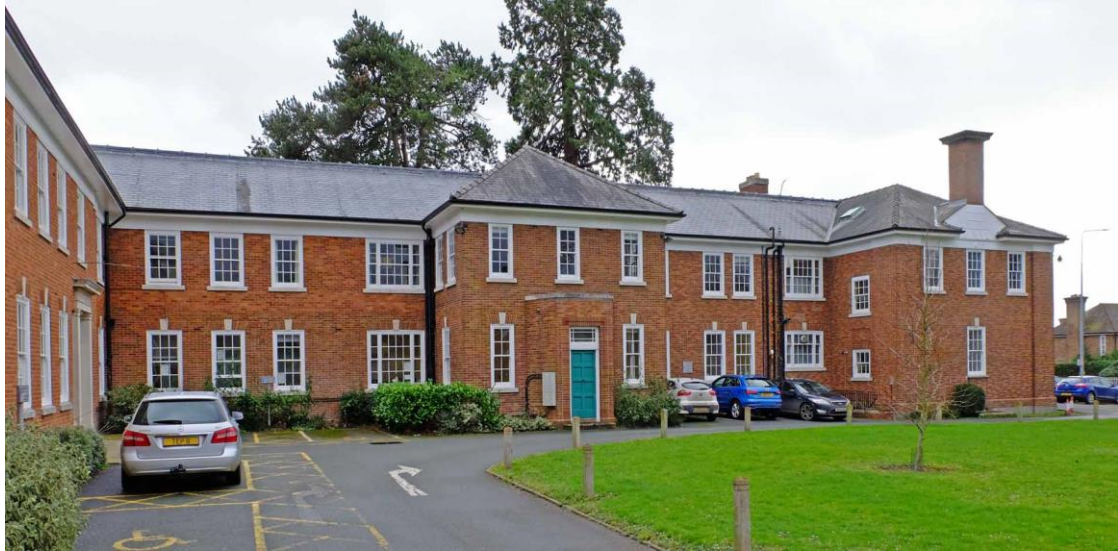
Figure 11. North-west front of entrance range (on the right) and later rear wings

4.4 The return walls are of three bays. On the left (north-west) side there is only a single ground-floor window and the eaves cornice is interrupted by a pediment crowned by the central chimney.

4.5 The original building extends for three bays of the rear wing which, on the left (north-west) side incorporates basement steps (fig 11). These bays have small-pane sash windows but in their use of shallower tripartite windows to the corner the fenestration differs slightly from the original design drawings of 1927.

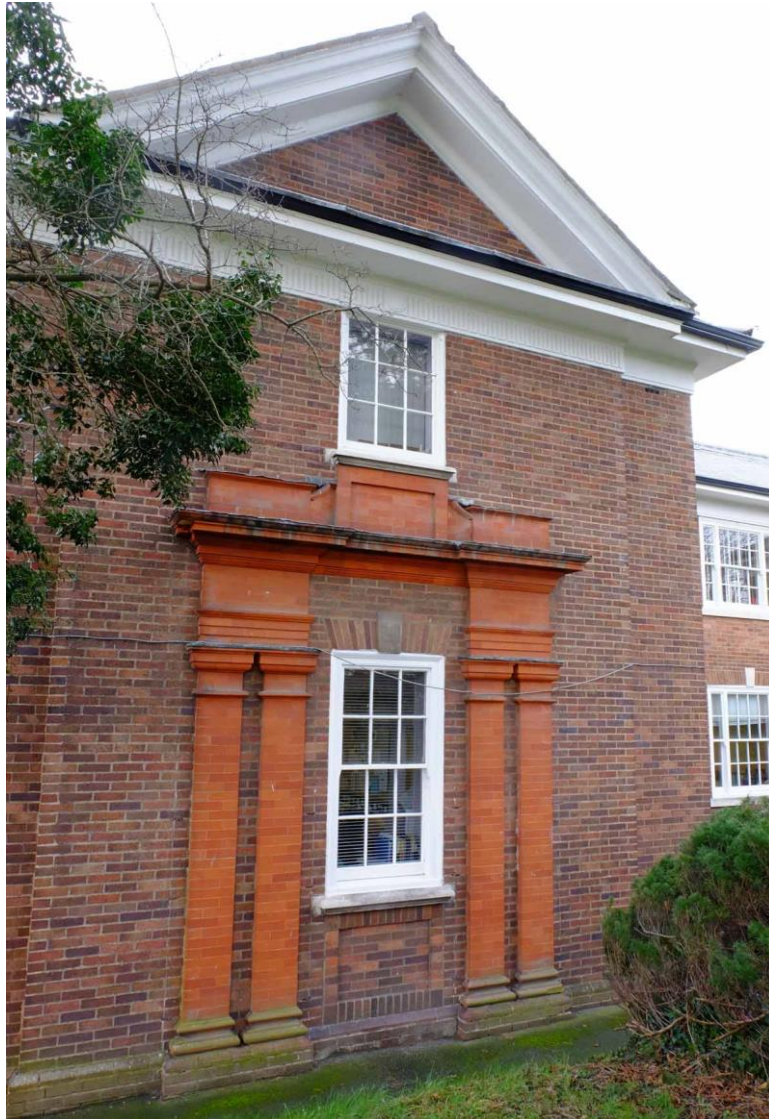
Figure 12. Detail of central pavilion in south-east front of rear wing.

4.7 The manner in which the new work respected the original design is best seen on the outer, south-east side. Here there is a corresponding central 'pavilion', stepped forward to the centre under a pedimented gable, and with a single ground-floor 12-pane sash window framed by paired terracotta pilasters and entablature (fig 12). This window has a panelled apron and to the 1st floor there is a 9-pane sash.

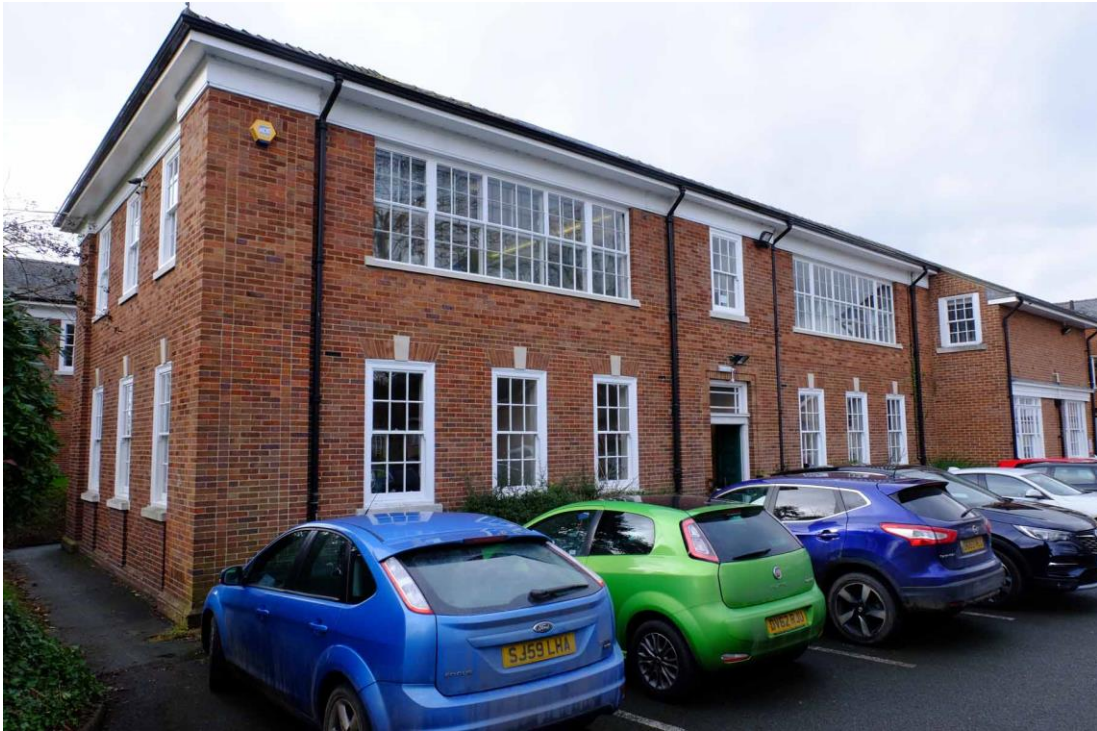
Figure 13. Rear (north-east) wall.

4.9 To the rear, the 1938 part of the north-east front has a central doorway under a margin-glazed overlight, flanked either side by three windows and, in the upper storey, two bands of small-pane sash windows (fig 13) that lit the drawing office to the former Council Architects Department. In the opposite south-west front there is a single window and pilaster which seems to mark the extent of the 1938 design (see fig 14).

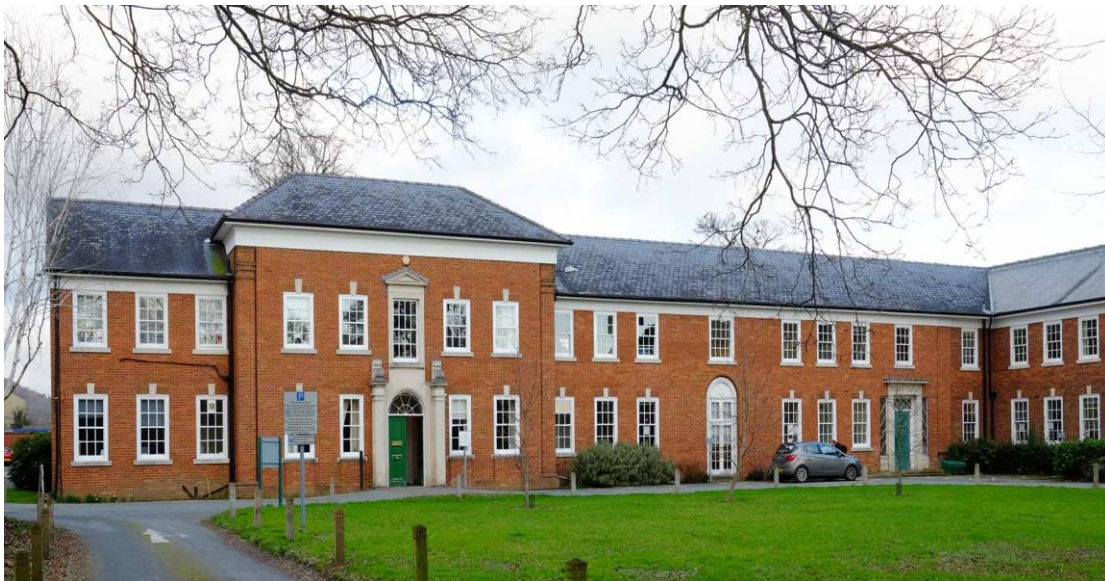
Figure 14. Secondary wing with council suite to left under taller hipped roof.

4.10 The secondary wing at right angles to the north-west is essentially of three phases, as seen on its south-west elevation.

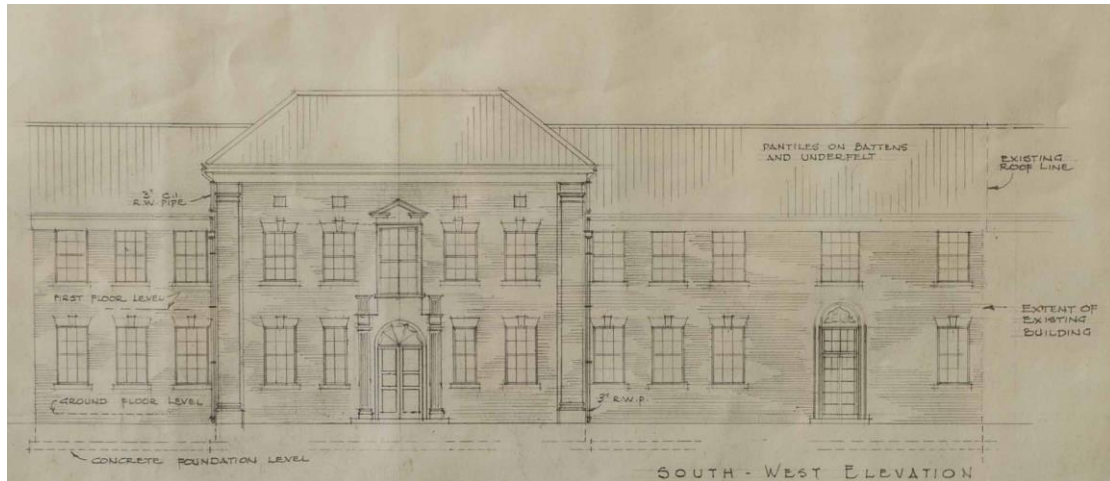
Figure 15. South-west elevation drawing, 1959, marking the "extent of existing building"

4.11 At the extreme right end is the termination of the 1938 work, marked by a pilaster. To the left of this are three unequal bays which appear from Carr's surviving drawings (fig 15) to have been built sometime between 1938 and 1959 (as discussed in 3.5 above).

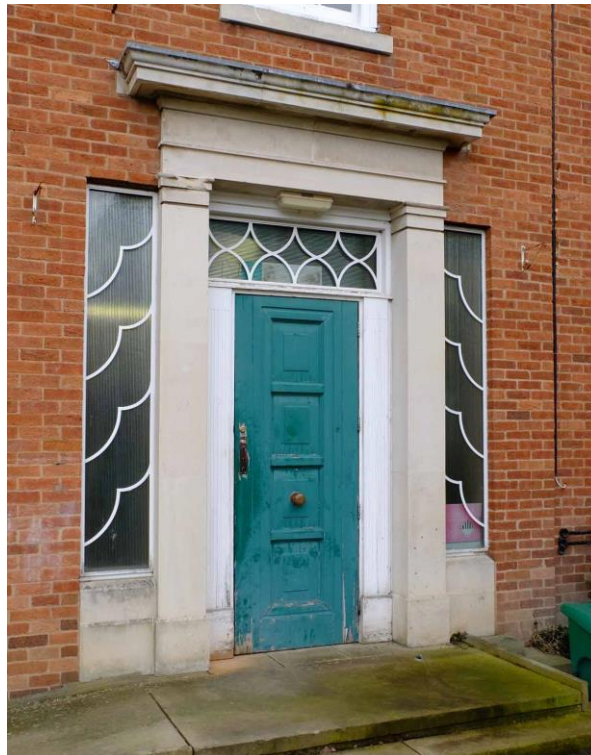
Figure 16. Doorway in the secondary wing.

4.12 This section incorporates a doorway in a reconstituted stone surround with simple cornice. The door has four vertically laid panels under an overlight with decorative lozenge pattern glazing bars. Either side are margin lights, which appear to be added later, with curious wave pattern glazing (fig 16).

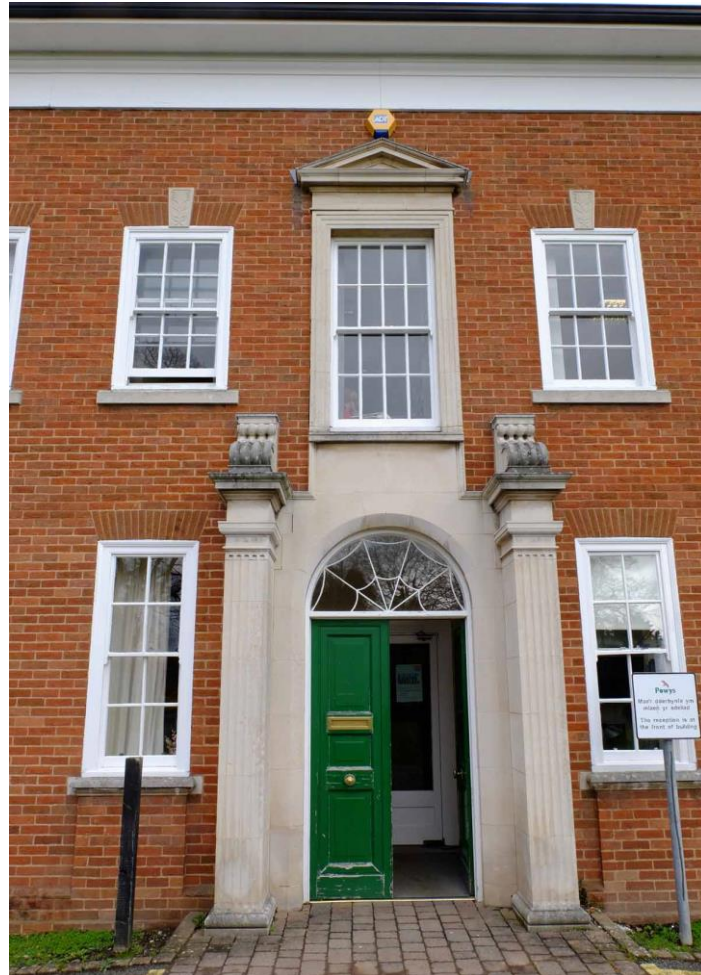
Figure 17. Entrance to the council suite.

4.13 The remainder is the design of 1959 with the dominant element being the five-bay council suite under its hipped roof flanked to the right by three plus two bays and to the left by three equal bays. The council suite is stepped forward and framed by angle pilasters and its greater height allows for the 1st floor windows to also have keystones, though these are curiously omitted from the narrower ground floor windows flanking the entrance. A stone architrave surrounds the central entrance, and the 16-pane window above it is beneath a small pediment (fig 17).

The doorway is framed by unusually deep fluted pilasters surmounted by boldly detailed scrolled brackets and there are panelled double doors under a neo-Georgian fanlight. The design drawings show a row of blind panels between the 1st floor windows and the frieze but these were not implemented to the front though they are seen at the rear.

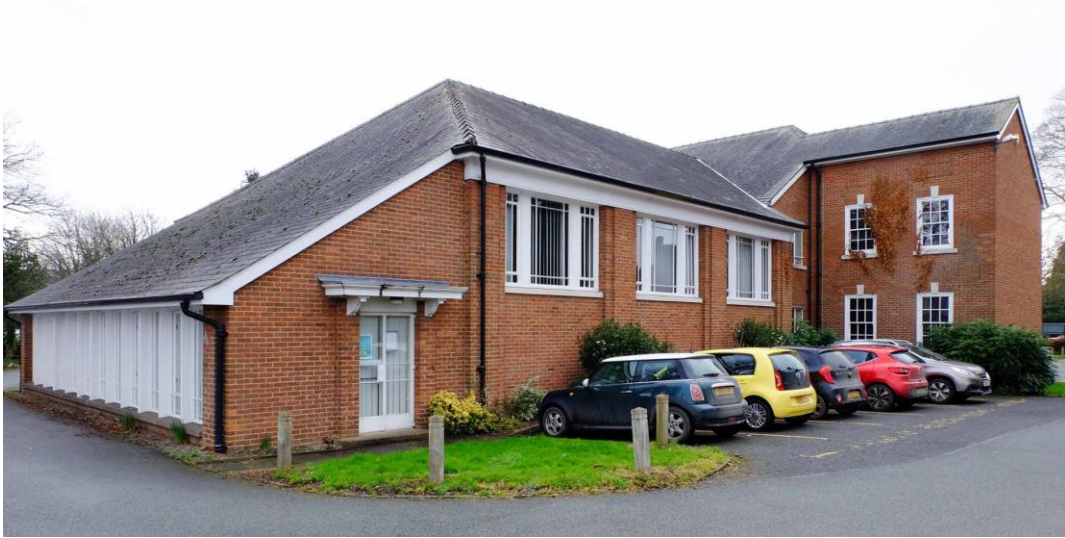
Figure 18. Council chamber and Committee Room to the left, viewed from the north-east.

4.15 The council chamber projects north-east to the rear of the secondary wing (fig 18). In its side walls the tripartite windows are set high and the three bays are framed by pilaster strips. On the end is the Committee Room under a catslide roof, which is not marked on the design drawing but appears to be contemporary with the remainder of the building, and has a band of windows in its end wall.

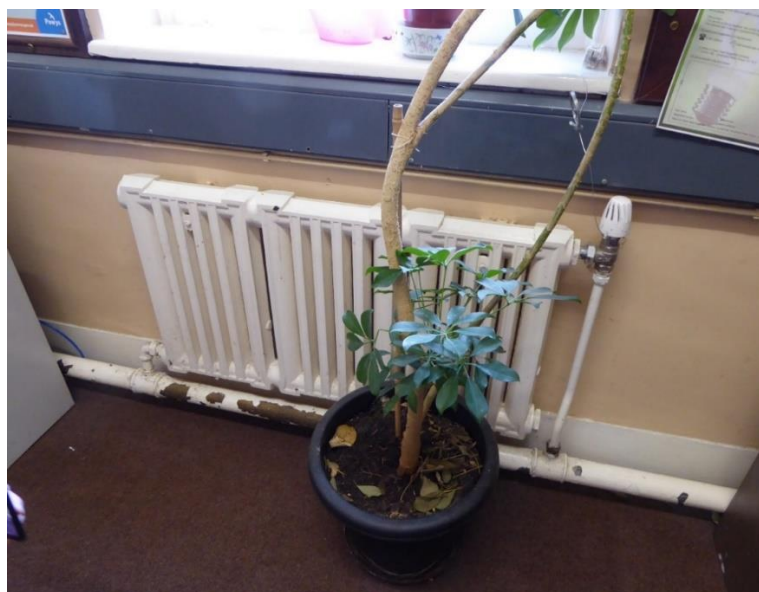
Figure 26. Original radiator seen in east/west corridor to rear

At the far end of this corridor is a hall near the secondary entrance on the north-east elevation, part of the 1938 extension. This retains original cornices and half-glazed panelled doors, as does the corridor at right-angles leading towards a further staircase hall built before 1959. The corridor also retains a rare example of a 1930s cast-iron radiator.

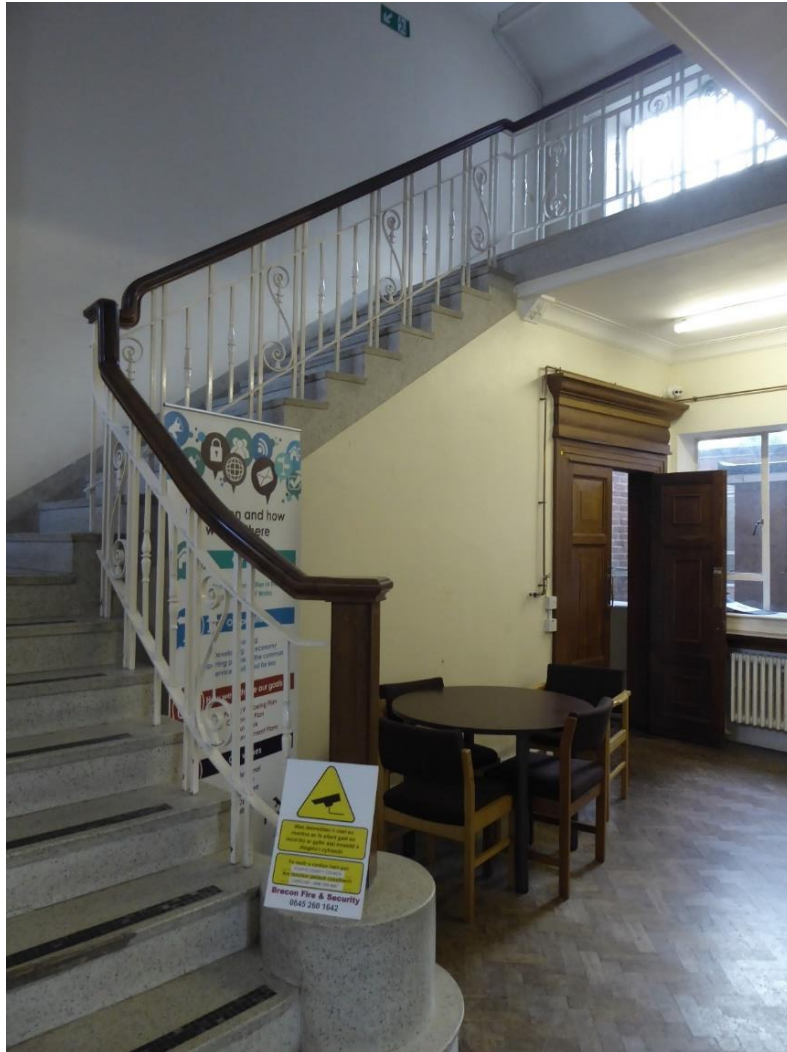
Figure 33. view showing 1959 staircase, parquet floor to staircase hall and one of the doors to the Council Chamber

The Imperial form of stairs has cantilevered flights with terrazzo finish, elegant metal balustrades and mahogany handrail and newel turned outwards at the base where the lower step is curved. At the half landing directly facing the entrance is a full-height recess with decorative detail painted within. At the foot of the stairs there is a timber plinth that formerly carried a bronze statue of Icarus (figure 32 below shows the statue when it was here). It was originally made for Leighton Hall and oddly despite having been later moved remained statutorily listed Grade II as at Leighton.

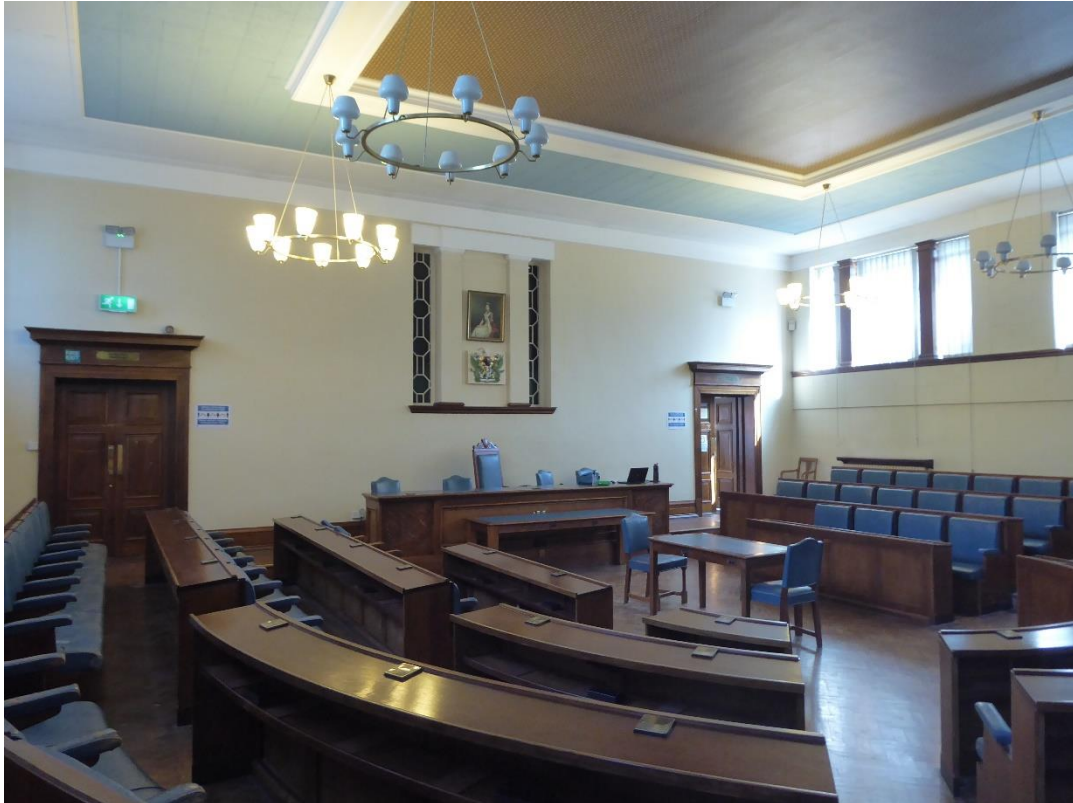
Figure 35. Council Chamber seating

The Council Chamber is a large rectangular room and retains its original raked seating with blue leather upholstery, laid out in a U-shape facing the dais. Behind the dais, is a tripartite feature containing a central blind panel with the county arms flanked by narrow metal-frame windows with decorative glazing bars forming bands of linked octagons. These were originally intended as exterior windows. The chamber has high-level tripartite windows to the north-west side and at the entrance side there is a modern translation booth added.

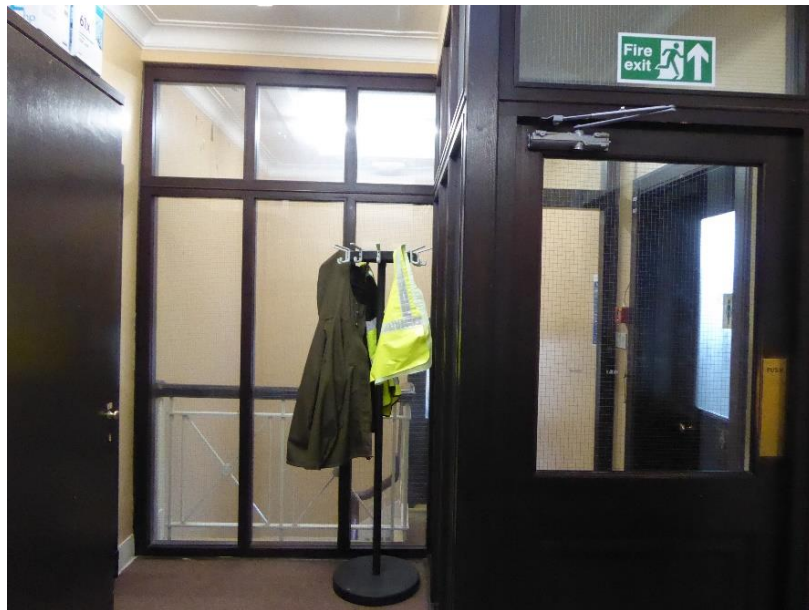
Figure. 41 1st floor landing in 1931 block showing modern enclosure of staircase

5.2.2 The 1931 staircase is enclosed by an unsympathetic modern glazed screen but opens onto a broad landing with good doorcases and cornice detail and a broad semi-circular arch, now obscured by filing cabinets.

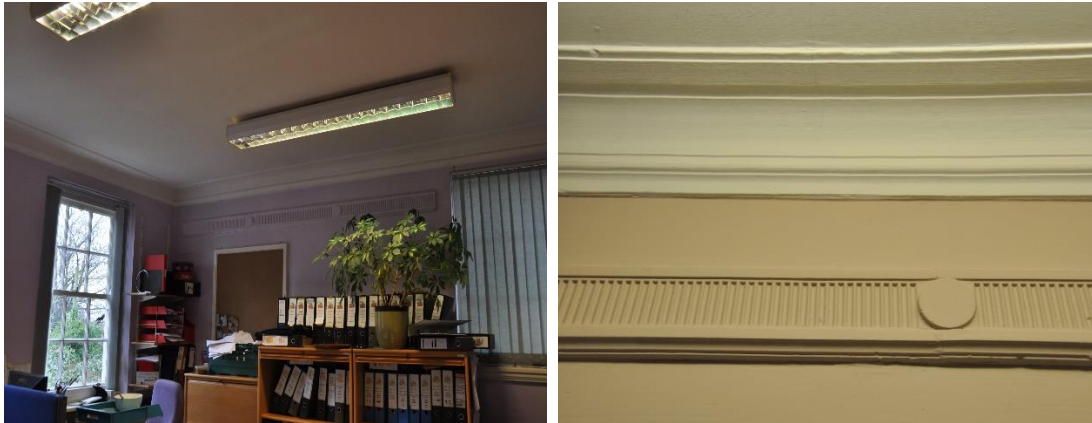
Figures 46 and 47 1st floor surviving sections of neo-classical frieze to centre of south-east elevation in 1938 phase © Lovelock Mitchell Architects

5.2.4 The 1938 part of the 1st floor has, to the centre of the south-east side, a much-subdivided area but with surviving fragments of frieze indicating that this was once a large high-status room. It is, however, puzzling that this frieze is so far below the cornice (figure 47).

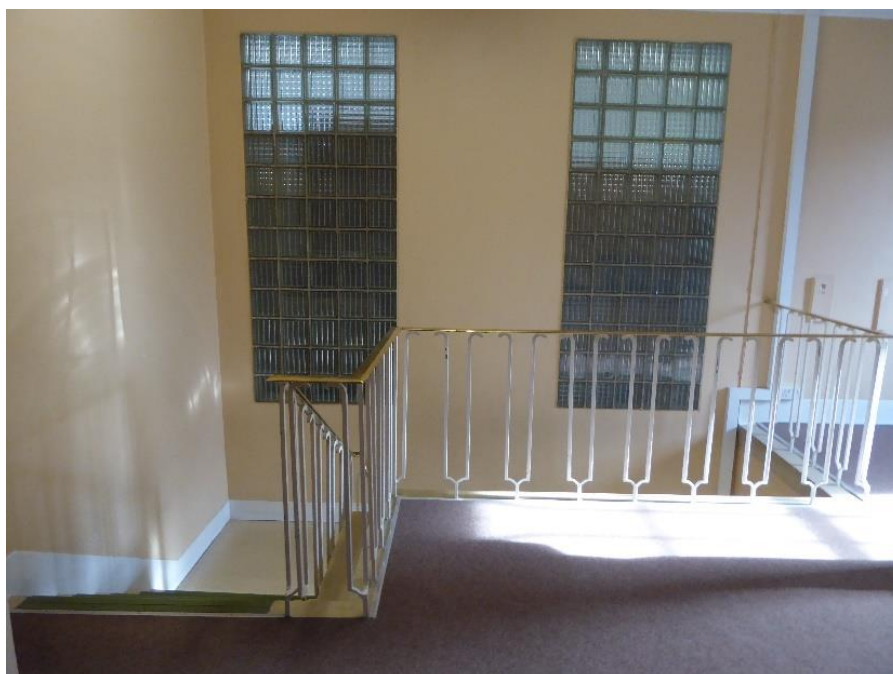
Figure. 48 1938 Staircase windows and 1st floor landing

5.2.5 The staircase at the northern extent of the 1938 block rises to a landing lit by a distinctive pair of multi-pane windows made of glass bricks (figure 48). These windows are also clearly seen from the other side in the neighbouring architects' office and there is a similar style window (figure 49) between the large office midway along the south-east front and its adjacent smaller office.

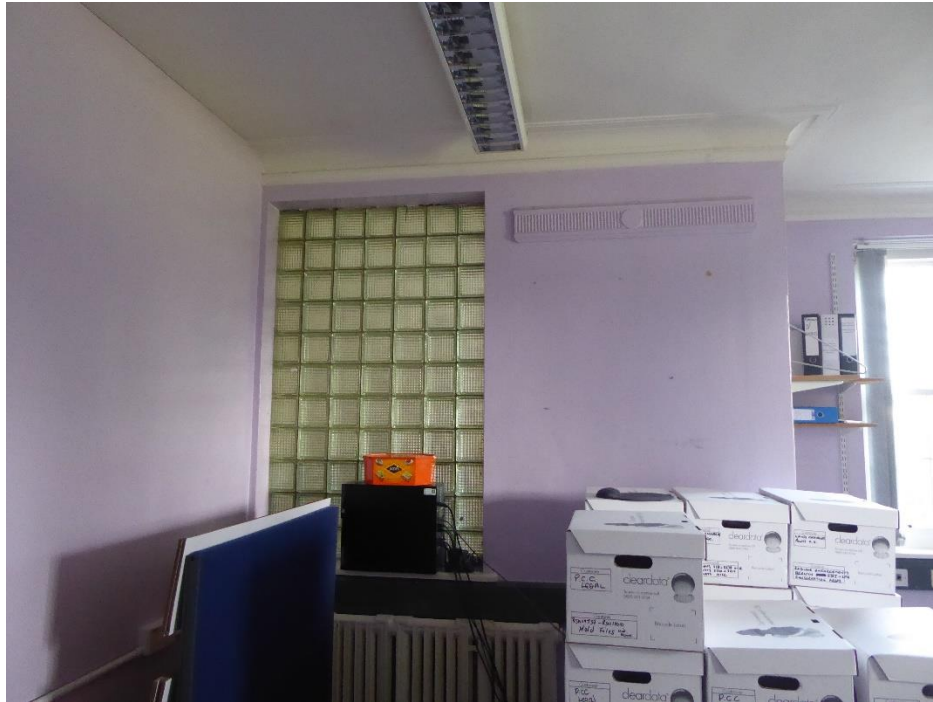
Figure. 49 same style of glazing seen in internal wall between the large south-eastern office to the centre of the 1938 enlargement and an adjacent single cell office

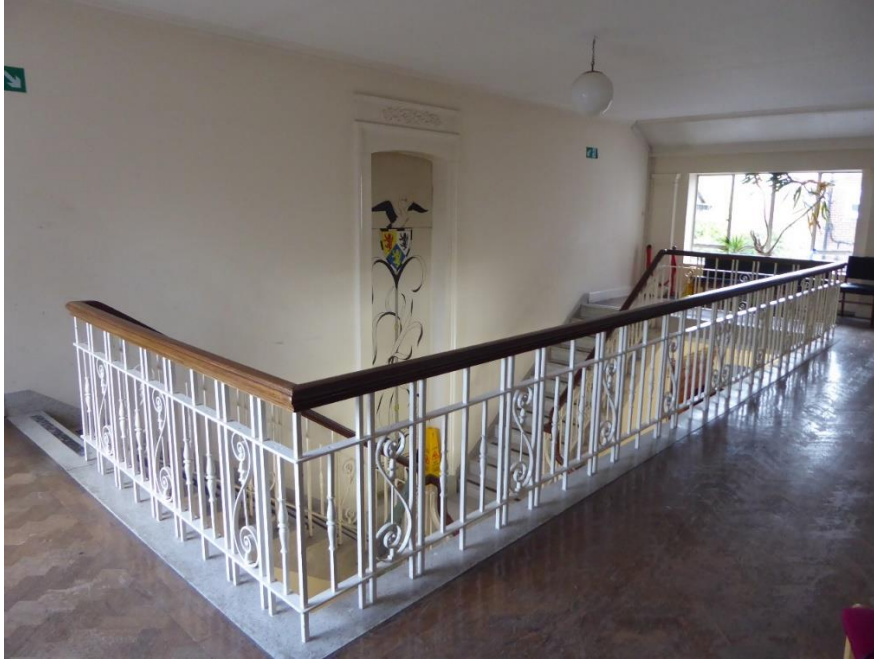
Figure. 51 1959 Staircase and 1st floor landing

5.2.7 The broad 1st floor landing to the 1959 staircase has a well detailed metal balustrade with scrolled panels and a wooden handrail. Like the ground floor of the staircase hall, the landing retains its parquet floor.

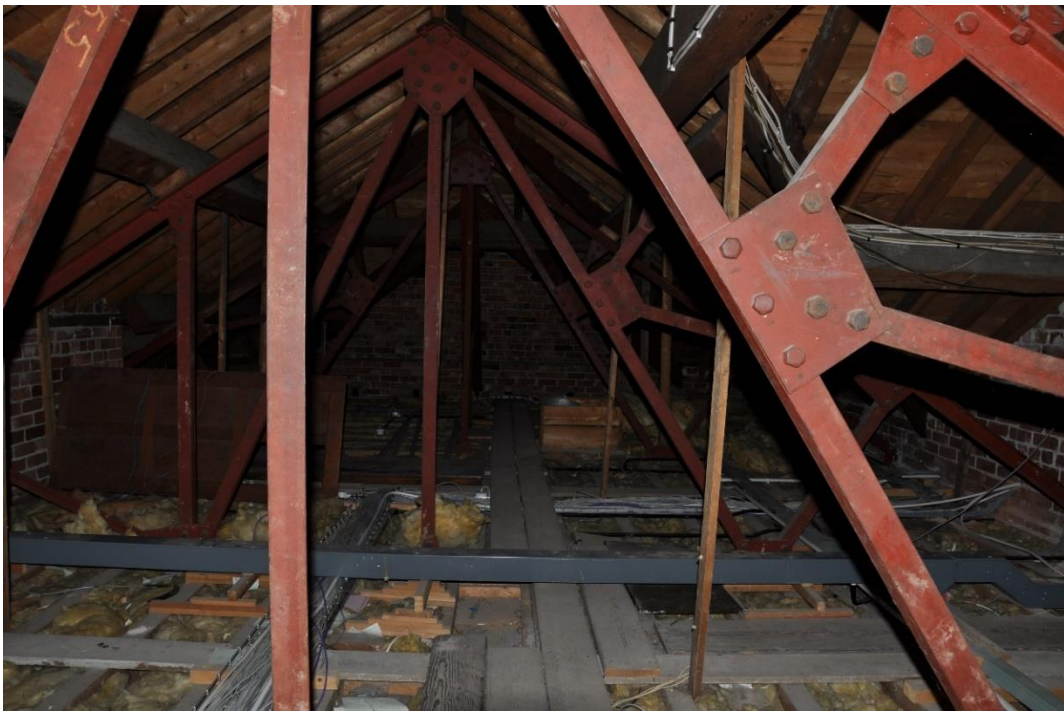
Figure. 55 Steel trusses to the attic over the 1931 block © Lovelock Mitchell Architects
