**A Photographic Survey
Oak Tree House
Llanmerewig
Powys
(NGR SO 15768 92511)**

ABRS Project No 2021-CBAP

Planning Permission 21/0223/FUL

**A Photographic Survey of an Outbuilding at Oak Tree House, Llanmerewig, Powys
(NGR SO 15768 92511).**

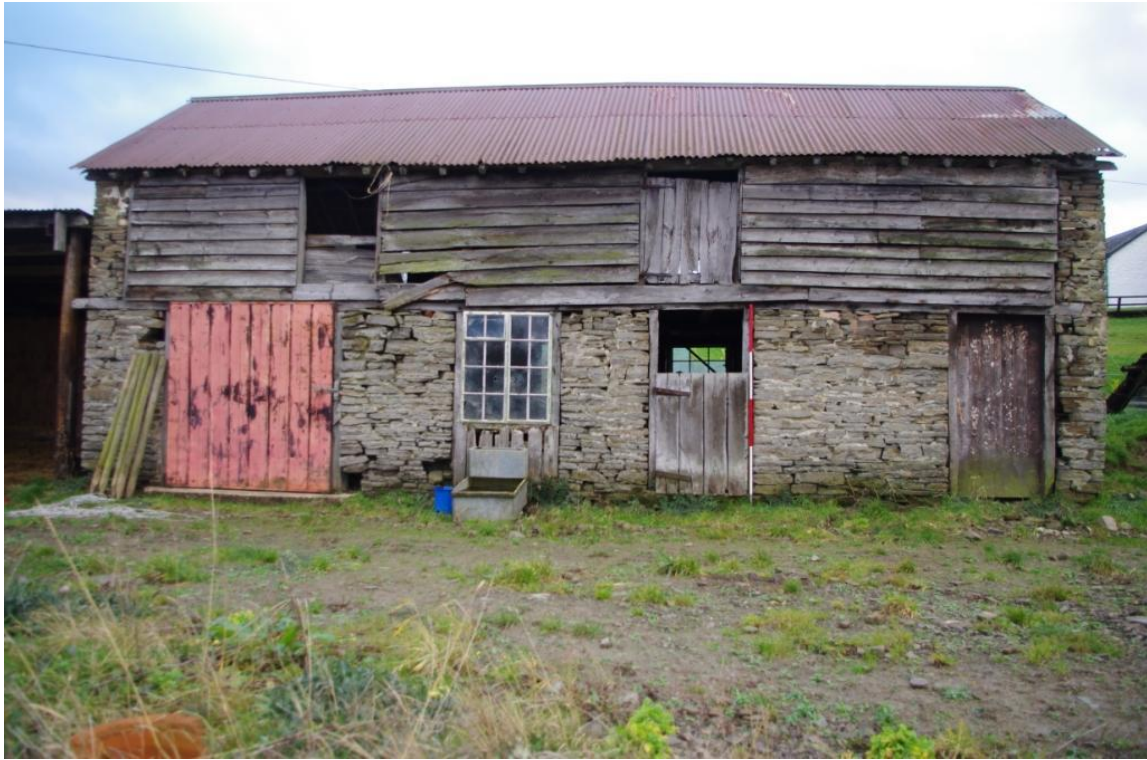
The outbuilding at Cefn Brith, building A is built of local coursed rubble with weatherboarded timber framing at first floor level under a corrugated tinned steel sheet pitched roof (*Figure 3*). To the north east is a modern pent roof extension, B (*Figure 4*) and to the south west is the remains of a recently collapsed pitched roofed building, C (*Figure 5*), historic photographs show this to have been a 20th century open fronted “pole barn”. The building is located to the south – south east (upslope) of the farmhouse (*Figure 2*). The building is clearly recorded by the second edition Ordnance Survey of 1903 and the tithe map

Figure 3
Principal Elevation, General View (Looking South East).

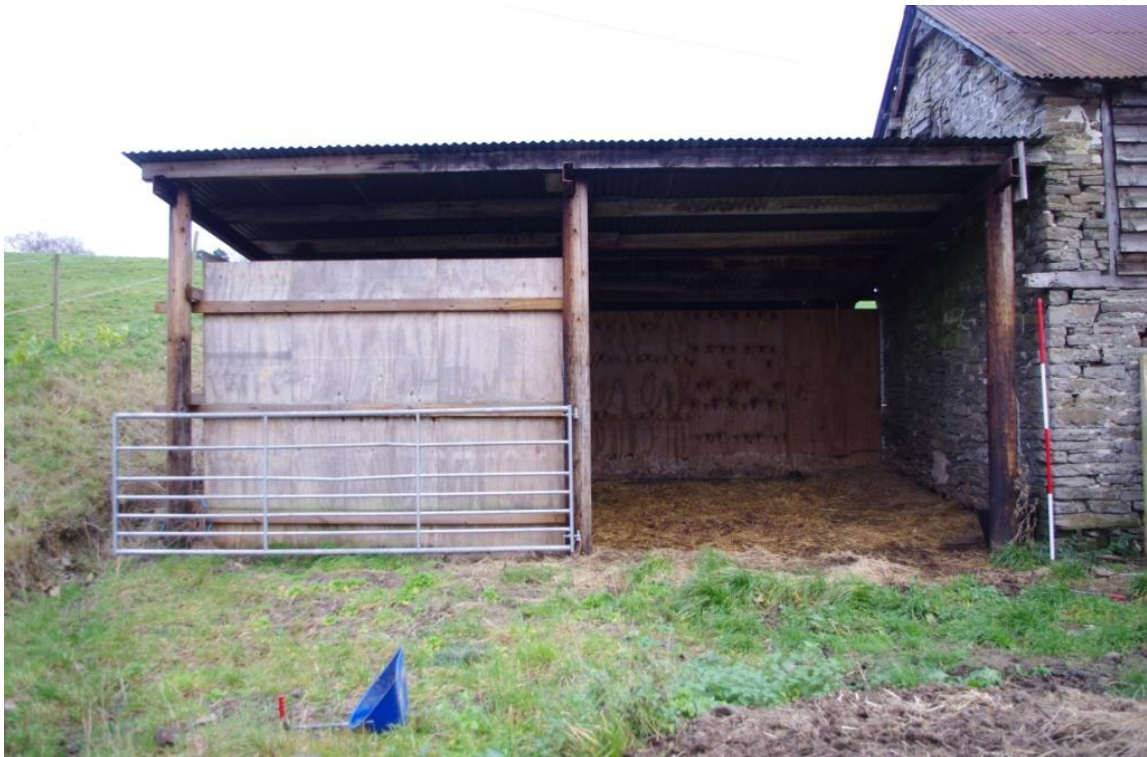
Figure 4
B, General View (Looking South East).

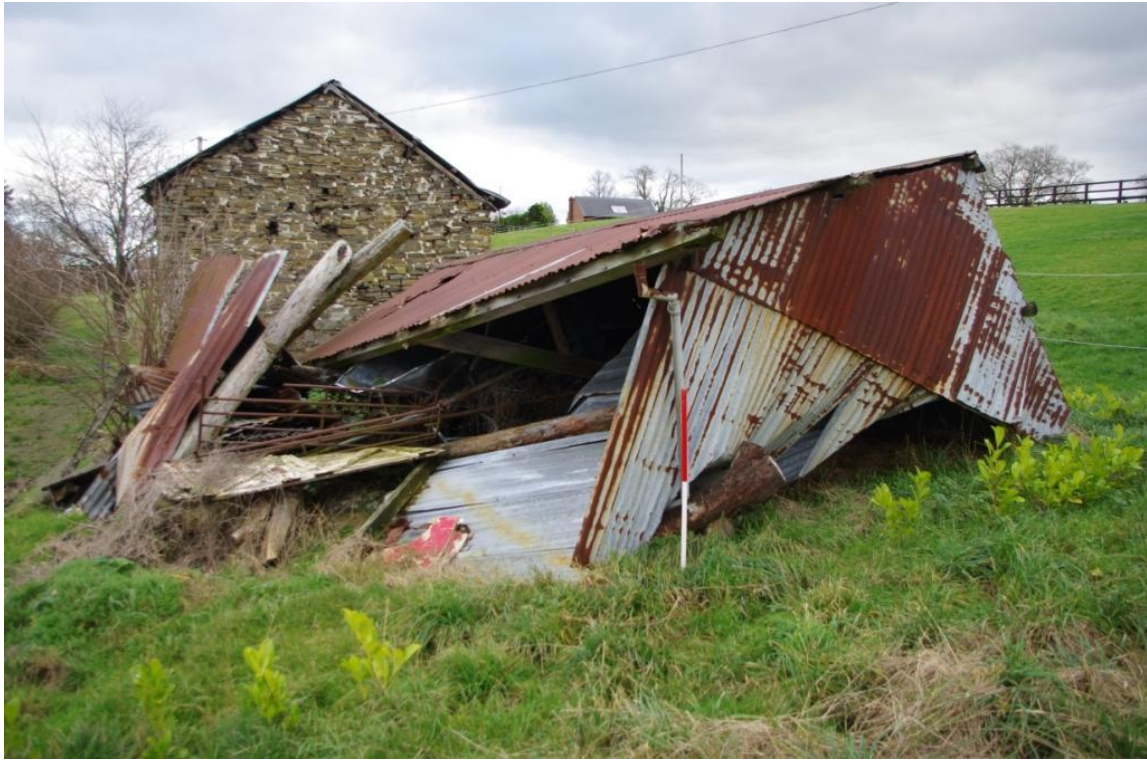
Figure 5
C. General View (Looking North East).

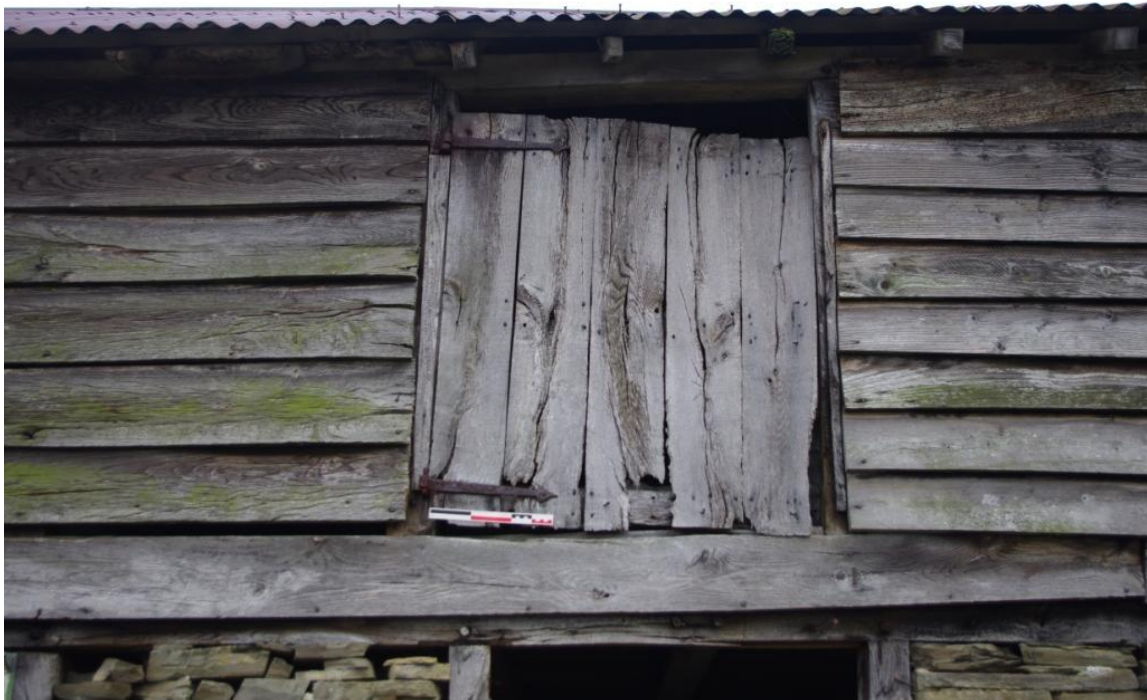
On the principal elevation are three pedestrian doors and a larger, possibly inserted, carriage door. On the first floor are two pitching doors, one of which uses a arrowhead strap hinge which stylistically appears to be 17th century in date (*Figure 6*). Given its exposed location it is likely to be reused or a later, locally made hinge. This arrangement of openings would suggest that the building was originally stabling or a cow hovel with a granary or fodder store above.

Figure 6
Pitching Door on Principal Elevation, Showing Potentially 17th Century Hinge (Looking South East).

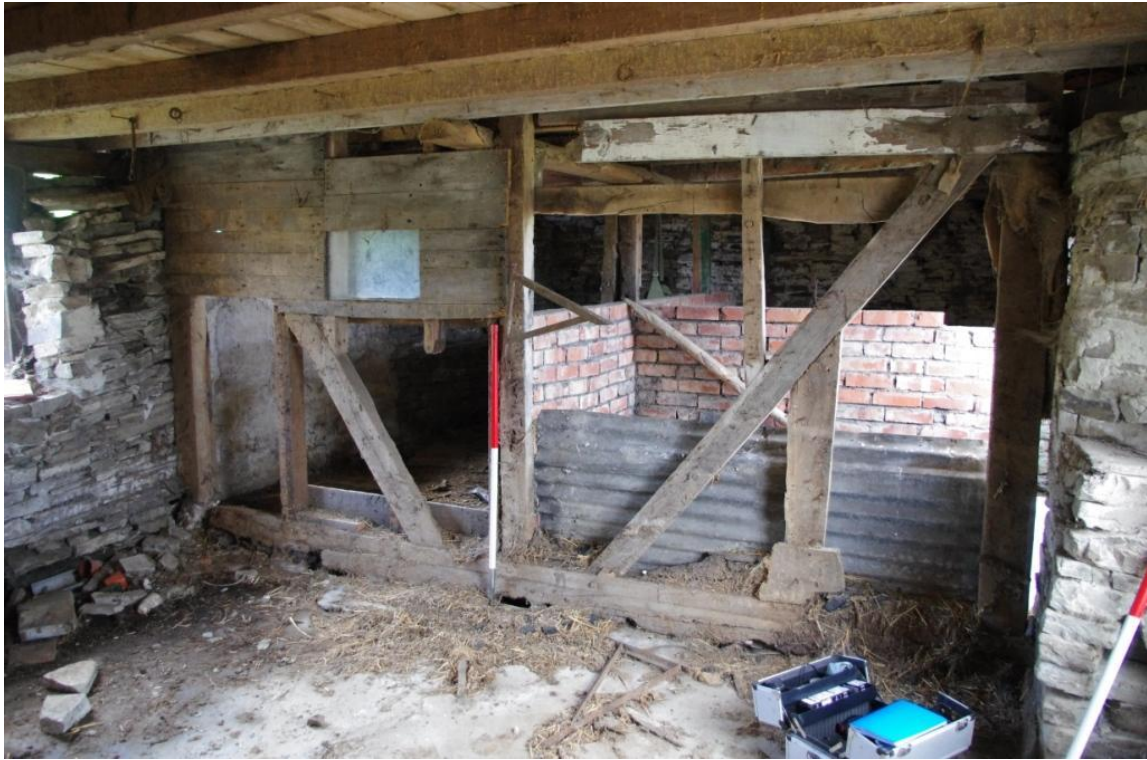
Internally, A consists of three bays divided by two cross frames, largely of reused timber, both nailed and pegged (*Figure 7*). There is no clear evidence of the original use or the layout; however the limited remains of lime plaster may suggest stabling.

Figure 7
A(2) Cross Frame (Looking South – South West).

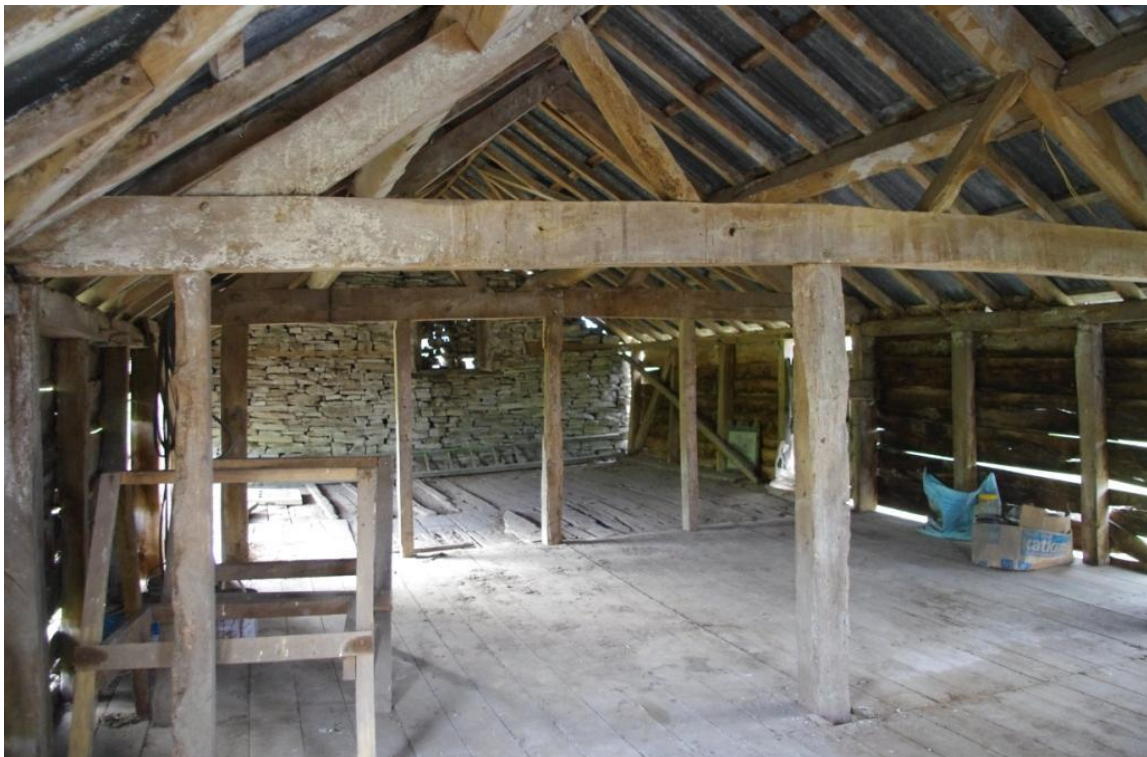
Access to the first floor, (4) was limited due to the condition of the floorboards and joists. The first floor consists of a single bay (*Figure 8*), the roof is carried on two pegged A frame trusses with raking struts in hardwood with paired purlins. There are assembly marks visible on the north east face of westernmost truss and on the south west face of the easternmost

truss; assembly marks being on opposite faces would suggest that the trusses are not contemporary. There are assembly marks on the purlins and the common rafters are hardwood. The roof structure appears to be single phase.

Figure 8
A(4) General View (Looking West).
