Poor Clare Colettine Monastery, Upper Aston Hall Lane, Hawarden, Flintshire CH5 3EN

Historic Building Record Level 2

Project Code: A0225.1

Report no. 0214

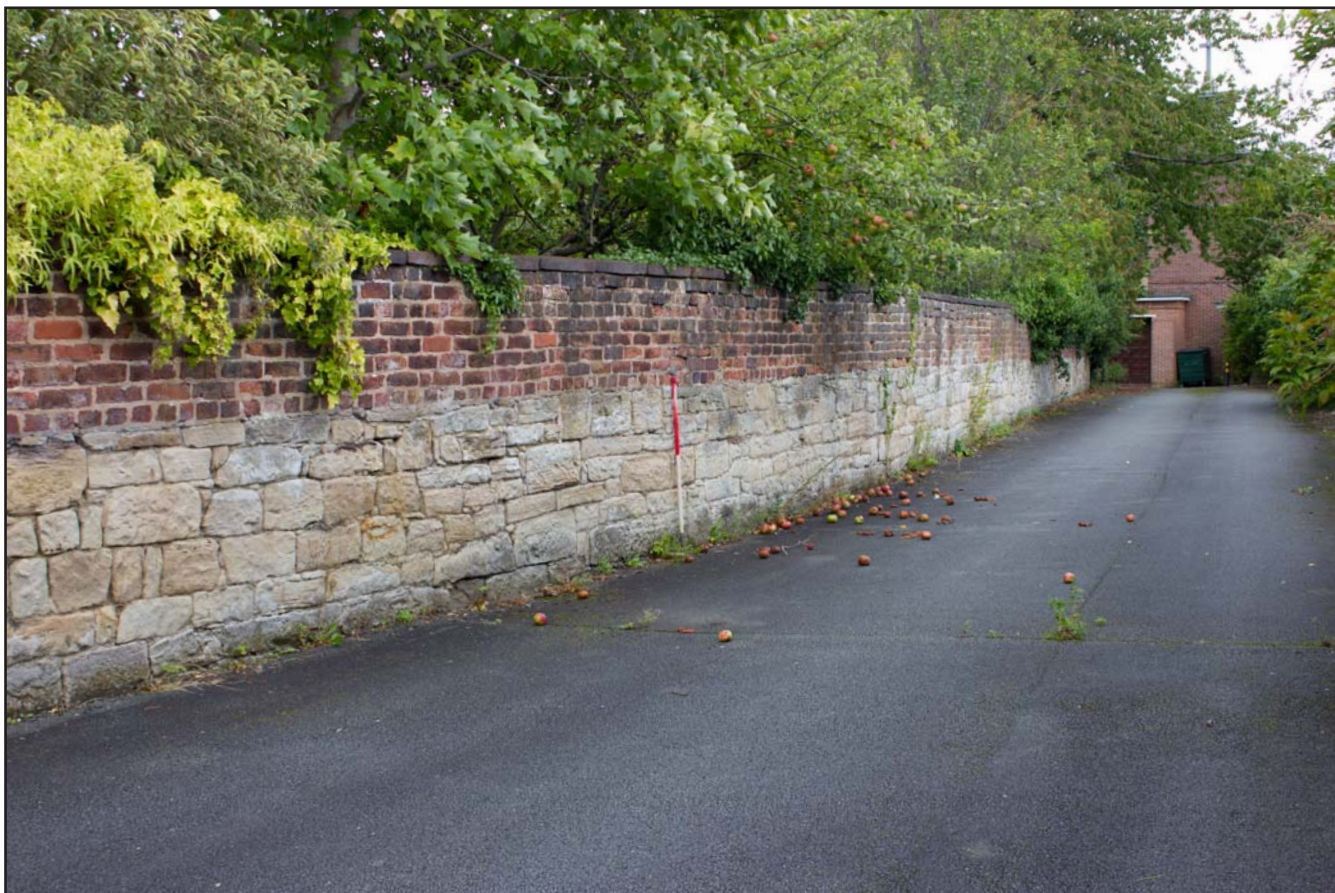
Plate 01: The carriage drive from Upper Aston Hall Lane, Poor Clare's Monastery, Upper Aston Hall Lane, Hawarden, Flintshire - from the west - scale 1m

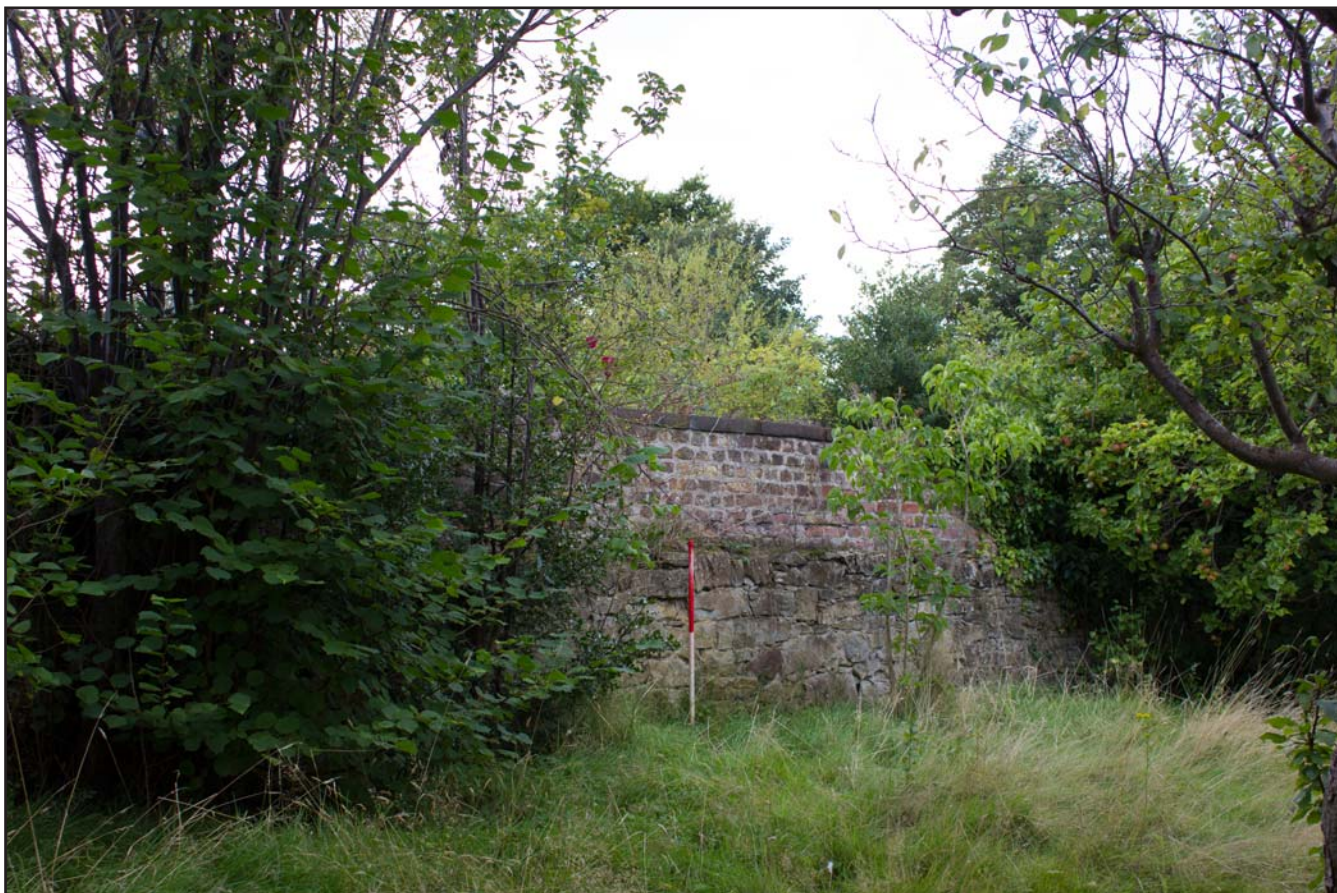
Plate 02: The carriage drive wall from the formal gardens, Poor Clare's Monastery, Upper Aston Hall Lane, Hawarden, Flintshire - from the northeast - scale 1m

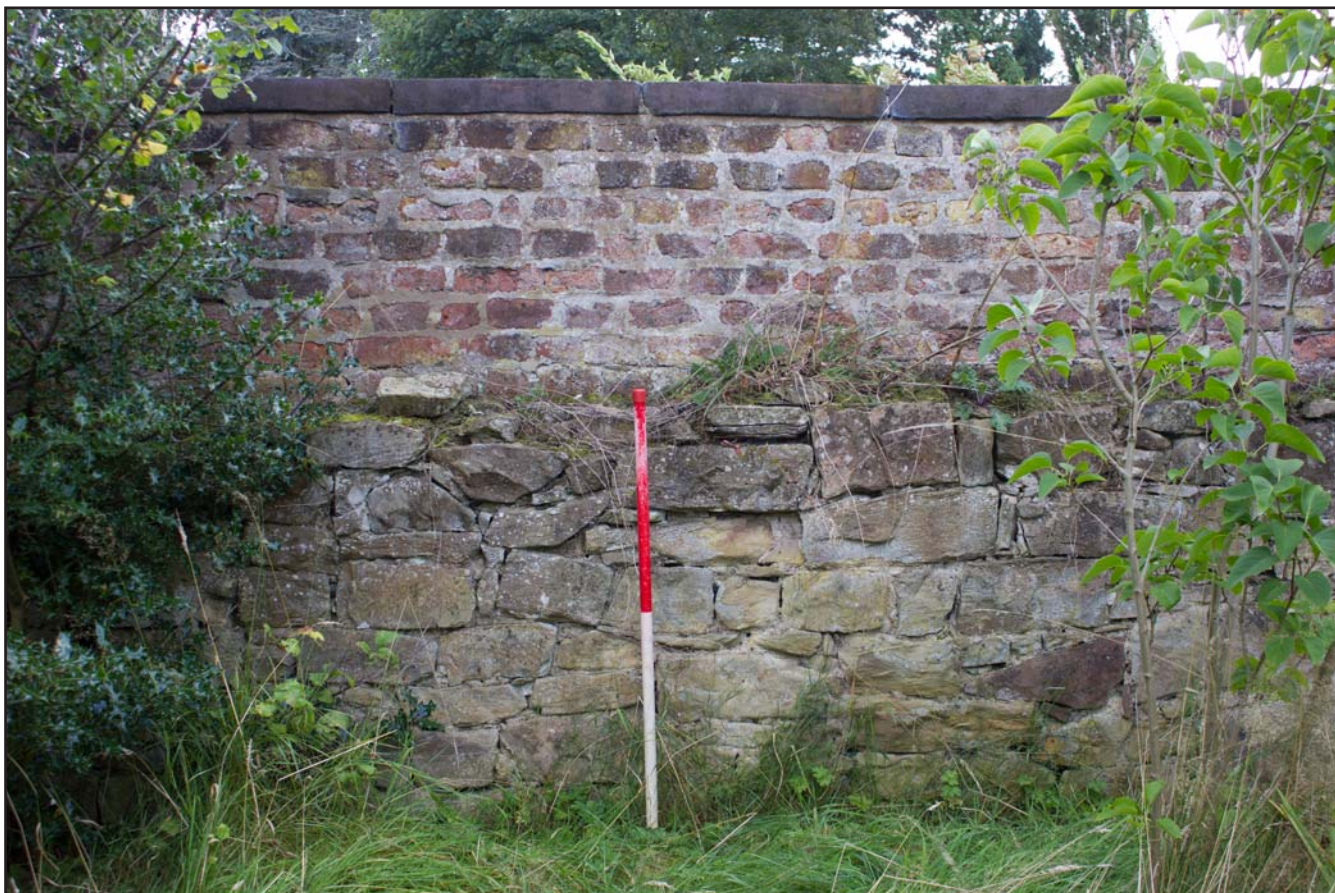
Plate 03: Example section of the carriage drive wall from the formal gardens, Poor Clare's Monastery, Upper Aston Hall Lane, Hawarden, Flintshire - from the northwest - scale 1m

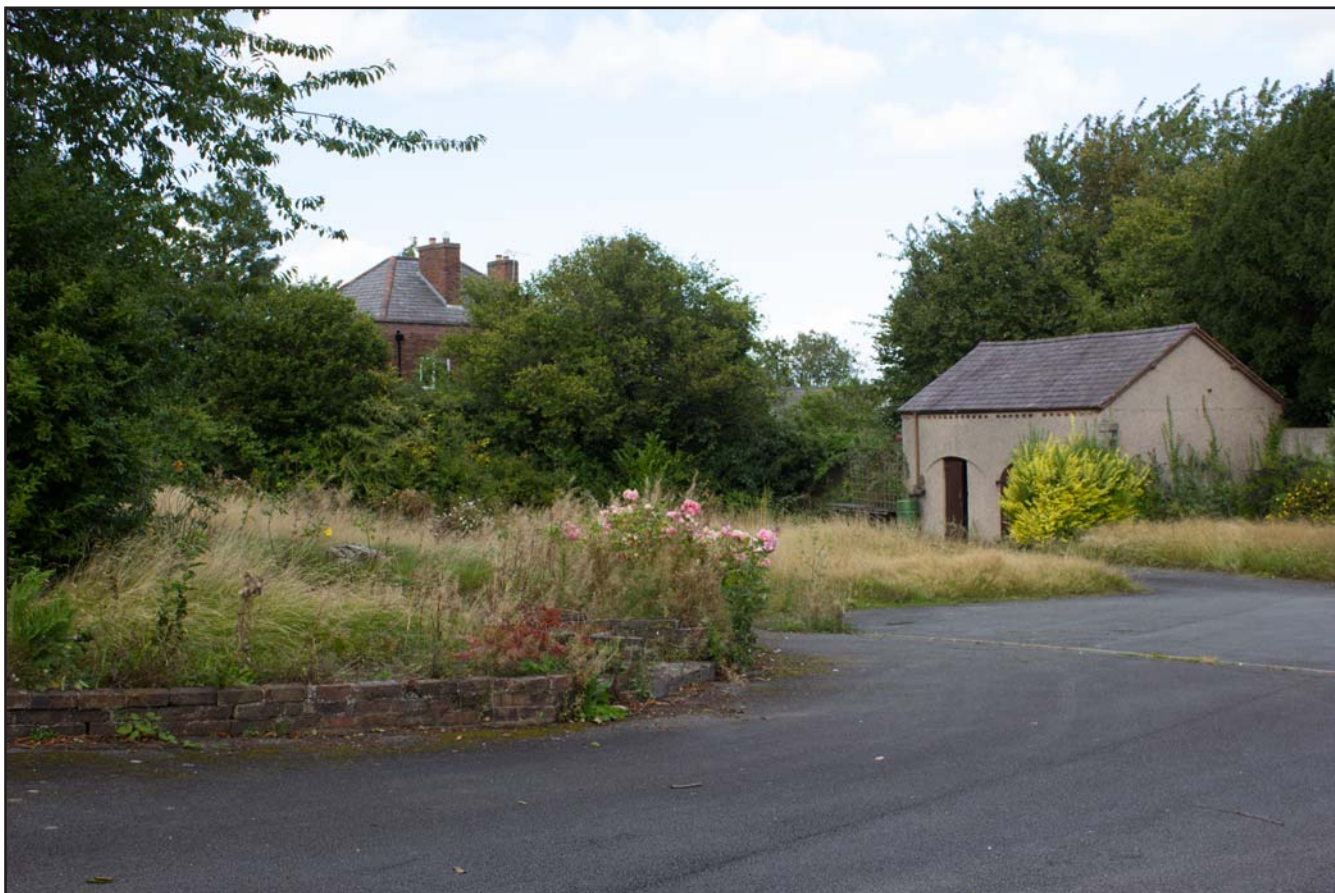
Plate 04: Context shot of formal gardens and Cart Shed, Poor Clare's Monastery, Upper Aston Hall Lane, Hawarden, Flintshire - from the south - scale 1m

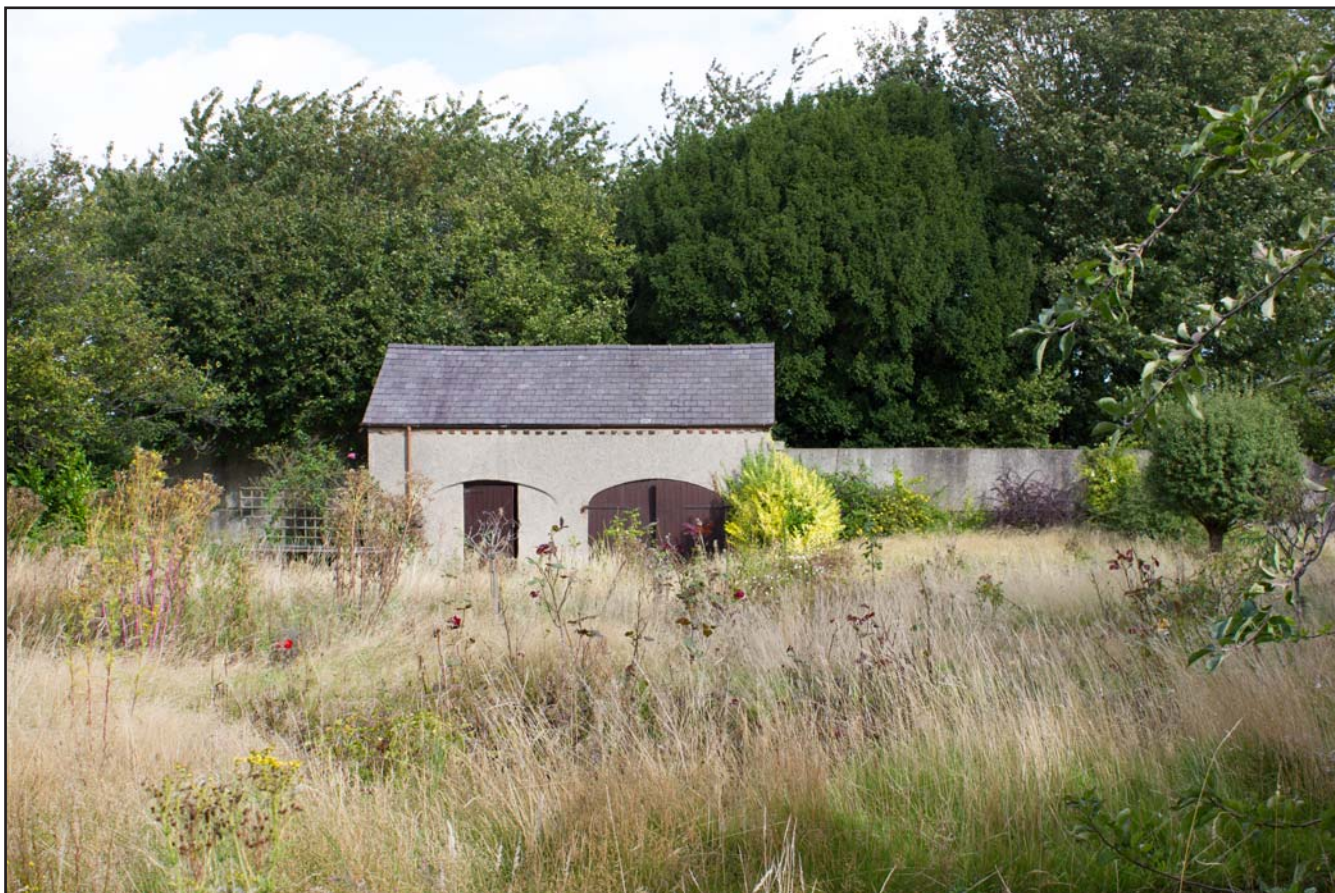
Plate 05: Context shot of formal gardens and Cart Shed, Poor Clare's Monastery, Upper Aston Hall Lane, Hawarden, Flintshire - from the southwest - scale 1m

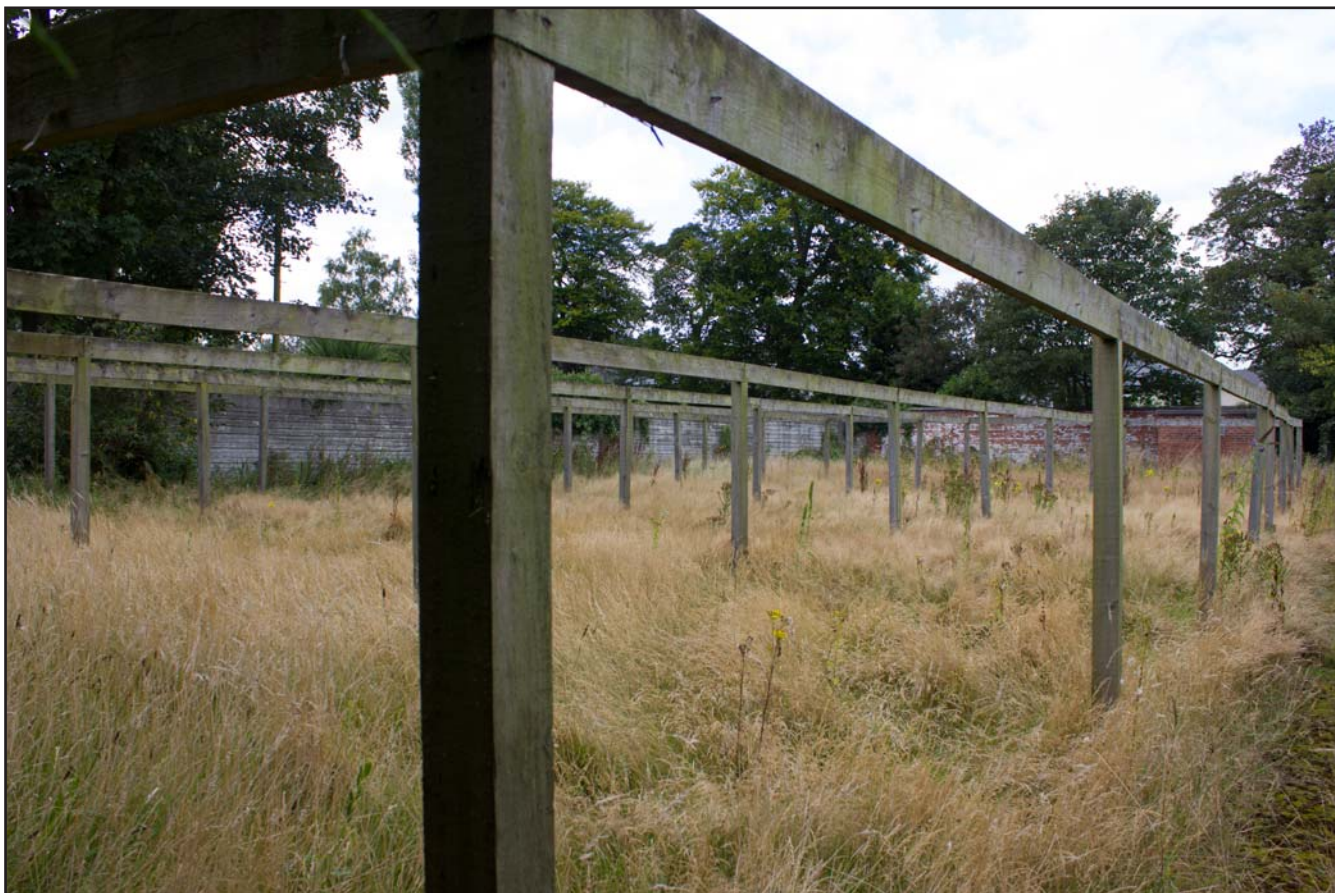
Plate 06: Context shot of kitchen gardens and boundary wall, Poor Clare's Monastery, Upper Aston Hall Lane, Hawarden, Flintshire - from the west - scale 1m

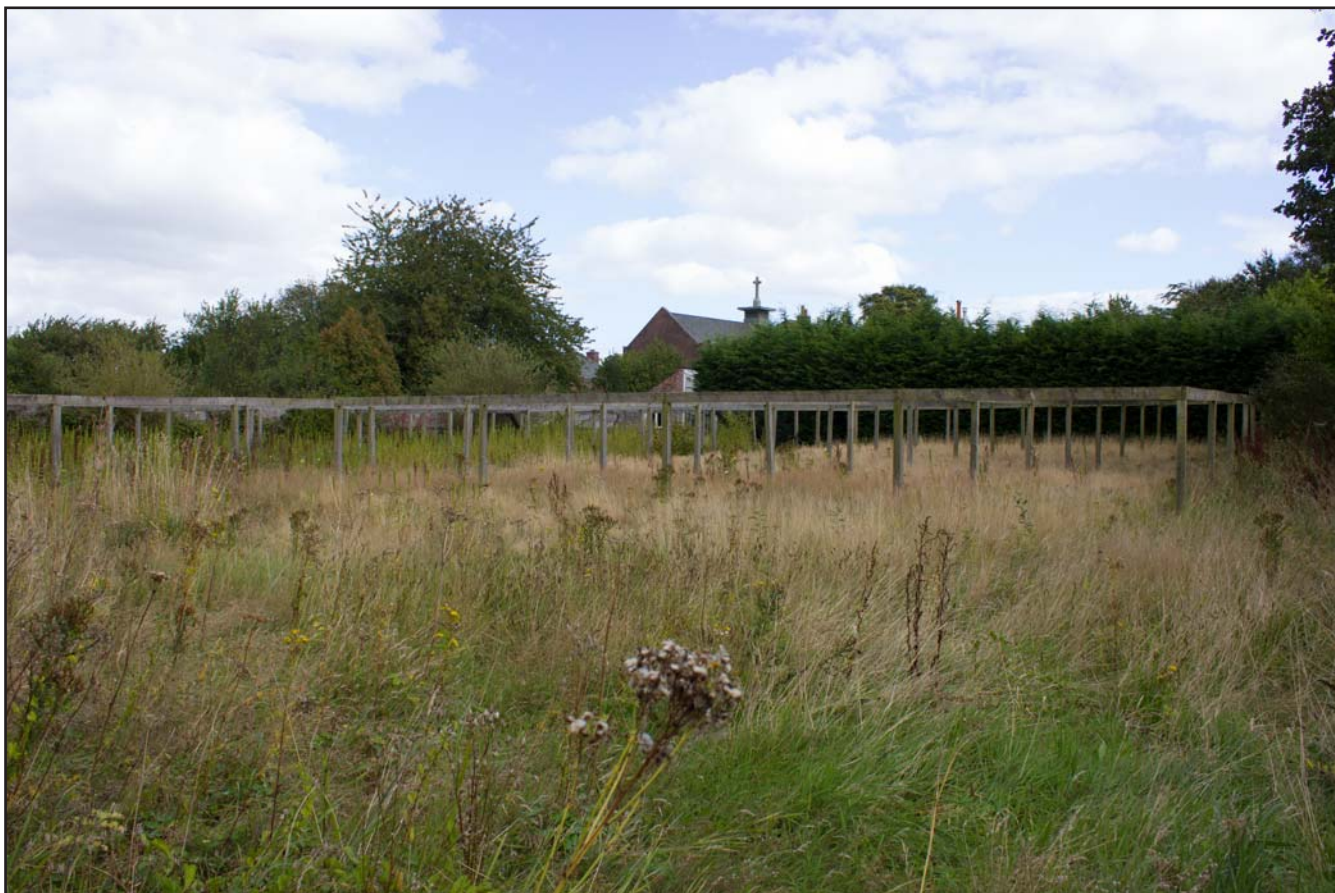
Plate 07: Context shot of kitchen gardens and Glasshouse (background), Poor Clare's Monastery, Upper Aston Hall Lane, Hawarden, Flintshire - from the east - scale 1m

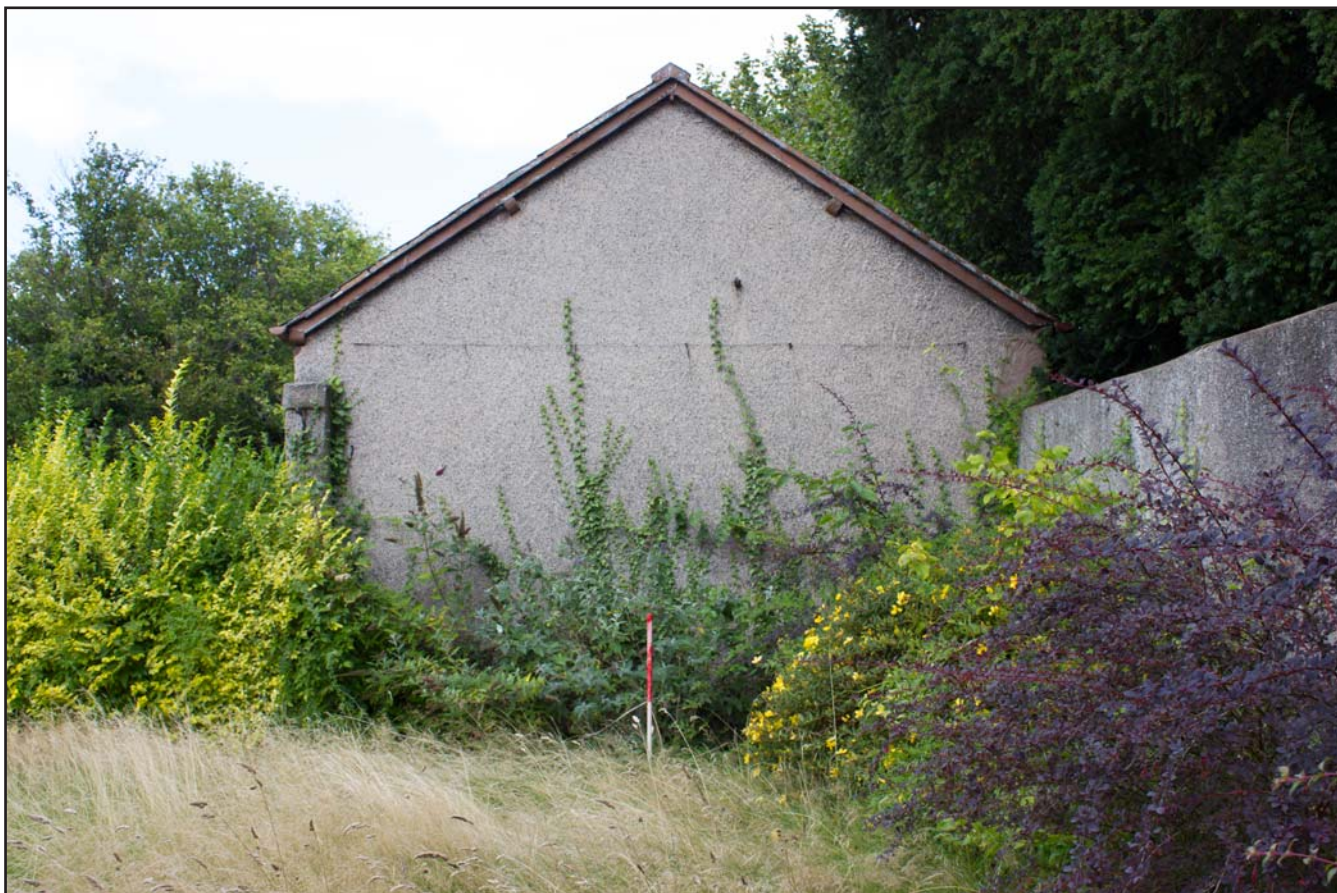
Plate 08: South eastern elevation of the Cart Shed, Poor Clare's Monastery, Upper Aston Hall Lane, Hawarden, Flintshire - from the west - scale 1m

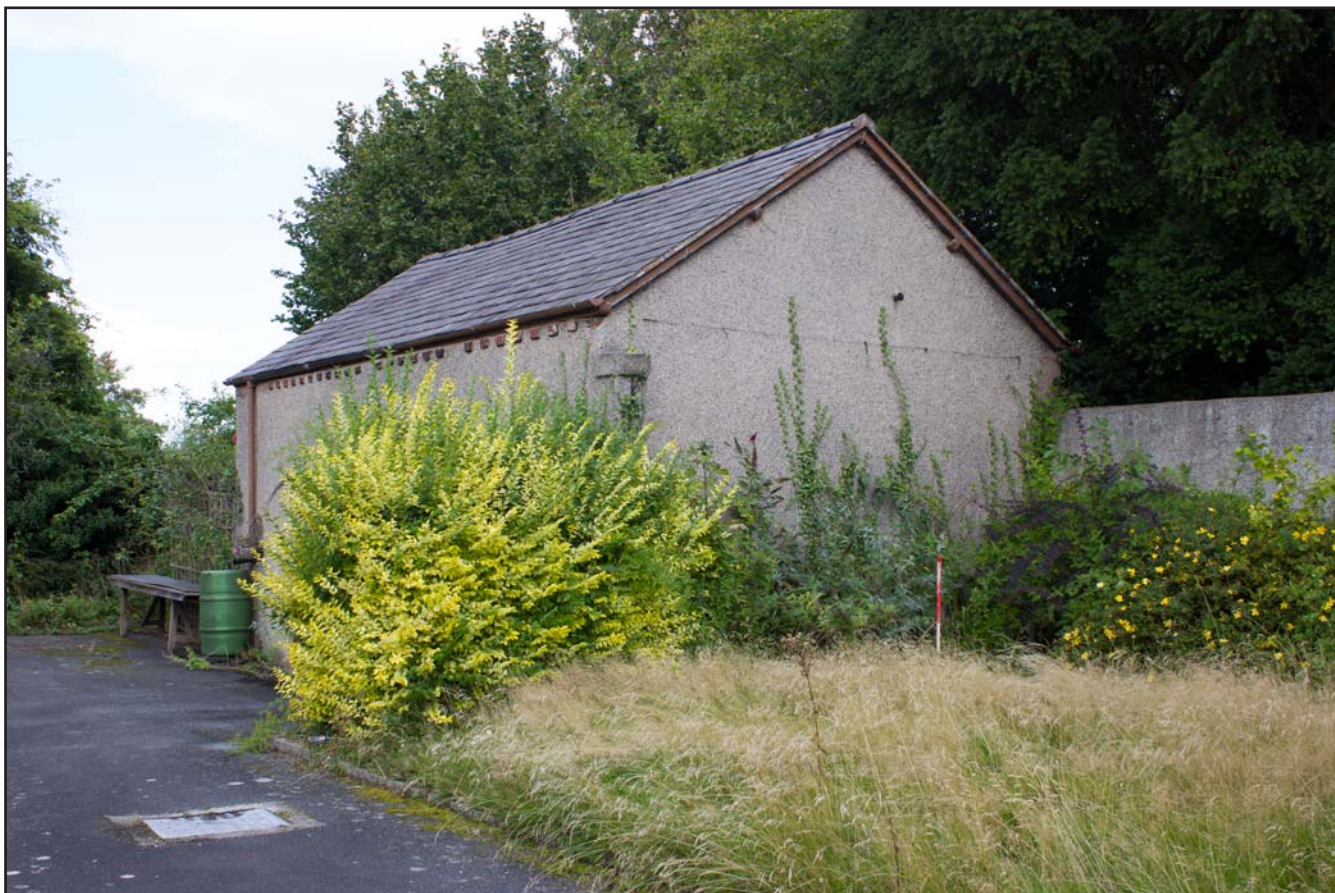
Plate 09: South eastern and south western elevations of the Cart Shed, Poor Clare's Monastery, Upper Aston Hall Lane, Hawarden, Flintshire - from the south - scale 1m

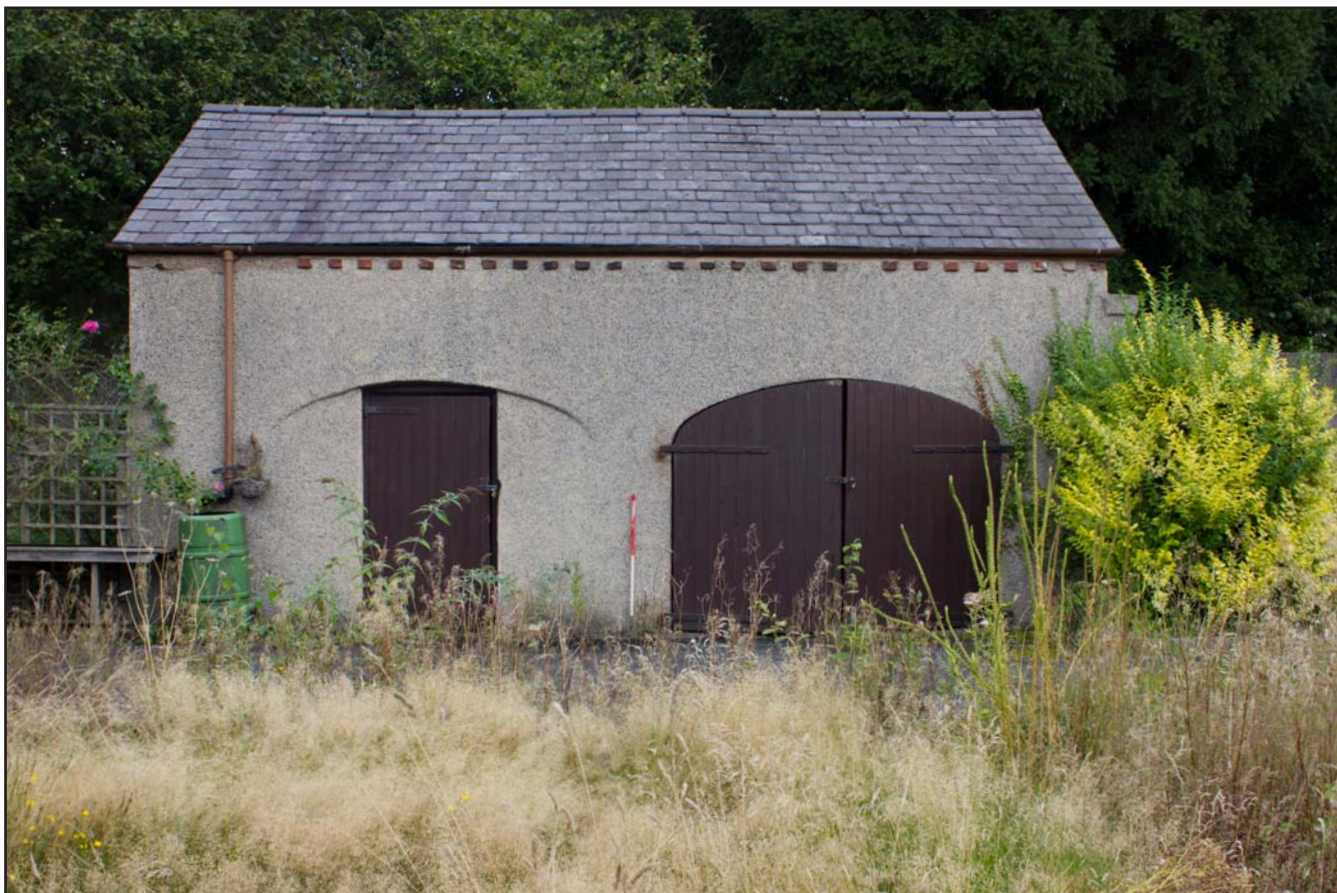
Plate 10: South western elevation of the Cart Shed, Poor Clare's Monastery, Upper Aston Hall Lane, Hawarden, Flintshire - from the southwest - scale 1m

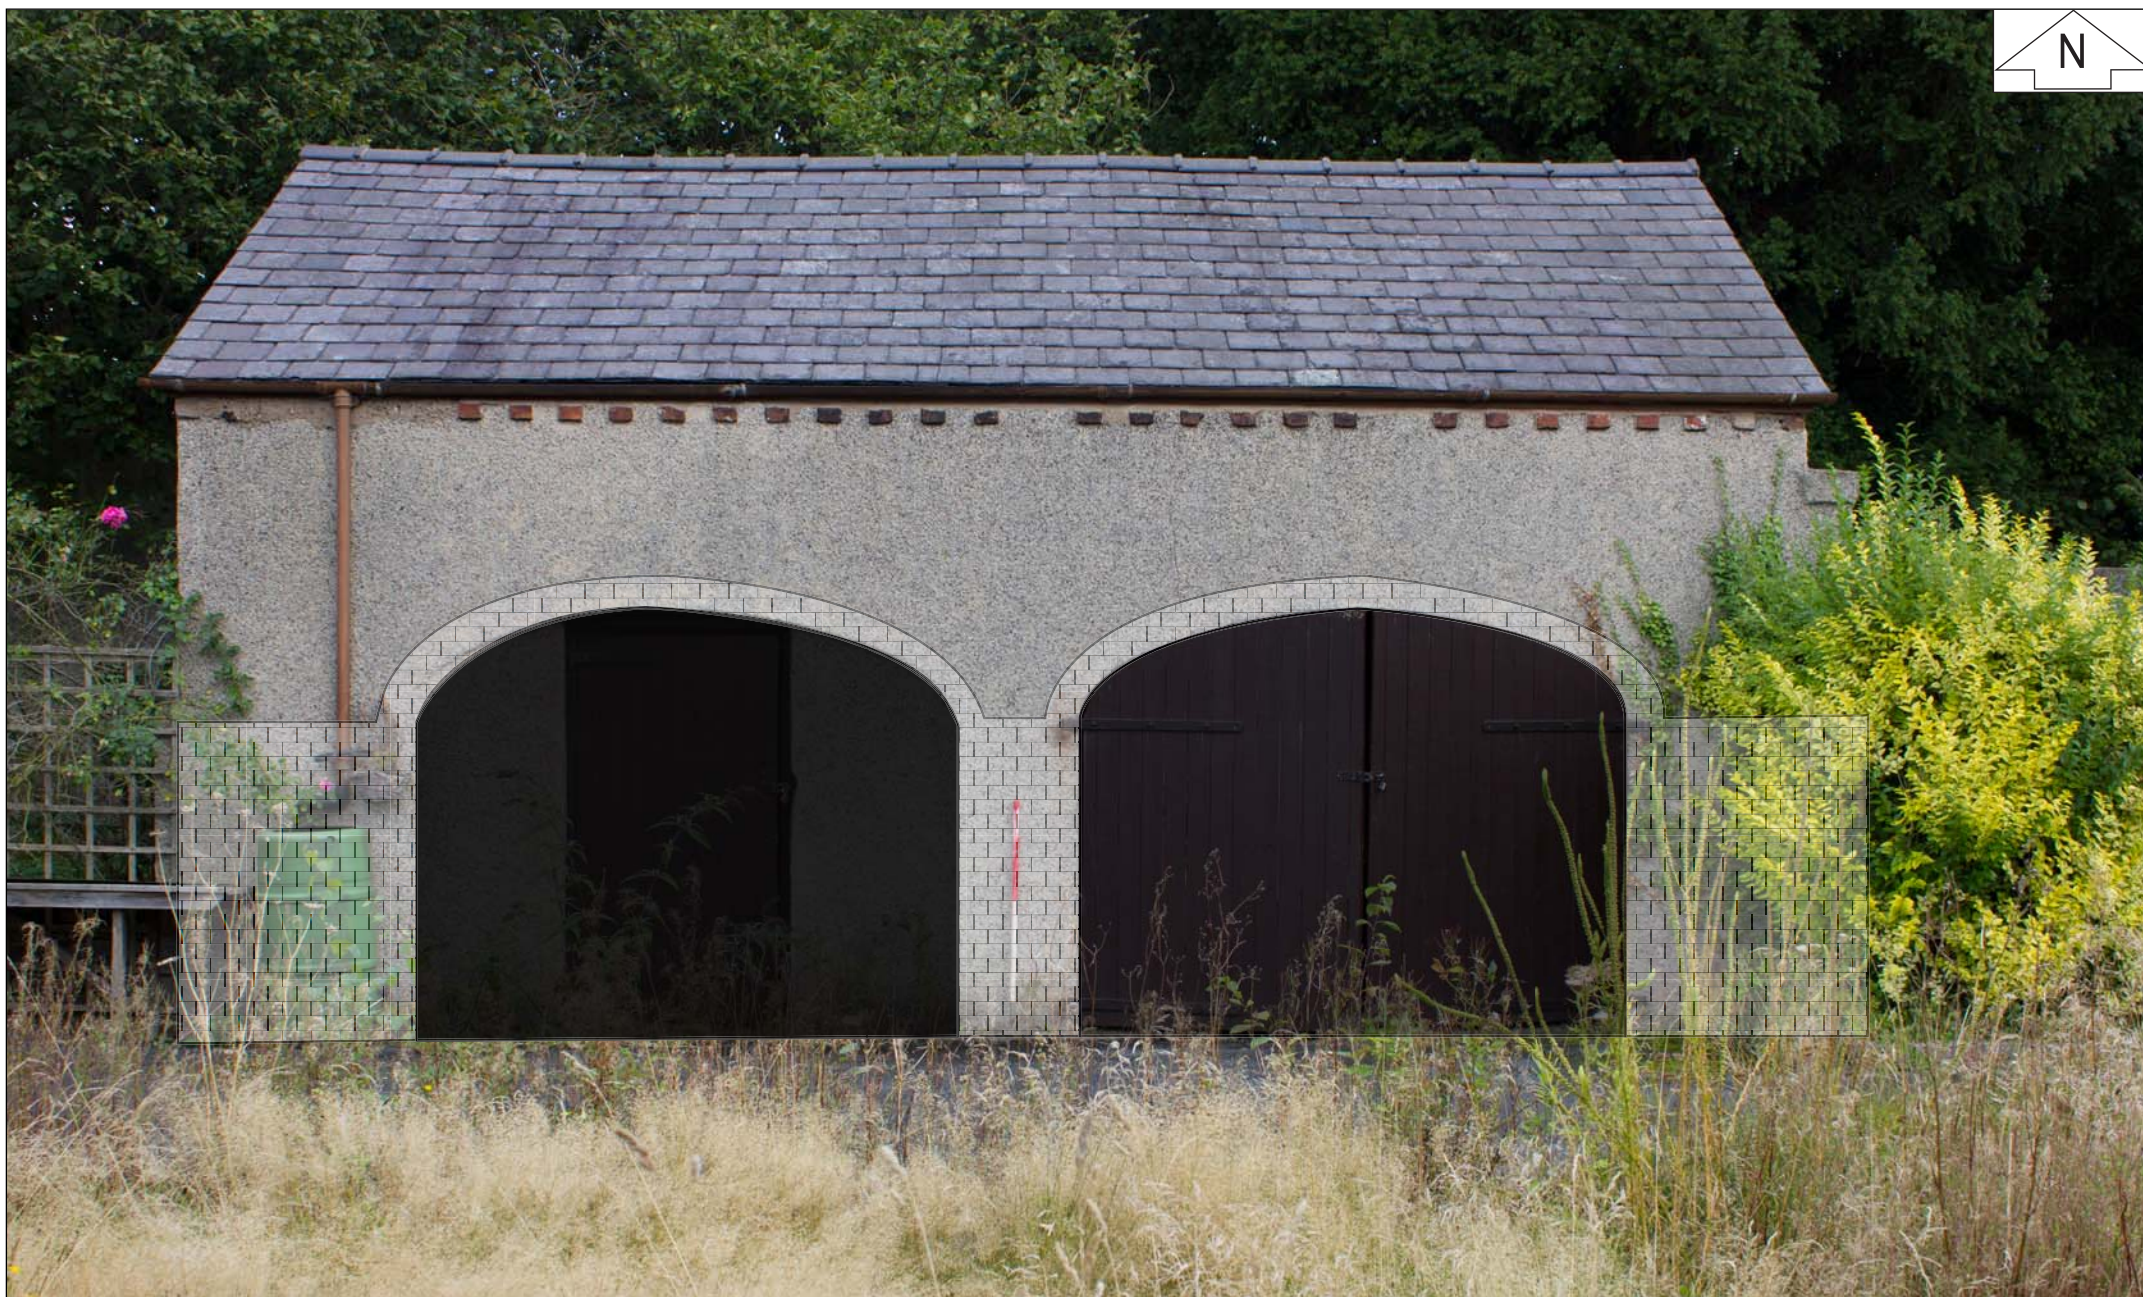
Figure 09. Mock up of the south western elevation of the Cart Shed depicting how the original facade would have appeared with two double cart doors. Scale 1m.

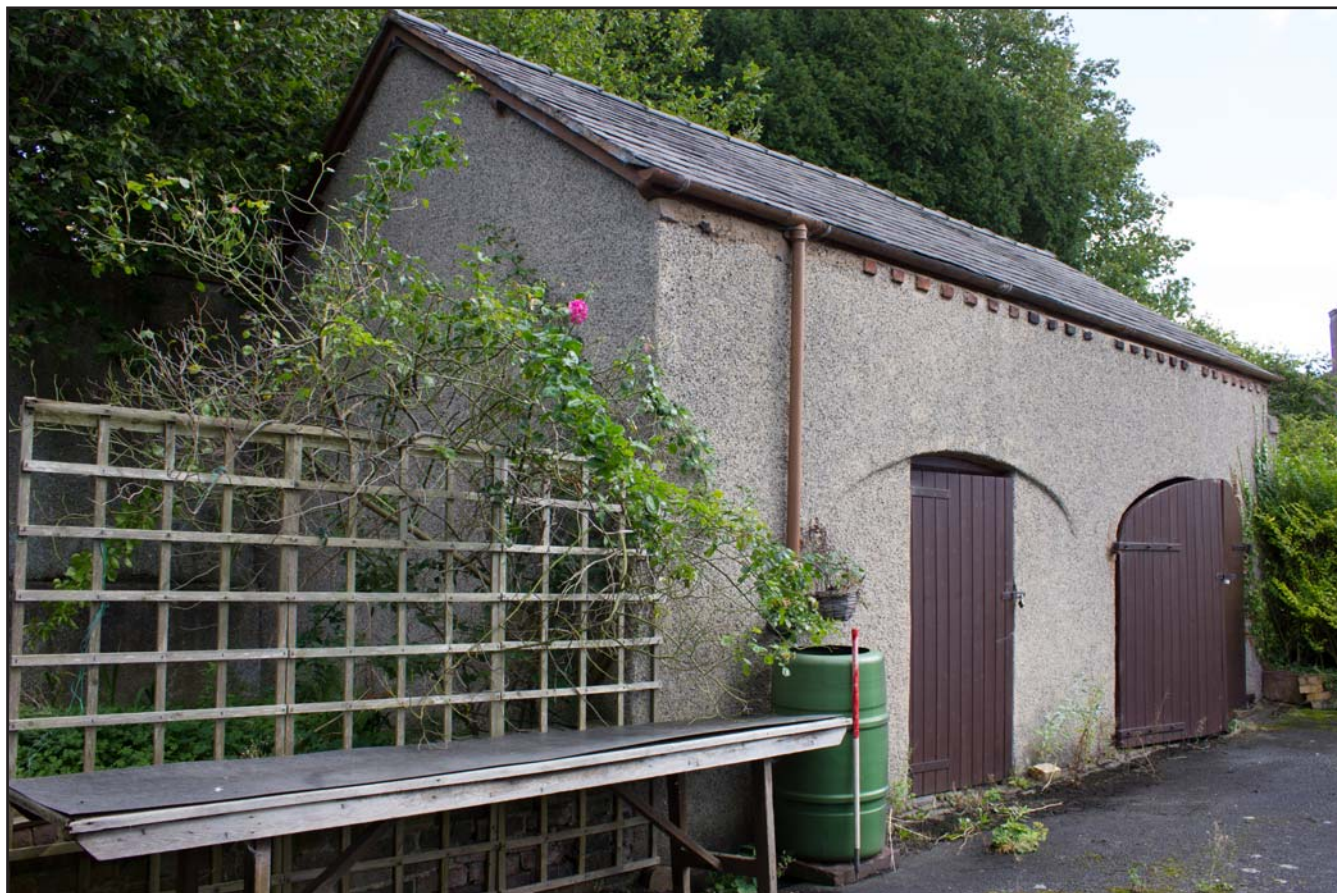
Plate 11: South western and north western elevations of the Cart Shed, Poor Clare's Monastery, Upper Aston Hall Lane, Hawarden, Flintshire - from the west - scale 1m

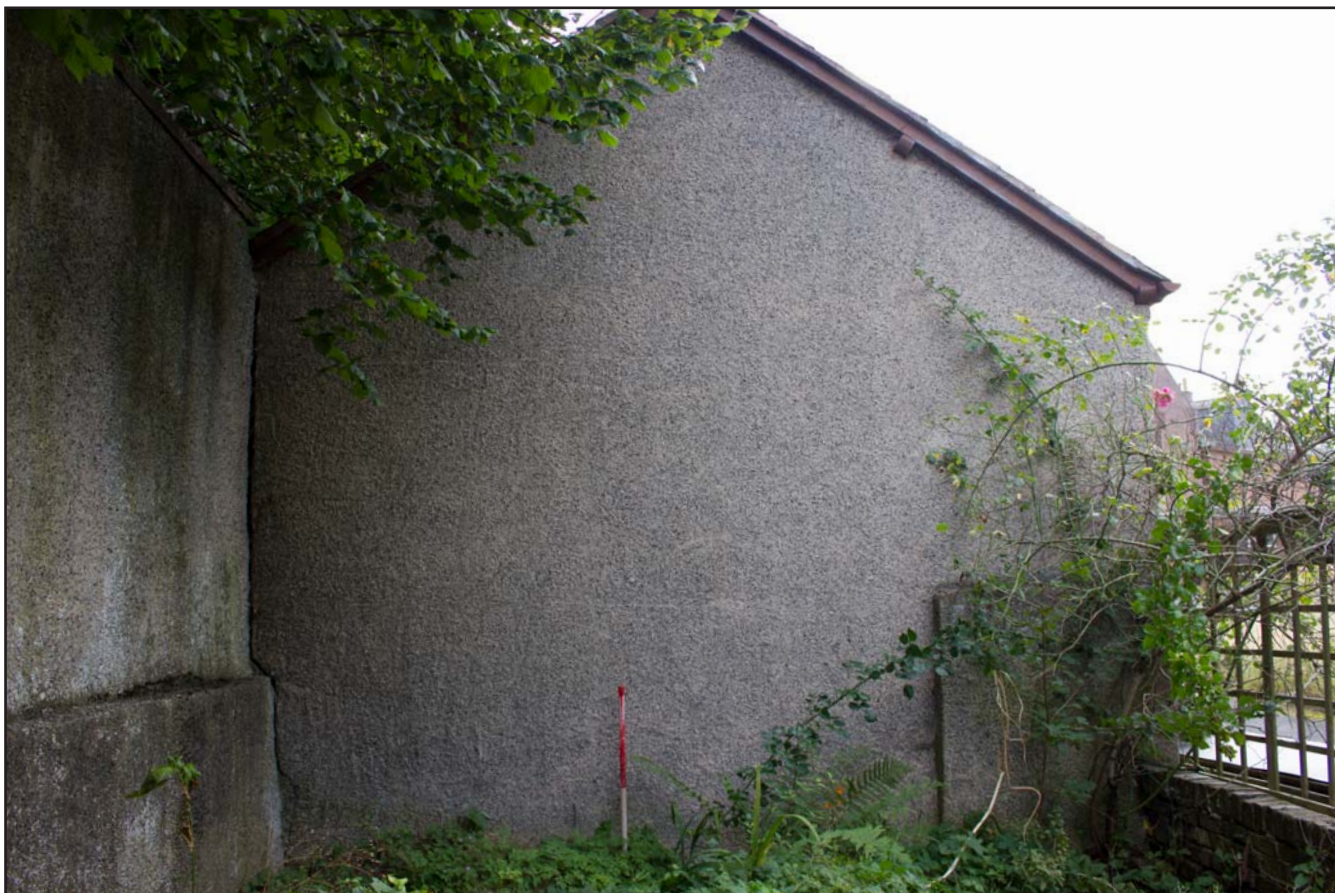
Plate 12: North western elevation of the Cart Shed, Poor Clare's Monastery, Upper Aston Hall Lane, Hawarden, Flintshire - from the northwest - scale 1m

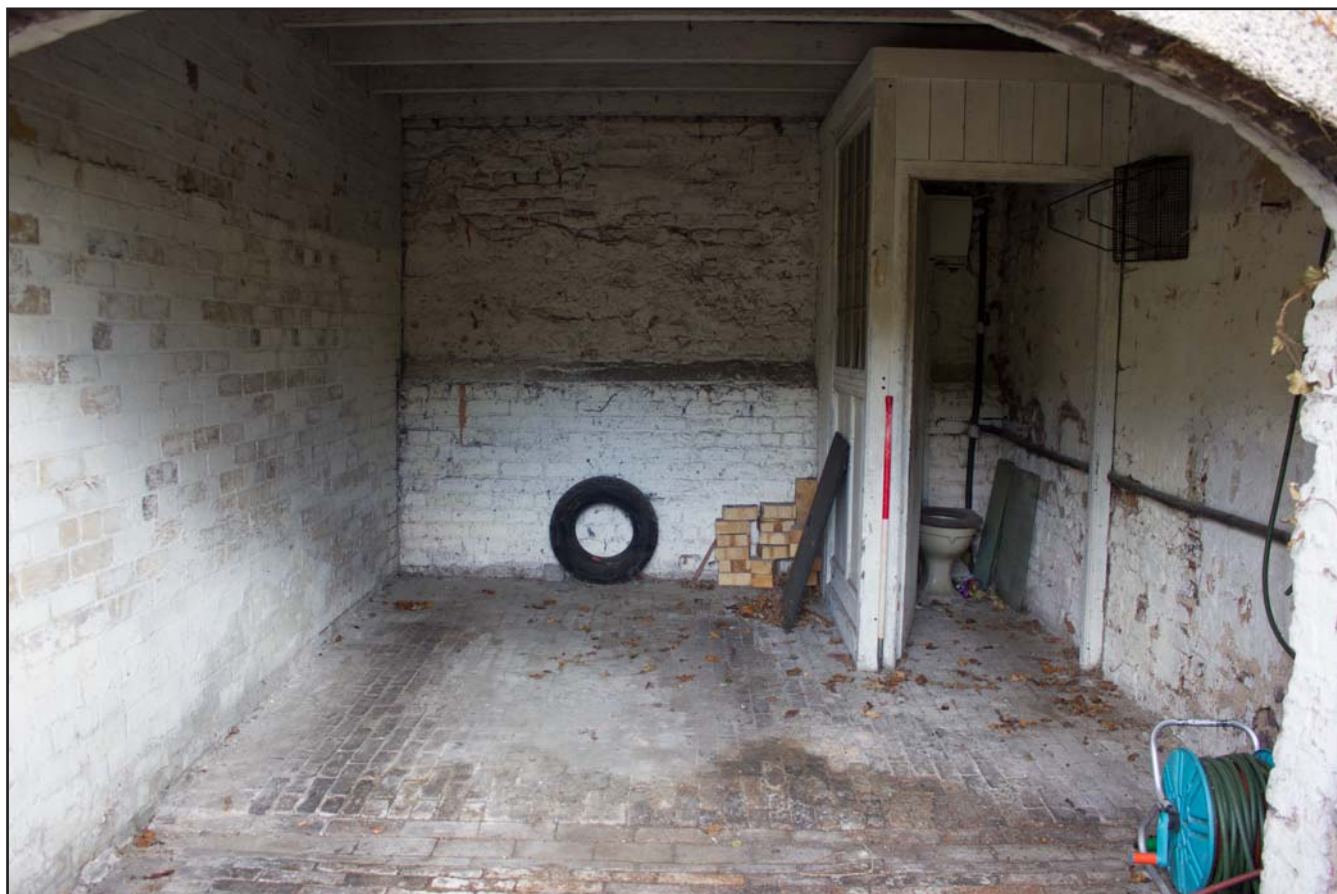
Plate 13: Interior of Cart shed 1, Poor Clare's Monastery, Upper Aston Hall Lane, Hawarden, Flintshire - from the northwest - scale 1m

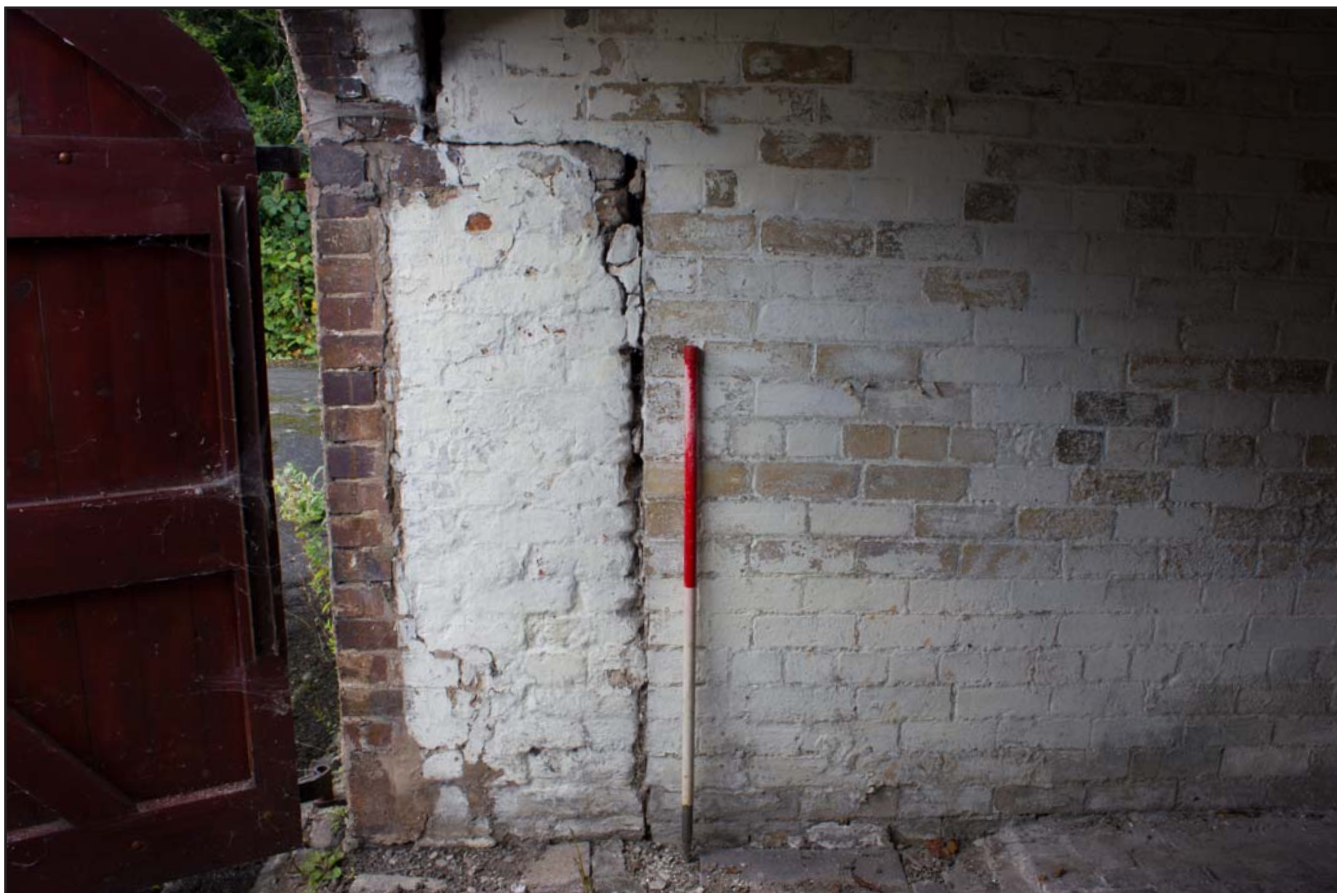
Plate 14: Partition wall and original pillar within Cart Shed 1, Poor Clare's Monastery, Upper Aston Hall Lane, Hawarden, Flintshire - from the northwest - scale 1m

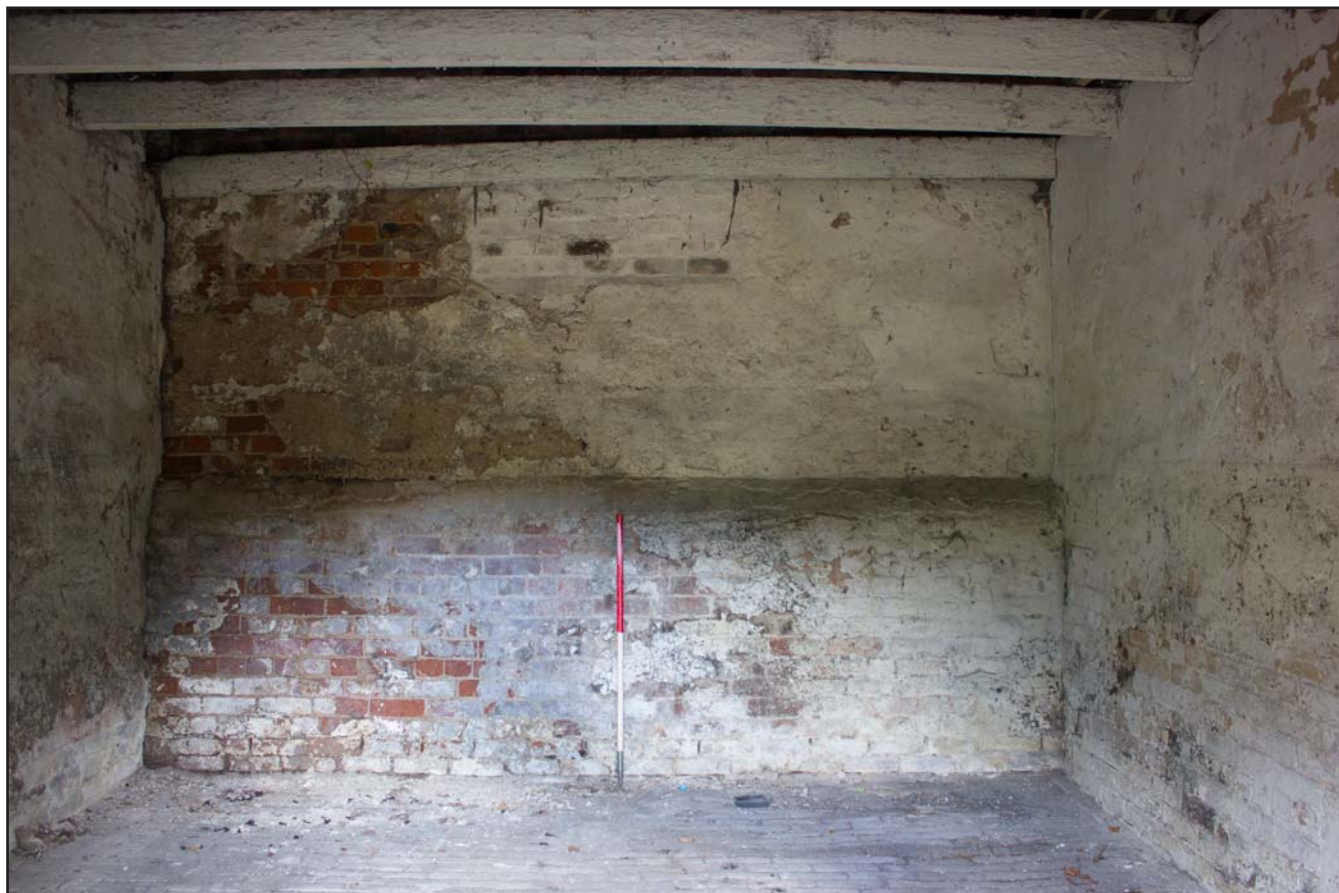
Plate 15: Interior of Cart shed 2, Poor Clare's Monastery, Upper Aston Hall Lane, Hawarden, Flintshire - from the northwest - scale 1m

This is a rectangular room orientated northeast to southwest, measuring 4.60m long by 4.00m wide. The ceiling is once more open to the roof pitch with the rafters visible above the hayloft floor joists; however, the central floor joist is missing in this room. The north western elevation is constructed from red brick bonded by lime mortar and has been rendered two-thirds of the way up from the floor and painted white. Above this level the bricks are exposed; visible near the apex of the roof pitch is a much larger opening (compared to cart shed (1)) this opening has also been bricked up but may once have been an access hatch for the hayloft it has a wooden lintel.

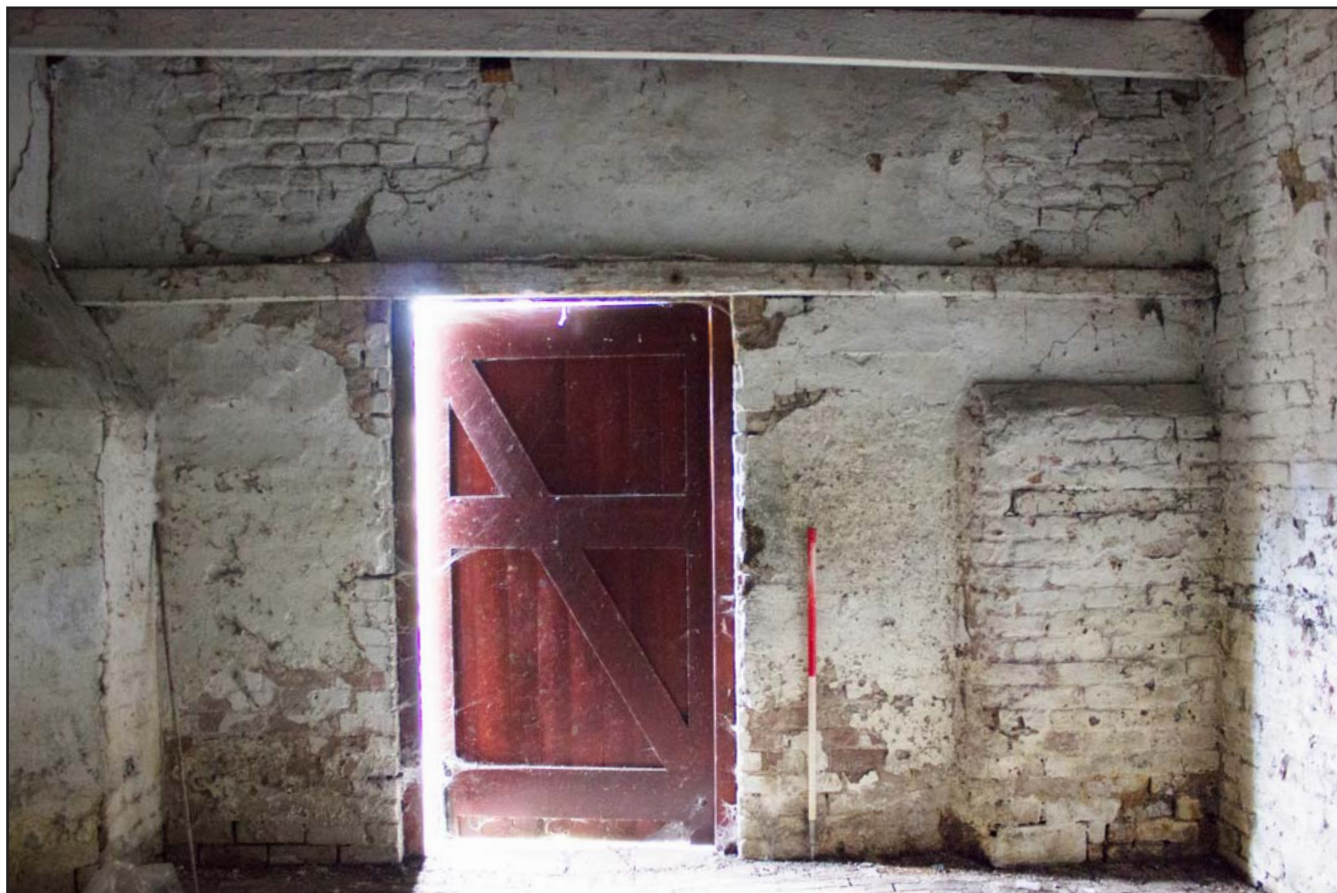
Plate 16: South western elevation of Cart shed 2, Poor Clare's Monastery, Upper Aston Hall Lane, Hawarden, Flintshire - from the northwest - scale 1m

The south western elevation has a single doorway opening to the left of centre which permits access to the exterior via a brown stained wooden board door set within brown painted wooden frame. At the left-hand end of the elevation is the substantial brick pillar mentioned in the paragraph above and at the right-hand end of the elevation is another smaller single course brick pillar; both of which are constructed from handmade redbrick bonded by lime mortar. Running the length of the elevation is a single substantial sawn timber beam which runs across the top of the doorframe; this beam obscures the remnants of a brick archway identical to that found in the first car shed, beneath the beam and in between the two brick pillars the masonry changes to machine-made red bricks (see figure 10) bonded by Portland cement, suggesting that the original elliptical archway was partially removed in the area between the two brick pillars and then the doorway was bricked up before a single doorway was installed. The floor is of heavily worn, narrow gauge blue bricks, these bricks are much narrower in profile than those found on the walls. Running north-east to south-west approximately 1.0m from the threshold is the same shallow gutter found in the first cart shed to the northeast; this suggests that both rooms were used for the storage of carts, before there was a change of use and the partition wall was added and a modification was made to the south western elevation to reduce the size of the doorway opening.
