Poor Clare Colettine Monastery, Upper Aston Hall Lane, Hawarden, Flintshire CH5 3EN

Historic Building Record Level 2

Project Code: A0225.1

Report no. 0214

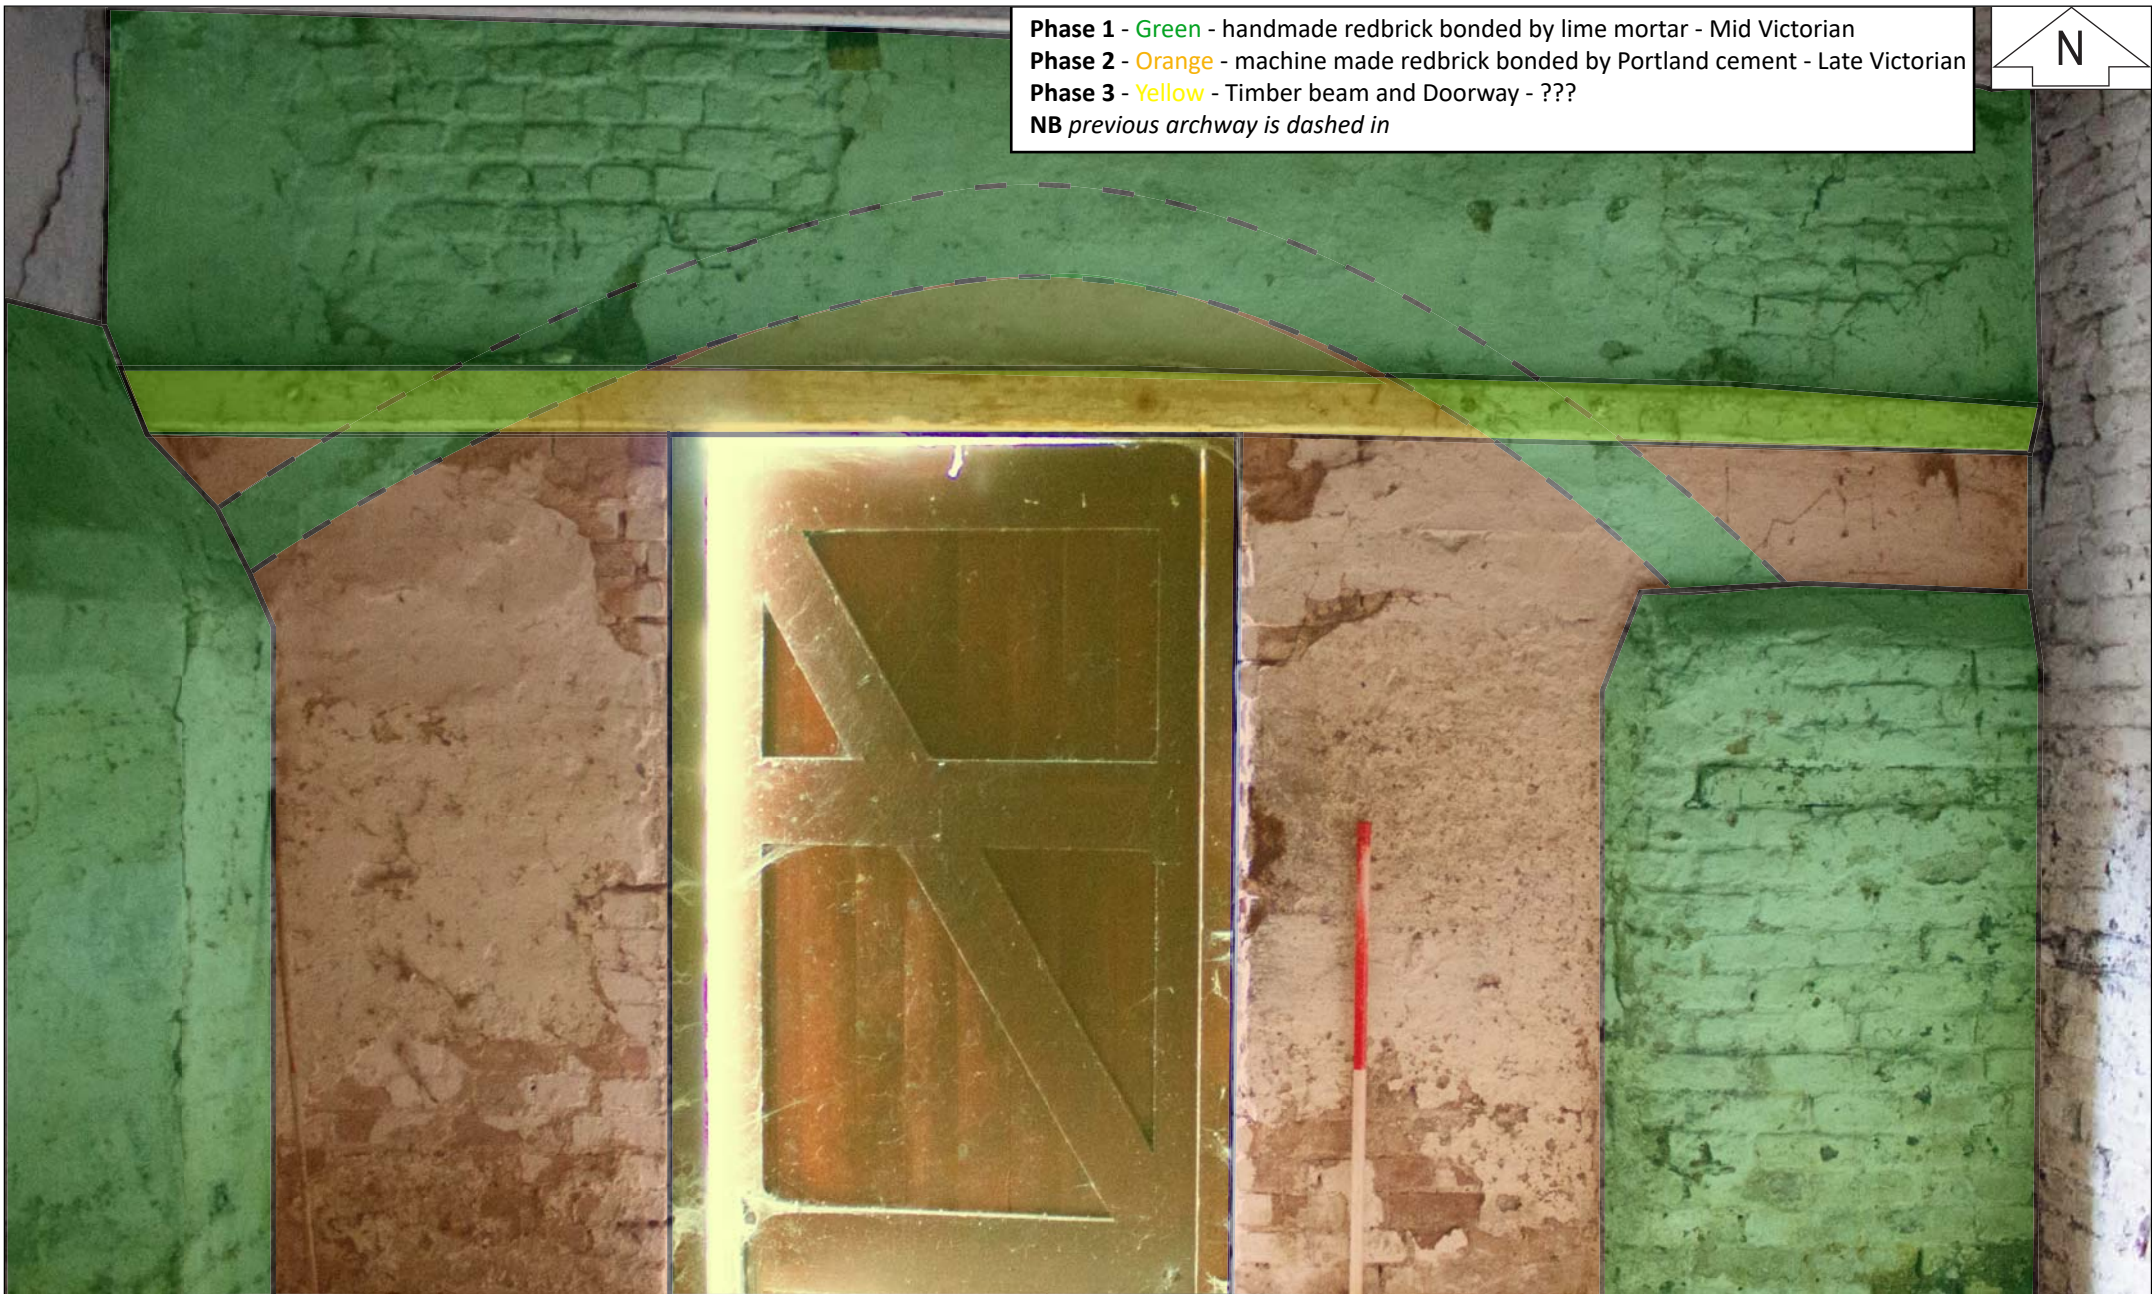
Phase 1 - Green - handmade redbrick bonded by lime mortar - Mid Victorian
Phase 2 - Orange - machine made redbrick bonded by Portland cement - Late Victorian
Phase 3 - Yellow - Timber beam and Doorway - ???
NB previous archway is dashed in

shed (2) via a brown stained wooden panelled door set within dark stained wooden frame. Visible as a shadow cast by the render above this door is another archway indicating that there was once a much wider doorway opening here which suggests that this was once a double cart shed or carriage house, with two bays, therefore representing the initial phase of the building.

The north eastern elevation exhibits the same projecting course of bricks as is found in cart shed (1) supporting the theory that the wall was constructed initially before the cart shed was built onto it. This elevation is constructed from red brick bonded by lime mortar which has been partially rendered and painted white. The south eastern elevation is constructed from machine-made redbrick bonded by Portland cement and is not tied into the masonry on the north eastern and south western elevations. The same opening (visible in cart shed (1)) is visible above the level of the joists also demonstrating that the wall is constructed of a double skin of red brick; this second skin is missing above the joists in this room. On the right-hand side of the elevation there is a projection of bricks (which are not tied into the elevation) which appear to be forming a substantial pillar (this pillar continues through the elevation form the other cart shed and was supporting the brick archway in that room).

The south western elevation has a single doorway opening to the left of centre which permits access to the exterior via a brown stained wooden board door set within brown painted wooden frame. At the left-hand end of the elevation is the substantial brick pillar mentioned in the paragraph above and at the right-hand end of the elevation is another smaller single course brick pillar; both of which are constructed from handmade redbrick bonded by lime mortar. Running the length of the elevation is a single substantial sawn timber beam which runs across the top of the doorframe; this beam obscures the remnants of a brick archway identical to that found in the first car shed, beneath the beam and in between the two brick pillars the masonry changes to machine-made red bricks (see figure 10) bonded by Portland cement, suggesting that the original elliptical archway was partially removed in the area between the two brick pillars and then the doorway was bricked up before a single doorway was installed. The floor is of heavily worn, narrow gauge blue bricks, these bricks are much narrower in profile than those found on the walls. Running north-east to south-west approximately 1.0m from the threshold is the same shallow gutter found in the first cart shed to the northeast; this suggests that both rooms were used for the storage of carts, before there was a change of use and the partition wall was added and a modification was made to the south western elevation to reduce the size of the doorway opening.

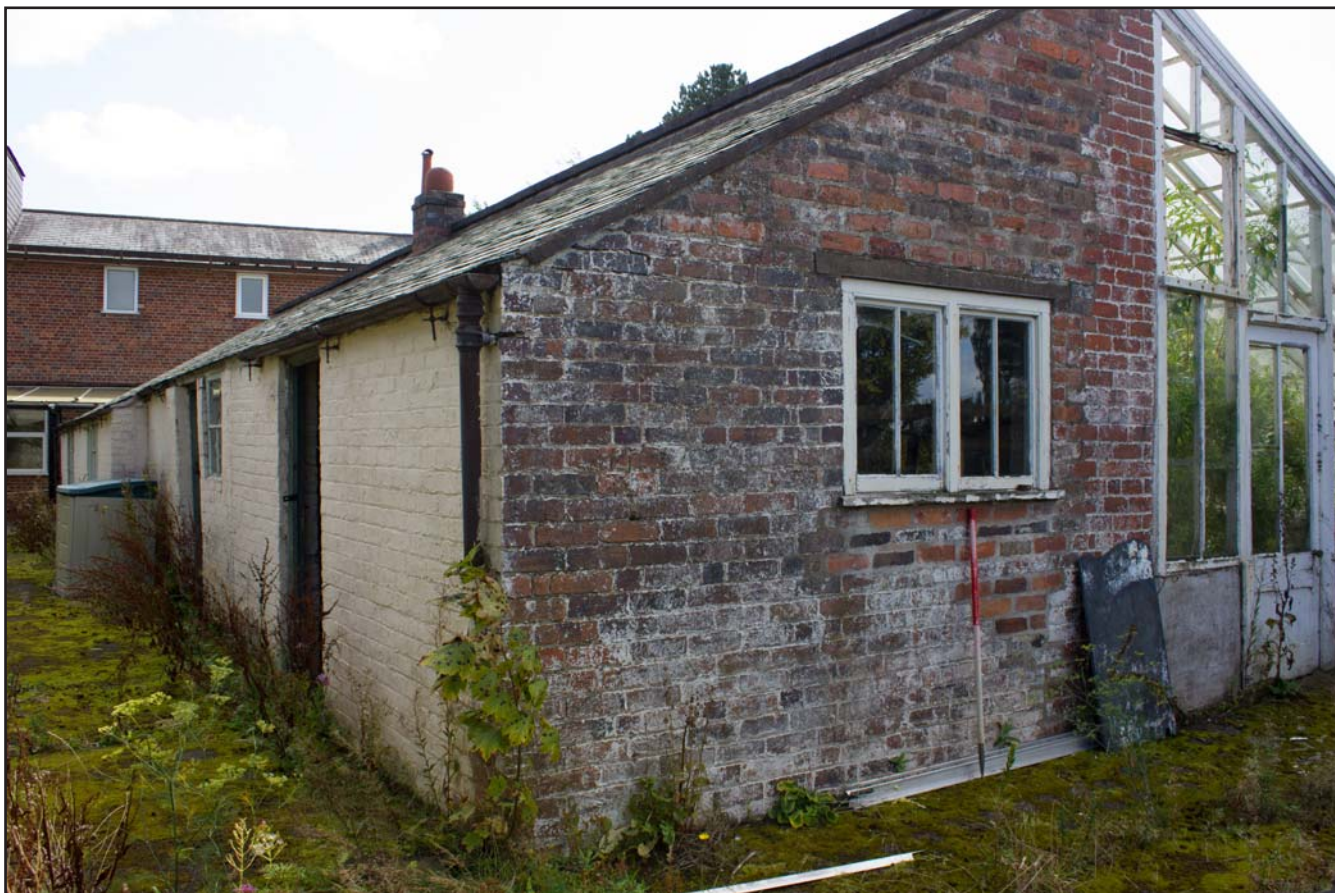
Plate 17: North eastern and north western elevations of the glasshouse and potting sheds, Poor Clare's Monastery, Upper Aston Hall Lane, Hawarden, Flintshire - from the north - scale 1m

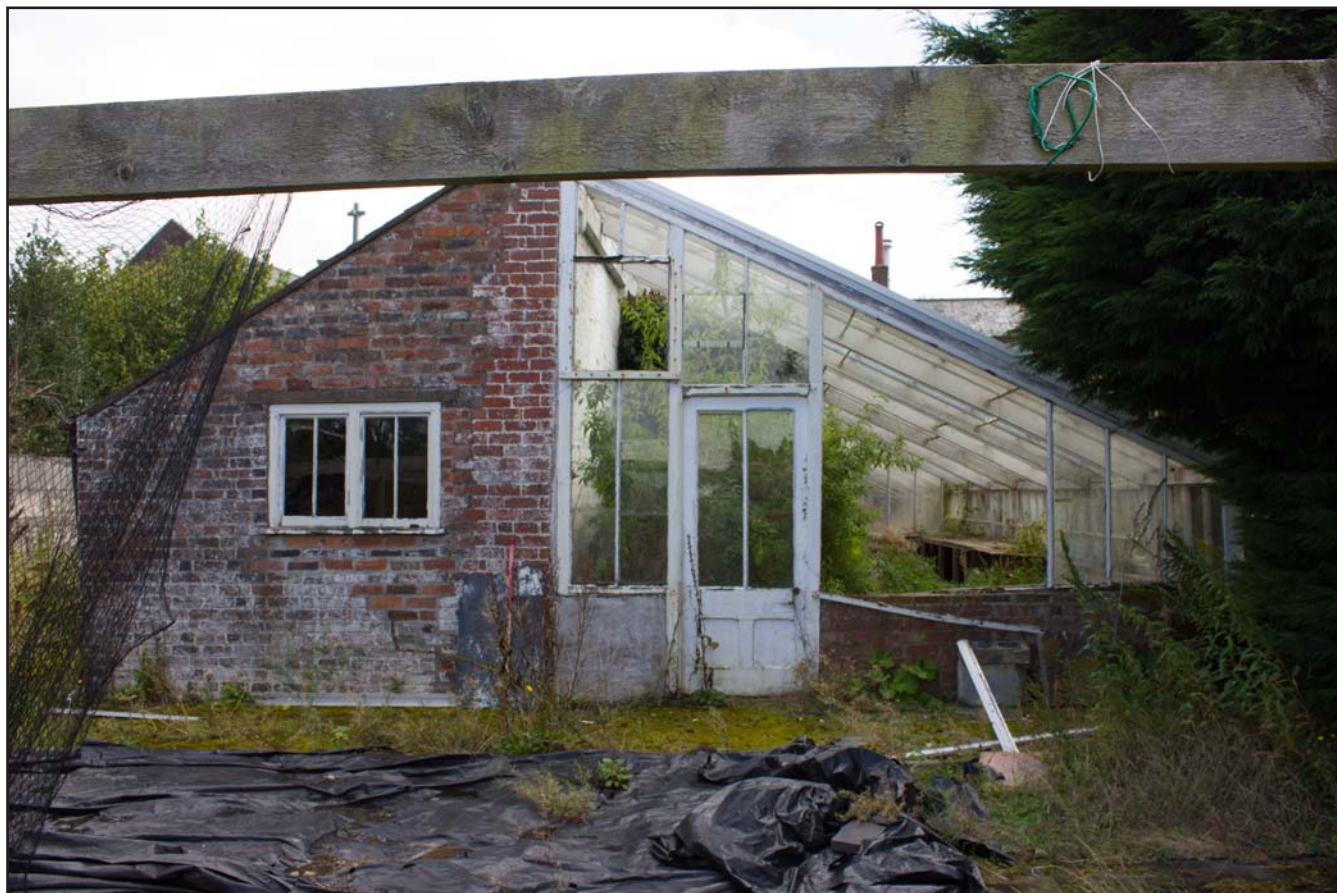
Plate 18: North western elevation of the glasshouse and potting sheds, Poor Clare's Monastery, Upper Aston Hall Lane, Hawarden, Flintshire - from the northwest - scale 1m

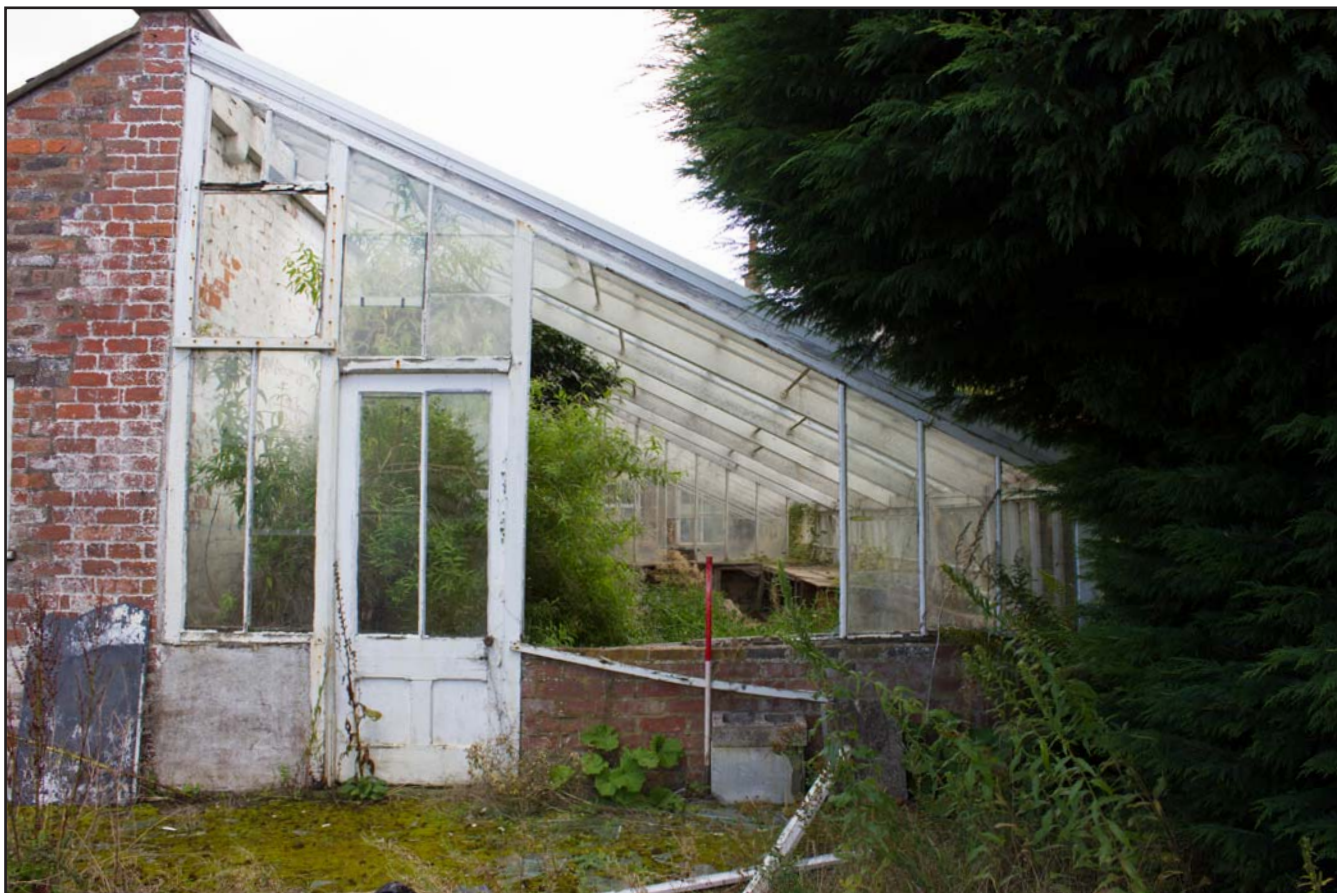
Plate 19: North western elevation of the glasshouse and potting sheds, Poor Clare's Monastery, Upper Aston Hall Lane, Hawarden, Flintshire - from the northwest - scale 1m

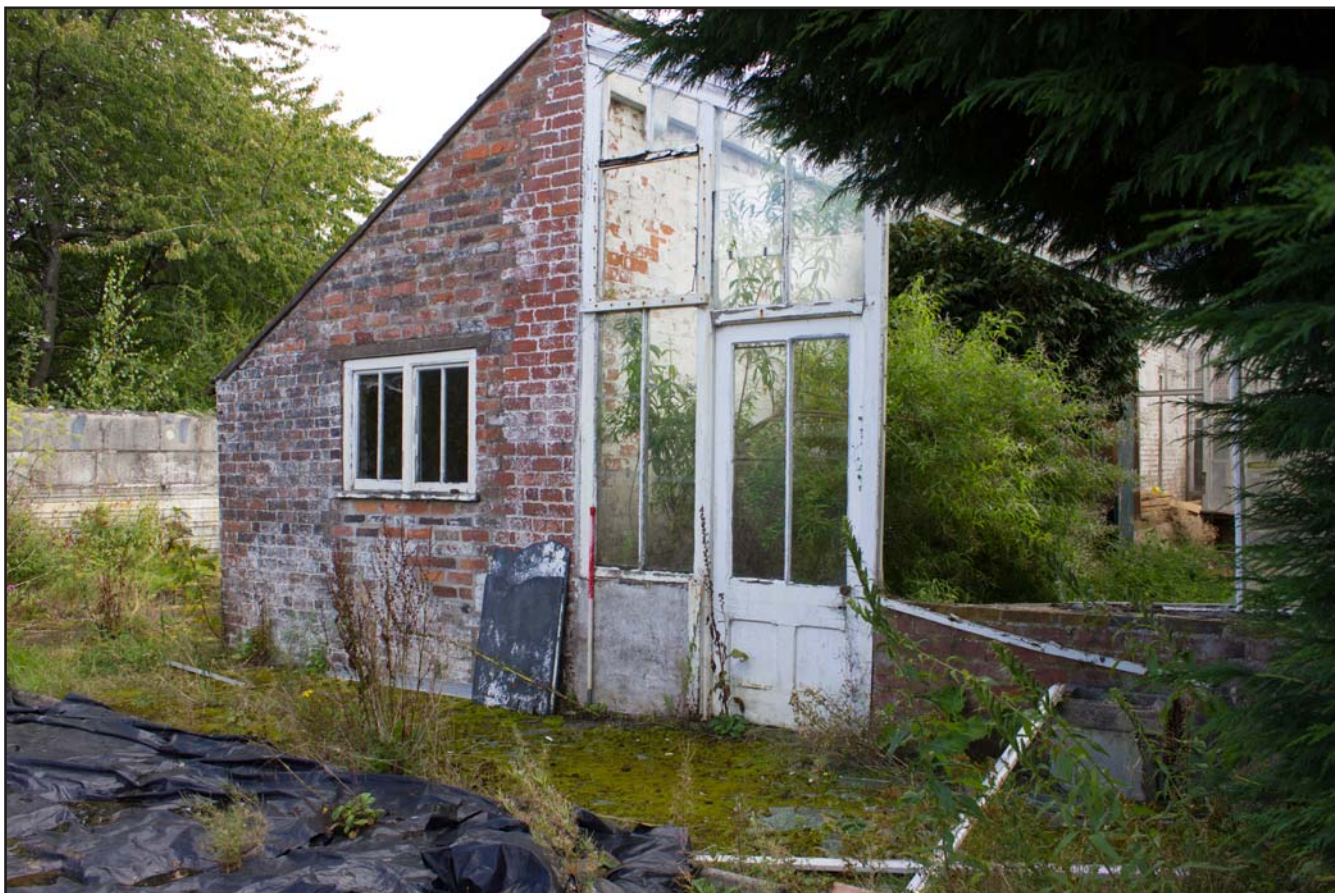
Plate 20: North western elevation (oblique view) of the glasshouse and potting sheds, Poor Clare's Monastery, Upper Aston Hall Lane, Hawarden, Flintshire - from the west - scale 1m

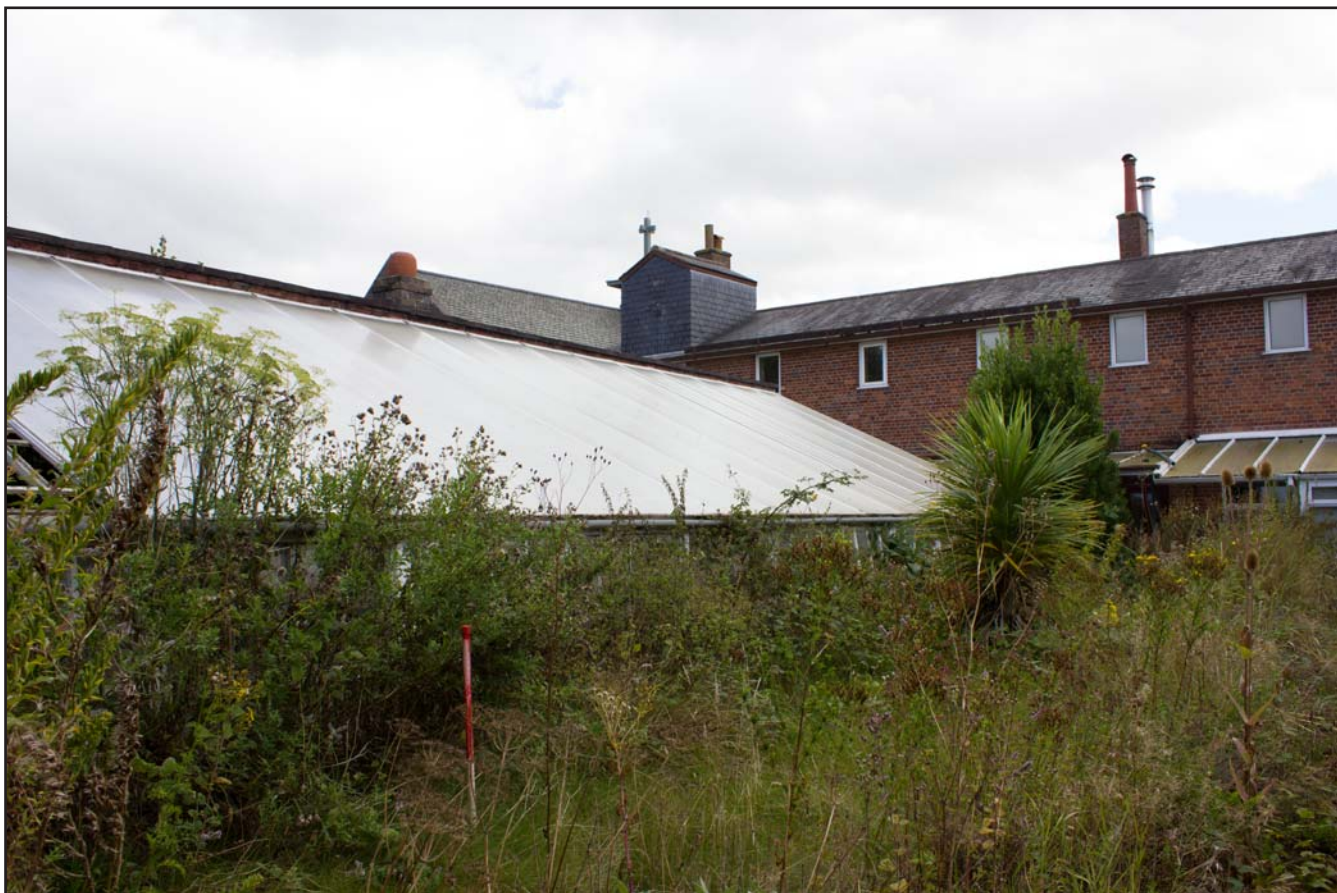
The south western elevation is very low as it receives the lowest point of the roof pitch. Along its length are six casement windows each with four glass panes set within white painted wooden frames. Running the length of the elevation and through into the north western glasshouse is a white painted iron bar/rod which connect to every other window via a metal bracket; this is a window opening mechanism. This is operated with a metal lever which is absent in this glass house but present in the other. It functions by opening the first, third and fifth windows from the left-hand side. These windows are set upon a low red brick wall bonded with lime cement which itself is obscured by a large raised bed, the wall for this bed is quite low consisting only of four courses and is constructed of red brick bonded by lime mortar. The floor of the glasshouse forms a narrow walkway connecting both the entrance to the south east and the doorway into the north western glasshouse, this floor is of poured concrete. Both of the raised beds contain a light grey brown silty sand soil. The glasshouse was also full of elements of timber, timber sheeting and plastic glazing panels at the time of this record.

Plate 21: South western elevation (oblique view) of the glasshouse and potting sheds, Poor Clare's Monastery, Upper Aston Hall Lane, Hawarden, Flintshire - from the west - scale 1m

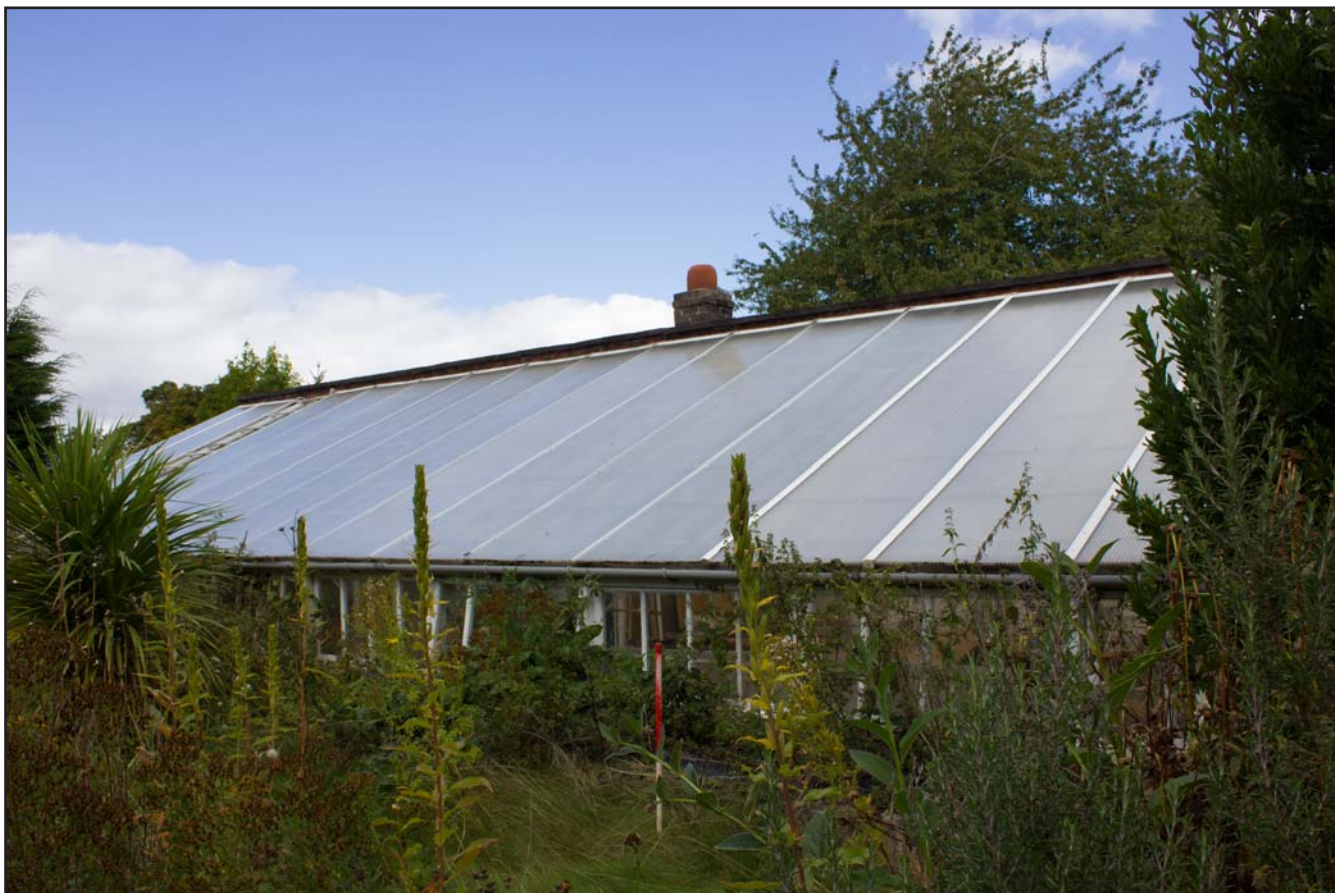
Plate 22: South western elevation (oblique view) of the glasshouse and potting sheds, Poor Clare's Monastery, Upper Aston Hall Lane, Hawarden, Flintshire - from the south - scale 1m

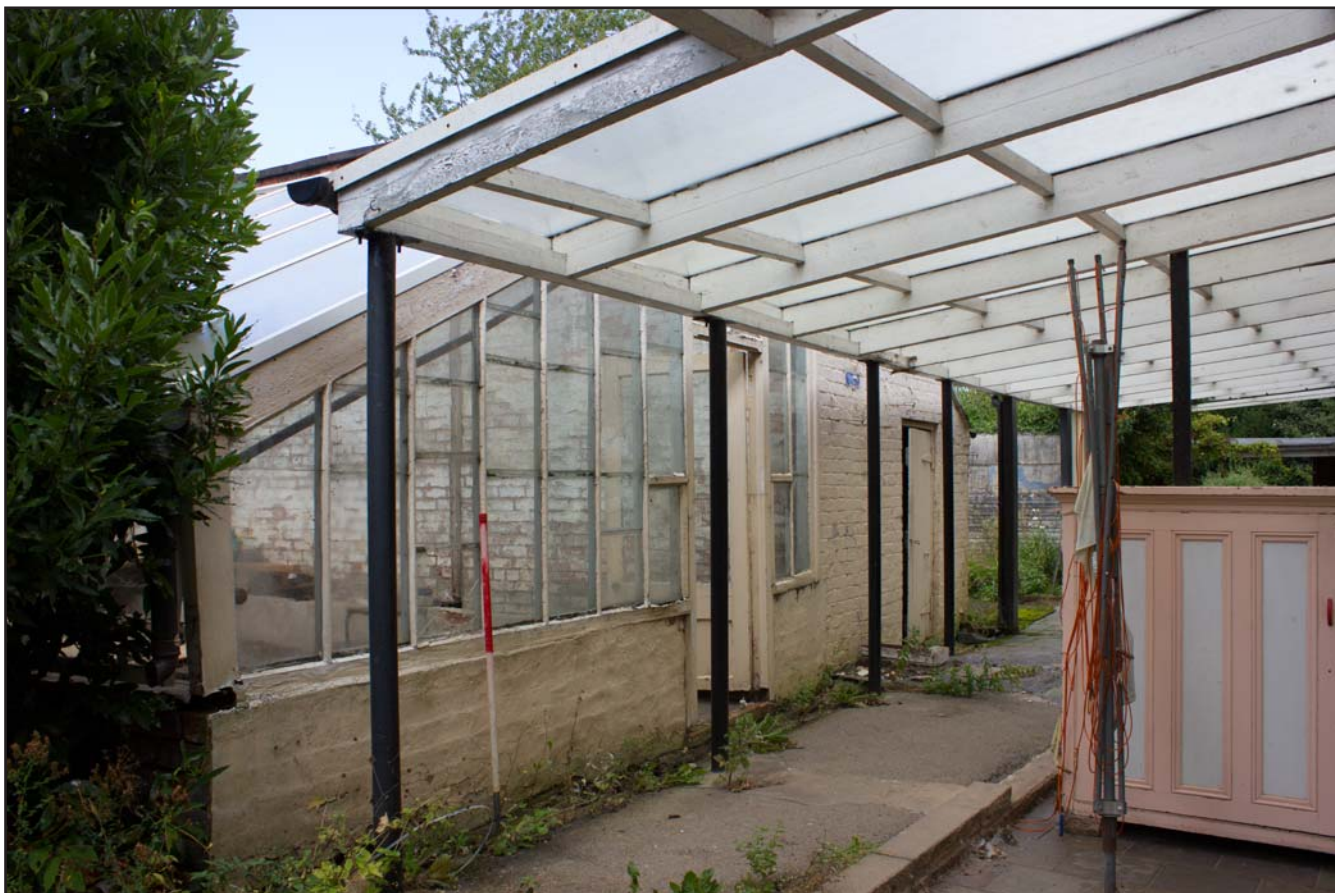
Plate 23: South eastern elevation (oblique view) of the glasshouse and potting sheds, Poor Clare's Monastery, Upper Aston Hall Lane, Hawarden, Flintshire - from the south - scale 1m

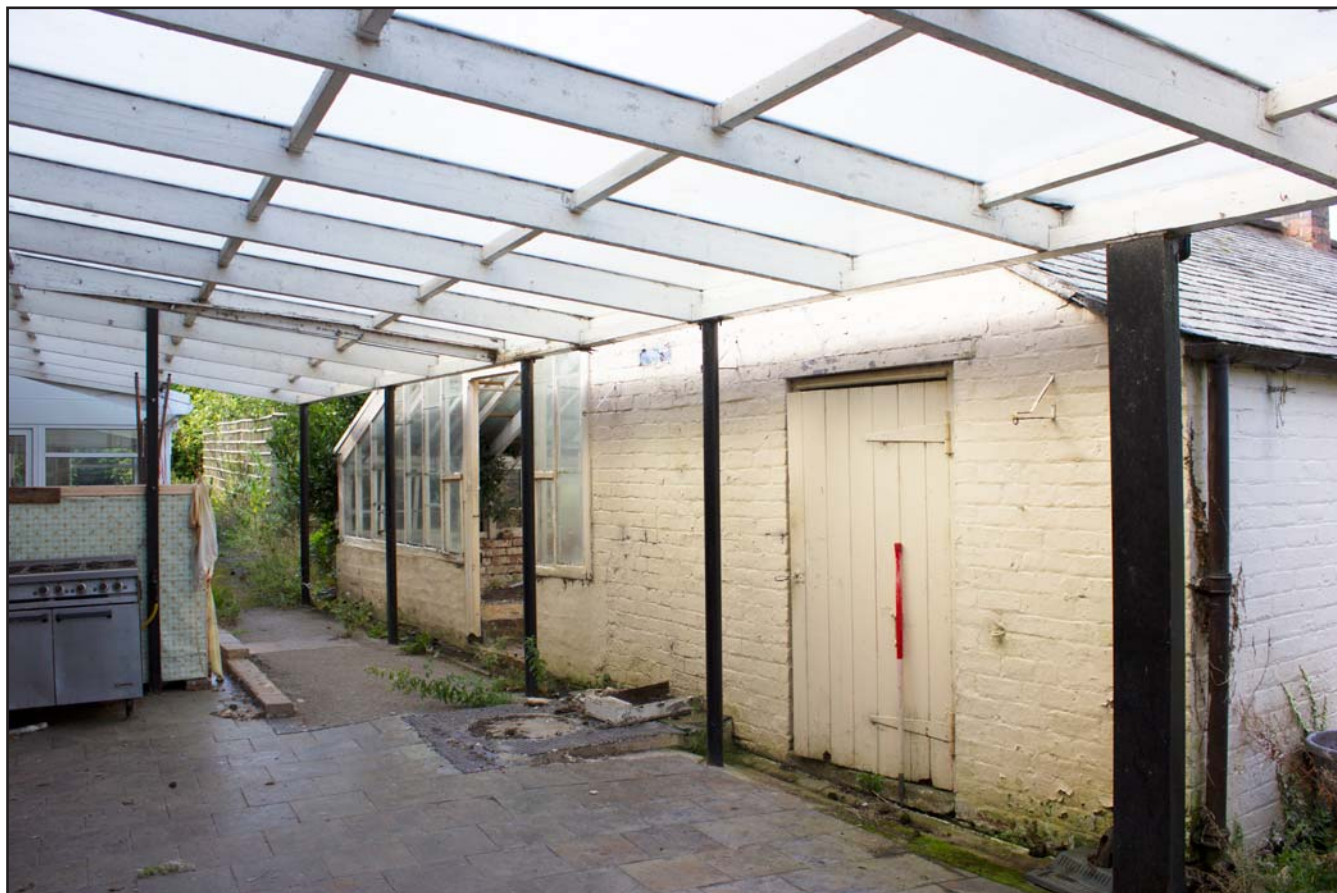
Plate 24: South eastern elevation (oblique view) of the glasshouse and potting sheds, Poor Clare's Monastery, Upper Aston Hall Lane, Hawarden, Flintshire - from the east - scale 1m

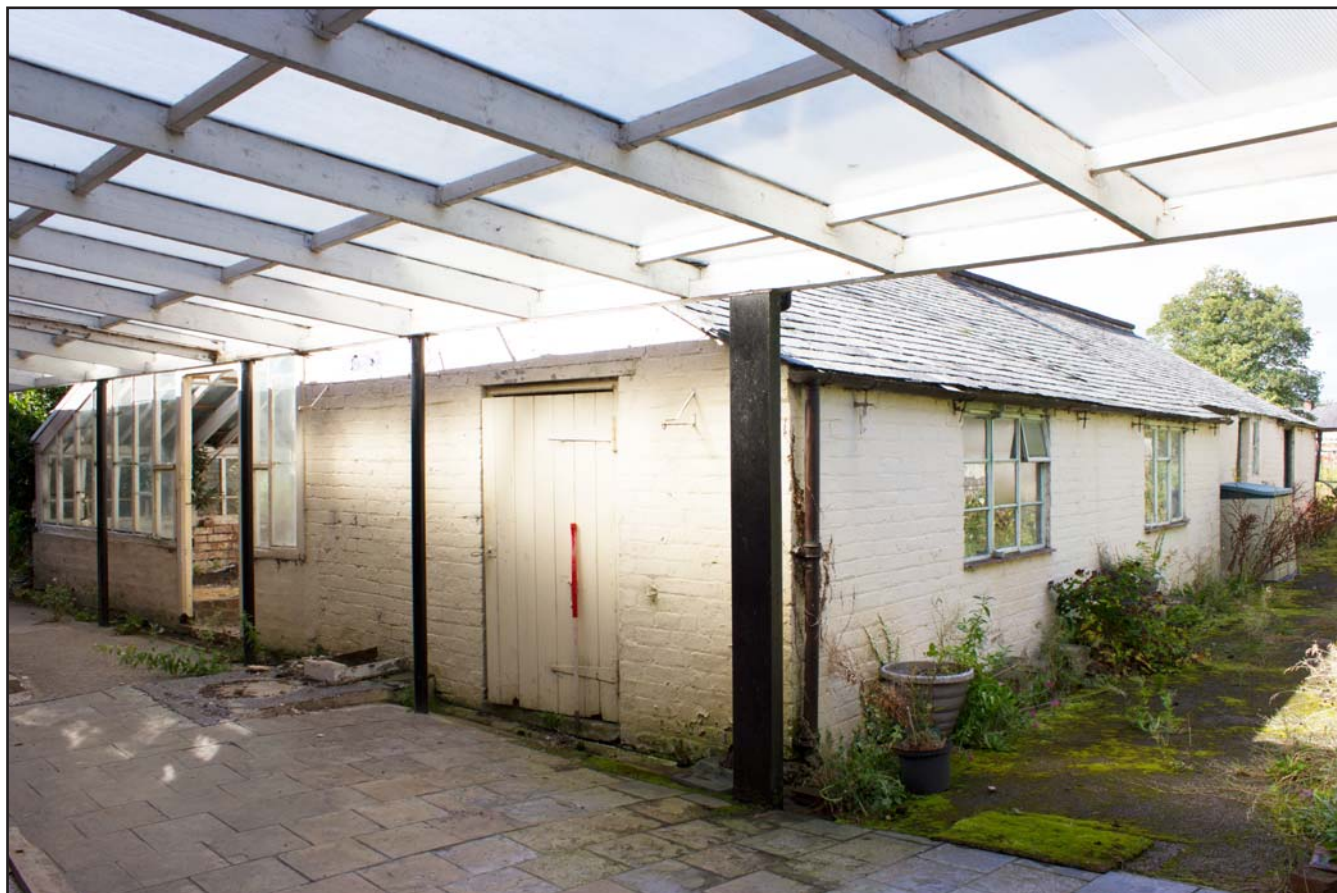
Plate 25: South eastern and north eastern elevations of the glasshouse and potting sheds, Poor Clare's Monastery, Upper Aston Hall Lane, Hawarden, Flintshire - from the east - scale 1m

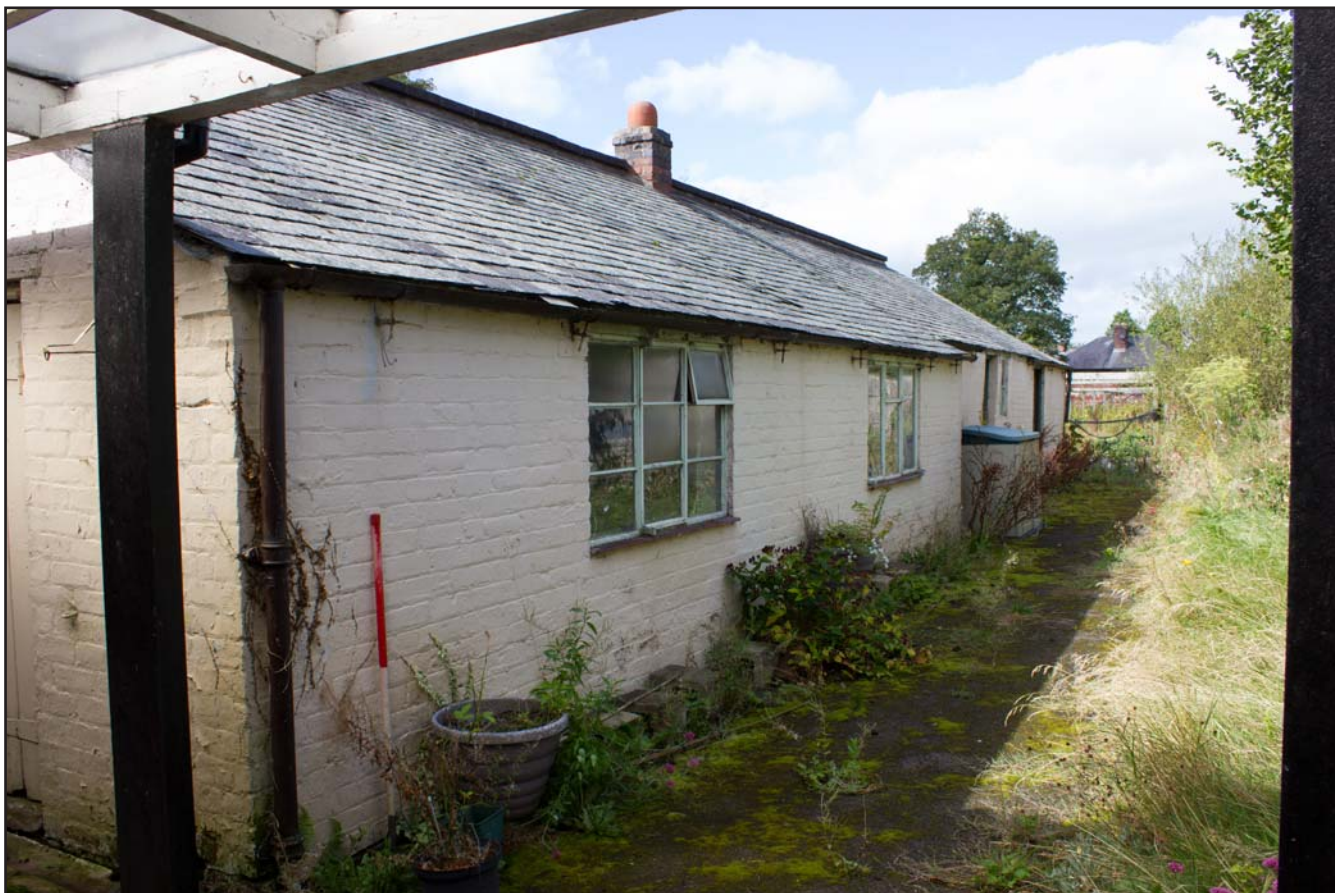
Plate 26: North eastern elevation (oblique view) of the glasshouse and potting sheds, Poor Clare's Monastery, Upper Aston Hall Lane, Hawarden, Flintshire - from the east - scale 1m

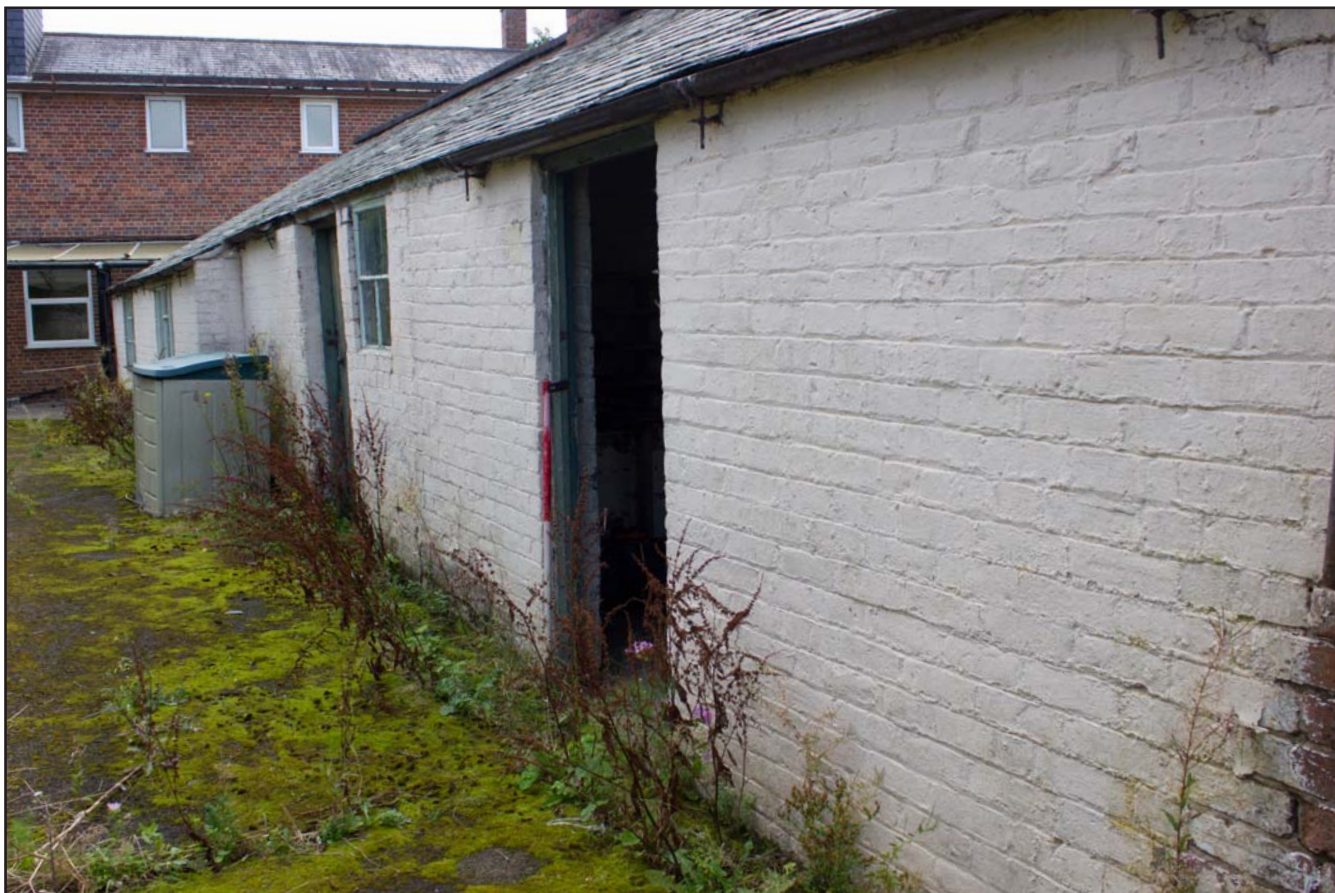
Plate 27: North eastern elevation (oblique view) of the glasshouse and potting sheds, Poor Clare's Monastery, Upper Aston Hall Lane, Hawarden, Flintshire - from the north - scale 1m

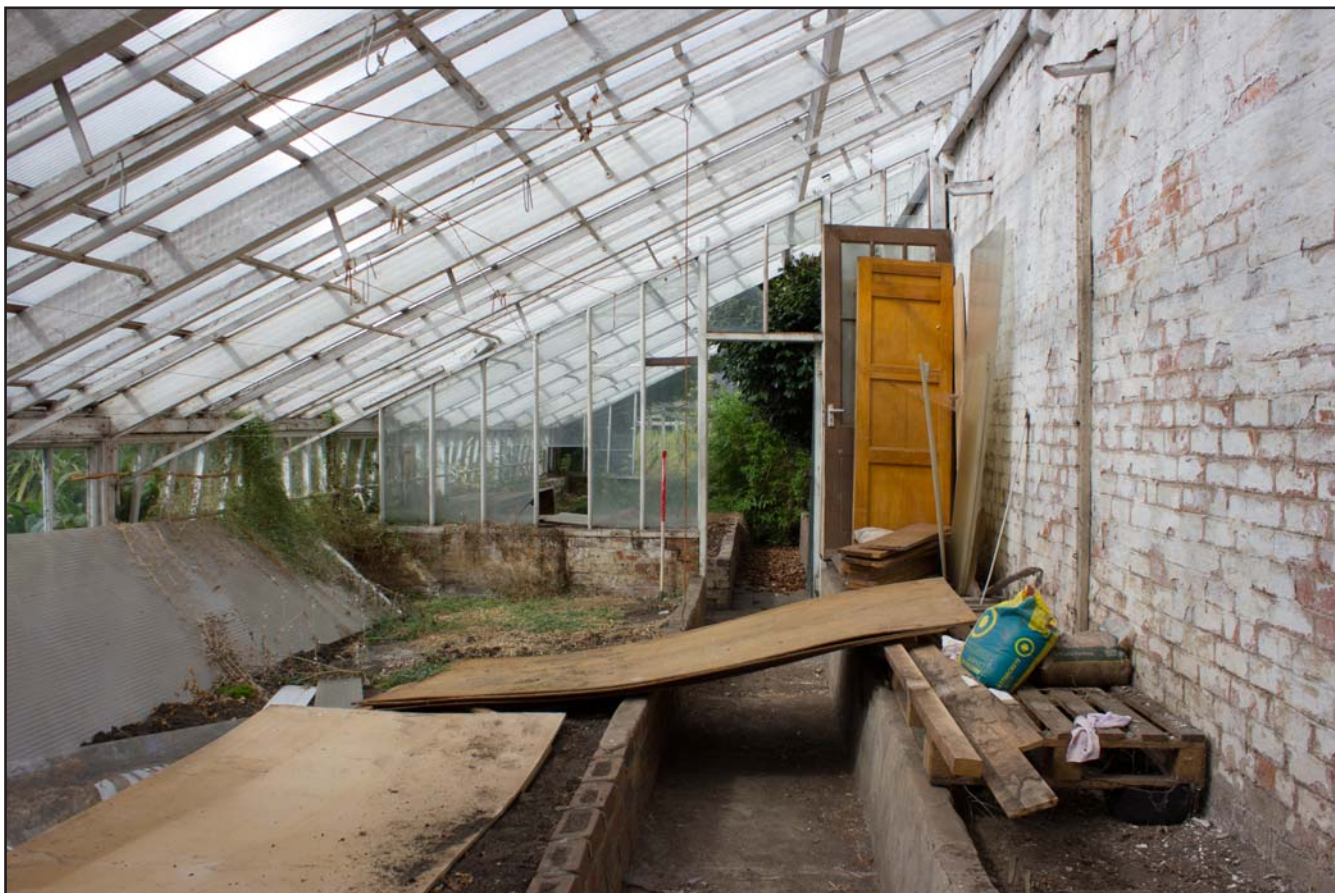
Plate 28: South eastern glasshouse interior, Poor Clare's Monastery, Upper Aston Hall Lane, Hawarden, Flintshire - from the southeast - scale 1m

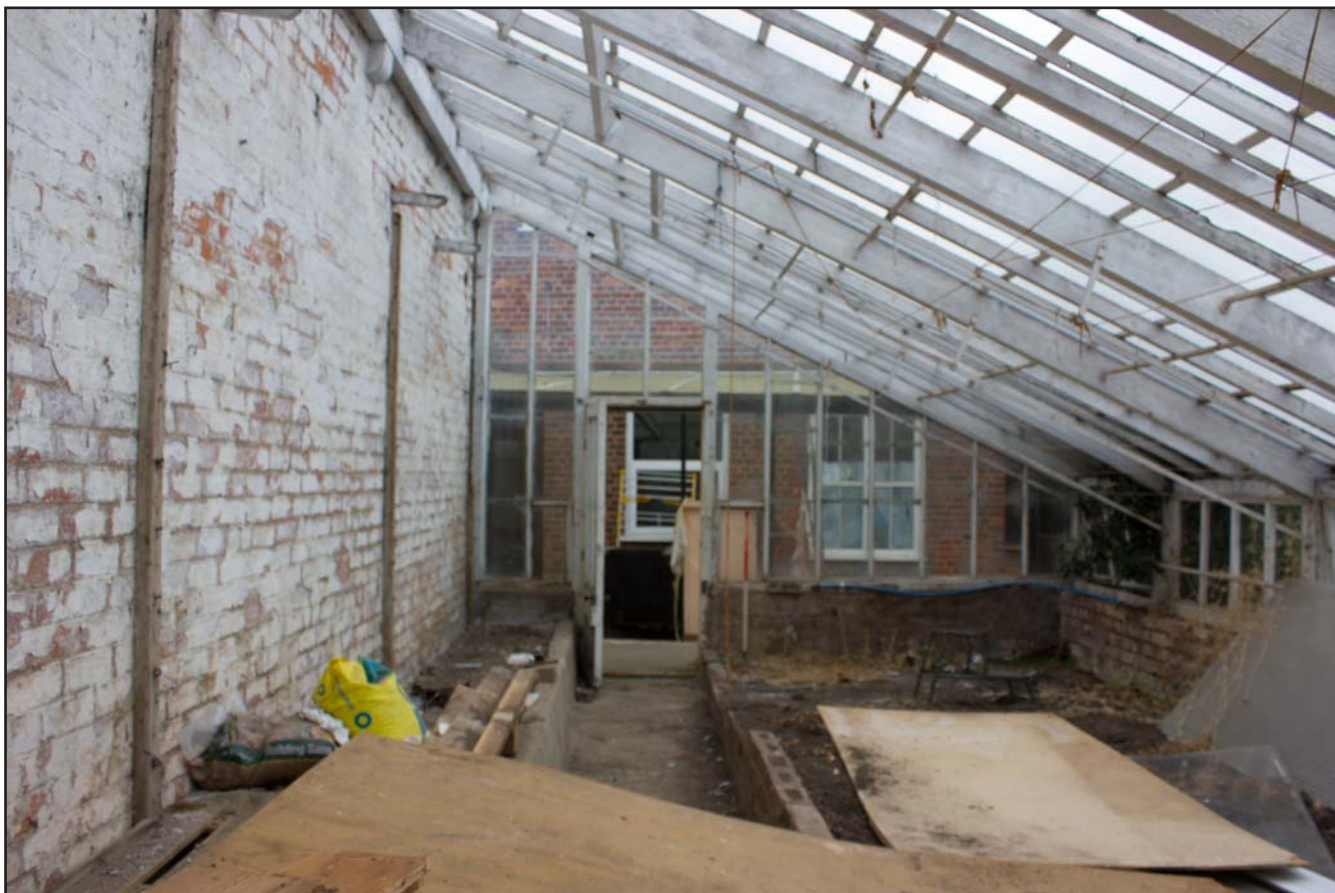
Plate 29: South eastern glasshouse interior, Poor Clare's Monastery, Upper Aston Hall Lane, Hawarden, Flintshire - from the northwest - scale 1m

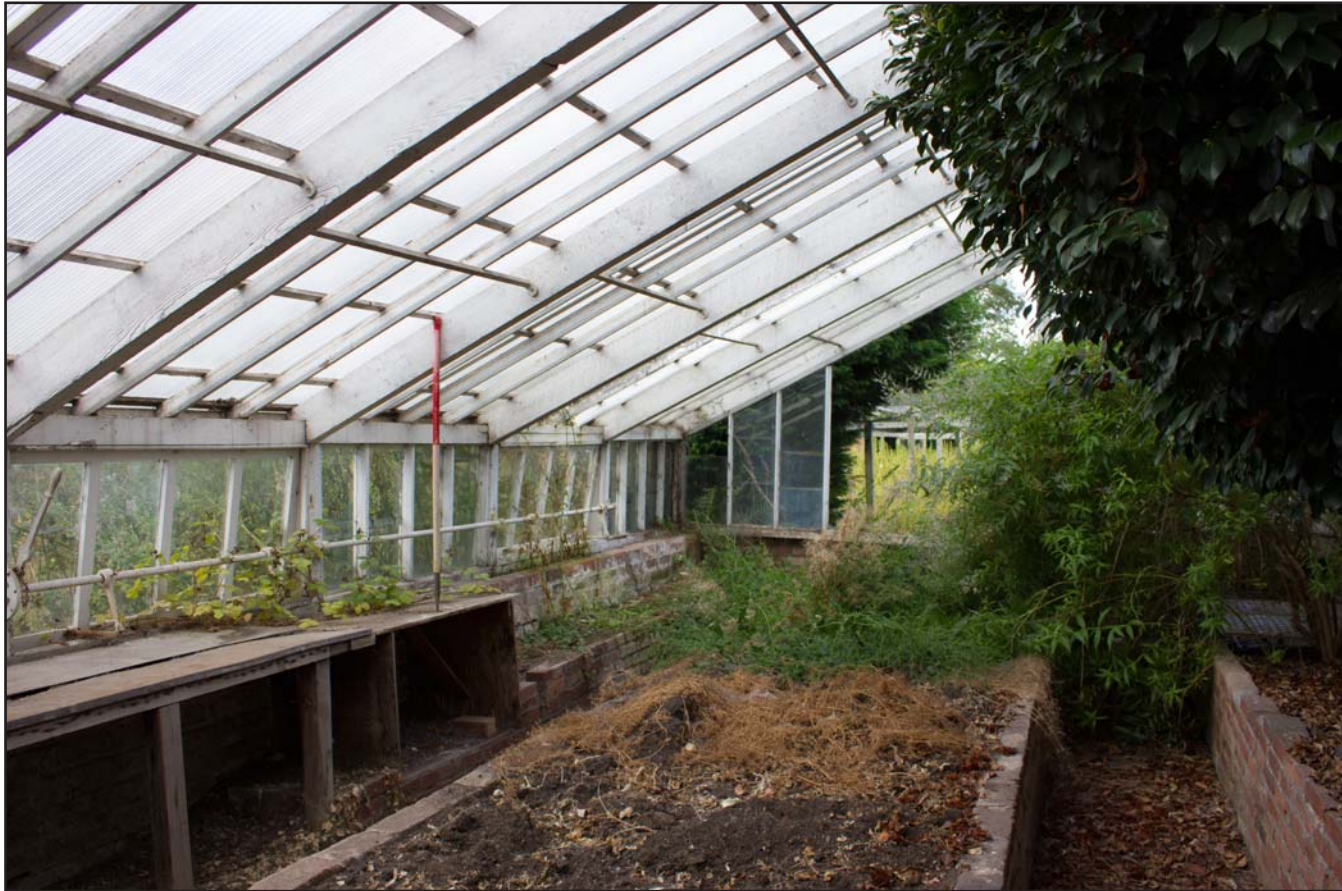
Plate 30: North western glasshouse interior, Poor Clare's Monastery, Upper Aston Hall Lane, Hawarden, Flintshire - from the southeast - scale 1m

The ceiling of the glasshouse is comprised of plastic glazing panels supported by sawn timber rafters and batons which have been painted white. The north western elevation is almost identical in configuration to the south eastern elevation seen in the south eastern glasshouse; although a large amount of the glass window panes are missing in this elevation forming a large void which is open to the elements. The north eastern elevation is constructed from red brick bonded by lime mortar, and has been painted white. At the right-hand end is a doorway opening permitting access to potting shed (3) via a wooden board door, painted green with six glass window panes in its upper two-thirds. To the left of the door is a raised bed constructed from red bricks and Portland cement this is eight courses high and has a large well established bay tree growing out of it close to the doorway to potting shed (3). To the right of the doorway is another raised bed constructed from red brick bonded by Portland cement; this is only three courses high with a wooden workbench placed on top.
