Poor Clare Colettine Monastery, Upper Aston Hall Lane, Hawarden, Flintshire CH5 3EN

Historic Building Record Level 2

Project Code: A0225.1

Report no. 0214

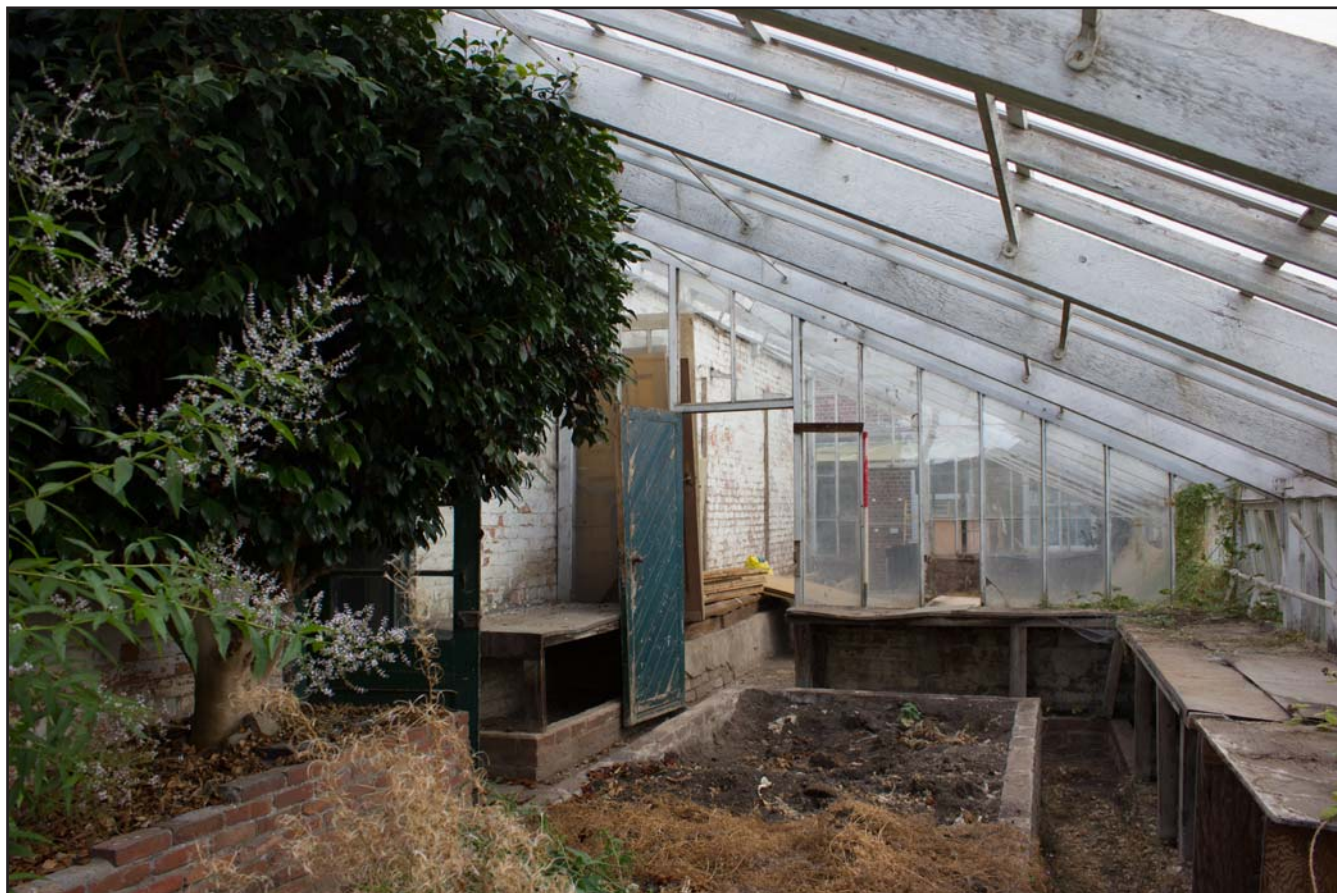
Plate 31: North western glasshouse interior, Poor Clare's Monastery, Upper Aston Hall Lane, Hawarden, Flintshire - from the northeast - scale 1m

The ceiling of the glasshouse is comprised of plastic glazing panels supported by sawn timber rafters and batons which have been painted white. The north western elevation is almost identical in configuration to the south eastern elevation seen in the south eastern glasshouse; although a large amount of the glass window panes are missing in this elevation forming a large void which is open to the elements. The north eastern elevation is constructed from red brick bonded by lime mortar, and has been painted white. At the right-hand end is a doorway opening permitting access to potting shed (3) via a wooden board door, painted green with six glass window panes in its upper two-thirds. To the left of the door is a raised bed constructed from red bricks and Portland cement this is eight courses high and has a large well established bay tree growing out of it close to the doorway to potting shed (3). To the right of the doorway is another raised bed constructed from red brick bonded by Portland cement; this is only three courses high with a wooden workbench placed on top.

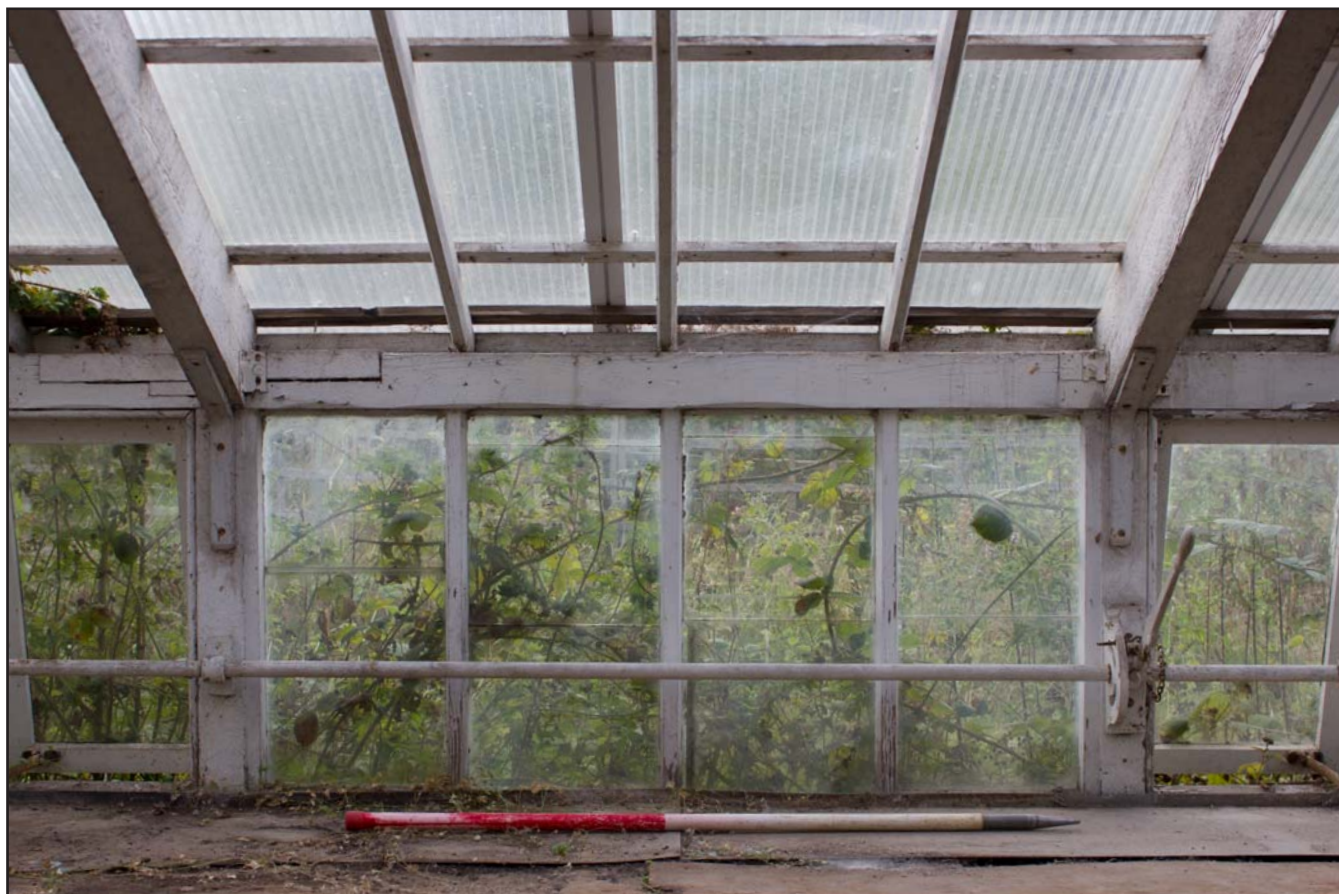
Plate 32: Example of opening casement window in North western glasshouse (showing lever mechanism), Poor Clare's Monastery, Upper Aston Hall Lane, Hawarden, Flintshire - from the northeast - scale 1m

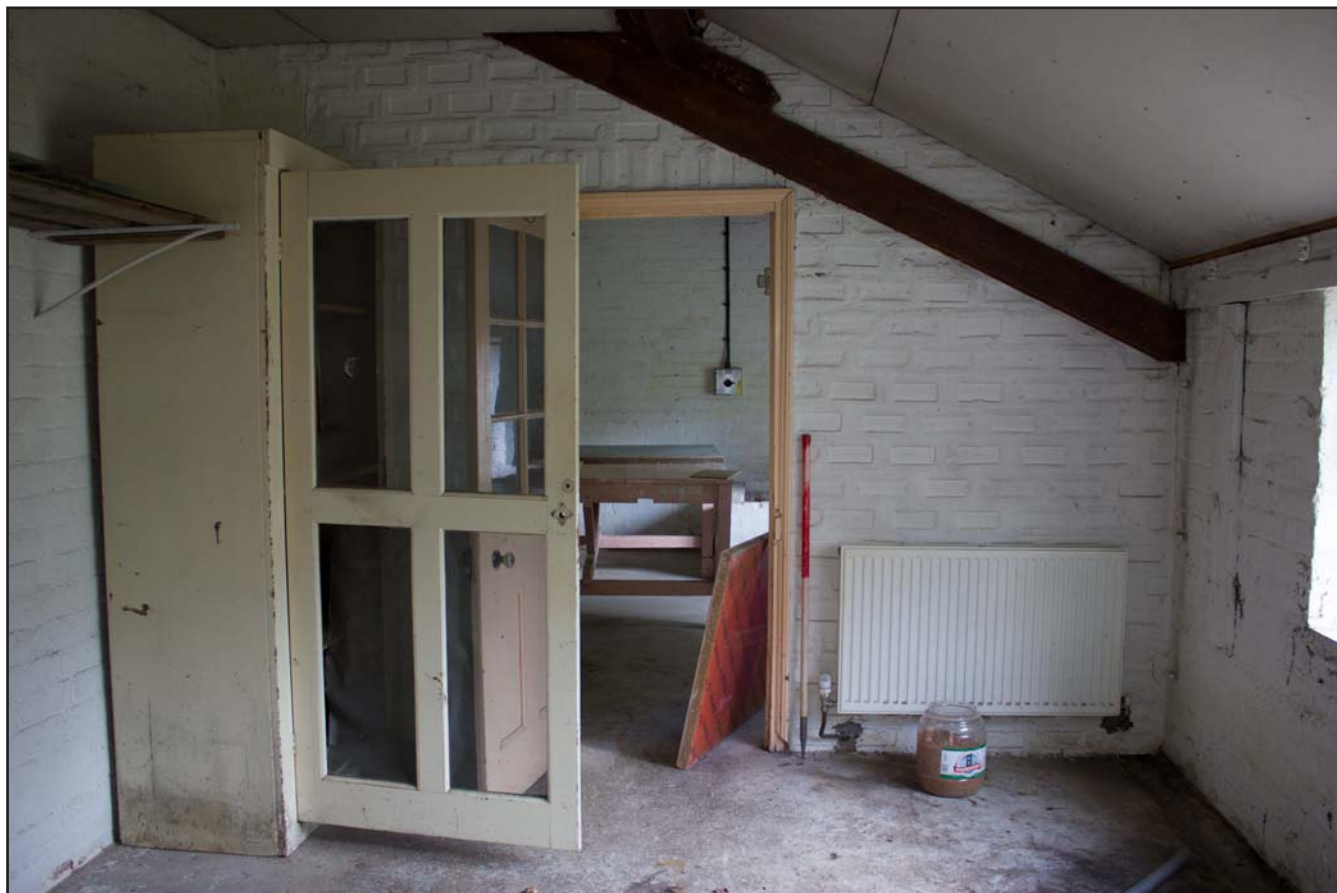
Plate 33: Interior of Potting Shed 1, Poor Clare's Monastery, Upper Aston Hall Lane, Hawarden, Flintshire - from the southeast - scale 1m

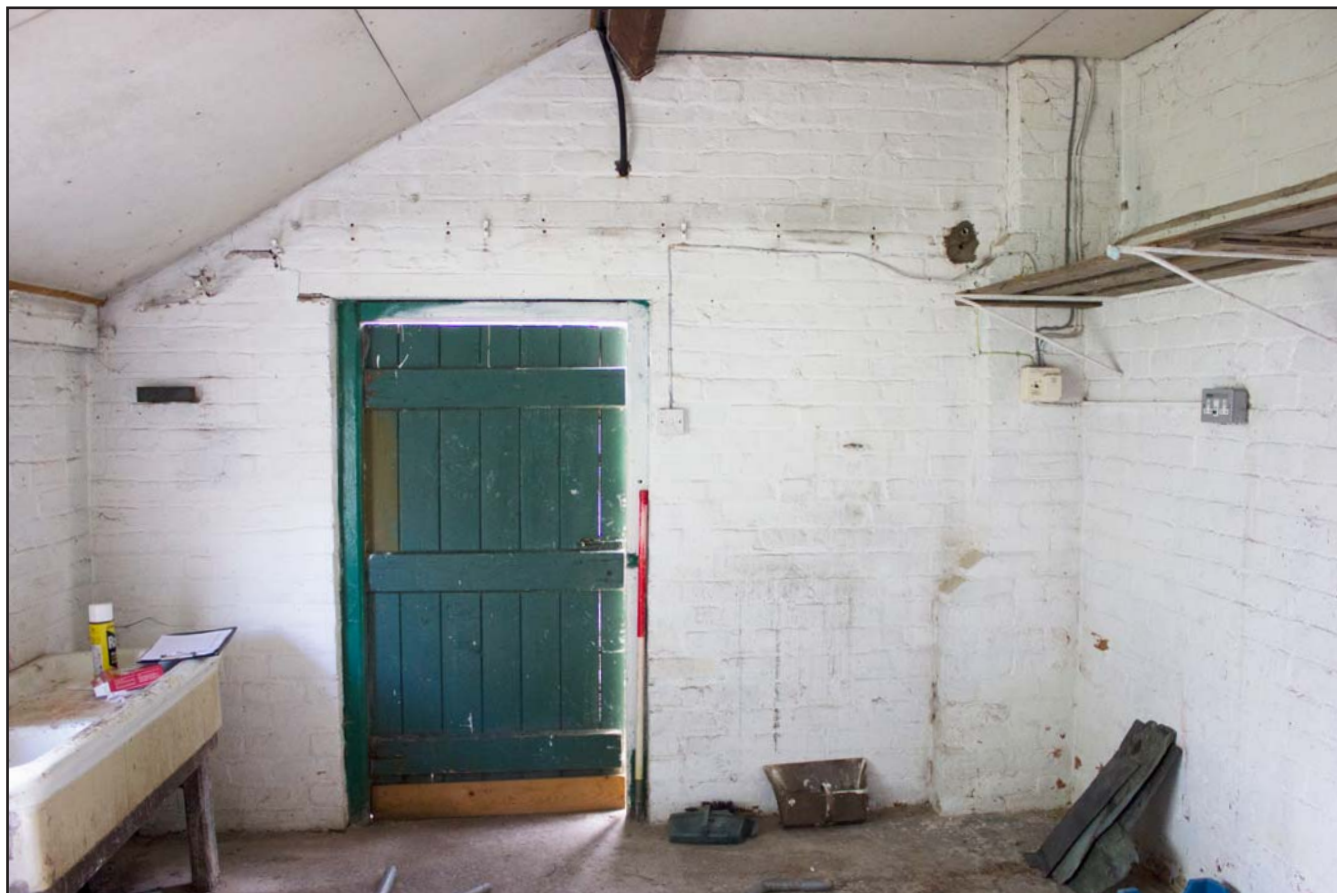
Plate 34: Interior of Potting Shed 1, Poor Clare's Monastery, Upper Aston Hall Lane, Hawarden, Flintshire - from the northwest - scale 1m

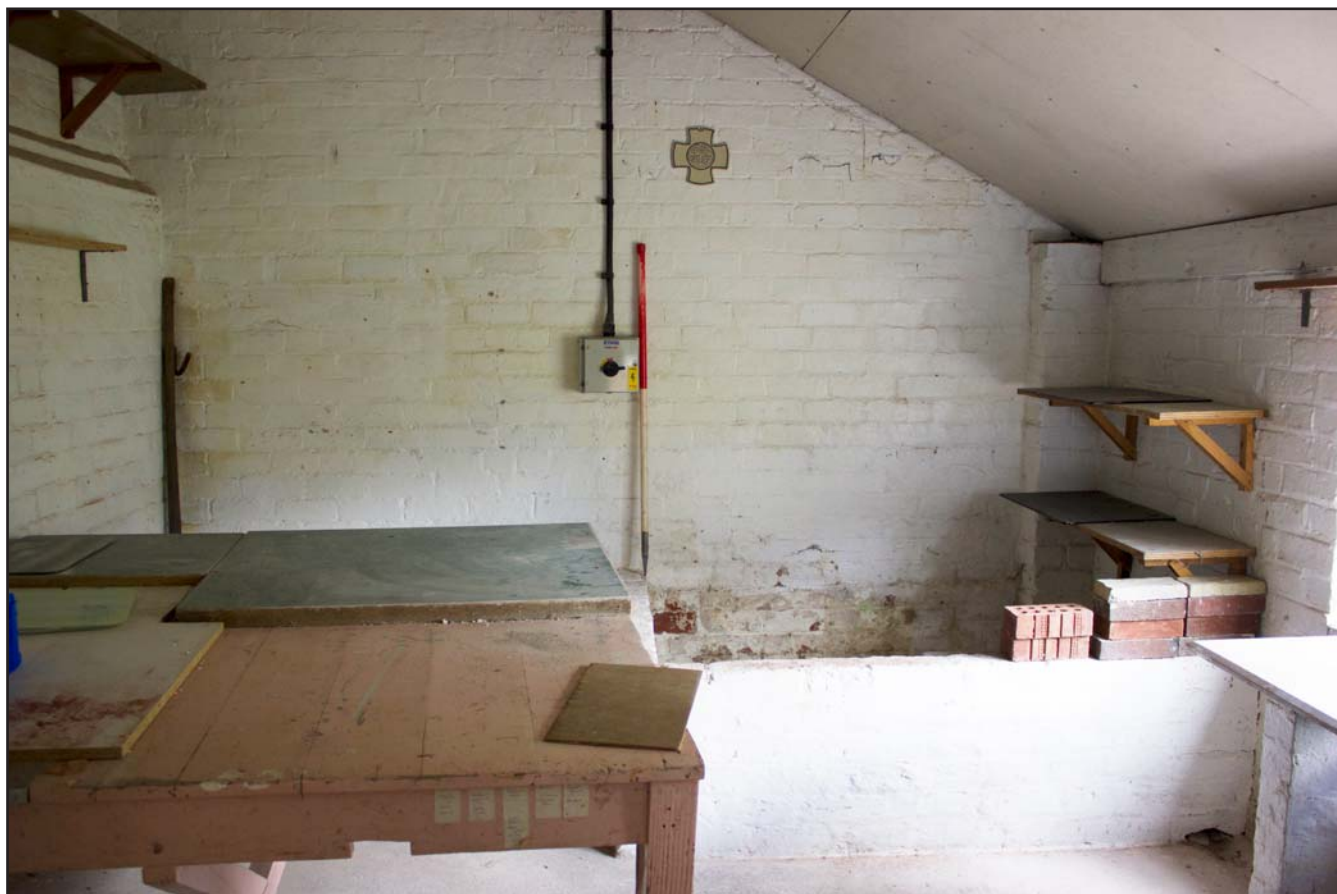
Plate 35: Interior of Potting Shed 2, Poor Clare's Monastery, Upper Aston Hall Lane, Hawarden, Flintshire - from the southeast - scale 1m

This is a rectangular room orientated southeast to northwest measuring 4.23m long by 3.35m wide. The ceiling within potting shed (2) is identical to the ceiling found in potting shed (1). The north western elevation is featureless aside from a raised bed located to the right-hand side of the elevation; this is constructed from redbrick bonded by Portland cement which has been painted white and is six courses high. The north eastern elevation has a single centralised window which is a fixed window with four glass panes set within white painted iron frames. In front of this window are two projecting brick-built walls which form the legs of a rudimentary table. The south eastern elevation has a single centralised doorway opening (as described earlier). The walls are constructed from red brick bonded by lime mortar and have been painted white. To the left of the doorway is a small modern metal radiator above which is a small cupboard unit. To the right-hand side of the elevation is a stepped brick peer which appears to be structural. The south western elevation is constructed from red brick painted white and projects into the room in a similar manner seen in potting shed (1). Apart from this the elevation is featureless. The floor is of poured concrete.

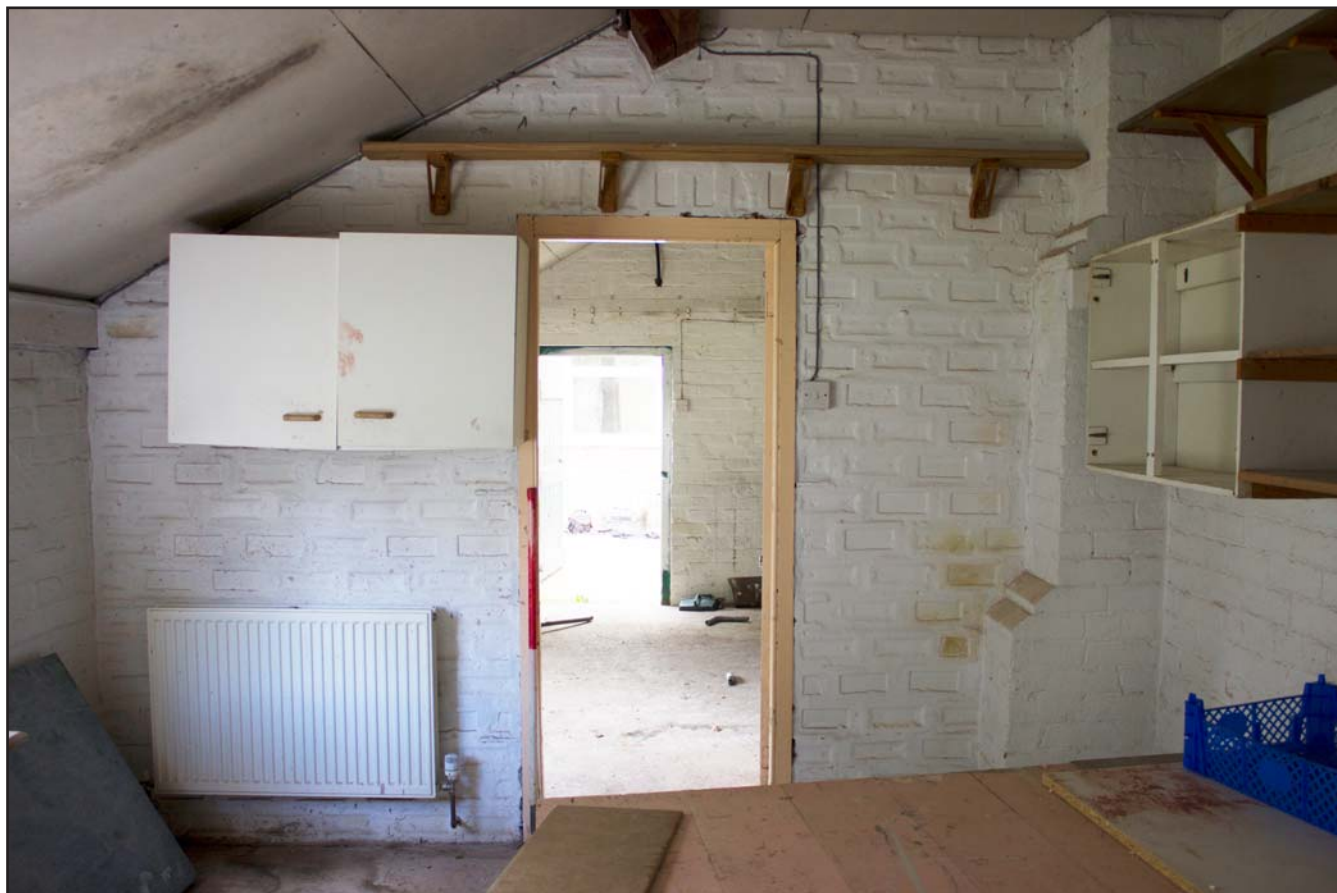
Plate 36: Interior of Potting Shed 2, Poor Clare's Monastery, Upper Aston Hall Lane, Hawarden, Flintshire - from the northwest - scale 1m

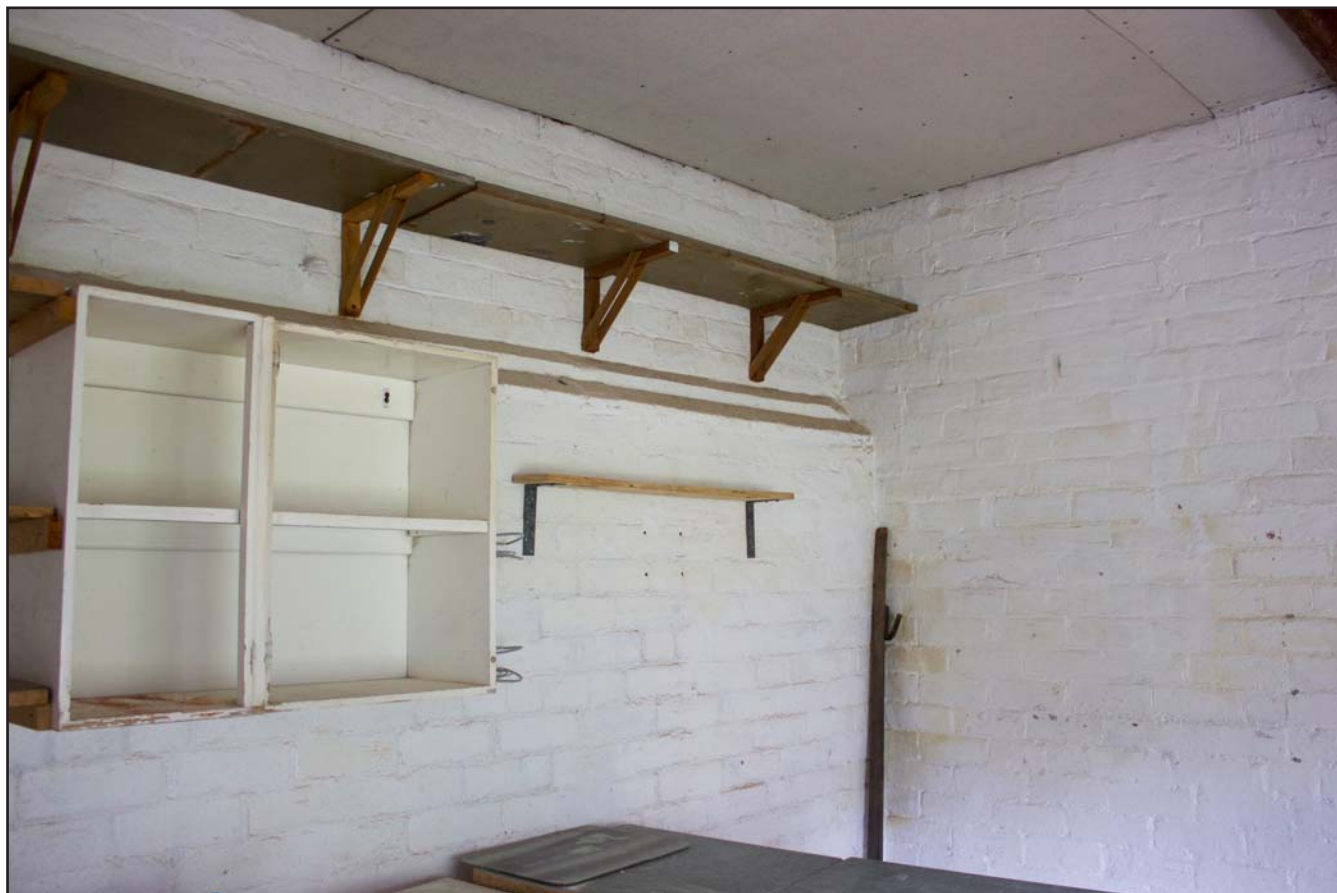
Plate 37: Example of stepped wall within Potting Shed 2, Poor Clare's Monastery, Upper Aston Hall Lane, Hawarden, Flintshire - from the northwest - no scale

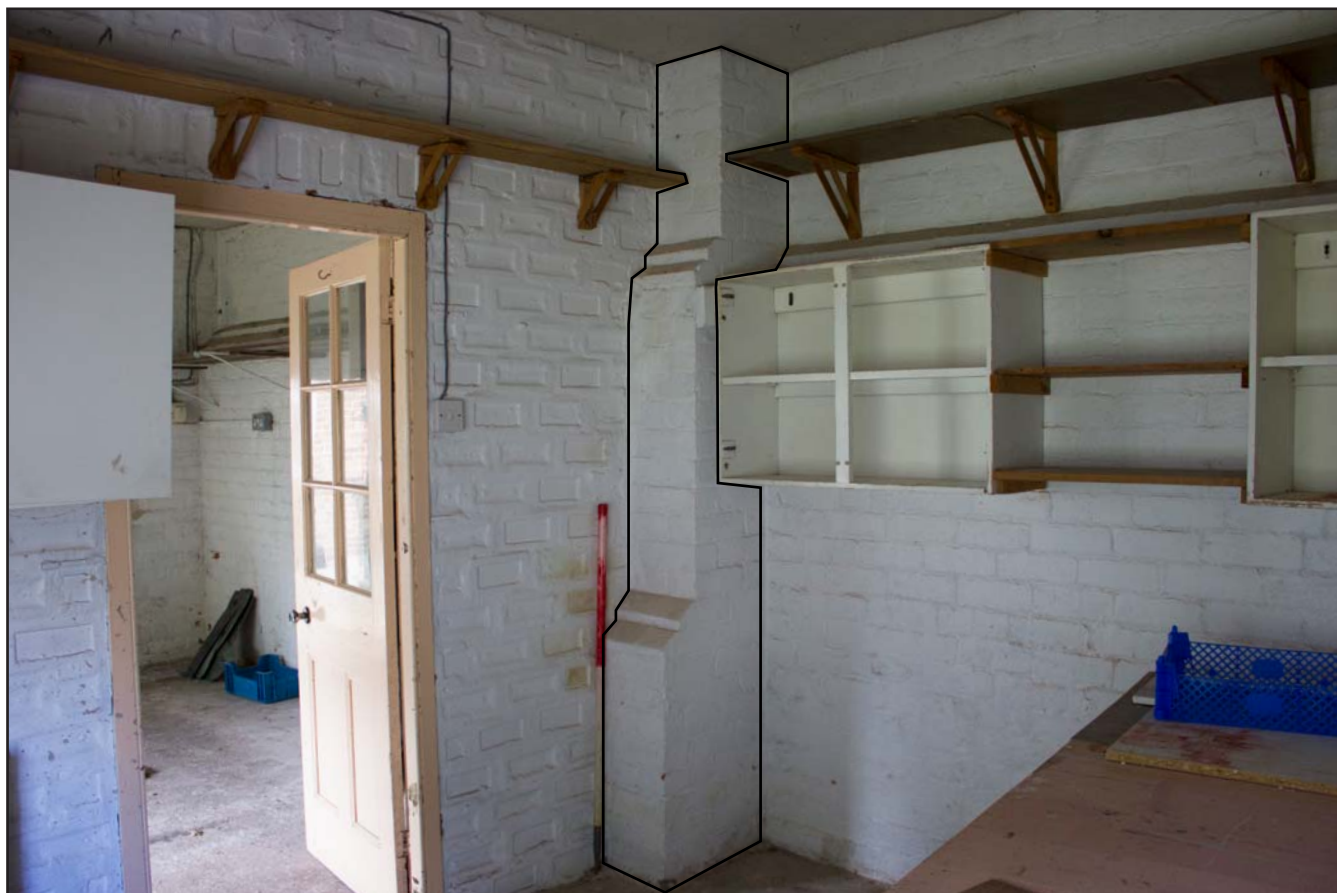
Plate 38: Example of brick pillar within Potting Shed 2 (outlined in black), Poor Clare's Monastery, Upper Aston Hall Lane, Hawarden, Flintshire - from the northwest - scale 1m

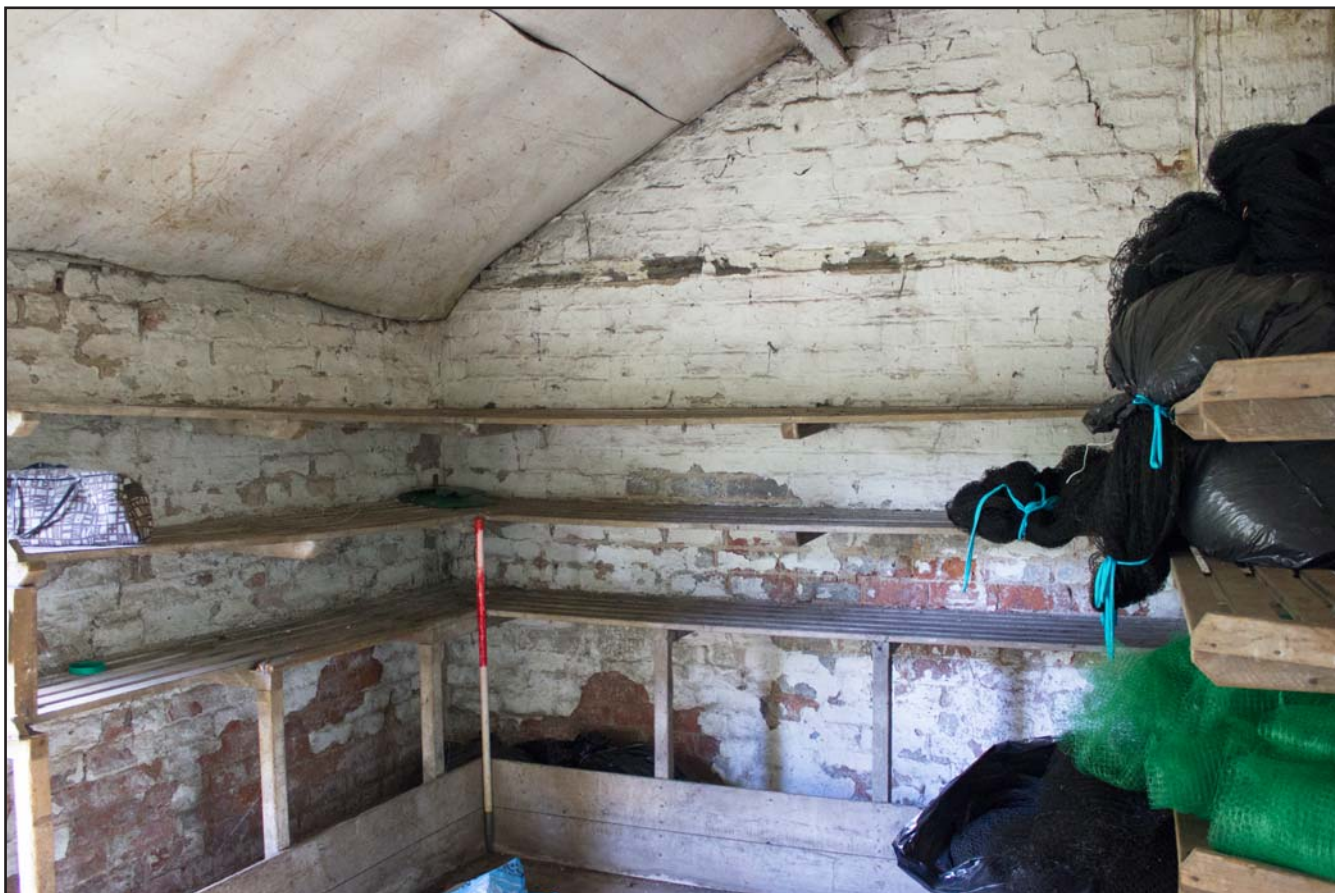
Plate 39: Interior of Potting Shed 3, Poor Clare's Monastery, Upper Aston Hall Lane, Hawarden, Flintshire - from the west - scale 1m

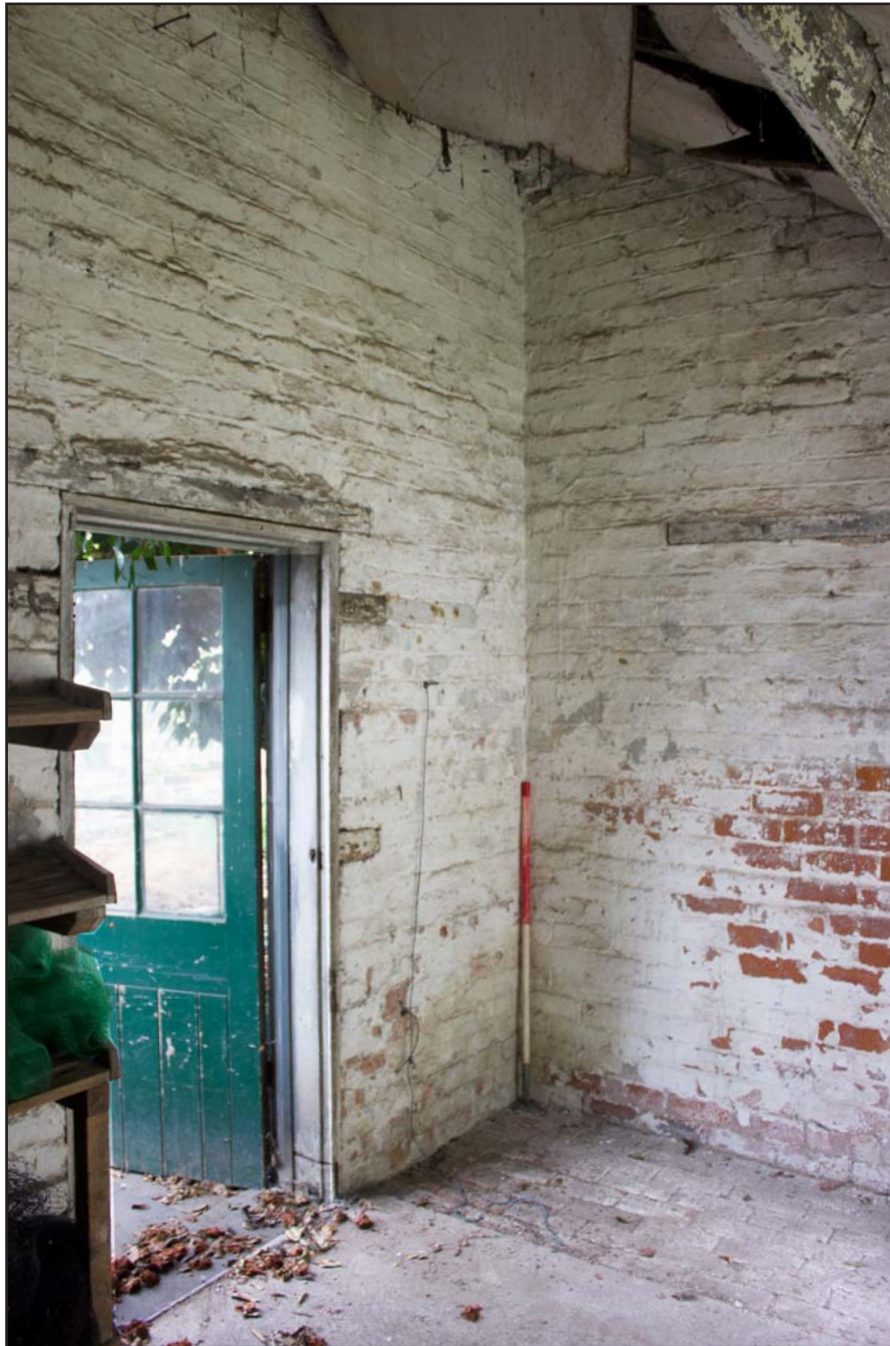
Plate 40: Interior of Potting Shed 3, Poor Clare's Monastery, Upper Aston Hall Lane, Hawarden, Flintshire - from the east - scale 1m

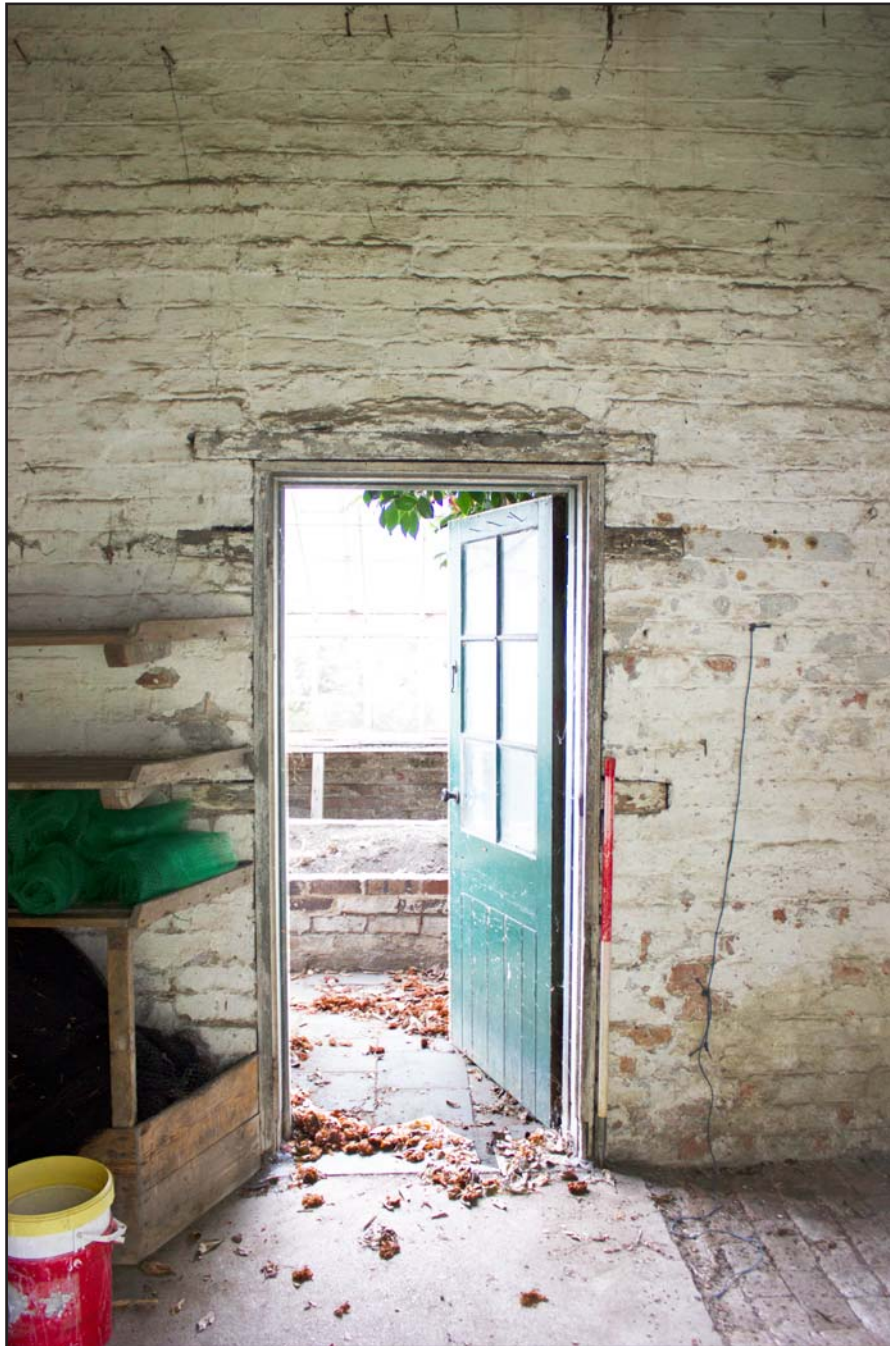
Plate 41: Door to north western glasshouse from Potting Shed 3, Poor Clare's Monastery, Upper Aston Hall Lane, Hawarden, Flintshire - from the northeast - scale 1m

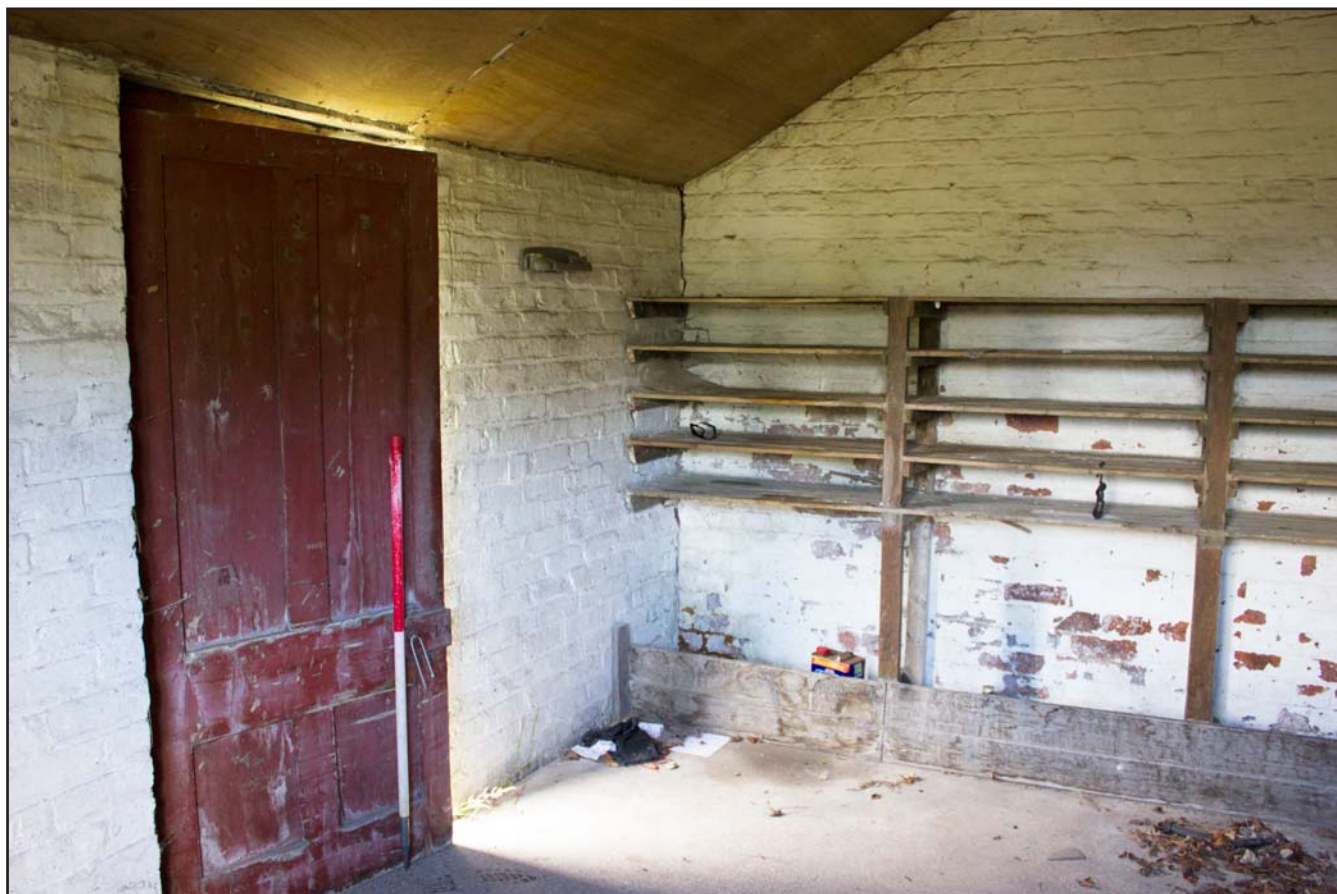
Plate 42: Interior of Potting Shed 4, Poor Clare's Monastery, Upper Aston Hall Lane, Hawarden, Flintshire - from the west - scale 1m

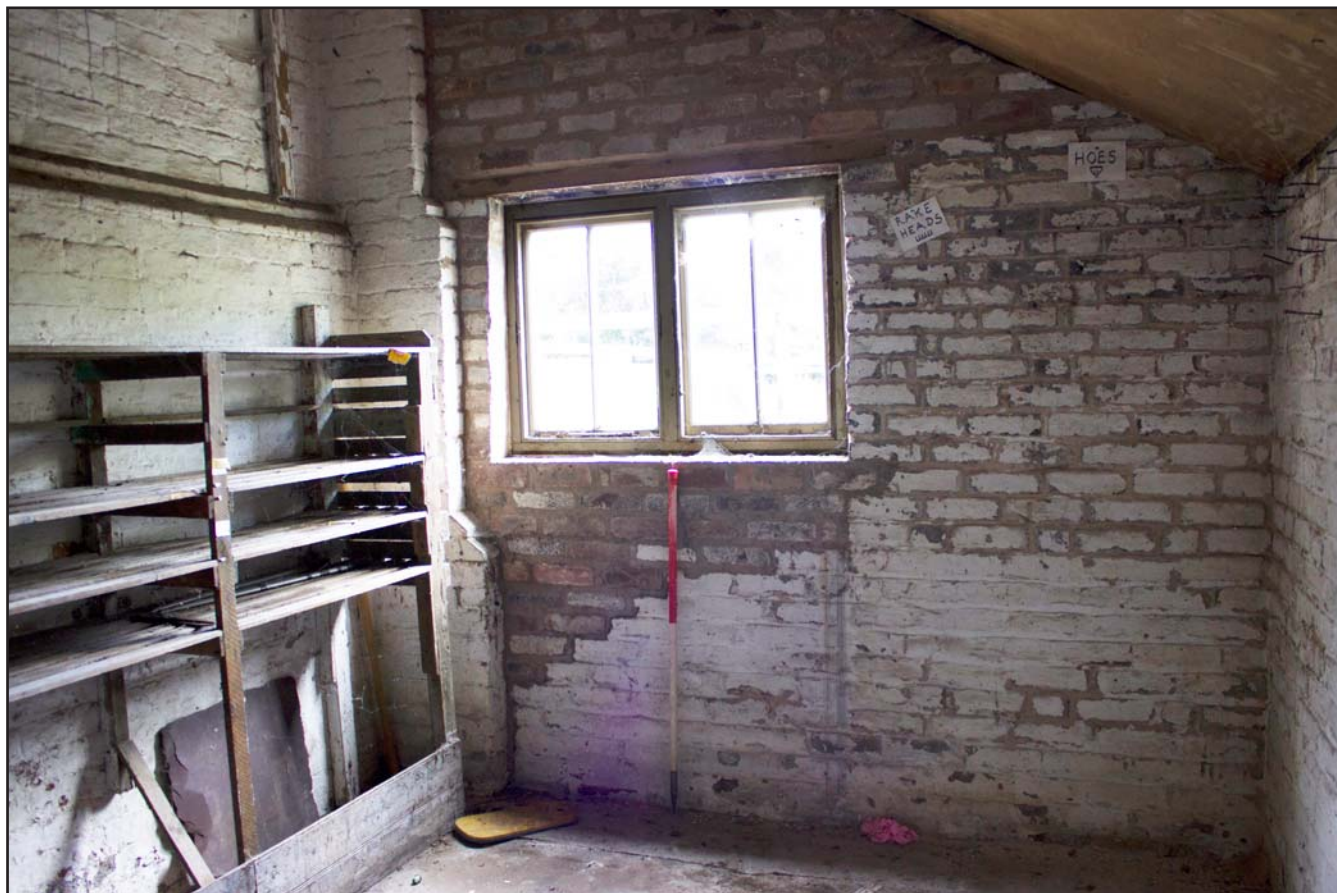
Plate 43: Interior of Potting Shed 4, Poor Clare's Monastery, Upper Aston Hall Lane, Hawarden, Flintshire - from the east - scale 1m
