KINGS HEAD, BETHESDA

Arolwg Ffotograffig / Photographic Record

Yr Amgylchedd Hanesyddol yn Cofnodi Prif Gyfeirnod /
Historic Environment Record Event Primary Reference Number: 46215

Prosiect Rhif / Project No. G2714

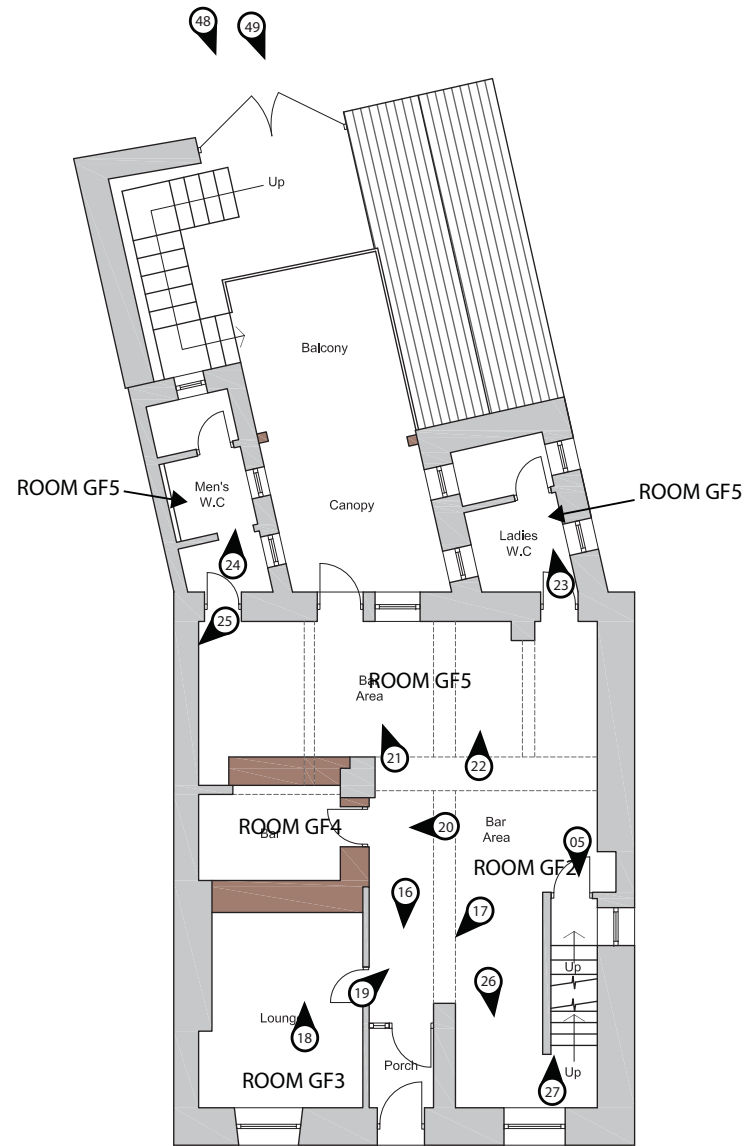
Figure 02 Reproduction of Ty Architecture Drawing No. Ty/1021/SL/01 showing location of images. Scale: As Shown

Existing Lower Ground Floor Plan

Existing Ground Floor Plan

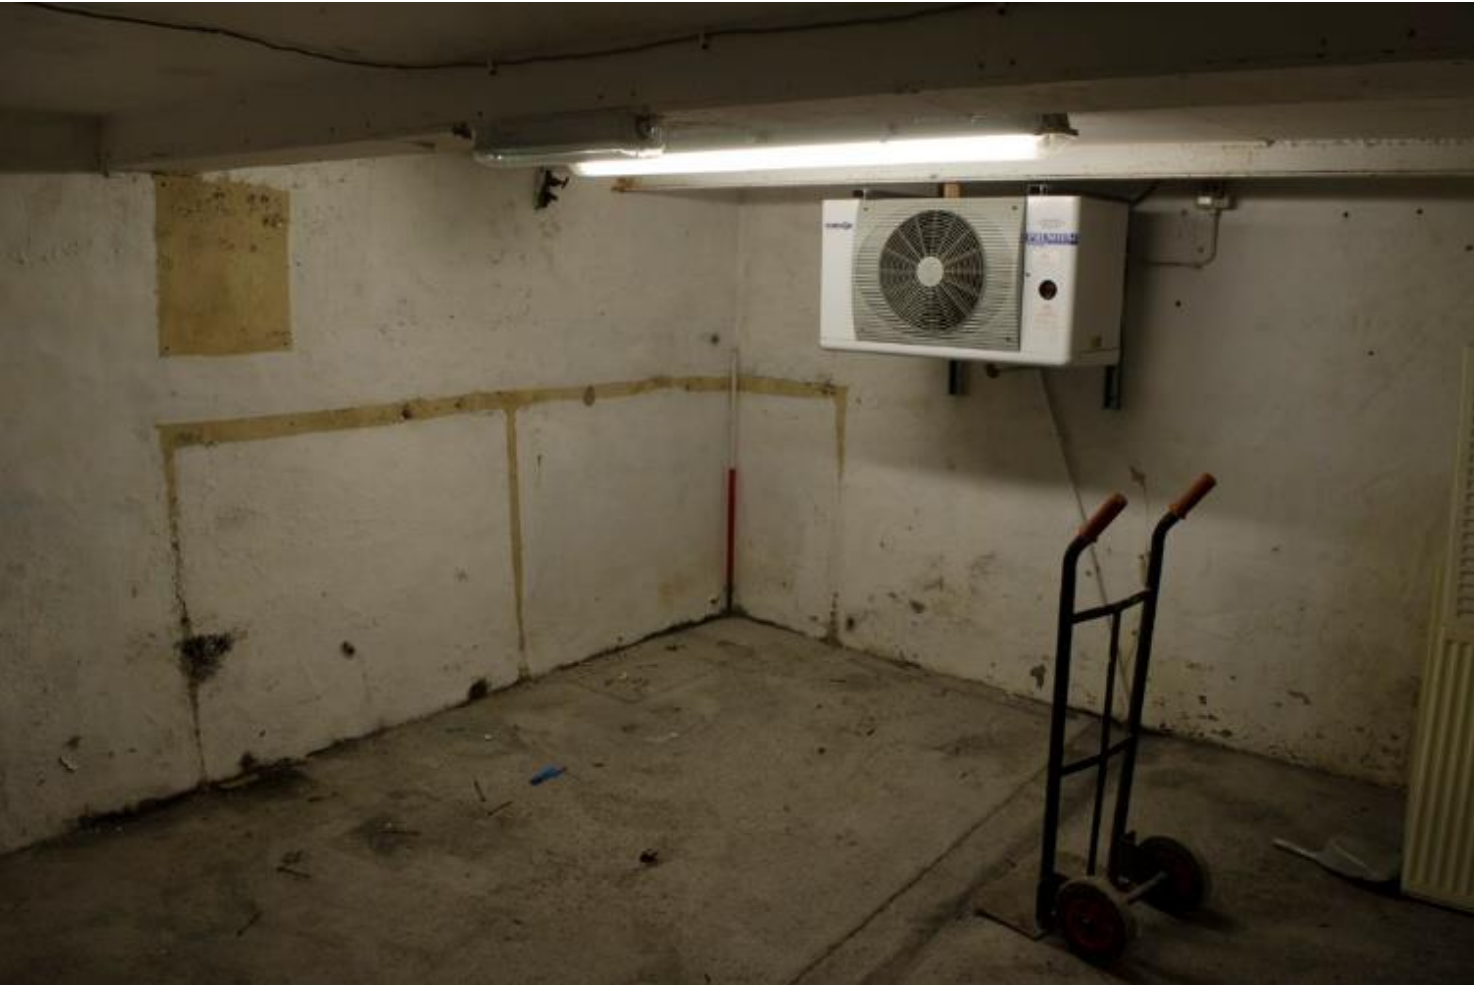
Location	Room LGF2	Photo ID No:	G2714_008
Description	Room LGF2: Cellar as viewed from the west		
Image

A photograph of a cellar room (Room LGF2) viewed from the west. The room has white walls with yellow tape marking a rectangular area. A white dehumidifier is mounted on the wall, and a blue hand truck is in the foreground.

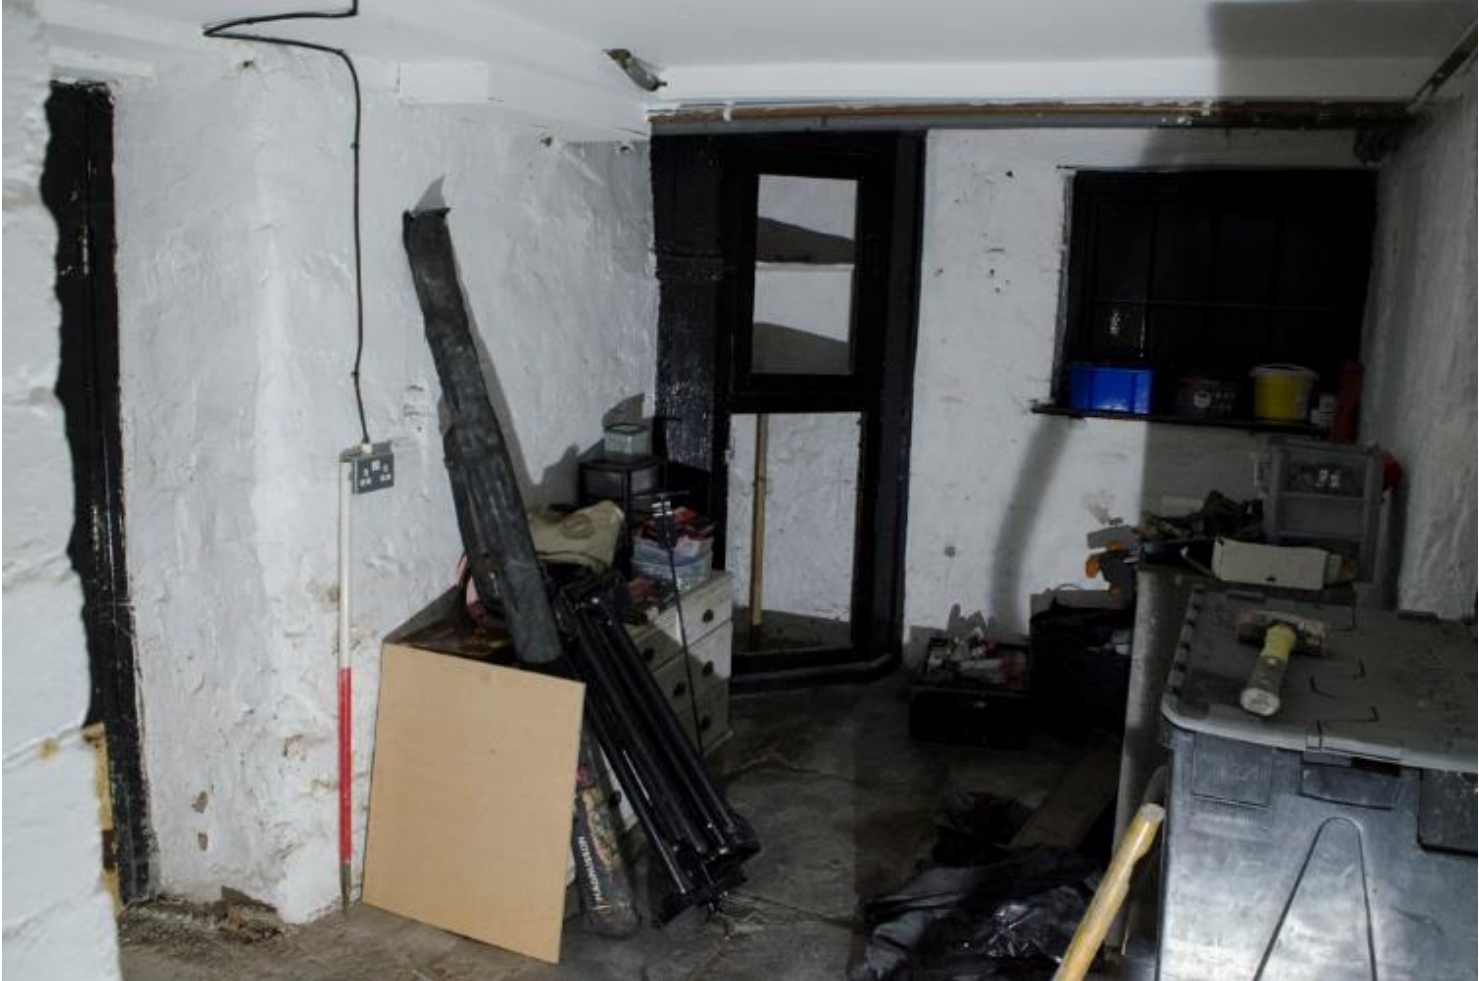
Location	Room LGF5	Photo ID No:	G2714_012
Description	Room LGF5: Cellar as viewed from the southeast		
Image

A photograph of a cluttered cellar room. The walls are white and appear to be made of plaster or concrete. On the left, there is a large, dark, vertical pipe or structure. In the center, there is a doorway leading to another room. To the right, there is a table with various items on it, including a blue container and a yellow container. A large, light-colored box is leaning against the wall on the left. The floor is concrete and has some debris on it. The lighting is somewhat dim, and the overall appearance is that of a storage or utility room.

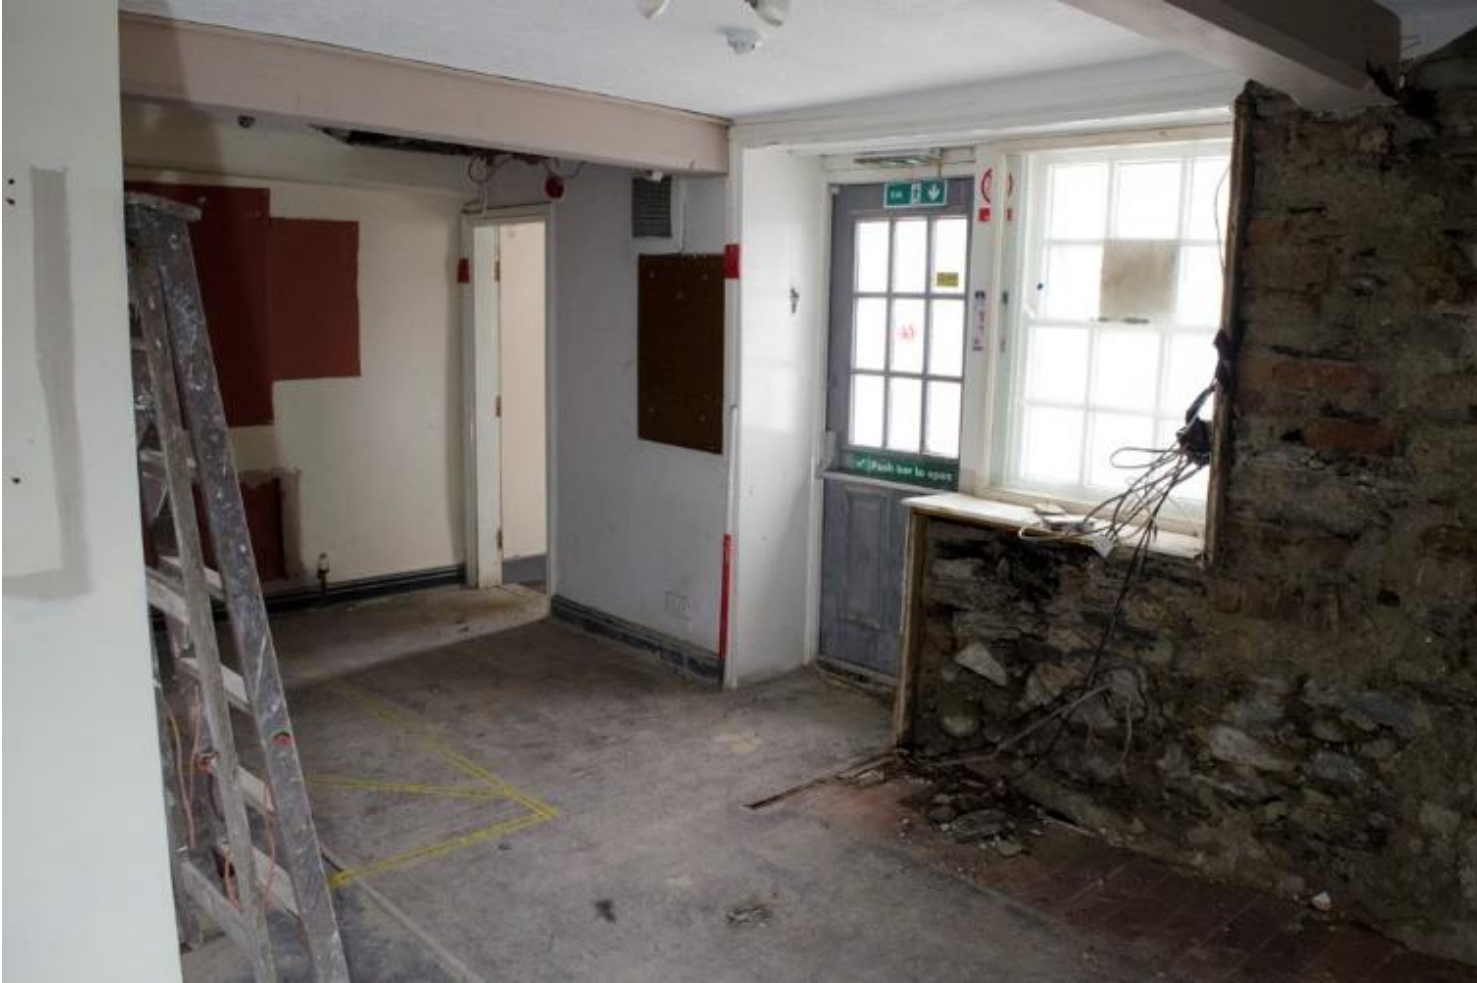
Location	Room GF5	Photo ID No:	G2714_021
Description	Room GF5: Ground Floor; view from the north-northeast		
Image

A photograph of the interior of Room GF5. The view is from the north-northeast. On the left, a silver step ladder leans against a white wall. In the center, a doorway leads to another room with red walls. To the right, there is a window with a blue frame and a green exit sign above it. The wall to the right of the window is made of rough, grey stone. The floor is concrete with yellow markings. The ceiling has a white beam and a light fixture.

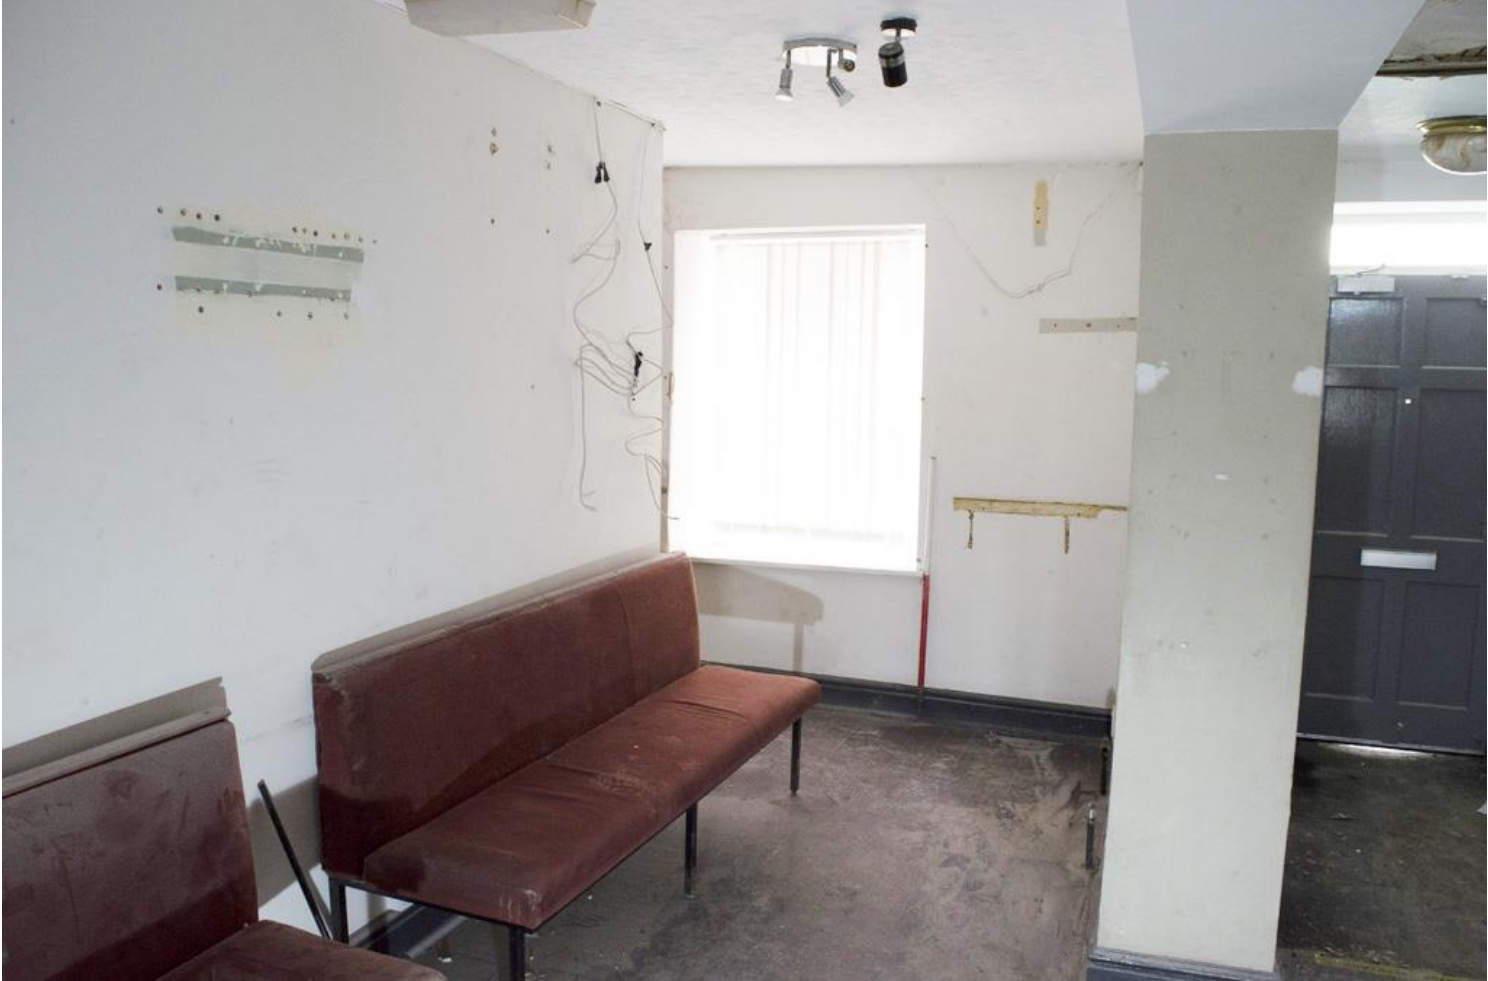
Location	Room GF2	Photo ID No:	G2714_026
Description	Room GF2: Ground Floor; view from the southwest		
Image

A photograph of Room GF2, Ground Floor, showing a view from the southwest. The room contains a red leather bench, a window with blinds, a door, and a pillar.

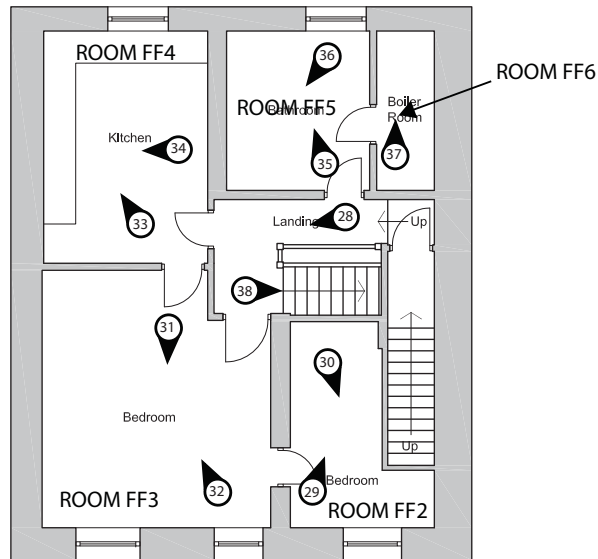
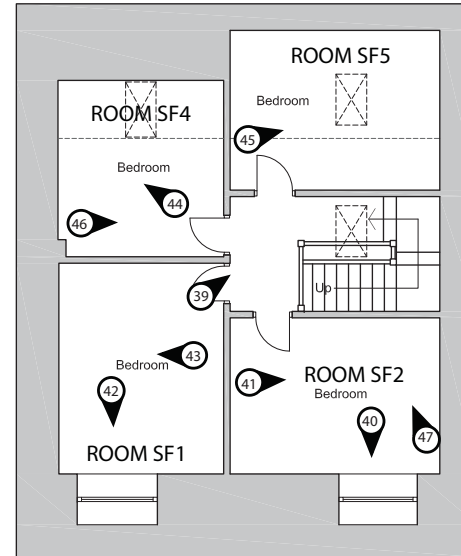
Existing First Floor Plan

Existing Second Floor Plan

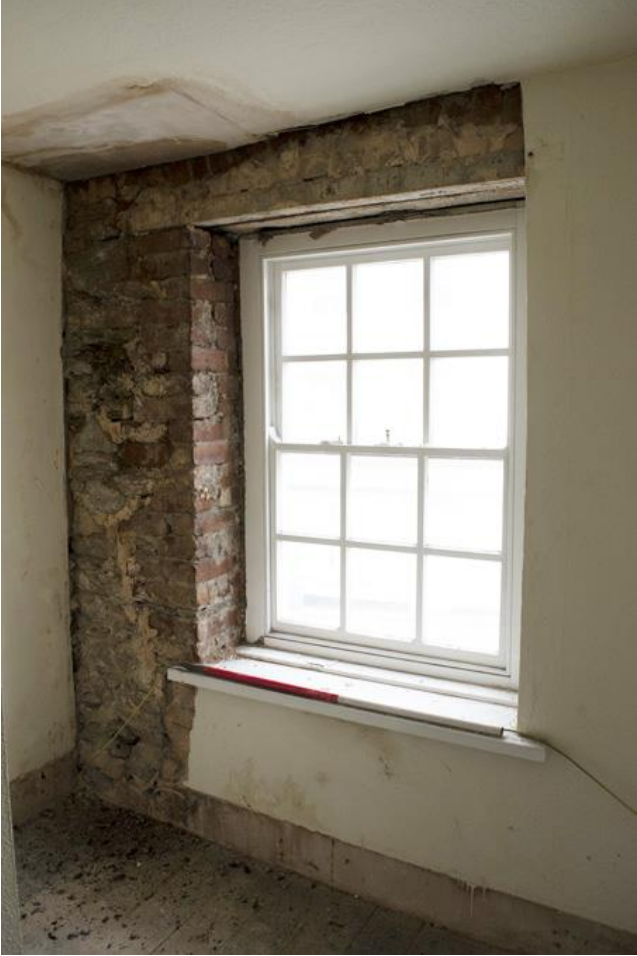
Location	Room FF2	Photo ID No:	G2714_030
Description	Room FF2: First Floor; detail of brickwork as viewed from south-southwest		
Image

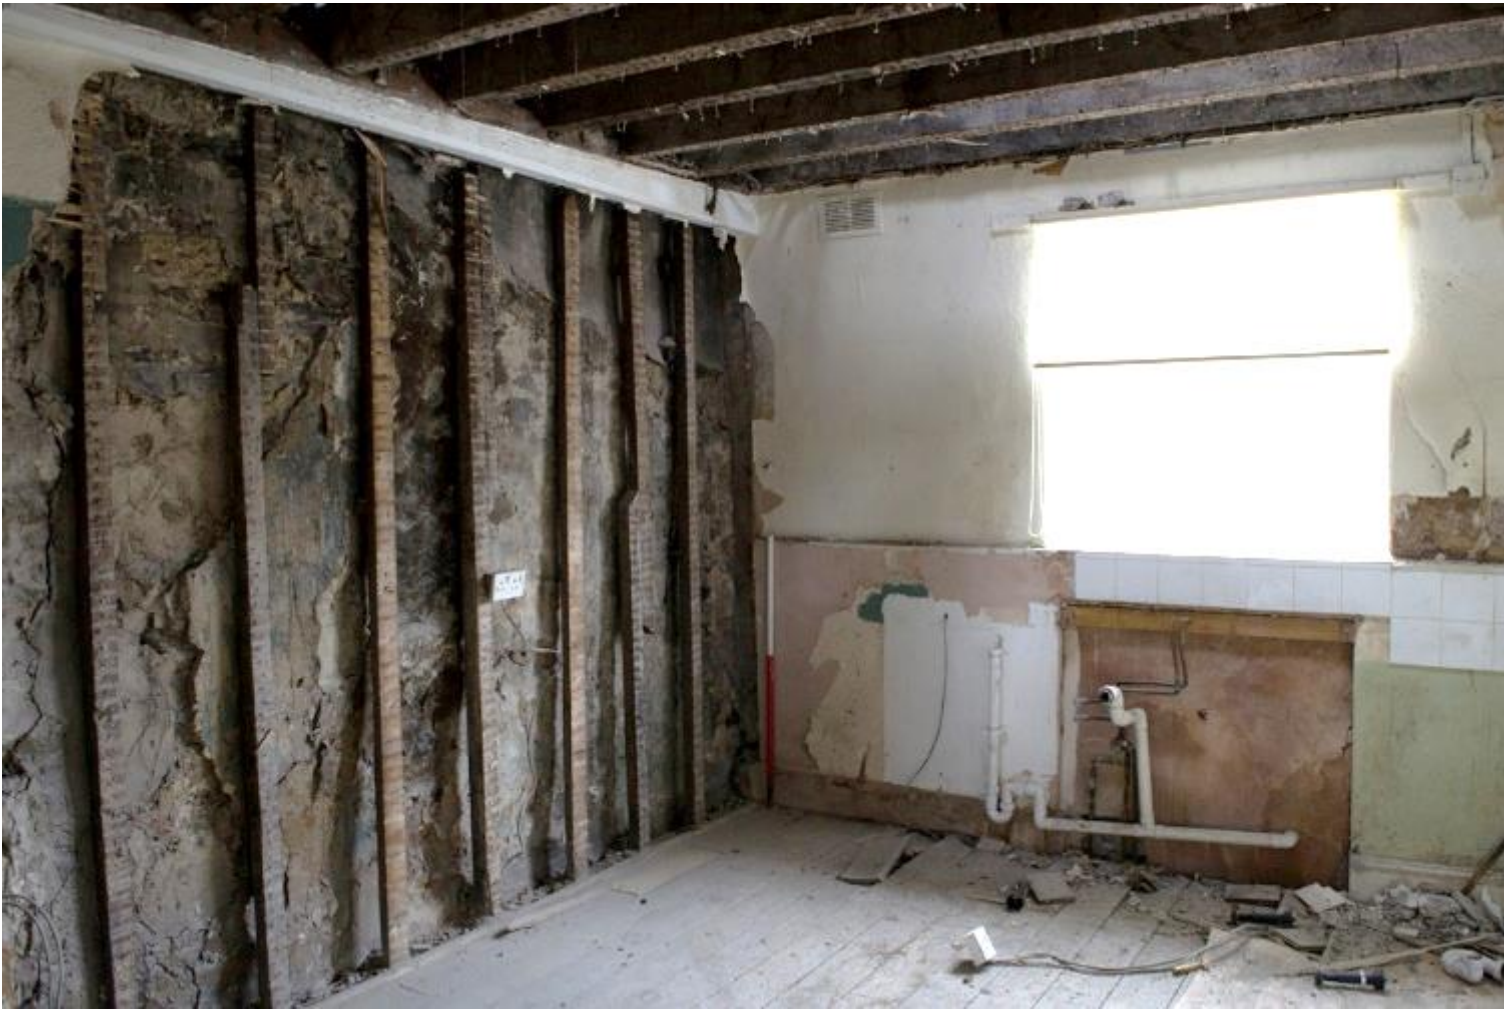
Location	Room FF4	Photo ID No:	G2714_033
Description	Room FF4: First Floor; view from the northeast		
Image

A photograph of the interior of Room FF4, showing a view from the northeast. The room is in a state of significant disrepair. The left wall is made of exposed brick, with some mortar missing and a small white label with the number '500' attached. The ceiling consists of dark wooden joists with a white pipe running across them. The right wall is white with a large window that is partially covered by a horizontal bar. Below the window, there is a section of wall with peeling paint and a white pipe. The floor is made of light-colored wooden planks and is covered with debris, including wood shavings and a blue tool. A green door is visible on the right side of the room.

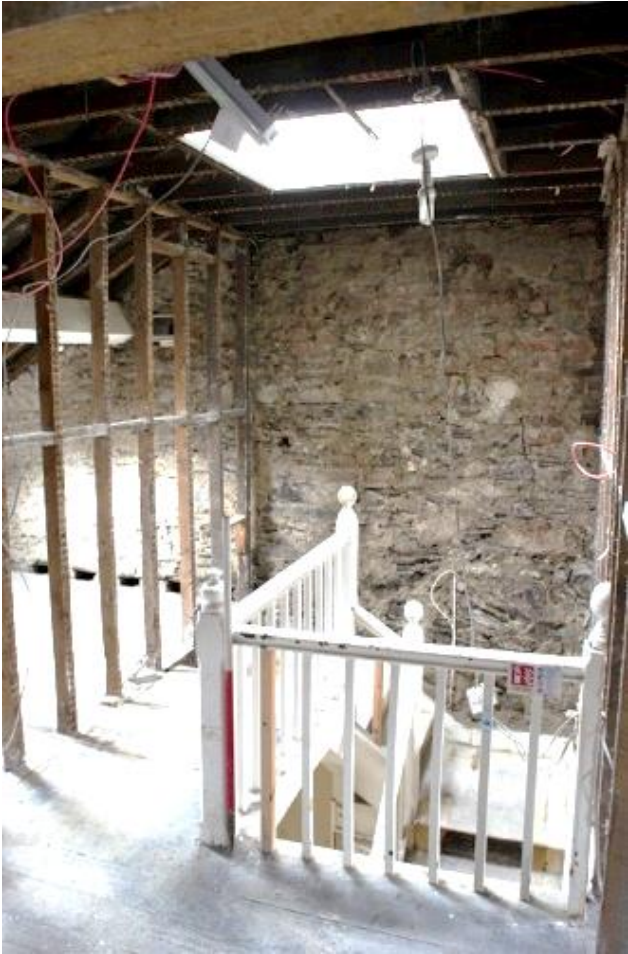
Location	Room SF1	Photo ID No:	G2714_039
Description	Room SF1: Second Floor; view from the east-southeast		
Image

A photograph showing the interior of Room SF1 on the second floor. The room is under construction or renovation. The ceiling is exposed, showing wooden joists and a large, bright light fixture. The walls are made of rough, textured concrete or masonry. In the foreground, there is a white wooden railing with a red vertical post. The floor is made of concrete. The view is from the east-southeast.

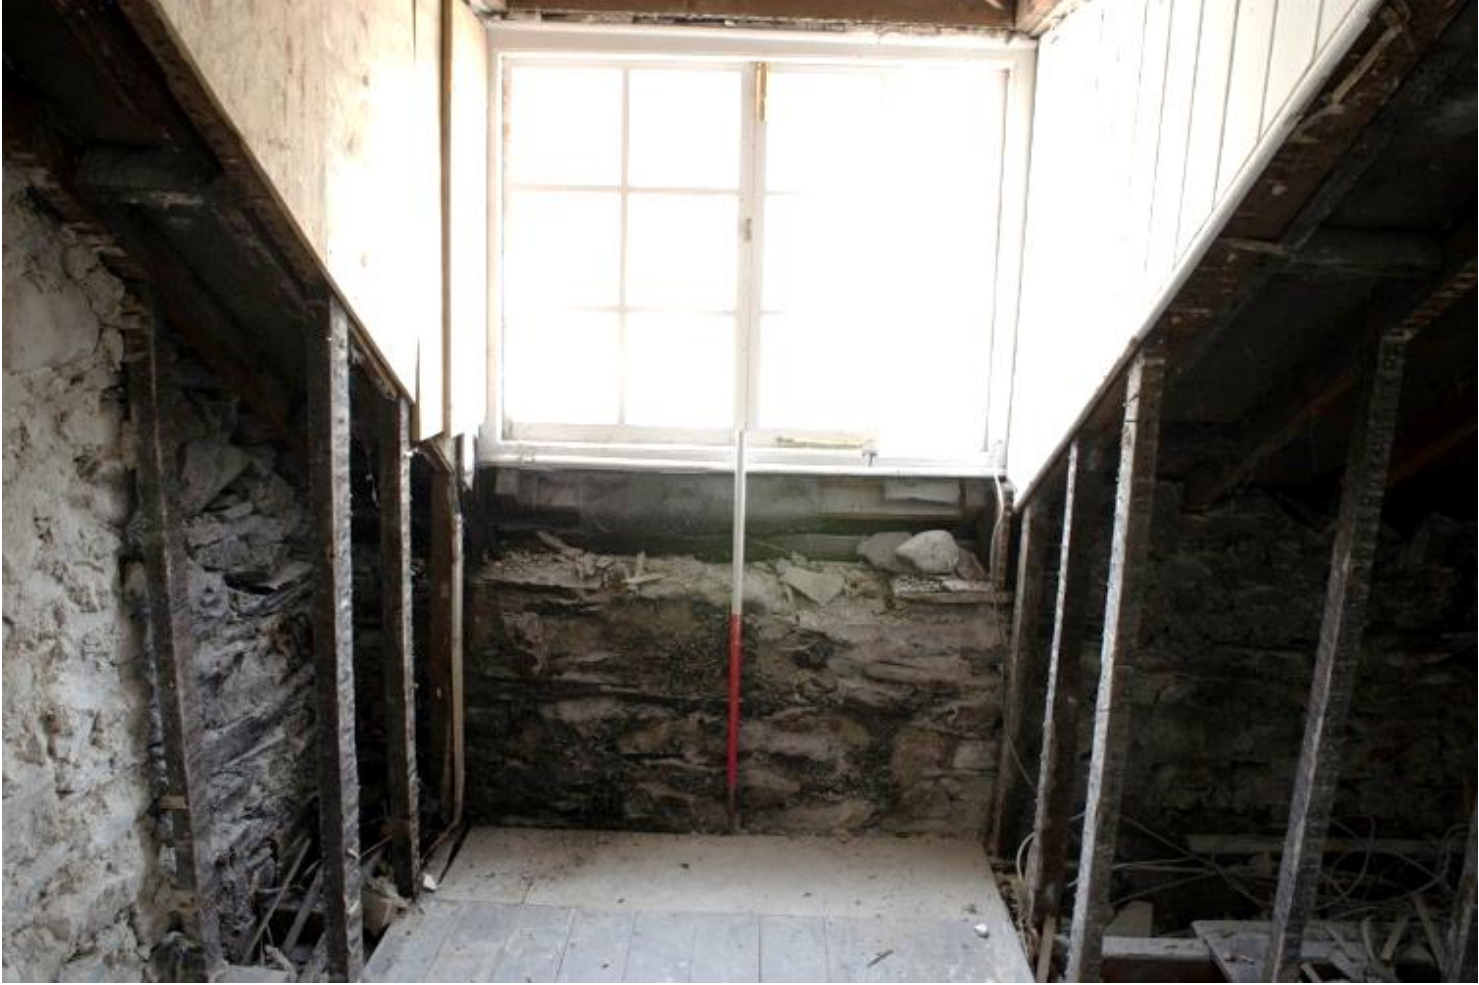
Location	Room SF2	Photo ID No:	G2714_040
Description	Room SF2: Second Floor; view from the west-southwest		
Image

A photograph showing the interior of a room, likely a second-floor storage area. The room is narrow and features a large window at the far end. The walls are made of brick and appear to be in poor condition, with some areas showing peeling plaster or missing material. The floor is made of wooden planks. A red vertical pole or marker is visible in the center of the room, extending from the floor to the window sill. The lighting is bright, coming from the window, which is partially covered by a white frame or blind.

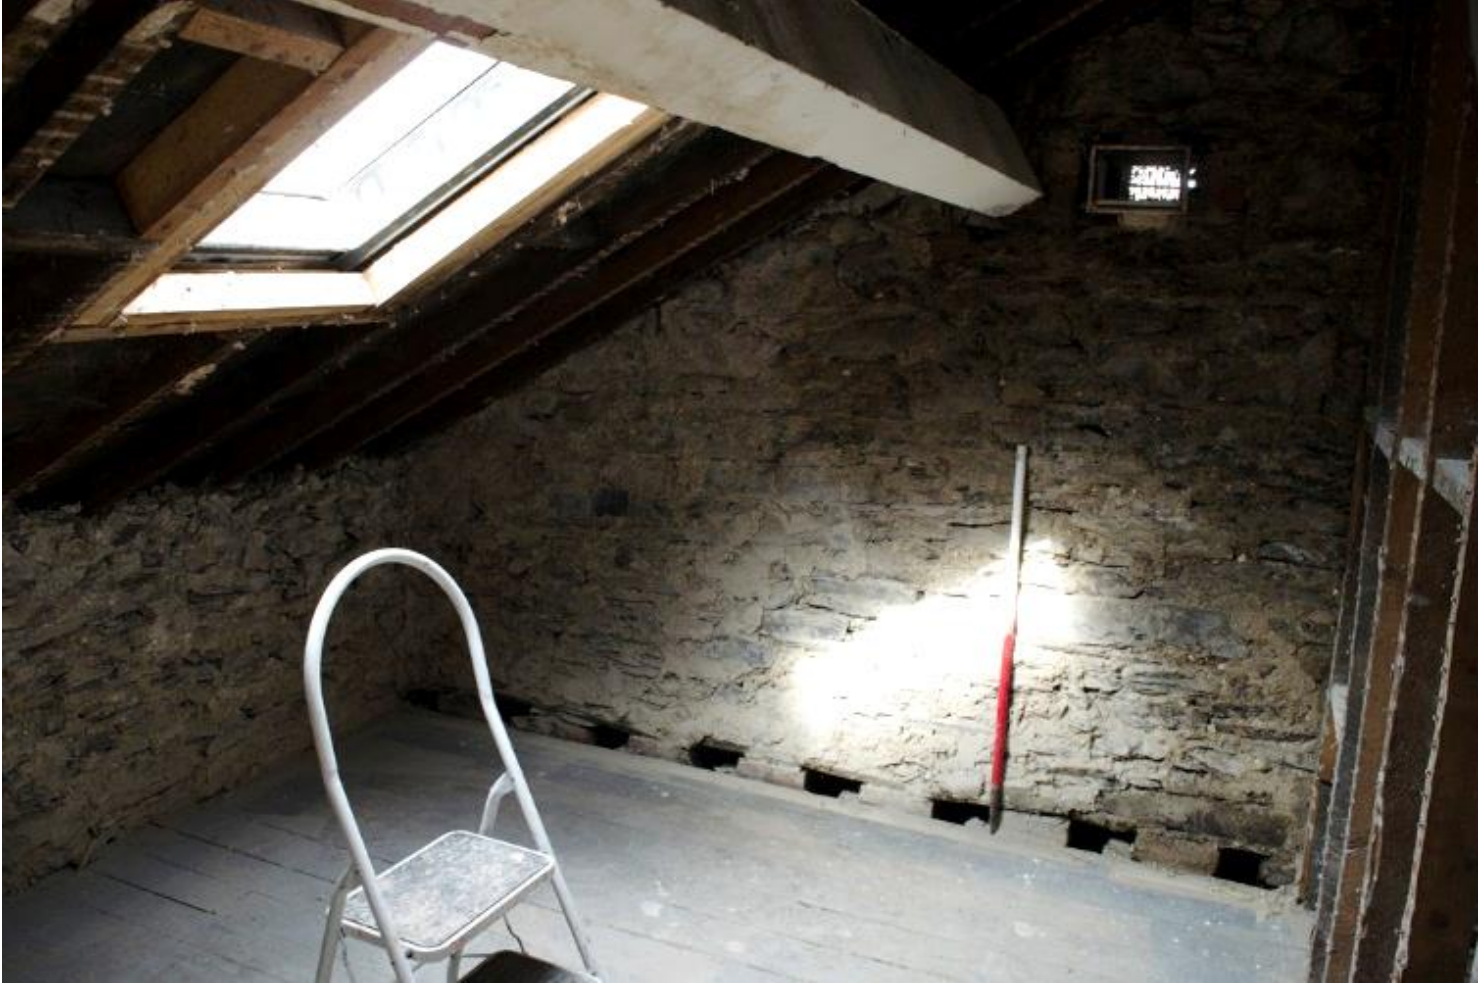
Location	Room SF5	Photo ID No:	G2714_045
Description	Room SF5: Second Floor; view from the east-northeast		
Image

A photograph of the interior of Room SF5. The room features a vaulted ceiling with exposed wooden rafters and a skylight. The walls are constructed of rough-hewn stone. A white metal chair is positioned in the foreground. A red and white measuring tool is leaning against the stone wall. A small, illuminated sign is visible on the wall above the chair. The floor is made of wooden planks.

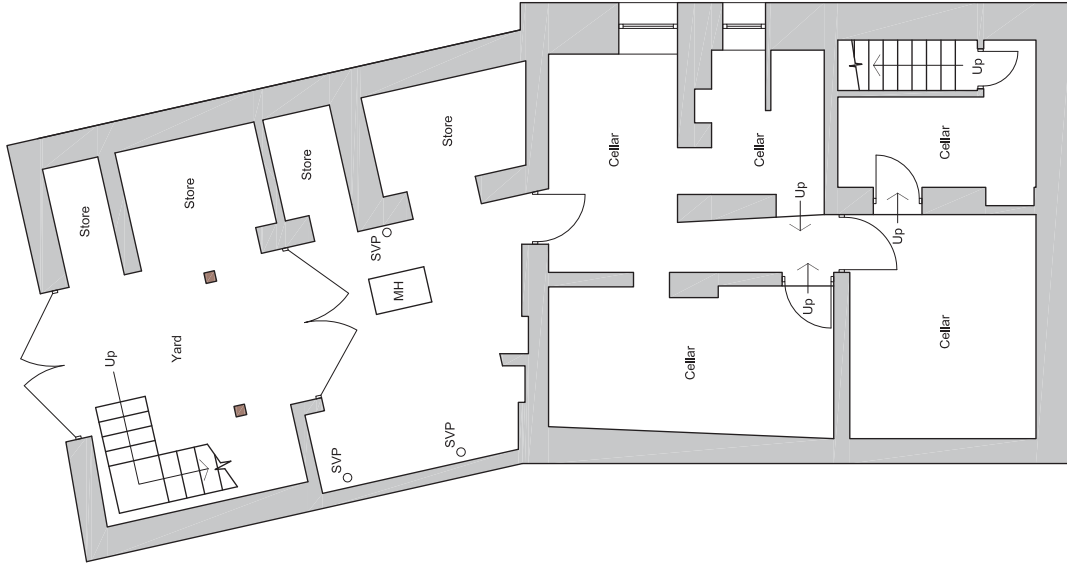
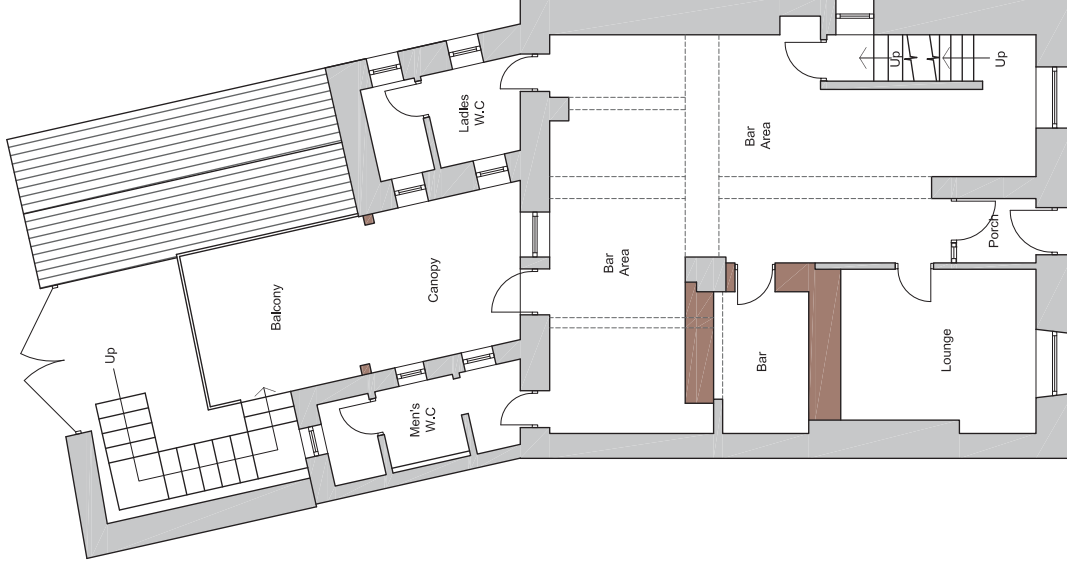
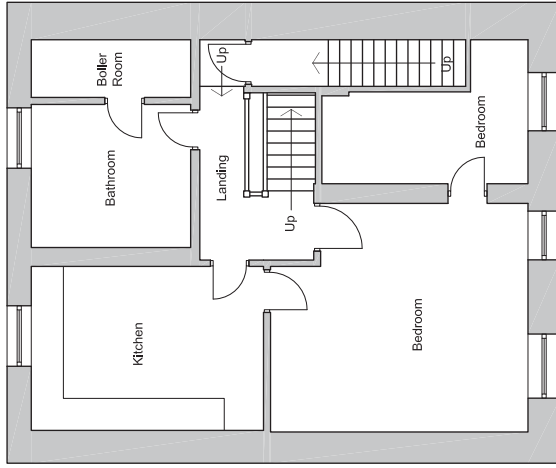
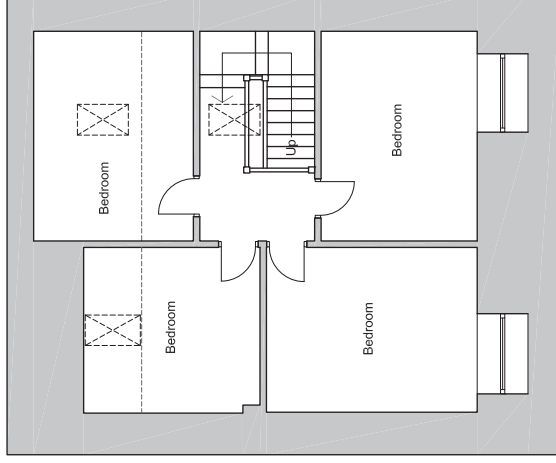
Reproduction of Ty Architecture Drawing Nos. Ty/1021/SL/01 to Ty/1021/SL/04. Scale: As Shown

Existing Lower Ground Floor Plan

Existing Ground Floor Plan

Existing First Floor Plan

Existing Second Floor Plan
