CPAT Report No. 1727

# Glan-y-Gors, Moelfre, Powys

Historic Building Recording

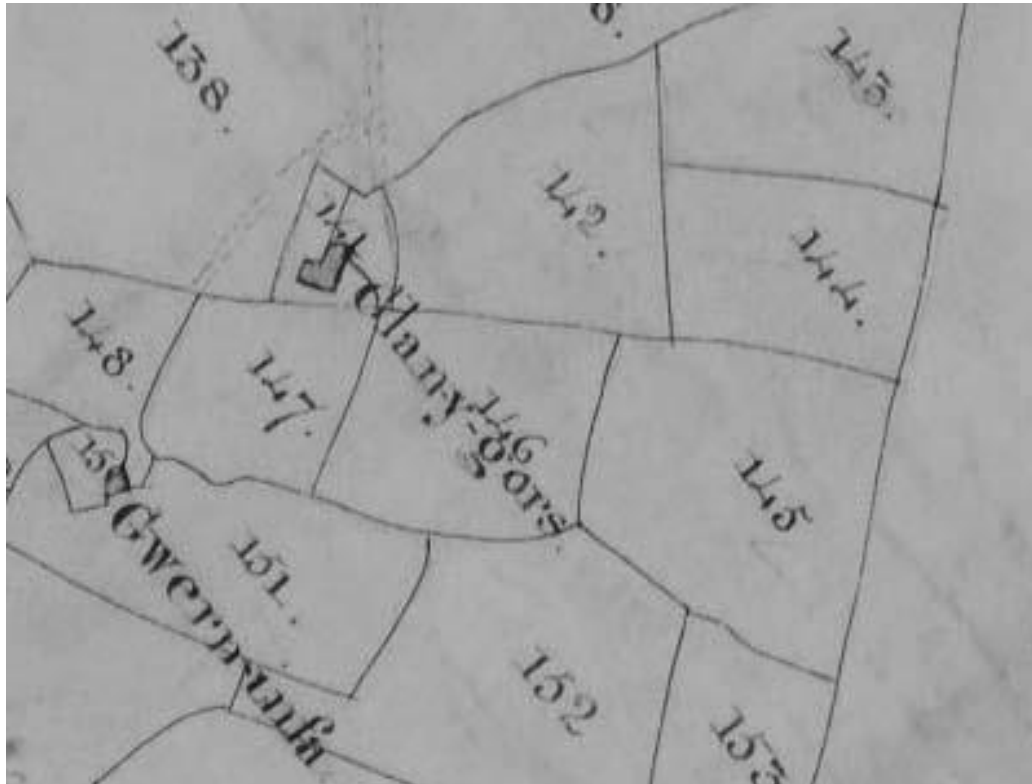
- 2.1. Glan-y-Gors is first named on the 1843 tithe map for the Llansilin Parish (Fig. 2). The building is shown as L-shaped in plan and was recorded at that time as having been owned by Sir Watkin Williams-Wynn, 6<sup>th</sup> Baronet, the conservative MP for Denbighshire between 1841 and 1885. The holding comprised the house, yard and gardens as well as a number of small, irregular arable and pasture fields to the east.

*Fig 2. Extract from the 1843 Tithe Map for Llansilin Parish.*

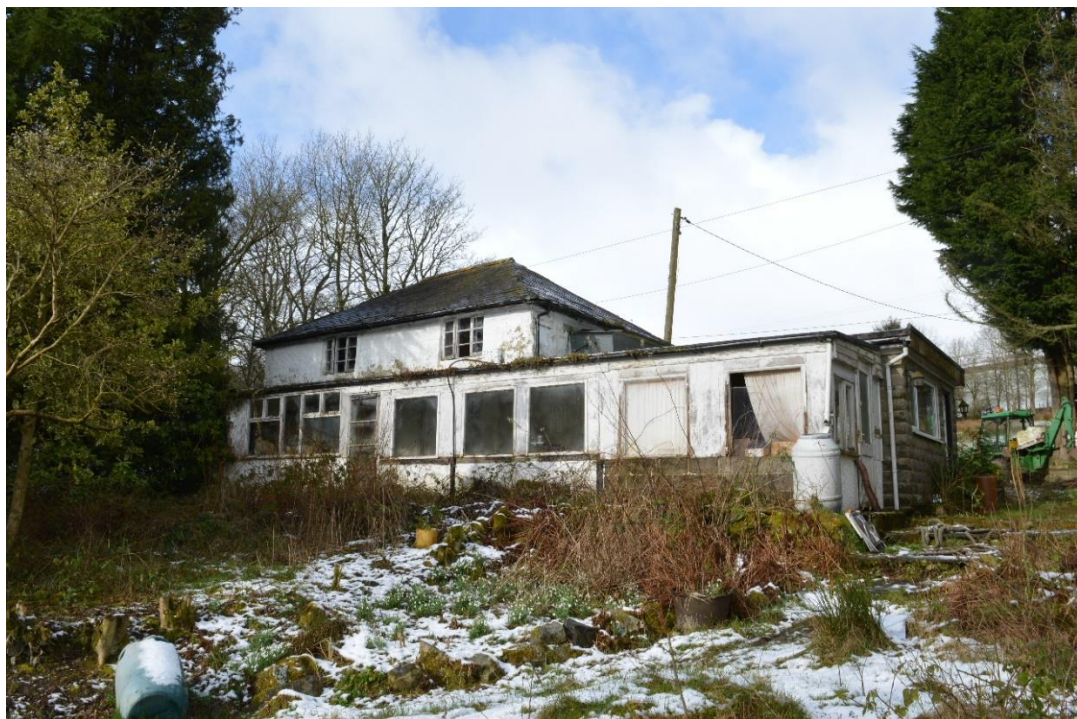
*Fig 4. View of Glan-y-Gors from the south-east. Photo CPAT 4740-0020*

- 3.5. The stone cottage is white-painted, with four wooden-framed casement windows to the façade, two to each floor, with a central doorway at ground floor level which is currently obscured externally by the single-storey lean-to (Fig. 4). The windows are of 9 panes with decorative iron handles (Fig. 8).

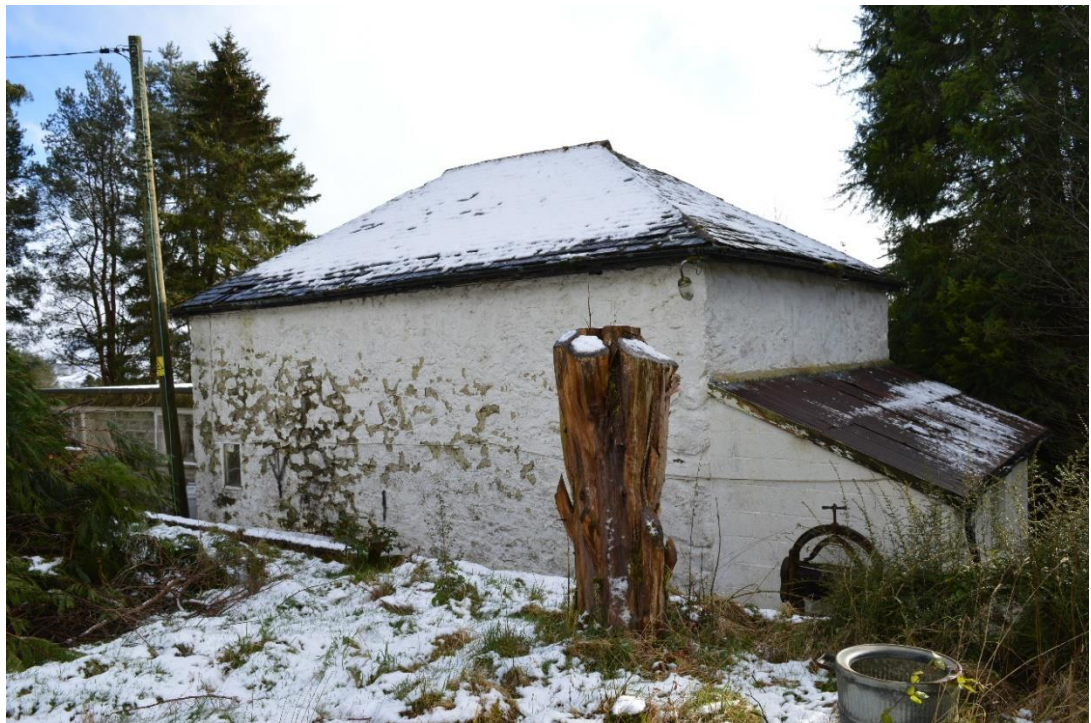
- 3.6. There is a single small, wooden-framed window to the north-western elevation at ground floor level, providing light to the kitchen (Fig. 5).

Fig 5. View of Glan-y-Gors from the north-west. Photo CPAT 4740-0024

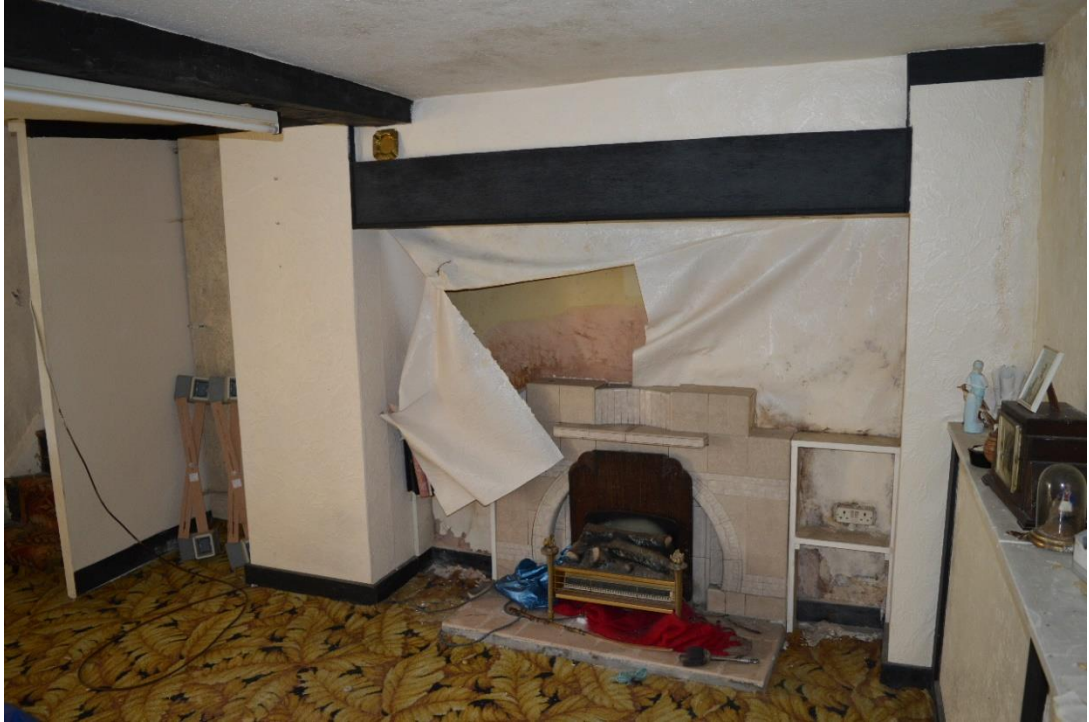
- 3.7. None of the original chimneys are surviving externally, having been removed by the former occupants according to the present owner. The building has also been re-roofed.
- 3.8. Internally, the stone cottage is divided on the ground floor into two rooms, with a small living room to the south-west and a kitchen to the north-east. To the living room there is faux timber planking to the dividing wall and a 1940s tiled fireplace opposite. A red quarry tiled floor survives beneath the carpet and a wooden staircase leads up to the first floor from the south-eastern corner with a small cupboard alongside the wide chimney breast.

*Fig 6. View into living room. Photo CPAT 4740-0010*

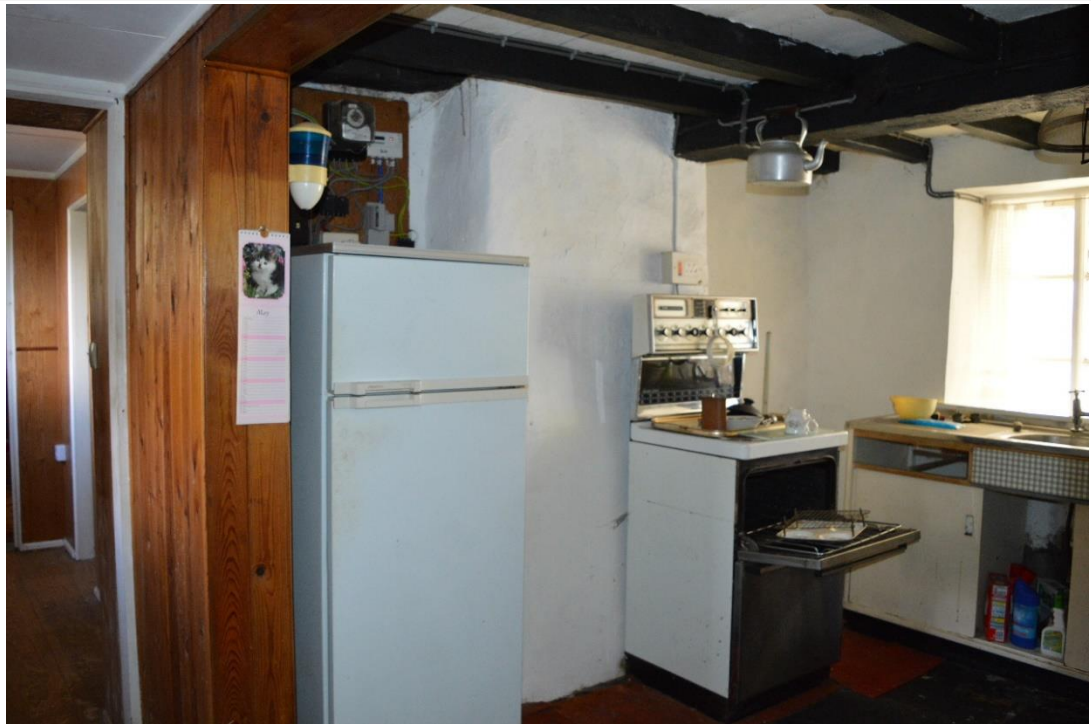
- 3.9. A single wooden beam extends across the ceiling to support the floor above and a narrow doorway through the partition wall provides access into the kitchen, which appears to have a stone floor beneath the later floor coverings. The kitchen walls are partially covered with tongue and groove cladding and a chimney breast is visible against the north-eastern wall. The joists supporting the first floor are exposed (Fig. 7).

- 3.10. An additional narrow doorway to the side of the kitchen chimney breast provides access into the modern single storey extension accommodating a bathroom and further bedroom to the north-east (Fig. 7).

*Fig 7. View into kitchen. Photo CPAT 4740-0034*

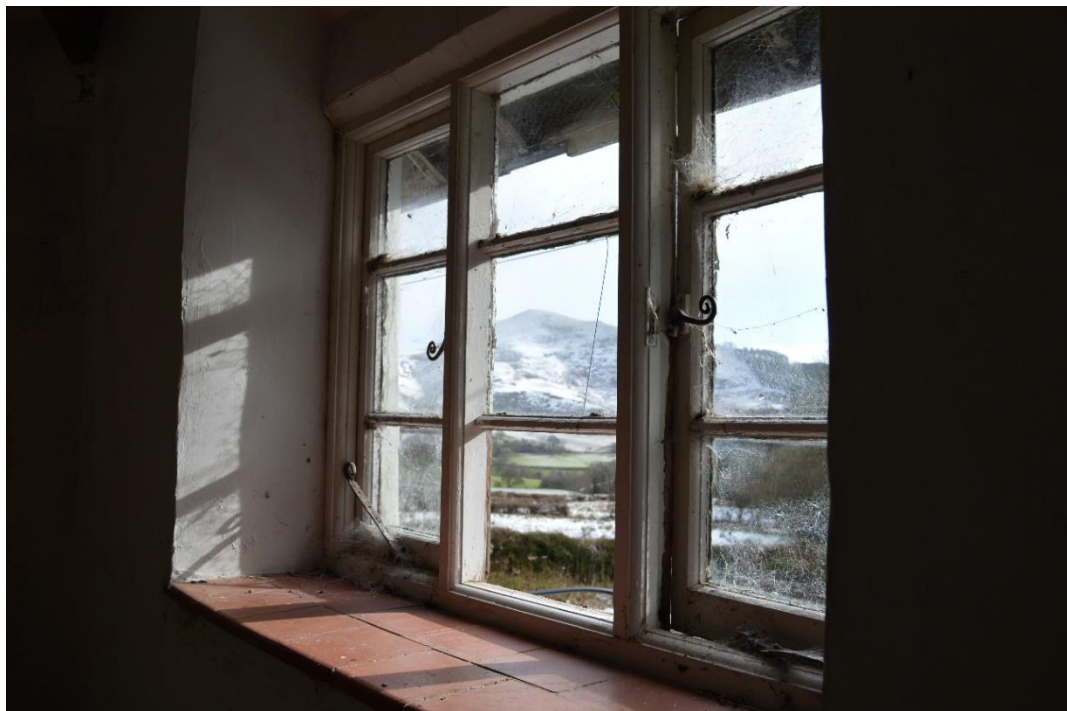
- 3.12. Like the ground floor, the first floor is partitioned into two rooms of similar proportions. The walls are painted in white and the floors are wooden. Each room contains a window with quarry tiled sills in the south-eastern elevation providing views across to Gyrn Moelfre (Fig. 8).

*Fig 8. View from first floor towards Gyrn Moelfre showing window details. Photo CPAT 4740-0032*

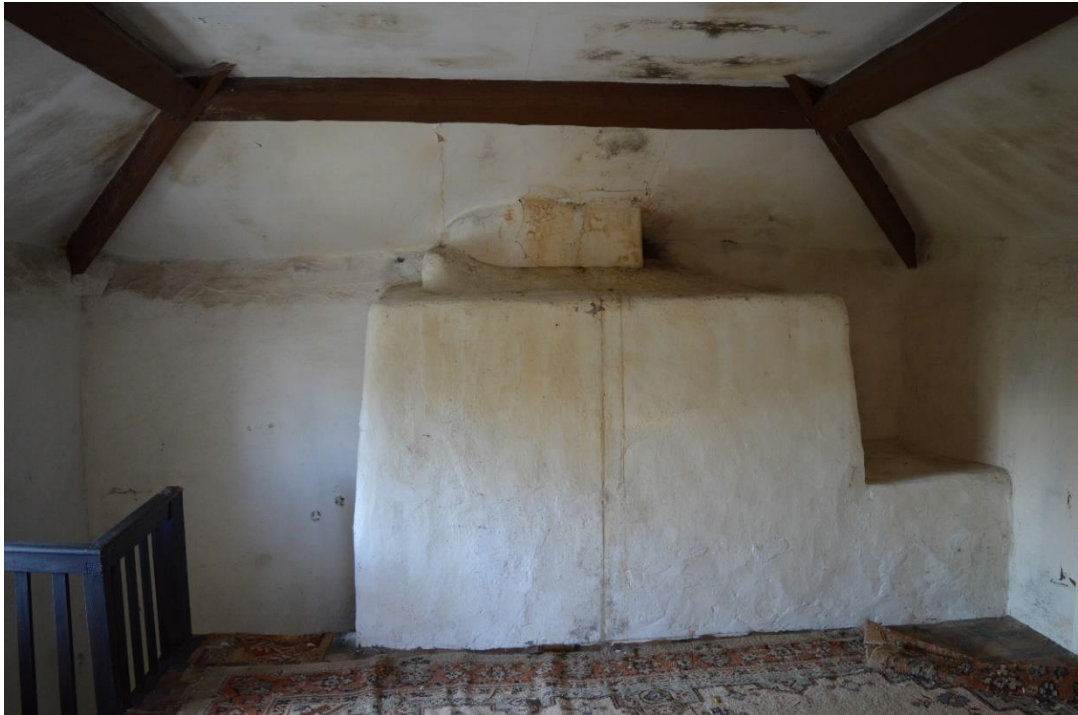
- 3.13. To the south-western room, a large chimney breast is visible against the south-western elevation (Fig. 9) and to the north-eastern room a smaller chimney breast is visible against the north-eastern wall (Fig. 10).

*Fig 9. View of large chimney breast to first floor (south-western room). Photo CPAT 4740-0014*

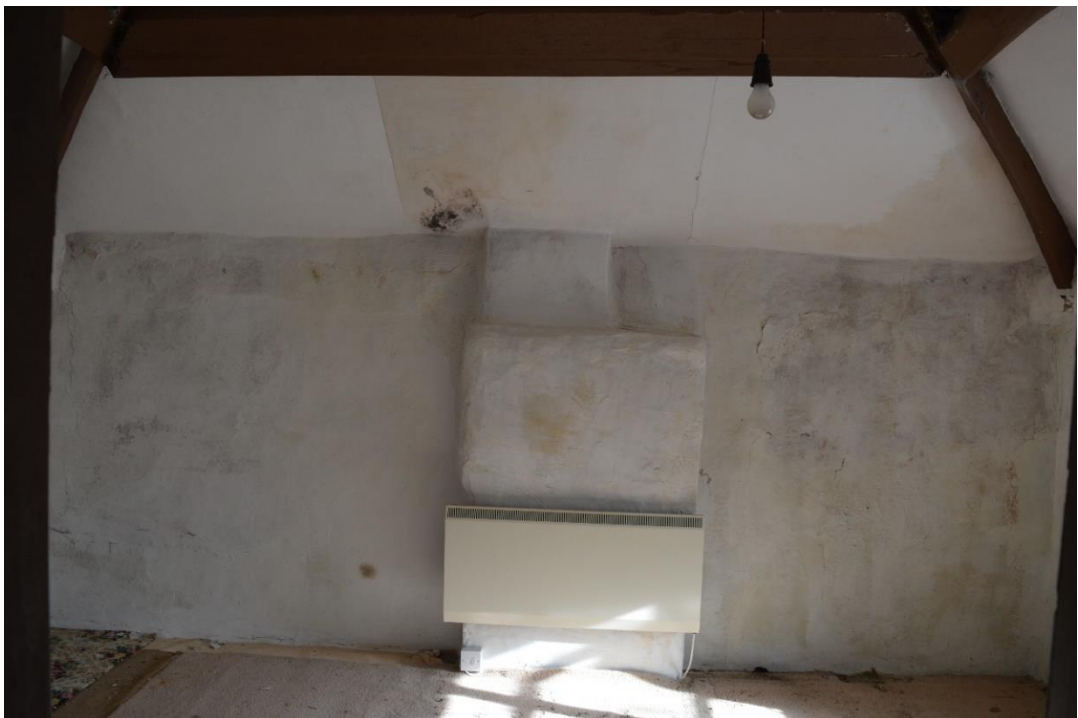
*Fig 10. View of chimney breast to first floor (north-eastern room). Photo CPAT 4740-0015*

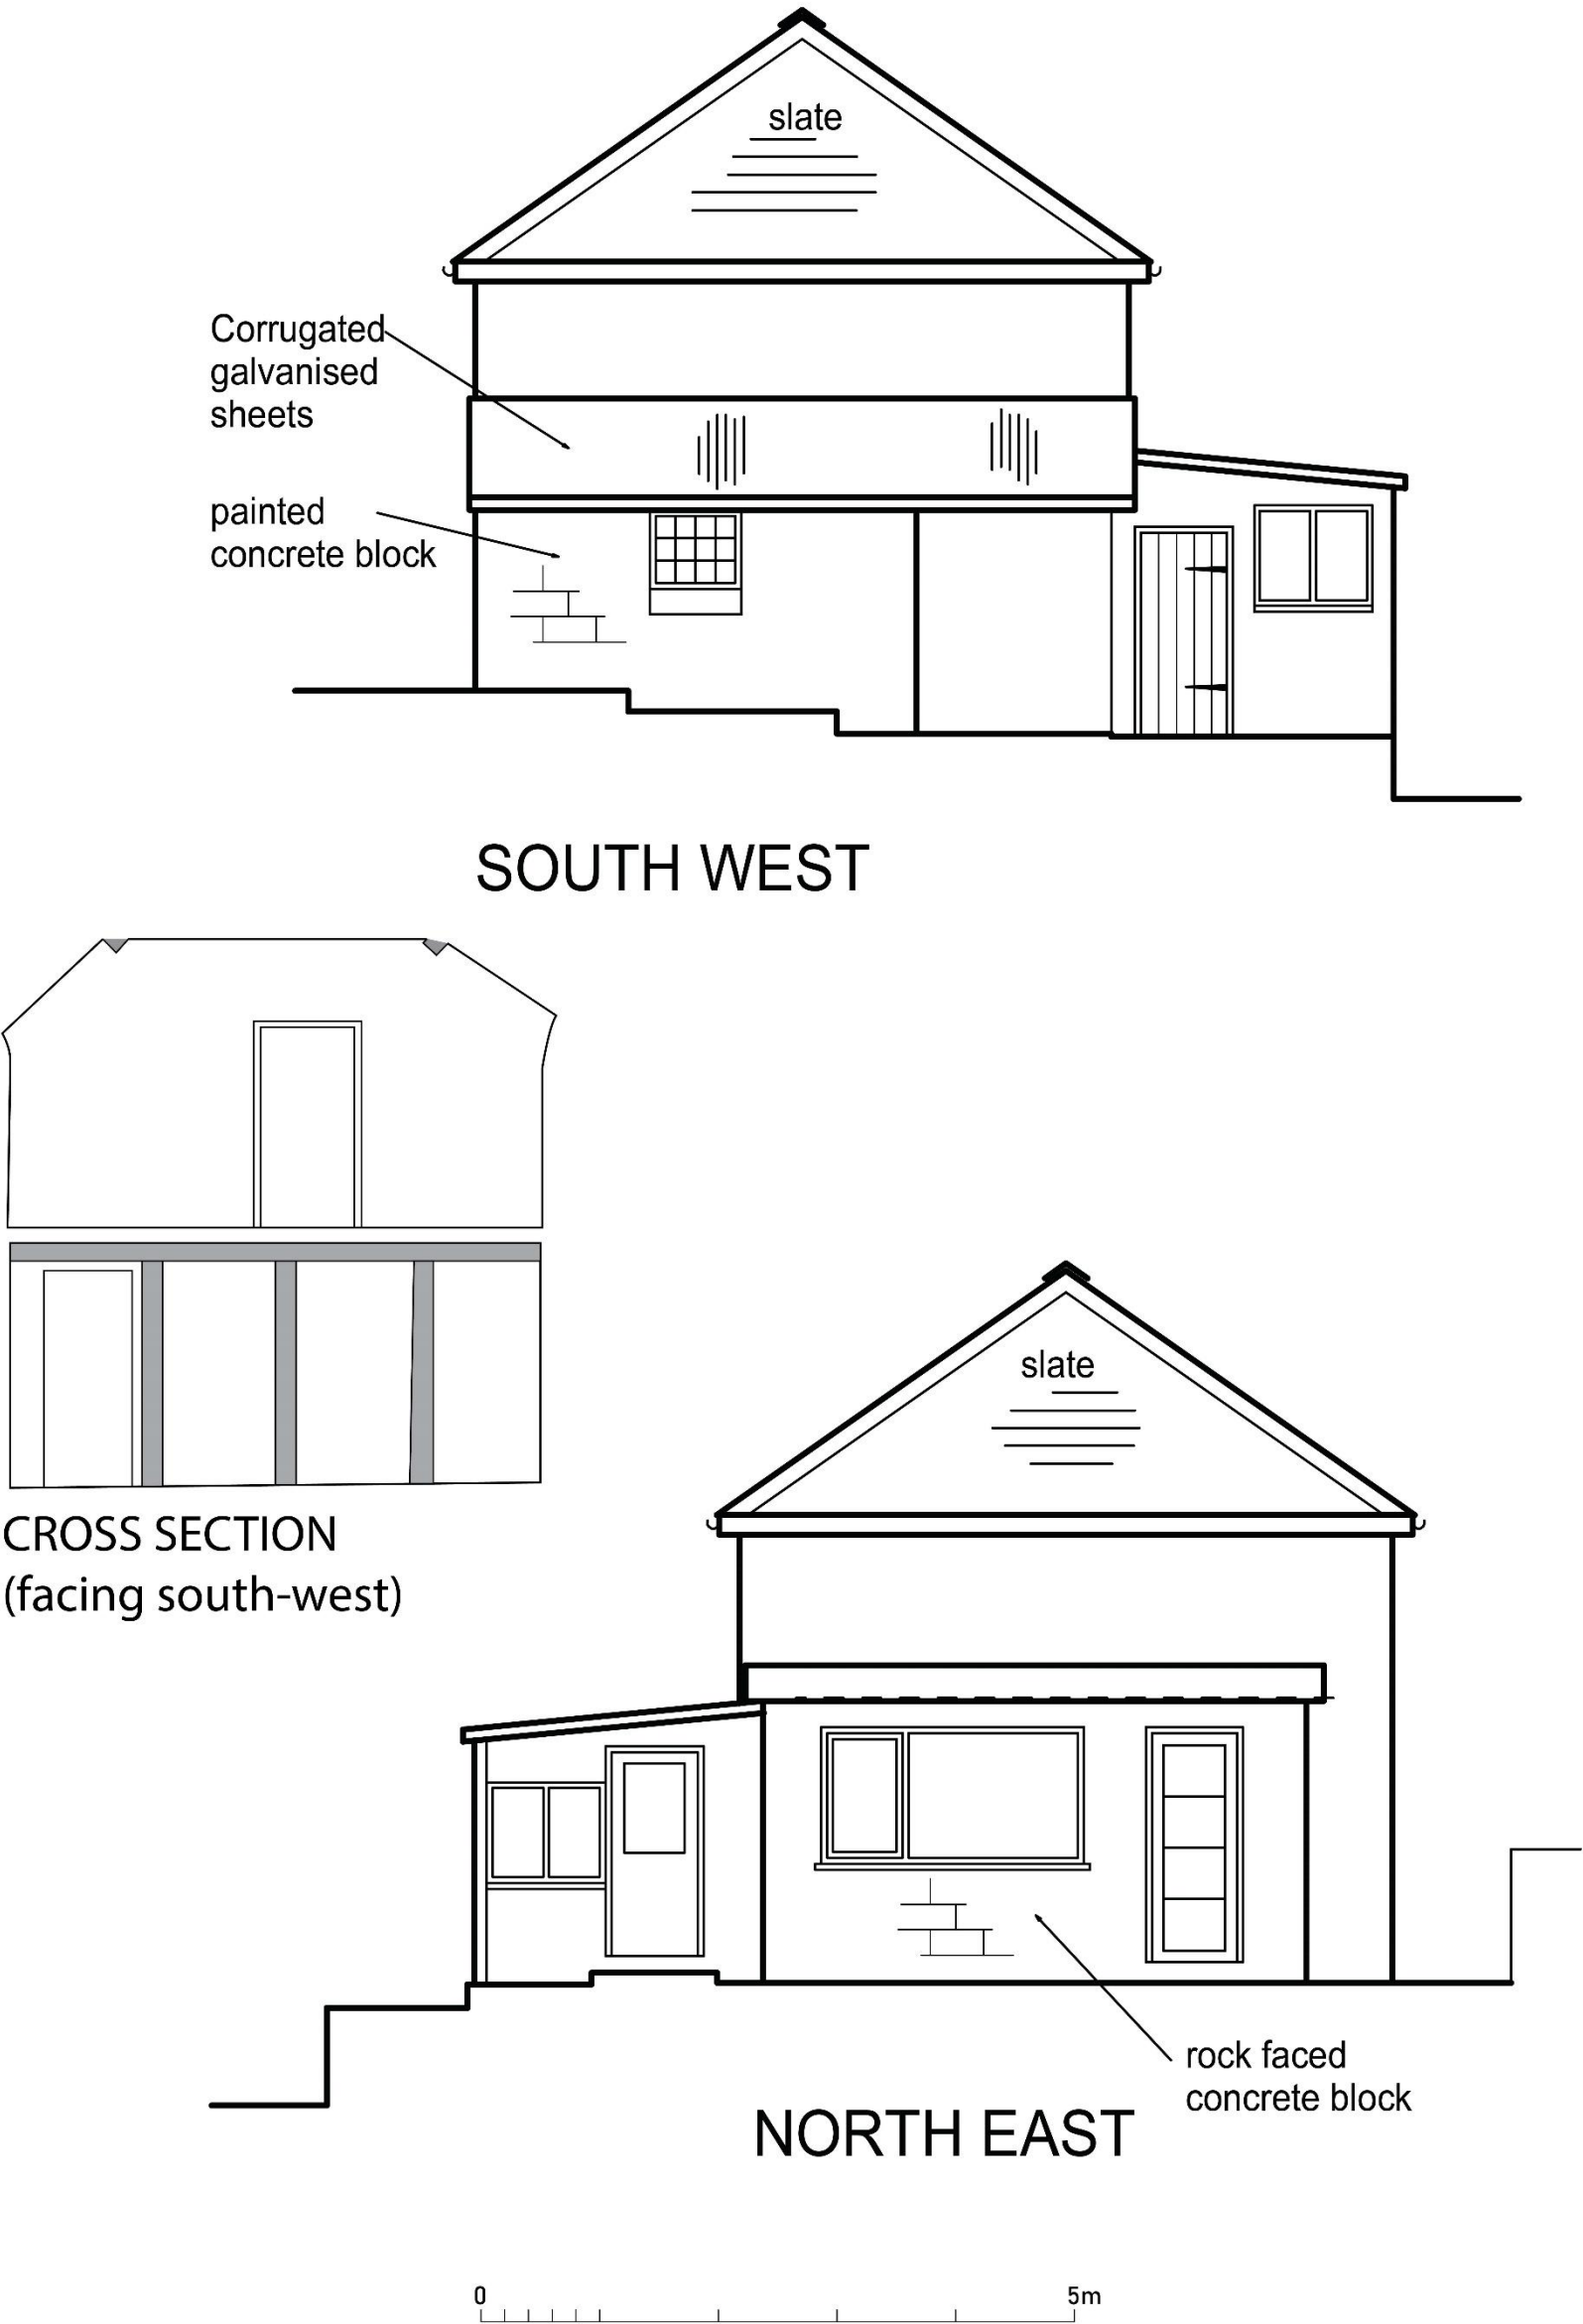
Fig 14. South-west and north-east facing elevations with cross-section as marked in Fig.10 (plans supplied by Roger Davies Ltd, Llanfyllin)
